**KINGSTON ASH RECOVERY PROJECT  
FIELD CHANGE NOTICE (FCN)**

FCN Number:	FCN-034	FCN Title:	Cold Joints	
Project Name:	Perimeter Wall Stabilization Segment 1 Sta. A161+50 to Sta. 179+50			
<b>DOCUMENT(S) AFFECTED BY THIS FIELD CHANGE NOTICE</b>				
Document Number	Revision	Document Title		
RDP-0113-E	R0 8/1/11	Technical Specification North Dredge Cell Segment 1 Section 02650		
References/Work Package (if applicable):				
Technical Specification Section 02650 -paragraph 4.3.8 "Cold Joints"				
Reason for Change/Information Requested:				
The current definition of 7 days does not allow enough physical separation of 1250 excavators during slurry wall construction which causes excessive pumping of water up from the local water table which contributes to instability of the working platform and potential safety problems for work in close proximity. Having a 14 or 21 day time would provide flexibility in spacing the work out to avoid local spots that are saturated from pumping of water to the surface, keep more reasonable physical separation of the excavators.

**Cold Joint Criteria  
Supporting Documentation for  
Field Change Notice No. 034**

**Kingston Recovery Project  
Perimeter W

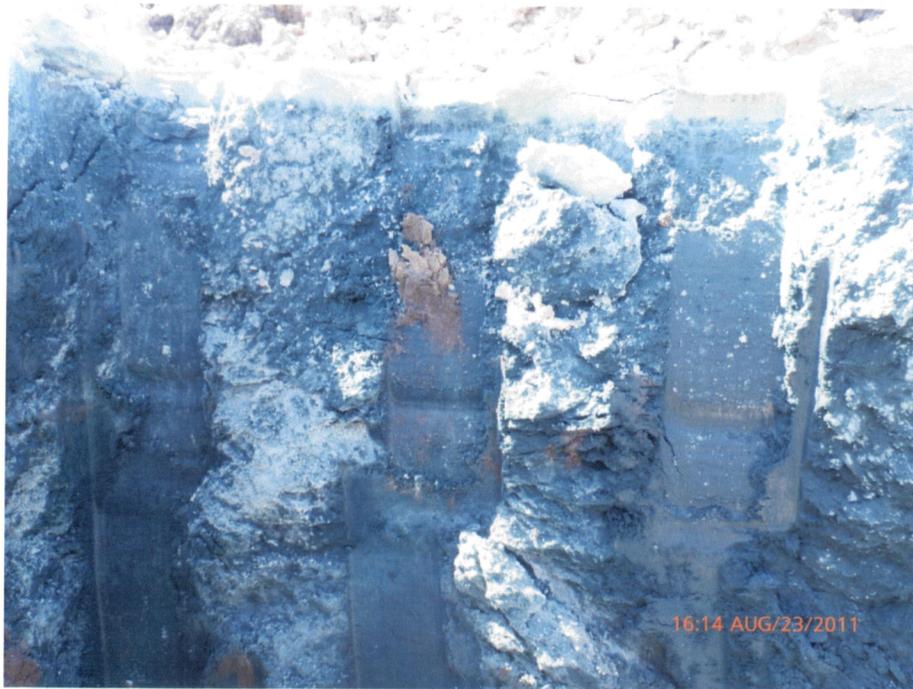
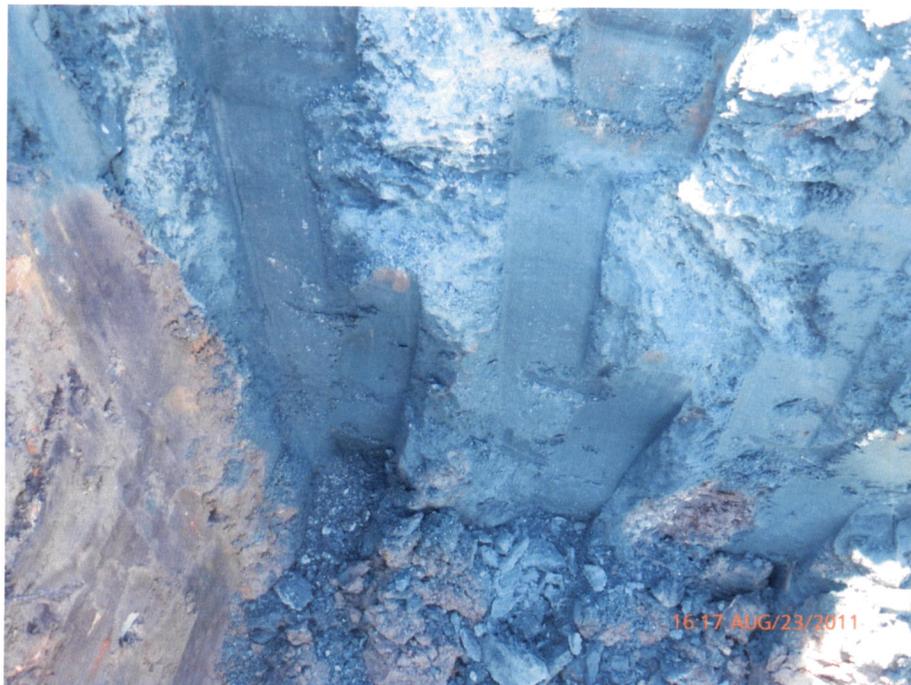
On August 23, 2011, a Kobelco PC250LC excavator was utilized to excavate into the cold joint test panel. The test trench was excavated from both the end of the trench (simulating a butt joint), and from the side of the trench (simulating a t-joint). The in-place material in the trench following excavation exhibited a bluish-green color, visually similar as that observed in the demonstration walls and production walls. The material was observed to be stiff with low to moderate plasticity, based on the penetration of a stiff heavy-duty 1-¼" wide paint scraper and lack of cracking around the insertion of the stiff blade. The paint scraper was inserted into the in-place material to a depth of ¼" to ½". The surface of the material was visually observed to be free of visible cracks or signs of promulgating fractures into the panel. Photographs were taken to document the surface; two representative images are provided below.

**Excavation at 4 days (P100468.jpg)**

**Excavation at 4 days (P100471.jpg)**

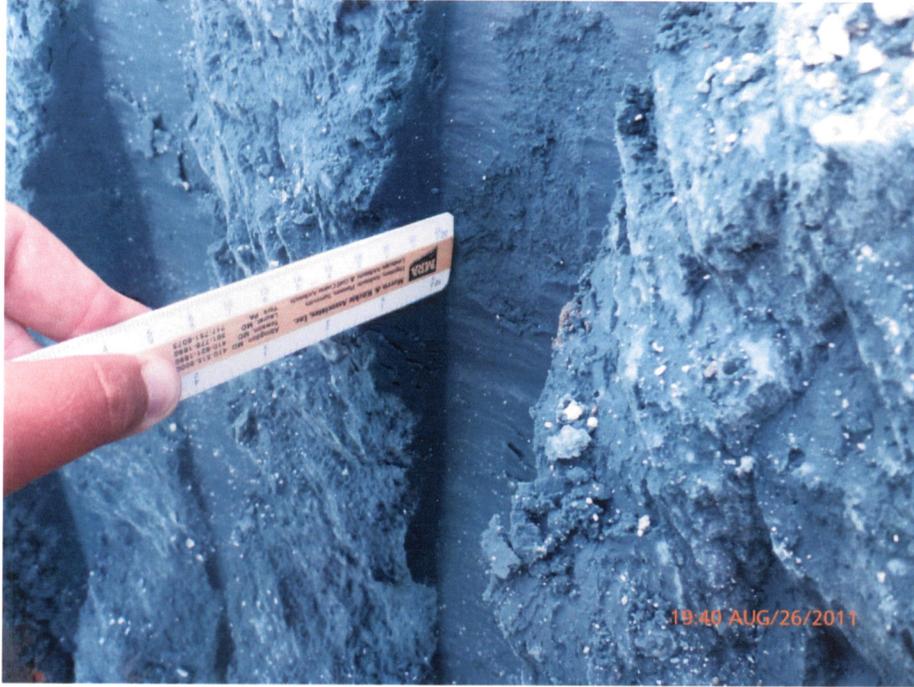
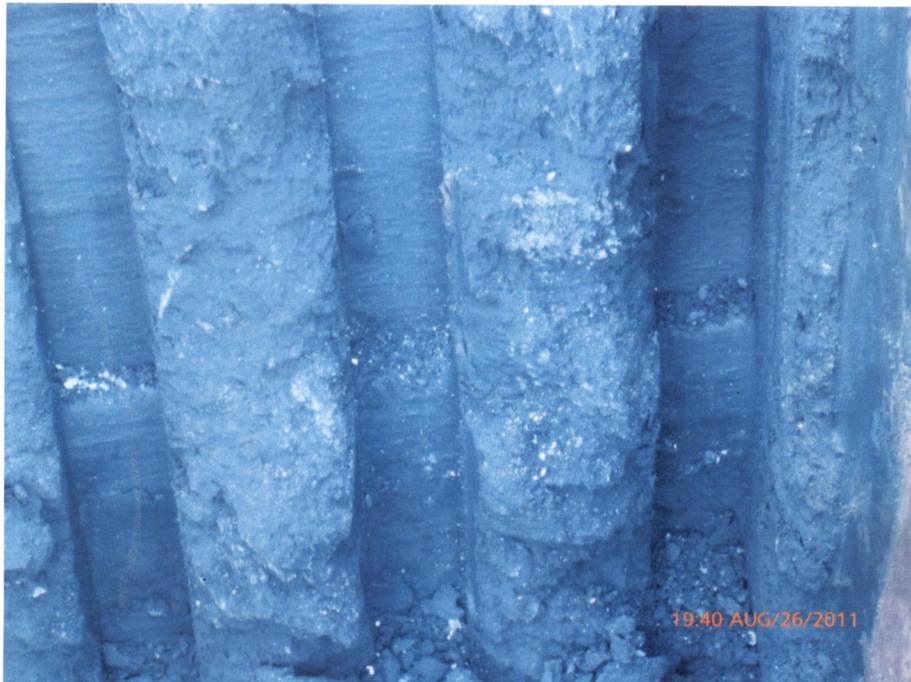
On August 26, 2011, a Kobelco PC250LC excavator was utilized to excavate into the cold joint test panel. The test trench was excavated from both the end of the trench to simulate a butt joint (through the portion previously exposed for the 4-day observation), and from the side of the trench to simulate a t-joint (12" to 18" into the side of the panel). The teeth on the bucket of the Kobelco excavator were utilized to excavate into the material, essentially "teething" the material by creating teeth marks of various depths. Teeth marks ranged from approximate 1" to 4" in depth into the material. Sporadic loose material was observed between the teeth marks and was easily removed by hand, but did not visually exhibit additional fracturing. The in-place material in the trench following the excavation exhibited a bluish-green color, visually similar as that observed in the demonstration and production walls. The material was observed to be stiff with low to moderate plasticity, based on the penetration of a stiff heavy-duty 1-1/4" wide paint scraper and lack of cracking around the insertion of the stiff blade. The paint scraper was inserted into the in-place material to a depth of 1/4" to 3/8". The surface of the material was visually observed to be free of visible cracks or signs of promulgating fractures into the panel. Photographs were taken to document the surface; two representative images are provided below.

**Excavation at 7 days (P100522.jpg)**

**Excavation at 7 days (P100527.jpg)**

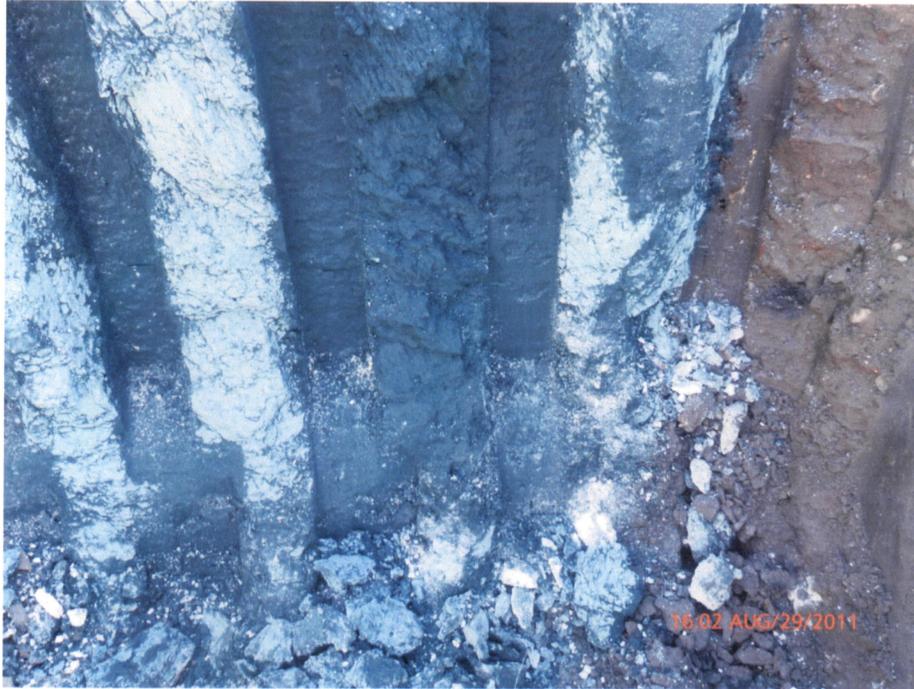
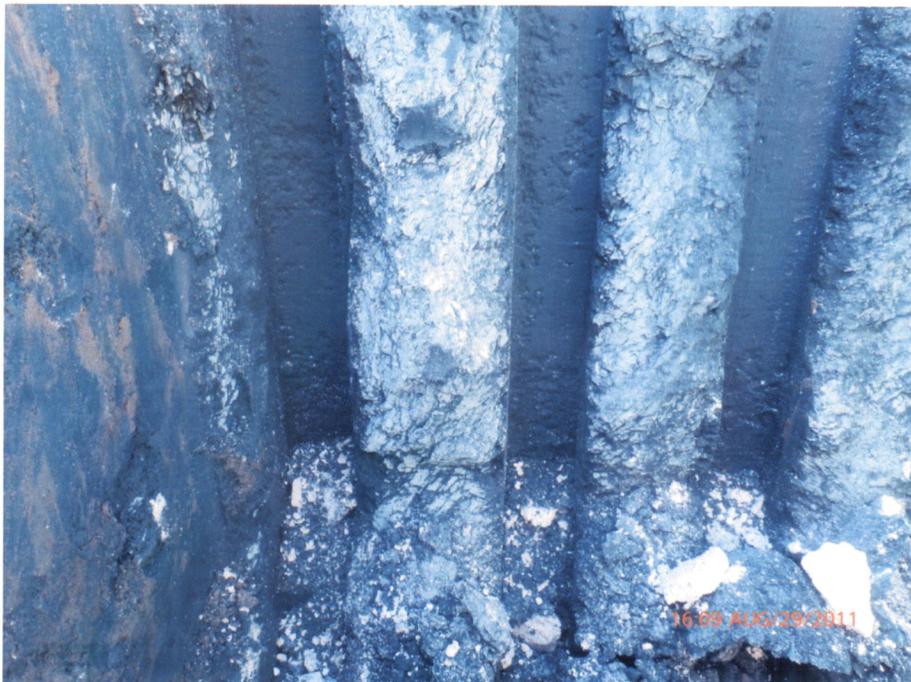
On August 29, 2011, a Kobelco PC250LC excavator was utilized to excavate into the cold joint test panel. The test trench was excavated from both the end of the trench to simulate a butt joint (through the portion previously exposed for the 7-day observation), and from the side of the trench to simulate a t-joint (12" to 18" into the side of the panel). The teeth on the bucket of the Kobelco excavator were utilized to excavate into the material, essentially "teething" the material by creating teeth marks of various depths. Teeth marks ranged from approximate 1" to 4" in depth into the material. Sporadic loose material was observed between the teeth marks and was easily removed by hand or by prying with the 1-1/4" scraper, but did not visually exhibit additional fracturing. The in-place material in the trench following the excavation exhibited a bluish-green color, visually similar as that observed in the demonstration and production walls. The material was observed to be stiff with relatively low plasticity, based on the penetration of a stiff heavy-duty 1-1/4" wide paint scraper and visual observation of the material where the teeth of the excavator bucket pressed against the in-place material. Areas where the teeth of the bucket pressed into the material during the downward stroke of the excavator was observed to be smooth with a consistent surface, without indication of cracking or brittleness. The paint scraper was inserted into the in-place material to a depth of approximately 1/8", without visual indication of cracking around the penetration though a small amount of material did fall off with the removal of the scraper. The surface of the material was visually observed to be free of visible cracks or signs of promulgating fractures into the panel. The surface was also observed to be slightly moist to the touch, but without free moisture that would transfer to cloth (that could be detected by the unaided human eye or sense of touch). A water bottle was utilized to mist portions of the exposed surface in an effort to expose small cracks with no visual indication of small cracks in the surface material. A pocket penetrometer borrowed from Geo-Con, Inc. and operated by their representative, Mrs. Amy Robinson Grass, was observed to max out on the material. A large area of loose material measuring approximately 6" wide by 18" long was observed between the teeth marks on the t-joint simulated excavation towards the bottom of the excavation. This area may have been impacted by the bucket during the removal of material. There was no further indication of cracking or damage to the in-place material after this area was removed by hand and cleaned with a stiff whisk broom. Photographs were taken to document the surface; two representative images are provided below.

**Excavation at 10 days (P100544.jpg)**

**Excavation at 10 days (P100549.jpg)**

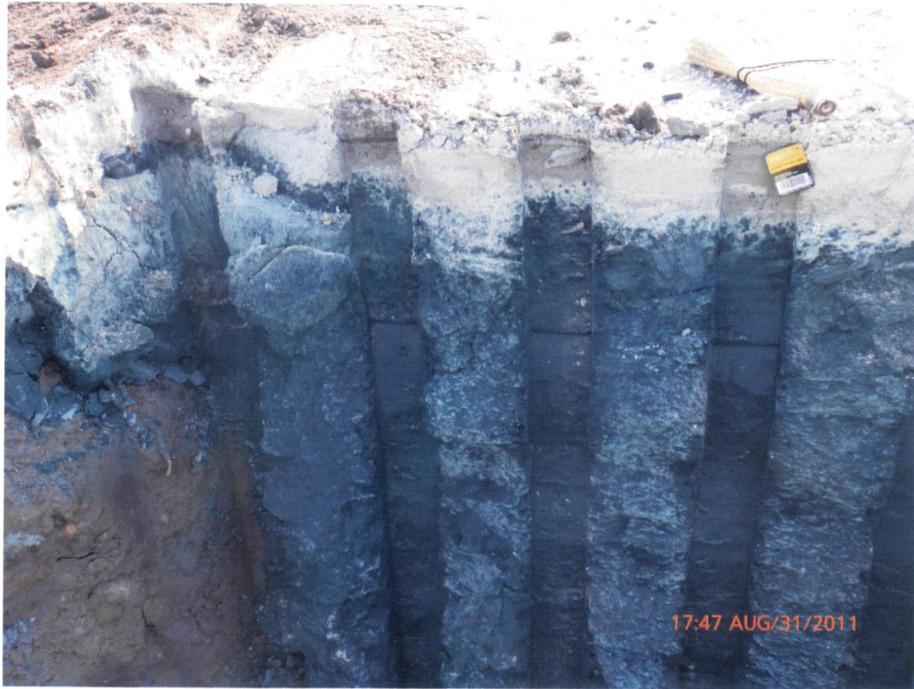
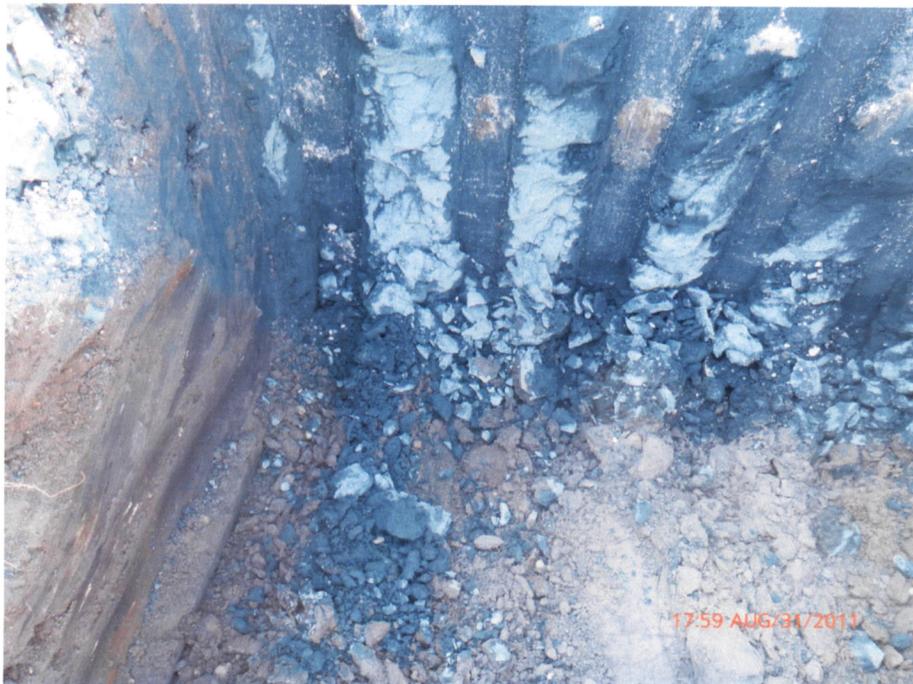
On August 31, 2011, a Kobelco PC250LC excavator was utilized to excavate into the cold joint test panel. The test trench was excavated from both the end of the trench to simulate a butt joint (through the portion previously exposed for the 10-day observation), and from the side of the trench to simulate a t-joint (12" to 18" into the side of the panel). The teeth on the bucket of the Kobelco excavator were utilized to excavate into the material, essentially "teething" the material by creating teeth marks of various depths. Teeth marks ranged from approximate 1" to 4" in depth into the material. Areas of small loose material were observed between the teeth marks and were easily removed by hand or by prying with the 1-¼" scraper, but did not visually exhibit additional fracturing promulgating into the wall. The in-place material in the trench following the excavation exhibited a bluish-green color, visually similar as that observed in the demonstration and production walls, but contained areas of a light grayish hue between the teeth marks. When pressed with a hard object, the light gray hue colored areas would turn light green, appearing as if the pressure of the object caused moisture to rise to the surface. The material was observed to be stiff with low plasticity, based on the penetration of a stiff heavy-duty 1-¼" wide paint scraper and visual observation of the material where the teeth of the excavator bucket pressed against the in-place material. Areas where the teeth of the bucket pressed into the material during the downward stroke of the excavator was observed to be relatively smooth, though less smooth than previous observations, and without indication of cracking or brittleness. The material contacted by the teeth exhibited slightly rough areas where material appeared to pull apart when the teeth raked across the surface. Some of these areas were scraped with the stiff paint scraper and material was easily removed in thin layers that remained mostly intact and not in chunks or irregular shaped pieces. The removed material was rolled between the observer's fingers and was slightly moist to the touch (without free moisture transfer to skin or cloth) and crumbled into small spherical pieces (1/16") after several passes. The paint scraper was inserted into the in-place material to a depth of approximately 1/8" without visual indication of cracking around the penetration, though a small amount of material did fall off with the removal of the scraper (the material was typically attached to the scraper surface and did not fall freely). The surface of the material was visually observed to be free of visible cracks or signs of promulgating fractures into the panel. The surface was also observed to be slightly moist to the touch, but without free moisture that would transfer to cloth (that could be detected by the unaided human eye or sense of touch). A water bottle was utilized to mist portions of the exposed surface in an effort to expose small cracks with no visual indication of small cracks in the surface material. Photographs were taken to document the surface; two representative images are provided below.

**Excavation at 12 days (P100554.jpg)**

**Excavation at 12 days (P100563.jpg)**

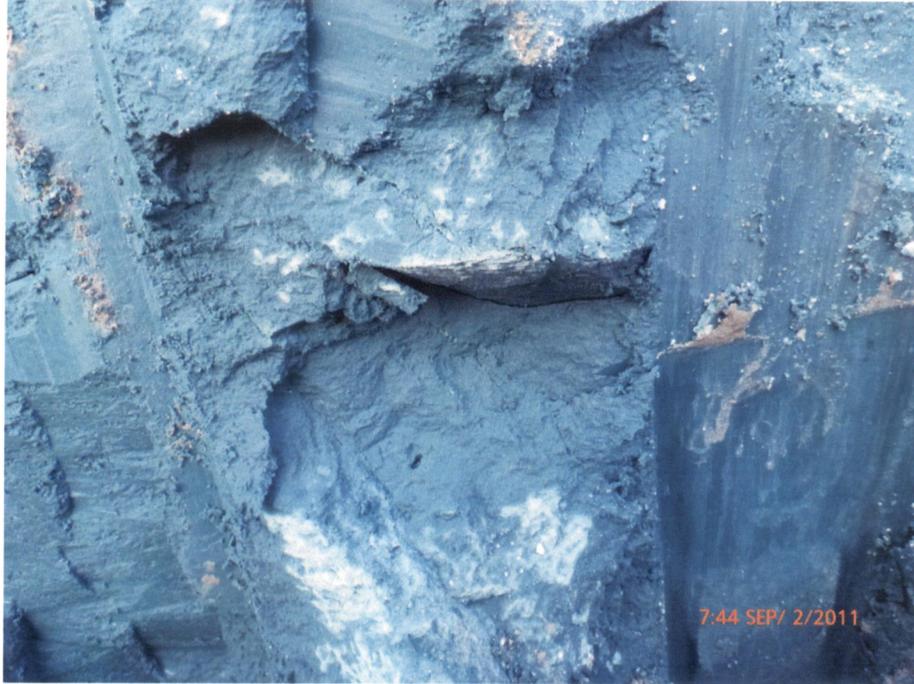
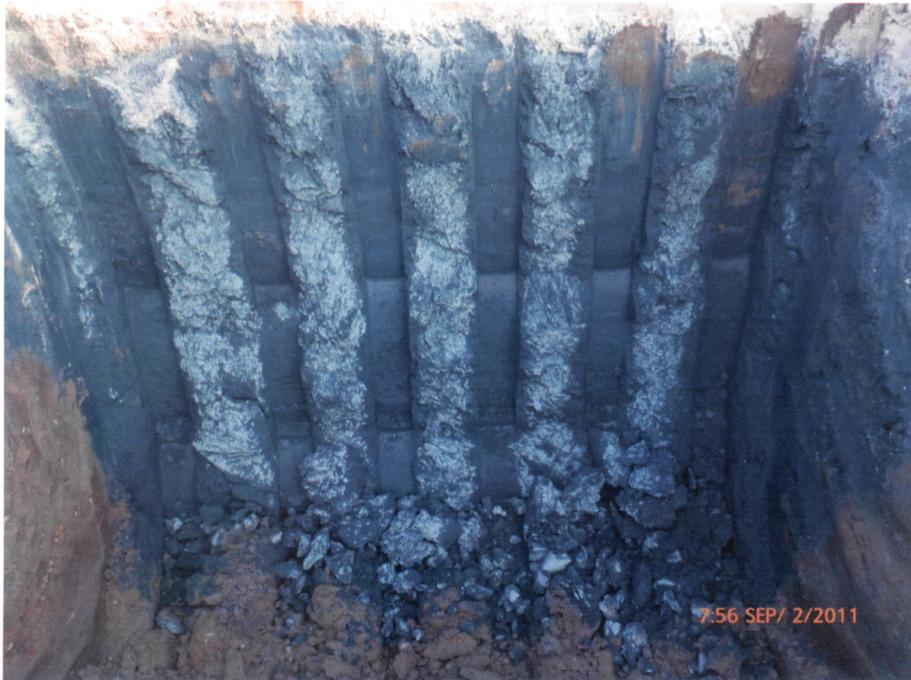
as only a few small cracks associated with small (<3") pieces of broken material along the surface. The simulated t-joint was excavated approximately 18" behind the simulated butt joint. The remaining area left in place between the two excavations, after the t-joint progressed into the wall, was observed to be intact without visual indication of cracking. Force was applied to this area by the observer's hands, attempting to push the remaining portion of wall, with no apparent indication of movement. Photographs were taken to document the surface; two representative images are provided below.

**Excavation at 14 days (P100582.jpg)**

**Excavation at 14 days (P100589.jpg)**

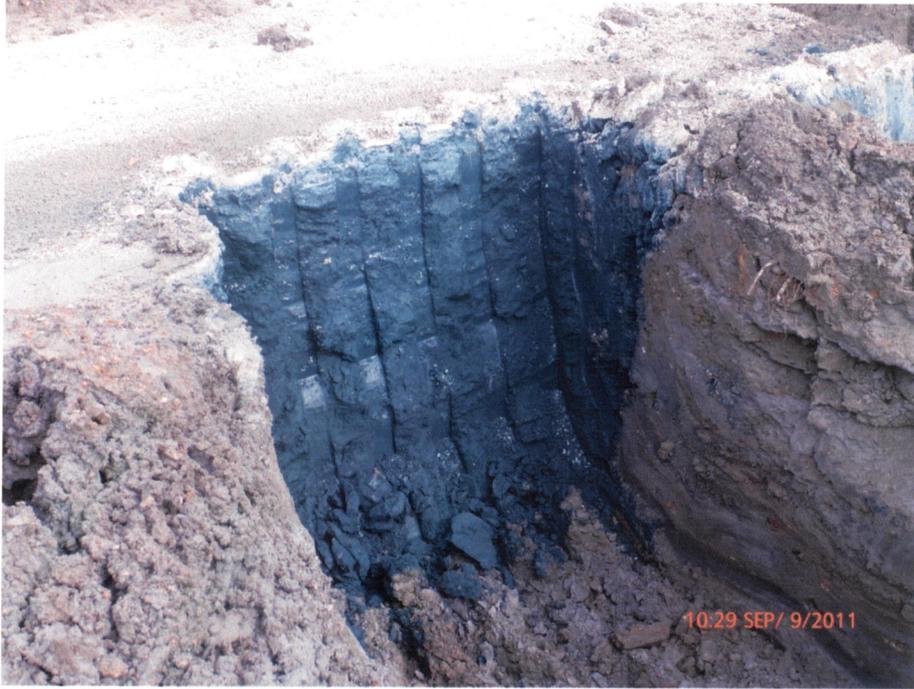
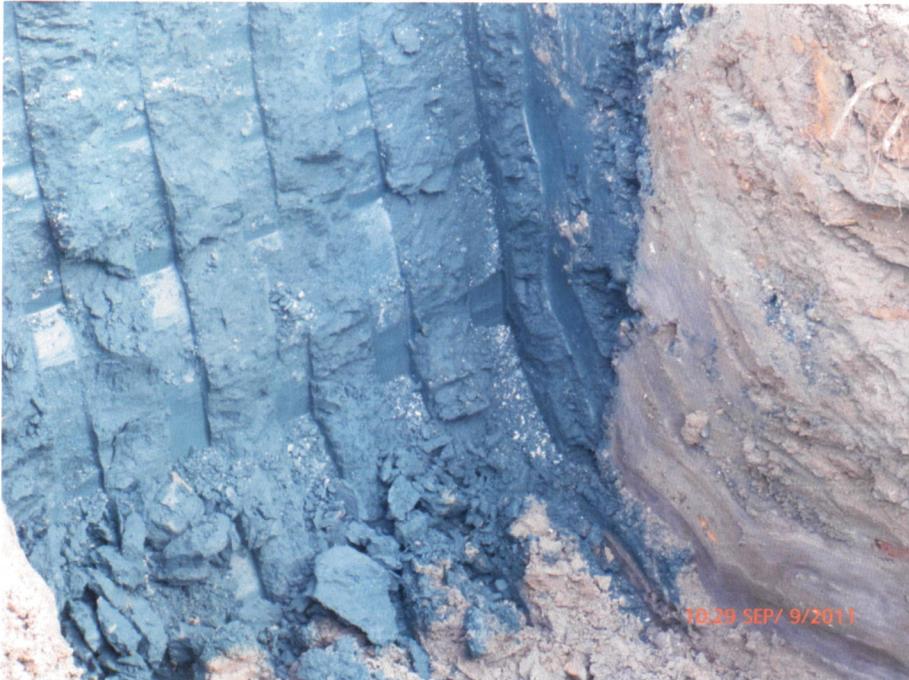
On September 9, 2011, a Kobelco PC250LC excavator was utilized to excavate into the cold joint test panel. The test trench was excavated from both the end of the trench to simulate a butt joint (through the portion previously exposed for the 14-day observation), and from the side of the trench to simulate a t-joint (12" to 18" into the side of the panel). The teeth on the bucket of the Kobelco excavator were utilized to excavate into the material, essentially "teething" the material by creating teeth marks of various depths. Due to the highly saturated nature of the ash material surrounding the cold joint test trench and the visual indications of instability in the sides of the excavation, observations for the subject cure age were made from the top of the trench without personnel entering. During excavation of the butt joint, the excavator was observed to be unstable and the weight of the machine caused saturated material to be pushed into the excavation from beneath the tracks. Adjacent ash material (which had been excavated previously during the preceding cold joint observations) was observed to flow into the excavation under its own weight, even when sloped. Teeth marks ranged from approximate 0 to 2" in depth into the material, based on visual observation. Areas of loose material were observed between the teeth marks and were visually observed to fall freely from the surface of the exposed material. The material between the teeth marks that broke off following the excavation was observed to be somewhat flush with the area impacted by the teeth and did not appear to break off further into the wall. The in-place material in the trench following the excavation exhibited a bluish-green color, visually similar as that observed in the demonstration and production walls, and were observed to not contain the previously noted areas of a light grayish hue between the teeth marks. The lack of a grayish hue to the material may be attributed to the more than 7" of rain received since Sunday, September 4<sup>th</sup>. Portions of the material excavated from the trench were observed to be stiff with very low plasticity, based on the material crumbling with relative ease when rolled in the observer's hand. The excavated material, when rolled between the observer's fingers, was moist to the touch (without free moisture transfer to skin or cloth) and crumbled into small spherical pieces (1/16") after only a few passes. Areas where the teeth of the bucket pressed into the material during the downward stroke of the excavator was observed to be relatively smooth, though less smooth than previous observations, and with an indication of cracking and/or brittleness. The material contacted by the teeth exhibited slightly rough areas where material appeared to pull apart when the teeth raked across the surface. The surface of the material was visually observed to contain visible cracks, but did not clearly exhibit signs of propagating fractures into the panel. The simulated t-joint was excavated approximately 18" behind the simulated butt joint. The remaining area left in place between the two excavations, after the t-joint progressed into the wall, was observed to be mostly intact without significant visual indication of cracking. The edges of the trench, where in contact with the existing ash material, were visually observed to indicate fracturing and brittleness. These areas were observed to contain angular pieces of slurry material, especially within the top 36" of the excavation (see photo P1000607.jpg). Photographs were taken to document the surface; two representative images are provided below.

**Excavation at 21 days (P1000607.jpg)**

**Excavation at 21 days (P1000610.jpg)**

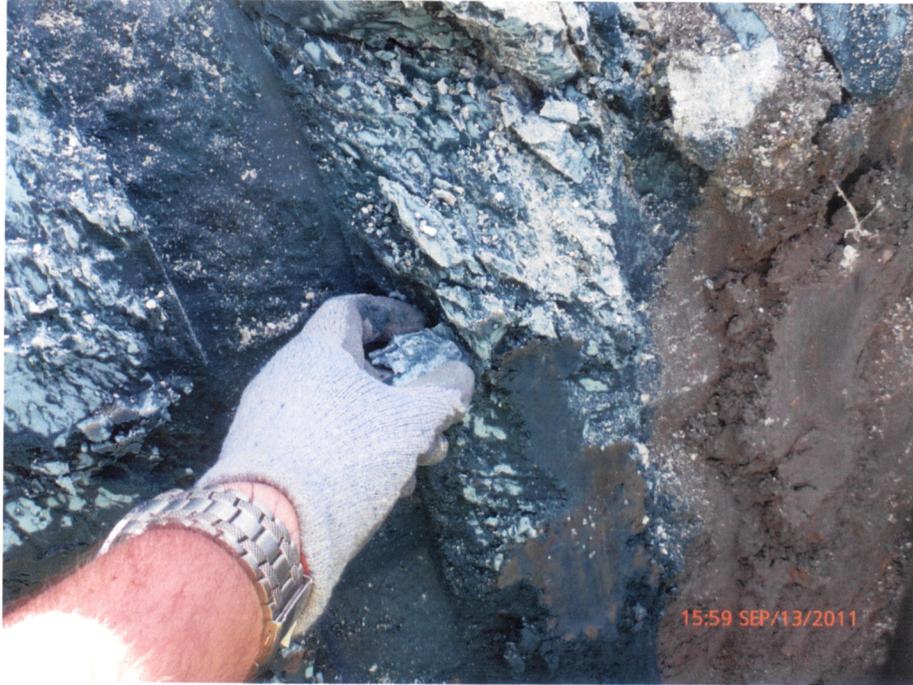
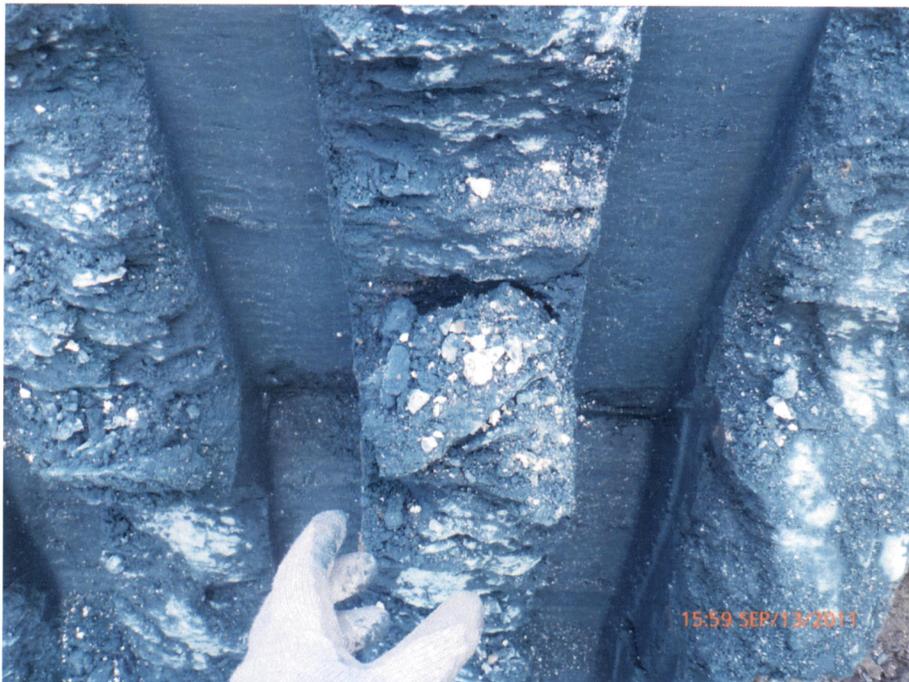
On September 13, 2011, a Kobelco PC250LC excavator was utilized to excavate into the cold joint test panel. The test trench was excavated from the end of the trench to simulate a butt joint (through the portion previously exposed for the 21-day observation). The teeth on the bucket of the Kobelco excavator were utilized to excavate into the material, essentially "teething" the material by creating teeth marks of various depths. Teeth marks ranged from approximately 0 to 6" in depth into the material, based on visual observation. The material was observed to be a bluish green color with sporadic areas of discoloration that was indicated by a light grayish hue. Visible fracturing was observed in the material remaining between the teeth. Small pieces less than 5" in size were easily removed, with no visual indication of promulgating cracks into the wall material. An area in the bottom right corner of the material remaining between the teeth marks was broken off by the observer by striking the area several times with the sole of a work boot. The material broke free from the remainder of the wall material, and left an area that slightly protruded into the wall by approximately 1" or less. While this area was on the side of the trench material, there was no visual indication of additional fracturing into the wall. A second area in the bottom left of the trench, between the teeth marks, was forcibly removed by the observer by striking repeatedly with the toe of the same steel toe work boot. The piece of material removed was observed to be intact, and the remaining surface remained intact and did not exhibit visual indication of additional fracturing. The piece of material removed was approximately 3" thick, while the surface of the remaining material still protruded from the wall by approximately 3". The material left in place where the teeth impacted the wall was observed to be intact and relatively smooth. This material could be easily shaved in thin layers by light pressure from a 1 ¼" heavy duty putty knife. The shaved material was rolled between the observer's fingers and was noted to be dry to the touch with no indication of free moisture, and quickly broke into granular pieces of material approximately 1/16" of an inch in size after only a few passes. Based on the observations of the force required to remove material by striking with a boot, the nature of the material when rolled between the fingers, and the visual observations of the material, the material at the age of 25-days is noted as being low plastic and stiff with little indication of brittleness. A visual indication of brittleness was observed within the top 8 to 12" of the excavation and was noted as exhibiting an angular surface, and a grayish discoloration. Photographs were taken to document the surface; two representative images are provided below.

**Excavation at 25 days (P1000623.jpg)**

**Excavation at 25 days (P1000624.jpg)**
