### Time-Critical Concurrence

Emory River, Segment Above Above 5, Area 2, Emory River mile 5.9 to 5.4

Ash removal activities have been completed in Segment Above Above 5, Area 2, Emory River mile 5.9 to 5.4.

Kingston Ash Recovery Project  
Dredging and Ash Processing  
Daily Report

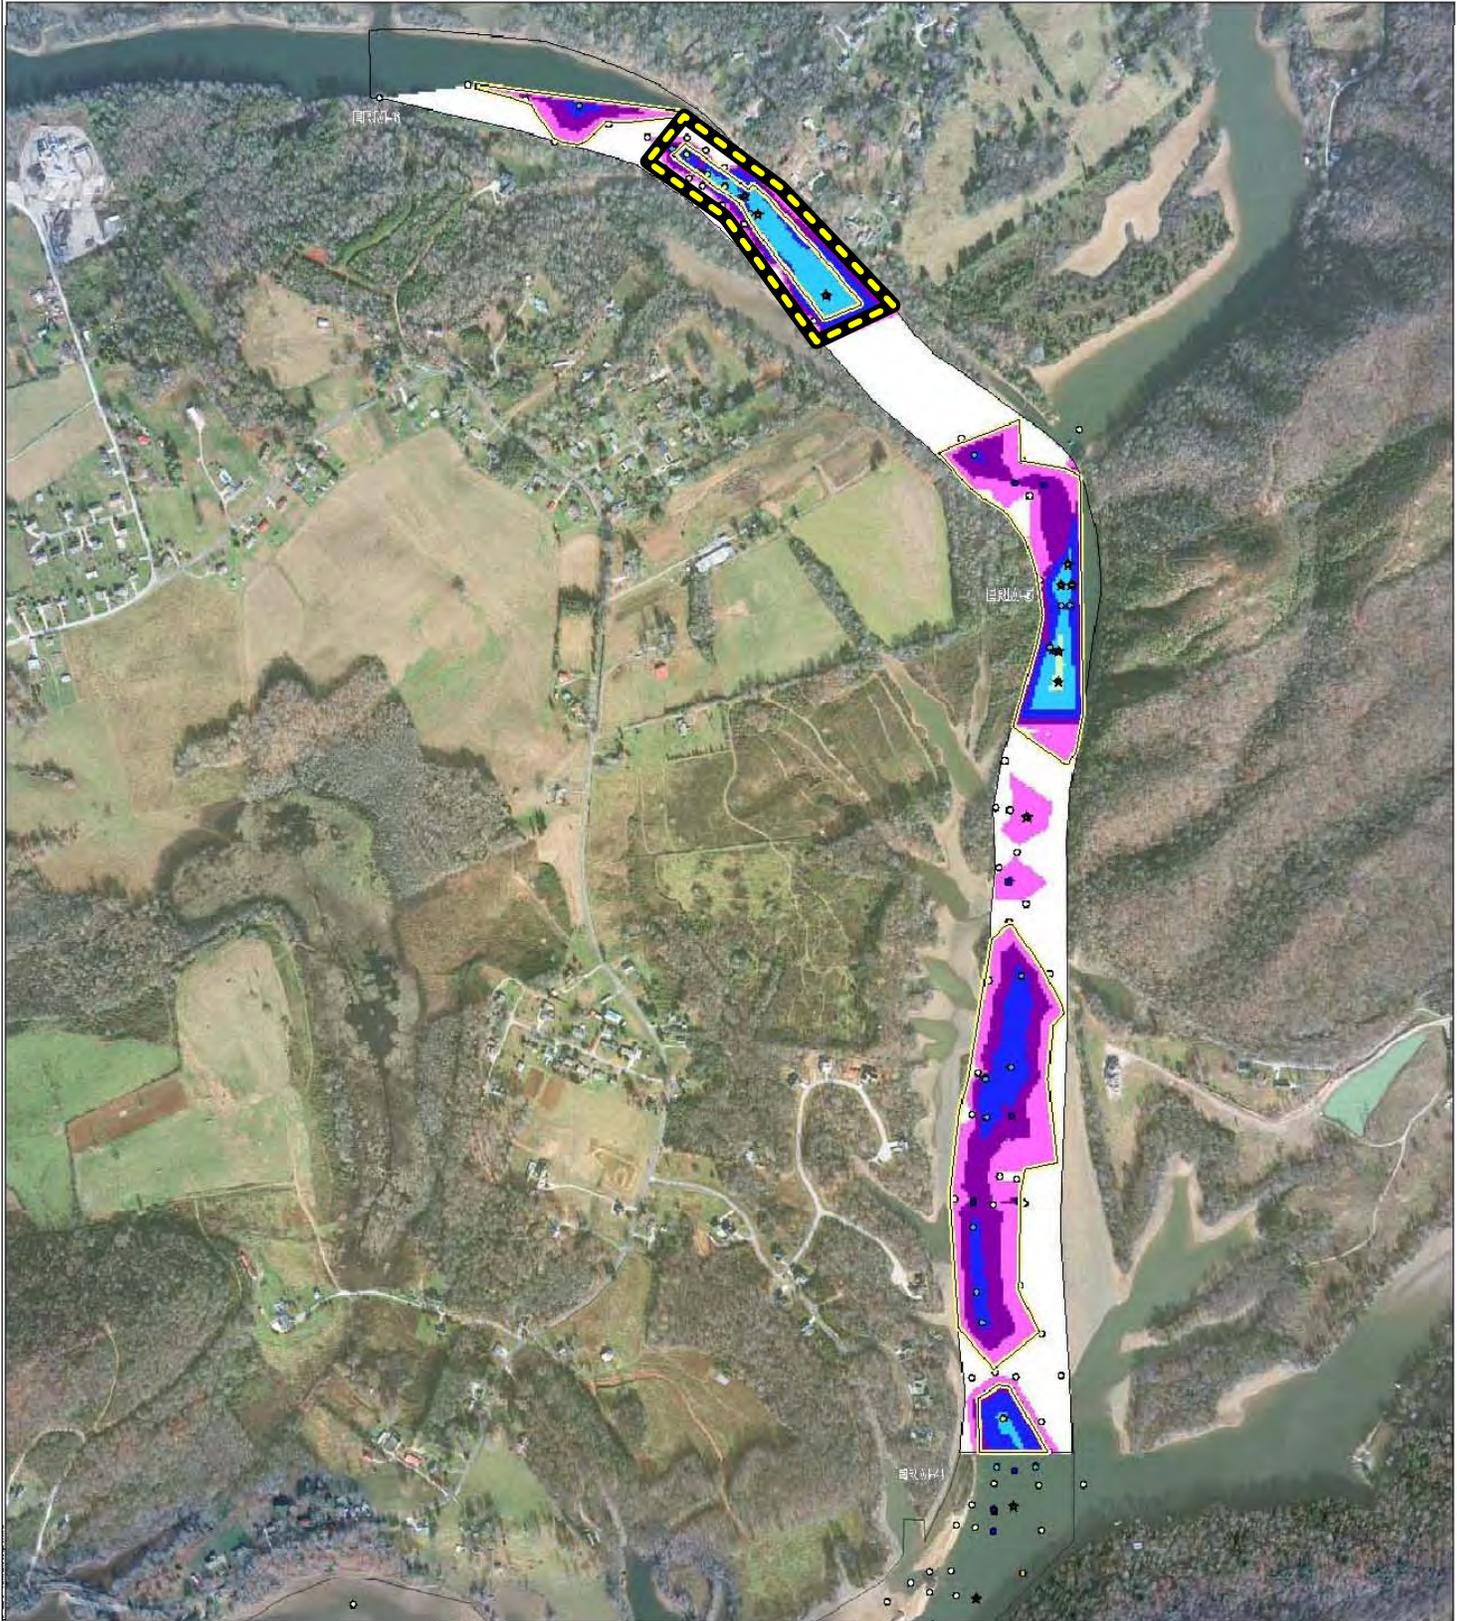
Figure 2

The area was identified by VibeCore drilling and included in the dredge plan addendum as shown in Figure 2, dated 3/15/10. The area was localized using pre-spill and post-spill bathymetric surfaces in addition to the VibeCore data creating the smaller area as shown in Figure 2, dated 4/20/10 and further reduced by supplemental VibeCore sampling, Figure 6 dated 5/25/10. Ash was initially recovered using a barge mounted Komatsu 800 excavator from April 19<sup>th</sup> to April 22<sup>nd</sup>. The results of the first pass were reviewed and the amount of the remaining ash located below the reach of the K-800 necessitated arrangements for equipment capable of greater excavation depth. A barge mounted crane equipped with a clamshell bucket was mobilized and mechanically dredged the area from May 5<sup>th</sup> to May 18<sup>th</sup>. An excavation control grid was developed for this work show on Figure 5, dated 5/22/10. A GPS unit on the crane and marked cable depths were used to verify that each grid was dredged to native sediment. Jacobs' field technicians were assigned to each shift and worked with the crane crew (Aquarius) in verifying that native sediments were reached in all grids. A coordinate was taken and a note was made at all locations where native sediments were reached. Report notes indicate type of material encountered above the native sediment contact. The operators of the mechanical excavation equipment were instructed to minimize dredging of native sediments and authorized to stop short of the targeted surface in areas where full buckets of native sediments had been recovered.

**Ash Remaining to Pre-Spill Surface Above Segment 5**

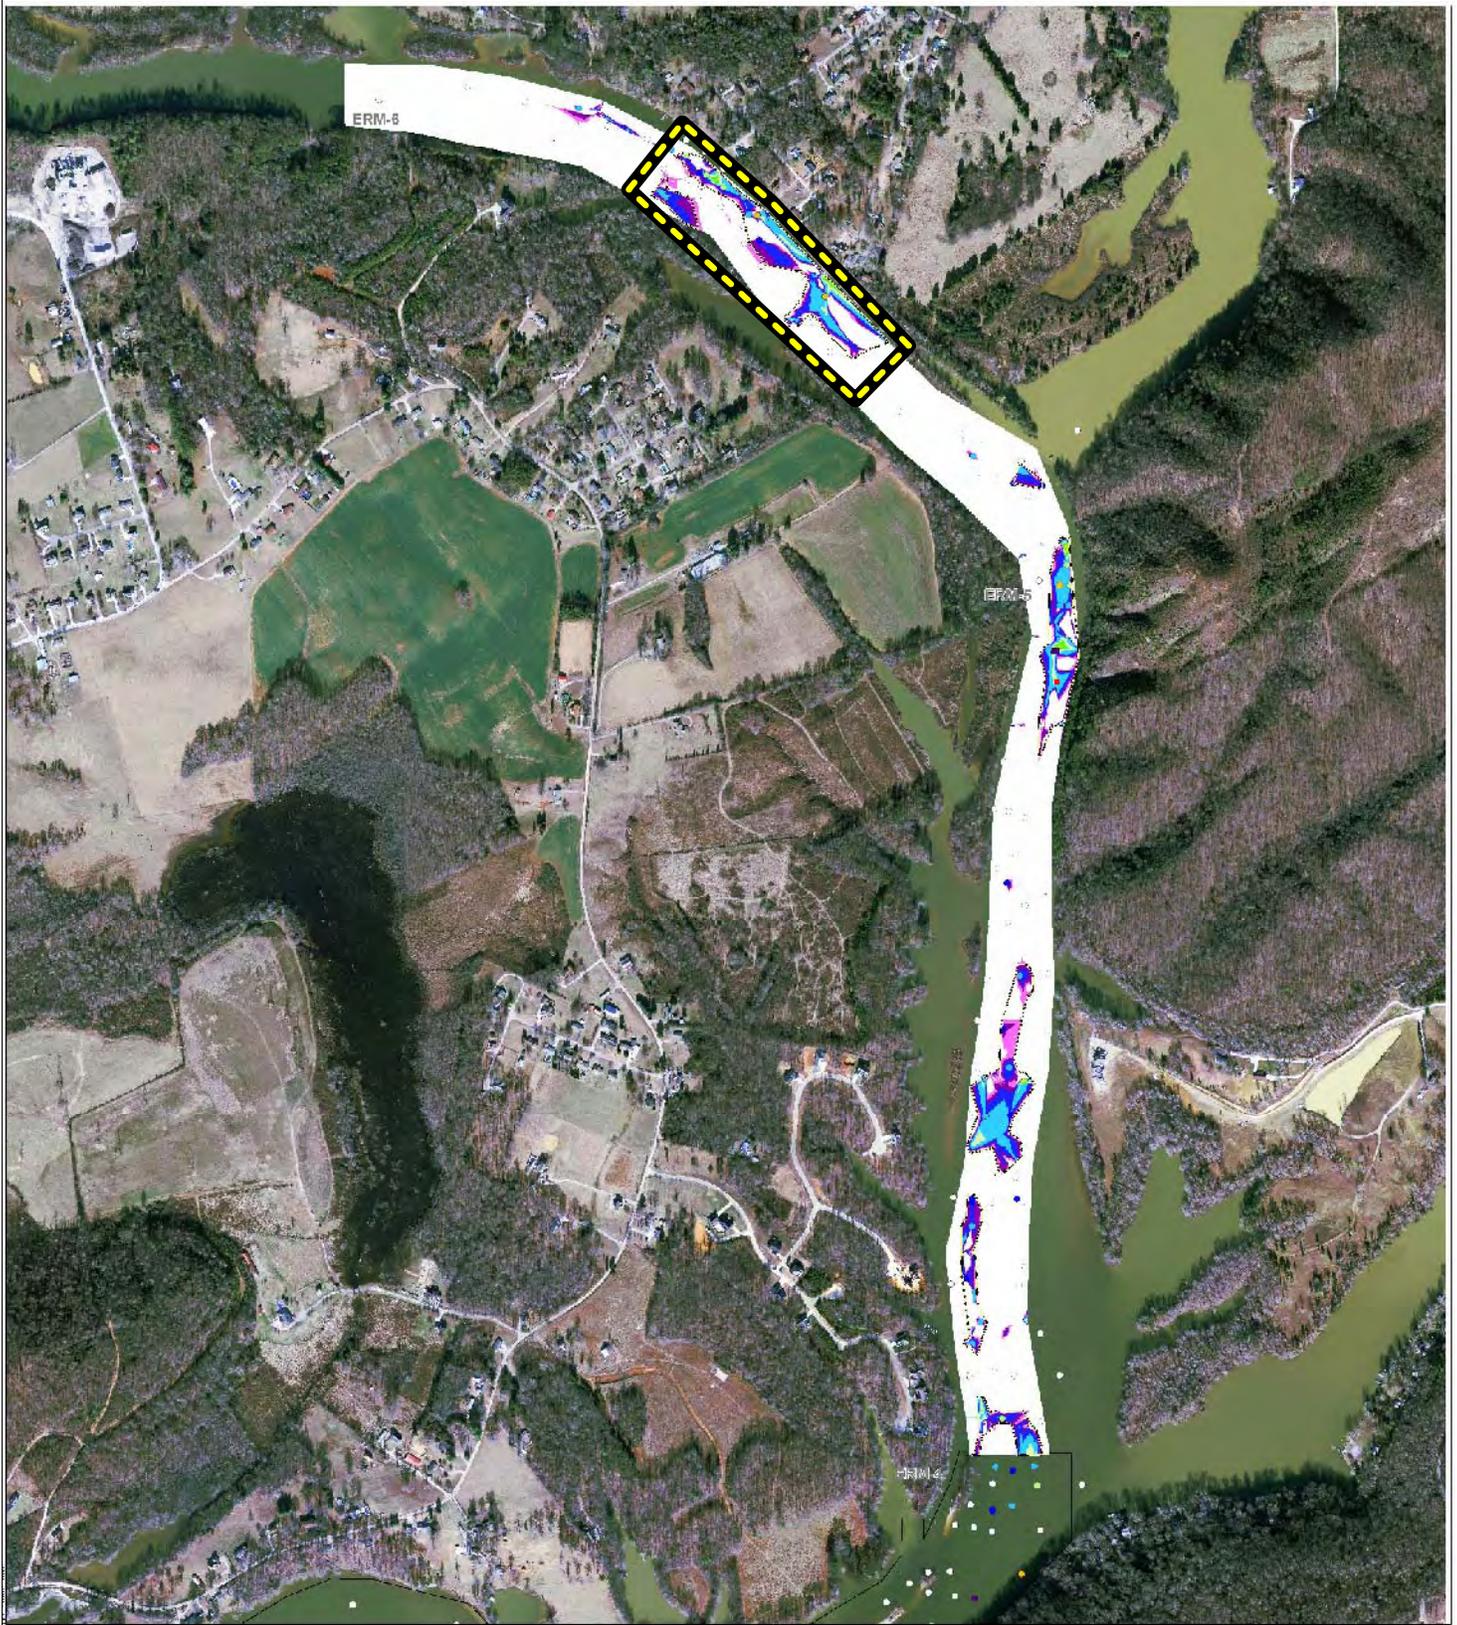
Figure 2

Ash Remaining to Pre-Spill Surface Above Above Segment 5

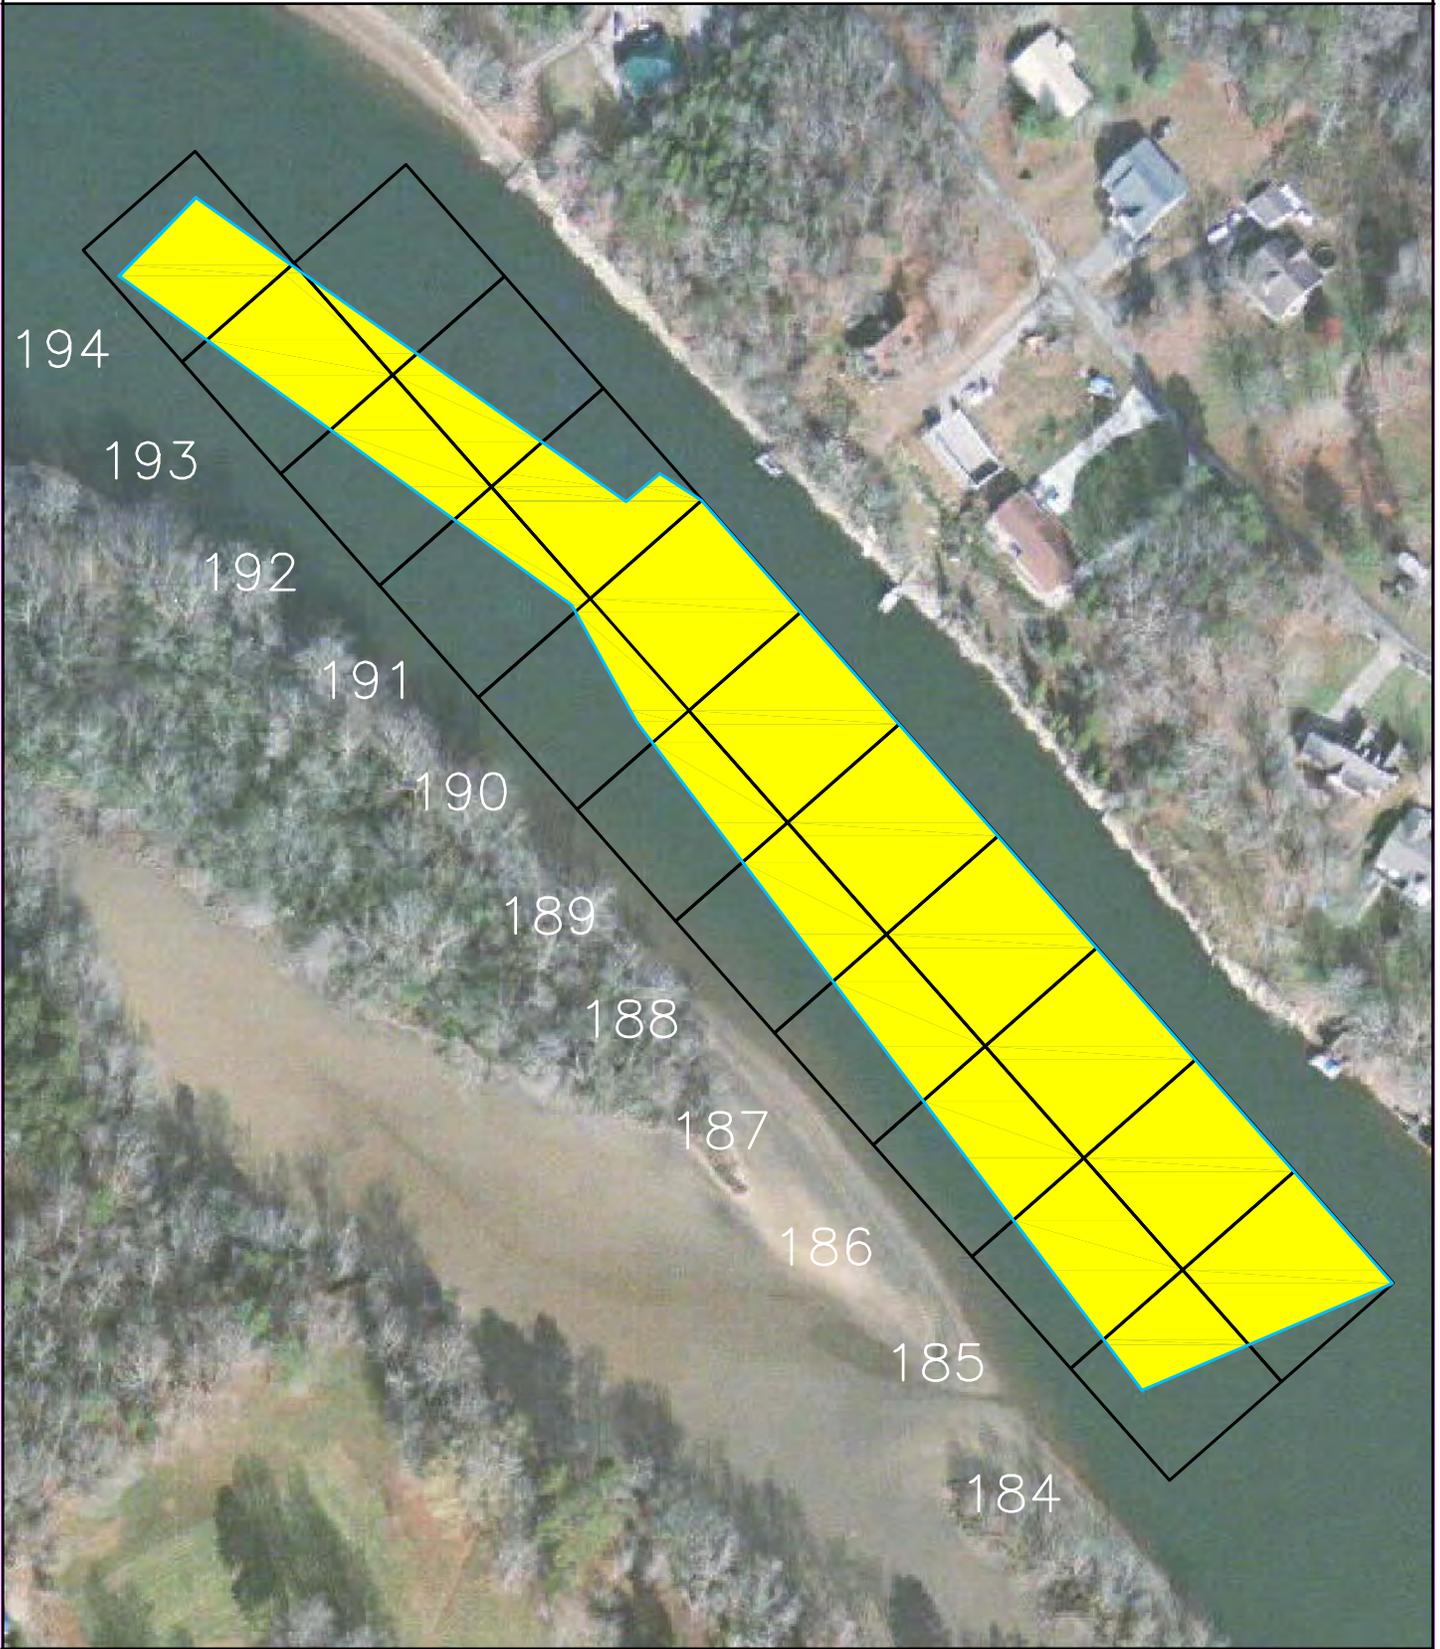
Figure 2

# Bathymetry Removal Areas - Above Above Segment 5

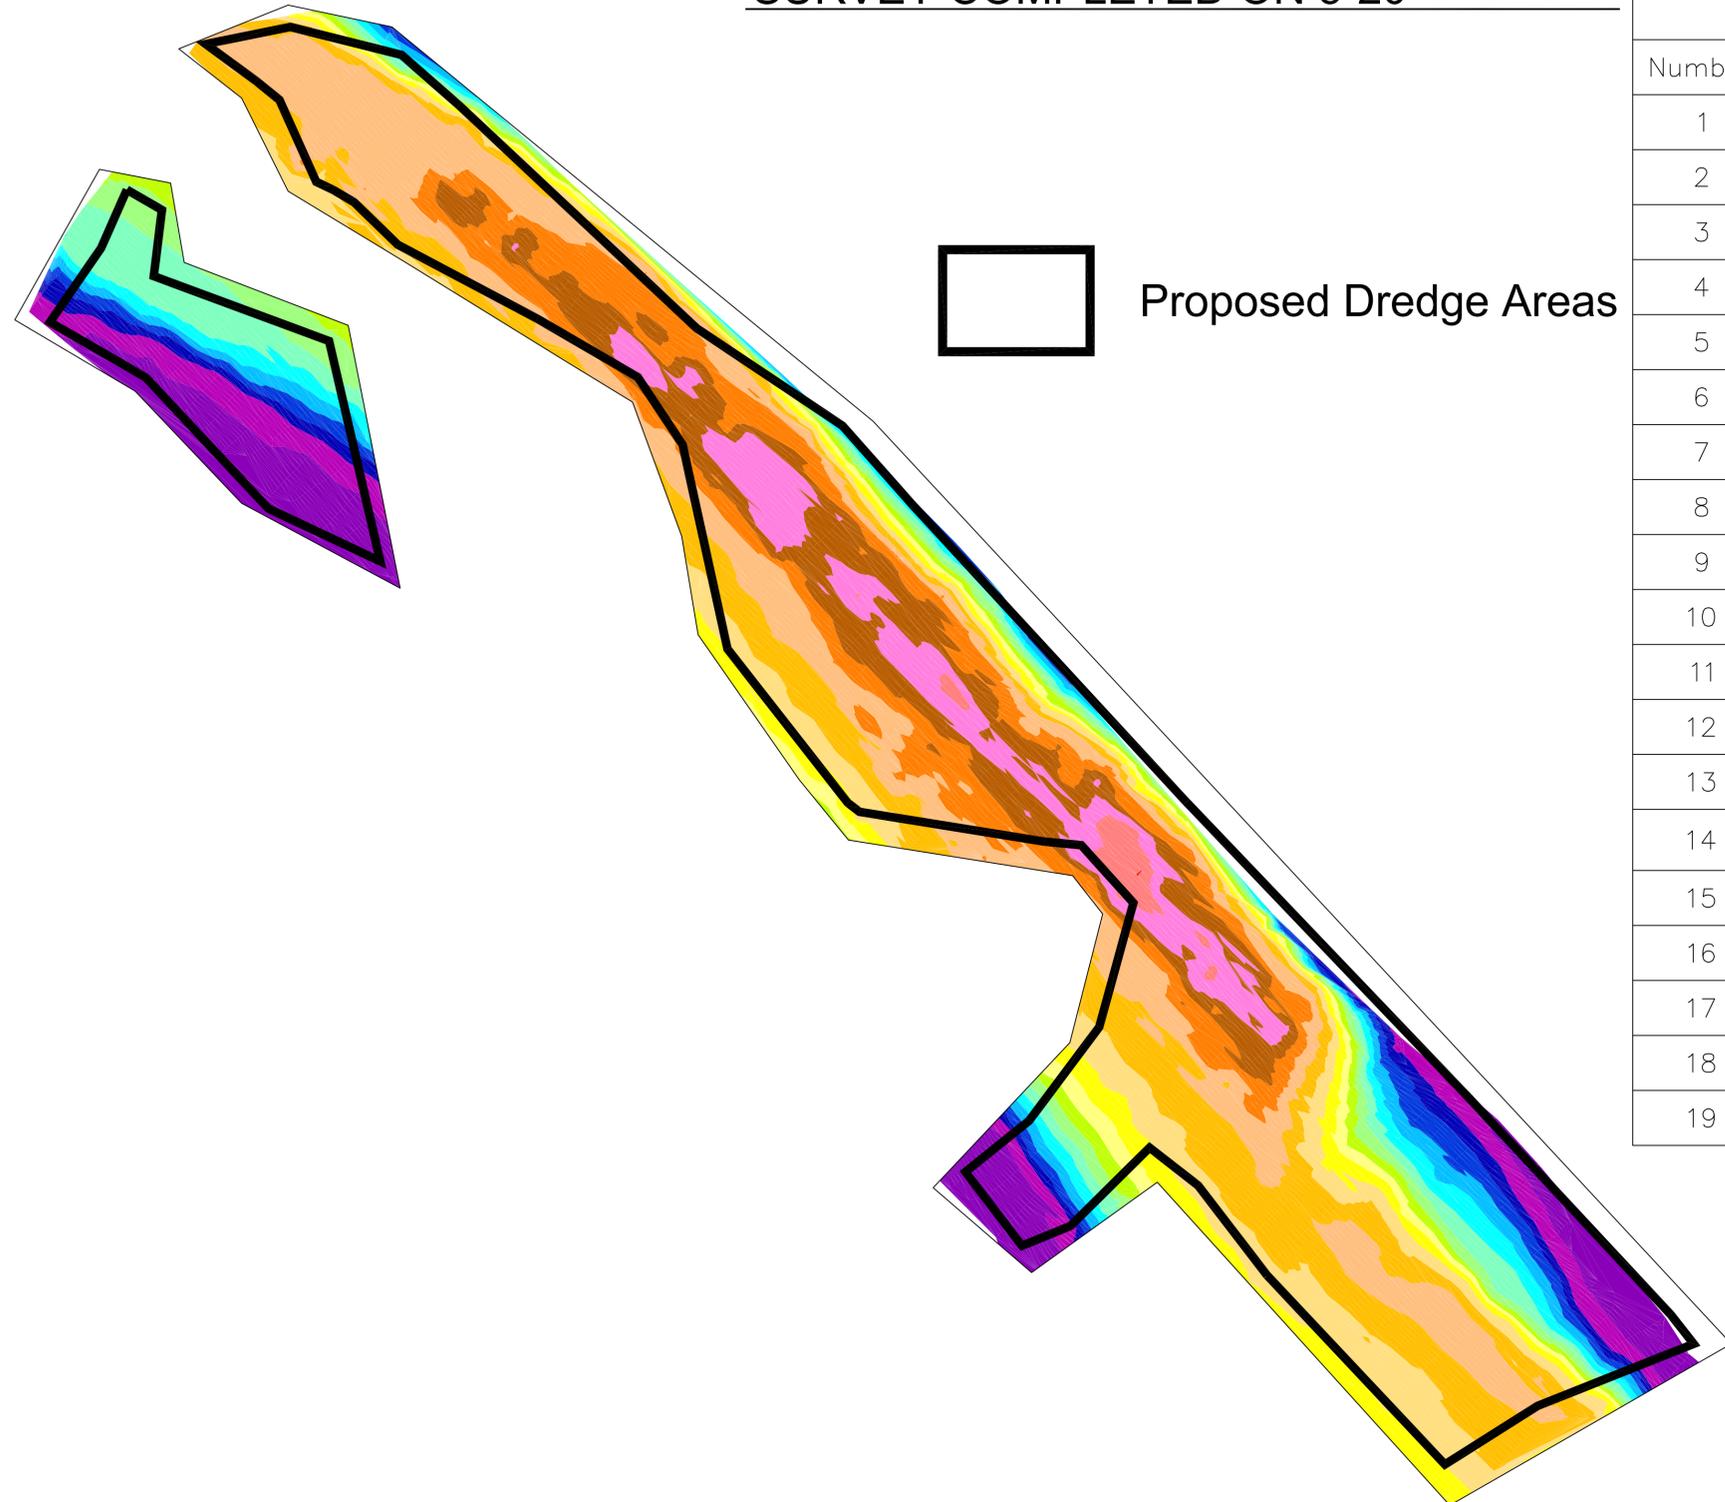
**BATHYMETRIC SURVEY  
05/20 AREA 2**

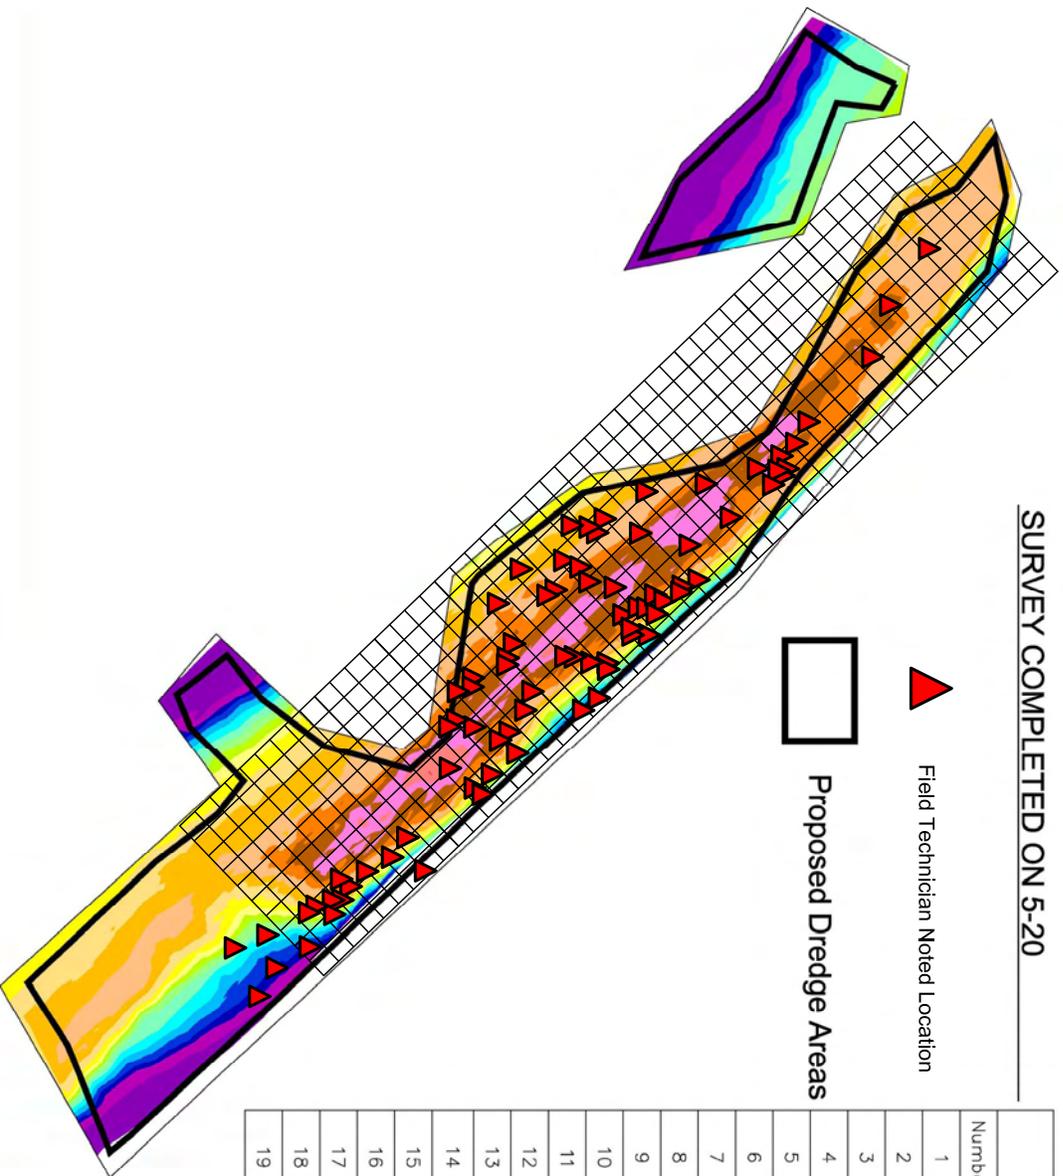
Figure 5

## BATHYMETRIC SURVEY 05/20 AREA 2

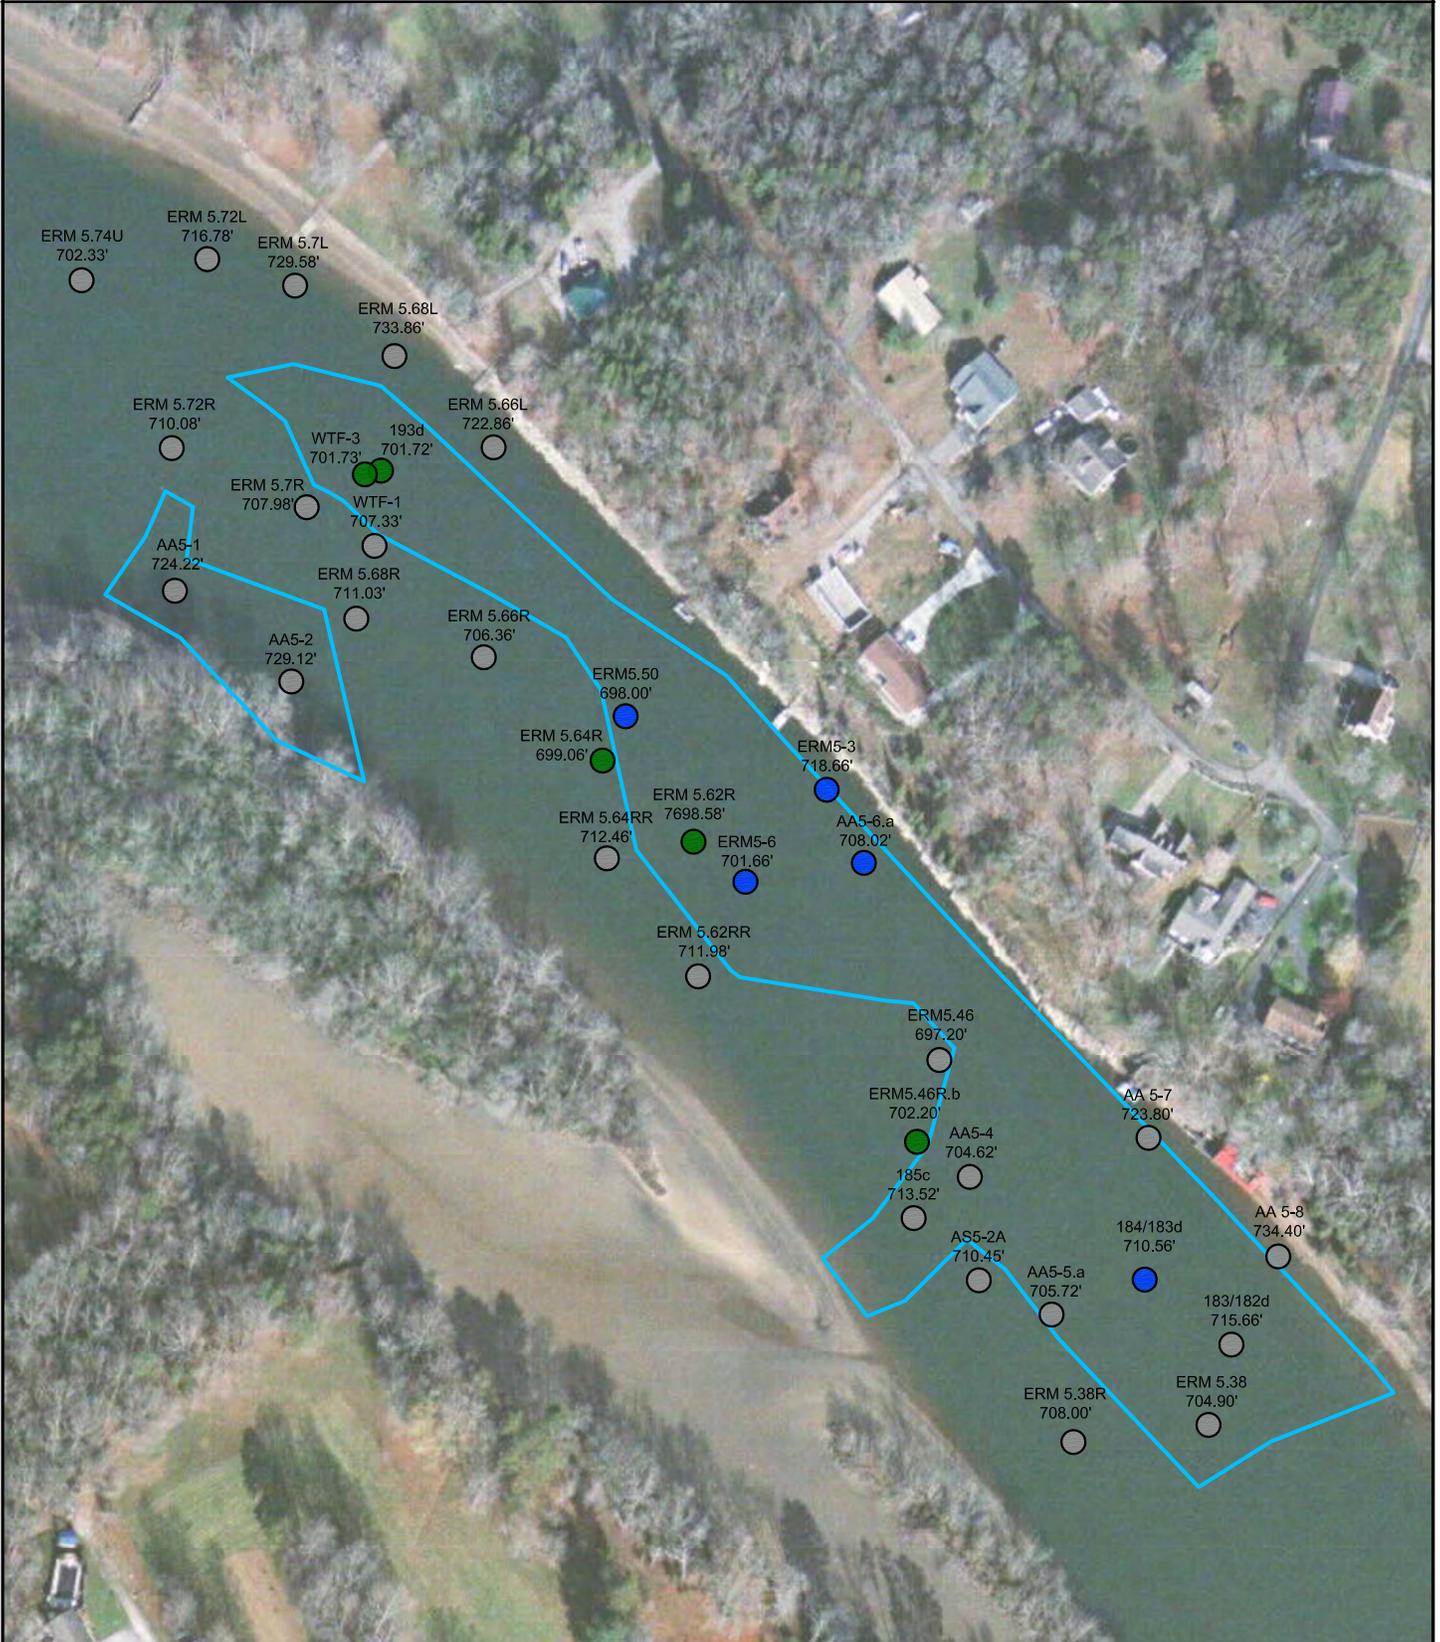
Documentation for completion of the grids includes post dredging bathymetric survey, supplemental VibeCore sediment sampling locations shown on Figure 6, and Dredging Daily Reports by Jacobs Field Technicians. The control grids and field technician completion notes have been plotted on the attached Figure 5. Where no notes are recorded, the VibeCore samples had shown no ash and no excavation was attempted.

# VibeCore Concurrence Sampling Results - Above Above Segment 5 - Area 2

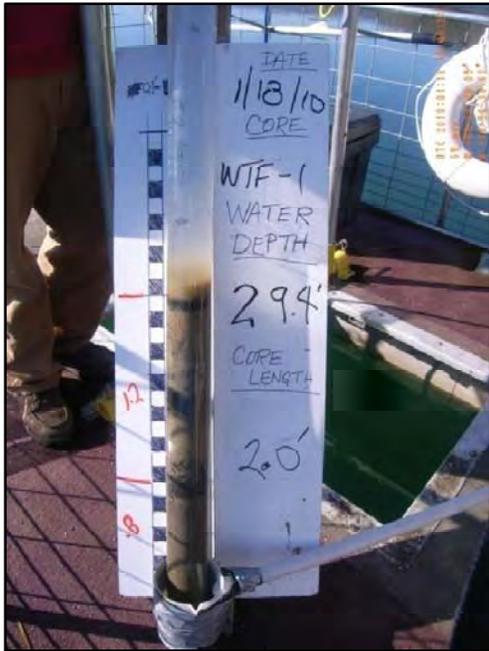
**Core WTF-1**  
 Total core depth = 2.0'  
 Ash thickness = 0.0'  
 Water depth = 29.4'

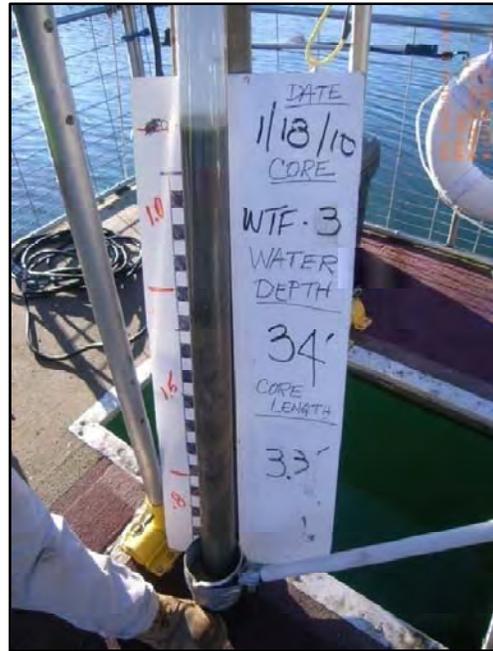
**Core WTF-3**  
 Total core depth = 3.3'  
 Ash thickness = 1.0'  
 Water depth = 34.0'

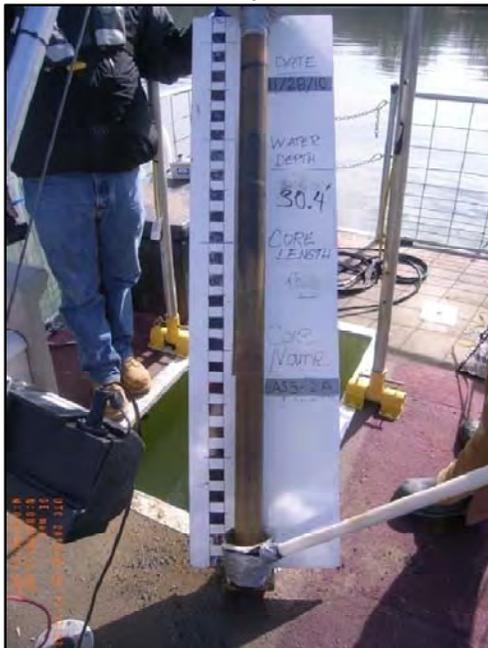
**Core AS5-2A**  
 Total core depth = 4.5'  
 Ash thickness = 0.0'  
 Water depth = 30.4'

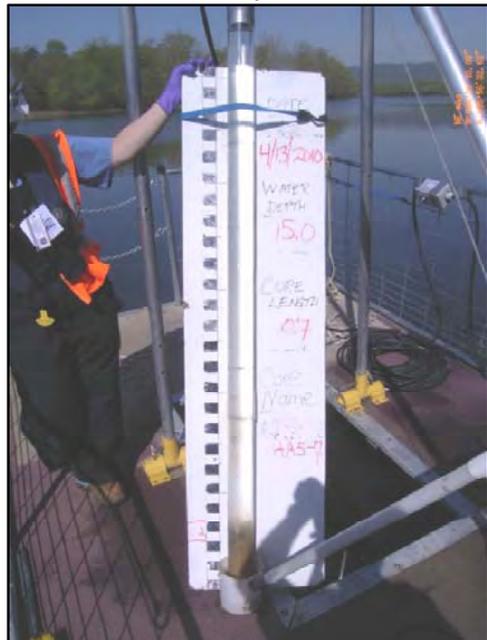
**Core AA5-7**  
 Total core depth = 0.7'  
 Ash thickness = 0.0'  
 Water depth = 15.0'

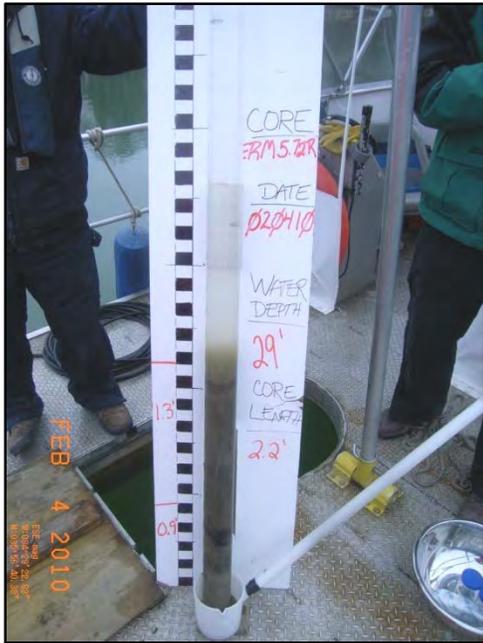
Core #	Photo #	Tube Type	6 ft acrylic	N	E	River Depth	Time	Core Description	Interval (ft)
ERM 5.72R	R0010304	6 ft acrylic	N	568498.49	2447044.1	29	11.00	<1% ash Mixed brown sand and fines with small amt. organic matter	0-1.3
Deviations encountered: Results of ash analysis sent for PLM noted as [%]									
ND ash Coarse sand with suspected coarse coal									1.3-2.2
Total Depth									2.2

**Core ERM5.72R**  
 Total core depth = 2.2'  
 Ash thickness = 0.0'  
 Water depth = 29.0'

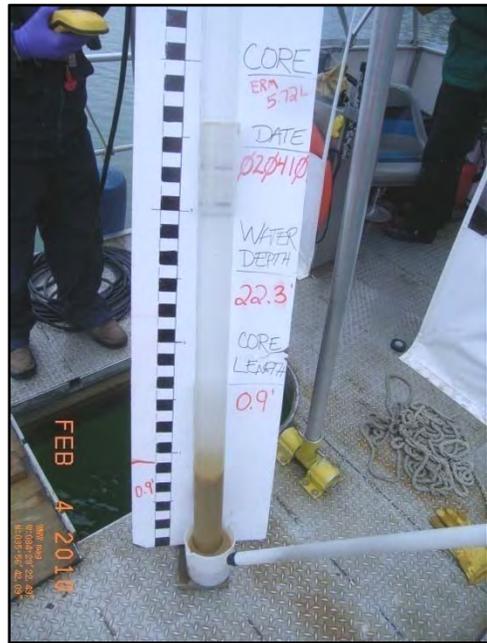
Core #	Photo #	Tube Type	6 ft acrylic	N	E	River Depth	Time	Core Description	Interval (ft)
ERM 5.72L	R0010305	6 ft acrylic	N	568697.19	2447081.13	22.3	11.50	ND ash Orange sandy clay	0-0.9
Deviations encountered: Photo differs from sediment description in log book. Upon extruding of the sample, there was only clearly only one type of sediment present. Results of ash analysis sent for PLM noted as [%]									
Total Depth									9

**Core ERM5.72L**  
 Total core depth = 0.9'  
 Ash thickness = 1.0'  
 Water depth = 22.3'

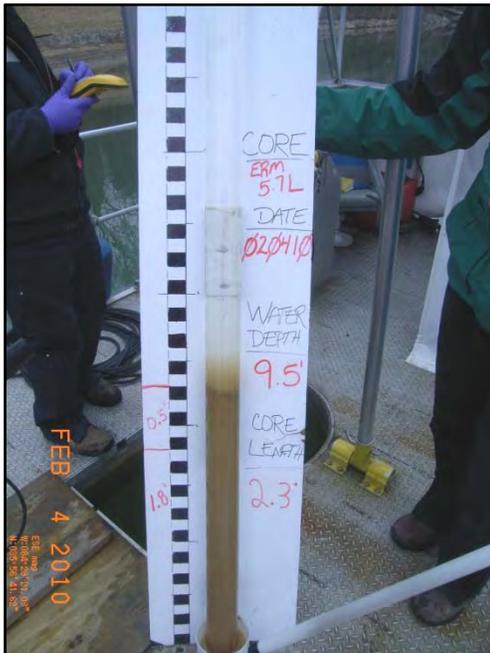
Core #	Photo #	Tube Type	6 ft acrylic	N	E	River Depth	Time	Core Description	Interval (ft)
ERM 5.7L	R0010307	6 ft acrylic	N	568668.21	2447172.77	9.5	14.23	<1% ash Orange clay with fine sand and organic material	2.3
Deviations encountered: Photo differs from sediment description in log book. Upon extruding of the sample, there was only clearly only one type of sediment present. Results of ash analysis sent for PLM noted as [%]									
Total Depth									2.3

**Core ERM5.7L**  
 Total core depth = 2.3'  
 Ash thickness = 0.0'  
 Water depth = 9.5'

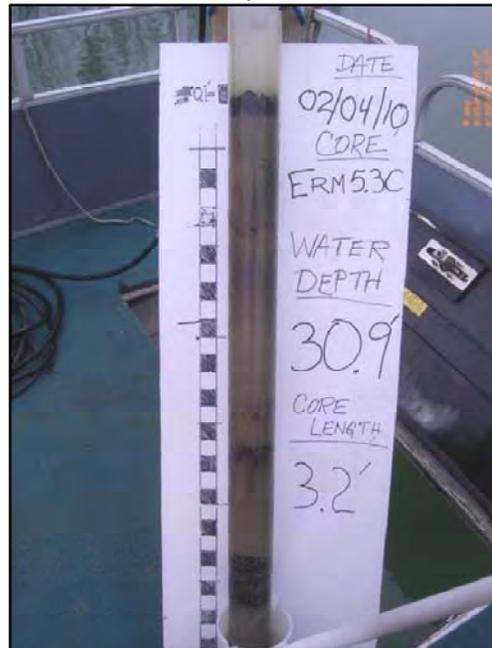
**Core ERM5.3-C**  
 Total core depth = 3.2'  
 Ash thickness = 0.0'  
 Water depth = 30.9'

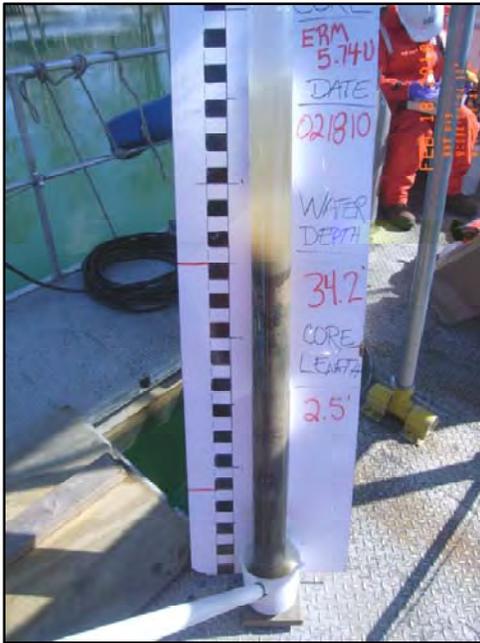
Core #	Photo #	Tube Type	6 Acrylic	N	E	River Depth	Time	Core Description	Interval (ft)
ERM 5.74U	R0010325	6 Acrylic	N	568673.34	2446949.88	34.2	10.47	<1% ash Coarse brown sand mixed with few pieces of coal. No Ash	0-1.5
Deviations encountered: Results of ash analysis sent for PLM noted as [%]									
5% ash Brown fines, silts and clay No ash <10% organic matter. No ash									1.5-2.5
Total Depth									2.5

Core ERM5.74U  
Total core depth = 2.5'  
Ash thickness = 0.0'  
Water depth = 34.2'

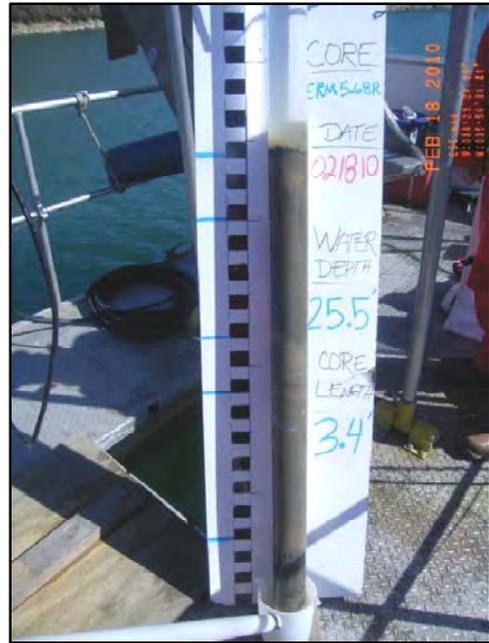
Core #	Photo #	Tube Type	6 Acrylic	N	E	River Depth	Time	Core Description	Interval (ft)
ERM 5.68R	R0010328	6 Acrylic	N	568319.89	2447239.69	25.5	13.57	<1% ash Brown sand mixed with native fines. No Ash	0-0.4
Deviations encountered: Results of ash analysis sent for PLM noted as [%]									
ND ash Brown fine sand. Few coal. No ash									0.4-1.2
ND ash Brown sand. No ash									1.2-1.6
ND ash Brown fines with sand mixed with 20% organic matter. No Ash									1.6-2.8
ND ash Brown coarse sand and coal pieces. Coal 80% No ash									2.8-3.4
Total Depth									3.4

Core ERM5.68R  
Total core depth = 3.4'  
Ash thickness = 0.0'  
Water depth = 25.5'

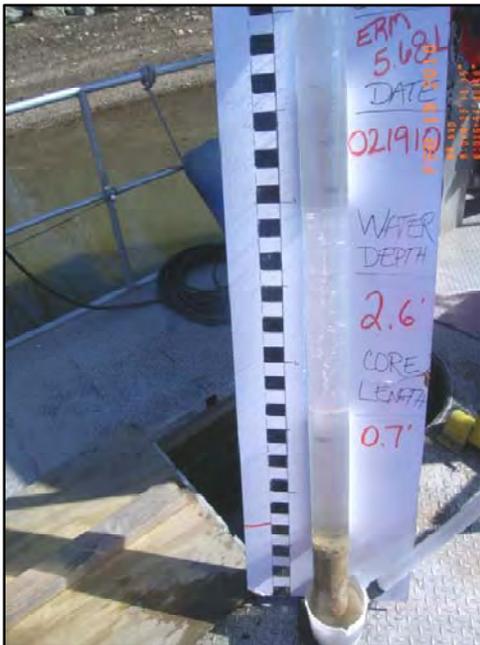
Core #	Photo #	Tube Type	6 Acrylic	N	E	River Depth	Time	Core Description	Interval (ft)
ERM 5.68L	R0010329	6 Acrylic	N	568595.56	2447277.73	2.6	11.30	<1% ash Mottled red clay with common pebbles near the surface. No ash	0-0.7
Deviations encountered: Results of ash analysis sent for PLM noted as [%]									
Refusal Met at heavy clay									
Total Depth									7

Core ERM5.68L  
Total core depth = 0.7'  
Ash thickness = 0.0'  
Water depth = 13.6'

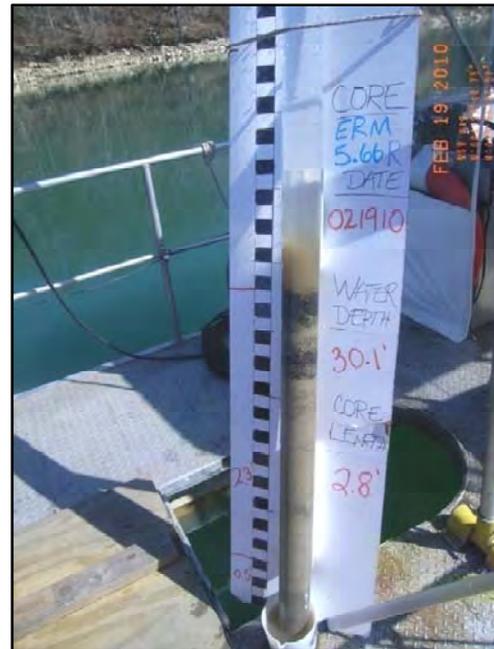
Core #	Photo #	Tube Type	6 Acrylic	N	E	River Depth	Time	Core Description	Interval (ft)
ERM 5.66R	R0010331	6 Acrylic	N	568278.63	2447370.29	30.1	12.58	1% ash Fine and coarse light brown sand mixed with coal pieces and <10% organic matter. No ash	0-2.3
Deviations encountered: Results of ash analysis sent for PLM noted as [%]									
<1% ash Brown sand mixed with native fines, coal pieces and ~10% organic matter. No ash									2.3-2.8
Total Depth									2.8

Core ERM5.66R  
Total core depth = 2.8'  
Ash thickness = 0.0'  
Water depth = 30.1'

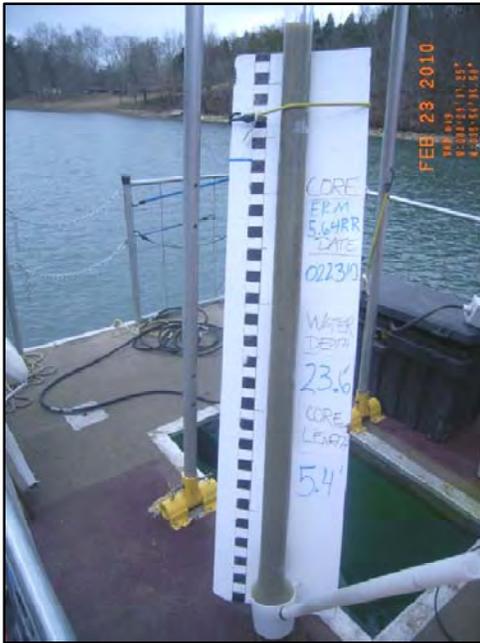
Core ERM5.64RR  
 Total core depth = 5.4'  
 Ash thickness = 0.0'  
 Water depth = 23.6'

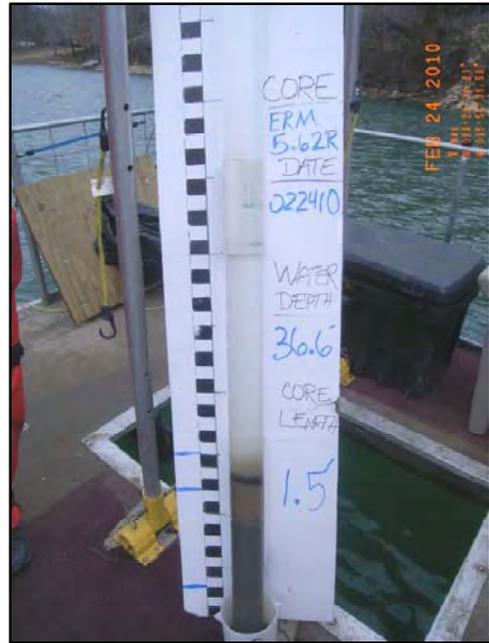
Core ERM5.62R  
 Total core depth = 1.5'  
 Ash thickness = 0.9'  
 Water depth = 36.6'

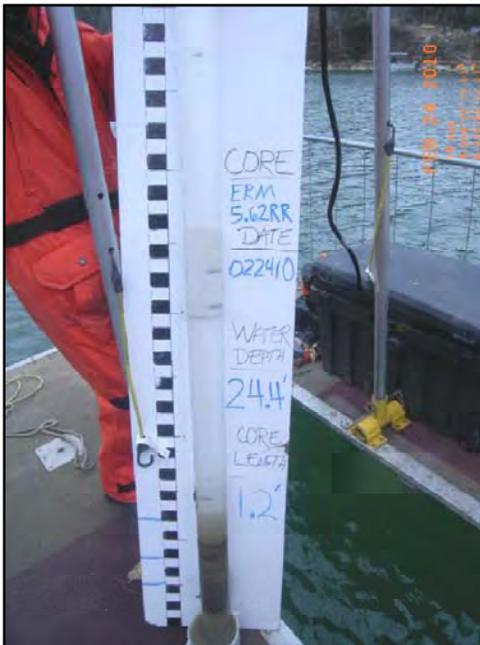
0.3-1.2
							1.2-1.5
							Total Depth
							1.5'
Core #	Photo #	Tube Type	Core Coordinates	River Depth	Time	Core Description	Interval (ft)
ERM 5 62RR	R0010340	6' Acrylic	N 567945 64' E 2447595 59'	24 4'	12:40	[2% ash] Medium and fine grained orange and brown sand. No ash	0-0.4
Deviations encountered Results of ash analysis sent for PLM noted as [%]

Core ERM5.62RR  
 Total core depth = 1.2'  
 Ash thickness = 0.0'  
 Water depth = 24.4'

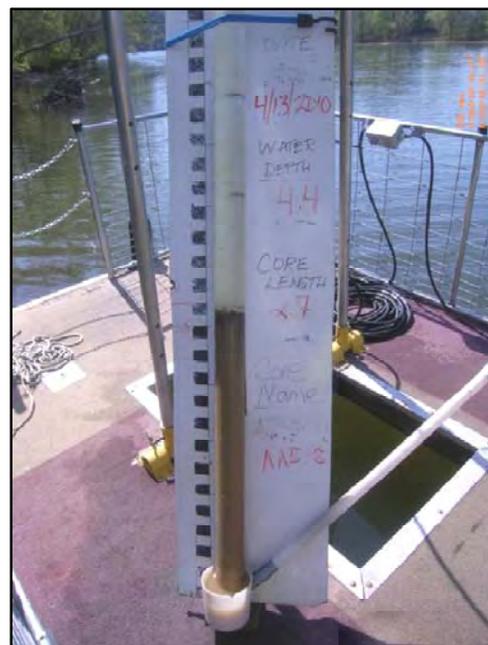
Core AA5-8  
 Total core depth = 2.7'  
 Ash thickness = 0.0'  
 Water depth = 4.4'

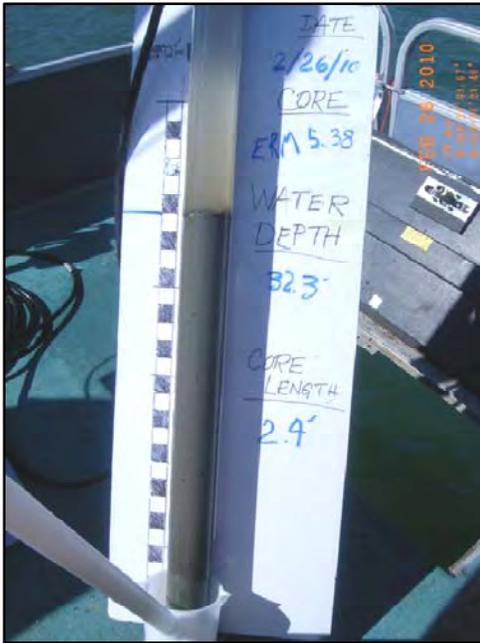
Core ERM5.38  
 Total core depth = 2.4'  
 Ash thickness = 0.0'  
 Water depth = 32.2'

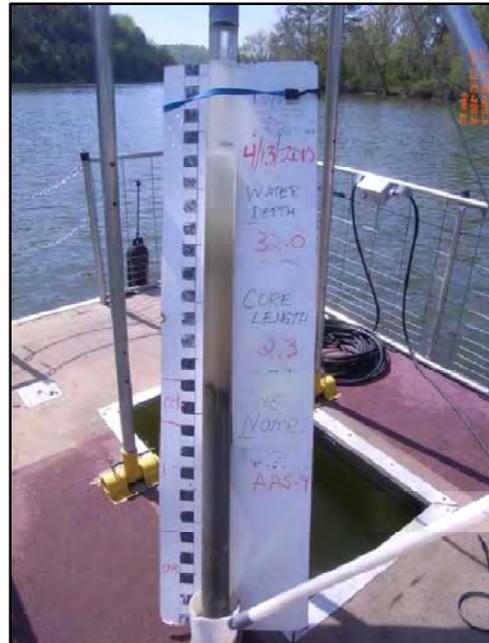
Core AA5-9  
 Total core depth = 2.3'  
 Ash thickness = 1.0'  
 Water depth = 32.0'

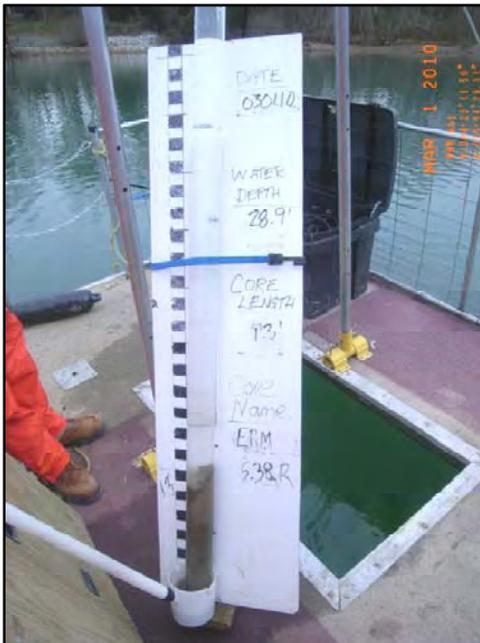
Core ERM5.38R  
 Total core depth = 1.3'  
 Ash thickness = 0.0'  
 Water depth = 28.9'

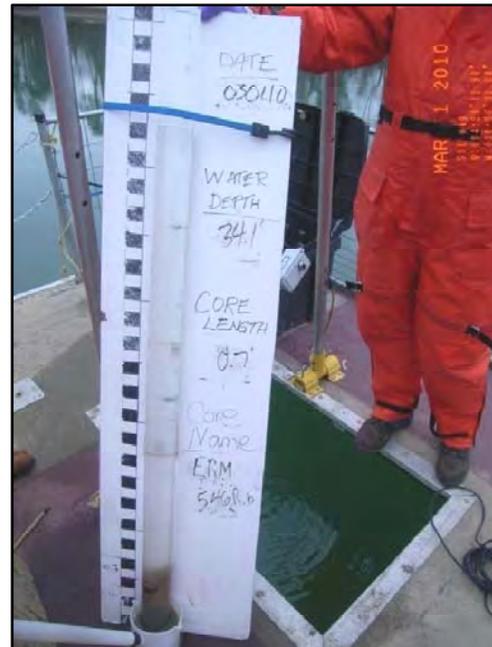
Core ERM5.4R.b  
 Total core depth = 0.7'  
 Ash thickness = 0.3'  
 Water depth = 34.1'

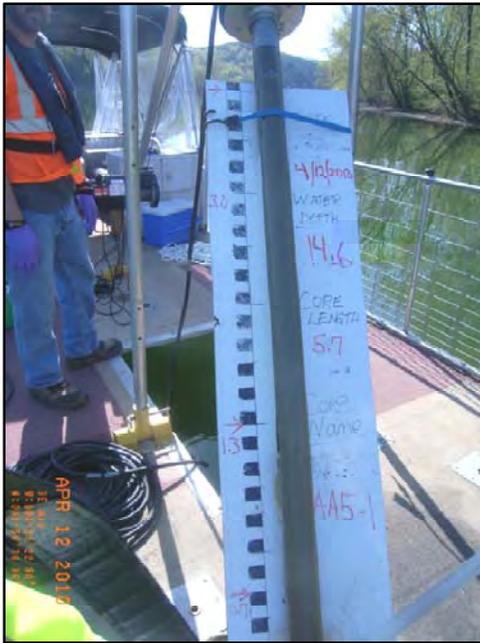
**Core AA5-1**  
 Total core depth = 5.7'  
 Ash thickness = 0.0'  
 Water depth = 14.6'

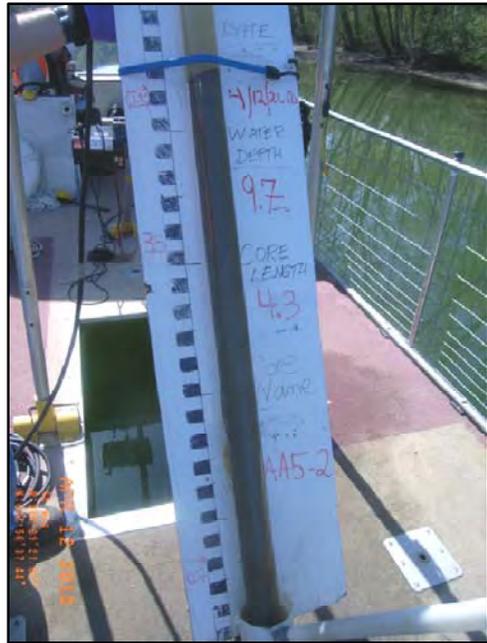
**Core AA5-2**  
 Total core depth = 4.3'  
 Ash thickness = 0.0'  
 Water depth = 9.7'

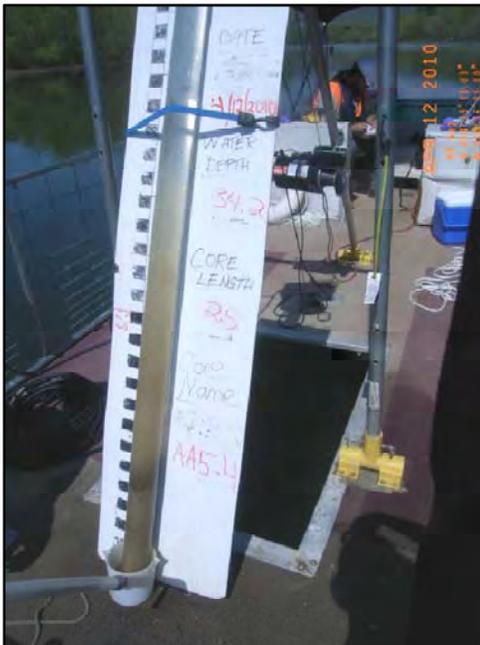
**Core AA5-4**  
 Total core depth = 2.5'  
 Ash thickness = 0.0'  
 Water depth = 34.2'

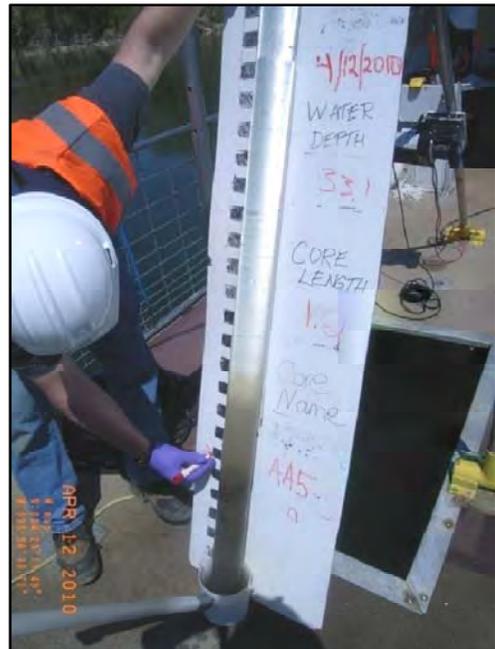
**Core AA5-5.a**  
 Total core depth = 1.2'  
 Ash thickness = 0.0'  
 Water depth = 33.1'
