**Time-Critical Concurrence****Area:**

Emory River, Segment Above Above 5, Area 3, Emory River mile 5.1 to 4.8

Ash removal activities have been completed in Segment Above Above 5, Area 3, Emory River mile 5.1 to 4.8.

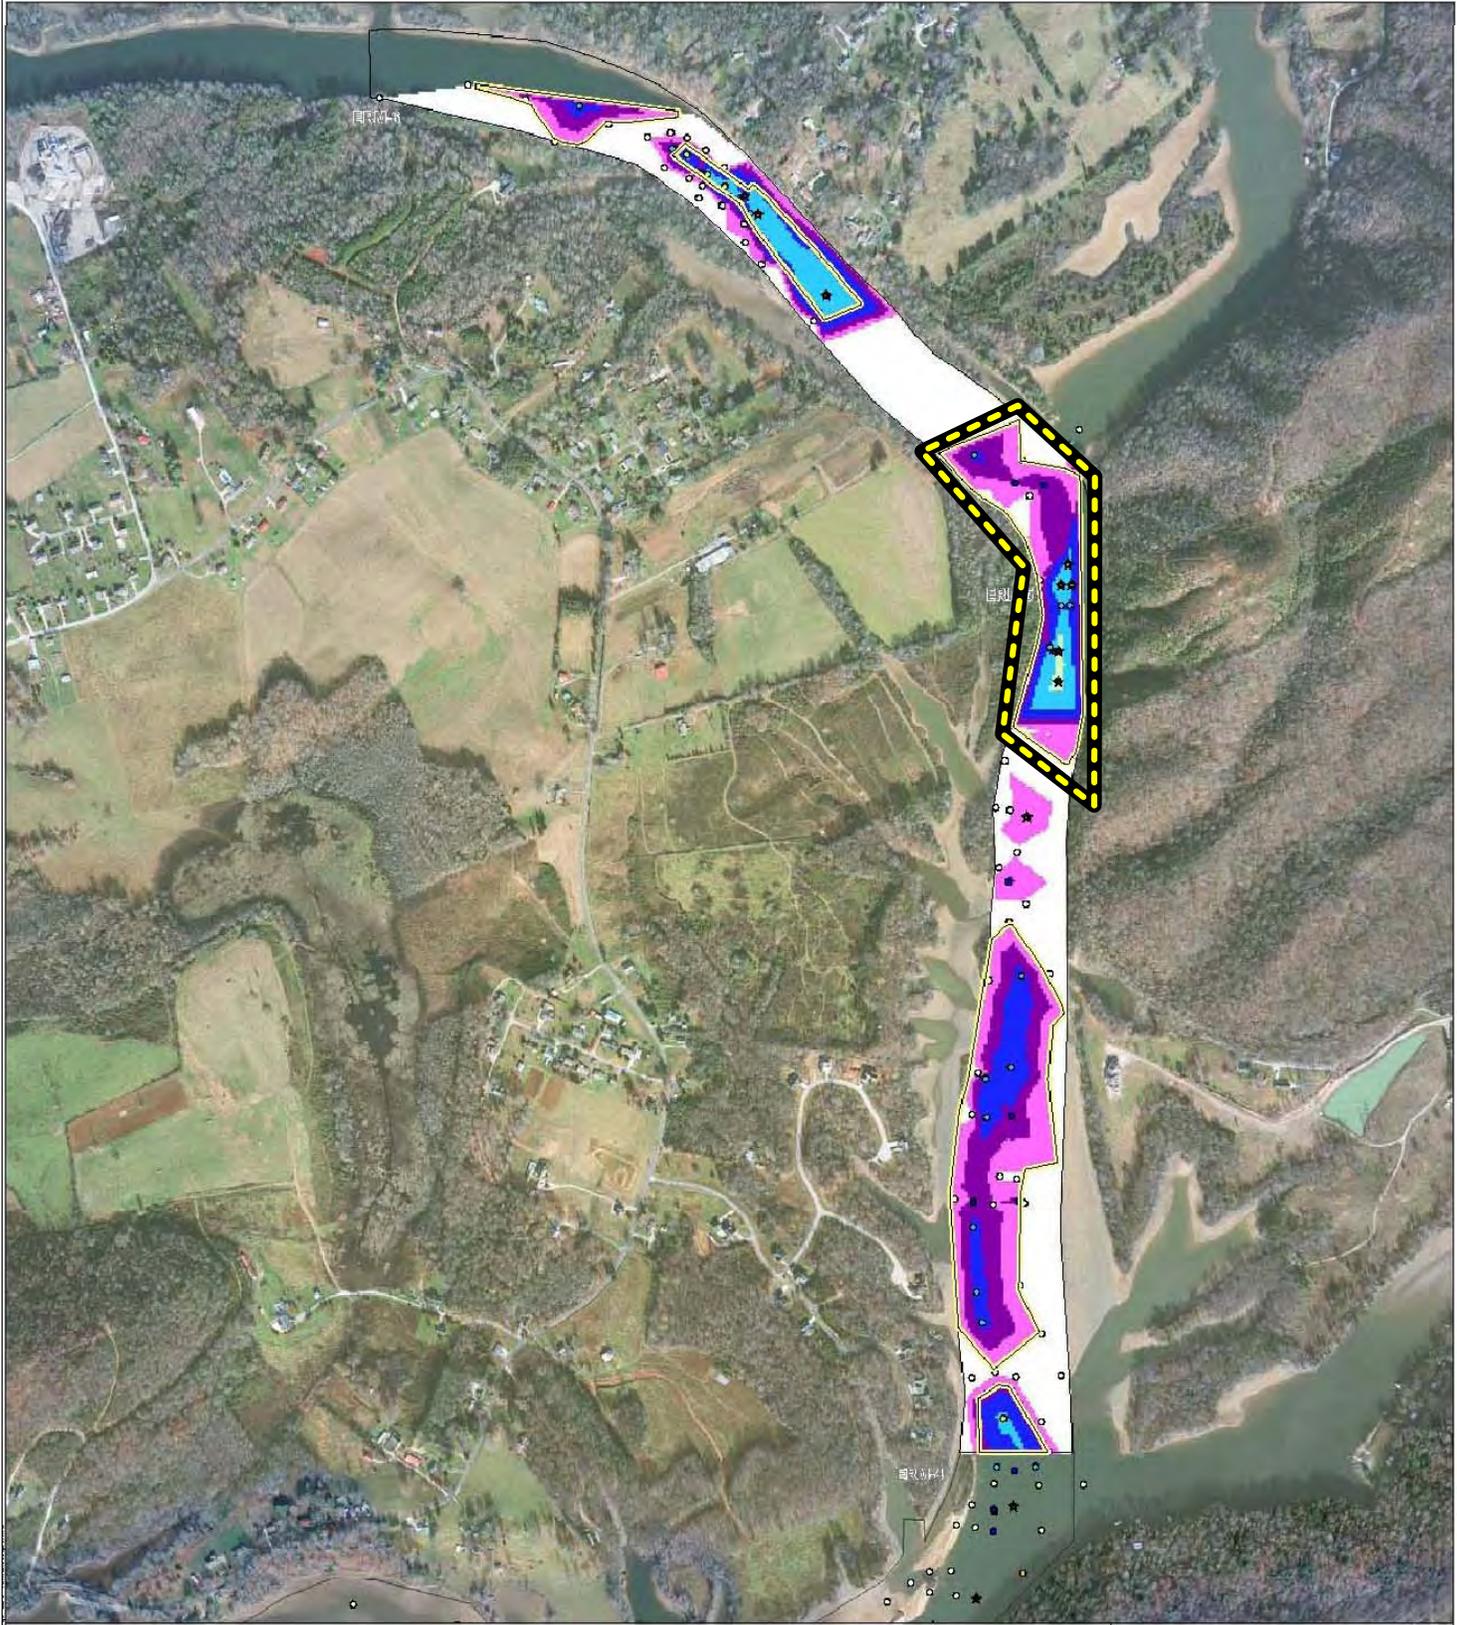
Figure 2

**Ash Remaining to Pre-Spill Surface Above Segment 5**

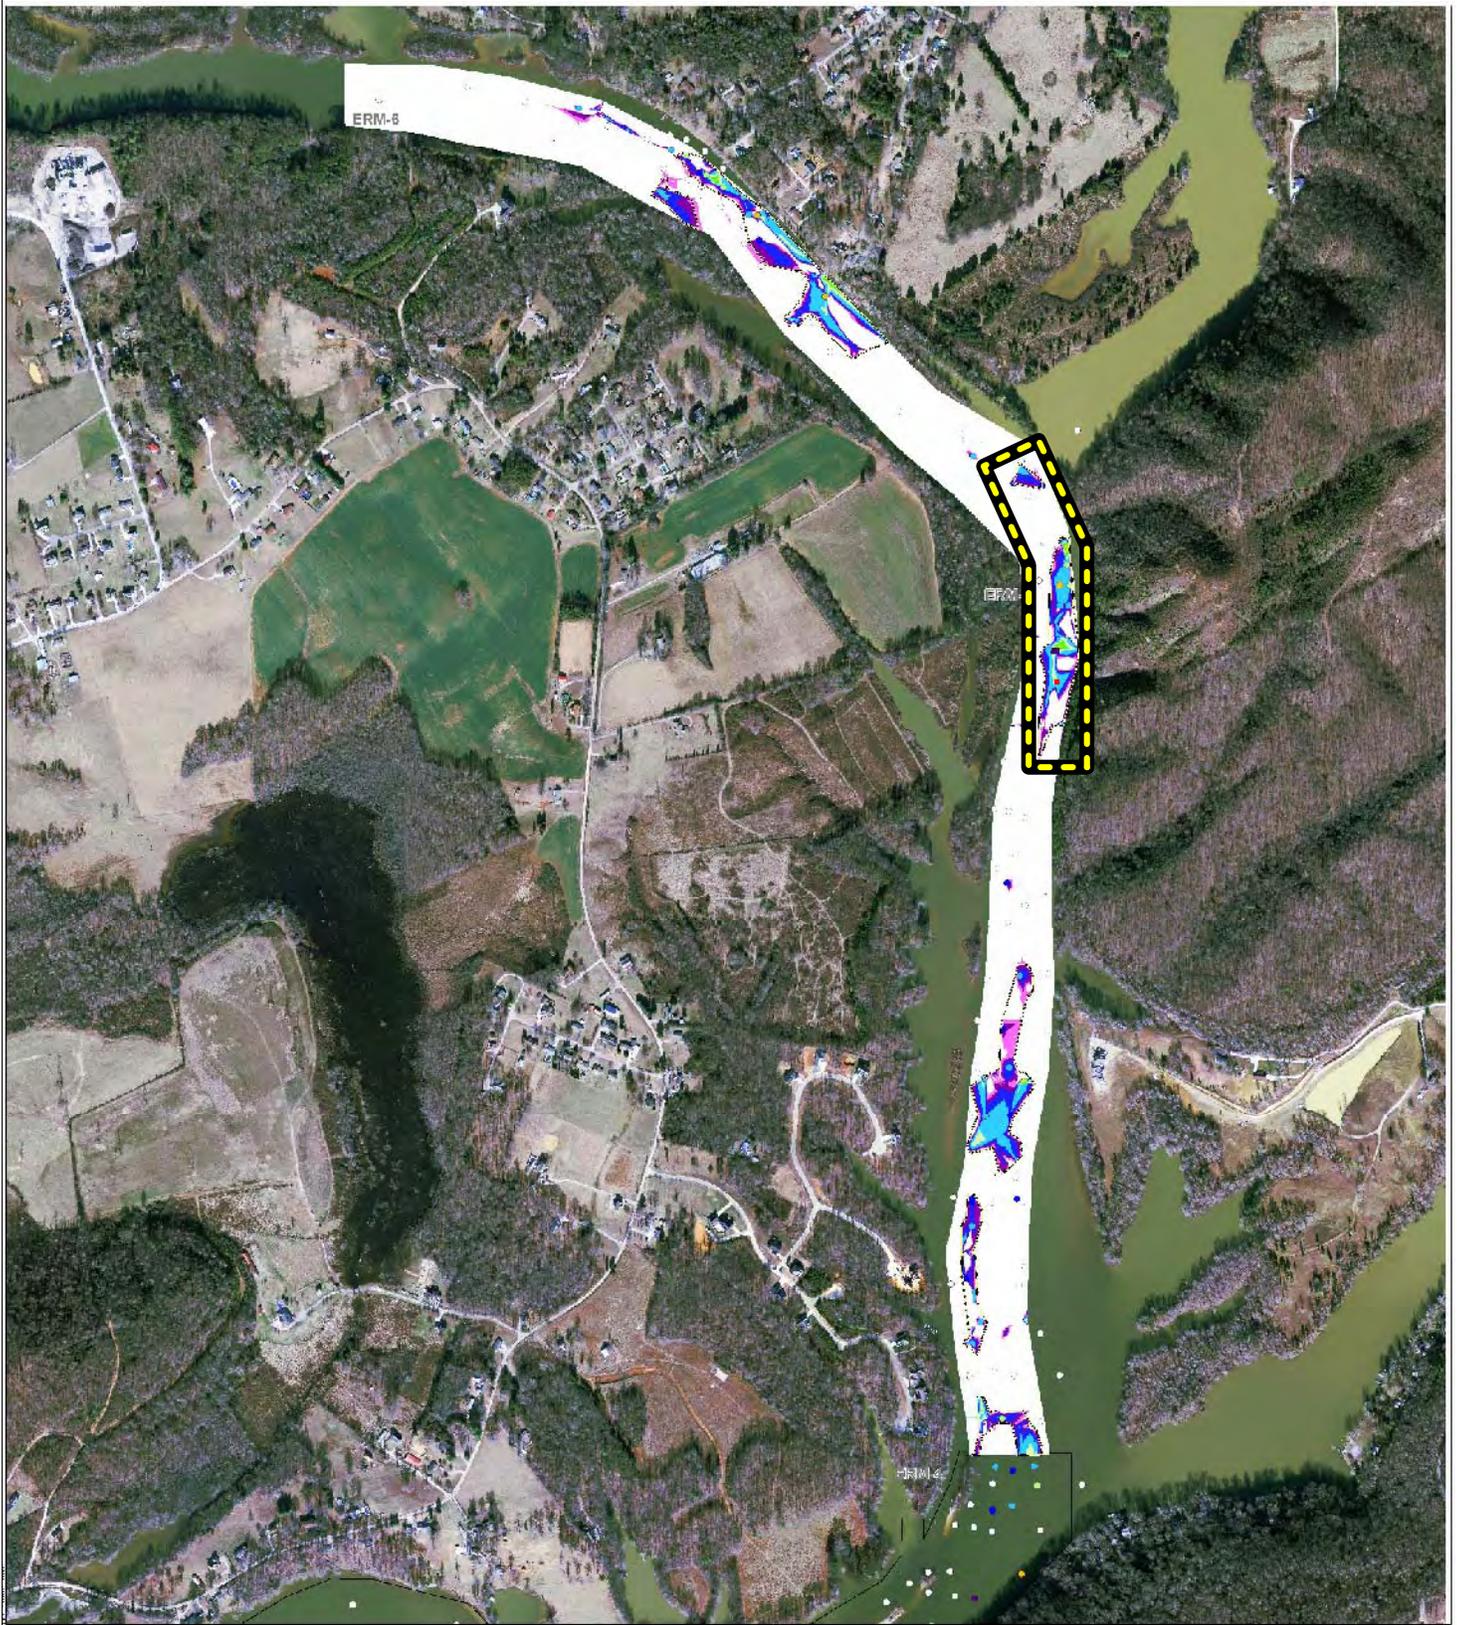
Figure 2

**Ash Remaining to Pre-Spill Surface Above Above Segment 5**

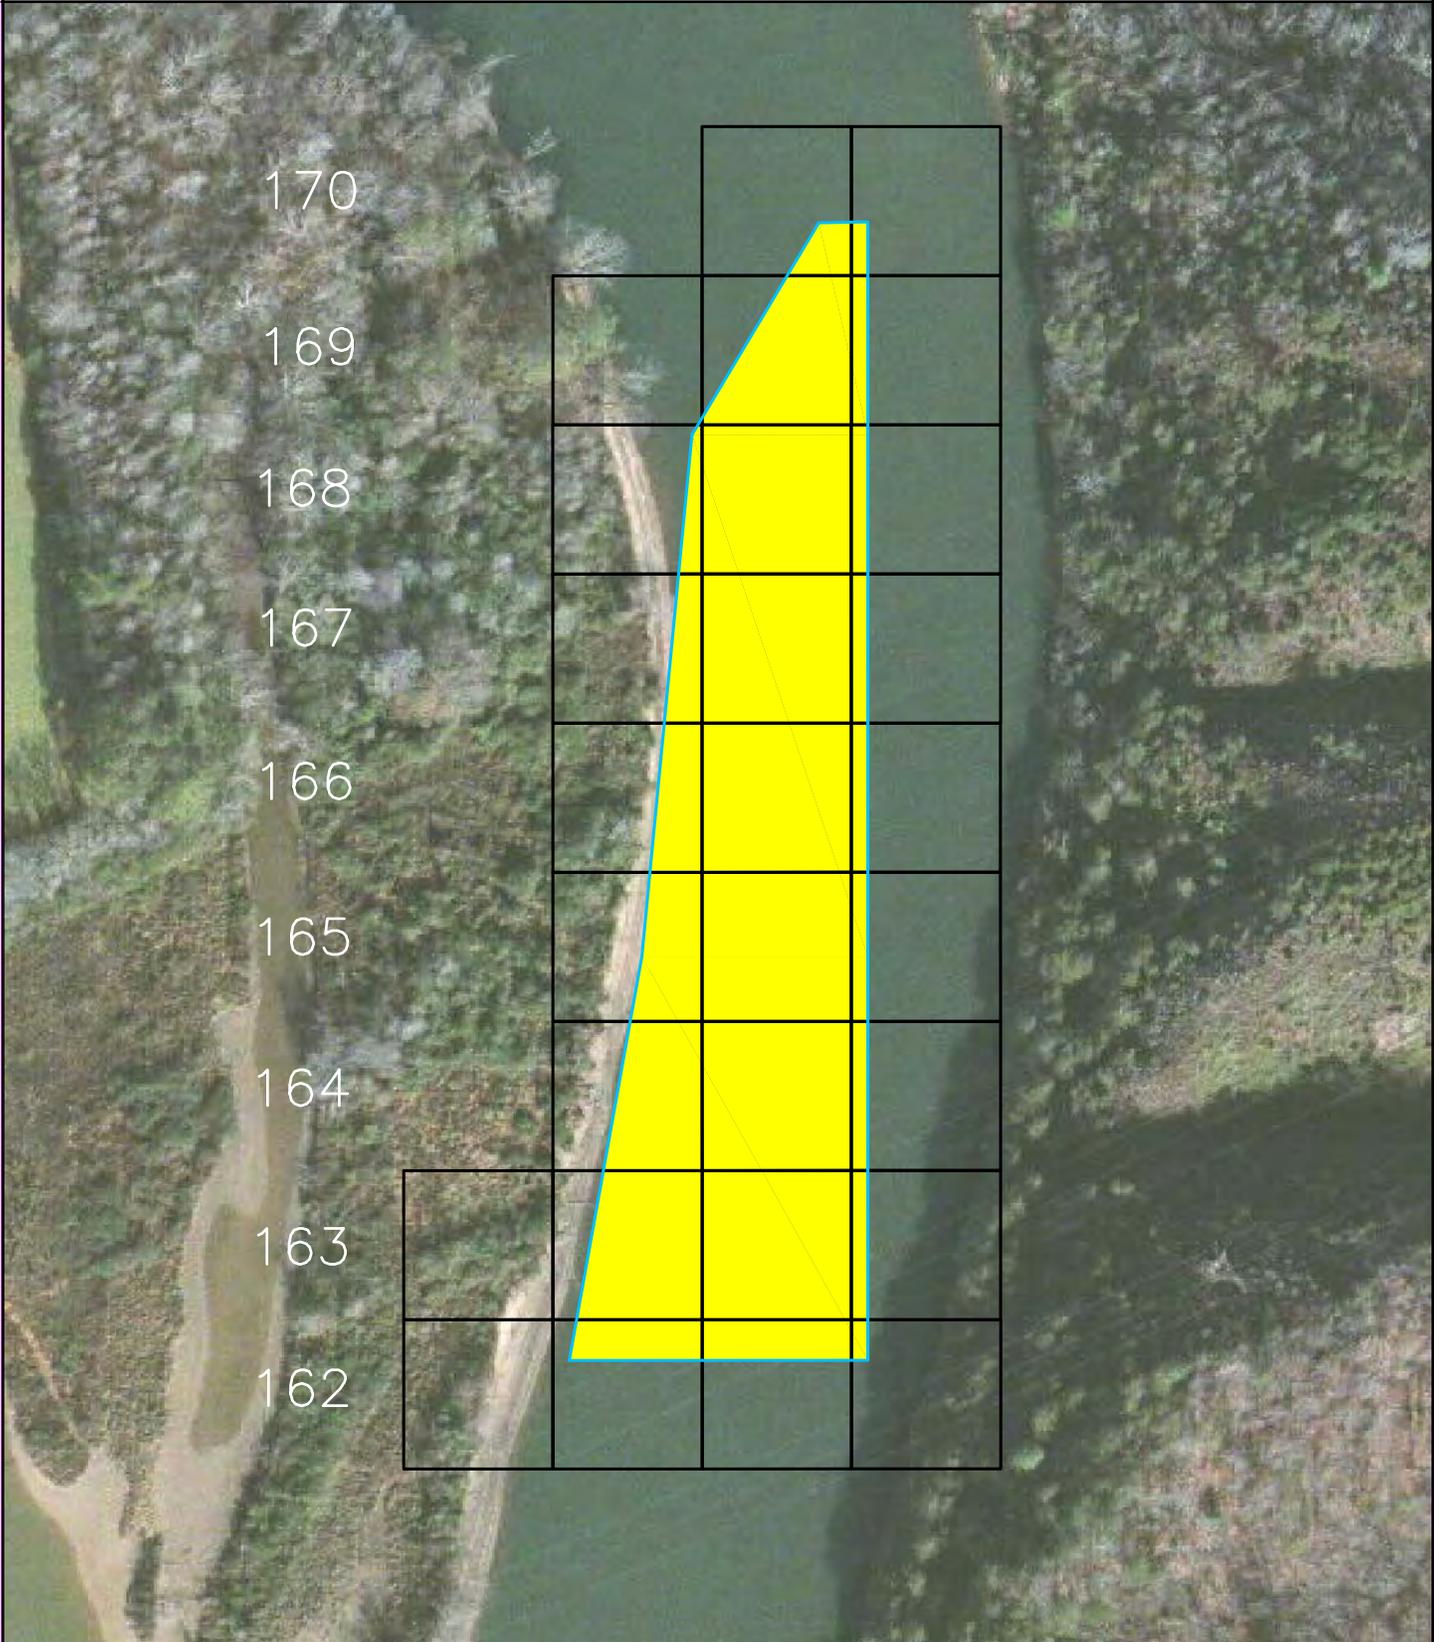
Figure 2

# Bathymetry Removal Areas - Above Above Segment 5

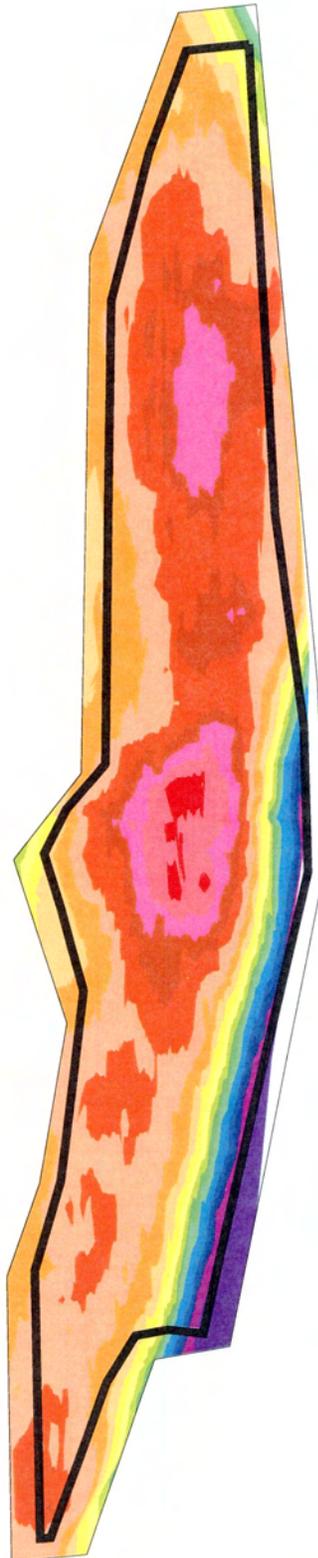
**BATHYMETRIC SURVEY  
05/24 AREA 3**

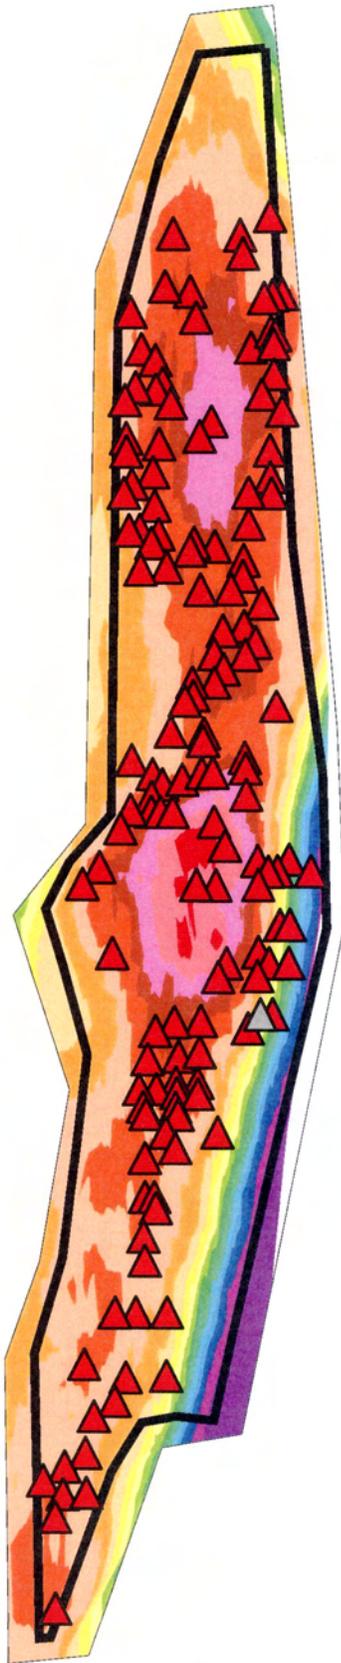
DRAWING	DATE: 05/25/10
	DRAWN BY: CML
	CHECKED BY:
Figure 5	CAD FILE: 0524_SEG 7 SURVEY
	SCALE:

The bathymetry dated 5/24 was used to calculate the ash that was not recoverable by this method. Approximately 1,000 cubic yards of modeled ash was calculated to be remaining at a greater depth than the clamshell bucket equipped PC-800 could reach. This ash is located below the 697' elevation and in portions of the area bounded by the pink hue and the field technician notes plotted in Figure 5.

**BATHYMETRIC SURVEY  
05/24 AREA 3**

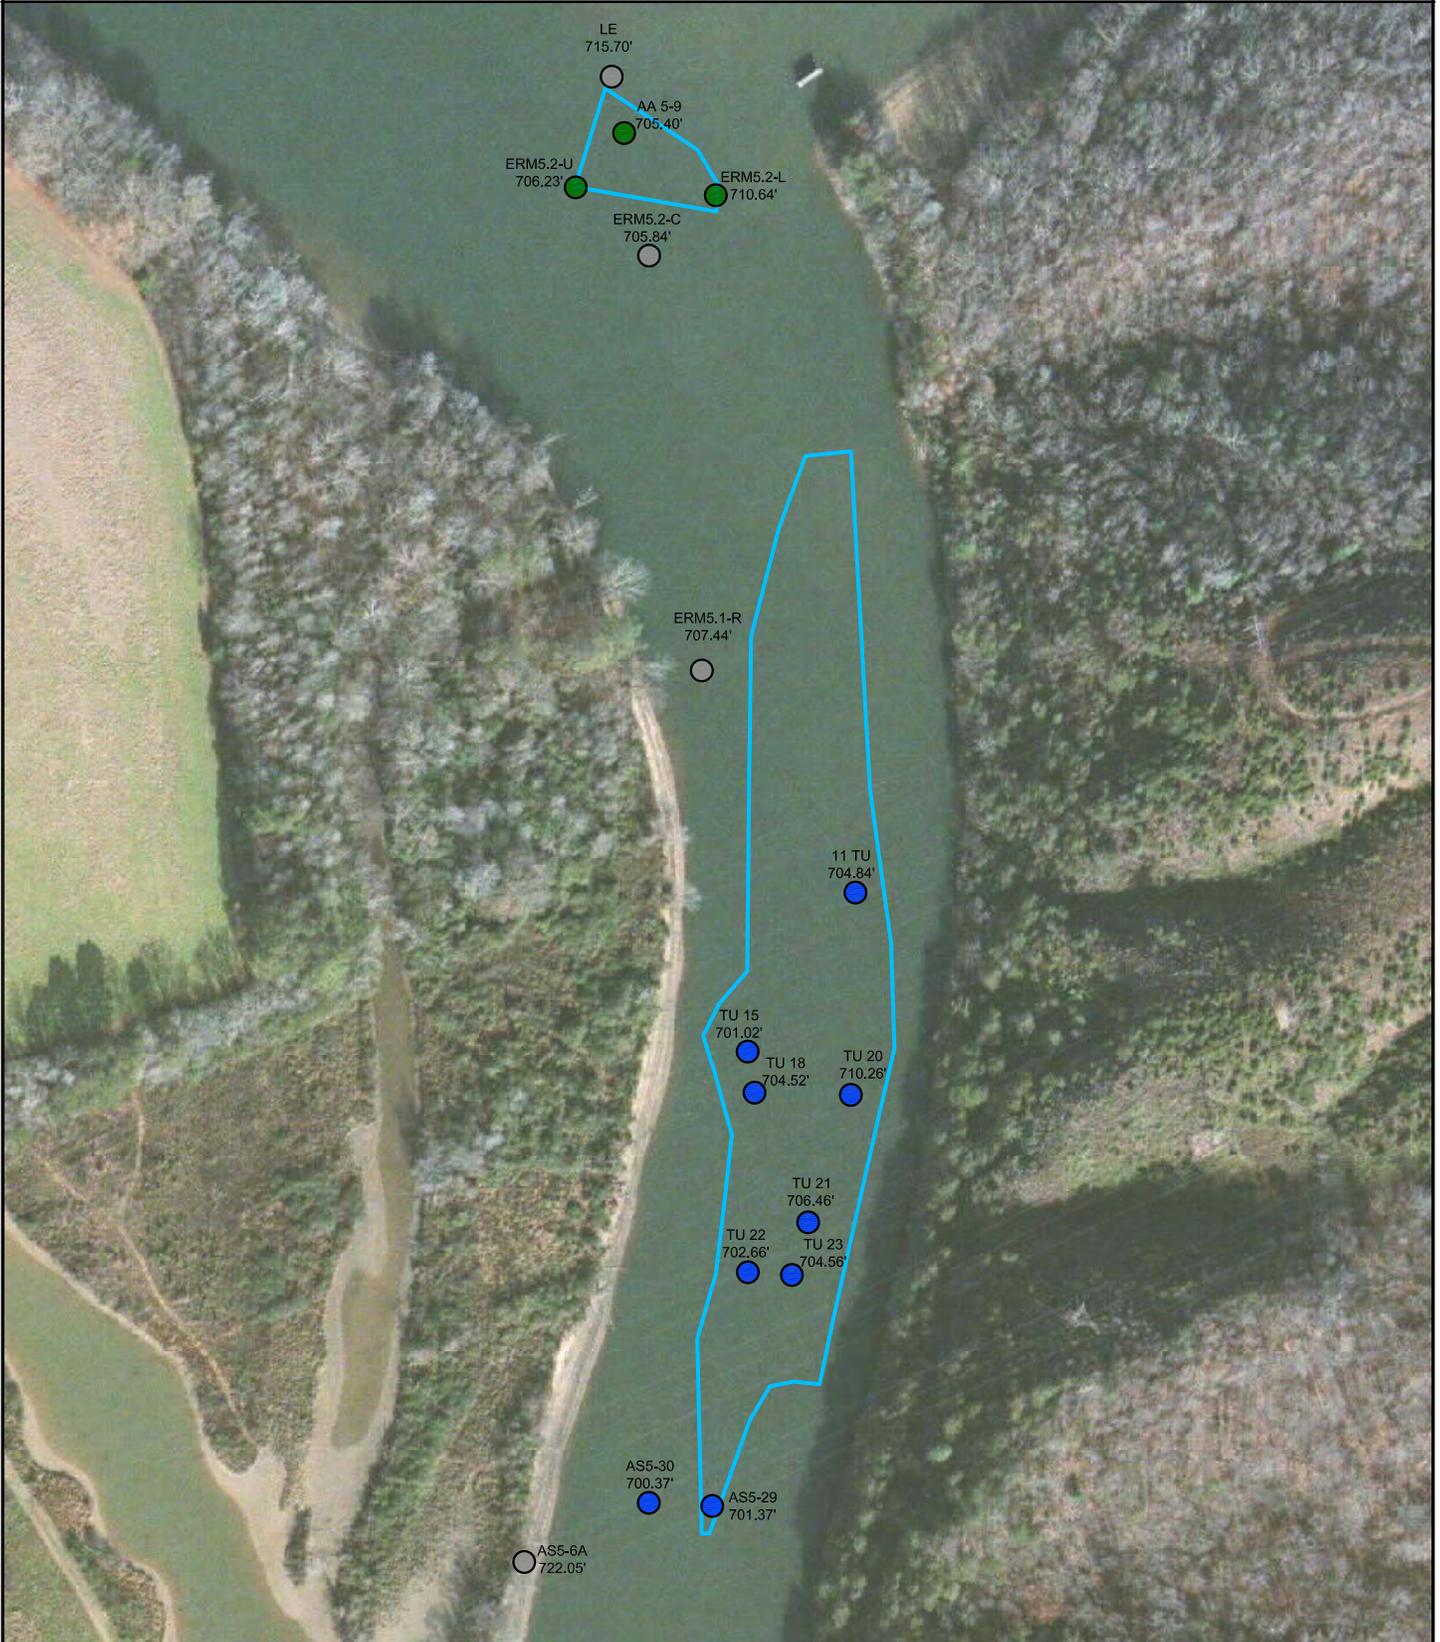
# VibeCore Concurrence Sampling Results - Above Above Segment 5 - Area 3

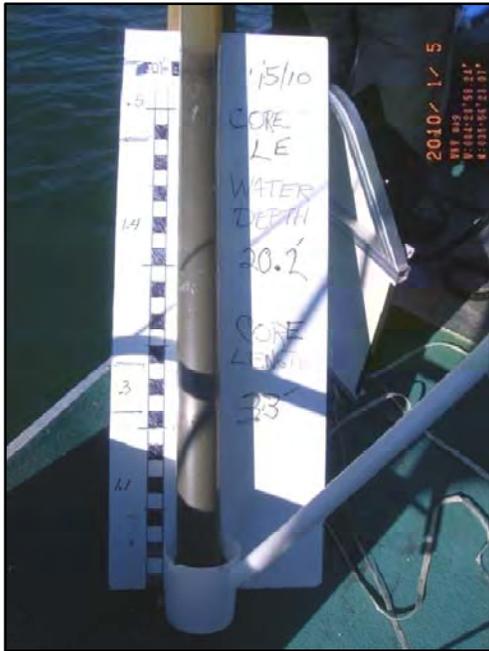
Core LE

Total core depth = 3.3'  
 Ash thickness = 0.0'  
 Water depth = 20.2'

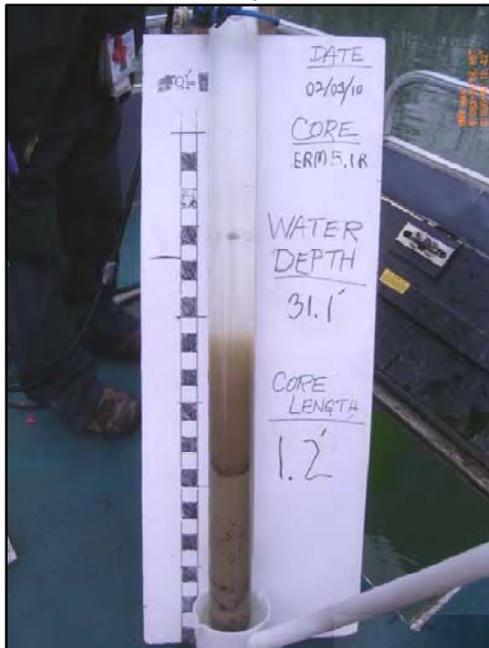
Core ERM5.1-R

Total core depth = 1.2'  
 Ash thickness = 0.0'  
 Water depth = 31.1'

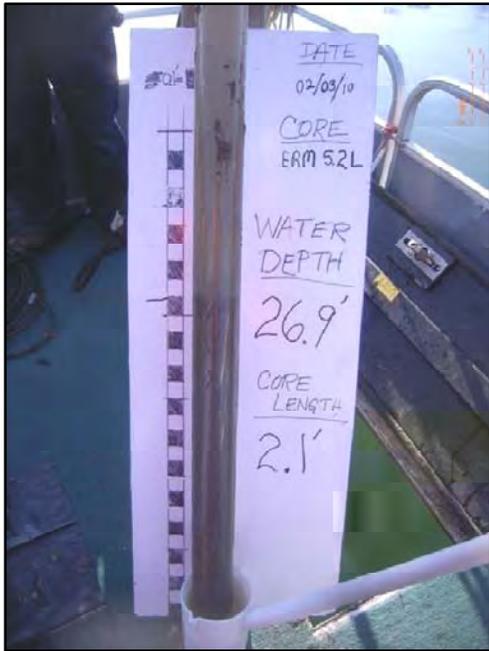
Core #	Photo #	Tube Type	Core Coordinates	River Depth	Time	Core Description	Interval (ft)
ERM5.2-L	R0010032	Acrylic	N: 566694.78' E: 2449195.7'	26.9'	16:29	[44% ash] ash with mixed fines approximately 50-60% organic matter; of fine fraction is >50%ash [5% ash] high organic material content, coarse sands mixed with silt, no visible ash, strong odor: decomp	0-1.0 1.0-2.1
Deviations encountered: refusal on rock Results of ash analysis sent for PLM noted as [%]							
						Total Depth	2.1'

Core ERM5.2-L  
Total core depth = 2.1'  
Ash thickness = 1.0'  
Water depth = 26.9'

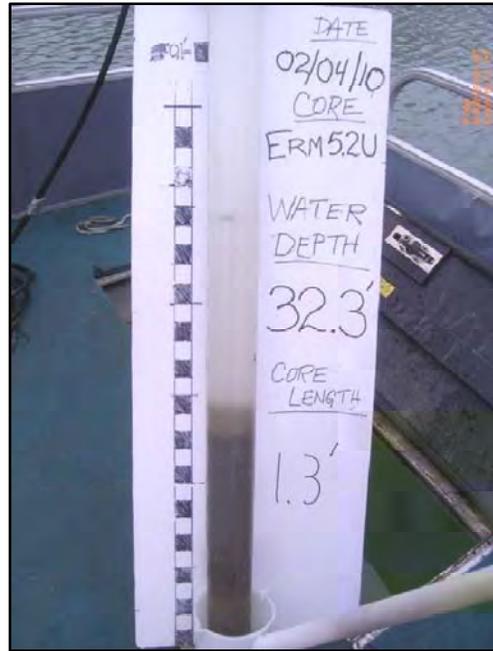
Core ERM5.2-U  
Total core depth = 1.3'  
Ash thickness = 0.6'  
Water depth = 32.3'

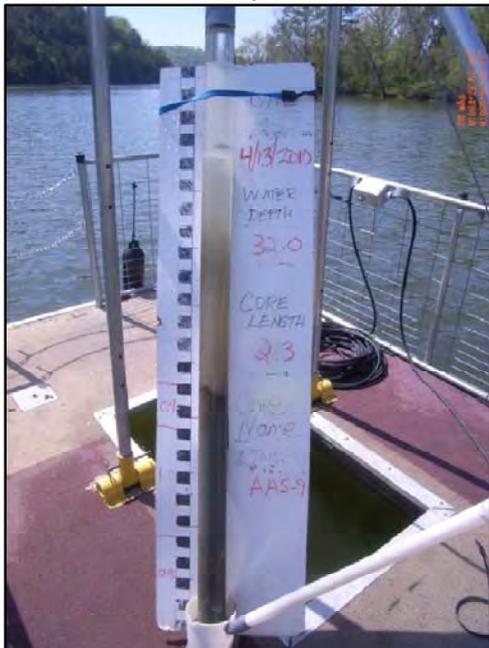
Core AA 5-9  
Total core depth = 2.3'  
Ash thickness = 1.0'  
Water depth = 32.0'
