SPILLWAY TEST TRENCHES NO. 1 AND NO. 2 PHOTOGRAPHIC LOG

Client Name: Tennessee Valley Authority	Site Location: Kingston Fossil Plant – Harriman, Tennessee	Project No.: 60095742
---	--	---------------------------------

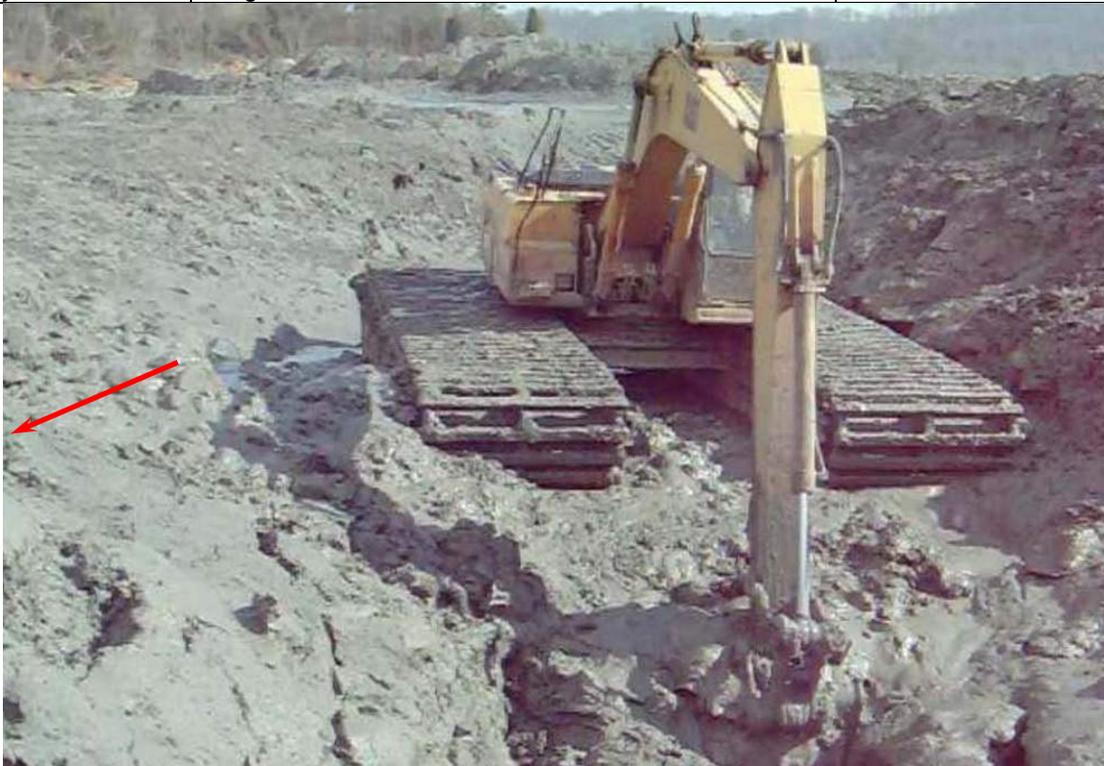
Photo No. 1	Date: 1-25-09
------------------------------	-------------------------

Screen capture 1 from a 14.25 minute QuickTime video of excavation attempt at Trench No. 1. Wide view looking toward the east. Arrow points to surveyor's stake location which is just off-screen to the left (north).

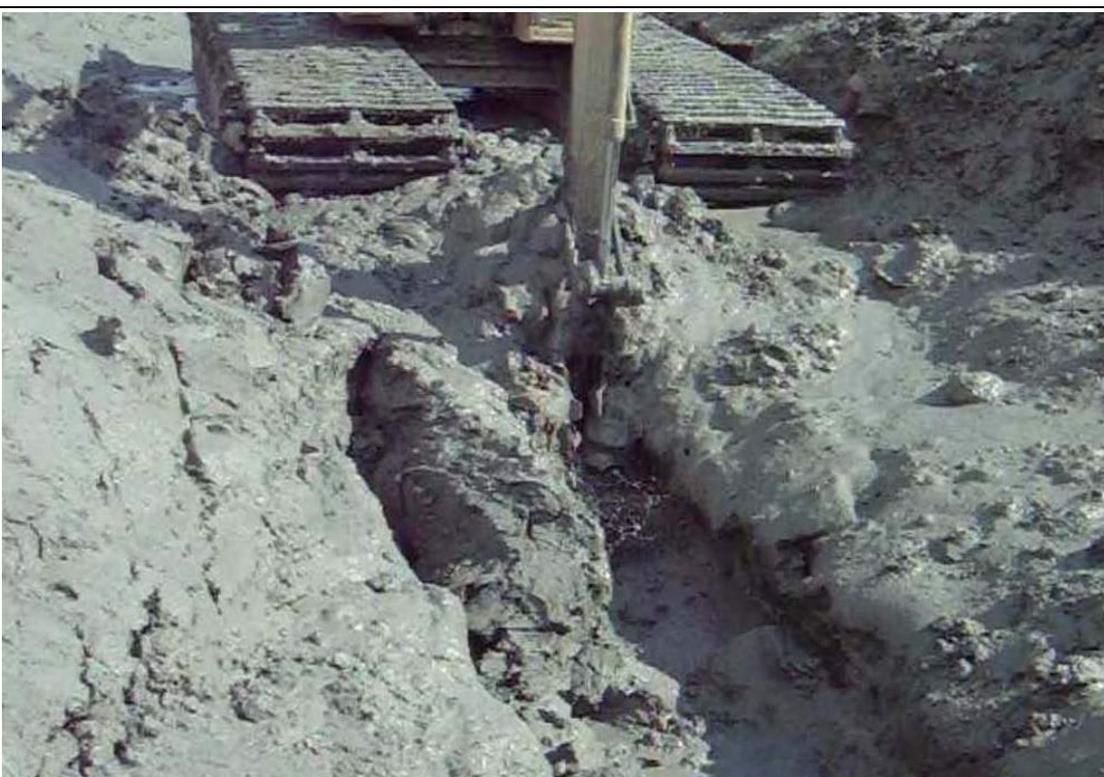
Photo No. 2	Date: 1-25-2009
------------------------------	---------------------------

Screen capture 2 from a 14.25 minute QuickTime video of excavation attempt at Trench No. 1.

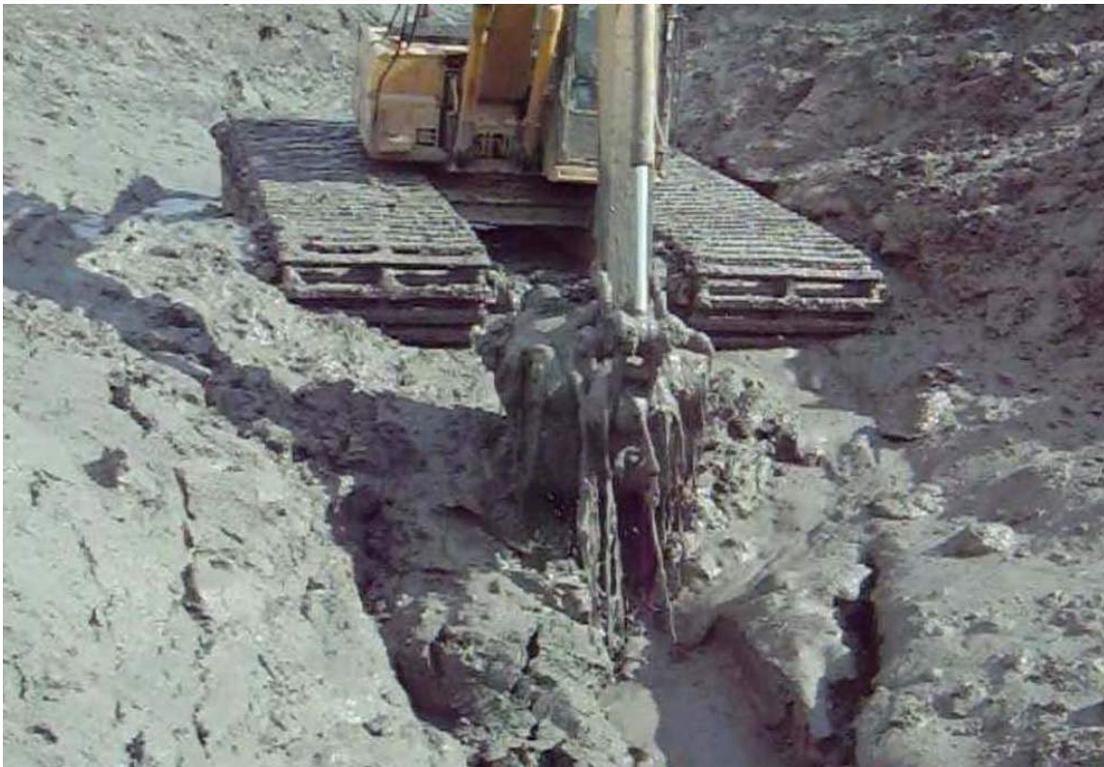
Direction Photo Taken: Looking east.			
Description: Screen capture 2 from a 14.25 minute QuickTime video of excavation attempt at Trench No. 1.

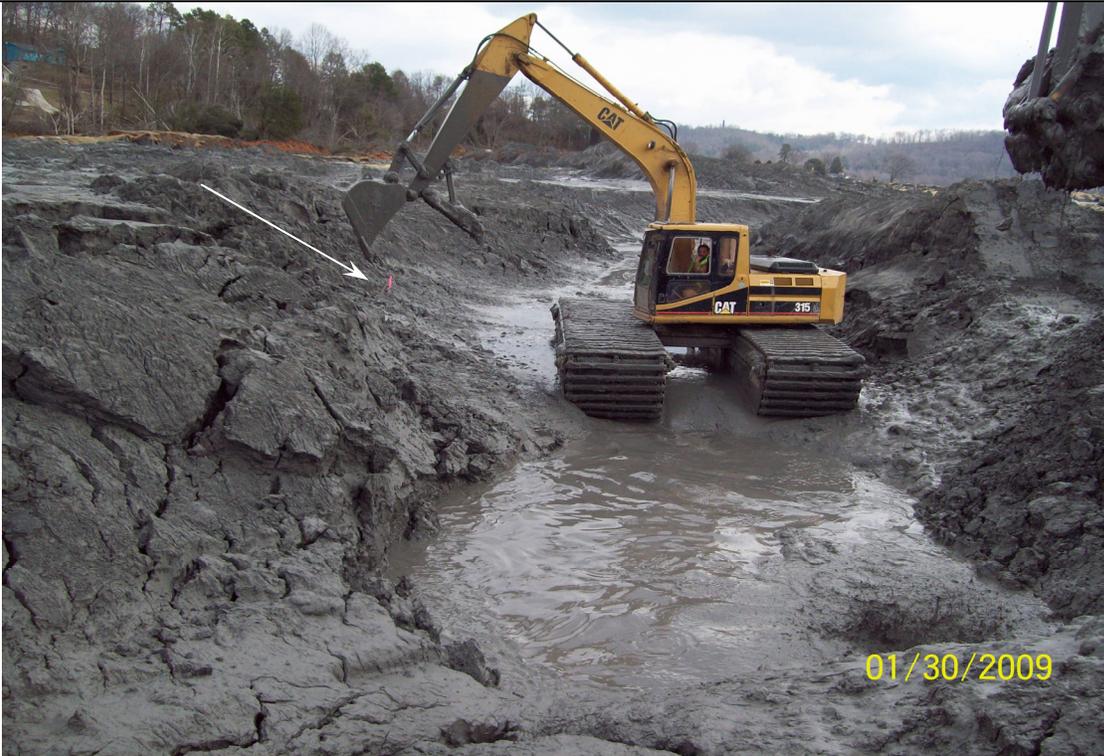
Photo No. 4	Date: 1-30-2009

Direction Photo Taken: Looking east.			
Description: Wide view of Trench No. 1 during second attempt to locate outfall piping. Two trackhoes working in tandem to probe for concrete outlet pipe or dike remnants. White arrow illustrates surveyor stake. Trackhoe has moved east along drainage. Initial excavation took place near stake.

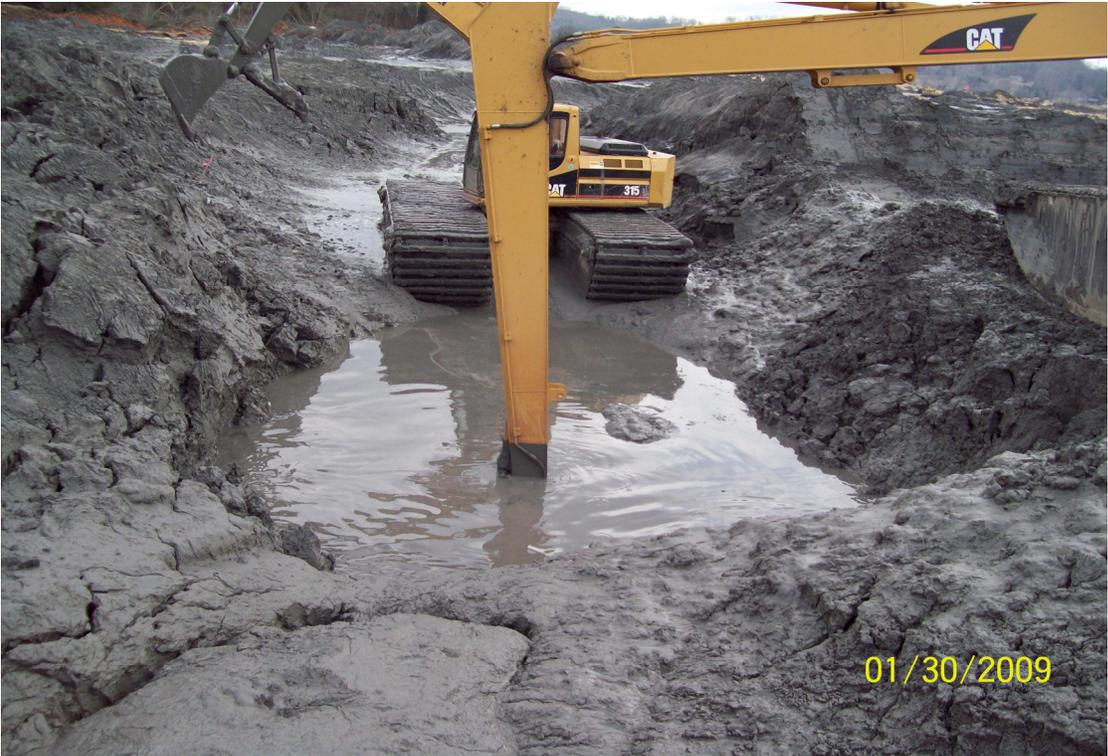
Direction Photo Taken: Looking east.			
Description: Long-stick amphibious trackhoe probing to a depth of approximately 10 feet at Trench No.1. Note: Consistency is that of a milkshake, thus any dike remnant, clay, or concrete pipe would be easily identifiable.

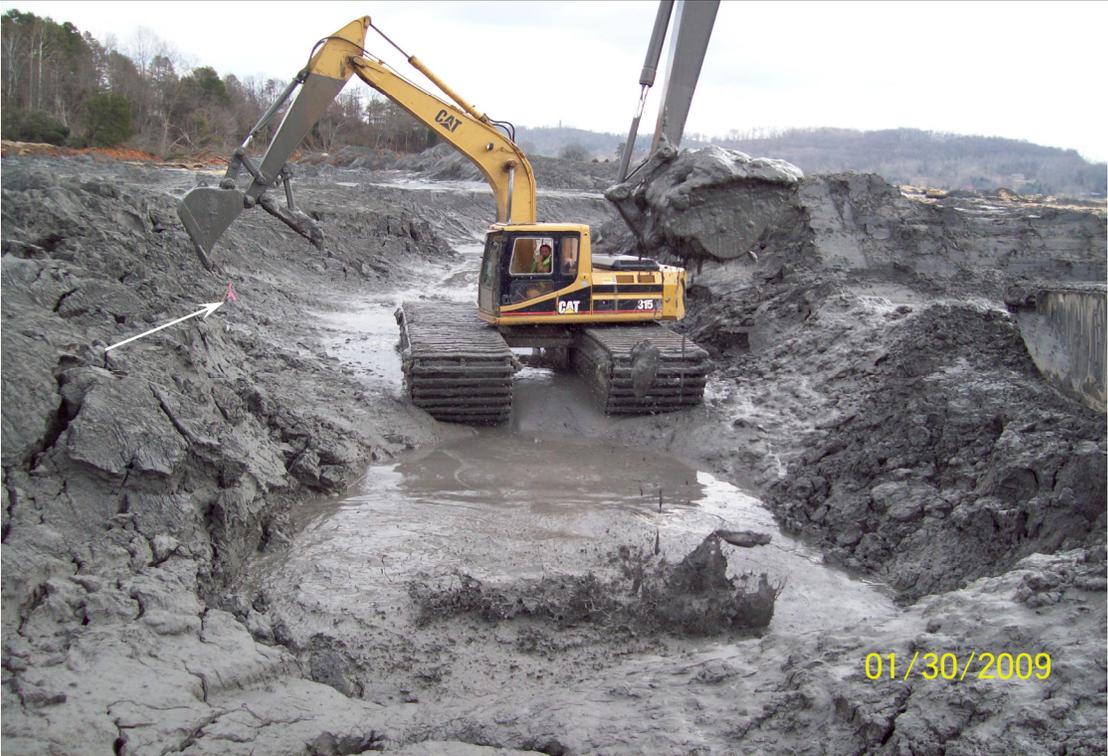
Photo No.: <b style="font-size: 1.2em;">6	Date: 1-30-2009

Direction Photo Taken: Looking east.			
Description: Long-stick trackhoe removing some ash from the base of the excavation at Location Trench No. 1. Note: Consistency is that of a milkshake, thus any dike remnant, clay, or concrete pipe would be easily identifiable. White arrow highlights surveyor's stake.

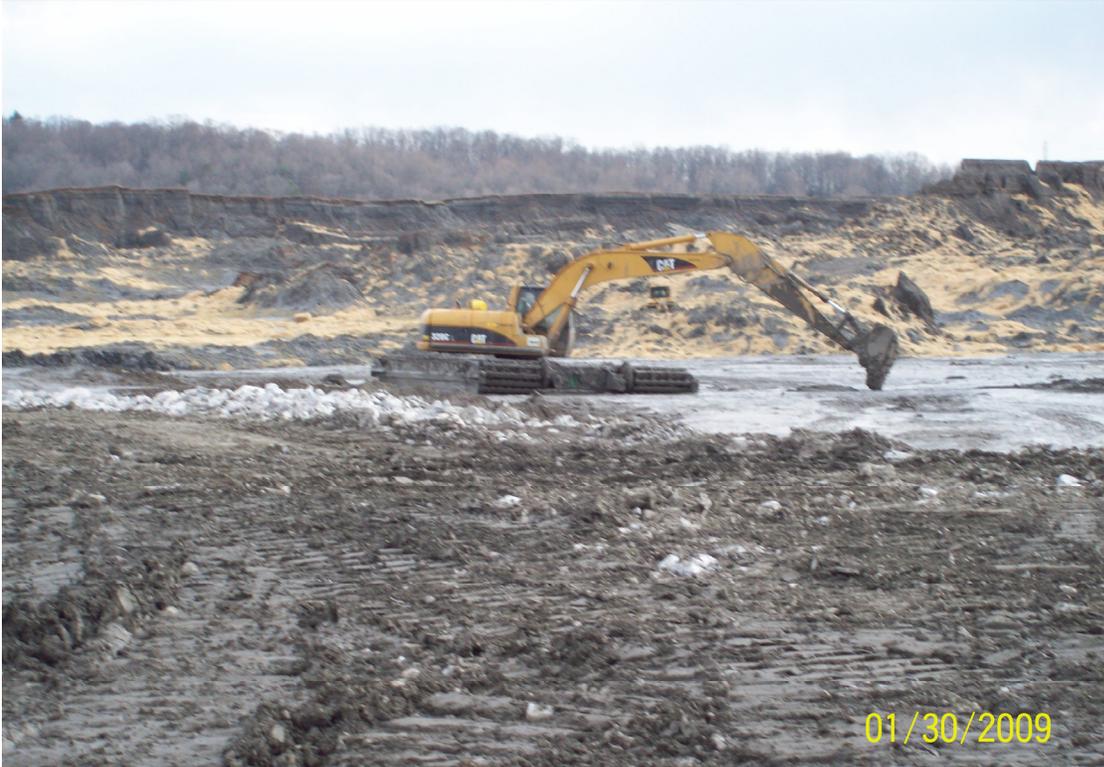
Direction Photo Taken: Looking southeast.			
Description: Initial excavation activity at Trench No. 2.

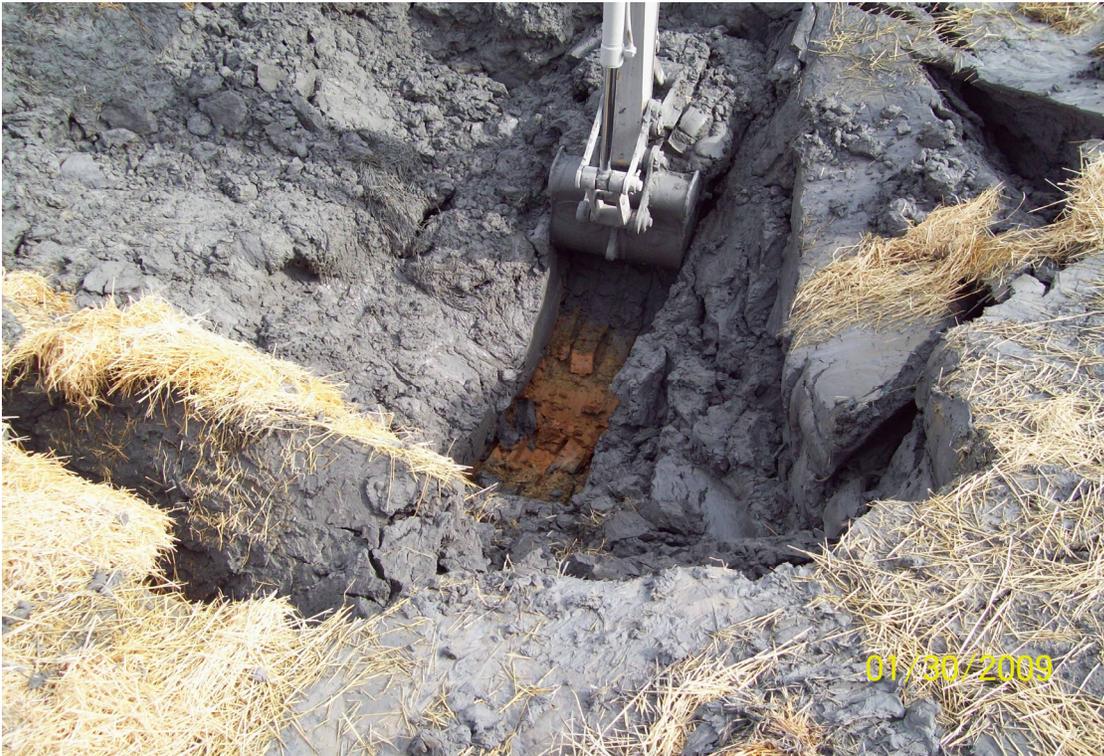
Photo No. 8	Date: 1-30-2009

Direction Photo Taken: Looking vertical.			
Description: Trench No. 2 encountered dike material at a depth of approximately 9 feet below ground (ash) surface near Test Boring Location 09-206.

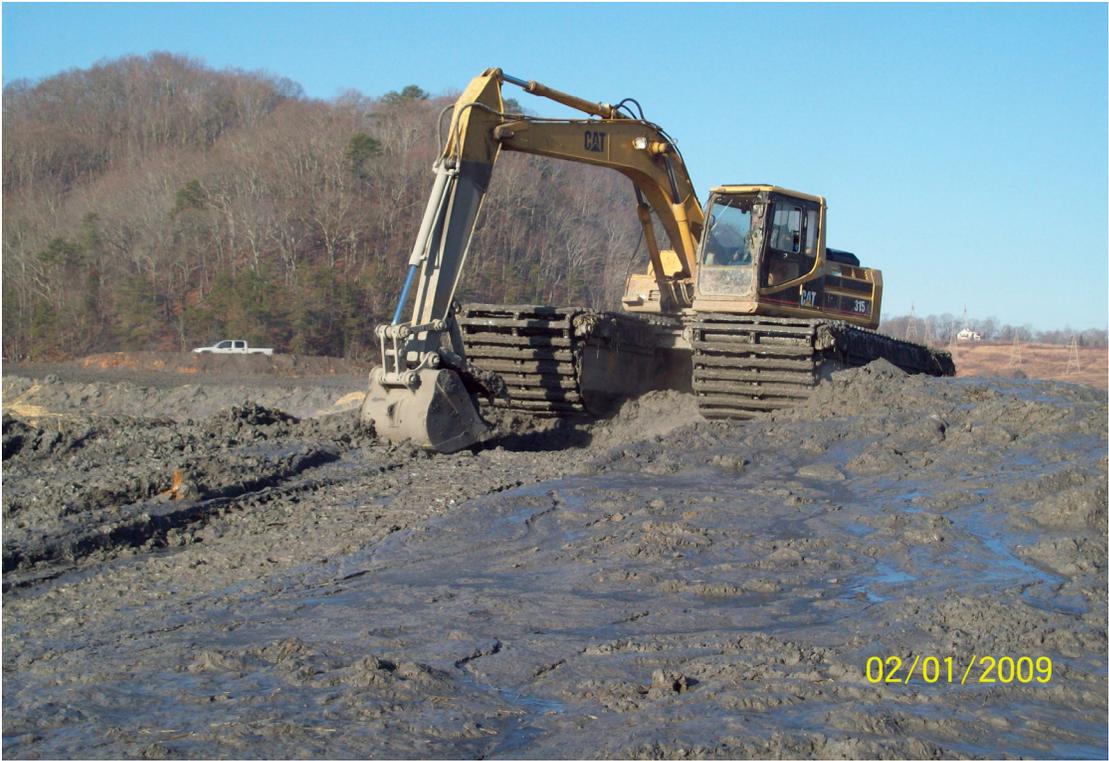
Direction Photo Taken: Looking northeast.			
Description: Amphibious trackhoe moving ash to prevent sloughing into Trench No. 2 during excavation of the outfall pipe. Immediately behind the hoe is a large surface water drainage that prevented exposure of the northeast end of the pipe.

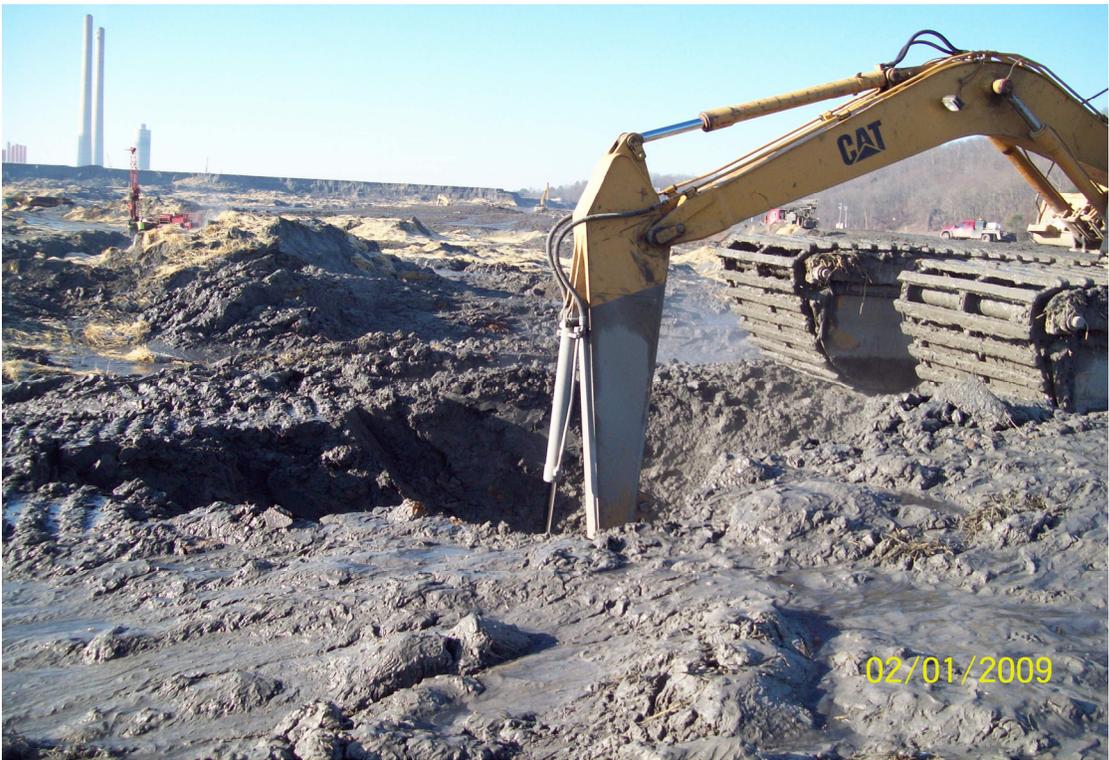
Photo No.: <b style="font-size: 1.2em;">10	Date: 2-1-2009

Direction Photo Taken: Looking south-southwest.			
Description: Trackhoe moving ash during excavation of the outfall pipe at Trench No. 2. Kingston Fossil Plant smokestacks in the background. AECOM drill rig visible in near background drilling at Location 09-105.

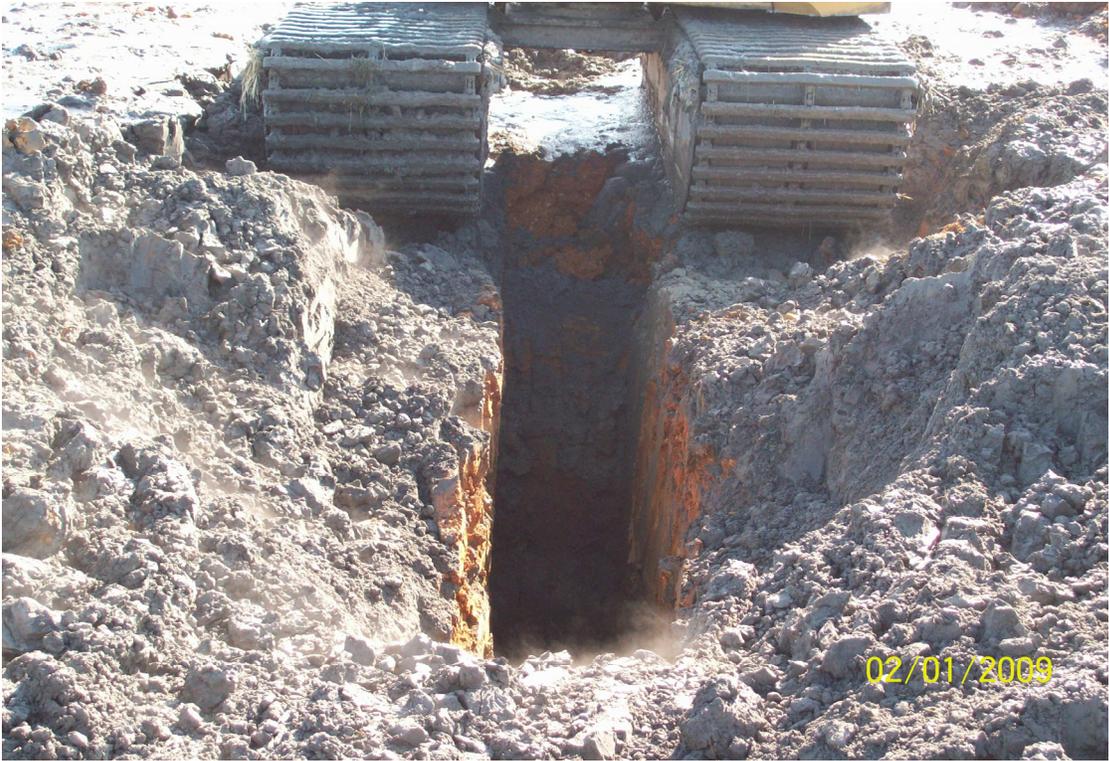
Direction Photo Taken: Nearly vertical.			
Description: Excavating through the dike material in search of the outfall pipe.

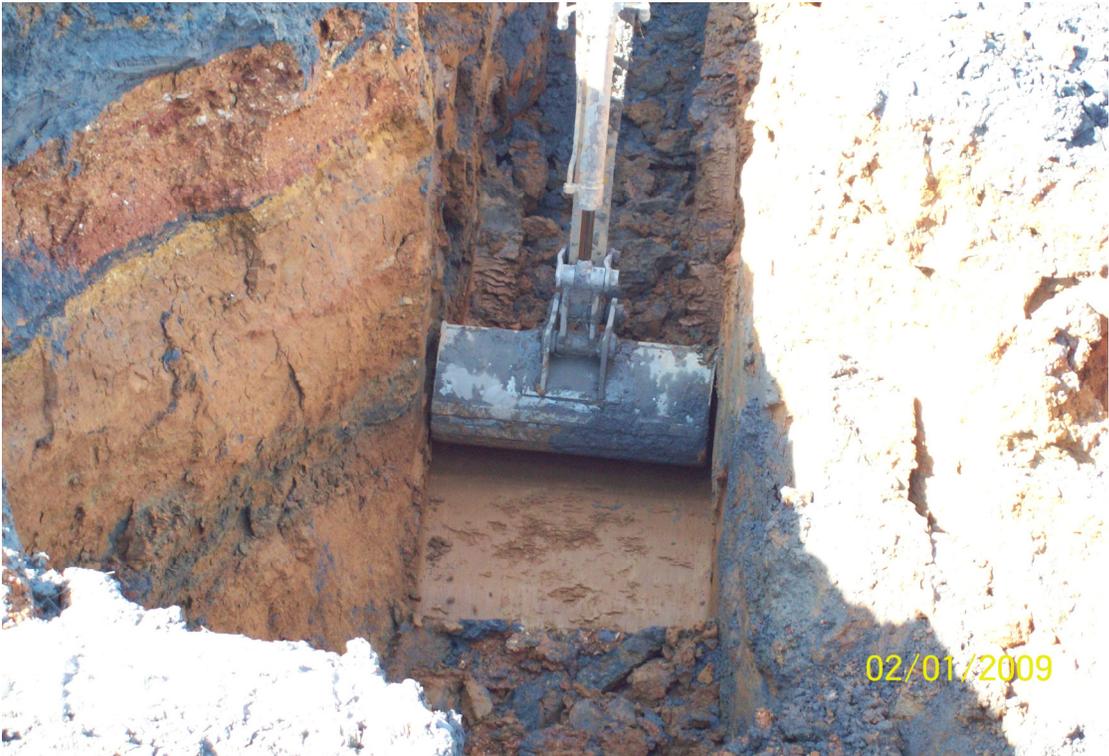
Photo No. 12	Date: 2-1-2009

Direction Photo Taken: Nearly vertical.			
Description: Excavation approaching outfall pipe. Note the red clay cap on top of the brown silt/silty clay natural soil material.

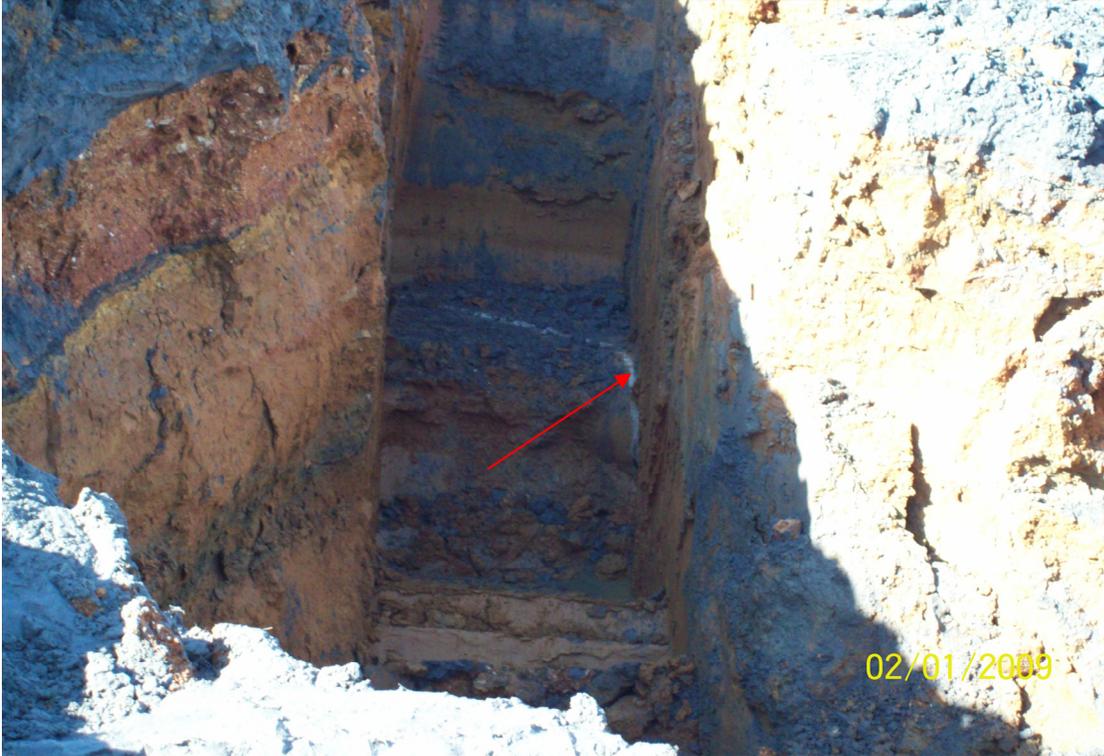
Direction Photo Taken: Nearly vertical.			
Description: Outfall pipe located. Arrow highlights a trackhoe bucket scratch on the concrete.

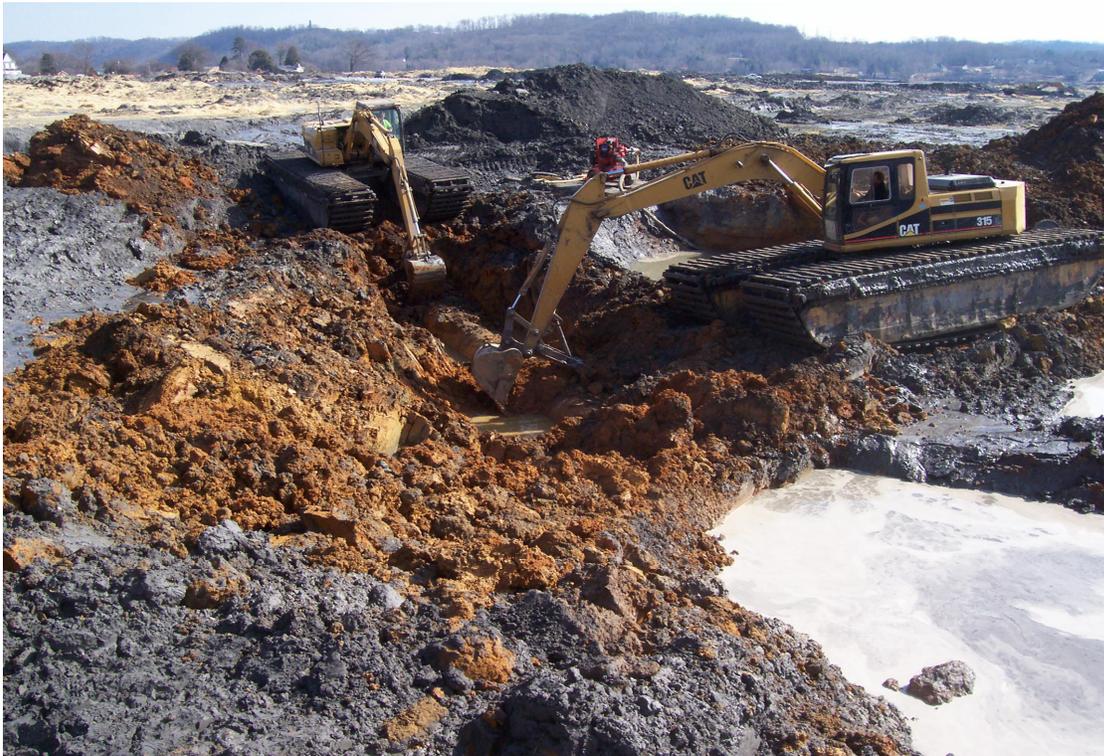
Photo No.: 14	Date: 2-1-2009

Direction Photo Taken: Looking east-southeast.		
Description: Unearthing the outfall pipe. Pool of water at the lower left was created by the clay “dam” to keep soft ash from sloughing into the trench.

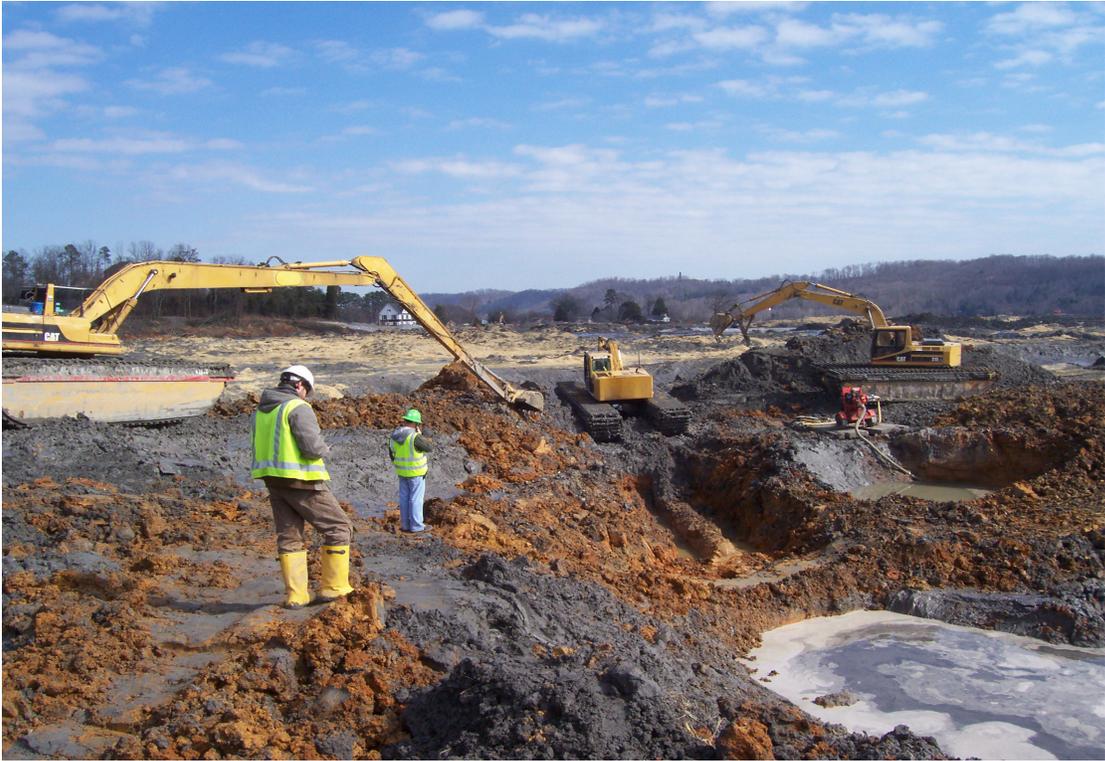
Direction Photo Taken: Looking east.			
Description: Trackhoes continue excavation of outfall pipe. Pump at right continues to keep water level low in adjacent sump which was originally dug to keep water out of excavation.

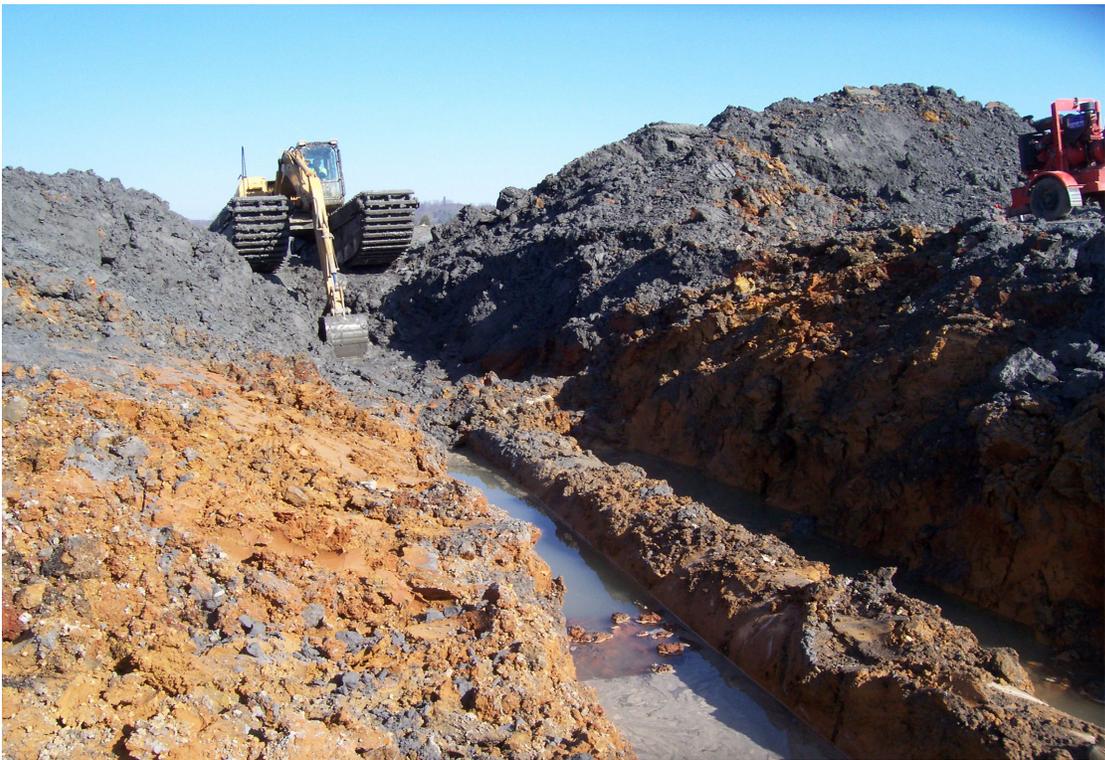
Photo No. 16	Date: 2-6-2009

Direction Photo Taken: Looking east.			
Description: Excavation nearly complete. East end of outfall pipe was not exposed because it extends underneath a large drainage immediately behind the trackhoe in this photo. The elevation of the water in the drainage would likely flood the excavation.

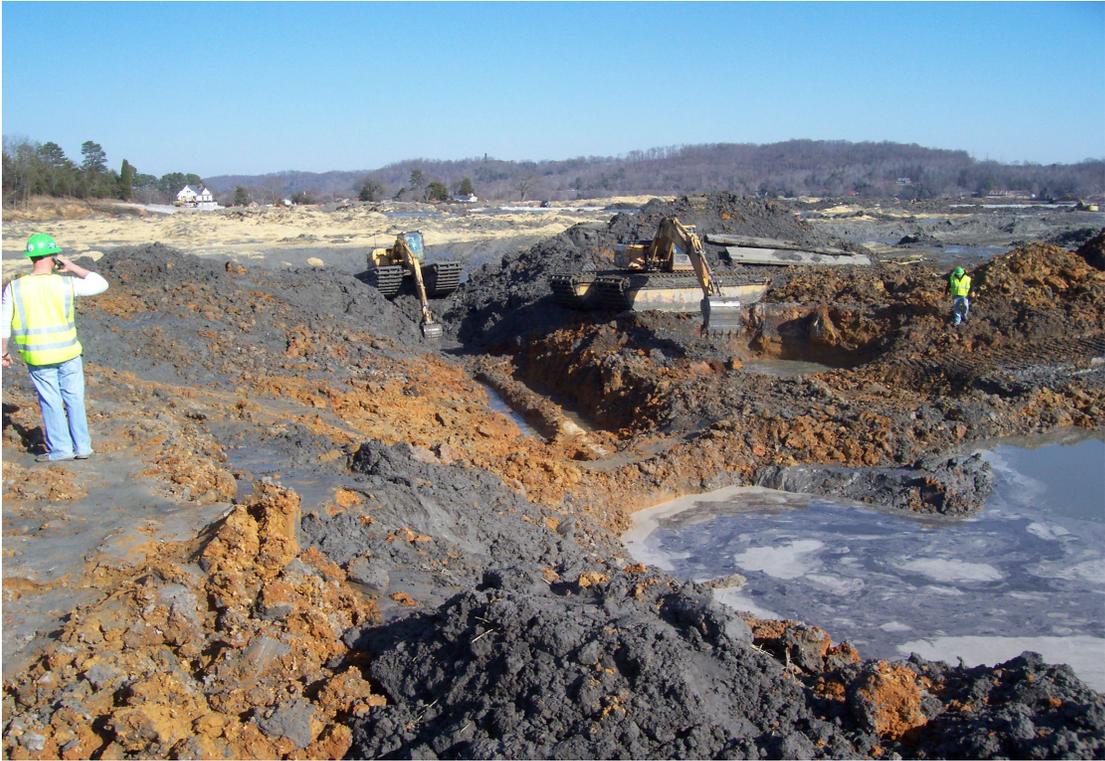
Direction Photo Taken: Looking east.			
Description: Deepening the sump to protect excavation from flooding.

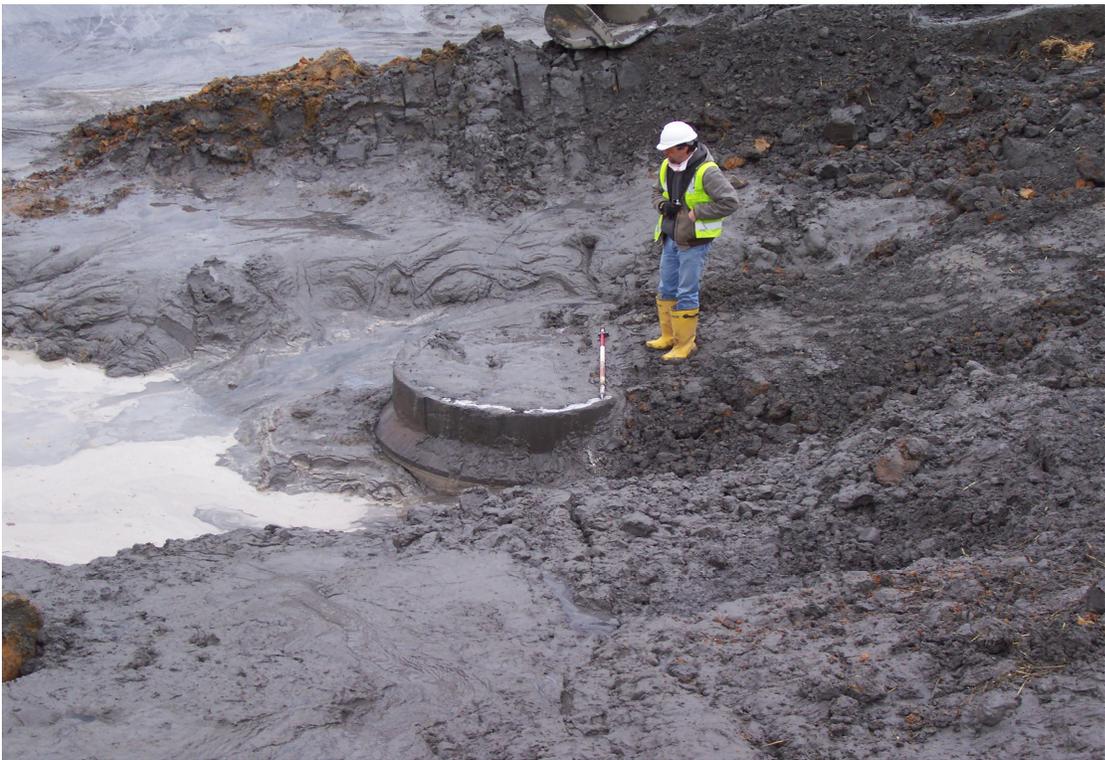
Photo No. 18	Date: 2-8-2009

Direction Photo Taken: Looking southwest.			
Description: Outfall pipe intake structure observed after water was drained from the upper pool into the lower sump and pumped out. Note that the intake pipe is intact and full of ash. Survey rod is approximately 4.5 feet long.

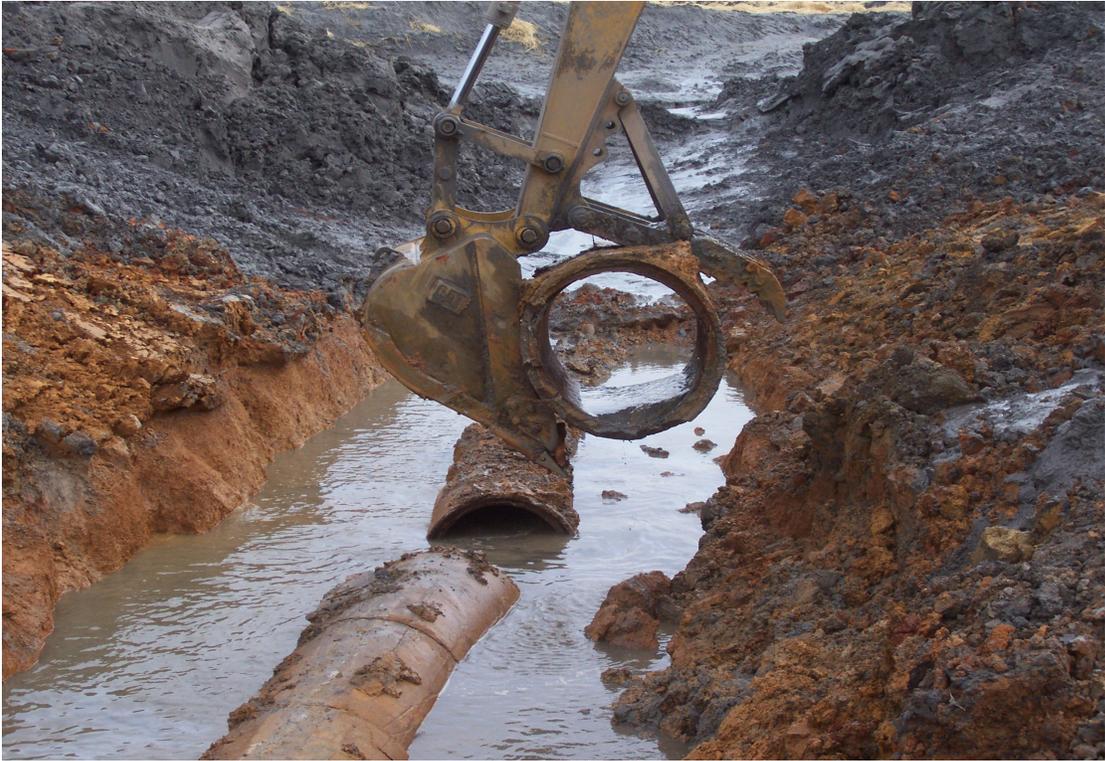
Direction Photo Taken: Looking east.			
Description: One four-foot section of the outfall pipe was removed to observe condition of the pipe. Note the small amount of ash inside the lateral portion of the pipe.

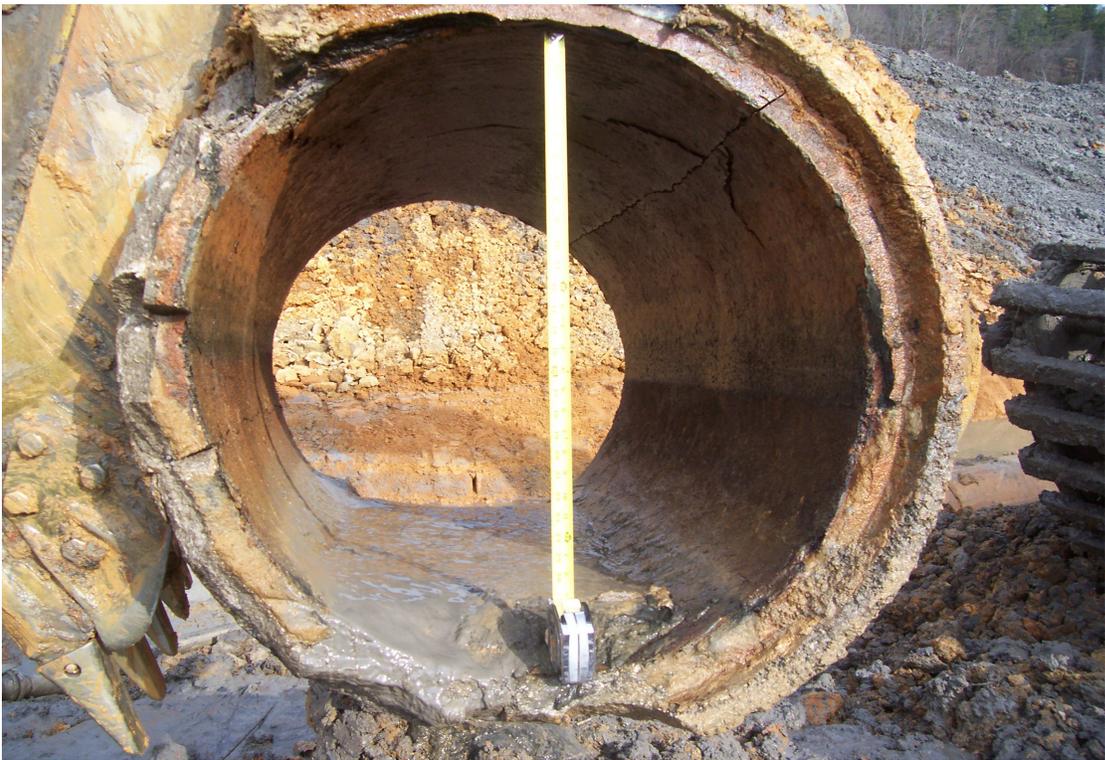
Photo No.: 20	Date: 2-8-2009

Direction Photo Taken: Looking northeast.		
Description: Pipe inside diameter is 30 inches. Approximately 3 inches of ash present in the pipe. Note the waterline on the sides of the pipe indicating it flowed approximately half-full.

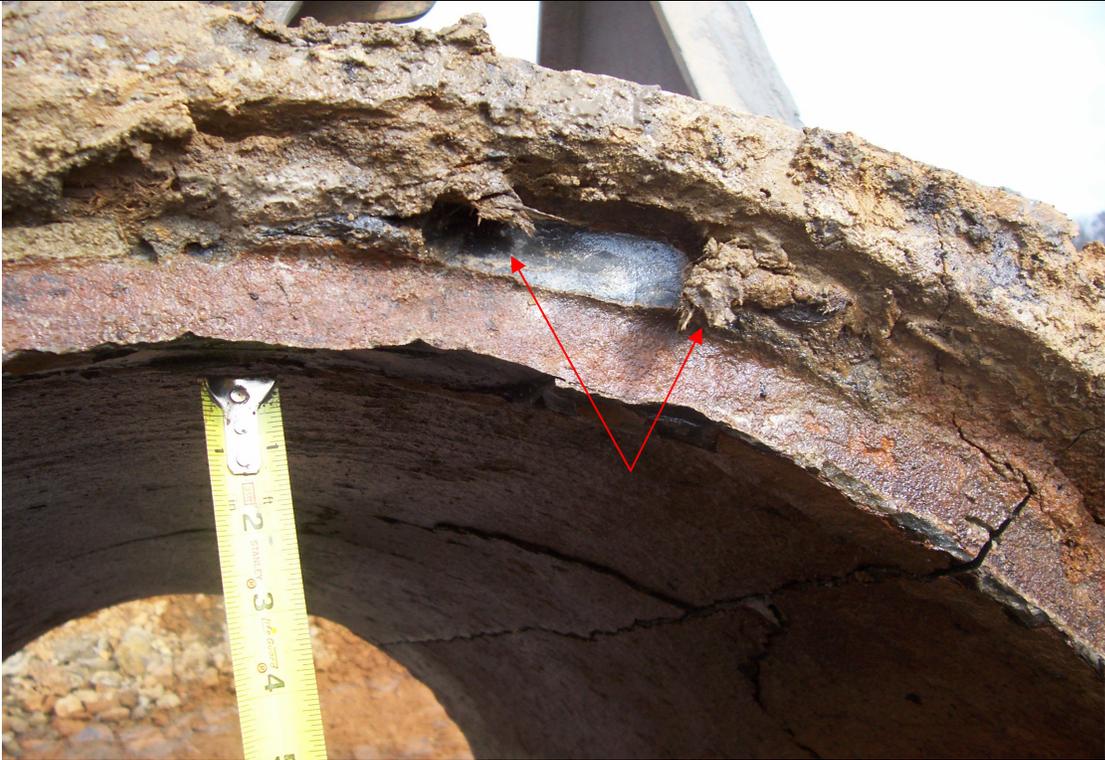
Direction Photo Taken: Looking northeast.			
Description: Arrows highlight the fibrous okum used to seal the pipe joints.

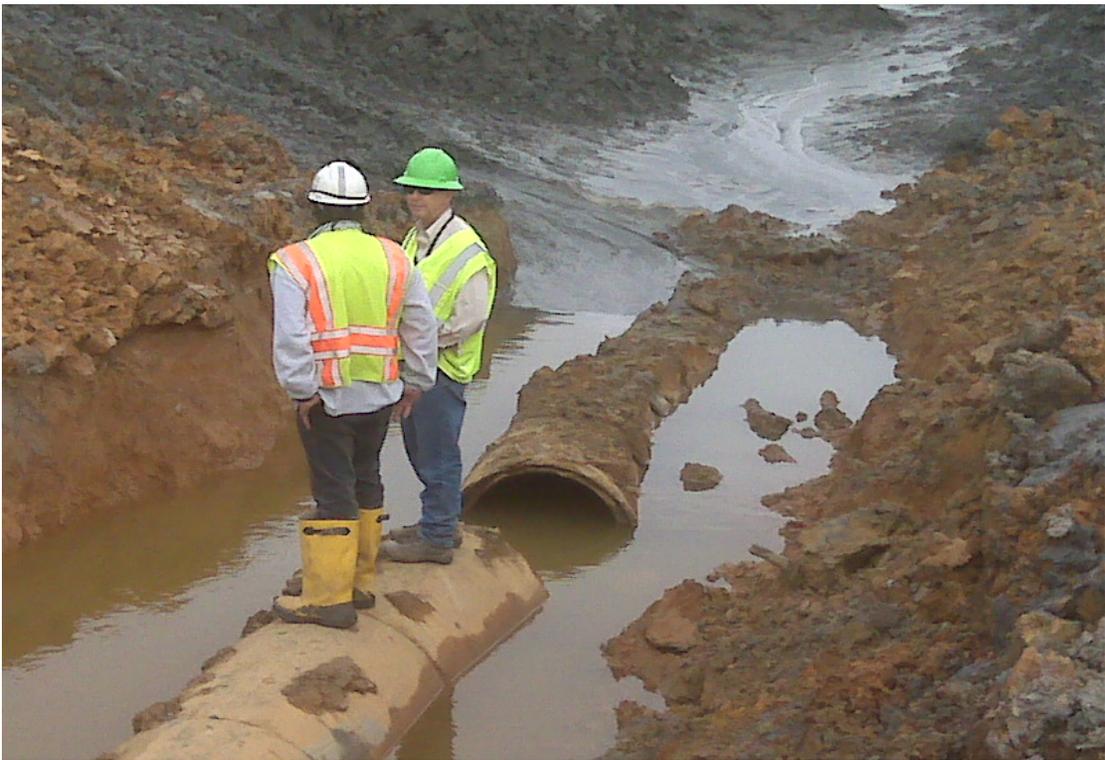
Photo No.: 22	Date: 2-10-2009

Direction Photo Taken: Looking northeast.		
Description: AECOM lead project engineer inspects the outfall pipe and condition of the dike walls exposed in the excavation.

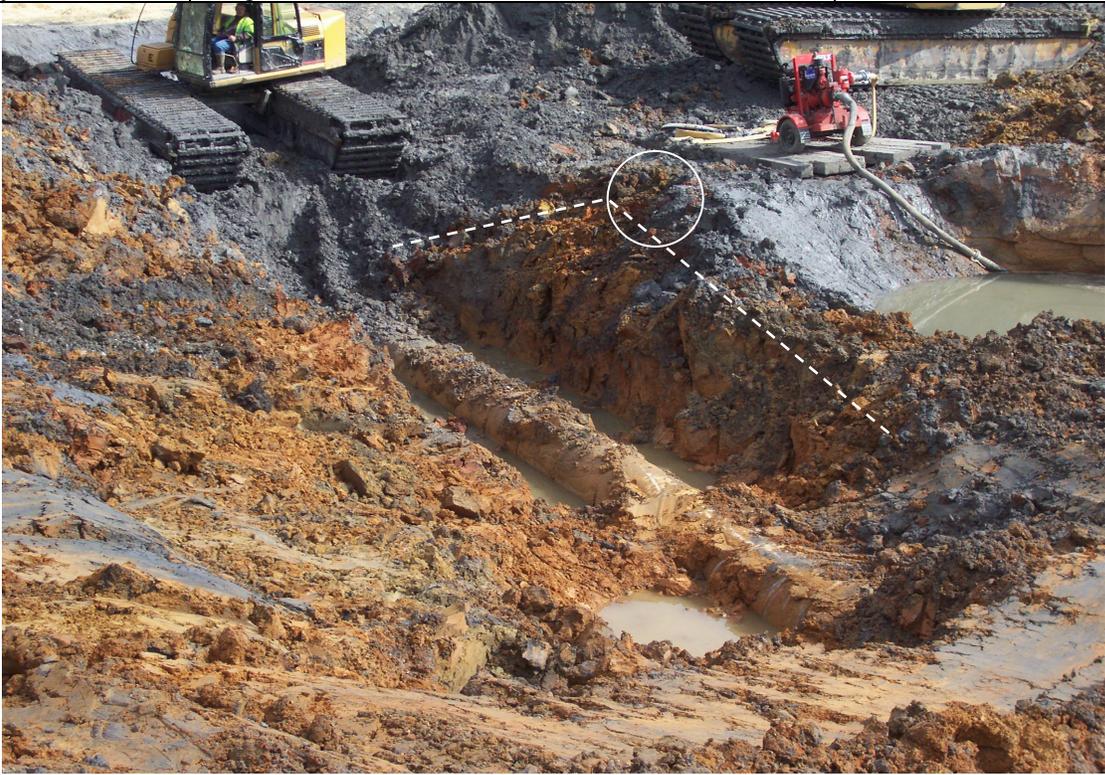
Direction Photo Taken: Looking southeast.			
Description: White dashed line approximates the starter dike material. White circle highlights the area where Photo 24 was taken.

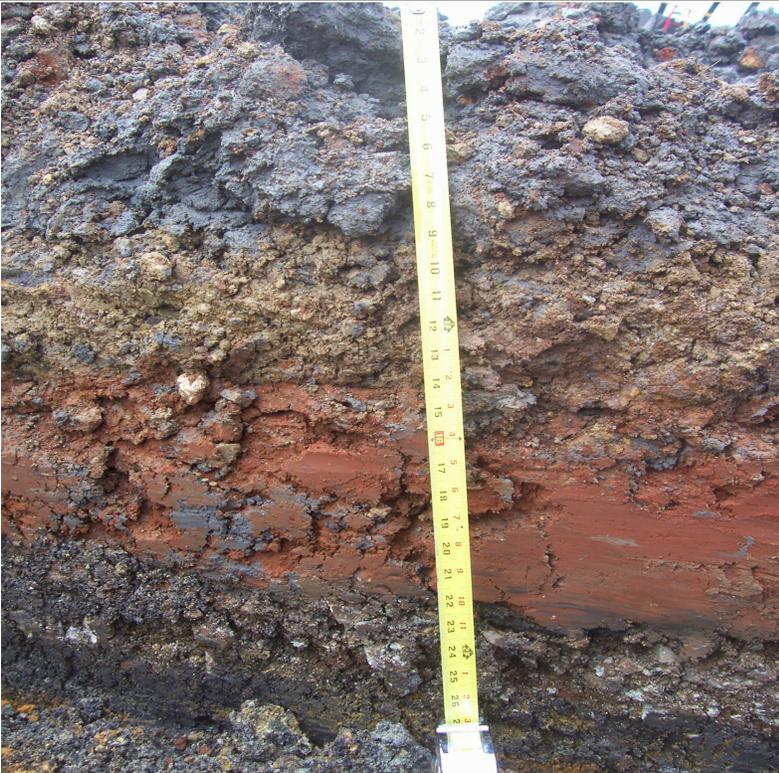
Photo No.: 24	Date: 2-8-2009

Direction Photo Taken: Looking southwest.		
Description: Clay cap material on top of Starter Dike. Note that it is likely that this thickness is not representative of the original thickness due to disturbance during excavation.
