Report of Phase 1 Facility
Assessment

Coal Combustion Product
Impoundments and Disposal
Facilities

Various Locations, Kentucky

June 24, 2009

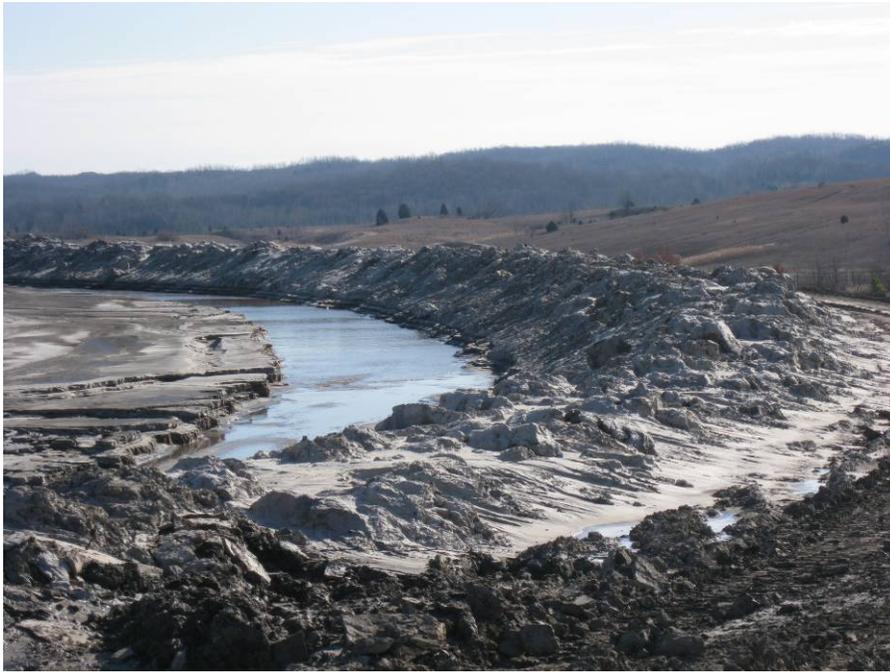
Drawing Mark GS-1

Minimal available freeboard along saddle dike and majority of west pond embankment.

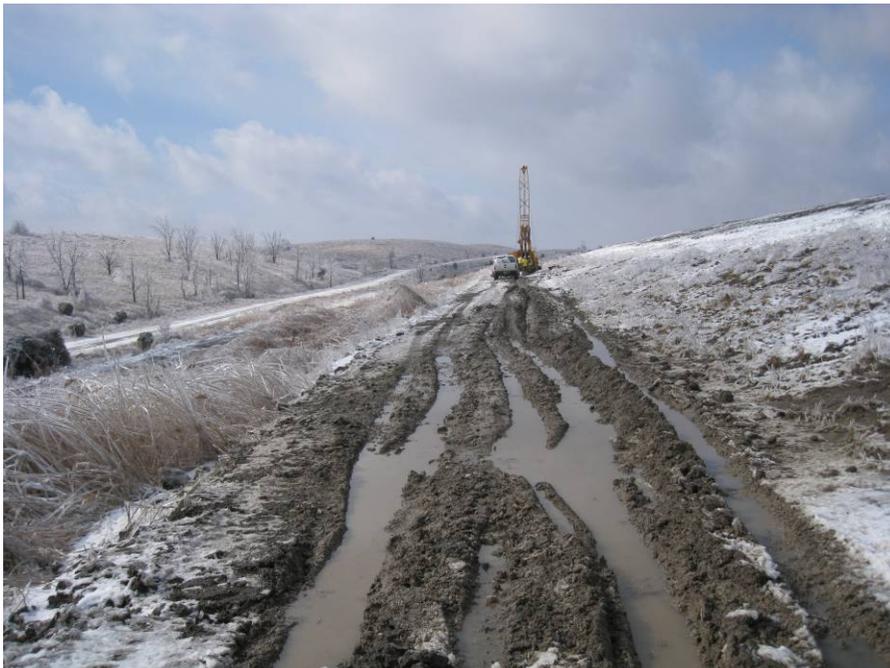
Drawing Mark GS-2

Significant rutting and ponding of water along majority of benches of both east and west pond embankments.

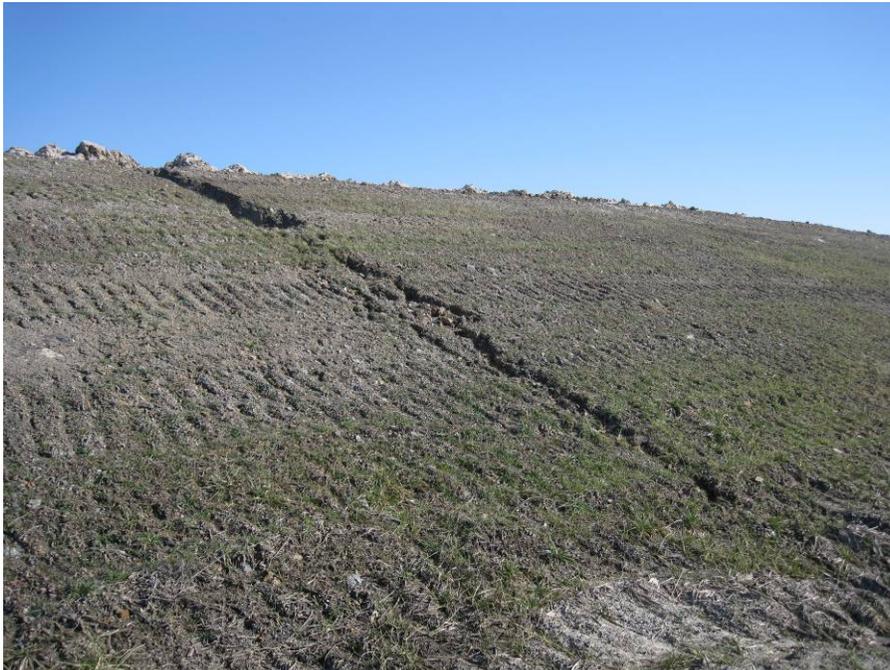
Drawing Mark GS-3

Multiple erosion channels, mainly in upper slope on both east and west pond embankments.

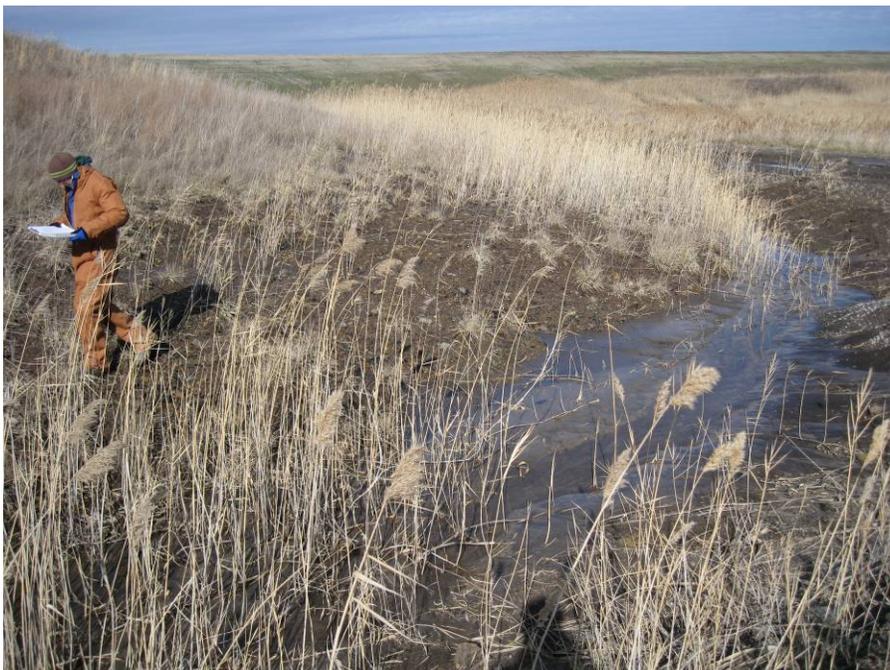
Drawing Mark GS-4

Uncontrolled seepage surfacing on majority of slopes and benches of both ponds leading to saturated conditions and poor drainage.

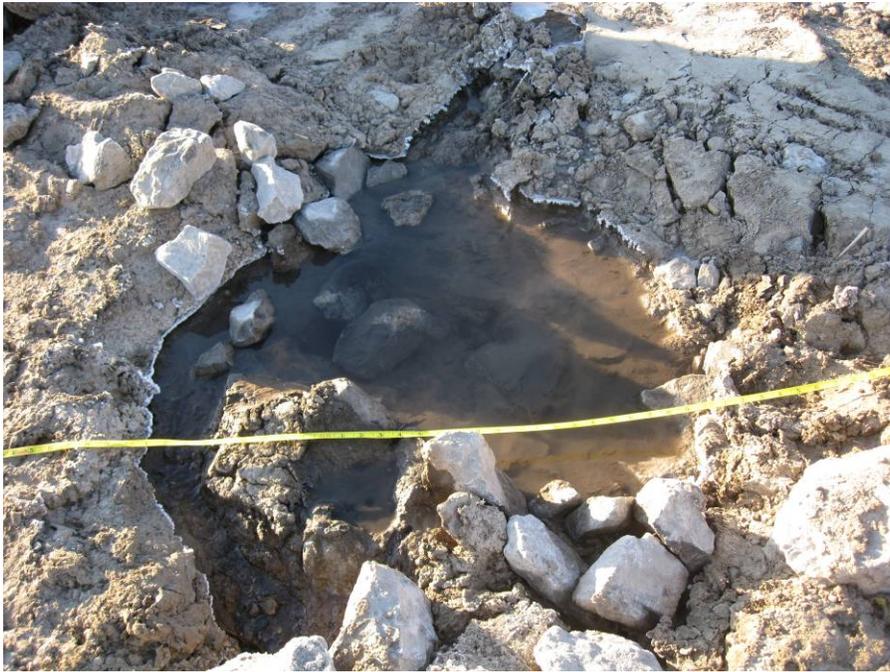
Drawing Mark GS-5

Active seep with boiling and material transfer on intermediate bench in vicinity of potential abandoned west pond spillway.

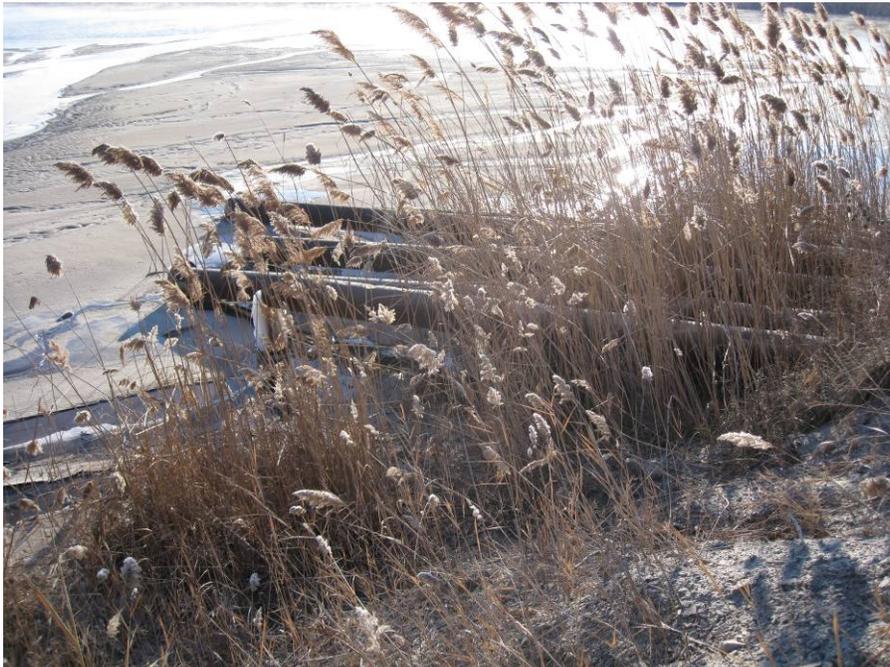
Drawing Mark GS-6

Five (5) inactive 12 inch sluice lines located at pool level of stilling pond below west pond east dike.

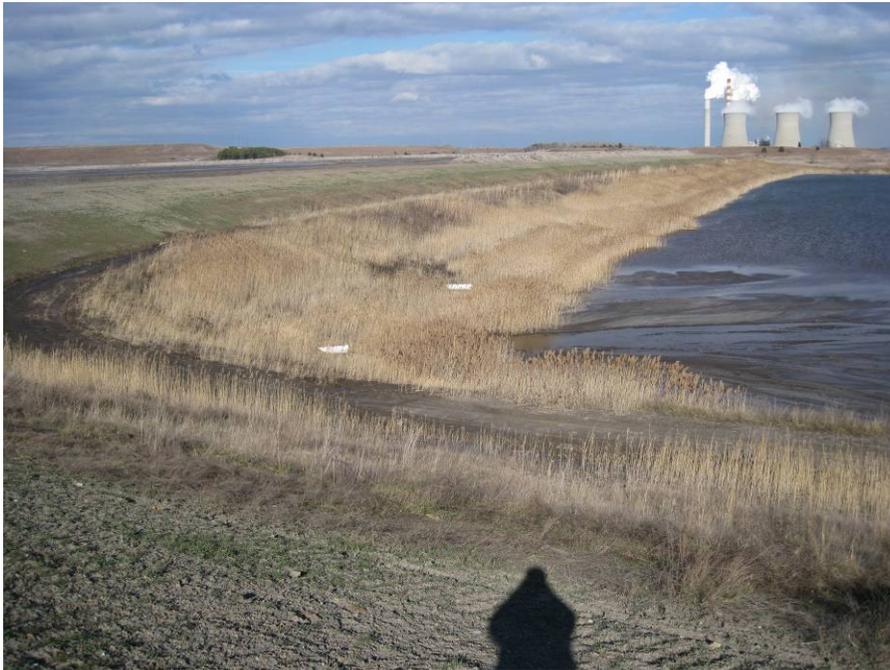
Drawing Mark GS-9

Dense phragmites growth on lower portion of slopes makes it difficult to assess dikes.

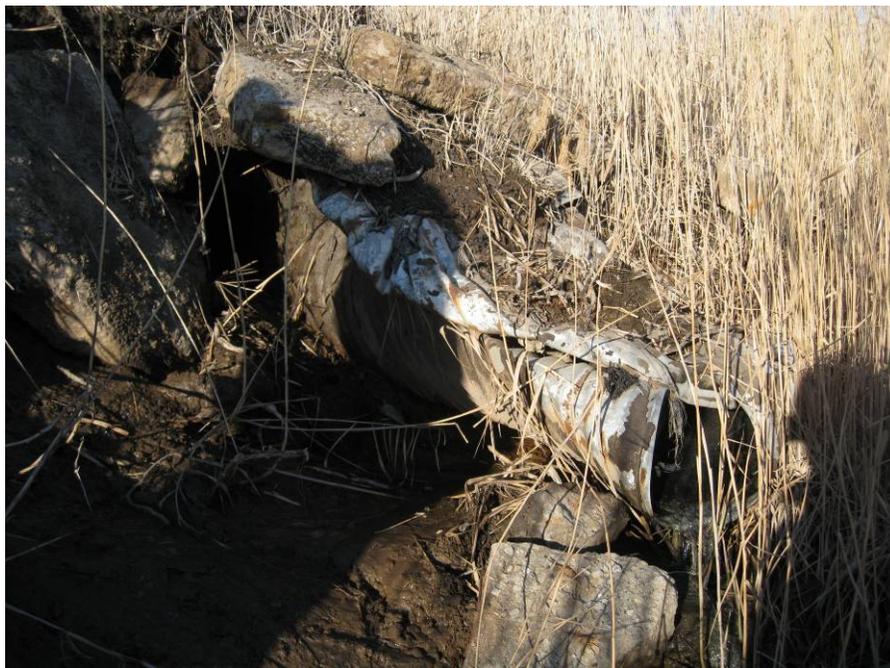
Drawing Mark GS-10

East pond abandoned spillway outlet located with water flowing. Abandonment techniques presumed inadequate.

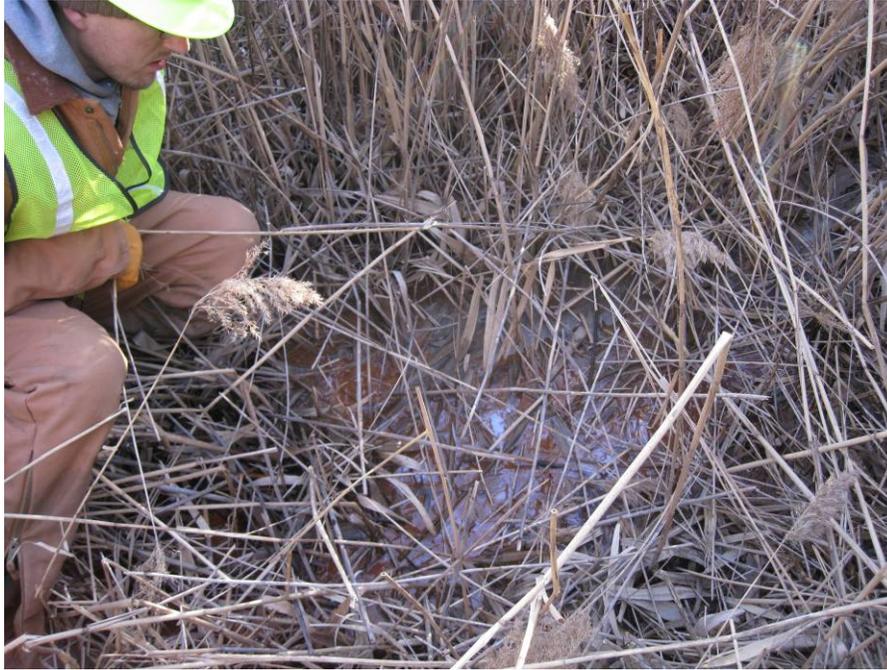
Drawing Mark GS-11 Red water seep on lower exterior slope on south side of east pond.

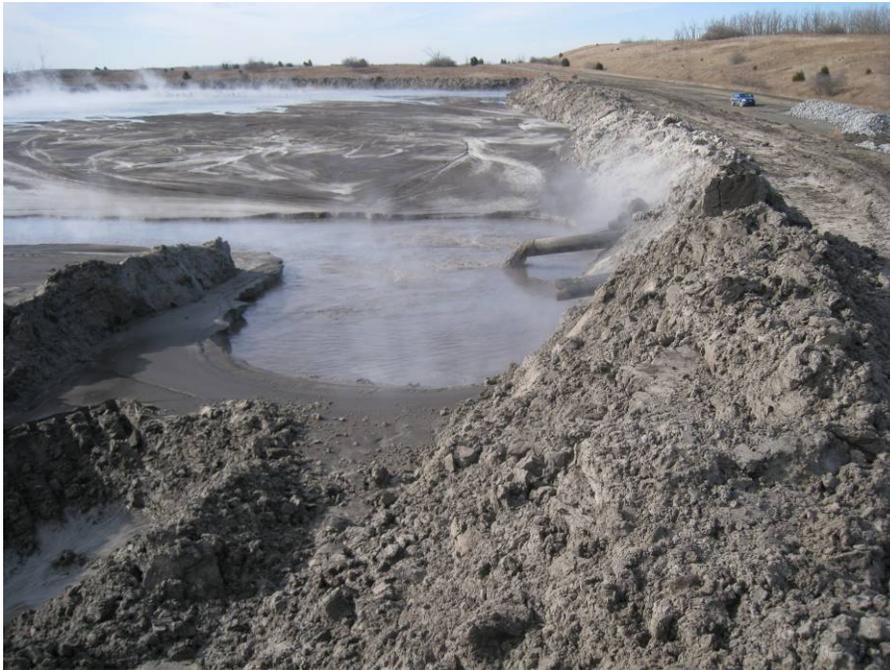
Drawing Mark GS-13 Steep interior slopes near influent sluice lines on north side of east pond.

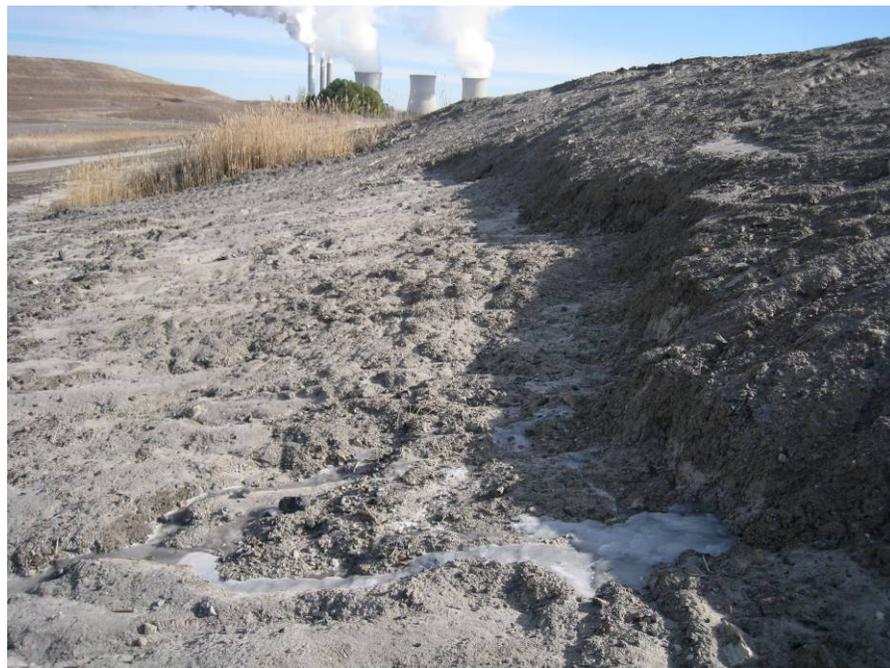
Drawing Mark GS-14 Slope slough to the west of influent sluice lines on north dike of east pond. Seepage surfacing in sloughing area.

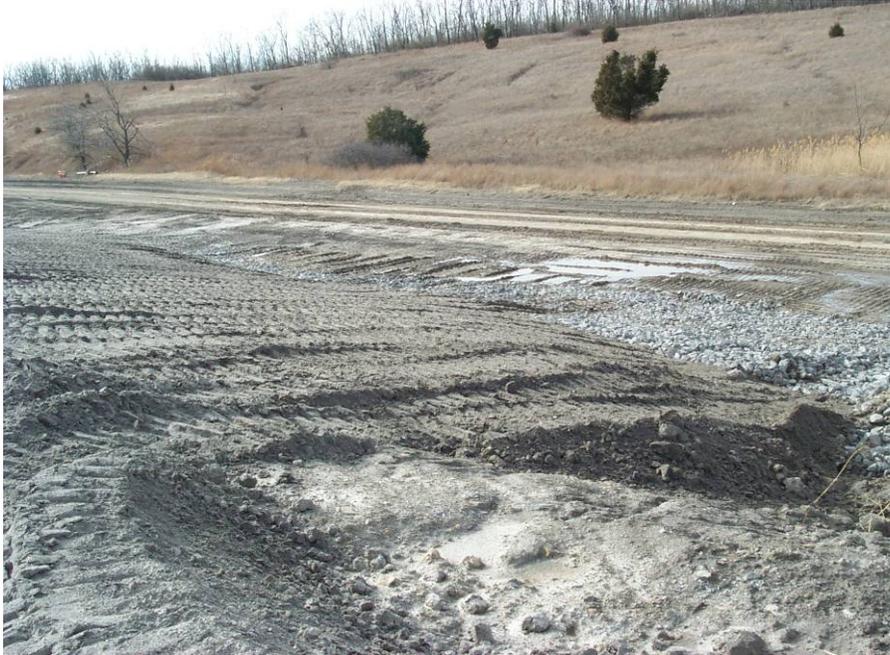
Drawing Mark GS-15 Slope repairs to west slough area.
Repairs including rip-rap and dry gypsum placement to achieve 4H:1V slope.

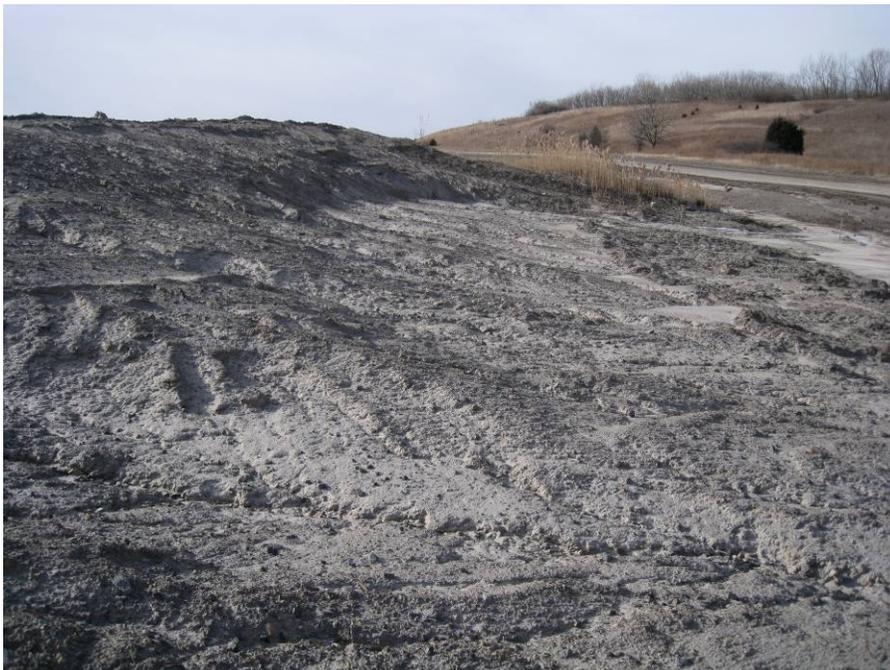
Drawing Mark GS-16 Slope slough to the east of sluice lines on north dike. Seepage surfacing in sloughing area.

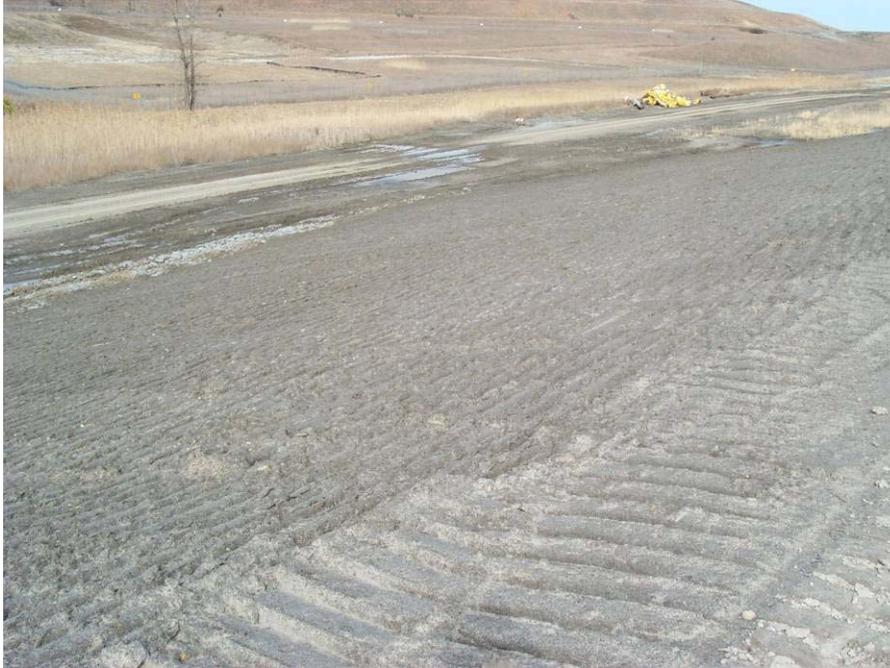
Drawing Mark GS-17 Slope repairs to east slough zone.
Repairs included rip-rap and dry gypsum
placement to achieve 4H:1V slope.

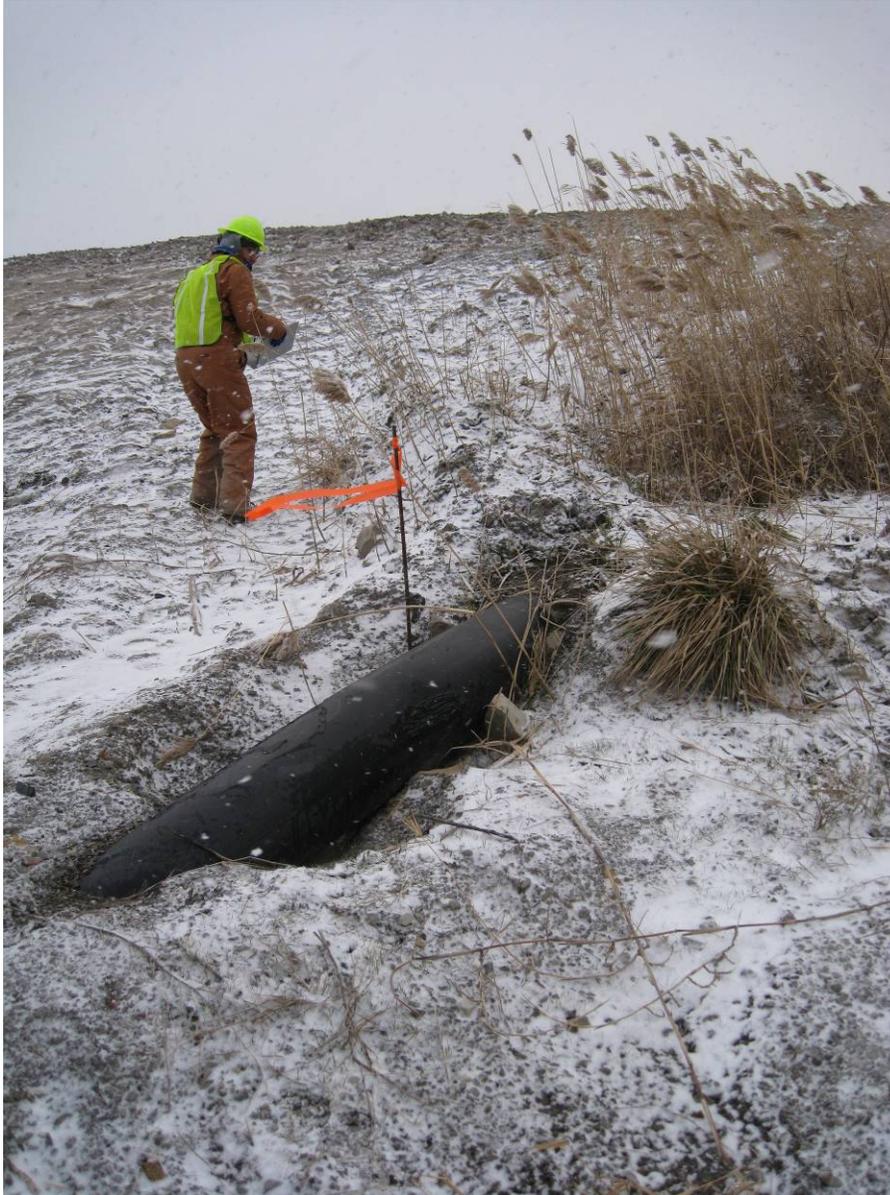
Drawing Mark GS-18 Sluice line exposed near toe of slope on north dike of east pond.

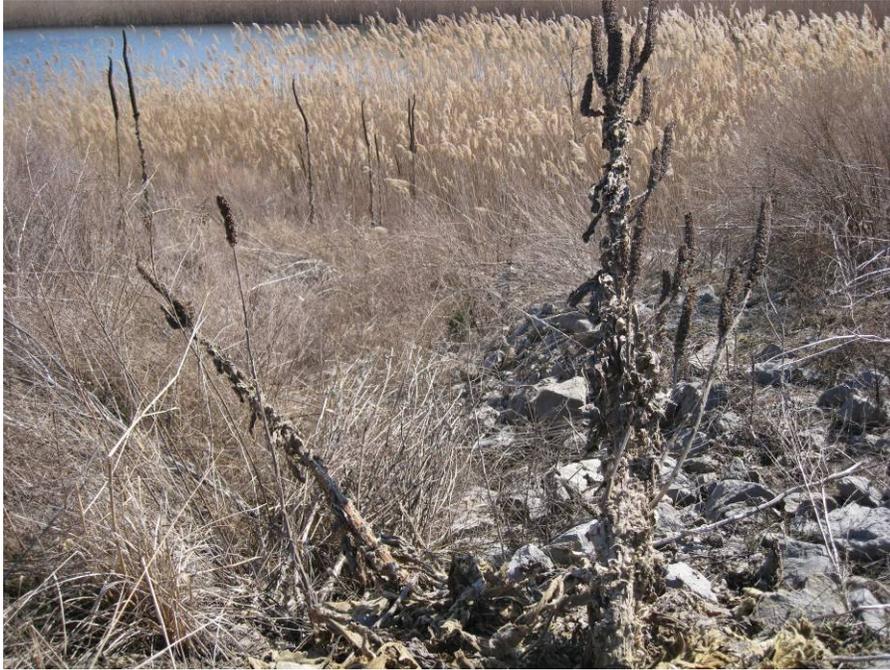
Drawing Mark GSP-1 Erosion gully next to rip-rap channel.

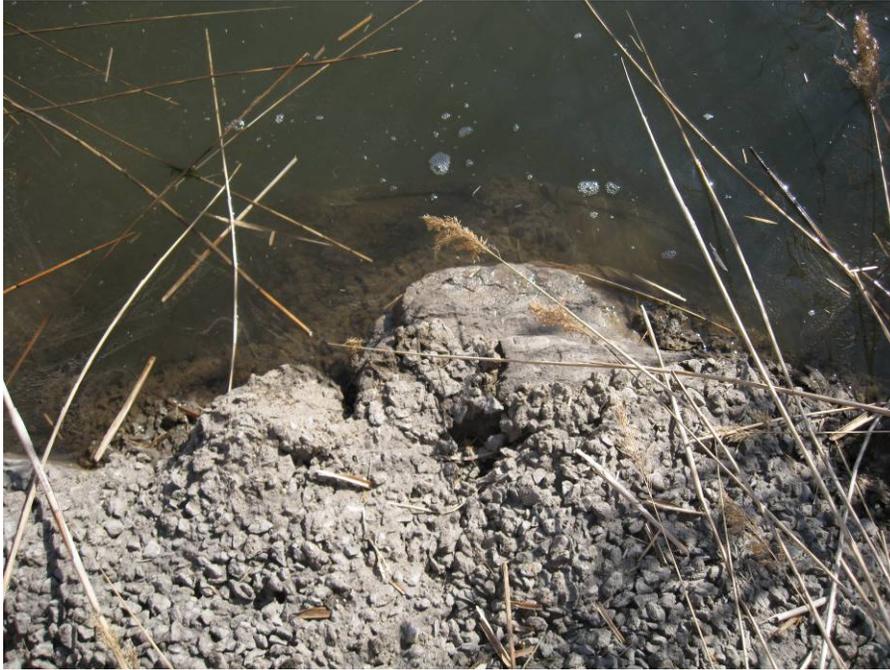
Drawing Mark GSP-3

Spillway pipe under pool level in lower stilling pond makes it difficult to observe.

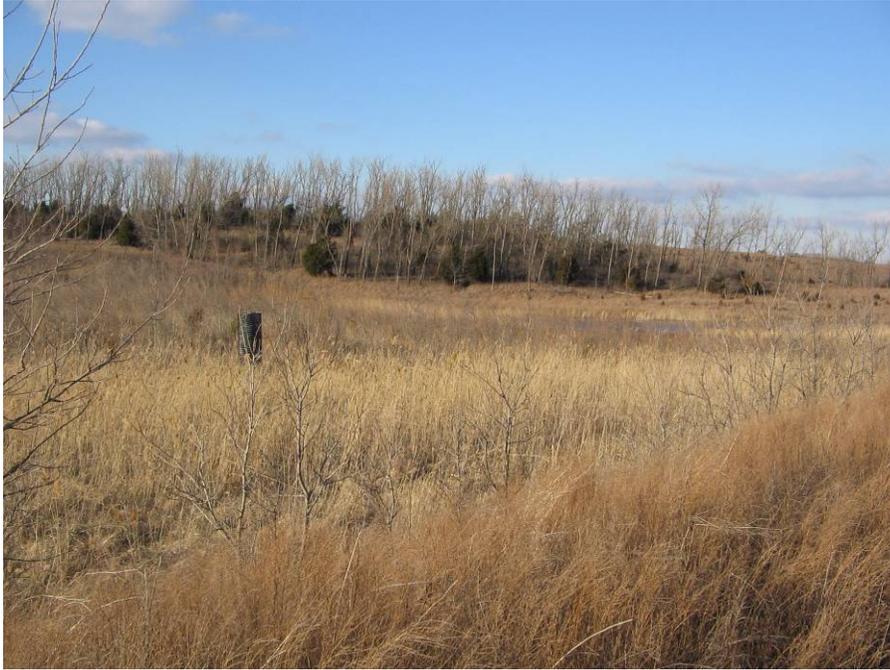
Drawing Mark DC-1

East Cell weir structure still exposed,
unknown abandonment procedures.

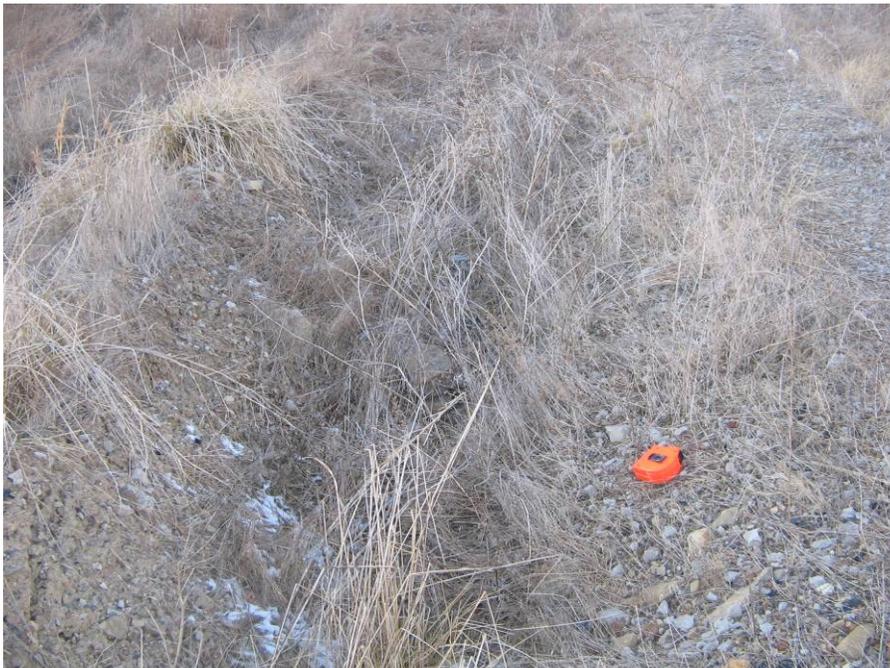
Drawing Mark DC-2

Erosion on access road area leading to
south side of East Cell.

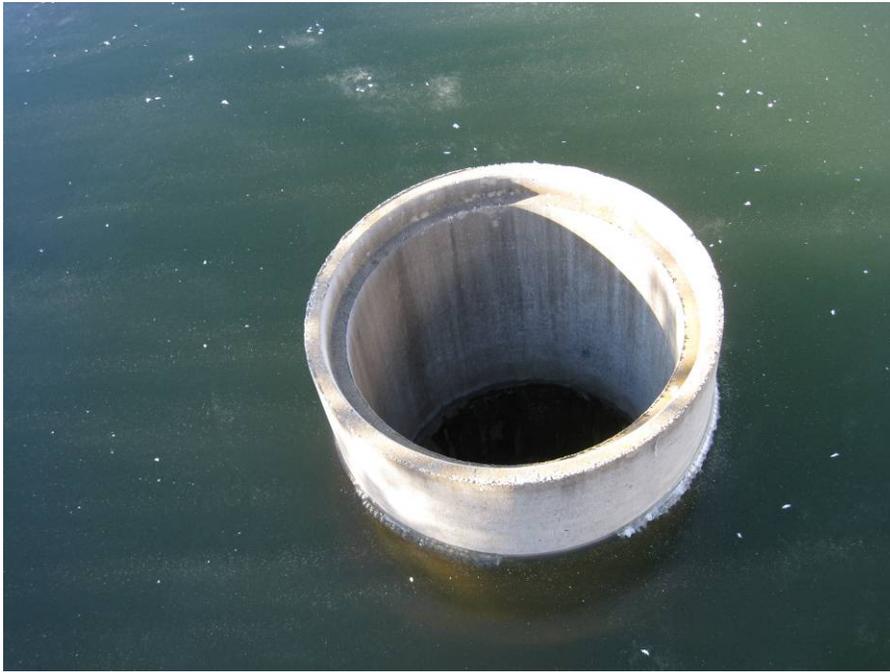
Drawing Mark JAP-1

Supposedly inactive concrete weir risers (3 total) in Stilling Pond observed with some flow through joints.

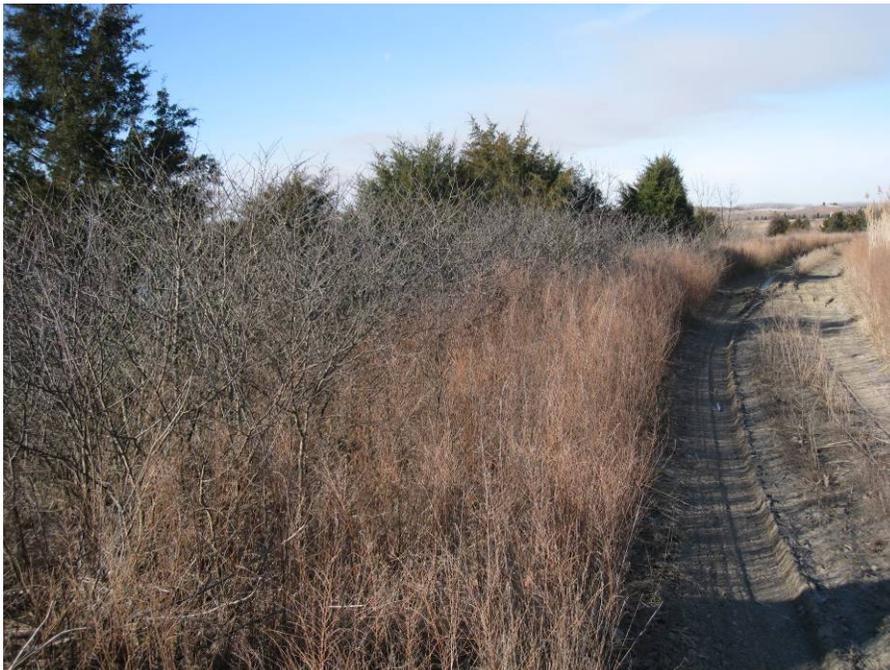
Drawing Mark JAP-2

Exterior slopes have thick vegetation and trees.

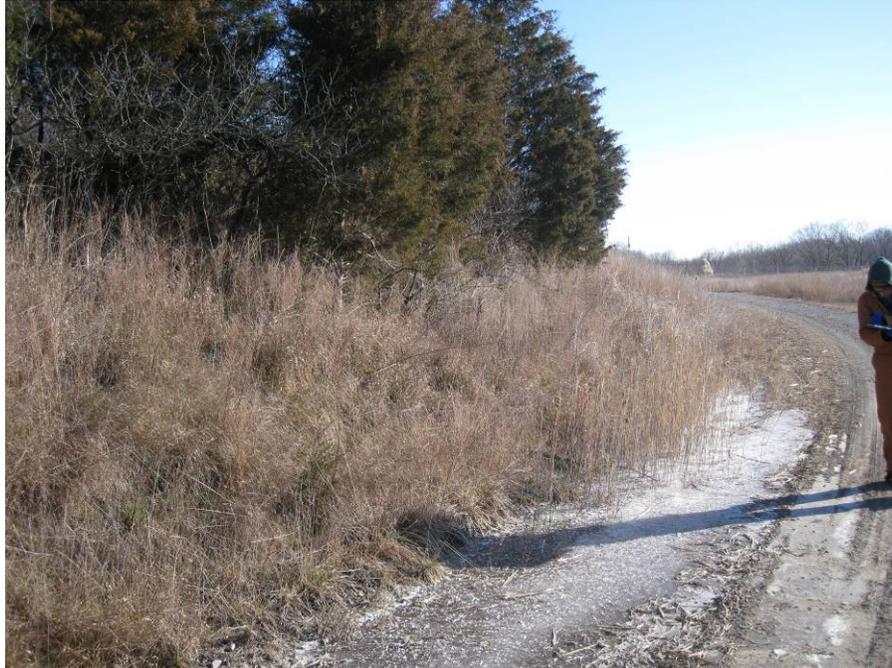
Drawing Mark JAP-3

Ponding of water on bench and erosion of bottom (1-3 feet) of exterior slope.

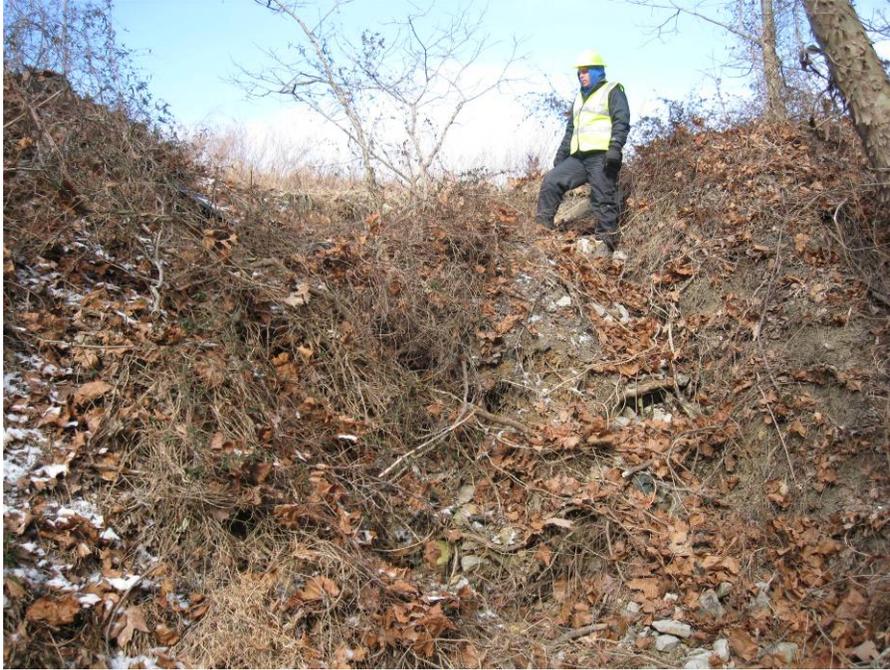
Drawing Mark PAP-1 Slope failure on exterior lower slope.

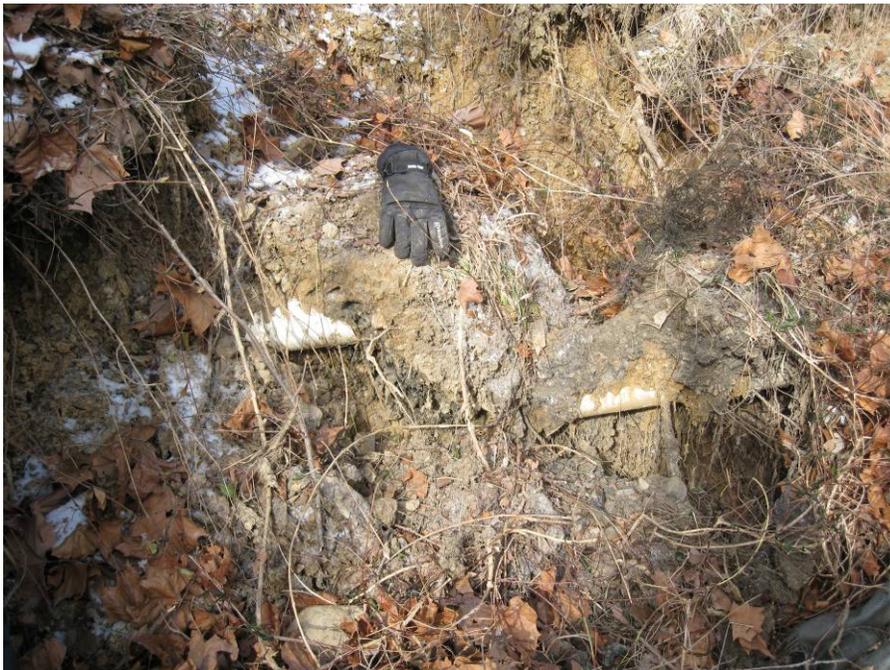
Drawing Mark PAP-2 Severed pipe within slope failure on exterior lower slope.

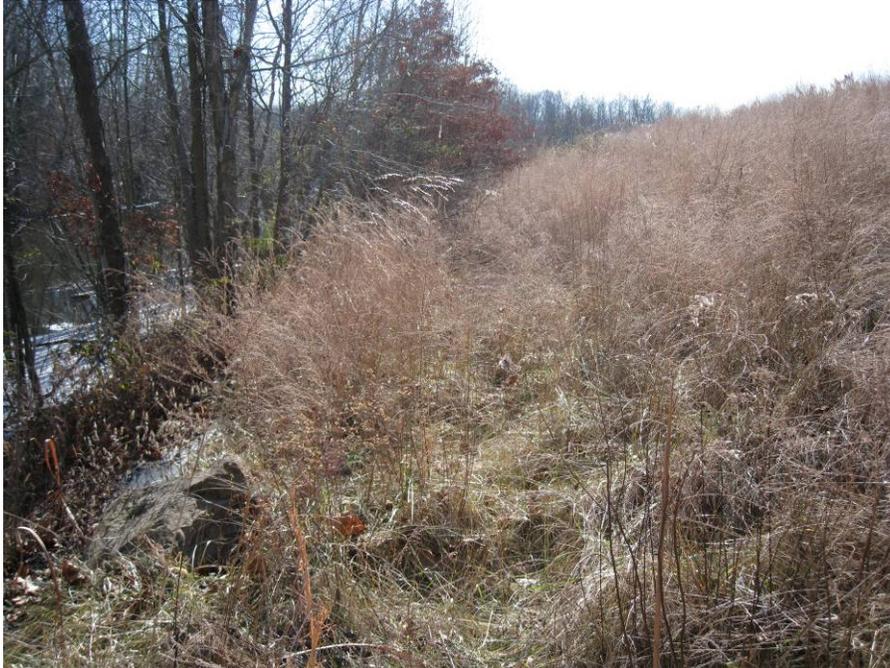
Drawing Mark PAP-3 Thick vegetation and trees along exterior.

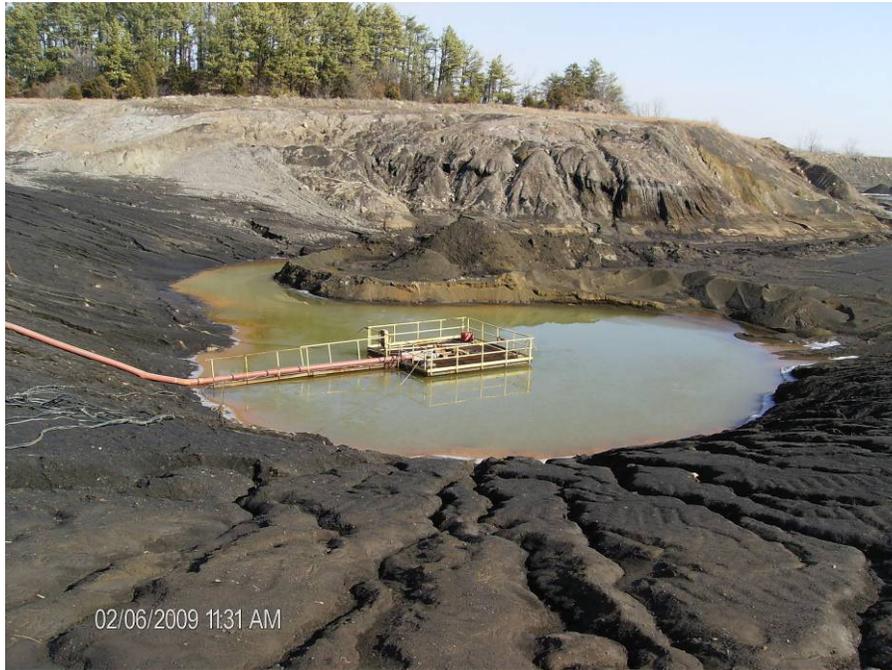
Drawing Mark SM-1

Pumping station that moves water from the west ponding area to the east ponding area.

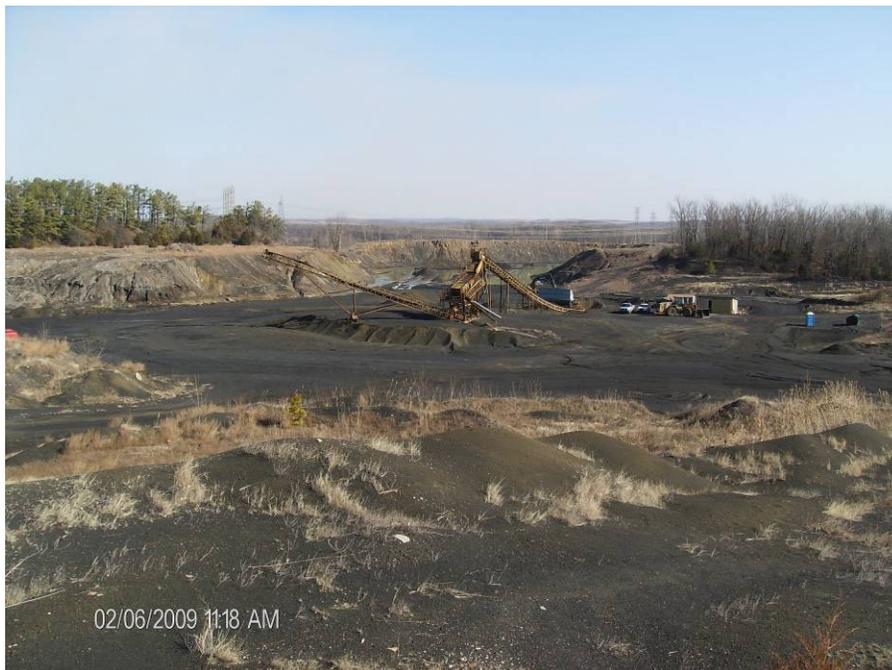
Drawing Mark SM-2

General conditions of coal ash staging/mining area.

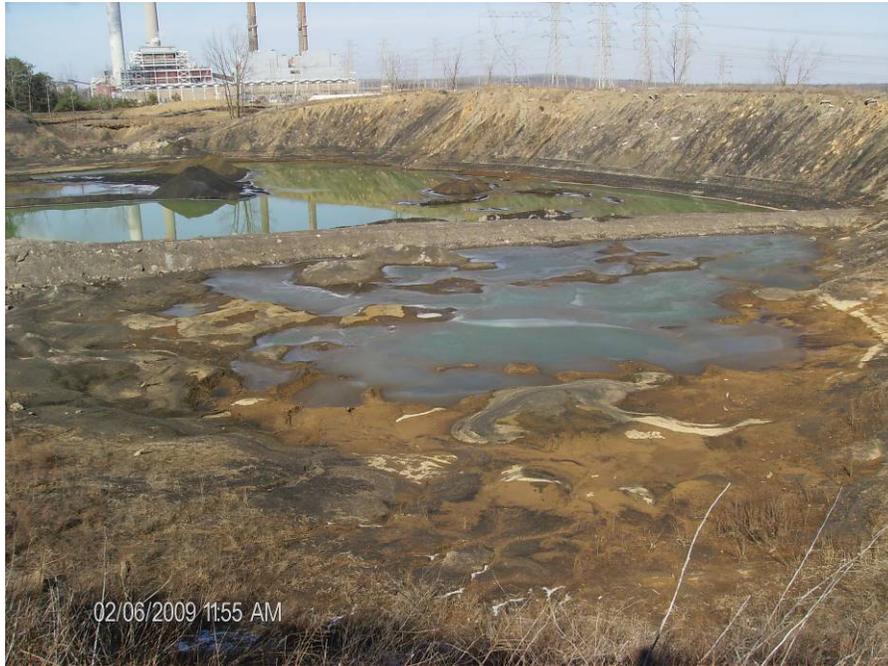
Drawing Mark SM-3

General conditions of the west end of the eastern ponding area.

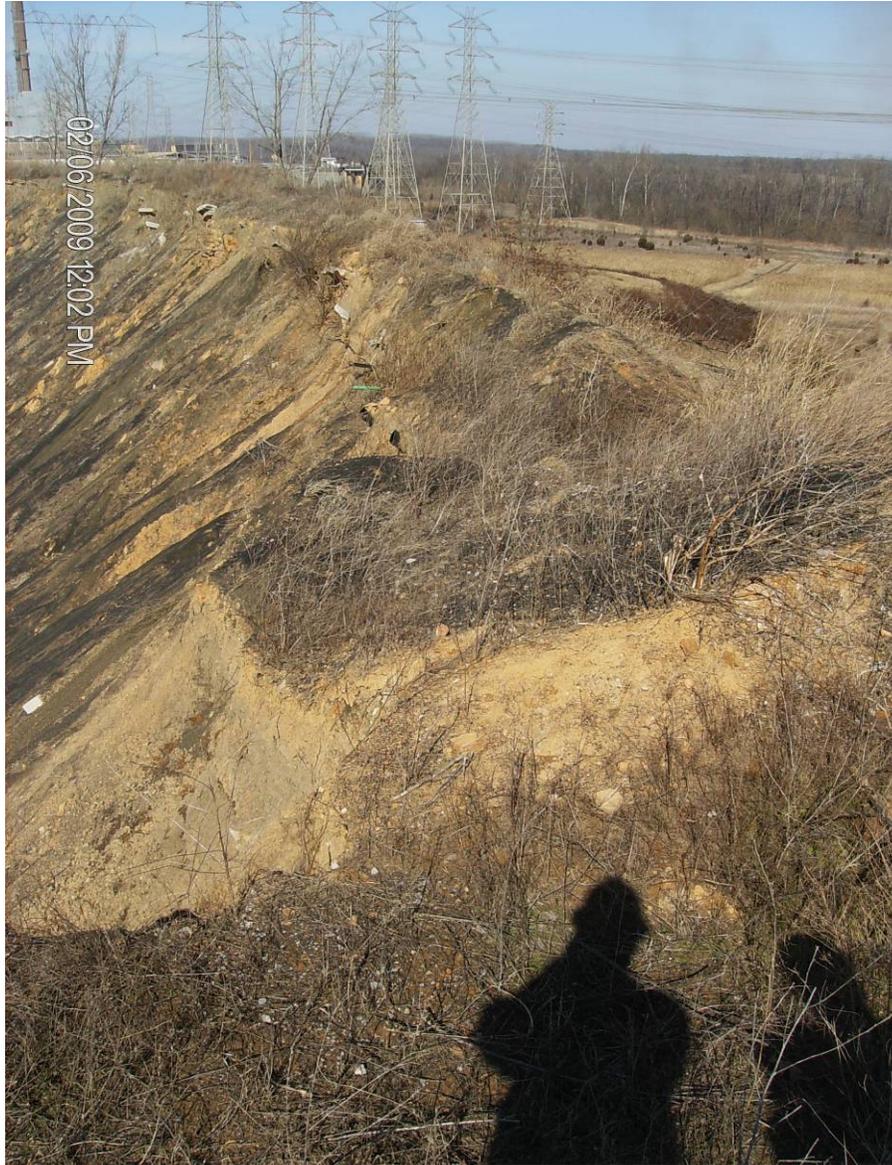
Drawing Mark SM-4

Erosion of high angle peak of the eastern embankment of stacking area.

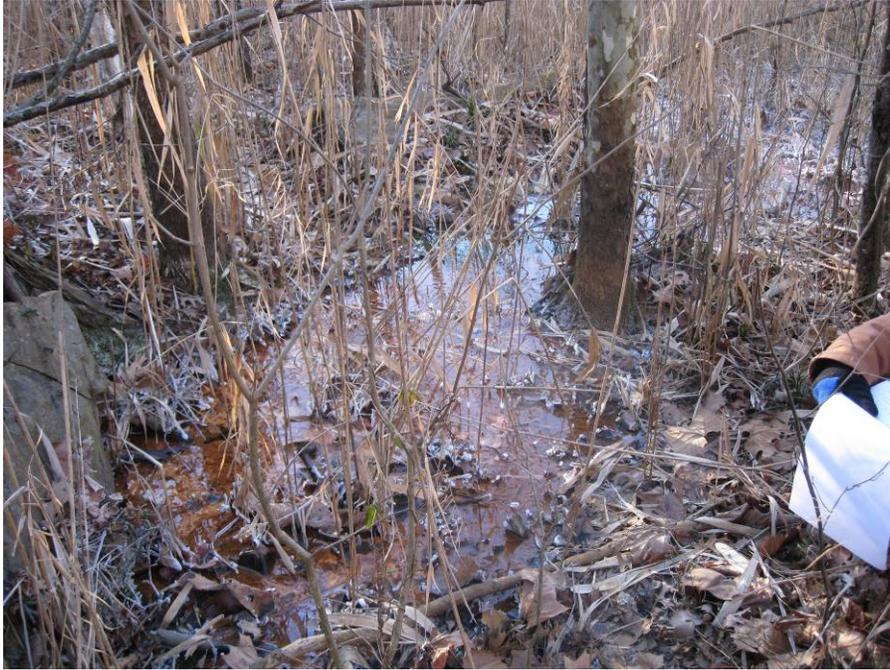
Drawing Mark SM P1-1 Active red water seep with flow at toe of exterior slope.

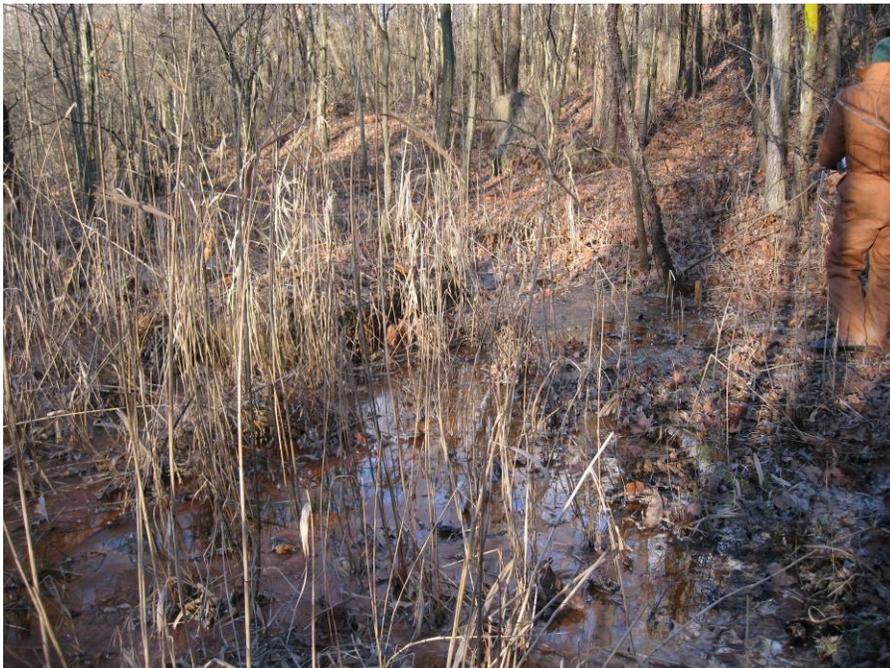
Drawing Mark SM P1-2 Active red water seep creating ponding area at toe of exterior slope.

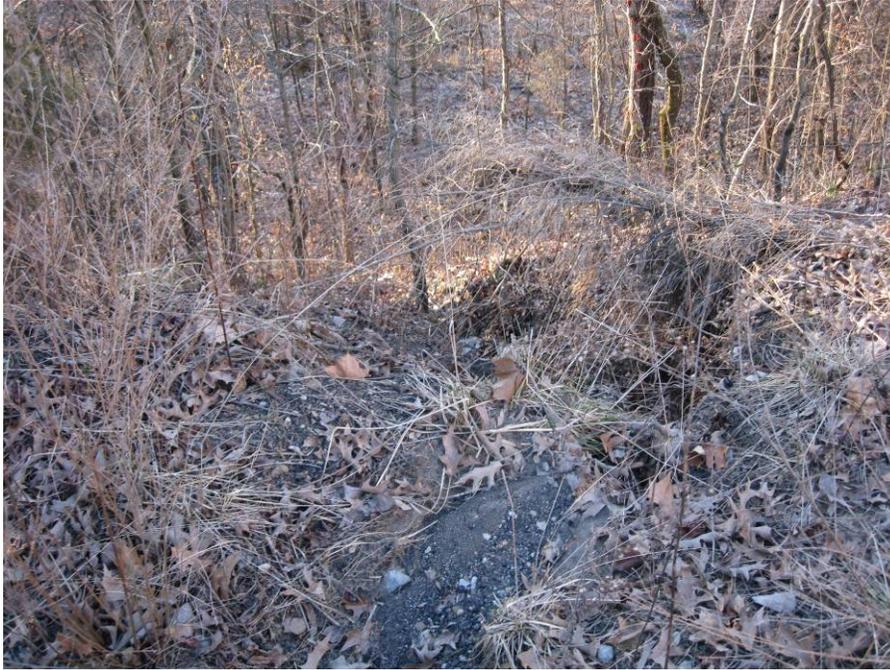
Drawing Mark SM P1-3 Erosion gully on steep exterior slope.

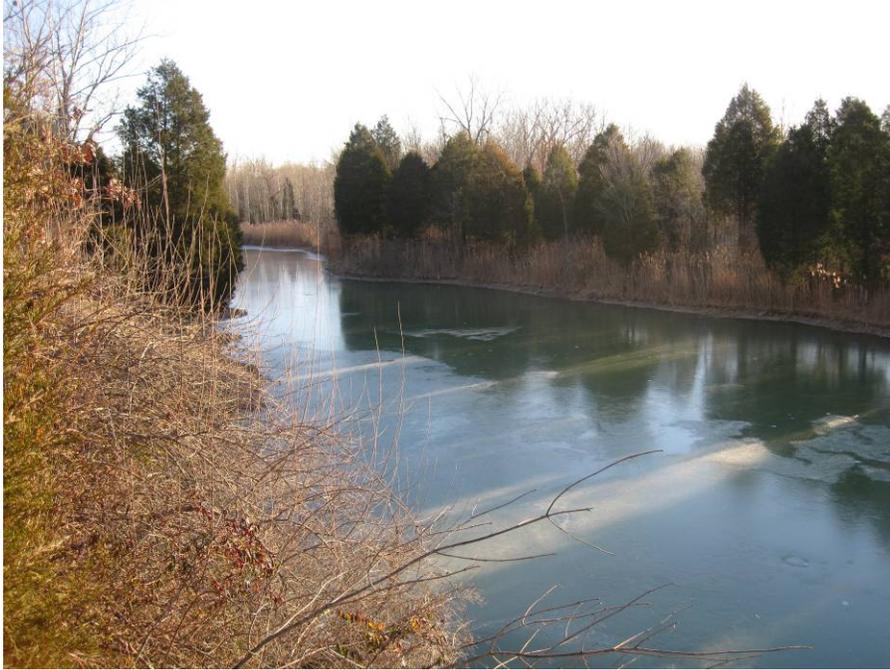
Drawing Mark SM P2-1 Trees present on interior and exterior slopes.

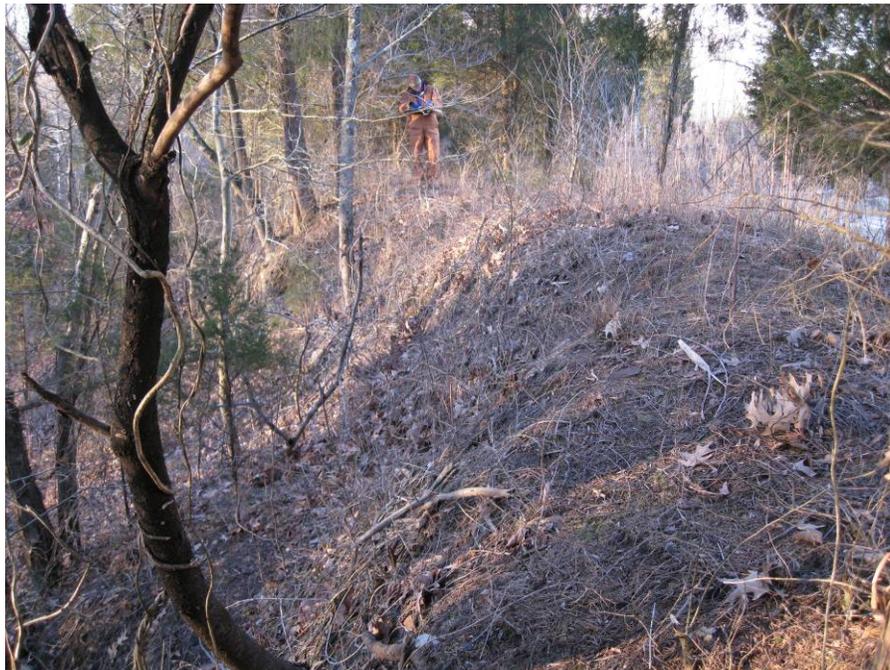
Drawing Mark SM P2-2 Small slide on exterior slope.

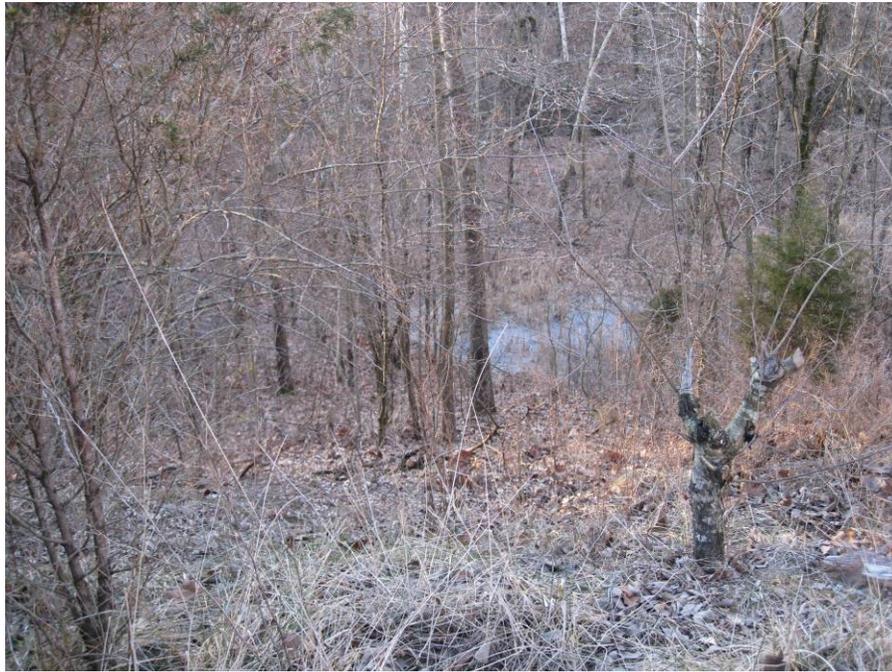
Drawing Mark SM P2-3 Seepage creating saturated area at toe of exterior slope.

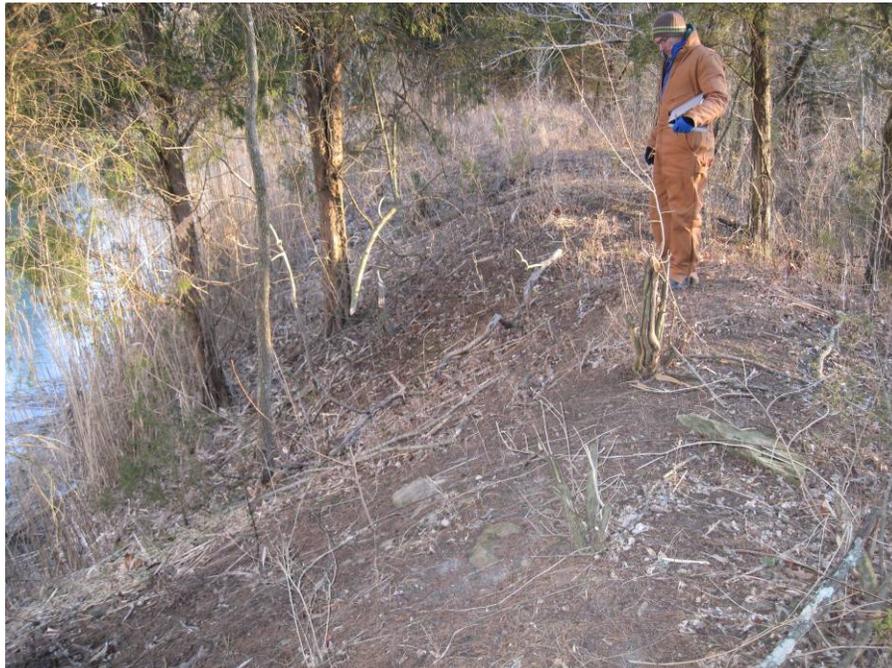
Drawing Mark SM P2-4 Uneven crest alignment both horizontally and vertically.
