Report of Phase 1 Facility
Assessment

Coal Combustion Product
Impoundments and Disposal
Facilities

Various Locations, Kentucky

June 24, 2009

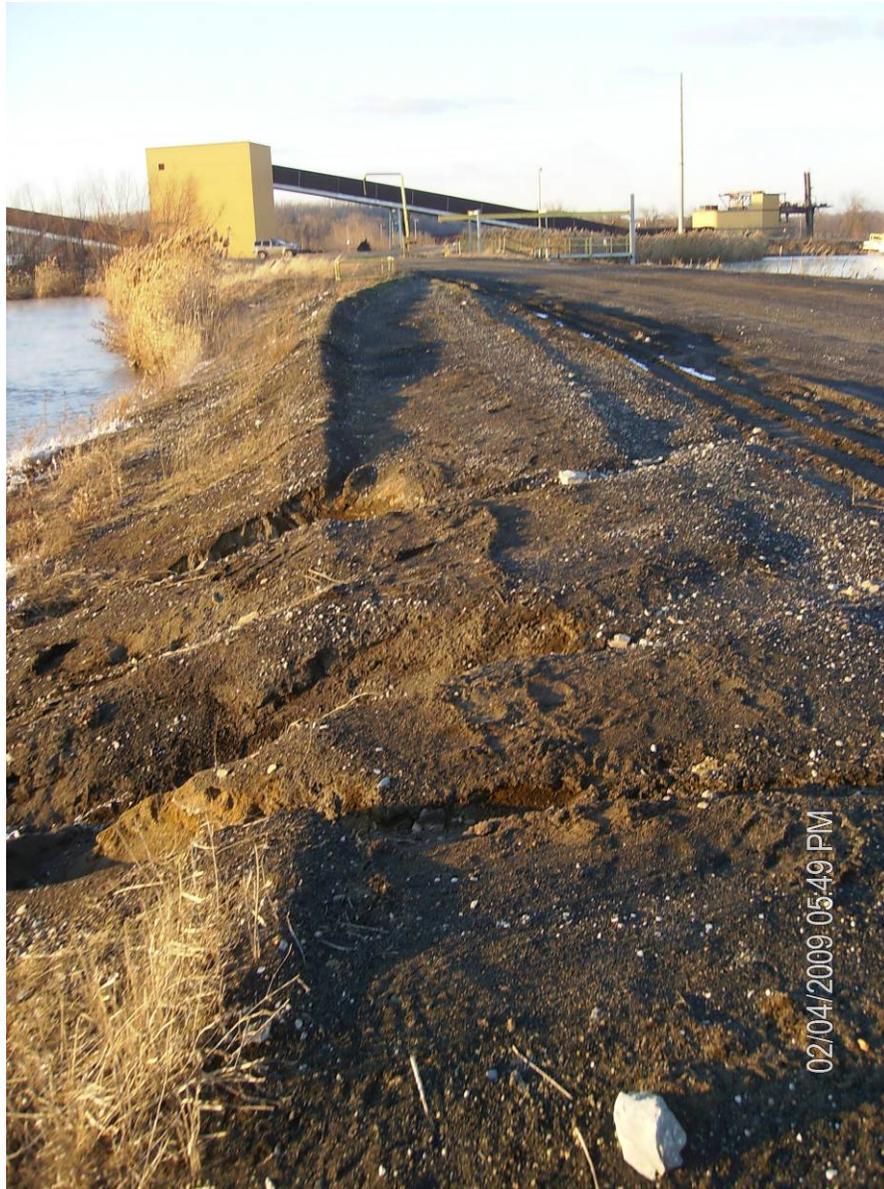
Drawing Mark SP 2A-2 View of general condition along separation dike, between Ponds 2A and 2B.

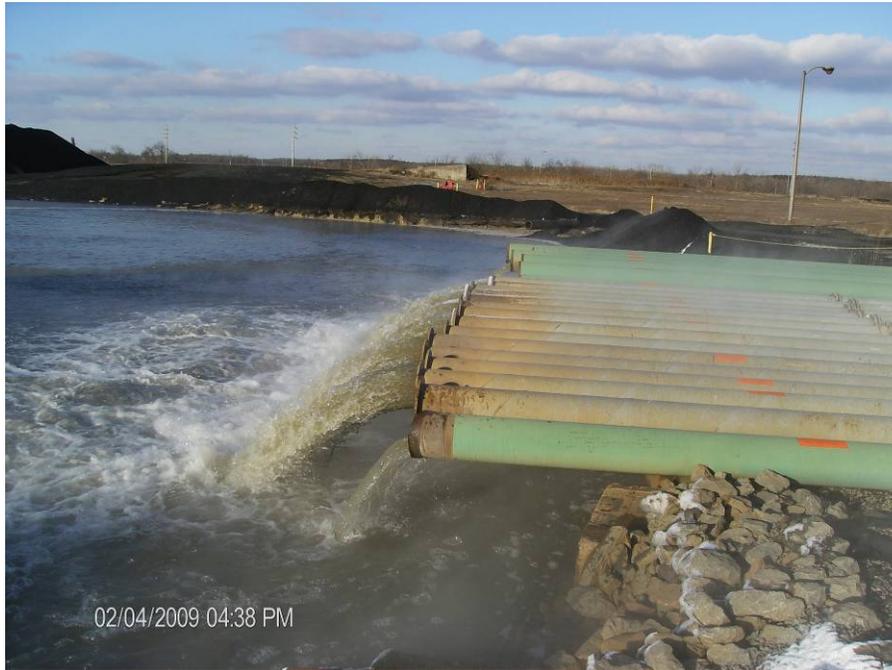
Drawing Mark SP 2A-3 Bottom ash inlets.

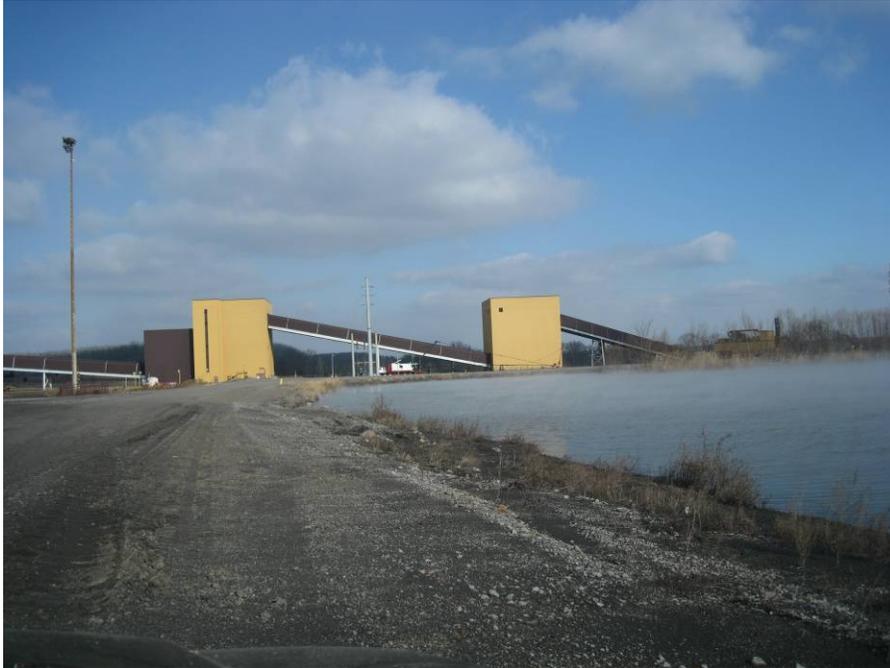
Drawing Mark SP 2A-5 General condition along west embankment of Pond 2A, note the low free board.

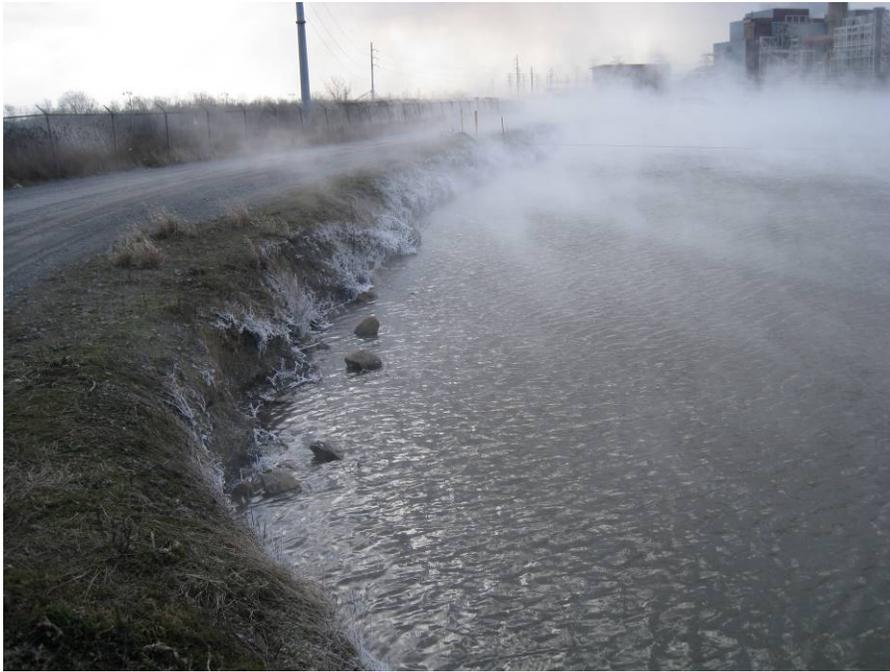
Drawing Mark SP 2B-1 Near vertical embankment along northernmost corner.

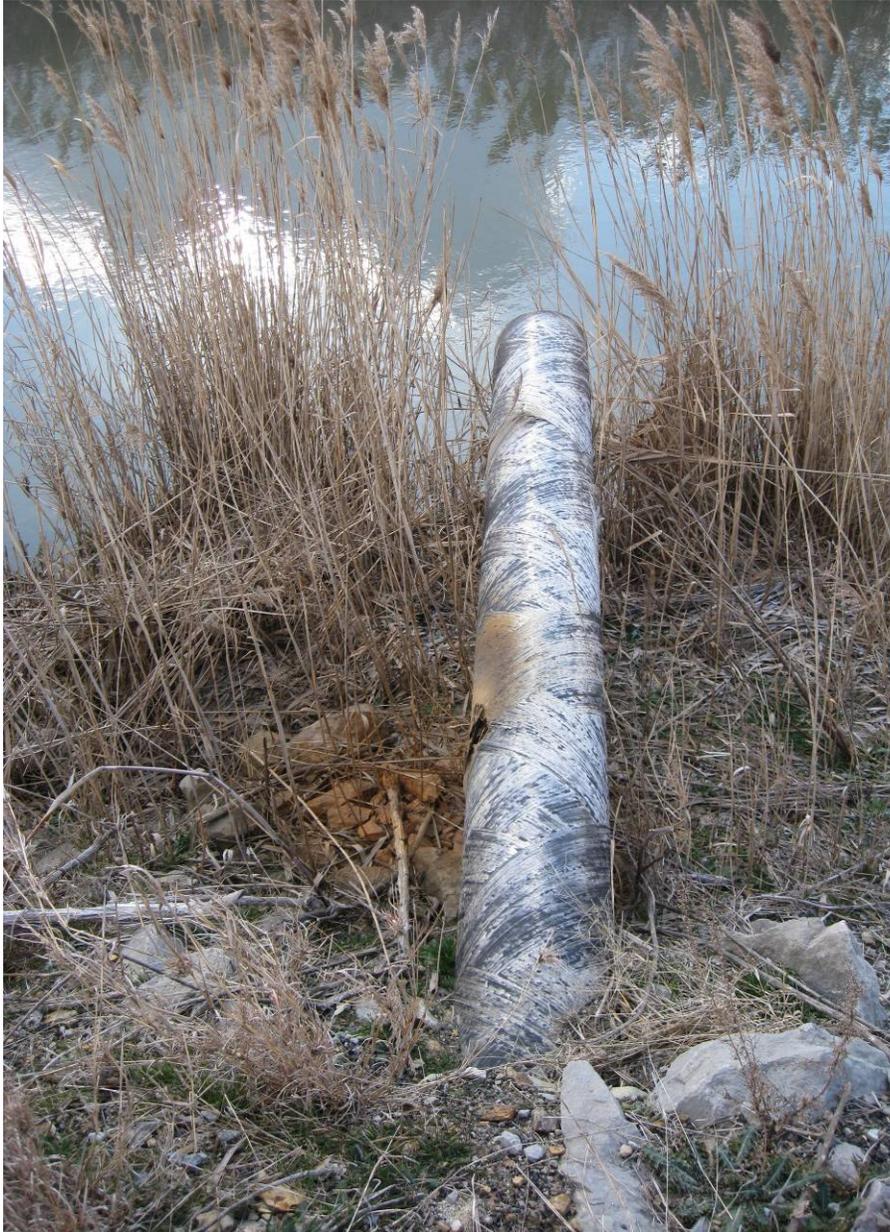
Drawing Mark SP 2B-3 Pipe with a hole discharging water into north embankment.

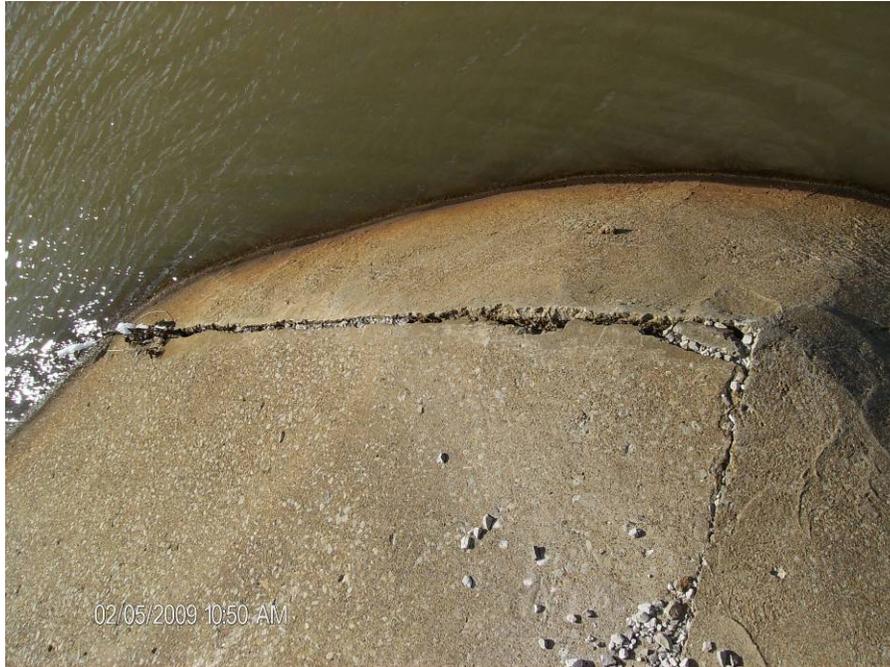
Drawing Mark SP 2B-4 Detailed image of cracks in north side of weir, between Pond 2B and the Slag Stilling Pond.

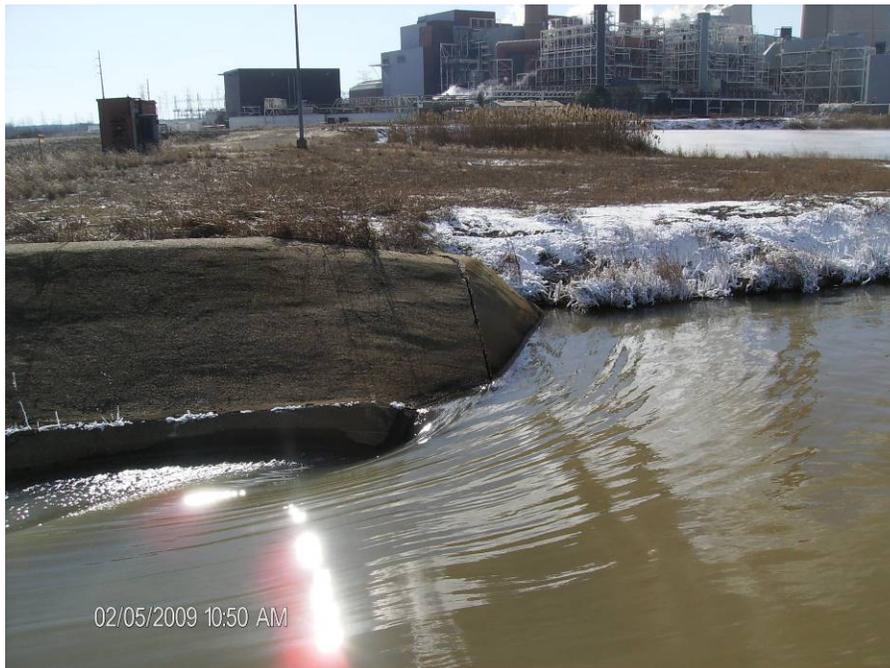
Drawing Mark SP 2B-5 Image of cracking on southern side of weir between Ponds 2B and Slag Stilling Pond.

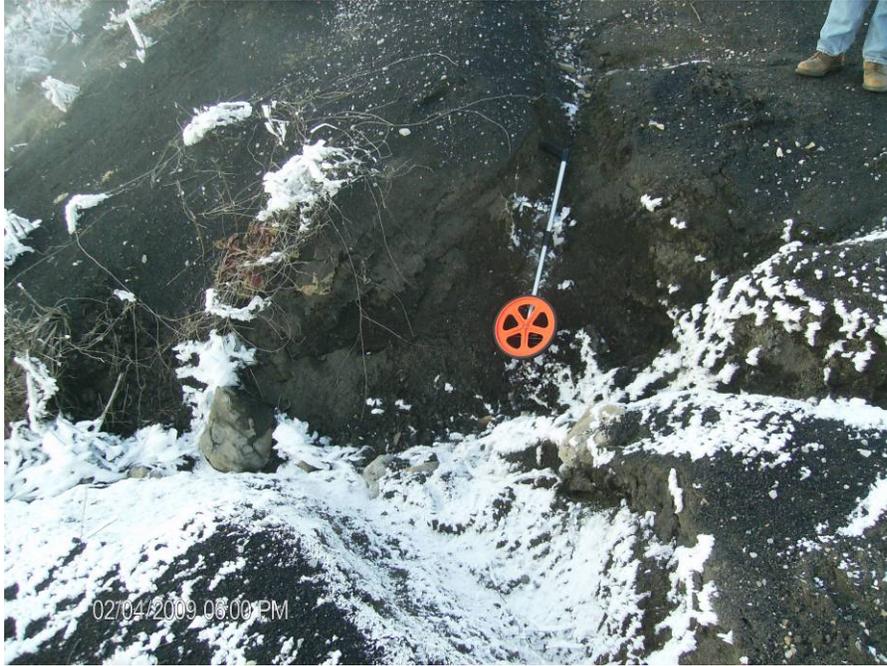
Drawing Mark SP 2B-6 Typical large erosion gully feature in the separation dike between Ponds 2A and 2B.

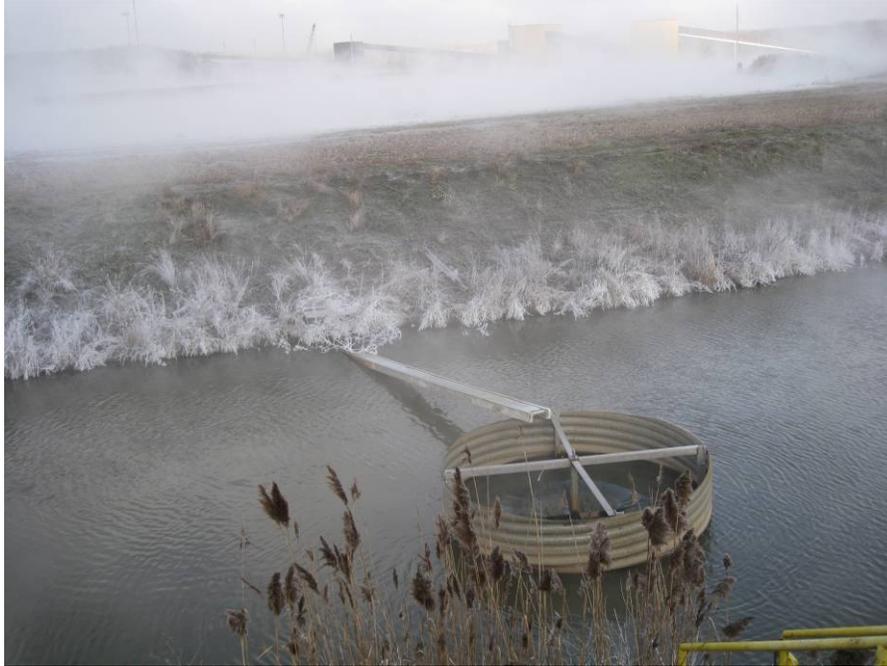
Drawing Mark SSP-1 Outlet pipe with wooden walk way partly under surface of water.

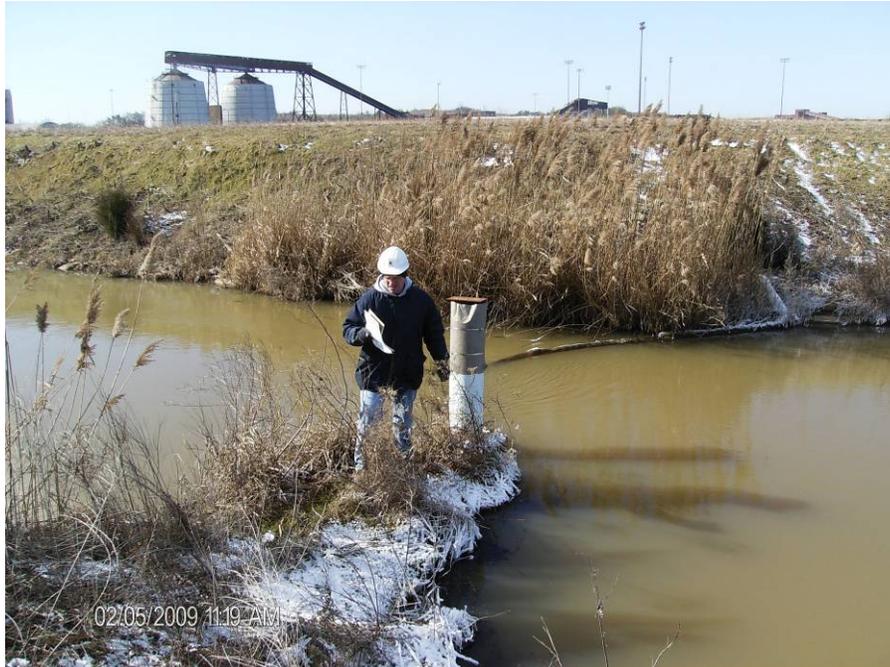
Drawing Mark SSP-3 10" PVC pipe off east embankment.

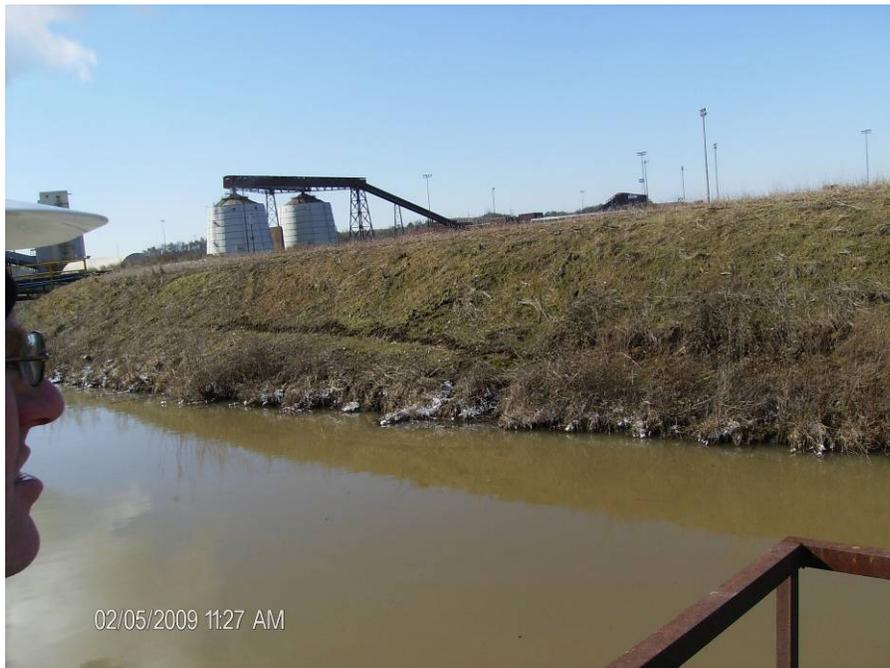
Drawing Mark SSP-4 Scarp along the southwest interior slope.

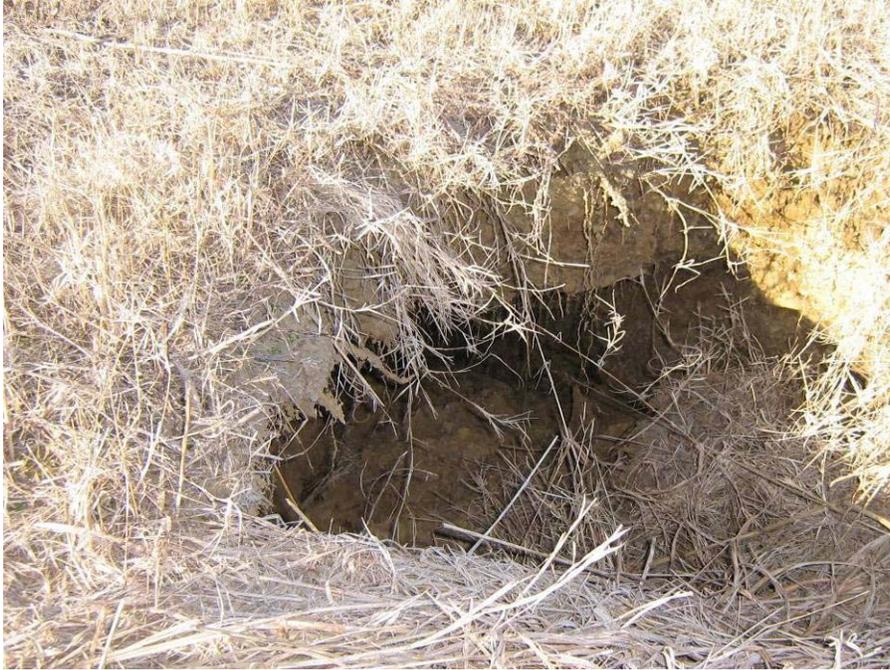
Drawing Mark DS-1-7 Deep washout along second bench (Typ.).

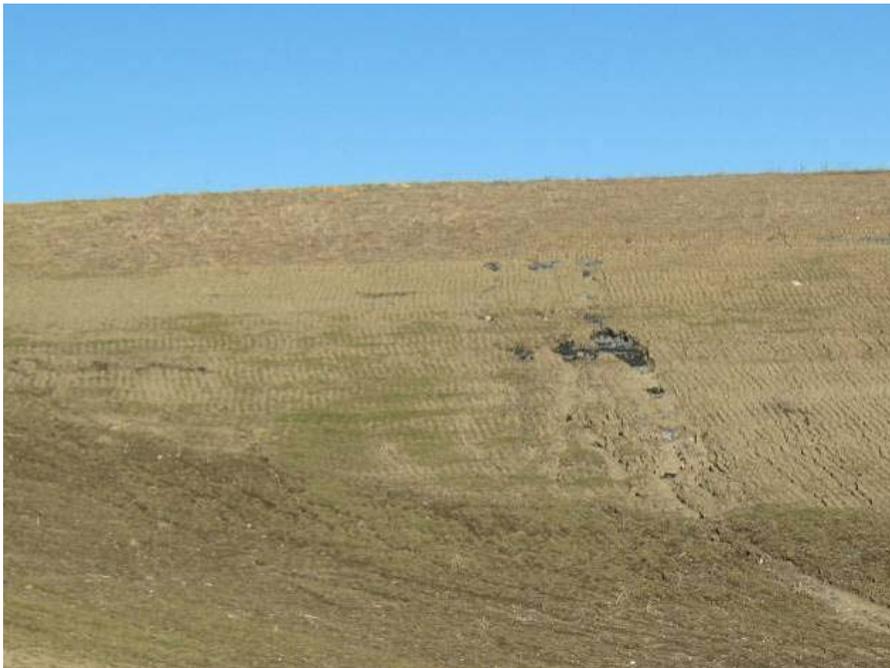
Drawing Mark DS-1-8 Washout and erosion on south face of newly completed area with lack of vegetation (Typ.).

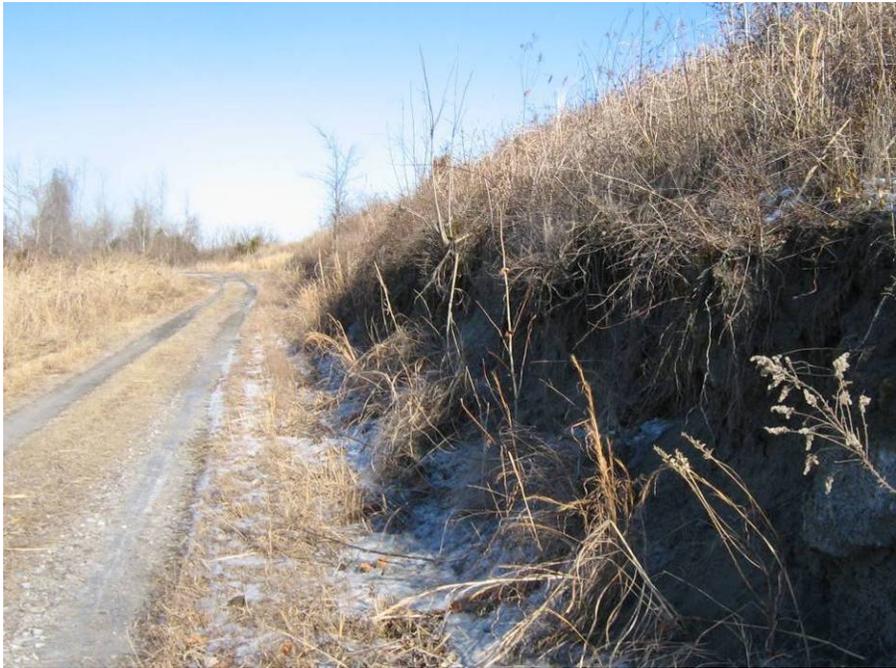
Drawing Mark CDA-1-1 Scarps along west shared ash dike (Typ.).

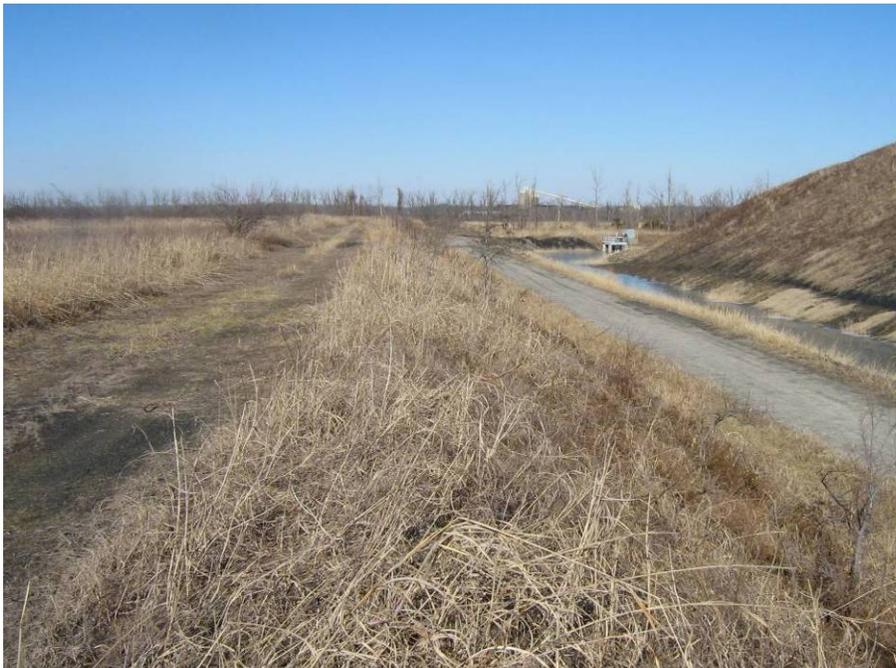
Drawing Mark CDA-1-4 Steep slopes along southeast exterior dike.
