TVA Disposal Facility Assessment Phase 1 Plant Summary Paradise Fossil Plant (PAF)

TVA Disposal Facility Assessment
Phase 1 Coal Combustion Product Disposal
Facility Summary
Paradise Fossil Plant (PAF)
Scrubber Sludge Complex - Gypsum Stack (GS)

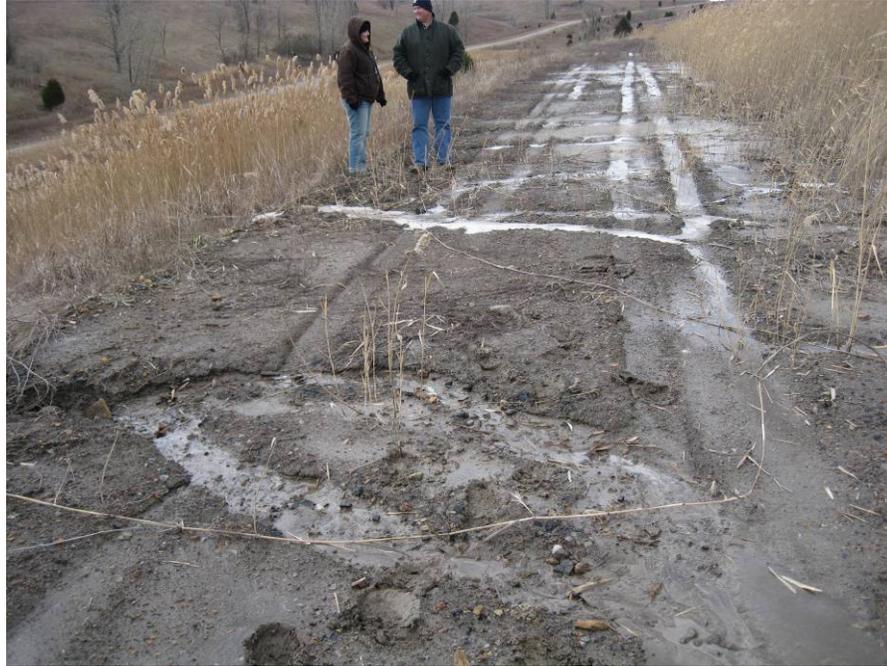
Drawing Mark GS-7

- According to the design drawings (10W4280-12 Rev 1 and 10W4280-13 Rev 1) the intermediate benches are to have high points around the middle of the embankment on each side of the dike. The benches should then have a 1% grade to low points on either side to facilitate drainage and allow for collection of seepage and runoff to route the water to the stilling pond or a drainage ditch. Standing water flowing over the bench and generally poor drainage conditions indicate that the benches have not been constructed in accordance with the design. Vehicular traffic is causing significant rutting along the benches due to the wet and soft conditions. (Photos GS-2 and GS-7)

Poor grading of all benches and drainage ditches leading to ponding water and flow over benches.

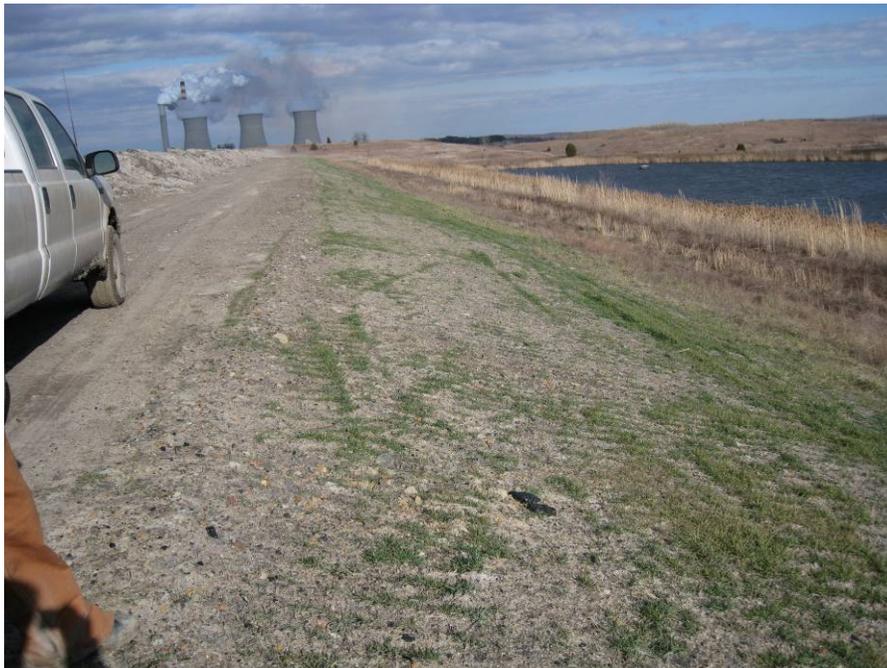
Drawing Mark GS-8

- Multiple erosion channels were noted on the upper exterior slopes of both the East and West Pond dikes. These channels extended from the outer edge of the crest down to the first bench. The upper slope level on both ponds contains sparse vegetative cover, providing little to no erosion protection. (Photos GS-3 and GS-8)

Sparse vegetation on upper lift of all exterior slopes.

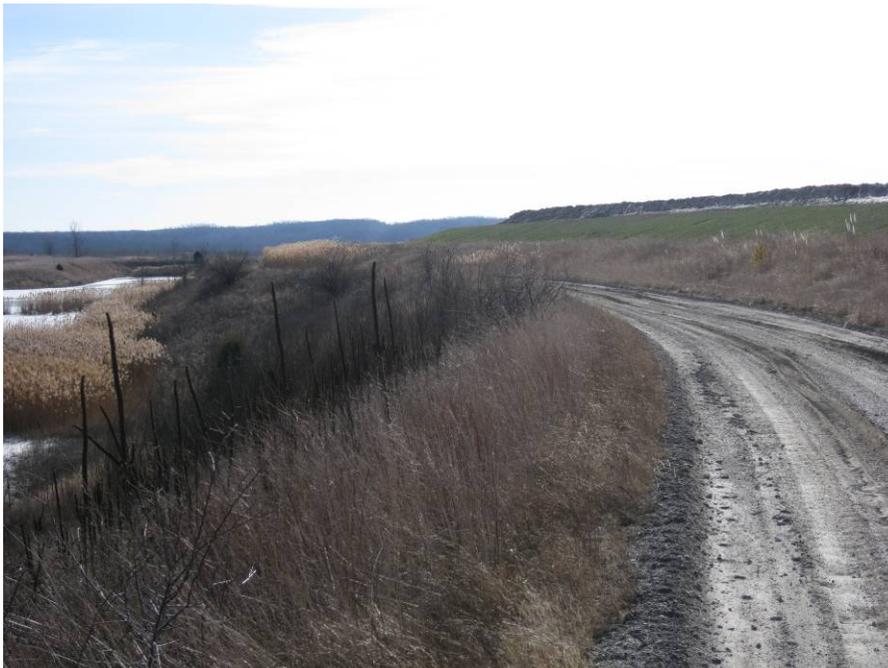
Drawing Mark GS-12 Steep exterior lower slopes on east side of east pond embankment.

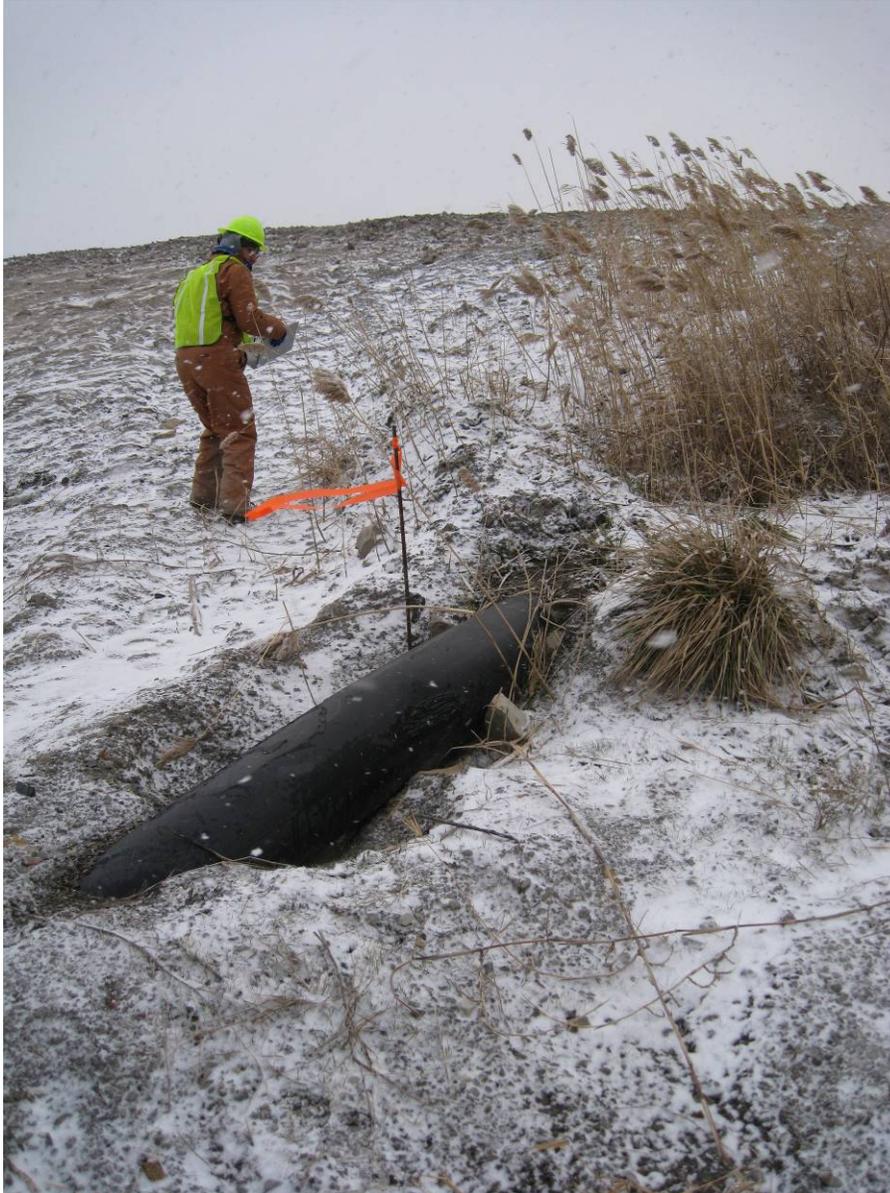
Drawing Mark GS-18 Sluice line exposed near toe of slope on north dike of east pond.

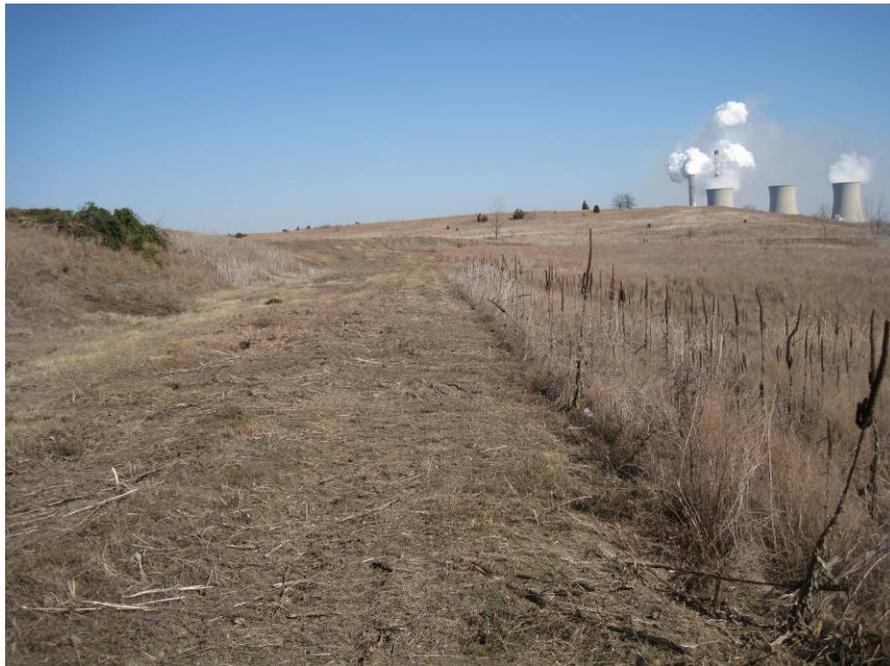
Drawing Mark GSP-2 Dense vegetation on lower half of slope.

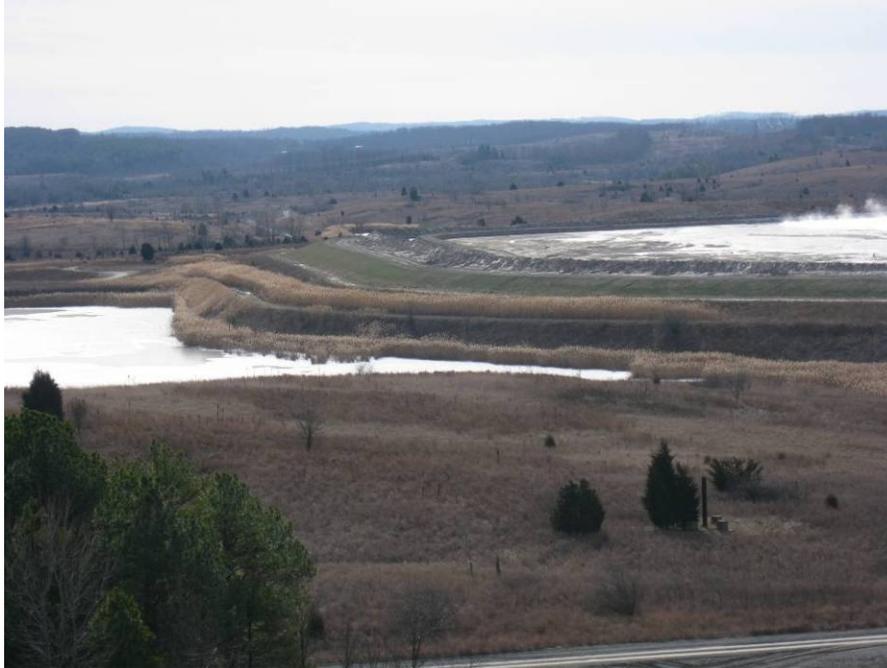
Drawing Mark DC-3

Steep West Dredge Cell interior slopes on west side also serve as exterior slopes to east pond of gypsum stack.

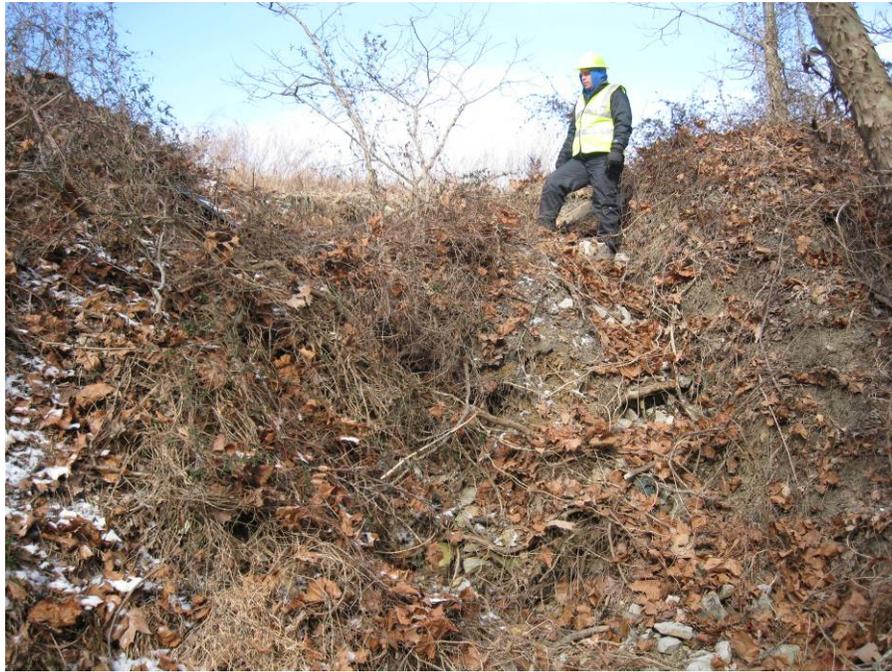
Drawing Mark PAP-1 Slope failure on exterior lower slope.

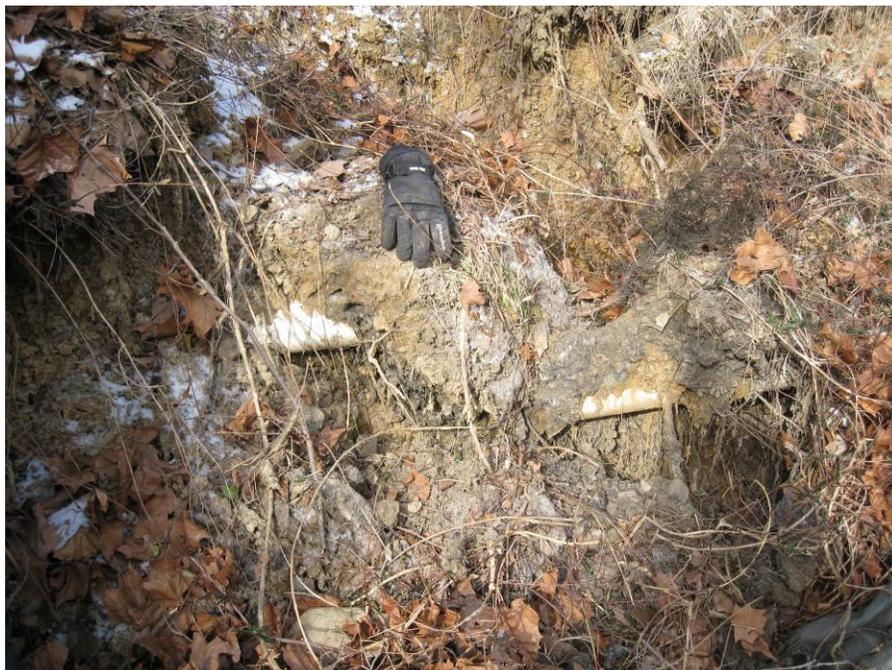
Drawing Mark PAP-2 Severed pipe within slope failure on exterior lower slope.

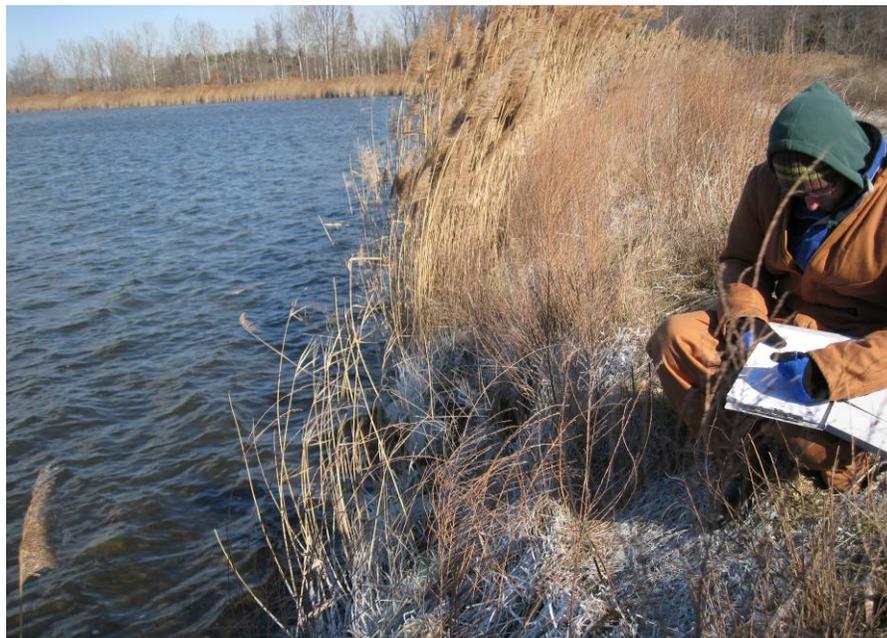
Drawing Mark PAP-4 Minimal freeboard (3-4 feet) in some areas.

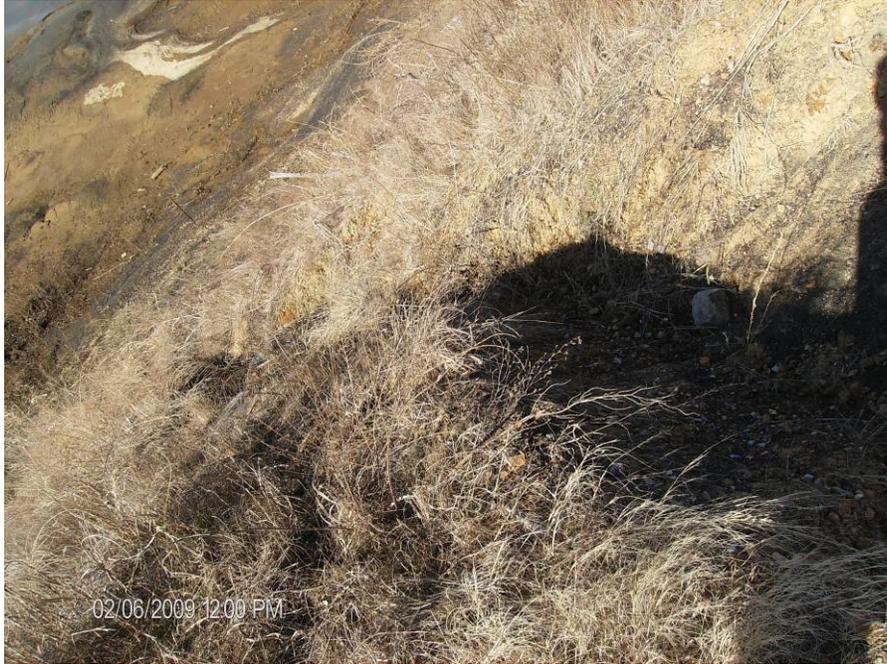
Drawing Mark SM-5

Detail photo of erosion on eastern embankment.

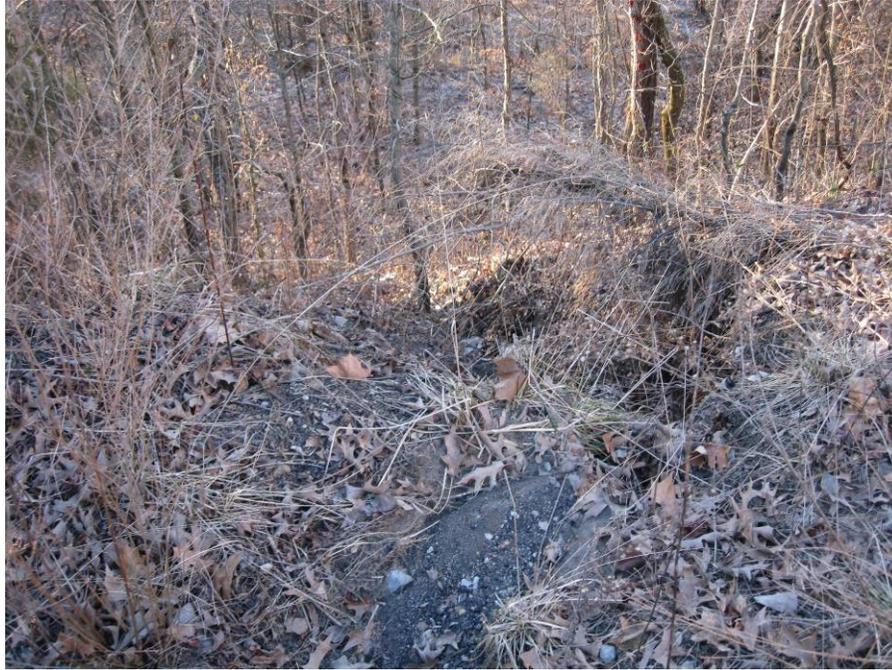
Drawing Mark SM P1-3 Erosion gully on steep exterior slope.

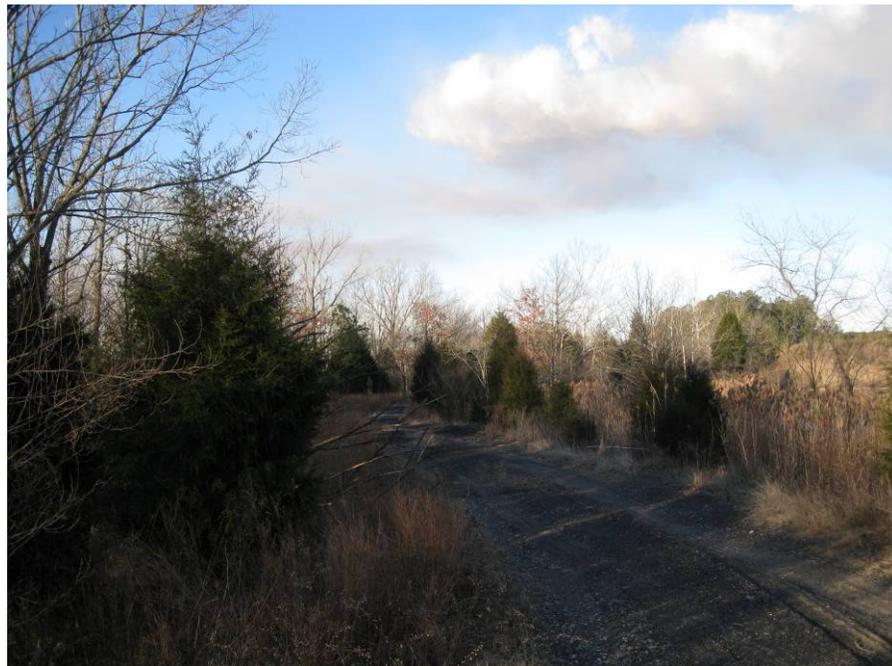
Drawing Mark SM P1-4 Dense vegetation including large trees on both interior and exterior slopes.

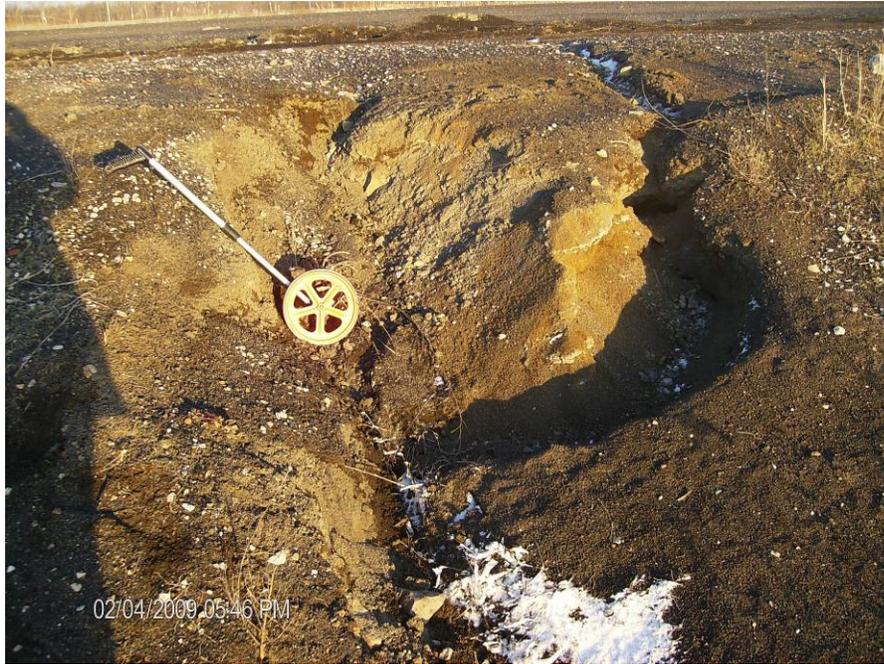
Drawing Mark SP 2A-1

Typical large erosion gully on the separation dike between Ponds 2A and 2B.

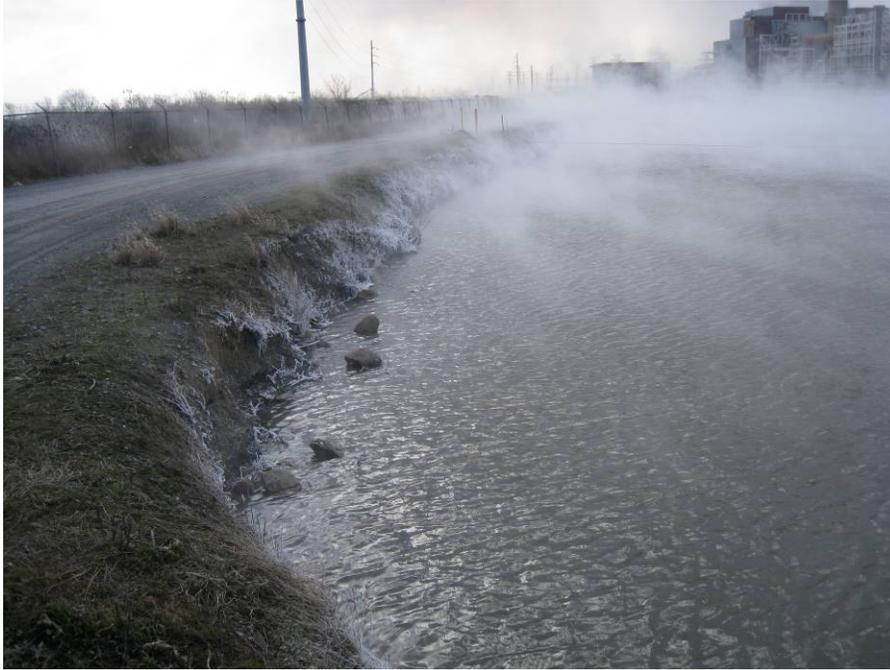
Drawing Mark SP 2B-1 Near vertical embankment along northernmost corner.

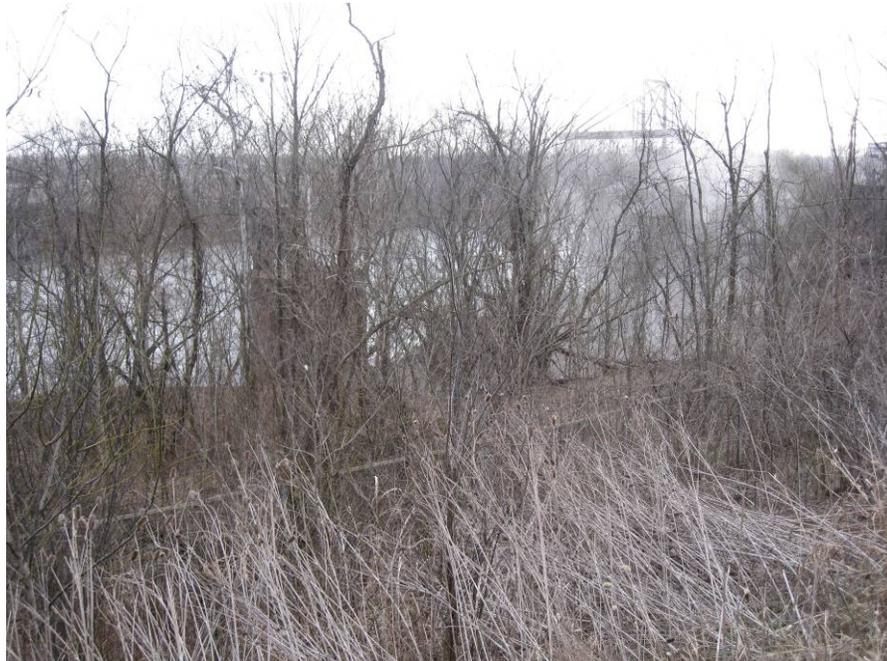
Drawing Mark SP 2B-2 Trees and other vegetation along north east slope to Green River.

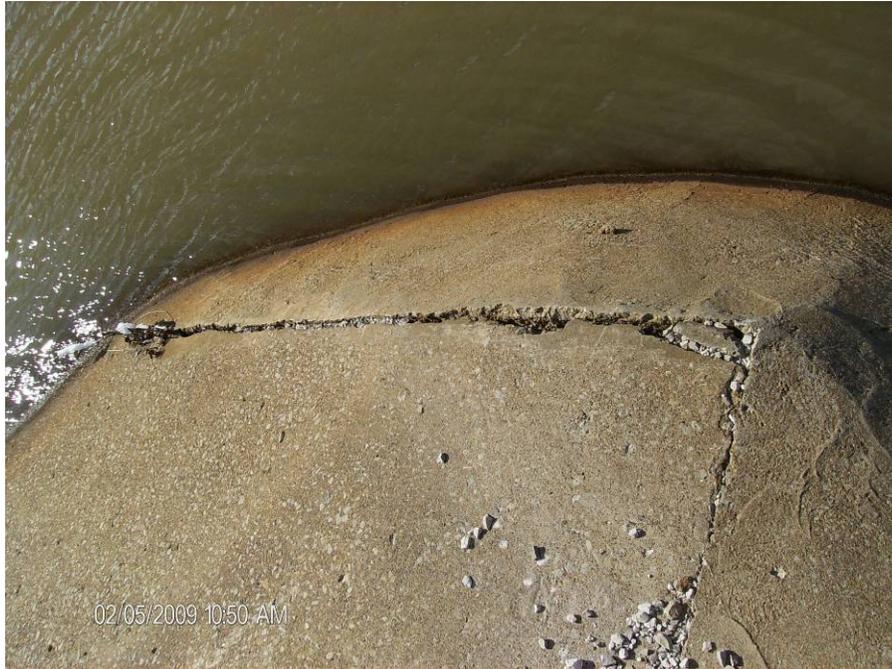
Drawing Mark SP 2B-4 Detailed image of cracks in north side of weir, between Pond 2B and the Slag Stilling Pond.

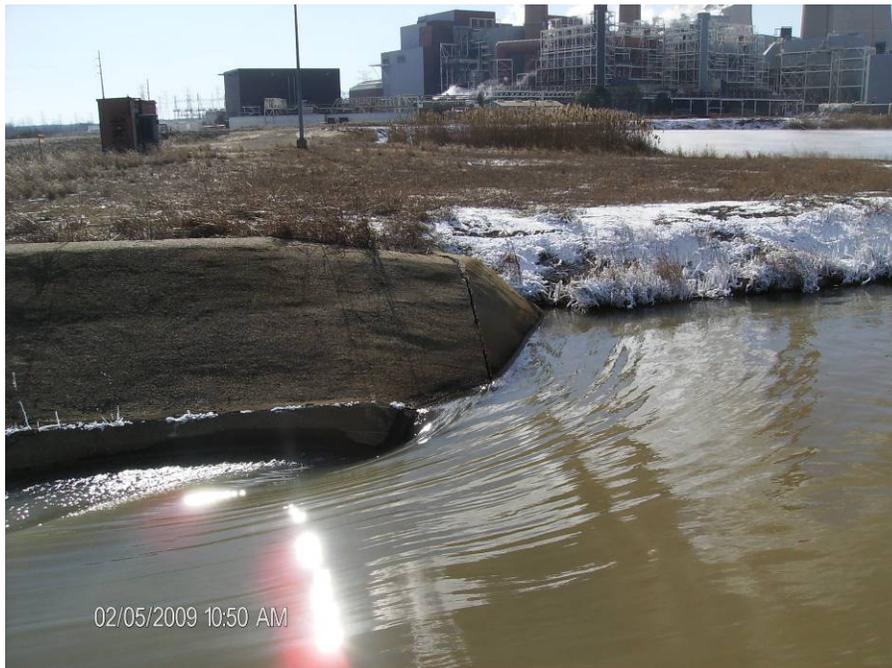
Drawing Mark SP 2B-5 Image of cracking on southern side of weir between Ponds 2B and Slag Stilling Pond.

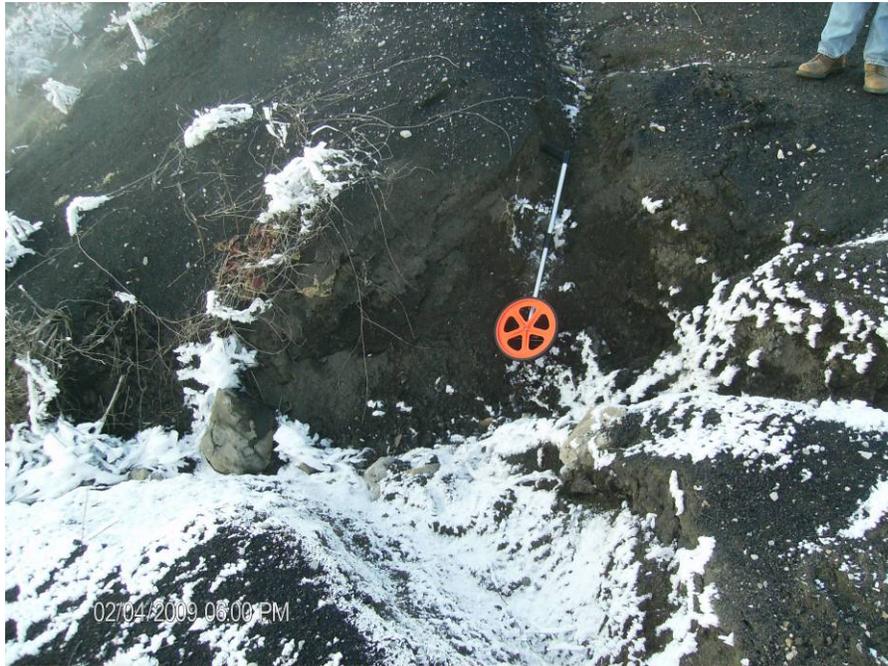
Drawing Mark SP 2B-6 Typical large erosion gully feature in the separation dike between Ponds 2A and 2B.

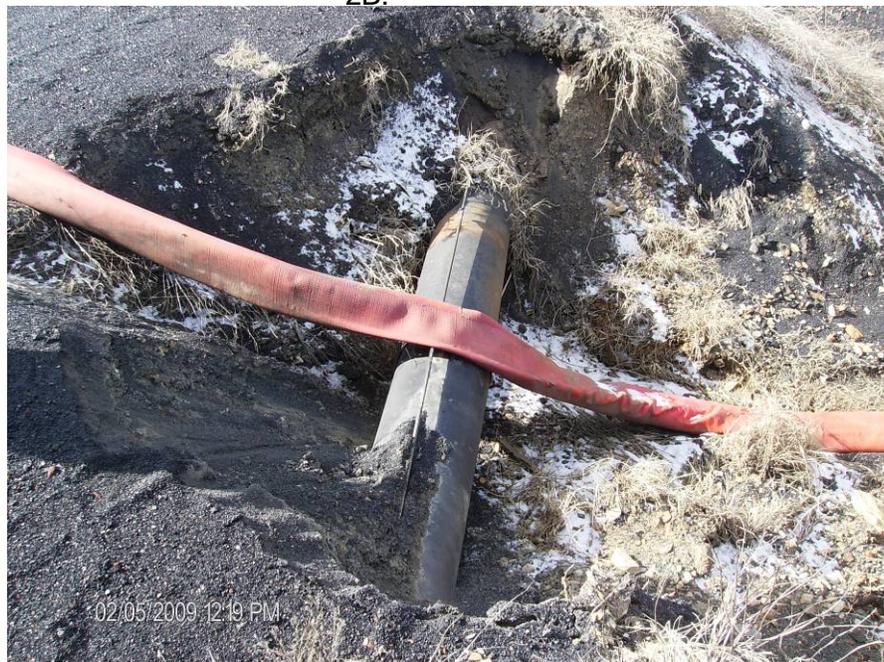
Drawing Mark SP 2B-7 Erosion gully exposing buried pipe line.

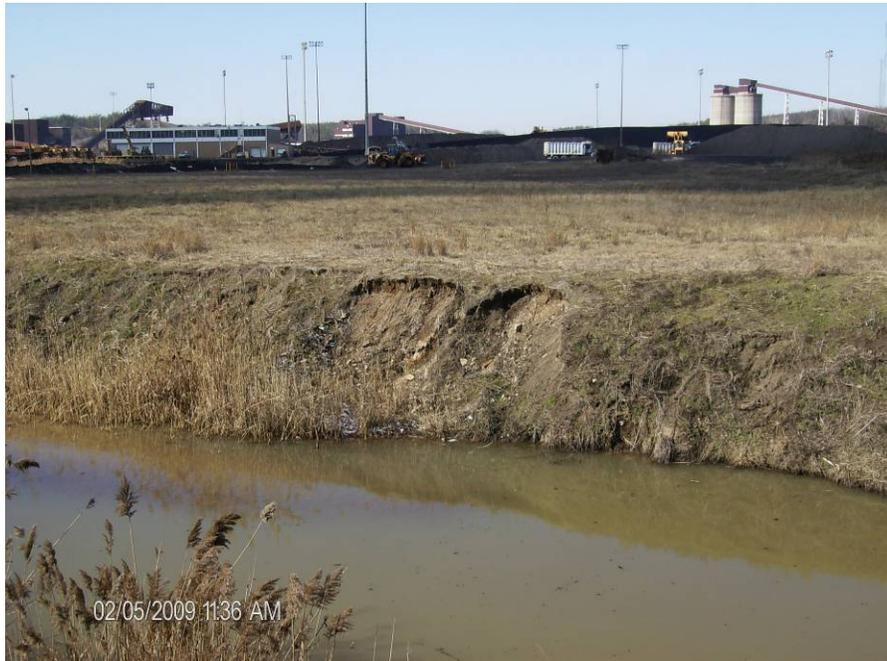
Drawing Mark SSP-2 Slumping along southwest interior slope of the Slag Stilling Pond.

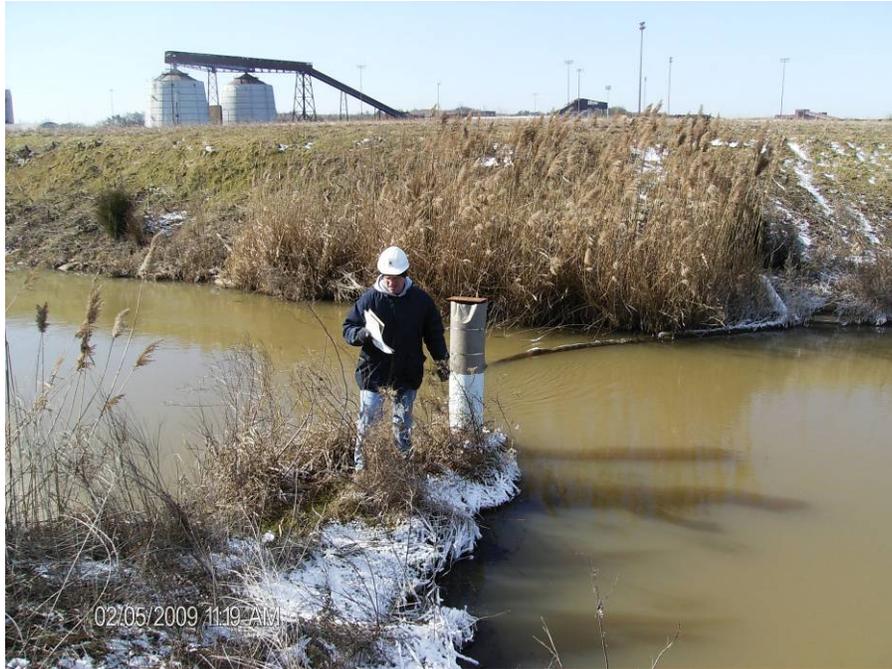
Drawing Mark SSP-3 10" PVC pipe off east embankment.

- The white 10 inch PVC standpipe needs to be evaluated to determine its origin and current status. If it is determined the pipe is out of service or not properly abandoned, an abandonment plan needs to be formulated or the pipe removed.

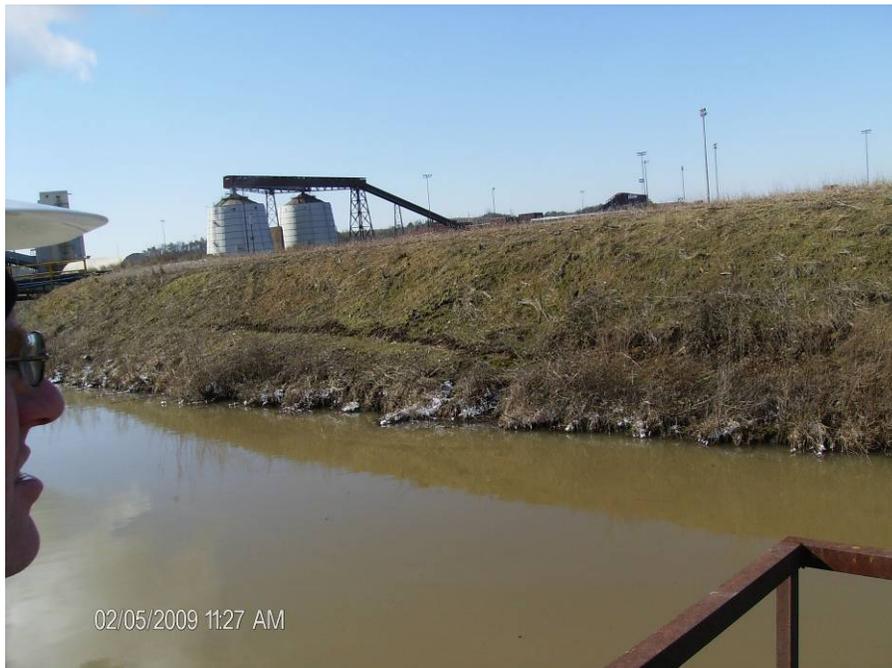
Drawing Mark SSP-4 Scarp along the southwest interior slope.
