TVA Disposal Facility Assessment Phase 1 Plant Summary Allen Fossil Plant (ALF)

TVA Disposal Facility Assessment
Phase 1 Coal Combustion Product Disposal
Facility Summary
Allen Fossil Plant (ALF)
East Ash Pond and Dredge Cell (EAP and EDC)

**TVA Disposal Facility Assessment
Phase 1 Coal Combustion Product Disposal
Facility Summary
Allen Fossil Plant (ALF)
East Ash Stilling Pond (EASP)**

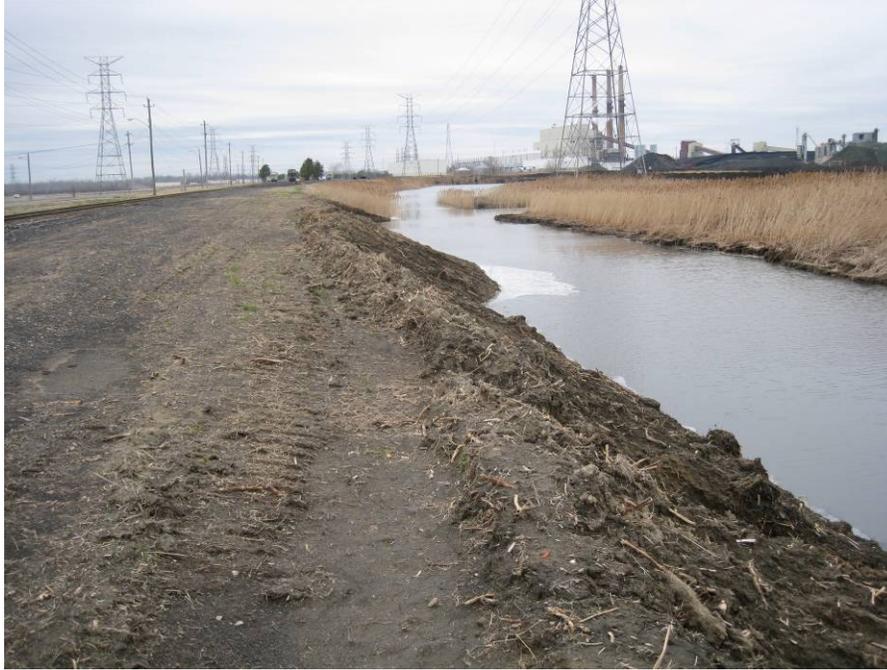
- Erosion is occurring on the interior slope along the south dike. This is considered a secondary issue since the crest width at this location is greater than 100 feet.

Drawing Mark EAP-1 Erosion is occurring on the interior slope along the south dike looking west.

- Cut and maintain heavy/tall vegetation on interior slopes.
- Repair erosion areas where noted and provide rip-rap as necessary.
- Repair / regrade animal paths and burrows and provide seeding and mulching to establish a vegetative cover. Continue to monitor on a regular basis.

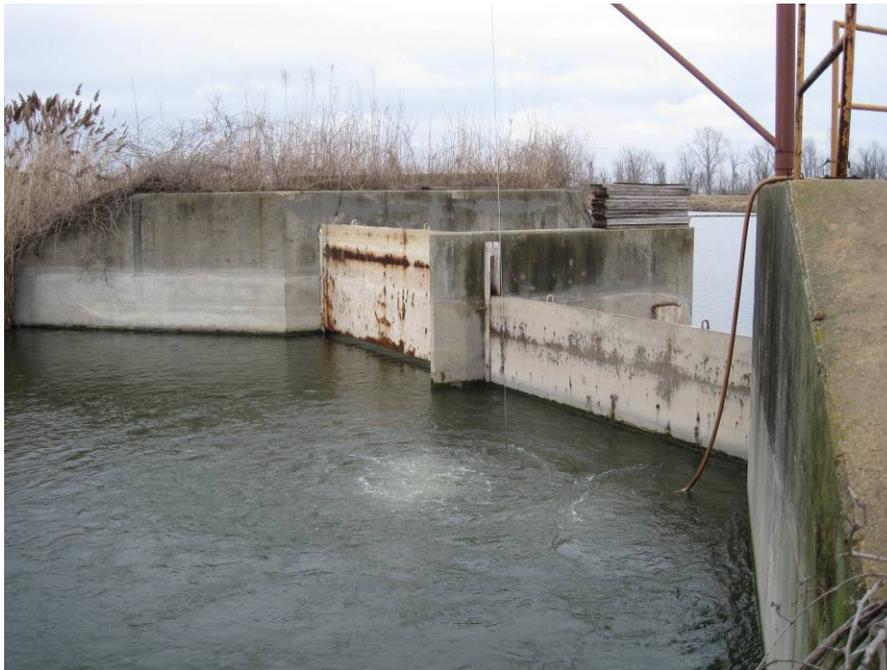
Drawing Mark EAP-2 Outlet Structure operated using stop logs.

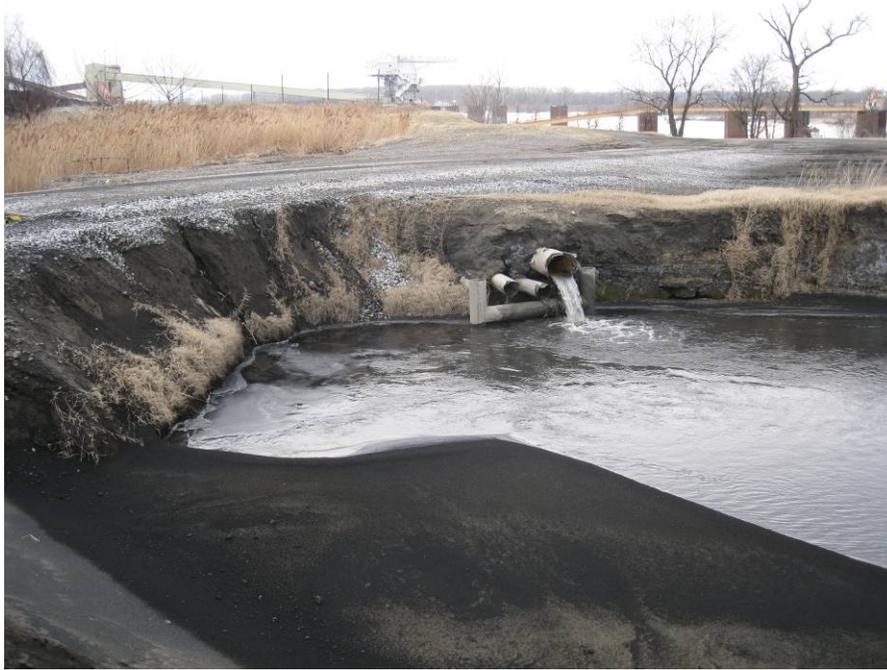
Drawing Mark EAP-3 Fly Ash influent pipes at northwest corner.

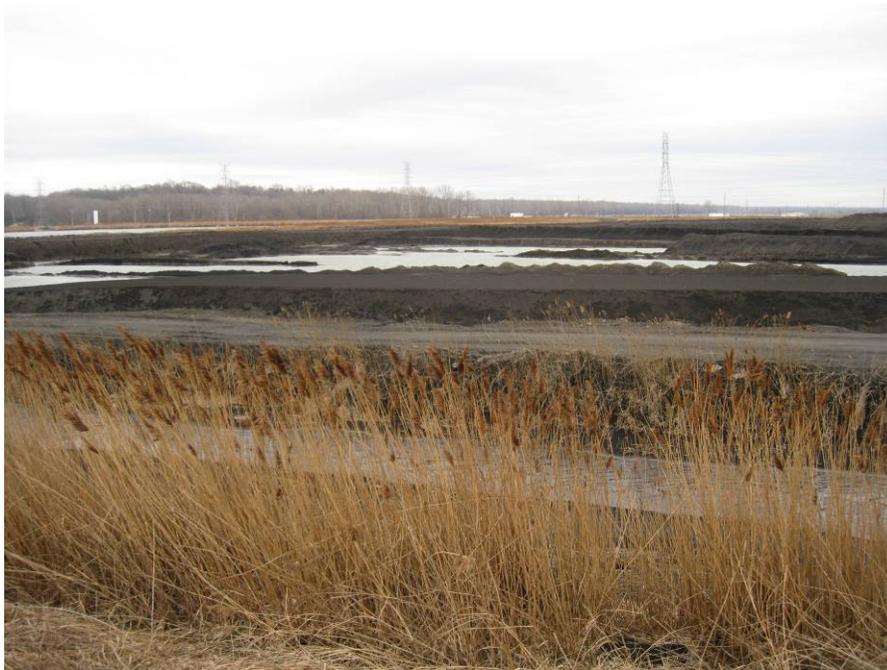
Drawing Mark EAP-4 Dredge Cell interior drainage looking south.

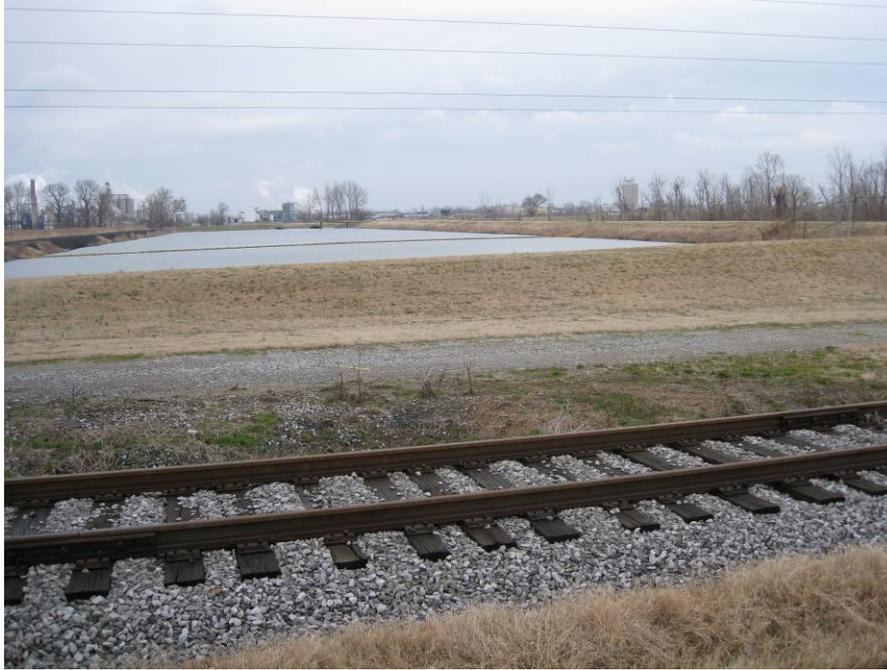
Drawing Mark EASP-1 Overview of pond showing railroad to the south.

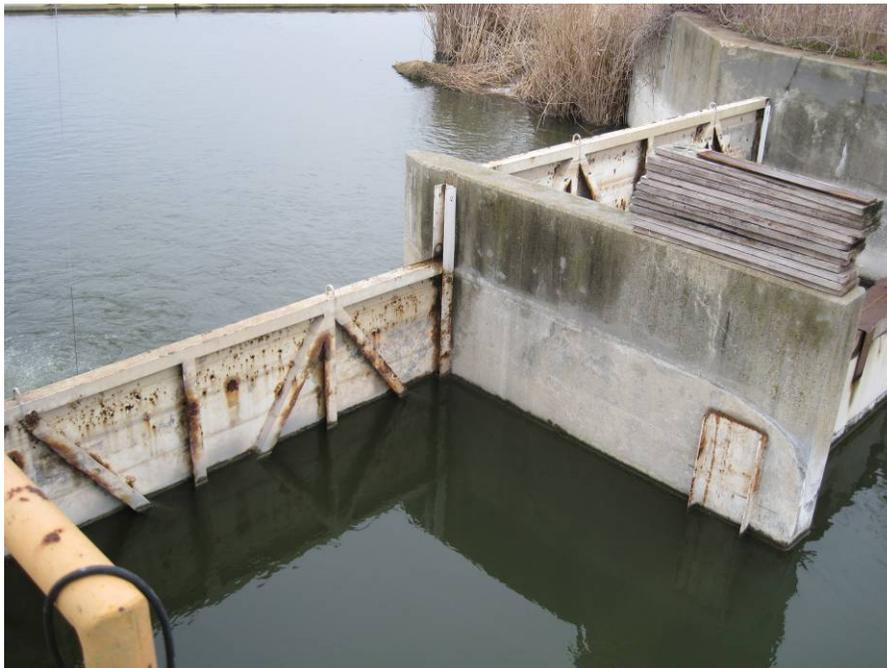
- The Outlet Structure that transfers flow from the Ash Pond into the Stilling Pond includes stop logs to control pool level. The top of the stop logs are approximately 2 to 3 feet below the crest of the divider berm. The pool levels at the time of the site visit were at nearly the same elevation even though the stop logs were well above the pool level. It is likely that flow is seeping through the divider berm keeping the pool levels at a similar elevation. This structure should be evaluated to determine if there are potential overtopping concerns. See Photo EASP-2.

Drawing Mark EASP-2 Concrete inlet structure with stop logs.

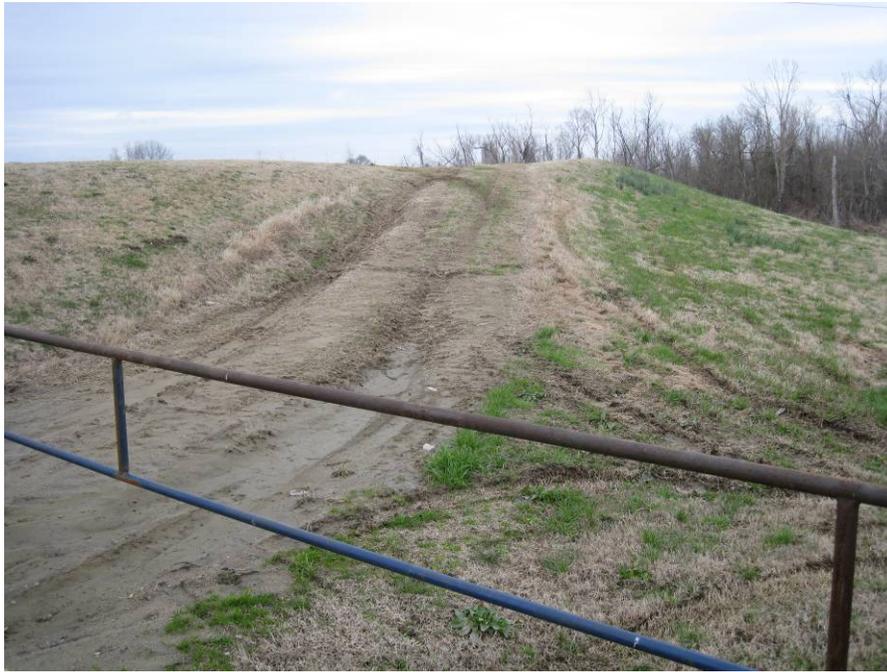
Erosion:	Primary erosion is on the access ramp located in the southeast corner of the pond. The erosion is 12 to 16 inches wide and approximately 30 feet long. The water drains down the ramp and into an adjacent swale which has also eroded.
Alignment:	Appears uniform.
Settlement/Cracking:	No significant settlement/cracking observed.
Bare Spots/Rutting:	The majority of the west (divider dike) and the access ramp is bare. Minor rutting on all dikes.
Width:	Measured: North - 30 to 35 feet East - 12 to 15 feet West (divider berm) - 22 to 25 feet South - 20 feet + Design: North - Unknown (USCOE Levee) South - Unknown (USCOE Levee) East - 16 feet West (divider dike) - Unknown

Drawing Mark EASP-3 Access ramp to crest on southeast corner of pond. Note the erosion on the ramp.

- Cut and maintain heavy/tall vegetation on interior slopes.
- Remove trees and brush from the exterior slope of the east dike.
- Repair erosion areas where noted and provide rip-rap as necessary.
- Repair / regrade animal paths and burrows and provide seeding and mulching to establish a vegetative cover. Continue to monitor on a regular basis.

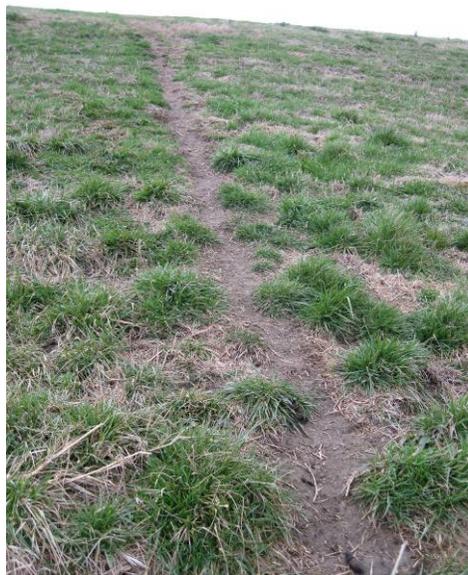
Drawing Mark EASP-4 Eastern embankment has animal paths extending from toe of exterior slope to water surface of interior slope.

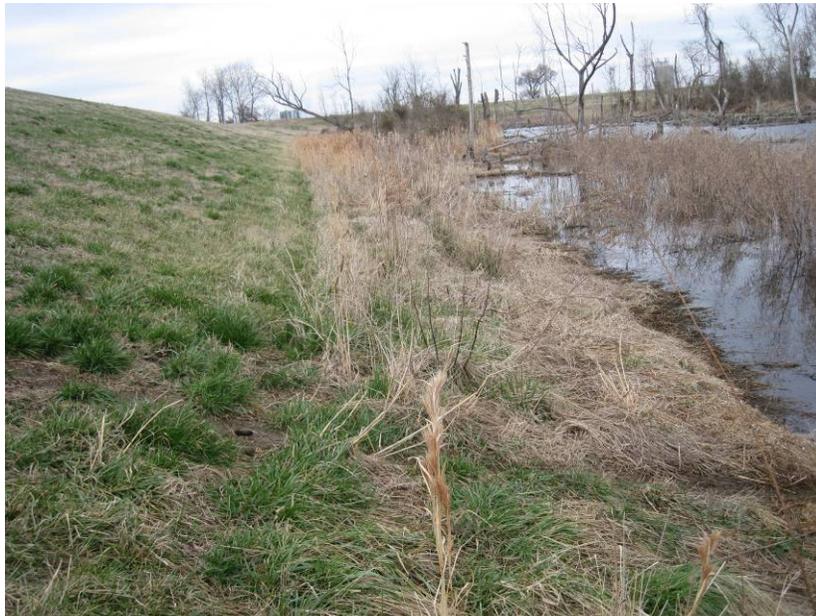
- Water is ponding at the toe of the exterior slope of the east dike making it difficult to evaluate if there is any seepage occurring (see Photo EASP-5).

- Tall vegetation has grown up along the lower portion of the exterior slope of the east dike (see Photo EASP-5).
- Animal paths and small (12 inch) animal burrows were present on the exterior slope of the east dike (see Photo EASP-4).
- The west slope (divider berm) has steep slopes (approximately 2H:1V) with some erosion.
- Wave erosion has occurred along the internal slope of the east dike. The height of the erosion varies from 6 inches up to 2 feet.
- Erosion has occurred on the crest ramp in the southeast corner of the pond (see Photo EASP-3).

Drawing Mark EASP-5 Eastern embankment showing ponding water and thick vegetation at the toe. Portions of the slope had small (1 to 2 inch diameter) animal burrow holes.

- Evaluate existing topography and drainage conditions at the toe of the east dike at the East Ash Stilling Pond. A hydraulic and hydrologic analysis should be performed to determine if positive drainage is being provided away from the east dike.

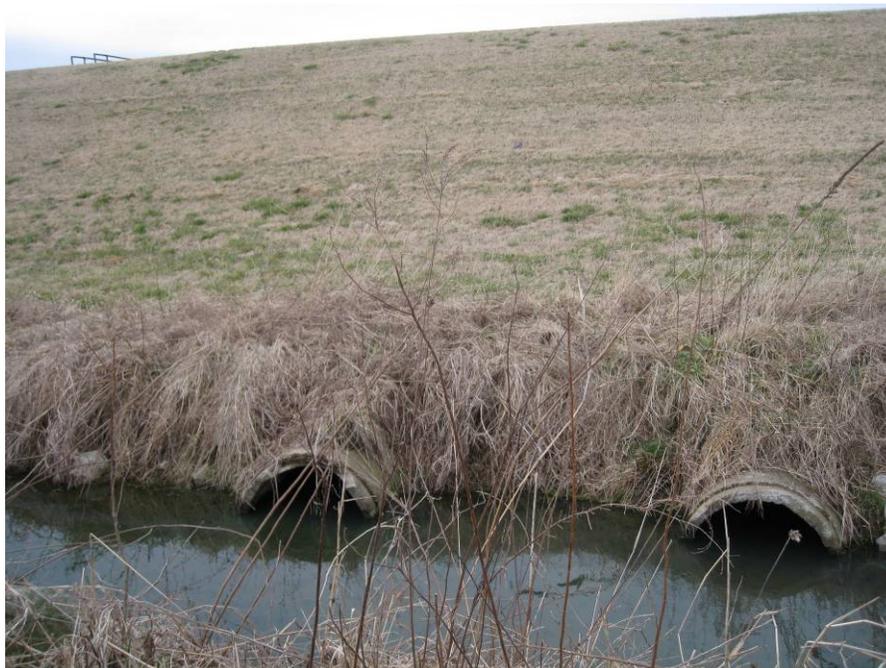
Drawing Mark EASP-6 Decant structure outlets to Horn Lake. Note partially submerged outlet pipes.

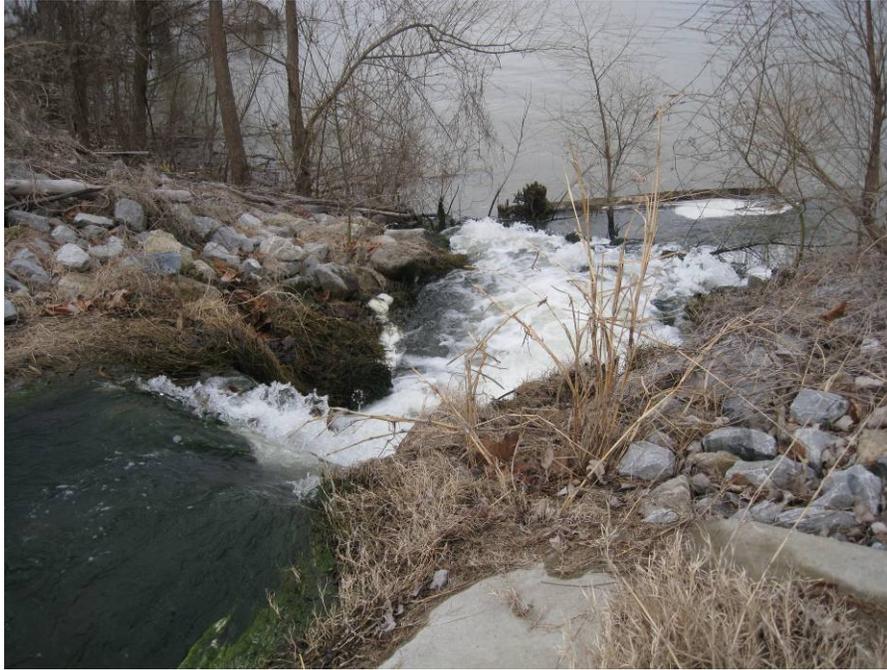
- The four decant structures are possibly constructed using stacked RCP risers. The two primary structures outlet into McKellar Lake and the secondary (emergency) structures outlet downstream of the east dike and flow to the south in a stream channel which outlets into Horn Lake. The two secondary outlets at the toe of the east dike are partially submerged (see Photo EASP-6). Erosion has occurred at the primary decant structure outlet where the concrete channel flows into McKellar Lake (see Photos EASP-7 and EASP-8).

Drawing Mark EASP-7 Decant structure outlet into McKellar Lake has erosion occurring.

- Evaluate the decant structures at the East Ash Stilling Pond for suitability and condition.
- Evaluate current operating procedures for working around the existing electric transmission lines including factor of safety for stability.

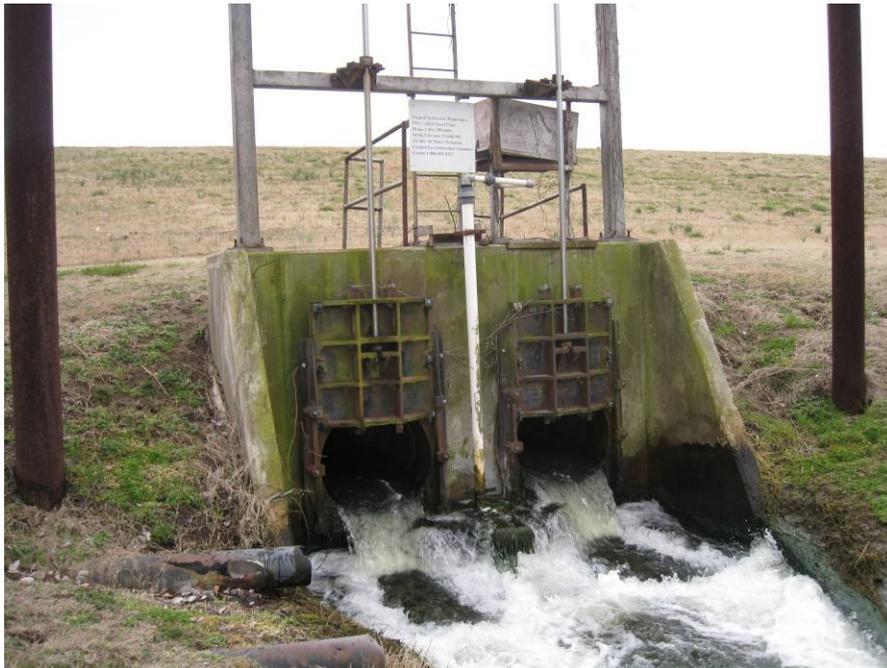
Drawing Mark EASP-8 Decant structure outlets to McKellar Lake.

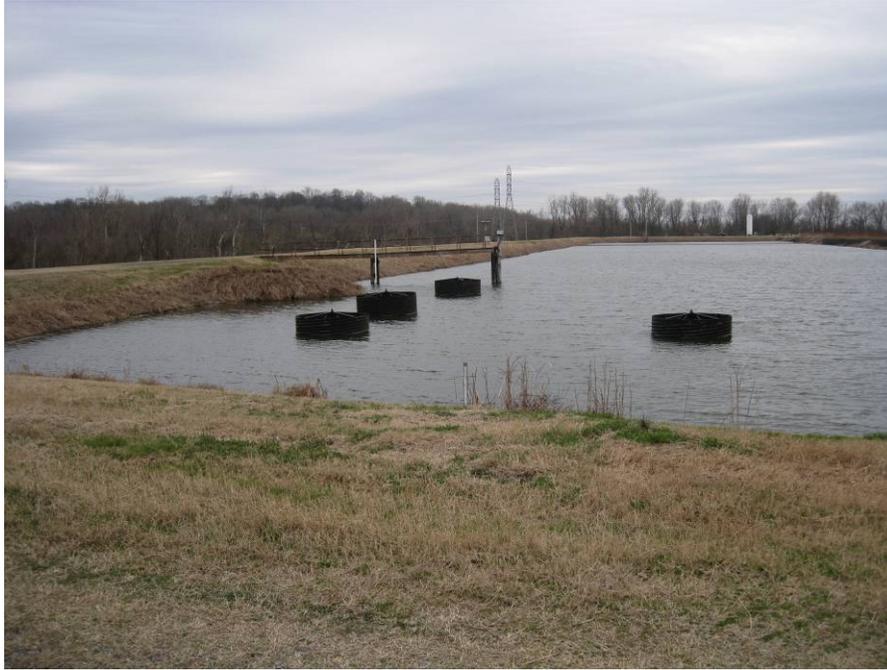
Drawing Mark EASP-9 Decant structure inlets with skimmers.

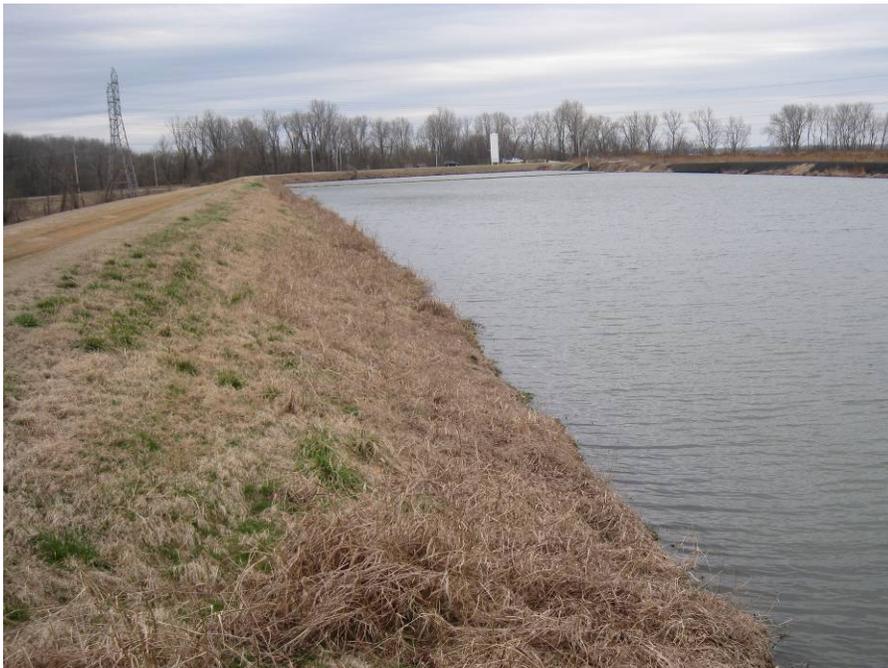
Drawing Mark EASP-10 Interior slope wave erosion.

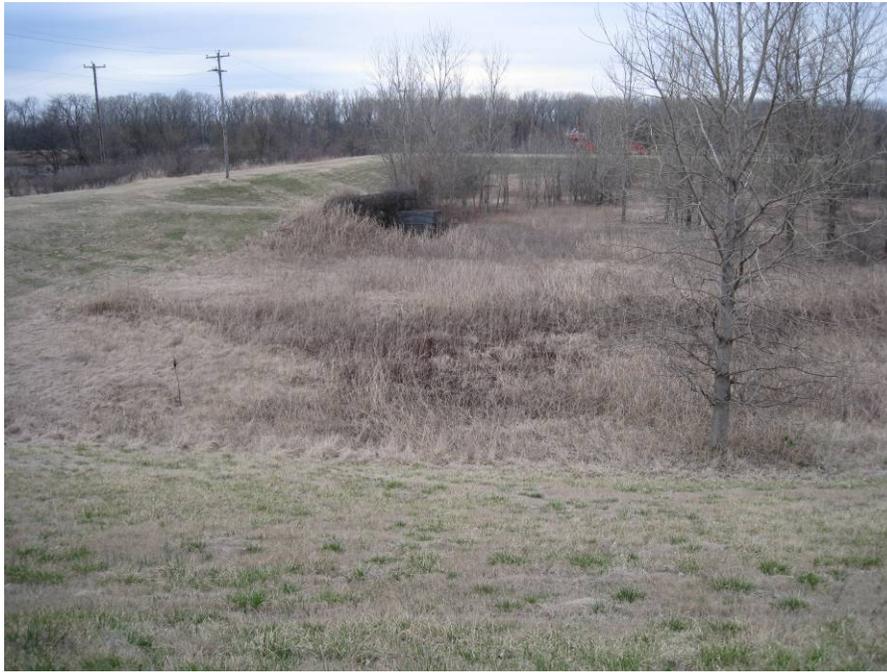
- This structure is inactive and appears to be empty. See Photo WAP-1.
- Original Decant Structure should be evaluated to determine if operation of the pond relies on this structure for storm water hydraulic and hydrologic capacity. No ponding water was observed within the pond during the site visit so the drainage may be adequate. See Photo WAP-1.
- Trees and dense vegetation are growing on the pond interior which is approximately 10 feet below the crest of the dikes (See Photo WAP-2).
- Trees and dense vegetation are growing on the exterior slope of the north dike (See Photo WAP-3).

Drawing Mark WAP-1 Interior of Ash Pond mainly empty and covered with trees and dense vegetation.

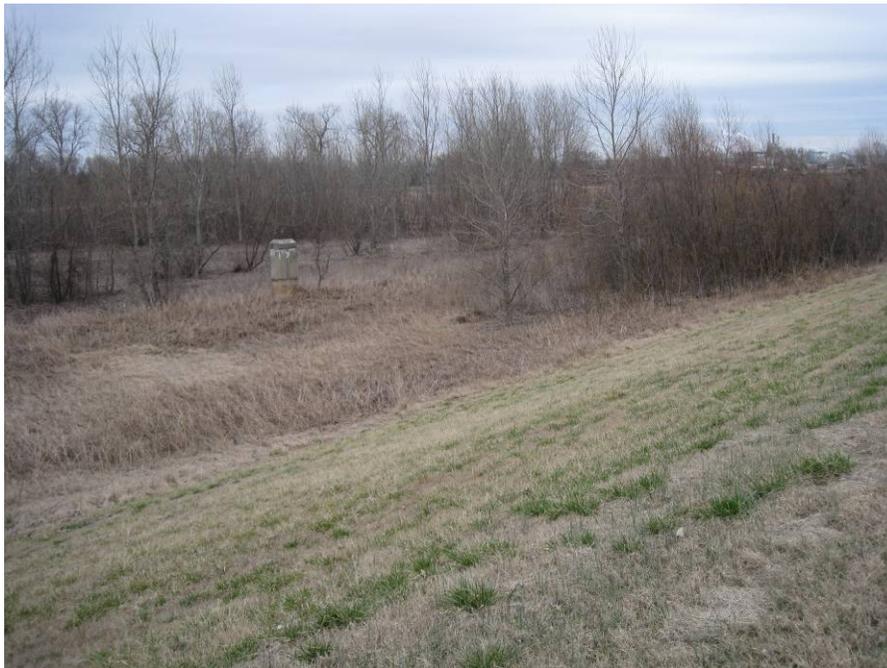
Drawing Mark WAP-2 Dense trees and vegetation are growing on the interior of the pond.

- Cut and maintain heavy/tall vegetation on interior and exterior slopes to allow better observation.
- Remove trees and brush from the interior and exterior slopes.

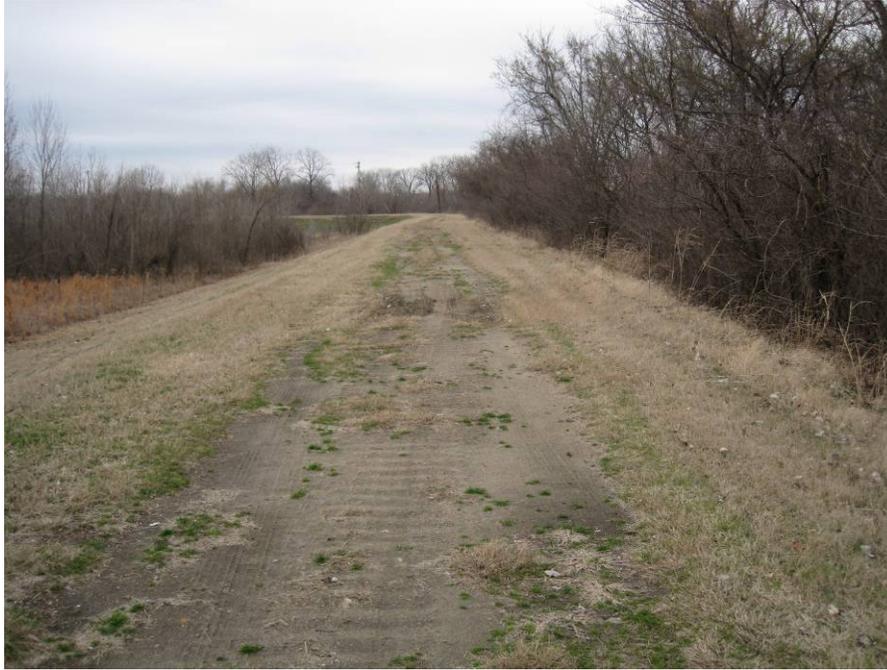
Drawing Mark WAP-3 Dense trees and vegetation are growing on the exterior slope of the north dike.

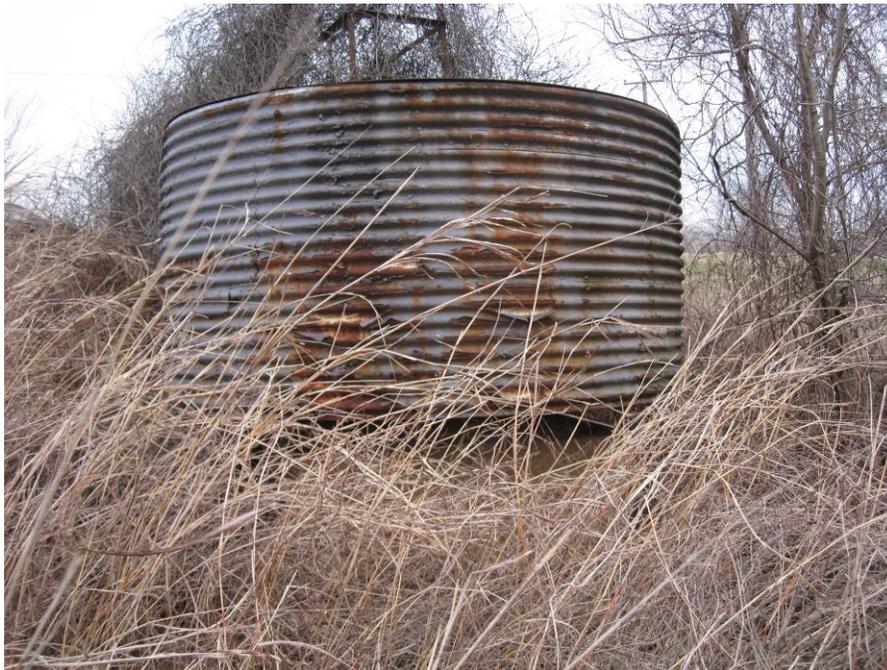
Drawing Mark WAP-4 Abandoned decant structure on west end of pond. Deteriorated and surrounded by heavy vegetation.
