TVA Disposal Facility Assessment Phase 1 Plant Summary Cumberland Fossil Plant (CUF)

**TVA Disposal Facility Assessment
Phase 1 Coal Combustion Product Disposal
Facility Summary
Cumberland Fossil Plant (CUF)
Gypsum Storage Area (GSA)**

**TVA Disposal Facility Assessment
Phase 1 Coal Combustion Product Disposal
Facility Summary
Cumberland Fossil Plant (CUF)
Ash Pond (AP-1)**

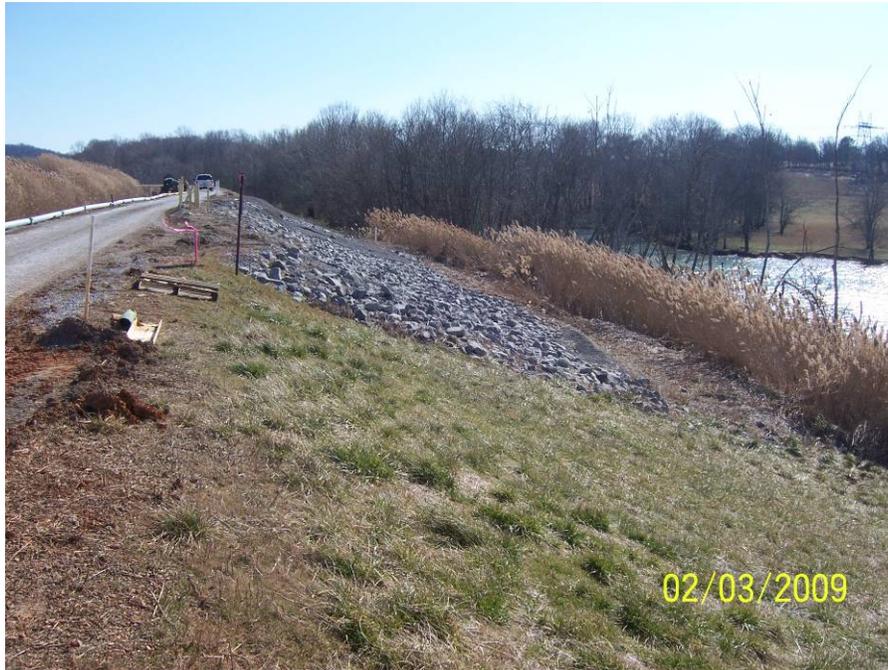
A slope slough along the perimeter clay dike in the northwest corner of the Gypsum Storage Area reportedly occurred in 2005. The slope was temporarily repaired using rip rap and Stantec is currently evaluating slope stability. Seepage has also been reported in this area and along the Gypsum Storage Area to the east. As a result, the pond has also been drained until Stantec's evaluation is complete.

Drawing Mark GP-1-1 Riprap placed in area to temporarily repair slope slough along the perimeter dike at the NW corner of the Gypsum Stack.

- CUF plant personnel should continue to monitor the existing slope failure along the perimeter dike outslope at the northwest corner of the Gypsum Storage Area until Phase 2 evaluations are complete and permanent repairs executed.

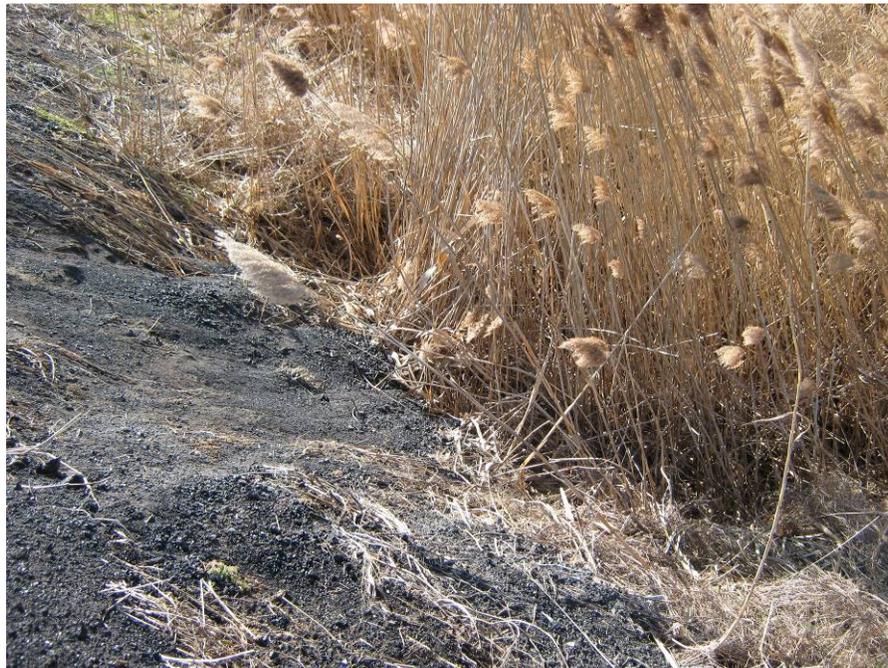
Drawing Mark GP-1-2 Small slope slough along ash divider dike outslope at NW side of the Gypsum Storage Area.

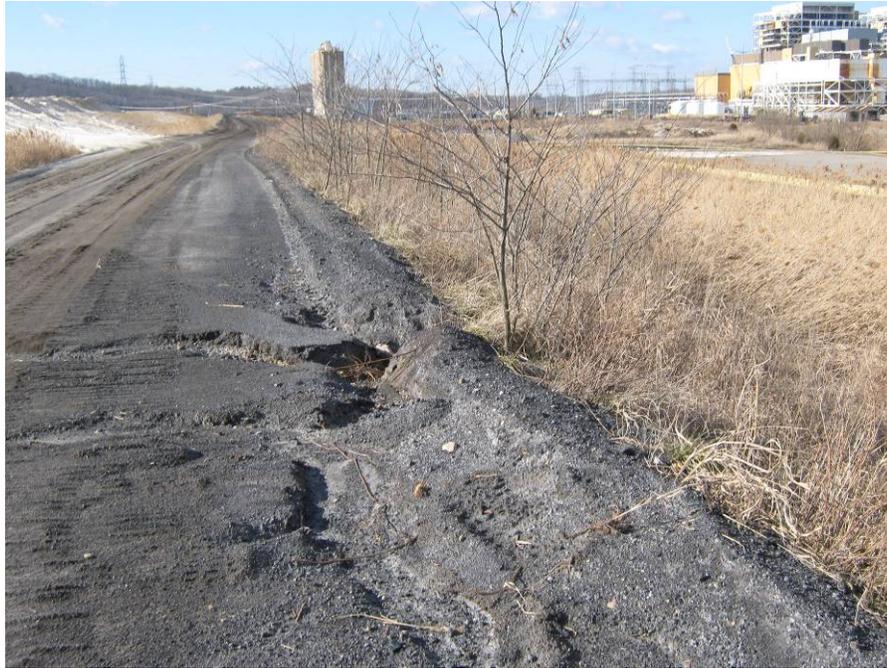
- Some trees were observed along the perimeter ash dike to the northeast of the Gypsum Storage Area.
- Erosion was observed along the crest and outslopes of the ash divider dike at several areas.

Drawing Mark GP-1-3 Trees and erosion along the perimeter ash dike at the northeast side of the Gypsum Storage Area.

- The discharge pipes that drain the interior portion of the Gypsum Storage Area should be extended to ground level and away from the toe of slope.
- Remove trees from noted locations.

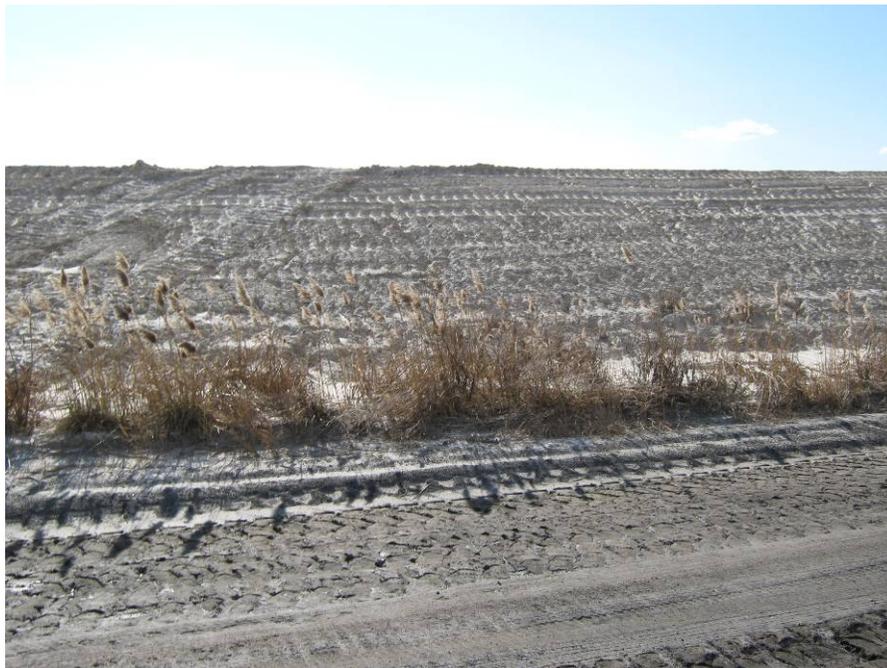
- The absence of an Emergency Action Plan, Operation and Maintenance Plan, as-built drawings and construction testing records is a concern.
- Reconstructed upper gypsum dikes are lacking vegetation.

Drawing Mark GP-1-4 Reconstructed gypsum dikes surrounding the two ponds lacking vegetation.

- The loosely stacked gypsum material around the perimeter of the Gypsum Storage Area should be spread in appropriate thicknesses and compacted properly wherever it is to be used as structural dike material. The material used for dikes at outlet areas should consist of coarser gypsum, which has higher strength. Efforts to establish vegetation on completed slopes should also be made.

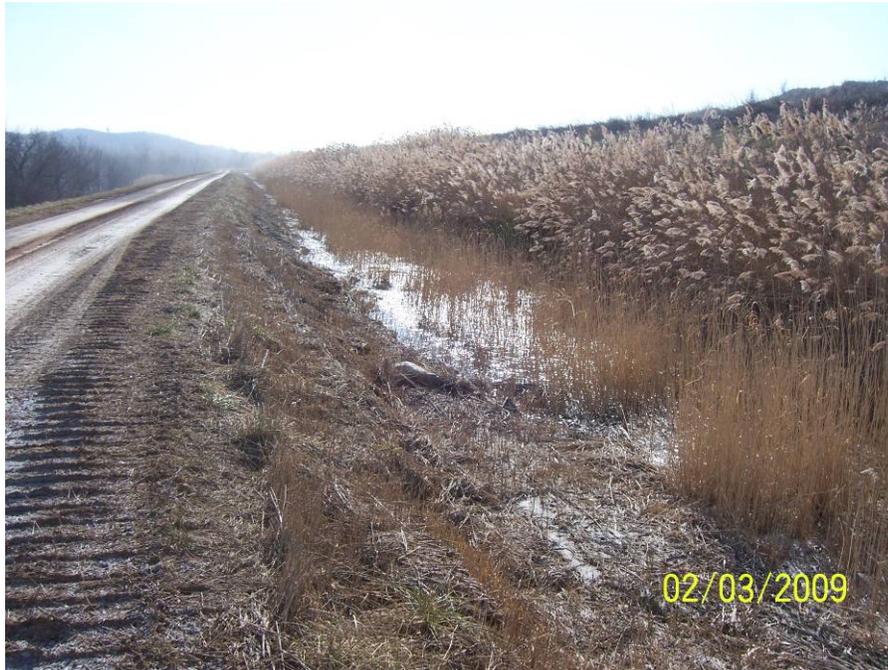
- The southwest and southeast sides of the perimeter ditch contain sediment build-up and standing water.
- Vegetation has not yet been re-established where trees have been removed from the downstream slope of the perimeter clay dike.

Drawing Mark GP-1-5 Heavy vegetation and sedimentation in perimeter drainage ditch along the southwest and southeast sides of the Gypsum Stack.

- Clean sedimentation and phragmites from Gypsum Storage Area perimeter ditches. Remove sedimentation, check grades and regrade the perimeter ditches as needed to promote positive drainage and alleviate standing water issues. Use of rip-rap to re-establish ditch side slopes should be considered.

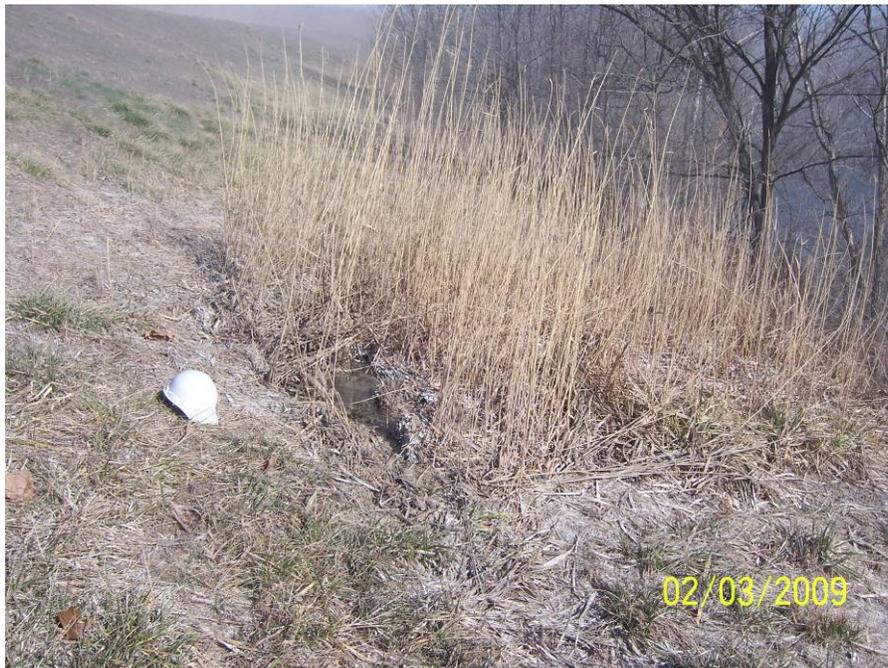
Drawing Mark GP-1-6 Seepage observed below the perimeter dike along the southeast side of the Gypsum Stack.

- CUF plant personnel should continue to monitor the seepage area below the perimeter clay dike.
- CUF personnel have reported a seepage area along the north corner of the Gypsum Storage Area that could not be seen because the pond is currently drained. If this seep re-appears upon re-filling, a crushed stone French drain should be installed by excavating back to intercept the gravel drainage layer that underlies the gypsum disposal area.

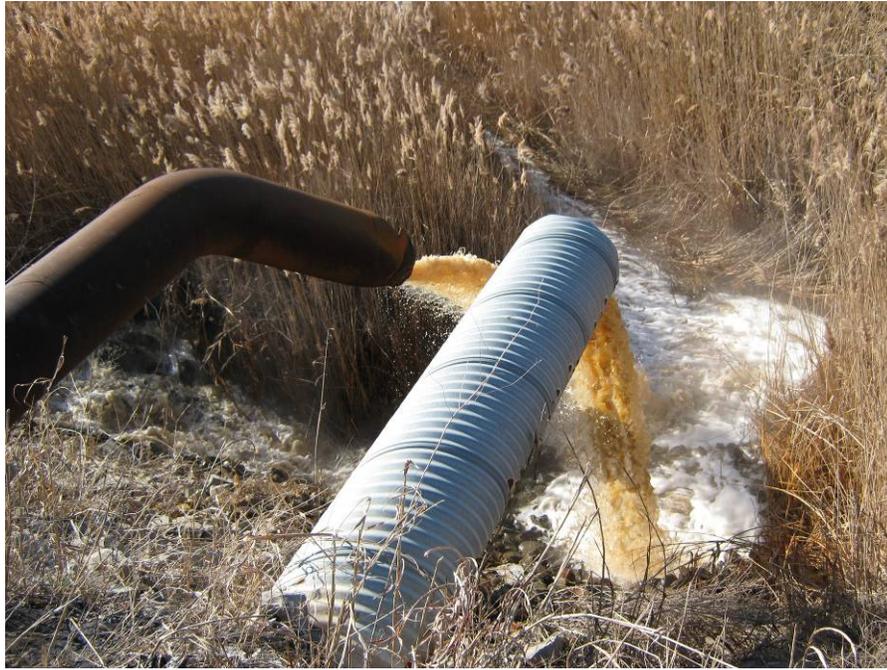
- Discharge pipes from interior pond drainage are elevated above a rip-rap channel. Over time, toe erosion will likely occur.

Drawing Mark GP-1-7 Discharge pipes and riprap channel along northwest corner of Gypsum Storage Area.

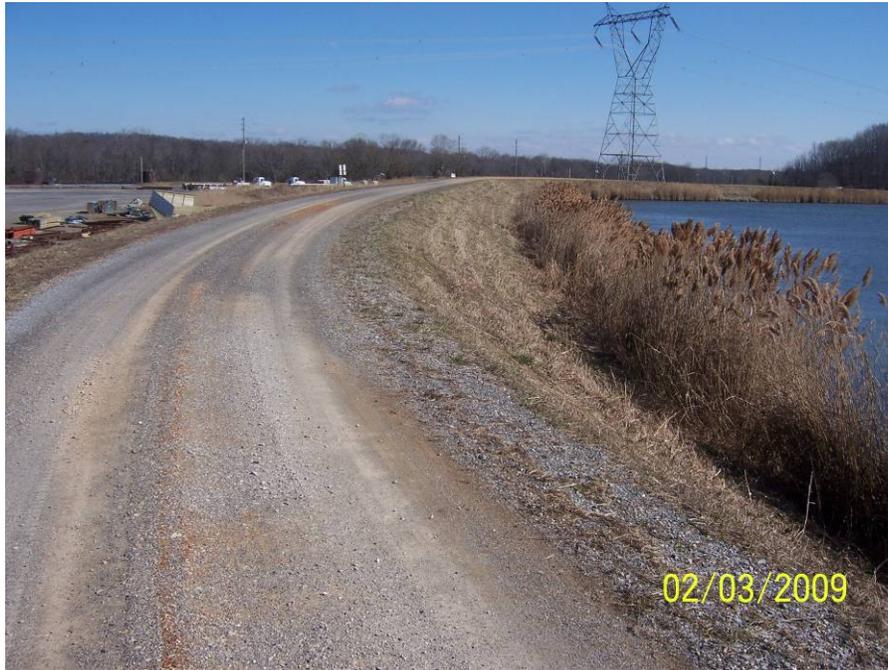
Drawing Mark AP-1-1 Crest and inside slopes of the perimeter dikes around the Ash Pond.

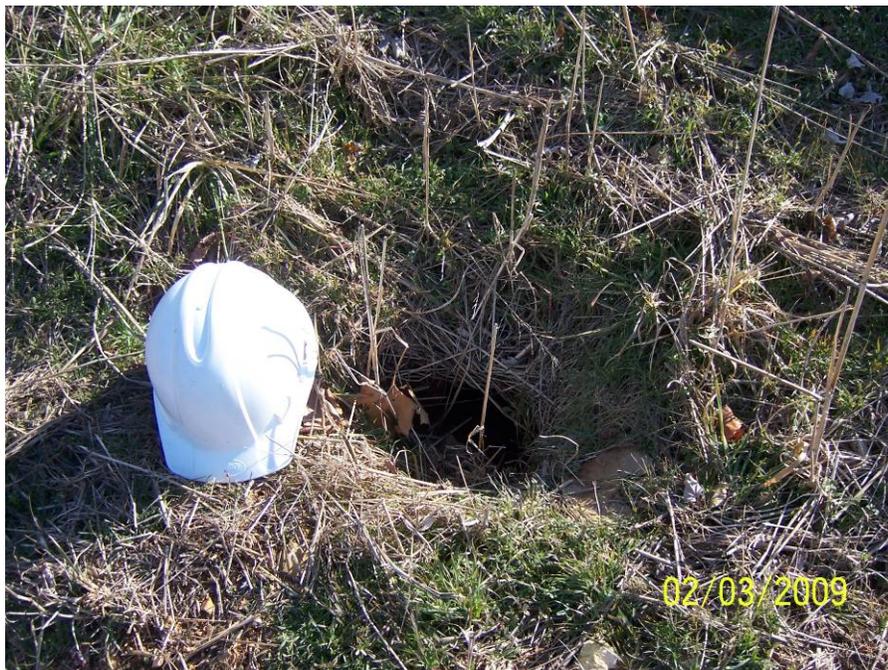
- The absence of an Emergency Action Plan, Operation and Maintenance Plan, as-built drawings and construction testing records is a concern.
- One animal burrow was noted along the perimeter dike.

Drawing Mark AP-1-2 Animal burrow along north perimeter dike of Ash Pond.

- Remove trees from noted locations.
- Repair animal burrows where noted.
- Cut and maintain heavy/tall phragmite growth on slopes of ponds to allow better observation. Establish mowing program of ponds and disposal areas.
- Regrade and repair erosion areas where noted.
- The RCP riser spillway outlet system may ultimately be modified or replaced, pending Stantec-TVA assessment of replacement system. Monitor the spillway systems until that time.
- Monitor standing water along toe of perimeter dike. Regrade adjacent drainage ditch if conditions worsen.
- Continue annual inspection program and execute recommendations.
- Evaluate the structural condition of the skimmers and the way walkways are supported, and modify or replace as necessary.

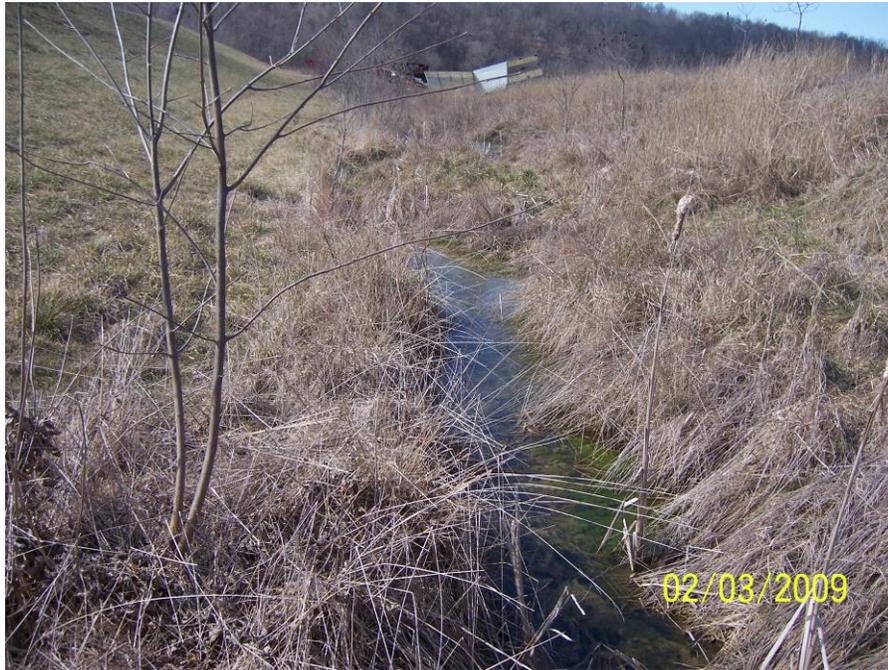
- Standing water attributed to poor drainage was noted along the toe of the north perimeter dike.
- RCP push-together riser spillways are a concern.
- Some minor erosion was noted along the outslope of the perimeter roadway just east of the sluicing channel.

Drawing Mark AP-1-3 Standing water along toe of north perimeter Ash Pond dike.

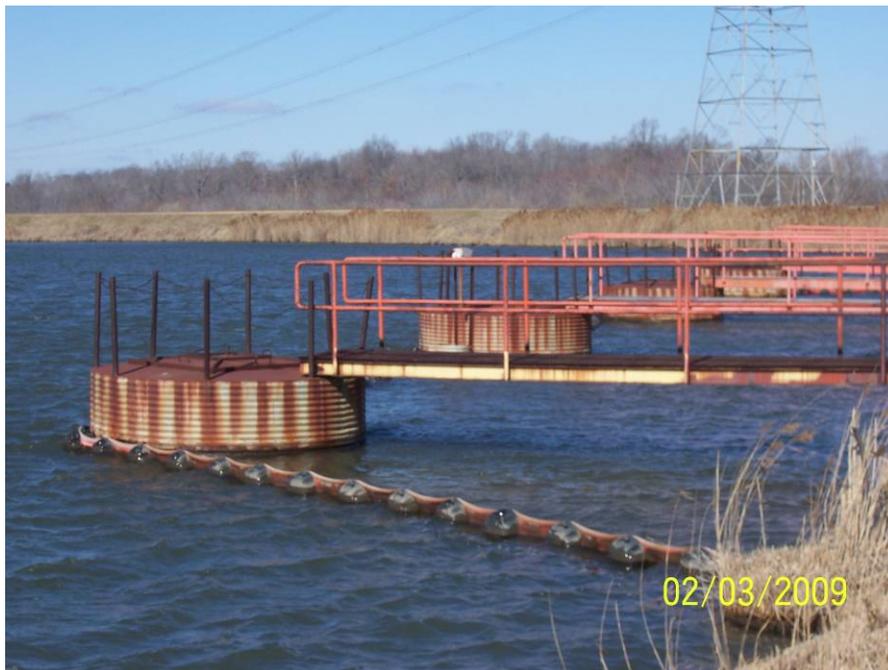
- Some erosion was noted along the north outslope of the bottom ash area.
- The steel angles within the standard skimmers were observed to be corroded and in poor condition. Walkways that are supported by the skimmers are putting eccentric loading on the structure.

Drawing Mark AP-1-4 Spillways at northeast side of Stilling Pond.

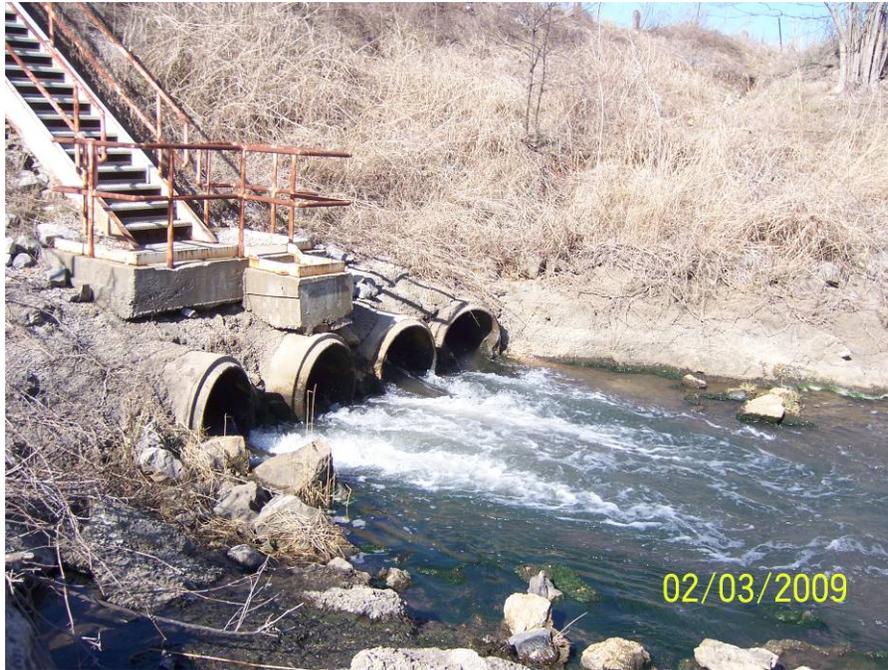
Drawing Mark AP-1-5 Spillway discharge and channel.

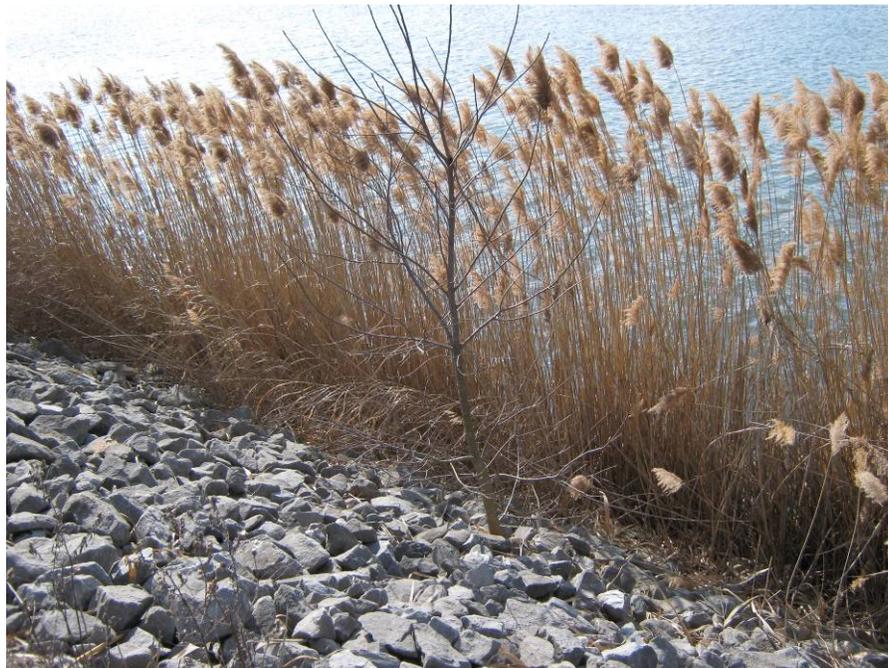
- A few small trees were noted along the stilling pond divider dike.
- Erosion was noted along the new 36-inch HDPE drain pipe along the west end of the Ash Pond-Dry Stack divider dike. Several other areas of minor erosion along this divider dike were also noted.

Drawing Mark AP-1-6 Trees on stilling pond divider dike.

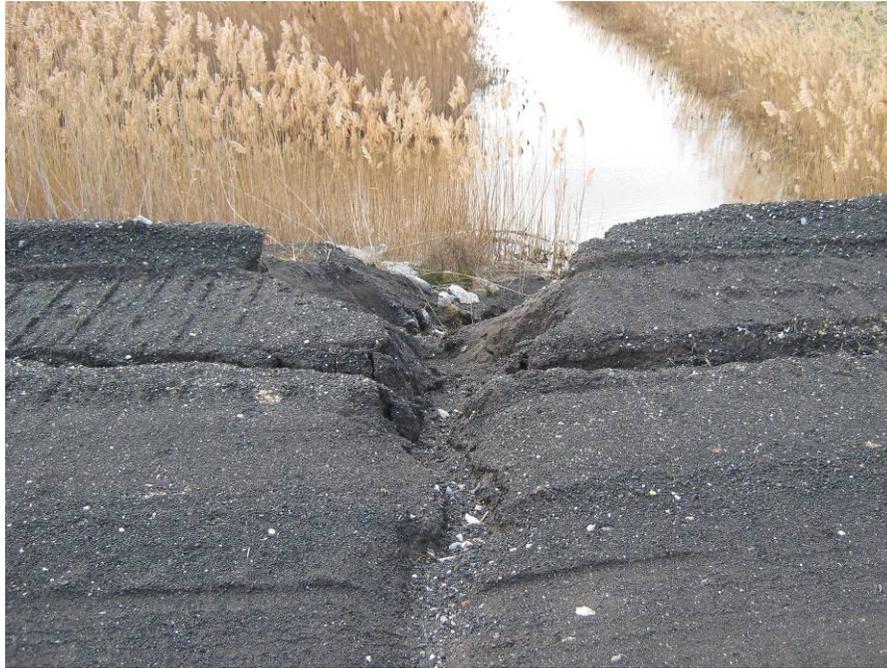
Erosion: Erosion observed along divider dike to Dry Ash Stack around 36 inch HDPE pipe. The pipe is located at the west end of the divider dike; rill/gullies noted in various areas along this divider dike.

Drawing Mark AP-1-7 Erosion around 36" HDPE drain pipe along the west end of the divider dike.

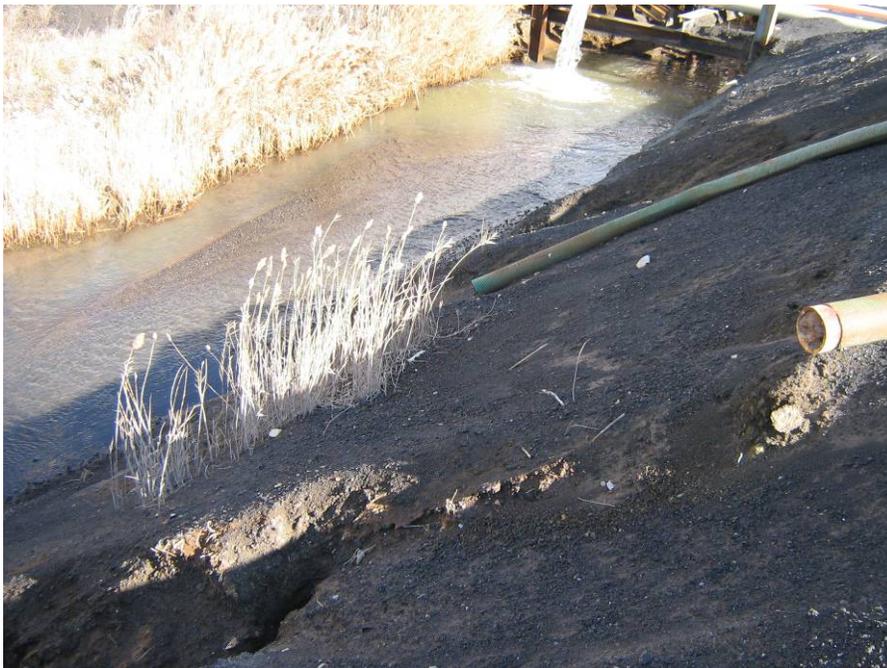
Drawing Mark AP-1-8 Erosion along north outslope of Bottom Ash Area.

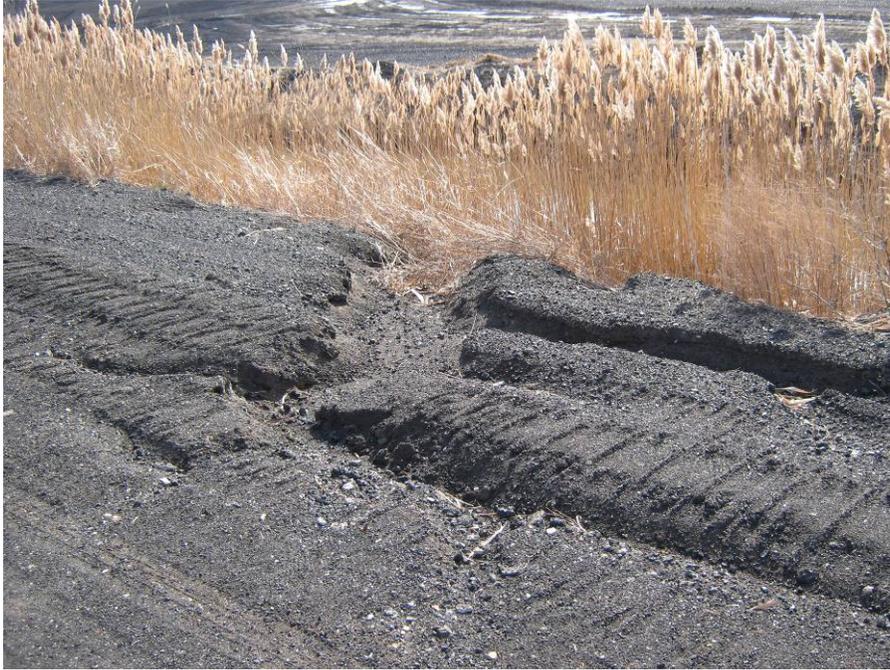
Drawing Mark AP-1-9 Erosion along divider dike between Dry Ash Stack and Ash Pond.

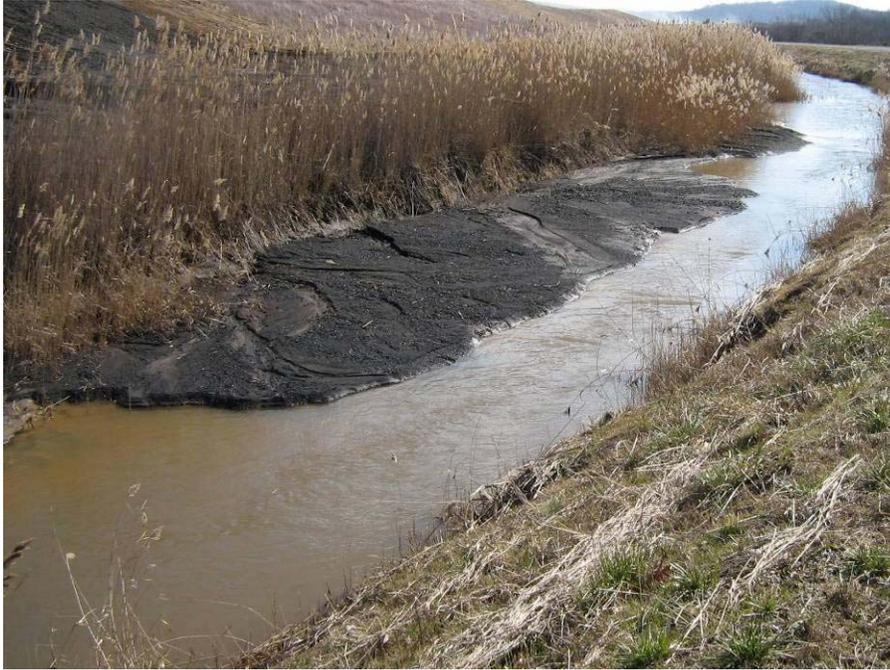
- Eroded ash sedimentation, vegetation, poor drainage, and standing water were observed throughout the perimeter ditch. The side slopes of the ditch also exhibit shallow sloughs and scarps due to excavations made for cleaning of sedimentation.

Drawing Mark DS-1-1 Eroded ash from the adjacent dry stack deposited within the west perimeter ditch.

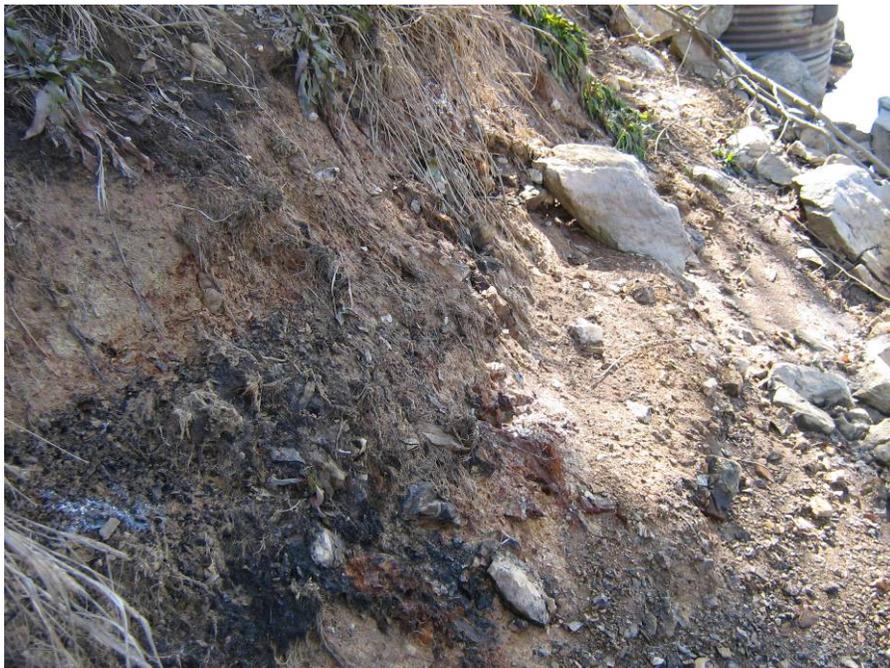
- Seepage was observed below the west perimeter dike along the banks of Wells Creek. The seepage does not appear to have changed from previous descriptions provided in inspection reports.

Drawing Mark DS-1-2 Seepage observed below the perimeter dike along the banks of Wells Creek.

- CUF plant personnel should continue to monitor the seepage area below the west perimeter clay dike.
- Cut and maintain heavy/tall phragmite growth to allow better observation specifically in the perimeter ditches. Establish mowing program.
- Regrade and repair erosion areas where noted.
- Regrade, place new clay cover, and reseed the southeast face of the stack. Monitor other dry stack areas for erosion/sparse vegetation and repair as needed.
- Repair ruts and eroded areas along access road at base of stack if it is to remain in service.
- Clean sedimentation and phragmites from Dry Ash Stack perimeter ditches. Remove sedimentation, check grades and regrade the perimeter ditches as needed to promote positive drainage and alleviate standing water issues.
- Continue annual inspection program and execute recommendations.

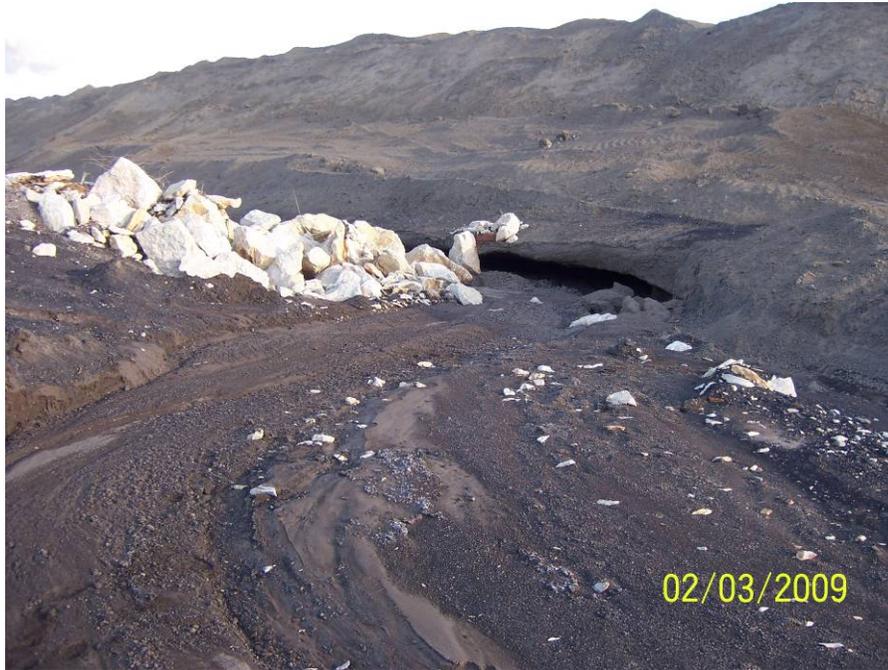
- Erosion was noted around the existing rock check within active portions of the stack.
- Areas of erosion and rutting were noted along the access road at the base of the stack.

Drawing Mark DS-1-3 Erosion around existing rock check in north portion of Dry Ash Stack

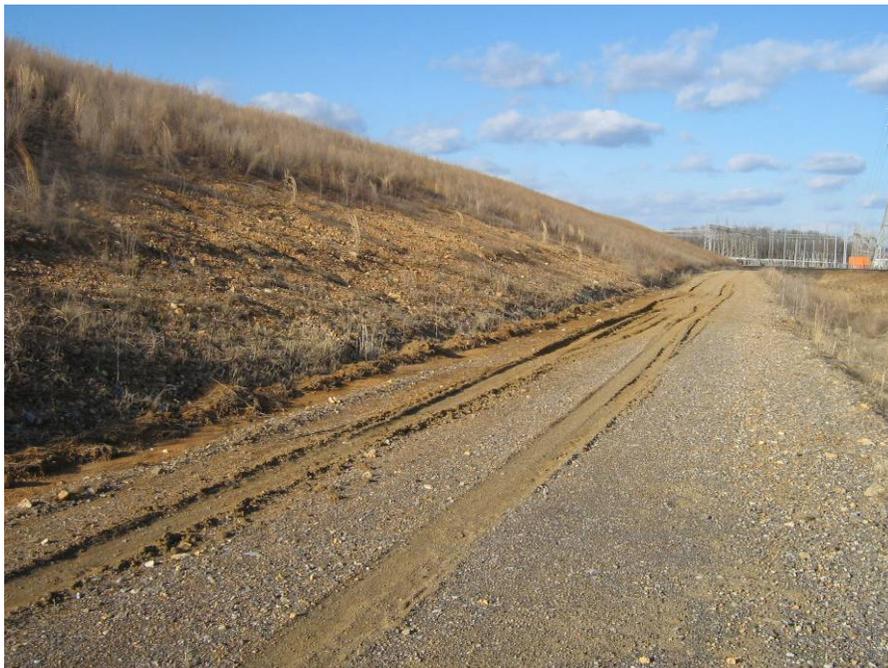
- The southeast face of the stack consists of exposed soil cover which is eroded throughout. Other small areas of sparse vegetation or erosion were also observed. Further to the north, soil cover and vegetation have not yet been completed and the exposed ash slopes exhibit some erosion.

Drawing Mark DS-1-4 Exposed soil and erosion along southeast face of Dry Ash Stack.

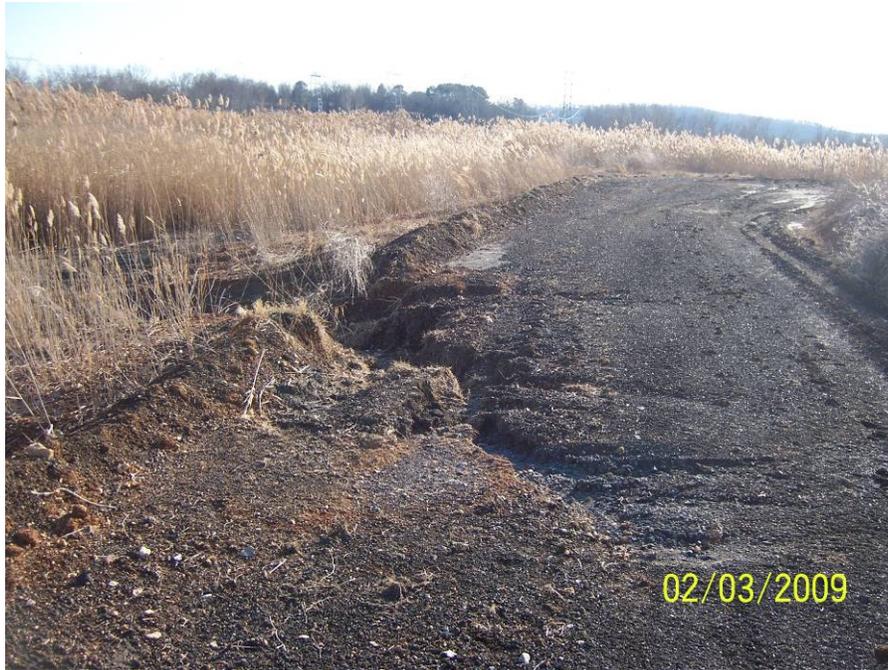
Drawing Mark DS-1-5 Erosion and rutting along access road at the base of the Dry Ash Stack.

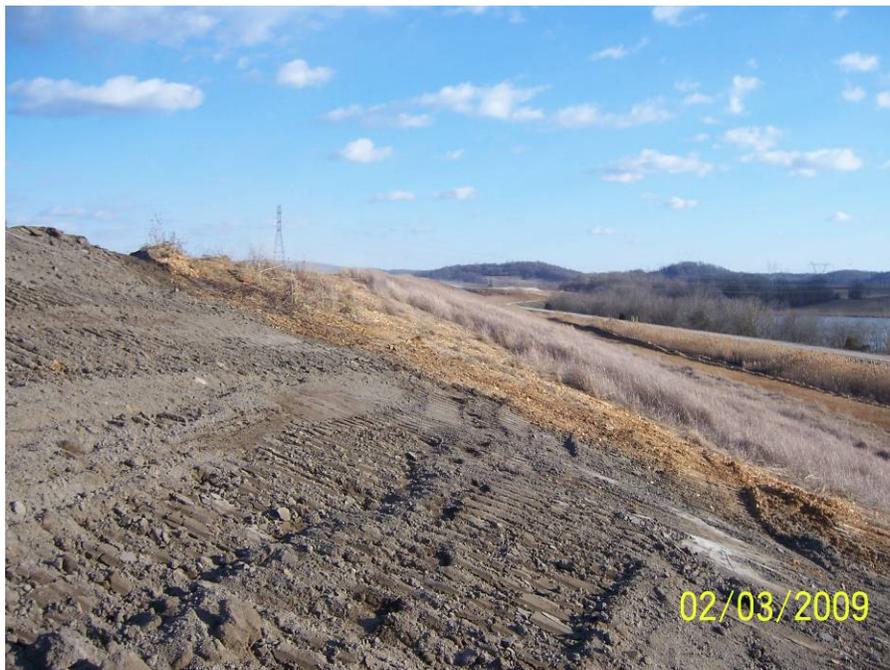
Drawing Mark DS-1-6 Uncompleted soil cover and vegetation along north end of Dry Ash Stack.
