TVA Disposal Facility Assessment Phase 1 Plant Summary Gallatin Fossil Plant (GAF)

Facilities Reviewed: Bottom Ash Pond A
 Fly Ash Pond E
 Stilling Ponds B, C and D
 Closed Disposal Area

**TVA Disposal Facility Assessment
Phase 1 Coal Combustion Product Disposal
Facility Summary
Gallatin Fossil Plant (GAF)
Bottom Ash Pond A (BAP-A)**

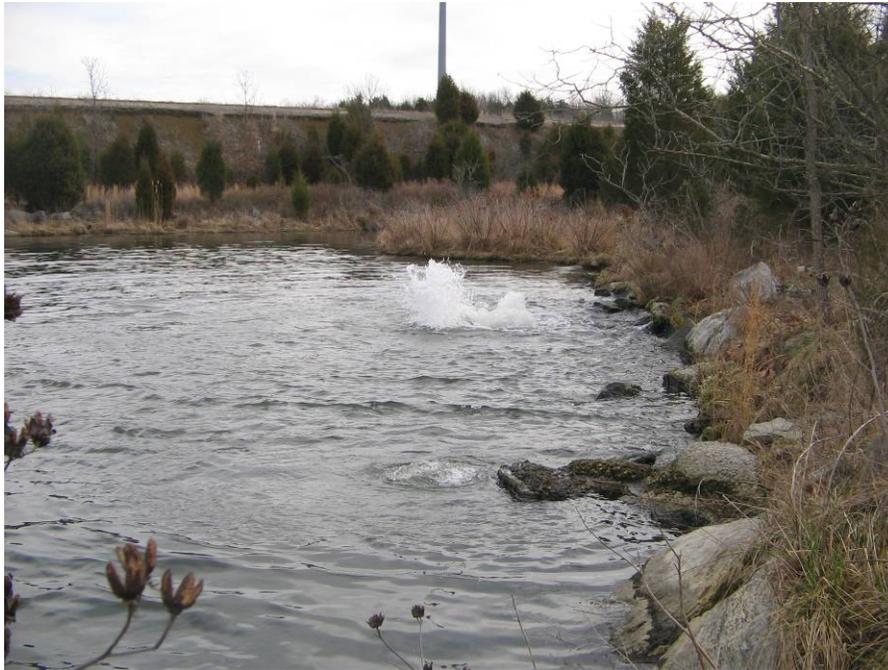
Drawing Mark AP-A-1 Submerged pipe outlet for Bottom Ash Pond A to Stilling Pond B, only two of the three observed.

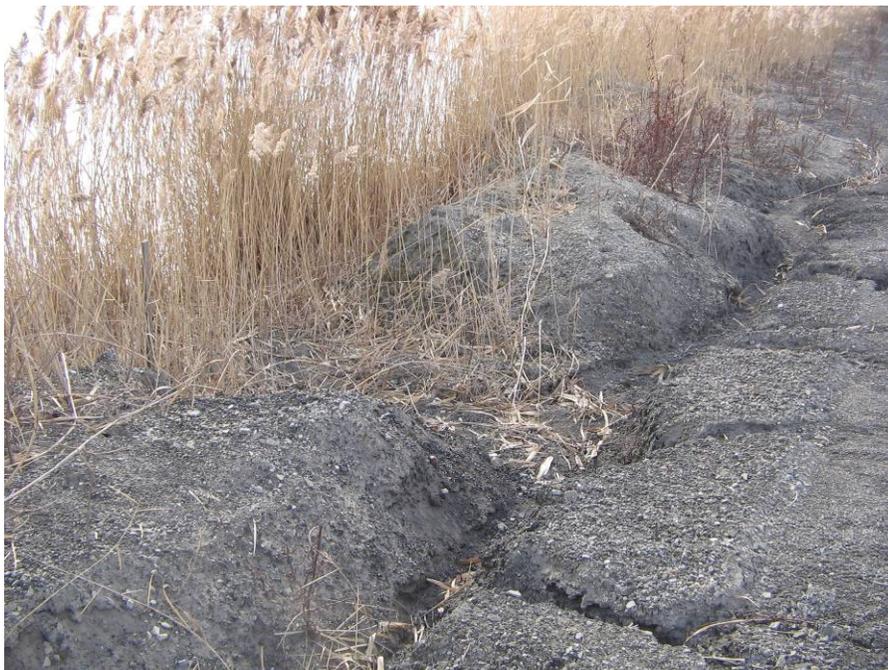
Drawing Mark AP-A-3 Isolated erosion along intermediate dike between Bottom Ash Pond A and Stilling Bond B (typical of a few locations along north end of dike).

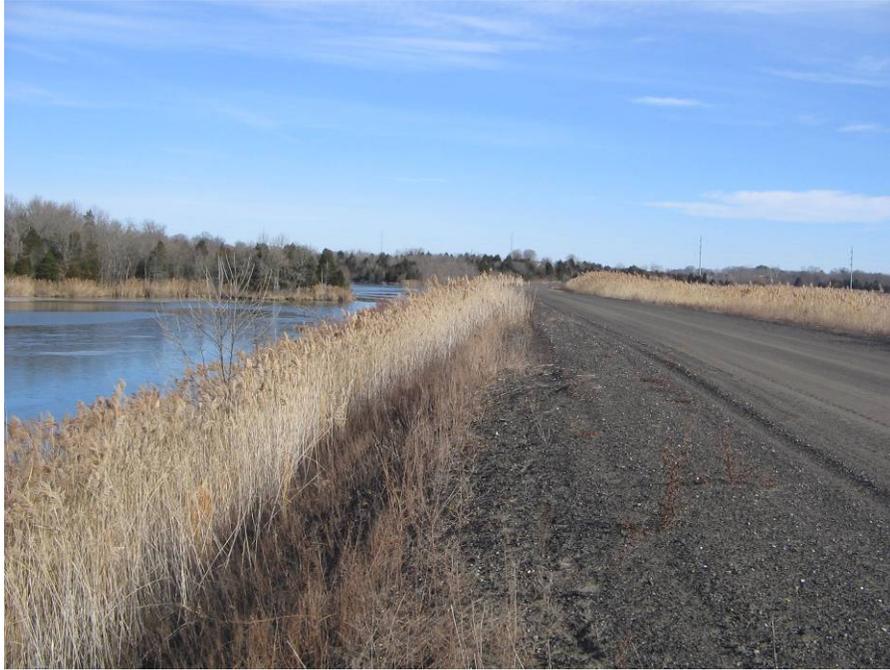
Drawing Mark AP-A-5 Unbalanced pool level between Bottom Ash Pond A and Stilling Ponds B, C, and D (Stilling Pool B on left, Bottom Ash Pond A on right).

- It is recommended that a capacity analysis be performed for the Stilling Ponds adjacent to Bottom Ash Pond A to check if sufficient volume capacity exists in the event of a breach/failure of the divider dike separating the stilling ponds from the ash ponds. Further hydraulic and hydrologic analysis may be warranted pending outcome of capacity analysis. It is also recommended that divider dike undergo further engineering to evaluate dike materials, slope stability, and seepage. Conclusions relative to the adequacy of the divider dike will be made based on these Phase 2 engineering activities.

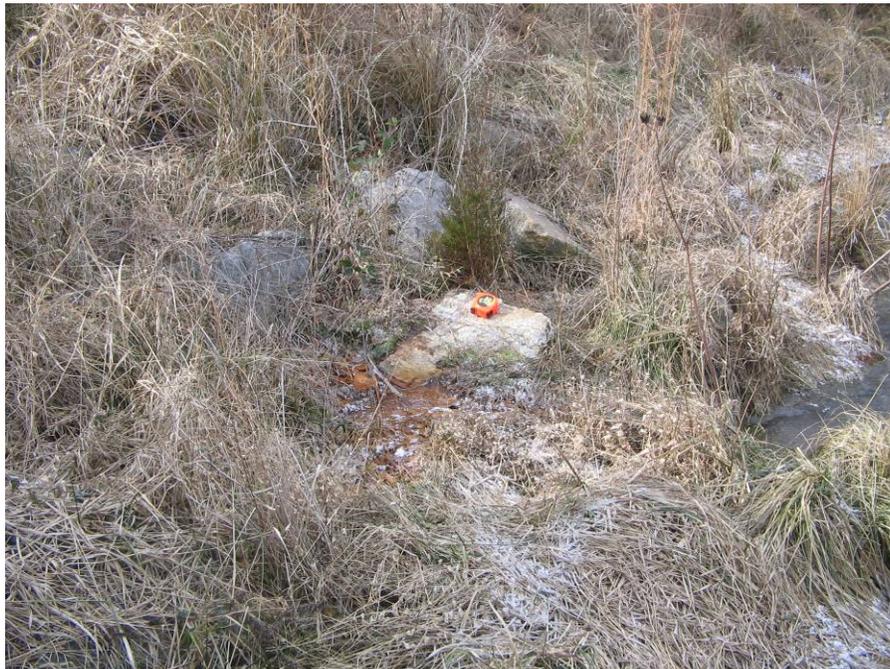
Seepage: One small area of red-water seepage observed at toe just above water surface of adjacent Stilling Pond B just east of submerged outlet pipes.

Drawing Mark AP-A-6 Seepage area located east of outlet structures.

- Cut and maintain heavy/tall cattail and grass growth on interior and exterior slopes of divider dike to allow better observation.
- Monitor minor seepage area located at dike toe just north of submerged outlet pipes. Any change in quantity or color should be reported to appropriate TVA personnel.
- Repair erosion areas and minor sloughed areas where noted on divider dike slopes. Establish vegetation on dike slopes where sparse areas exist. Monitor and make repairs or re-seed as needed.
- Line divider dike slopes with rip-rap on both sides at pool level to help reduce and control erosion.
- Monitor RCP spillway risers. These spillway systems may ultimately be modified or replaced, pending Stantec-TVA assessment of replacement system.
- Establish mowing program of this area.
- Continue annual dike and facility inspections and execute recommendations.

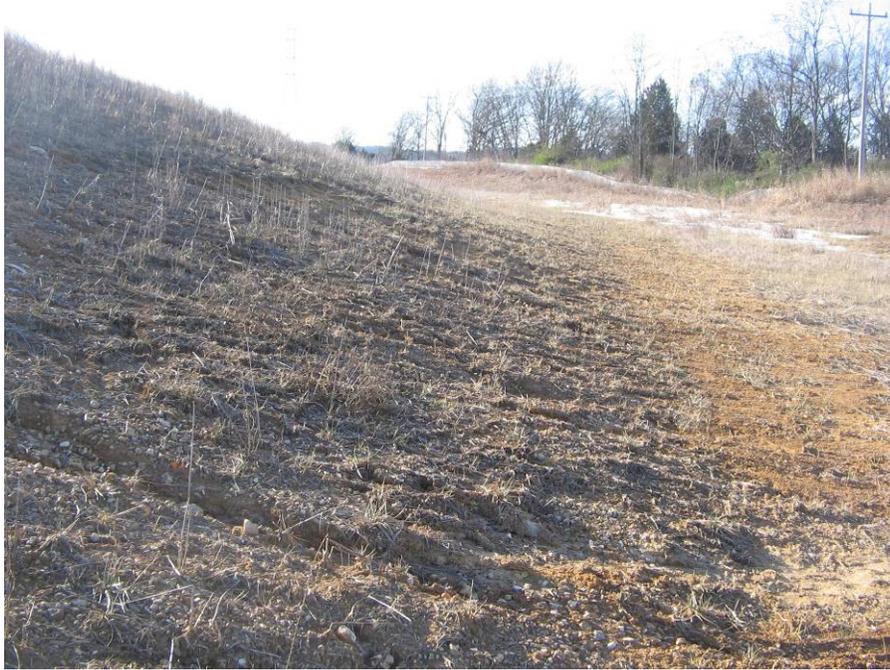
Drawing Mark AP-E-1 Erosion on exterior slope of dike.

- Cut and maintain heavy/tall cattail and grass growth on interior and exterior dikes to allow better observation.
- Repair erosion areas on slopes. Establish vegetation where sparse areas exist. Monitor and make repairs or re-seed as needed.
- Line interior slopes with rip-rap at pool level to help reduce and control erosion.
- Monitor RCP spillway risers. These spillway systems may ultimately be modified or replaced, pending Stantec-TVA assessment of replacement system.
- Establish mowing program of this area.
- Continue annual dike and facility inspections and execute recommendations.

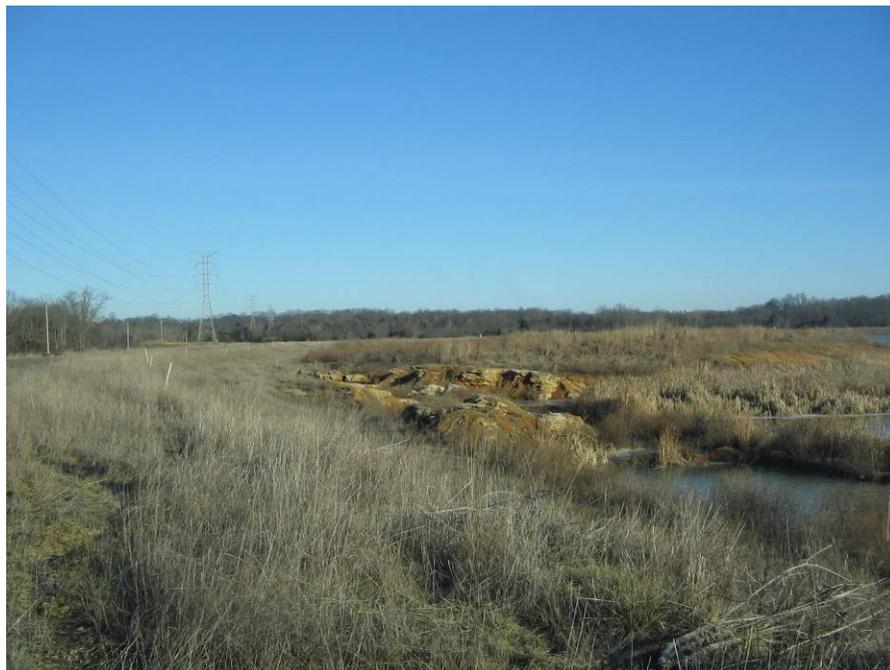
Drawing Mark AP-E-2 Rock outcrop and erosion on inner portion of pond.

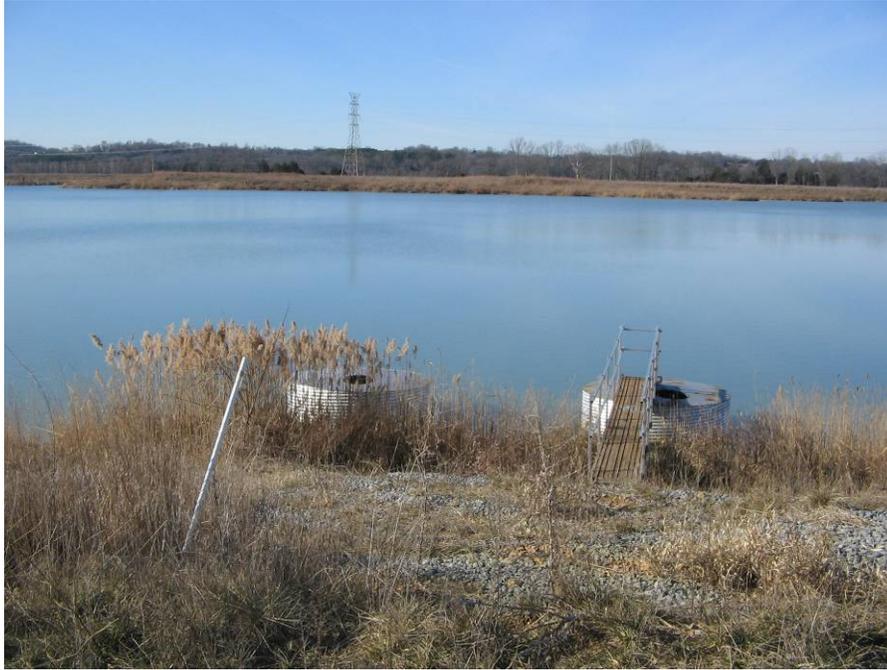
Drawing Mark AP-E-3 Weir structures at Fly Ash Pond E to Stilling Pond C

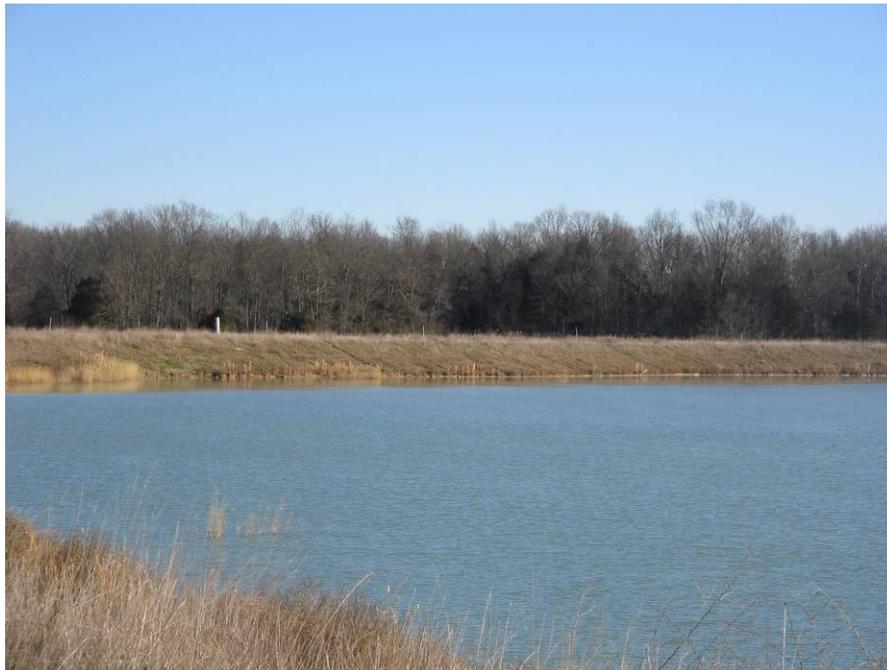
- Karst bedrock and sinkhole activity is present plant-wide and is a concern. There is also historical documentation in annual reports from late 1970's that discuss sinkhole leakage in Fly Ash Pond E through a sinkhole located in the north portion of the pond.

Drawing Mark AP-E-4 Sinkhole reportedly repaired by plant personnel (approximate area).

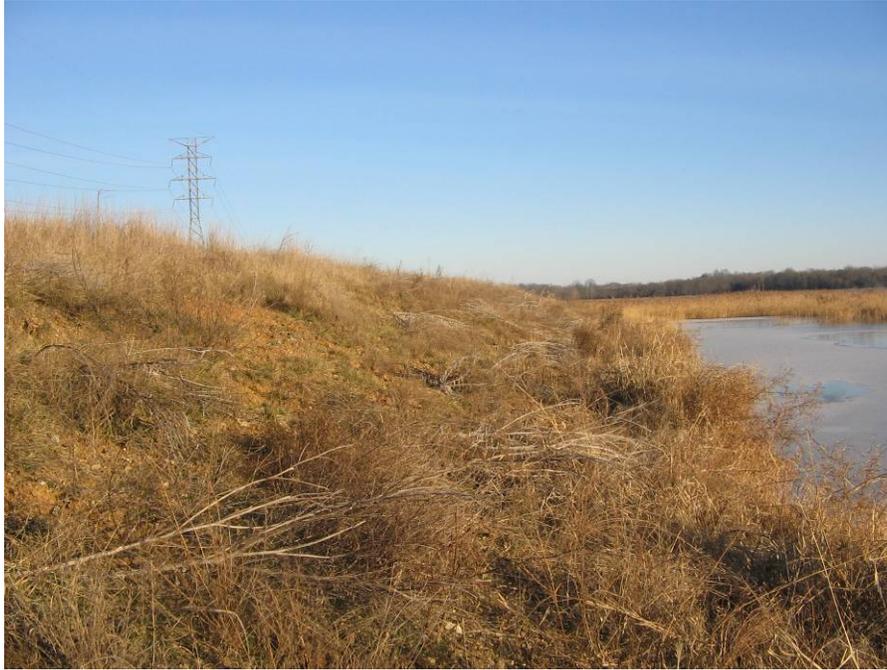
Drawing Mark AP-E-5 Sparse vegetation and erosion on inner face of dike (typical of several locations)

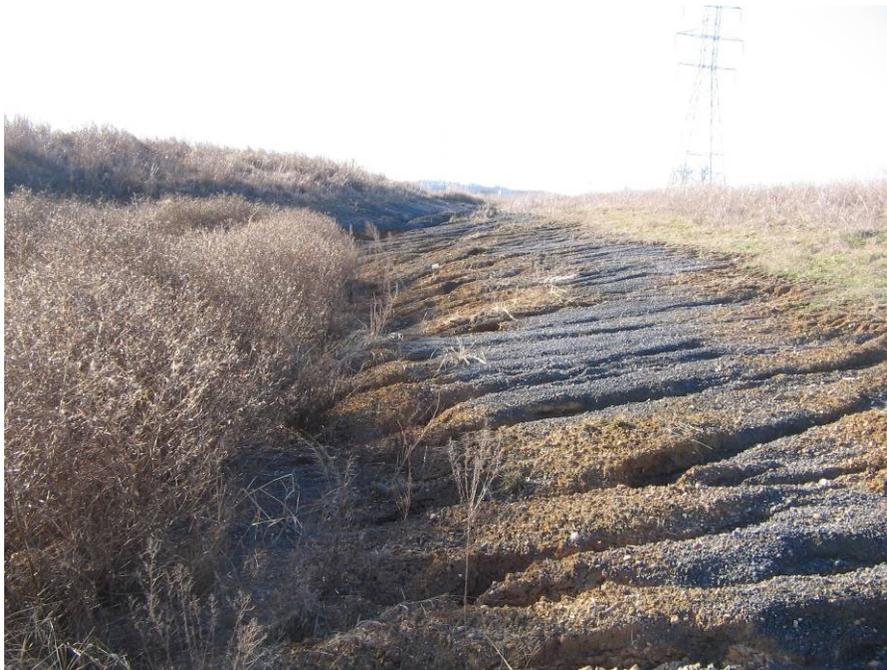
Drawing Mark AP-E-6 Sparse vegetation and erosion on inner face of dike (typical of several locations).

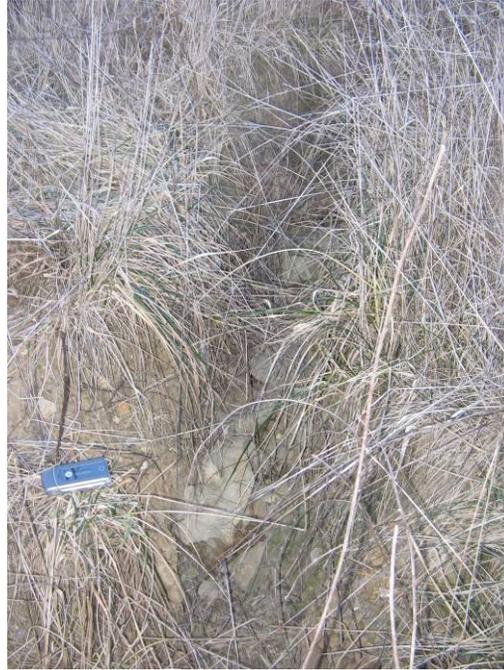
Drawing Mark AP-E-7 Erosion rill/gully on inner face of dike (typical of several locations).

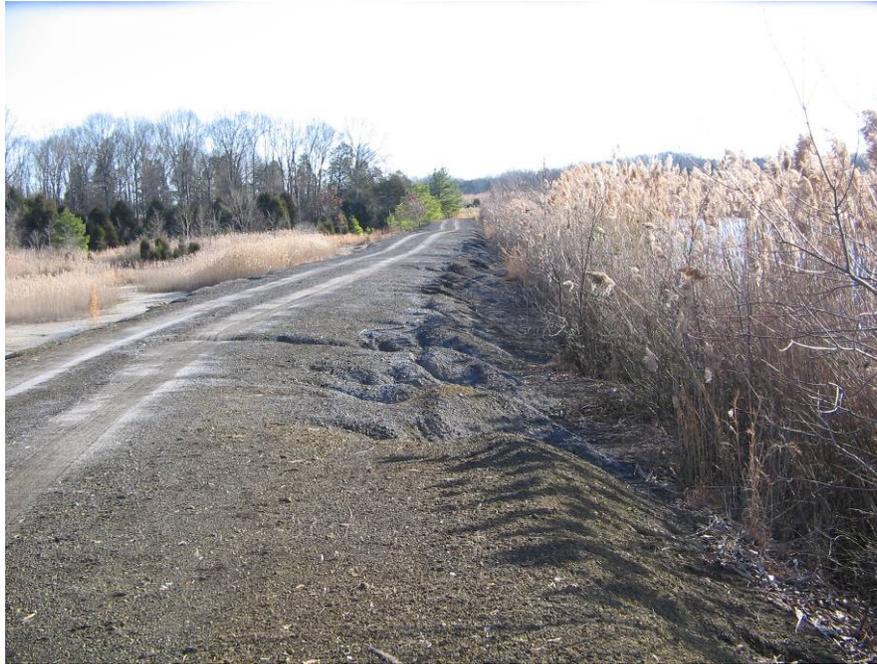
- Widespread erosion was noted along sparsely vegetated bottom ash saddle dike on north side of Pond C.
- Trees were noted along exterior dike slope at outlet end of Stilling Pond D.

Drawing Mark P-C-1 Erosion on inner face of saddle dike at Pond C.

- Cut and maintain heavy/tall cattail and grass growth on interior slopes of ponds to allow better observation.
- Remove trees/brush from downstream dike slope of Stilling Pond D outlet area.
- Repair erosion areas where noted on dike slopes.
- Line interior pond slopes with rip-rap to help reduce erosion.
- Continue to monitor RCP spillway risers. These spillway systems may ultimately be modified or replaced, pending Stantec-TVA assessment of replacement system.
- Establish mowing program of ponds and disposal areas.
- Continue annual dike and facility inspections.

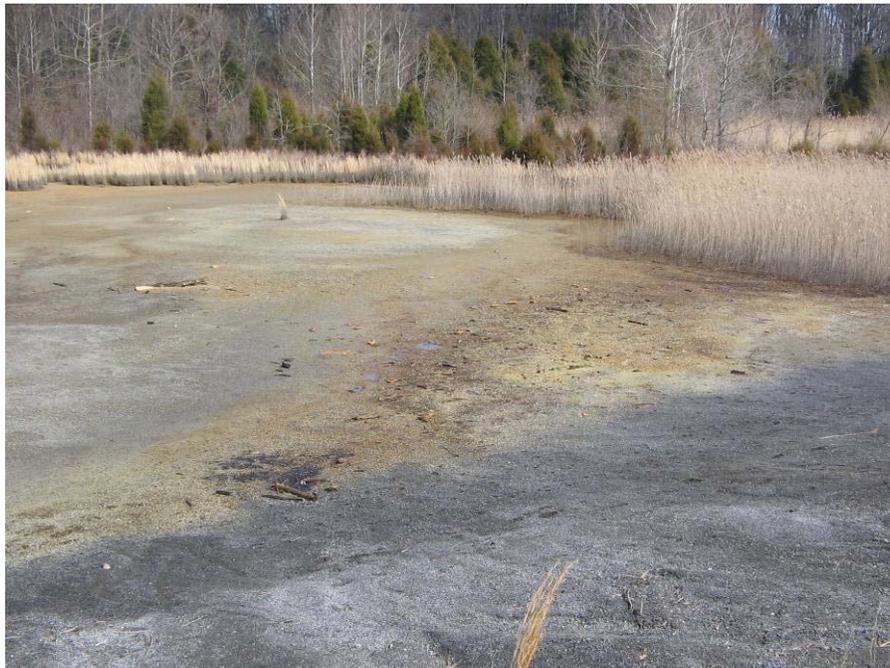
- A short length, low-height saddle dike is located along the north perimeter of Pond C. It is constructed of bottom ash, and is eroding. It currently pools approximately 2 to 3 feet of water. The dike appears to protect an adjacent sinkhole. If saddle dike failure occurred, or if adjacent dikes separating Stilling Ponds from Ash Ponds failed causing capacity of stilling ponds to be exceeded, water and/or sluiced ash could be released into adjacent land/sinkhole. A small amount of seepage was also observed just beyond the exterior toe of this saddle dike.

Drawing Mark P-C-2 Possible toe seepage near exterior toe of saddle dike at Pond C.

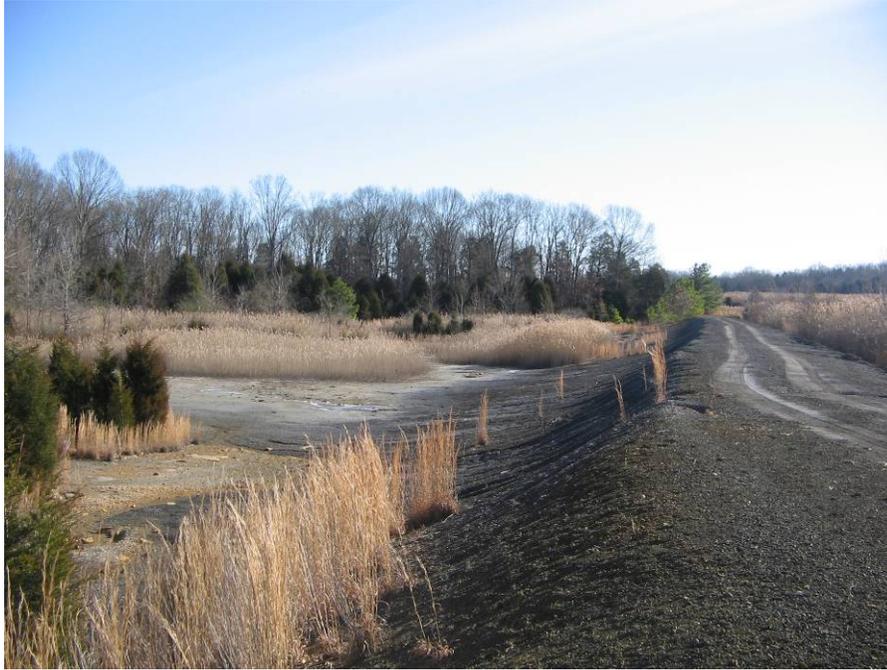
Drawing Mark P-C-3 Bottom ash saddle dike at Pond C (Pond C on right).

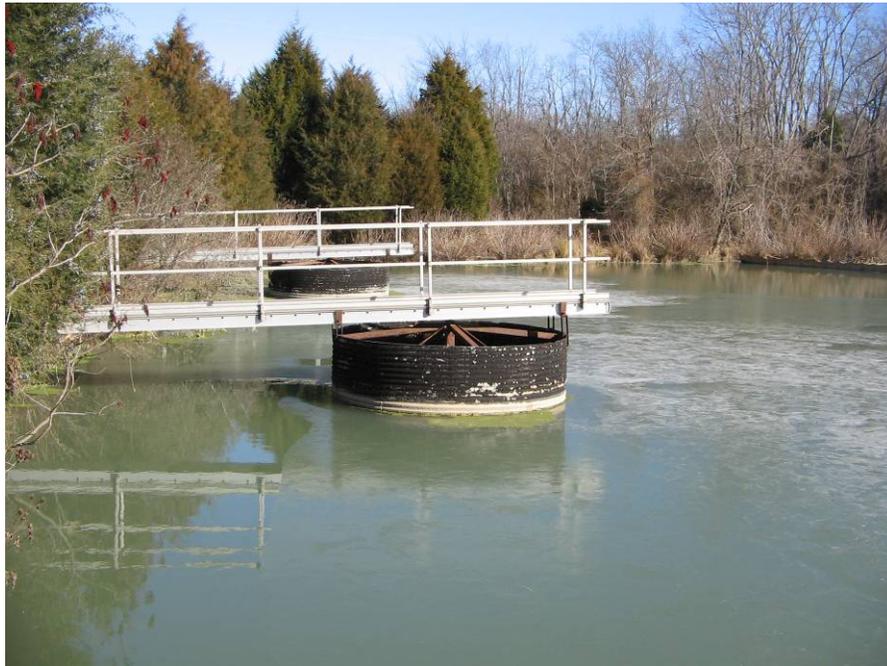
- RCP push-together riser structure spillways at outlet of Stilling Pond D are a concern.
- Erosion was noted at a few locations along stilling basin perimeter access road below Fly Ash Pond E.

Drawing Mark P-D-1 Weir structures at Stilling Pond D.

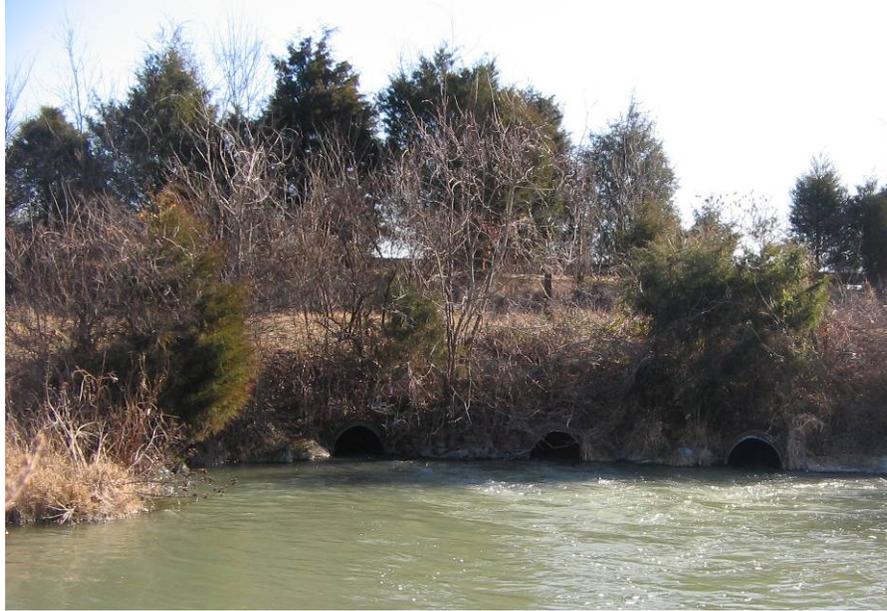
Drawing Mark P-D-2 Tree growth on exterior slope of Pond D outlet.

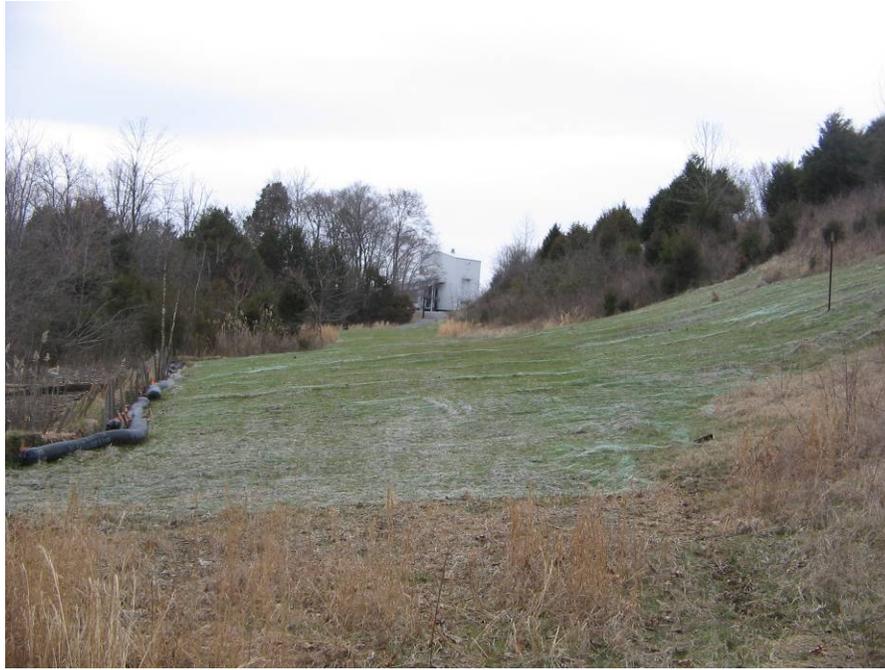
- Indications of on-going seepage were observed at Seepage Areas 1A, 2E, and 2F

Drawing Mark CDA-1-1 Seepage Area 2E.

- Continue to monitor seepage areas at dike toe areas. Any change should be reported to TVA engineering staff. Consider installing collection system at active seeps to control seepage.
- Repair erosion areas as they become prevalent near active seeps.
- Continue annual dike and facility inspections.

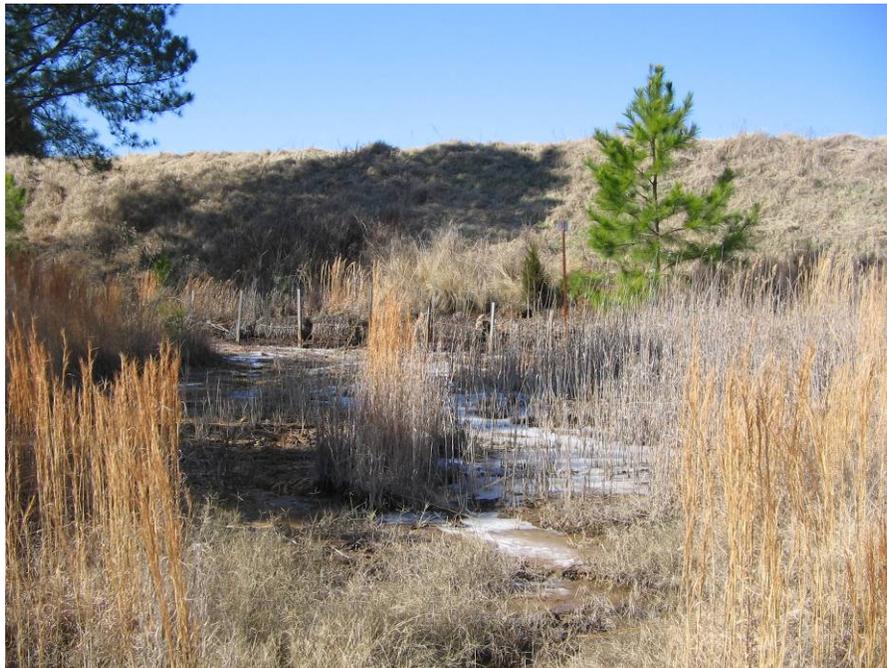
Drawing Mark CDA-1-2 Seepage Area 1A.

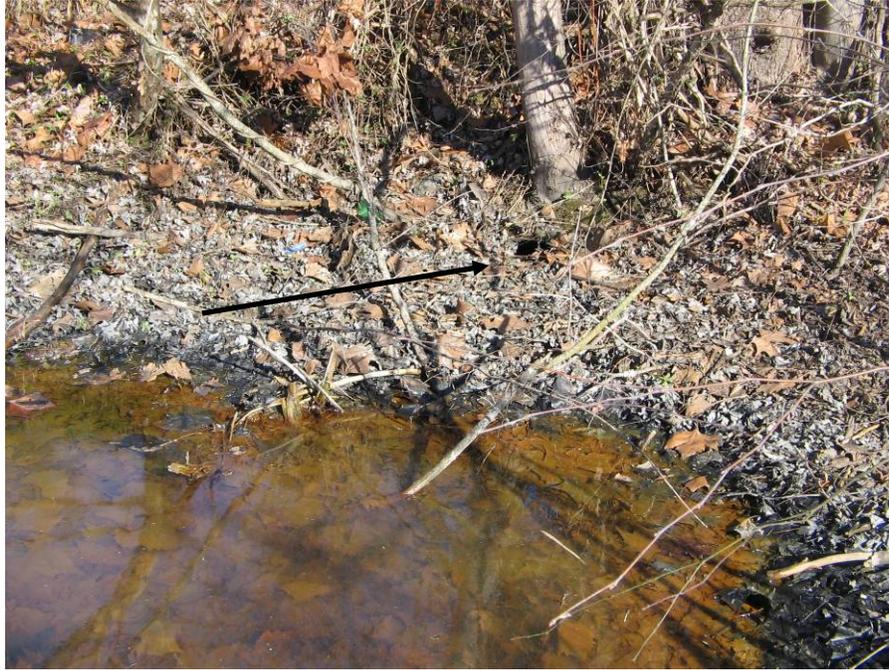
Drawing Mark CDA-1-3 Seepage Area 2B. No seepage observed (note the pipe outlet).

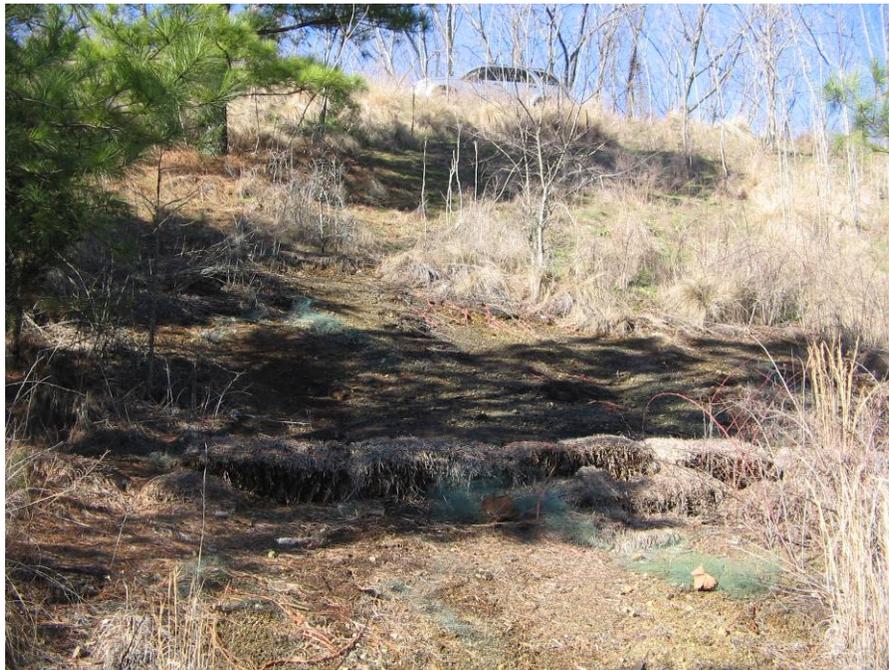
Drawing Mark CDA-1-4 Seepage Area 1B. No seepage observed.
