# **Historic Architecture Reconnaissance Survey Supplemental Information**

## **Cimarron Wind Energy Project – Phase 1 Gray County, Kansas KSR&C No. 09-12-054**

July 2011

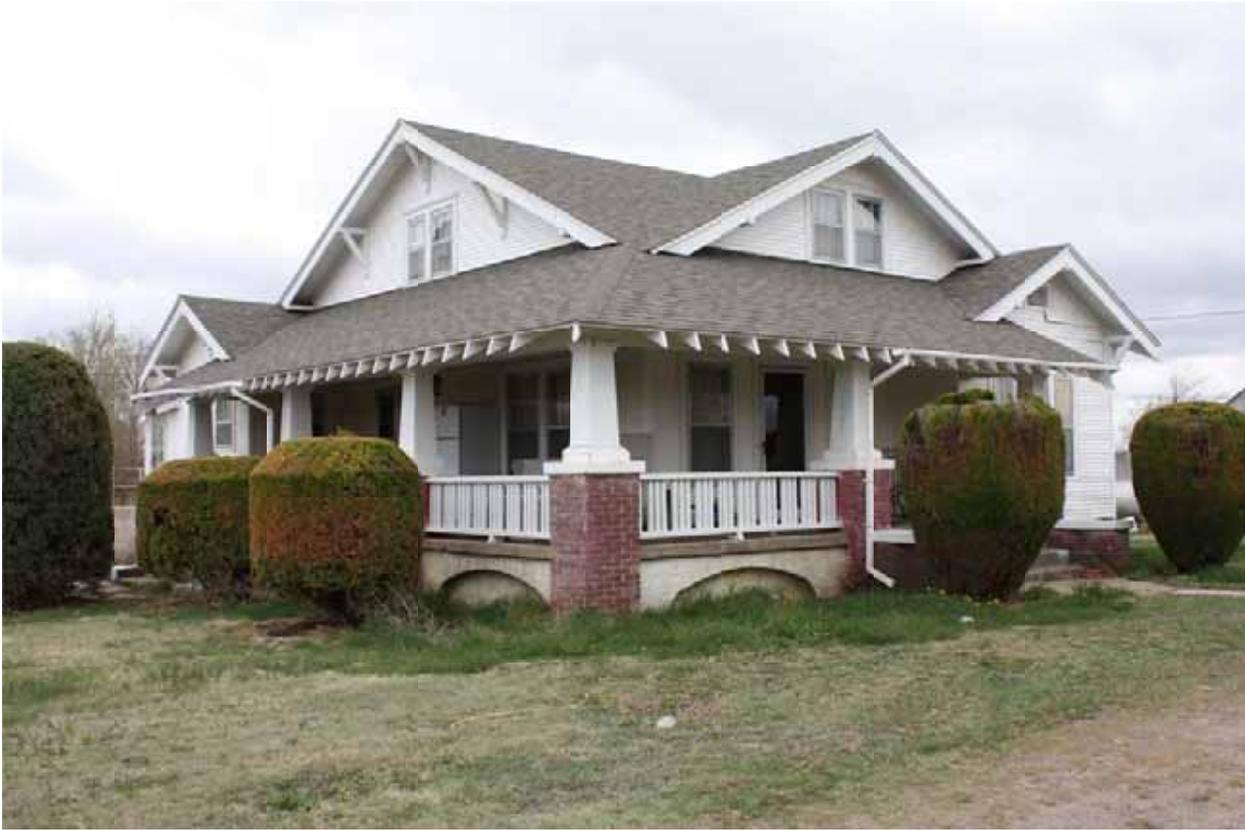
**Photograph 1** -- TTCW 8 Farmhouse --T25S, R27W, Sec. 22. Photograph looking southwest. (James Sexton – Tetra Tech, April 27, 2011)

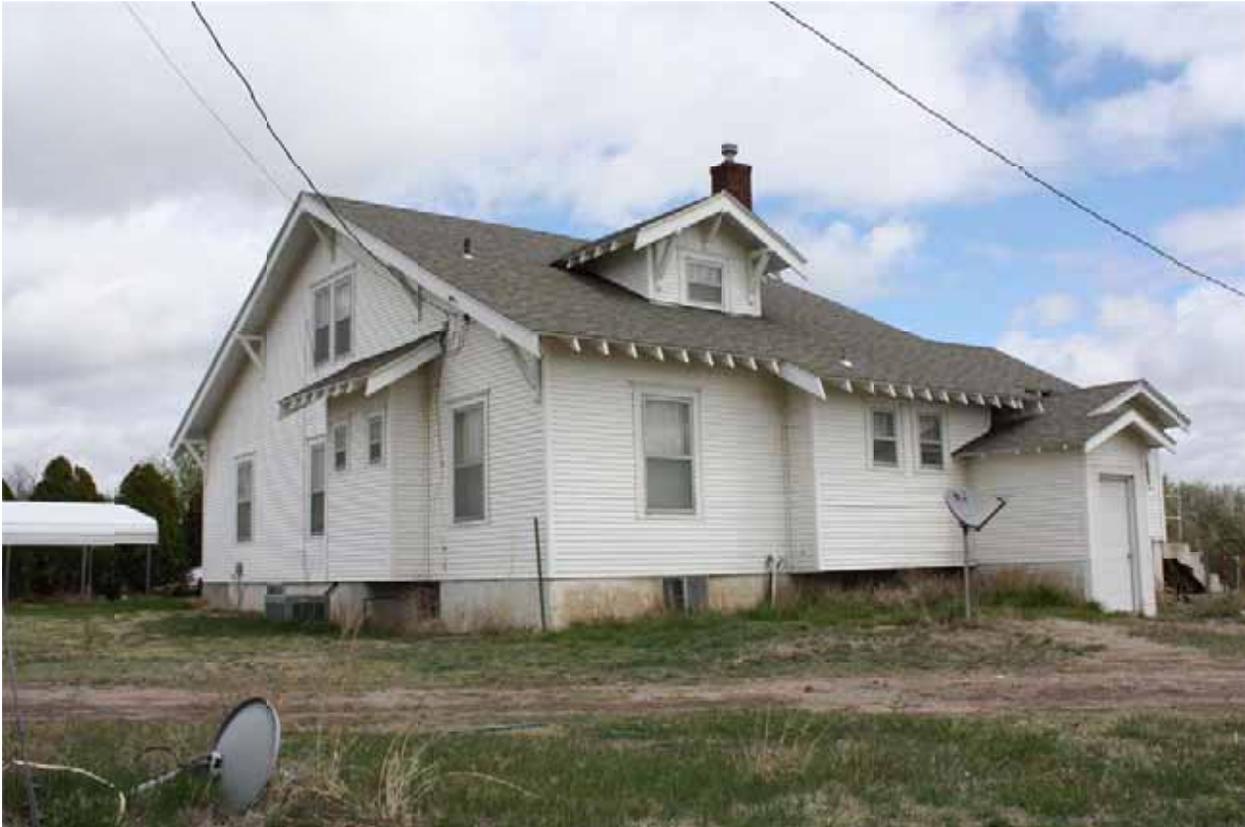
**Photograph 2** -- TTCW 8 Farmhouse --T25S, R27W, Sec. 22. Photograph looking northeast. (James Sexton – Tetra Tech, April 27, 2011)

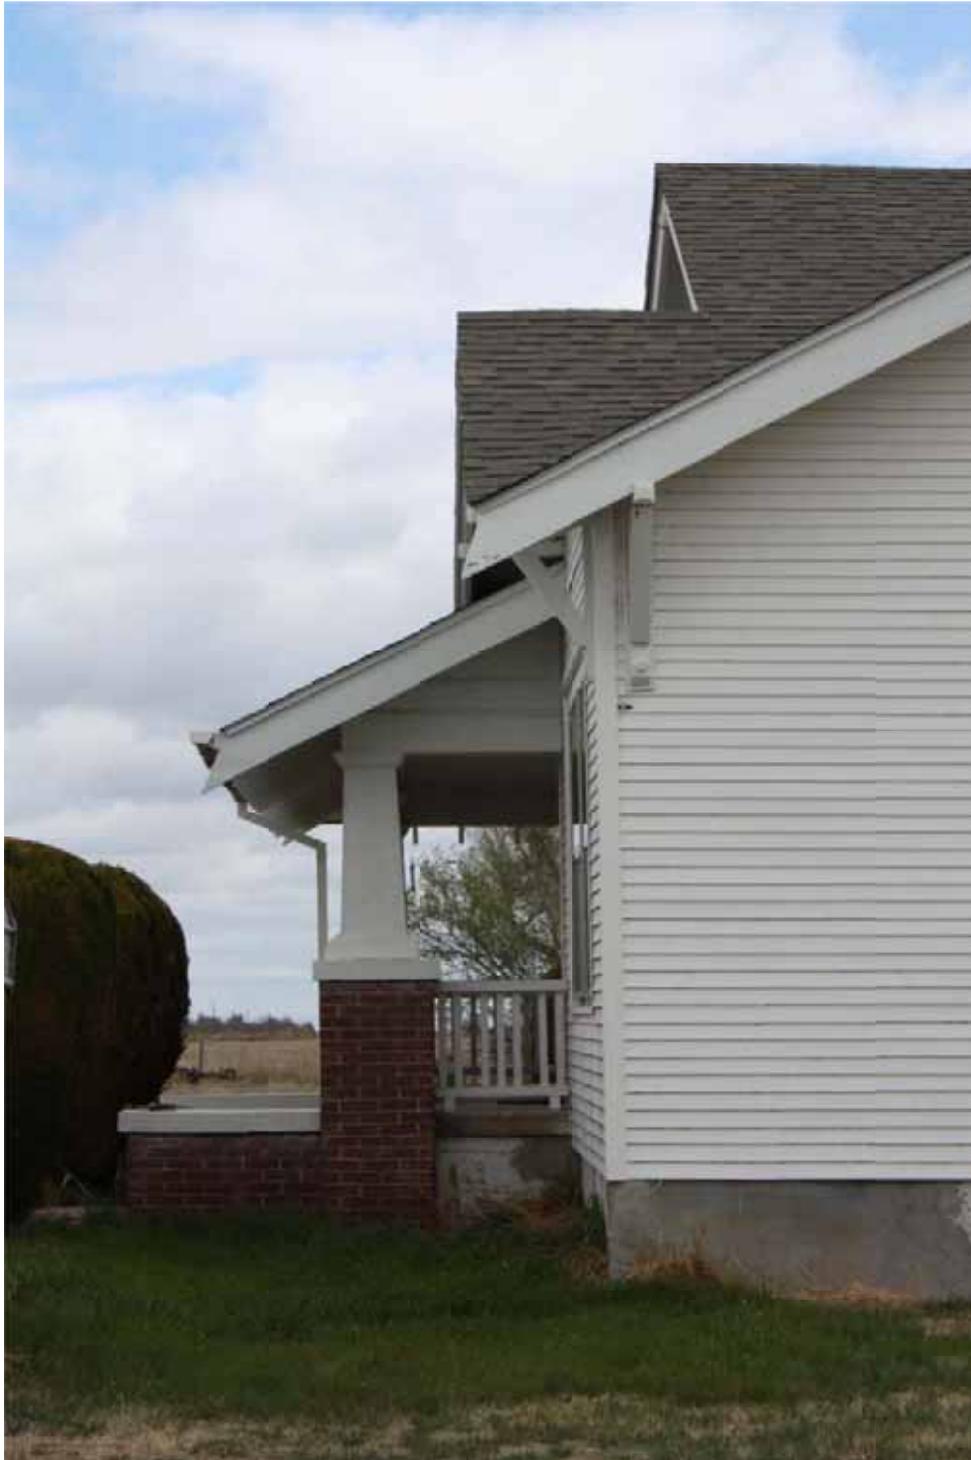
**Photograph 3** -- TTCW 8 Farmhouse --T25S, R27W, Sec. 22. Photograph looking east. (James Sexton – Tetra Tech, April 27, 2011)

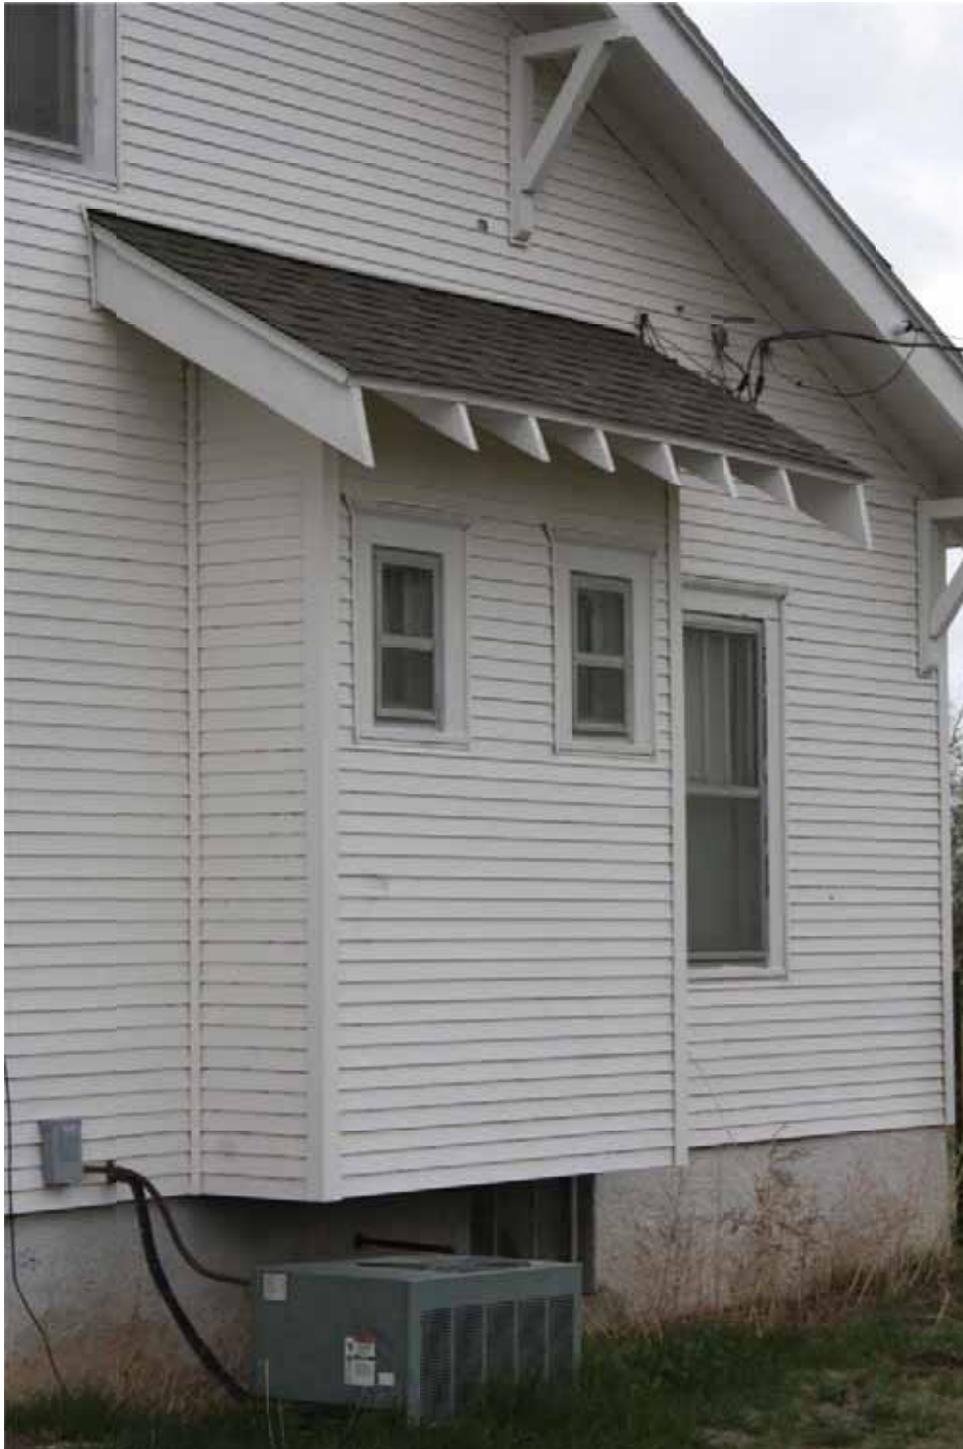
**Photograph 4** -- TTCW 8 Farmhouse --T25S, R27W, Sec. 22. Photograph looking southeast. (James Sexton – Tetra Tech, April 27, 2011)

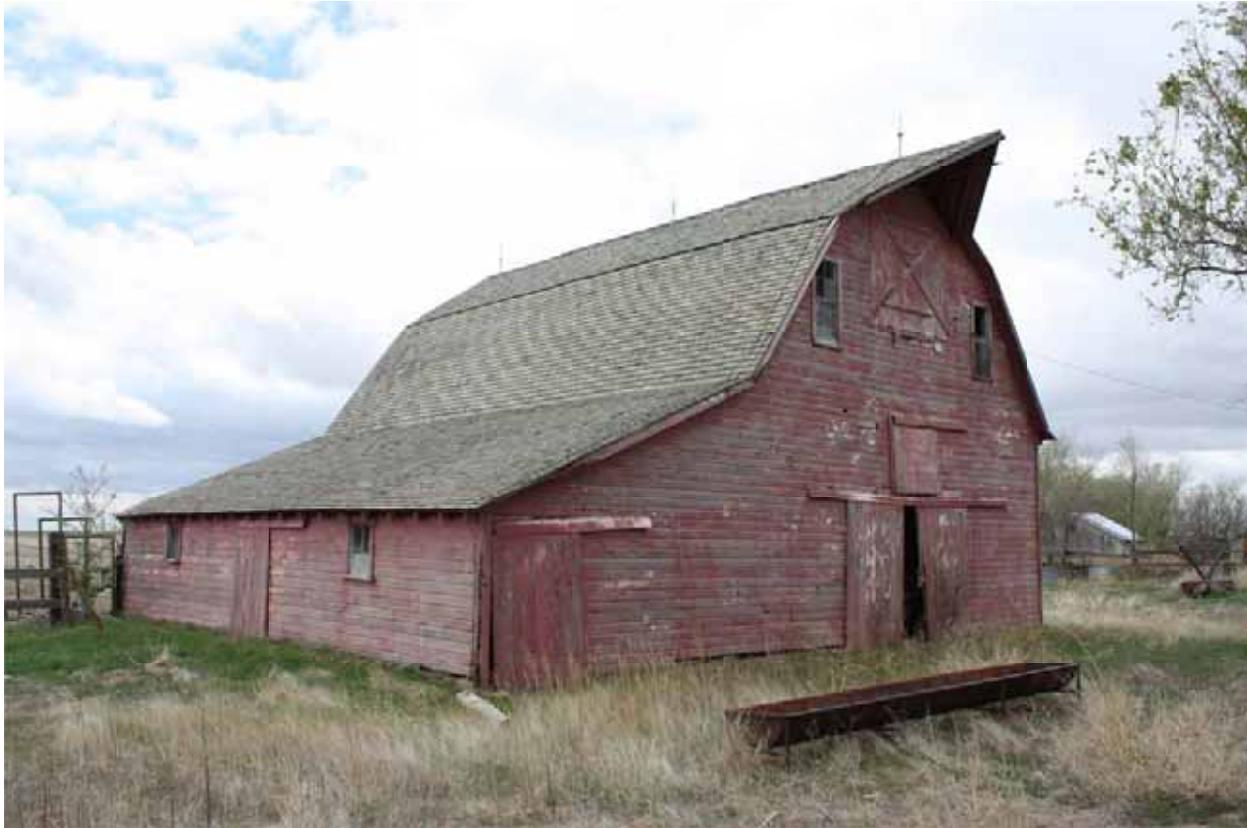
**Photograph 5** -- TTCW 8 Gambrel-Roof barn --T25S, R27W, Sec. 22. Photograph looking southwest.  
(James Sexton – Tetra Tech, April 27, 2011)

Additionally, considered in light of the MPS, it is Tetra Tech’s opinion that the Gambrel-Roof barn qualifies as a historic barn and demonstrates sufficient integrity to be potentially eligible for the National Register of Historic Places as an individual resource. It is a two-story, gable-front barn oriented with its long axis running north-south with a gambrel roof and a one-story section along the length of the east wall (Photographs 5 and 6). The walls are clad in novelty siding and the roof is covered with wooden shingles. Three lightning rods are located along the ridge of the roof.

The northern façade has a large opening centered under the ridge of the roof. It is covered by a pair of sliding doors. Above this opening sits a small, square opening covered by a single sliding door. A single, square door with diagonal cross-bracing sits in the middle of the gable, flanked by a pair of double-hung windows. One of these retains evidence of a four-over-four light pattern; the other has lost all of its glazing and muntins (if these ever existed). A single sliding door at the eastern end of the wall covers an opening into the lower section of the building.

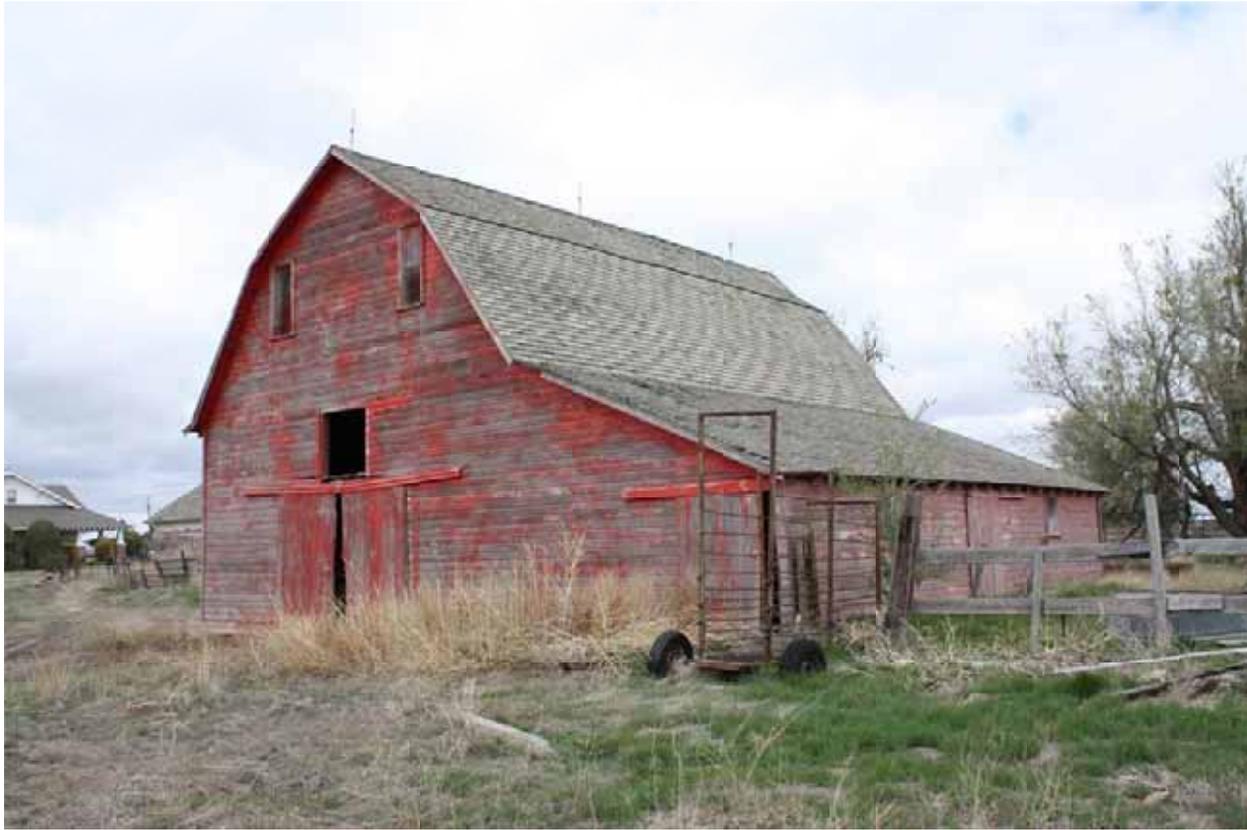
**Photograph 6** -- TTCW 8 Gambrel-Roof barn --T25S, R27W, Sec. 22. Photograph looking northwest.  
(James Sexton – Tetra Tech, April 27, 2011)

The southern wall of the building is similar to the northern one. It has a large central opening on the ground floor covered by a pair of sliding doors. A small door in the western end of the wall provides access to the lower section of the building. Above this sits a square opening with no covering at this time. A pair of narrow rectangular openings is located in the gable with their tops sitting just above the point where the roof slope changes pitch.

The eastern wall has two windows evenly spaced from a central door. One of these shows evidence of having once had four lights.

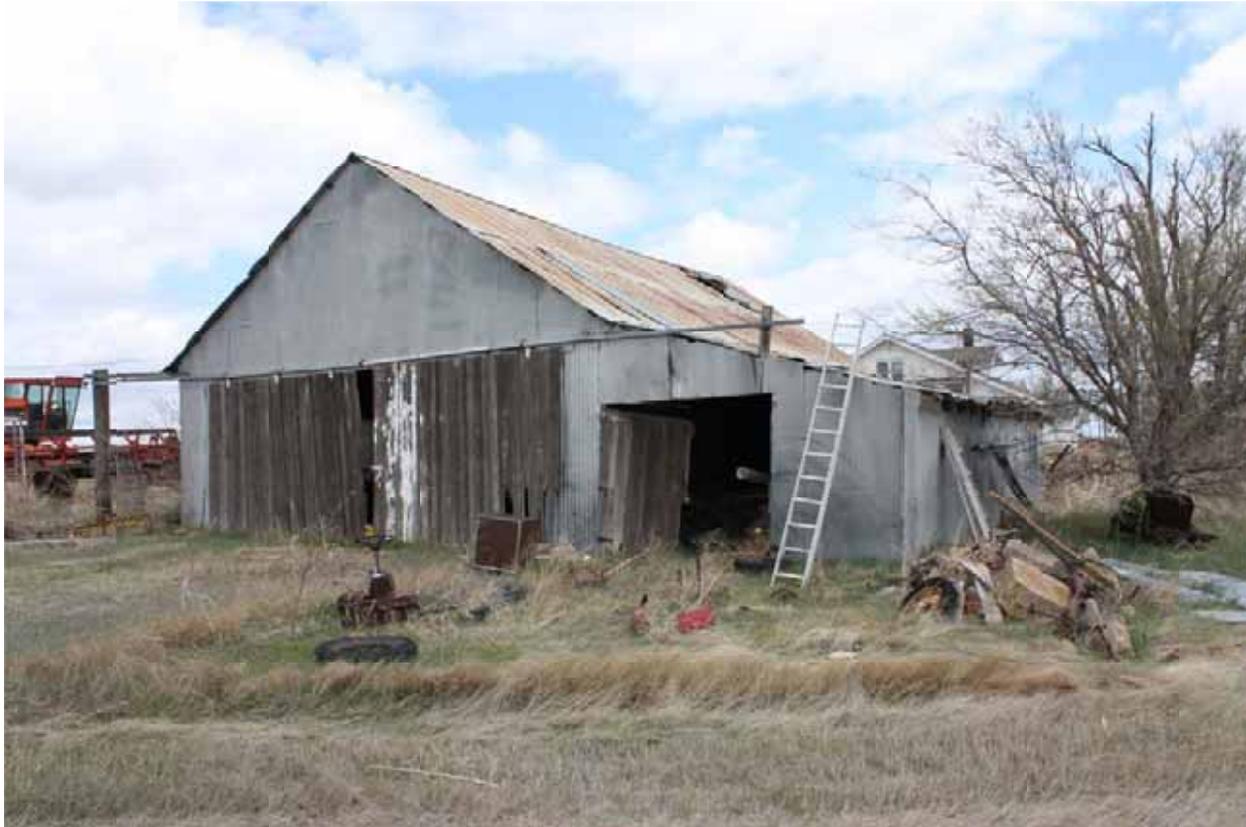
**Photograph 7** -- TTCW 8 Gable-Roof storage building --T25S, R27W, Sec. 22. Photograph looking northeast. (James Sexton – Tetra Tech, April 27, 2011)

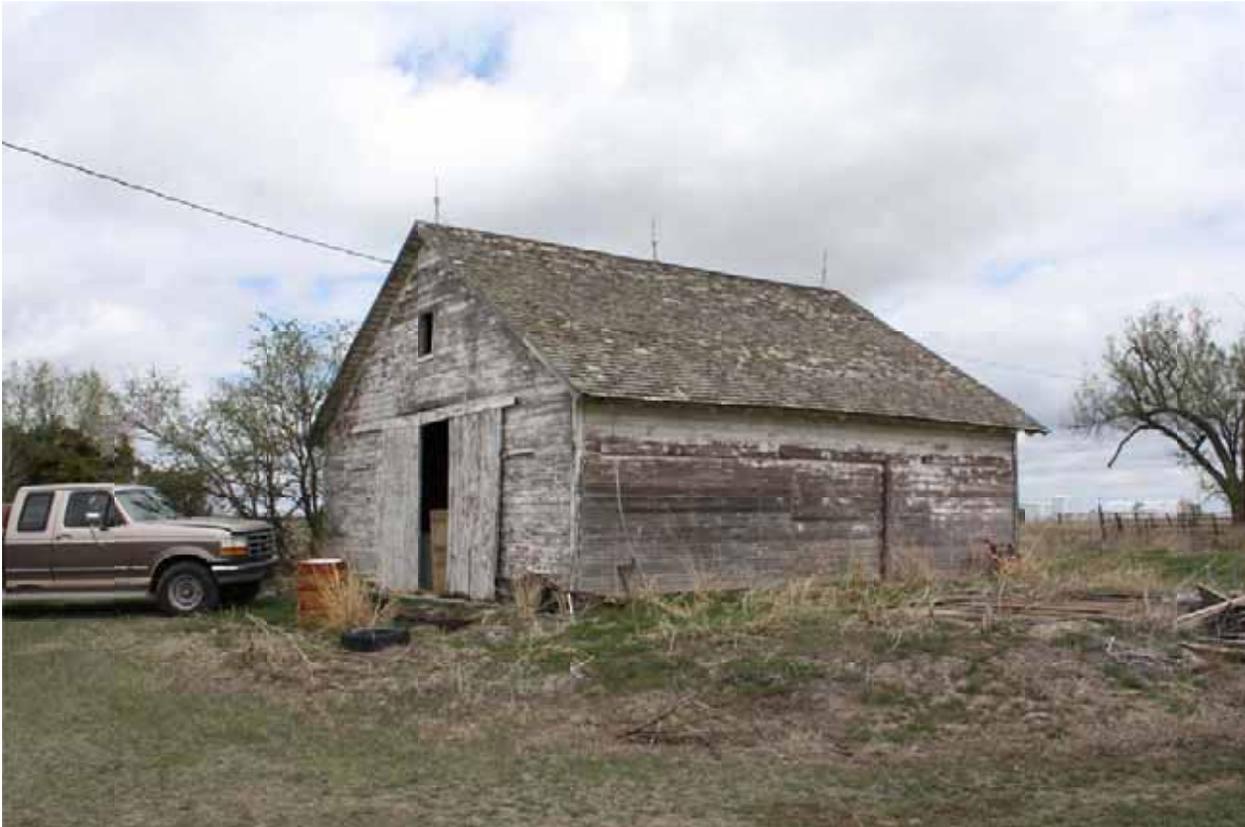
**Photograph 8** -- TTCW 8 Gable-Roof garage --T25S, R27W, Sec. 22. Photograph looking northeast.  
(James Sexton – Tetra Tech, April 27, 2011)

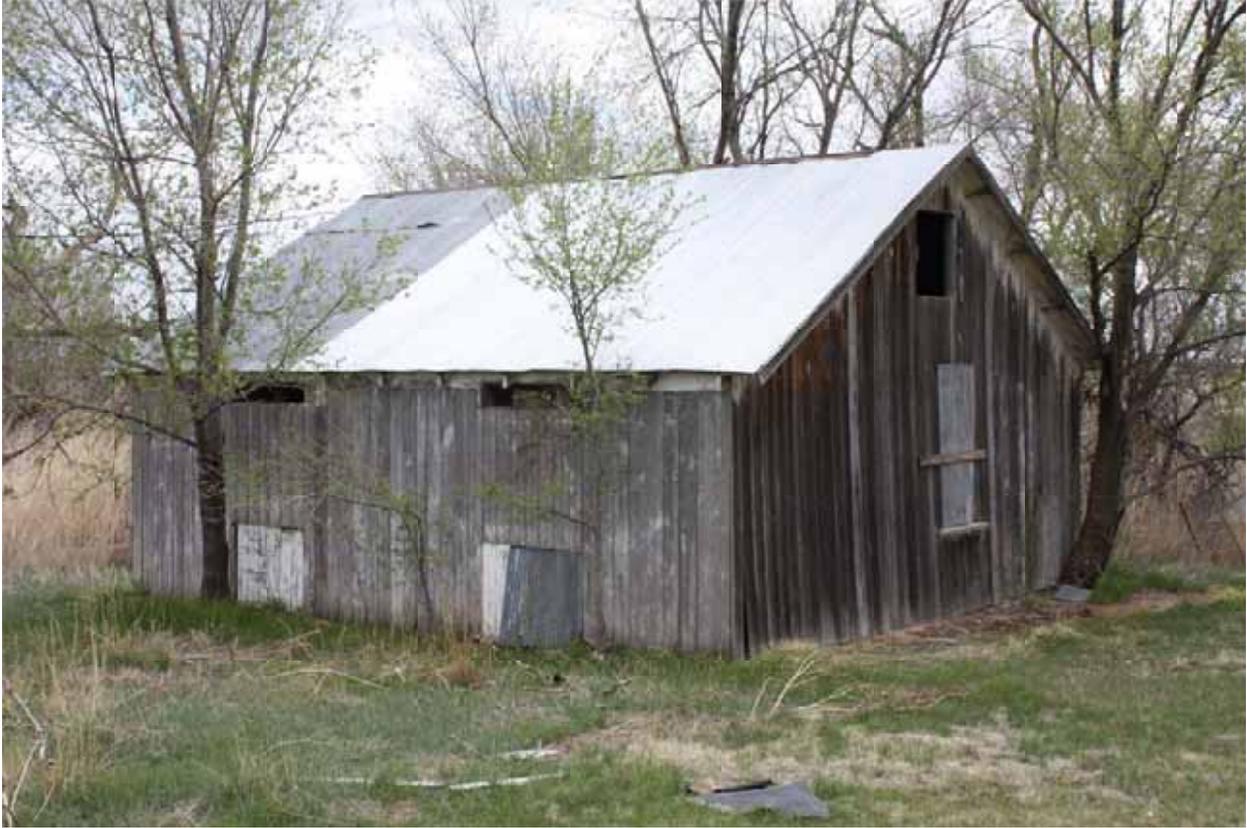
**Photograph 9** -- TTCW 8 Small animal shed --T25S, R27W, Sec. 22. Photograph looking southwest.  
(James Sexton – Tetra Tech, April 27, 2011)

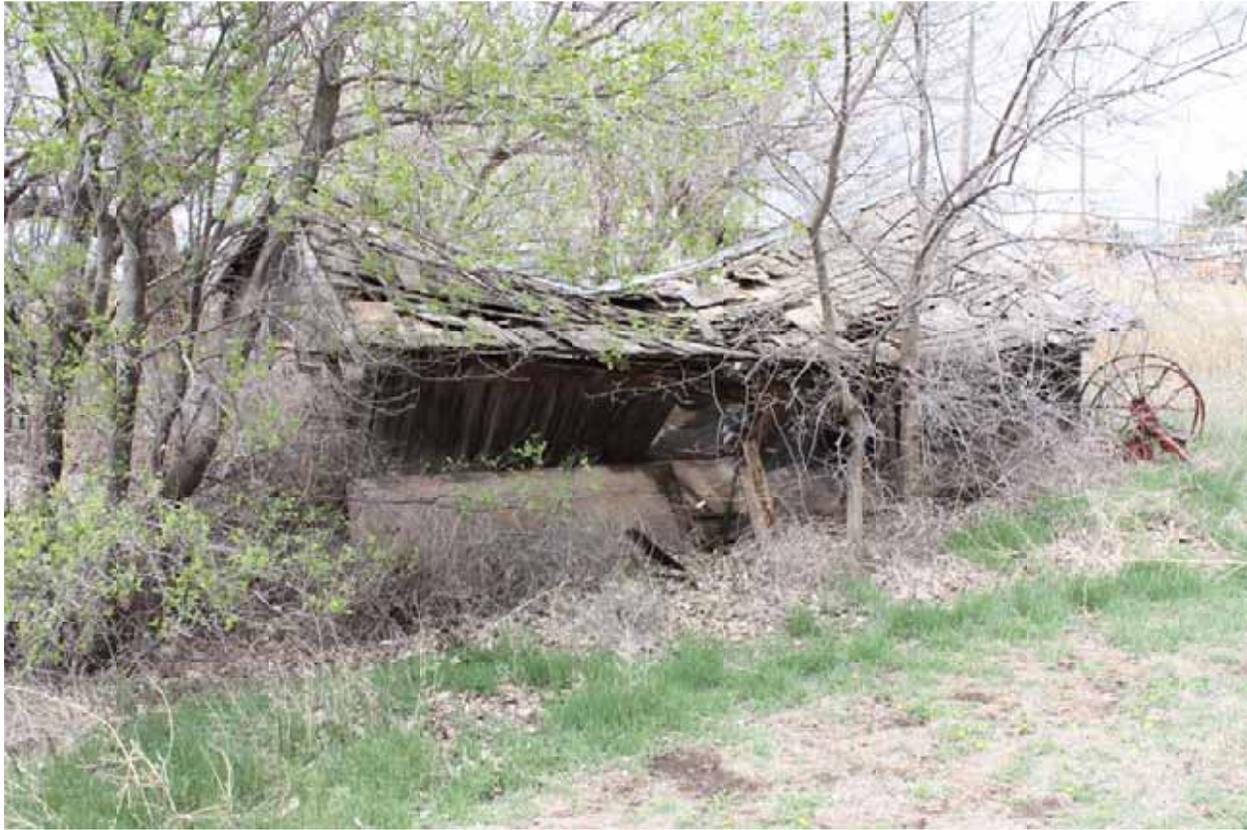
**Photograph 10** -- TTCW 8 Dilapidated building --T25S, R27W, Sec. 22. Photograph looking east.  
(James Sexton – Tetra Tech, April 27, 2011)

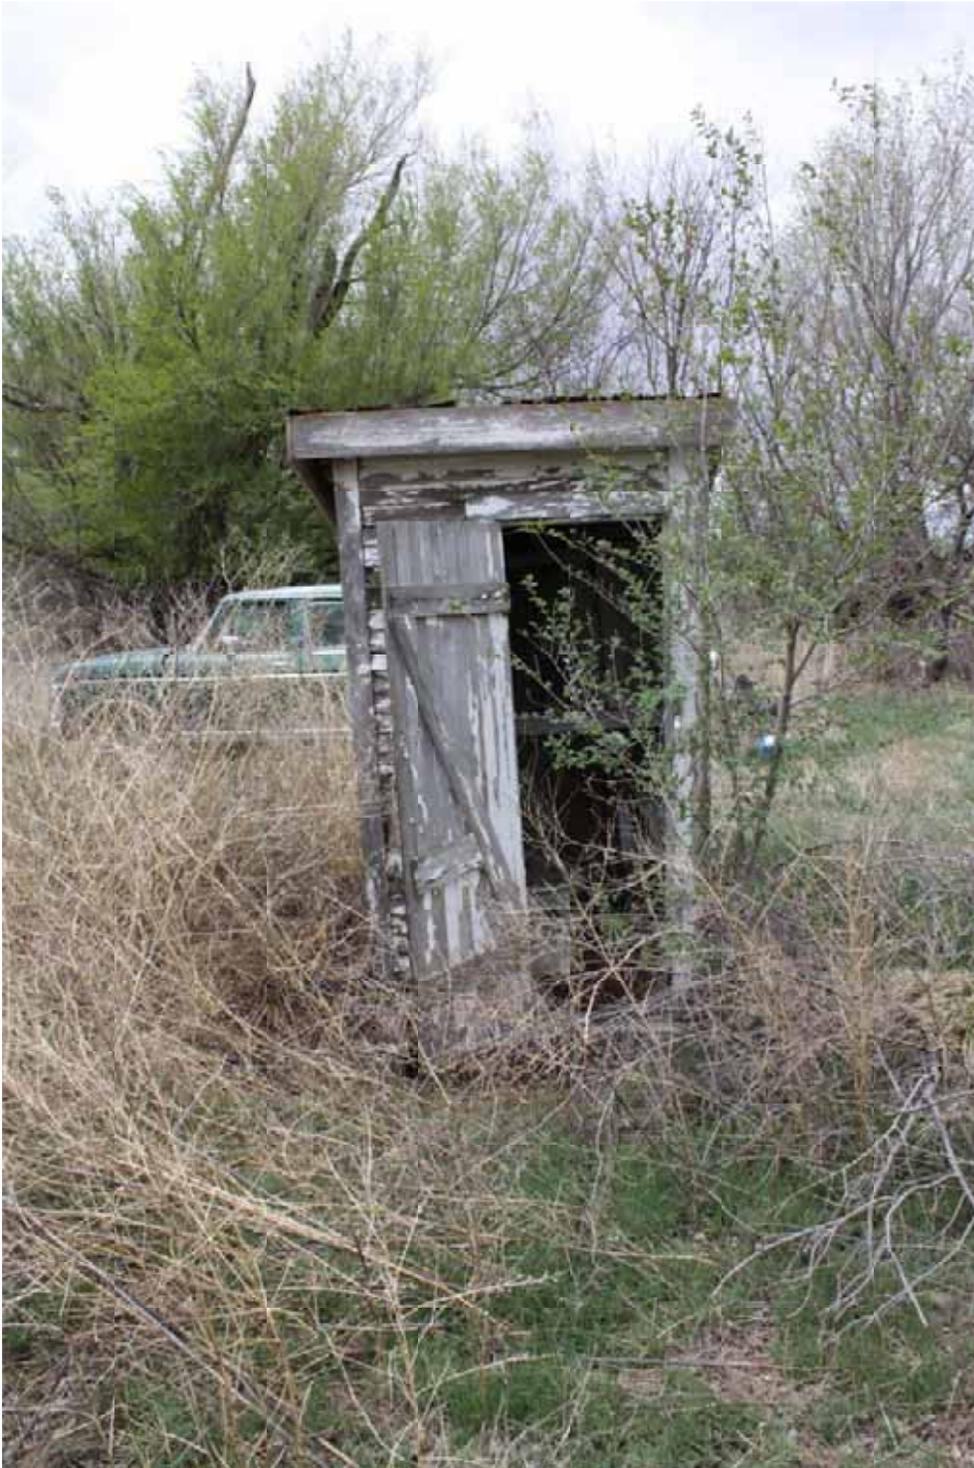
**Photograph 11** -- TTCW 8 Outhouse --T25S, R27W, Sec. 22. Photograph looking west. (James Sexton – Tetra Tech, April 27, 2011)

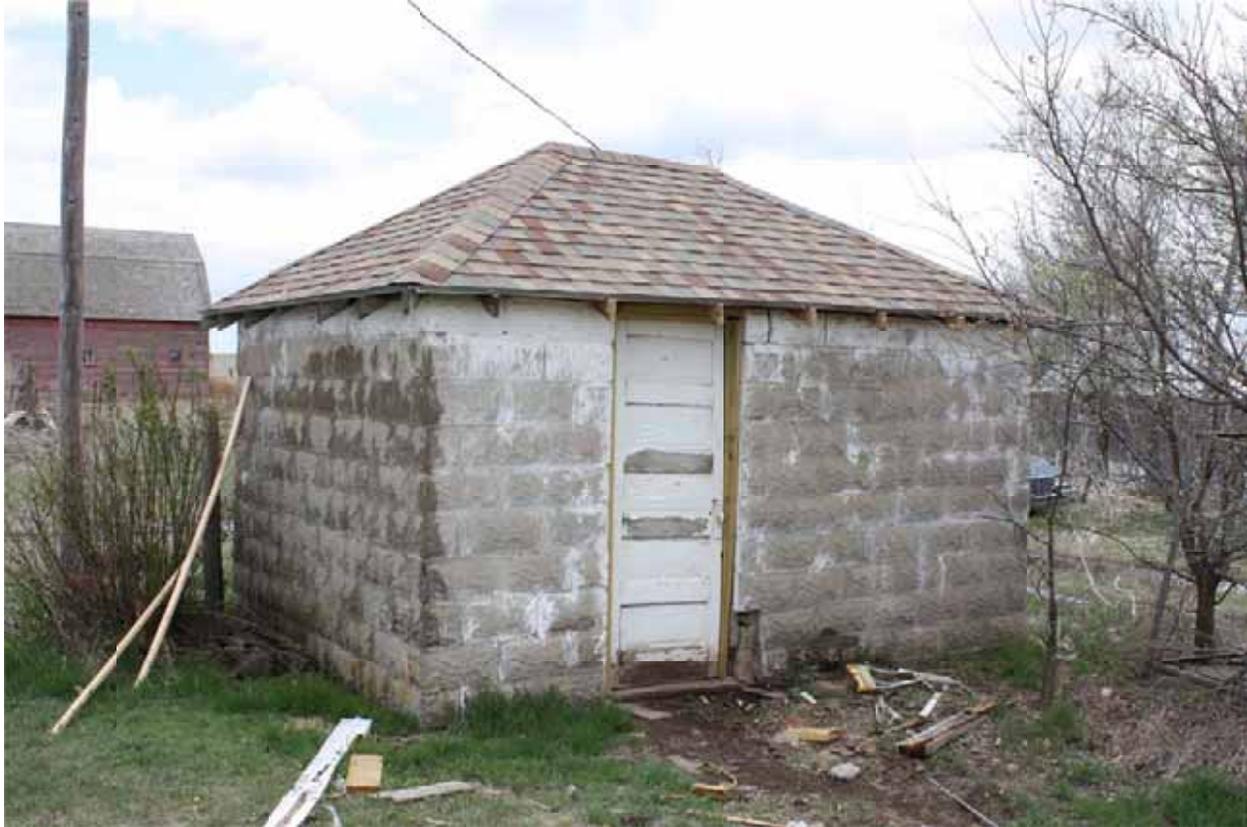
**Photograph 12** -- TTCW 8 Pumphouse --T25S, R27W, Sec. 22. Photograph looking southeast. (James Sexton – Tetra Tech, April 27, 2011)

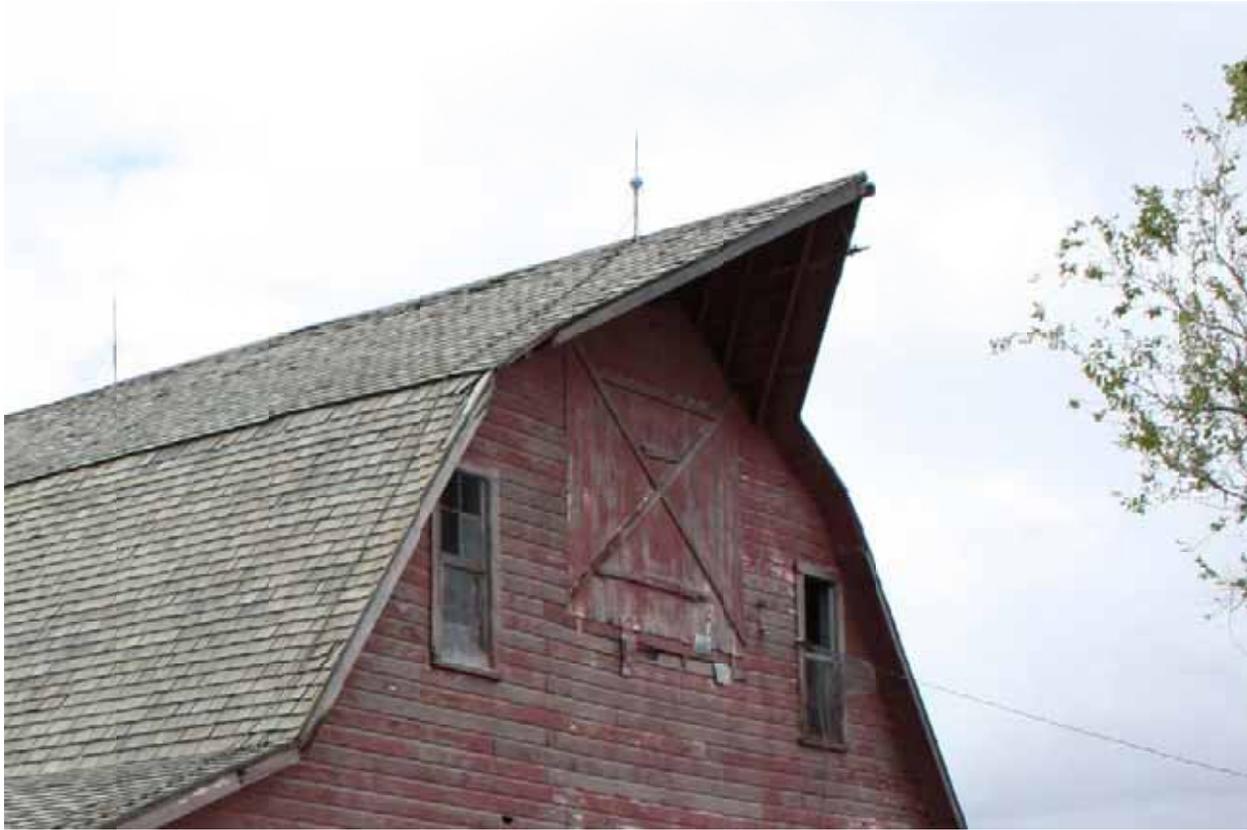
**Photograph 14** -- TTCW 8 Gambrel-Roof barn --T25S, R27W, Sec. 22. Detail of primary hay hood, door and track. Photograph looking east. (James Sexton – Tetra Tech, April 27, 2011)

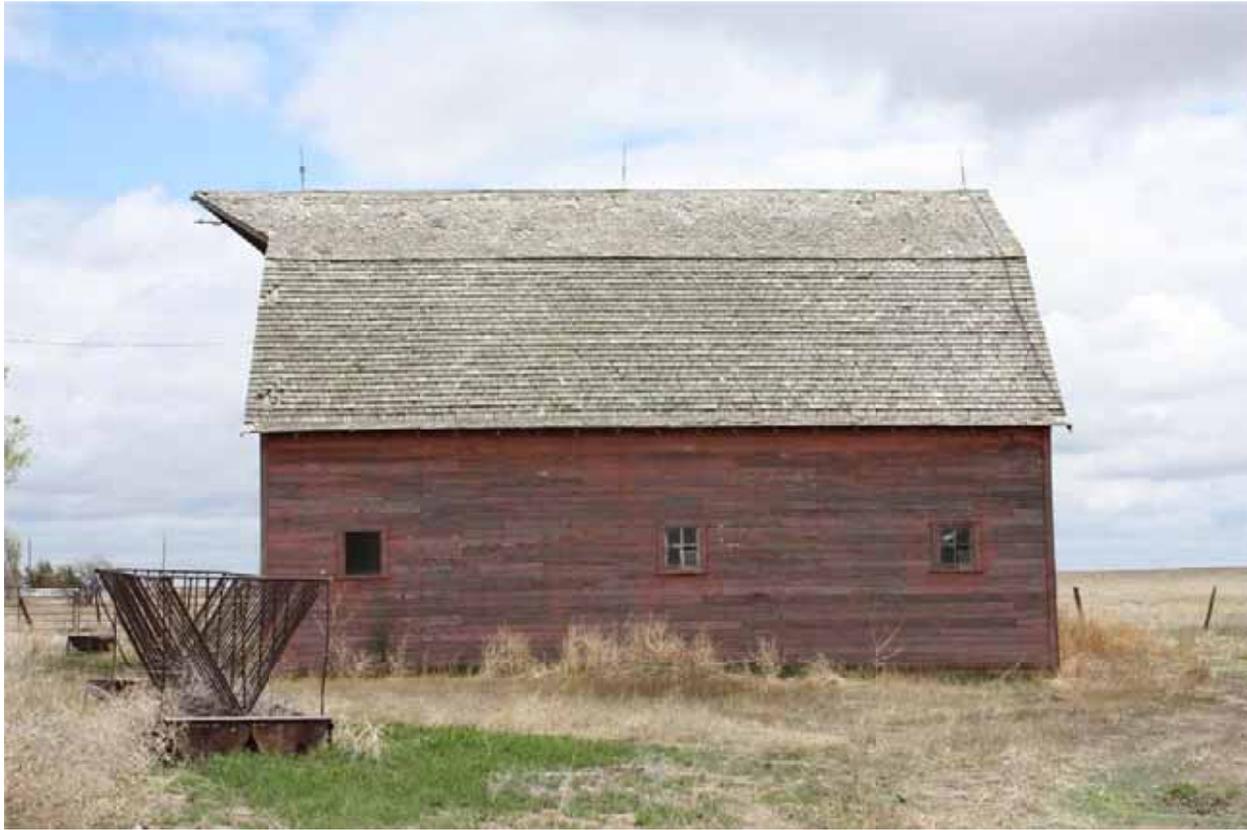
The western wall of the building has three evenly spaced square windows. Two of these retain evidence of four lights.

**Photograph 15** -- TTCW 8 Gambrel-Roof barn --T25S, R27W, Sec. 22. Detail of primary windows in west wall. Photograph looking east. (James Sexton – Tetra Tech, April 27, 2011)

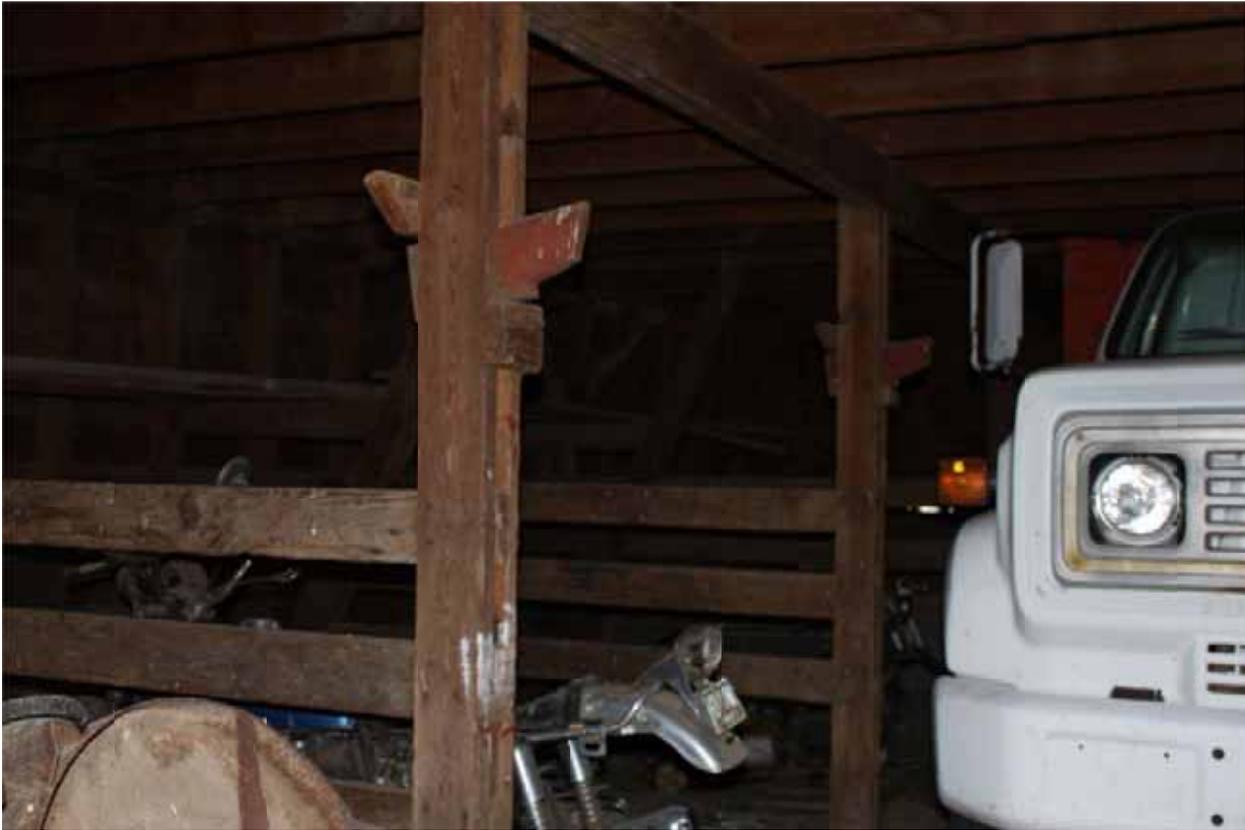
**Photograph 16** -- TTCW 8 Gambrel-Roof barn --T25S, R27W, Sec. 22. Detail of stalls and central aisle. Photograph looking northwest. (James Sexton – Tetra Tech, April 27, 2011)

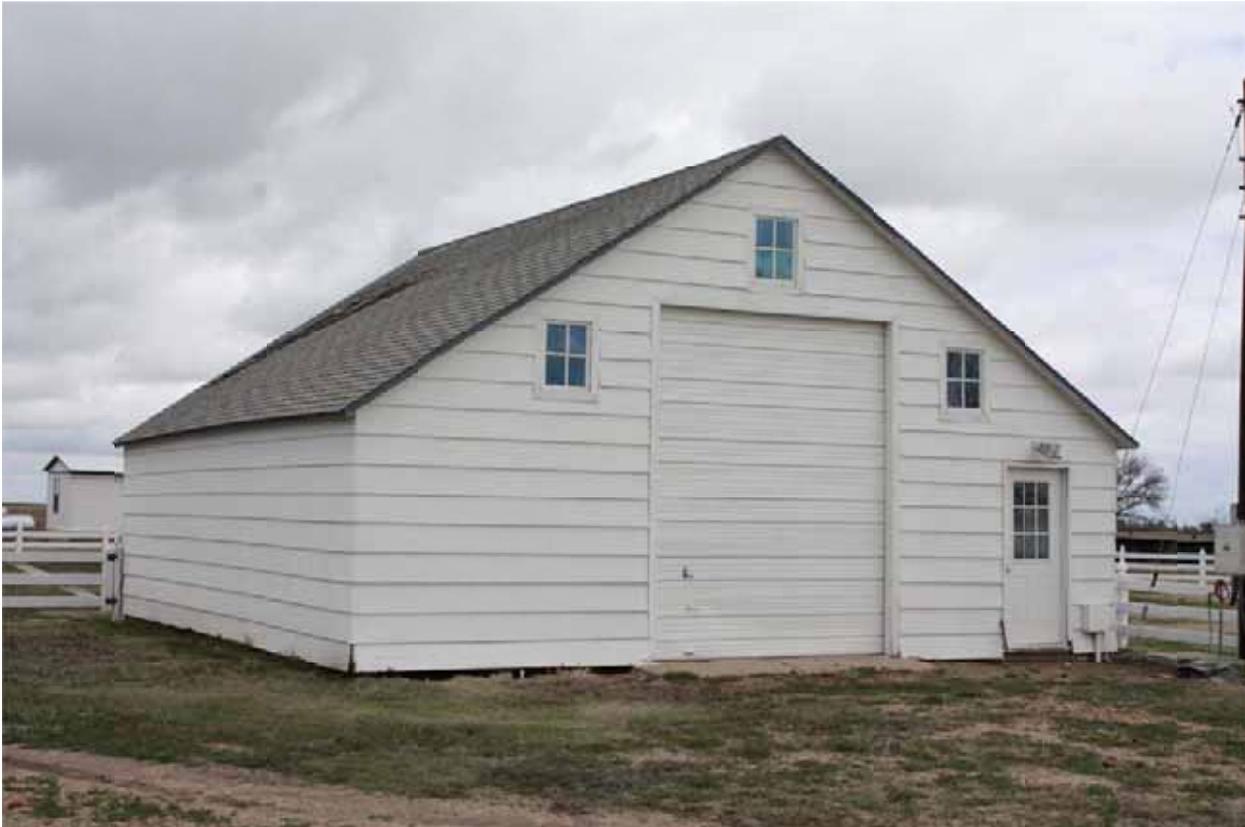
**Photograph 17** -- TTCW 20 Barn -- T25S, R27W, Sec. 27. Photograph looking northeast. (James Sexton – Tetra Tech, April 27, 2011)

The KSHS sought more information about the barn on the property, which the Appraiser's records indicate was constructed in 1940. It is a one-story, gable-front building with hardboard siding, metal corner pieces, and an asphalt shingle roof (Photograph 17). The building sits on a partial concrete foundation; part of the building sits on concrete block footings (Photograph 18). The façade has a large, centrally-located overhead door and a modern aluminum or vinyl door, with two panels under a fixed nine-light window, at the eastern end of the wall (Photograph 19). Three, four-light windows are arrayed in the gable: one sits over the middle of the overhead door, while the other two sit just outside the corners of the large door opening. The doors and windows sit within simple board surrounds; the windows have no sills (Photograph 20). The western and northern walls are blank (Photographs 17 and 21). The eastern wall has a door at the northern end and a row of four, four-light windows at the southern end. The windows appear to match those in the front gable. A modern vinyl fence creates a paddock by running from the southeast corner of the building in a large loop to the northeast and returns to the building at its northwest corner (Photograph 22).

The building retains integrity of location and setting as the building remains on its original site in an agricultural area. The integrity of design appears to have been lost due to the introduction of new doors in the façade. The MPS emphasizes the importance of the barn's main entrance. On page 83, it states, "...a barn's main entrance, generally centered on the gable end or broad side and accessed by a sliding door, must be extant...." Further, on page 85, it states "Principal entrances, generally centered on the gable ends or broad sides of barns, must be intact in order for a barn to be individually eligible." While the building has had new roofing materials and new doors added, the MPS indicates that the change in roof cladding is not sufficient to affect the building's integrity of materials. It is unclear whether evidence of the builder's workmanship has been removed. However, the MPS indicates that "...former removal of some of these features will not, in itself, render the barn ineligible for listing." The building retains a compromised integrity of feeling, as the large overhead door makes diminishes the sense of the building as a historic barn. In light of the MPS, it is Tetra Tech's opinion that this barn appears not to be eligible for the NRHP as an individual resource.

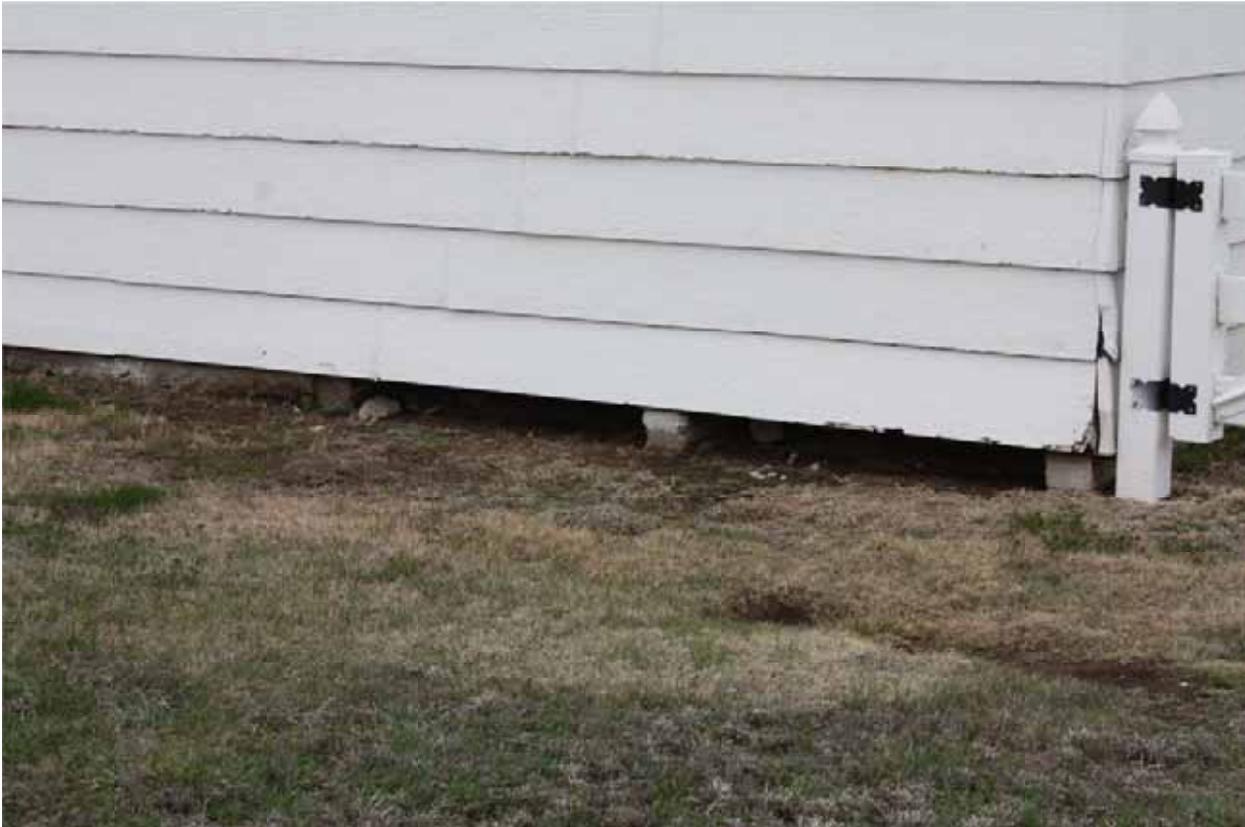
**Photograph 18** -- TTCW 20 Barn -- T25S, R27W, Sec. 27. Detail of foundation showing concrete block and poured concrete foundation. Photograph looking northeast. (James Sexton – Tetra Tech, April 27, 2011)

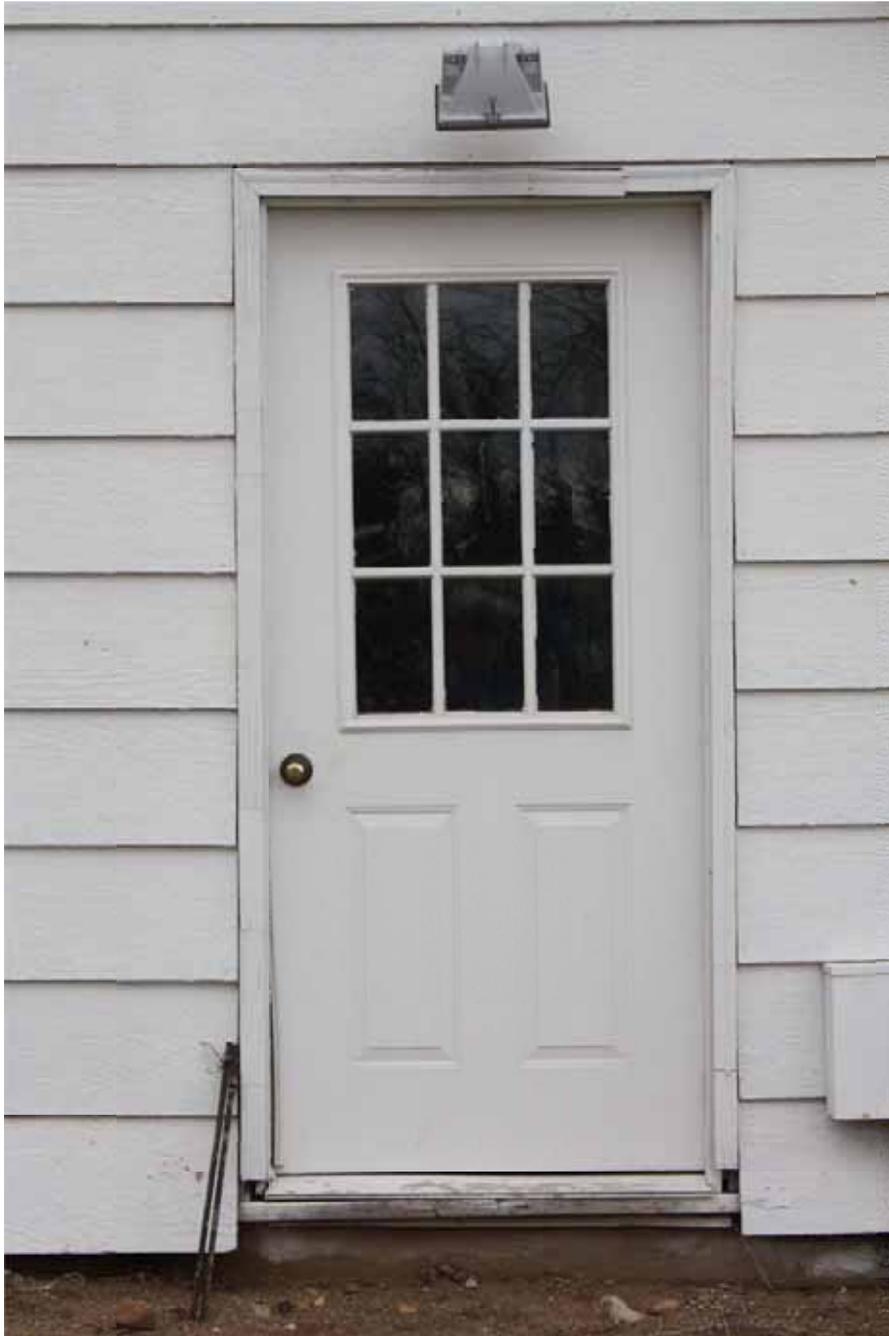
**Photograph 19** -- TTCW 20 Barn -- T25S, R27W, Sec. 27. Detail of modern door. Photograph looking north. (James Sexton – Tetra Tech, April 27, 2011)

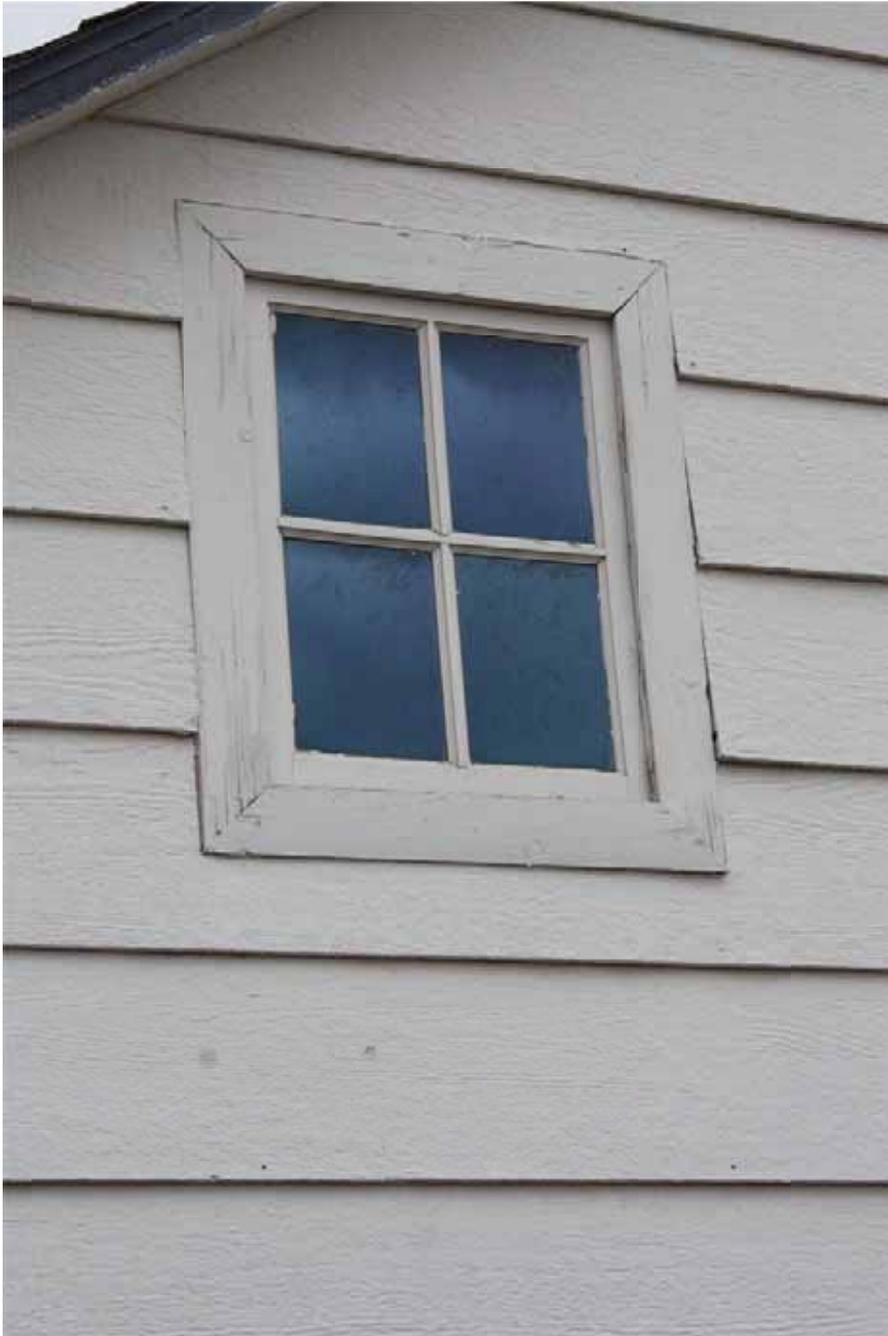
**Photograph 20** -- TTCW 20 Barn -- T25S, R27W, Sec. 27. Detail of gable window. Photograph looking north. (James Sexton – Tetra Tech, April 27, 2011)
