Phase I Cultural Resource Assessment

**Phase I Cultural Resource Survey For
The Proposed Construction of Improvements
At The Guntersville Municipal Airport
Marshall County, Alabama**

February 4, 2003

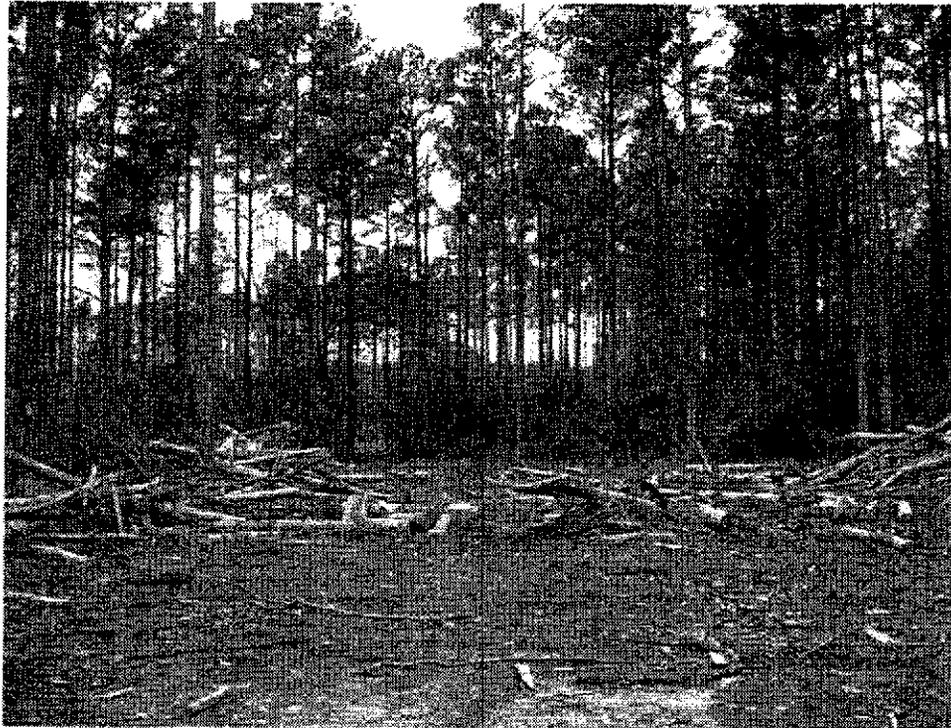
Figure 2. Typical Logged Area Facing Northwest.

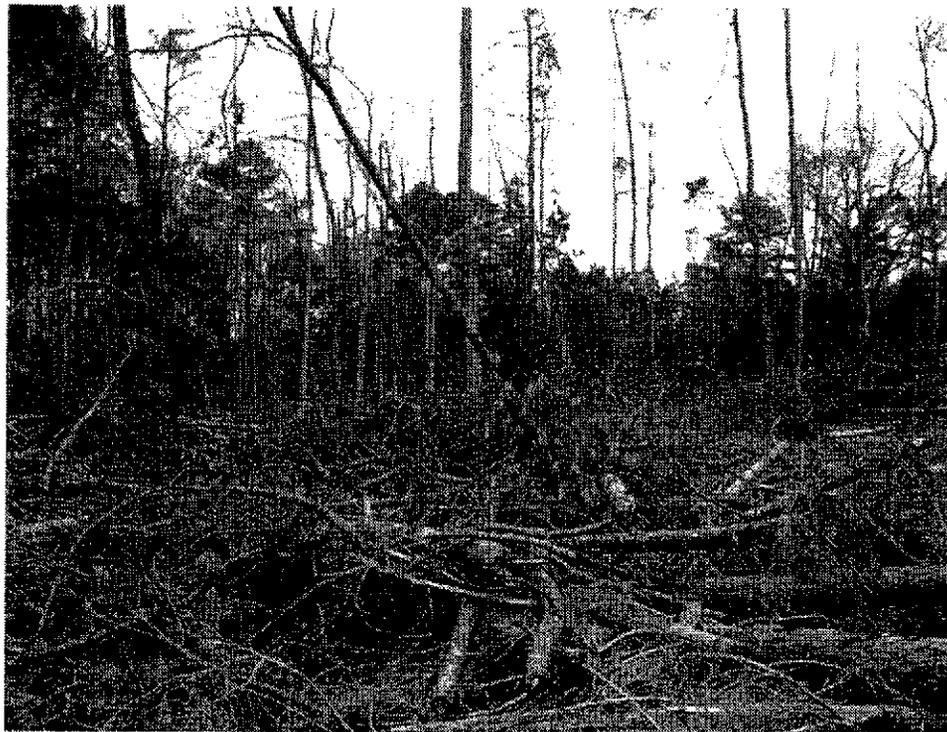
Figure 3. View of Logging Disturbance Facing North.

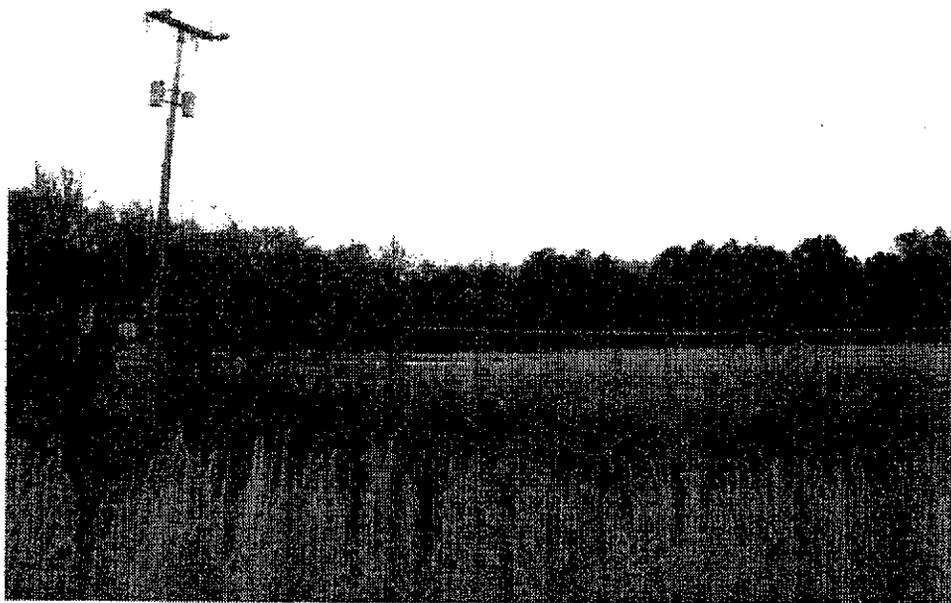
Figure 4. View of the Water Treatment Pond Facing North.

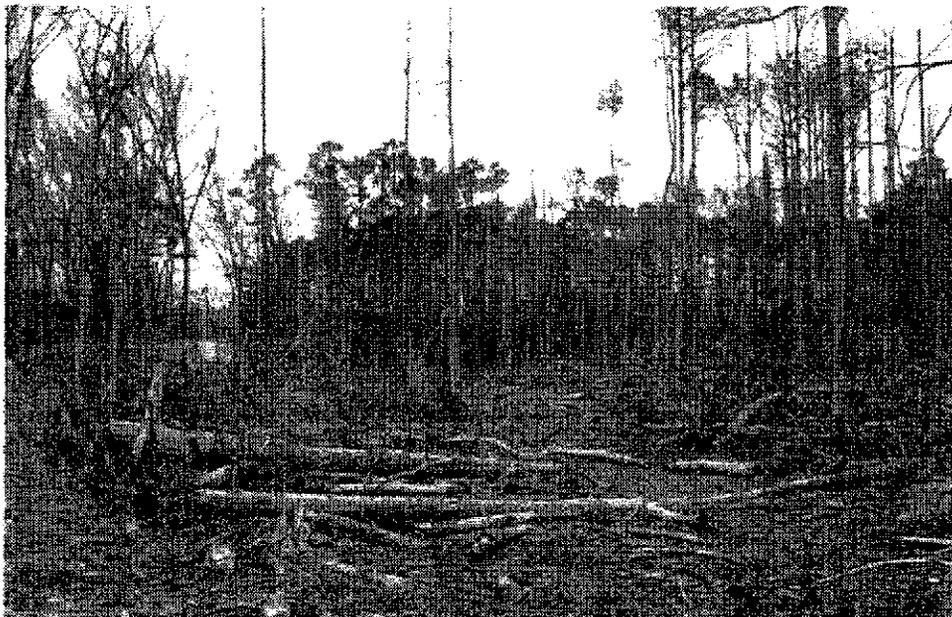
Figure 7. View of Site 1MS460 Facing North.

Site 1MS460. This site (Figures 7 and 8) is comprised of a surface scatter of plain whiteware ceramics (n=6), clear glass (n=7), and one clear glass machine-made bottleneck. In addition to nearby transect shovel tests, eight additional shovel tests were excavated in cardinal directions around the surface finds with no additional cultural material recovered. The general soil profile from delineation shovel tests consisted of 0-14 centimeters of dark brown (7.5YR3/2) silt loam, overlying strong brown (7.5YR5/8) clay subsoil. A structure appears on the Mt. Carmel topographic quadrangle to the south of this site (Figure 1). No evidence of the structure at its' mapped location was observed in the field. It is likely that these artifacts are related to that structure and were deposited here when the structure was removed. This find is not considered significant and no further cultural resource investigations are recommended.

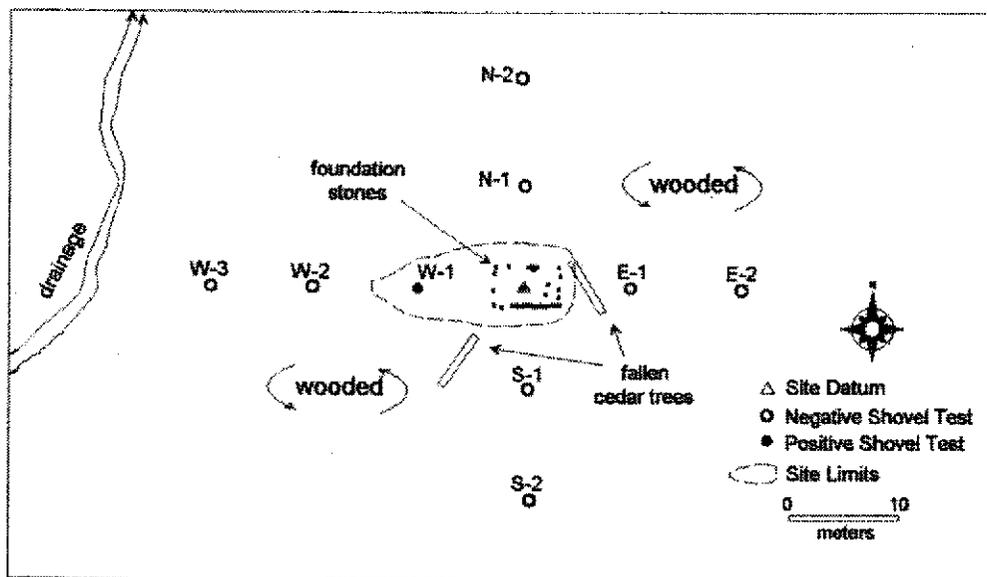
Figure 9. Plan View of Site 1MS461.

Site 1MS461. A stone foundation (Figures 9 and 10) was observed between shovel tests 1-60-2 and 1-60-3. The southwest corner of the foundation consisted of four stacked stones approximately 60 centimeters high. The remaining 4 meter by 6 meter foundation consisted of a stack of one or two stones in a rectangular form. Some stones were missing or misplaced along the foundation outline. A total of ten shovel tests were excavated to delineate the site. Two shovel tests were positive and consisted of one piece of plain whiteware, a piece of amethyst glass, and one round nail. Based on the presence of the amethyst glass, a date prior to 1916 is possible for the site.

The general soil profile within the site consisted of 0-12 centimeters of dark brown silty loam (7.5YR3/2) overlying strong brown (7.5YR5/8) and yellow (10YR7/8) sticky clay subsoil. The absence of any other cultural material or further evidence of structural remains indicates that this site is not significant and does not warrant further investigation.

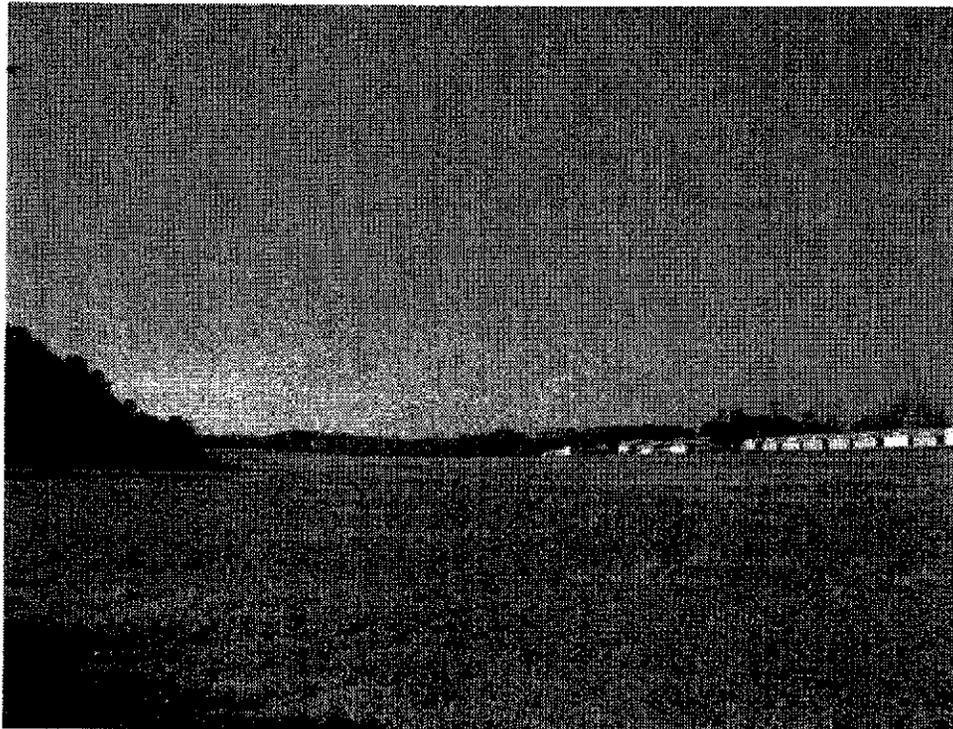
Figure 11. View of the Field Parallel to the Existing Runway Facing South.

The remainder of the surveyed area consisted of the grass field (Figure 11) adjacent to the existing runway and wooded areas between the runway and a small drainage. Some standing water was present in the grass field. Limestone outcrops were present in the southwest portion of the

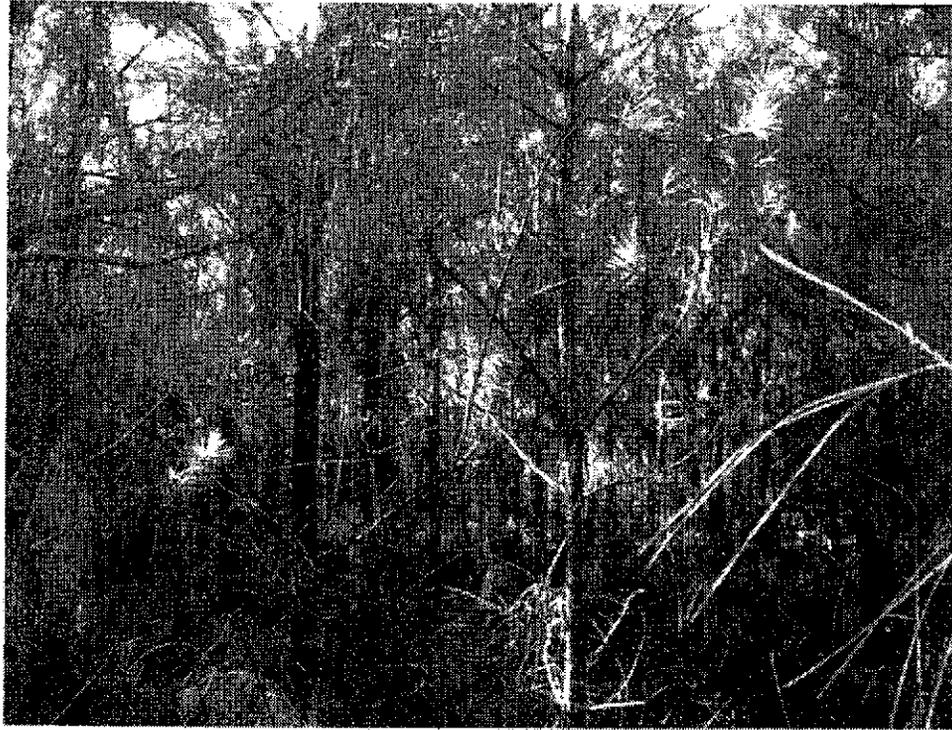
Figure 12. General View of Pine Forest in the Western Portion of the Project Area Facing East.

project area between Buck Island Road and the runway. Pines dominated the wooded areas in this portion of the project area (Figure 12). Pine planting has taken place in the last 20 years as the current treeline east of the runway (Figure 1) is different from what is shown on the Mt. Carmel topographic map (USGS 1983).

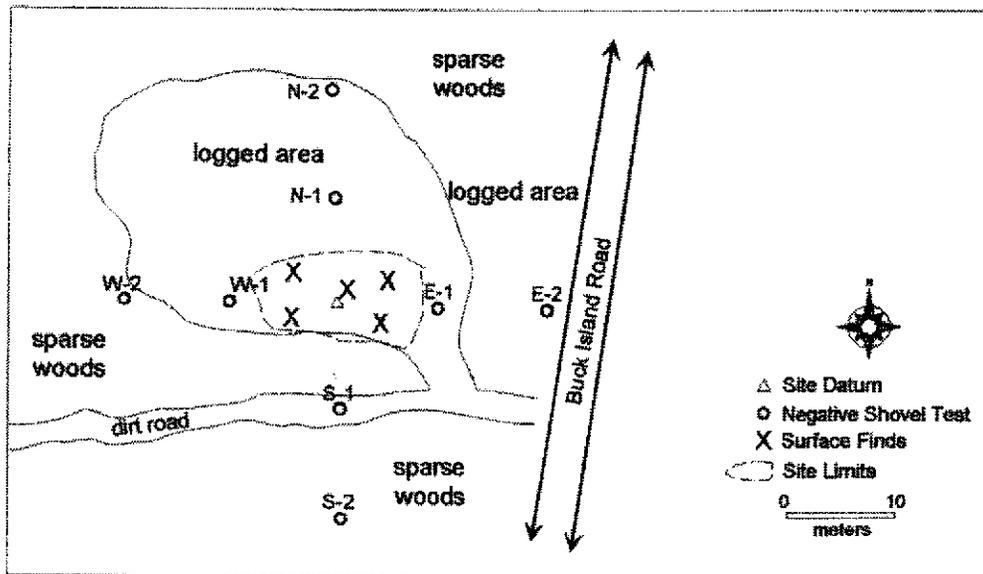
Figure 13. Plan View of Site 1MS462.

Site 1MS462. The site area (Figures 13 and 14) had been recently logged with many felled trees still on the ground. A small dirt road was present along the southern edge of the site. Ample ground surface visibility allowed a thorough inspection for surface artifacts. In addition to nearby transect shovel tests, eight additional shovel tests were excavated in cardinal directions around the surface finds with no additional cultural material recovered. The general soil profile from delineation shovel tests consisted of 0-21 centimeters of dark brown (7.5YR3/2) silt loam, overlying brownish-yellow (10YR6/8) clay subsoil. Large amounts of limestone were present on the ground surface and in shovel tests.

The material collection from the site consisted of plain whiteware (n=4), amber glass (n=1), clear glass (n=3), a brick fragment (n=1), and stoneware (n=1). The artifacts do not reflect a specific time period, so dating the occupation of the site is difficult. Since the structure did not appear on any maps prior to 1911, it is assumed that the site is more recent. The absence of any further cultural material or evidence of structural remains suggests that this site is not significant and does not warrant further investigation.

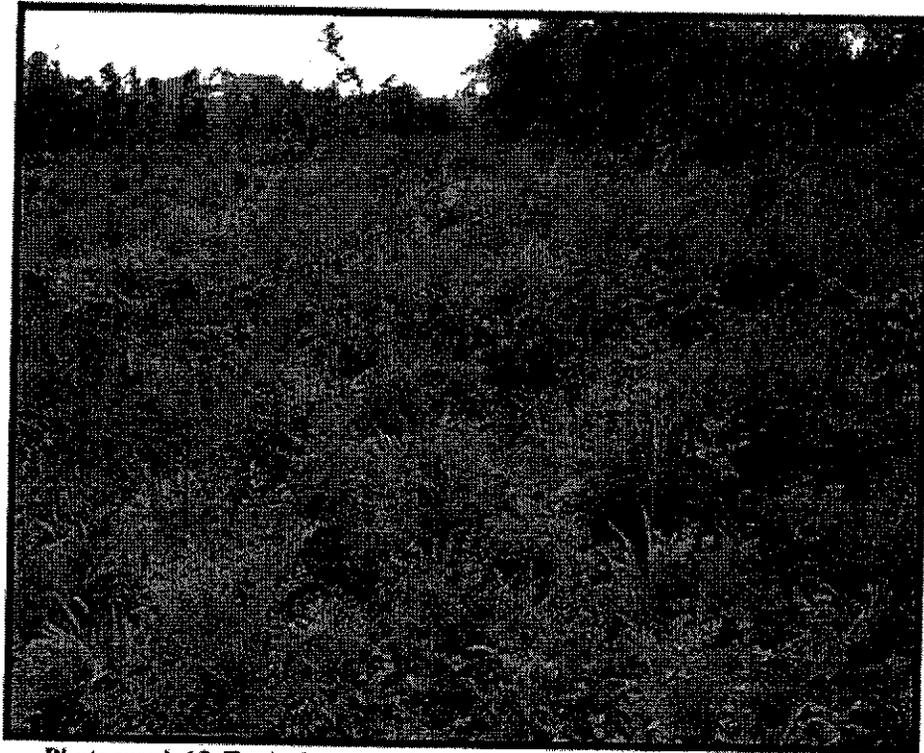
Photograph 18. Typical re-growth condition of much of the clear-cut areas.

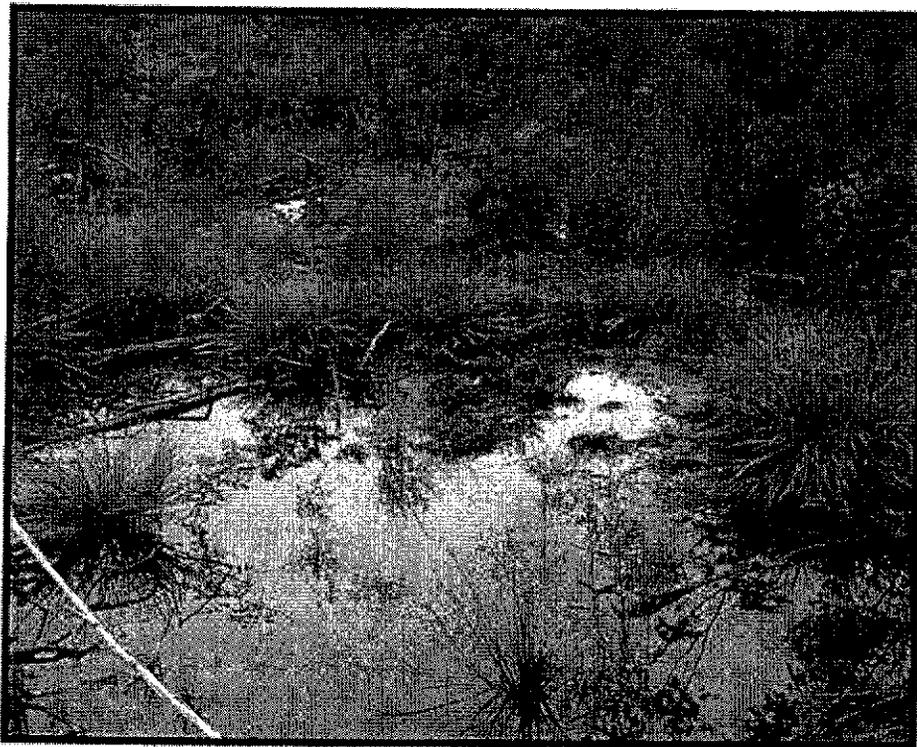
Photograph 20. Typical condition of intermittent drainageway located within cleared section of the parcel.

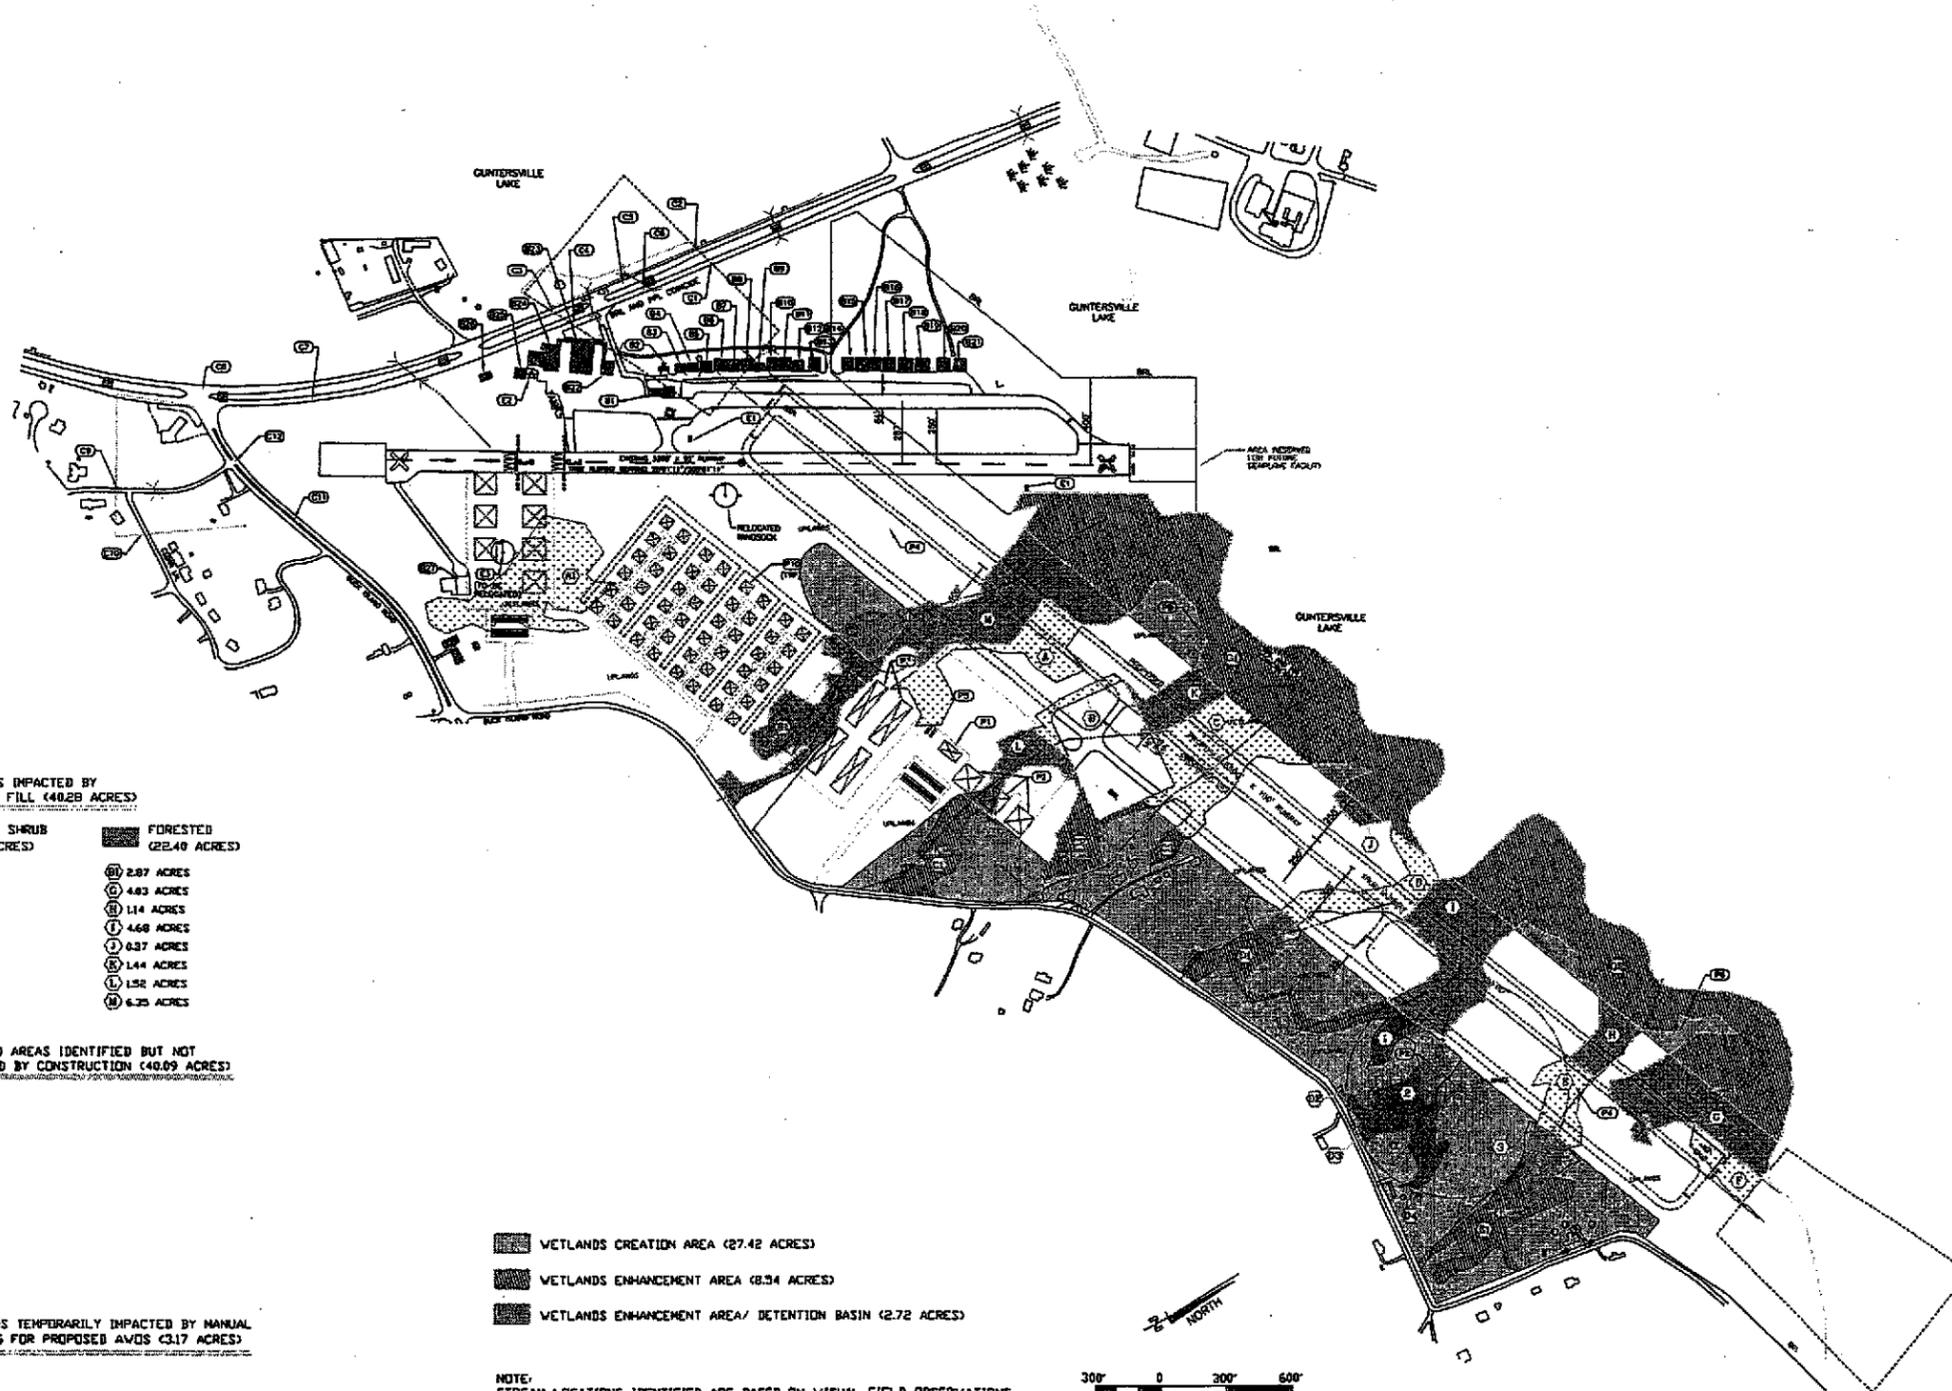
FIGURE
2

- WETLANDS CREATION AREA (27.42 ACRES)
- WETLANDS ENHANCEMENT AREA (8.34 ACRES)
- WETLANDS ENHANCEMENT AREA/ DETENTION BASIN (2.72 ACRES)

SITE MAP ~ WITH WETLAND DELINEATION & WETLAND IMPACT
