Non-Time-Critical Concurrence

Area: North Embayment Grids 4-E and Grid 3-J.

Kingston Ash Recovery Project (KRP)
Quality Assurance
Daily Report

North Embayment Sampling - Cleared Grids - Concurrence #2

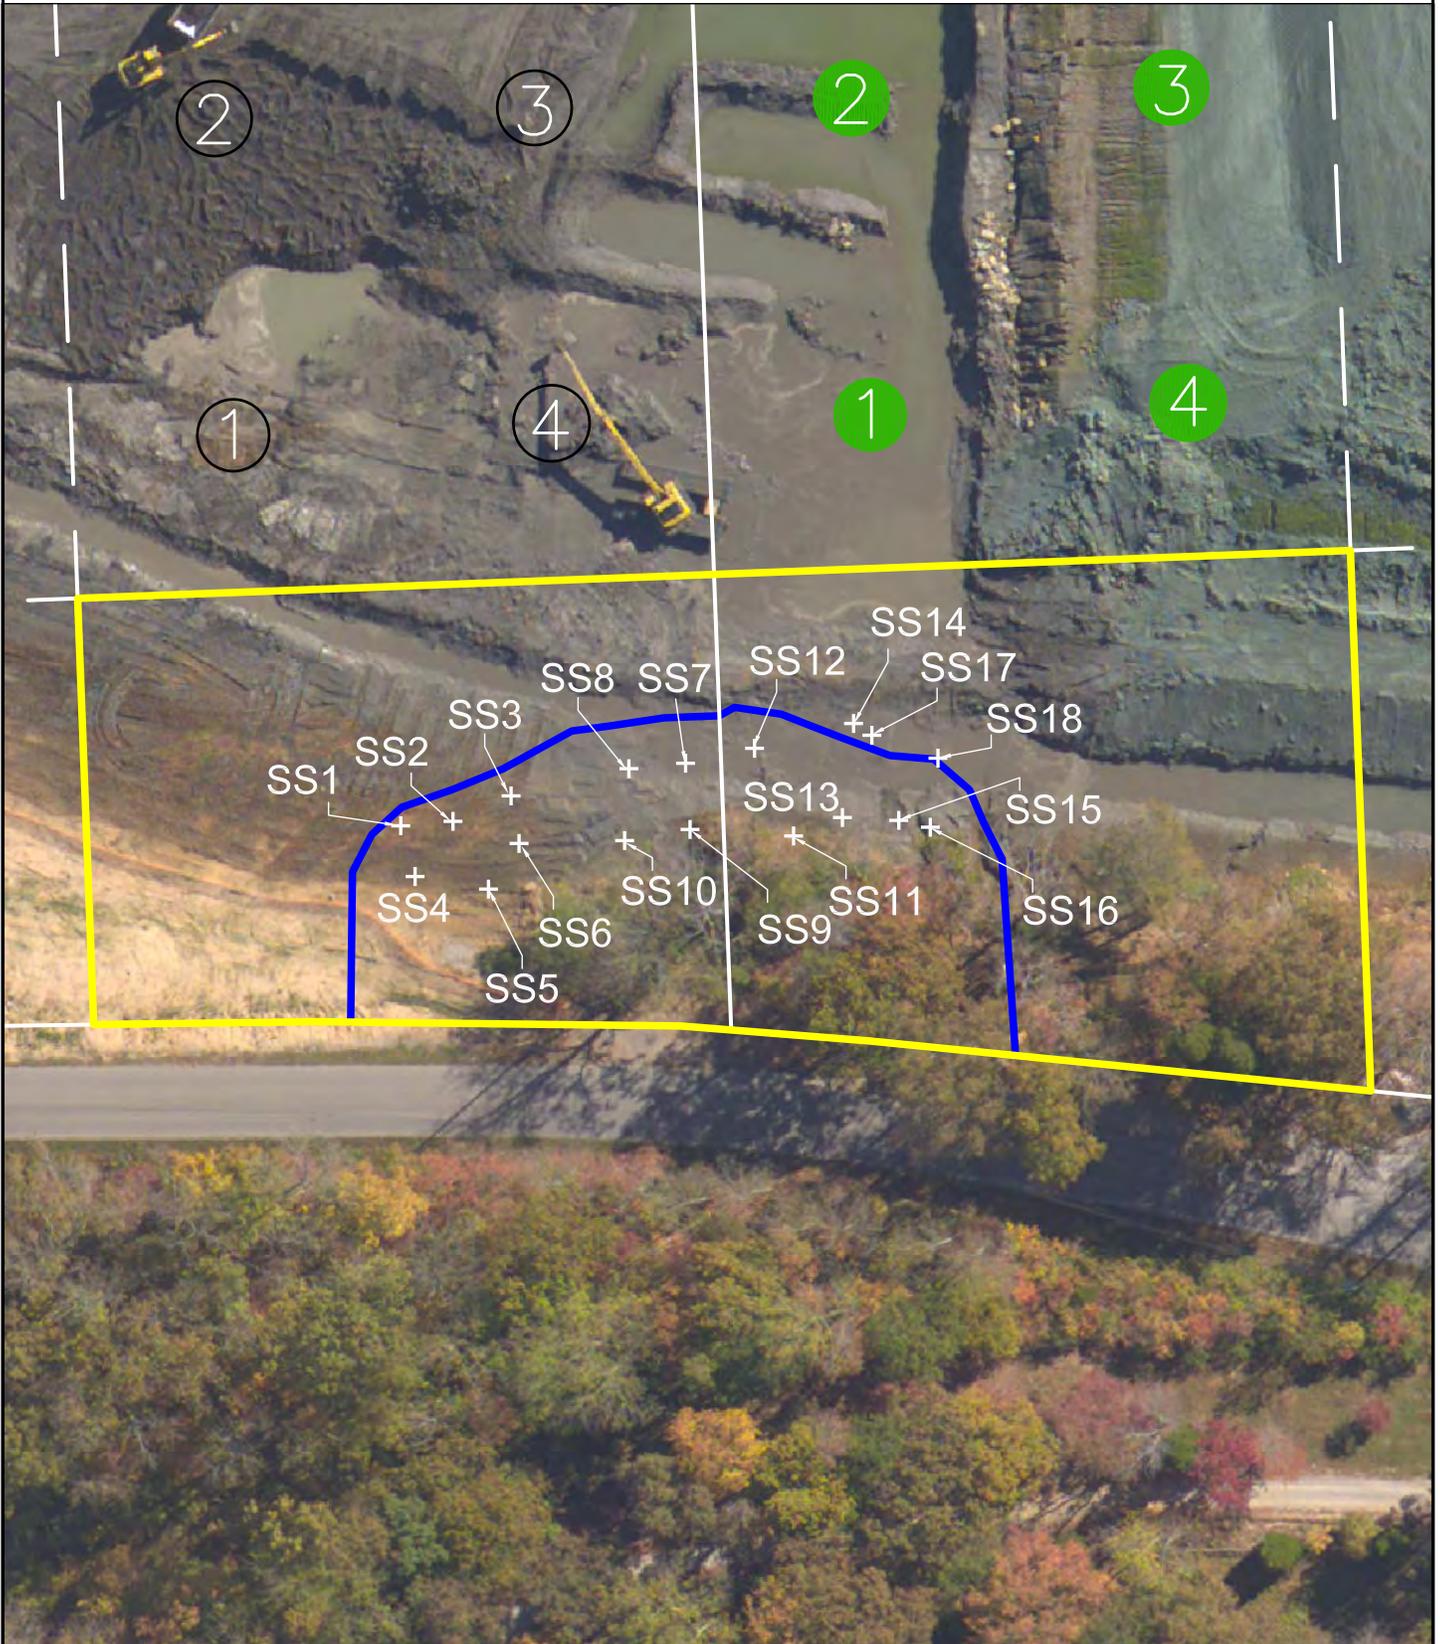
Figure 1

SAMPLE RESULTS SATISFACTORY

CLEARED GRID BOUNDARY

SAMPLE RESULTS UNSATISFACTORY

TOE OF BUTTRESS

TO BE SAMPLED	N

Ash removal has been completed or was not required in the North Embayment area delineated by Grids 4E and 3-J.

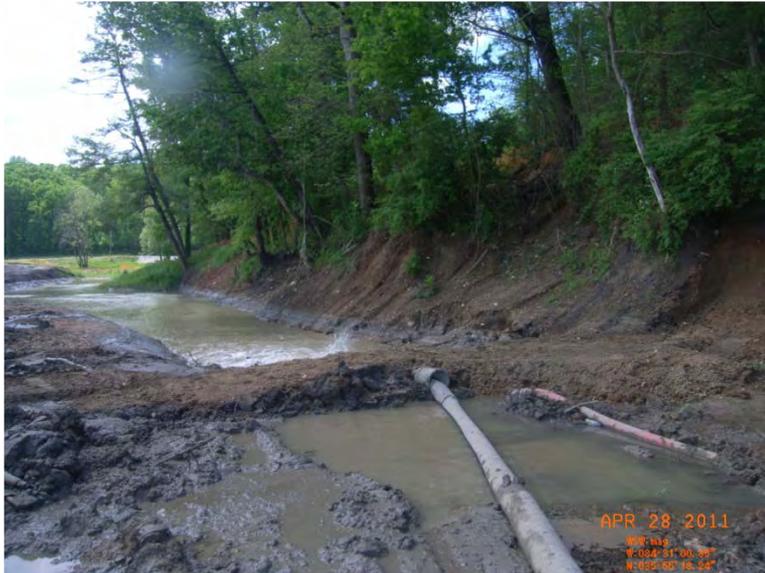
RO11123

<u>Photographer</u>	<u>Image ID</u>	<u>Date</u>	<u>Event</u>	<u>Orientation</u> (N,S,E,W)	<u>Latitude</u> <u>DD,MM.MMM</u>	<u>Longitude</u> <u>DD,MM.MMM</u>	<u>Location/Detailed Description</u> Weather Conditions, GPS locations, Names of individuals in photo, Approx. time of day, specific equipment and activity
	Walter Burns	R0011123	04/28/2011	North Embayment	WSW	35 55'18.24"	84 31'00.85"	Pre-existing condition of buttress location
	Walter Burns	R0011153	05/10/2011	North Embayment	S	35 55'18.42"	84 31'00.94"	Buttress cleaning, 39' deemed clean
	Walter Burns	R0011164	05/10/2011	North Embayment	SSW	35 55'18.53"	84 31'00.29"	RSI collecting concurrences samples; Civil Projects continuing to clean
	Walter Burns	R0011167	05/11/2011	North Embayment	SSW	35 55'17.92"	84 31'00.69"	Perimeter of the first 39' deemed clean staked
	Walter Burns	R0011168	05/11/2011	North Embayment	SSW	35 55'19.14"	84 30'59.47"	Rock being placed in clean areas only

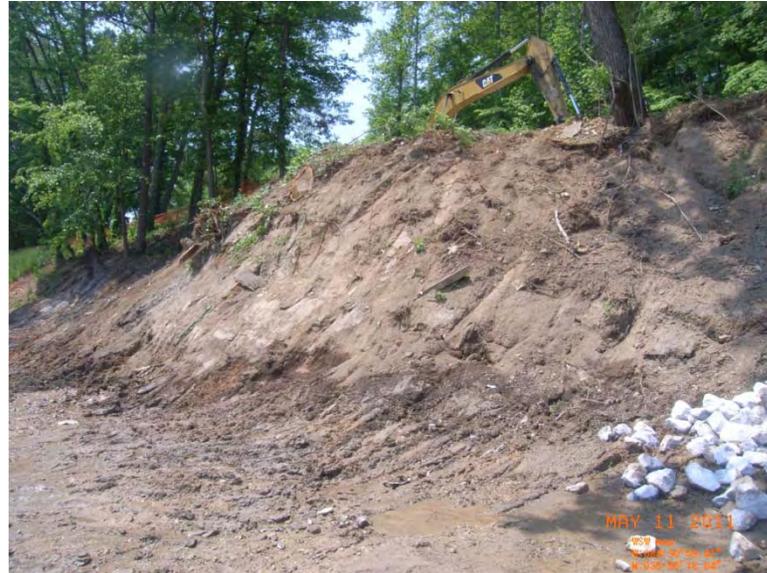
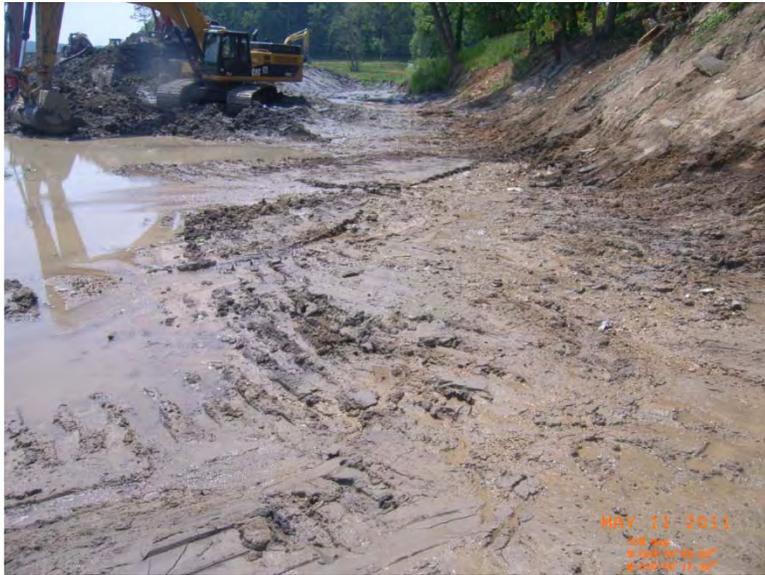
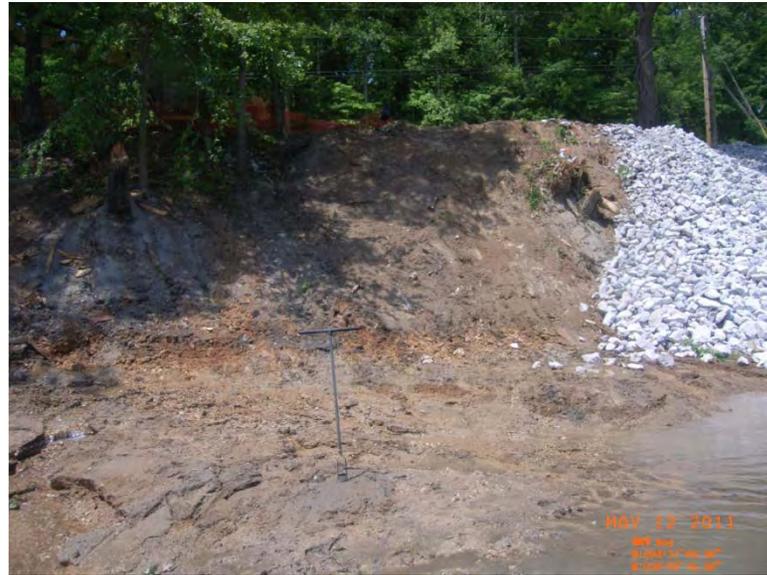
RO11178

Walter Burns	R0011178	05/11/2011	North Embayment	SW	35 55'18.04"	84 30'59.41"	Area determined to be clean and ready for concurrence sampling
	Walter Burns	R0011179	05/11/2011	North Embayment	SW	35 55'17.98"	84 30'59.47"	Area determined to be clean and ready for concurrence sampling
	Walter Burns	R0011193	05/12/2011	North Embayment	NW	35 55'16.98"	84 31'00.96"	Area determined to be clean and ready for concurrence sampling
	Walter Burns	R0011195	05/12/2011	North Embayment	NW	35 55'16.91"	84 30'00.72"	Area determined to be clean and ready for concurrence sampling
	Walter Burns	R0011198	05/12/2011	North Embayment	SW	35 55'17.58"	84 31'.10"	Concurrence sampling
	Walter Burns	R0011200	05/13/2011	North Embayment	SW	35 55'16.39"	84 31'00.45"	Area determined to be clean and ready for concurrence sampling
	Walter Burns	R0011202	05/13/2011	North Embayment	NW	35 55'16.22"	84 31'.67"	Area determined to be clean and ready for concurrence sampling

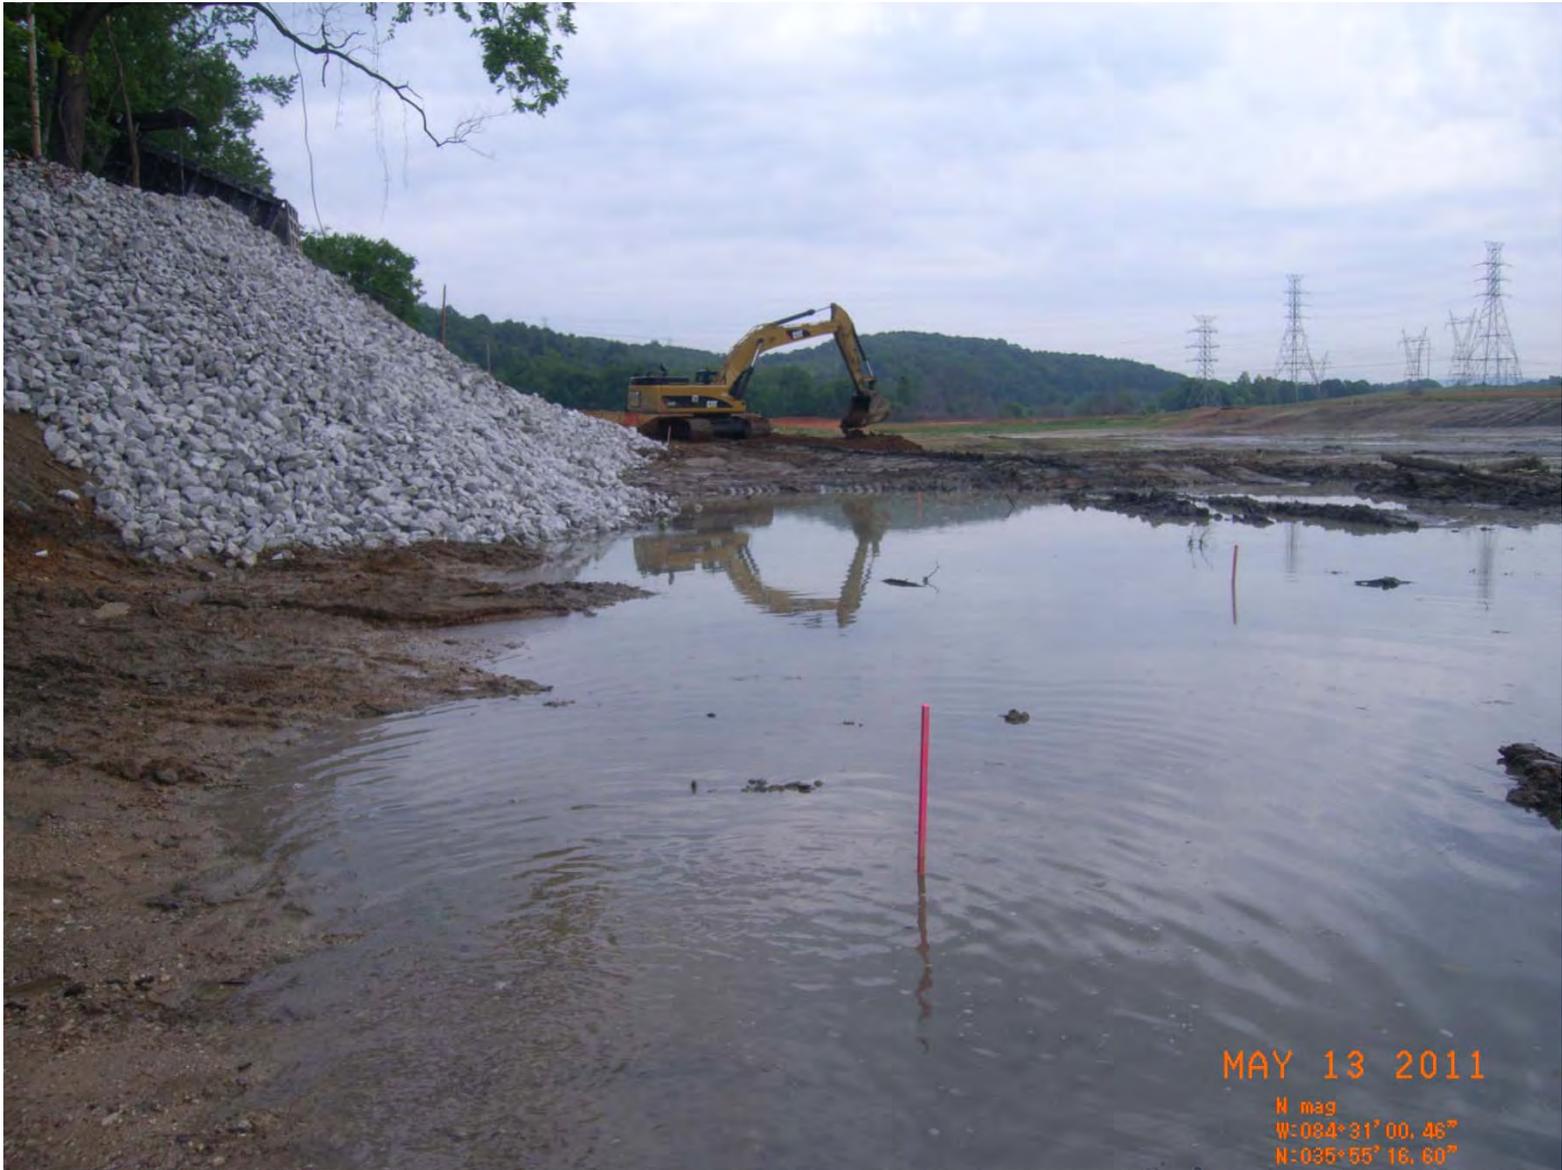
RO011203

Walter Burns	R0011203	05/13/2011	North Embayment	N	35 55'16.60"	84 31'00.46"	Southern extent of the Buttress

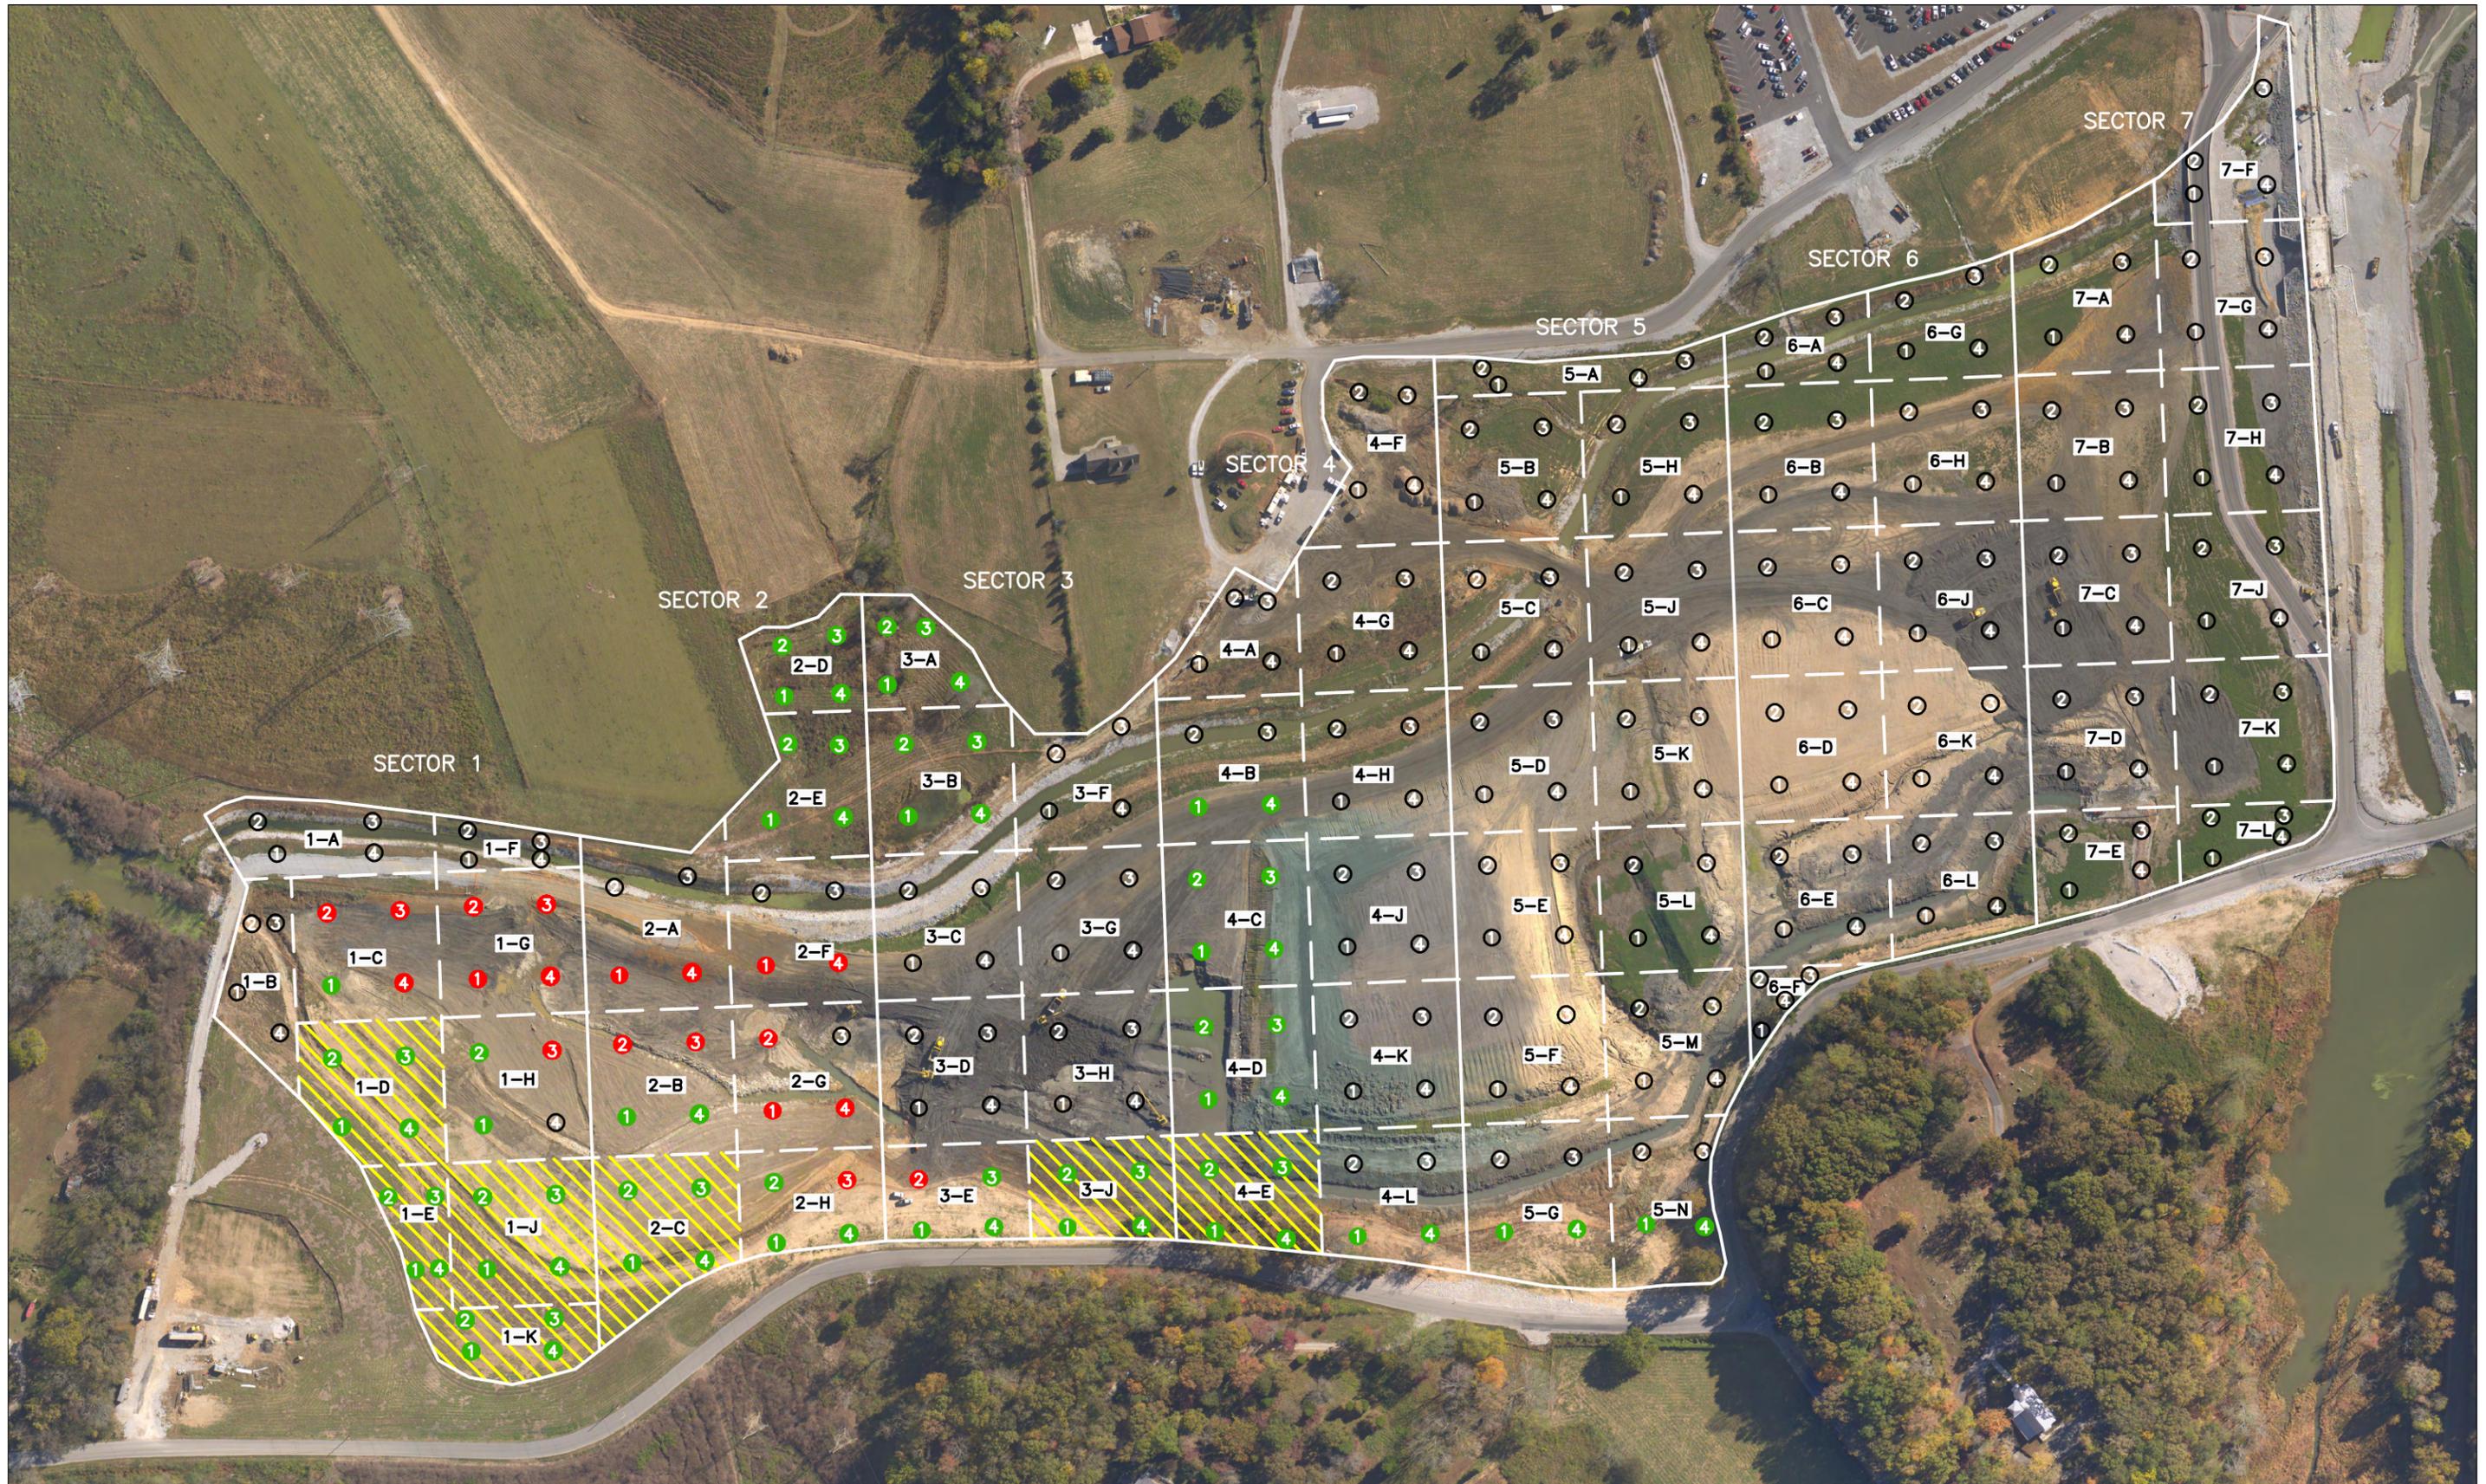
DRAWN BY	REVISION NO.	DATE	SCALE
SHOWN	FIG-NESAM-02		A

- ① SAMPLE RESULTS SATISFACTORY
- ① SAMPLE RESULTS UNSATISFACTORY
- ① TO BE SAMPLED
- CLEARED GRIDS

NORTH EMBAYMENT SAMPLE GRID
