**Time-Critical Concurrence**

Emory River, Above Segment 5, A-127 & A-128, B127 & B-128, C-125 through C-128; D-125 & D-126

Ash removal activities have been completed in Above Segment 5 for complete dredge grids B127 & B-128 and planned portions of grids C-125, C-126, and A-127 & A-128.

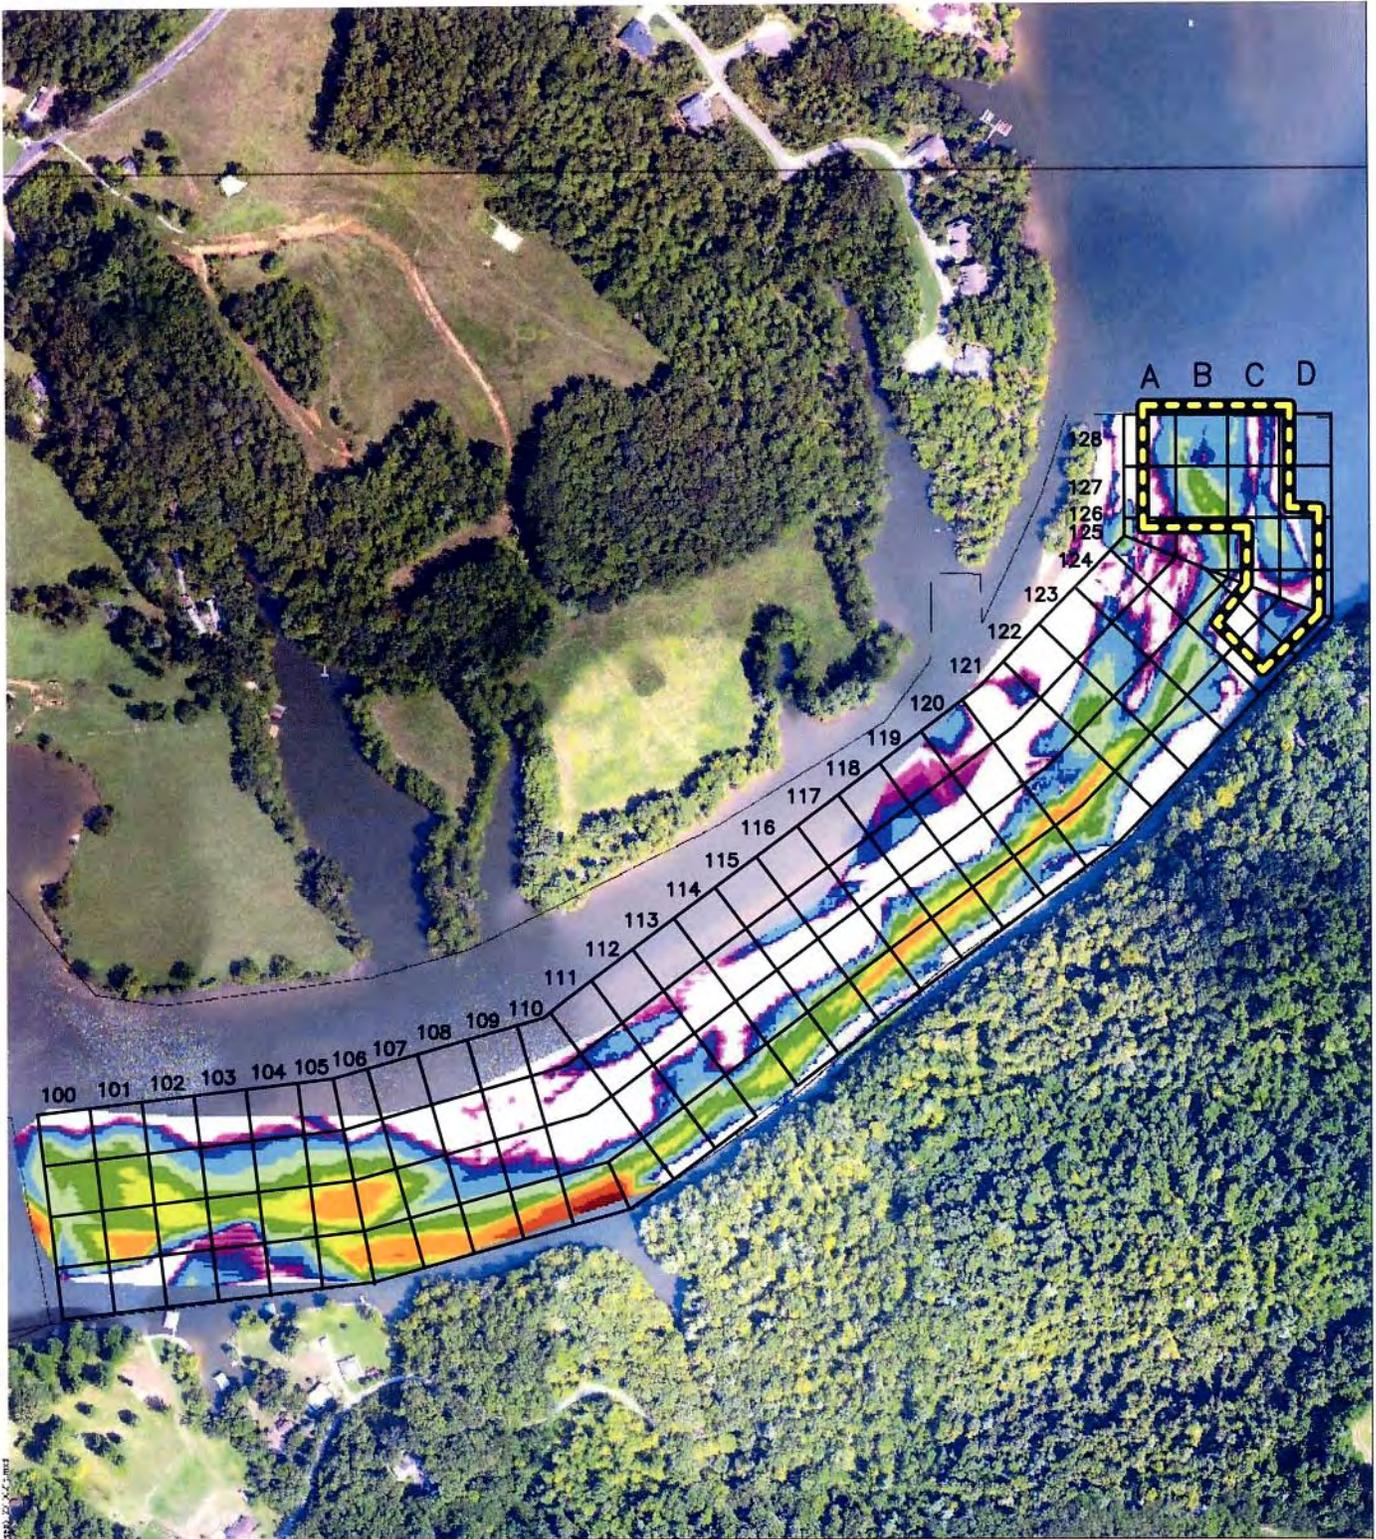
Figure 4

**Ash Remaining: ~184,467 cy**

**Ash Remaining to Pre-Spill Surface Above Segment 5**

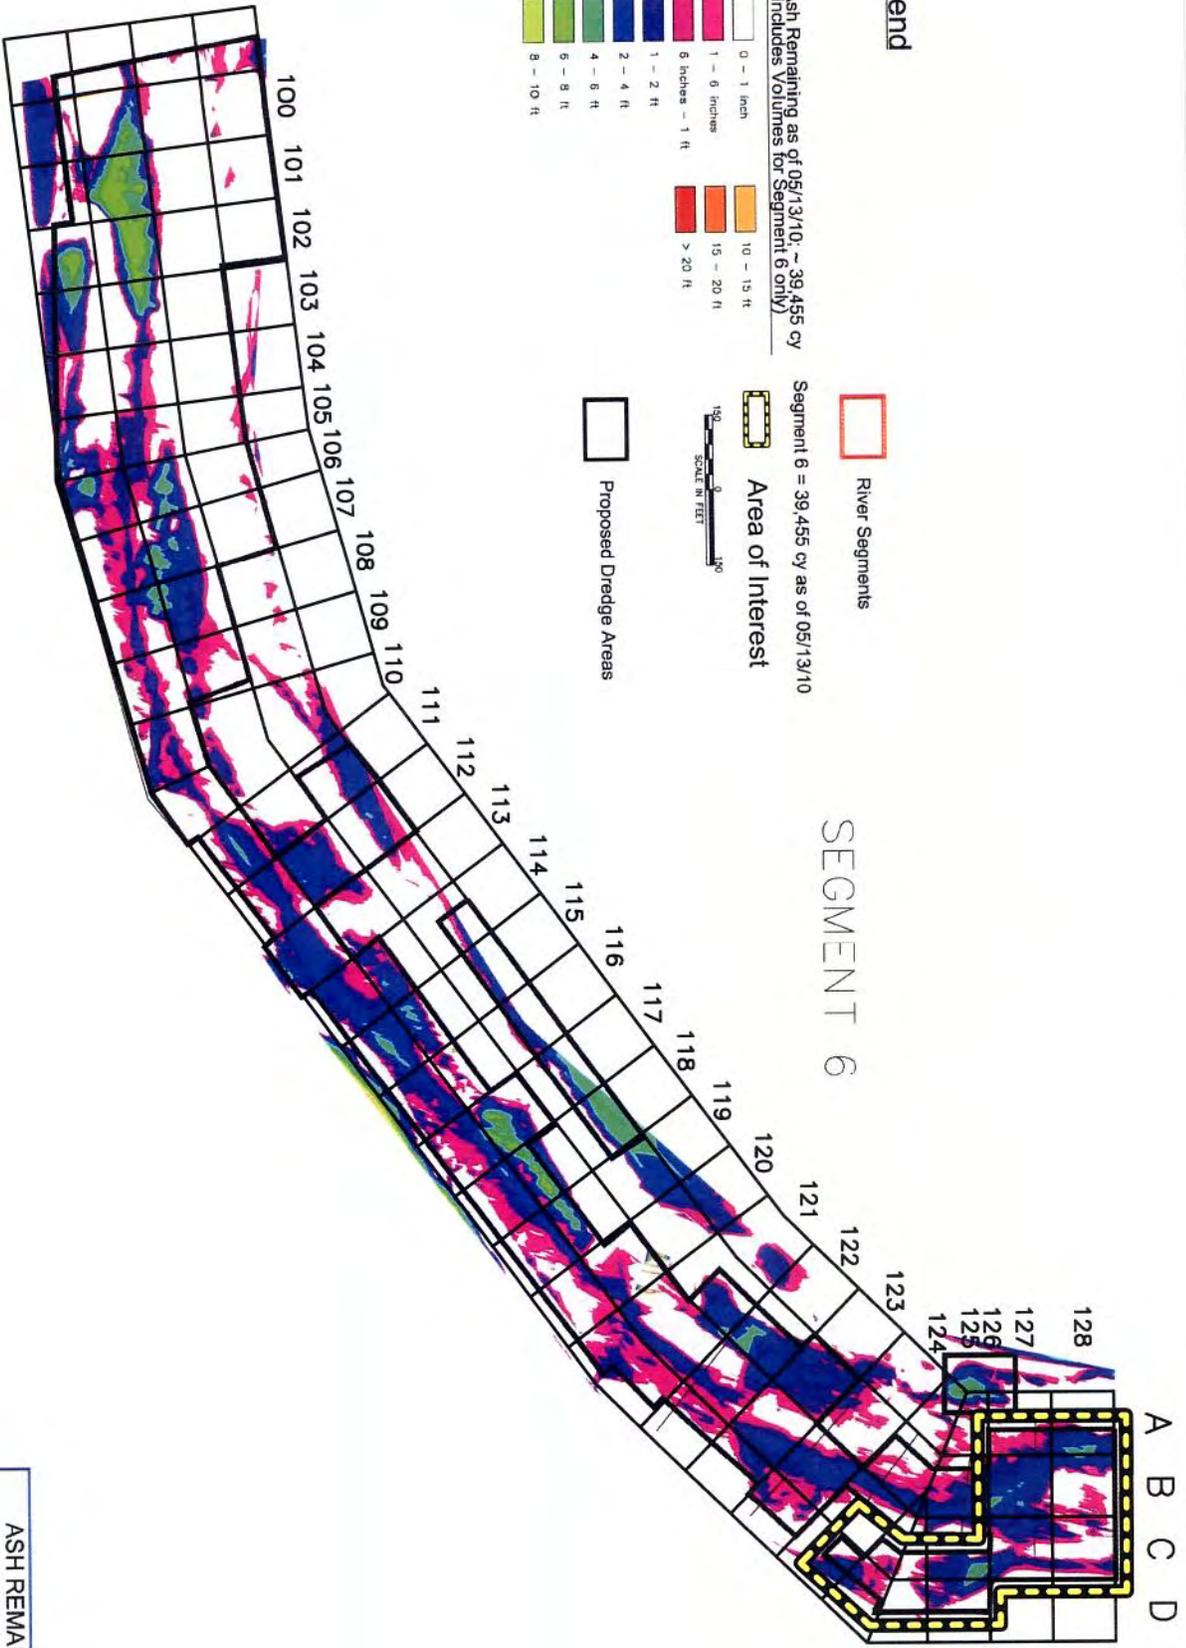
Figure 1

Segment 6 = 39,455 cy as of 05/13/10

**ASH REMAINING THROUGH SEVENSON 05-13 SURVEY**

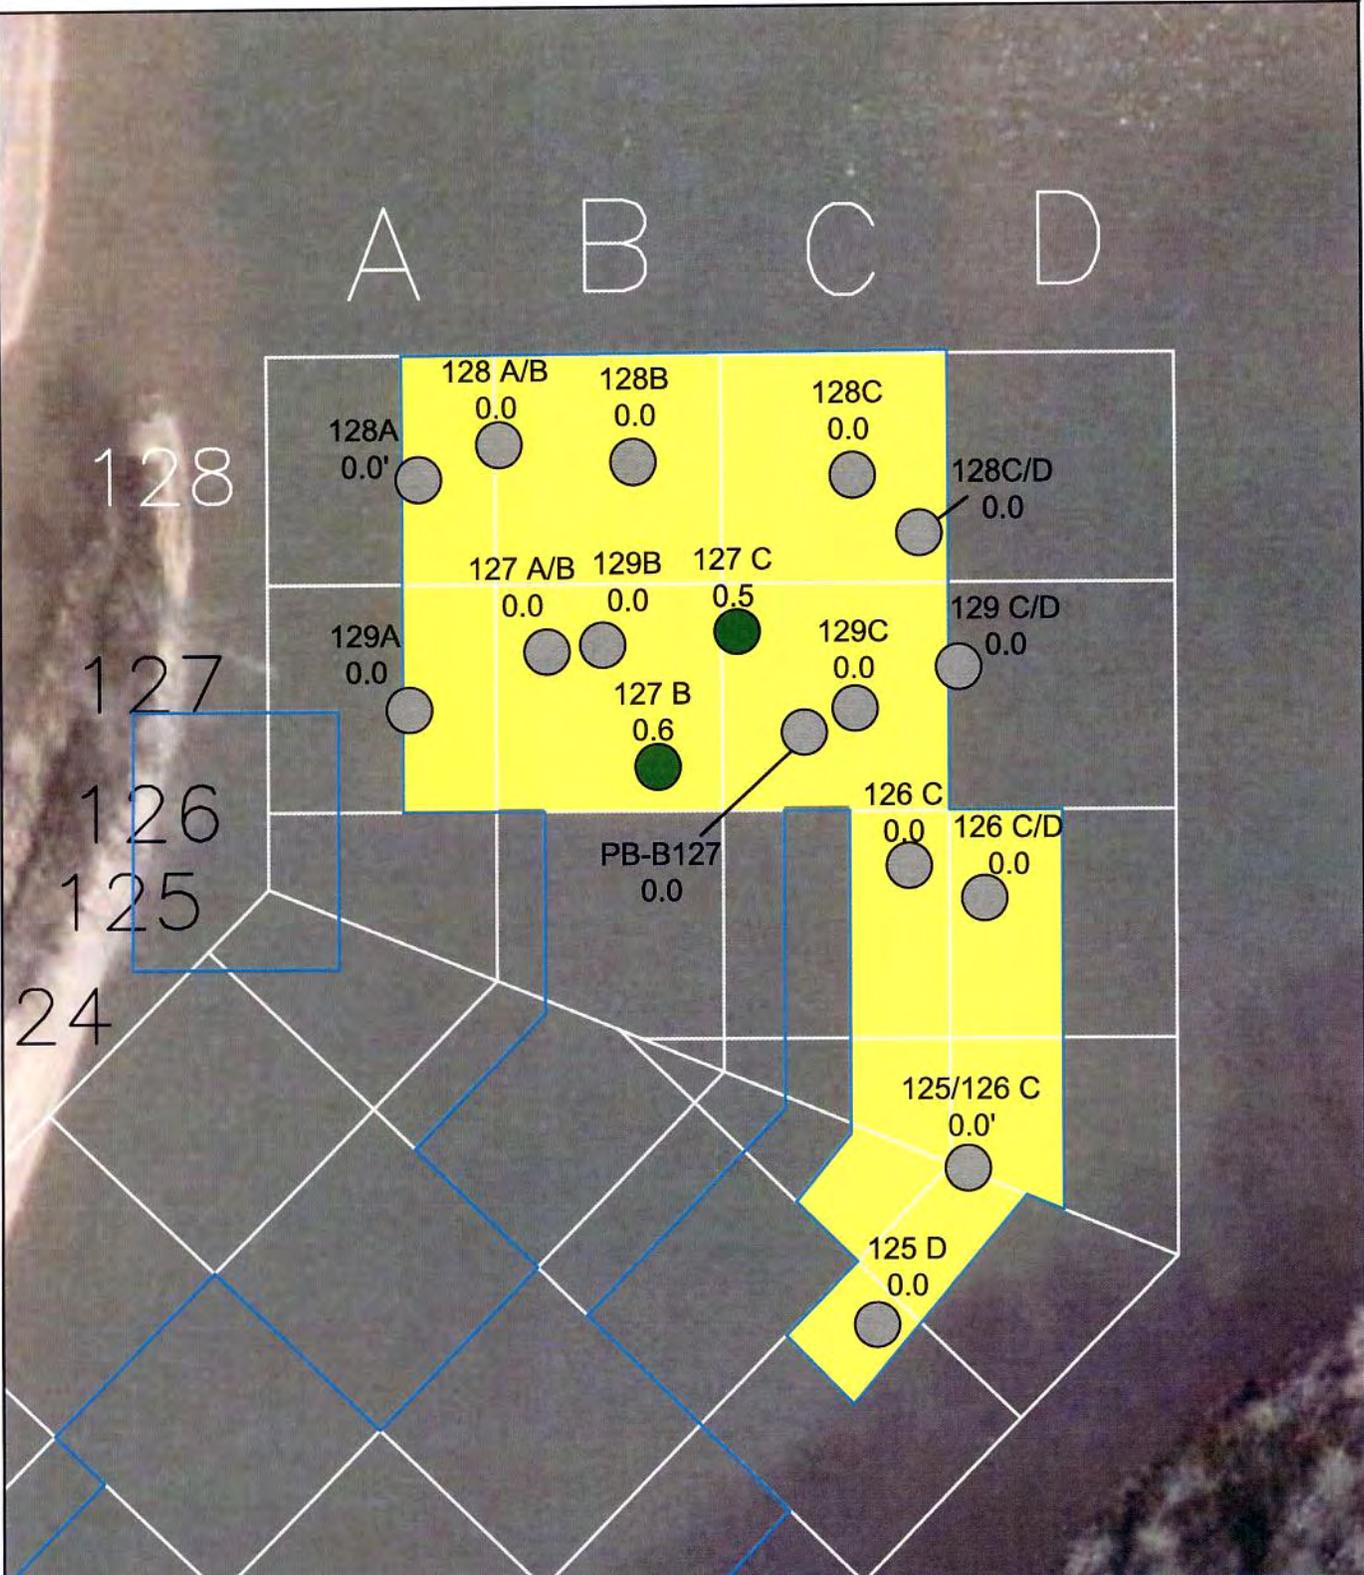
Figure 2

# VibeCore Concurrence Sampling Results - Above Segment 5

- Ash Recovered
- No Ash Present
- Removed From Plan
- Phase 2 Dredging Path

VibeCore Label Format:  
Core Number  
Ash Thickness (ft)

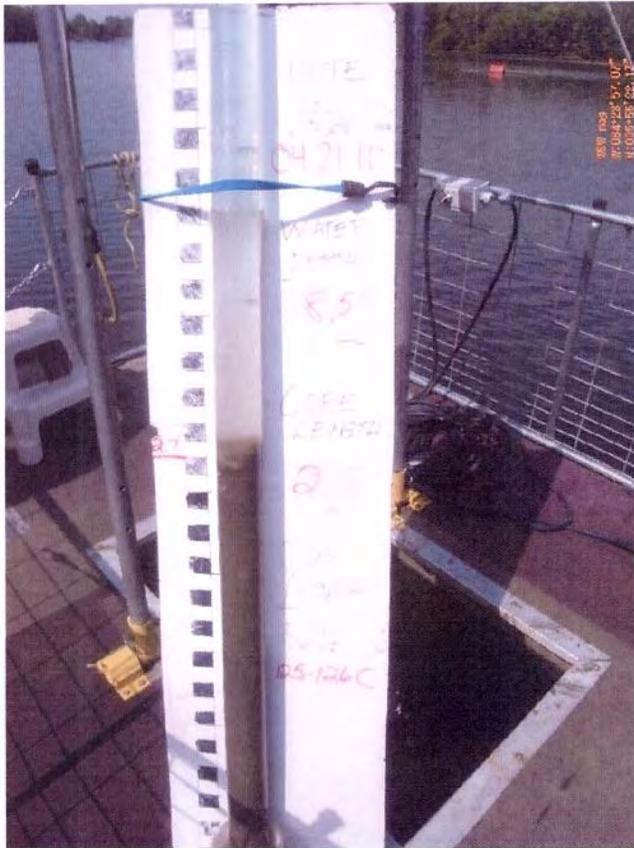
Core #	Photo #	Tube Type	Core Coordinates	River Depth	Time	Core Description	Interval (ft)
125/126 C	R0010520	Acrylic	N: 560755.21' E: 2449250.8'	8.5'	10:56	Native Fines w/ Organics	0.0 - 2.7

Core 125/126-C  
Total core depth = 2.7'  
Ash thickness = 0.0'  
Water depth = 8.5'

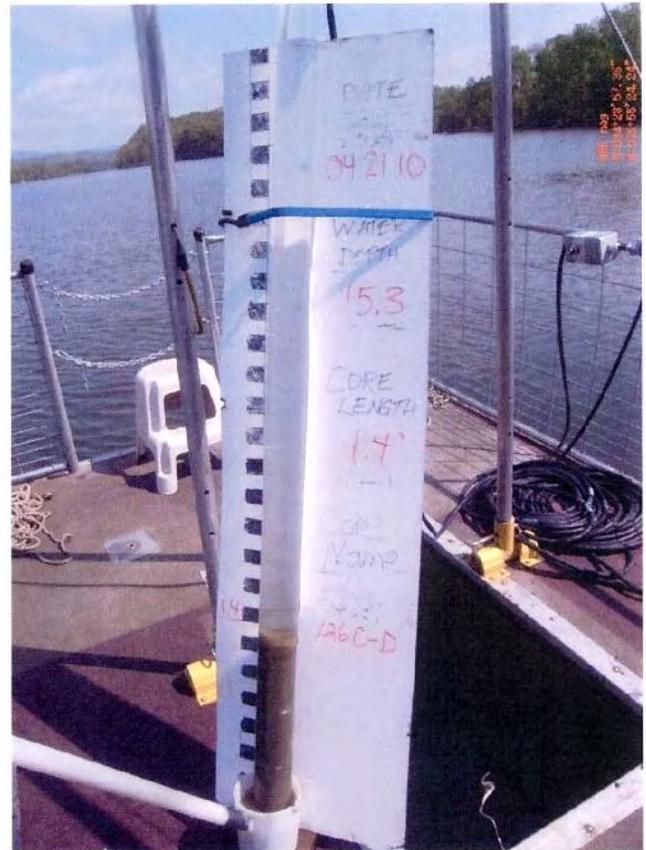
Core #	Photo #	Tube Type	Core Coordinates	River Depth	Time	Core Description	Interval (ft)
126 C/D	R0010521	Acrylic	N: 560903.49' E: 2449260.64'	15.3'	11:08	Mixed Native Fines	0.0 - 1.4

Core 126-C/D  
Total core depth = 1.4'  
Ash thickness = 0.0'  
Water depth = 15.3'

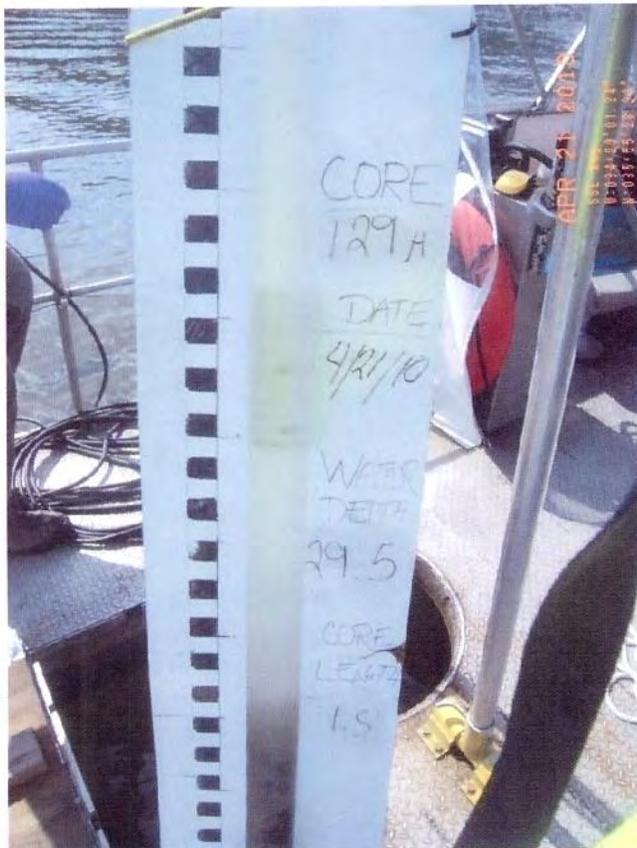
Core 129-A

Total core depth = 1.5'

Ash thickness = 0.0'

Water depth = 29.5'

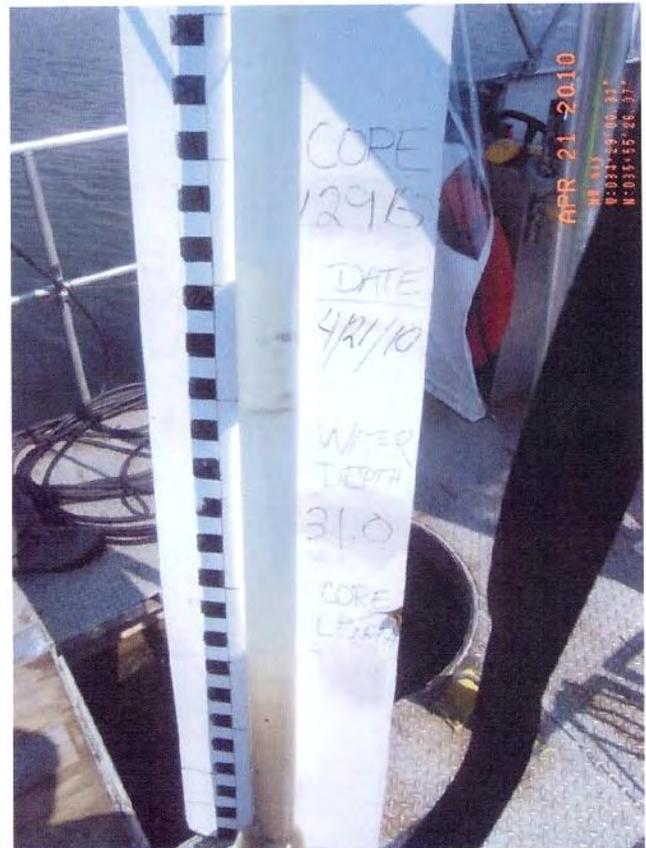
Core 129-B

Total core depth = 0.6'

Ash thickness = 0.0'

Water depth = 31.0'

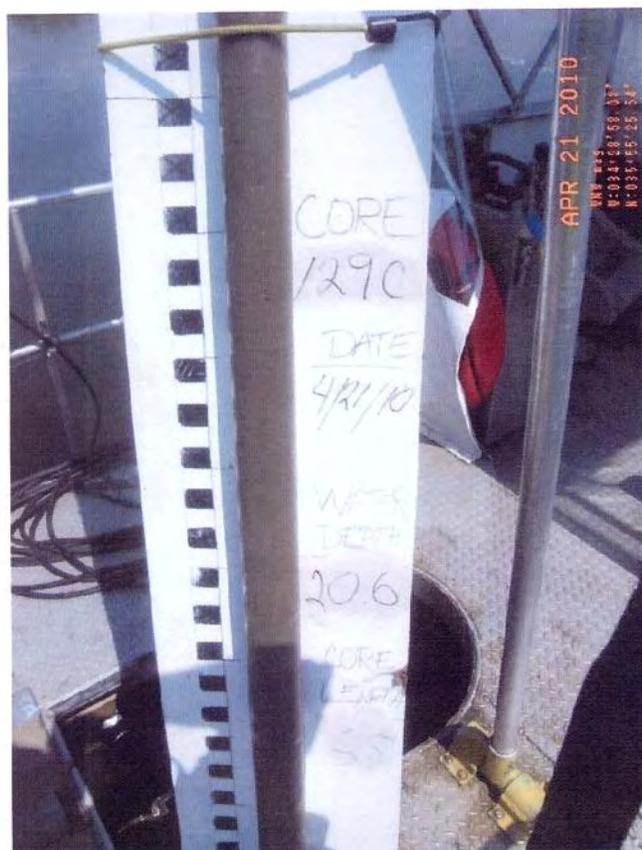
Core 129 -C  
Total core depth = 5.5'  
Ash thickness = 0.0'  
Water depth = 20.6'

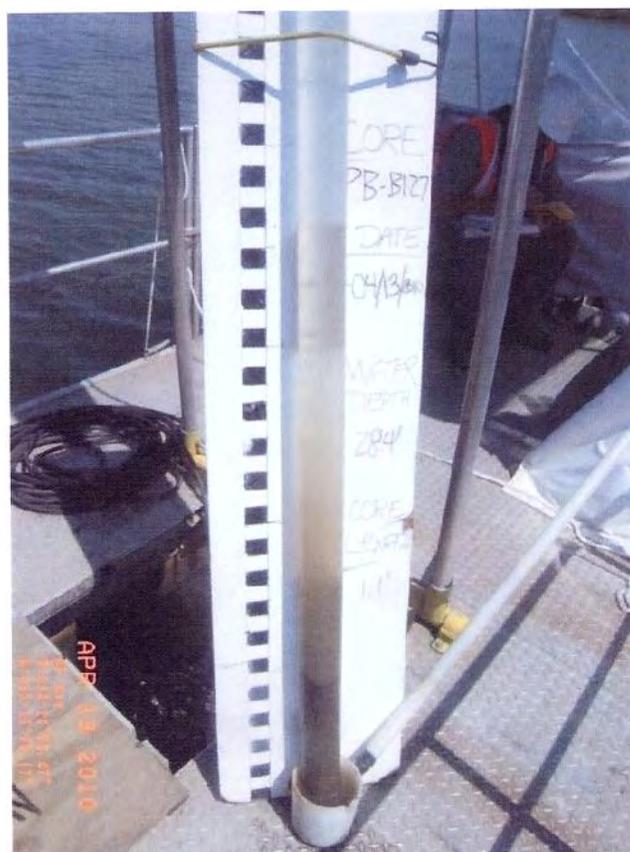
## Vibecore Documentation

Core PB-B127  
Total core depth = 1.1'  
Ash thickness = 0.0'  
Water depth = 28.4'

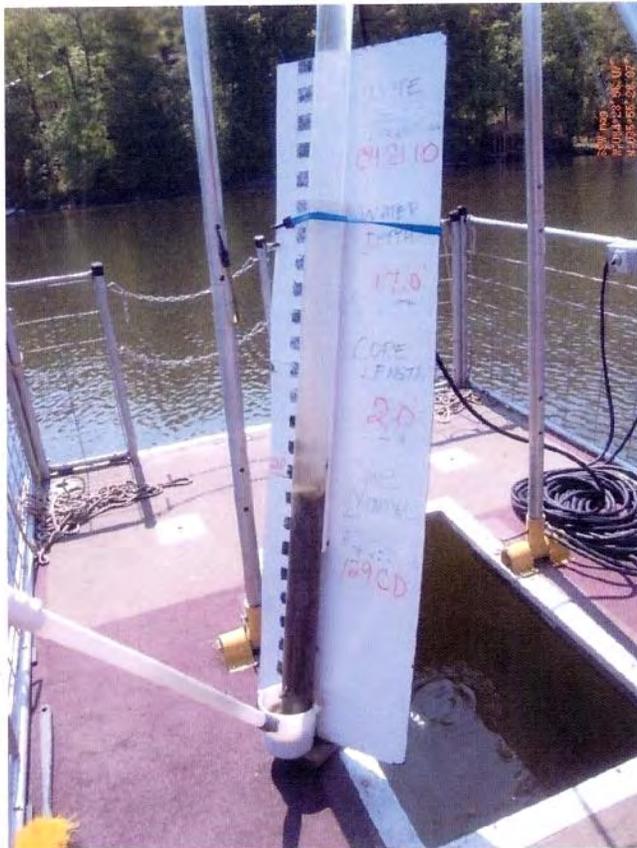
Core #	Photo #	Tube Type	Core Coordinates	River Depth	Time	Core Description	Interval (ft)
129 C/D	R0010523	Acrylic	N: 561030.11' E: 2449246.82'	17.1'	11:44	Brown Native Fines	0.0 - 2.0

Core 129 -C/D  
Total core depth = 2.0'  
Ash thickness = 0.0'  
Water depth = 17.0'

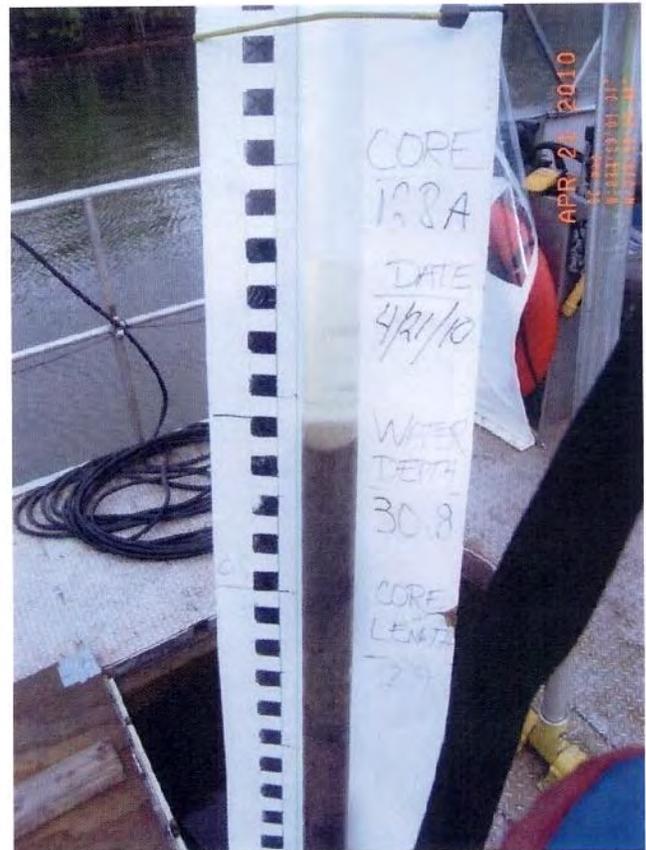
Core #	Photo #	Tube Type	Core Coordinates	River Depth	Time	Core Description	Interval (ft)
128A	R0010511	Acrylic	561133.71' E: 2448949.03'	30.8'	9:24	Sand mixed with ash (<50%) Coarse sand with coal fragments	0.0-0.9 0.9-2.9
Deviations encountered: Refusal met						Total Depth	2.9'
Core #	Photo #	Tube Type	Core Coordinates	River Depth	Time	Core Description	Interval (ft)
128B	R0010512	Acrylic	561142.72' E: 2449067.35'	27.3'	9:45	Brown coarse sand with coal	0.0-1.0
Deviations encountered: Refusal met						Total Depth	1.0'
Core #	Photo #	Tube Type	Core Coordinates	River Depth	Time	Core Description	Interval (ft)
128C	R0010513	Acrylic	561135.03' E: 2449188.55'	21.4'	10:02	Brow coarse sand with OM Brown medium sand with ash (<50%) Brown mixed fines	0.0-0.1 0.1-0.9 0.9-5.5
Deviations encountered: Refusal not met						Total Depth	5.5'
Core #	Photo #	Tube Type	Core Coordinates	River Depth	Time	Core Description	Interval (ft)

Core 128-A  
Total core depth = 2.9'  
Ash thickness = 0.0'  
Water depth = 30.8'

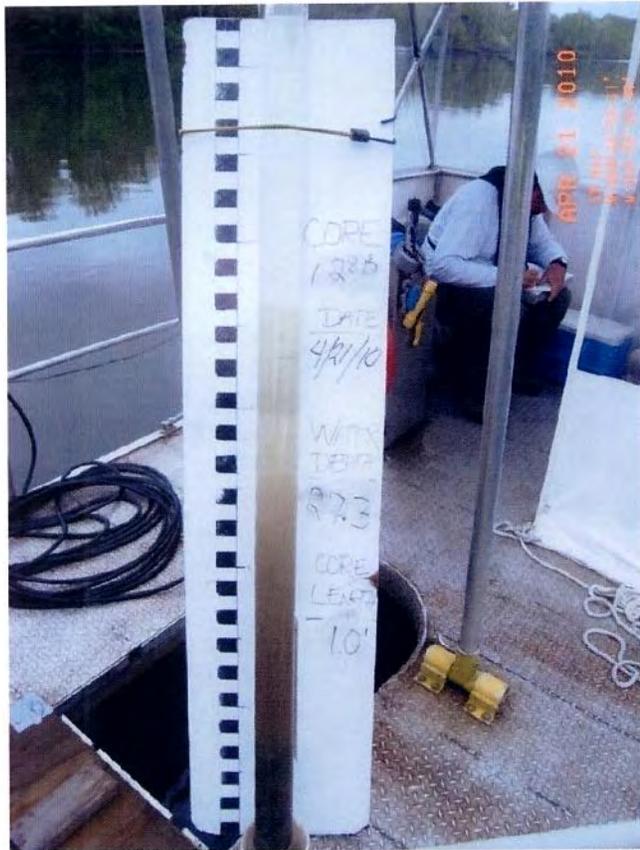
Core 128-B

Total core depth = 1.0'

Ash thickness = 0.0'

Water depth = 27.3'

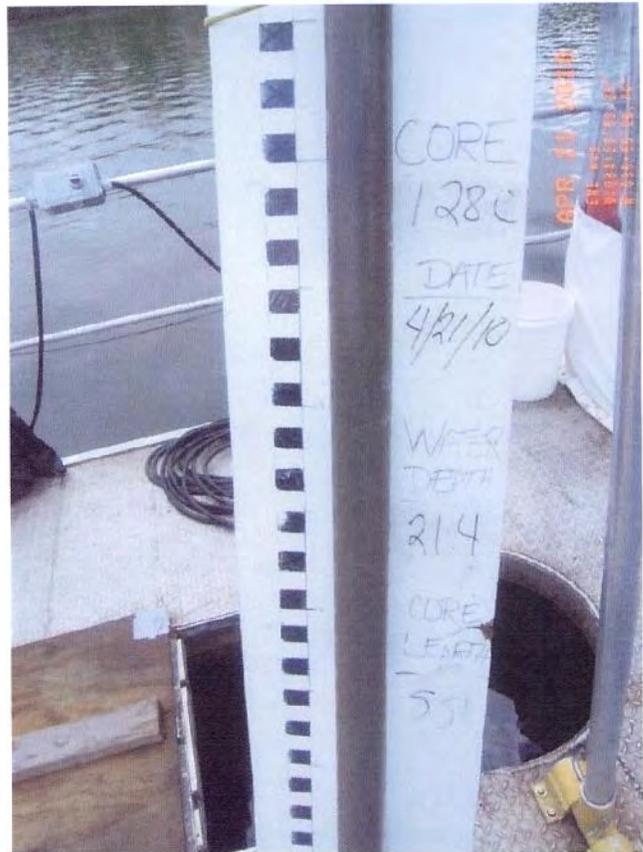
Core 128-C

Total core depth = 5.5'

Ash thickness = 0.0'

Water depth = 21.4'

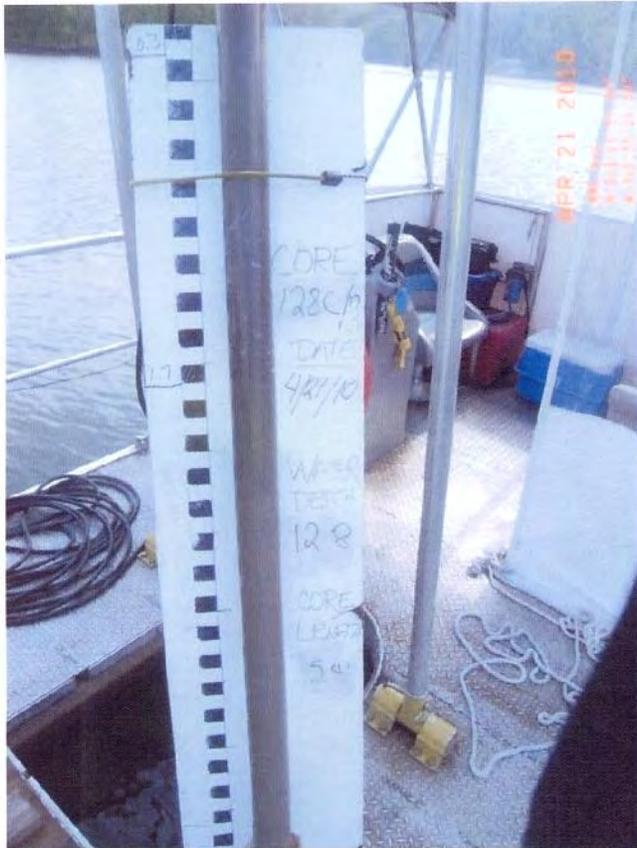
Core 128-CD

128C/D	R0010514	Acrylic	561103.58' E: 2449225.25'	12.8'	10:35	Coarse brown sand Medium sand Brown native fines Light brown fines	0.0-0.3 0.3-2.0 2.0-5.0 5.0-5.4
Deviations encountered: Refusal not met						Total Depth	5.4'
Core #	Photo #	Tube Type	Core Coordinates	River Depth	Time	Core Description	Interval (ft)
129A	R0010515	Acrylic	561007.57' E: 2448943.64'	29.5'	10:53	Coarse sand with ash (<50%) Brown coarse sand and coal	0.0-0.5 0.5-1.5
Deviations encountered: Refusal met						Total Depth	1.5'
Core #	Photo #	Tube Type	Core Coordinates	River Depth	Time	Core Description	Interval (ft)
129B	R0010516	Acrylic	561042.86' E: 2449050.23'	31.1'	11:19	Brown coarse sand with coal Light brown coarse sand	0.0-0.3 0.3-0.6
Deviations encountered: Refusal met						Total Depth	0.6'
Core #	Photo #	Tube Type	Core Coordinates	River Depth	Time	Core Description	Interval (ft)
129C	R0010517	Acrylic	561007.42' E: 2449189.55'	20.6'	11:50	Brown medium sand and fines Brown fines	0.0-1.0 1.0-5.5

Total core depth = 5.4'

Ash thickness = 0.0'

Water depth = 12.8'

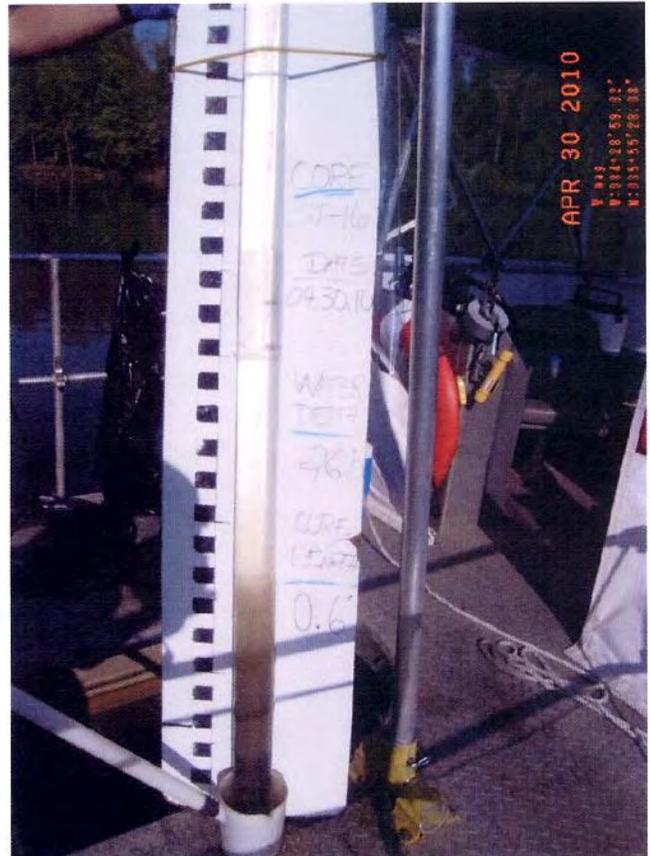
Core St-16

Total core depth = .6'

Ash thickness = 0.0'

Water depth = 26.0'

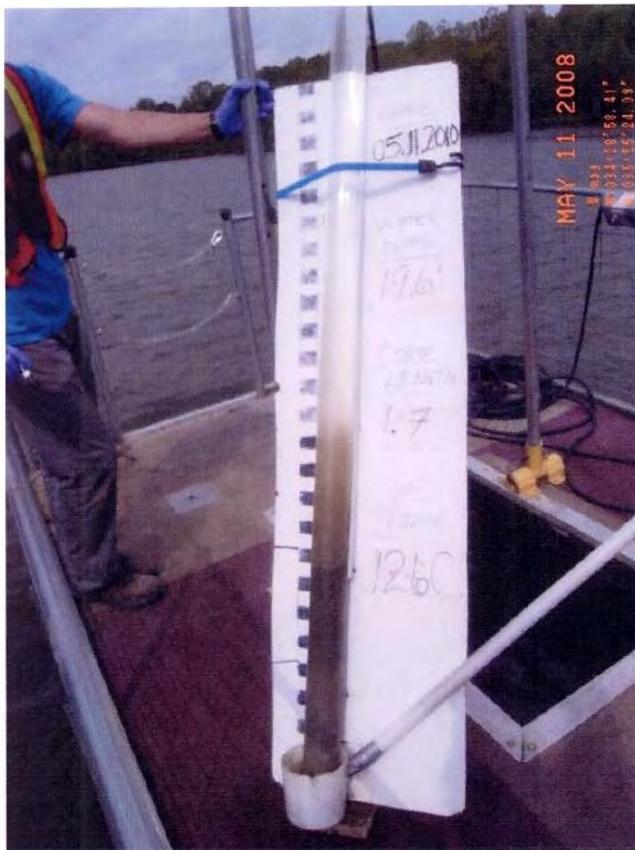
Core 126-C

Core #	Photo #	Tube Type	Core Coordinates	River Depth	Time	Core Description	Interval (ft)	Top/Bottom of Ash
126 C	R0010565	6' Acrylic	N: 560921.42' E: 2449219.04'	19.6'	10:38	Brown Native Fines Clay w/ Sand	0.0 - 0.8 0.8 - 1.7	N/A
Deviations encountered: Core met refusal								
Total Depth							1.7'

Total core depth = 1.7'

Ash thickness = 0.0'

Water depth = 19.6'

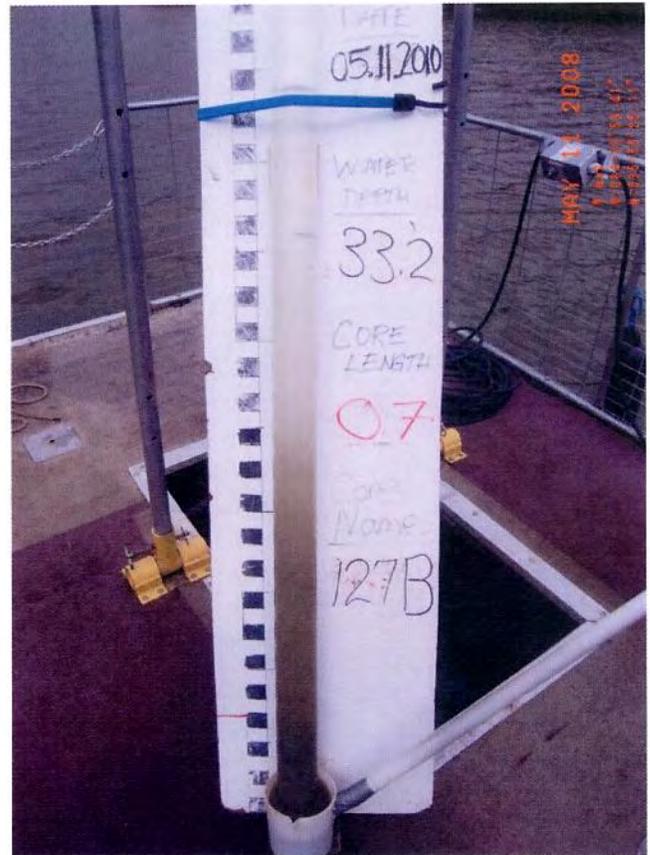
Core 127-B

Core #	Photo #	Tube Type	Core Coordinates	River Depth	Time	Core Description	Interval (ft)	Top/Bottom of Ash
127 B	R0010566	6' Acrylic	N: 560975.72' E: 2449080.43'	33.2'	11:23	Ash > 50 % Organic Material	0.0 - 0.6 0.6 - 0.7	6'
Deviations encountered: Core met refusal								
Total Depth							.7'

Total core depth = .7'

Ash thickness = 0.6'

Water depth = 33.2'

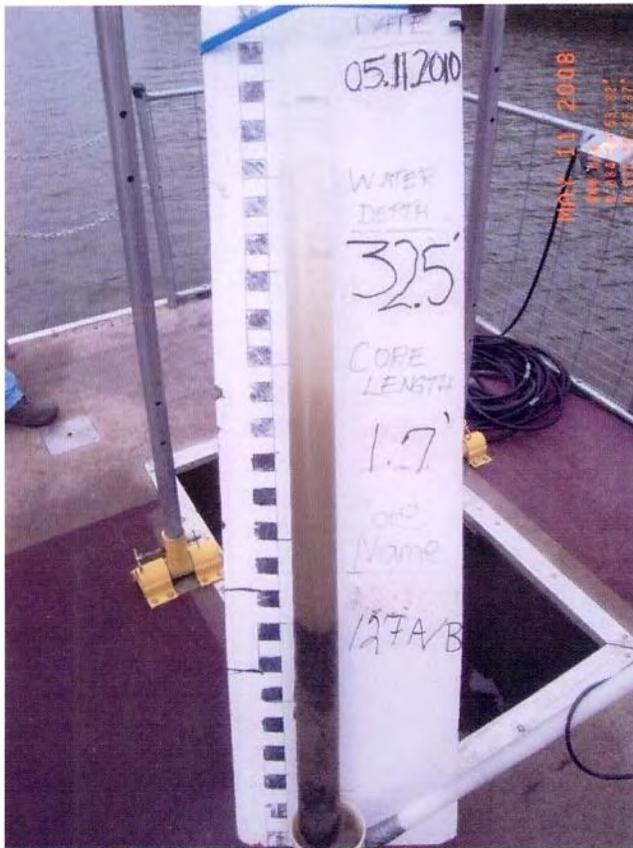
Core 127-A/B

Core #	Photo #	Tube Type	Core Coordinates	River Depth	Time	Core Description	Interval (ft)	Top/Bottom of Ash
127 A/B	R0010567	6' Acrylic	N: 561039.28' E: 2449019.45'	32.5'	11:53	Organic Material Sand w/ Organic Material	0.0 - 0.5 0.5 - 1.7	NA
Deviations encountered: Core met refusal								
Total Depth							1.7'

Total core depth = 1.7'

Ash thickness = 0.0'

Water depth = 32.5'

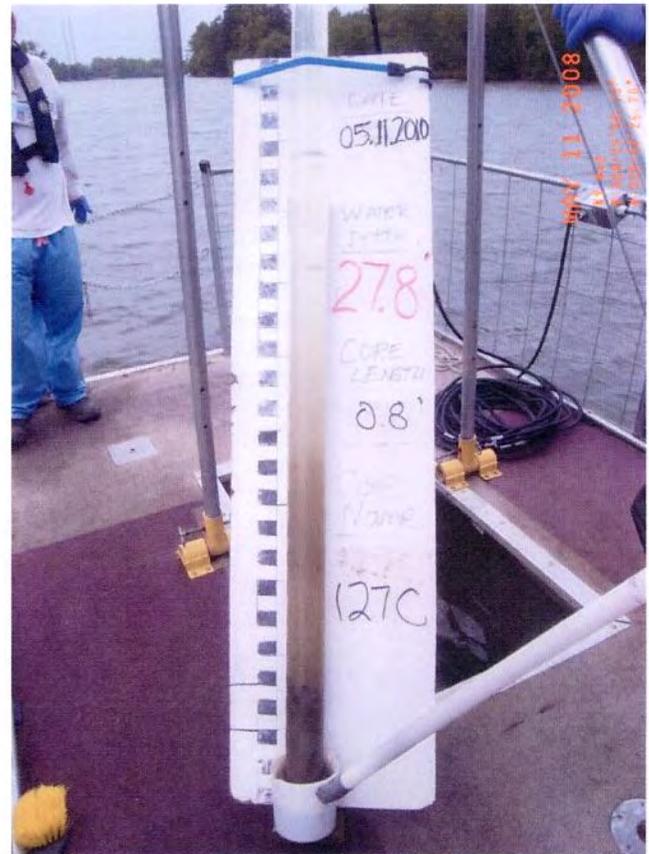
Core 127-C

Core #	Photo #	Tube Type	Core Coordinates	River Depth	Time	Core Description	Interval (ft)	Top/Bottom of Ash
127 C	R0010568	6' Acrylic	N: 561050.06' E: 2449124.53'	27.8'	12:53	Organic Materials w/ Fines Ash > 50%	0.0 - 0.3 0.3 - 0.8	8'
Deviations encountered: Core met refusal. Bottom of ash not found								
Total Depth							.8'

Total core depth = .8'

Ash thickness = 0.5'

Water depth = 27.8'

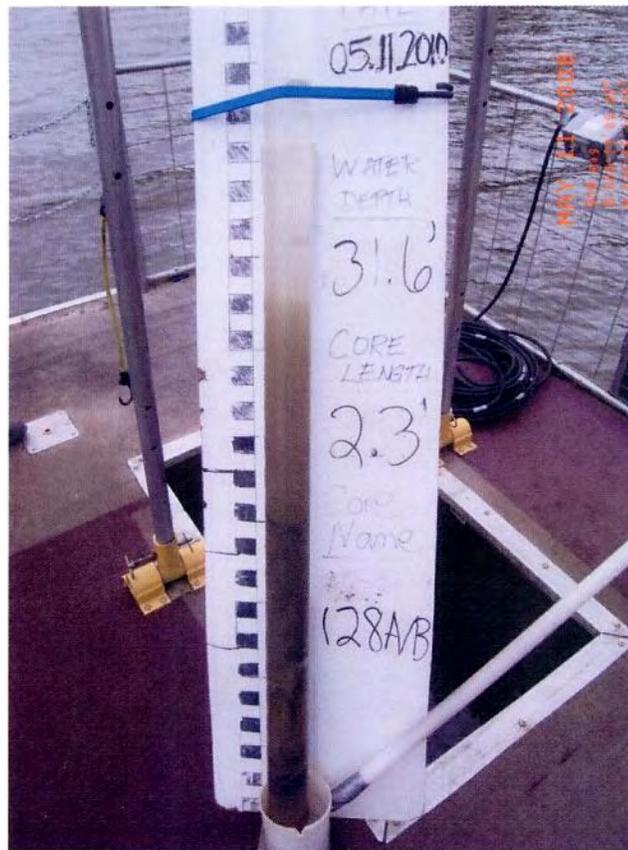
Core 128-A/B

Core #	Photo #	Tube Type	Core Coordinates	River Depth	Time	Core Description	Interval (ft)	Top/Bottom of Ash
128 A/B	R0010569	6' Acrylic	N: 561152.38' E: 2448993.46'	31.6'	13:34	Organic Material Sand with Loam Sand w/ Organics	0.0 - 0.5 0.5 - 1.1 1.1 - 2.3	NA
Deviations encountered: Core met refusal								
Total Depth							2.3'

Total core depth = 2.3'

Ash thickness = 0.0'

Water depth = 31.6'
