Time-Critical Concurrence

Emory River, Segment 4, D-66, E-63 through E-66, F-63 through F-70

Ash removal activities have been completed in Segment 4 for dredge grids D-66, E-63 through E-66, F-63 through F-70.

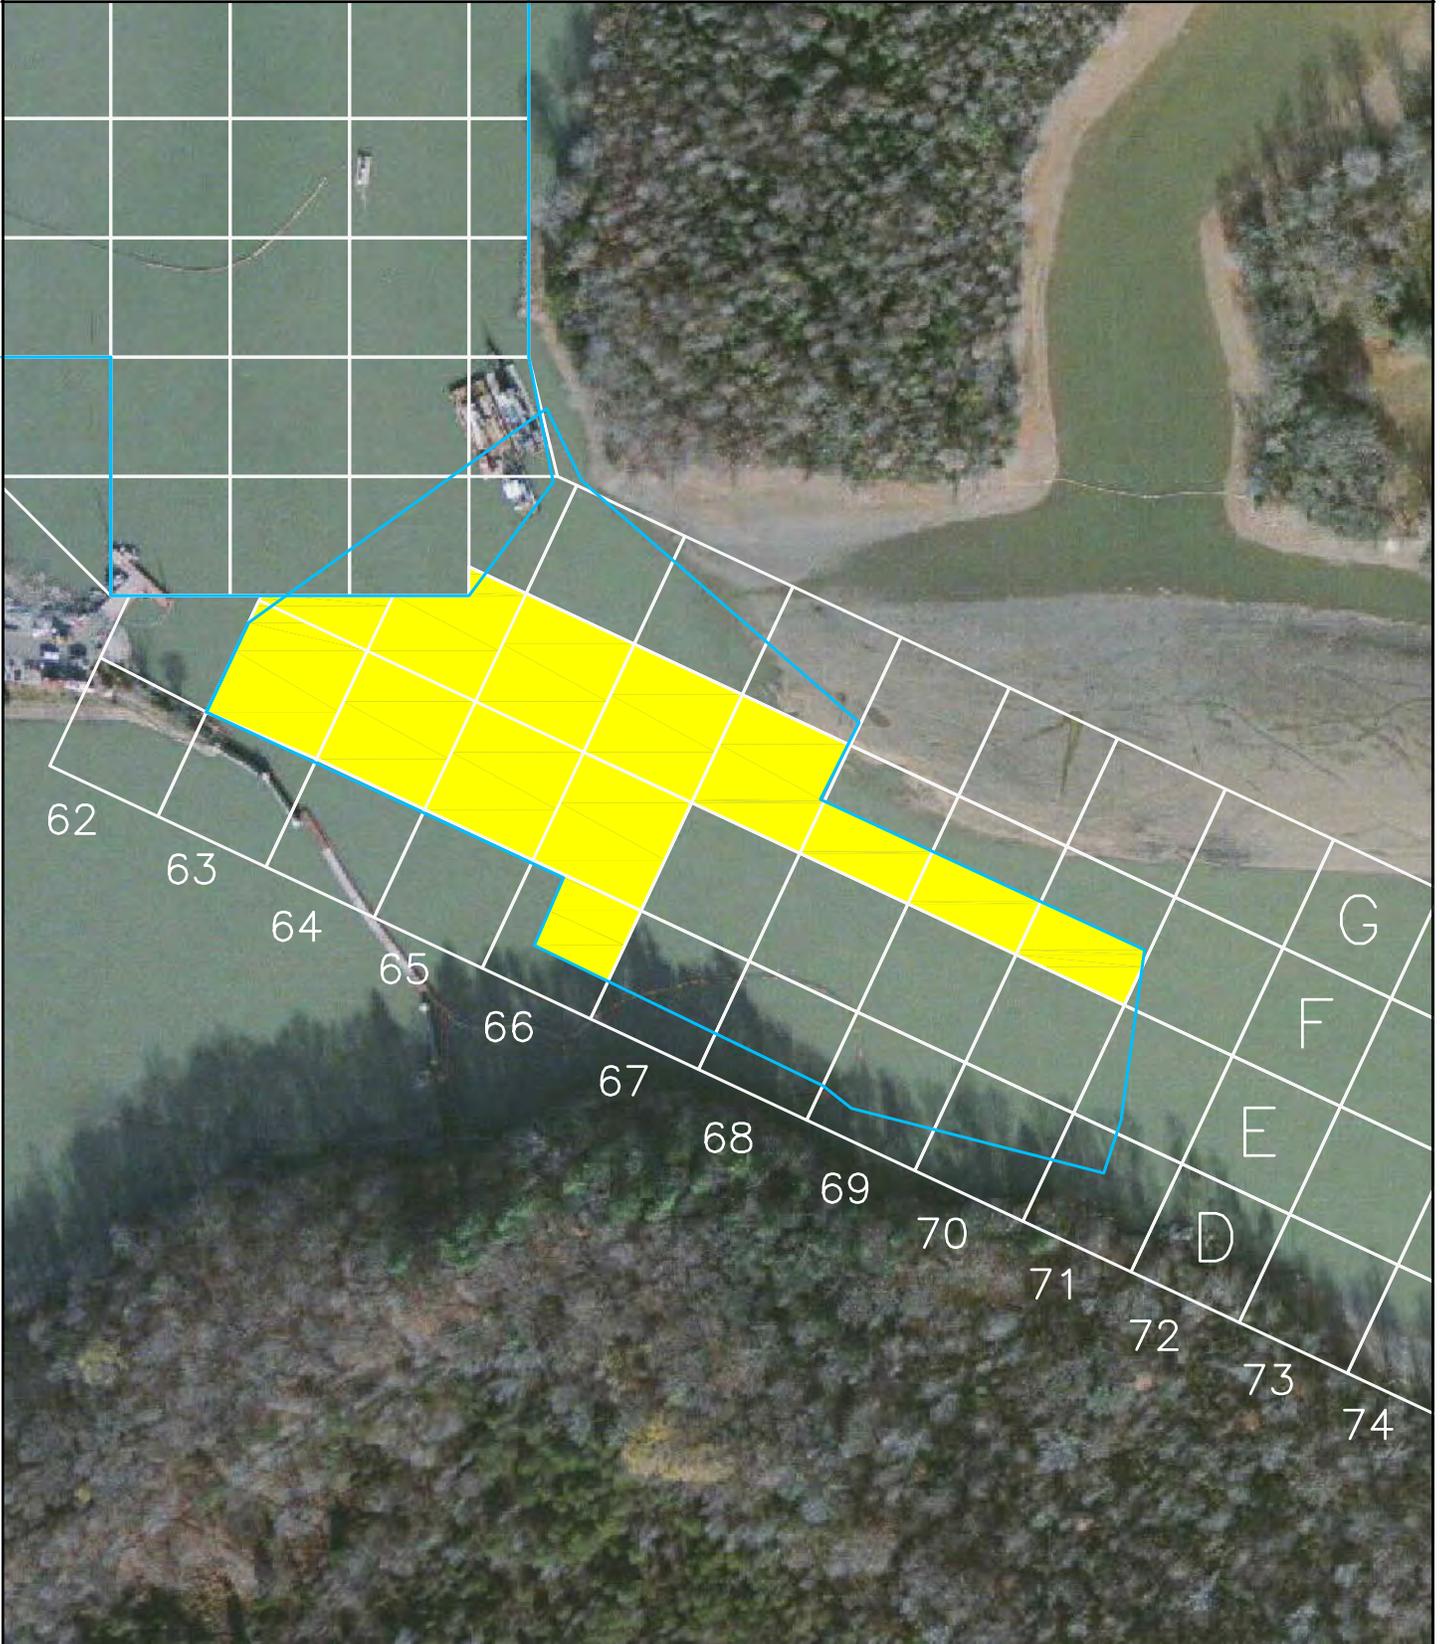
Figure 2

Bathymetry Removal Areas - Segment 4

Phase 2 Dredging Path

VibeCore Label Format:
Core Number
Ash Thickness (ft)

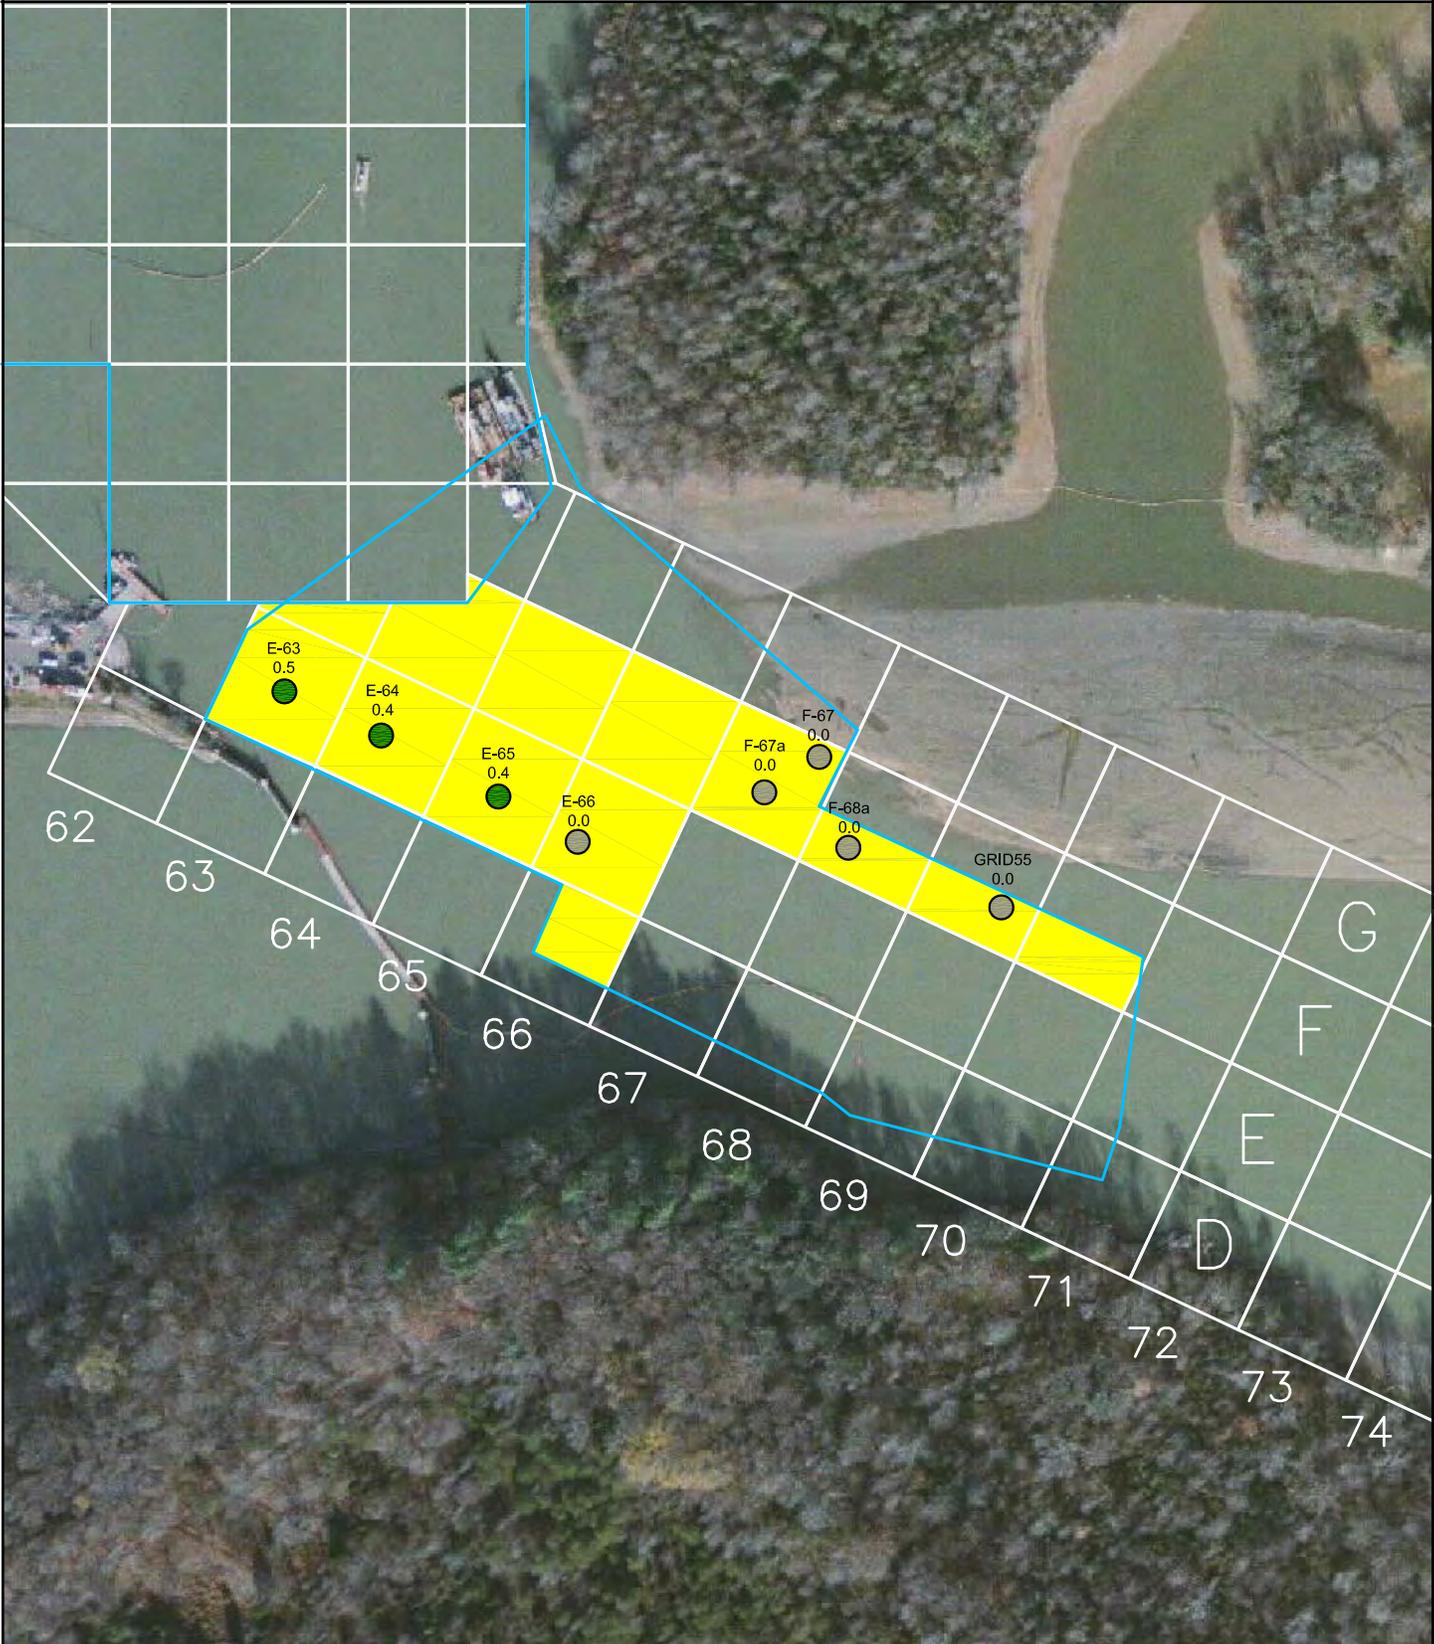
Figure 3

VibeCore Concurrence Sampling Results - Segment 4

- Ash Recovered
- No Ash Present
- Removed From Plan
- Phase 2 Dredging Path

VibeCore Label Format:
Core Number
Ash Thickness (ft)

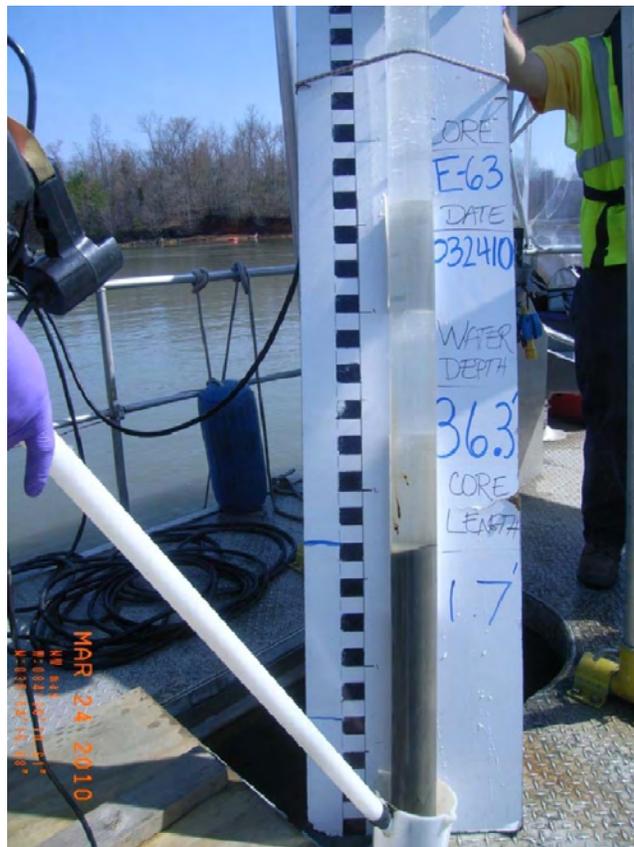
Core E-63
Total core depth = 1.7'
Ash thickness = 0.5'
Water depth = 36.3'

Core #	Photo #	Tube Type	Core Coordinates	River Depth	Time	Core Description	Interval (ft)
E-63	R0010410	5' Acrylic	N: 553979.19' E: 2443316.76'	36.3'	11:28	>50% Ash	0-0.5
Deviations encountered: Sediment description depths will be different than those seen in the photo.						Medium and fine grained brown sand with few pebbles and <10% organics. No ash.	0.5-1.7
						Total Depth	1.7'
E-64	R0010411	5' Acrylic	N: 553932.91' E: 2443417.98'	36.2'	12:38	Ash >50%	0-0.4
Deviations encountered:						Medium and coarse grained brown sand. Few pebbles. No ash.	0.4-3.0
						Native fines mixed with clay. <10% organics. No ash.	3.0-4.2
						Total Depth	4.2'
E-65	R0010412	5' Acrylic	N: 553869.03' E: 2443540.75'	35.1'	13:01	Ash >50%	0-0.1
Deviations encountered: Sediment description depths will be different than those seen in the photo.						>50% Ash mixed with clumps of clay and chert fragments and some brown native fines.	0.1-0.4

Brown fine sands. No ash.	0.4-0.8
						Native brown fines. No ash.	0.8-1.5
						Total Depth	1.5'
E-66	R0010413	5' Acrylic	N: 553821.59' E: 2443623.75'	29.9'	13:28	Fine grained sand mixed with native fines. Light brown in color. No ash.	0-1.1
Deviations encountered:							
						Total Depth	1.1'

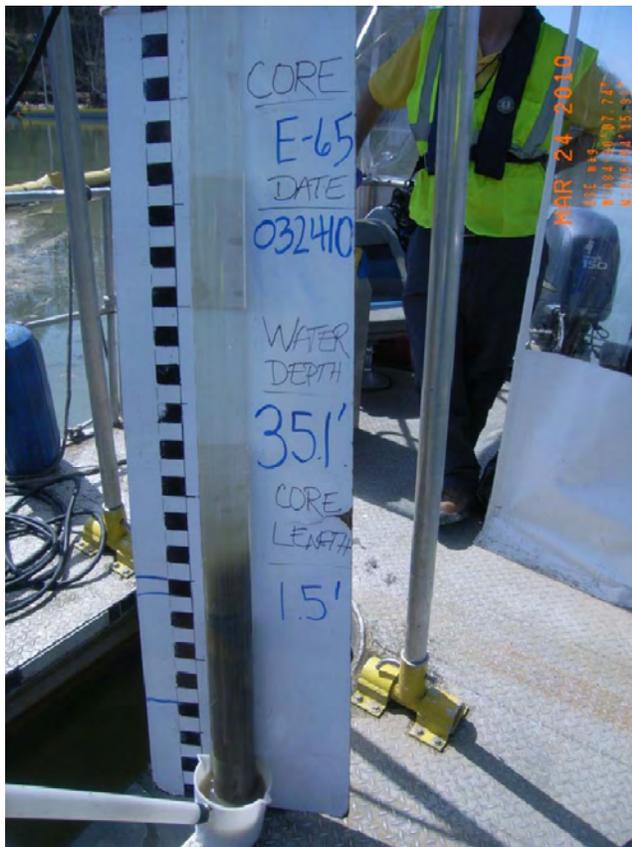
Core E-65

Total core depth = 1.5'

Ash thickness = 0.3'

Water depth = 35.1'

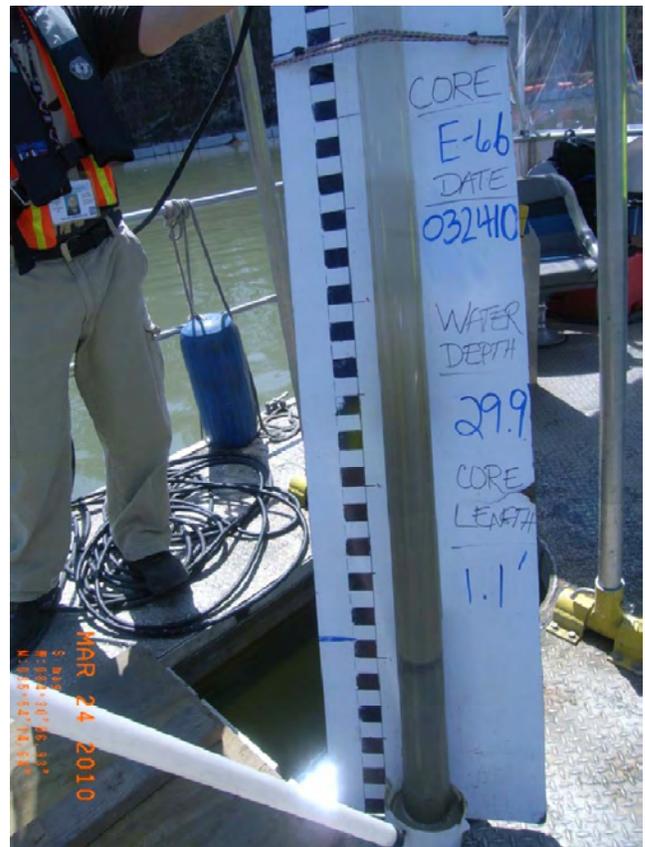
Core E-66

Total core depth = 1.1'

Ash thickness = 0.0'

Water depth = 29.9'

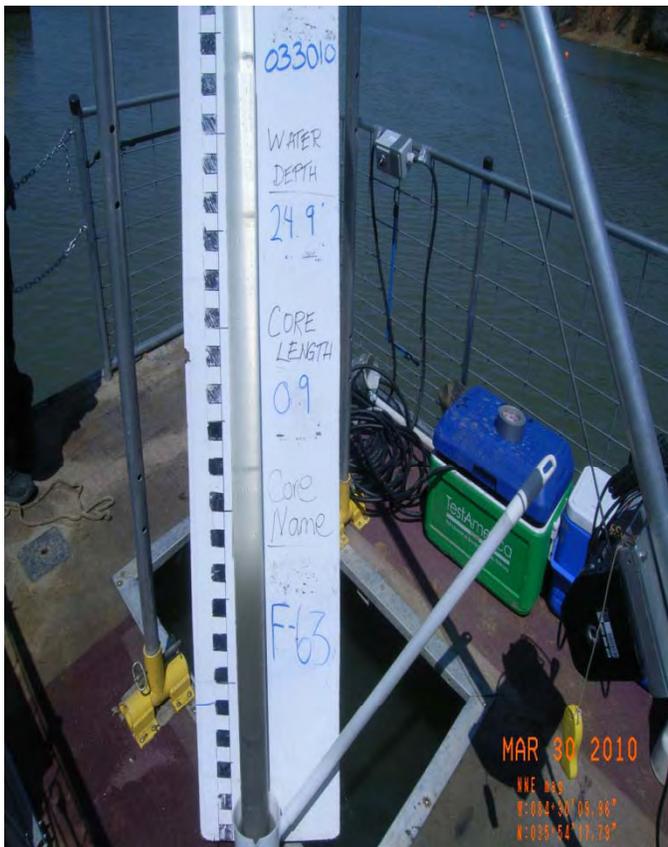
Core F-63

Core #	Photo #	Tube Type	Core Coordinates	River Depth	Time	Core Description	Interval (ft)
F-63	R0010425	6' Acrylic	N: 554087.45' E: 2443380.1'	24.9'	13:53	A mixture of sand (various grain sizes) and ash >50% with pieces of clay and <10% organics.	0-0.5
Deviations encountered: Description will be different than boundaries noted in photo.						Ash >50%	0.5-0.9
						Total Depth	.9'

Total core depth = 0.9'

Ash thickness = 0.4'

Water depth = 24.9'

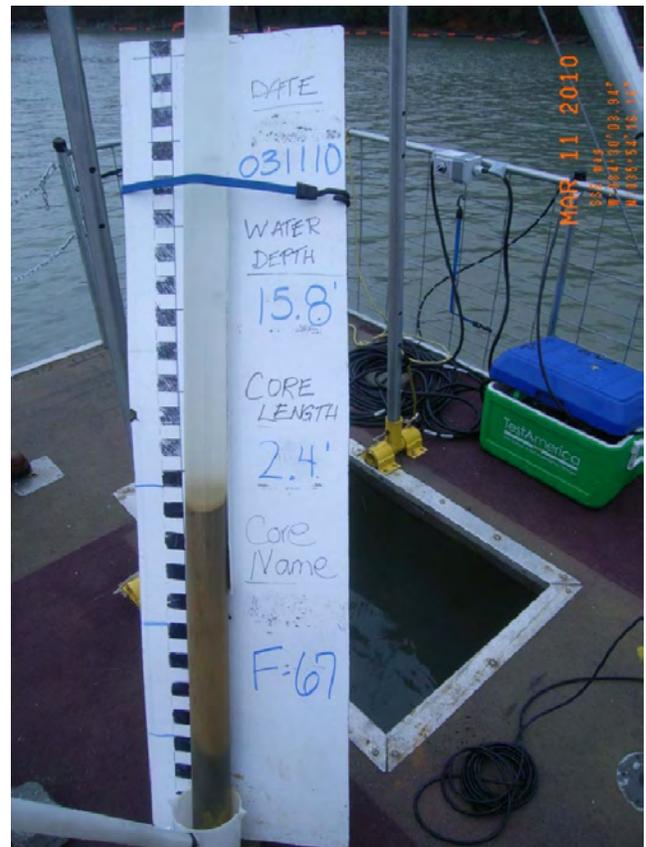
Core F-67

Core #	Photo #	Tube Type	Core Coordinates	River Depth	Time	Core Description	Interval (ft)
F-67	R0010354	6' Acrylic	N: 553910.51' E: 2443876.58'	15.8'	12:53	Orange and brown medium and fine grained sands. No ash	0-1.7
Deviations encountered: After the photo was taken and core extruded it became evident the top two layers were of the same material and lumped together.							1.7-2.4
Total Depth							2.4'
F-68	R0010355	6' Acrylic	N: 553890.91' E: 2443996.51'	12.6'	13:19	Brown fine and medium grained sands mixed with native fines. Approx 20% organics and 20% coal pieces. No ash.	0-0.6
Deviations encountered:							0.6-4.0
Total Depth							4.'
F-69	R0010356	6' Acrylic	N: 553840.84' E: 2444118.02'	10.4'	13:32	Brown medium and fine sands mixed with native fines. No ash.	0-0.6
Deviations encountered:							0.6-2.9
Total Depth							2.9'

Total core depth = 2.4'

Ash thickness = 0.0'

Water depth = 15.8'

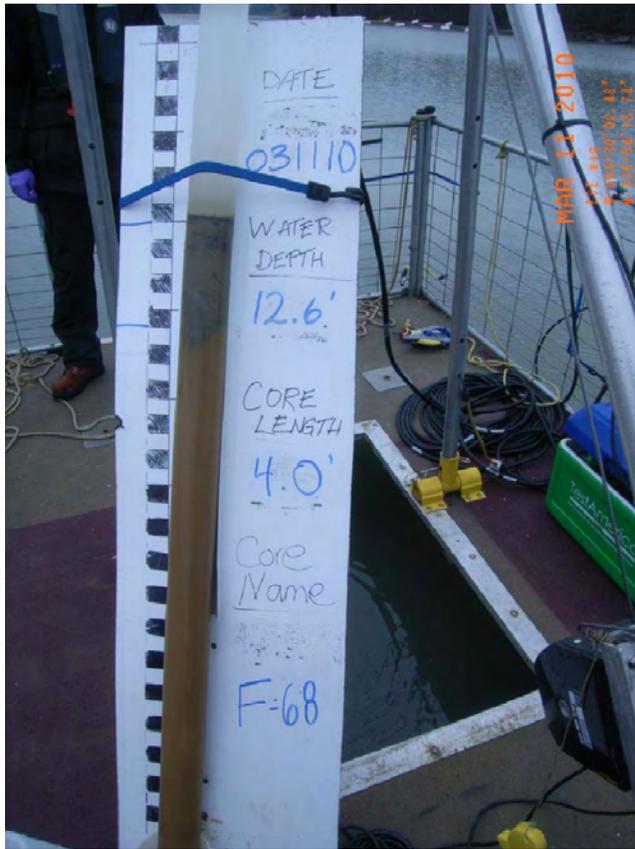
Core F-68

Total core depth = 4.0'

Ash thickness = 0.0'

Water depth = 12.6'

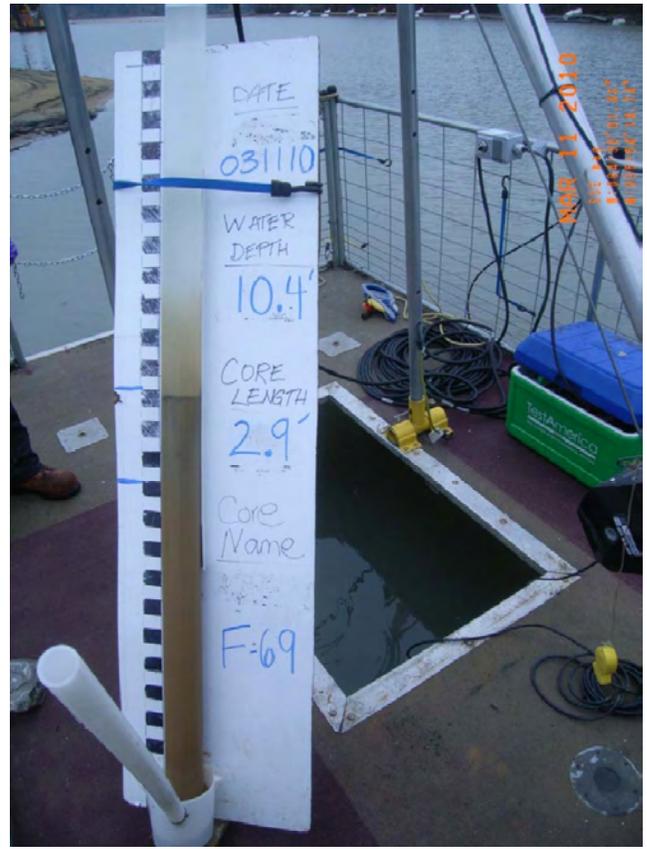
Core F-69

Total core depth = 2.9'

Ash thickness = 0.0'

Water depth = 10.4'

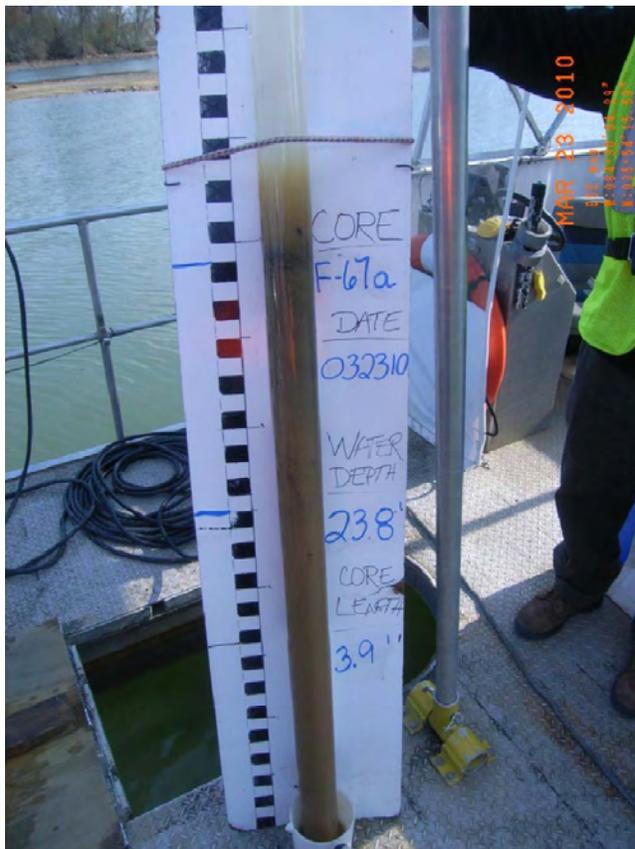
Core F-67a

Core #	Photo #	Tube Type	Core Coordinates	River Depth	Time	Core Description	Interval (ft)
F-67a	R0010406	6' Acrylic	N: 553873.41' E: 2443819.09'	23.8'	10:09	Orange medium and coarse grained sand mixed with >10% organics. A very thin layer of ash was on the surface <0.01'.	0-1.4
Deviations encountered:						Orange sandy clay mixed with >10% organics. No ash.	1.4-3.9
						Total Depth	3.9'
F-68a	R0010407	6' Acrylic	N: 553815.35' E: 2443907.03'	25.7'	10:42	Brown medium and coarse grained sand mixed with >10% coal pieces. No ash.	0-1.6
Deviations encountered:						Orange medium grained sand mixed with clay. No ash.	1.6-4.6
						Total Depth	4.6'

Total core depth = 3.9'

Ash thickness = 0.0'

Water depth = 23.8'

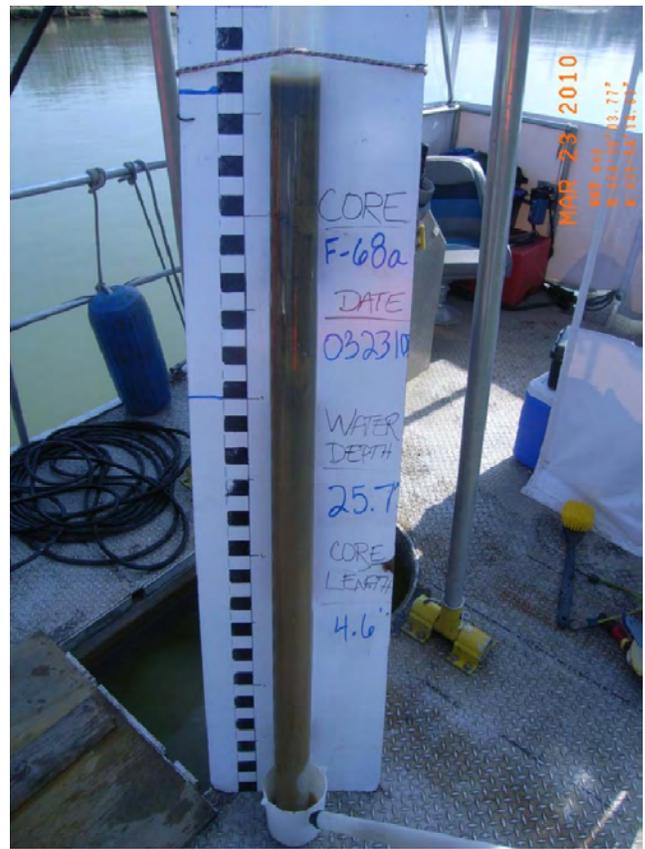
Core F-68a

Total core depth = 4.6'

Ash thickness = 0.0'

Water depth = 25.7'

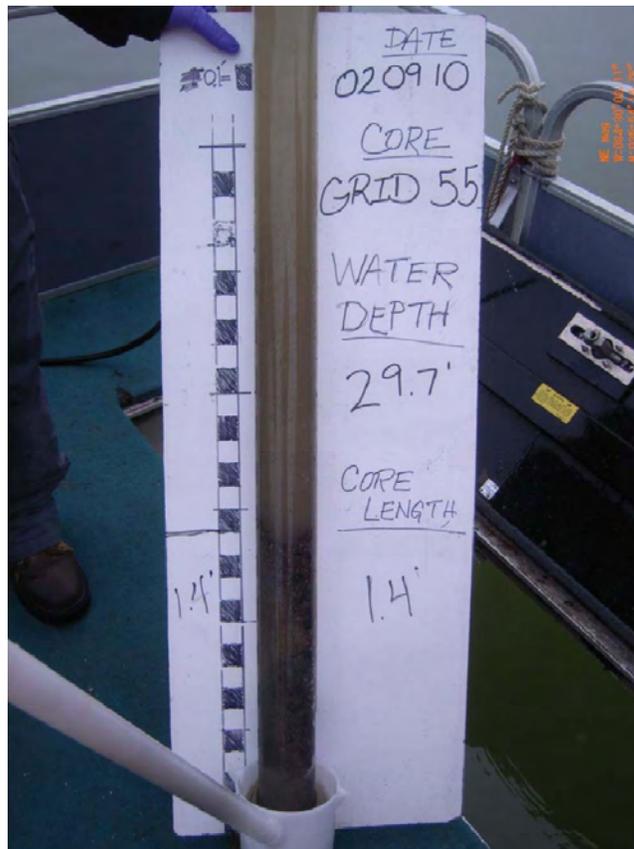
Core Grid 55

Core #	Photo #	Tube Type	Core Coordinates	River Depth	Time	Core Description	Interval (ft)
GRID55	R0010036	Acrylic	N: 35d54'14.145" W: 84d30'1.932"	29.7'	9:42	Coarse material brown in color with few large agrigates	0-1.4
Deviations encountered: refusal met (Coordinates converted to : N 553752.898 E:2444067.214)							
Total Depth							1.4'

Total core depth = 1.4'

Ash thickness = 0.0'

Water depth = 29.7'
