<b>ASH REMAINING THROUGH SEVENSON 06-23 SURVEY</b>	
TVA DREDGING OF THE IVORY RIVER AND ASH PROCESSING HARRISMAN, TN

# Bathymetry Removal Areas - Segment 1

# Shirley eTrack Day Shift 6/21/10

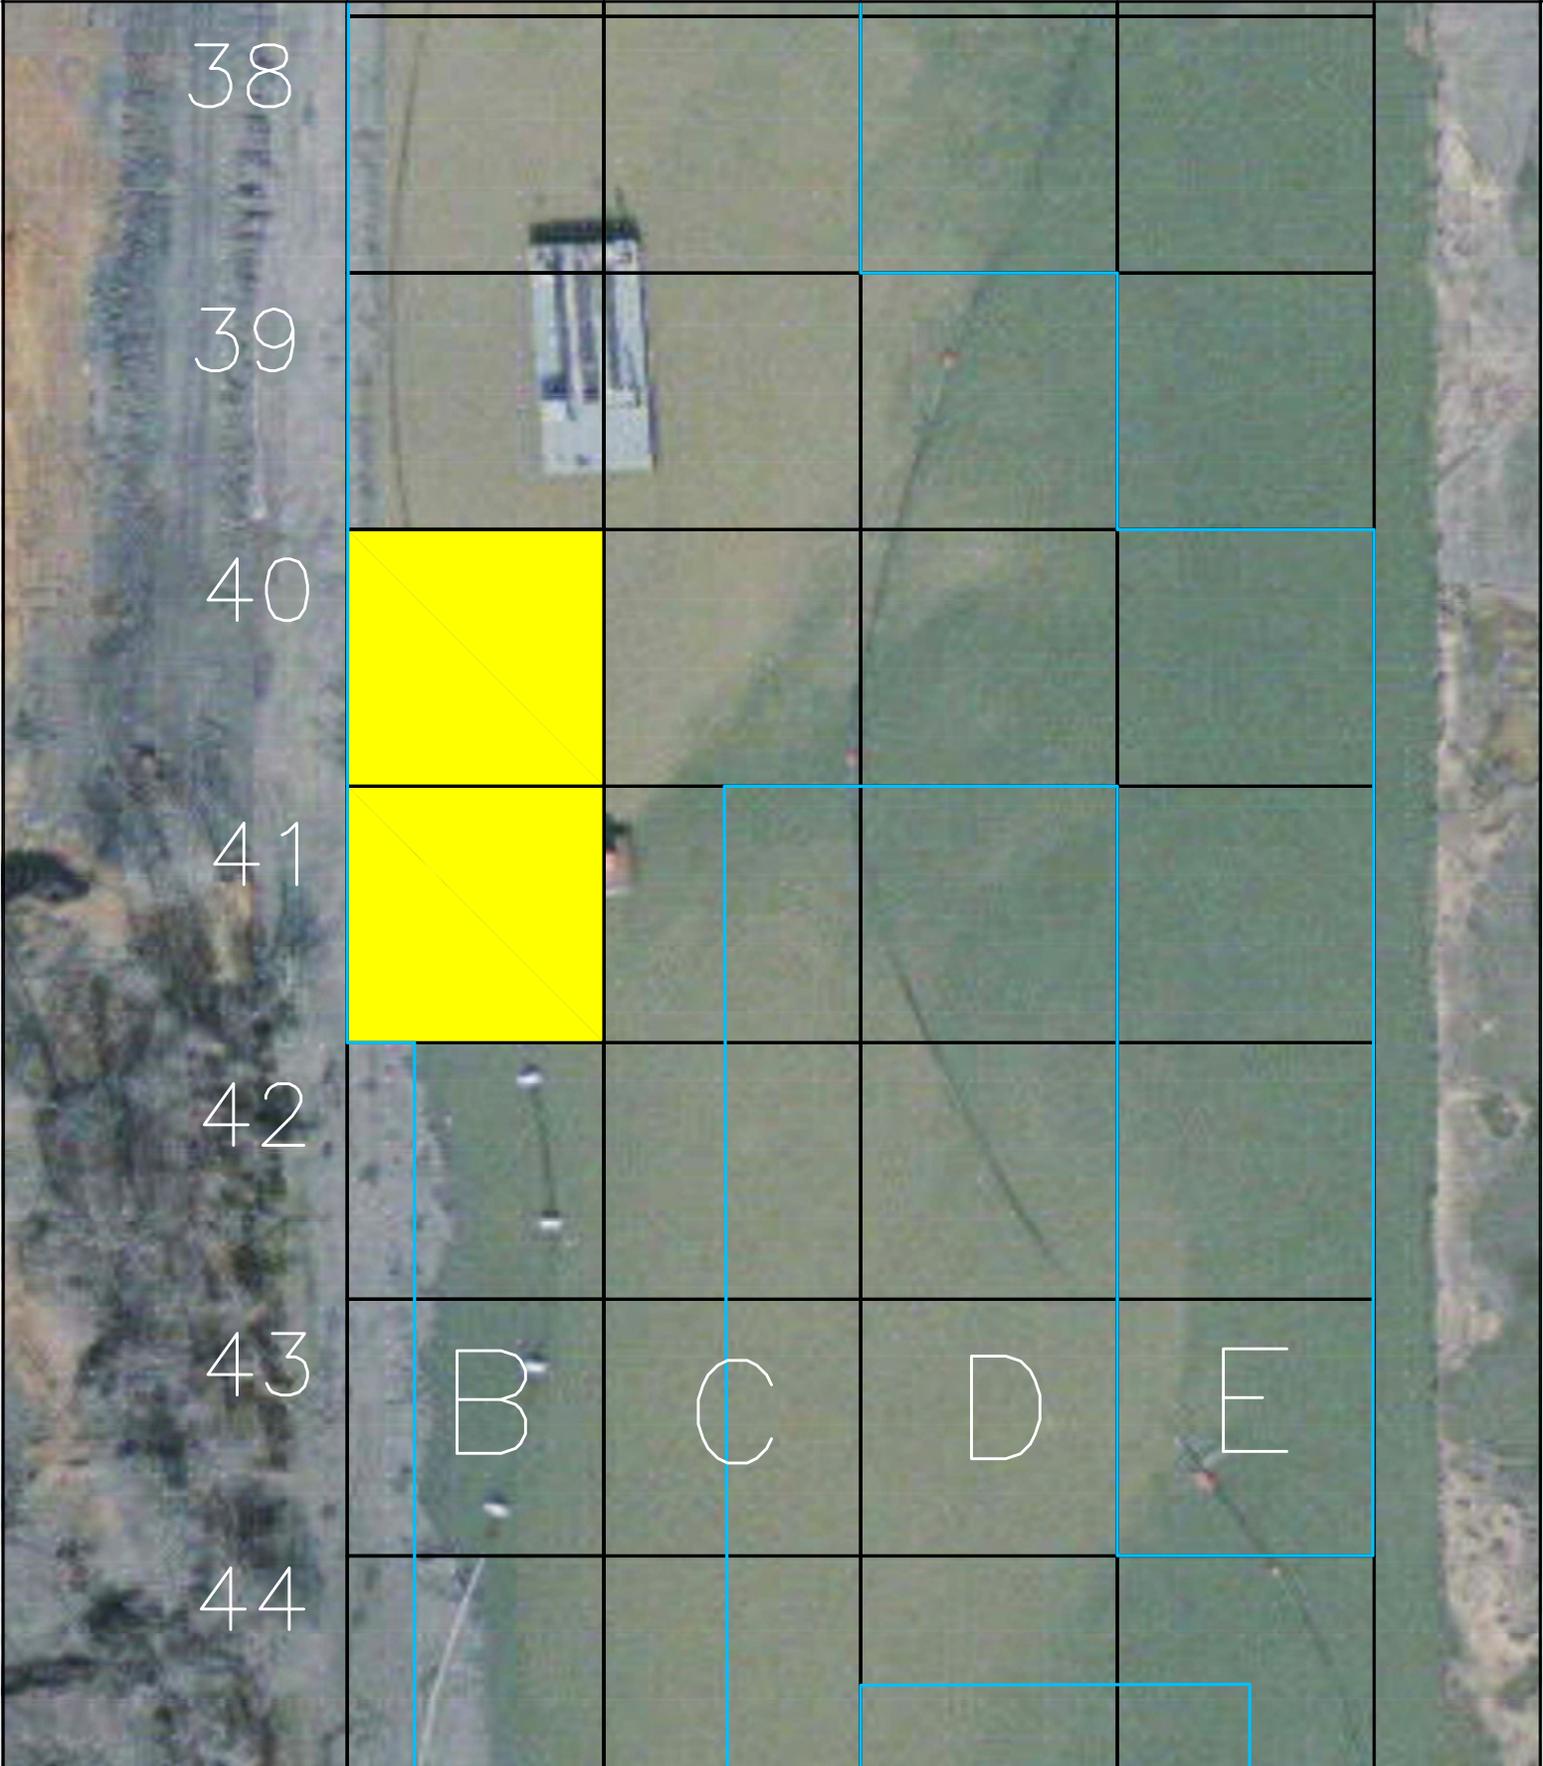
Figure 1

Removed From Plan

E-trac Dredging Path

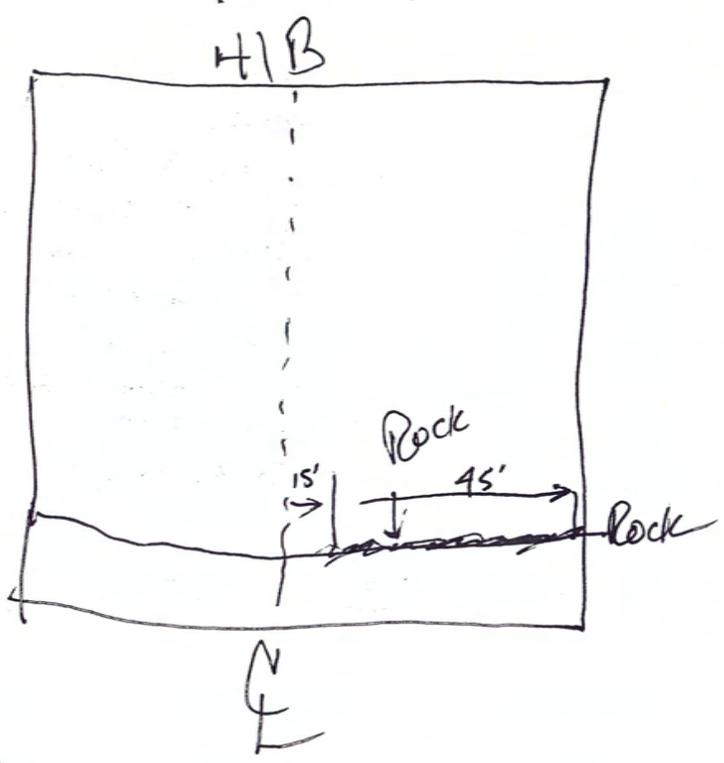
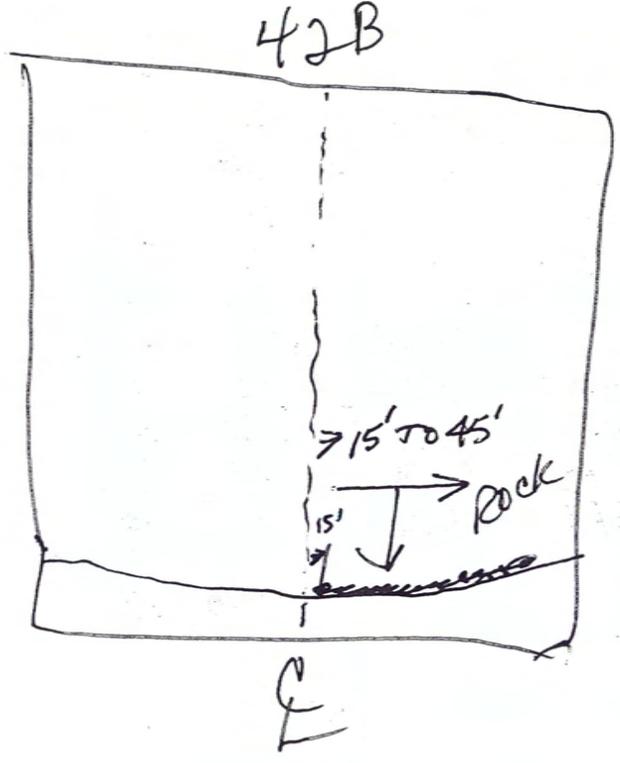
Comments: NOTE: Before digging, 8 teeth are missing from cutter. Were supposed to weld the 8 teeth on cutter today. THESE 8 teeth need to be welded on or there will be no teeth bases to weld on!! This is the NEW cutter put on when Shirley was brought back on line.

X 2442966 Y 556484 @ TO 45' STRAD Rock sticks 3-6" Above Grasp  
X 2442974 Y 556417

HARD DIGGING ENCOUNTERING UNDERLYING NATIVE MATERIALS 06-21-10

From 15' STRB of  $\bar{L}$  over 45' TOWARDS STRB TOE IS Rock 3-6" ABOVE GRADE
