Time-Critical Concurrence

Area: "Bob Summer's Road" area East of Dike 2

Bob Summers Road Removal Area

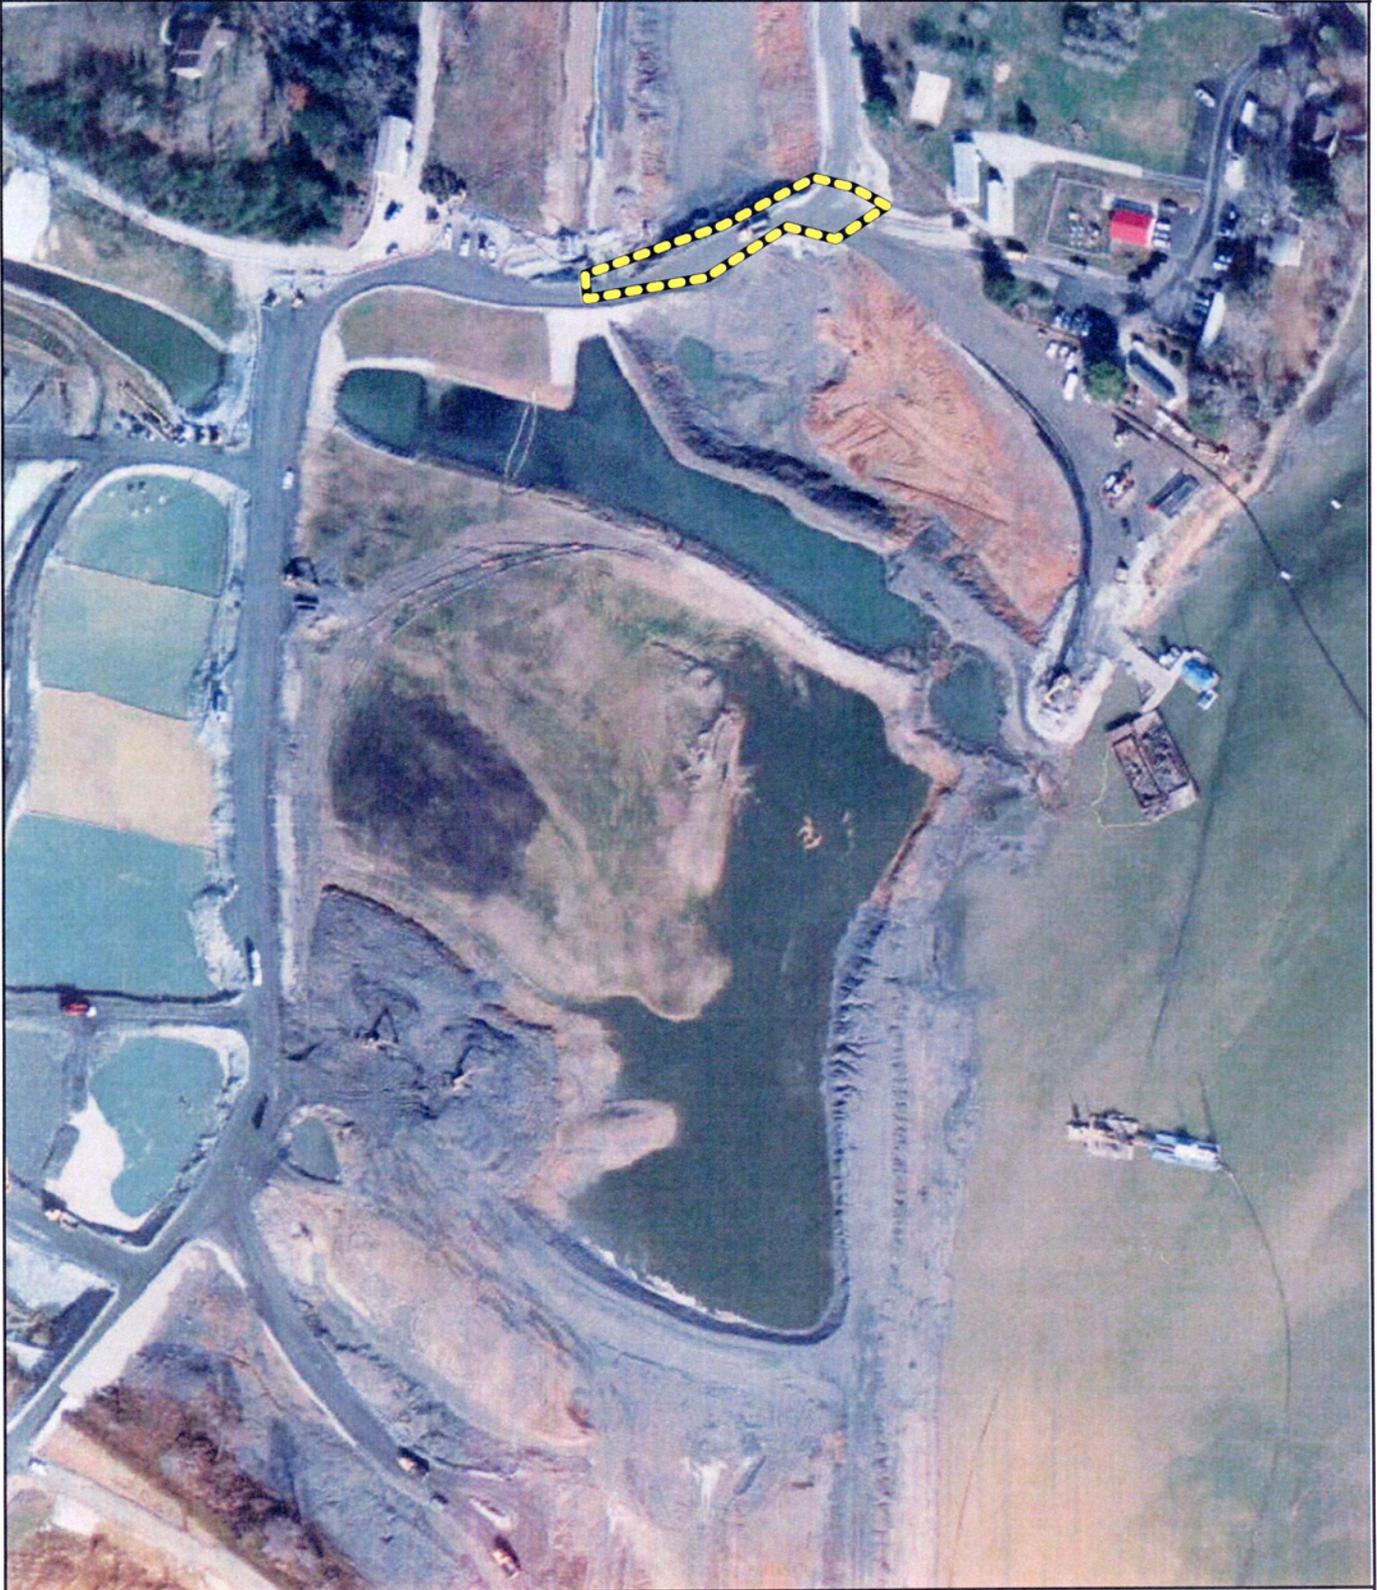
Figure 1

Area of Interest

The ash and ash covered rock associated with "Bob Summers Road" adjacent to the East Embayment has been removed.

An area between the land mass containing the North Point and that on the west shore of the East Embayment from the North Point had been filled in shortly after the spill to construct access to the North Point area. Considerable amount of rock and a series of culverts were placed between the East Embayment and the main portion of Swan Pond Embayment on top of ash. The rock and ash were initially removed using amphibious excavators in late June 2010 with additional dredging using a barge-mounted crane with a clamshell conducted from August 4th through August 19th.

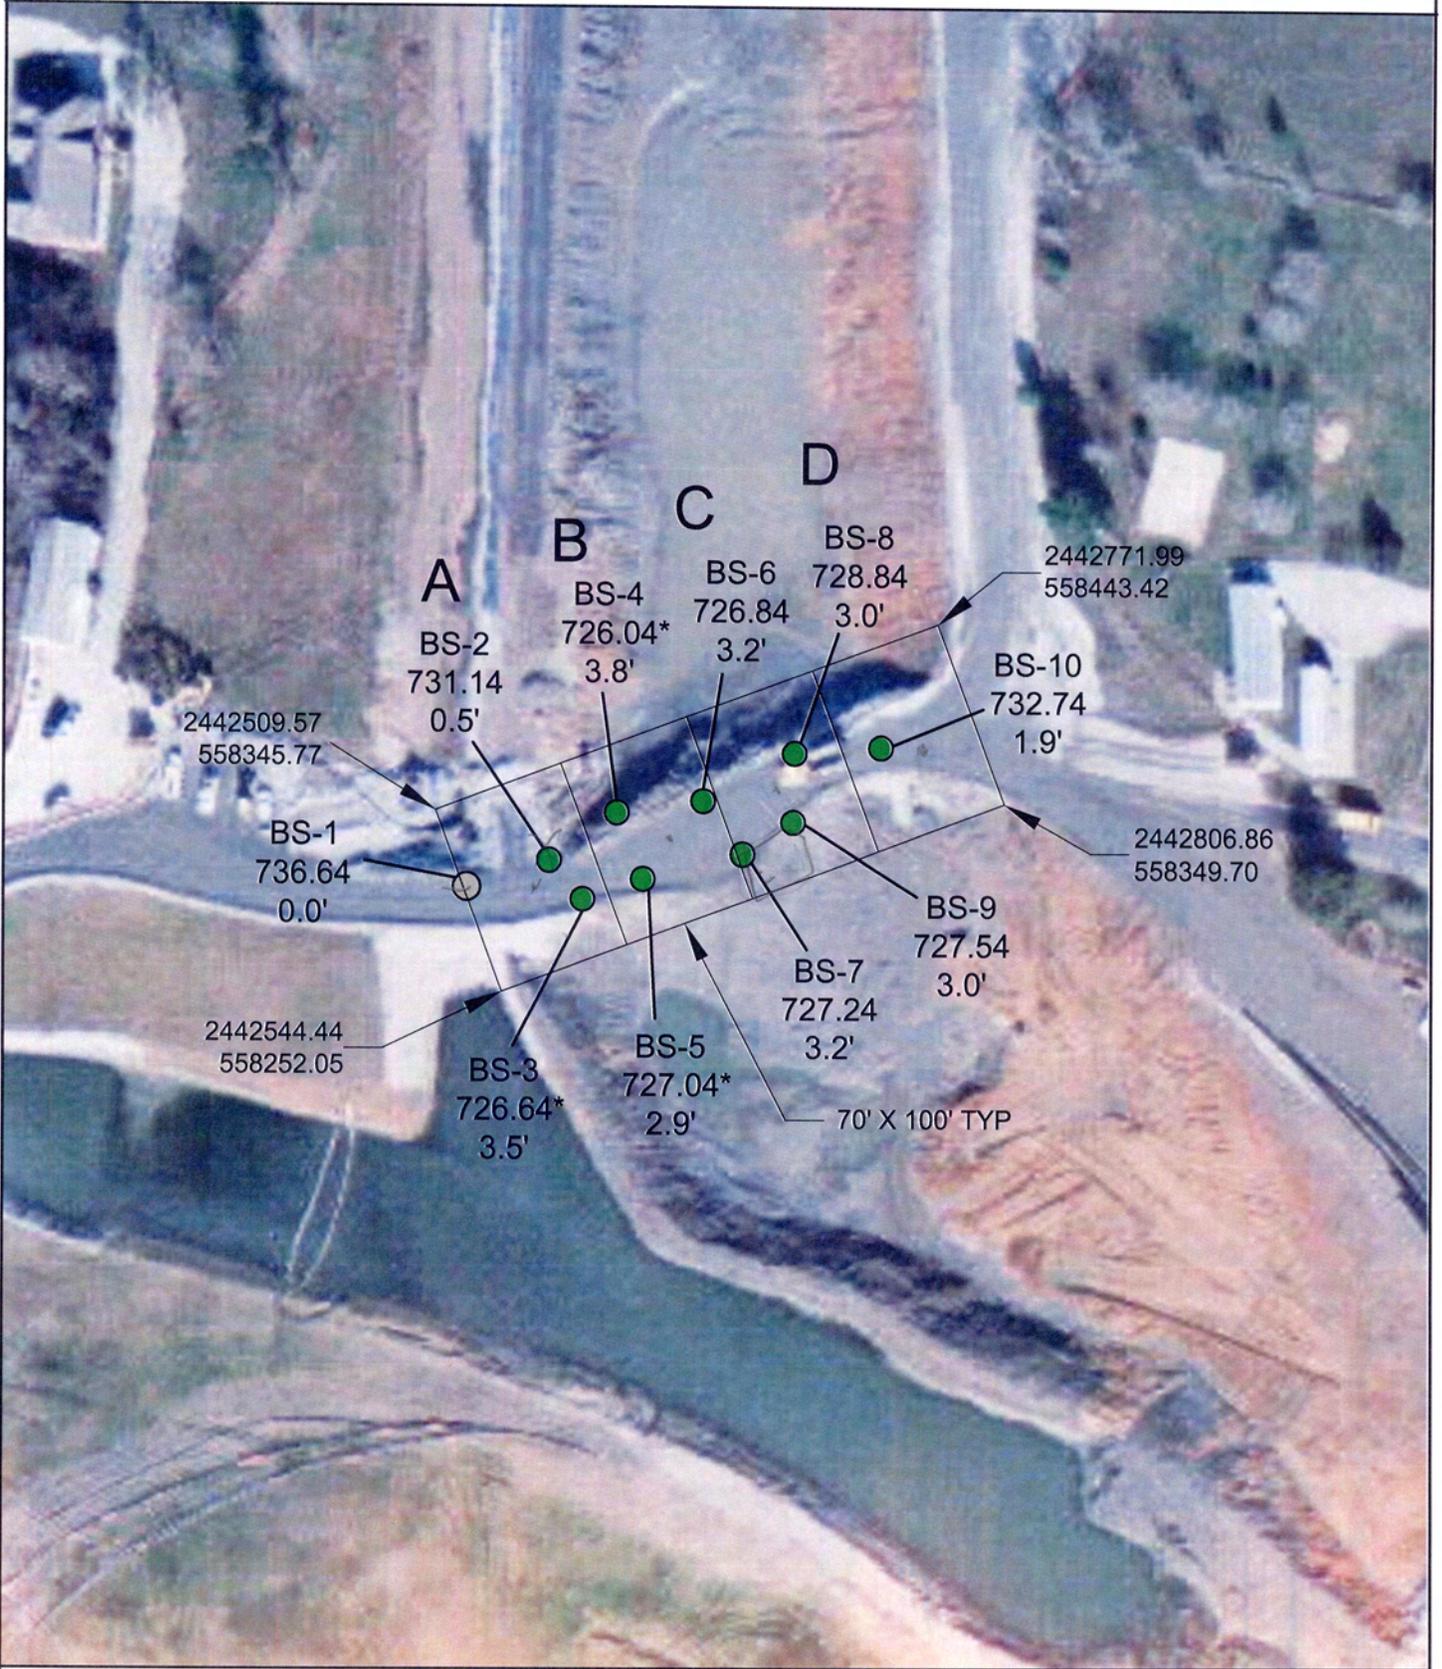
Figure 2

VibeCore Concurrence Sampling Results - Bob Summers Road

- Ash Recovered
- No Ash Present

VibeCore Label Format:
 Core Number
 Sediment Elevation
 Ash Thickness (ft)

* Bottomed in Ash

Vibecore sampling was used to assess residual conditions after the June excavator phase on June 30, 2010. The results indicated that there was an average of 2.5 ft of residual ash in the area. Mechanical excavation with a clamshell crane was scheduled to remove the remaining ash as located by the Vibecore sampling. The clamshell excavated ash from the area from August 4th to August 19th. A Jacobs' field technician observed the clamshell crane excavation noting depths of cuts and developed a photo record of the activities. The photo record confirms that the clamshell crane was reaching the underlying clay sediments throughout the "Bob Summers Road" area. Post dredging Vibecore sampling was conducted to confirm that ash was removed to original surface and also indicates that resettlement of suspended ash slurry has occurred to thicknesses from 0.5' to 1.7'.

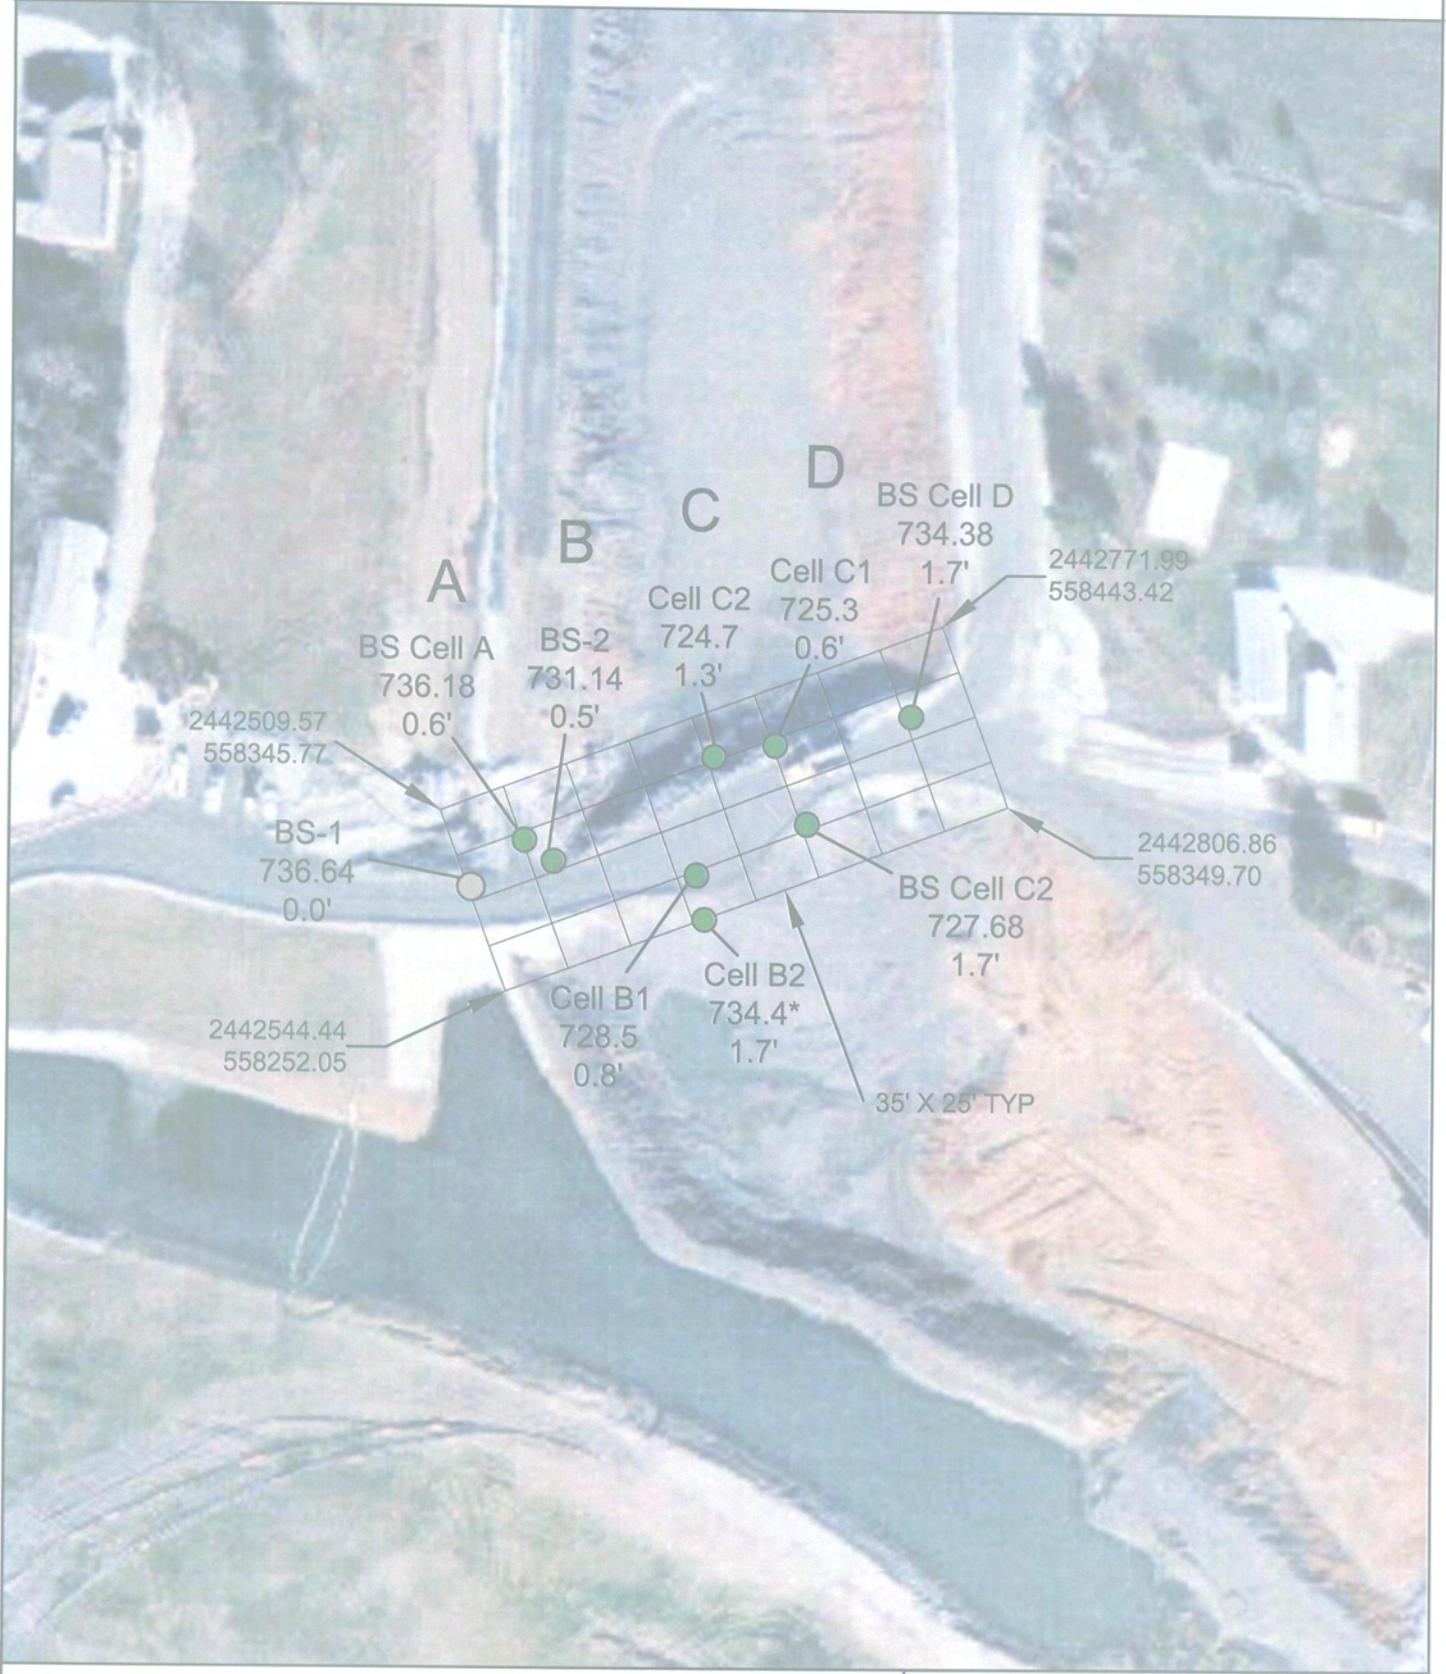
Figure 3

VibeCore Concurrence Sampling Results - Bob Summers Road

- Ash Recovered
- No Ash Present

* Bottomed in Ash

VibeCore Label Format:
 Core Number
 Sediment Elevation
 Ash Thickness (ft)

Volume of Ash Remaining at Bob Summers Road

VibeCore Results Ash Remaining (ft)

BS-1	0.0
BS Cell A	0.6
BS-2	0.5
Cell B1	0.8
Cell B2	1.7
BS Cell C2	1.7
Cell C2 (<50% Ash)	1.3*
BS Cell D (slurry)	1.7*
Cell C1 (<50% Ash)	0.6*
Average	0.88

Initial estimates utilized an average thickness of 2.5 ft resulting in approximately 2,600 yd³ of material to be removed. Overall, 4,300 yd³ were removed from the area. VibeCore samples resulted in an average thickness of 0.88 ft over the 28,000 ft² dredge area, which yields approximately 900 yd³ of material remaining.

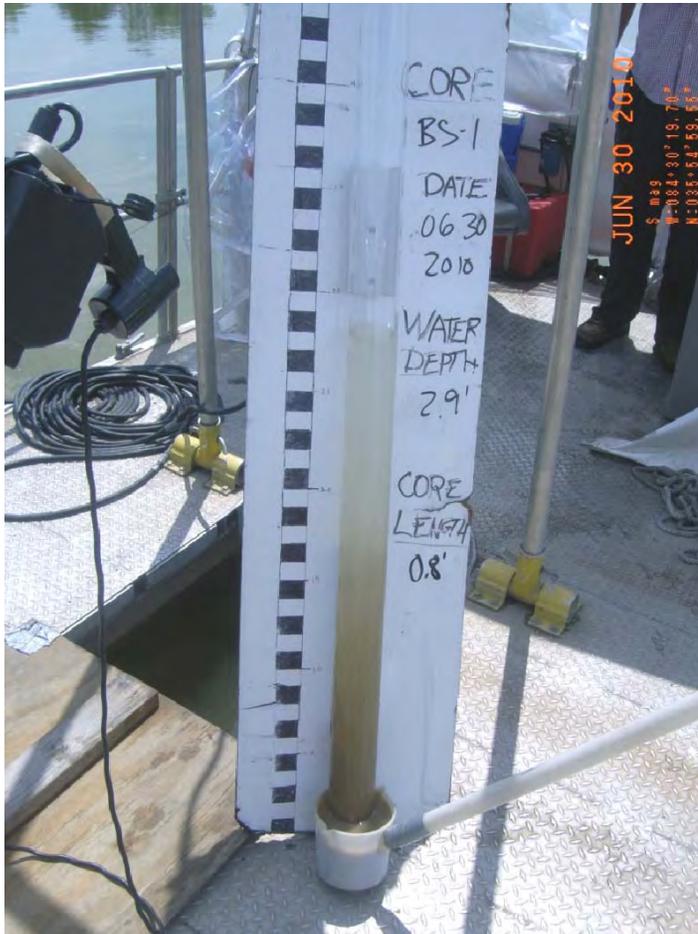
Core BS-1

Total core depth = 0.6'

Ash thickness = 0'

Water depth = 2.9'

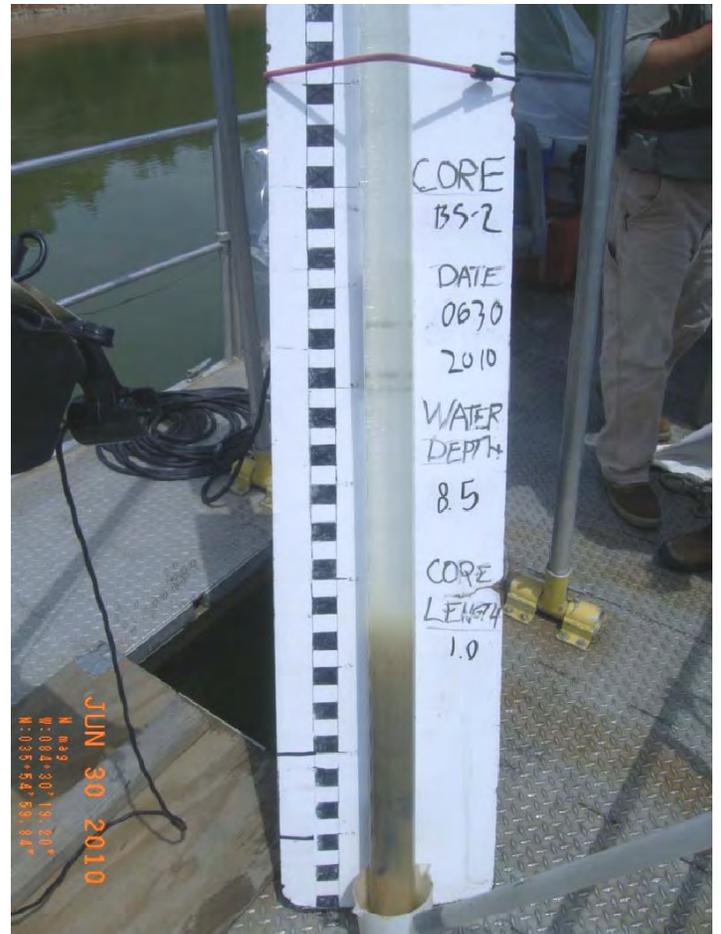
Core BS-2

Total core depth = 1.0'

Ash thickness = 0.5'

Water depth = 8.5'

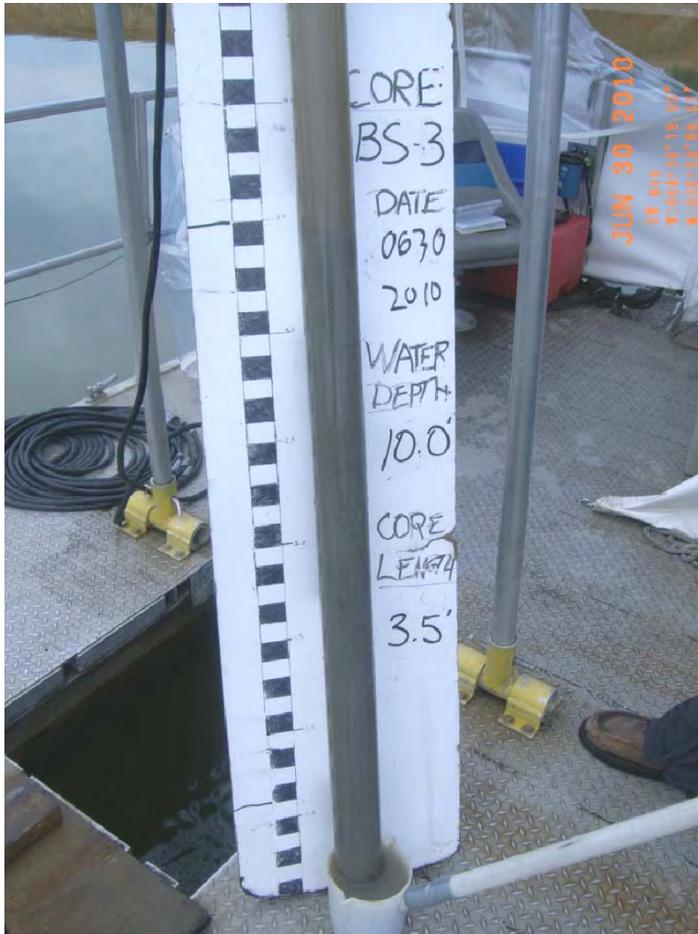
Core BS-3

Total core depth = 3.5'

Ash thickness = 3.5'

Water depth = 10.0'

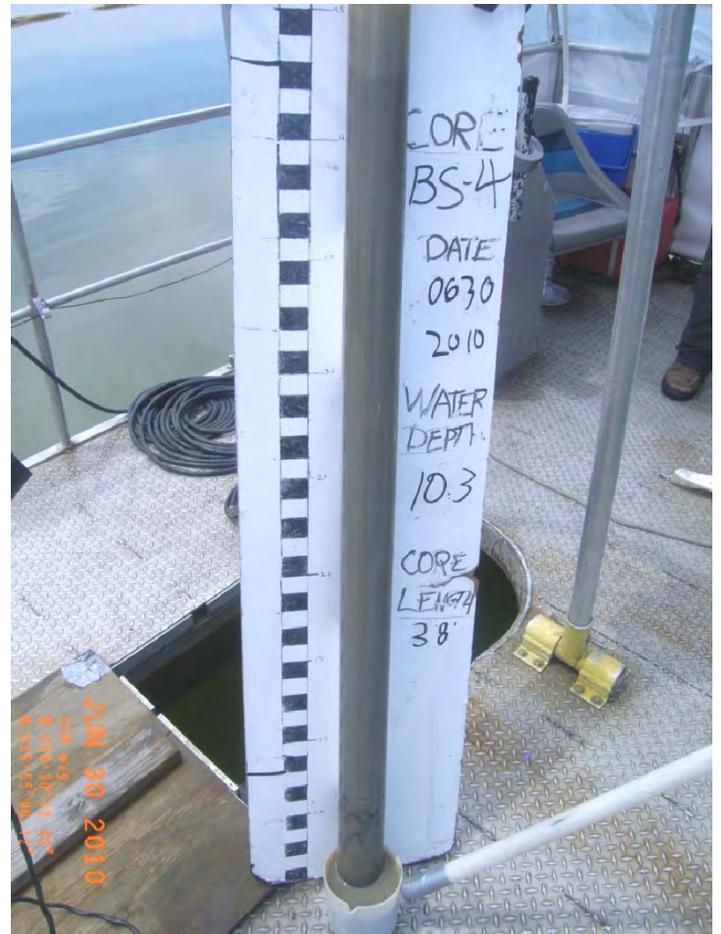
Core BS-4

Total core depth = 3.8'

Ash thickness = 3.8'

Water depth = 10.3'

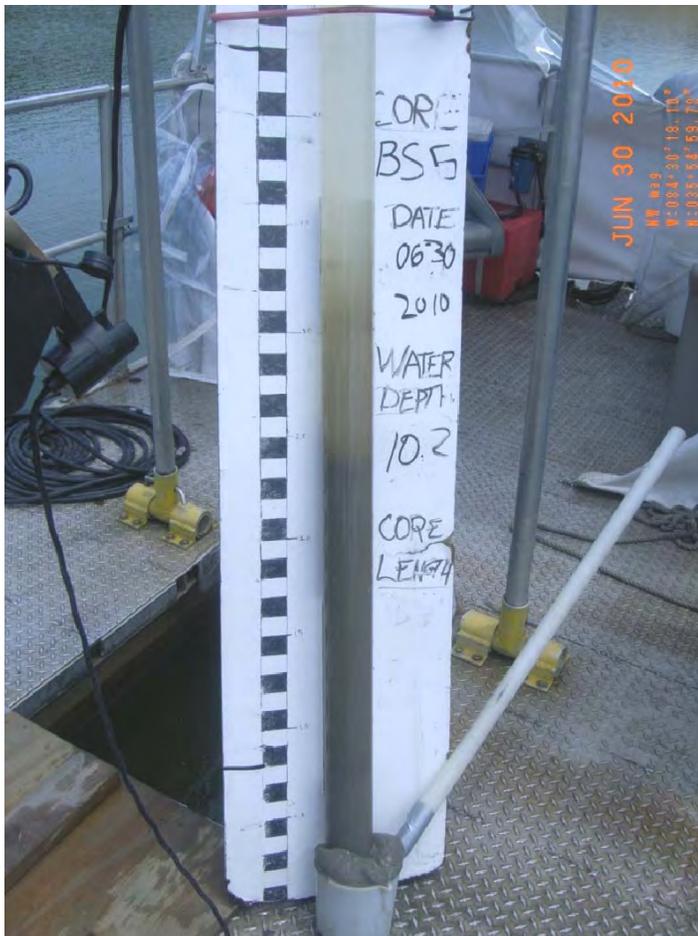
Core BS-5

Total core depth = 2.9'

Ash thickness = 2.9'

Water depth = 10.2'

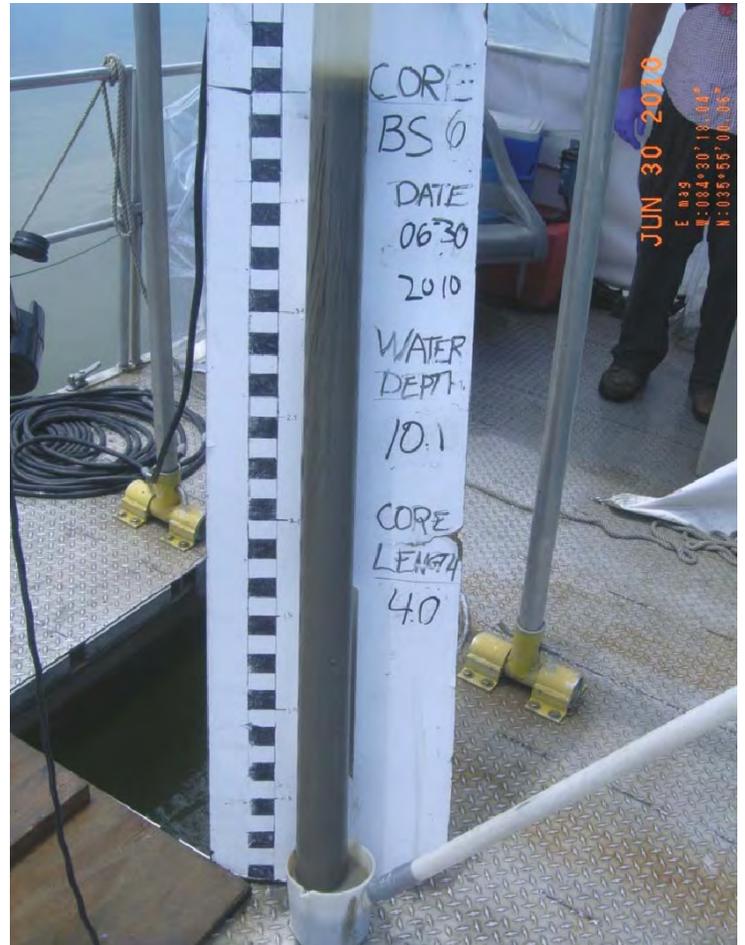
Core BS-6

Total core depth = 4.0'

Ash thickness = 3.2'

Water depth = 10.1'

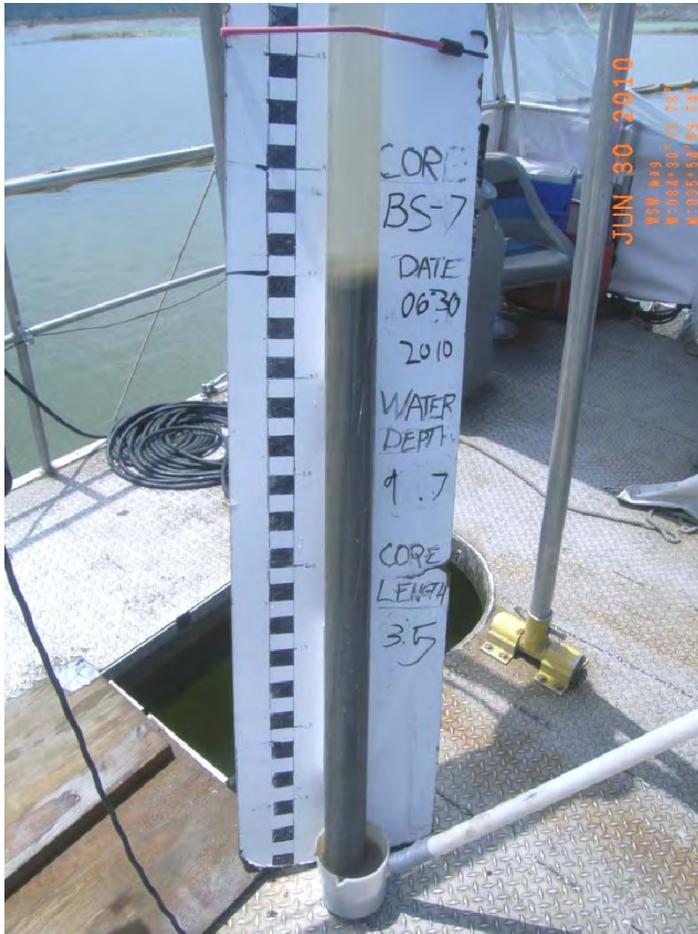
Core BS-7

Total core depth = 3.5'

Ash thickness = 3.2'

Water depth = 9.7'

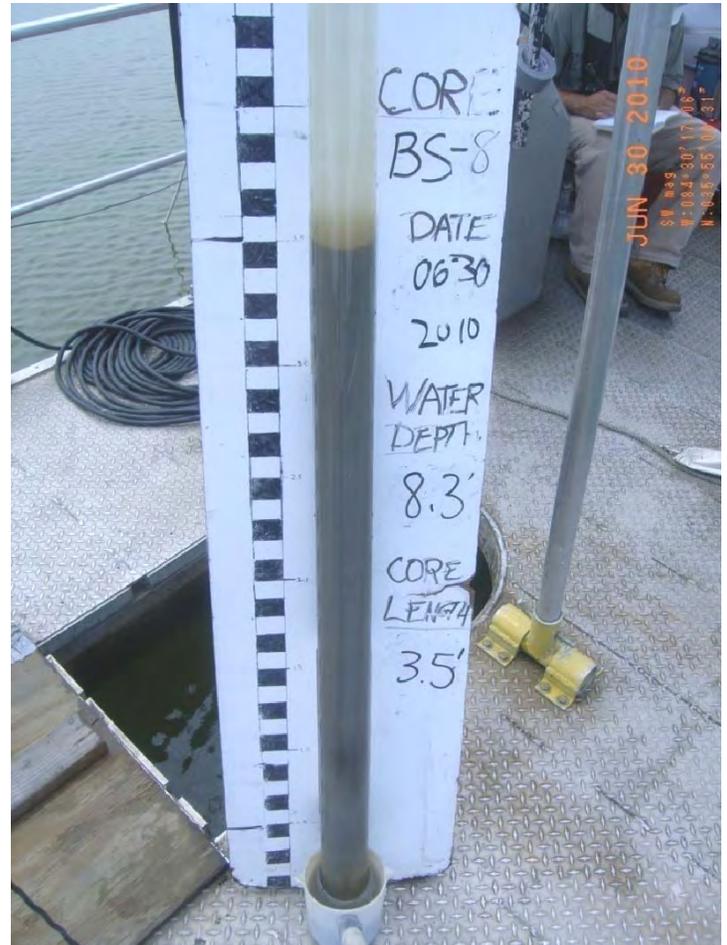
Core BS-8

Total core depth = 3.5'

Ash thickness = 3.0'

Water depth = 8.3'

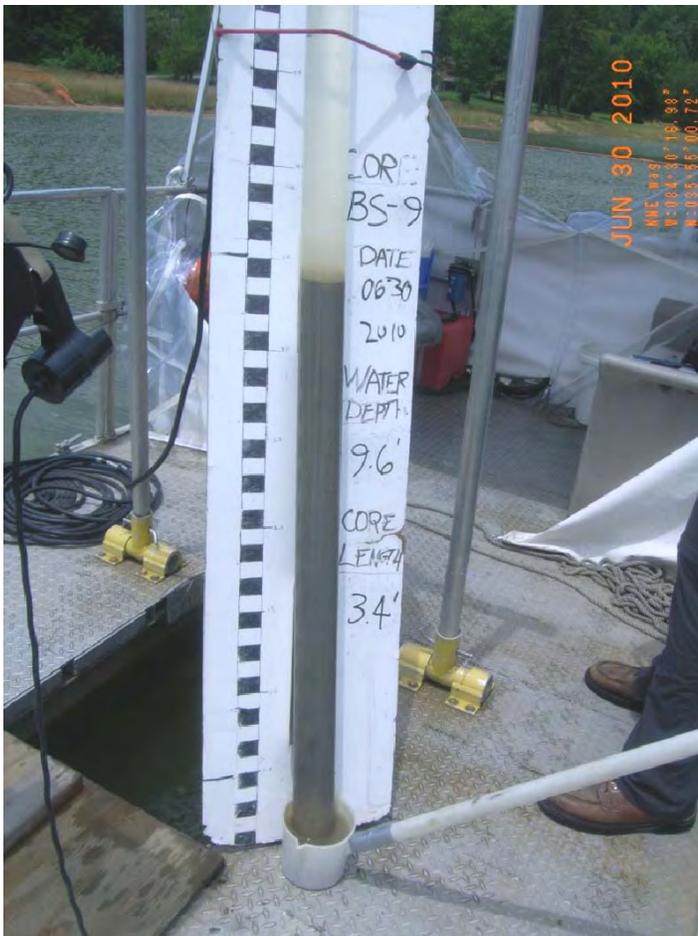
Core BS-9

Total core depth = 3.5'

Ash thickness = 3.0'

Water depth = 9.6'

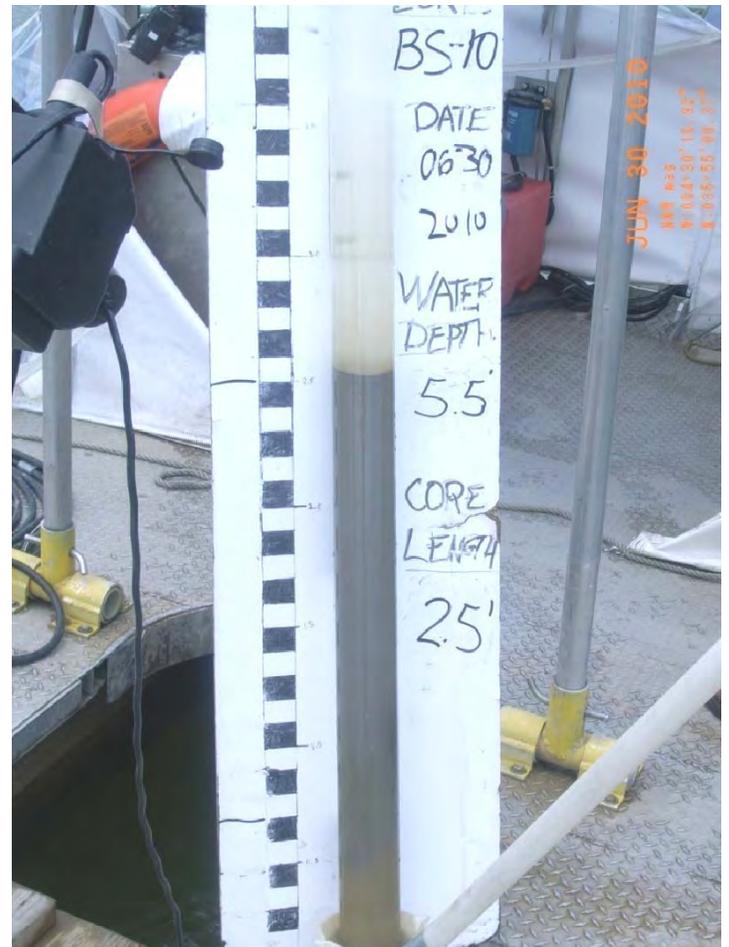
Core BS-10

Total core depth = 2.5'

Ash thickness = 1.9'

Water depth = 5.5'

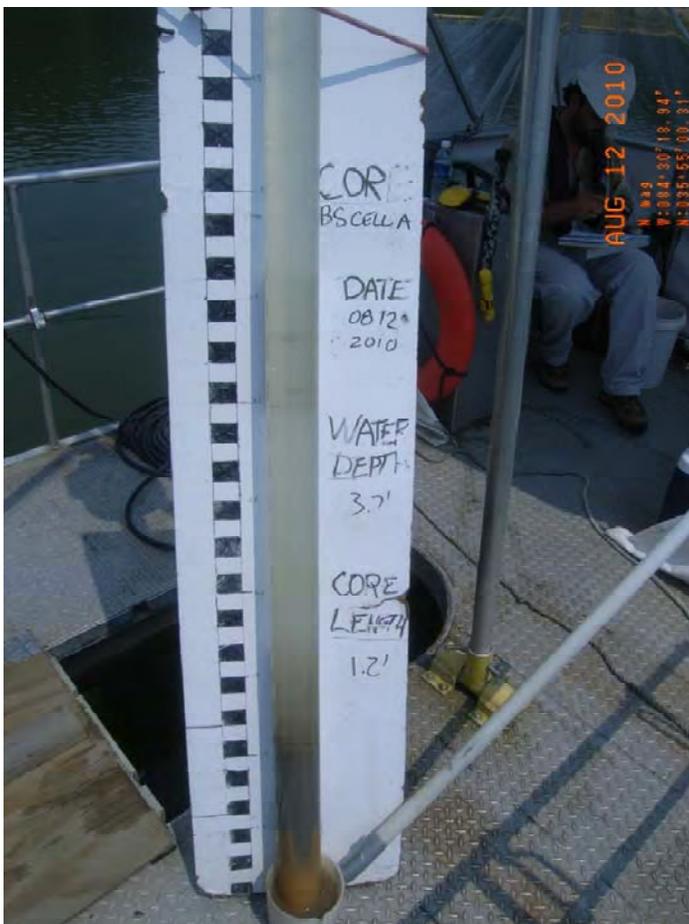
Core BS Cell A
Total core depth = 1.2'
Ash thickness = 0.6'
Water depth = 3.7'

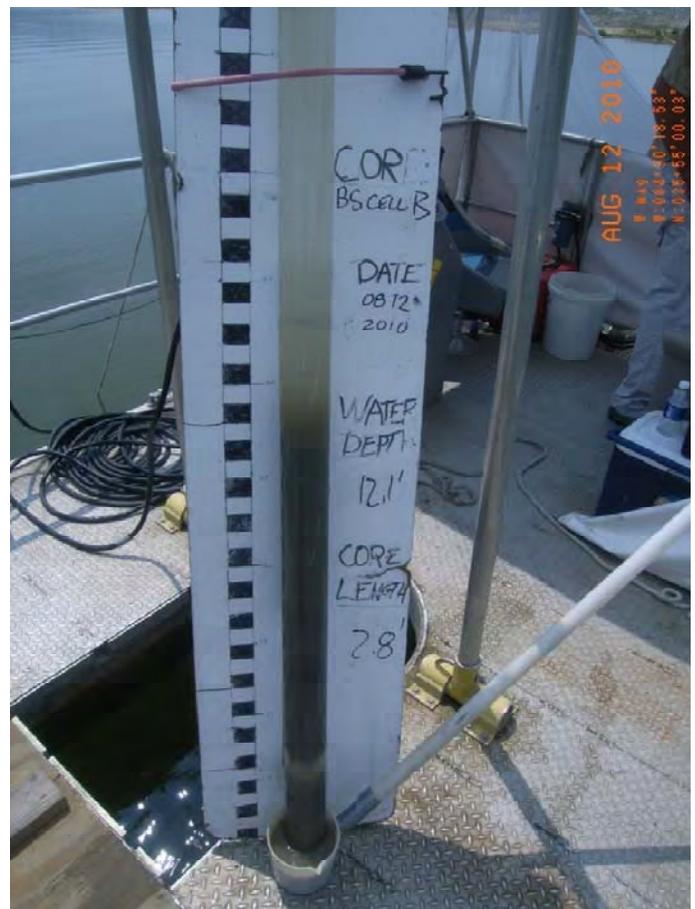
Core BS Cell B
Total core depth = 2.8'
Ash thickness = 2.2'
Water depth = 12.1'

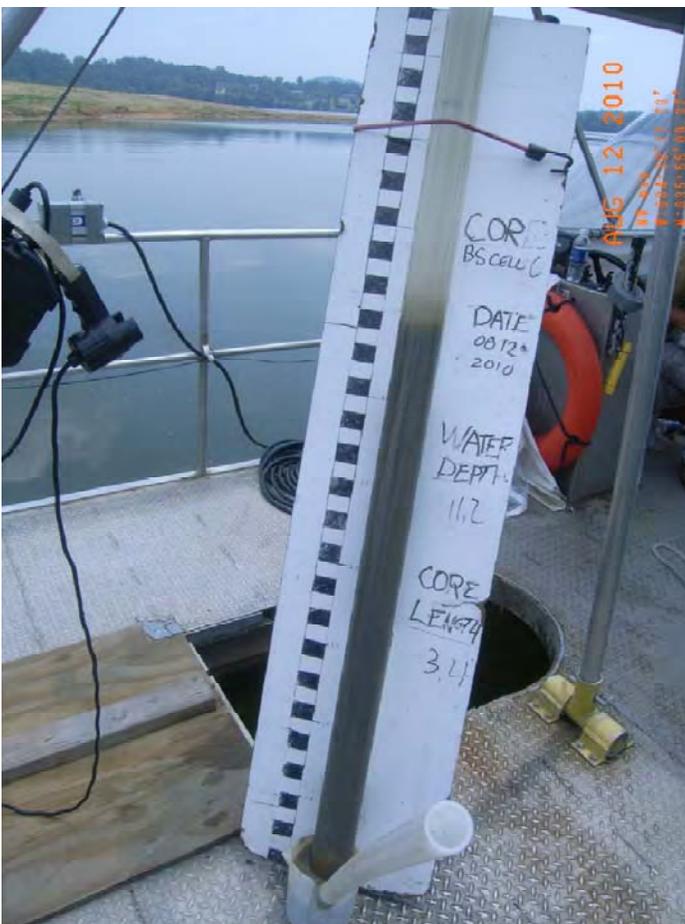
Core BS Cell C
Total core depth = 3.4'
Ash thickness = 3.0'
Water depth = 11.2'

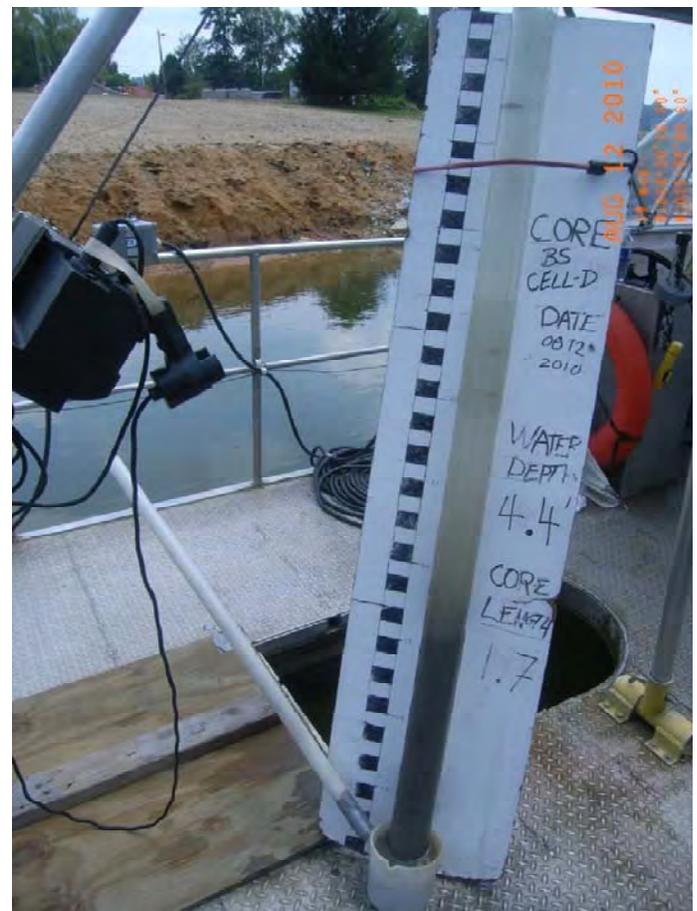
Core BS Cell D
Total core depth = 1.7'
Ash thickness = 1.7'
Water depth = 4.4'

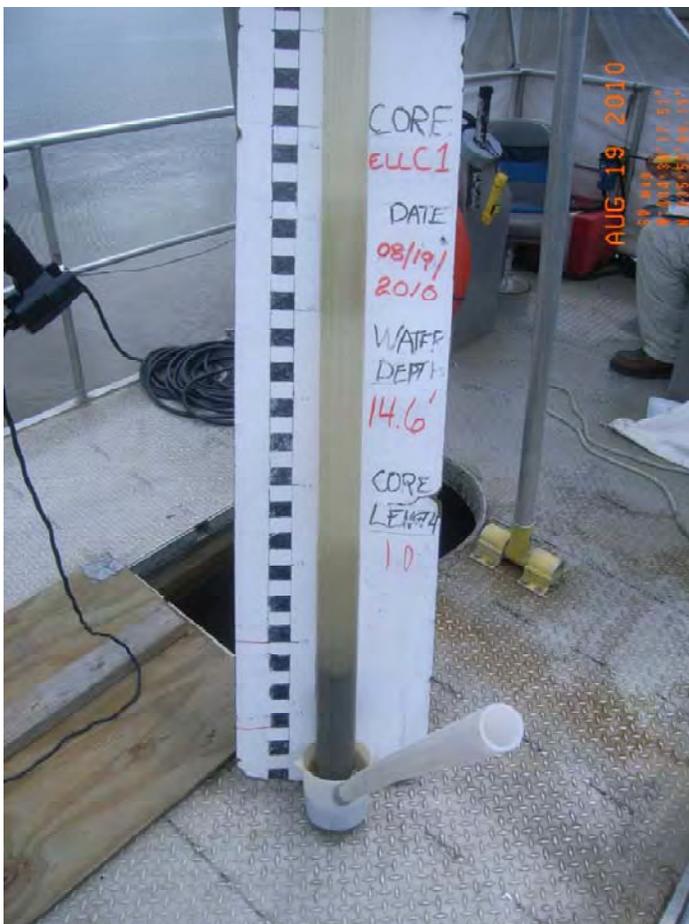
Core C1
Total core depth = 1'
Ash thickness = 0.6'
Water depth = 14.6'

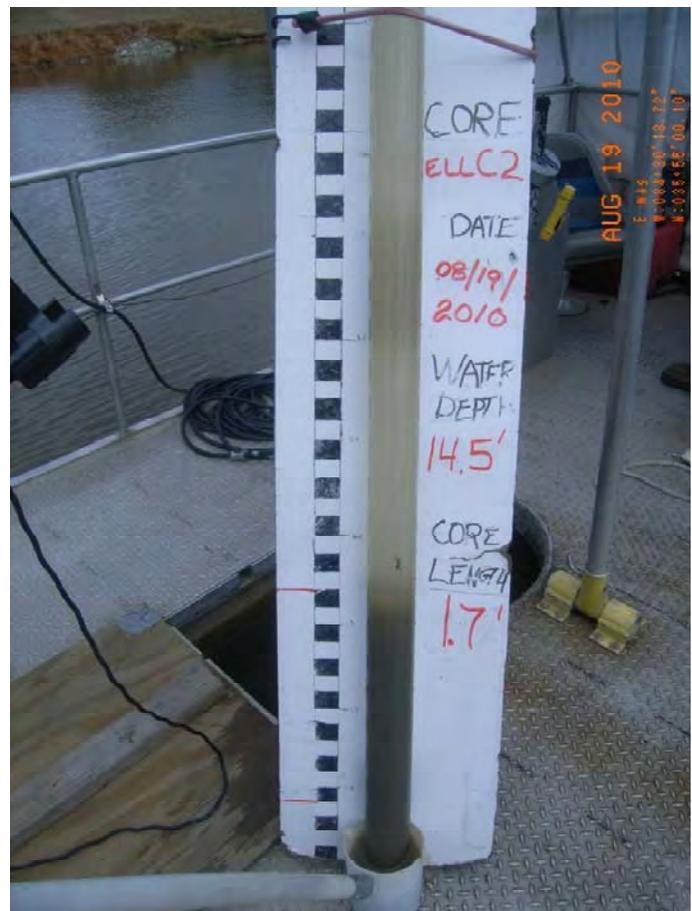
Core C2
Total core depth = 1.7'
Ash thickness = 0'
Water depth = 14.5'

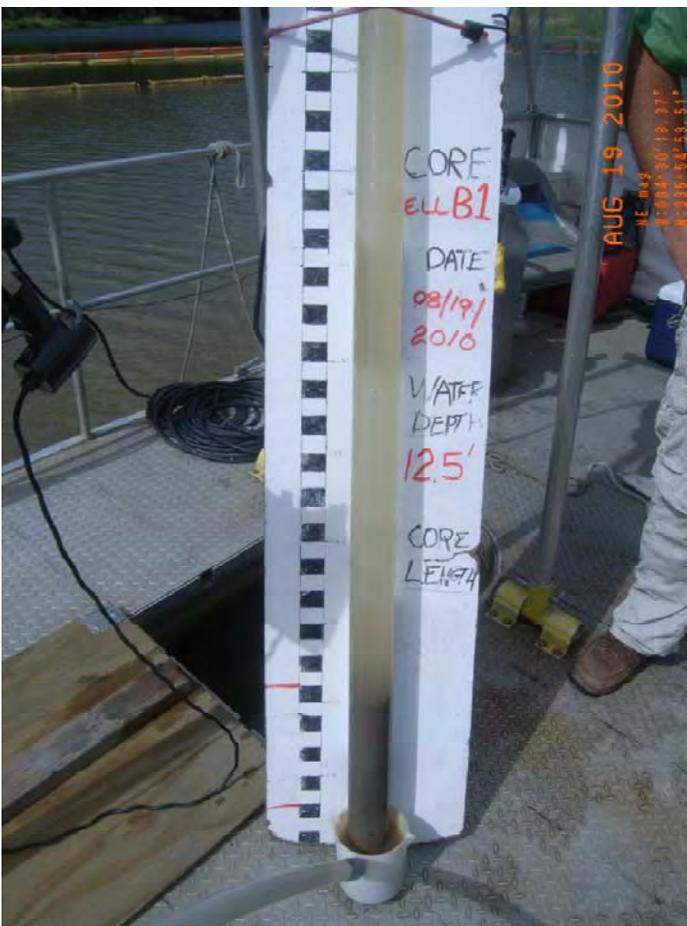
Core B1
Total core depth = 1.1'
Ash thickness = 0.8'
Water depth = 11.2'

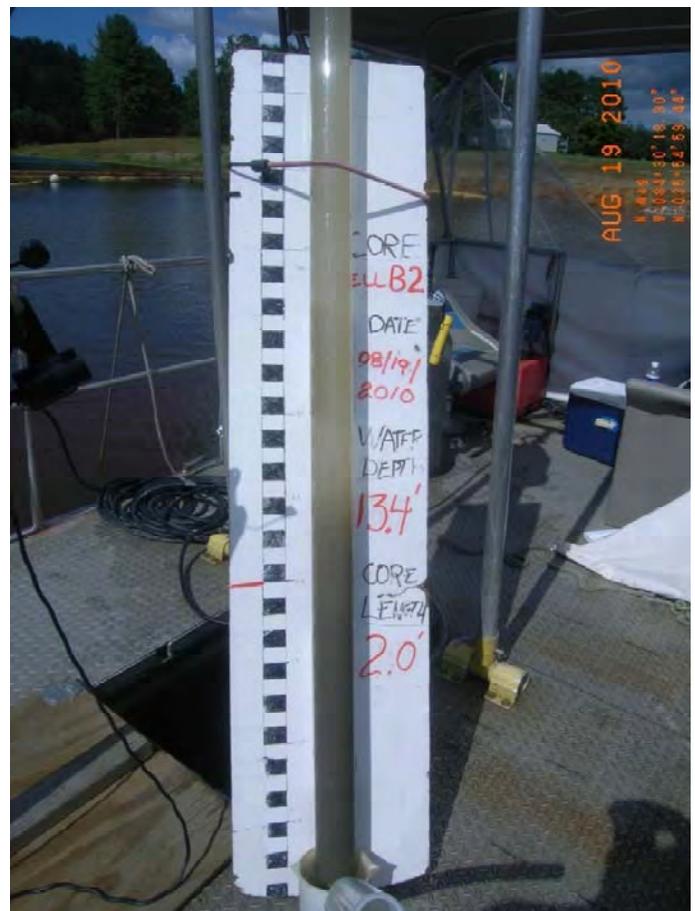
Core B2
Total core depth = 1.7'
Ash thickness = 1.7'
Water depth = 4.4'

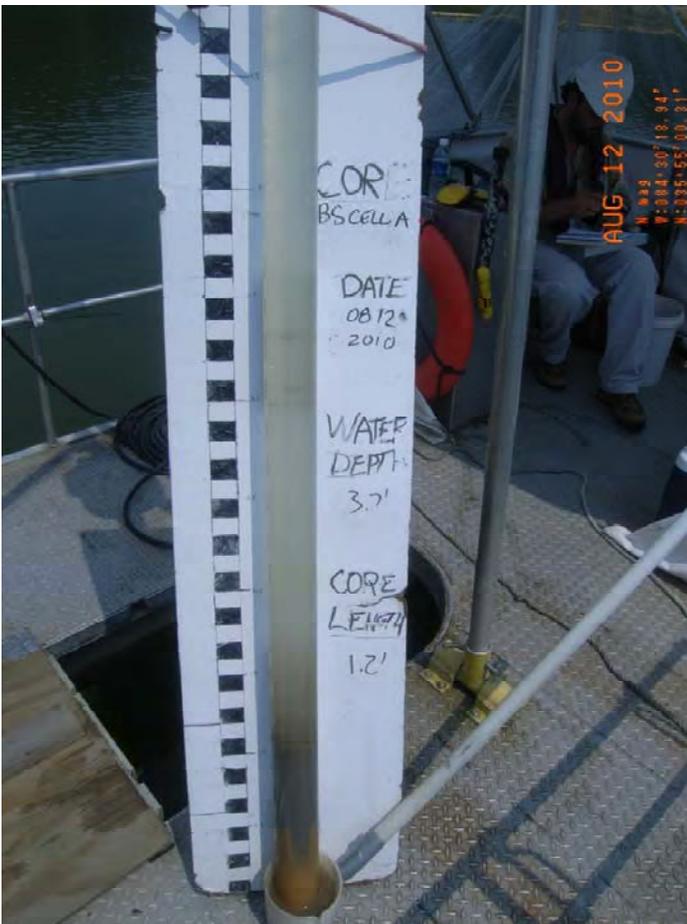
Core BS Cell A
Total core depth = 1.2'
Ash thickness = 0.6'
Water depth = 3.7'

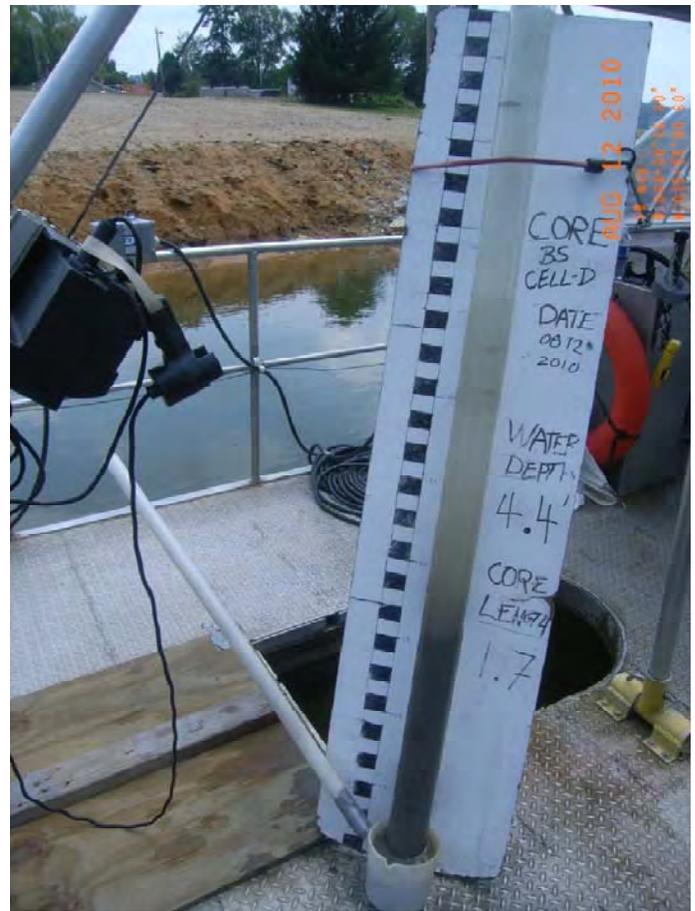
Core BS Cell D
Total core depth = 1.7'
Ash thickness = 1.7'
Water depth = 4.4'

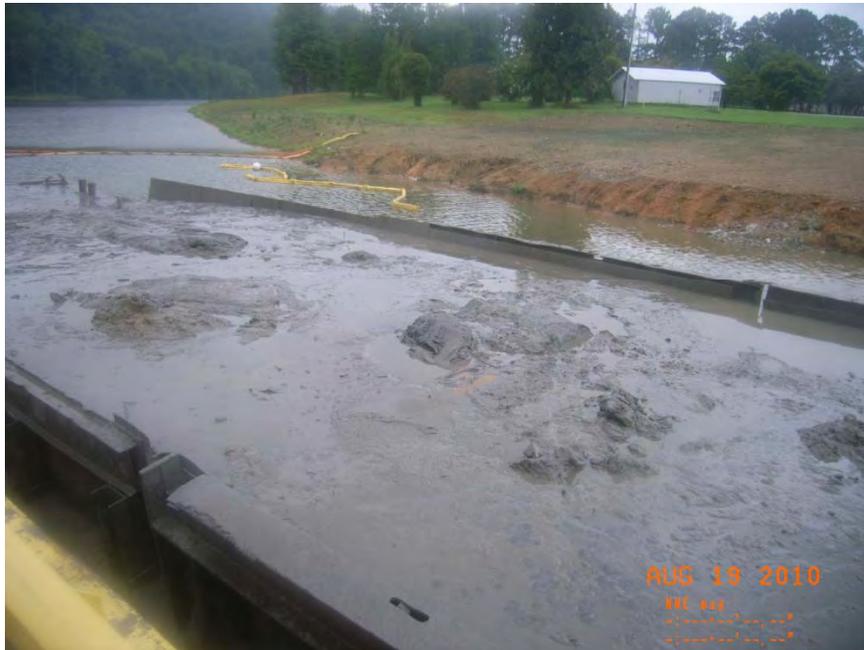
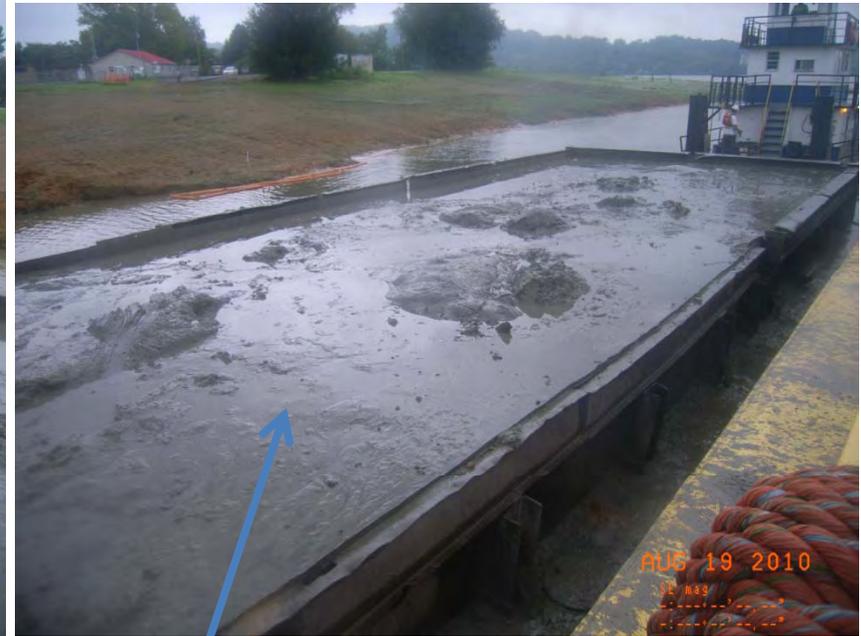
8/19/10 10:52, ID# R0010558

Ash Slurry
