Time-Critical Concurrence

Emory River, Segment 5, Dredge Areas D-1, 2, 3, 4, 5, 6, 7 & 8

Eliminate planned dredging of dredge grid areas D-1, 2, 3, 4, 5, 6, 7 & 8.

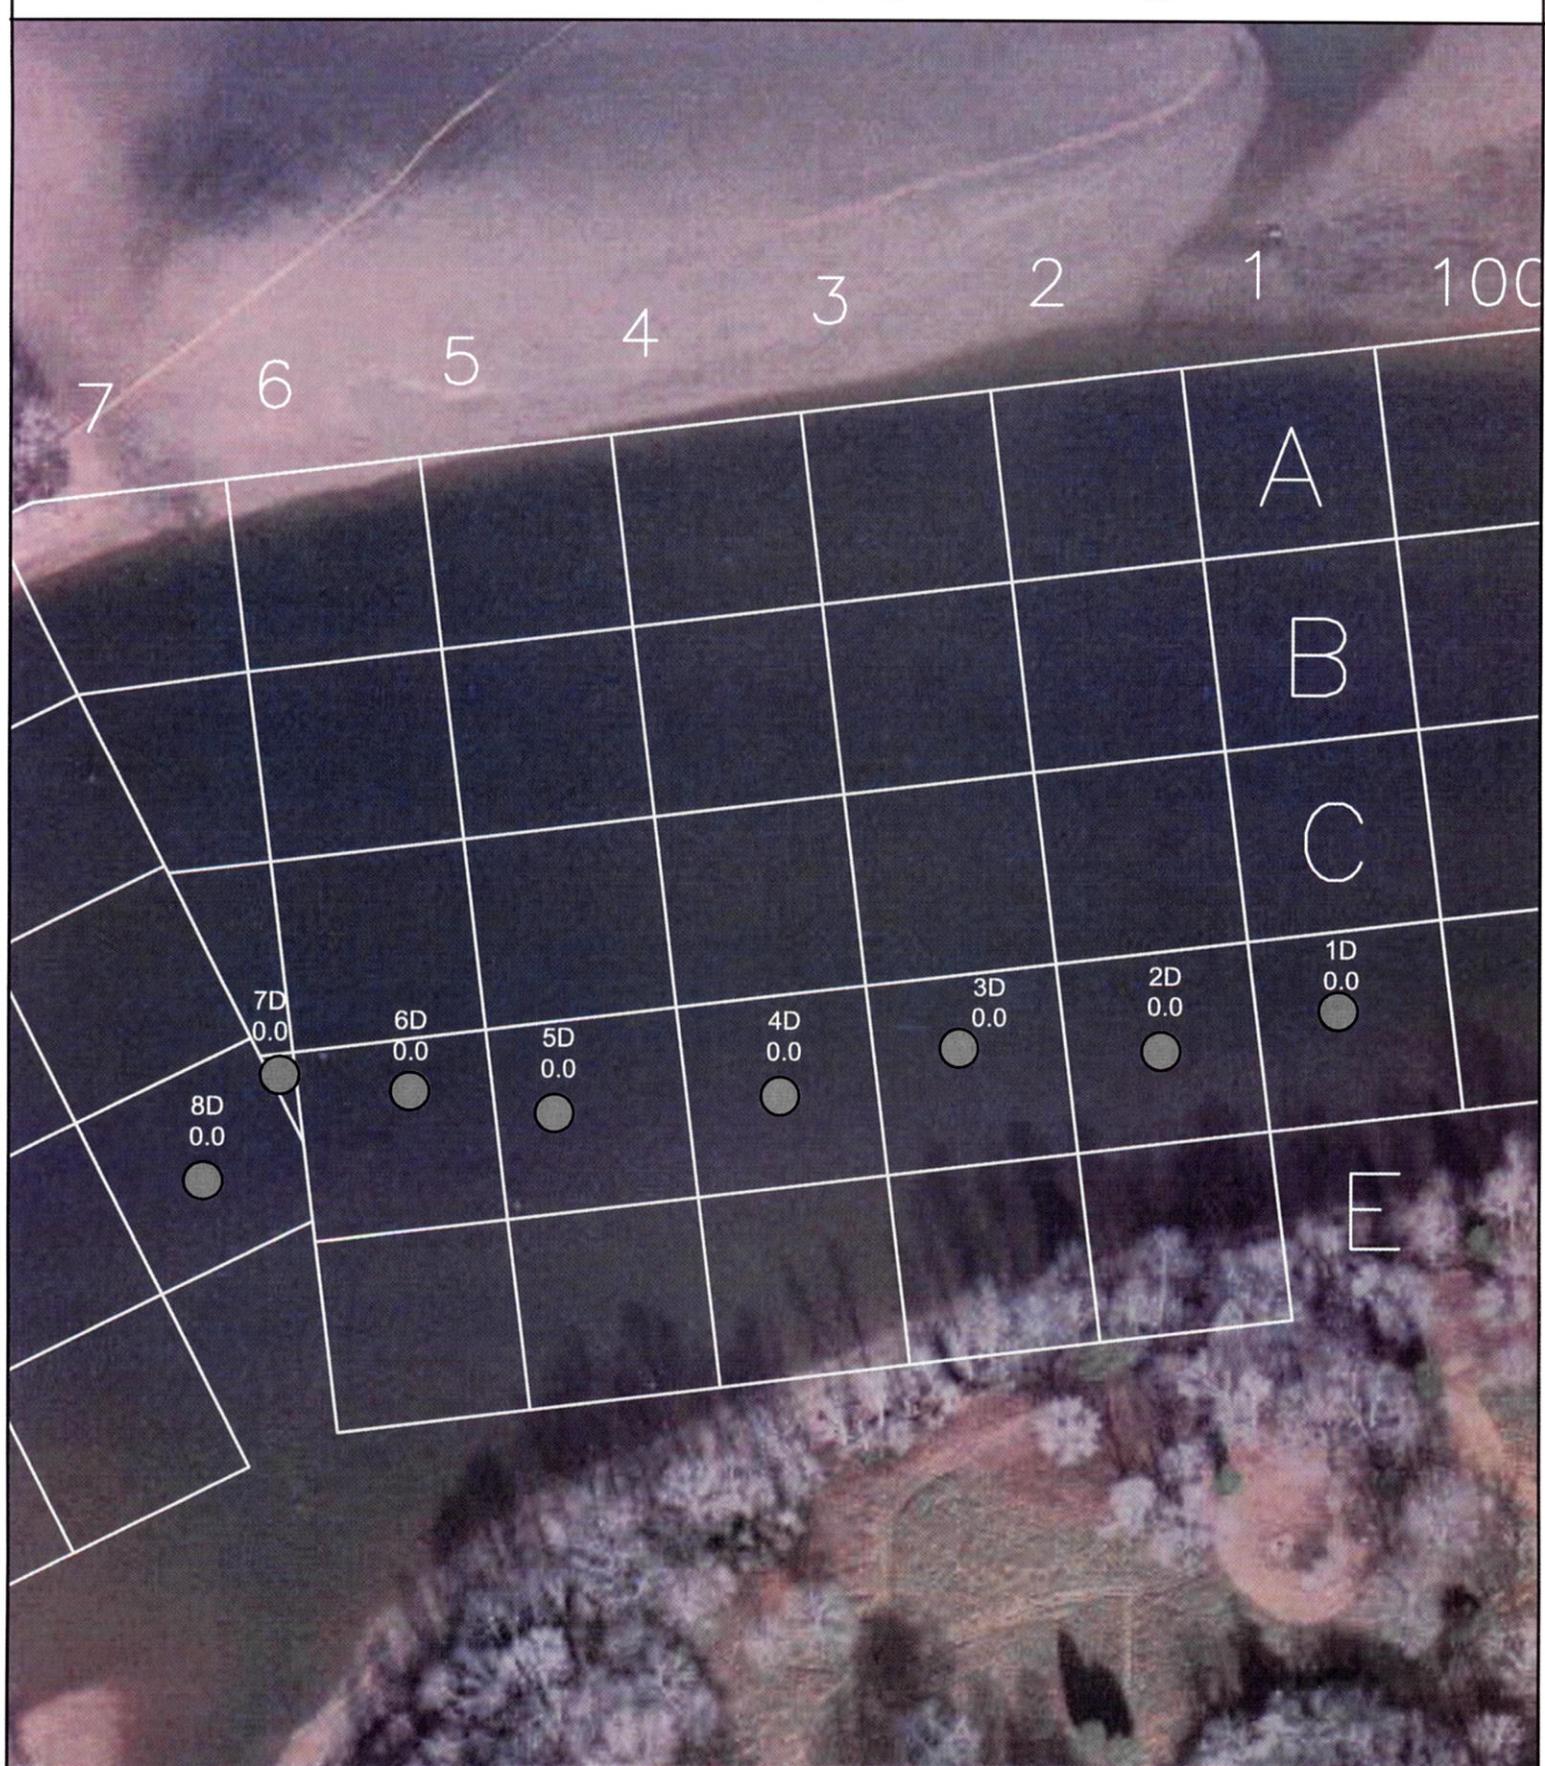
Figure 1

The results of the sediment sampling indicate that the targeted ash removal volume calculated by comparing the pre-spill bathymetry and the post-spill bathymetry surfaces was the result of sediment buildup prior to the post spill survey and that there is no recoverable ash in these grids.

VibeCore Concurrence Sampling Results - Segment 5

VibeCore Label Format:
Core Number
Ash Thickness (ft)

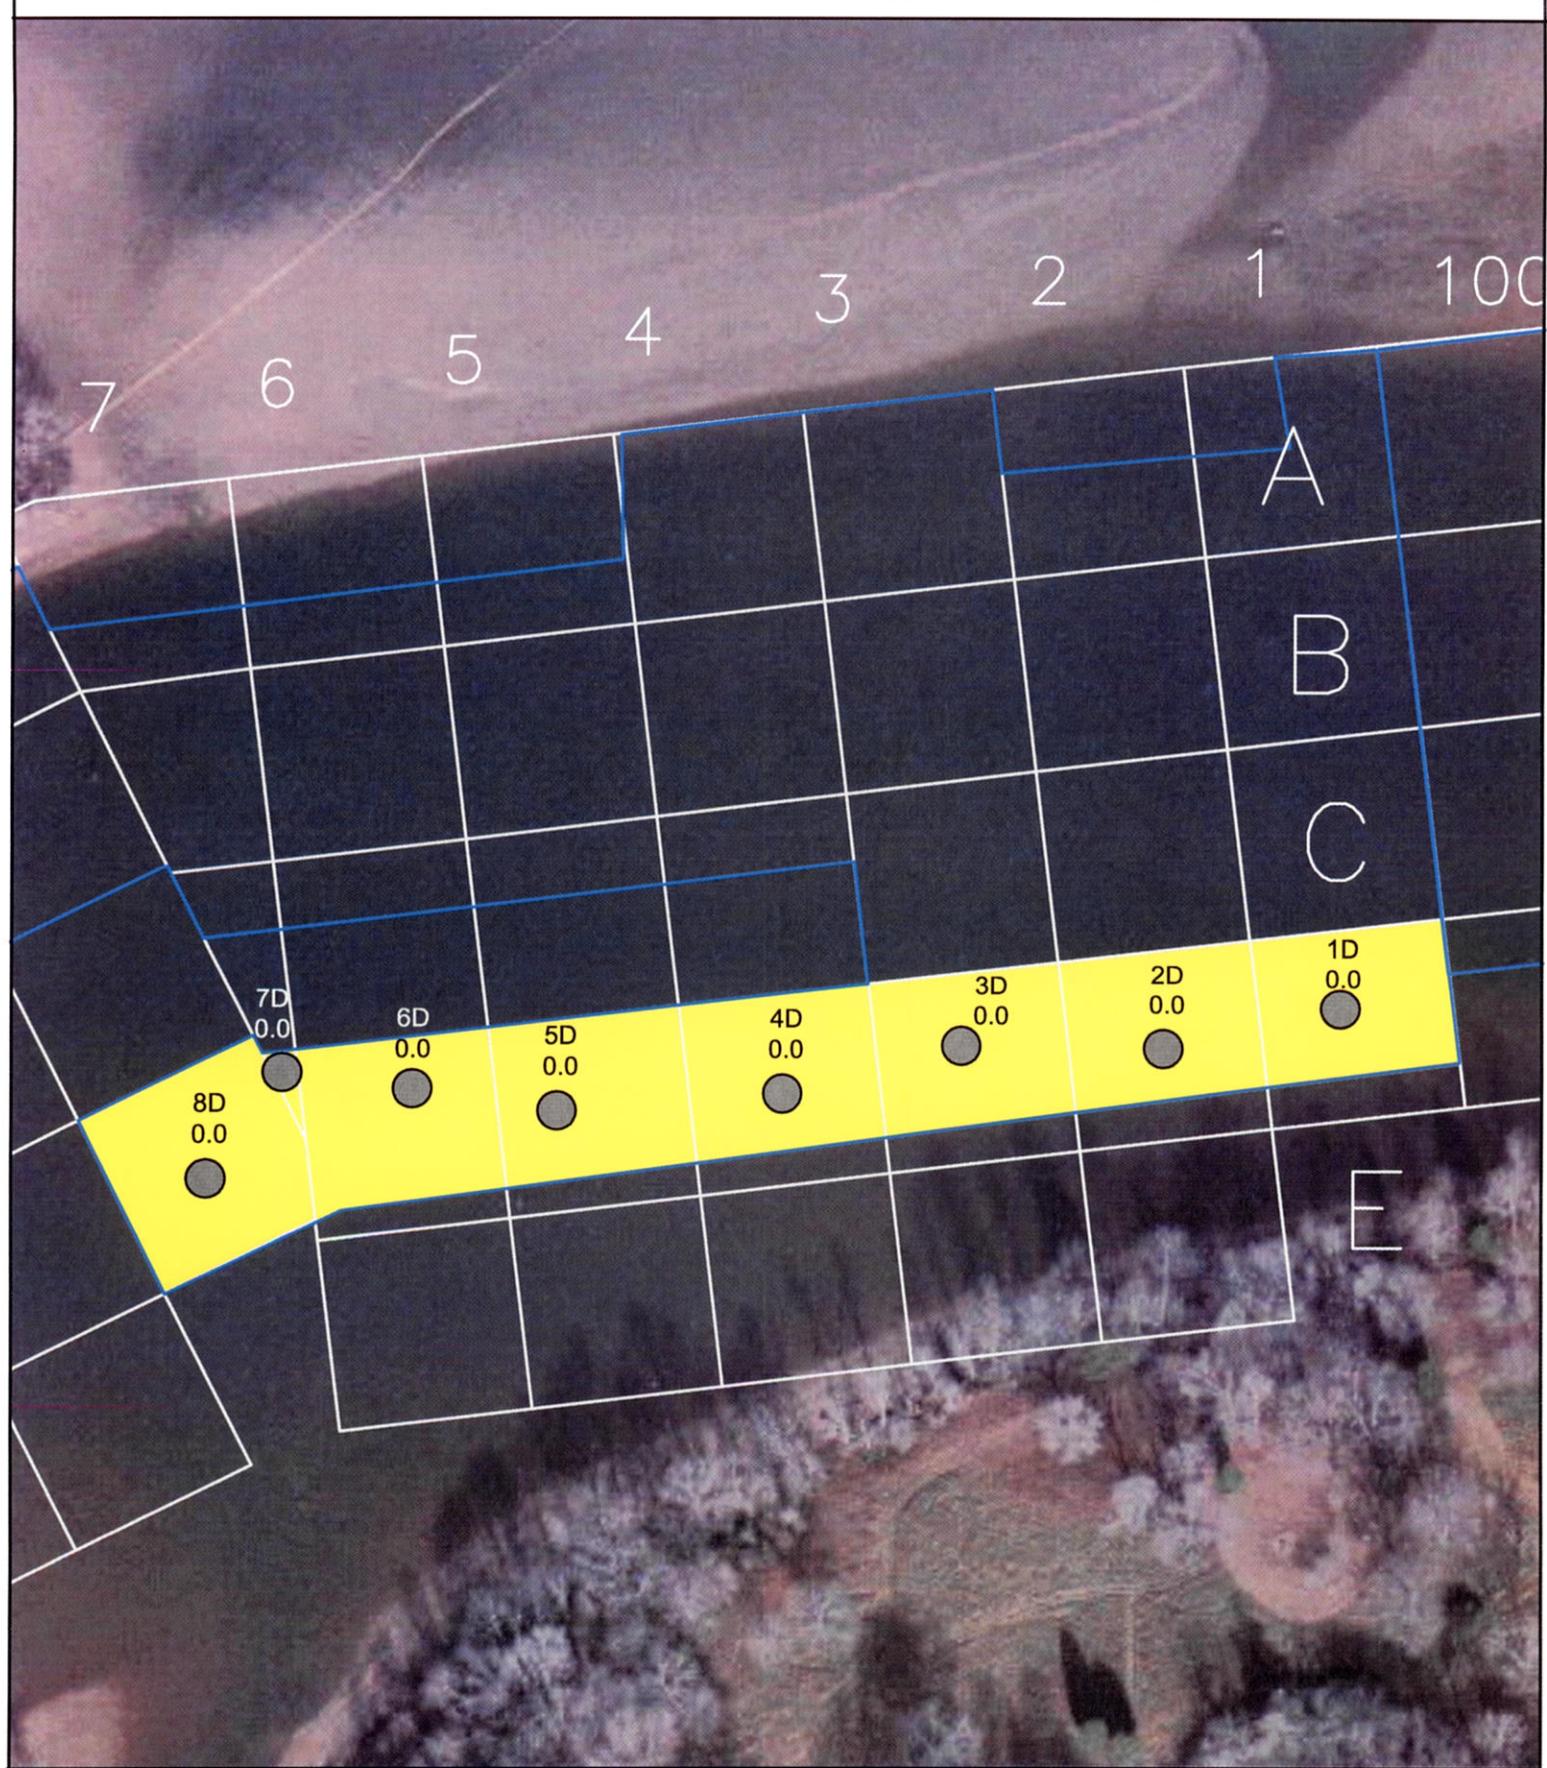
Figure 2

VibeCore Concurrence Sampling Results - Segment 5

● Ash Recovered
● No Ash Present
■ Removed From Plan
— Phase 2 Dredging Path

VibeCore Label Format:
Core Number
Ash Thickness (ft)

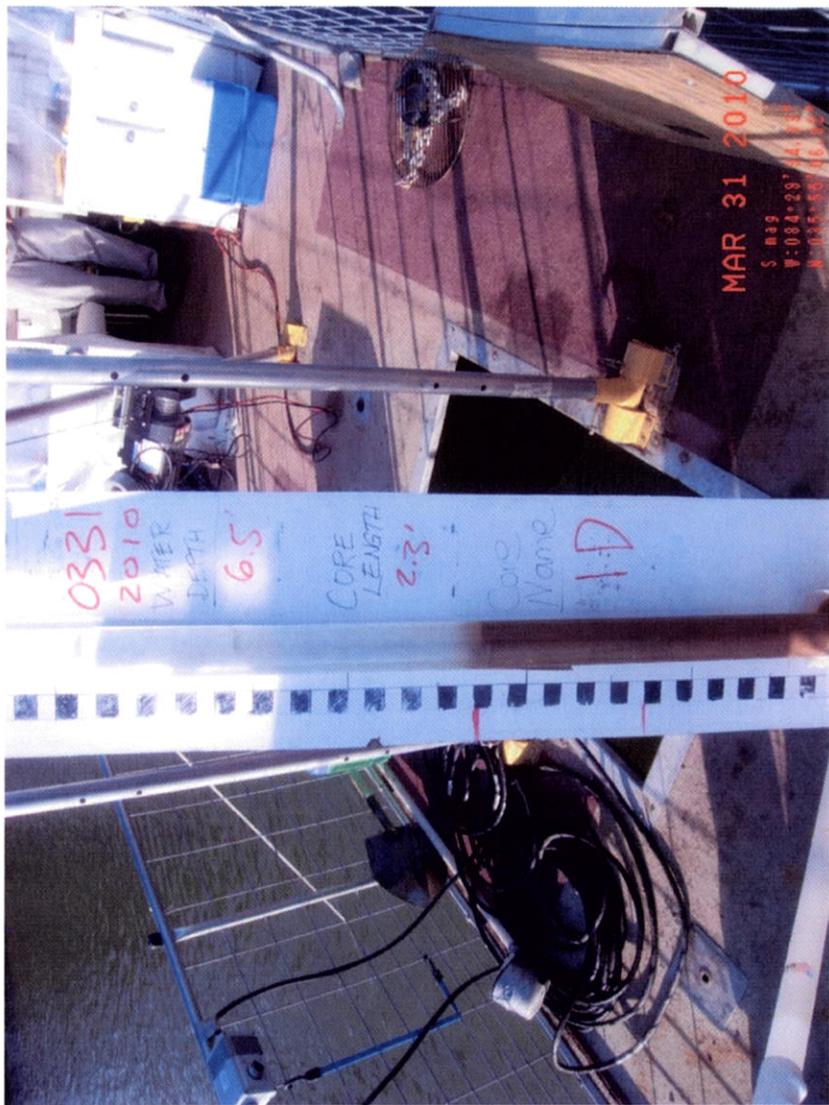
Sunny							Location:			Revised Segment 5 Coordinates		
Core #	Photo #	Tube Type	Core Coordinates	River Depth	Time	Core Description	Interval (ft)					
1D	R0010426	6' Acrylic	N: 559098.17' E: 2446220.93'	6.5'	8:48	Orange loam, some coal fragments Orange clay loam with sand	0.0-1.0	1.0-2.3				
Deviations encountered:												
Core #	Photo #	Tube Type	Core Coordinates	River Depth	Time	Core Description	Total Depth 2.3'			Interval (ft)		
8D	R0010427	6' Acrylic	N: 558986.49' E: 2445484.73'	7.'	9:21	Orange fine sediment with sand Orange fine sediment Orange clay loam	0.0-0.7	0.7-4.1	4.1-5.1			
Deviations encountered:										Total Depth 5.1'		
Core #	Photo #	Tube Type	Core Coordinates	River Depth	Time	Core Description	Interval (ft)			Interval (ft)		
2D	R0010428	6' Acrylic	N: 559071.74' E: 2446106.85'	5.5'	9:44	Orange fine sediments Orange clay loam	0.0-0.4	0.4-2.3	0.4-3.6	0.0-0.4	0.4-3.6	
Deviations encountered:

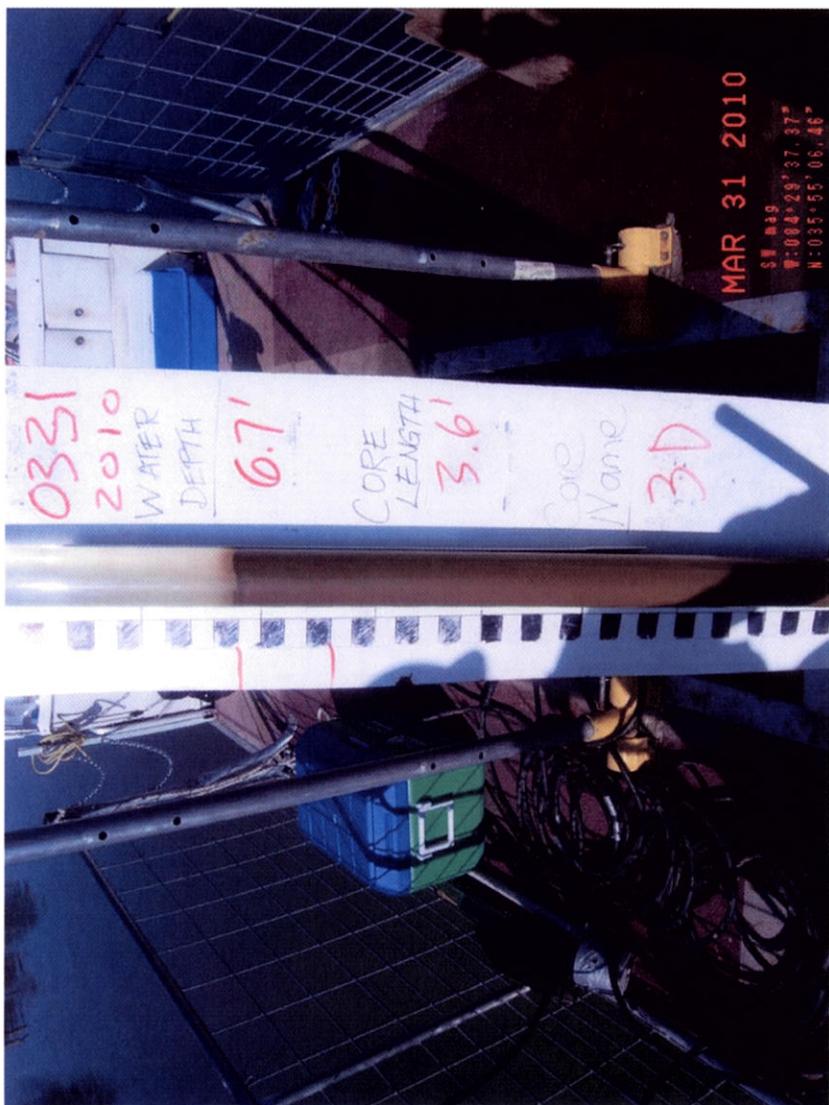
Core #	Photo #	Tube Type	Core Coordinates	River Depth	Time	Core Description	Total Depth 2.3'			Interval (ft)		
3D	R0010429	6' Acrylic	N: 559073.29' E: 2445975.54'	6.7'	10:04	Orange fine sediment Orange clay loam	0.0-0.4	0.4-3.6	0.4-3.6	0.0-0.4	0.4-3.6	
Deviations encountered:										Total Depth 3.6'		
Core #	Photo #	Tube Type	Core Coordinates	River Depth	Time	Core Description	Interval (ft)			Interval (ft)		
4D	R0010430	6' Acrylic	N: 559041.89' E: 2445858.25'	6.5'	10:30	Orange fines with sand Orange clay loam	0.0-0.9	0.9-3.2	0.9-3.2	0.0-0.8	0.8-2.2	
Deviations encountered:												
Core #	Photo #	Tube Type	Core Coordinates	River Depth	Time	Core Description	Total Depth 3.2'			Interval (ft)		
5D	R0010431	6' Acrylic	N: 559030.68' E: 2445710.84'	6.9'	10:50	Orange brown fine sediment Orange clay loam	0.0-0.9	0.9-3.2	0.9-3.2	0.0-0.8	0.8-2.2	
Deviations encountered:												
Core #	Photo #	Tube Type	Core Coordinates	River Depth	Time	Core Description	Total Depth 2.2'			Interval (ft)

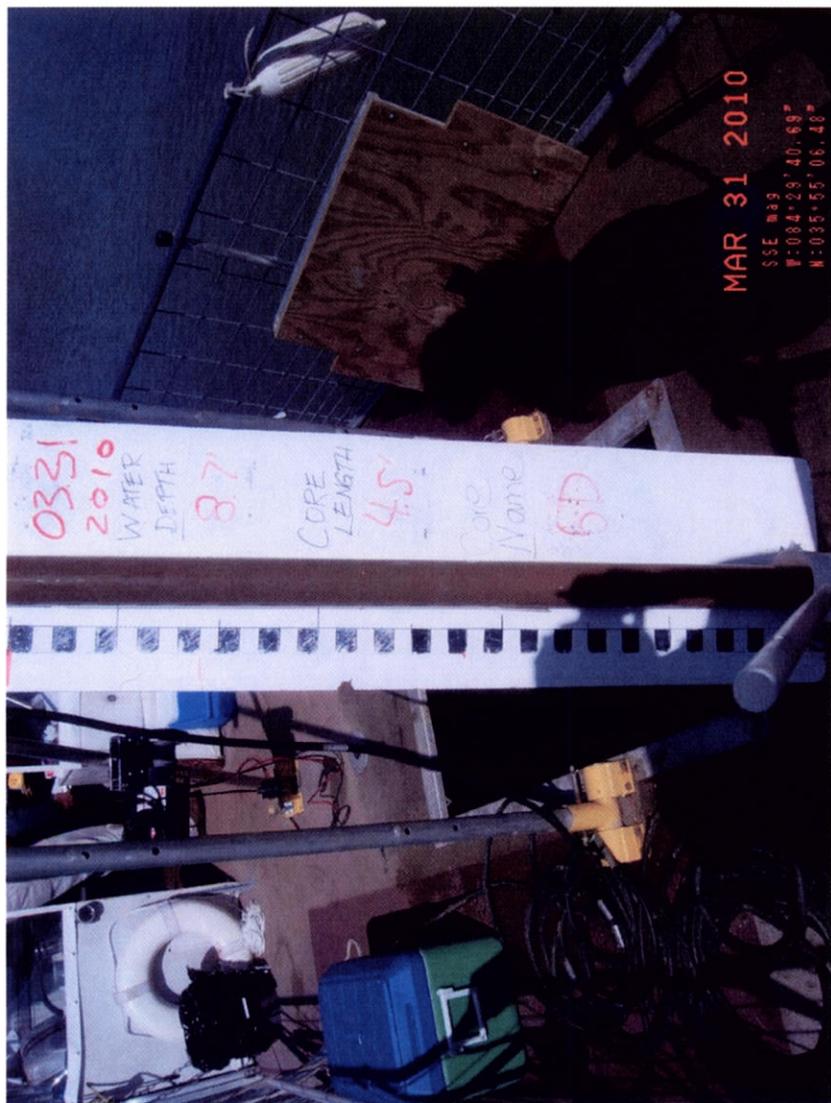
6D	R0010432	6' Acrylic	N: 559045.07' E: 2445617.08'	8.7'	11:03	Orange fines with trace coal fragments Orange clay loam	0.0-0.9	0.9-4.5	0.9-4.5	0.0-0.9	0.9-4.5	
Deviations encountered:												
Core #	Photo #	Tube Type	Core Coordinates	River Depth	Time	Core Description	Total Depth 4.5'			Interval (ft)		
7D	R0010433	6' Acrylic	N: 559055.64' E: 2445533.53'	14.4'	11:17	Orange fines with coal fragments and OM Orange clay loam Orange clay	0.0-1.4	1.4-3.5	3.5-4.9	0.0-1.4	1.4-3.5	
Deviations encountered:										Total Depth 4.9'
