# KINGSTON ASH RECOVERY PROJECT MONTHLY REPORT December 2011

# KINGSTON ASH RECOVERY PROJECT

## MONTHLY REPORT

December 2011

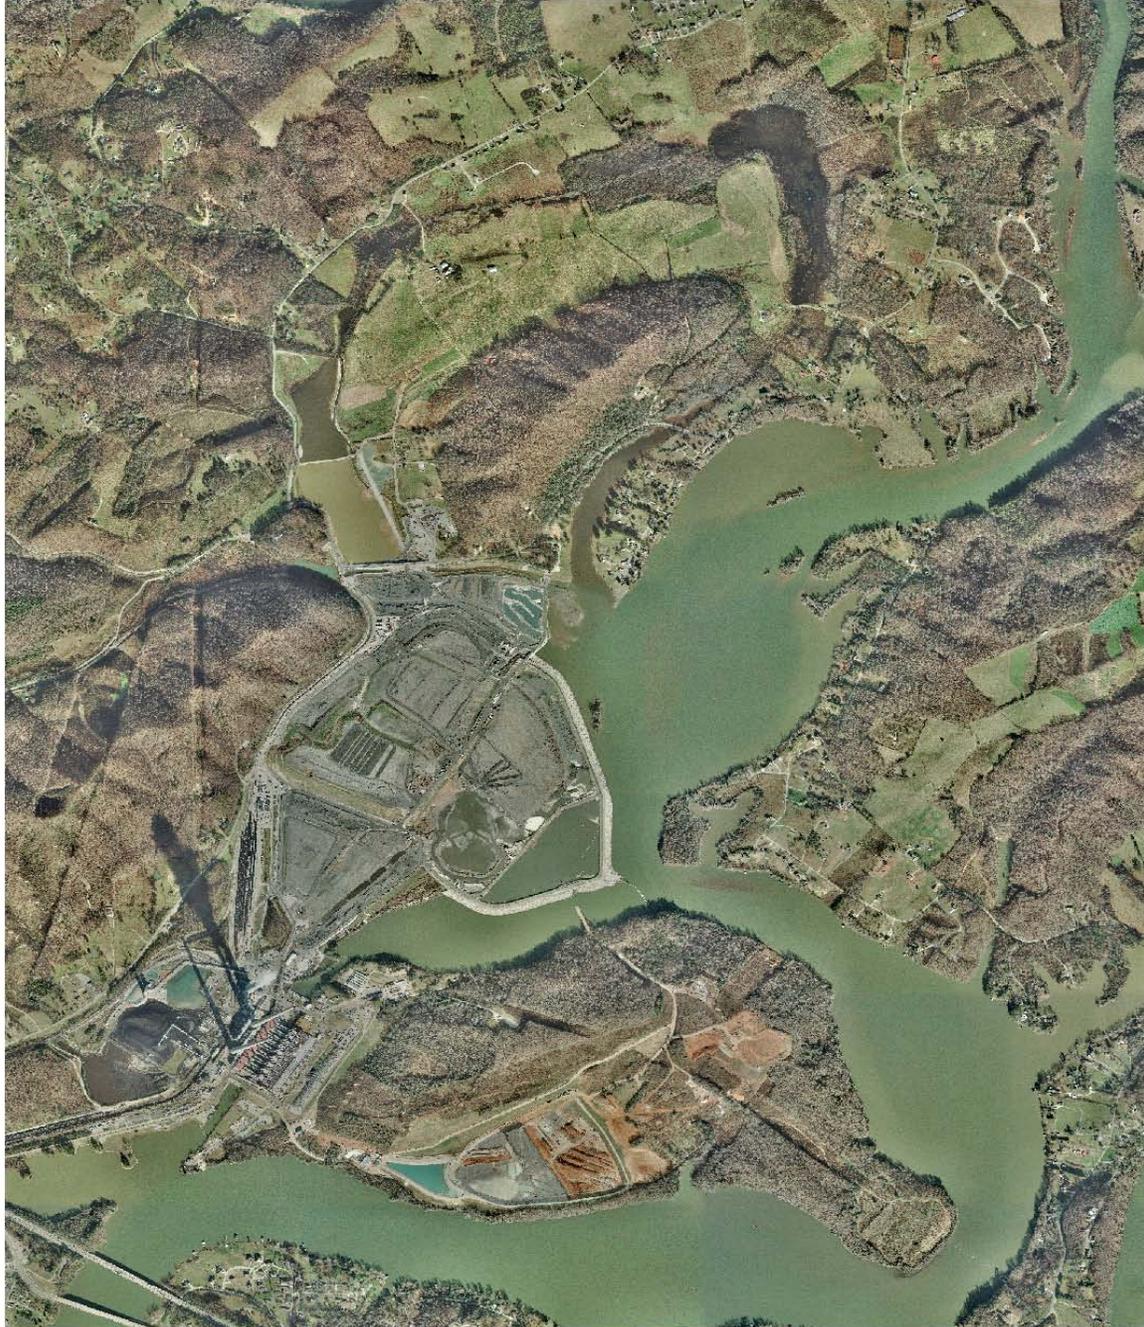
**Aerial Image of Kingston Ash Slide (12/02/2011)**

Date of imagery: 12/02/2011

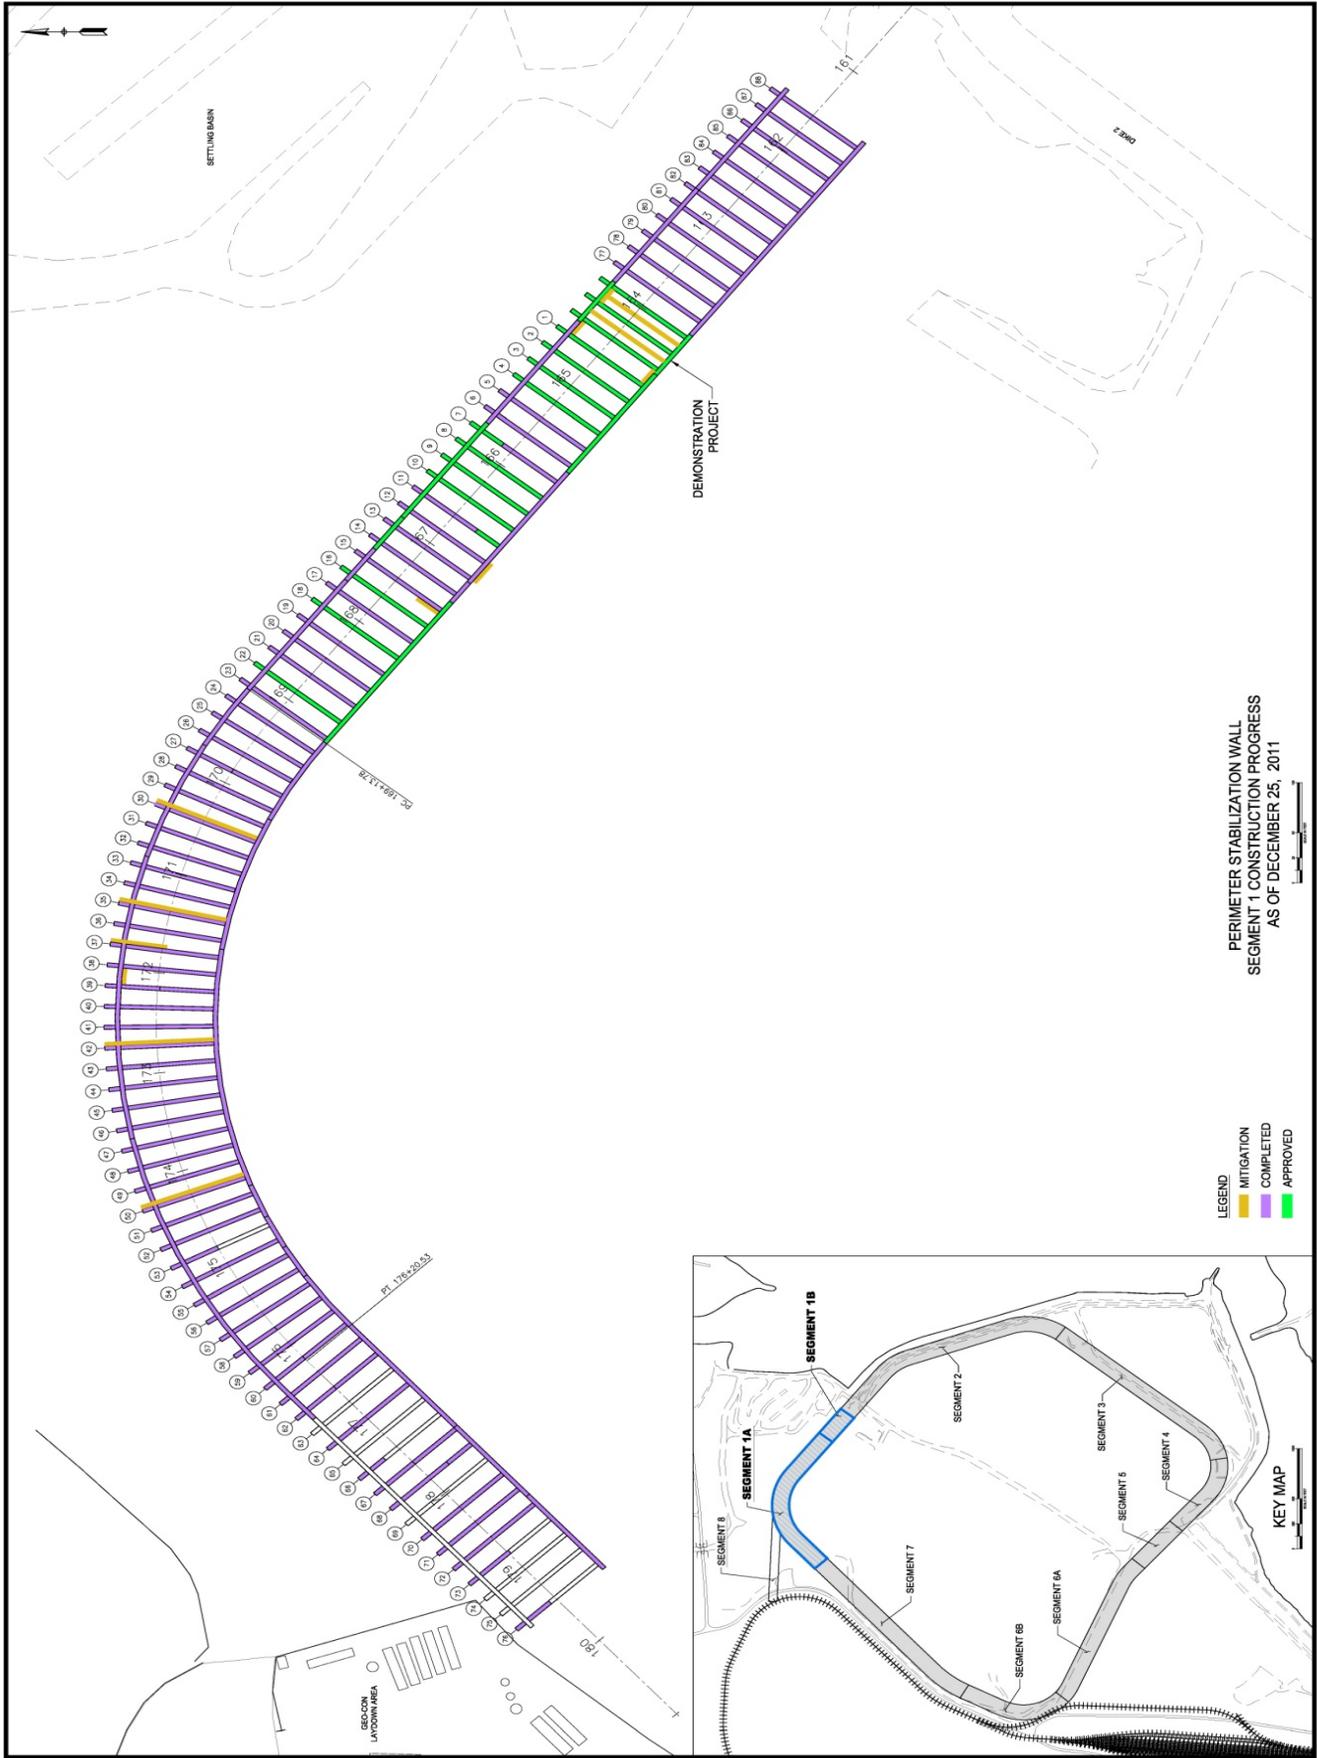
PERIMETER STABILIZATION WALL  
 SEGMENT 1 CONSTRUCTION PROGRESS  
 AS OF DECEMBER 25, 2011

- Continued PWS construction of Segment 1 at the transition slope in the northwest corner of the dredge cell and Segment 1B in the eastern end of the Segment. Work locations are being spread out to avoid areas where subgrade has become wet.
- Completed preparation of the Segment 8 working platform, including test sections for rock surfacing, rock surfacing with geogrid reinforcement, and bottom ash, but holding off on the lime-treated test section until just prior to wall construction.
- Stantec design team continued running computer FLAC models for redesign of Segments 7 and 8.
- Stacking continued in north dredge cell until conditions became too wet.
- Stantec design team was onsite to evaluate defect and cold joint repairs.

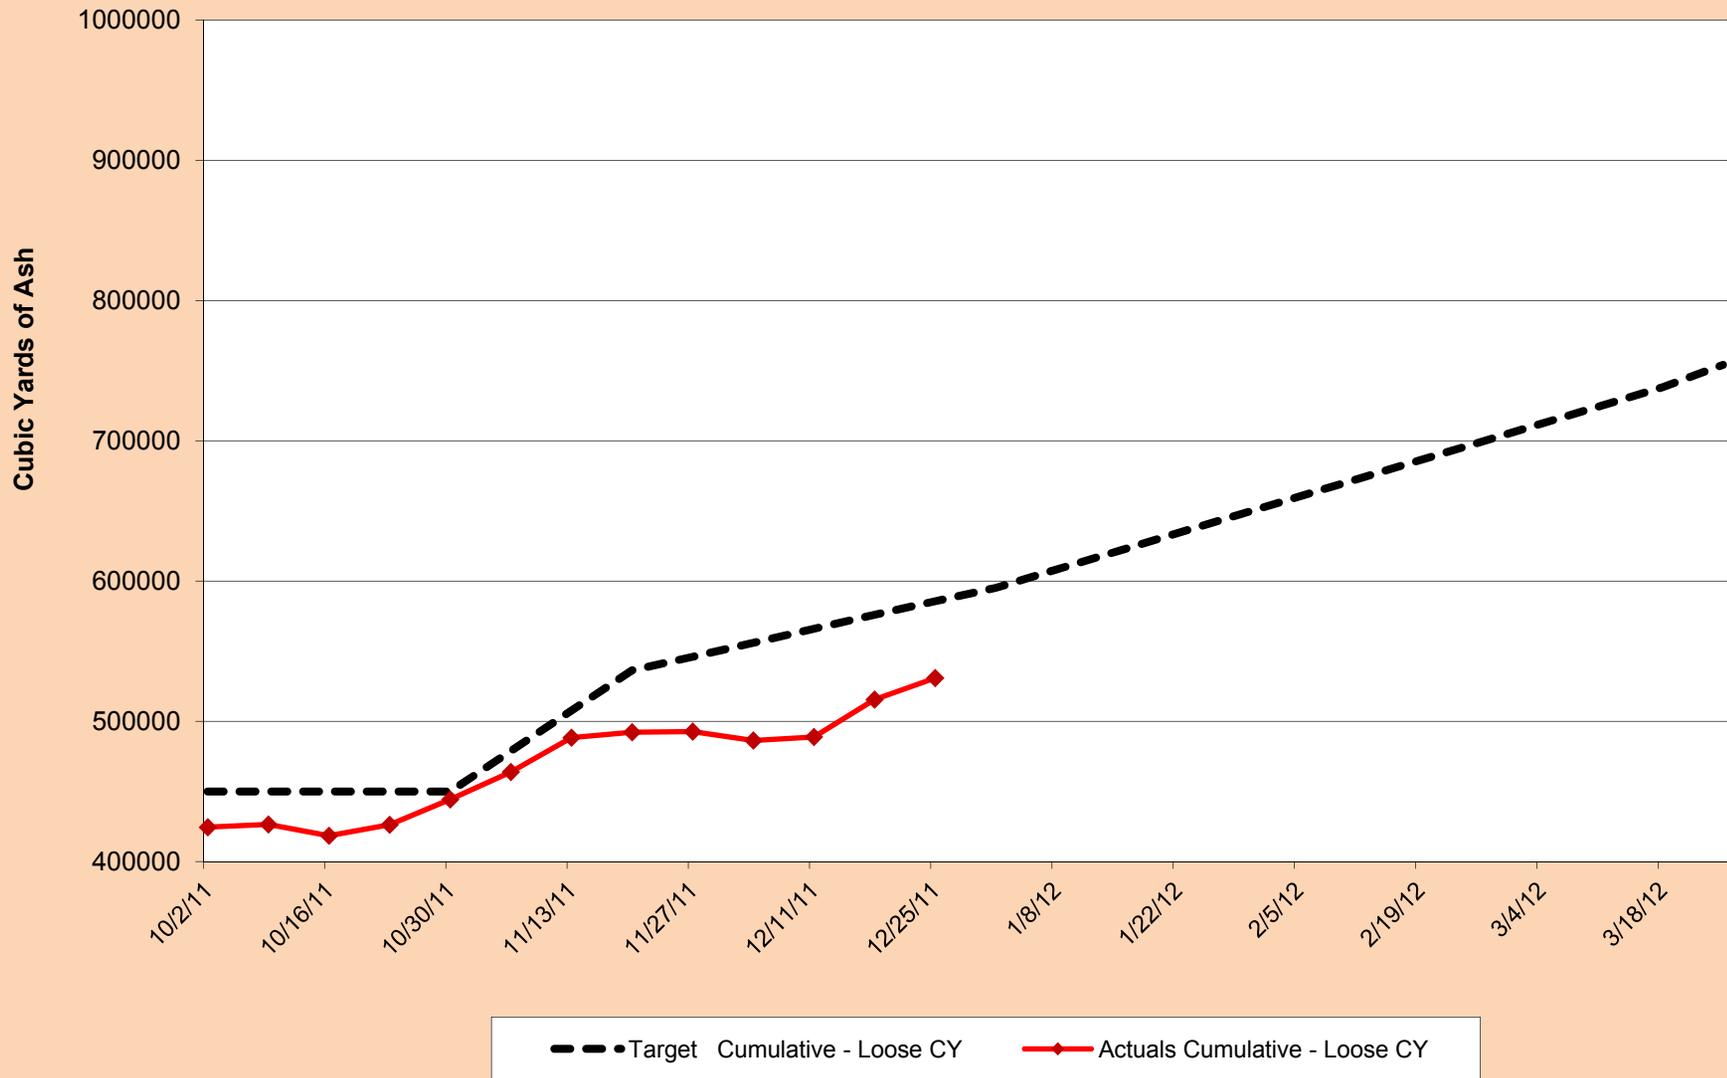
### Ash Excavation from Middle Embayment as of December 25

- Continued bulk excavation work from west to east.

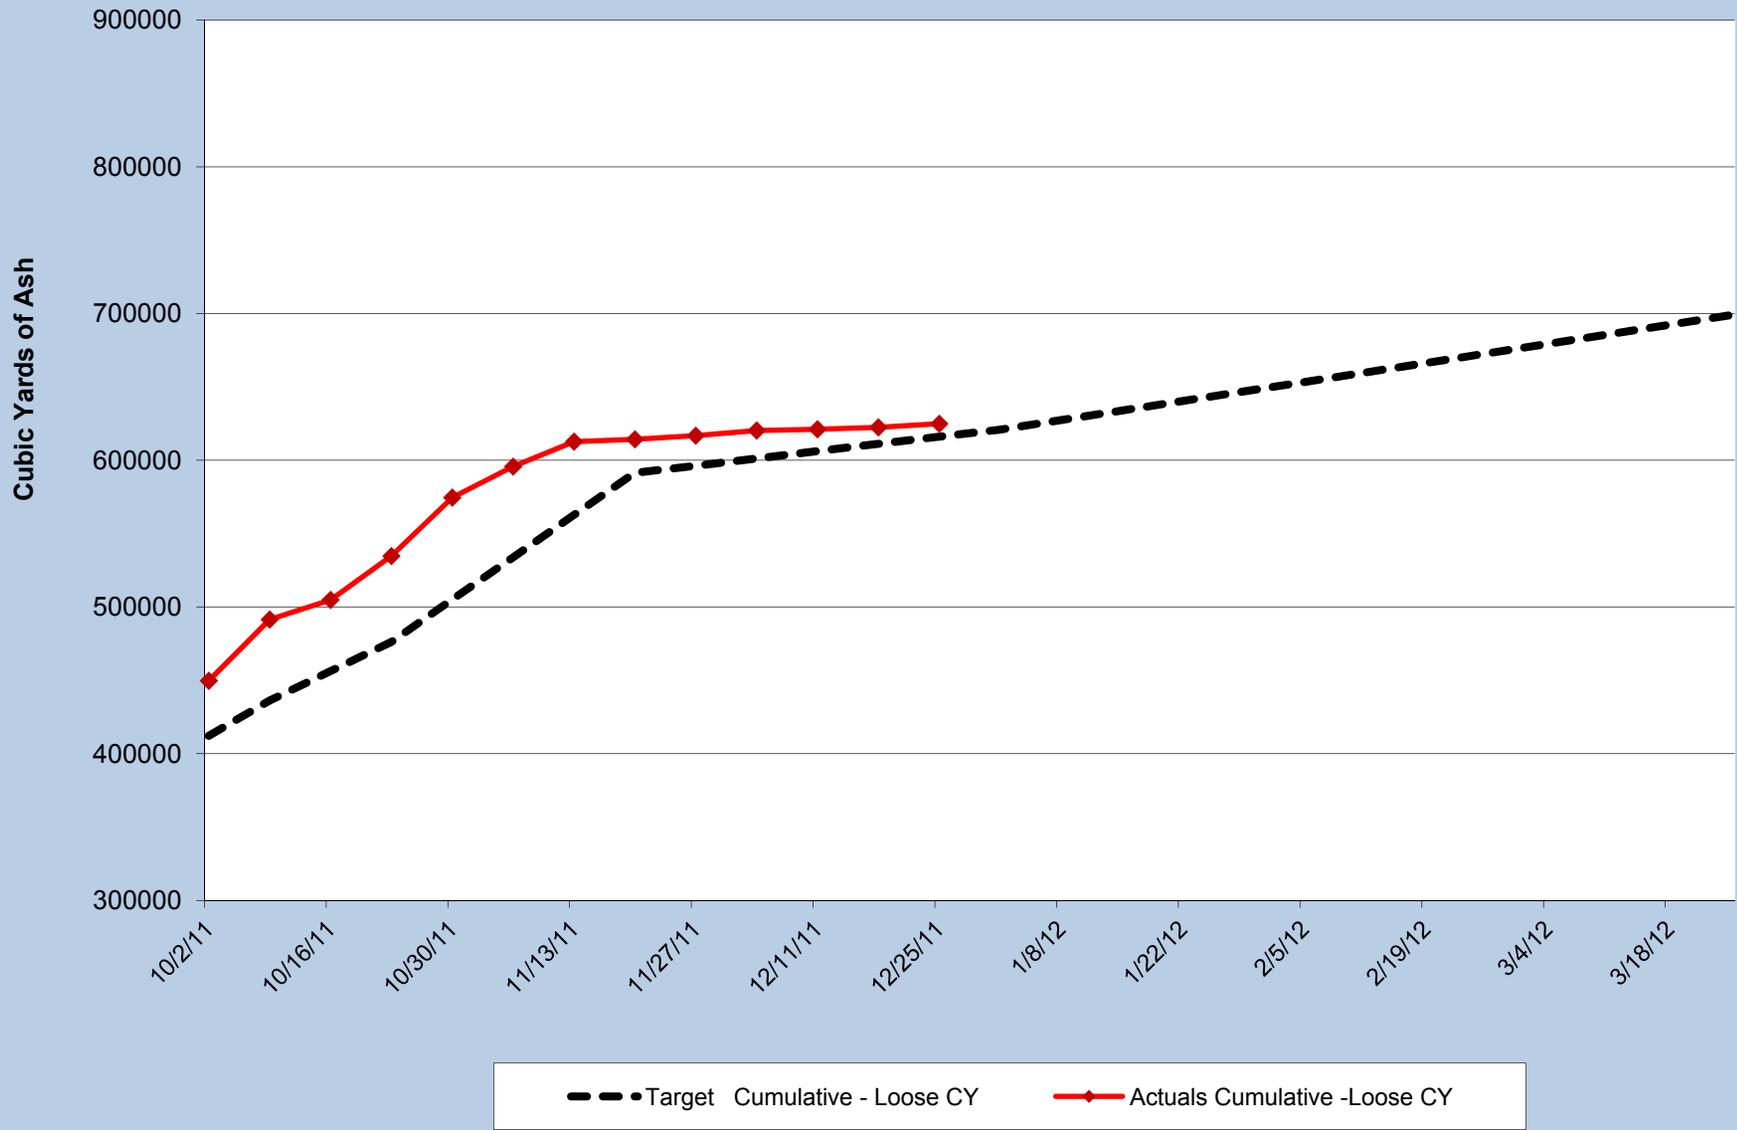
### Ash Stacking in Lateral Expansion as of December 25

- Restrictions remain that limit stacking to a maximum of 1 foot per day. These restrictions are in response to lateral movements observed in several slope inclinometers.
- No stacking was done for much of the month in the lateral expansion due to wet conditions; stacking continued the last week of the month.
- Wet ash was placed in the ash pond in preparation of the subgrade prior to stacking.
