KINGSTON ASH RECOVERY PROJECT

MONTHLY REPORT

July 2011

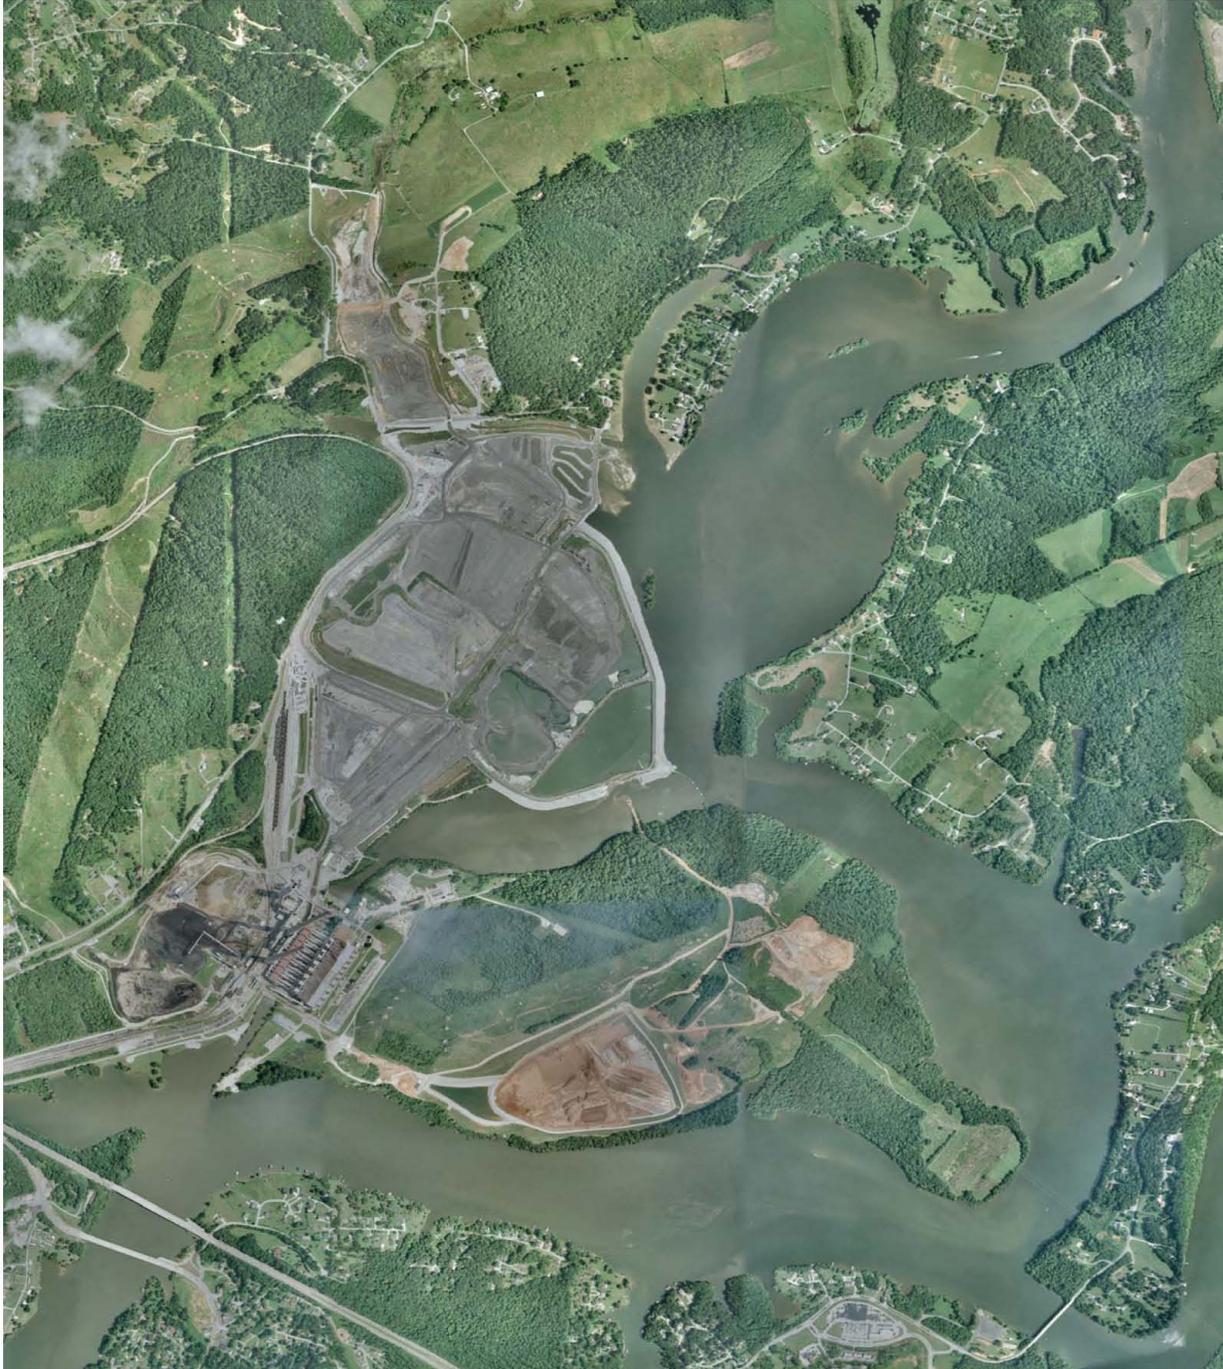
Aerial Image of Kingston Ash Slide 07/06/2011
Water Surface Elevation : 740.67'

Date of Photography : 07/06/2011

Water Surface Elevation is the
Watts Bar Headwater Elevation
Tennessee Valley Authority
Geographic Information & Engineering

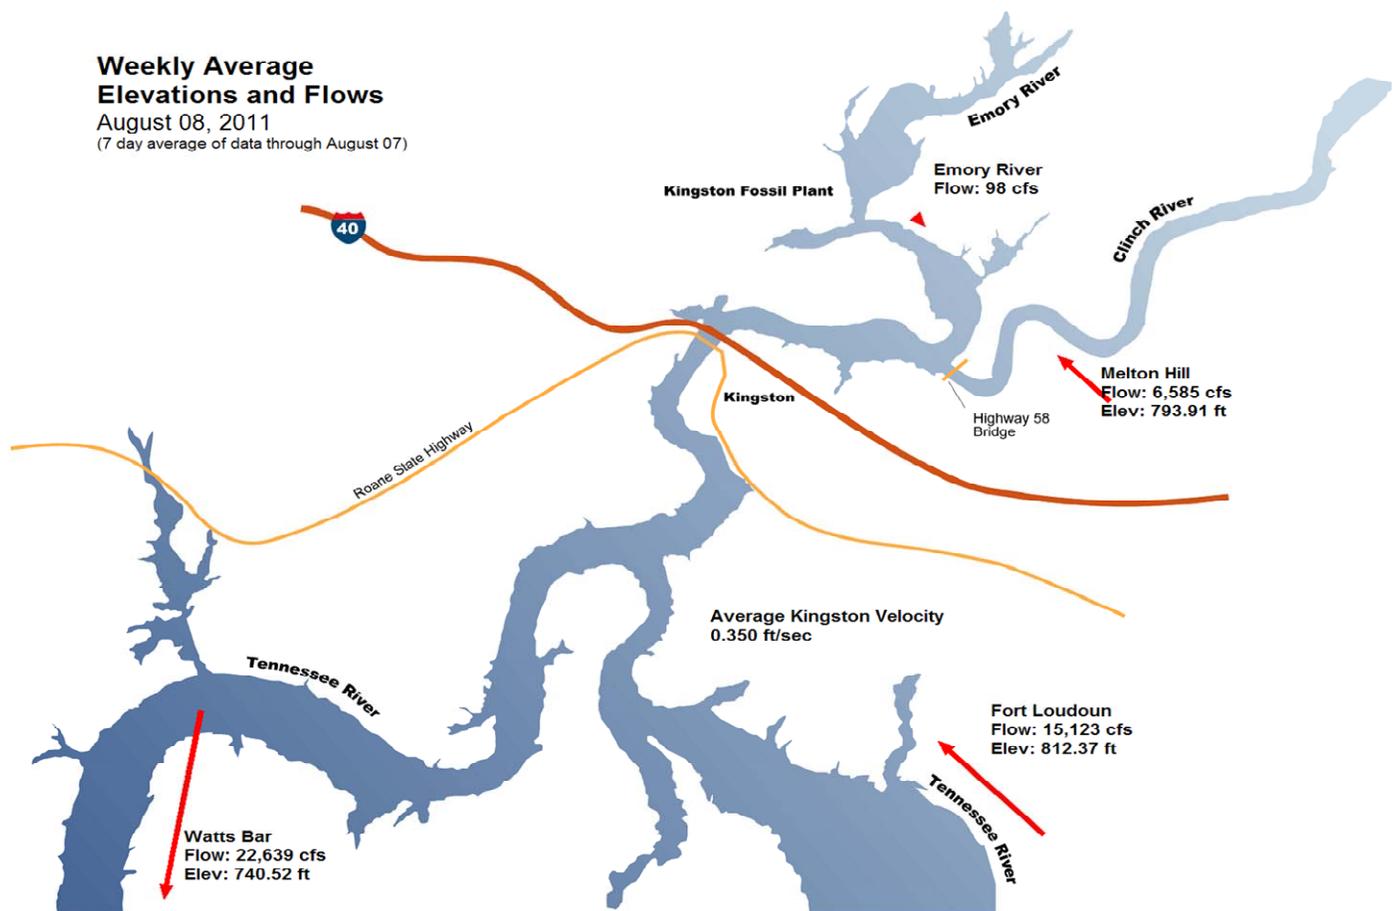
Weekly Average Elevations and Flows

August 08, 2011
(7 day average of data through August 07)

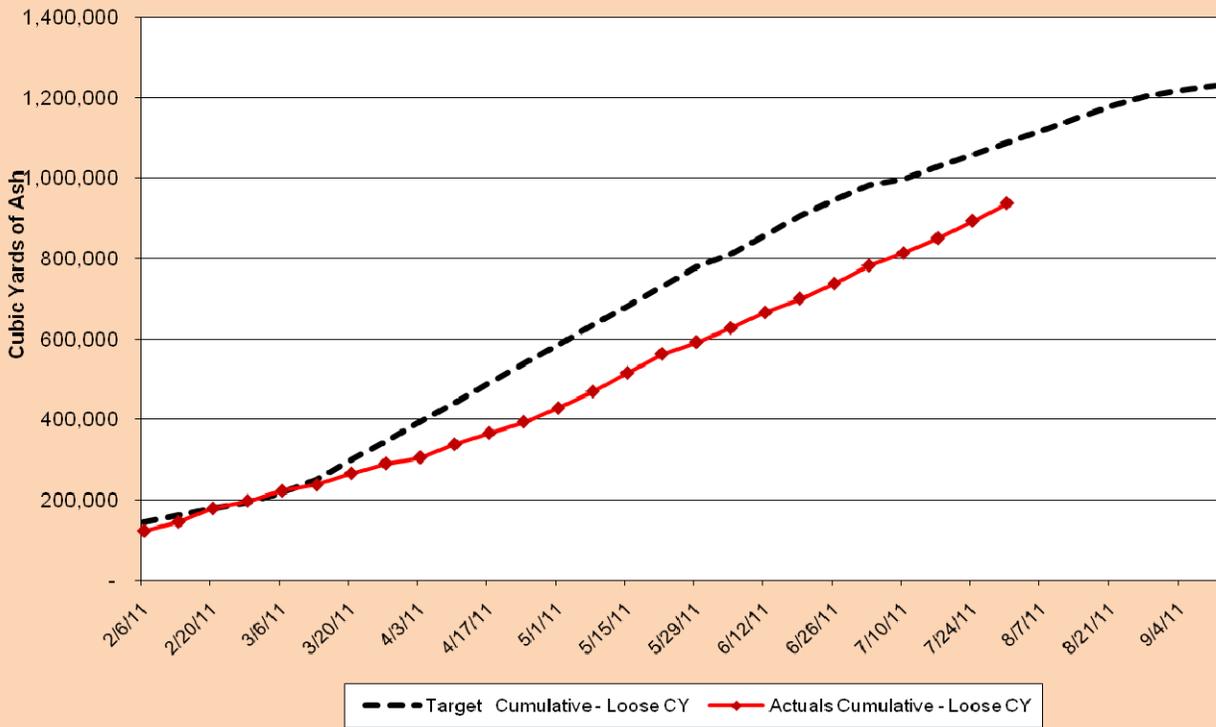
Ash Excavation from North Embayment - Weekly
as of July 31st

- Continued excavation of ash.
- Completed installation of clay berm for water diversion.
- Performed confirmation sampling and reporting process for verifying areas are clean of ash deposits.

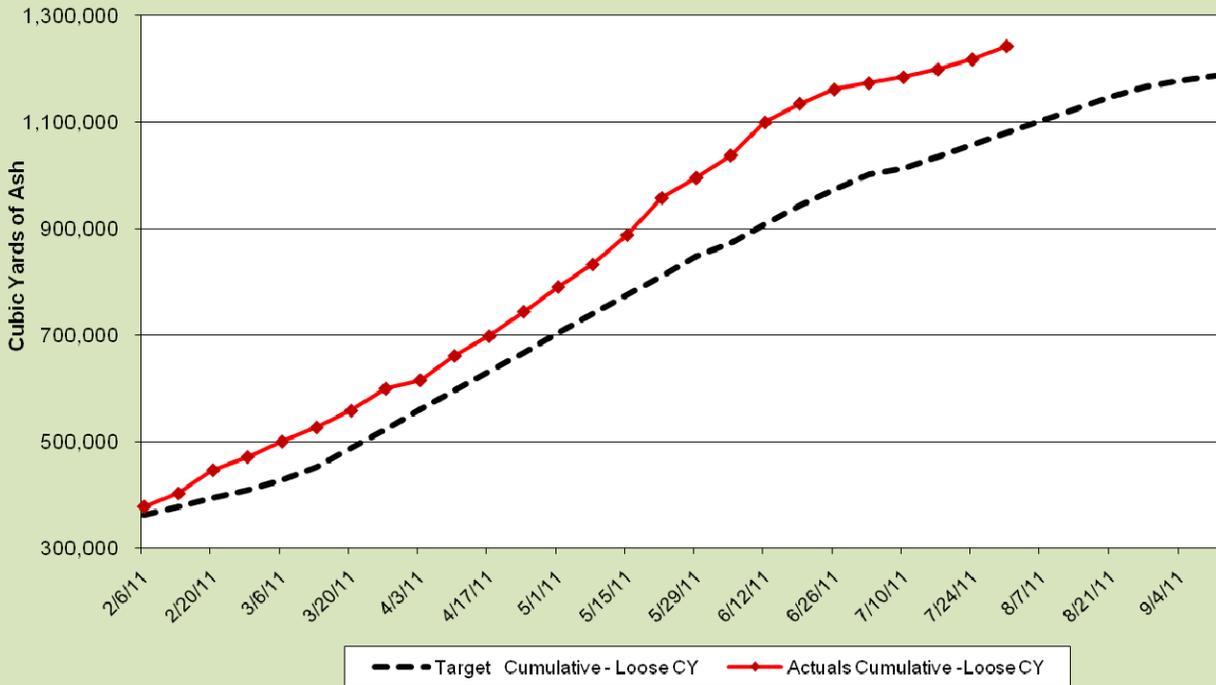
Ash Stacking in Dredge Cell - Weekly
as of July 31st

- Issued a revised set of technical specifications and quality control plans for construction of the Perimeter Wall Stabilization (PWS) for Segment 1 – North Dredge Cell (Dike C).
- Held a briefing with the regulators on the revised PWS design, including the revised specifications and QC plans.
- Completed installation of the shear walls for repair of the demonstration section of the PWS.
- Began construction of the full-scale PWS in the North Dredge Cell (Dike C), also referred to as Segment 1.
- Continued stacking in the central Dredge Cell.

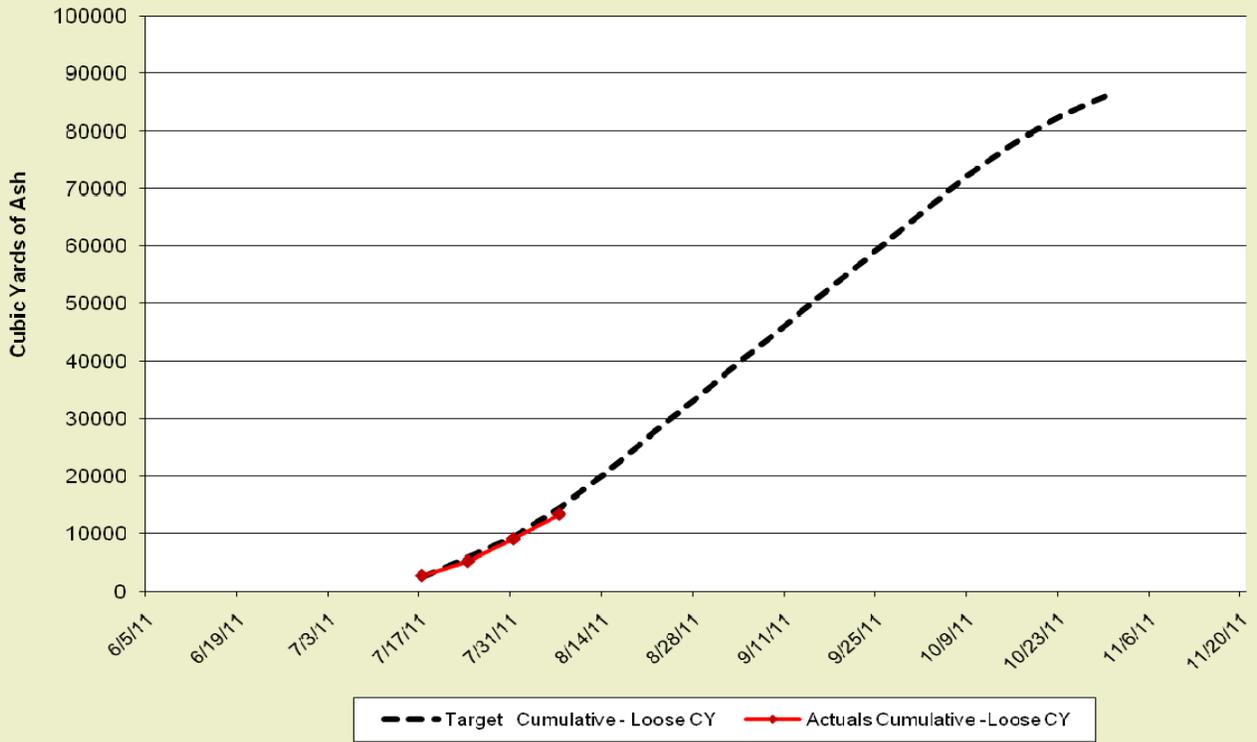
Perimeter Wall Stabilization Segment 1A - Weekly
as of August 7th
