# TVA Kingston Ash Recovery Project Roane County, TN

Status Update – December 8, 2011

Craig Zeller, P.E.

US EPA Region 4 – Superfund Division

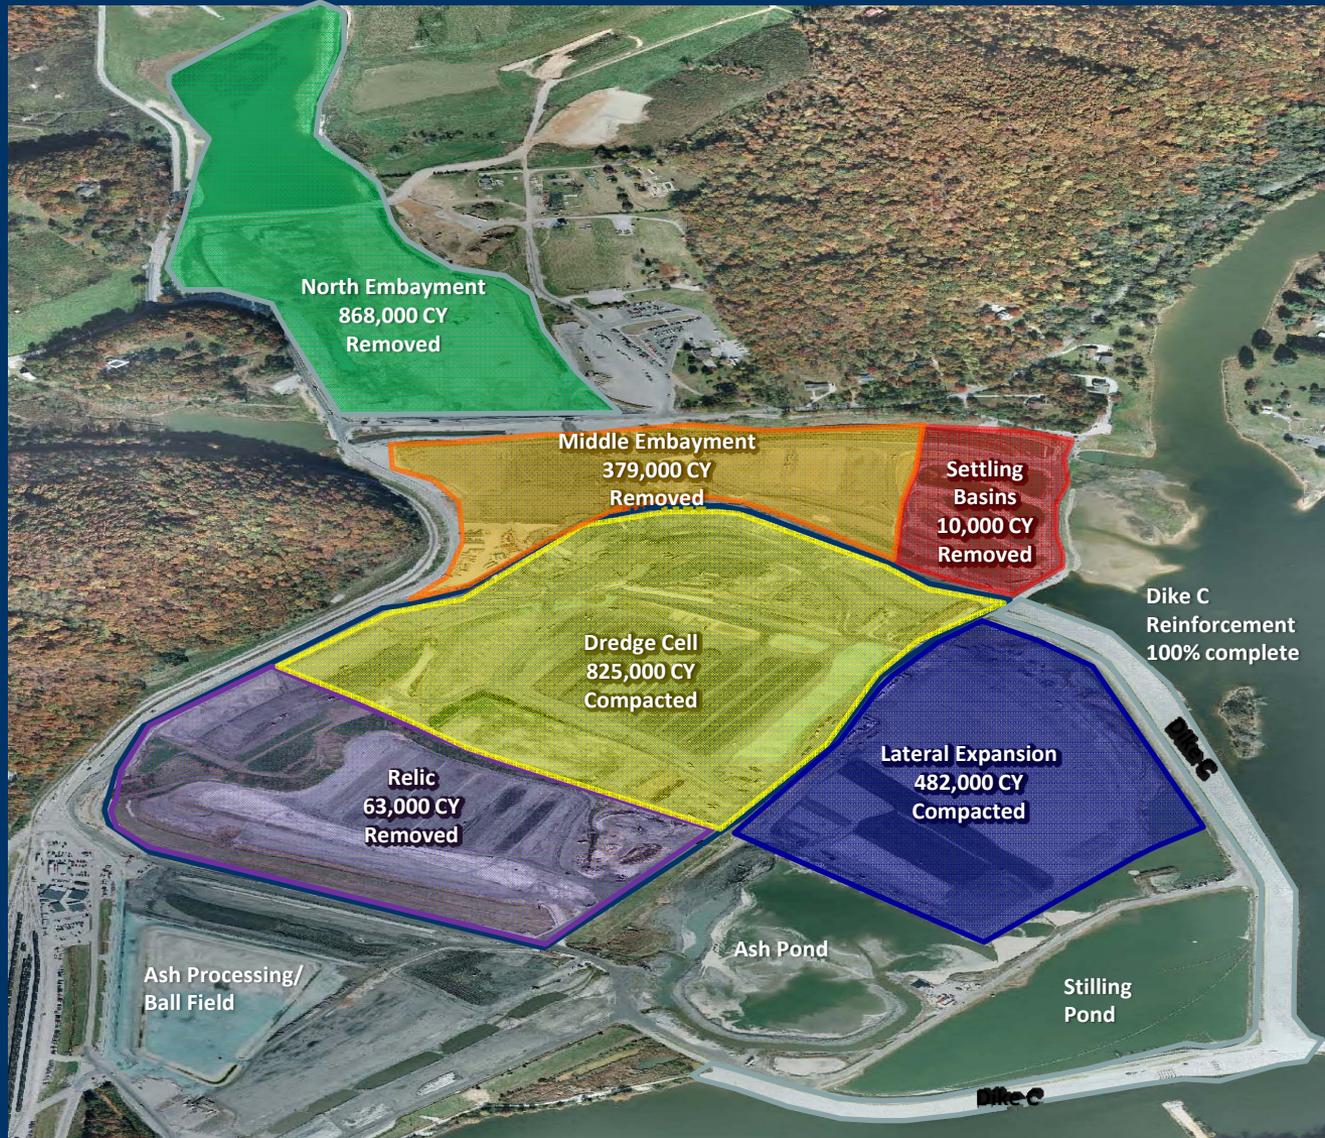
# Phase 2 Work Areas

\*amounts representative of in-place estimates as of December 1, 2011

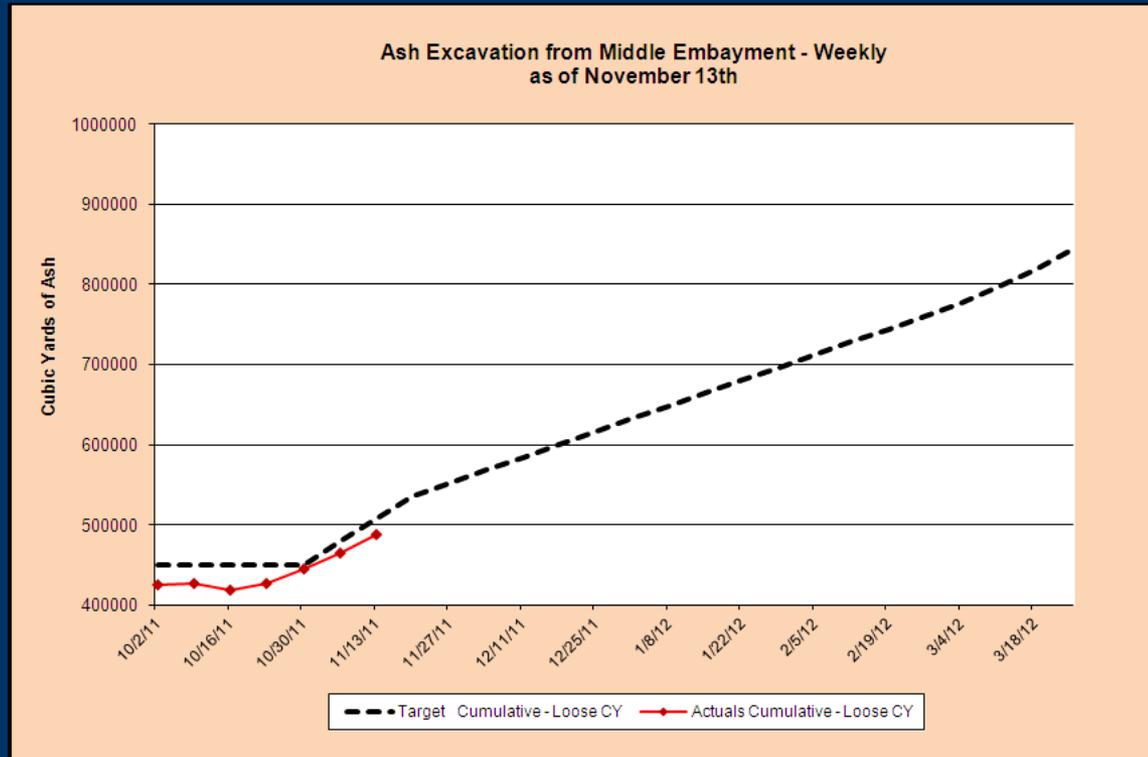
# Ash Excavation

- North embayment ash excavation complete
  - 868,000 CY removed (1,212,000 CY loose)
- Excavate middle embayment ash
  - 379,000 of 1, 048,000 (492,000 CY loose)
  - Stacked in dredge cell and lateral expansion
  - Expected completion **November 2012**

\*amount in loose CY

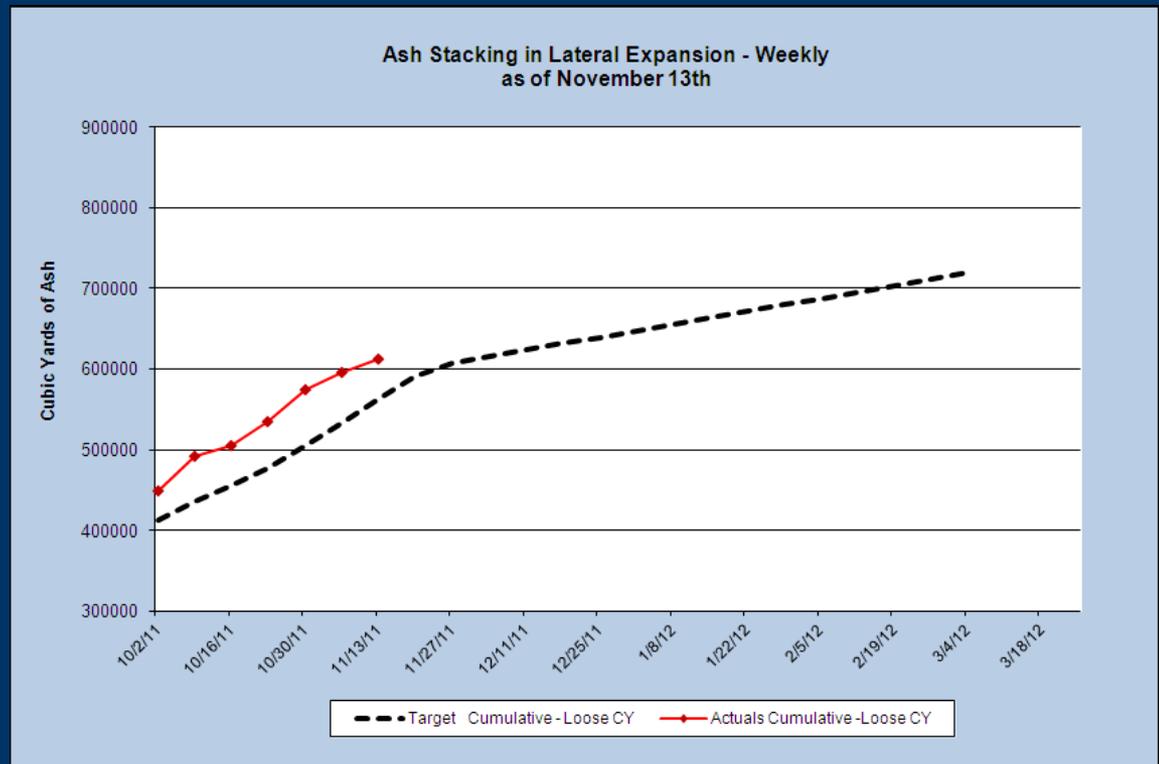
# Ash Stacking

- Dredge Cell
  - 53% complete (1.3 of 2.5 million cy)
- Lateral Expansion
  - 43% complete (640k of 1.5 million cy)
- Ash Pond
  - Recently initiated

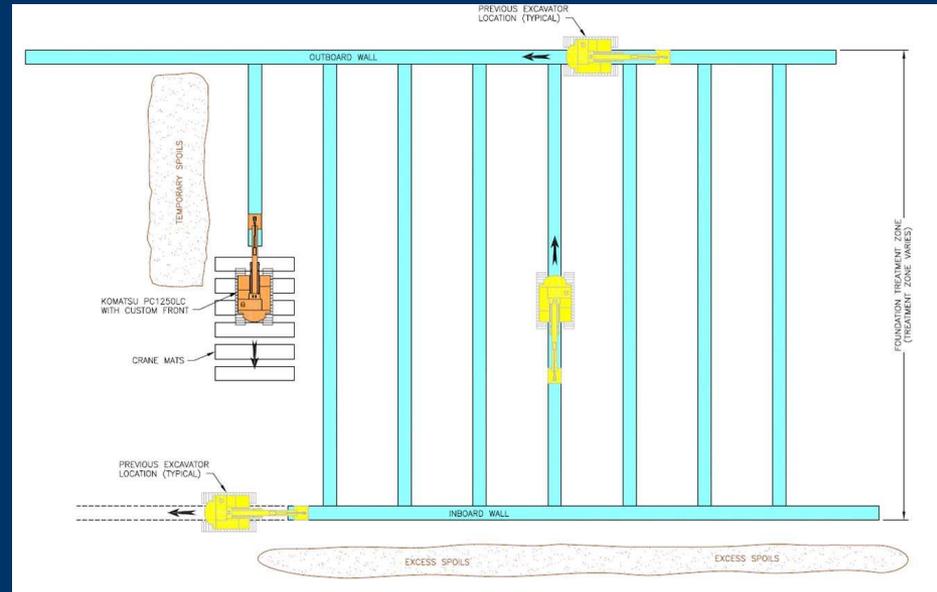
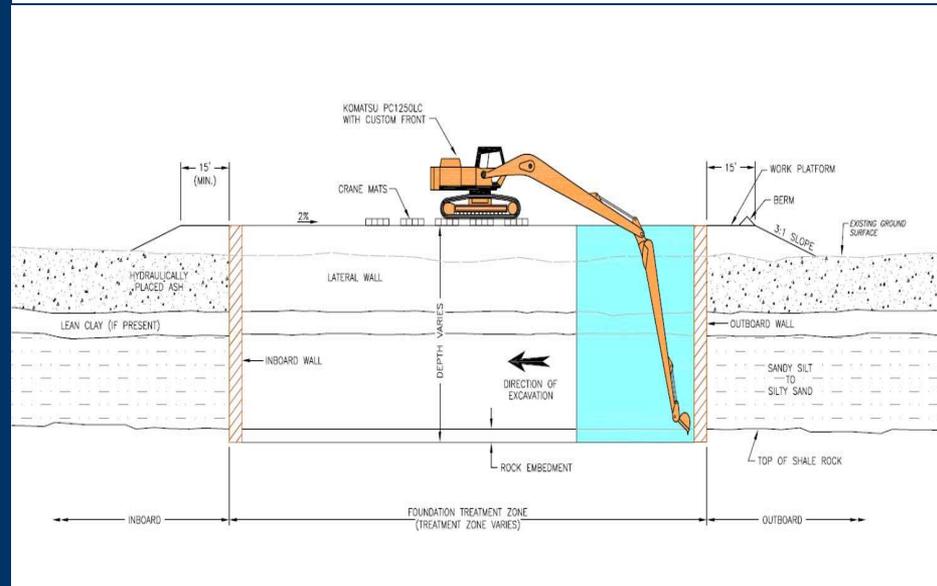
# Perimeter Wall Stabilization

- Design based on 3-D Seismic Model (FLAC)
  - 6.0 earthquake on East TN fault
  - 7.6 earthquake on New Madrid fault
- ≈11,500 linear feet (around perimeter of cell)
- 50-70 feet BGS
- Keyed 2-3 feet into shale bedrock
- Average UCS is 280 psi
- GeoCon contracted to construct

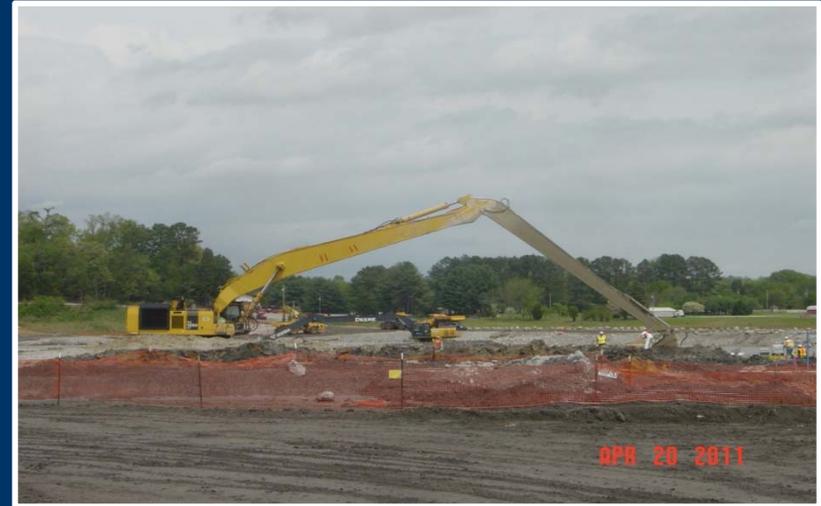
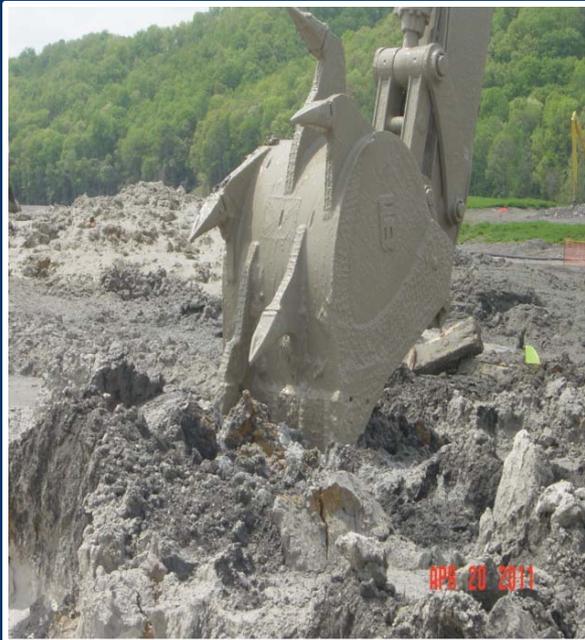
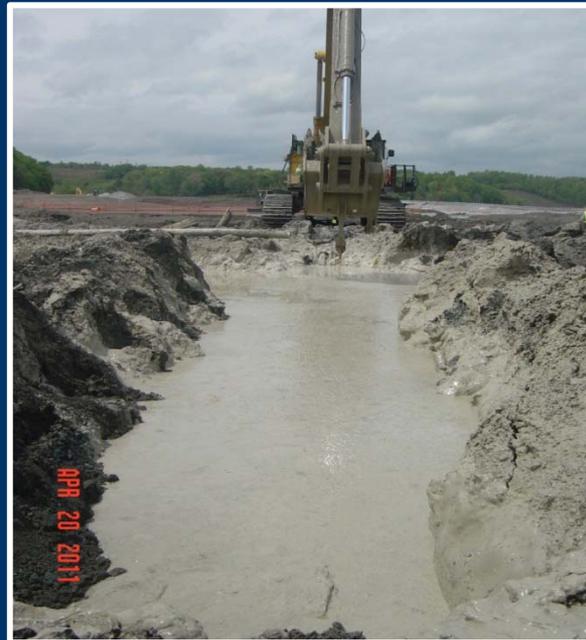
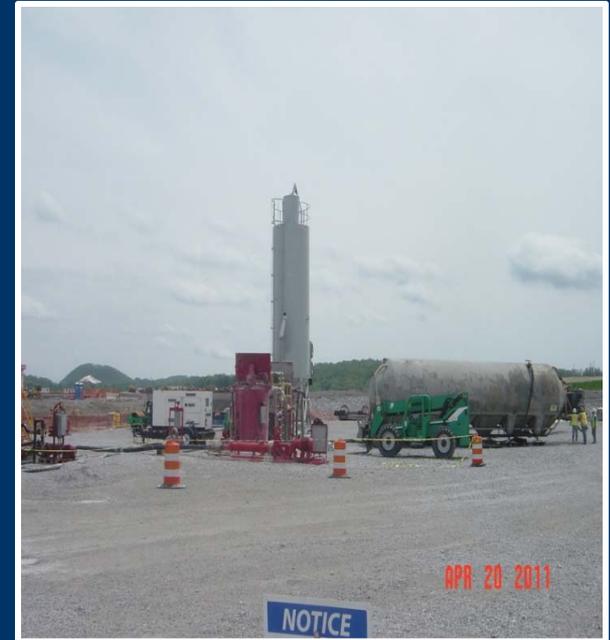
# Perimeter Wall Stabilization Project

- Batch plant for slurry recipe
  - Up to 25% fine blast furnace slag
  - 3% bentonite
  - 0.5% portland cement
- Long-stick Komatsu 1250 excavator
- 4' wide bucket with teeth

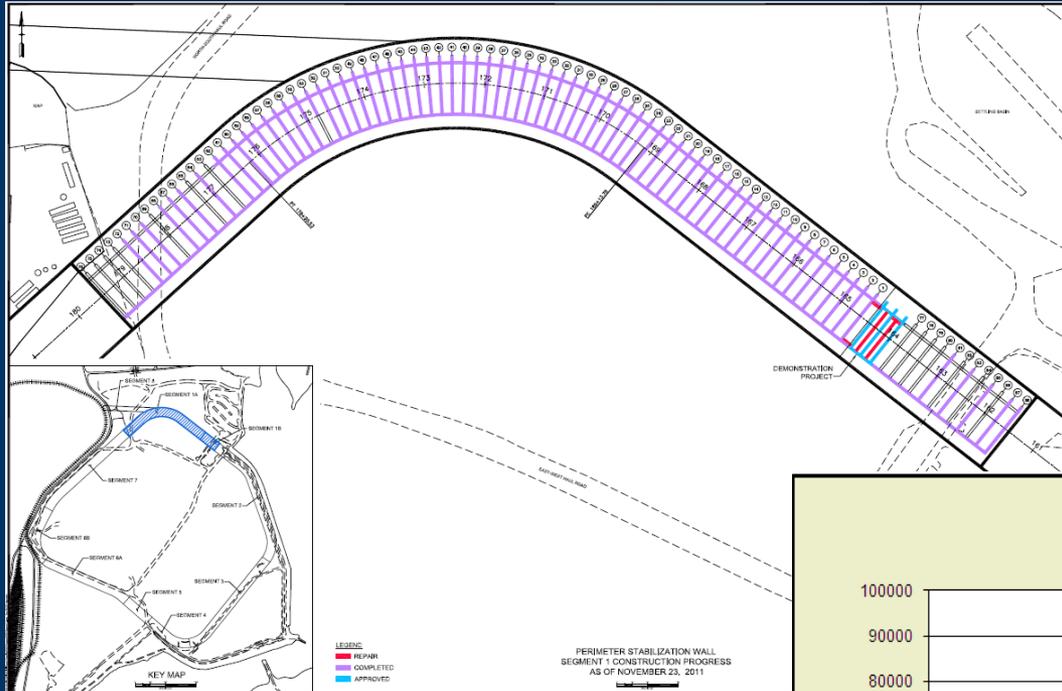
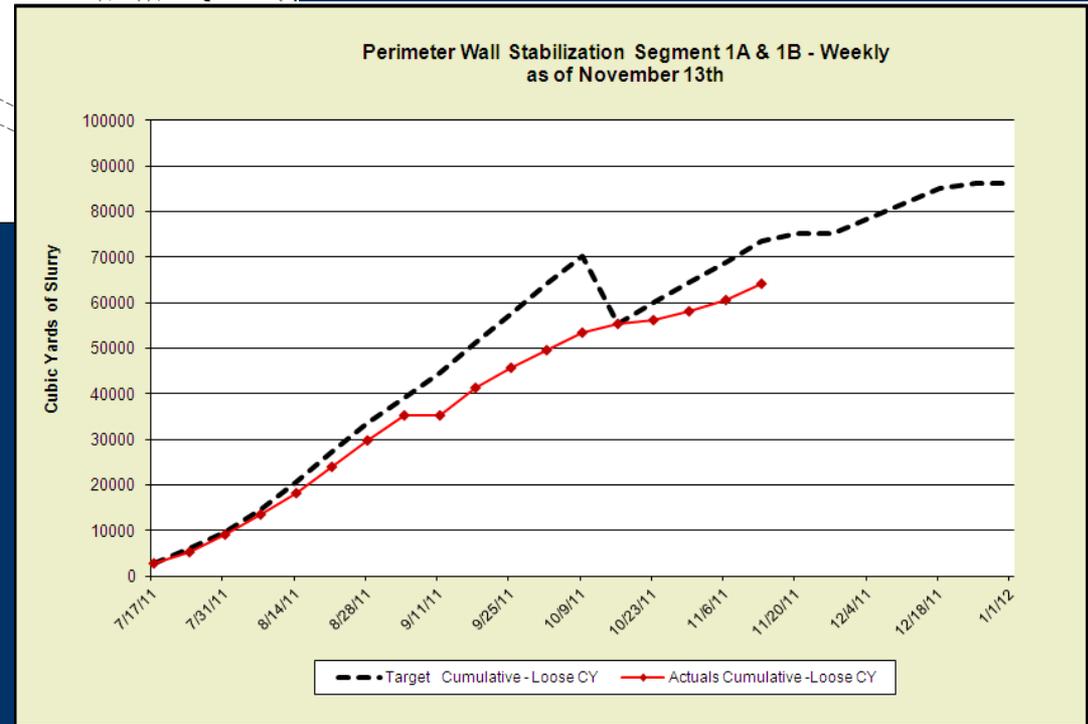
# Perimeter Wall Progress

- Eight segments
- Segment 1 = 70% complete

- North Embayment ash removal complete
- Perimeter Wall Progress = 70% of Segment 1 complete
- Base Line Ecological Risk Assessment (BERA) sampling completed Sept 2011
- BERA - April 2012
  - Tech memos available to public on EPA website
    - Amphibians, birds, turtles, tree swallows, fish, and raccoons
    - Surface water, ground water, aquatic vegetation and periphyton
    - Ash deposits, submerged sediment, and seasonally exposed sediment
- River System EE/CA - June 2012
- Action Memo for Phase 3 (River System) - end of 2012
- Construction schedules currently run thru 2014
- Questions?
  - [Zeller.Craig@epa.gov](mailto:Zeller.Craig@epa.gov)
  - [www.epakingstontva.com](http://www.epakingstontva.com)

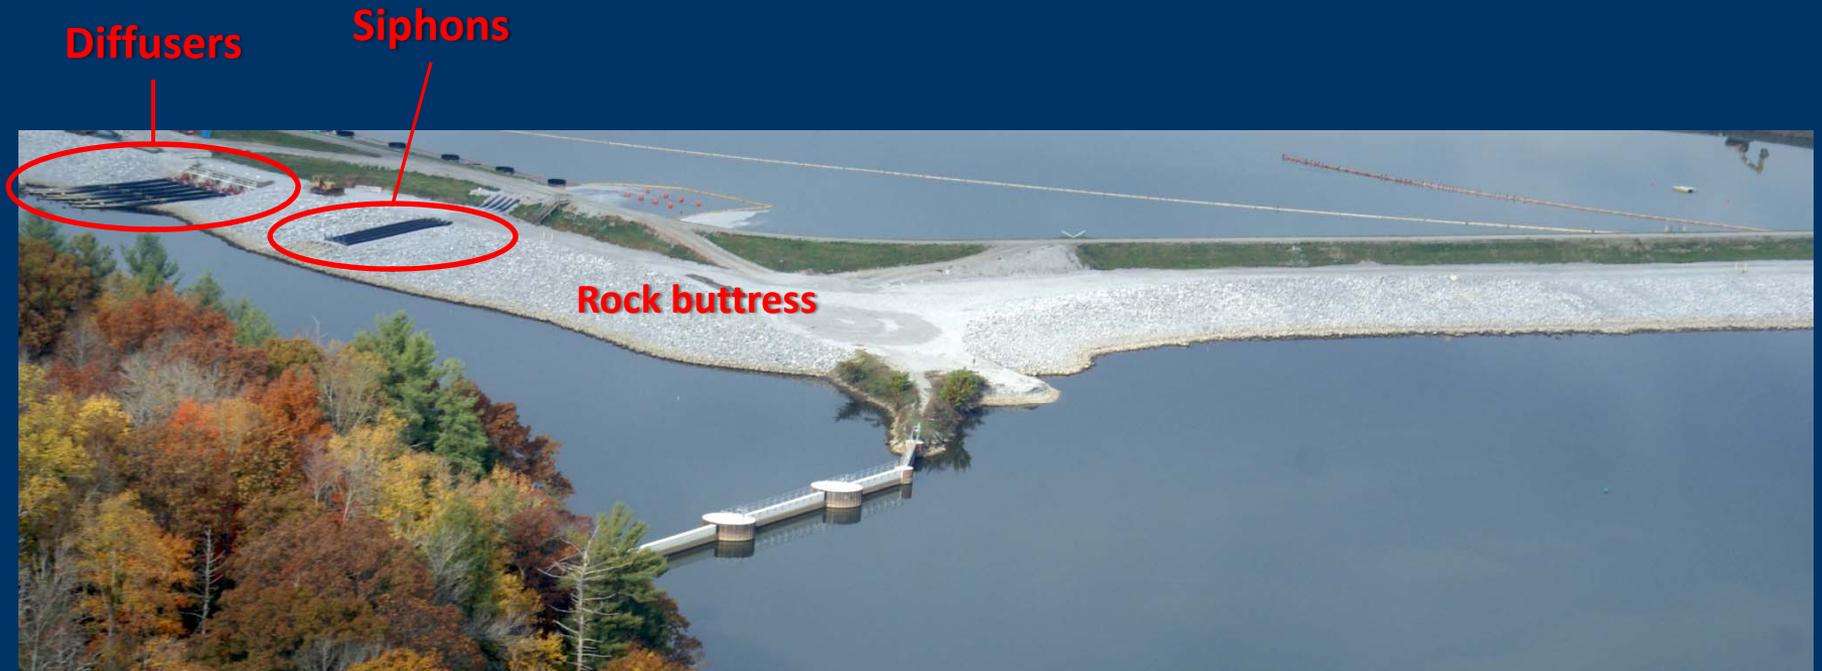
# Dike C Buttress

- Siphon installation
- Diffuser removal
- Bridge demolition
- Causeway excavation
- Rock buttress complete August 6, 2011
- Diffusers re-installed October 14, 2011

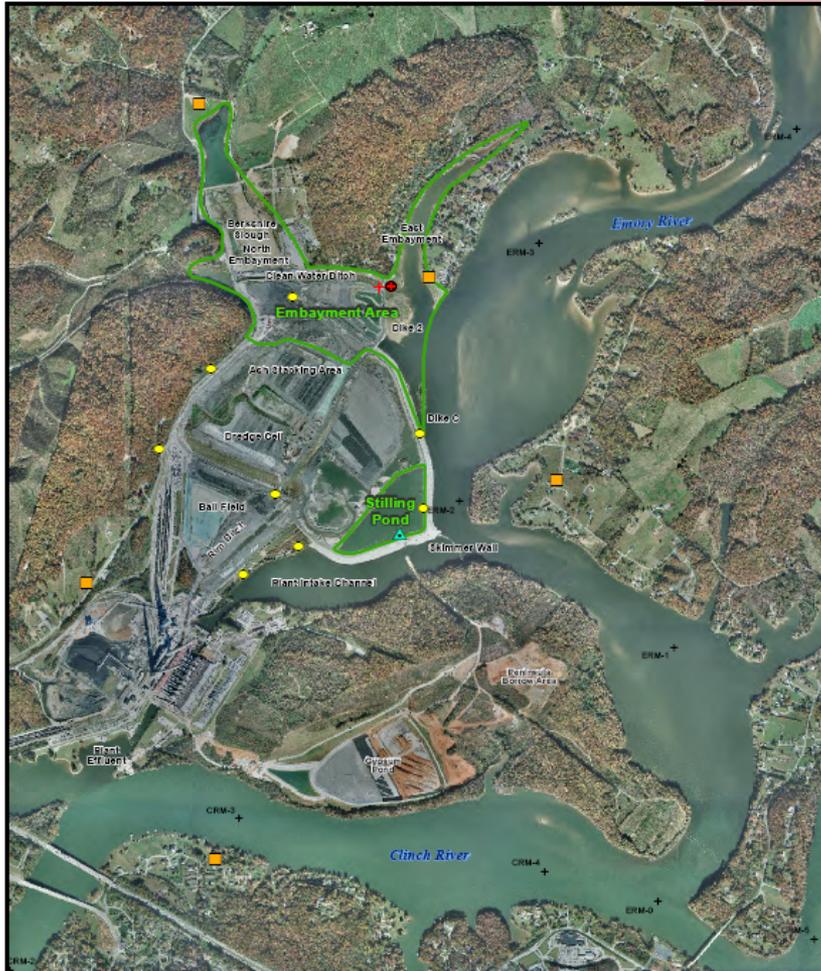
Kingston Ash Recovery NTC Environmental Monitoring November, 2011

■ Stationary Air Monitoring Locations  
● Monitoring Well Location  
▲ HydroLab Monitor and NTC Sample Location  
+ Settling Basin Effluent  
● Embayment Auto Sampler

# Surface Water Monitoring

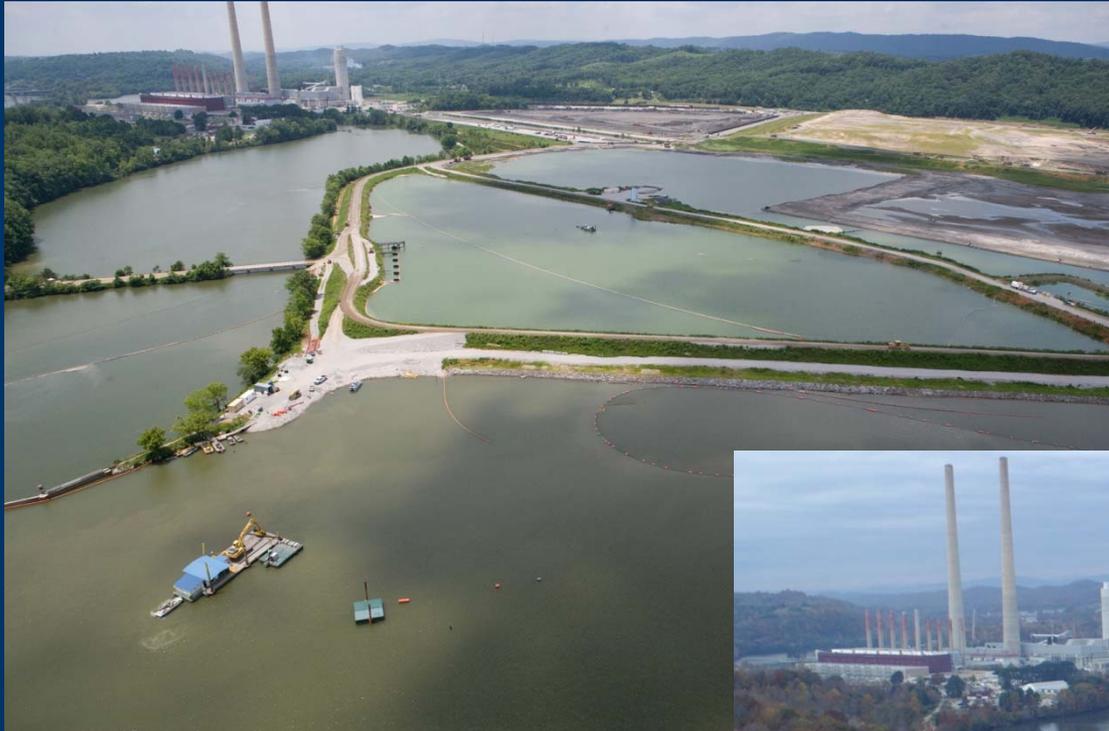
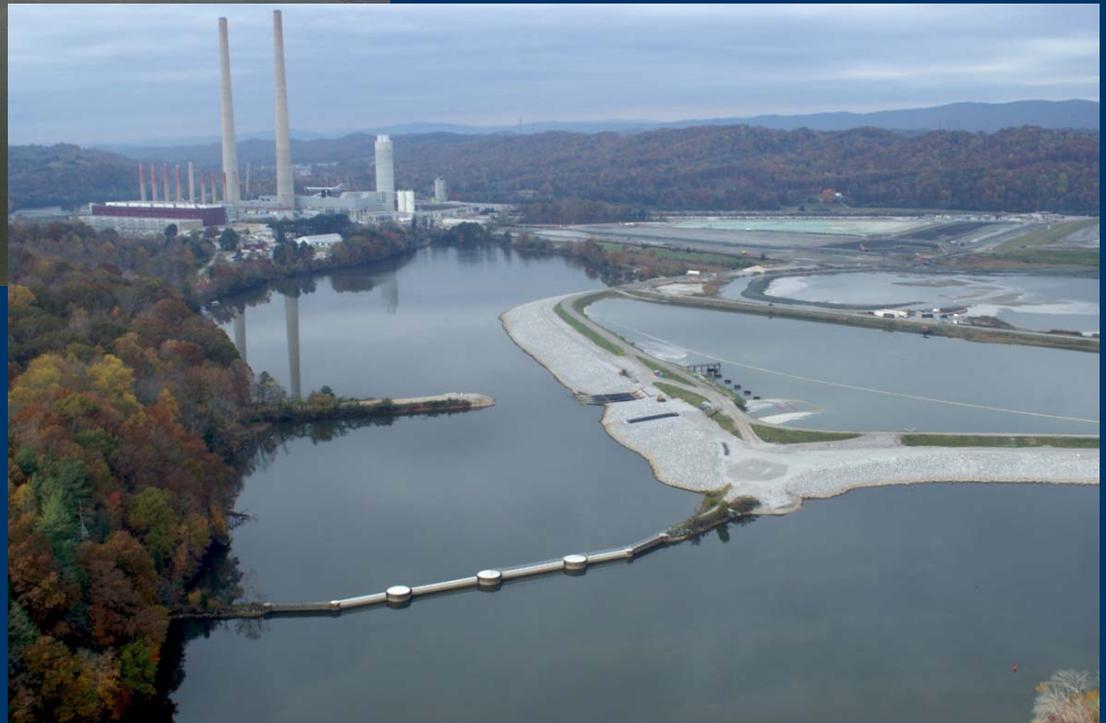
# Dike C

Then

Now

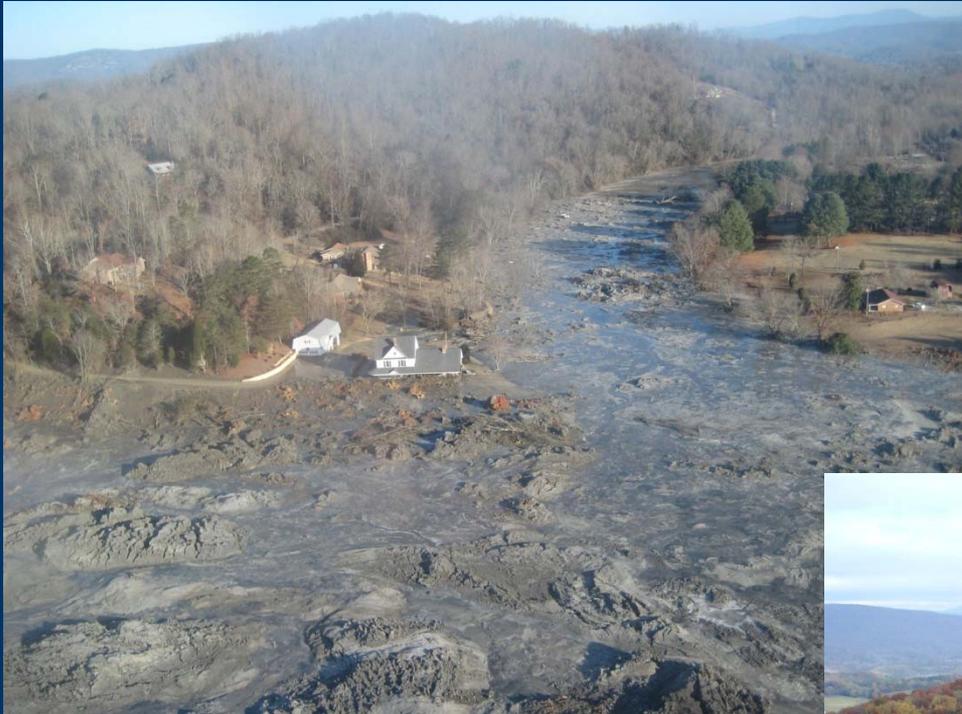
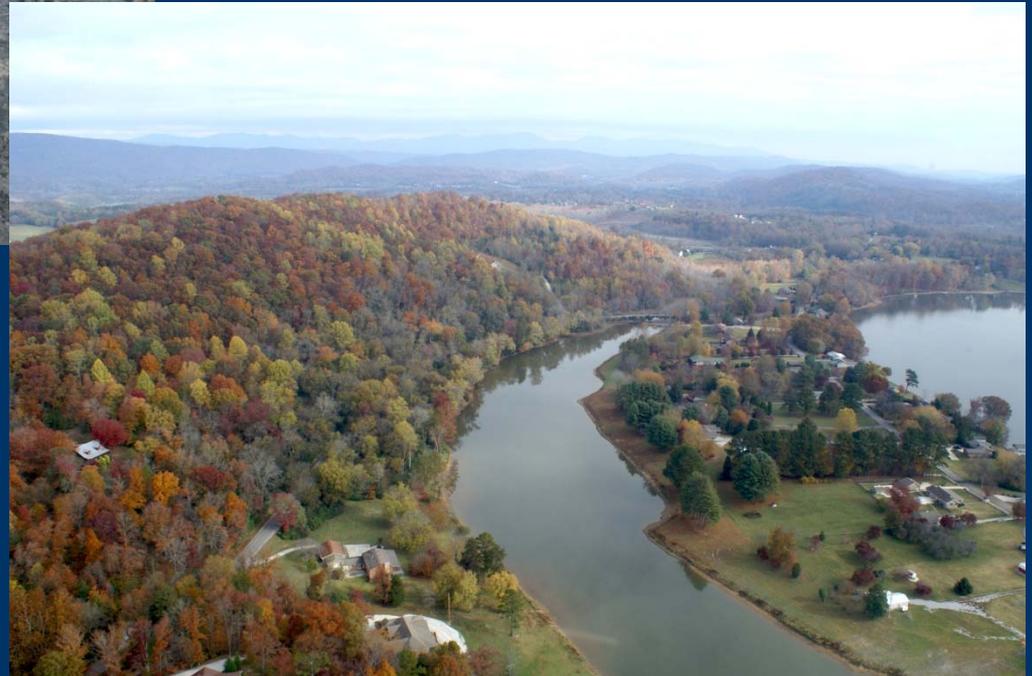
# East Embayment

Then

Now
