TVA Kingston Fossil Fuel Plant
Release Site
Non-Time Critical Removal Update

September 23, 2010

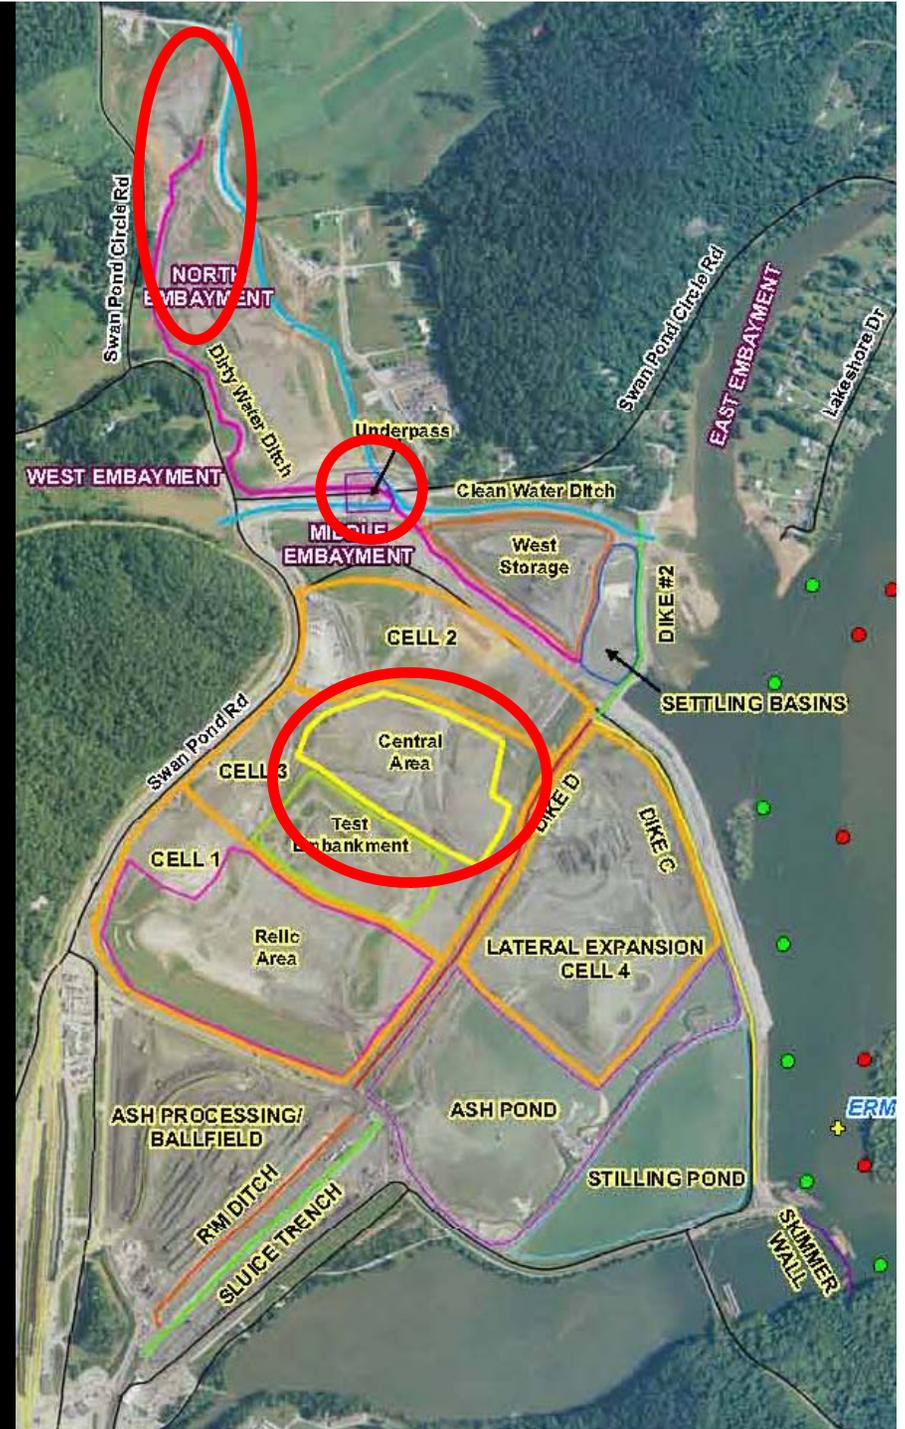
Transition Activities

- North Embayment ash consolidation
- Swan Pond Cir. bridge, underpass, haul road
- Dredge cell contouring

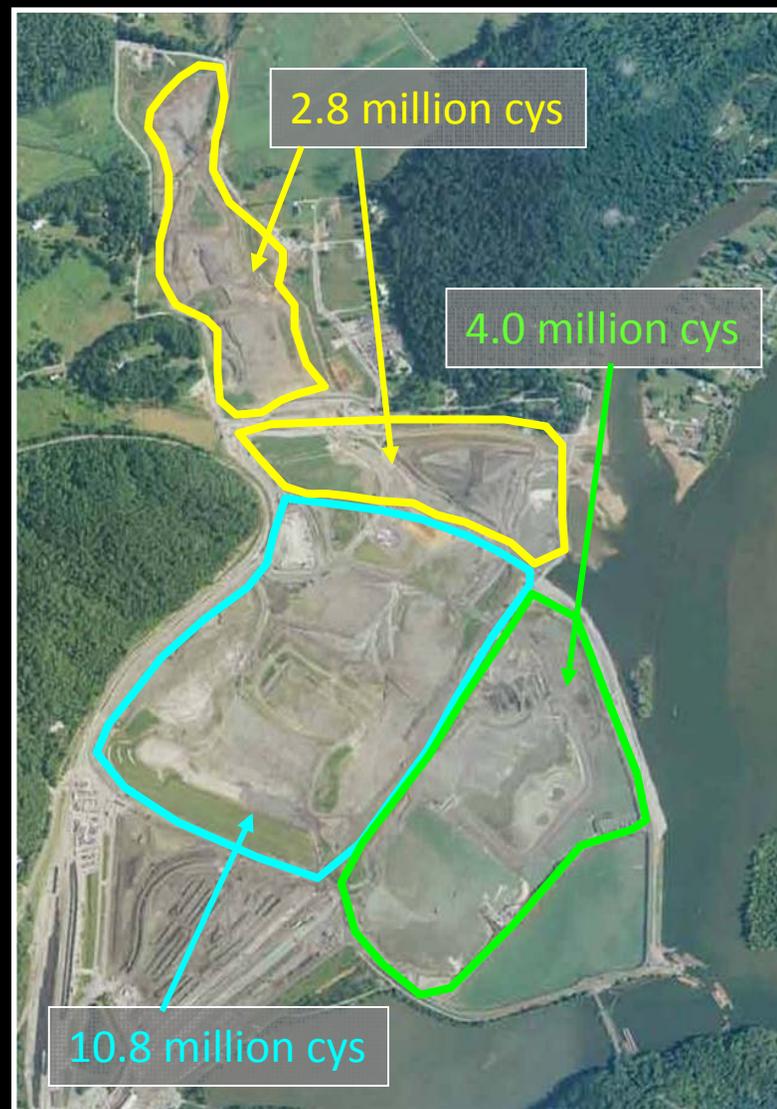
On-site Ash Numbers

- **2.8 million cys**
 - North Embayment
 - Middle Embayment
- **10.8 million cys**
 - Dredge Cell
- **4.0 million cys**
 - Ash Pond
 - Lateral Expansion
- **17.6 million cys total on-site disposal**

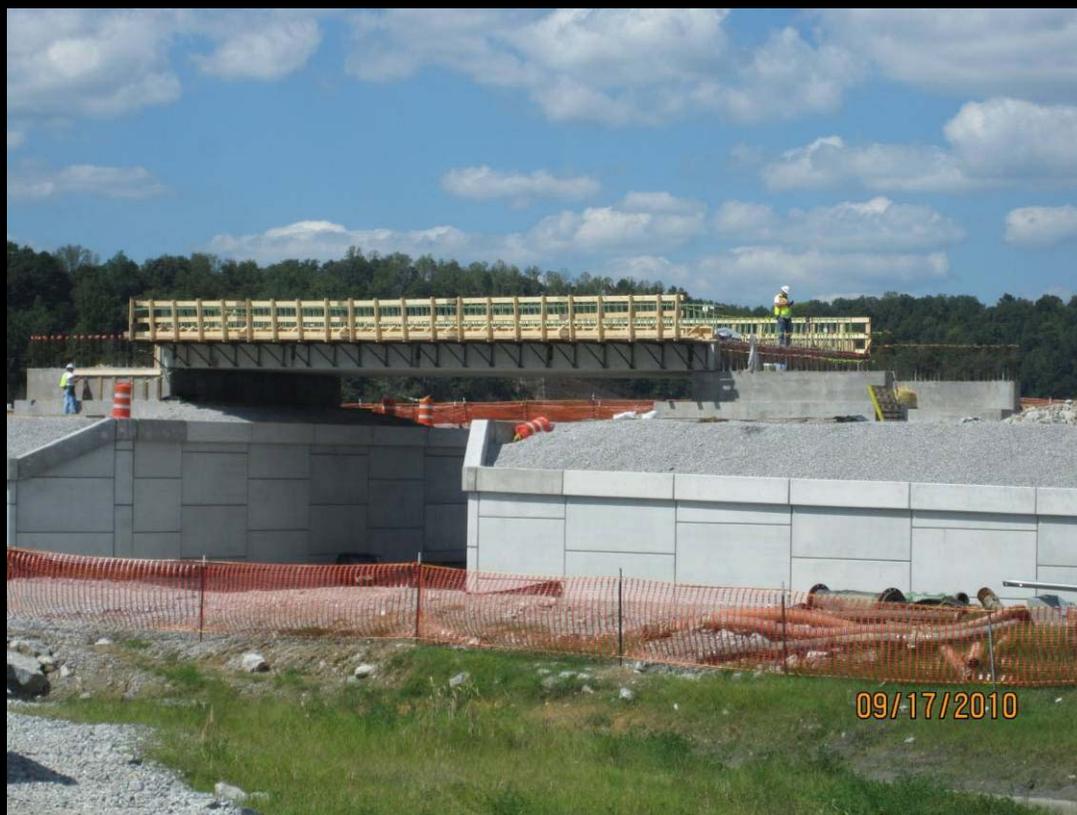
What's Happening Now?

- Continue to build **infrastructure**
 - 78% complete
 - Underpass and bridge construction on-going
 - Bridge scheduled to open Oct. 18
 - Haul road complete

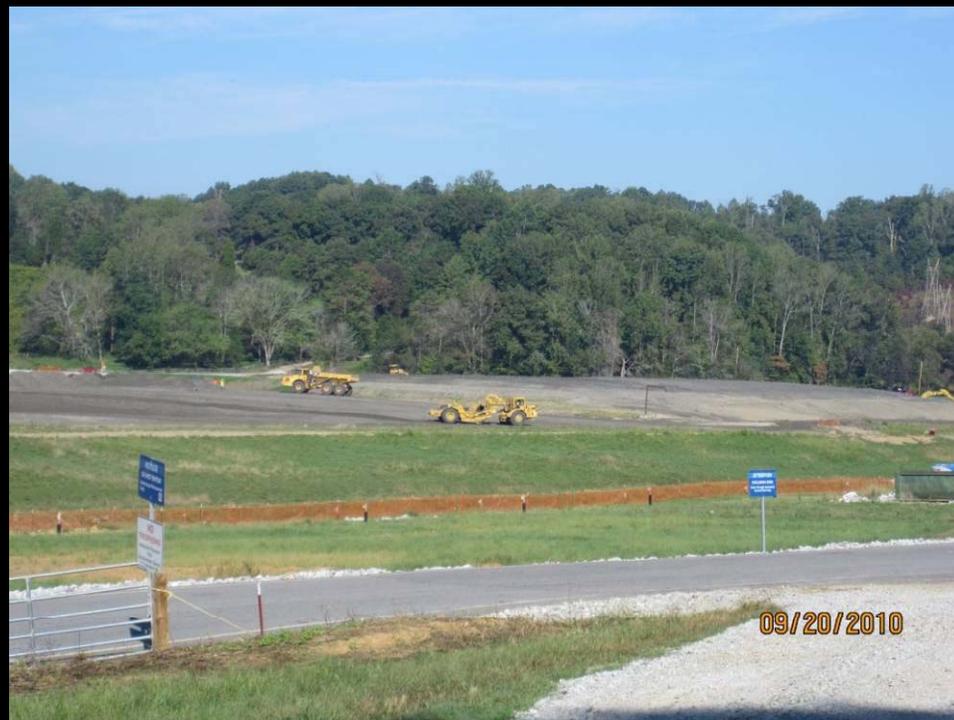
What's Happening Now?

- **North Embayment** ash consolidation
 - 89% complete
 - Scraping ash away from natural water springs
 - Consolidating ash until underpass is complete

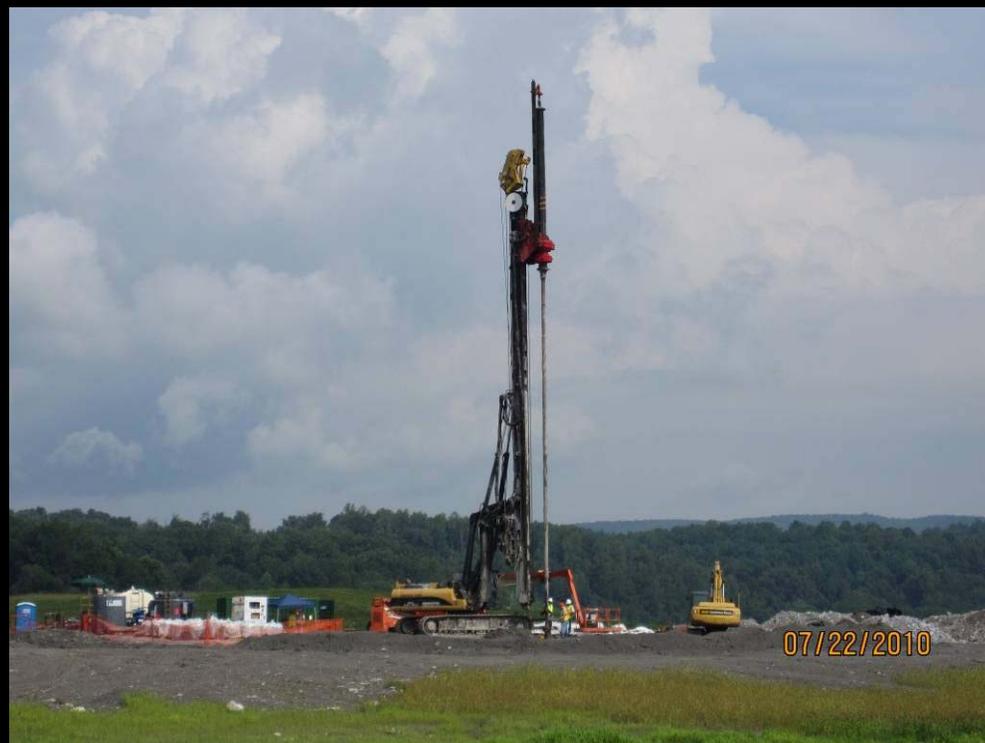
What's Happening Now?

- Perimeter **Containment**
 - Deep soil mixing pilot study **complete**
 - 11 columns constructed
 - Column borings collected for testing
 - Report is pending

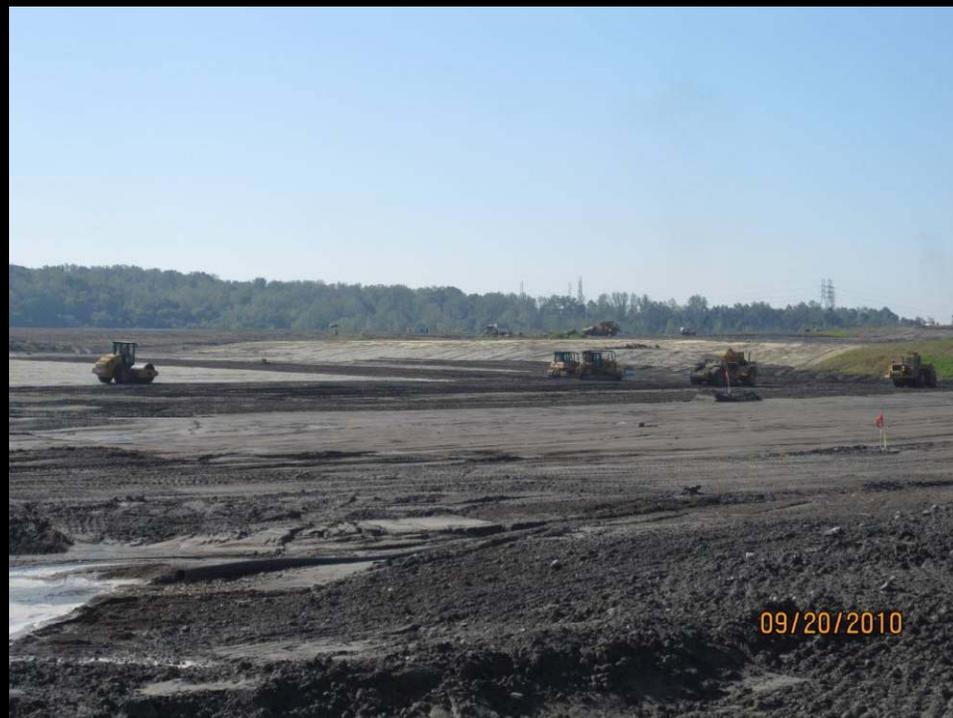
What's Happening Now?

- Central Area **contouring**
 - 29% complete
 - Middle Embayment ash being removed and used to contour Central Area
 - Relic area and test embankment height removed down to final elevation

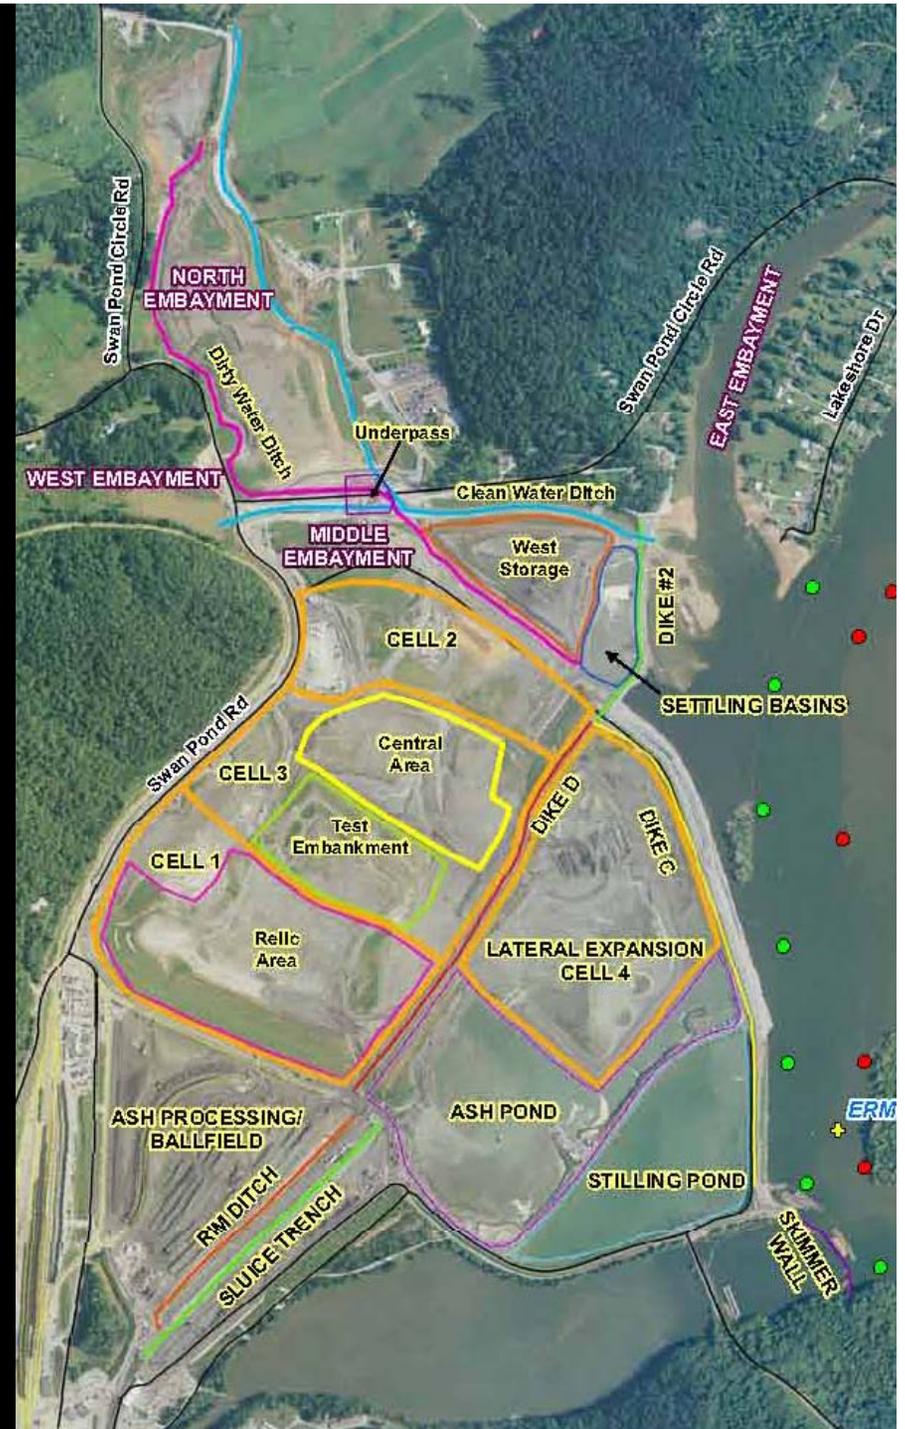
Contouring

- Central Area
 - Middle Embayment
- Reducing height
 - Test Embankment
 - Relic Area

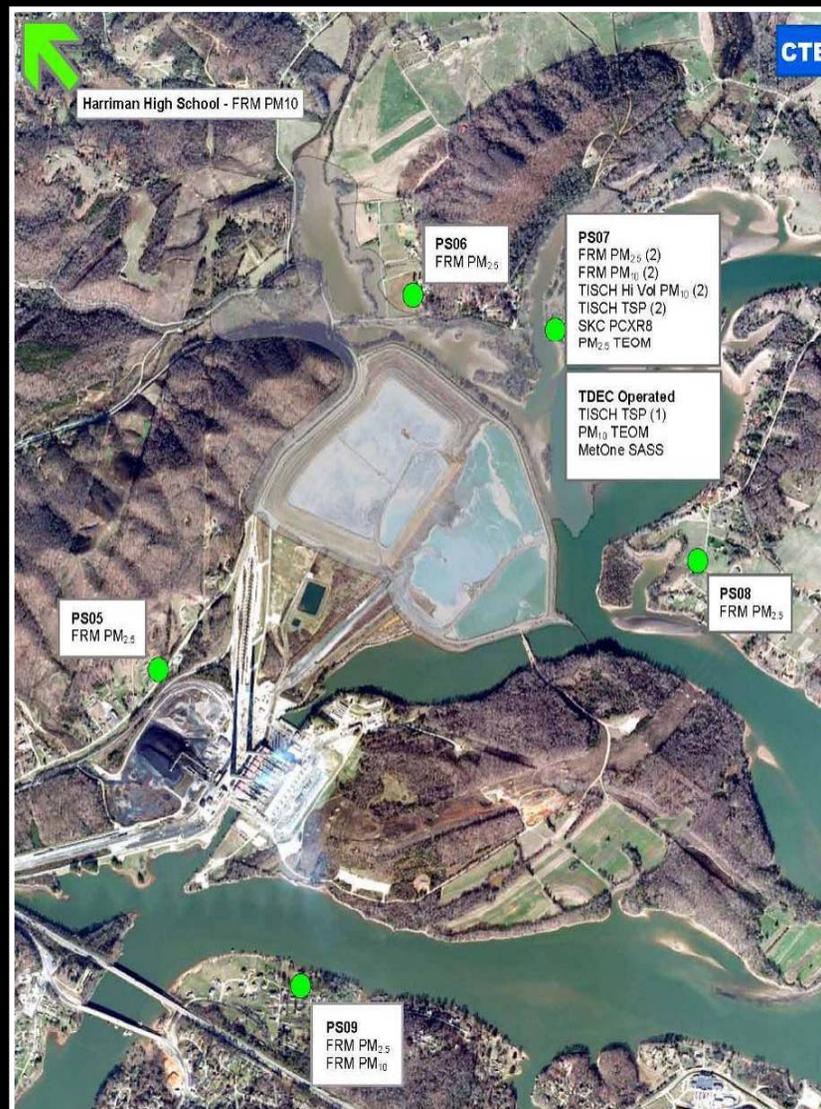
Air Monitoring

- Real-time air monitors (5 stations)
 - 2 TEOMs (PM 2.5 & 10)
 - 5 BAMs (PM 2.5)
 - 1 FRM (PM 2.5)

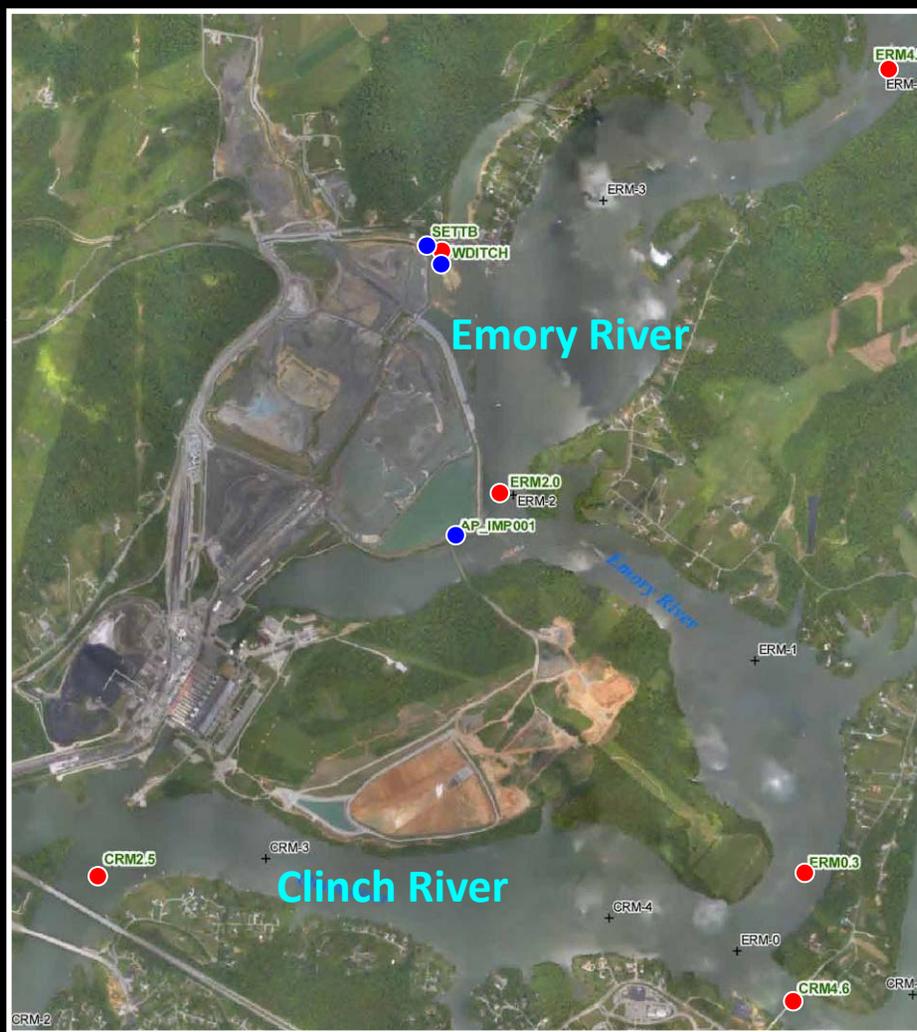
Surface Water Monitoring

- 3 on-site locations sampled 1/week
- ISCO automated samplers (rain events)
 - 3 locations on Emory River
 - 2 locations on Clinch River
 - 1 location on-site (clean water ditch)

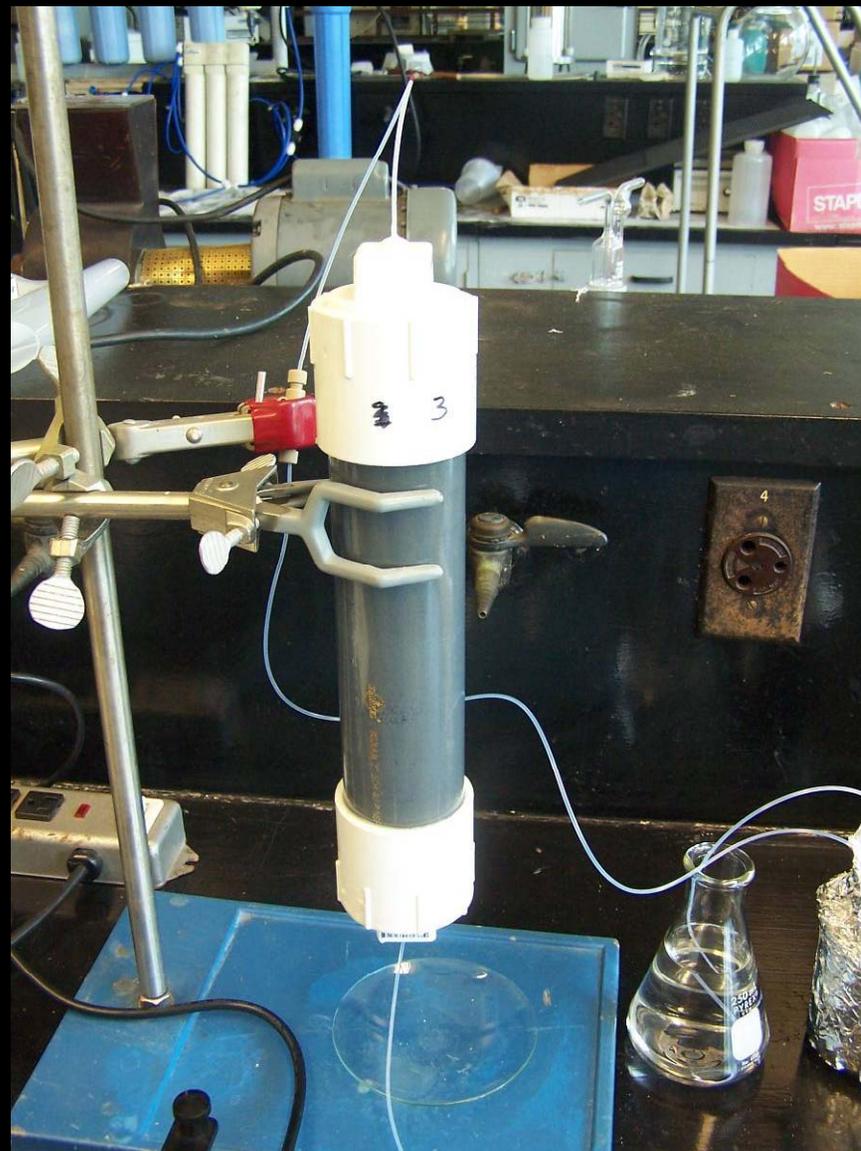
Leachability Testing

- 70% complete
- Evaluating **leaching behavior** of ash using site-specific conditions
- Using **ash, lime-treated ash, and cement-treated ash**
- Support **groundwater transport modeling**

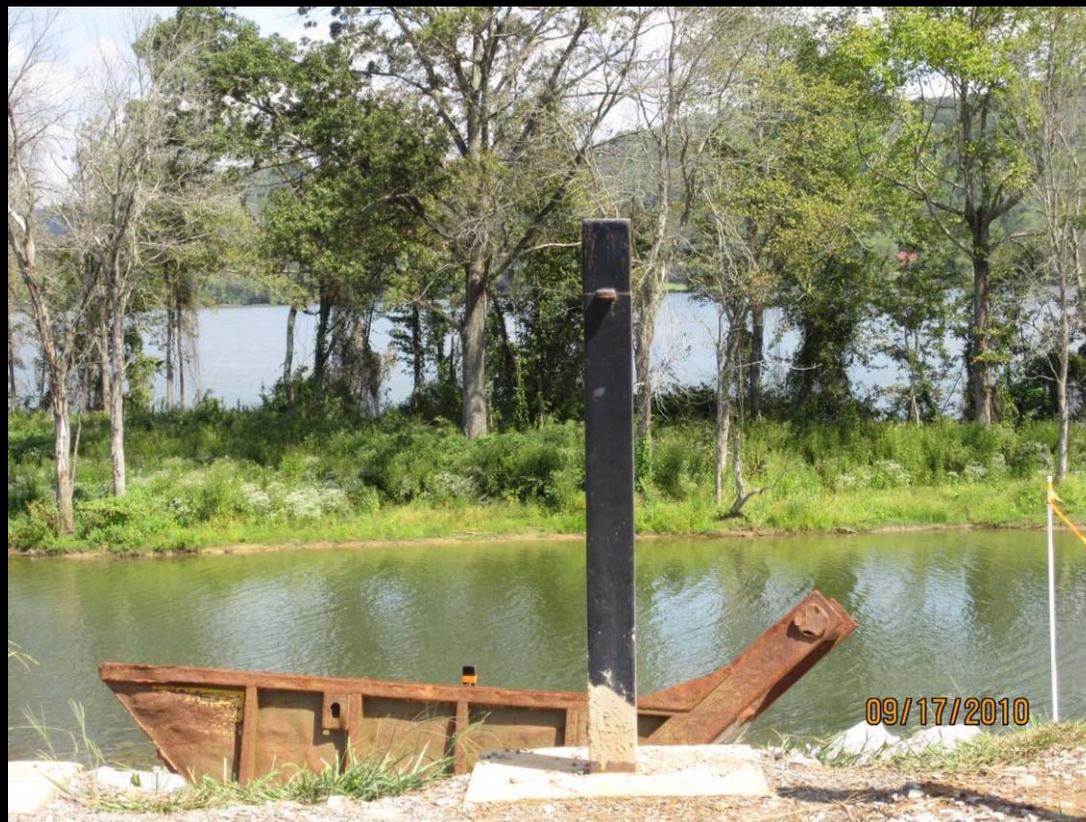
New Well Installations

- **Proposed** wells:
 - 6 existing
 - 3 permanent
 - 7 temporary
 - 16 boreholes
- **Installed** wells:
 - 3 permanent
 - 2 temporary
 - 0 boreholes

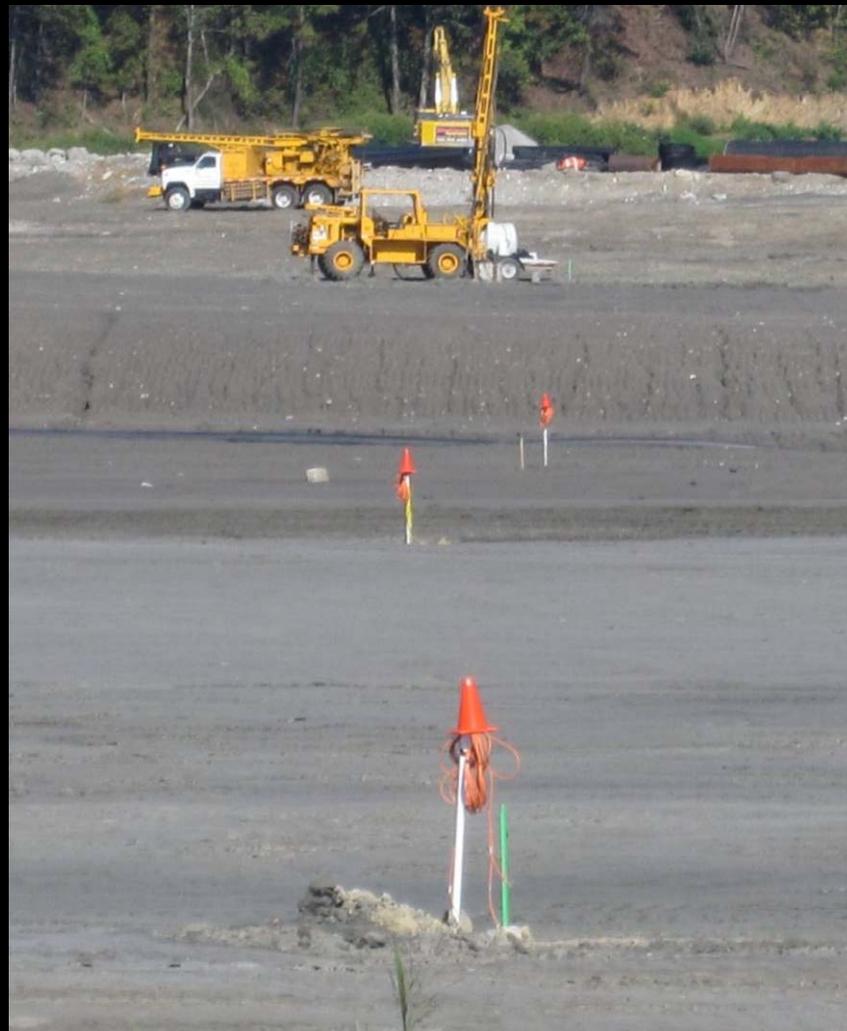
Instrumentation

- Installing in central and north dredge cell area
 - 50% complete
 - 18 piezometers (pore pressure)
 - 9 slope inclinometers (vertical movement)
 - 5 settlement plates (vertical movement)

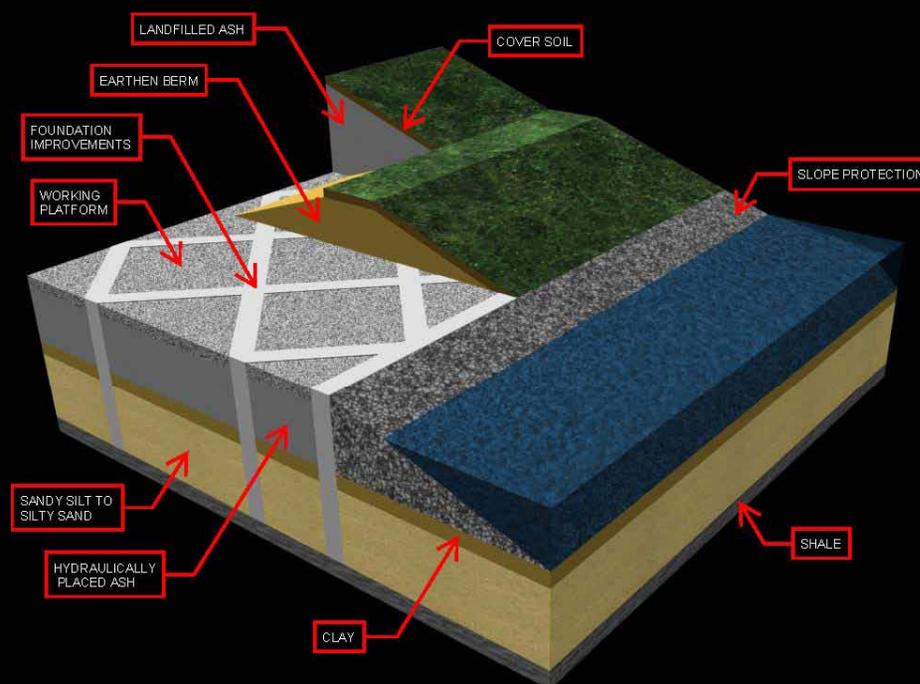
Next Steps

- **Construction** of perimeter containment
 - Working platform
 - Deep soil mixing columns

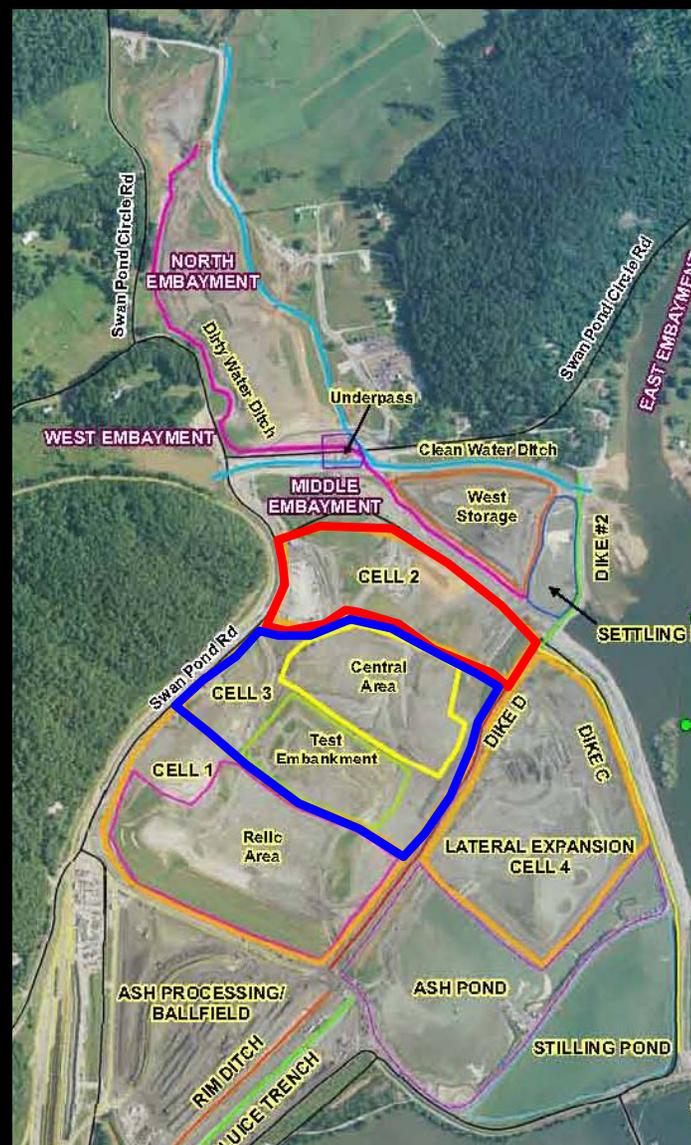
Next Steps

- **Stacking and compacting ash** in dredge cell
 - Preparation of subgrade to capillary break elevation
 - Start in central contoured area (**Cell 3**)
 - Next area is north near east-west haul road (**Cell 2**)

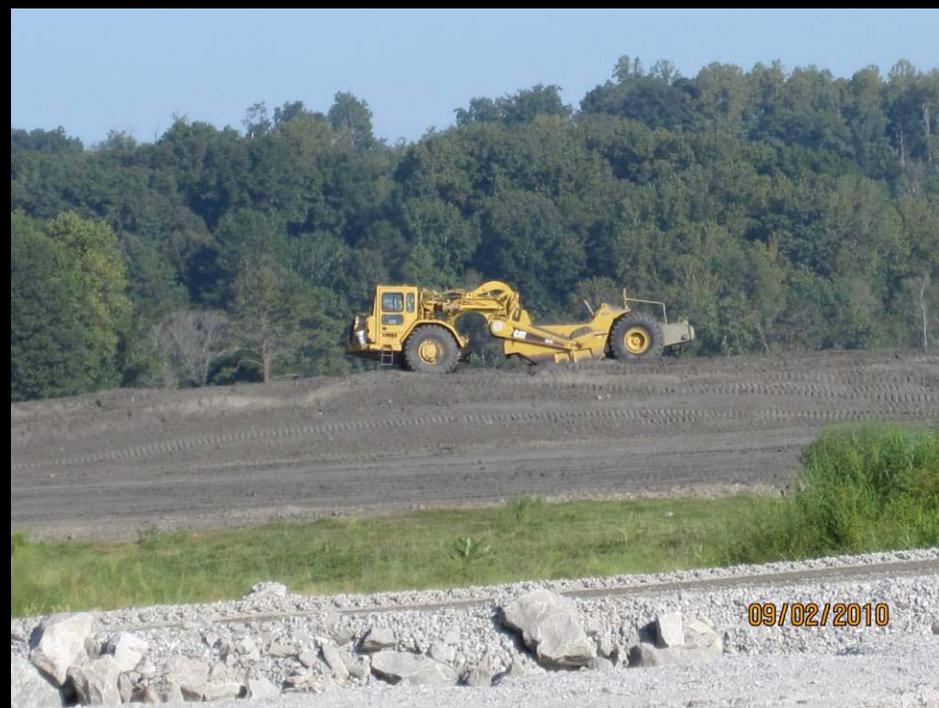
Next Steps

- **Hauling ash**
 - From North Embayment and Middle Embayment
 - Use underpass for North Embayment ash hauling
