FIELD OBSERVATIONS TO LOCATE RELICS PHOTOGRAPHIC LOG

Client Name: Tennessee Valley Authority		Site Location: Kingston Fossil Plant – Harriman, Tennessee	Project No.: 60095742
Photo No. 1	Date: 1-21-2009

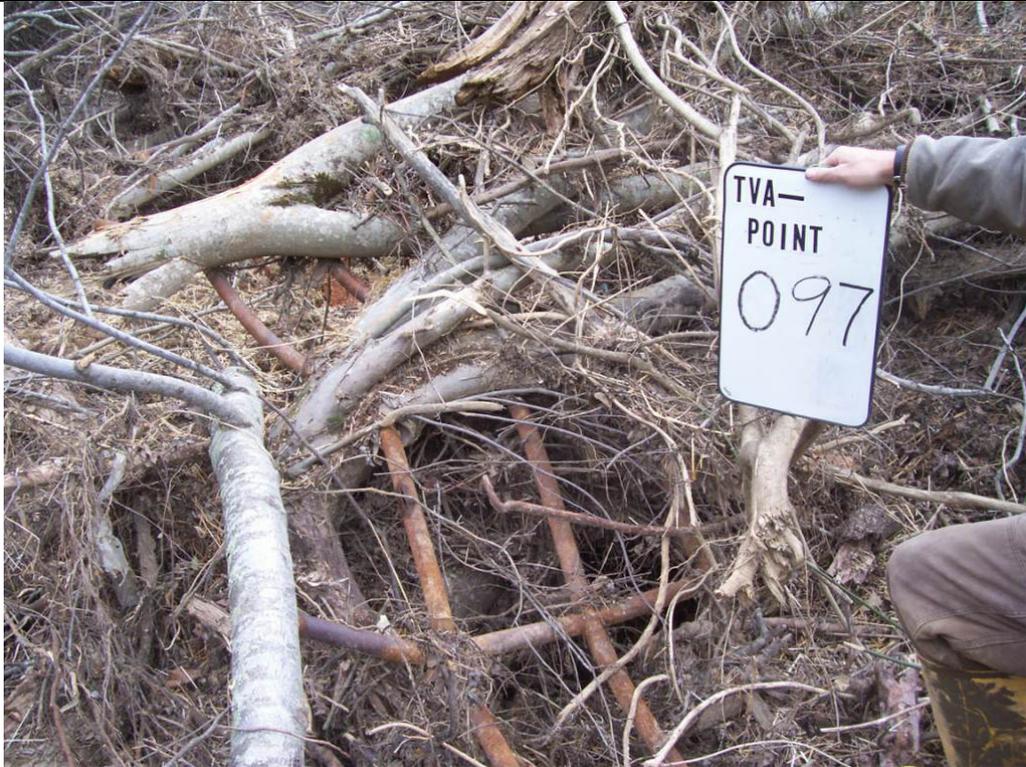
Client Name: Tennessee Valley Authority		Site Location: Kingston Fossil Plant – Harriman, Tennessee	Project No.: 60095742
Photo No. 5	Date: 1-26-2009

Direction Photo Taken: Looking southeast.			
Description: Relic Location 097. Handrail formerly located on top of concrete wall around Dike C spillway outfall pipe. Confirmed by interview with TVA personnel. The railing was transported approximately 700 feet north-northeast from its original position.

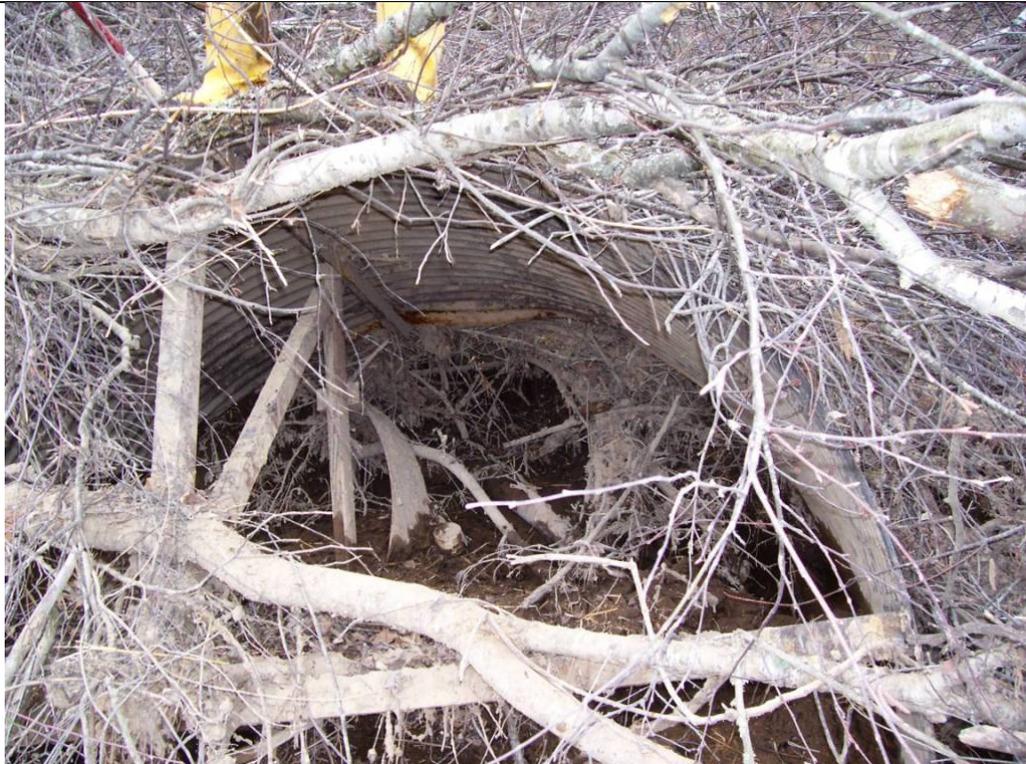
Photo No. 6	Date: 1-26-2009

Direction Photo Taken: Looking north.			
Description: Relic Location 098_2. Corrugated, 8 to 10-foot diameter metal pipe. Identified as a skimmer top by TVA personnel. Formerly located on the bank next to the Dike C spillway outfall pipe. The skimmer top was transported approximately 700 feet north-northeast from its original position.
