## FIELD OBSERVATIONS TO LOCATE RELICS PHOTOGRAPHIC LOG

<b>Client Name:</b> Tennessee Valley Authority		<b>Site Location:</b> Kingston Fossil Plant – Harriman, Tennessee	<b>Project No.:</b> 60095742
<b>Photo No.</b> <b>1</b>	<b>Date:</b> 1-21-2009

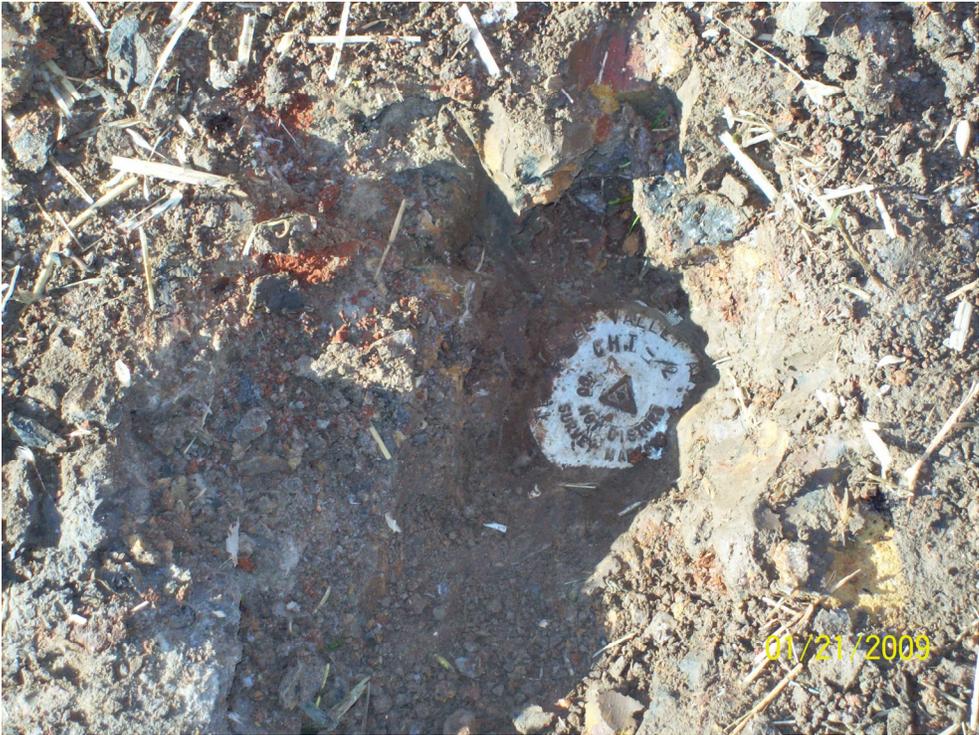
<b>Direction Photo Taken:</b>  Looking vertical.			
<b>Description:</b>  TVA Survey monument CHT-2.  The relic block of Dike C containing the monument traveled approximately 700 feet north-northwest across the Tail Water.

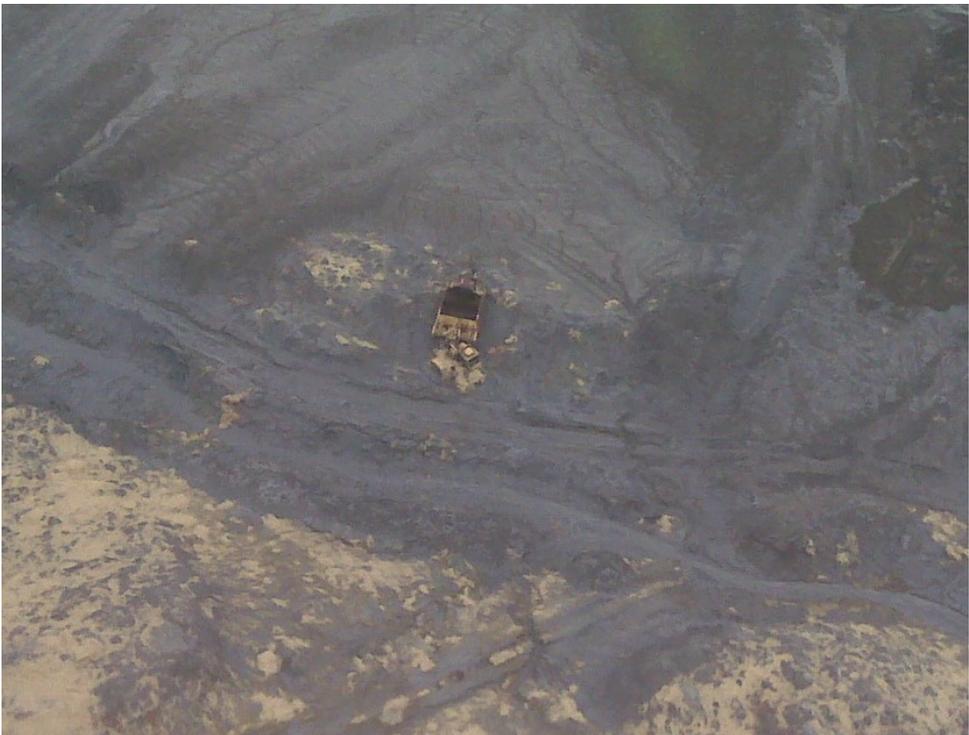
<b>Photo No.</b> <b>2</b>	<b>Date:</b> 2-25-2009

<b>Direction Photo Taken:</b>  Looking vertical/west.			
<b>Description:</b>  Scraper formerly parked on Center Dike.  The scraper traveled approximately 1,200 feet and rotated from a parked position facing north-northeast to a final position facing east-southeast.

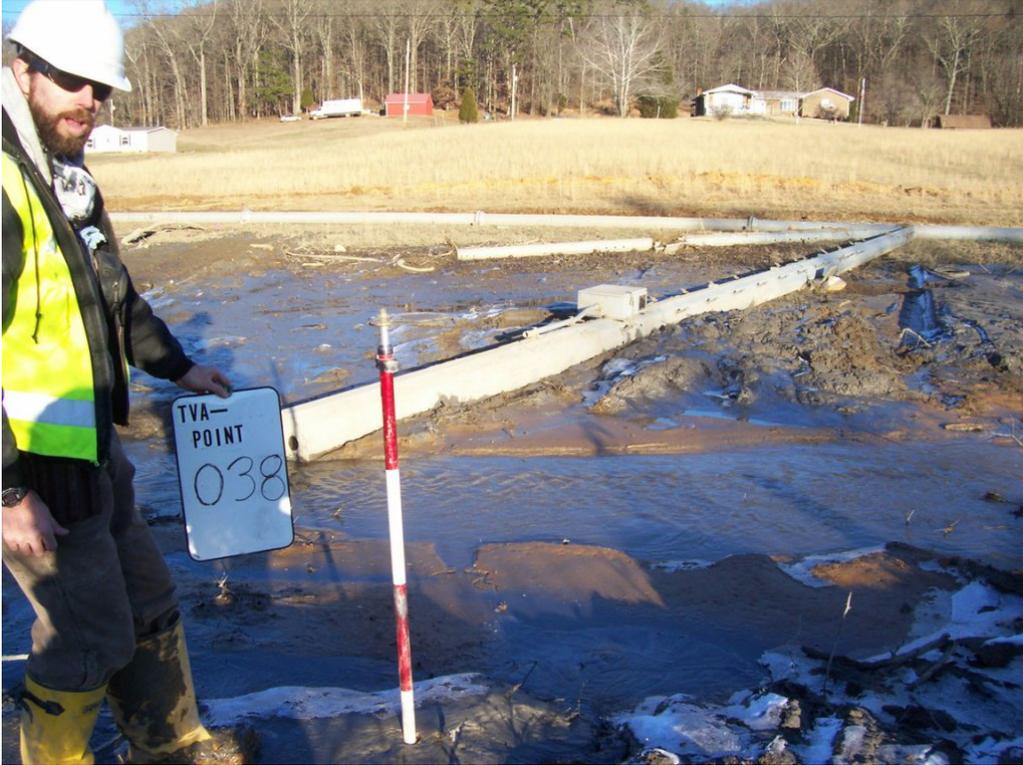
<b>Direction Photo Taken:</b>  Looking east.			
<b>Description:</b>  Relic Location 038. Cell telephone repeater tower originally located on the northwest corner of the Starter Dike/Dike C in Slough 2.  The cell tower was transported approximately 1,500 feet north-northwest from its original position.

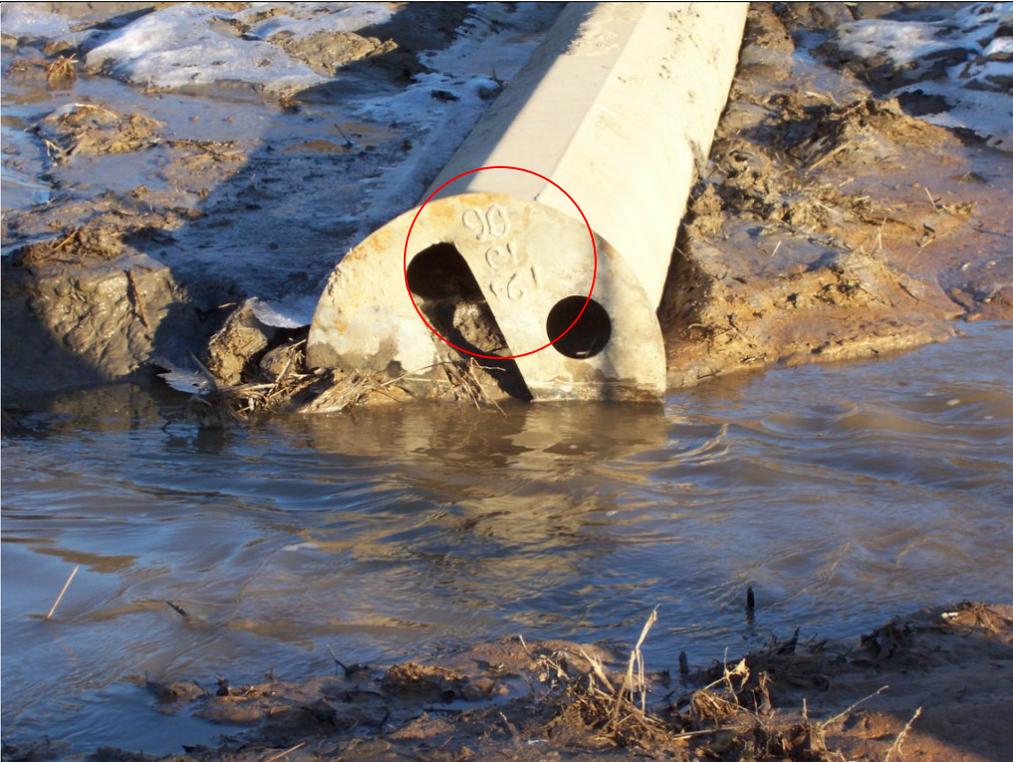
<b>Photo No.:</b> <b>1.3.2_4</b>	<b>Date:</b> 1-21-2009

<b>Direction Photo Taken:</b>  Looking east.			
<b>Description:</b>  Relic Location 038_A. Same cell repeater tower shown in 038. Numbers visible on the base of the tower "12, 15, 06" (red circle).

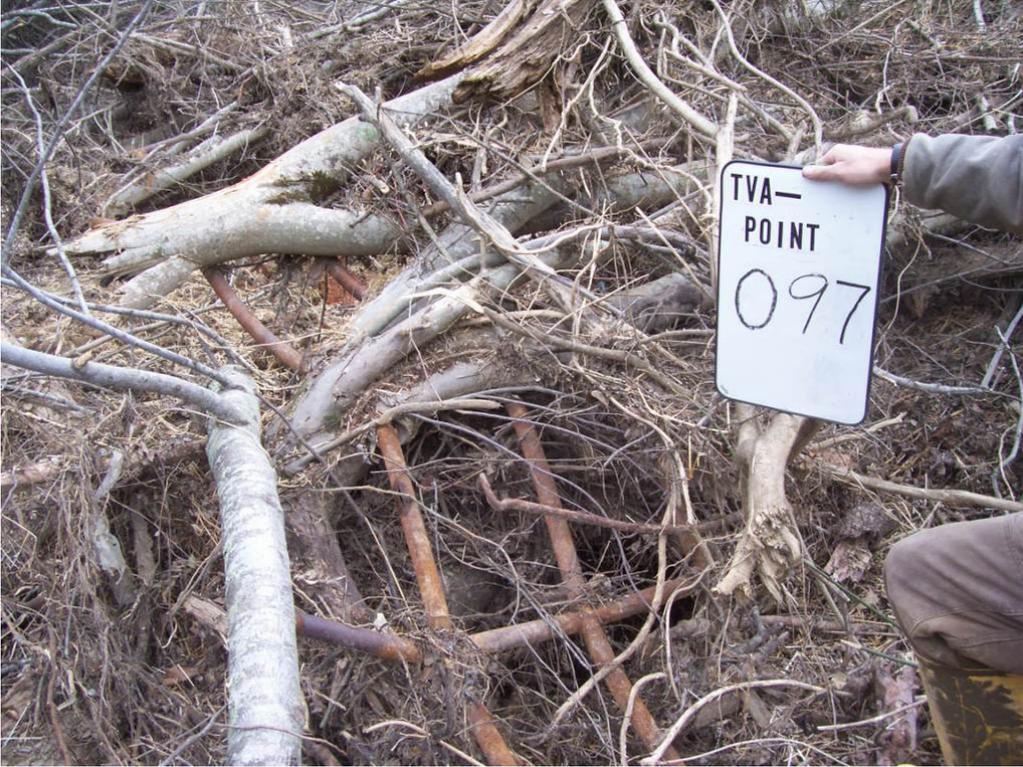
<b>Direction Photo Taken:</b>  Looking southeast.			
<b>Description:</b>  Relic Location 097. Handrail formerly located on top of concrete wall around Dike C spillway outfall pipe. Confirmed by interview with TVA personnel.  The railing was transported approximately 700 feet north-northeast from its original position.

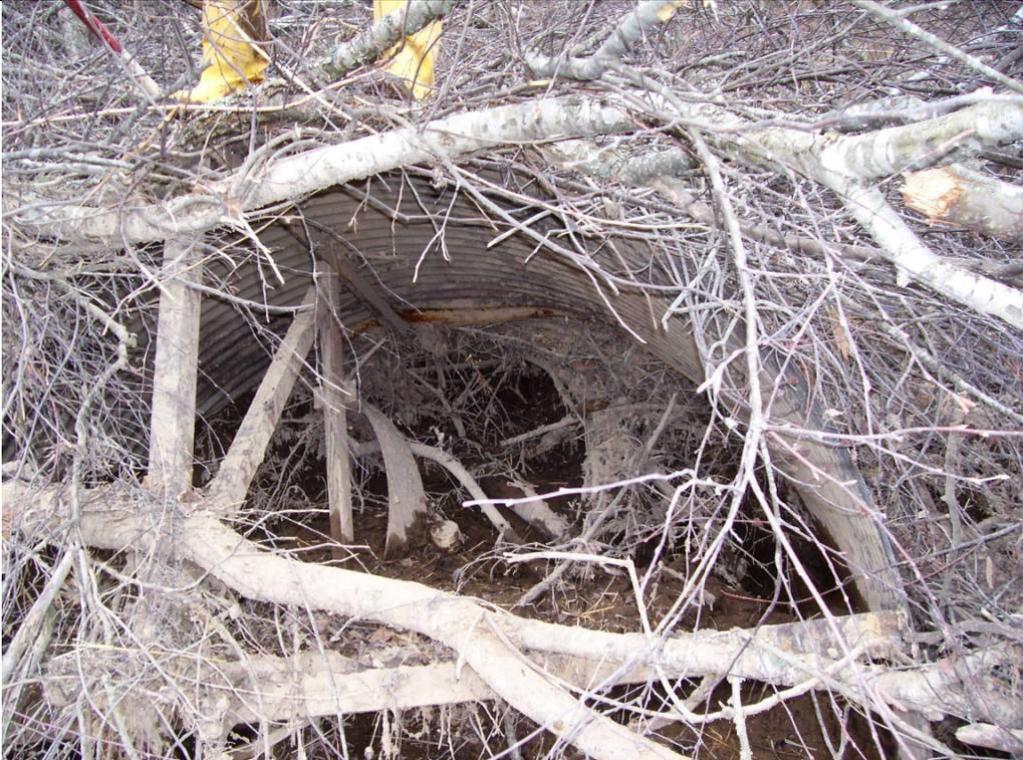
<b>Photo No.:</b> <b>6</b>	<b>Date:</b> 1-26-2009

<b>Direction Photo Taken:</b>  Looking north.			
<b>Description:</b>  Relic Location 098_2. Corrugated, 8 to 10-foot diameter metal pipe. Identified as a skimmer top by TVA personnel. Formerly located on the bank next to the Dike C spillway outfall pipe.  The skimmer top was transported approximately 700 feet north-northeast from its original position.

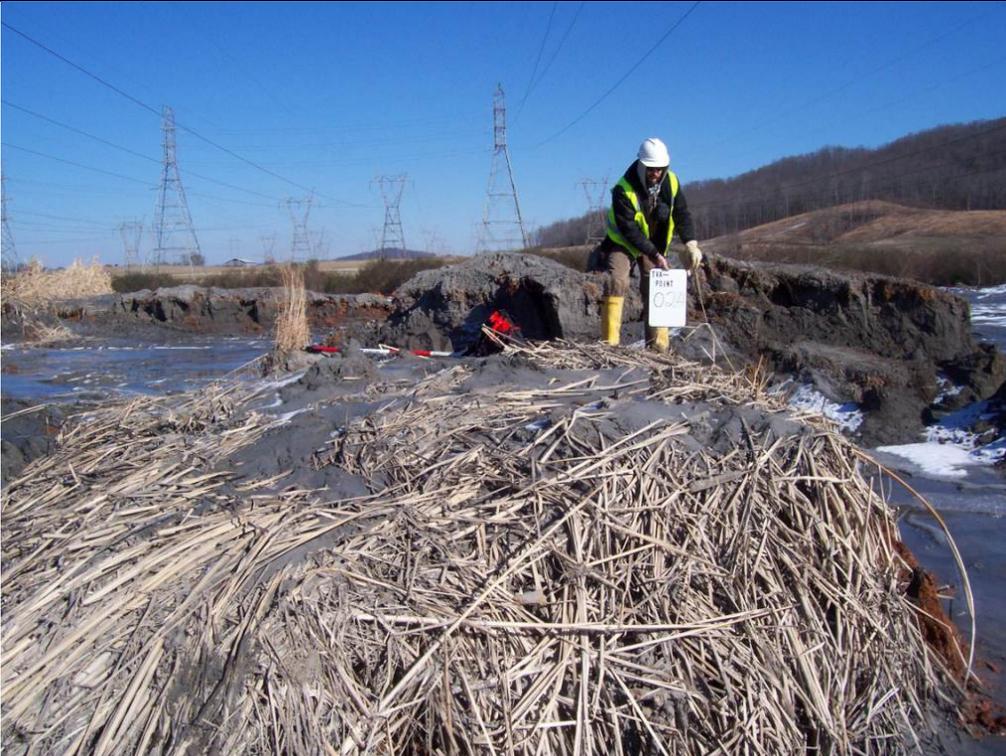
<b>Direction Photo Taken:</b>  Looking east.			
<b>Description:</b>  Relic Location 024. Cattails formerly at the northwest corner of setback area, now in Slough 2 over-washed by ash. Relic dike material in the background was also over-washed.  The cattails were transported approximately 3,300 feet.

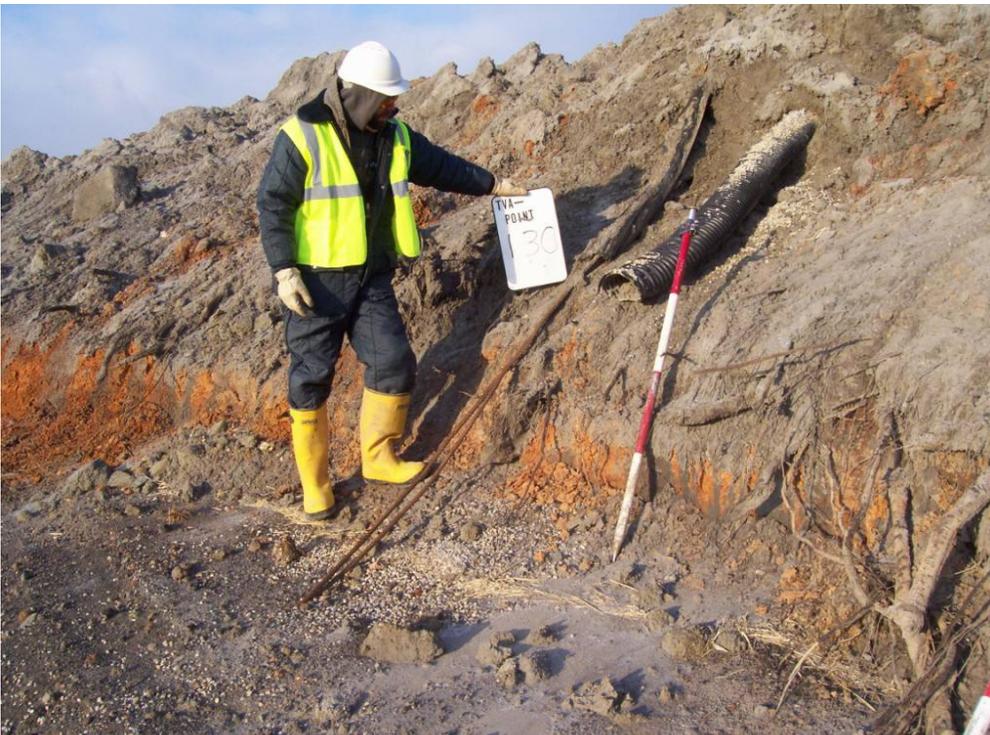
<b>Photo No.:</b> <b>8</b>	<b>Date:</b> 2-4-2009

<b>Direction Photo Taken:</b>  Looking west-southwest.			
<b>Description:</b>  Relic Location 130. 5/8-inch steel cable (looped or two cables) encased in woven geotextile. Nearby is a piece of corrugated PE (8-inch). Geotextile and #57 stone are most likely associated with the corrugated pipe.  The cable was transported approximately 1,600 feet.

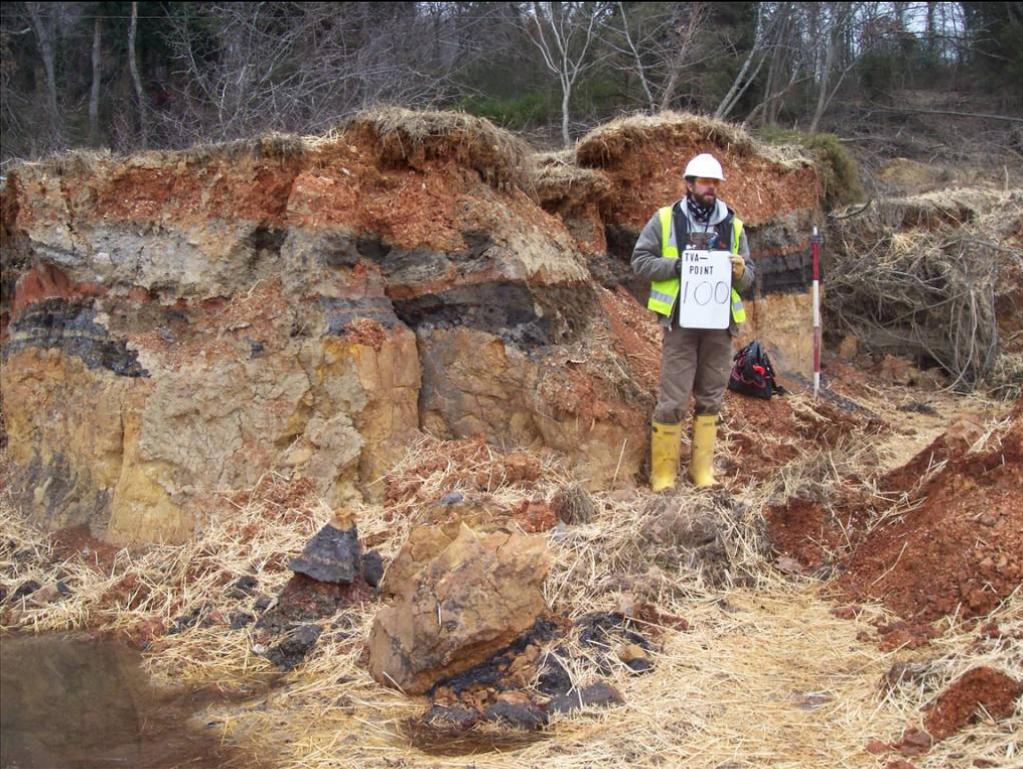
<b>Direction Photo Taken:</b>  Looking northeast.			
<b>Description:</b>  Relic Location 100. Remnant of Dike C with bottom ash layer and clay cover material over native silty clay on north shore of Tail Water.  The Dike C relic was transported approximately 700 feet northward from its original position.

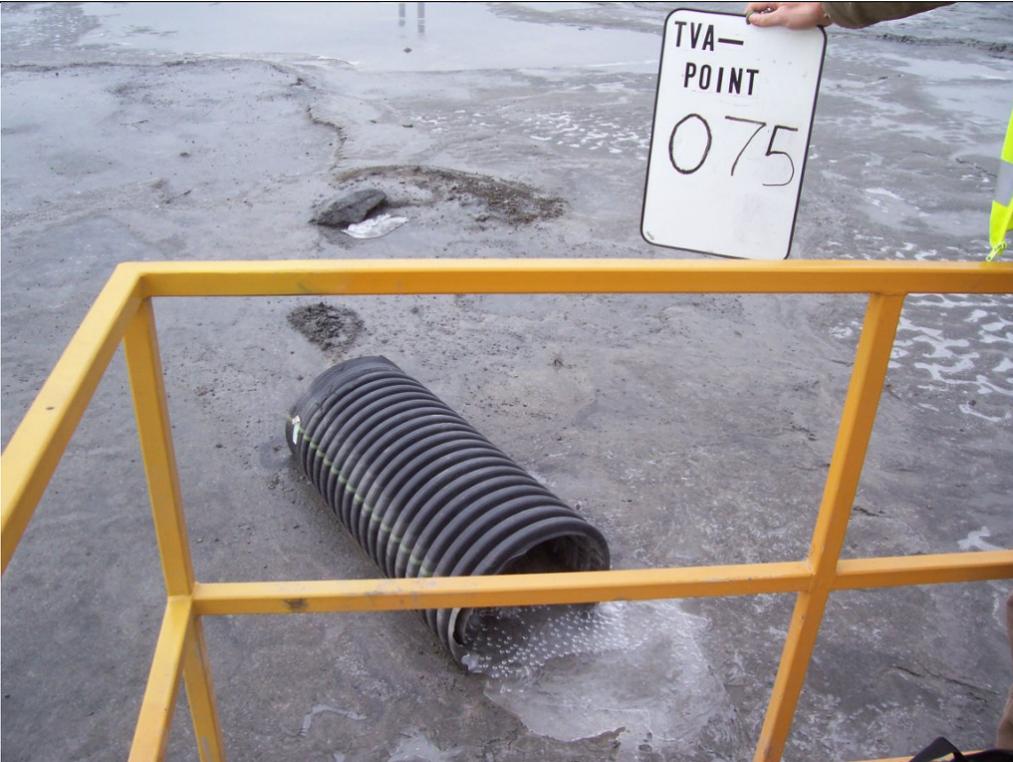
<b>Photo No.:</b> 10	<b>Date:</b> 1-23-2009

<b>Direction Photo Taken:</b>  Looking west.			
<b>Description:</b>  Relic Location 075. 24-inch corrugated PE piping. Thought to have originated from one of two stockpiles: one at the northern end of the east dike of Dredge Cell 2, or a second at the northeastern edge of Dike D. Location is in the Emory River channel.  The pipe was transported between approximately 2,600 and 3,300 feet.

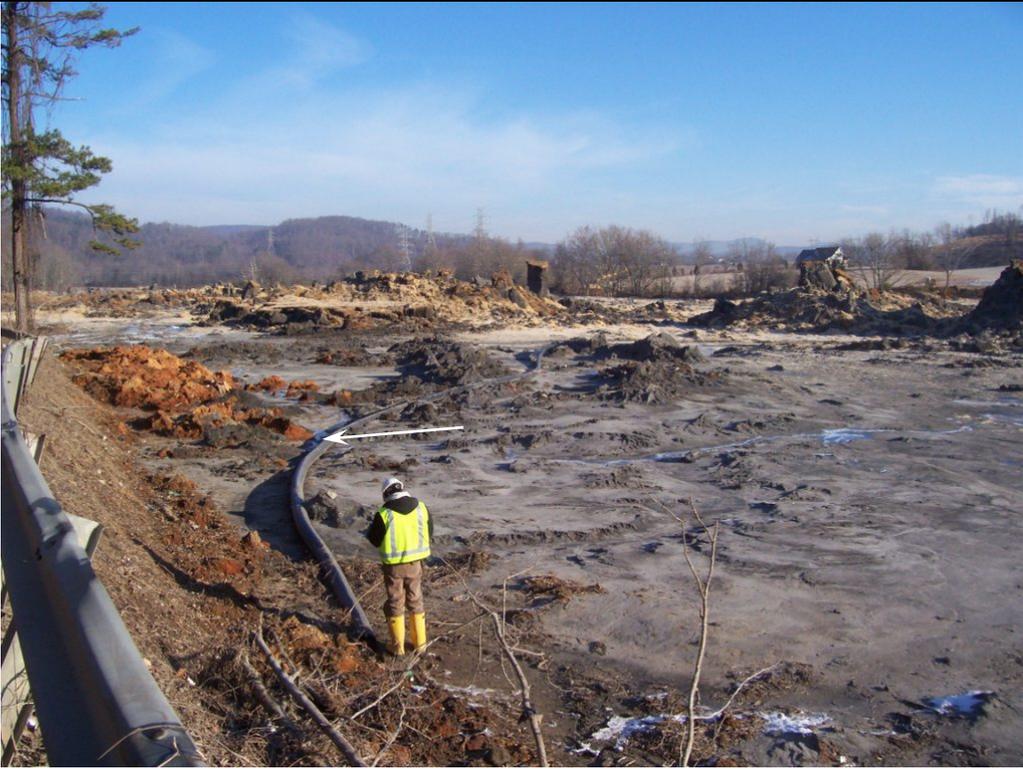
<b>Direction Photo Taken:</b>  Looking north-northeast.			
<b>Description:</b>  Relic Locations 043 and 044. South end of 10-inch HDPE pipe (dredge pipeline?) located in Slough 2.  The HDPE pipe was transported approximately 1,400 feet north-northwest from its original position.

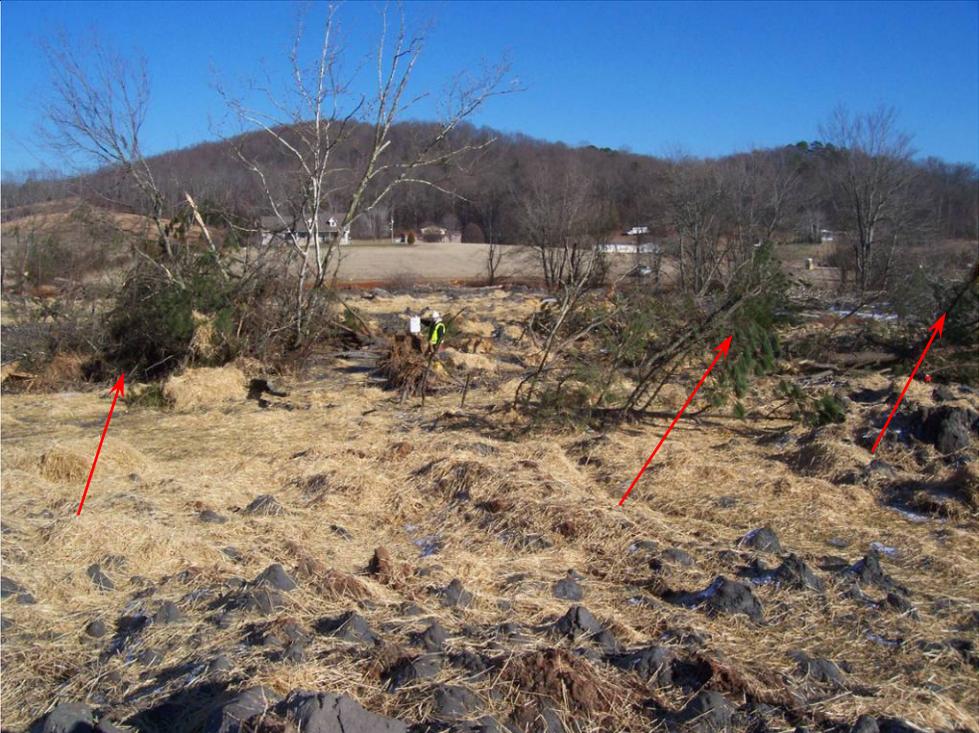
<b>Photo No.:</b> <b>12</b>	<b>Date:</b> 1-21-2009

<b>Direction Photo Taken:</b>  Looking east.			
<b>Description:</b>  Relic Location 030. Pine trees formerly located on downstream north slope of Dike C (red arrows).  The trees were transported approximately 2,100 feet north-northwest from their original position.

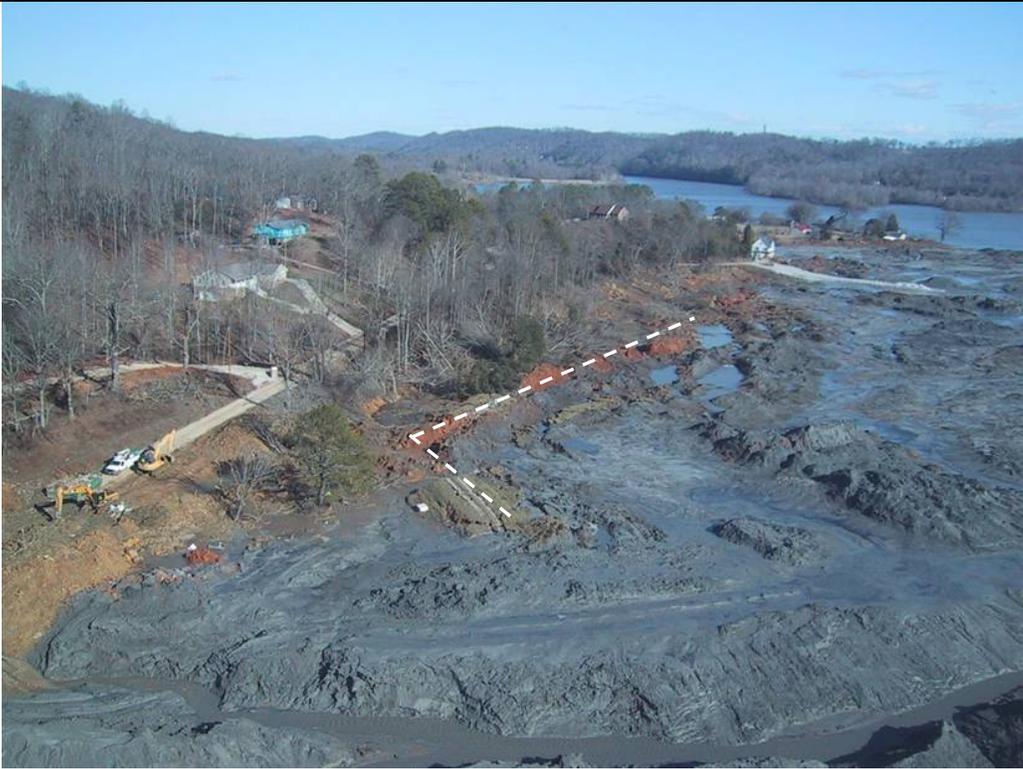
<b>Direction Photo Taken:</b>  Looking east-northeast.			
<b>Description:</b>  Relic Dike C (dashed line) on north shore of Tail Water.  Dike C was transported approximately 700 feet northward from its original position.

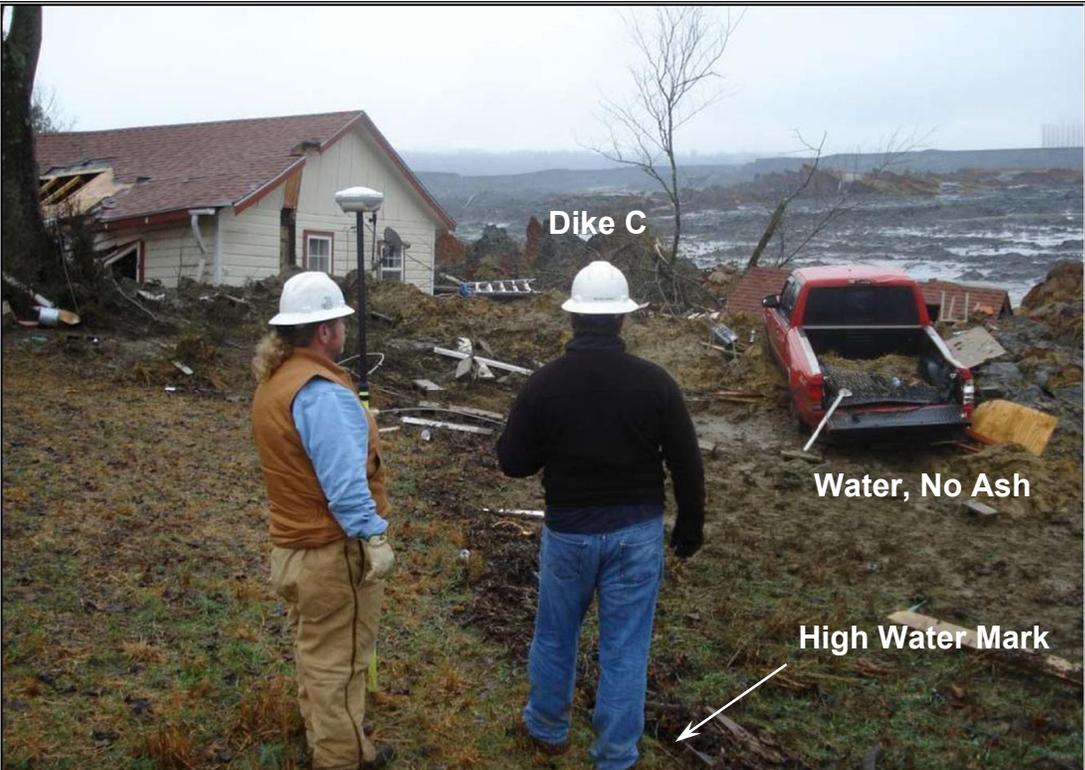
<b>Photo No.</b> <b>14</b>	<b>Date:</b> Uncertain

<b>Direction Photo Taken:</b>  Looking south-southeast.			
<b>Description:</b>  Schean home pushed by Dike C and water surge.  The Schean home was moved approximately 65 feet northward from its original location.  (Photo by TVA)

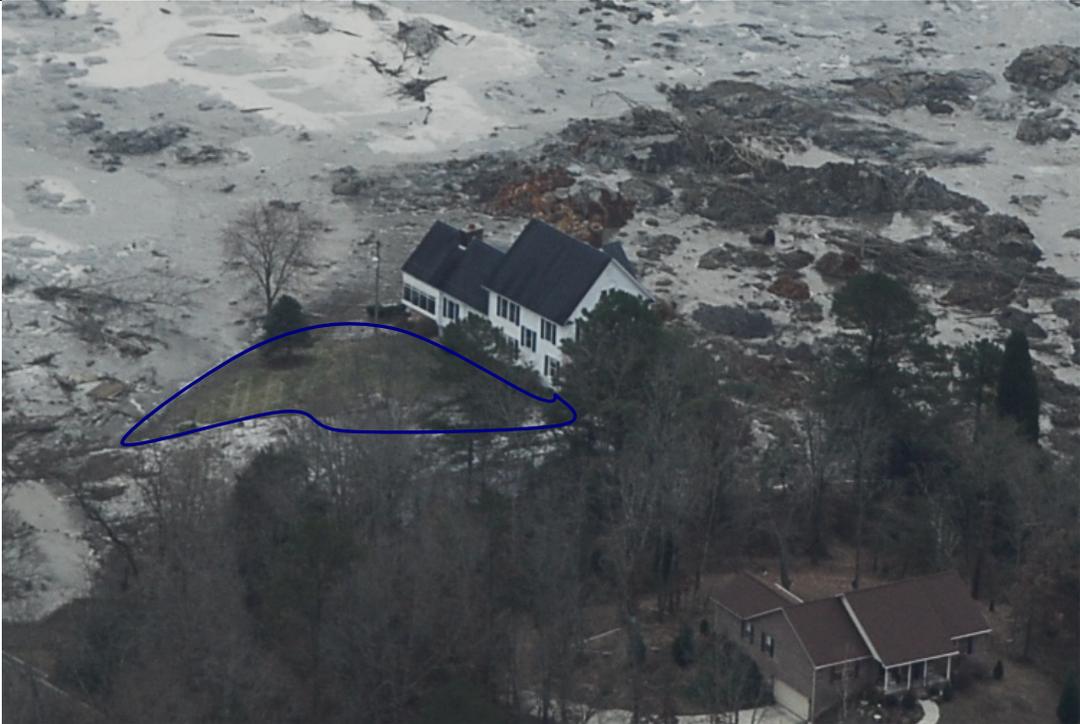
<b>Direction Photo Taken:</b>  Looking southeast.			
<b>Description:</b>  The James home damaged during event. Areas over-washed by water but not ash (blue area).  (Photo by TVA)

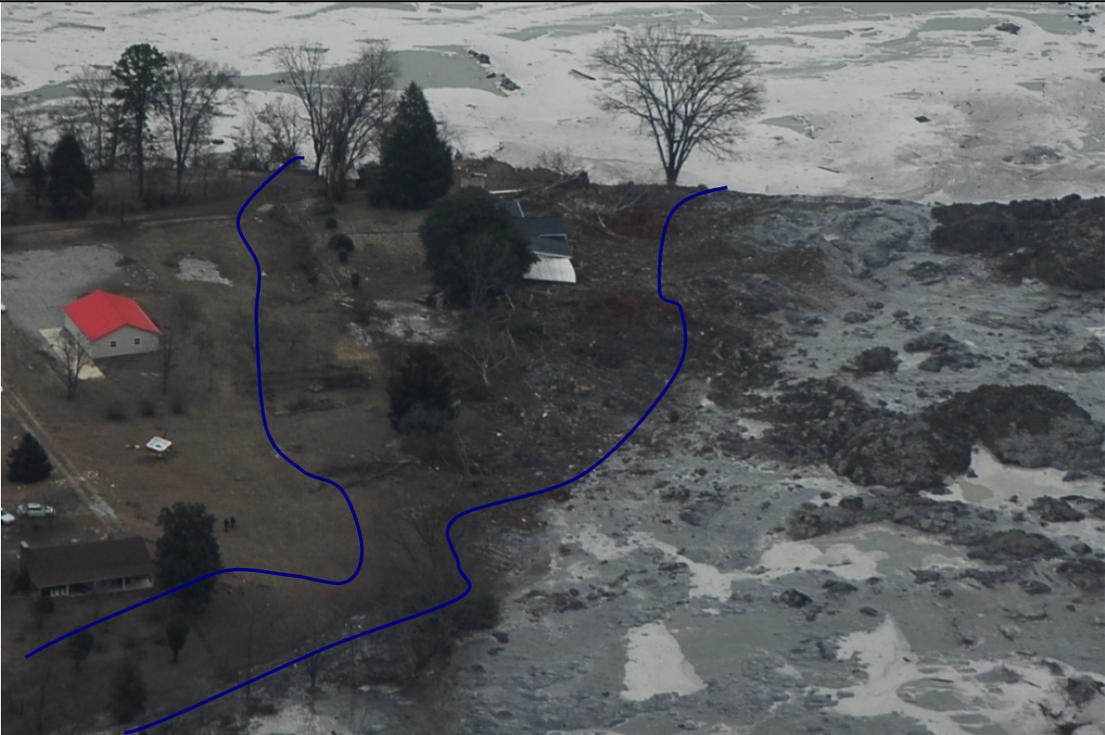
<b>Photo No.</b> <b>16</b>	<b>Date:</b> 12-23-09

<b>Direction Photo Taken:</b>  Looking southwest.			
<b>Description:</b>  The Hanover home damaged during event. Located on the peninsula between Slough 3 and the reservoir. Area between blue lines was over-washed with water but not ash.  (Photo by TVA)
