**CELL 1 TEST TRENCH NO. 3  
PHOTOGRAPHIC LOG**

<b>Client Name:</b> Tennessee Valley Authority		<b>Site Location:</b> Kingston Fossil Plant – Harriman, Tennessee	<b>Project No.:</b> 60095742
<b>Photo No.</b> <b>1</b>	<b>Date:</b> 3-7-2009

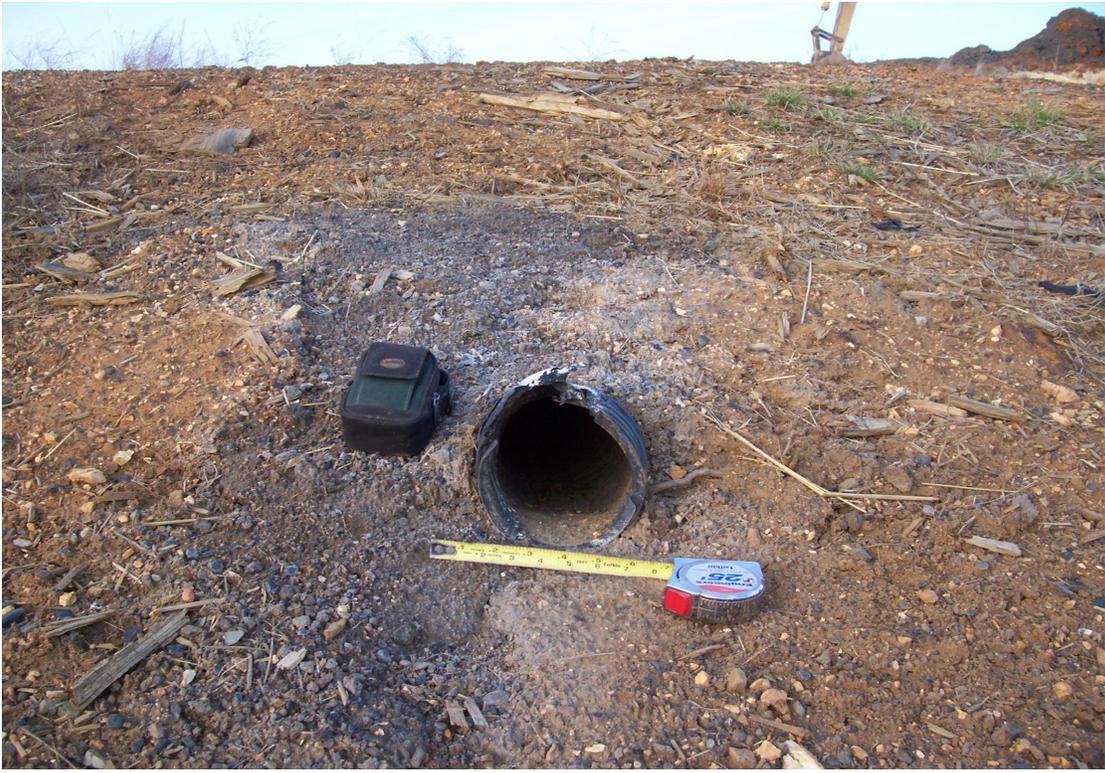
<b>Direction Photo Taken:</b>  Looking north.			
<b>Description:</b>  Typical “daylight” for the sideslope drains.

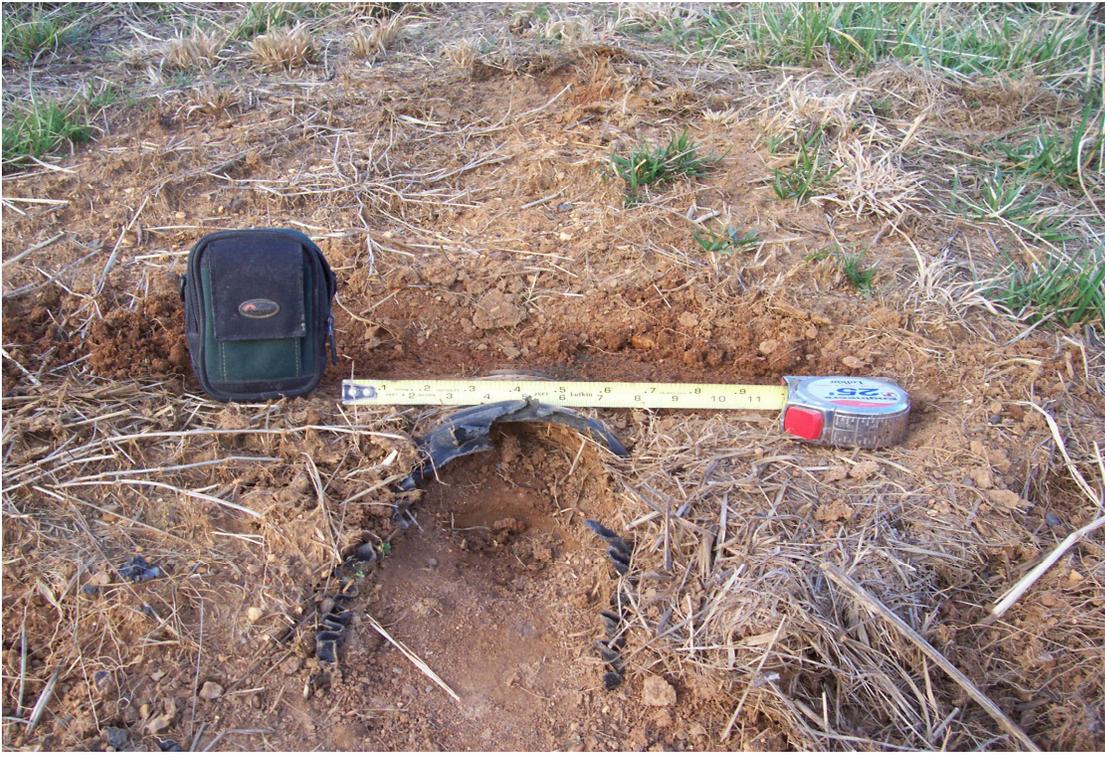
<b>Photo No.</b> <b>2</b>	<b>Date:</b> 3-7-2009

<b>Direction Photo Taken:</b>  Looking north.		
<b>Description:</b>  One example of a plugged sideslope drain. The plug appeared to be at the surface.

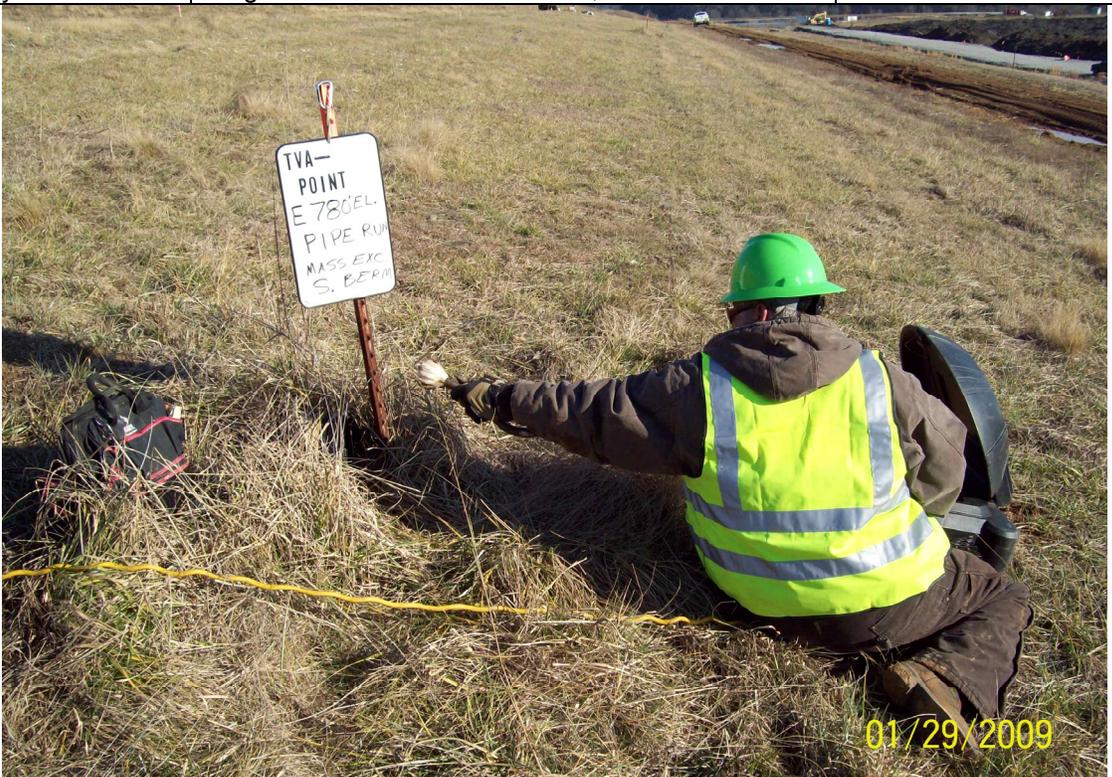
<b>Photo No.</b> <b>3</b>	<b>Date:</b> 1-29-09
------------------------------	-------------------------

Preparing to feed video equipment into one of the sideslope drains.

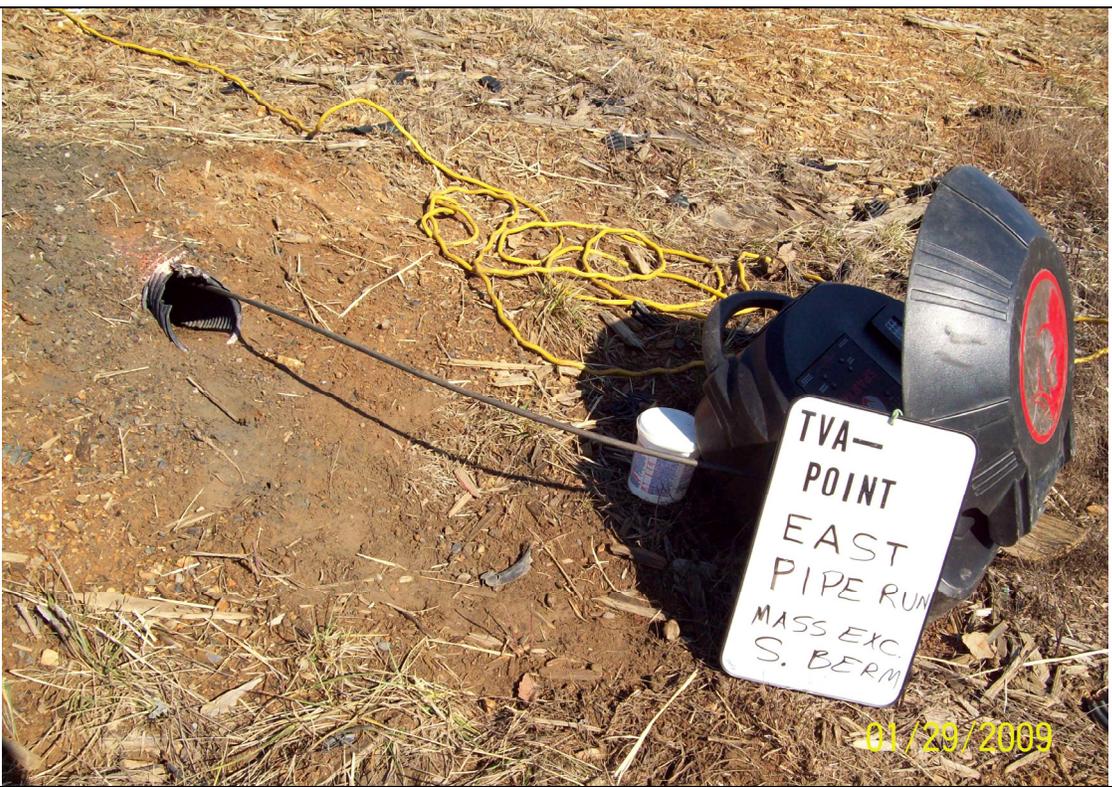
<b>Photo No.</b> <b>4</b>	<b>Date:</b> 1-29-2009
------------------------------	---------------------------

Video equipment inside one of the sideslope drains.

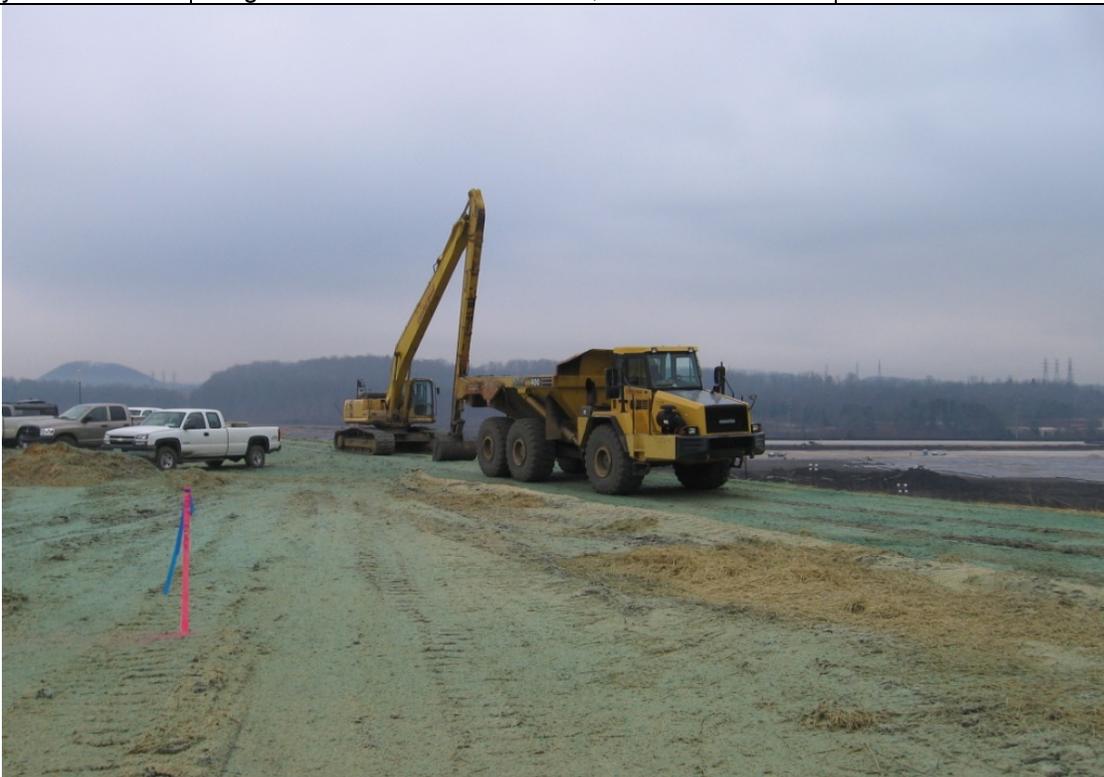
<b>Client Name:</b> Tennessee Valley Authority		<b>Site Location:</b> Kingston Fossil Plant – Harriman, Tennessee	<b>Project No.:</b> 60095742
<b>Photo No.:</b> <b>9</b>	<b>Date:</b> 3-6-2009

<b>Direction Photo Taken:</b>  Looking southeast.			
<b>Description:</b>  Staging equipment immediately before beginning excavation.

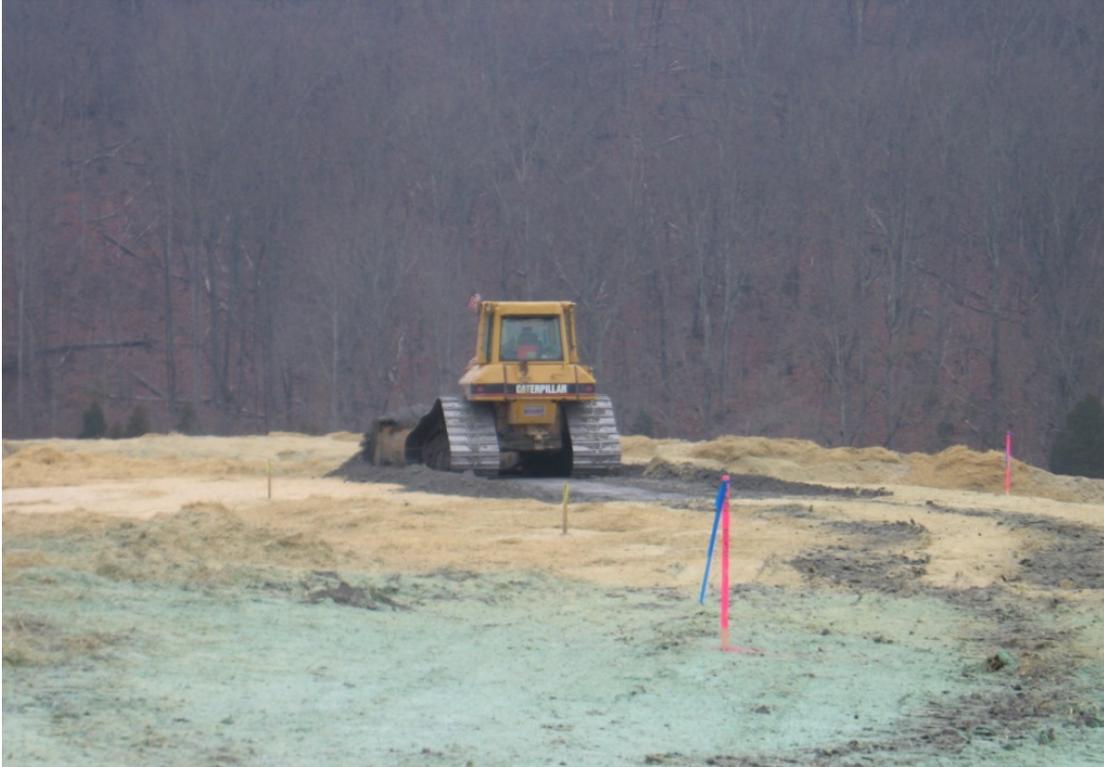
<b>Photo No.:</b> <b>10</b>	<b>Date:</b> 3-6-2009

<b>Direction Photo Taken:</b>  Looking west.		
<b>Description:</b>  Dozer beginning removal of Stage D3 Dike material.

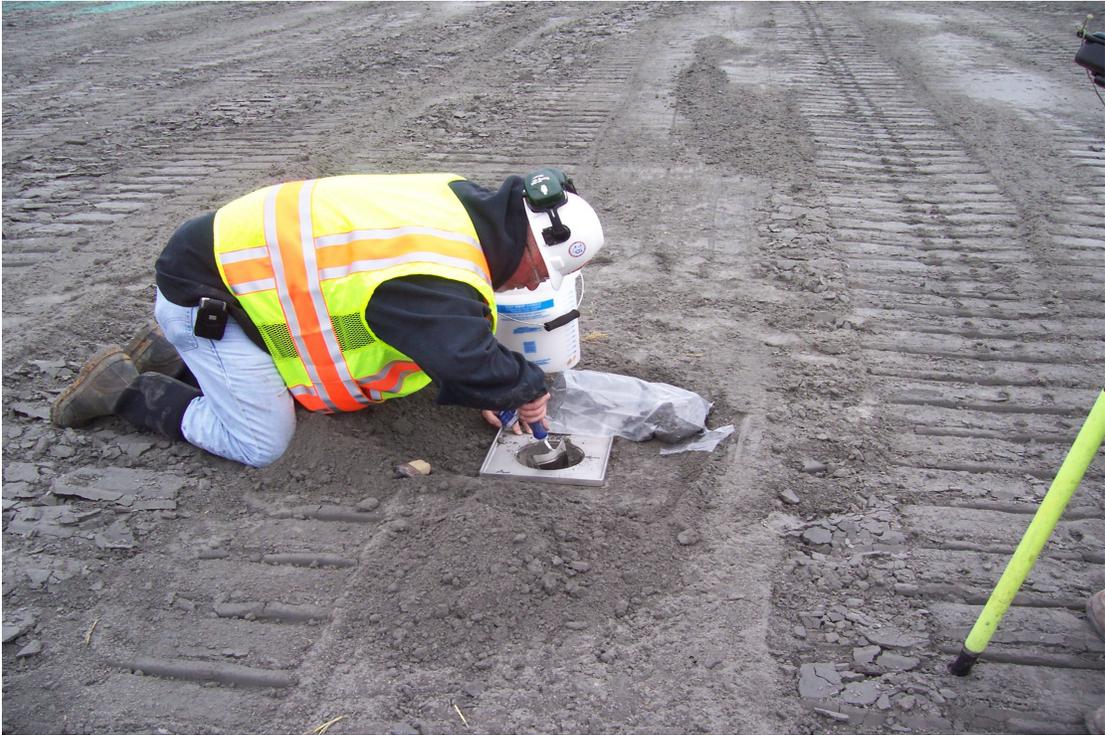
<b>Client Name:</b> Tennessee Valley Authority		<b>Site Location:</b> Kingston Fossil Plant – Harriman, Tennessee	<b>Project No.:</b> 60095742
<b>Photo No.:</b> <b>13</b>	<b>Date:</b> 3-7-2009

<b>Direction Photo Taken:</b>  Looking east.			
<b>Description:</b>  Performs a sand cone test. Plastic bag contains ash being removed from sand cone hole for weighing and water content analysis. (Bill Butler, P.E. – AECOM)

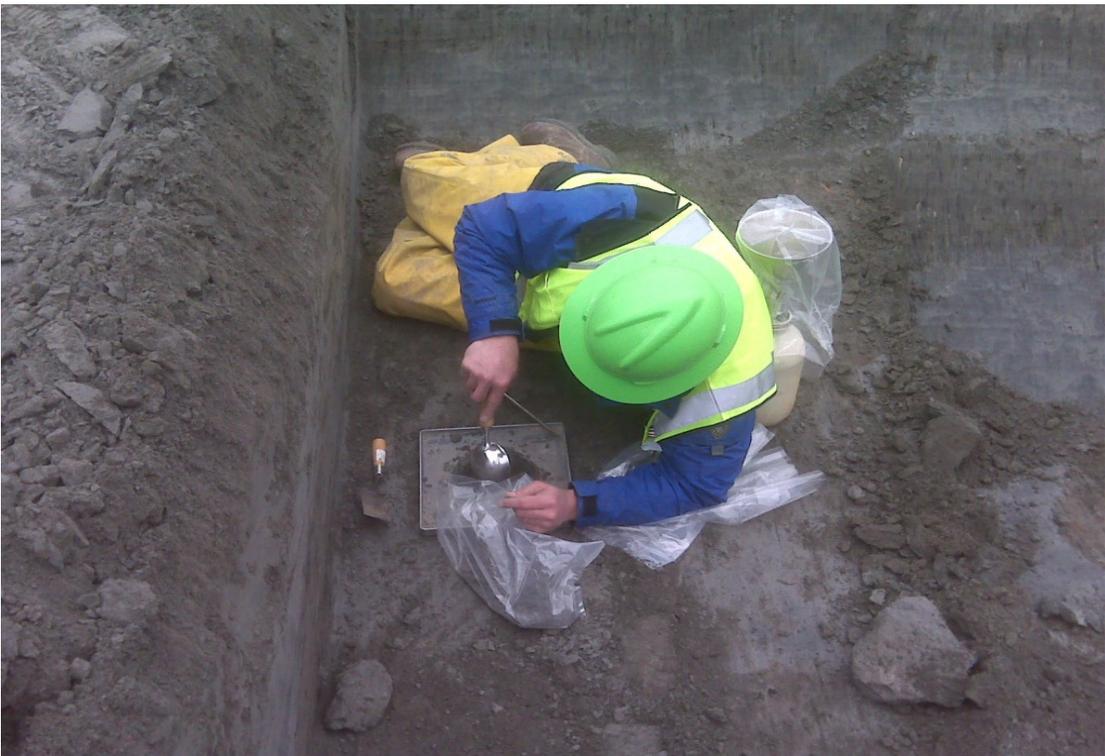
<b>Photo No.:</b> <b>14</b>	<b>Date:</b> 3-8-2009

<b>Direction Photo Taken:</b>  Looking southwest.		
<b>Description:</b>  Removing ash from sand cone hole as weather turns. Note plastic bag covering sand cone to keep out moisture. (Dan Braatz – AECOM Environment)

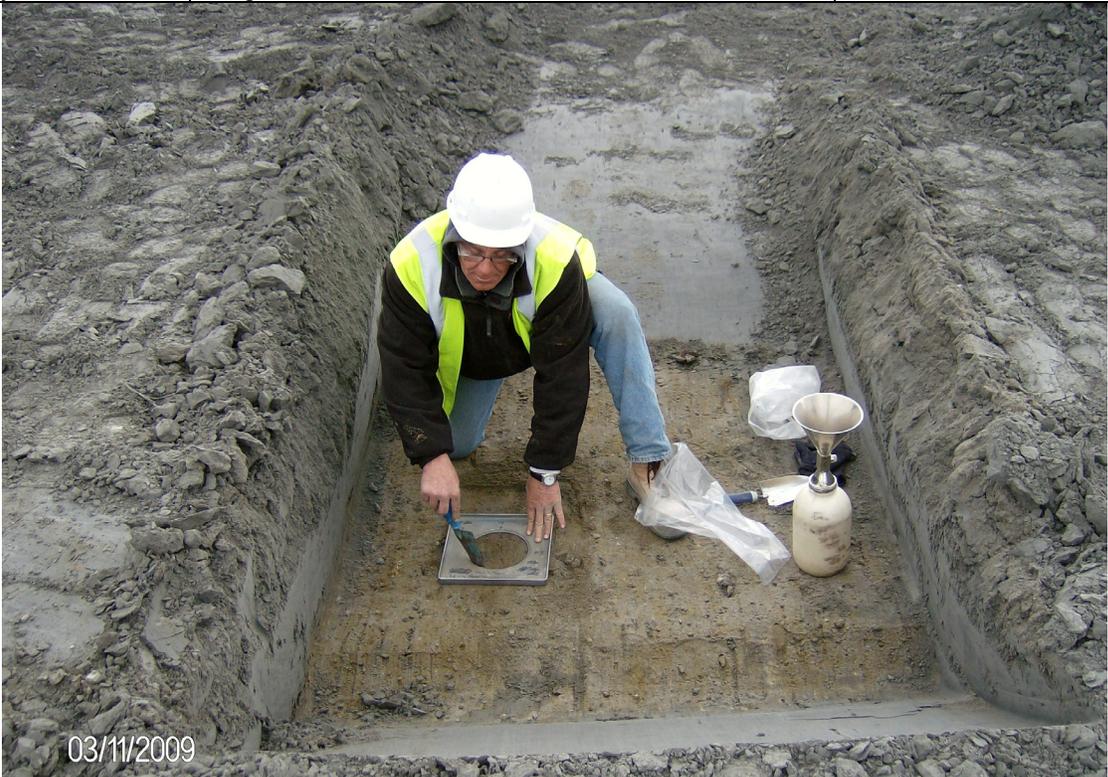
<b>Client Name:</b> Tennessee Valley Authority		<b>Site Location:</b> Kingston Fossil Plant – Harriman, Tennessee	<b>Project No.:</b> 60095742
<b>Photo No.:</b> <b>15</b>	<b>Date:</b> 3-11-2009

<b>Direction Photo Taken:</b>  Looking north.			
<b>Description:</b>  Beginning sand cone hole in bottom ash. Lighter brown color indicative of bottom ash found in compacted dike. (Randy Sederstrom – AECOM Environment)

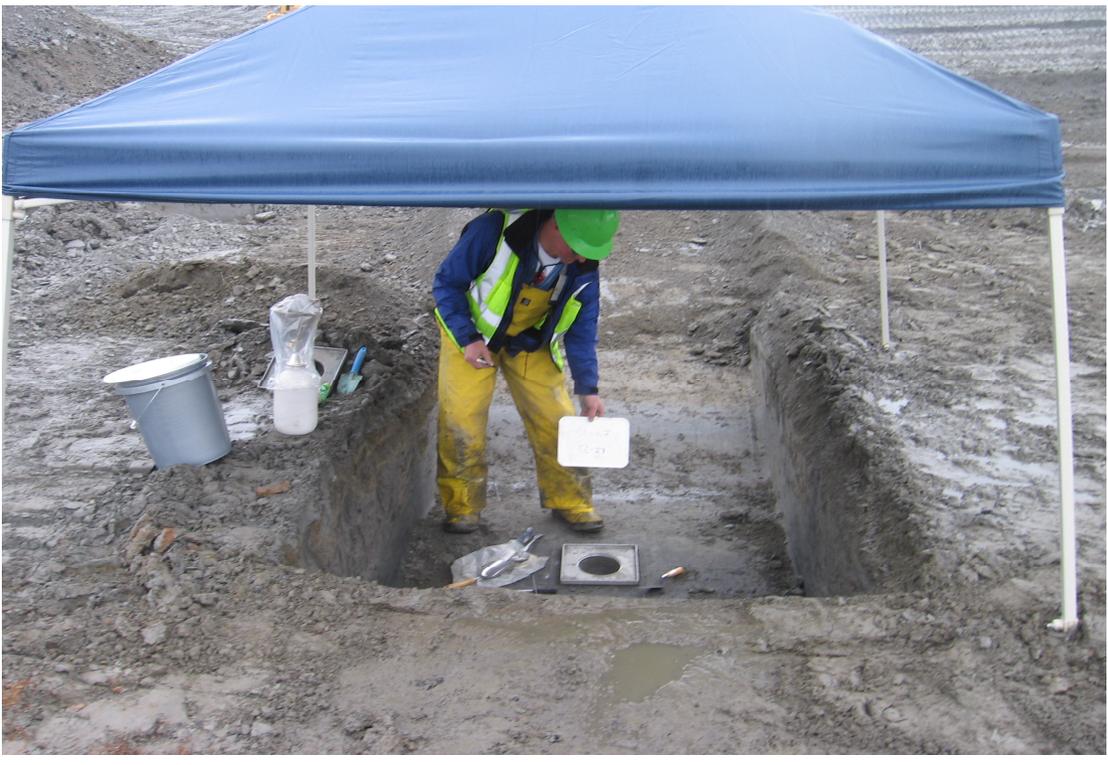
<b>Photo No.:</b> <b>16</b>	<b>Date:</b> 3-13-2009

<b>Direction Photo Taken:</b>  Looking north.		
<b>Description:</b>  Sand cone testing conducted beneath portable tarp during rain events to prevent materials from getting wet.

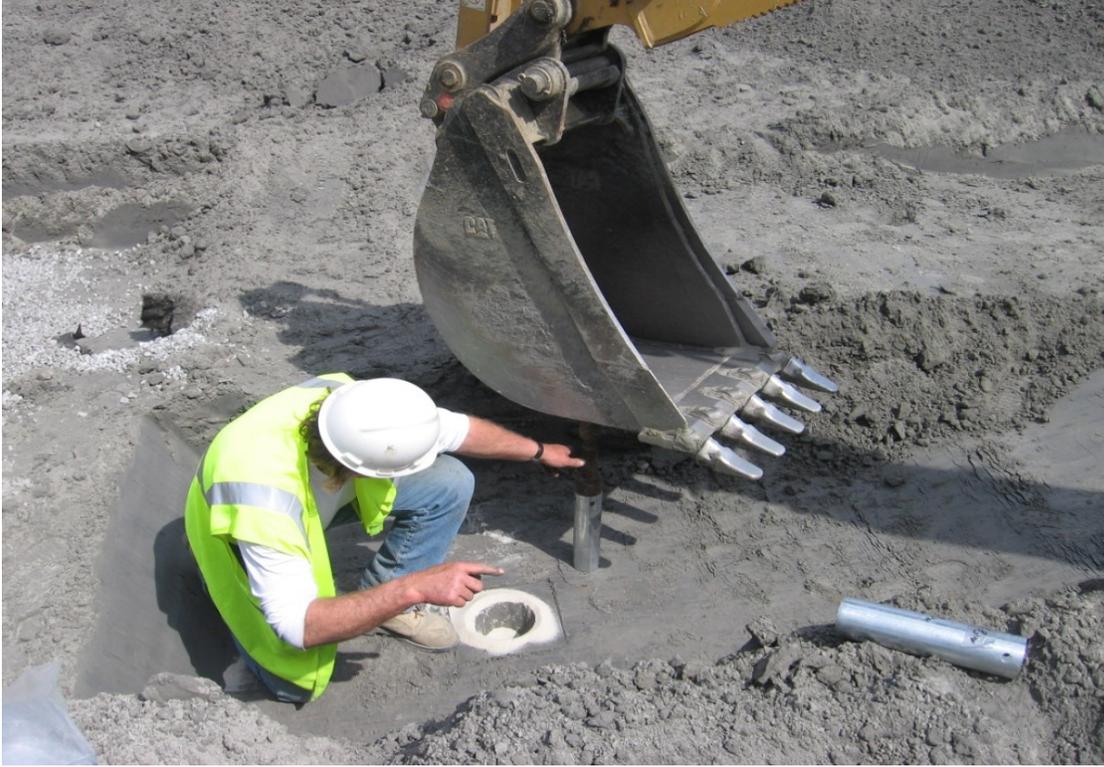
<b>Client Name:</b> Tennessee Valley Authority		<b>Site Location:</b> Kingston Fossil Plant – Harriman, Tennessee	<b>Project No.:</b> 60095742
<b>Photo No.</b> <b>17</b>	<b>Date:</b> 3-9-2009

<b>Direction Photo Taken:</b>  Looking northeast.			
<b>Description:</b>  Pushing a vertical Shelby Tube with trackhoe bucket.

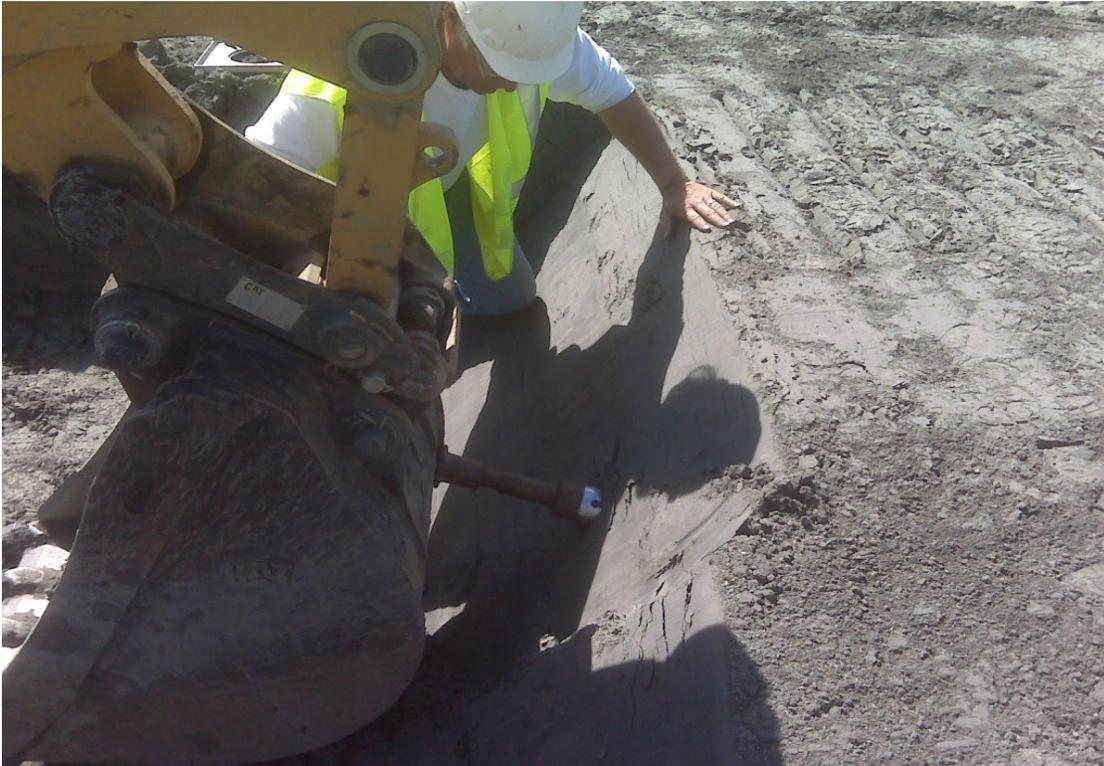
<b>Photo No.</b> <b>18</b>	<b>Date:</b> 3-7-2009

<b>Direction Photo Taken:</b>  Looking southwest.		
<b>Description:</b>  Pushing a horizontal Shelby Tube with trackhoe bucket.

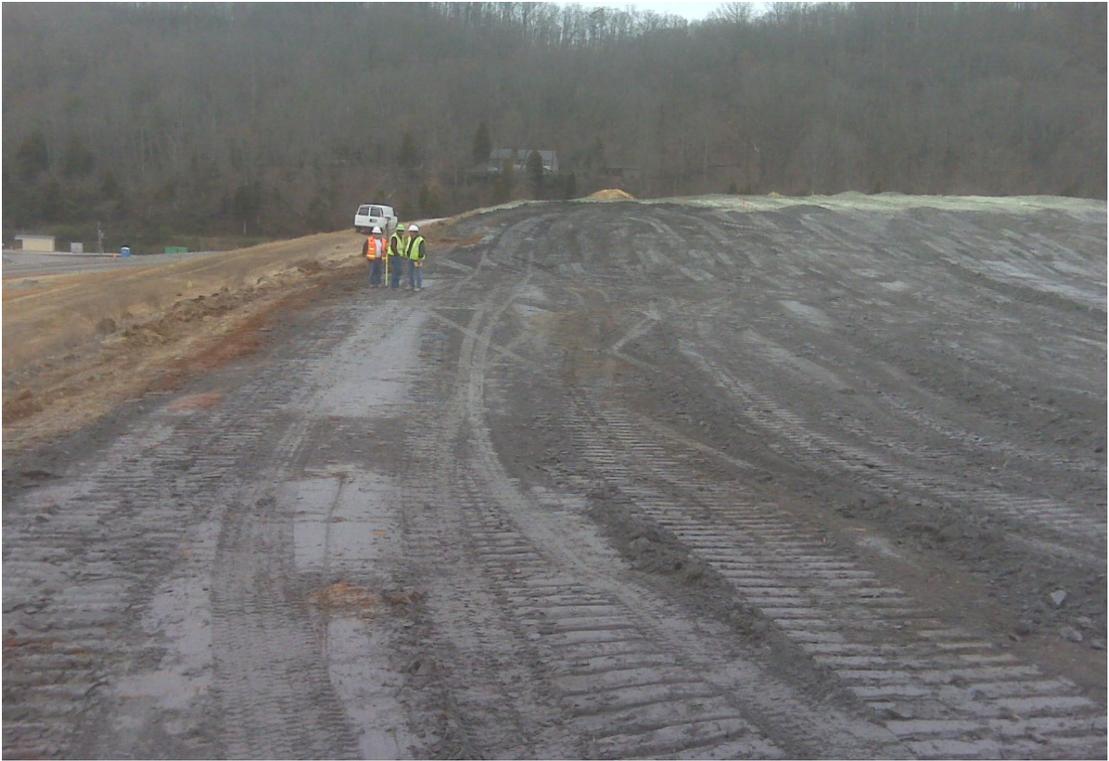
<b>Client Name:</b> Tennessee Valley Authority		<b>Site Location:</b> Kingston Fossil Plant – Harriman, Tennessee		<b>Project No.:</b> 60095742	
<b>Photo No.</b> <b>21</b>	<b>Date:</b> 3-10-2009

<b>Direction Photo Taken:</b>  Looking west.					
<b>Description:</b>  Excavation progress prior to encountering uppermost drain pipe.

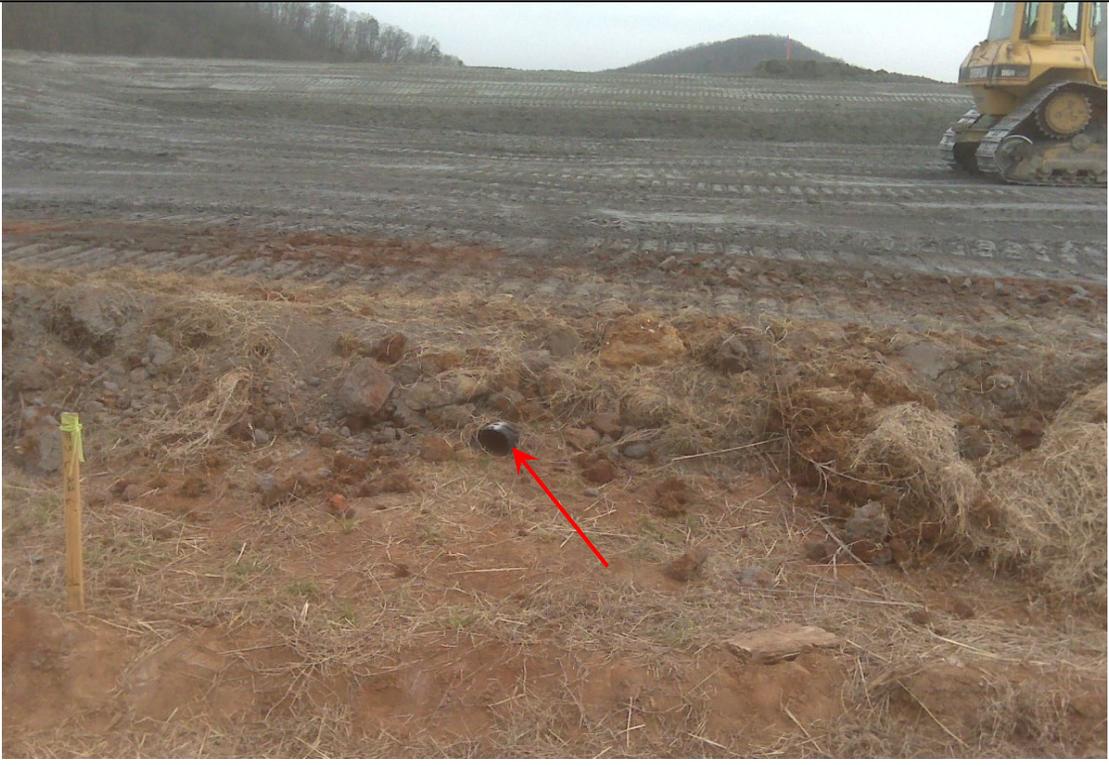
<b>Photo No.</b> <b>22</b>	<b>Date:</b> 3-10-2009

<b>Direction Photo Taken:</b>  Looking north.					
<b>Description:</b>  Red arrow points to surface expression of one of the drain pipes placed into the ash during construction of the dike.

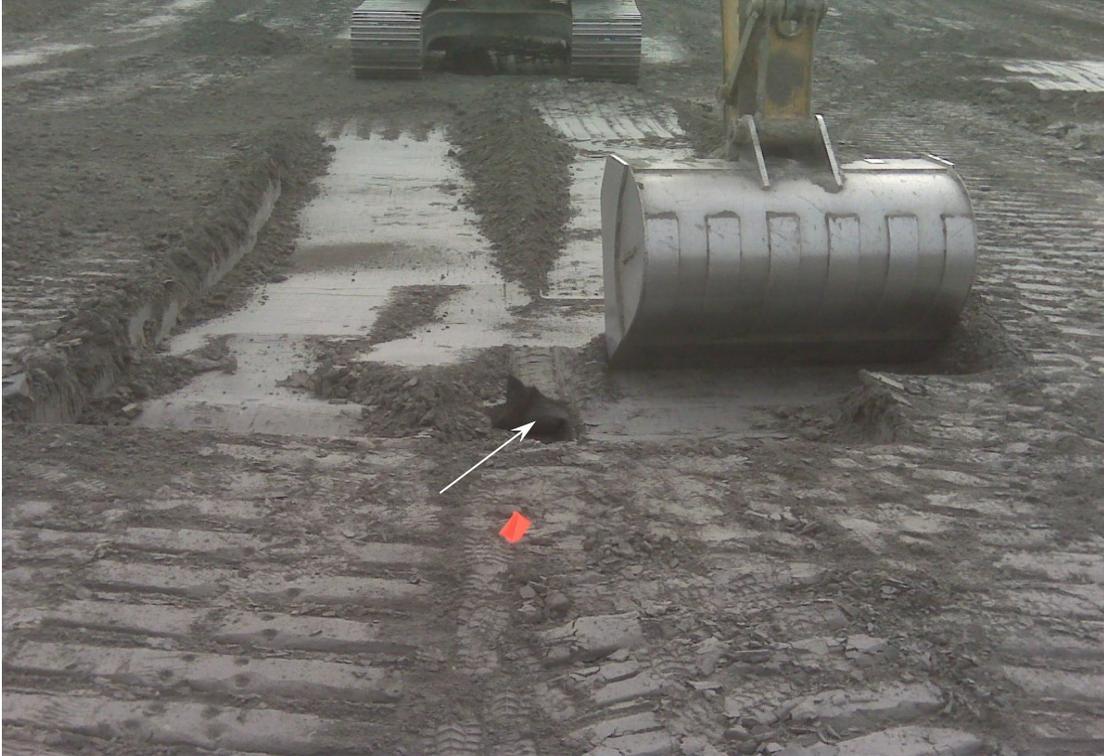
<b>Client Name:</b> Tennessee Valley Authority		<b>Site Location:</b> Kingston Fossil Plant – Harriman, Tennessee	<b>Project No.:</b> 60095742
<b>Photo No.:</b> <b>23</b>	<b>Date:</b> 3-10-2009

<b>Direction Photo Taken:</b>  Uncertain.			
<b>Description:</b>  Uncovering polyethylene drainage pipe. White arrow highlights drainage fabric encountered during excavation.

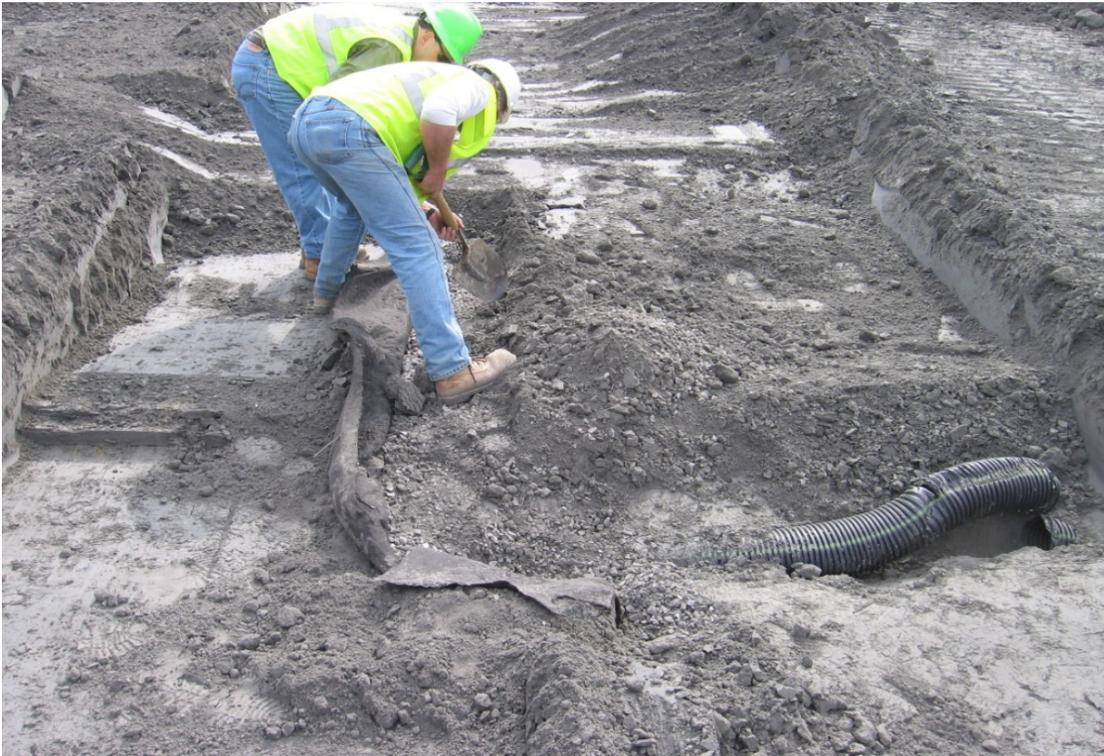
<b>Photo No.:</b> <b>24</b>	<b>Date:</b> 3-9-2009

<b>Direction Photo Taken:</b>  Looking east.		
<b>Description:</b>  Polyethylene pipe exposed for sample collection. Work is being conducted on a lateral, perforated section of pipe. The non-perforated pipe that daylights on the slope of the berm exits the right side of the photo.

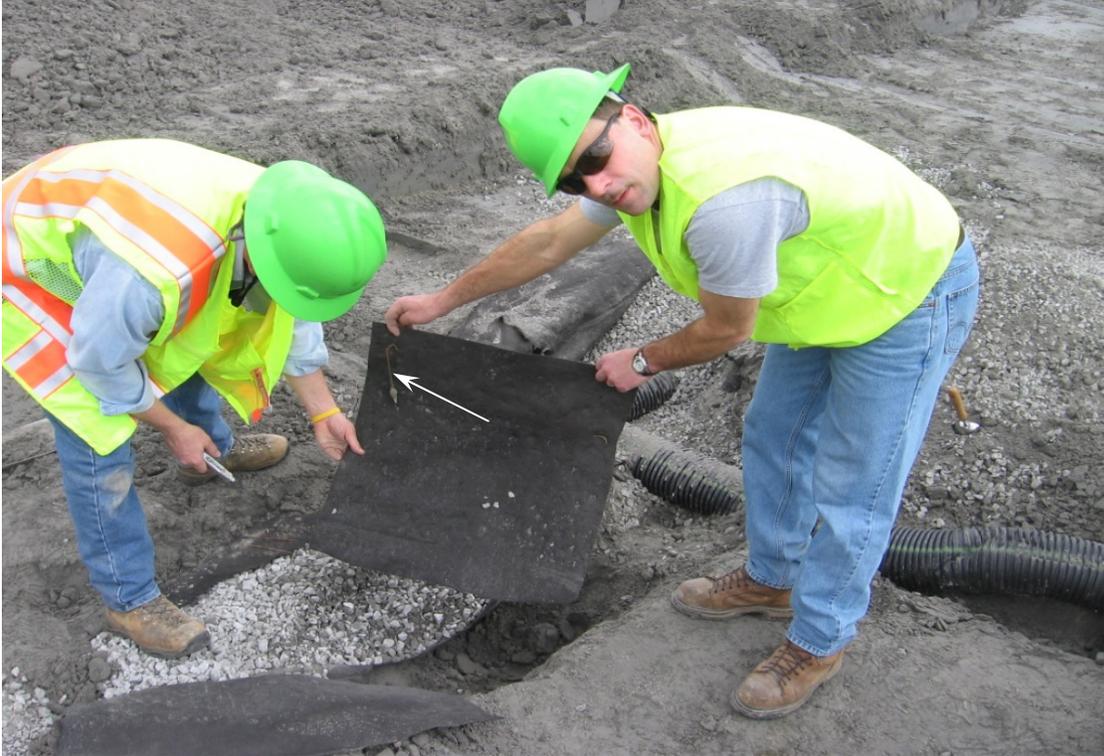
<b>Client Name:</b> Tennessee Valley Authority		<b>Site Location:</b> Kingston Fossil Plant – Harriman, Tennessee	<b>Project No.:</b> 60095742
<b>Photo No.:</b> <b>25</b>	<b>Date:</b> 3-9-2009

<b>Direction Photo Taken:</b>  Looking northeast.			
<b>Description:</b>  Sample of drainage fabric. White arrow points to metal staple used to secure the fabric. Surface rust on staple indicates presence of water.

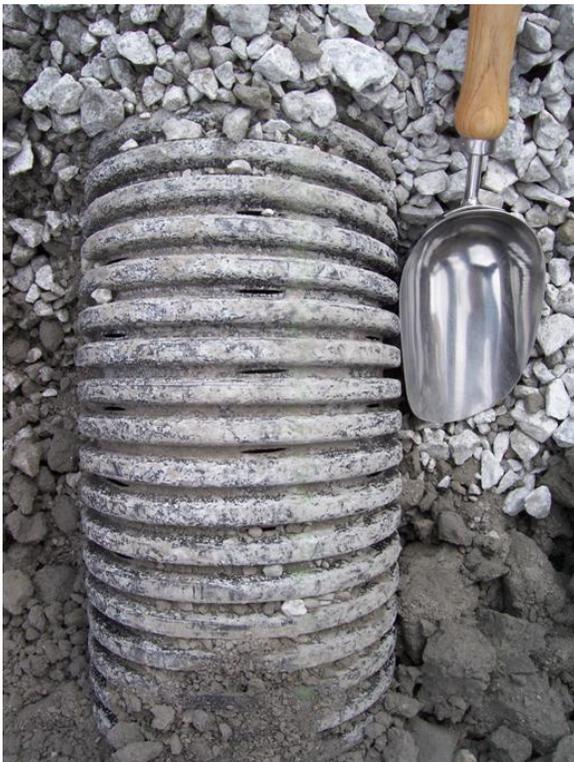
<b>Photo No.:</b> <b>26</b>	<b>Date:</b> 3-10-2009

<b>Direction Photo Taken:</b>  Vertical.		
<b>Description:</b>  Perforated polyethylene pipe with evidence of water movement through the gravel pack and into the pipe (white surface coating on pipe).

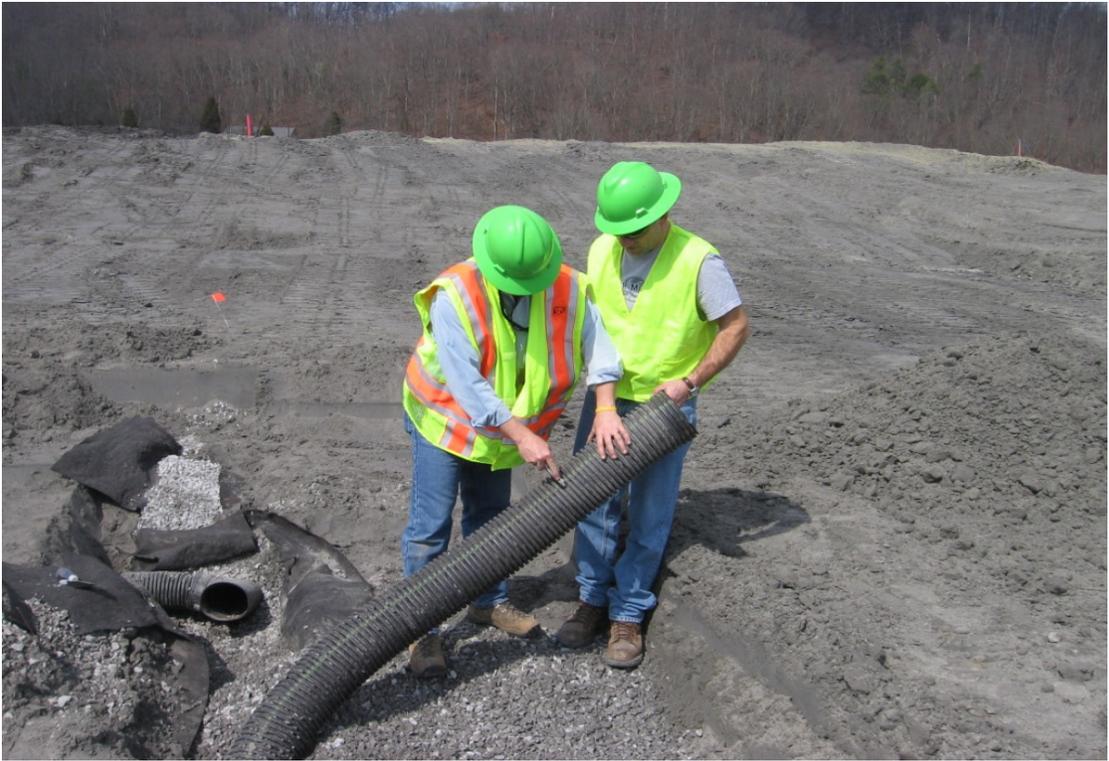
<b>Client Name:</b> Tennessee Valley Authority		<b>Site Location:</b> Kingston Fossil Plant – Harriman, Tennessee	<b>Project No.:</b> 60095742
<b>Photo No.</b> <b>27</b>	<b>Date:</b>

<b>Direction Photo Taken:</b>  Looking west.			
<b>Description:</b>  Collecting a sample of lateral perforated polyethylene pipe.

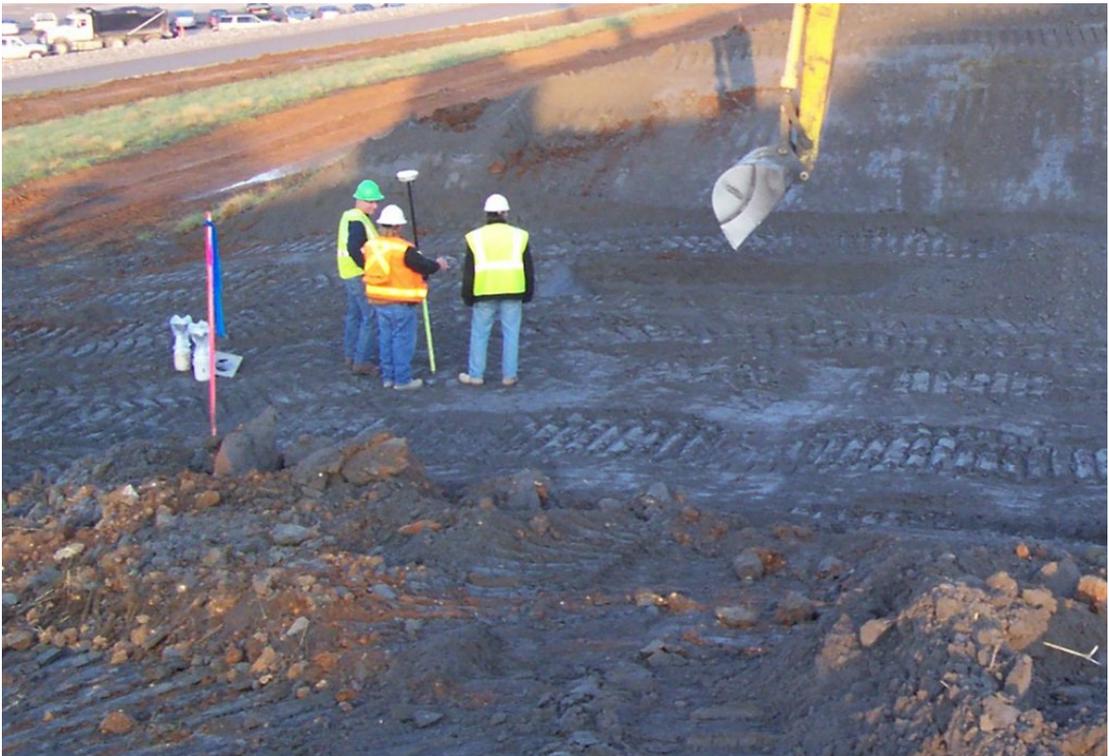
<b>Photo No.</b> <b>28</b>	<b>Date:</b> 3-18-2009

<b>Direction Photo Taken:</b>  Looking west.		
<b>Description:</b>  Surveyor with GPS preparing to locate sand cone and Shelby Tube locations in preparation for trackhoe excavation.

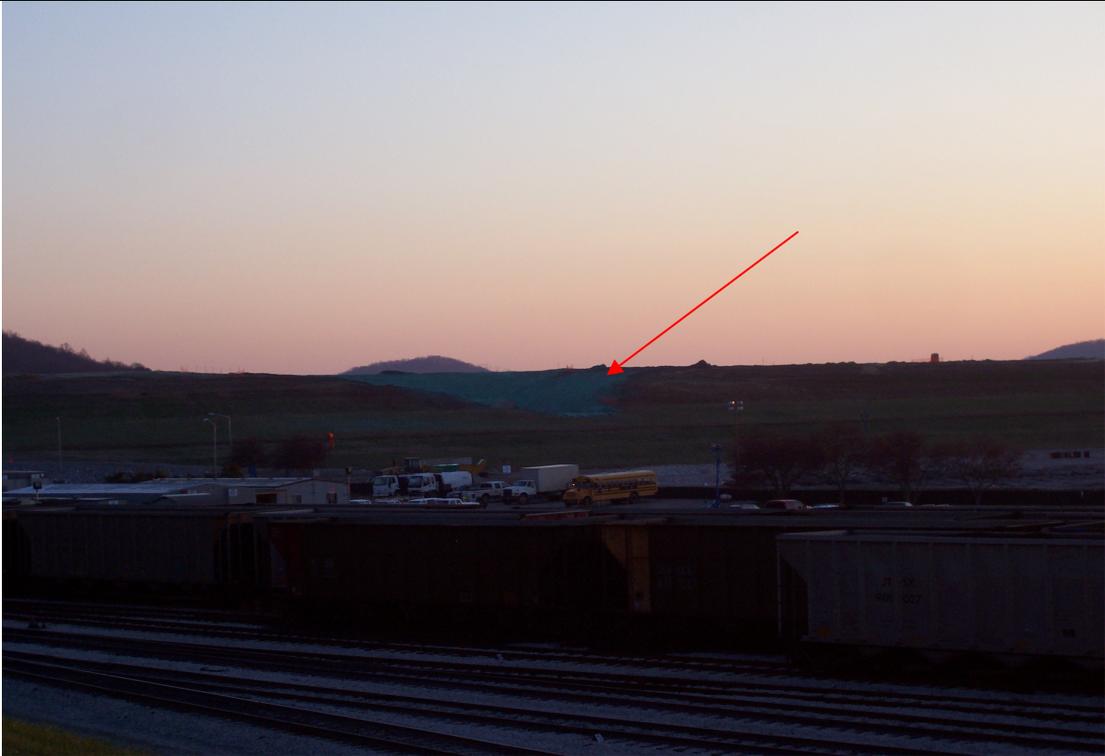
<b>Client Name:</b> Tennessee Valley Authority		<b>Site Location:</b> Kingston Fossil Plant – Harriman, Tennessee	<b>Project No.</b> 60095742
<b>Photo No.</b> <b>29</b>	<b>Date:</b> 3-22-2009

<b>Direction Photo Taken:</b>  Looking northeast.			
<b>Description:</b>  Arrow points to completed excavation of south berm recently coated with Flexterra® dust control material (green) as seen from Swan Pond Road approximately 200 yards south of plant entrance/guard shack.

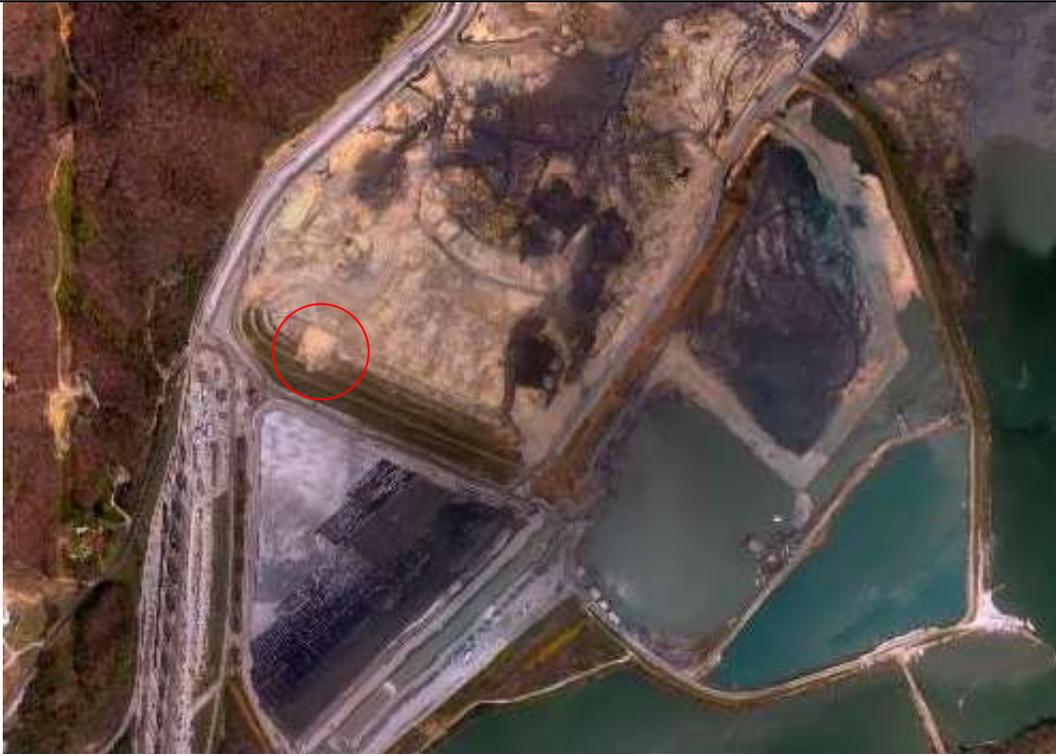
<b>Photo No.</b> <b>30</b>	<b>Date:</b> 4-9-2009

<b>Direction Photo Taken:</b>  Vertical.		
<b>Description:</b>  TVA air photograph taken April 9, 2009. The red circle outlines the completed excavation. The green Flexterra® dust control material has dried to tan.
