RELIC IDENTIFICATION PHOTOGRAPHIC LOG

Client Name: Tennessee Valley Authority		Site Location: Kingston Fossil Plant – Harriman, Tennessee	Project No.: 60095742
Photo No.: 001	Date: 1-18-2009

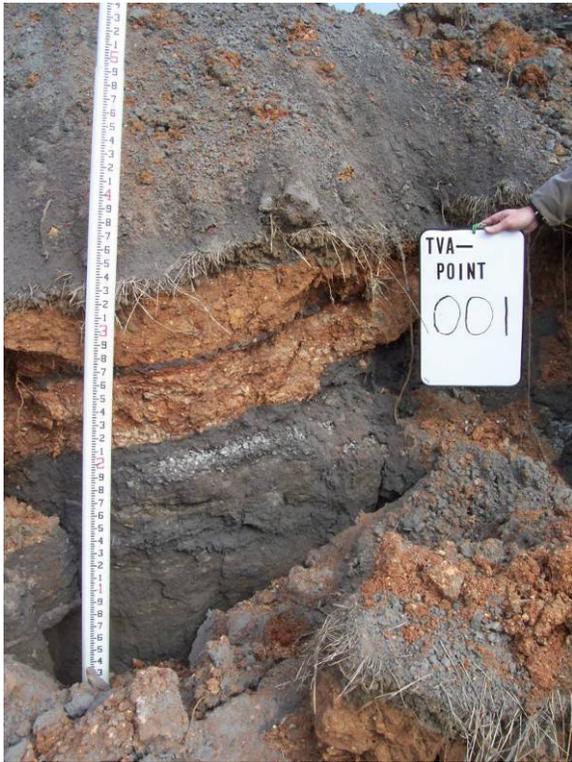
Direction Photo Taken: Looking north.			
Description: Clay cap material on unbroken piece of West Dike approximately 150 feet south of Borehole 09-102.

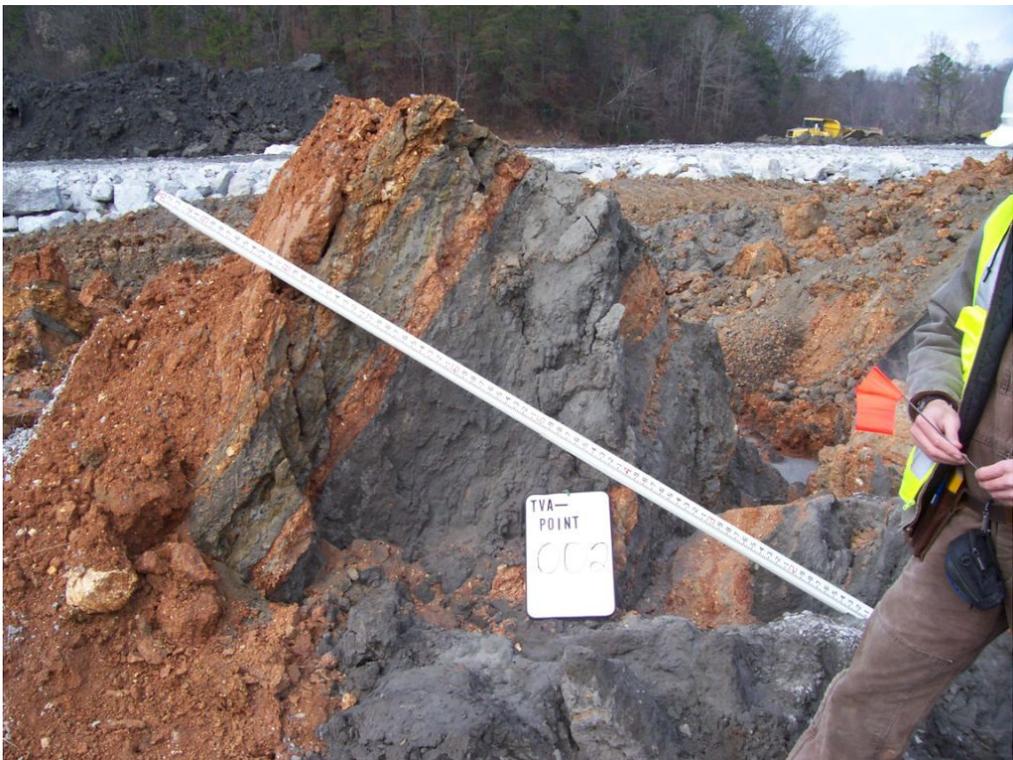
Photo No.: 002	Date: 1-18-2009

Direction Photo Taken: Looking west.		
Description: Clay cap material on unbroken piece of West Dike approximately 150 feet south of Borehole 09-101.

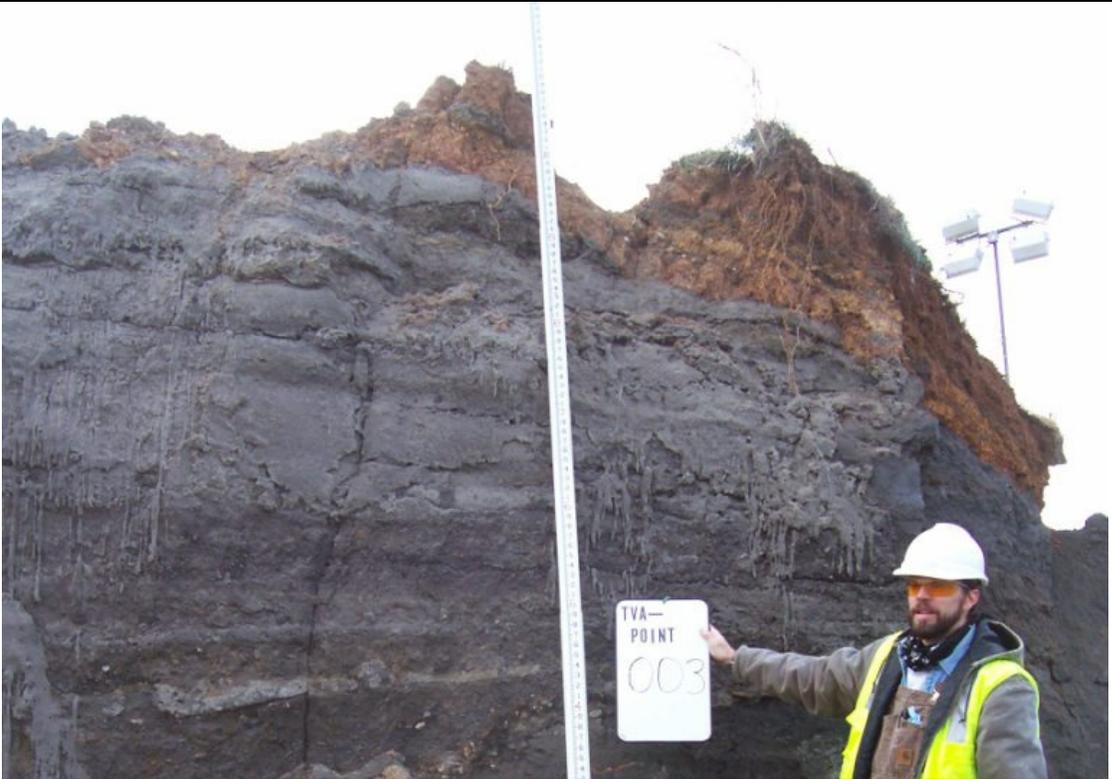
Client Name: Tennessee Valley Authority		Site Location: Kingston Fossil Plant – Harriman, Tennessee	Project No.: 60095742
Photo No.: 003	Date: 1-18-2009

Direction Photo Taken: Looking southwest.			
Description: North end of West Dike relic approximately 110 feet north of 09-101. Note the “fining upward” sequences of bottom ash (coarse) to fly ash (fine).

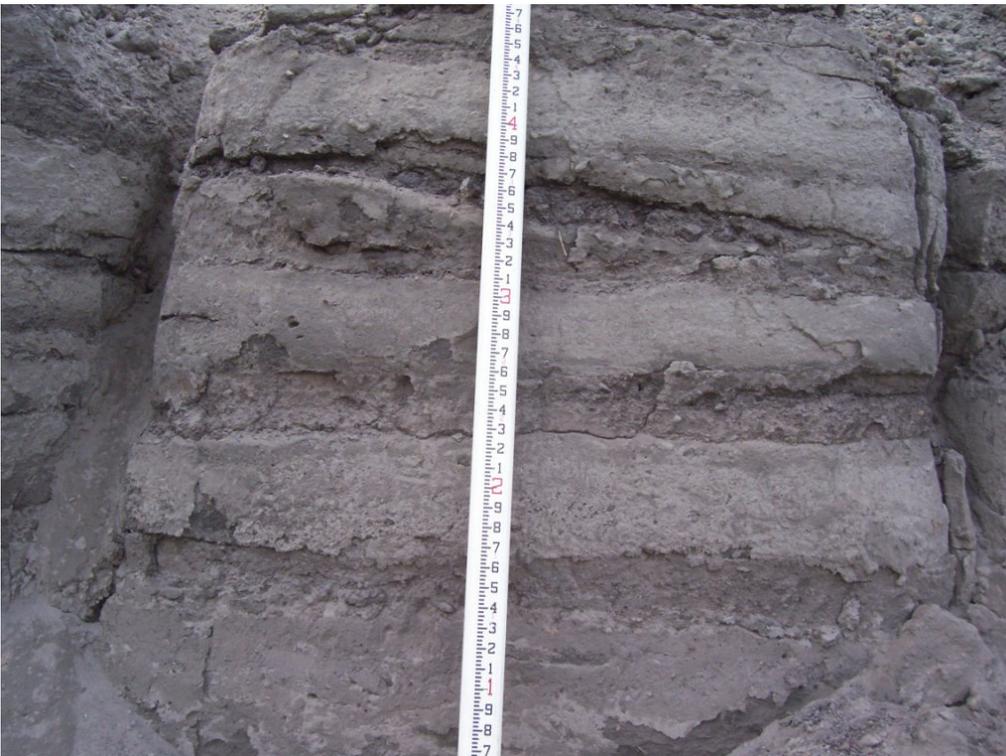
Photo No.: 003_2	Date: 1-18-2009

Direction Photo Taken: Looking southwest.		
Description: Closer view of the “fining upward” sequences in the West Dike. West end of relic location 003. Bottom ash (coarse) to fly ash (fine).

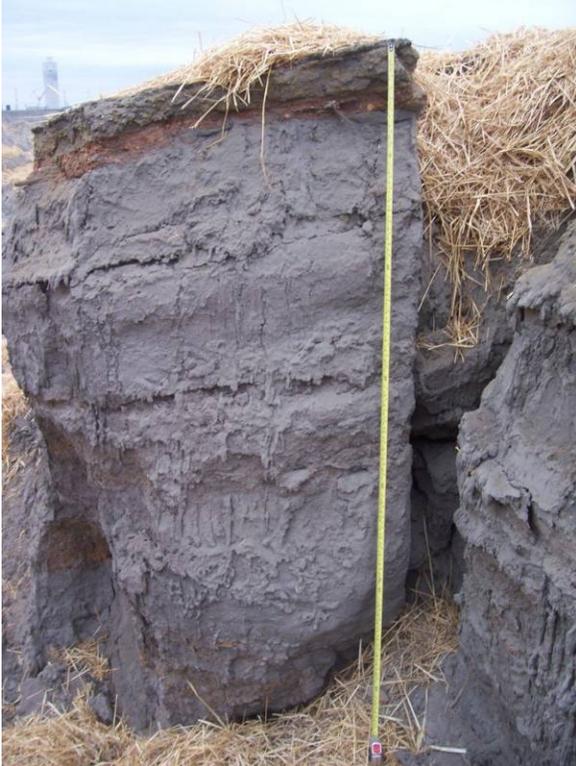
Client Name: Tennessee Valley Authority		Site Location: Kingston Fossil Plant – Harriman, Tennessee	Project No.: 60095742
Photo No.: 004	Date: 1-18-2009

Direction Photo Taken: Looking south.			
Description: Relic of West Dike. Note fining upward sequences of sluiced ash.

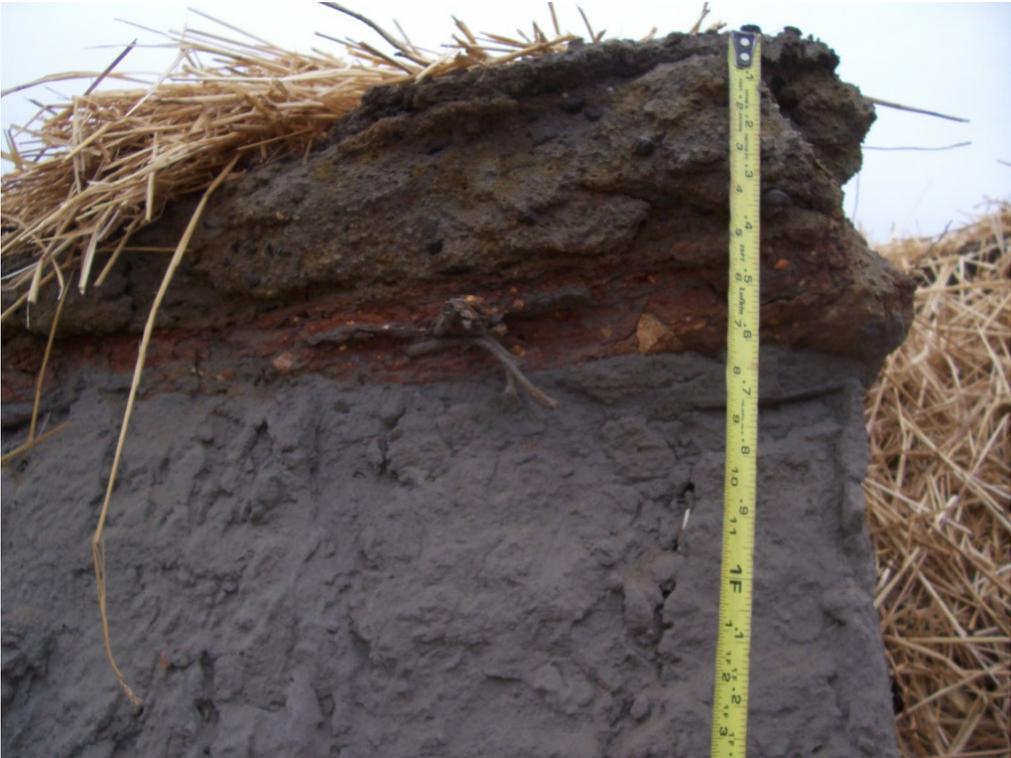
Photo No.: 004_2	Date: 1-18-2009

Direction Photo Taken: Looking south.		
Description: Close-up of 004. Note roots in clay cover layer indicating this area was vegetated.

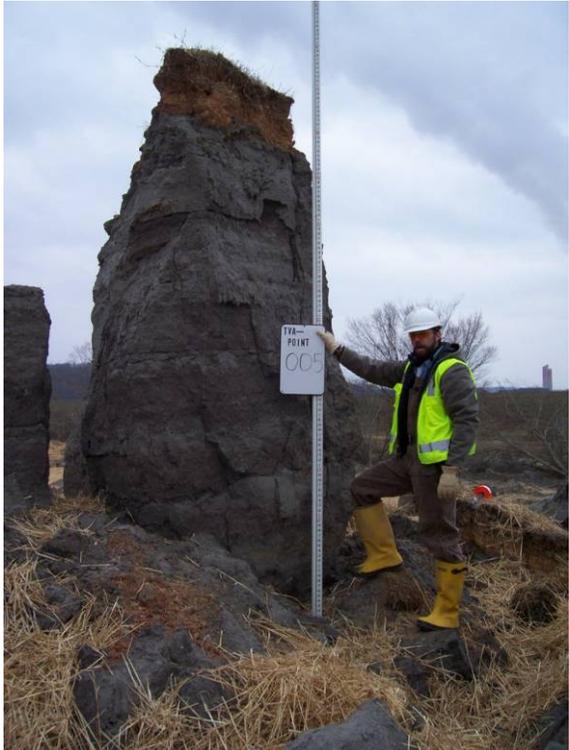
Client Name: Tennessee Valley Authority		Site Location: Kingston Fossil Plant – Harriman, Tennessee	Project No.: 60095742
Photo No.: 005	Date: 1-18-2009

Direction Photo Taken: Looking southeast.			
Description: Remnant of unknown dike material located east of the settling pond in slough between settling pond dike and island in Emory River. Fining upward sequences visible.

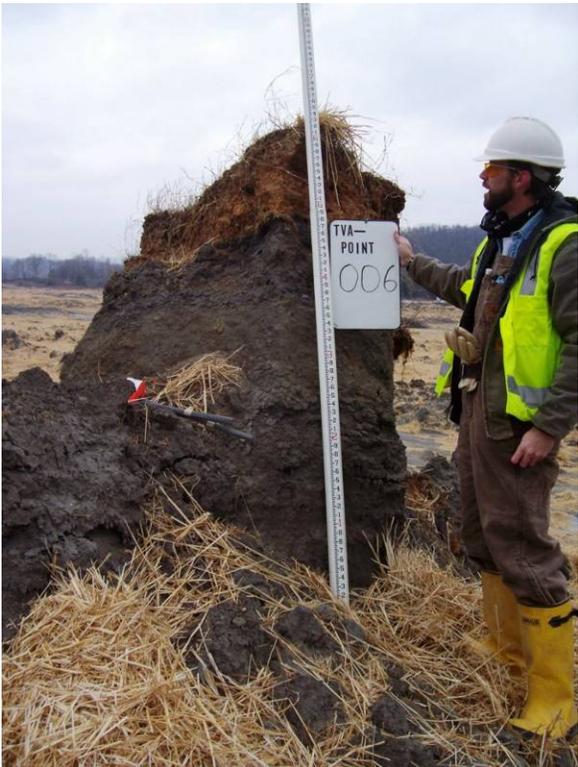
Photo No.: 006	Date: 1-18-2009

Direction Photo Taken: Looking southeast.			
Description: Remnant of unknown dike material located east of the settling pond in slough between settling pond dike and island in Emory River. Clay cover over bottom ash.

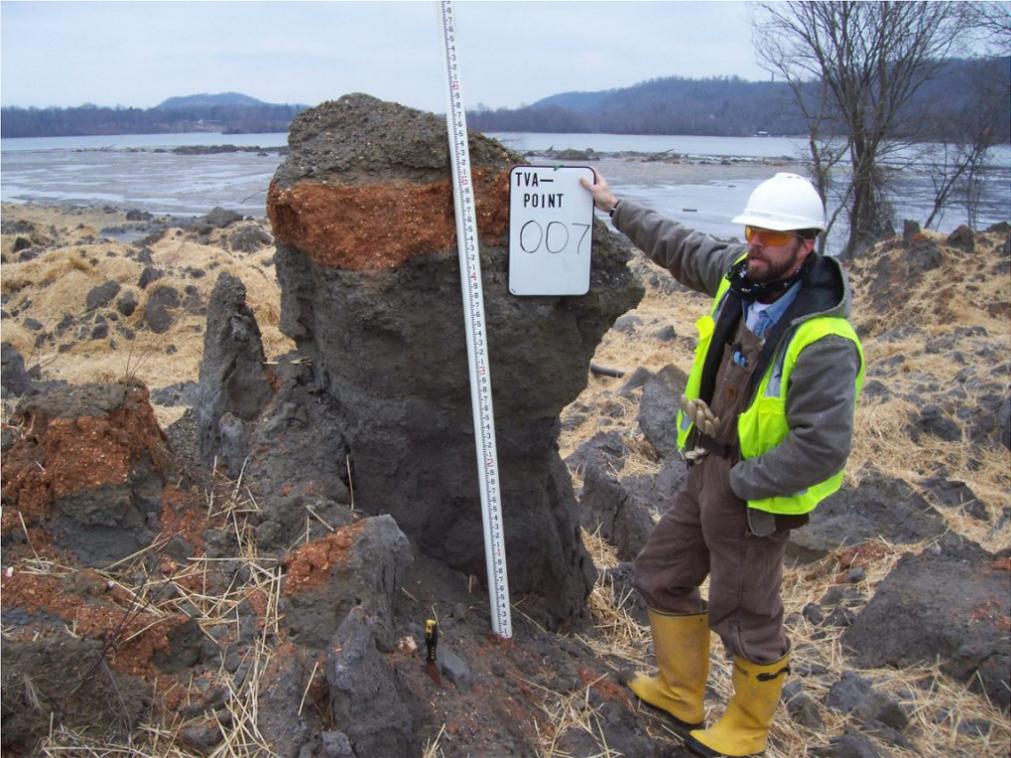
Client Name: Tennessee Valley Authority		Site Location: Kingston Fossil Plant – Harriman, Tennessee		Project No.: 60095742	
Photo No.: 007	Date: 1-18-2009

Direction Photo Taken: Looking northeast.					
Description: Remnant of unknown dike material located east of the settling pond in slough between settling pond dike and island in Emory River. Clay cover with bottom ash both above and below.

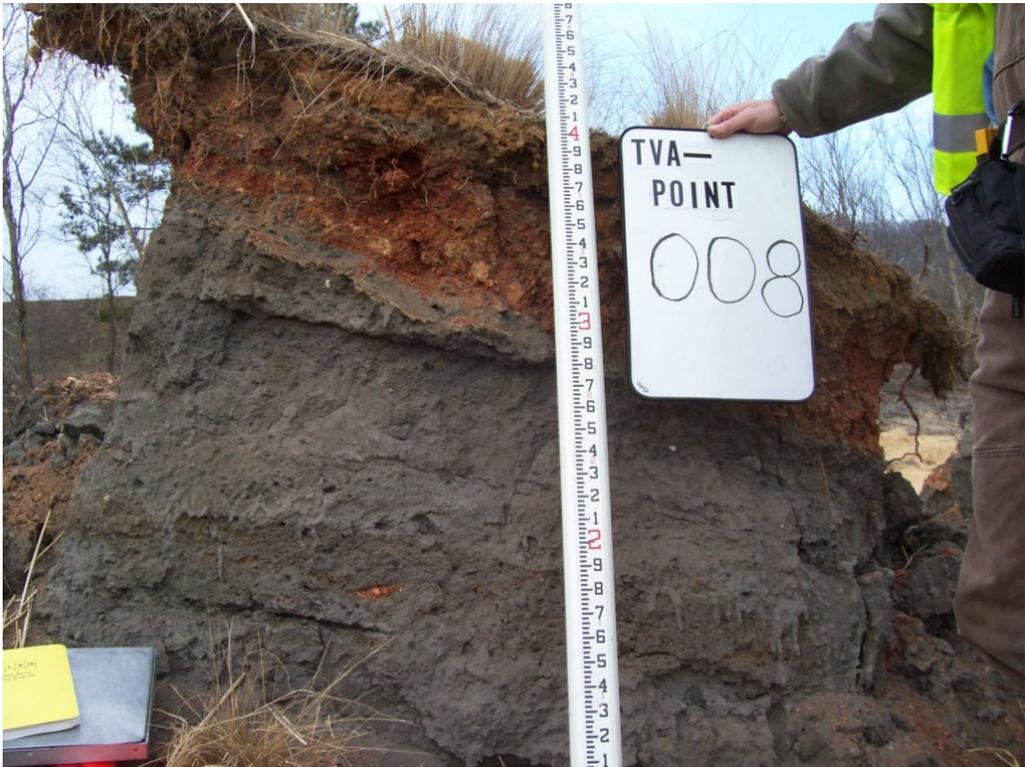
Photo No.: 008	Date: 1-18-2009

Direction Photo Taken: Looking east.					
Description: Remnant of unknown dike material located east of the settling pond in slough between settling pond dike and island in Emory River. Note vegetation on surface and primarily bottom ash below clay cover.

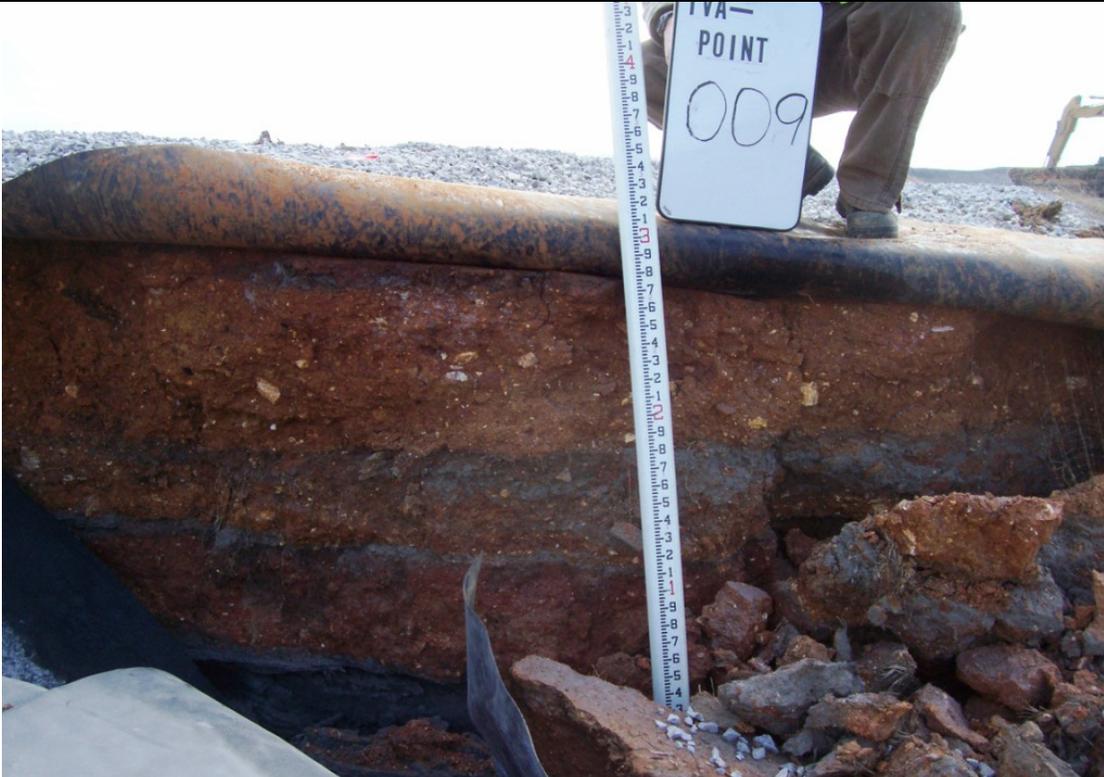
Client Name: Tennessee Valley Authority		Site Location: Kingston Fossil Plant – Harriman, Tennessee	Project No.: 60095742
Photo No.: 009	Date: 1-18-2009

Direction Photo Taken: Looking south.			
Description: Northwest corner of large remnant of West Dike located southeast of Boring 09-102 beneath the gravel drainage layer and geotextile.

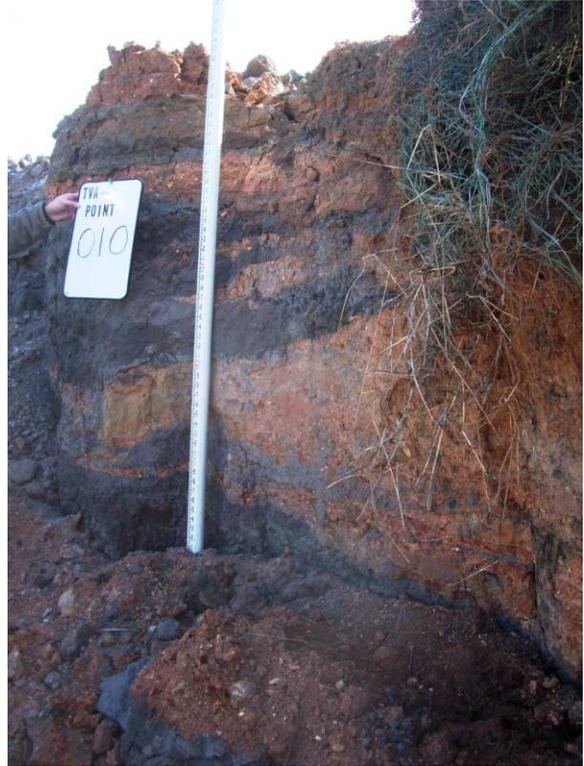
Photo No.: 010	Date: 1-18-2009

Direction Photo Taken: Looking east.		
Description: Approximately 75 feet east of Location 009. Interlayered clay cover material and bottom ash.

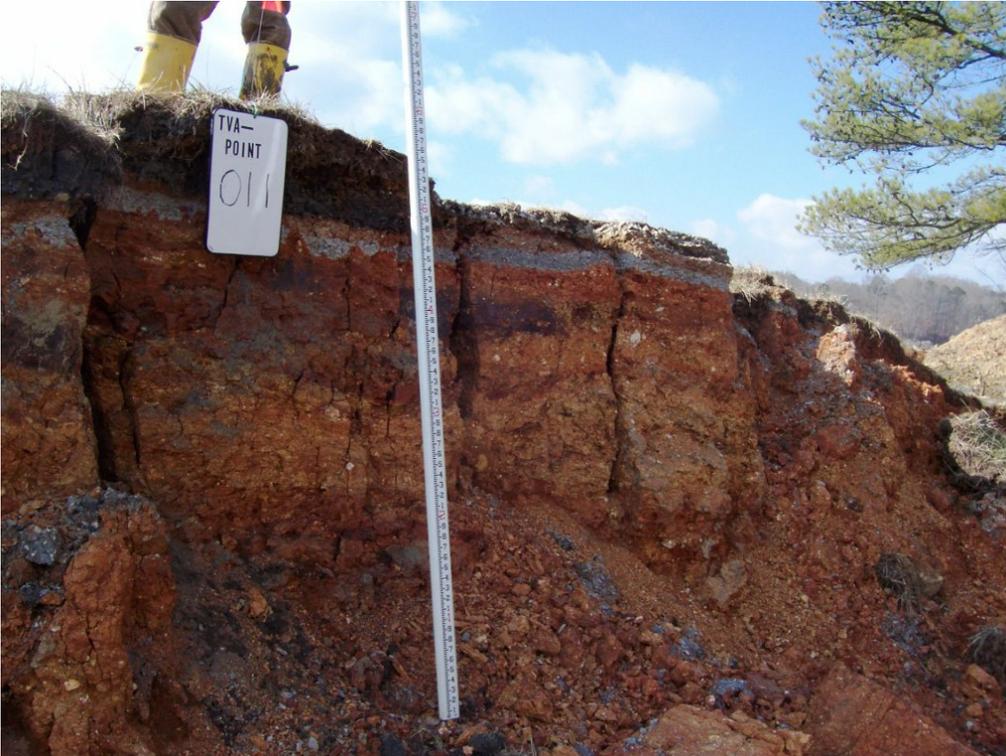
Client Name: Tennessee Valley Authority		Site Location: Kingston Fossil Plant – Harriman, Tennessee	Project No.: 60095742
Photo No.: 011	Date: 1-18-2009

Direction Photo Taken: Looking northwest.			
Description: Northeast side of large relic of Dike C located on north shore of former backwater. Interlayered clay cover material, bottom ash, and gravel overlying the natural silty clay bottom material from the backwater.

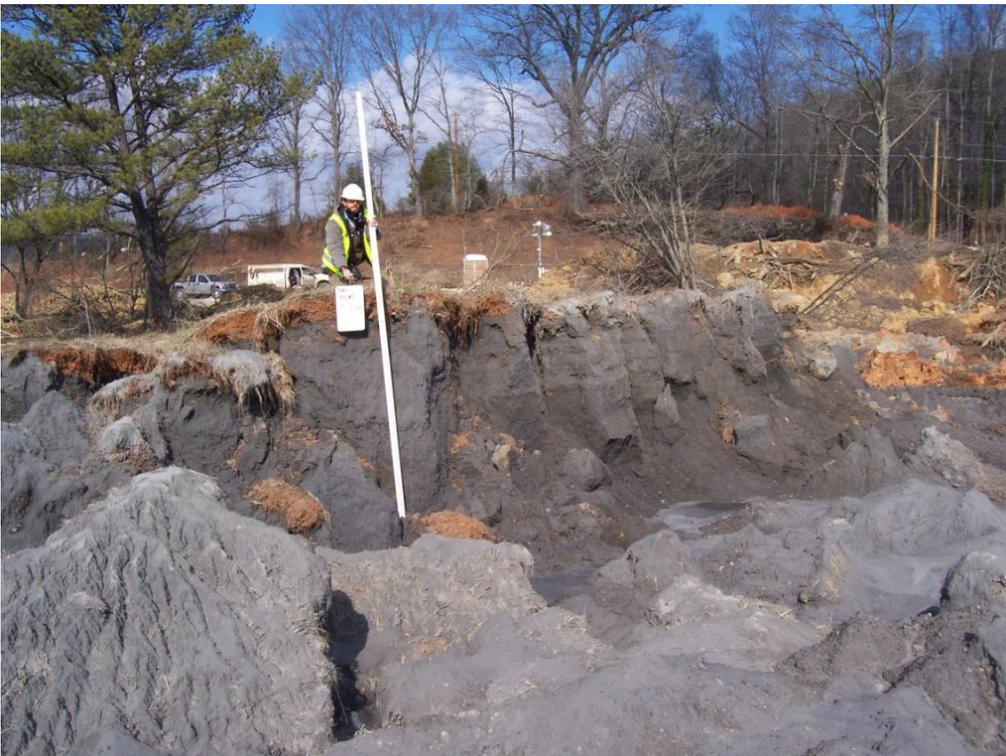
Photo No.: 011B	Date: 1-18-2009

Direction Photo Taken: Looking north-northwest.		
Description: South side of block at 011. Ash beneath clay cap and behind relic Dike C material in above photo.

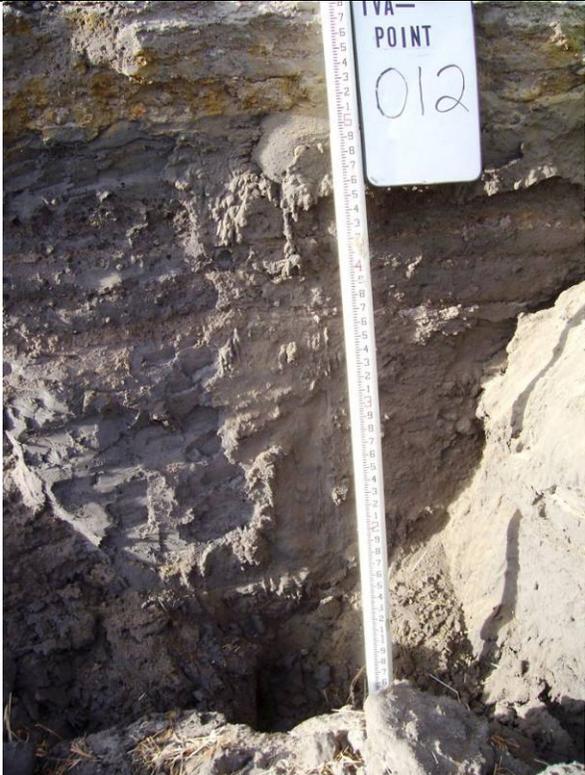
Client Name: Tennessee Valley Authority		Site Location: Kingston Fossil Plant – Harriman, Tennessee	Project No.: 60095742
Photo No.: 012	Date: 1-18-2009

Direction Photo Taken: Looking southwest.			
Description: Approximately 130 to 140 feet south of Location 011. Primarily bottom ash beneath a cap consisting of coarse bottom ash. Wind blown upper surface. Sluiced ash (fining upward sequences) below.

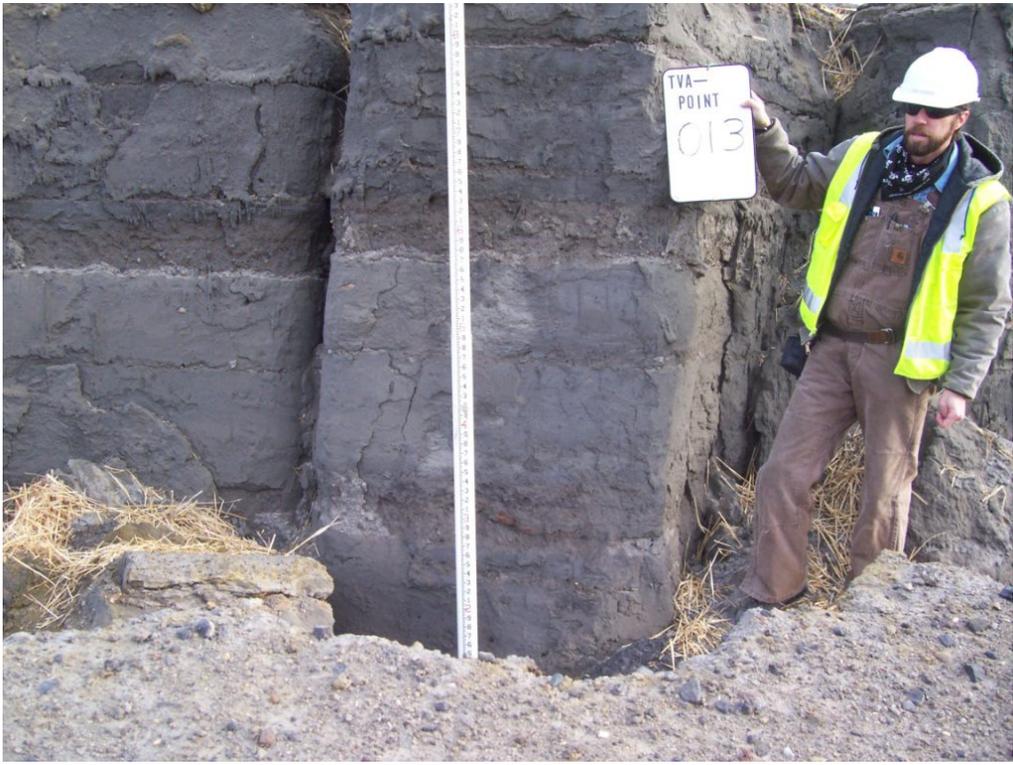
Photo No.: 013	Date: 1-18-2009

Direction Photo Taken: Uncertain.		
Description: Large relic block of ash with clear fining upward ash sequences (sluiced ash).

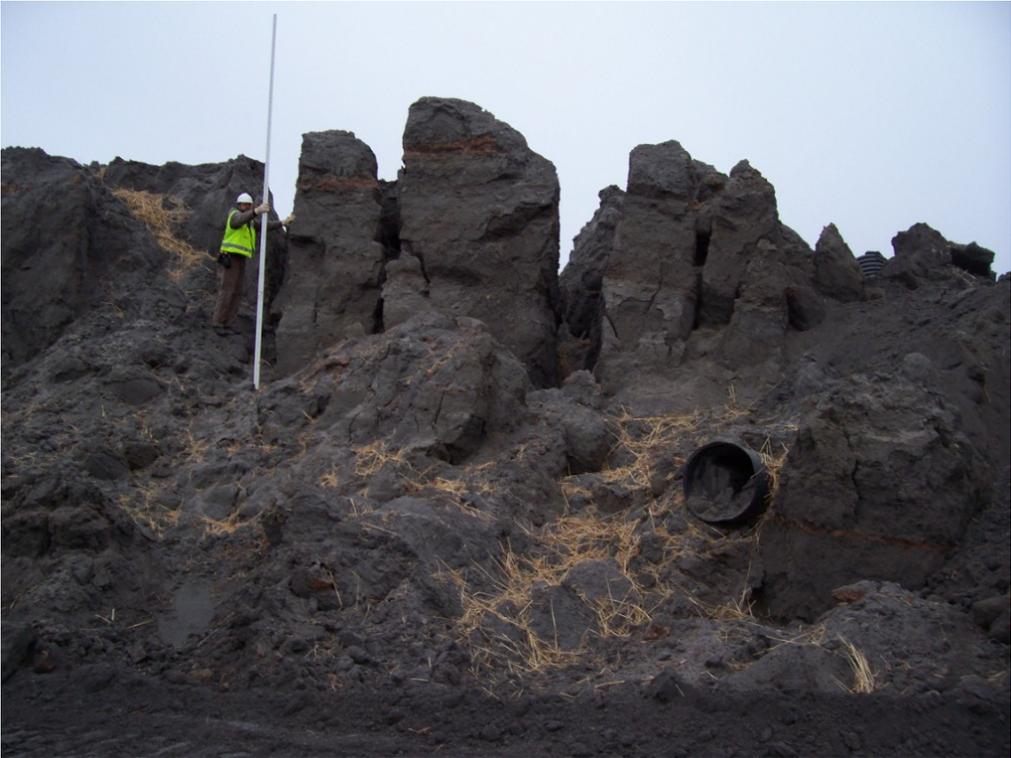
Client Name: Tennessee Valley Authority		Site Location: Kingston Fossil Plant – Harriman, Tennessee	Project No.: 60095742
Photo No.: 014	Date: 1-19-2009

Direction Photo Taken: Looking west.			
Description: Very large block of ash displaying fining upward sequences (sluiced ash) located approximately 150 feet south-southeast of Boring 09-107

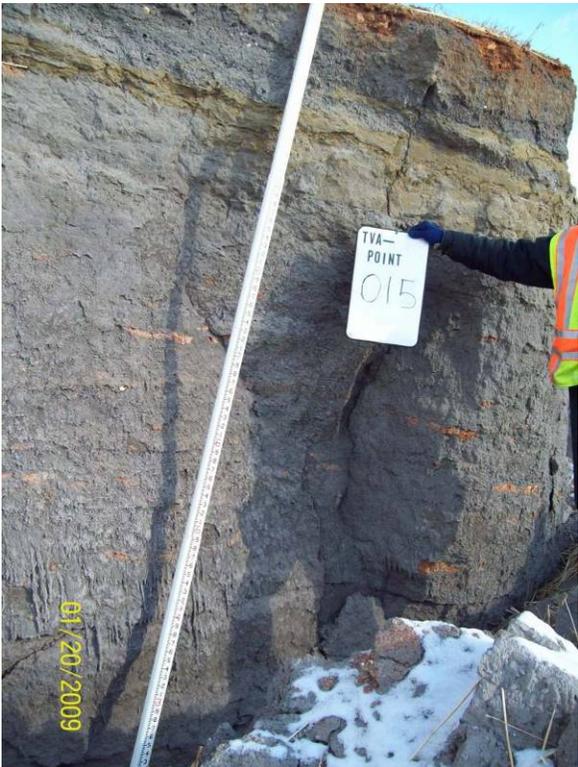
Photo No.: 015	Date: 1-20-2009

Direction Photo Taken: Looking east.			
Description: Large remnant ash block in Slough 2. Mostly bottom ash with very thin clay cover. Olive colored layer appears to be a weathered (leached) zone.

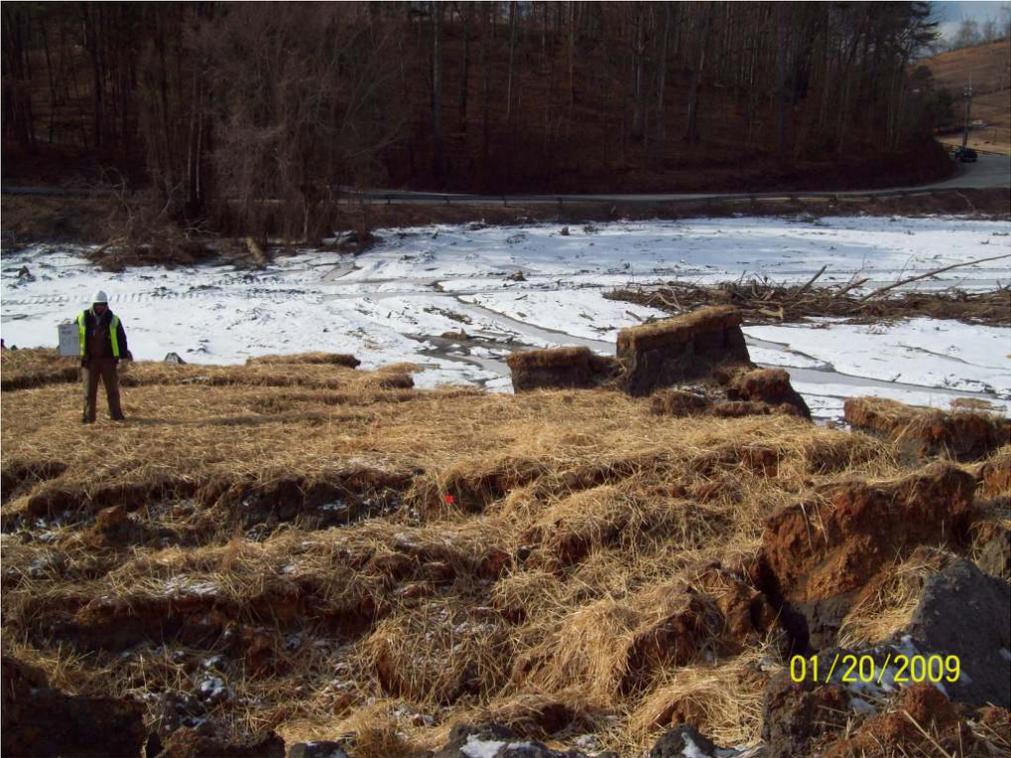
Client Name: Tennessee Valley Authority		Site Location: Kingston Fossil Plant – Harriman, Tennessee	Project No.: 60095742
Photo No.: 019_2	Date: 1-20-2009

Direction Photo Taken: Looking south-southwest.			
Description: Northern half of a large relic of the West Dike located in Slough 2. Much of the relic is grass-covered. Natural grass is obscured by hay dropped as a dust-control measure.

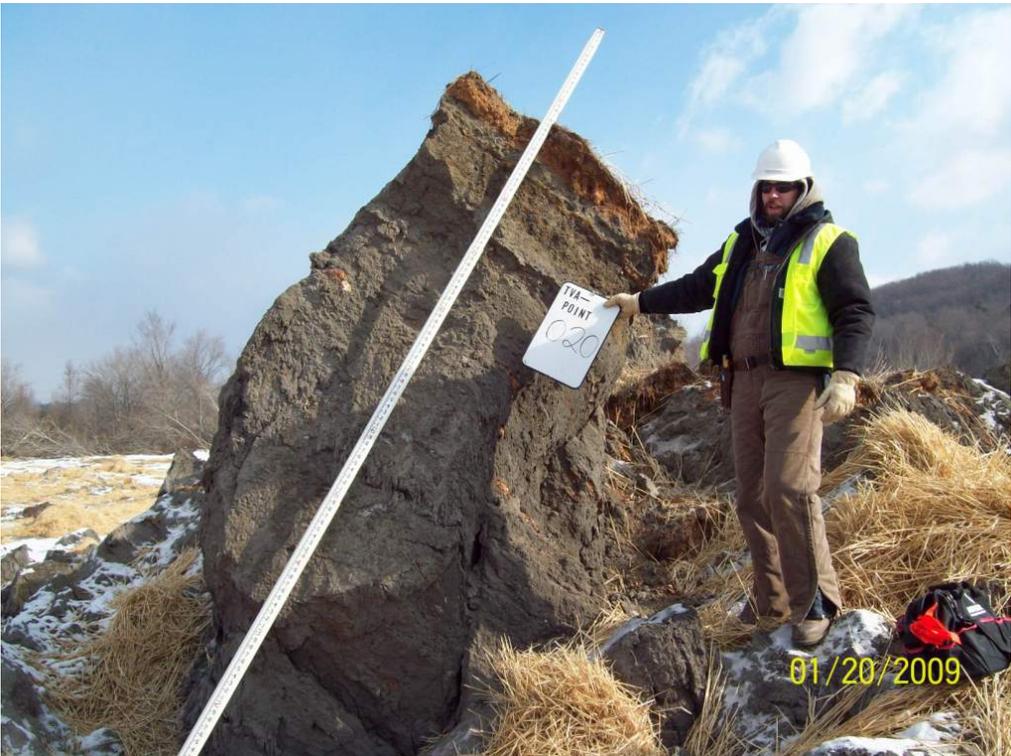
Photo No.: 020	Date: 1-20-2009

Direction Photo Taken: Looking northeast.		
Description: Relic block of West Dike consisting predominantly of bottom ash with a thin vegetated clay cover.

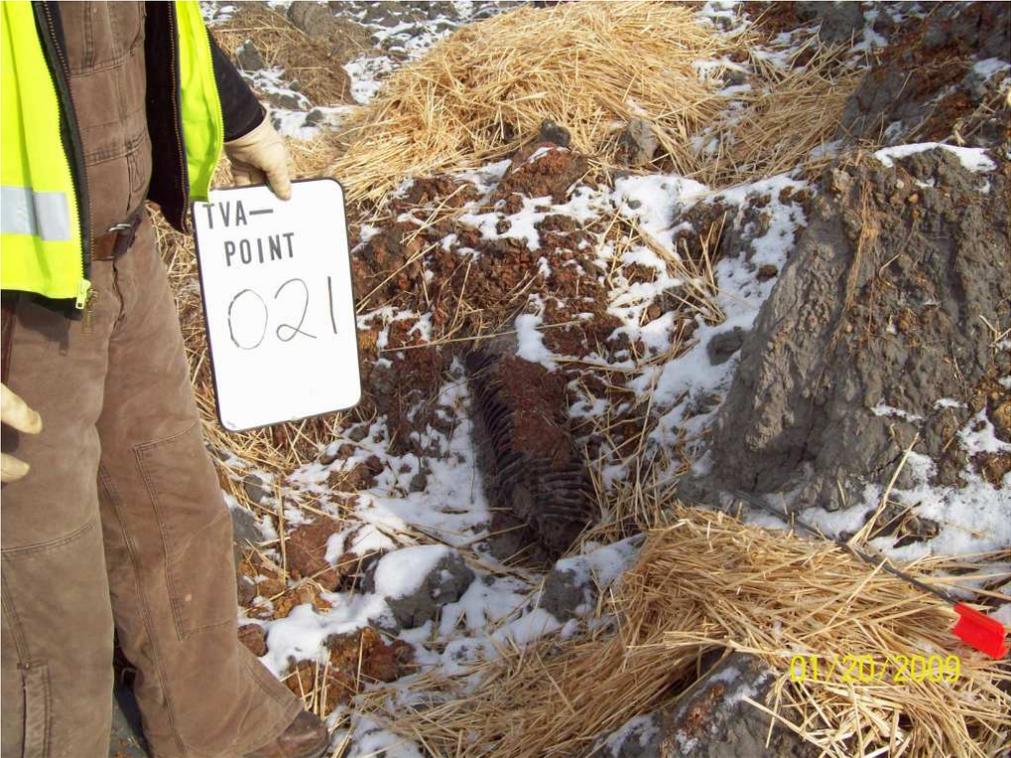
Client Name: Tennessee Valley Authority		Site Location: Kingston Fossil Plant – Harriman, Tennessee	Project No.: 60095742
Photo No.: 021	Date: 1-20-2009

Direction Photo Taken: Looking northwest.			
Description: Corrugated, perforated polyethylene (PE) drain piping at the base of West Dike relic 021. The piping is obscured by clay cover material and hay below and to the left of the feet of the AECOM staff in the 020 photo above.

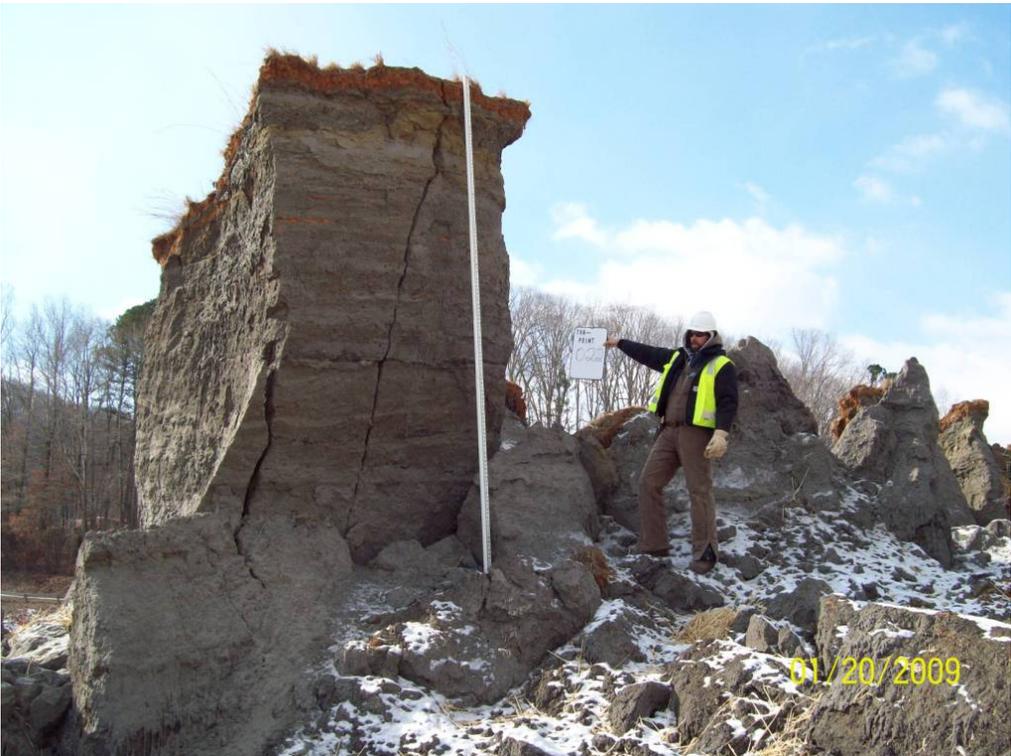
Photo No.: 022	Date: 1-20-2009

Direction Photo Taken: Looking west.			
Description: Large relic block of West Dike comprised primarily of bottom ash in Slough 2.

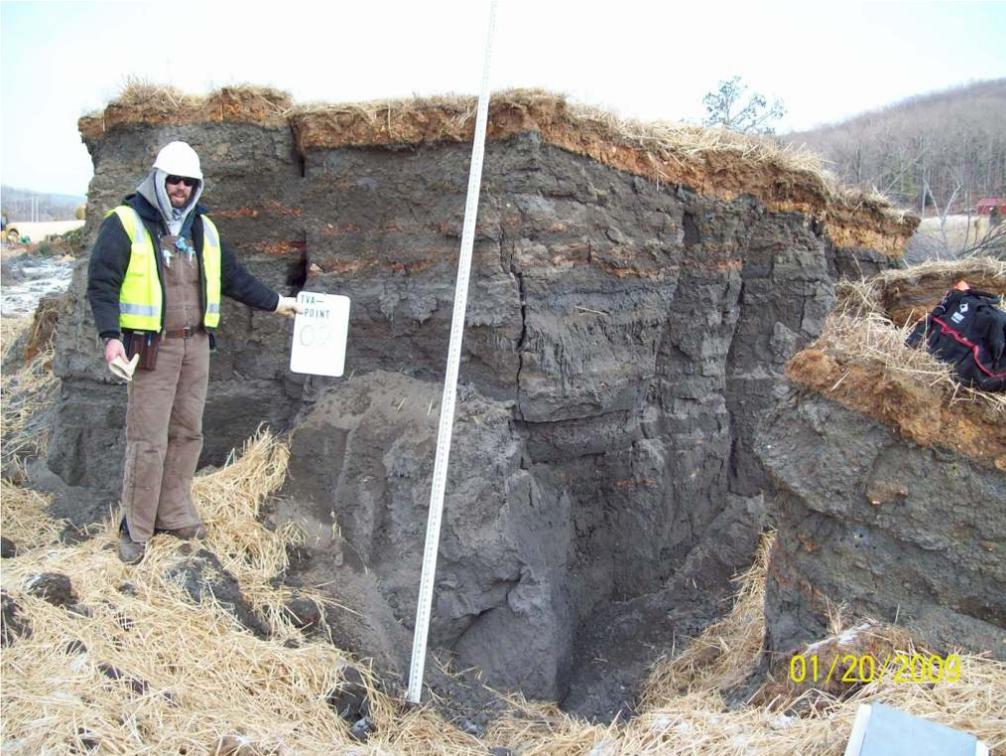
Client Name: Tennessee Valley Authority		Site Location: Kingston Fossil Plant – Harriman, Tennessee	Project No.: 60095742
Photo No.: 023	Date: 1-20-2009

<p>A photograph showing a vertical cross-section of a relic dike. The dike is composed of dark, layered ash and clay. A worker in a yellow safety vest and white hard hat stands to the left of the dike, holding a white sign that says 'FIX-POINT 023'. A tall white measuring scale is positioned vertically against the dike. The top of the dike is covered with dry grass. The background shows a hilly landscape under a clear sky. A yellow date stamp '01/20/2009' is visible in the bottom right corner of the photo.</p>	
Direction Photo Taken: Looking northeast.			
Description: Last photo of relic West Dike located in Slough 2. Sluiced ash sequences (fining upward) are clearly visible as is the slight angle between the sluiced ash and clay cover.

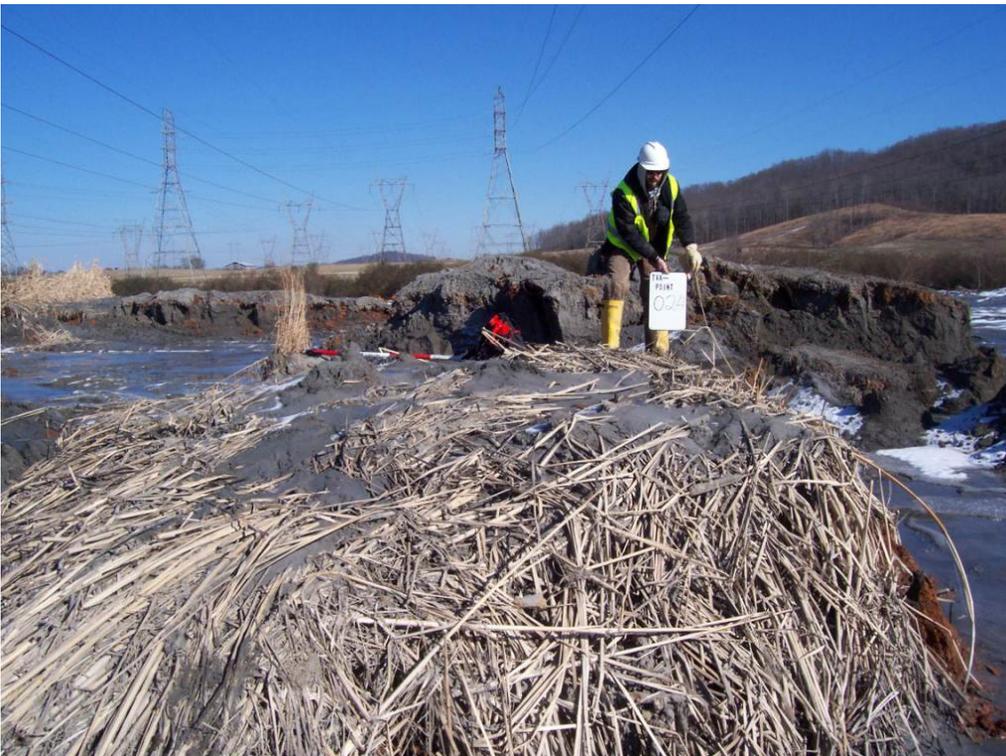
Photo No.: 024	Date: 1-21-2009

<p>A photograph showing a relic dike in a slough. The dike is covered with a thick layer of dry, tangled reeds or cattails. A worker in a yellow safety vest and white hard hat is kneeling on the dike, holding a white sign that says 'FIX-POINT 024'. In the background, several high-voltage power lines and towers are visible against a clear blue sky. The surrounding area is a flat, open landscape with some snow on the ground.</p>	
Direction Photo Taken: Looking east.			
Description: Cattails formerly present at the northwest corner of the Starter Dike/Dike C over-washed by ash beneath power lines in Slough 2. Note that the wash-over direction is perpendicular to mud flow direction. Relic dike material in the background was completely over-washed.

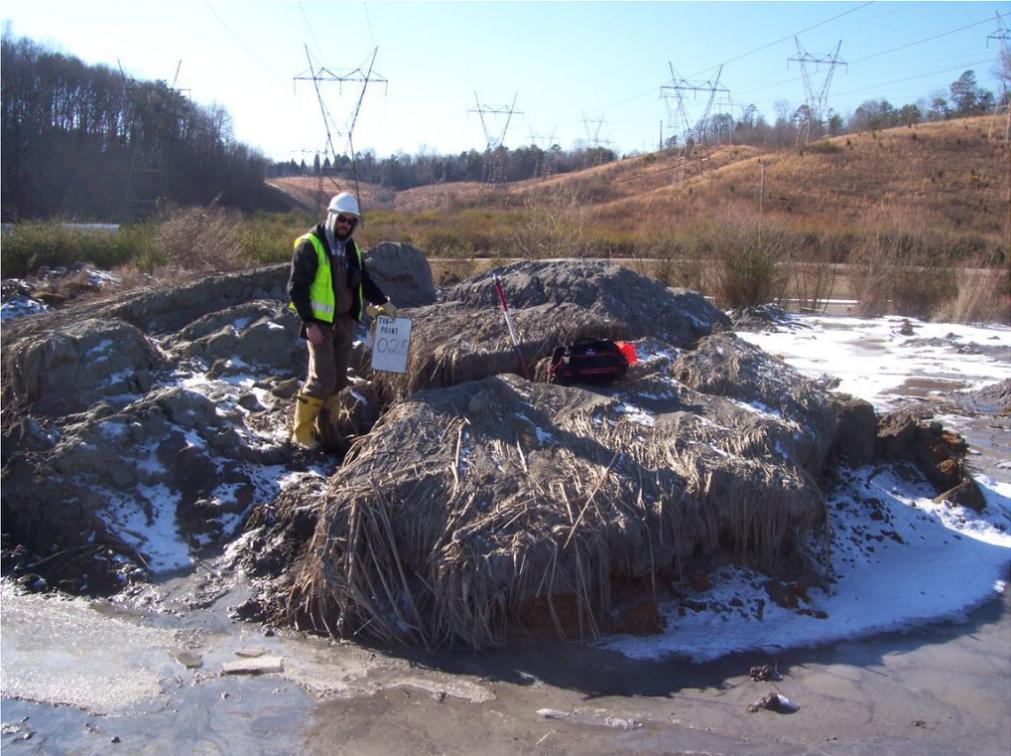
Client Name: Tennessee Valley Authority		Site Location: Kingston Fossil Plant – Harriman, Tennessee	Project No.: 60095742
Photo No.: 025	Date: 1-21-2009

Direction Photo Taken: Looking west.			
Description: Cattails formerly present at the northwest corner of the Starter Dike/Dike C over-washed by ash. Note wash-over direction is perpendicular to mud flow direction and opposite the direction observed at Location 024.

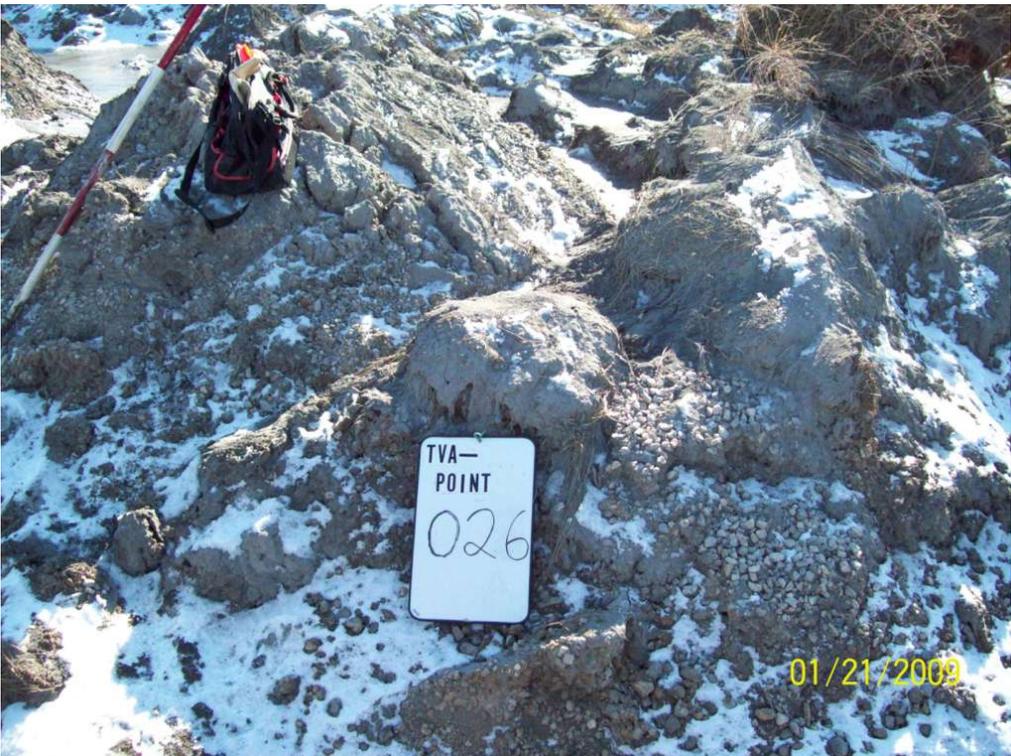
Photo No.: 026	Date: 1-21-2009

Direction Photo Taken: Looking south.		
Description: Relic of drainage layer formerly located on the surface of West Dike, now in Slough 2. #57 stone over clay cover material.

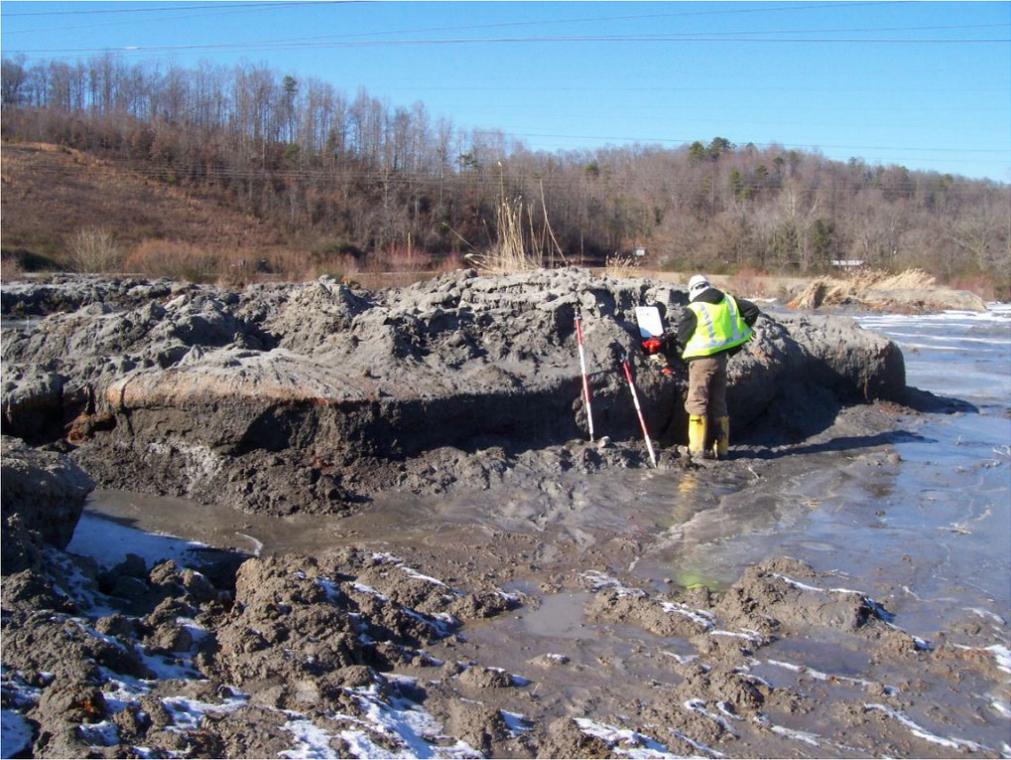
Client Name: Tennessee Valley Authority		Site Location: Kingston Fossil Plant – Harriman, Tennessee	Project No.: 60095742
Photo No.: 027	Date: 1-21-2009

Direction Photo Taken: Looking north-northwest.			
Description: Over-washed vegetation on relic Starter Dike/Dike C.

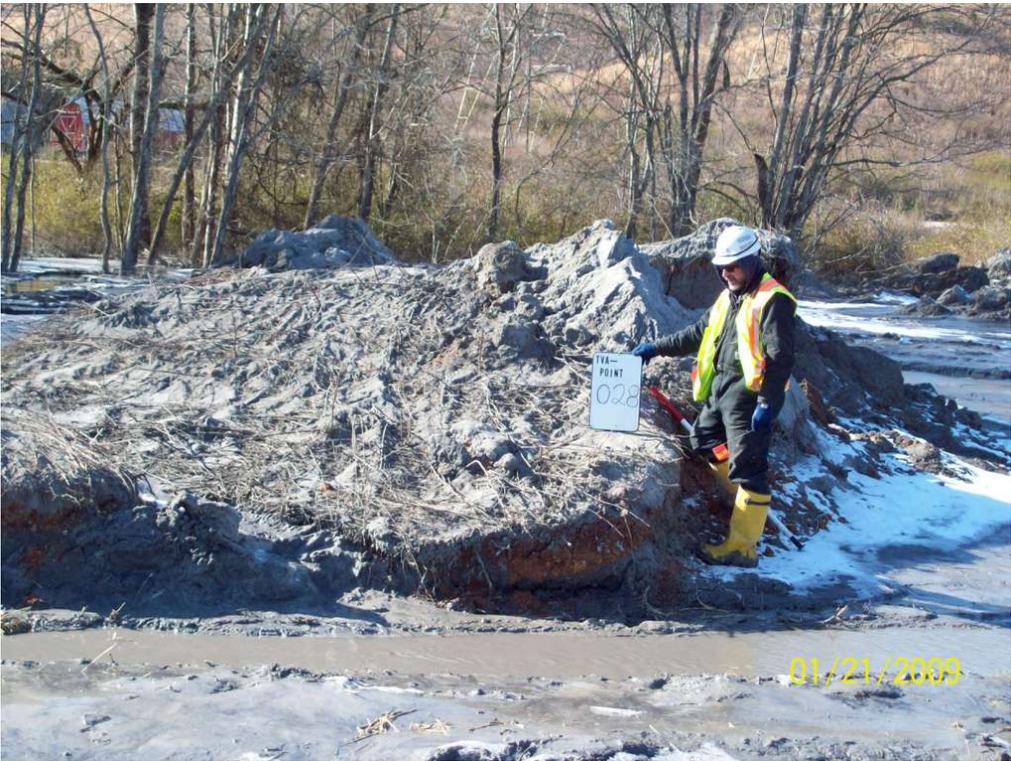
Photo No.: 028	Date: 1-21-2009

Direction Photo Taken: Looking west.		
Description: Cattails formerly present at the northwest corner of the Starter Dike/Dike C over-washed by ash south of Location 024. Note wash-over direction is perpendicular to mud flow direction and similar to the direction observed at Location 024.

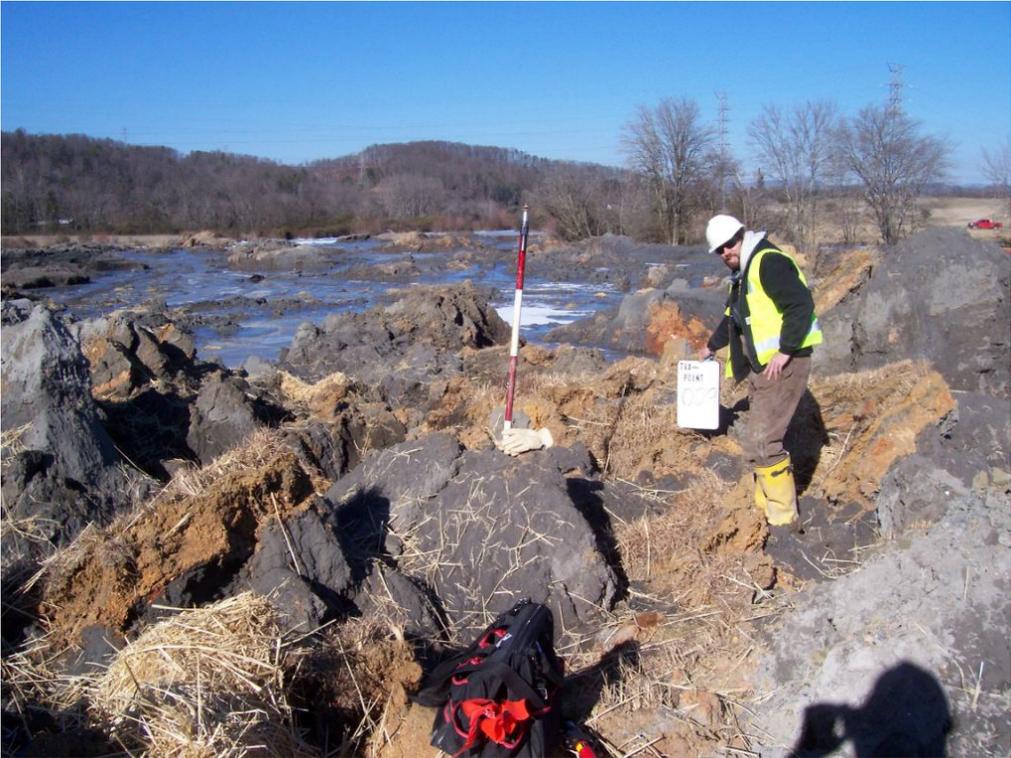
Client Name: Tennessee Valley Authority		Site Location: Kingston Fossil Plant – Harriman, Tennessee	Project No.: 60095742
Photo No.: 029	Date: 1-21-2009

Direction Photo Taken: Looking north.			
Description: Grass-topped relic ash blocks NOT overtopped by ash.
