RELIC IDENTIFICATION PHOTOGRAPHIC LOG

Client Name: Tennessee Valley Authority		Site Location: Kingston Fossil Plant – Harriman, Tennessee	Project No.: 60095742
Photo No.: 001	Date: 1-18-2009

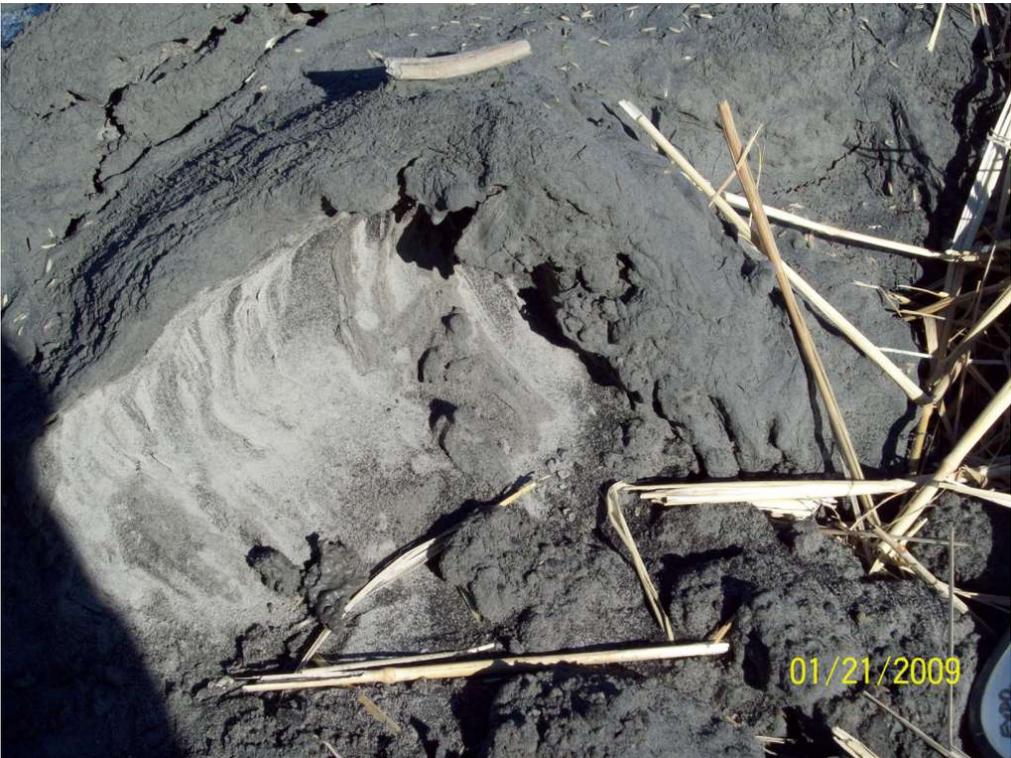
Photo No.: 029_A	Date: 1-21-2009

Direction Photo Taken: Looking north.		
Description: Finely laminated bottom and fly ash deposits (sluiced material) sheared during movement from original location northward up Slough 2. Located slightly west of 029 above.

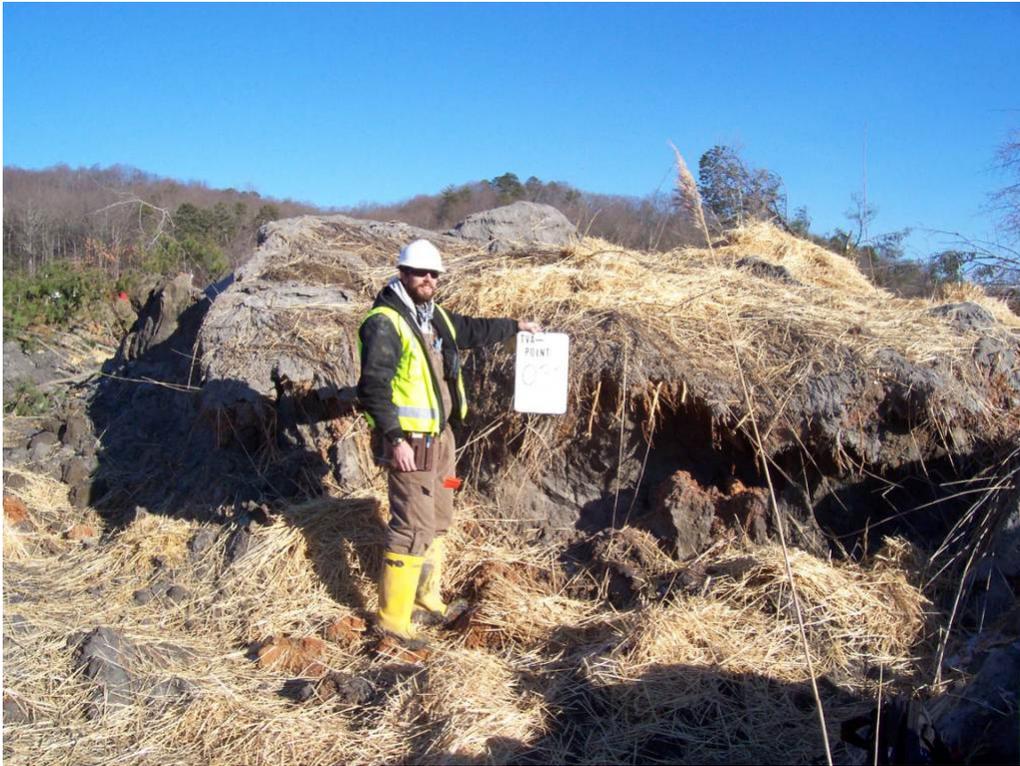
Client Name: Tennessee Valley Authority		Site Location: Kingston Fossil Plant – Harriman, Tennessee	Project No.: 60095742
Photo No.: 032	Date: 1-21-2009

Direction Photo Taken: Looking southeast.			
Description: Grass covered by ash on a relic section of the Starter Dike/Dike C in Slough 2.

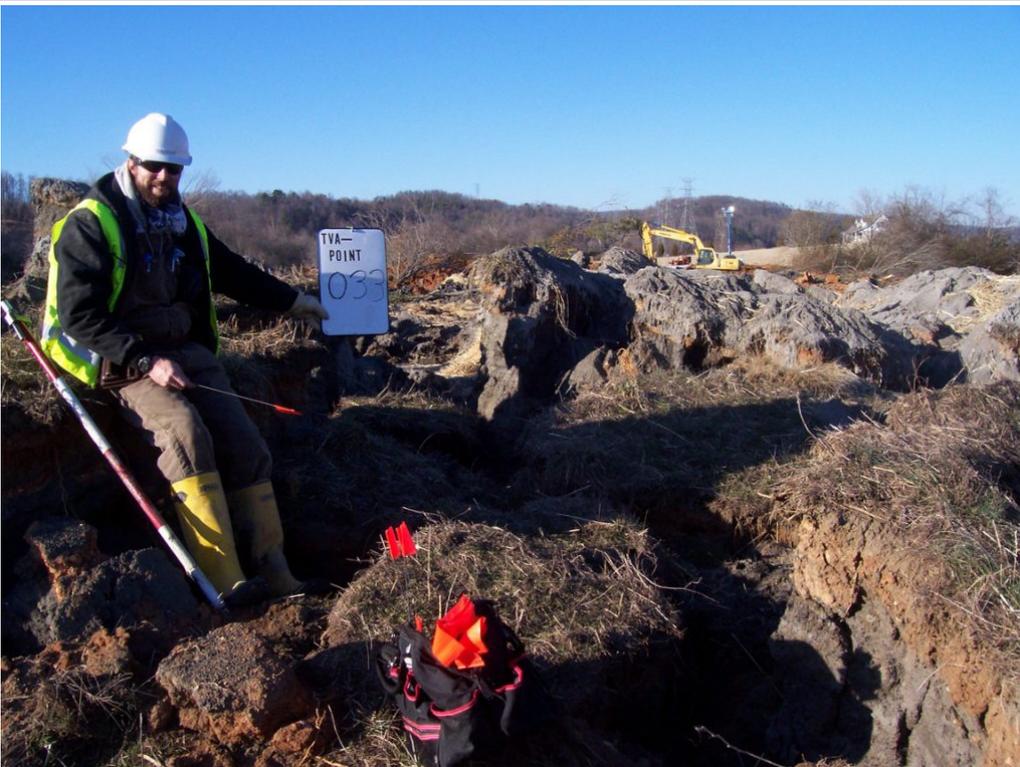
Photo No.: 033	Date: 1-21-2009

Direction Photo Taken: Looking northeast.		
Description: Grass covered by ash on a relic section of the Starter Dike/Dike C in Slough 2.

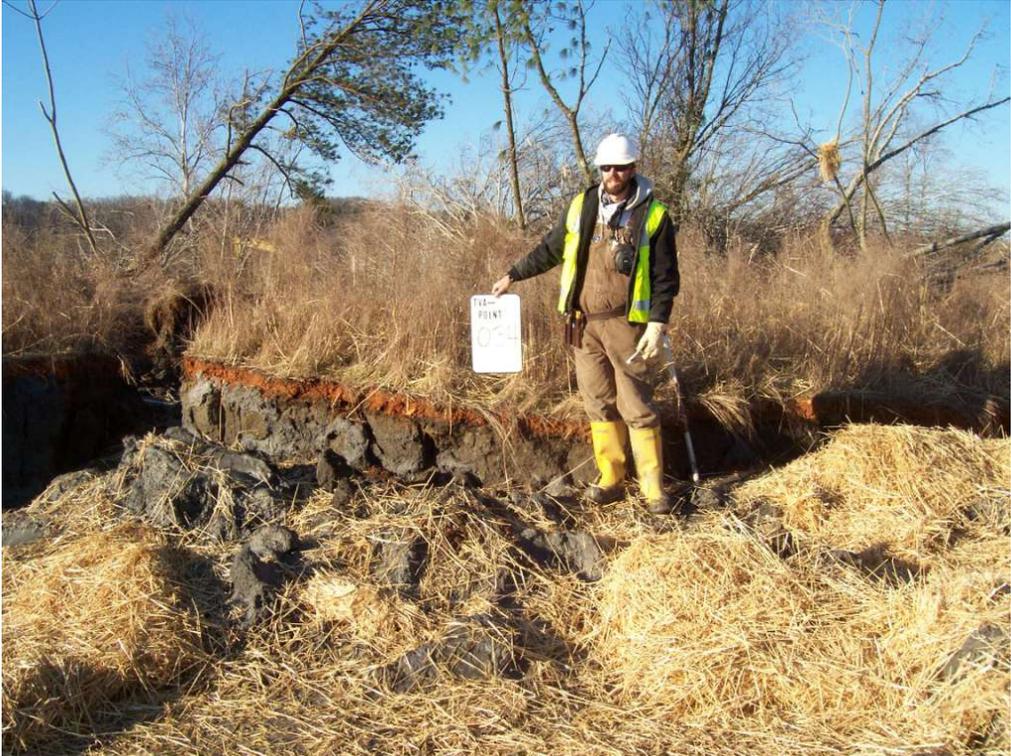
Client Name: Tennessee Valley Authority		Site Location: Kingston Fossil Plant – Harriman, Tennessee	Project No.: 60095742
Photo No.: 034	Date: 1-21-2009

Direction Photo Taken: Looking east-northeast.			
Description: Long, un-mowed grass not overtopped by ash on a relic of the Starter Dike/Dike C in Slough 2. Long grass may be an indicator of steep-slope in original position. Trees are on separate pieces or floating in the ash.

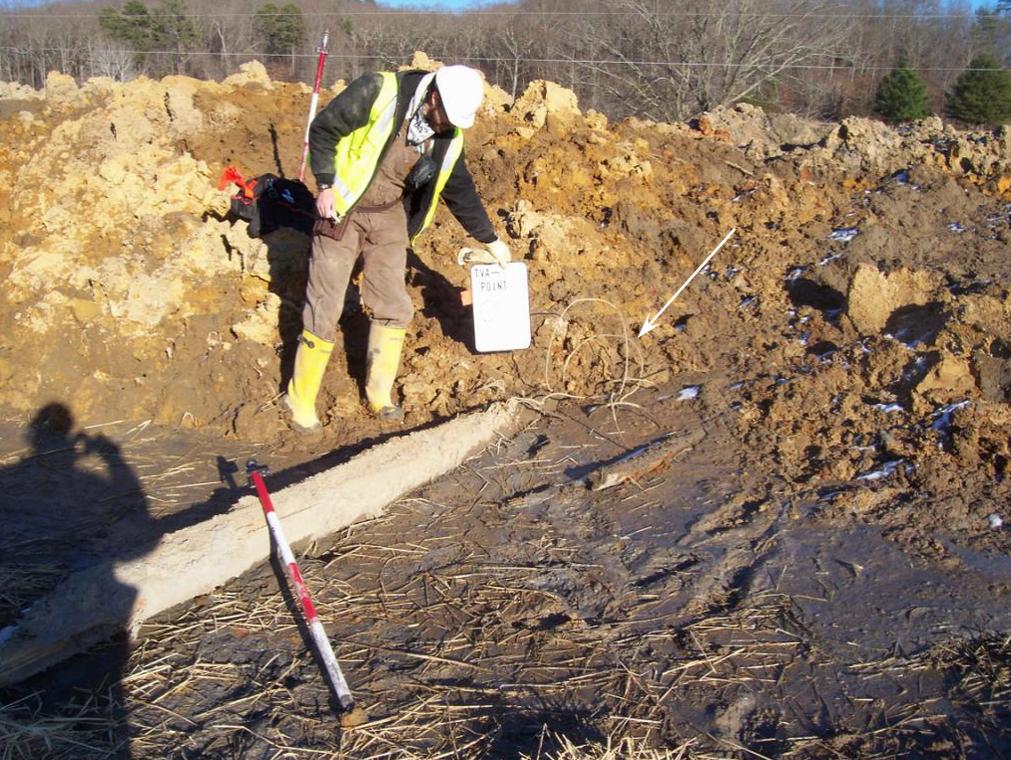
Photo No.: 035	Date: 1-21-2009

Direction Photo Taken: Looking east.			
Description: Telephone pole with attached guy cable (arrow) in Slough 2. Likely a corner or brace pole.

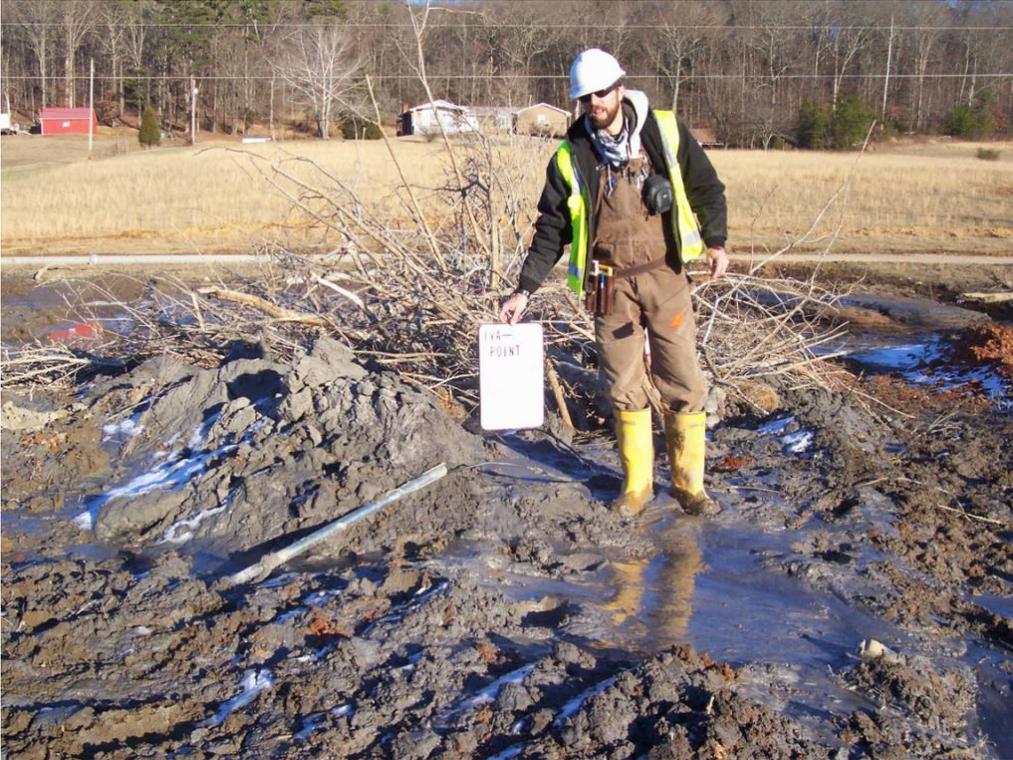
Client Name: Tennessee Valley Authority		Site Location: Kingston Fossil Plant – Harriman, Tennessee	Project No.: 60095742
Photo No.: 036	Date: 1-21-2009

Direction Photo Taken: Looking east.			
Description: Coaxial cable inside conduit along eastern side of Slough 2. Origin uncertain.

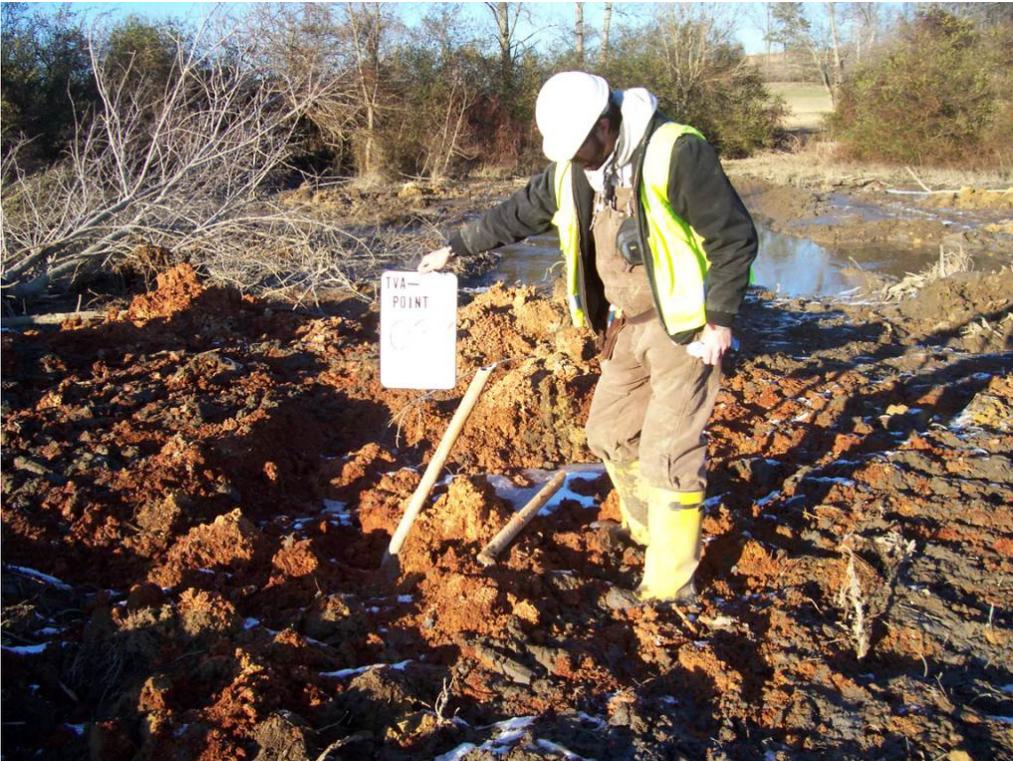
Photo No.: 037	Date: 1-21-2009

Direction Photo Taken: Looking northeast.			
Description: Two pieces of gray PVC electrical conduit likely associated with cell phone repeater tower found in Slough 2 (see 038).

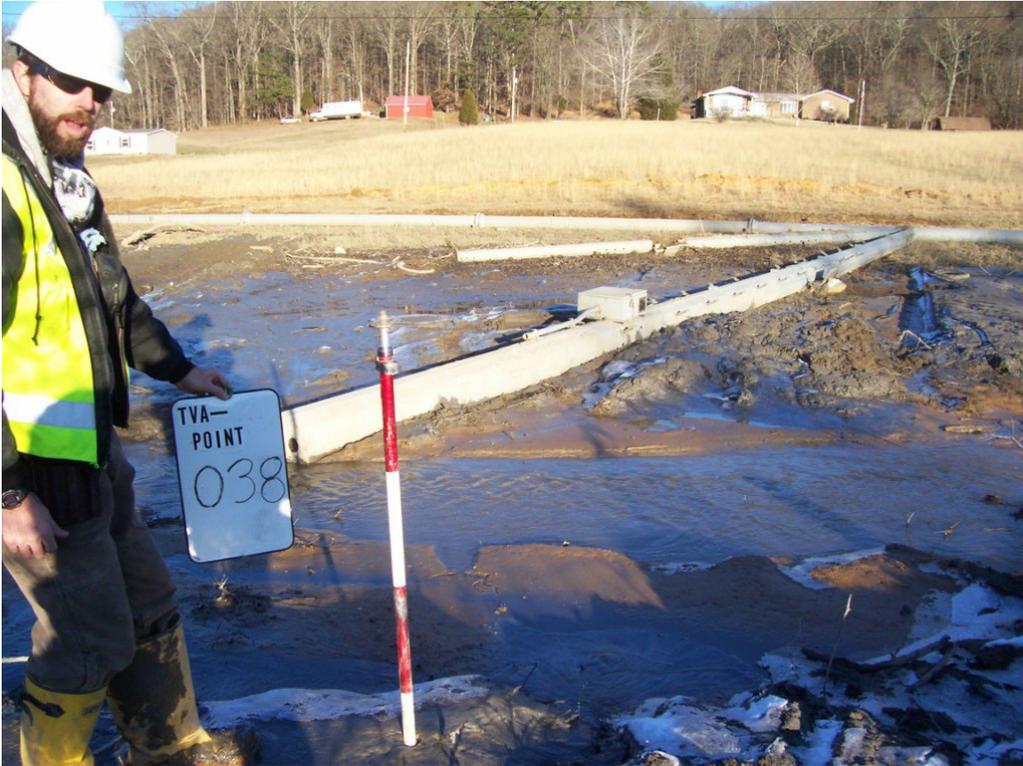
Client Name: Tennessee Valley Authority		Site Location: Kingston Fossil Plant – Harriman, Tennessee	Project No.: 60095742
Photo No.: 038	Date: 1-21-2009

Direction Photo Taken: Looking east.			
Description: Cell phone repeater tower originally located on the northwest corner of the Starter Dike/Dike C in Slough 2 near the Horse Farm.

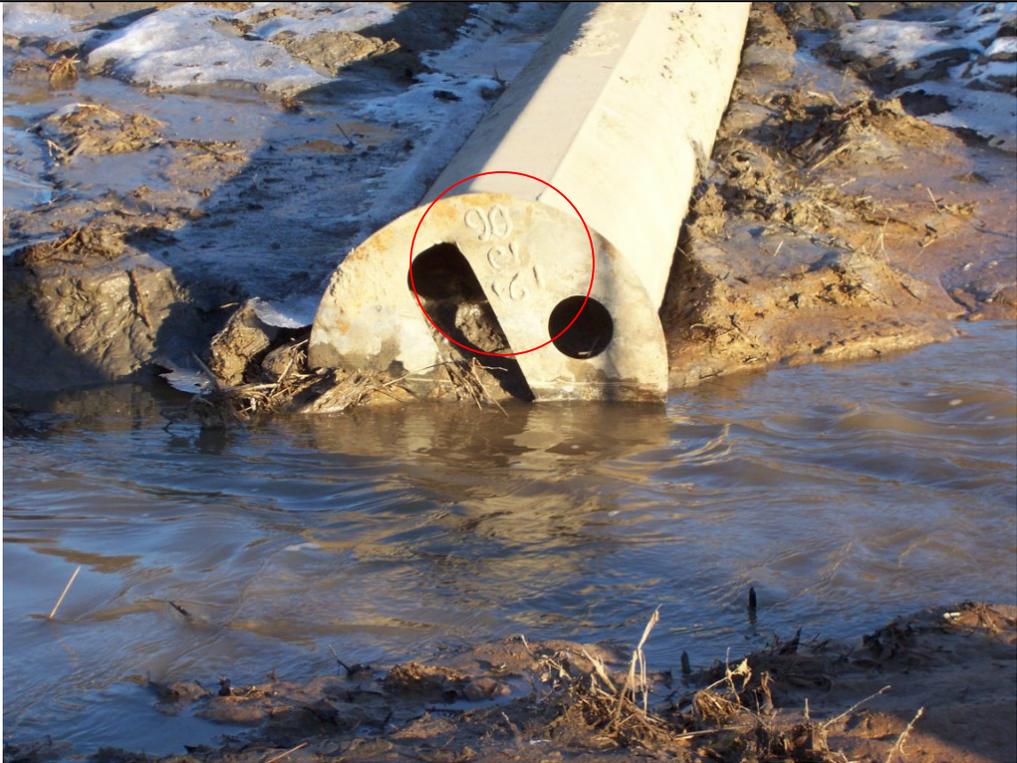
Photo No.: 038_A	Date: 1-21-2009

Direction Photo Taken: Looking east.		
Description: Same cell phone repeater tower shown in 038. Numbers visible on the base of the tower "12, 15, 06" (circle).

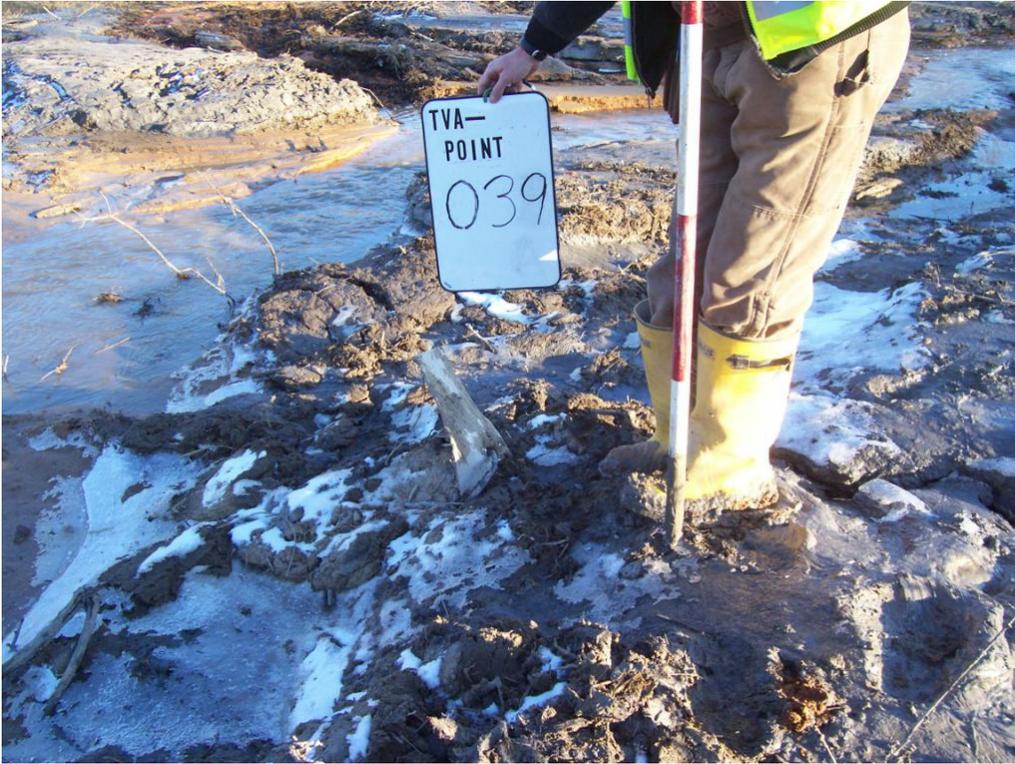
Client Name: Tennessee Valley Authority		Site Location: Kingston Fossil Plant – Harriman, Tennessee	Project No. 60095742
Photo No. 039	Date: 1-21-2009

Direction Photo Taken: Looking southeast.			
Description: Metal cover with associated cable. May be associated with the cell phone repeater tower pictured previously.

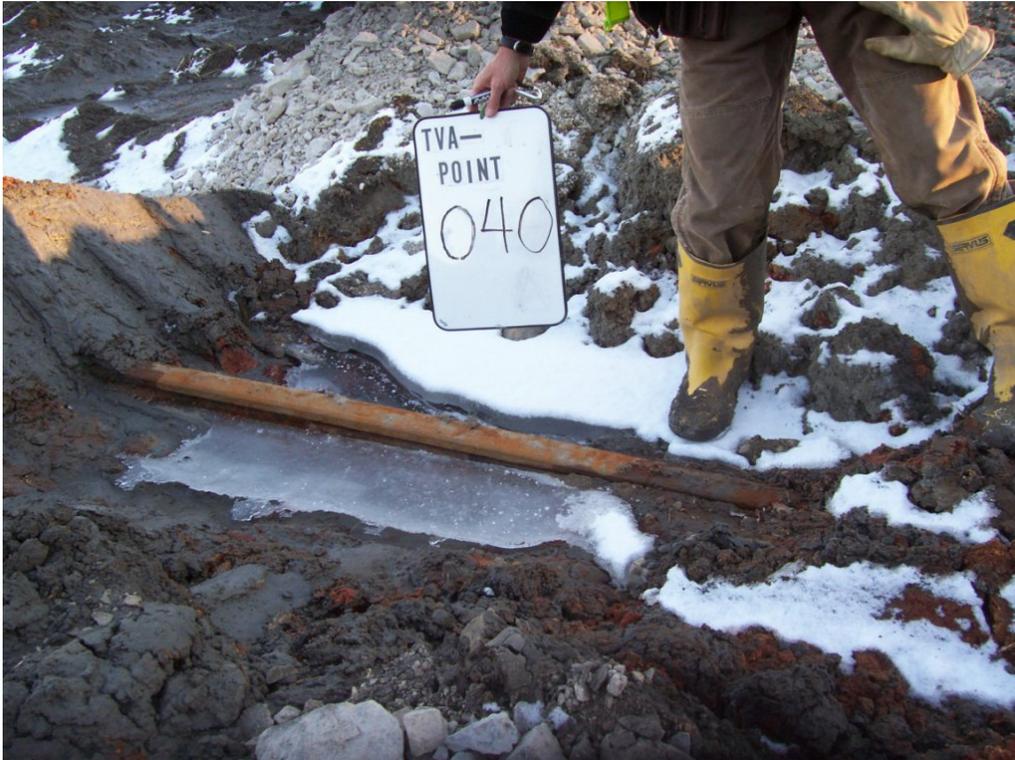
Photo No. 040	Date: 1-21-2009

Direction Photo Taken: Looking west.		
Description: Railroad rail located along west bank between Sloughs 1 and 2, near northwest construction trailer.
