RELIC IDENTIFICATION PHOTOGRAPHIC LOG

Client Name: Tennessee Valley Authority		Site Location: Kingston Fossil Plant – Harriman, Tennessee	Project No.: 60095742
Photo No. 041	Date: 1-22-2009

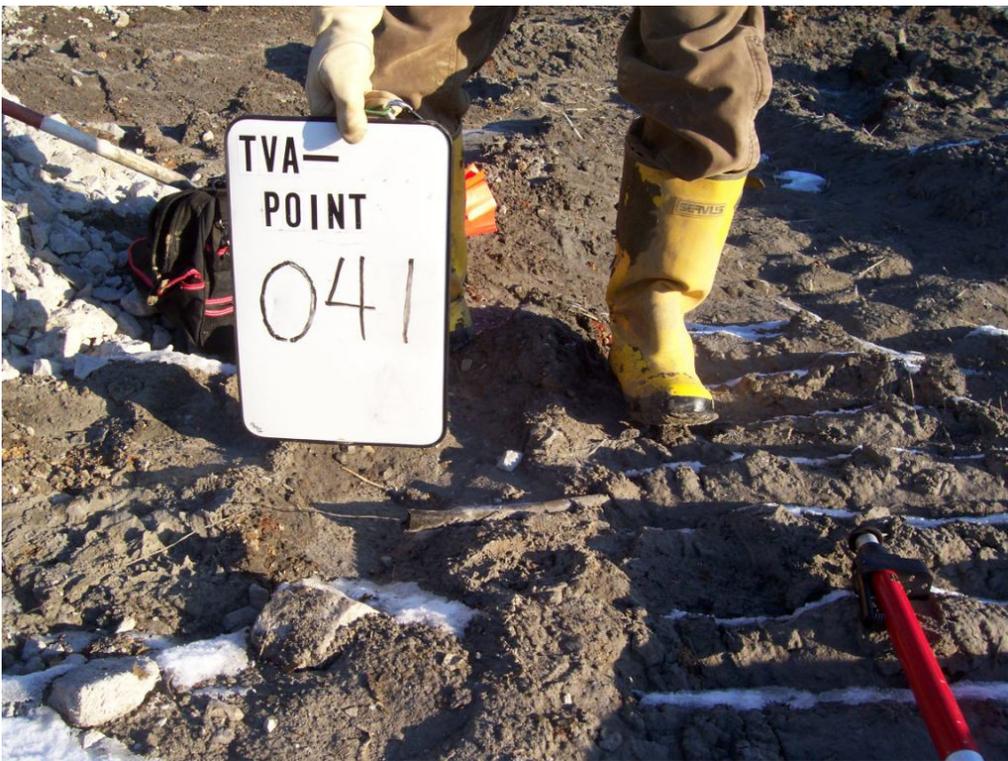
Direction Photo Taken: Looking northeast.			
Description: Plastic conduit with bare copper grounding wire. Location near the northwest construction trailer.

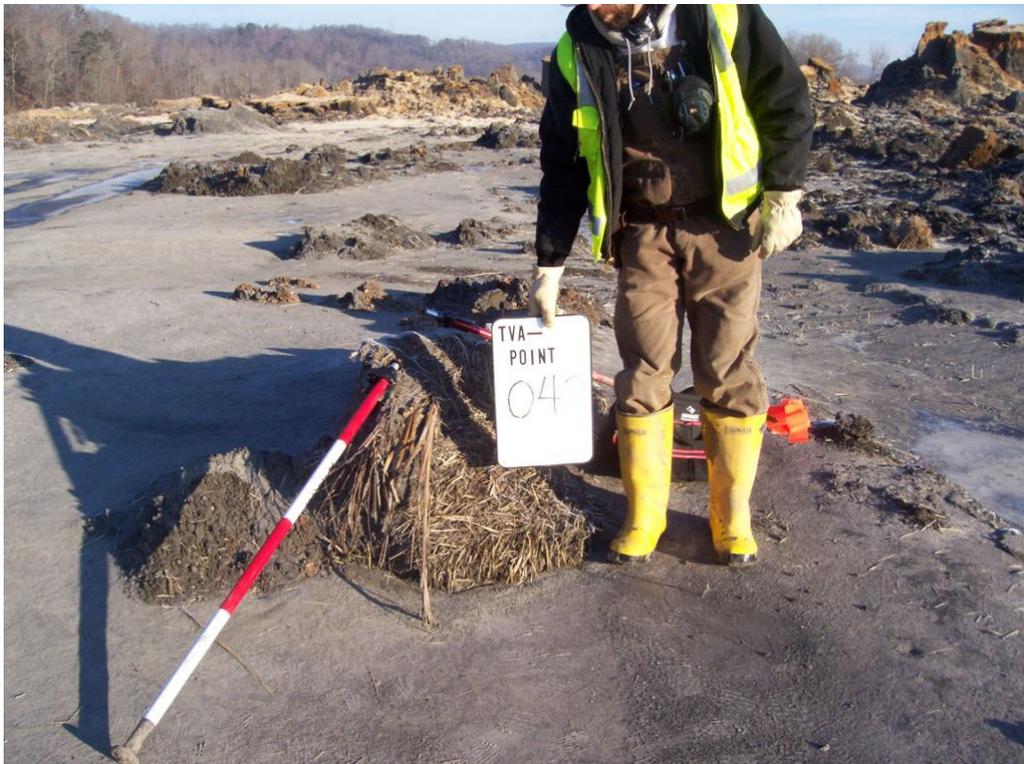
Photo No. 042	Date: 1-22-2009

Direction Photo Taken: Looking north.			
Description: Relic of Starter Dike/Dike C with cattails near the southern end of Slough 2. Cattails are bent "upstream" with respect to ash flow direction.

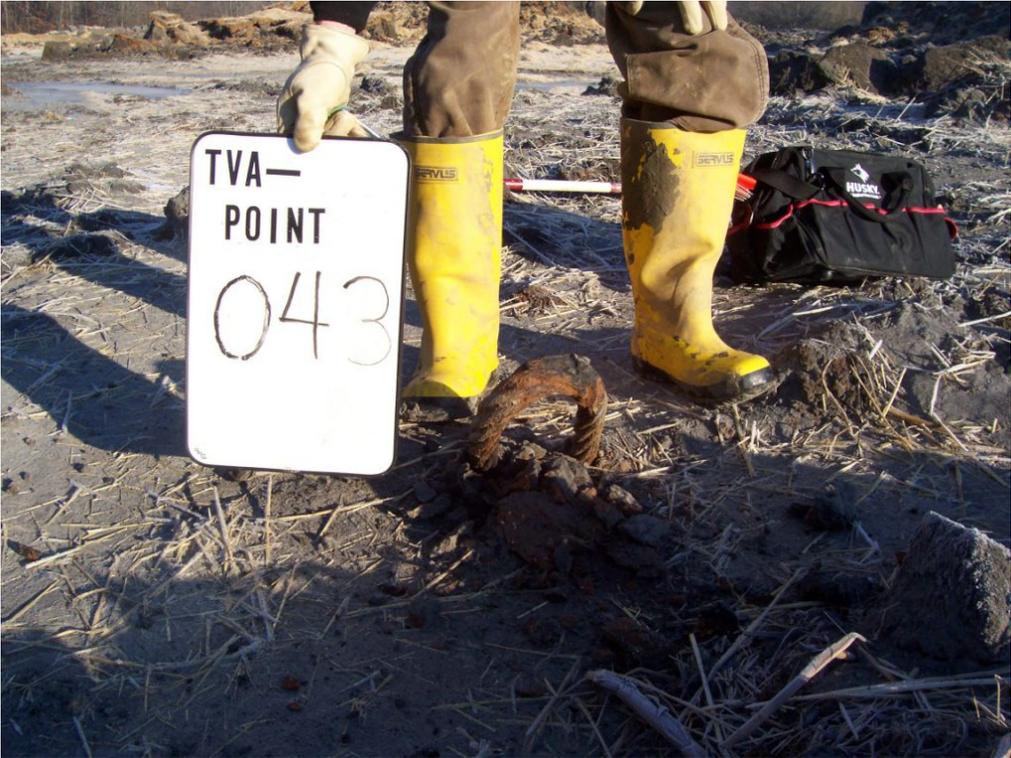
Client Name: Tennessee Valley Authority		Site Location: Kingston Fossil Plant – Harriman, Tennessee	Project No.: 60095742
Photo No.: 043	Date: 1-22-2009

Direction Photo Taken: Looking north.			
Description: 1.5-inch steel cable. May be a tow cable loop. Near the southern end of Slough 2.

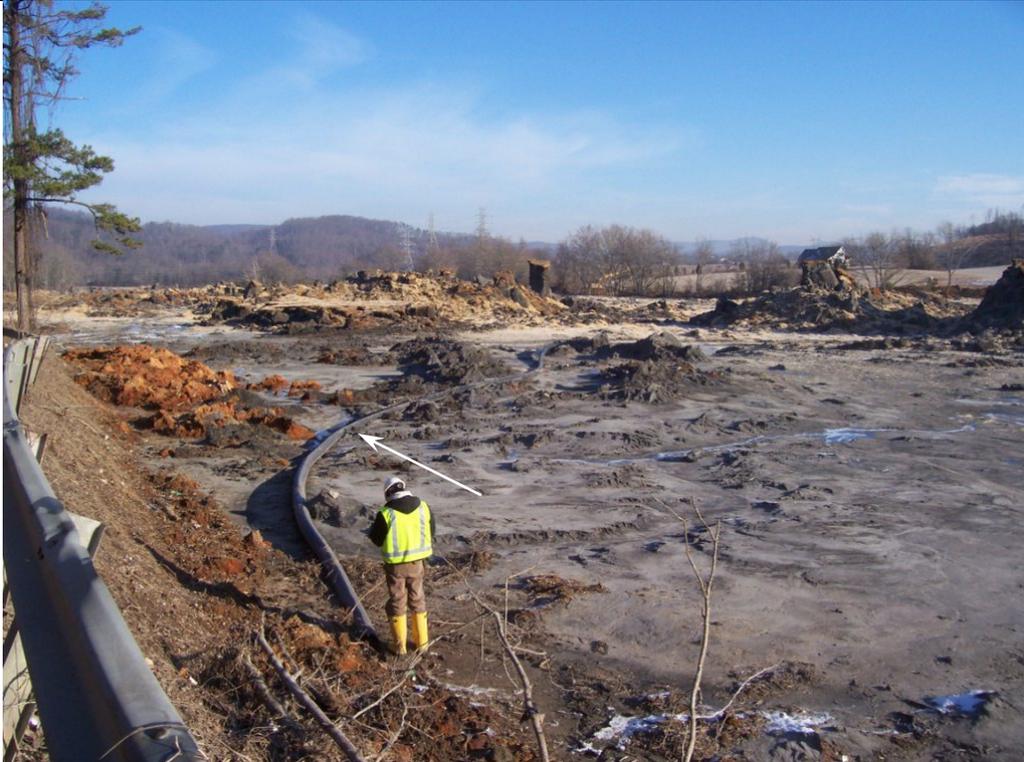
Photo No.: 044	Date: 1-22-2009

Direction Photo Taken: Looking north-northeast.		
Description: South end of 10-inch HDPE pipe (dredge pipeline?) located in Slough 2.

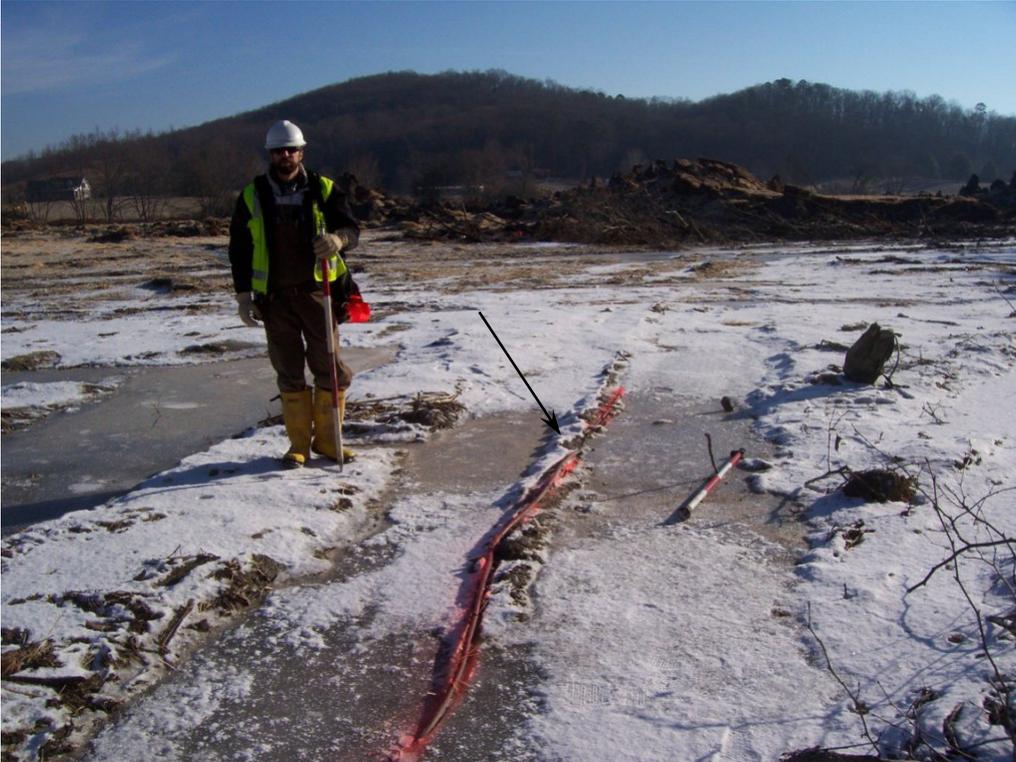
Client Name: Tennessee Valley Authority		Site Location: Kingston Fossil Plant – Harriman, Tennessee	Project No.: 60095742
Photo No.: 047	Date: 1-22-2009

Direction Photo Taken: Looking east.			
Description: 1/2-inch diameter wire w/plastic coating (3/4-inch diameter overall) telephone cable (painted to highlight). An additional 21-feet of the same wire is exposed 125' west. Another 20-feet is exposed 150 feet north of the second piece. The pieces roughly parallel the path of Swan Pond Road.

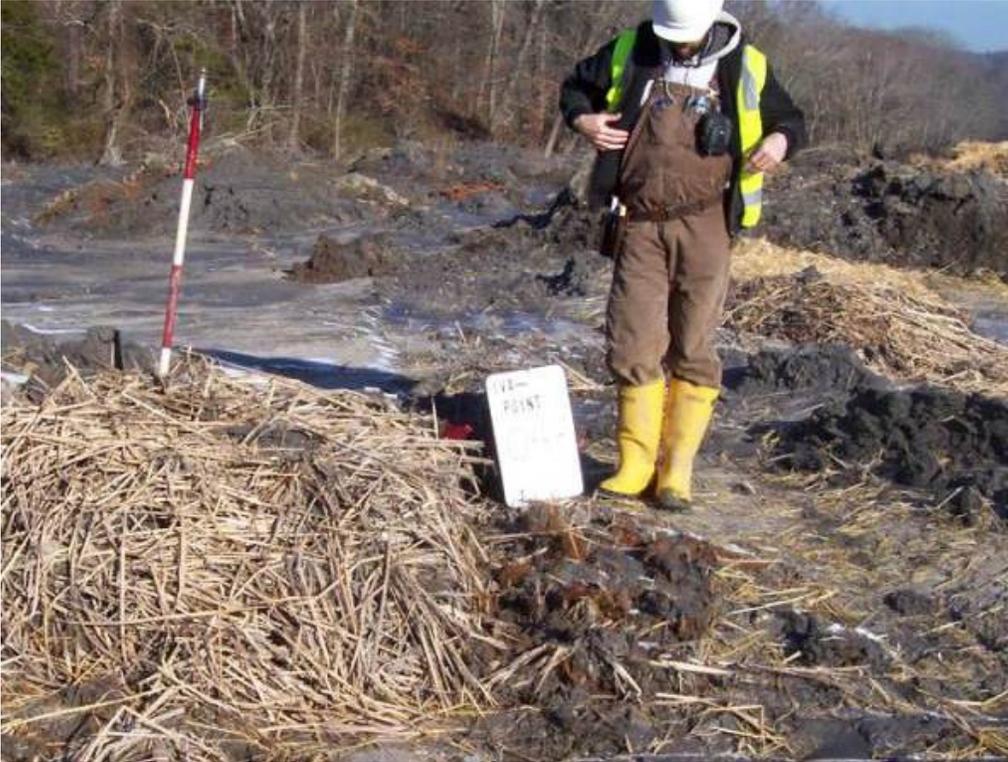
Photo No.: 048	Date: 1-22-2009

Direction Photo Taken: Looking north.		
Description: Geogrid is present in the hay-covered remnant of dike to the left of the whiteboard. Slough 2.

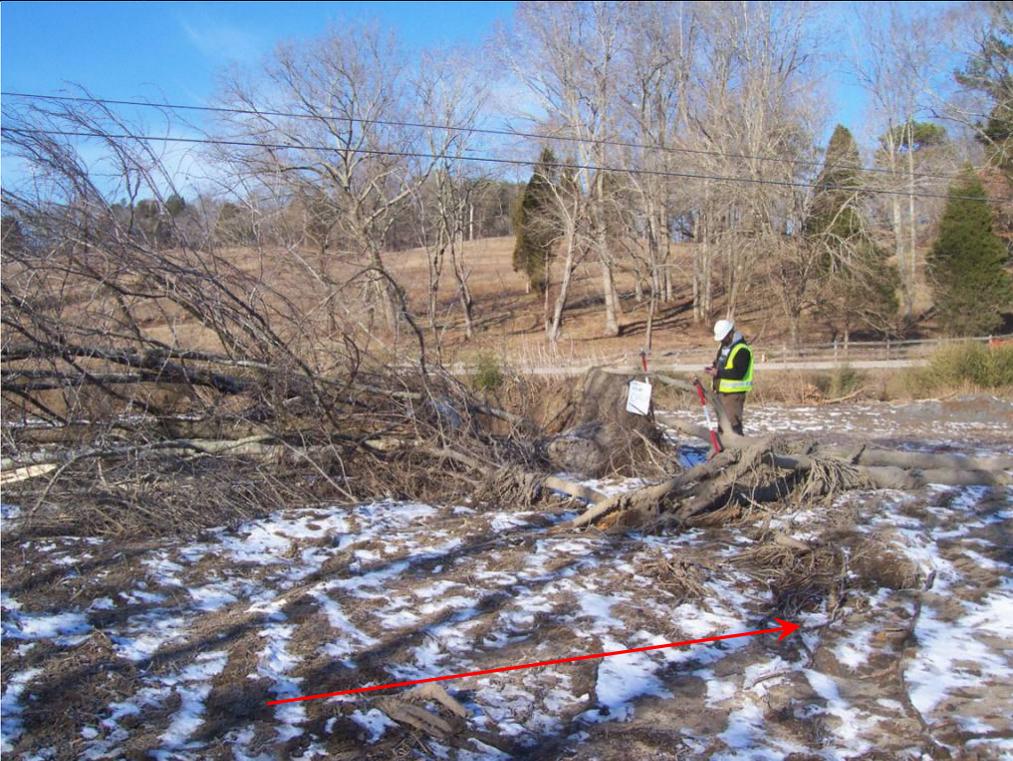
Client Name: Tennessee Valley Authority		Site Location: Kingston Fossil Plant – Harriman, Tennessee		Project No.: 60095742	
Photo No. 049	Date: 1-22-2009

Direction Photo Taken: Looking northwest.					
Description: Trees toppled against the flow along the western edge of Slough 2. Flow direction is indicated by the red arrow at bottom of photo.

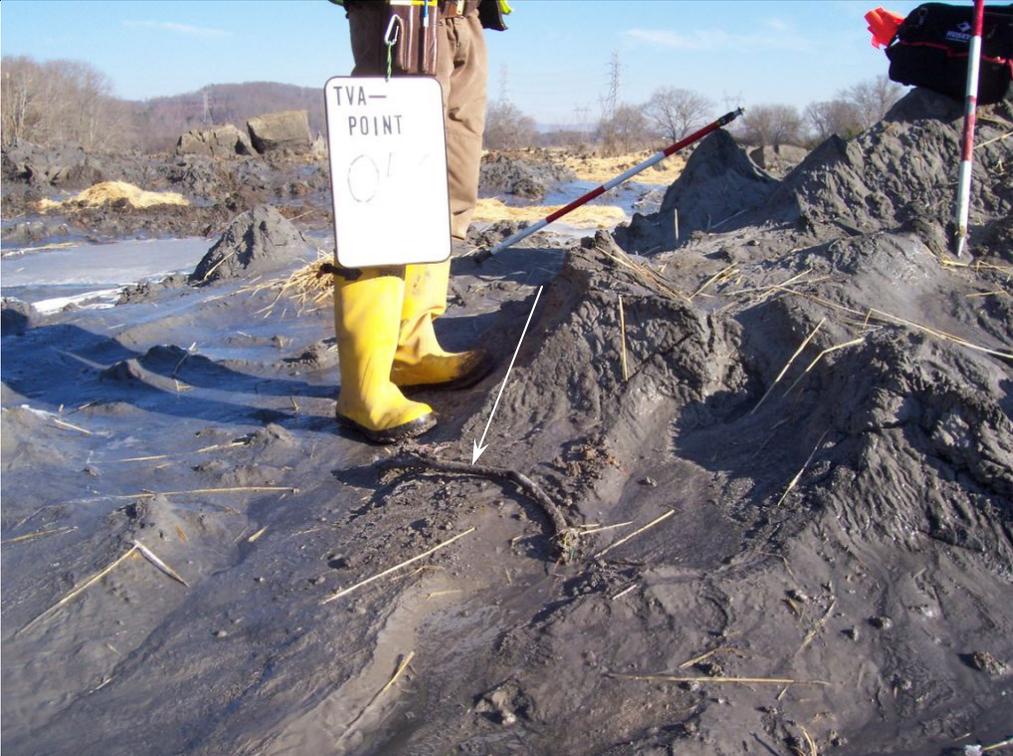
Photo No. 050	Date: 1-22-2009

Direction Photo Taken: Looking north-northeast.					
Description: Telephone cable (white arrow) in Slough 2.

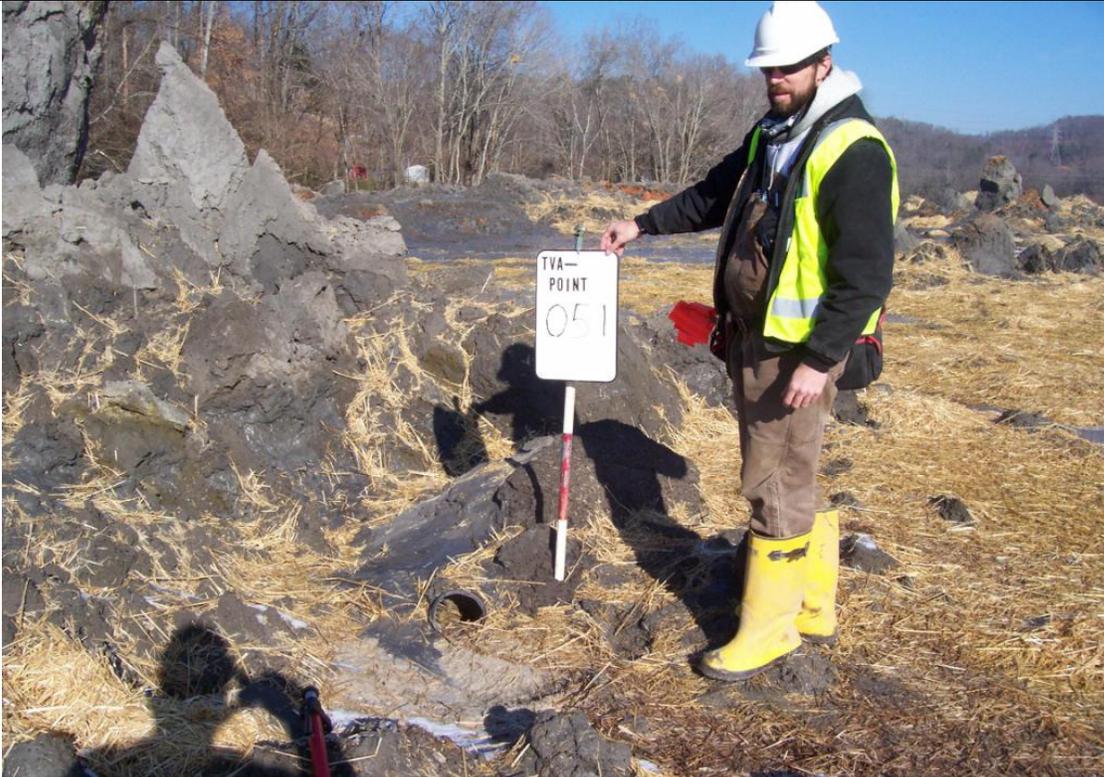
Client Name: Tennessee Valley Authority		Site Location: Kingston Fossil Plant – Harriman, Tennessee	Project No.: 60095742
Photo No.: 051	Date: 1-22-2009

Direction Photo Taken: Looking north.			
Description: Corrugated, non-perforated polyethylene (PE) piping (8-inch) in slough 2.

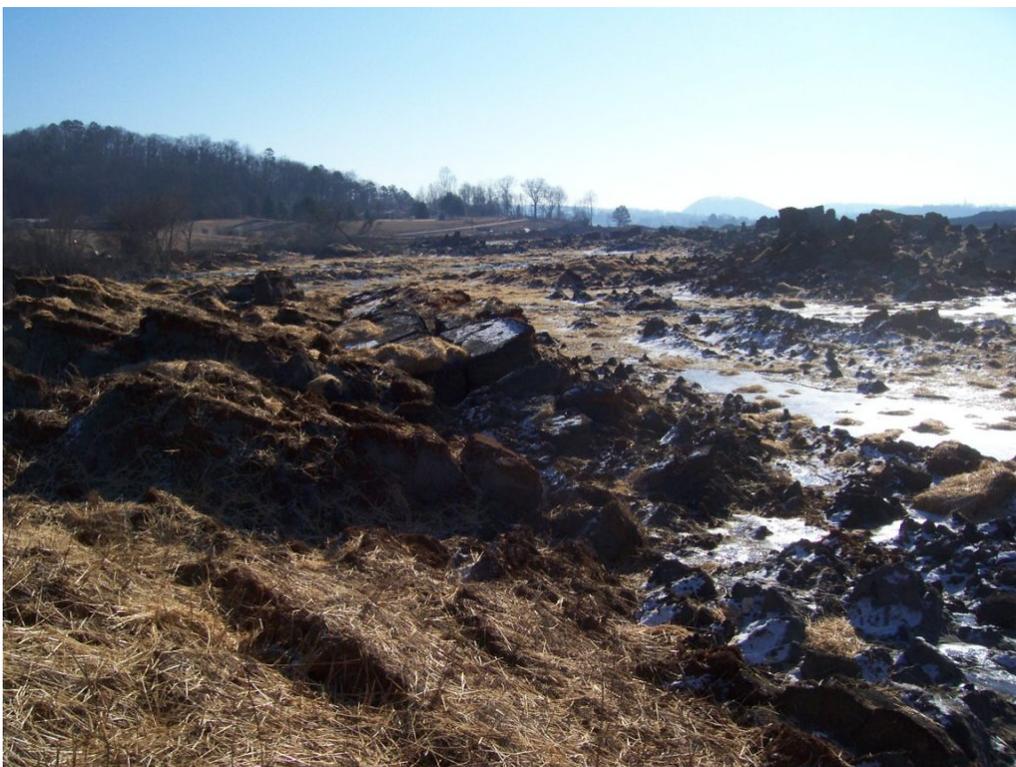
Photo No.: 052*	Date: 1-22-2009

Direction Photo Taken: Looking east. *Representative photo for a 360 panorama series. This photo is labeled 052_Wide View 2 in Photo Library.		
Description: Remnants of Starter Dike/Dike C (left side of photo) and West Dike (center right side of photo) near the southern end of Slough 2.

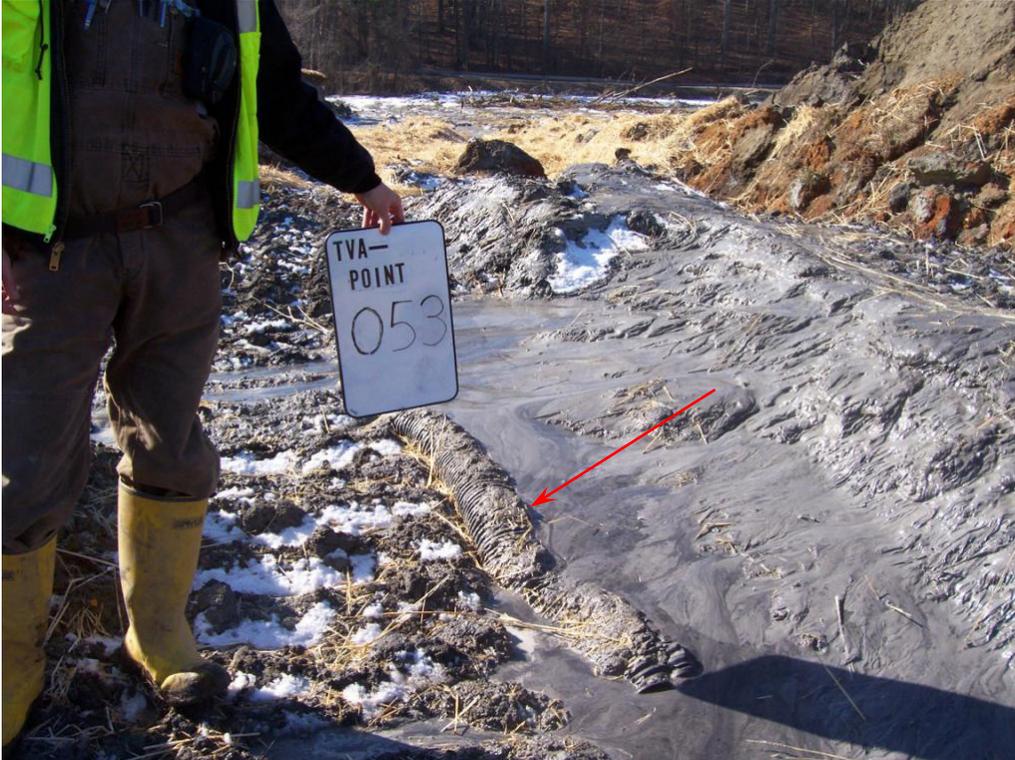
Client Name: Tennessee Valley Authority		Site Location: Kingston Fossil Plant – Harriman, Tennessee	Project No.: 60095742
Photo No.: 053	Date: 1-22-2009

Direction Photo Taken: Looking southwest.			
Description: Corrugated, non-perforated PE piping (8-inch) in Slough 2.

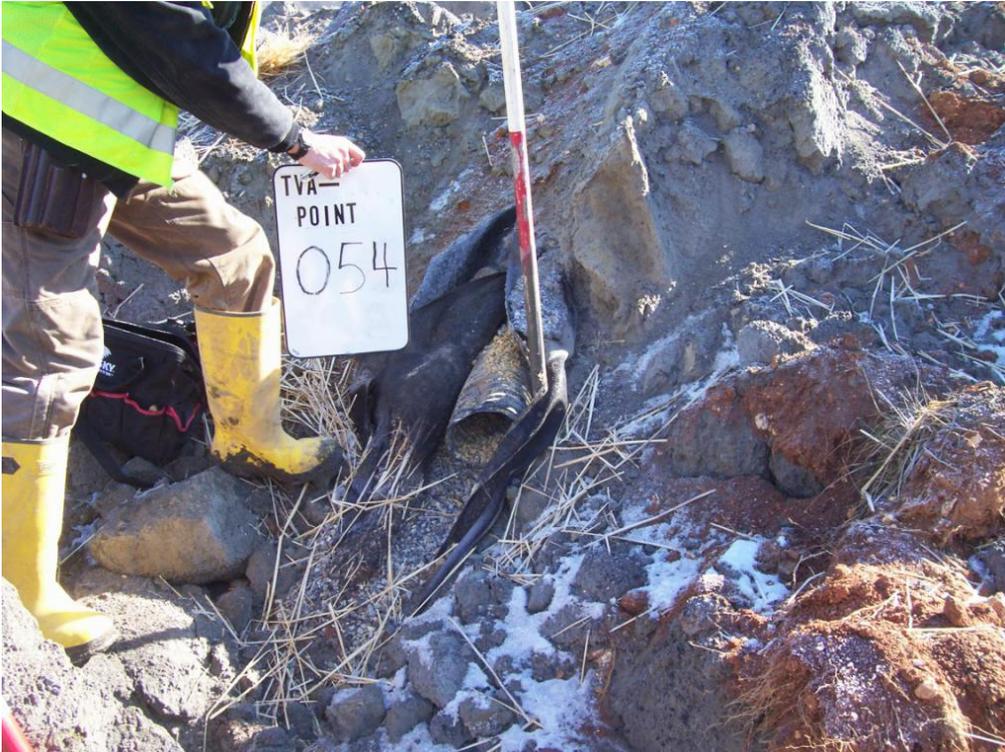
Photo No.: 054	Date: 1-22-2009

Direction Photo Taken: Looking east.			
Description: Corrugated, perforated drain pipe (8-inch) with #57 stone and geotextile in Slough 2.

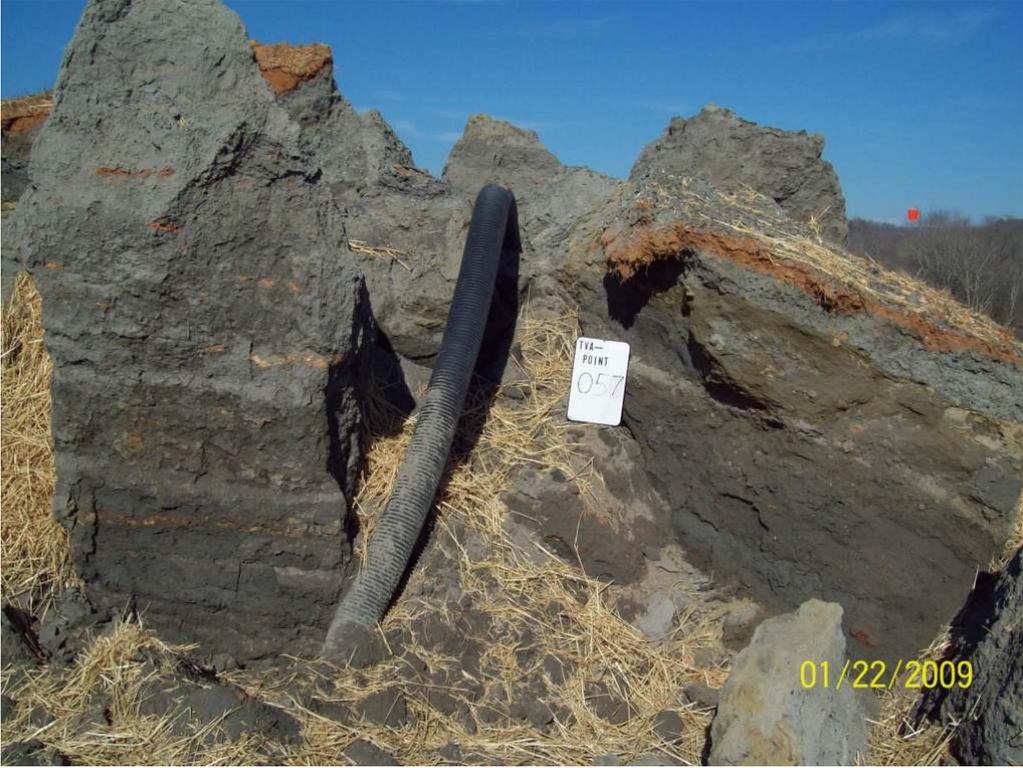
Client Name: Tennessee Valley Authority		Site Location: Kingston Fossil Plant – Harriman, Tennessee	Project No.: 60095742
Photo No.: 057	Date: 1-22-2009

Direction Photo Taken: Looking north.			
Description: Corrugated, non-perforated PE drain pipe (8-inch) in a remnant of the West Dike in Slough 2.

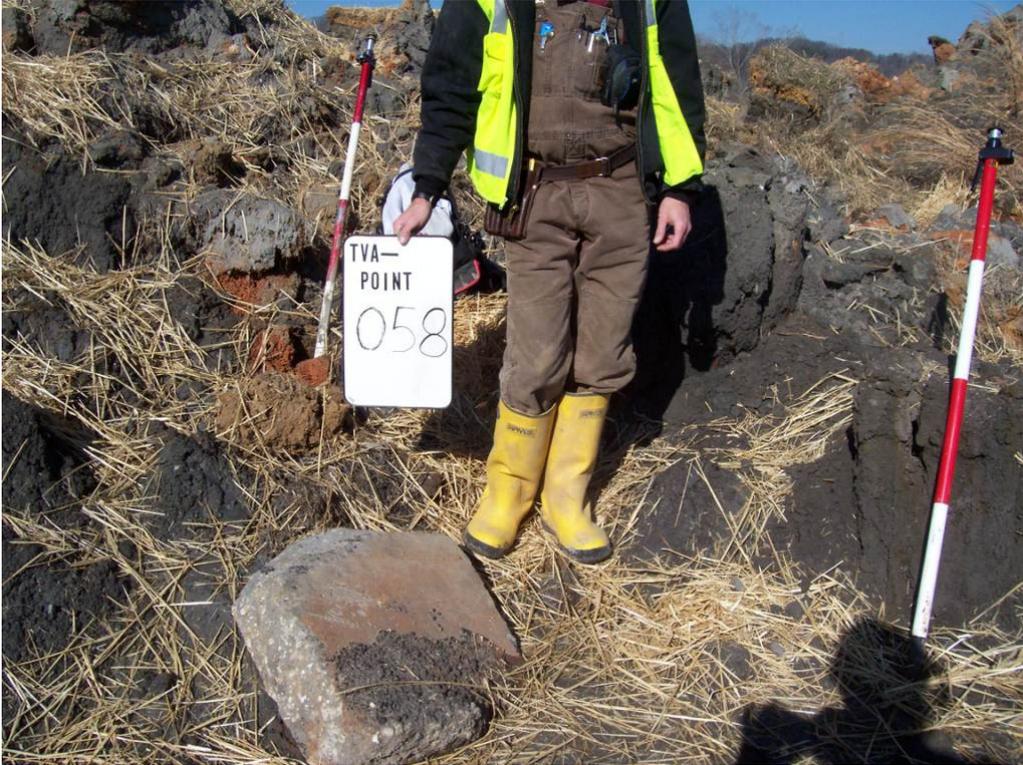
Photo No.: 058	Date: 1-22-2009

Direction Photo Taken: Looking north-northwest.		
Description: Two-foot by two-foot by 6-inch poured concrete block in Slough 2.

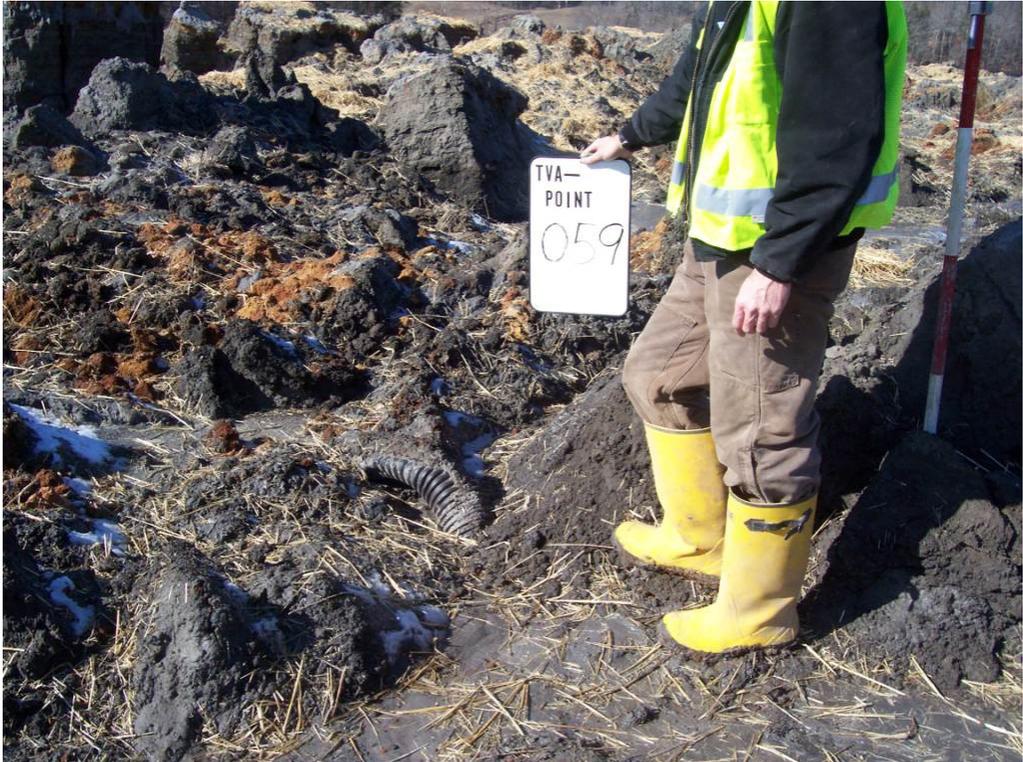
Client Name: Tennessee Valley Authority		Site Location: Kingston Fossil Plant – Relic Identification	Project No.: 60095742
Photo No. 059	Date: 1-22-2009

Direction Photo Taken: Looking west.			
Description: Corrugated, non-perforated PE drain pipe (8-inch) in a remnant of the West Dike in Slough 2.

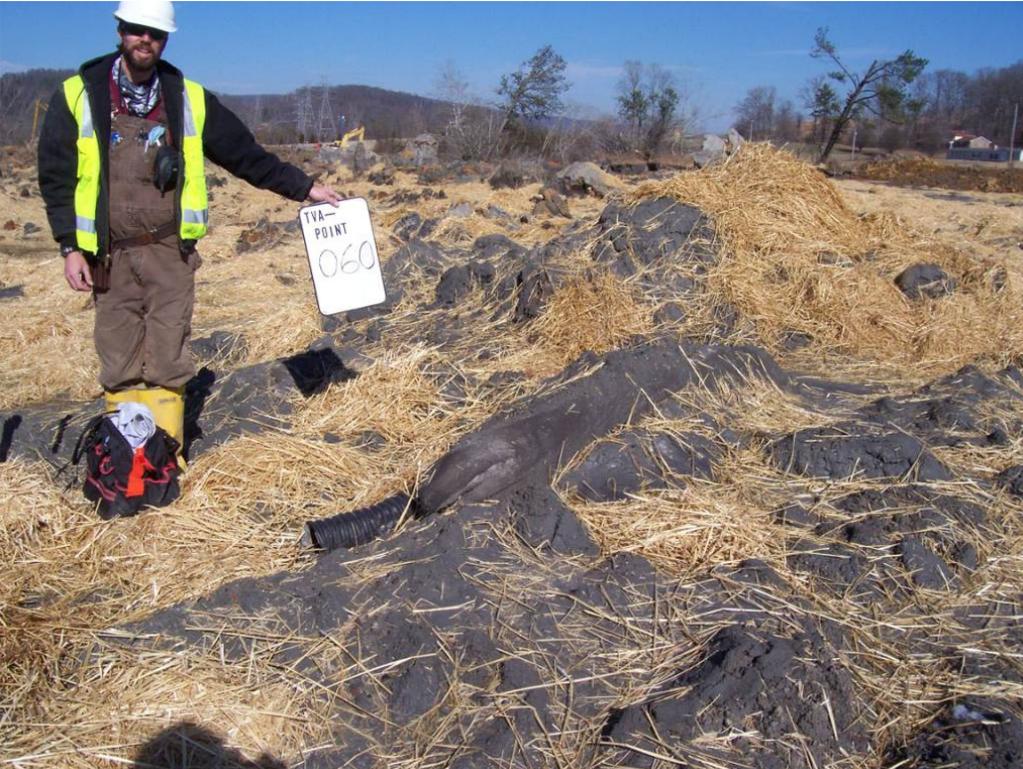
Photo No. 060	Date: 1-22-2009

Direction Photo Taken: Looking north-northeast.			
Description: Corrugated, perforated PE drain pipe (8-inch) with #57 stone and geotextile. Likely a lateral drain in a remnant of the West Dike in Slough 2.

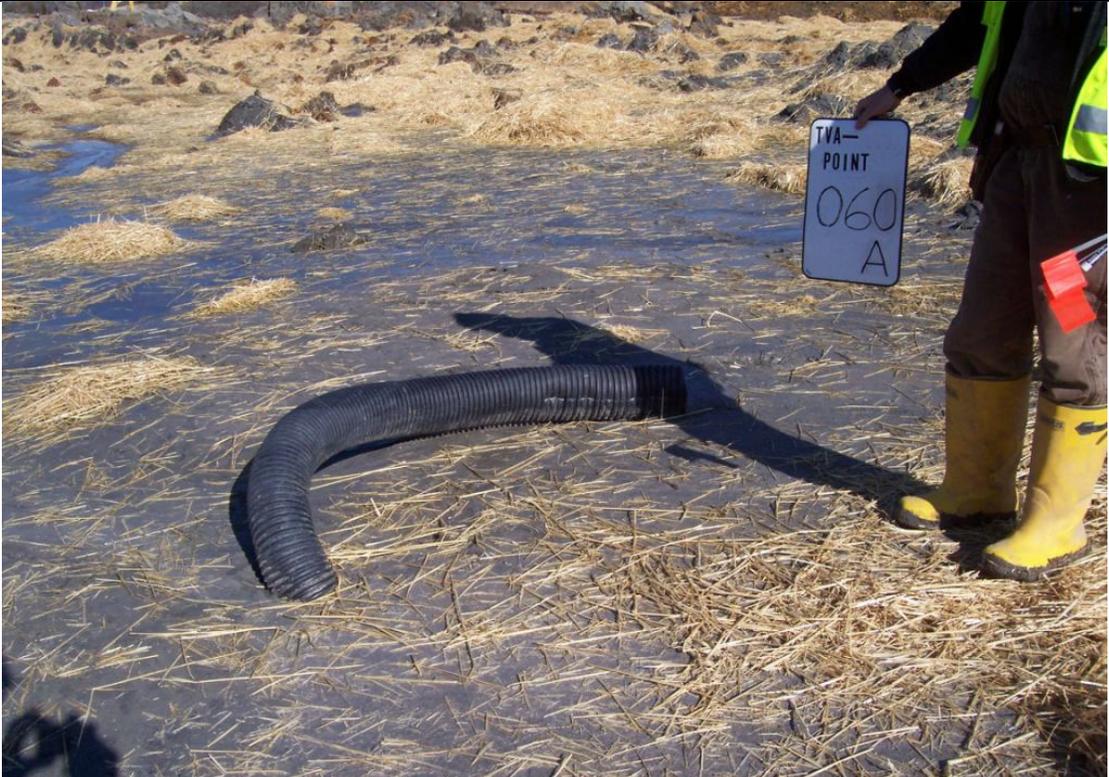
Client Name: Tennessee Valley Authority		Site Location: Kingston Fossil Plant – Relic Identification	Project No.: 60095742
Photo No.: 060_A	Date: 1-22-2009

Direction Photo Taken: Looking east-northeast.			
Description: Corrugated non-perforated PE drain pipe (8-inch) in Slough 2, approximately 25 feet southwest of 060.

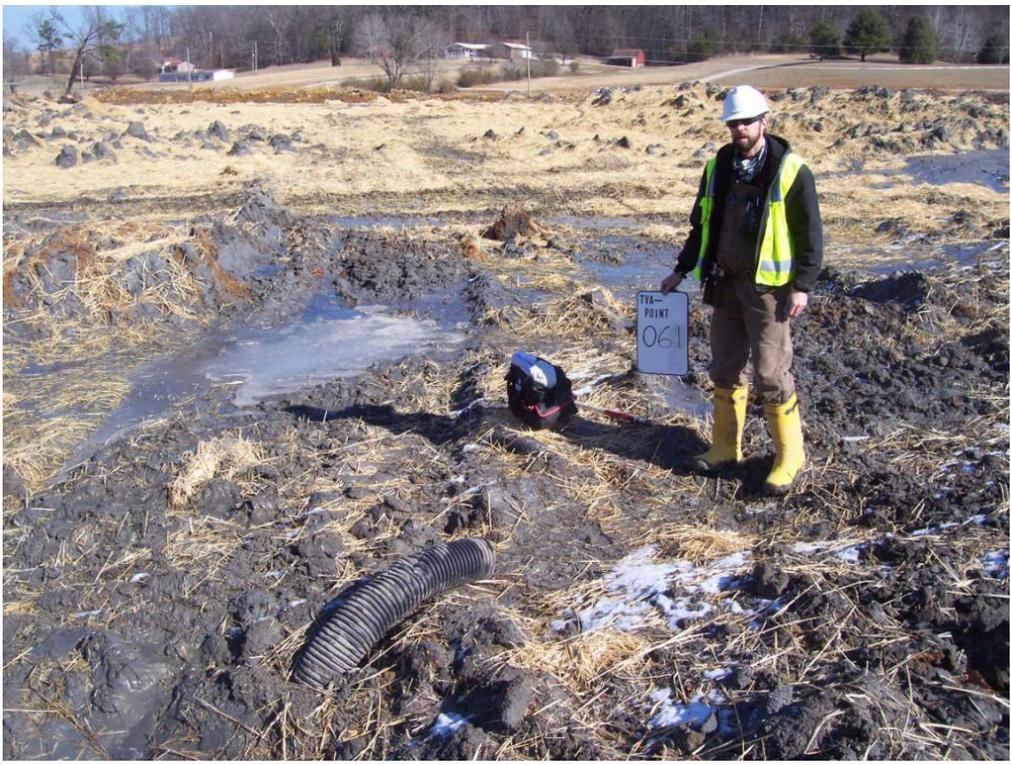
Photo No.: 061	Date: 1-22-2009

Direction Photo Taken: Looking northeast.			
Description: Corrugated non-perforated PE drain pipe (8-inch) in Slough 2.

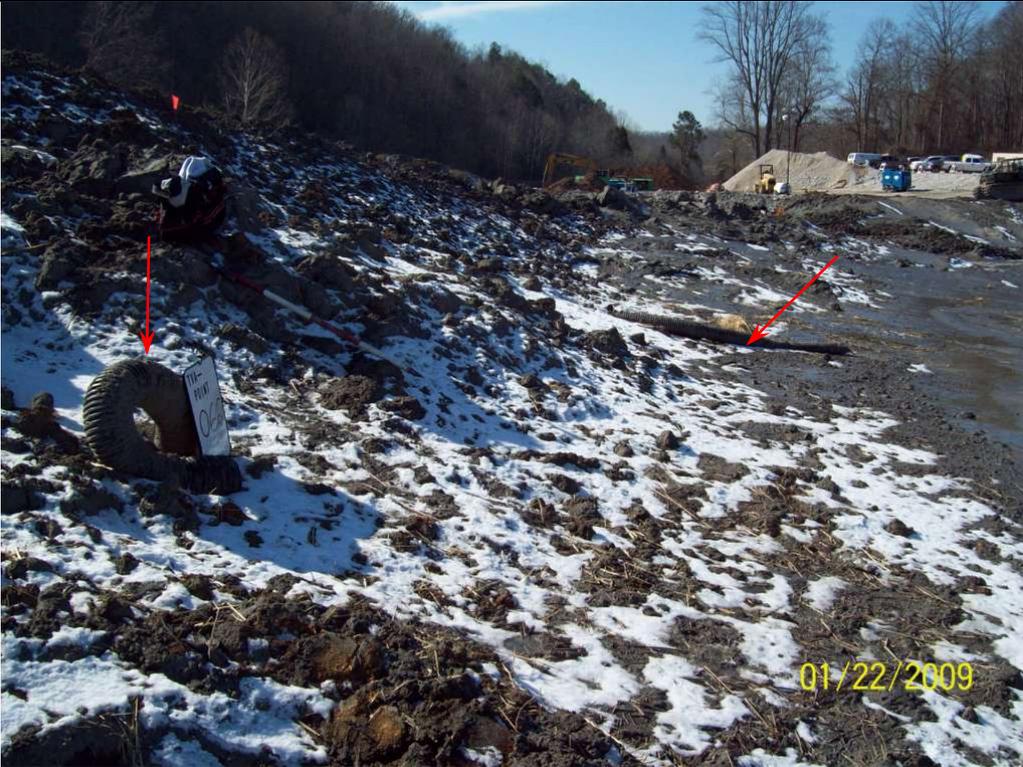
Client Name: Tennessee Valley Authority		Site Location: Kingston Fossil Plant – Relic Identification	Project No.: 60095742
Photo No.: 062_A	Date: 1-22-2009

Direction Photo Taken: Looking west.			
Description: Corrugated non-perforated PE drain pipe (8-inch) in Slough 2. Both ends of the same pipe are exposed at this location (red arrows).

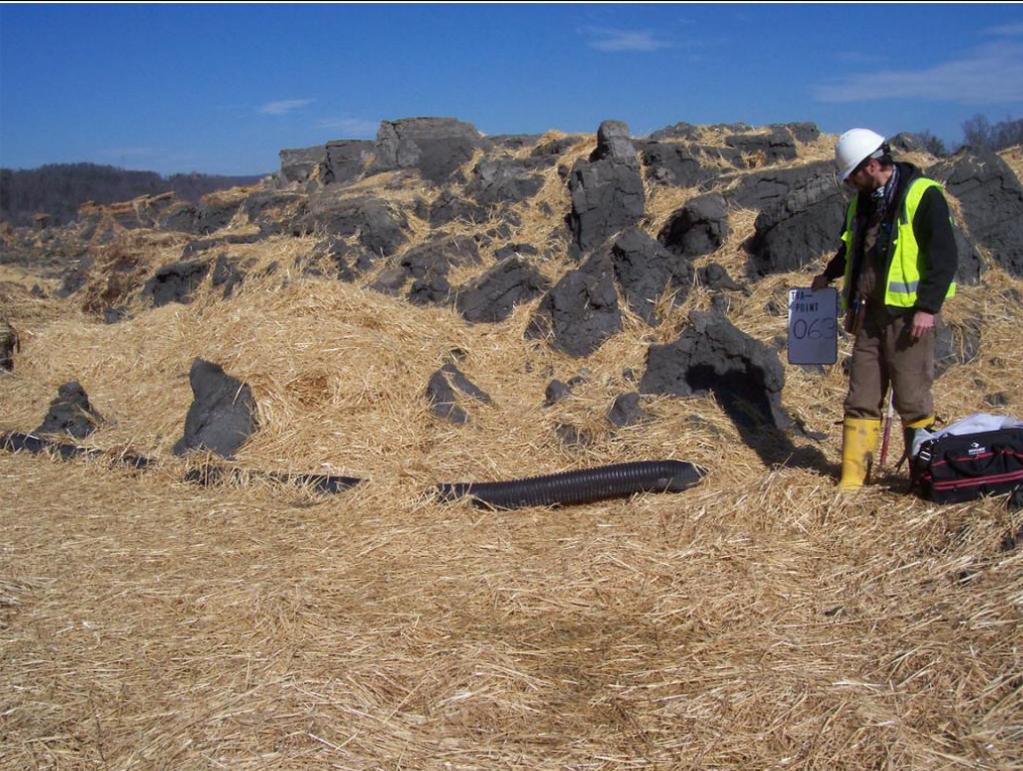
Photo No.: 063	Date: 1-22-2009

Direction Photo Taken: Looking north.		
Description: Corrugated non-perforated PE drain pipe (8-inch) in Slough 2.

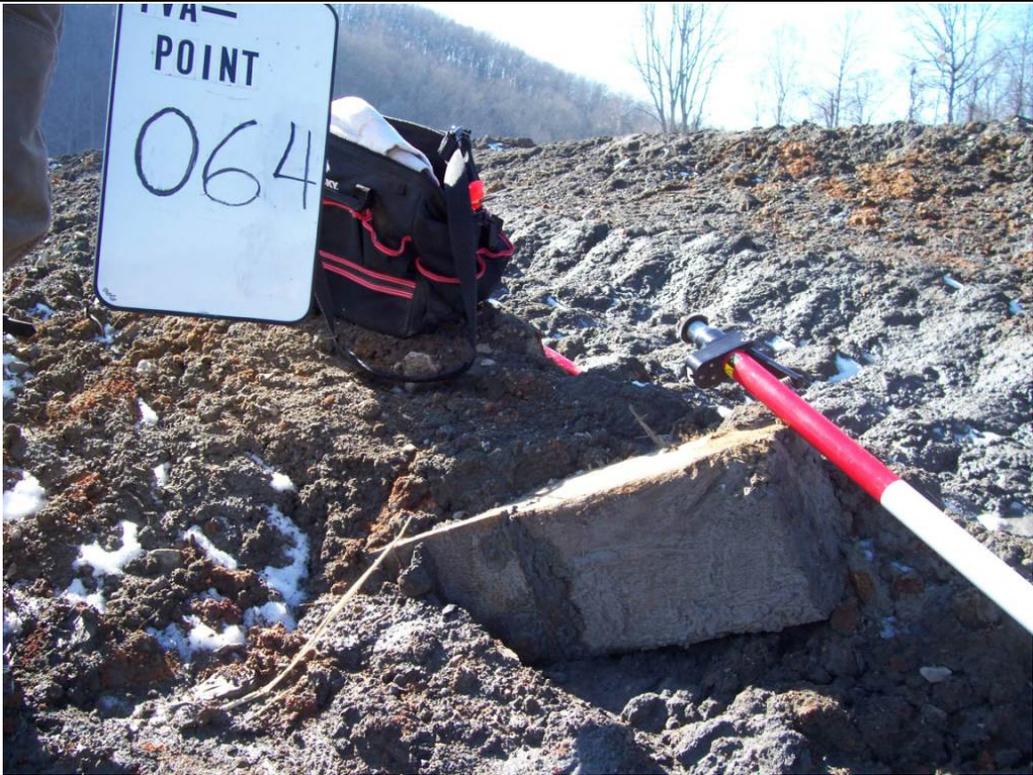
Client Name: Tennessee Valley Authority		Site Location: Kingston Fossil Plant – Relic Identification	Project No.: 60095742
Photo No.: 064	Date: 1-22-2009

Direction Photo Taken: Looking southwest.			
Description: Railroad tie with rail plate located in Slough 2, east of northwest construction trailers.

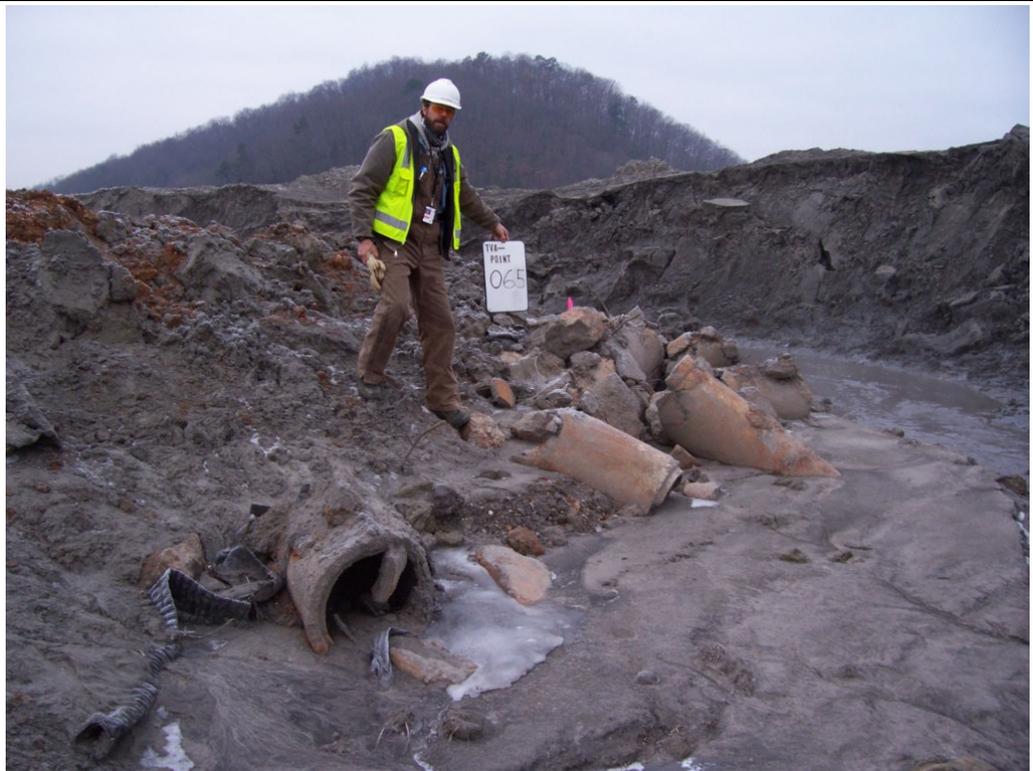
Photo No.: 065	Date: 1-23-2009

Direction Photo Taken: Looking southwest.		
Description: 24-inch diameter bell and socket pipe located in a large drainage north of Boring 09-105.

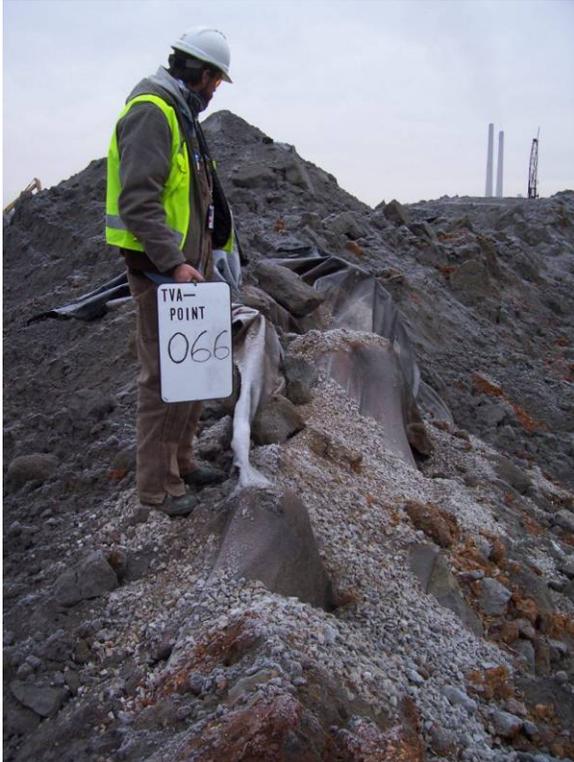
Client Name: Tennessee Valley Authority		Site Location: Kingston Fossil Plant – Relic Identification		Project No. 60095742
Photo No. 066	Date: 1-23-2009

Direction Photo Taken: Looking south.				
Description: Plastic, geotextile, and #57 stone. Remnants of the former surface drainage layer from West Dike.

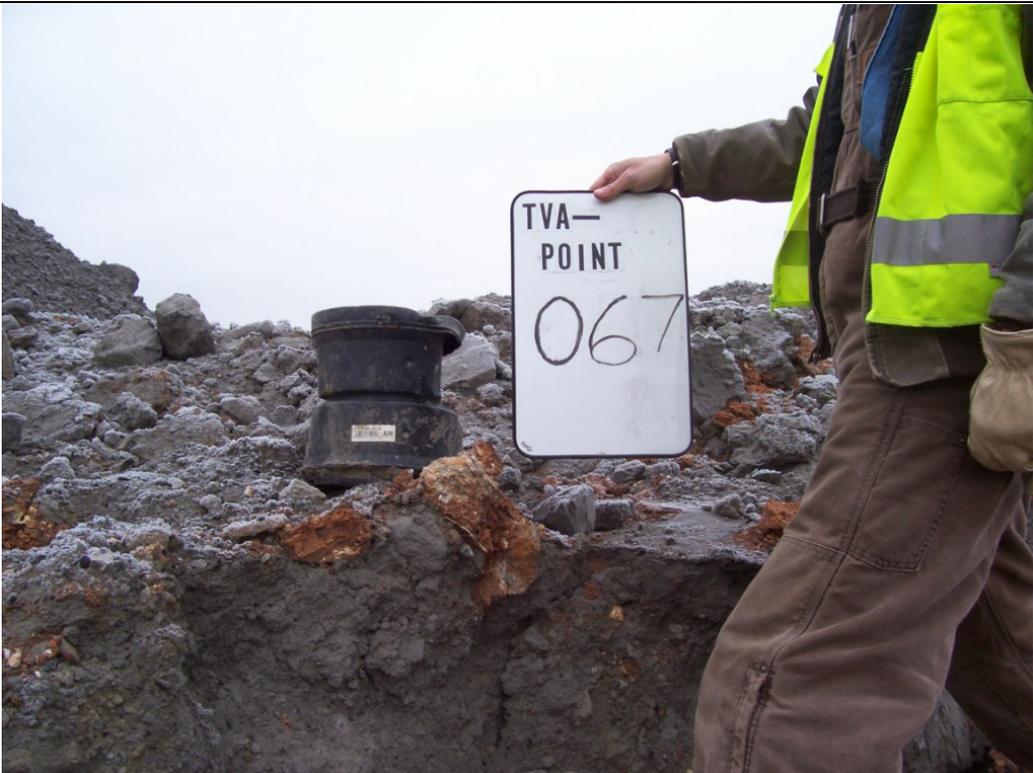
Photo No. 067	Date: 1-23-2009

Direction Photo Taken: Looking southeast.				
Description: PE plastic drain pipe fitting with UPC code "8" N-12 Snap End Cap."

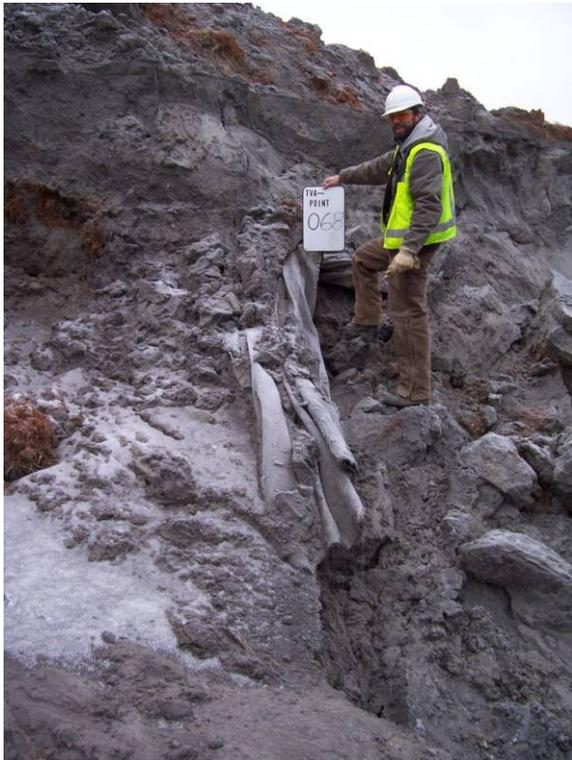
Client Name: Tennessee Valley Authority		Site Location: Kingston Fossil Plant – Relic Identification		Project No.: 60095742	
Photo No.: 068	Date: 1-23-2009

Direction Photo Taken: Looking south.					
Description: Geotextile and gravel from West Dike nearly buried by debris.

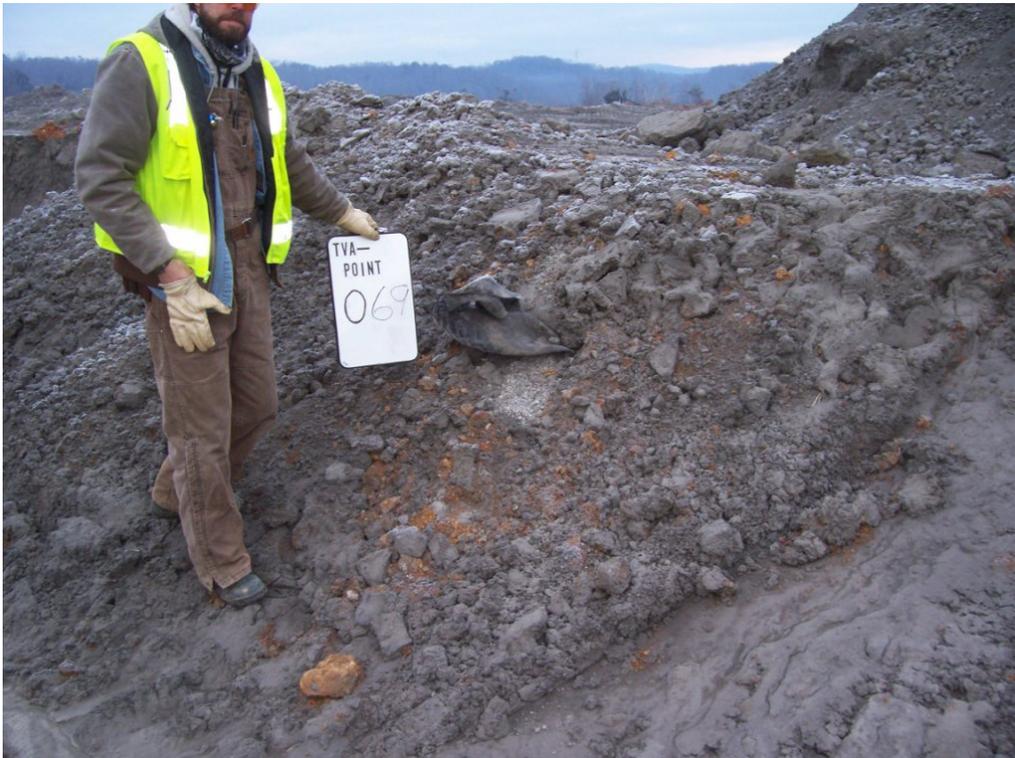
Photo No.: 069	Date: 1-23-2009

Direction Photo Taken: Looking northwest.					
Description: Geotextile and #57 stone typically found around PE lateral drain pipe. No pipe observed at this location.

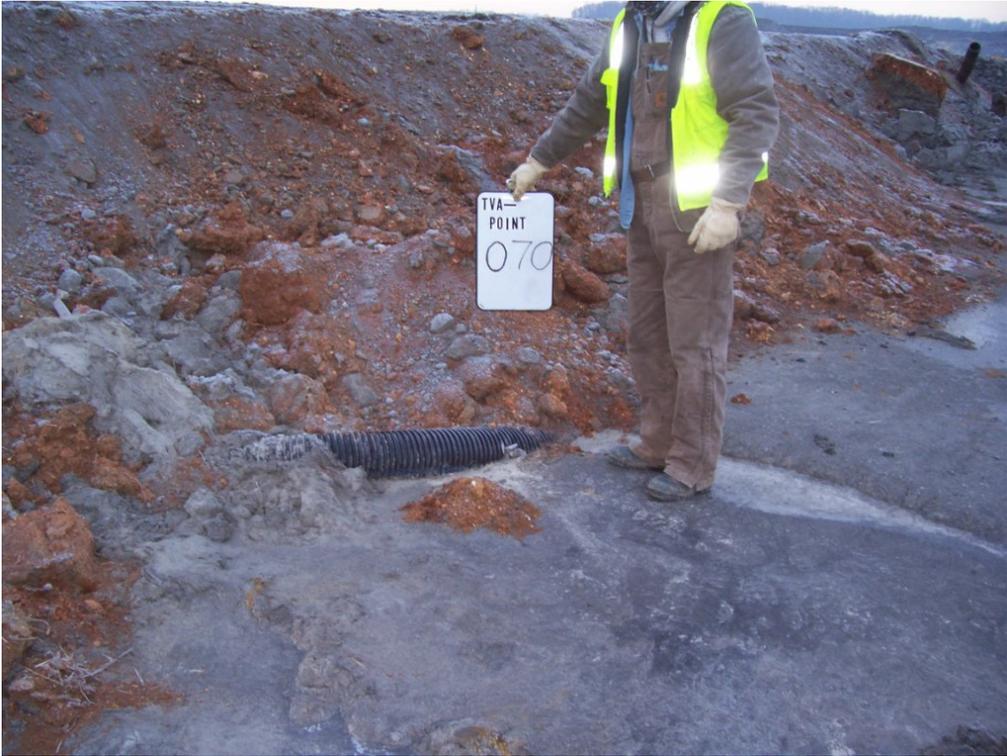
Client Name: Tennessee Valley Authority		Site Location: Kingston Fossil Plant – Relic Identification	Project No.: 60095742
Photo No.: 070	Date: 1-23-2009

Direction Photo Taken: Looking south.			
Description: Corrugated non-perforated PE drain pipe (8-inch) located in the man-made drainage for Slough 1.

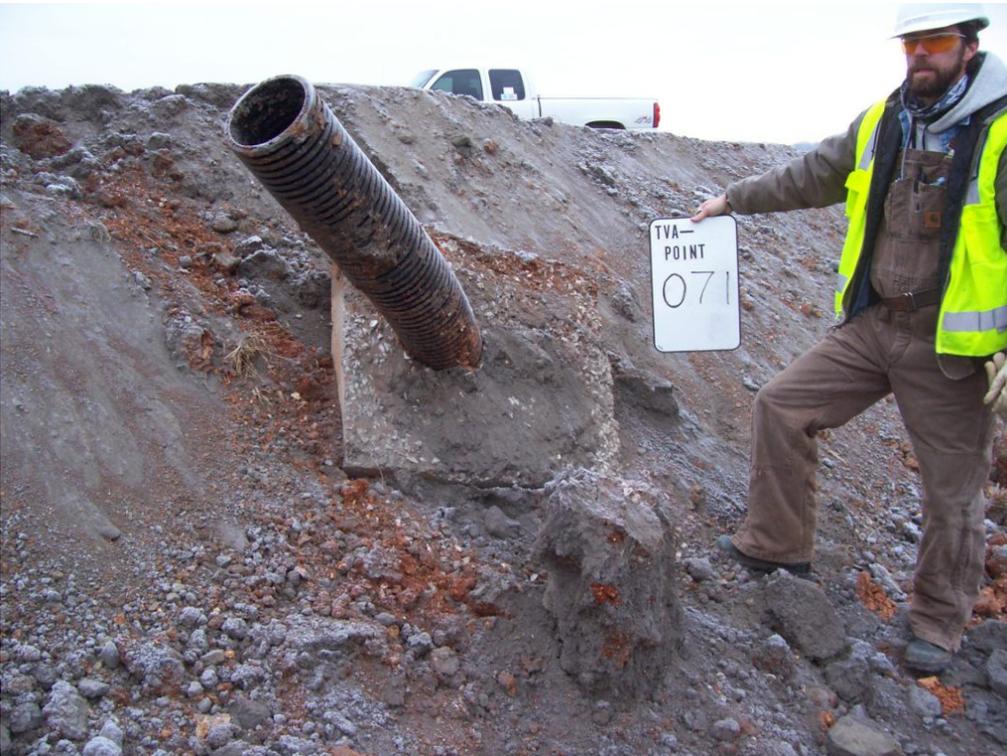
Photo No.: 071	Date: 1-23-2009

Direction Photo Taken: Looking south.			
Description: PVC cleanout cover, concrete pad, and corrugated, non-perforated PE drain pipe. One of the side-slope drains from the West Dike.
