RELIC IDENTIFICATION PHOTOGRAPHIC LOG

Client Name: Tennessee Valley Authority		Site Location: Kingston Fossil Plant – Harriman, Tennessee	Project No.: 60095742
Photo No. 041	Date: 1-22-2009

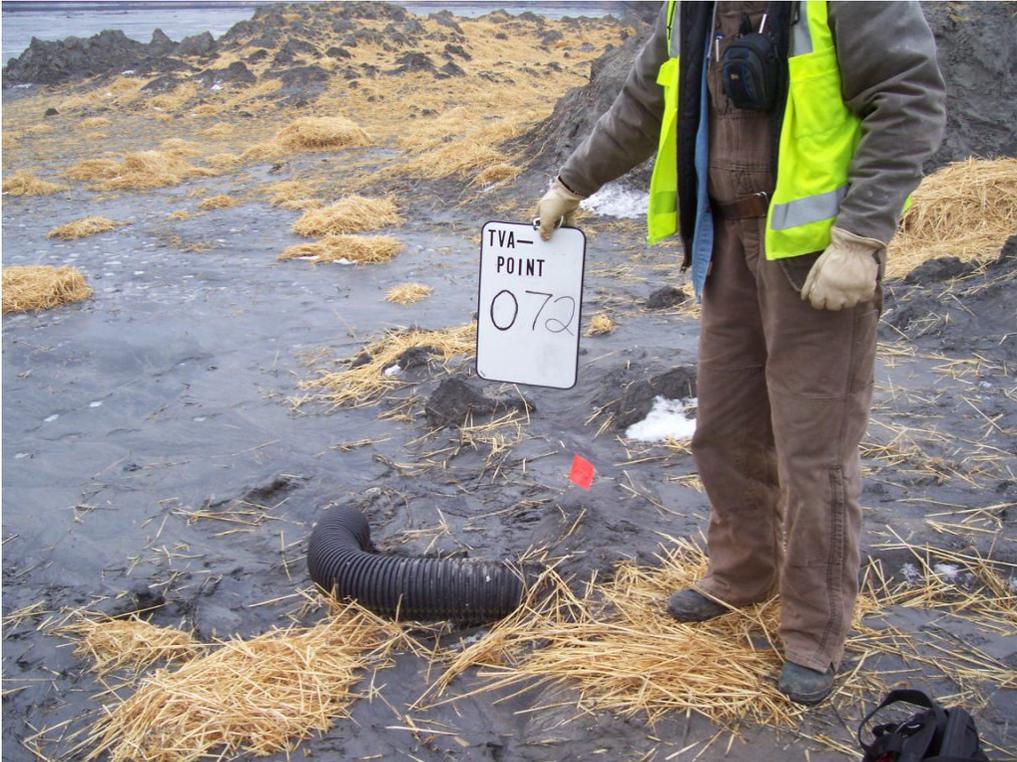
Client Name: Tennessee Valley Authority		Site Location: Kingston Fossil Plant – Relic Identification		Project No.: 60095742	
Photo No.: 072	Date: 1-23-2009

Direction Photo Taken: Looking south.					
Description: Corrugated perforated PE drain pipe (8-inch). Note no geotextile or #57 stone filter pack.

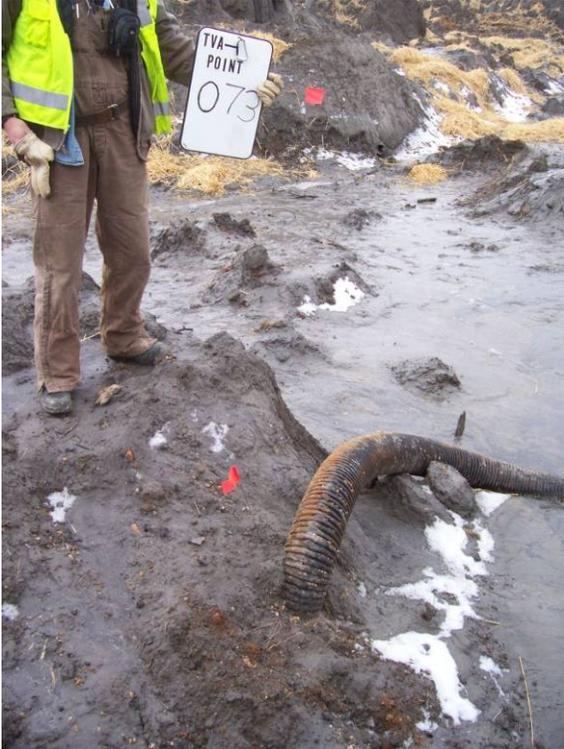
Photo No.: 073	Date: 1-23-2009

Direction Photo Taken: Looking south.					
Description: Corrugated non-perforated PE drain pipe (8-inch). Note no geotextile or #57 stone filter pack.

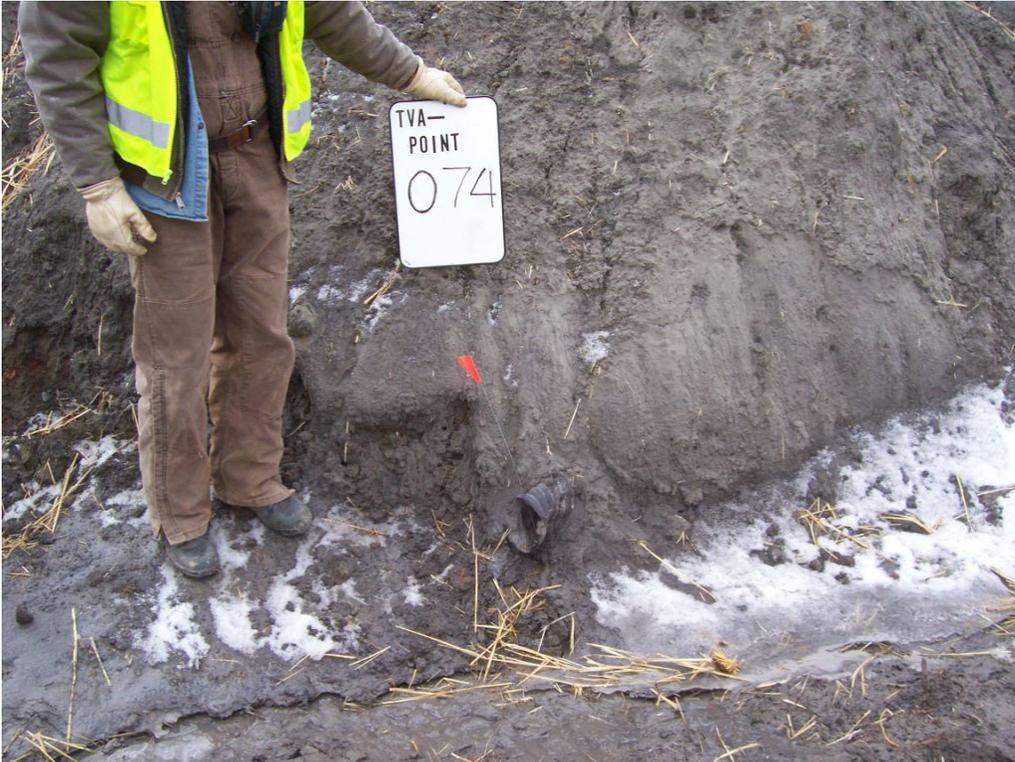
Client Name: Tennessee Valley Authority		Site Location: Kingston Fossil Plant – Relic Identification	Project No.: 60095742
Photo No.: 074	Date: 1-23-2009

Direction Photo Taken: Looking south.			
Description: Corrugated perforated PE drain pipe (8-inch). Note no geotextile or #57 stone filter pack.

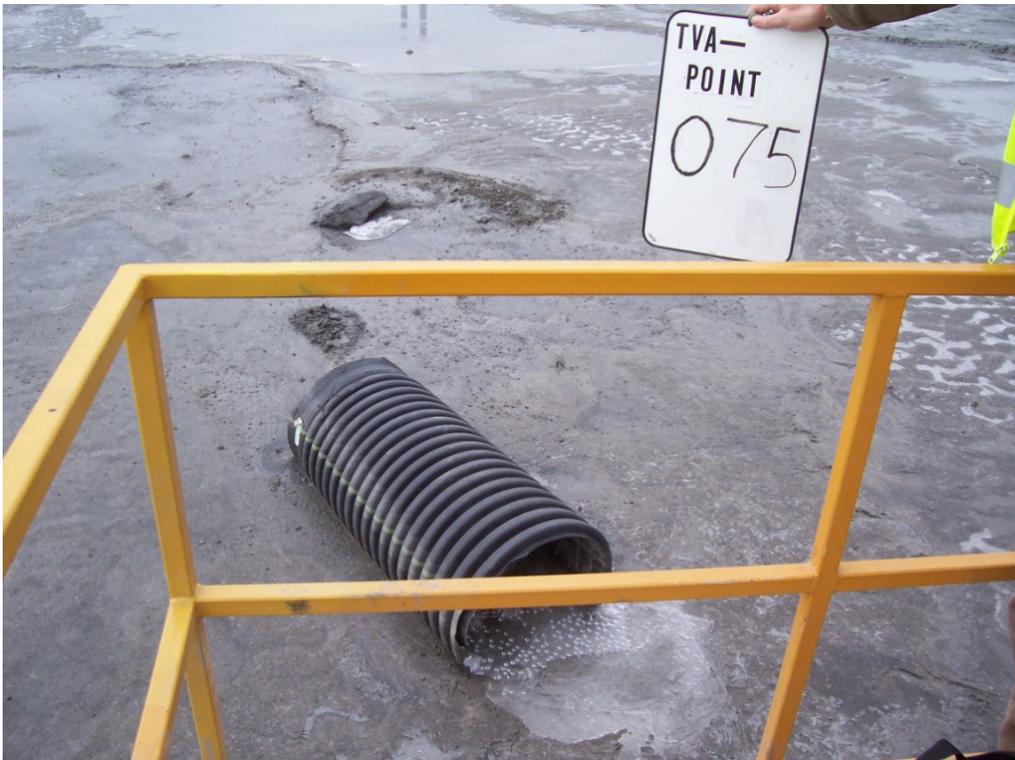
Photo No.: 075	Date: 1-23-2009

Direction Photo Taken: Looking west.		
Description: 24-inch corrugated PE piping. Thought to have originated from one of two stockpiles: one at the northern end of the east dike of Dredge Cell 2, or a second at the northeastern edge of Dike D. Location is in the Emory River channel.

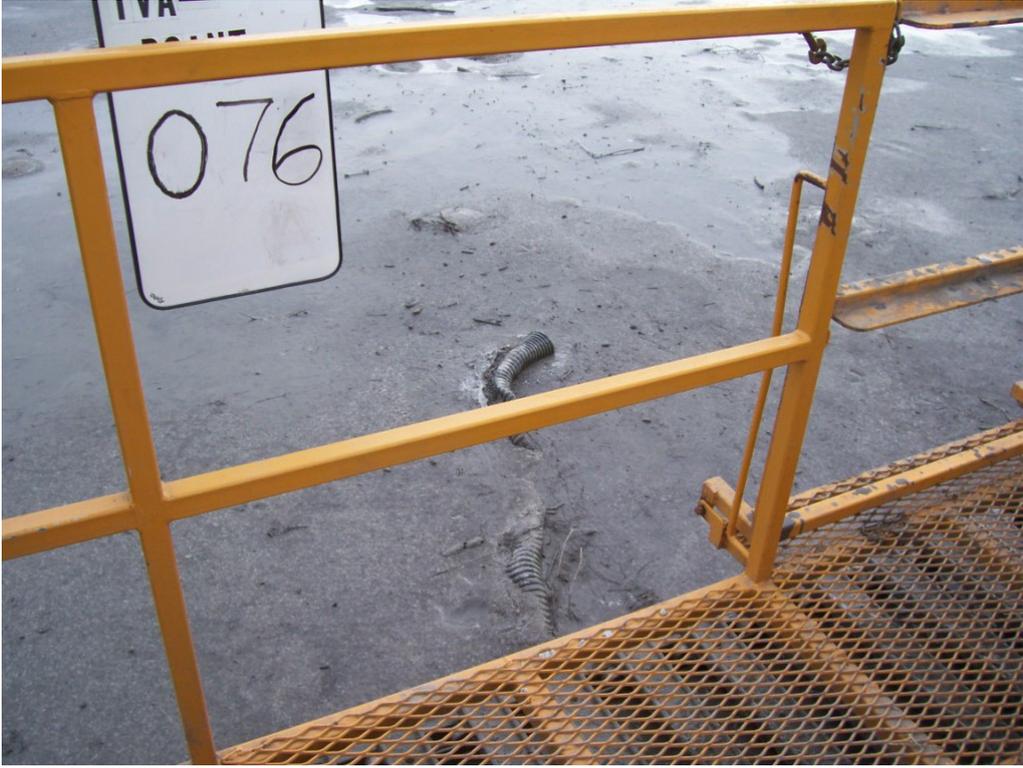
Client Name: Tennessee Valley Authority		Site Location: Kingston Fossil Plant – Relic Identification	Project No.: 60095742
Photo No.: 076	Date: 1-23-2009

Direction Photo Taken: Looking south.			
Description: Corrugated non-perforated PE drain pipe (8-inch). Location is the former Emory River channel.

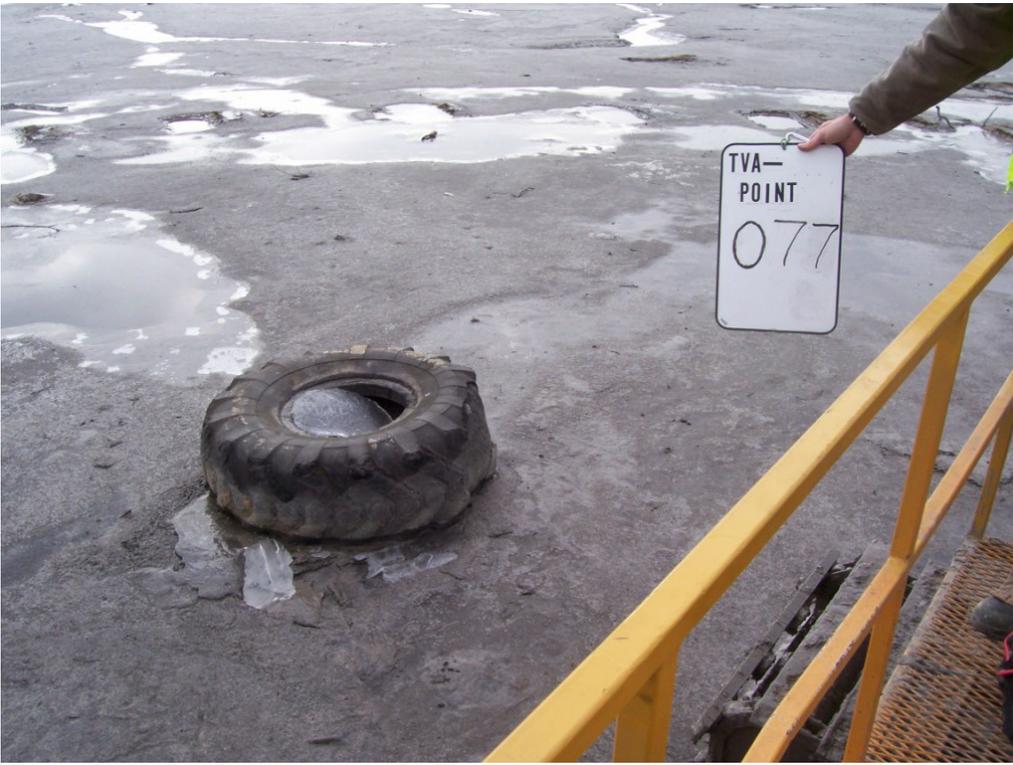
Photo No.: 077	Date: 1-23-2009

Direction Photo Taken: Looking south.		
Description: Old Goodyear loader tire in the former Emory River channel.

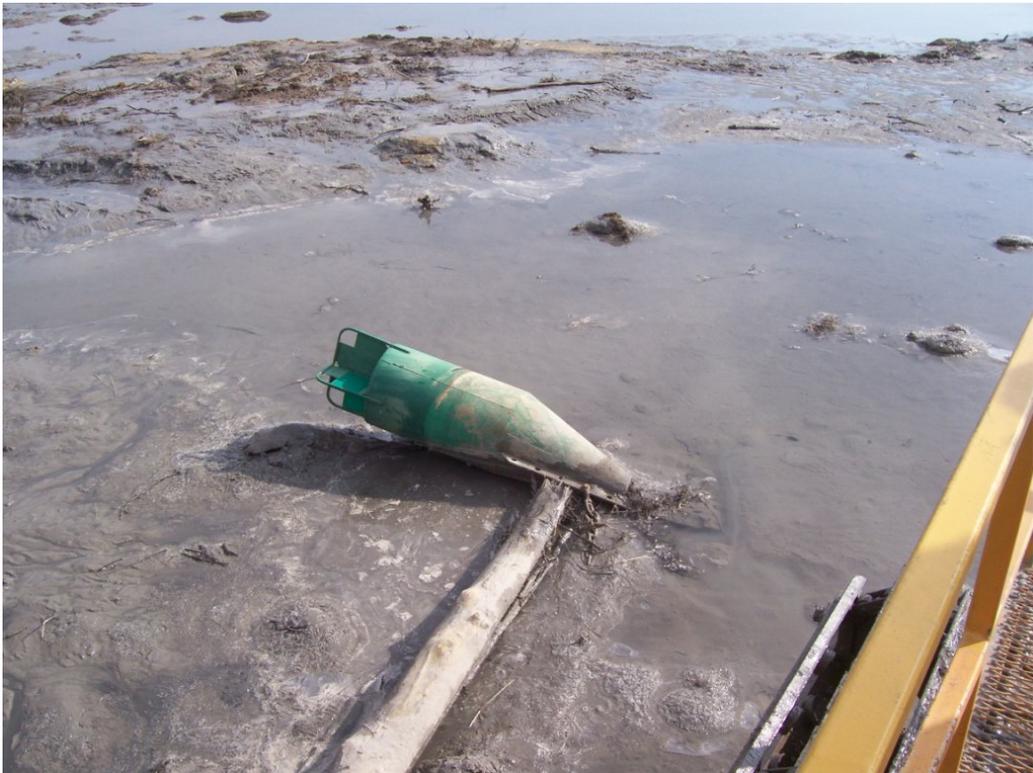
Client Name: Tennessee Valley Authority		Site Location: Kingston Fossil Plant – Relic Identification	Project No.: 60095742
Photo No.: Green Buoy	Date: 1-23-2009

Direction Photo Taken: Looking east.			
Description: Former channel buoy relocated by ash flow to the east side of the channel (incorrect side).

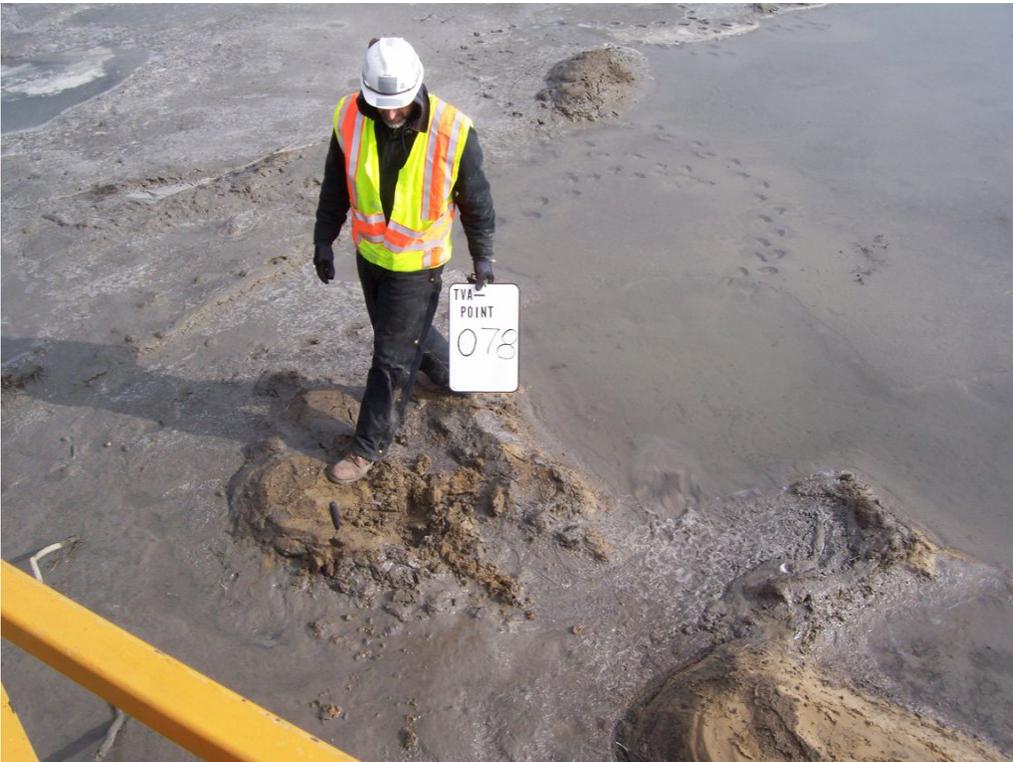
Photo No.: 078	Date: 1-23-2009

Direction Photo Taken: Looking east.			
Description: Sand bar sand protruding through ash.

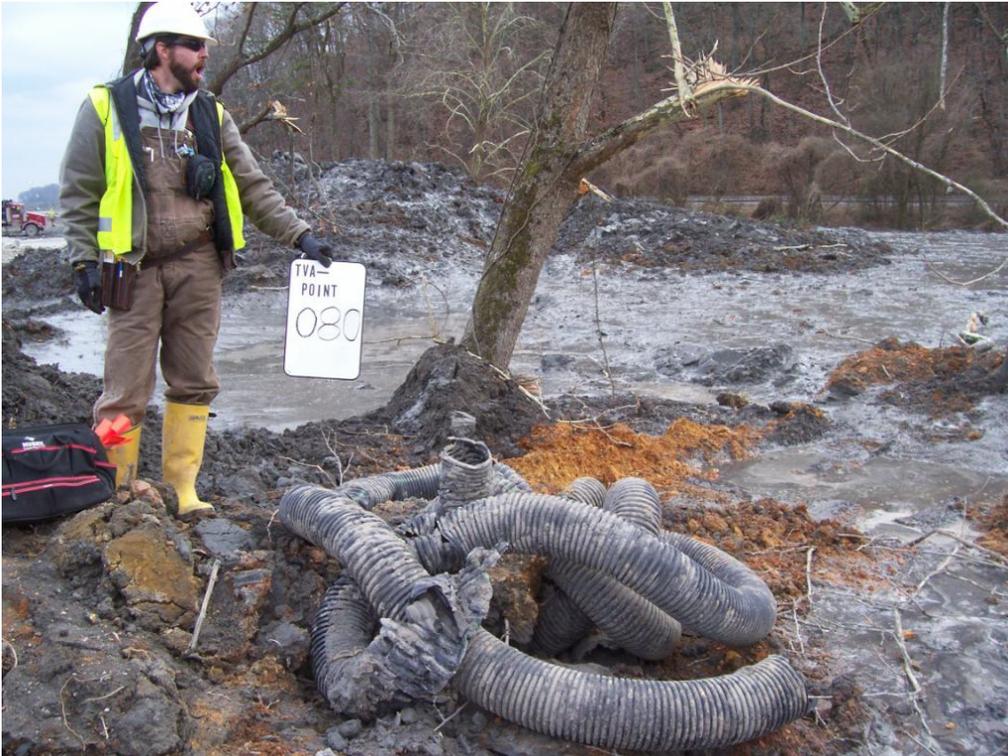
Client Name: Tennessee Valley Authority		Site Location: Kingston Fossil Plant – Relic Identification	Project No.: 60095742
Photo No.: 080	Date: 1-23-2009

Direction Photo Taken: Looking south.			
Description: Corrugated, perforated PE piping (8-inch) recovered from Slough 1. Pipe was placed at this location adjacent to Swan Pond Road. Location where recovered is uncertain.

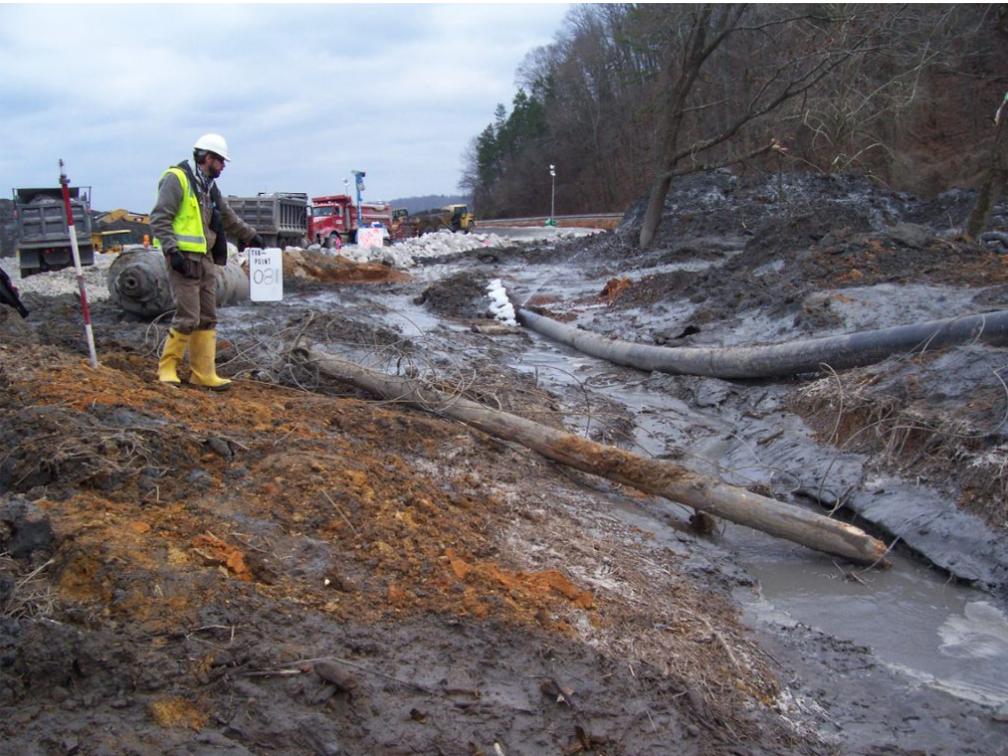
Photo No.: 081	Date: 1-23-2009

Direction Photo Taken: Looking south.			
Description: Telephone pole and cable recovered along Swan Pond Road near Slough 1. Original recovery location uncertain.
