RELIC IDENTIFICATION PHOTOGRAPHIC LOG

Client Name: Tennessee Valley Authority		Site Location: Kingston Fossil Plant –Harriman, Tennessee	Project No.: 60095742
Photo No. 128	Date: 2-3-2009

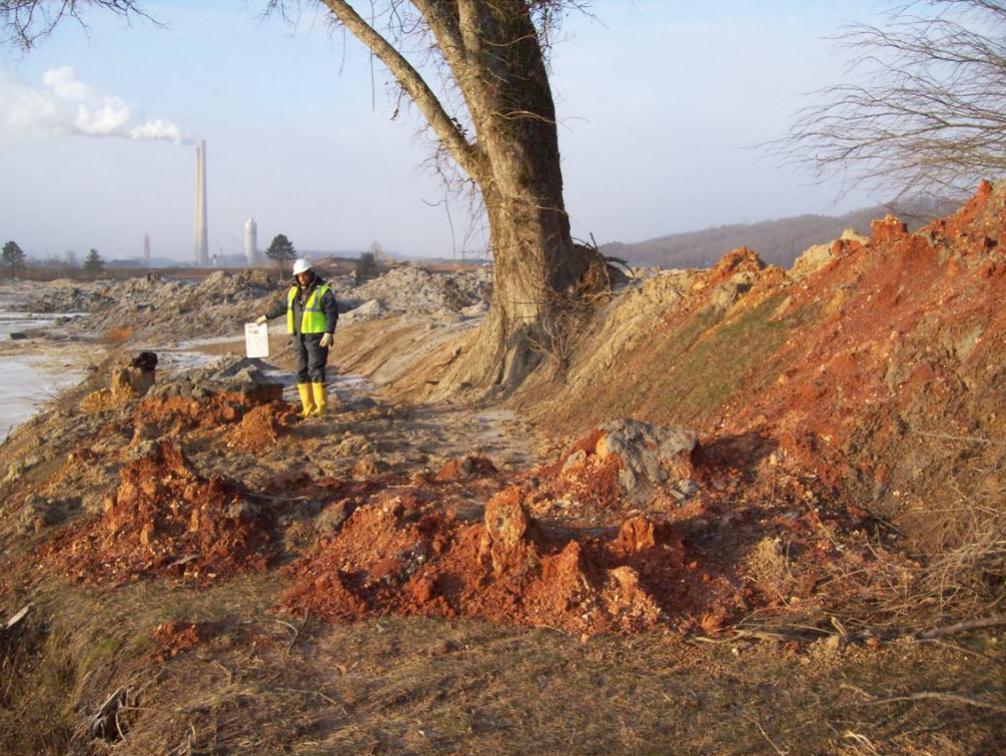
Photo No. 129	Date: 2-4-2009

Direction Photo Taken: Looking northeast.			
Description: Remnants of clay cover from C-Dike washed by water over the peninsula between Slough 3 and the Emory River. Note: no ash present around the clay cover material.

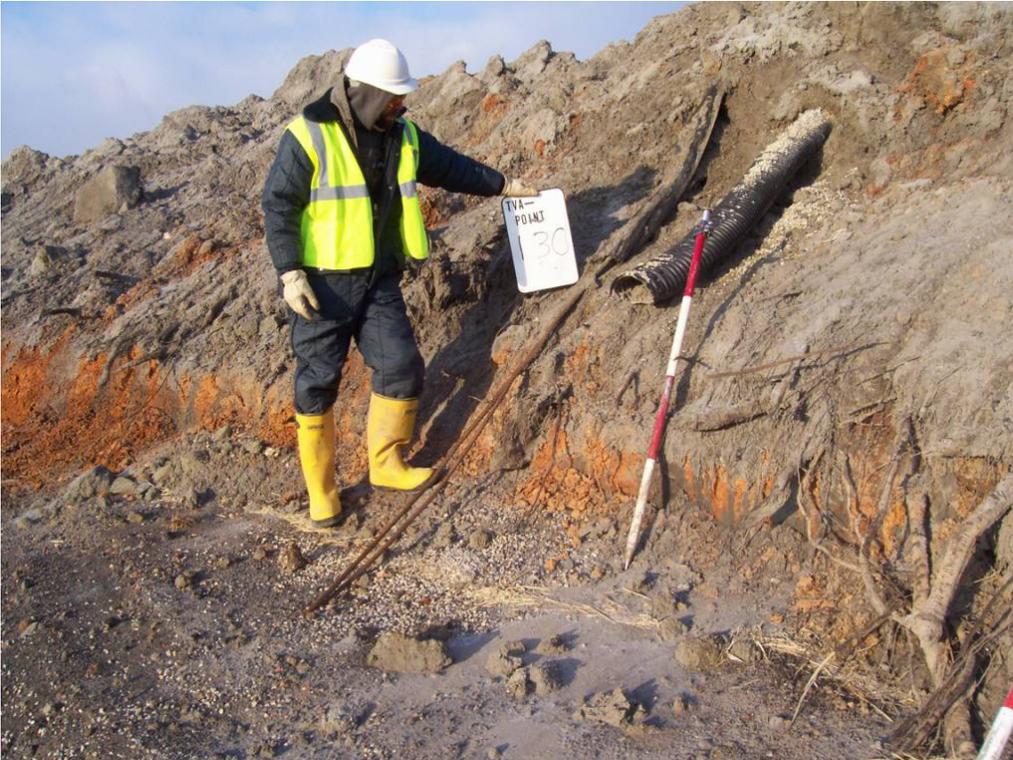
Client Name: Tennessee Valley Authority		Site Location: Kingston Fossil Plant –Harriman, Tennessee	Project No.: 60095742
Photo No.: 130	Date: 2-4-2009

Direction Photo Taken: Looking west-southwest.			
Description: 5/8-inch steel cable (looped or two cables) encased in woven geotextile. Nearby is a piece of corrugated PE (8-inch). Geotextile and #57 stone are most likely associated with the corrugated pipe.

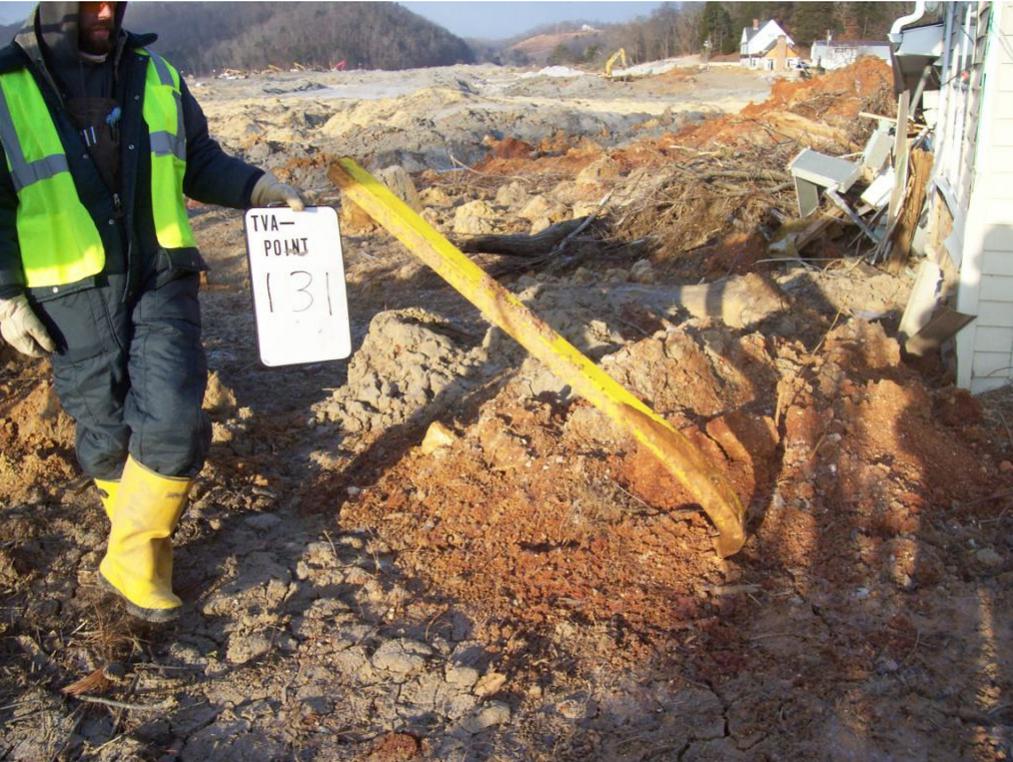
Photo No.: 131	Date: 2-4-2009

Direction Photo Taken: Looking west.			
Description: Heavy gauge iron pipe, originally 3" square, painted yellow. Part of a gate? See also Photo 133.

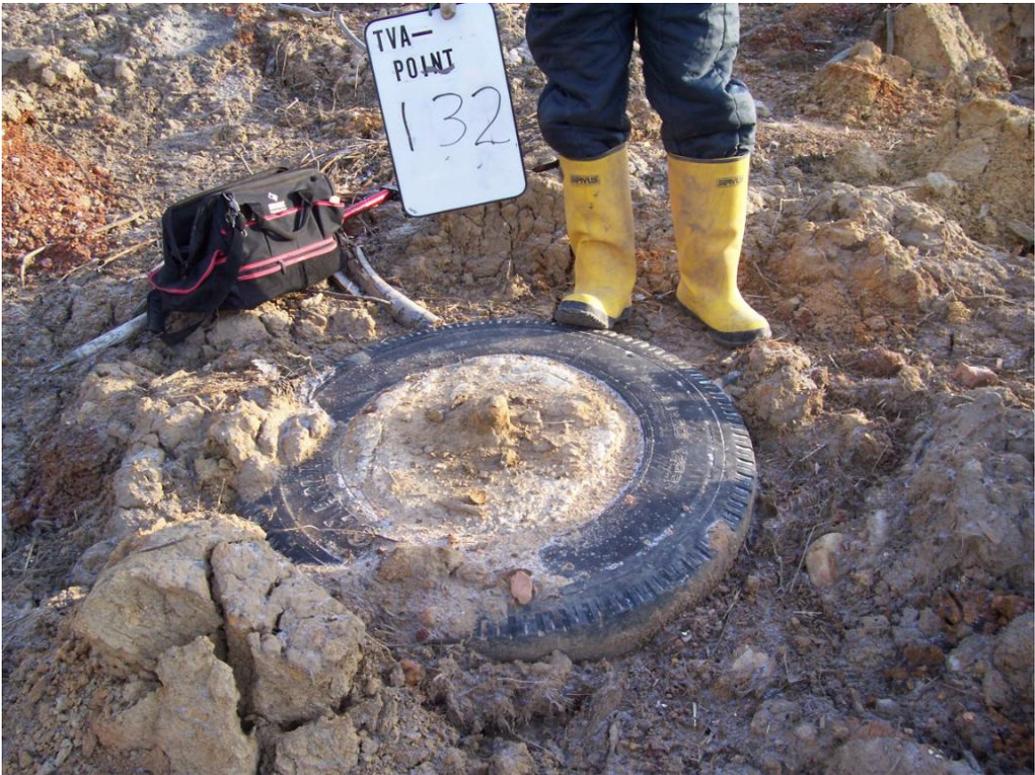
Client Name: Tennessee Valley Authority		Site Location: Kingston Fossil Plant –Harriman, Tennessee	Project No.: 60095742
Photo No.: 132	Date: 2-4-2009

Direction Photo Taken: Looking north.			
Description: Yokohama brand truck tire filled with concrete with round metal pipe at the center. Possibly a base for a sign or mailbox.

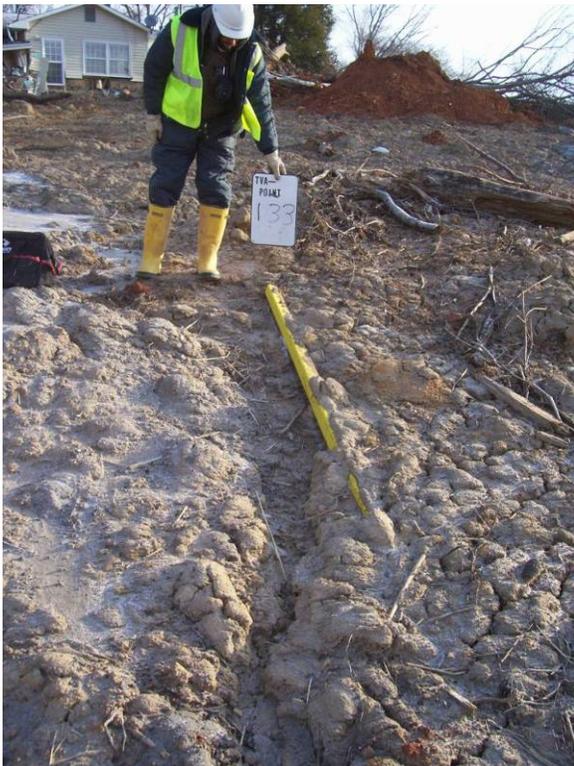
Photo No.: 133	Date: 2-4-2009

Direction Photo Taken: Looking northeast.			
Description: Heavy gauge iron pipe, originally 3" square, painted yellow. Part of a gate? See also Photo 131.

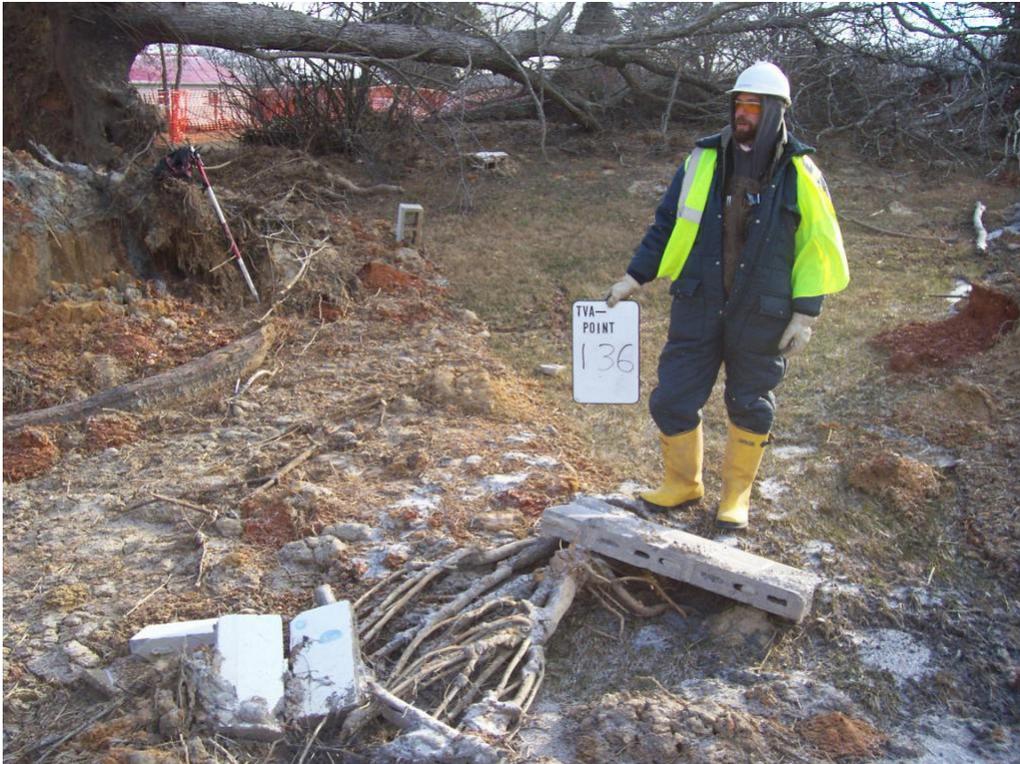
Client Name: Tennessee Valley Authority		Site Location: Kingston Fossil Plant –Harriman, Tennessee	Project No.: 60095742
Photo No.: 136	Date: 2-4-2009

Direction Photo Taken: Looking northeast.			
Description: Scattered concrete blocks. Some blocks are standard size (8-inch), others are thinner. All bricks are painted on at least one side.

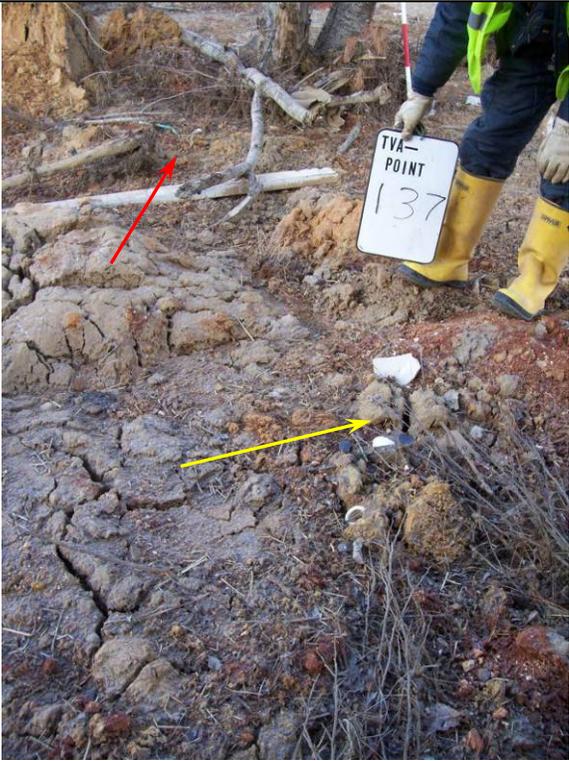
Photo No.: 137	Date: 2-4-2009

Direction Photo Taken: Looking north-northwest.			
Description: MC-6 channel steel filled with concrete at background (red arrow). Swimming pool filter box (yellow arrow).

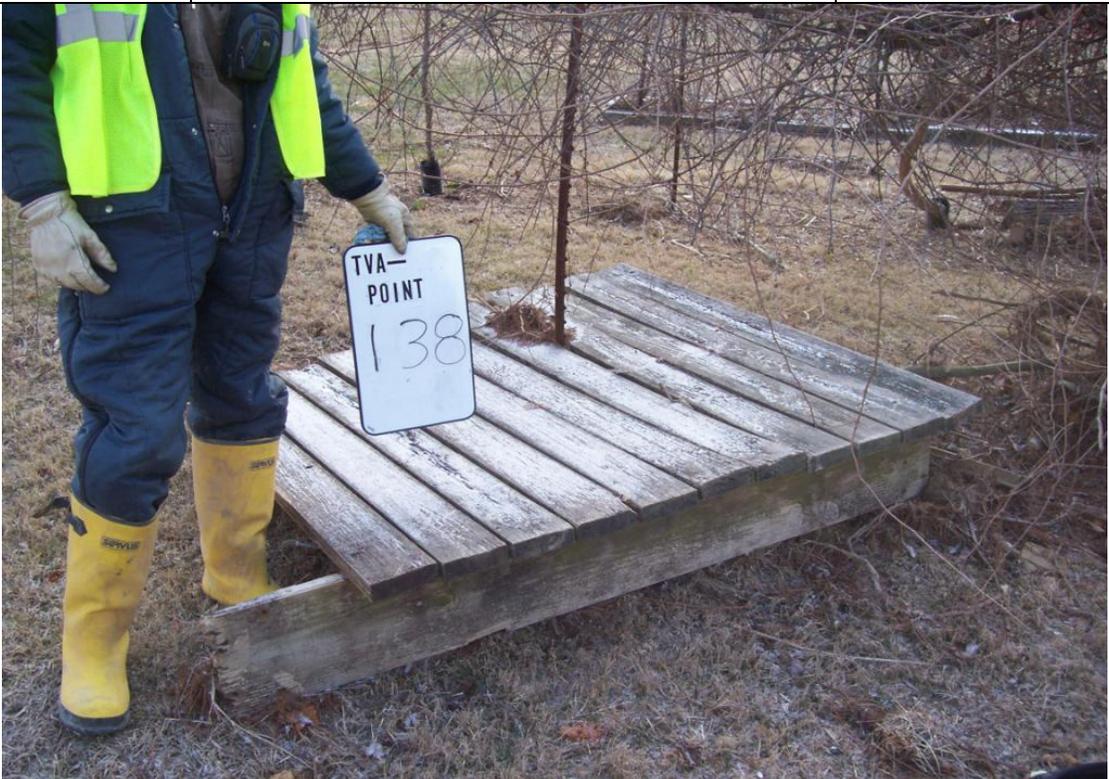
Client Name: Tennessee Valley Authority		Site Location: Kingston Fossil Plant –Harriman, Tennessee	Project No.: 60095742
Photo No.: 138	Date: 2-4-2009

Direction Photo Taken: Looking east.			
Description: Section of dock or deck pushed into grape plantings located west-northwest of the damaged home on the peninsula between Slough 3 and the Emory River.

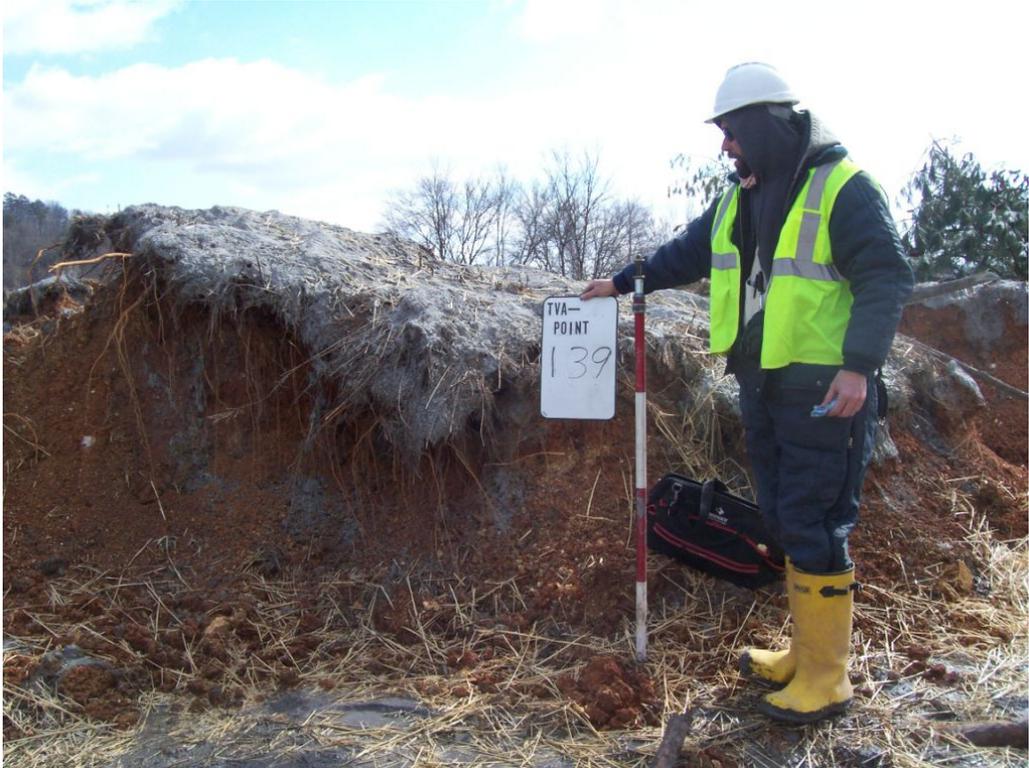
Photo No.: 139	Date: 2-4-2009

Direction Photo Taken: Looking south.		
Description: Remnant of C-Dike overtopped by ash.

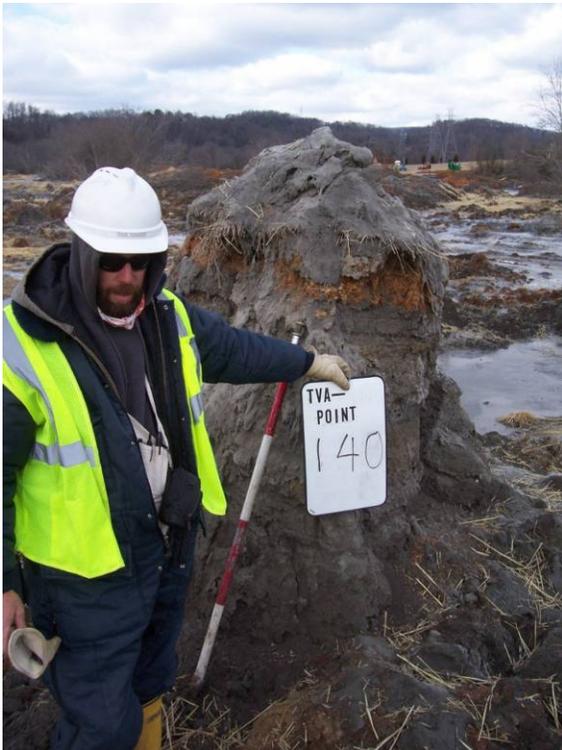
Client Name: Tennessee Valley Authority		Site Location: Kingston Fossil Plant –Harriman, Tennessee	Project No.: 60095742
Photo No.: 140	Date: 2-4-2009

Direction Photo Taken: Looking northeast.			
Description: Relic ash block overtopped by ash in Slough 2.

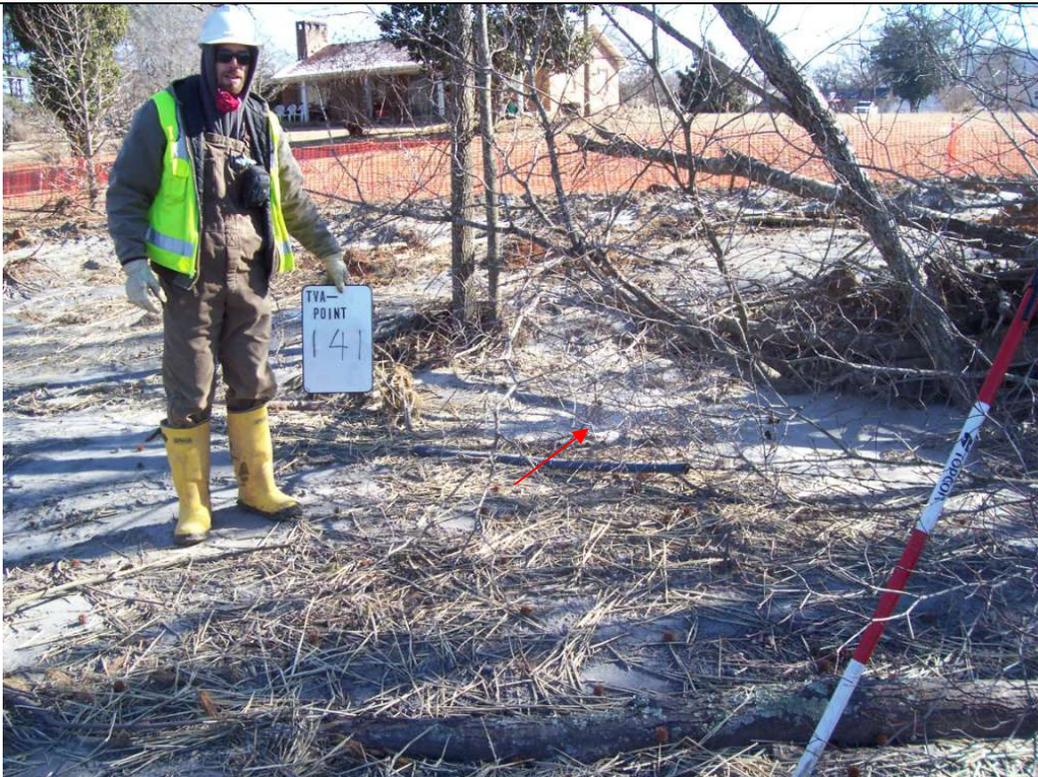
Photo No.: 141	Date: 2-5-2009

Direction Photo Taken: Looking east.			
Description: Swimming pool cleaner hose located in Slough 3.

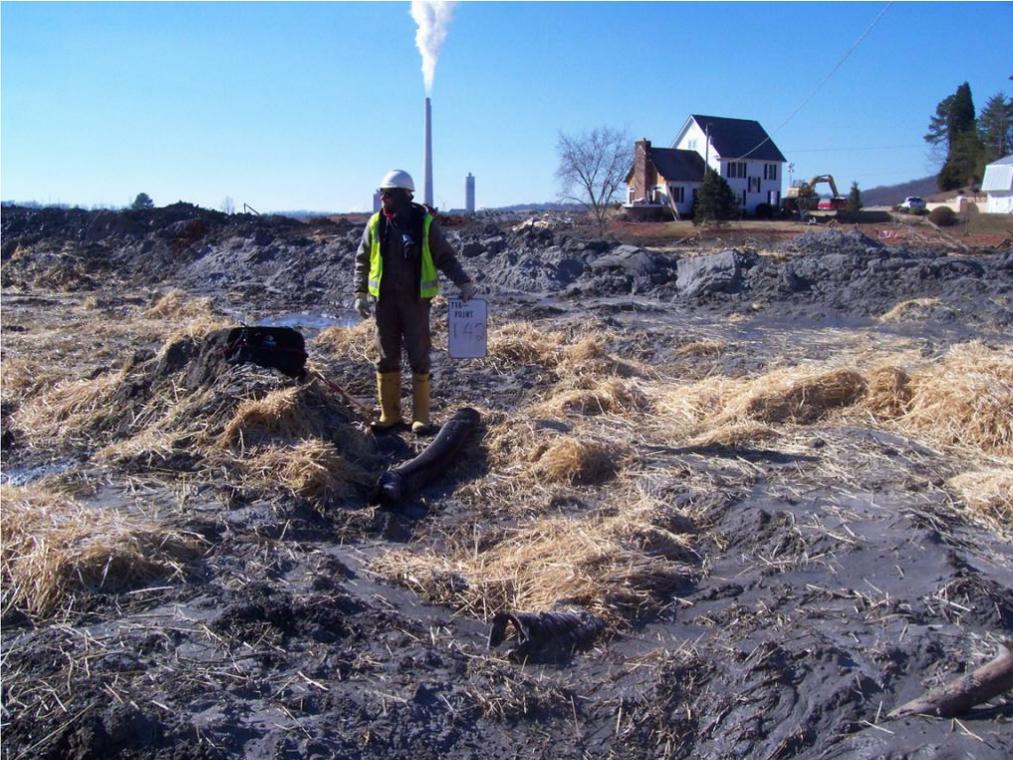
Client Name: Tennessee Valley Authority		Site Location: Kingston Fossil Plant –Harriman, Tennessee	Project No. 60095742
Photo No. 142	Date: 2-5-2009

Direction Photo Taken: Looking southwest.			
Description: Corrugated PE pipe (8-inch) in Slough 3. Note no geotextile or #57 stone around or near the pipe.

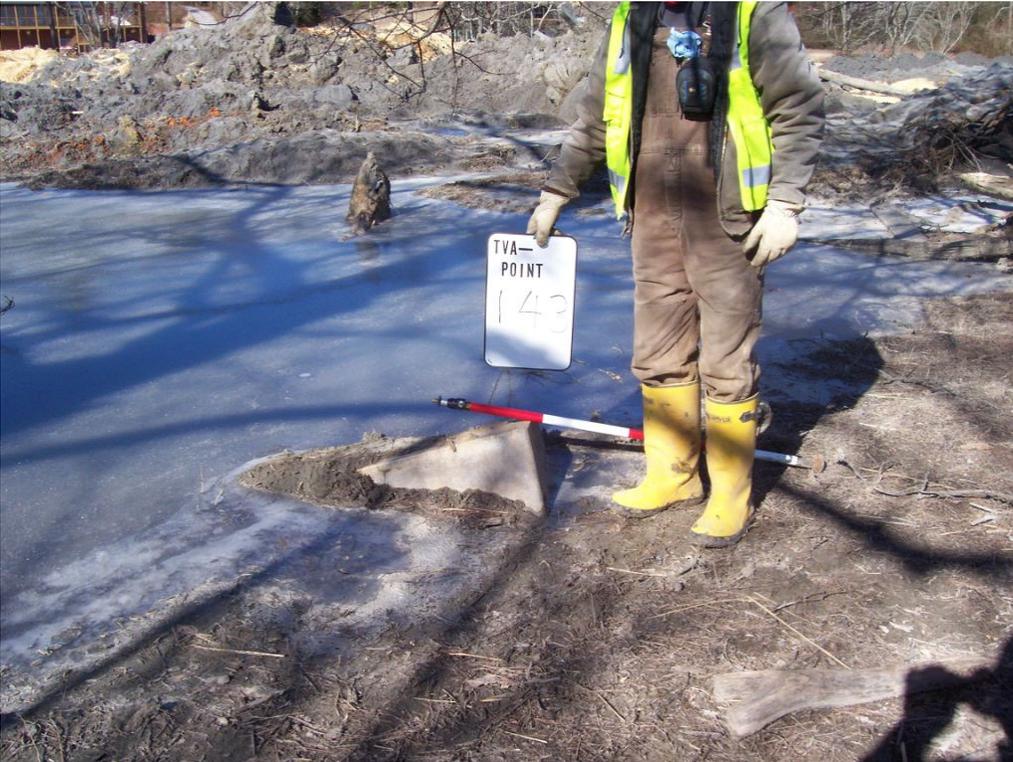
Photo No. 143	Date: 2-5-2009

Direction Photo Taken: Looking northwest.		
Description: Large concrete block. Possibly an anchor or base for structure (pier, etc.).

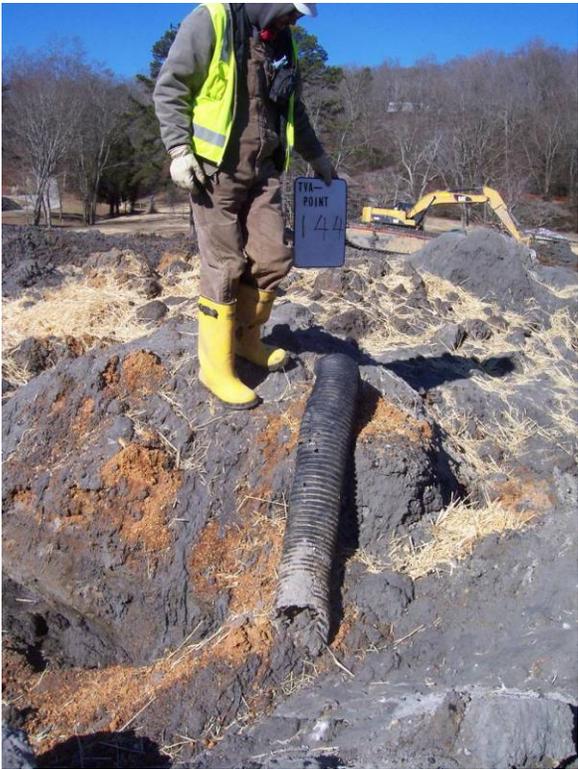
Client Name: Tennessee Valley Authority		Site Location: Kingston Fossil Plant –Harriman, Tennessee	Project No.: 60095742
Photo No.: 144	Date: 2-5-2009

Direction Photo Taken: Looking west.			
Description: Corrugated, non-perforated PE pipe (8-inch) in Slough 3. Note no geotextile or #57 stone around or near the pipe.

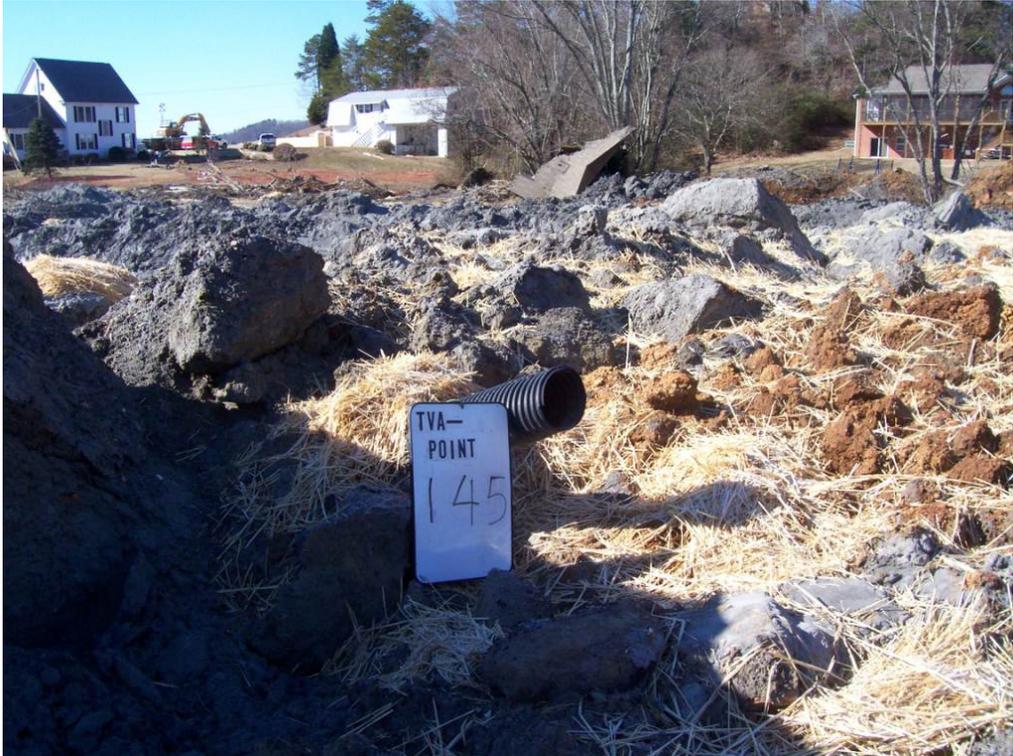
Photo No.: 145	Date: 2-5-2009

Direction Photo Taken: Looking west.		
Description: Corrugated, non-perforated PE pipe (8-inch) in Slough 3. Note no geotextile or #57 stone around or near the pipe.

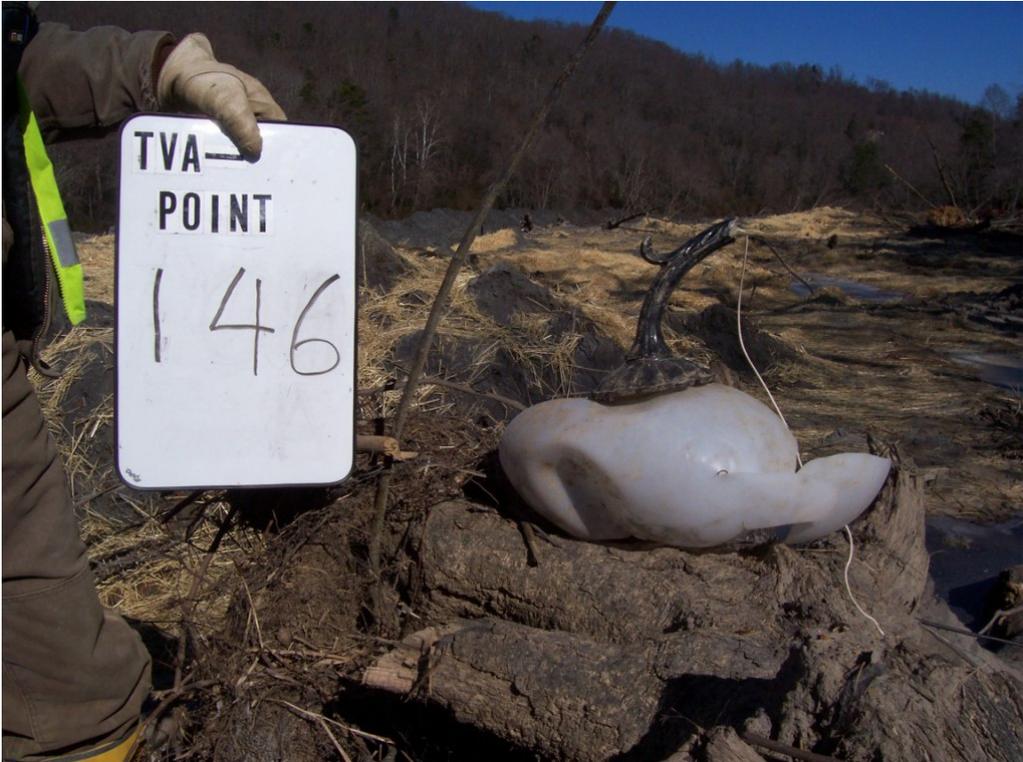
Client Name: Tennessee Valley Authority		Site Location: Kingston Fossil Plant –Harriman, Tennessee	Project No.: 60095742
Photo No.: 146	Date: 2-5-2009

Direction Photo Taken: Looking north.			
Description: Outdoor light fixture “pumpkin” shaped with a stem-styled connection at the top.

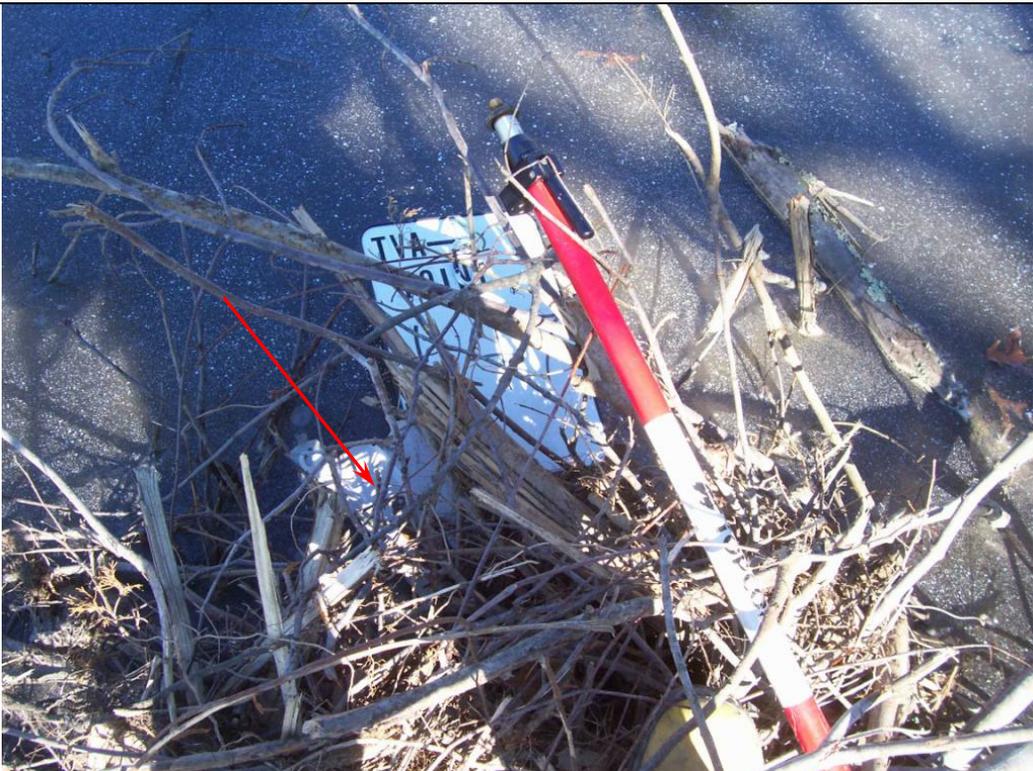
Photo No.: 147	Date: 2-5-2009

Direction Photo Taken: Looking north.		
Description: Thin steel channel filled with concrete (red arrow). Possibly a doorframe.

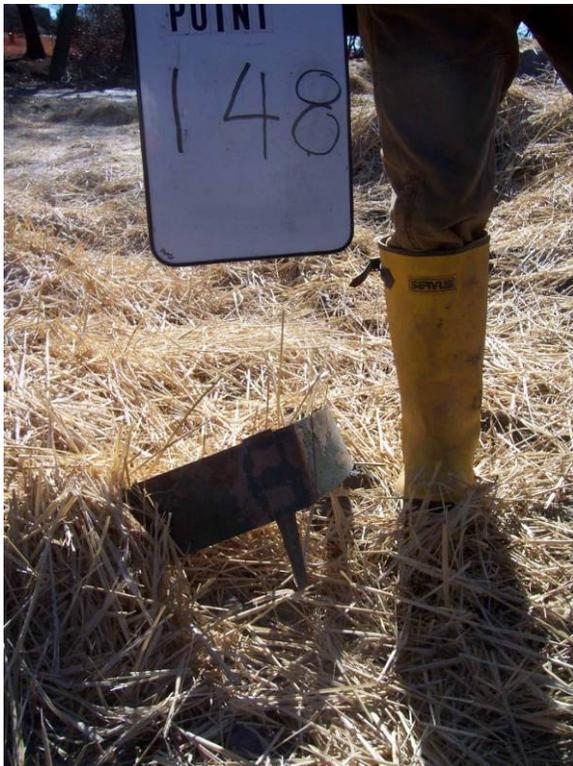
Client Name: Tennessee Valley Authority		Site Location: Kingston Fossil Plant –Harriman, Tennessee	Project No. 60095742
Photo No. 148	Date: 2-5-2009

Direction Photo Taken: Looking south.			
Description: Light steel lawn edging (painted green).

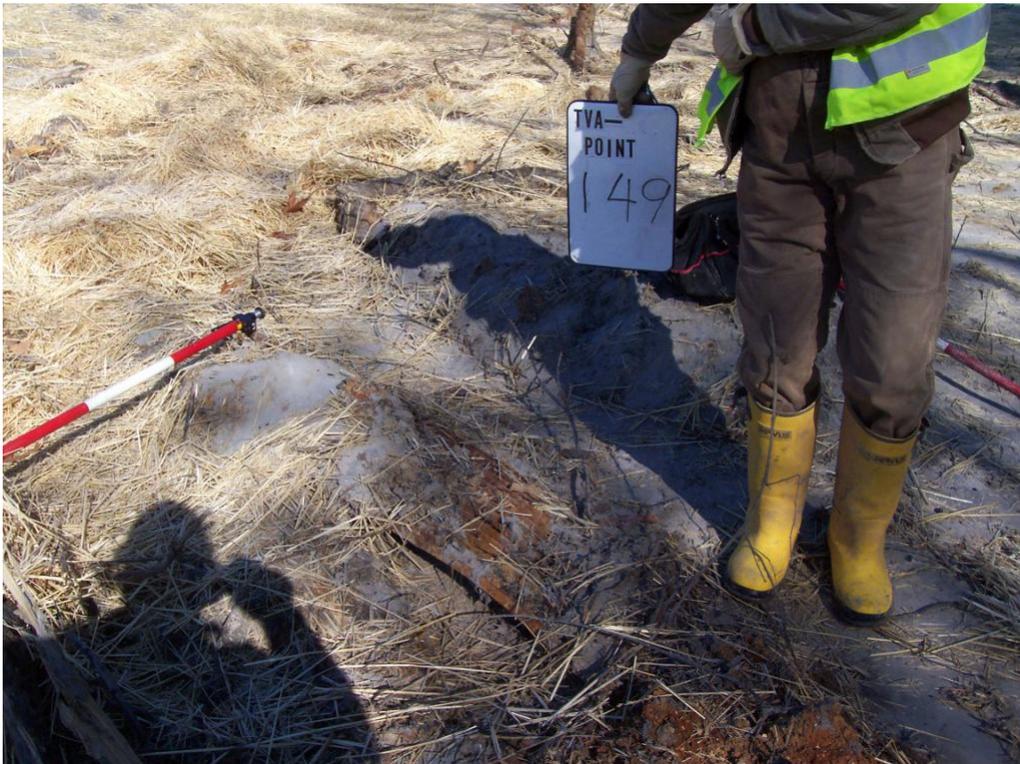
Photo No. 149	Date: 2-5-2009

Direction Photo Taken: Looking north.		
Description: Heavy metal grate/walkway. Not heavy enough for vehicle traffic. A similar grate was observed in place on the northwest side of the bridge between the perimeter dike and the gravel stockpile. The in-place grate covered a corrugated steel drain pipe.

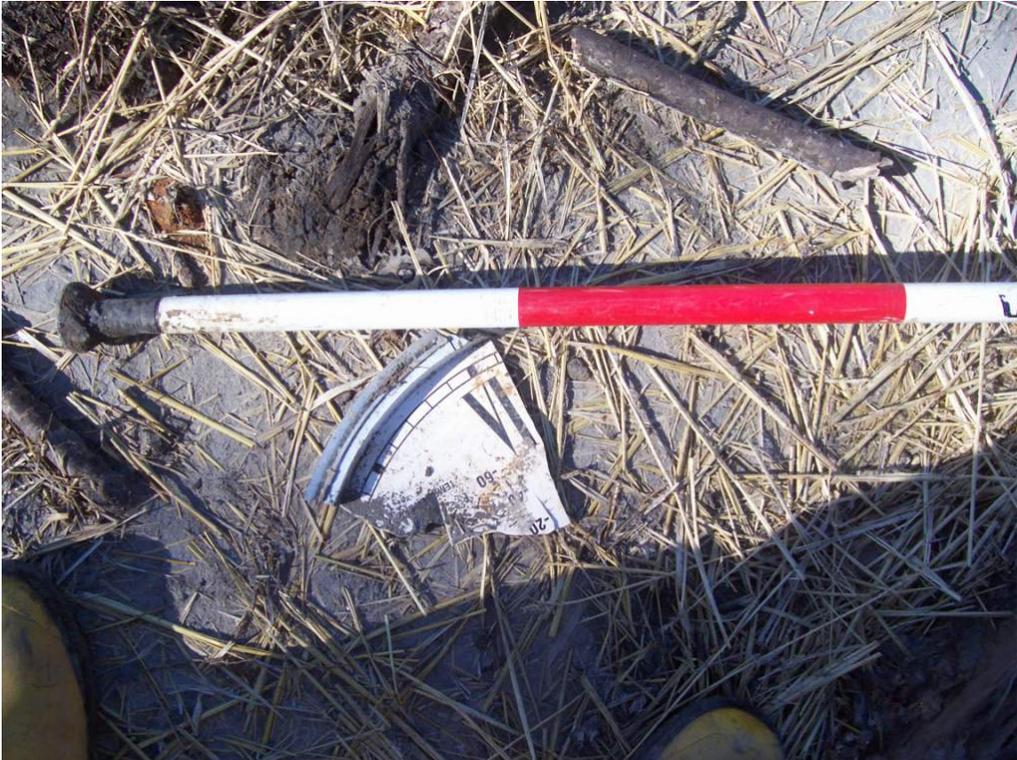
Client Name: Tennessee Valley Authority		Site Location: Kingston Fossil Plant –Harriman, Tennessee	Project No.: 60095742
Photo No.: 149_A	Date: 2-5-2009

Direction Photo Taken: Vertical.			
Description: Face from a combination clock/thermometer in Slough 3.

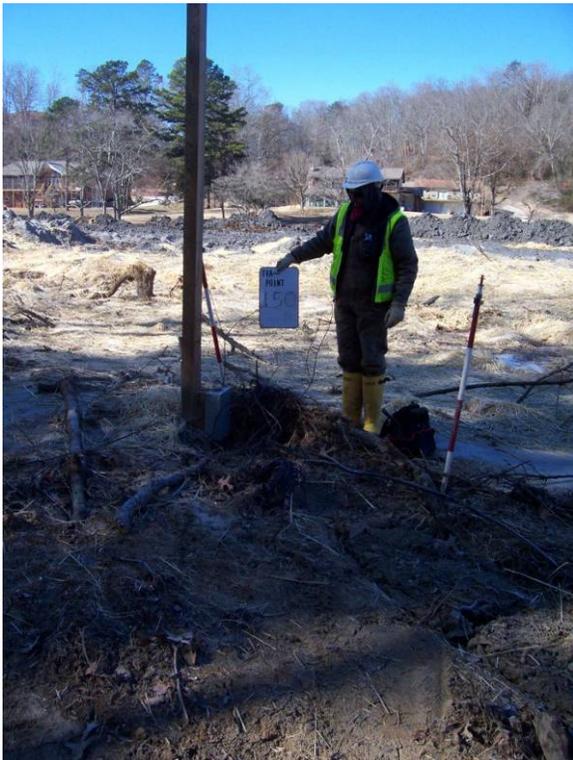
Photo No.: 150	Date: 2-5-2009

Direction Photo Taken: Looking west.		
Description: Post with attached electrical connection and adjacent yard hydrant. Likely associated with dock. Electrical wire stretched out to the north.

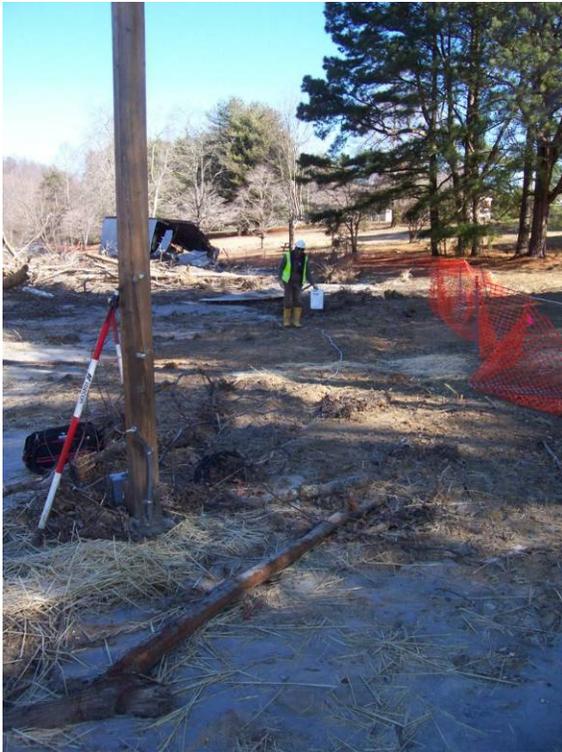
Client Name: Tennessee Valley Authority		Site Location: Kingston Fossil Plant –Harriman, Tennessee	Project No.: 60095742
Photo No.: 150_2	Date: 2-5-2009

Direction Photo Taken: Looking northeast.			
Description: Garden hose illustrates direction of movement.

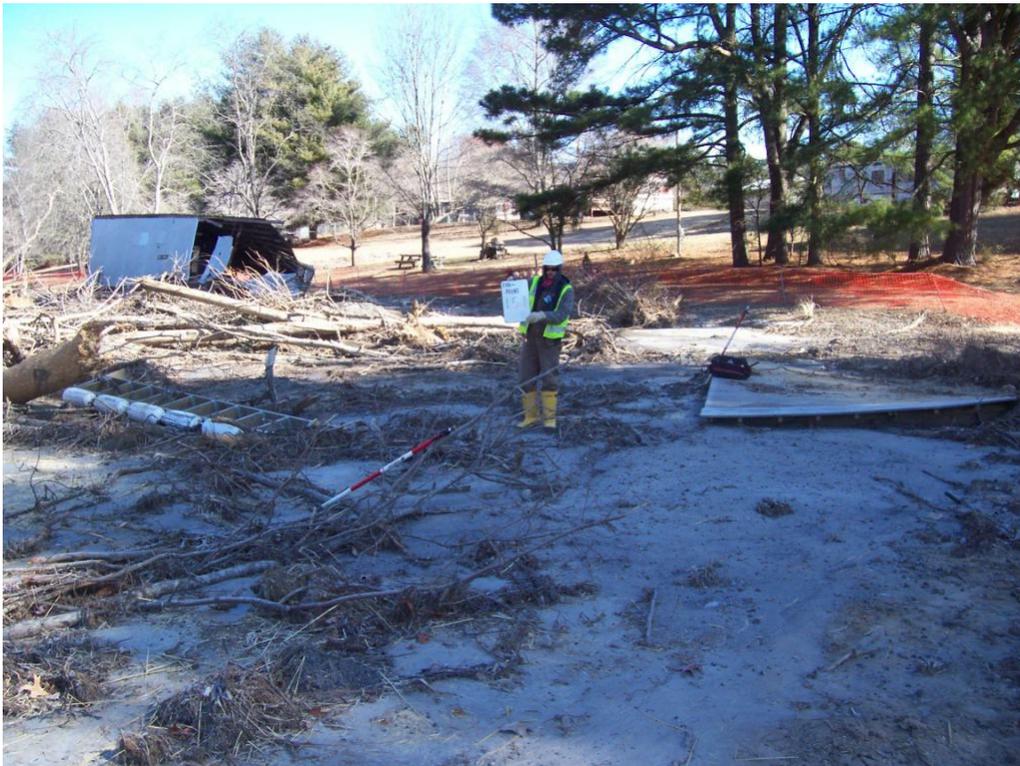
Photo No.: 151	Date: 2-5-2009

Direction Photo Taken: Looking northeast.		
Description: Dock sections. At right is dock constructed of treated lumber stringers and plastic, simulated wood grain decking. At left is a treated lumber dock with boat bumpers.

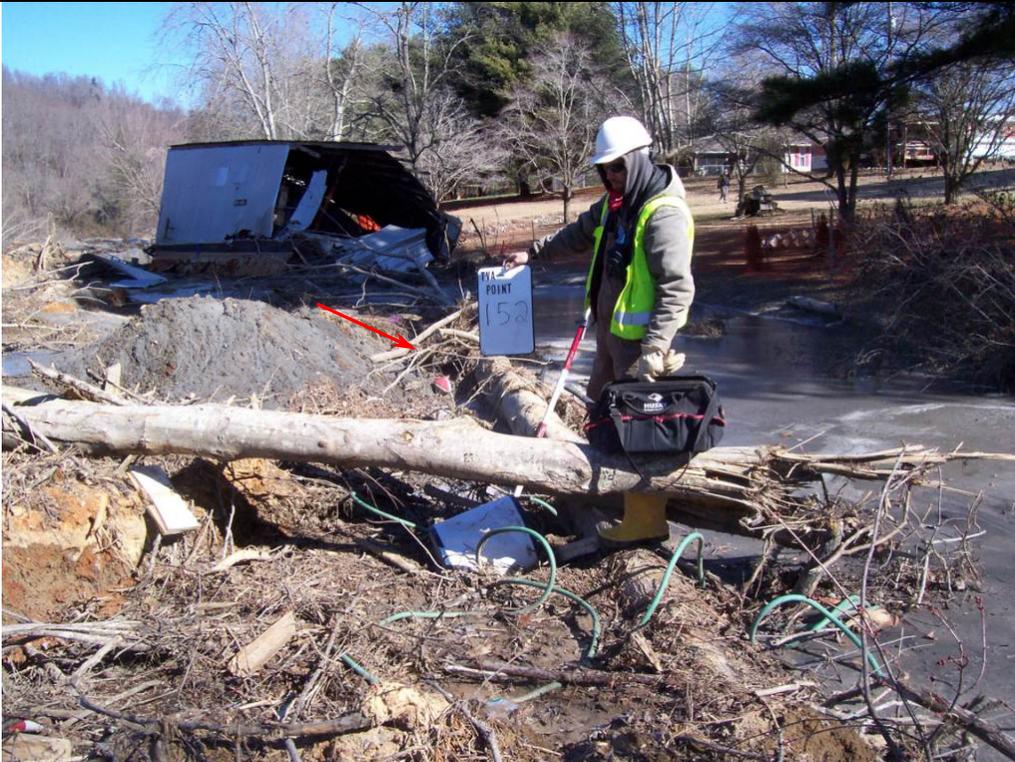
Client Name: Tennessee Valley Authority		Site Location: Kingston Fossil Plant –Harriman, Tennessee	Project No. 60095742
Photo No. 152	Date: 2-5-2009

Direction Photo Taken: Looking northeast.			
Description: 10-gallon water heater and garden hose and "GRIPTECH" football (red arrow in background).

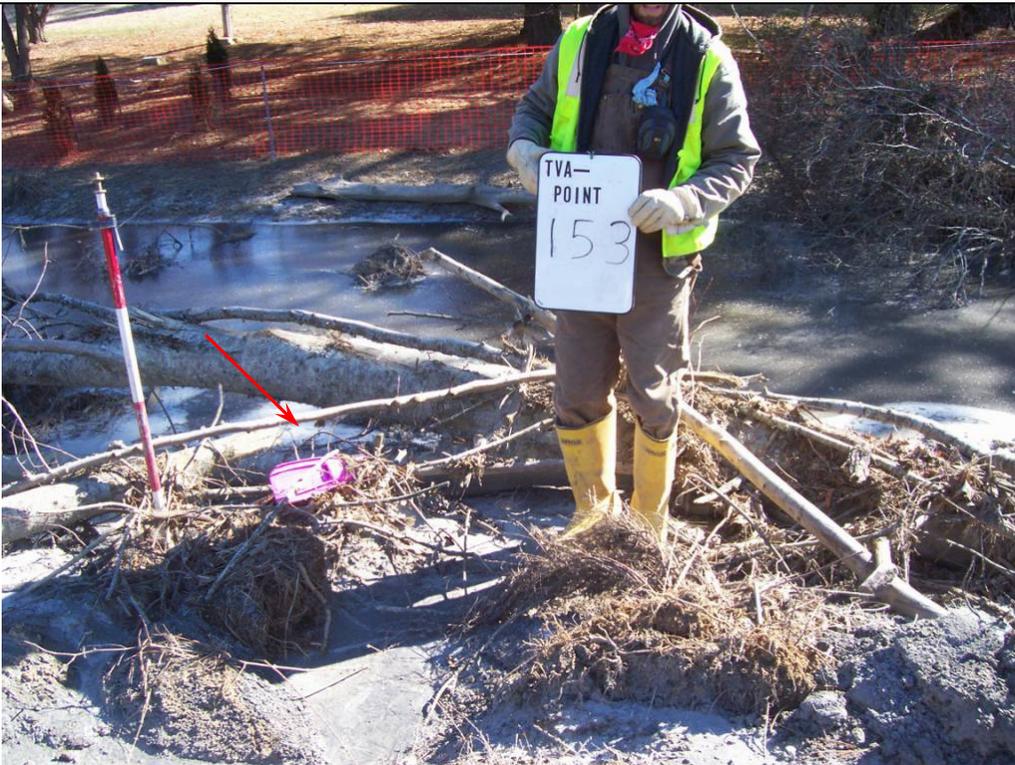
Photo No. 153	Date: 2-5-2009

Direction Photo Taken: Looking northeast.			
Description: Section of pier, purple swim fin (red arrow).

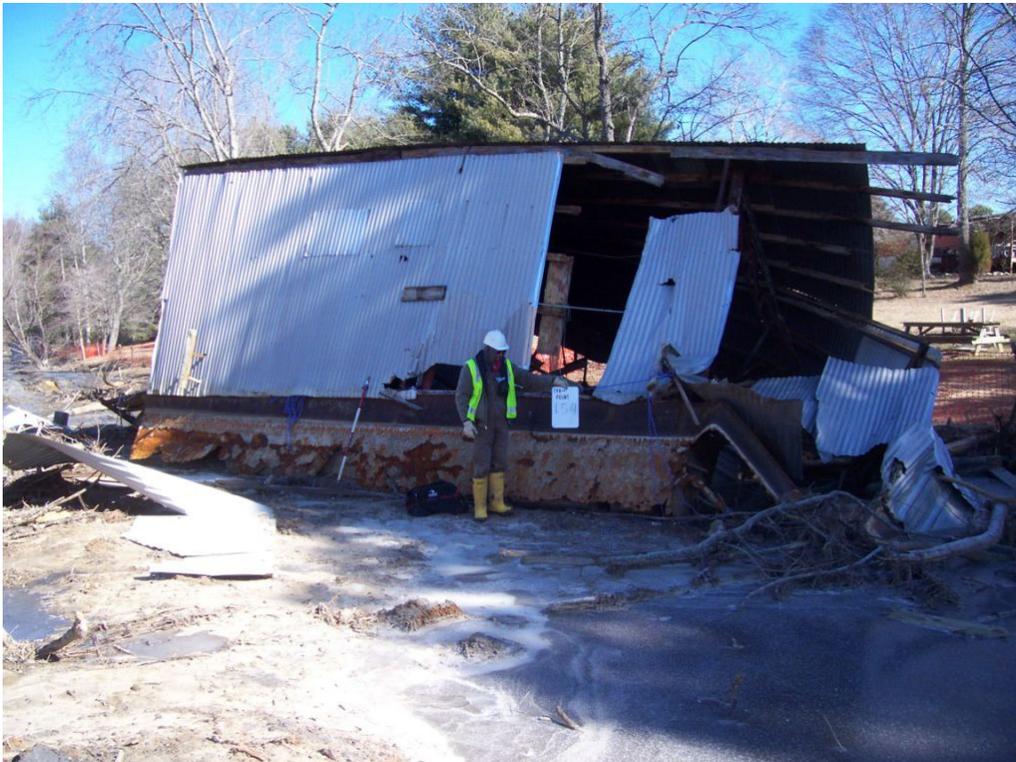
Client Name: Tennessee Valley Authority		Site Location: Kingston Fossil Plant –Harriman, Tennessee	Project No.: 60095742
Photo No.: 154	Date: 2-5-2009

Direction Photo Taken: Looking northeast.			
Description: Floating boathouse/dock. Posts match location in Photo 153.

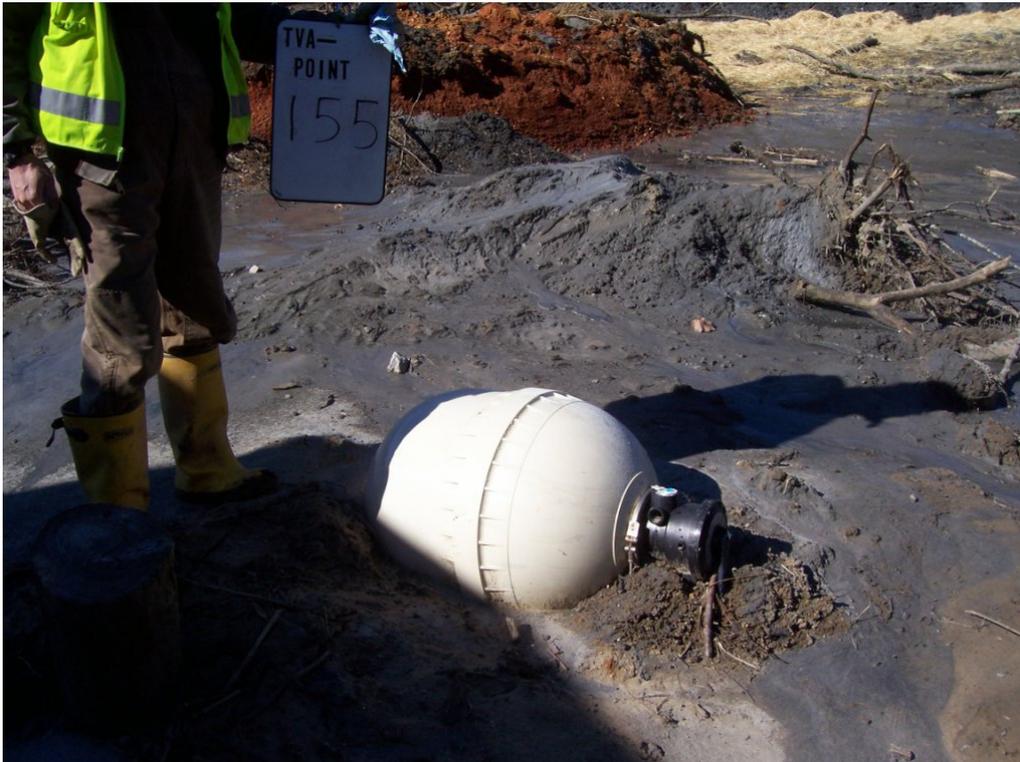
Photo No.: 155	Date: 2-5-2009

Direction Photo Taken: Looking west.		
Description: Swimming pool filter.

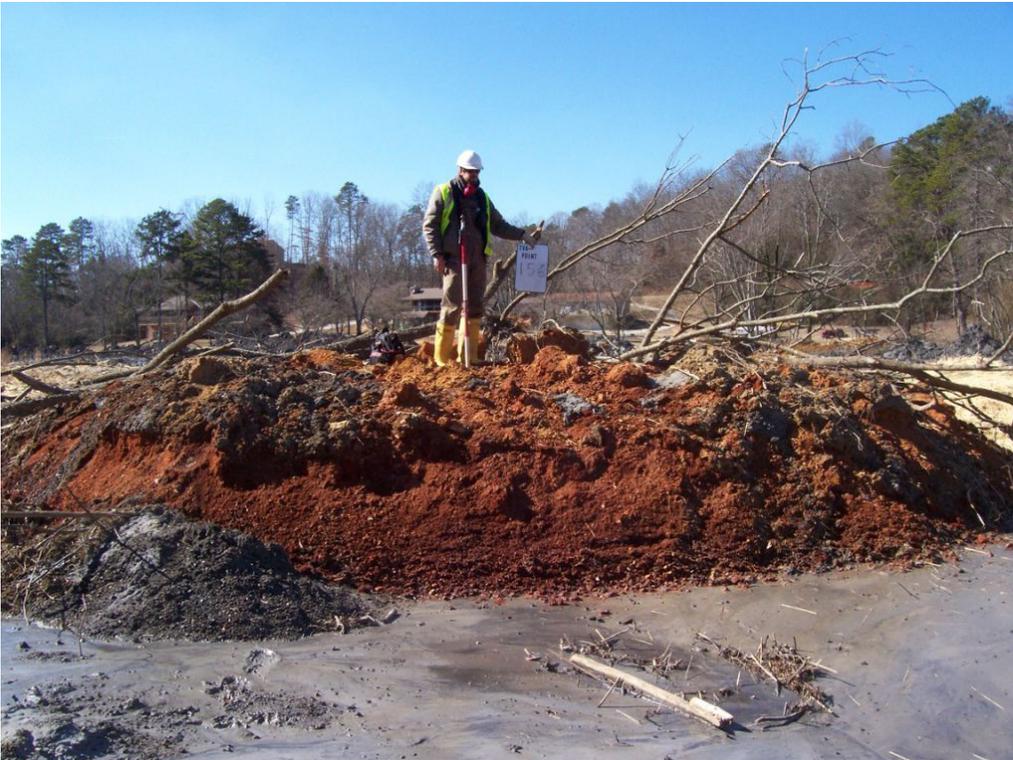
Client Name: Tennessee Valley Authority		Site Location: Kingston Fossil Plant –Harriman, Tennessee	Project No.: 60095742
Photo No.: 156	Date: 2-5-2009

Direction Photo Taken: Looking west.			
Description: C-Dike material in Slough 3.

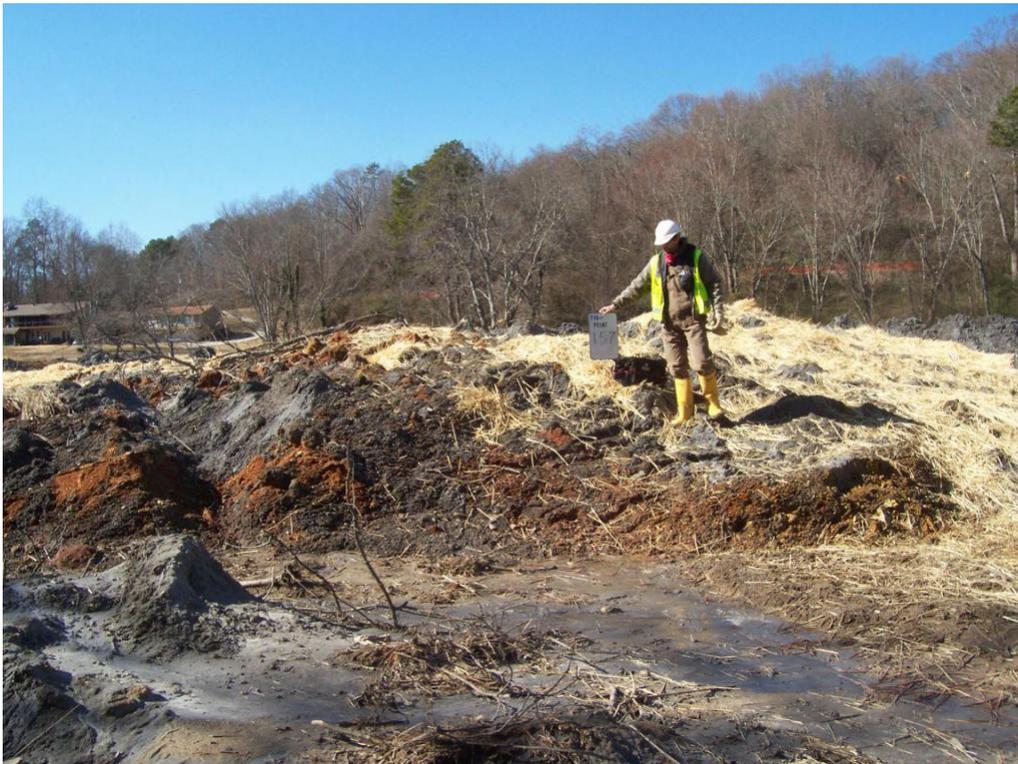
Photo No.: 157	Date: 2-5-2009

Direction Photo Taken: Looking west.		
Description: C-Dike material in Slough 3 northeast of location shown in Photo 156.

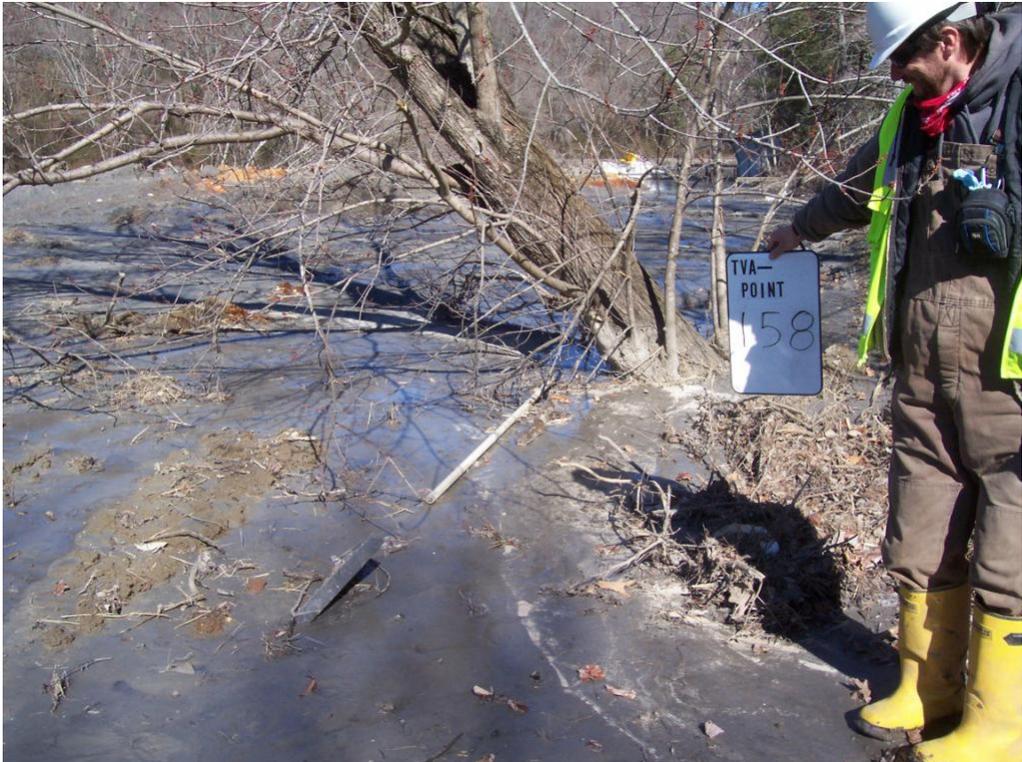
Client Name: Tennessee Valley Authority		Site Location: Kingston Fossil Plant –Harriman, Tennessee	Project No.: 60095742
Photo No.: 158	Date: 2-5-2009

Direction Photo Taken: Looking northeast.			
Description: Black metal grate (red arrow) and unbroken 8-foot fluorescent light bulb in Slough 3.
