RELIC IDENTIFICATION PHOTOGRAPHIC LOG

Client Name: Tennessee Valley Authority		Site Location: Kingston Fossil Plant –Harriman, Tennessee	Project No.: 60095742
Photo No. 128	Date: 2-3-2009

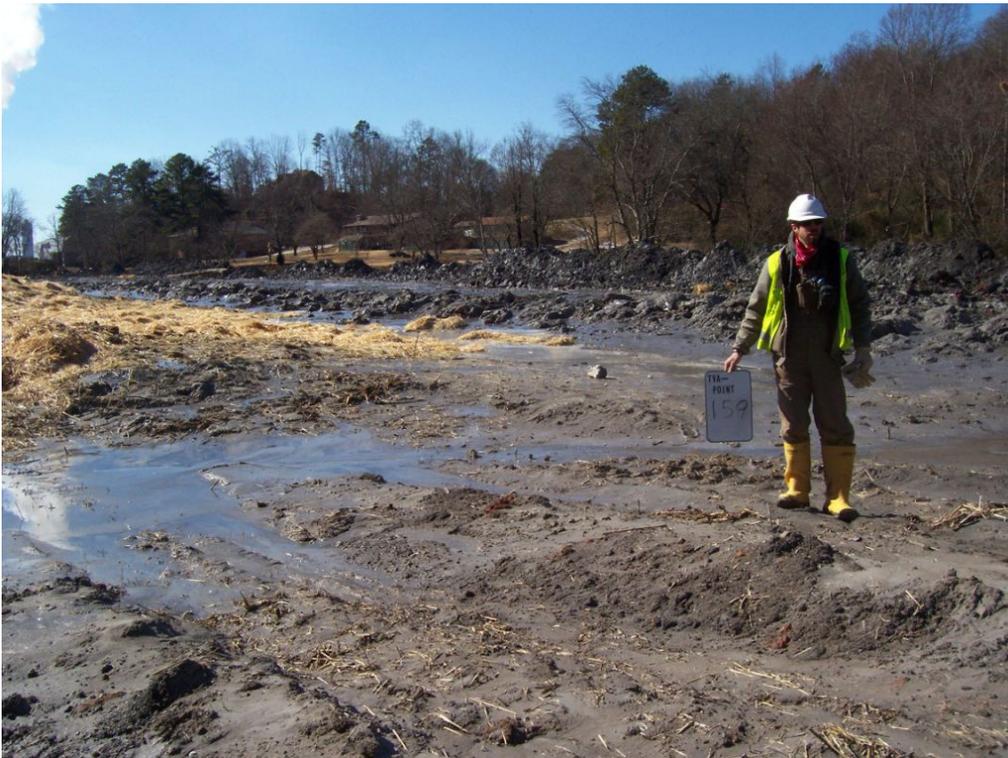
Photo No.: 159	Date: 2-5-2009

Direction Photo Taken: Looking west.		
Description: Cattails and root balls from cattails in Slough 3.

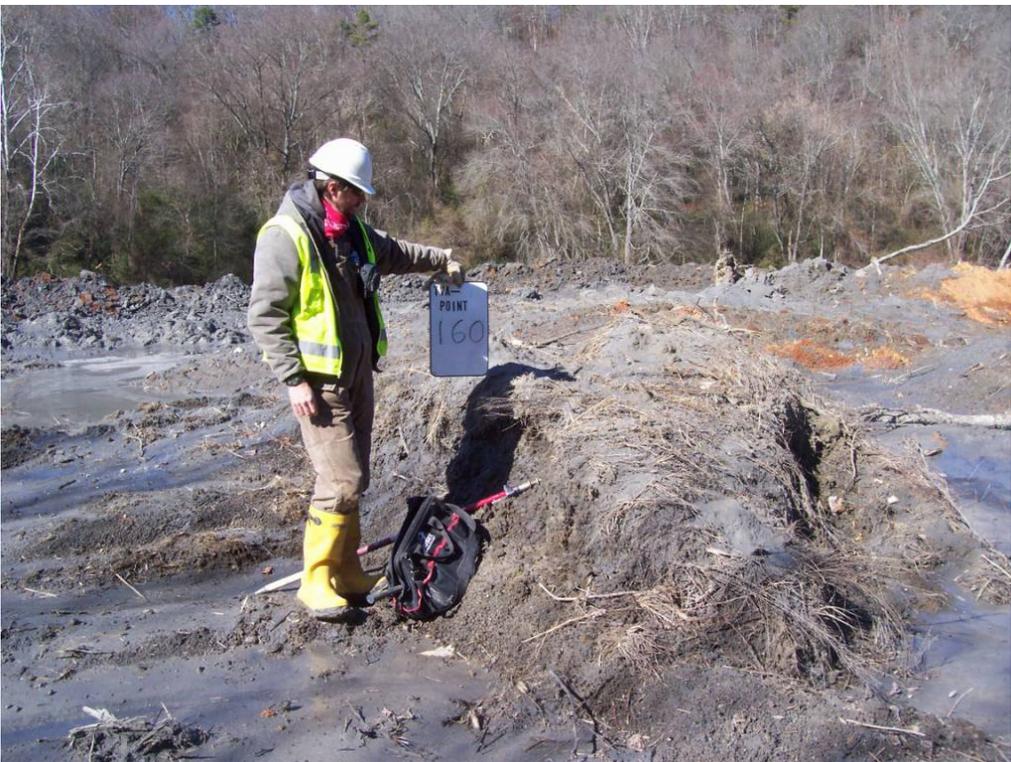
Client Name: Tennessee Valley Authority		Site Location: Kingston Fossil Plant –Harriman, Tennessee	Project No. 60095742
Photo No. 160	Date: 2-5-2009

Direction Photo Taken: Looking north.			
Description: Vegetation (long grass) overtopped by ash in Slough 3.

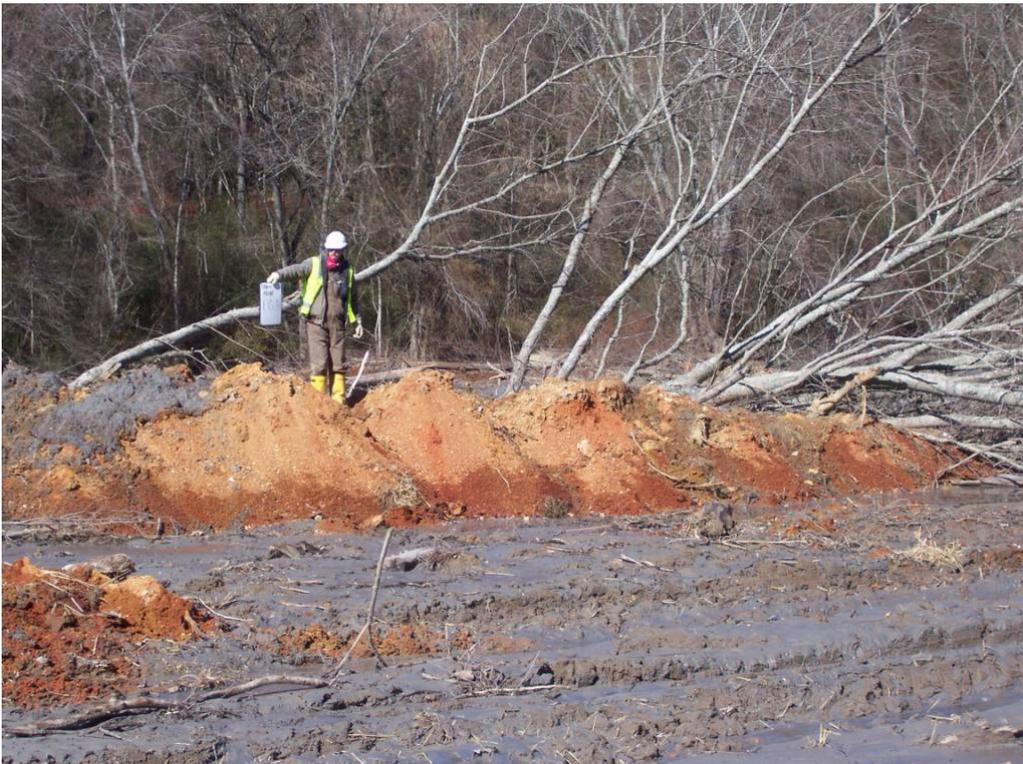
Photo No. 161	Date: 2-5-2009

Direction Photo Taken: Looking northwest.		
Description: Remnants of C-Dike in Slough 3.

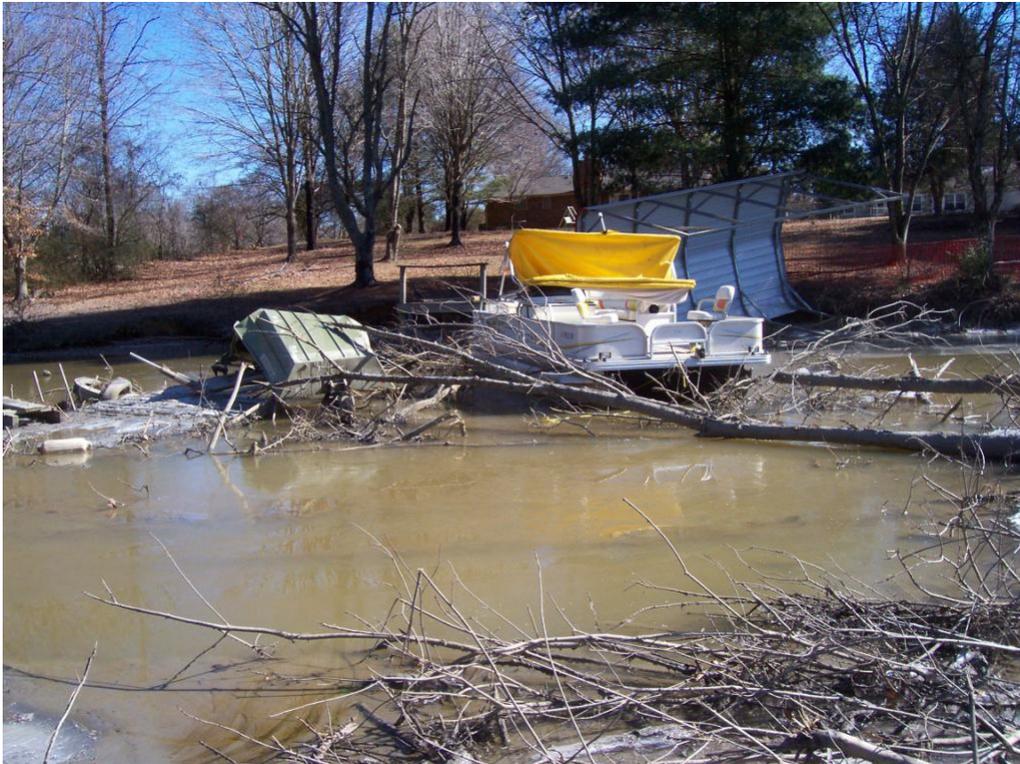
Client Name: Tennessee Valley Authority		Site Location: Kingston Fossil Plant –Harriman, Tennessee	Project No.: 60095742
Photo No.: 162	Date: 2-5-2009

Direction Photo Taken: Looking northeast.			
Description: Beachcomber pontoon boat, Tennessee Registration Number TN 3573 DV with Lowe's aluminum johnboat, Tennessee Registration Number TN 7753 BJ wrapped over a section of dock.

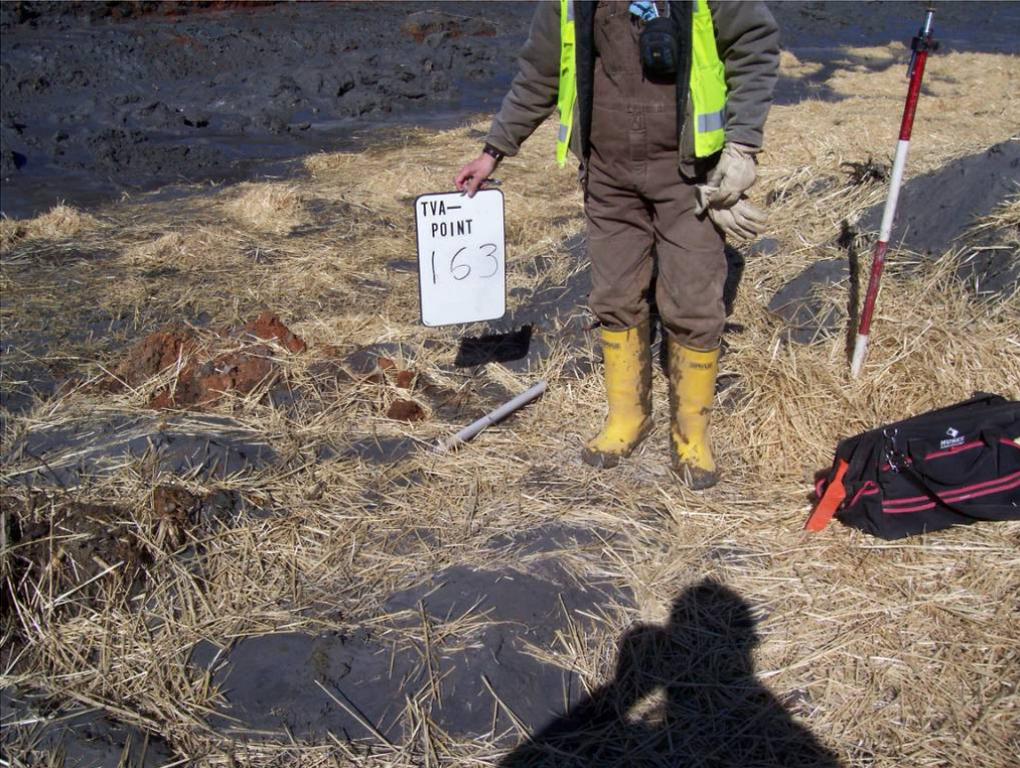
Photo No.: 163	Date: 2-5-2009

Direction Photo Taken: Looking north.			
Description: Gray PVC electrical conduit (1.5-inch dia.).

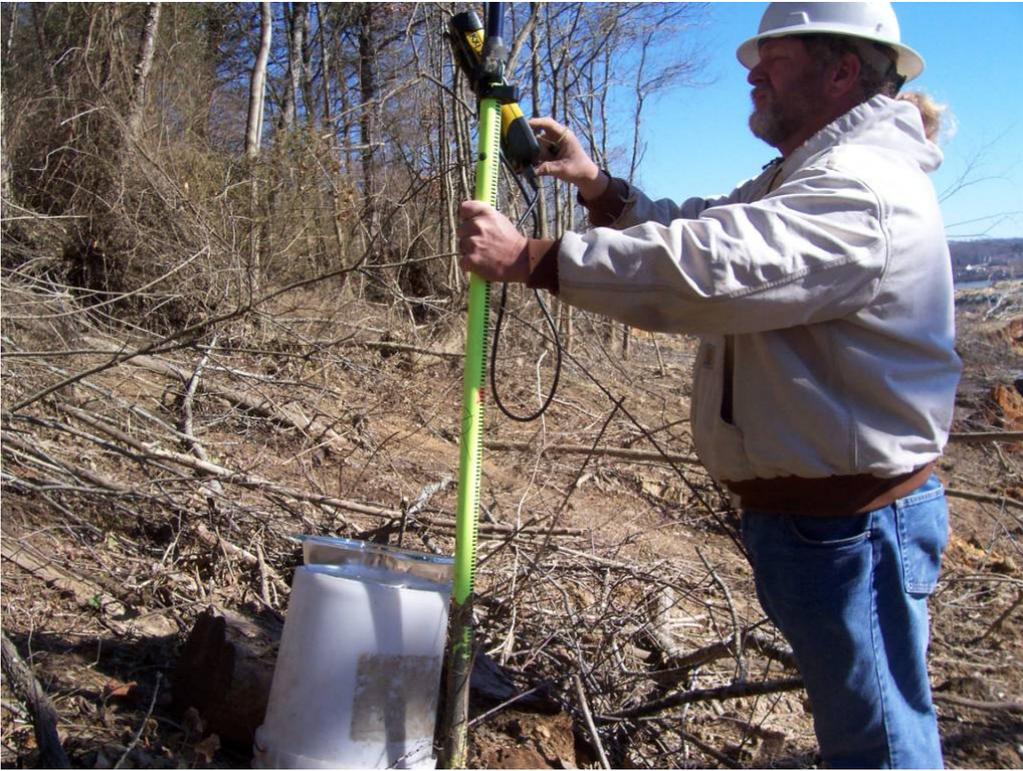
Client Name: Tennessee Valley Authority		Site Location: Kingston Fossil Plant –Harriman, Tennessee	Project No.: 60095742
Photo No.: 164	Date: 2-7-2009

Direction Photo Taken: Looking east.			
Description: 8" x 8" Pyrex dish and 5-gallon pail on north shore of Emory River backwater.

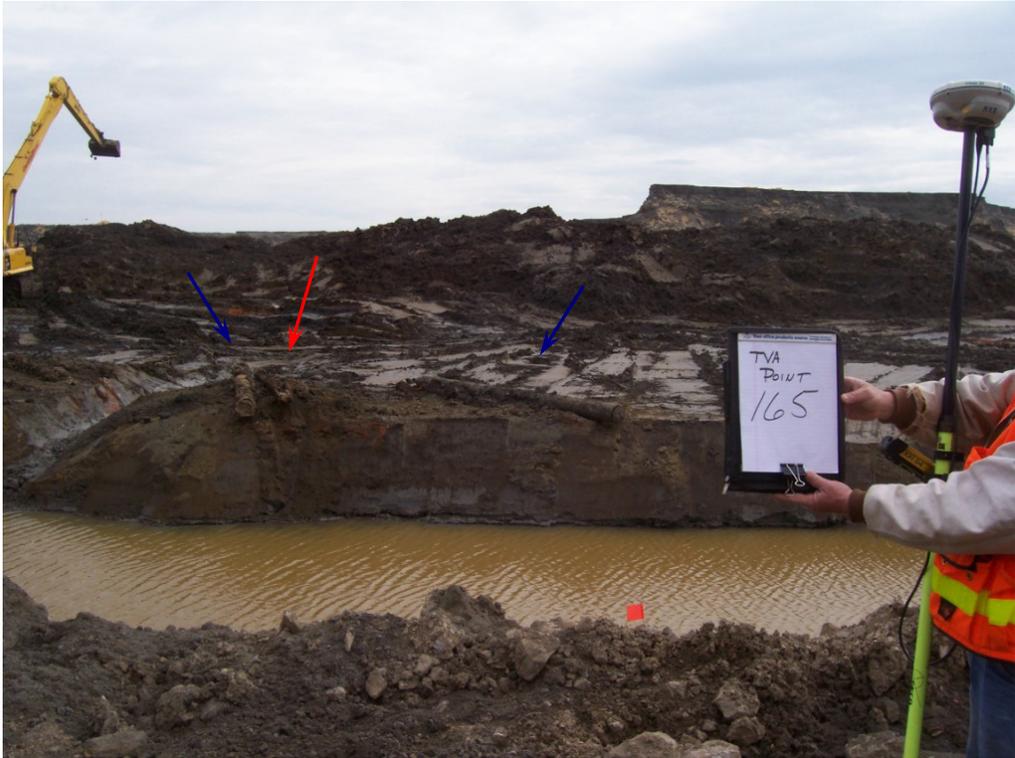
Photo No.: 165	Date: 2-10-2009

Direction Photo Taken: Looking east.		
Description: Iron pipes (blue arrows) and railroad rail (red arrow) unearthed east of Swan Pond Road – inaccessible due to ditch and soft ash.

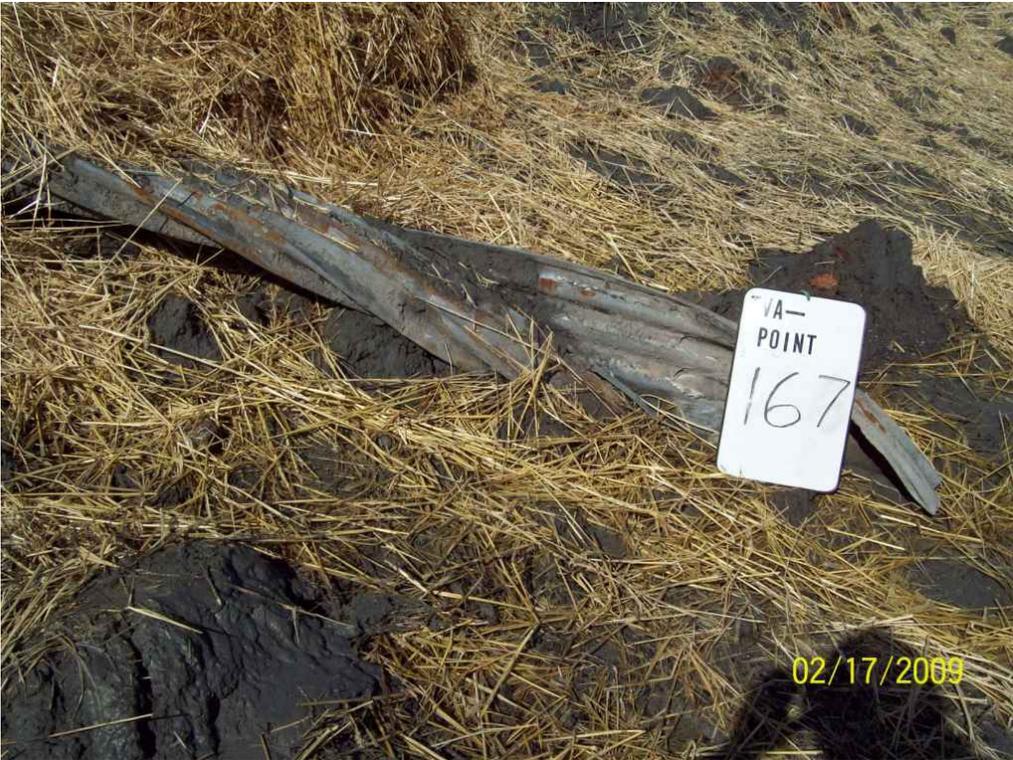
Client Name: Tennessee Valley Authority		Site Location: Kingston Fossil Plant –Harriman, Tennessee	Project No.: 60095742
Photo No.: 167	Date: 2-17-2009

Direction Photo Taken: Looking north.			
Description: Portion of corrugated metal pipe, likely a section of the pipe identified in Photo 166.

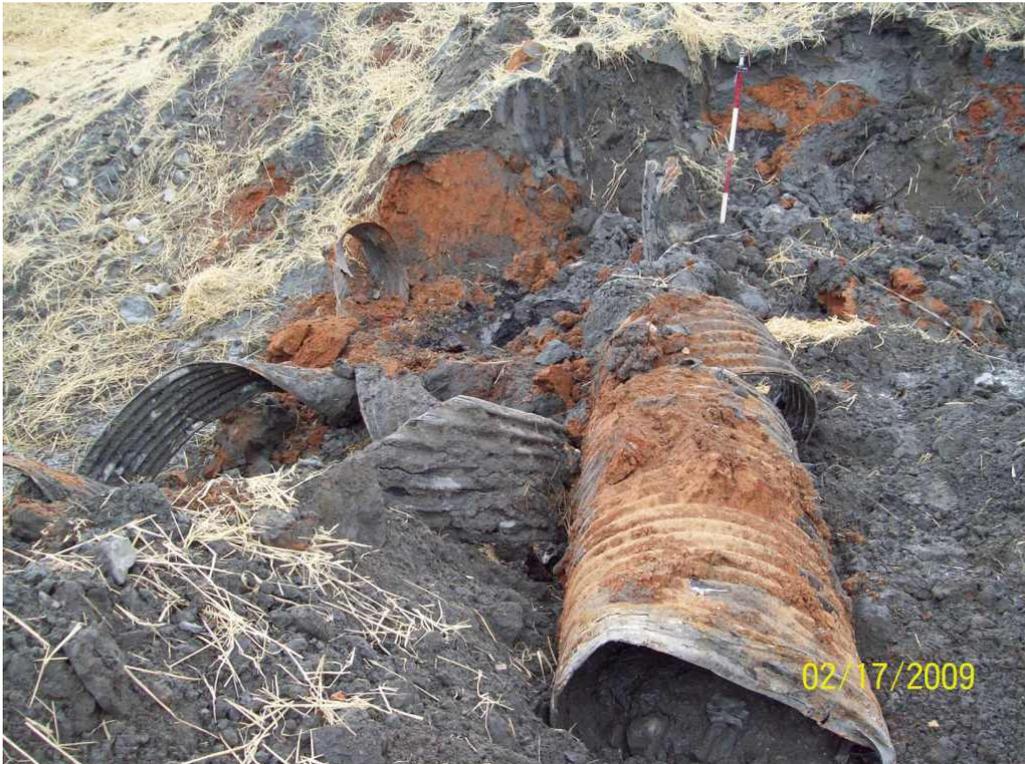
Photo No.: 168	Date: 2-17-2009

Direction Photo Taken: Looking southeast.			
Description: Corrugated metal pipe similar to the pipe shown in Photo 166.

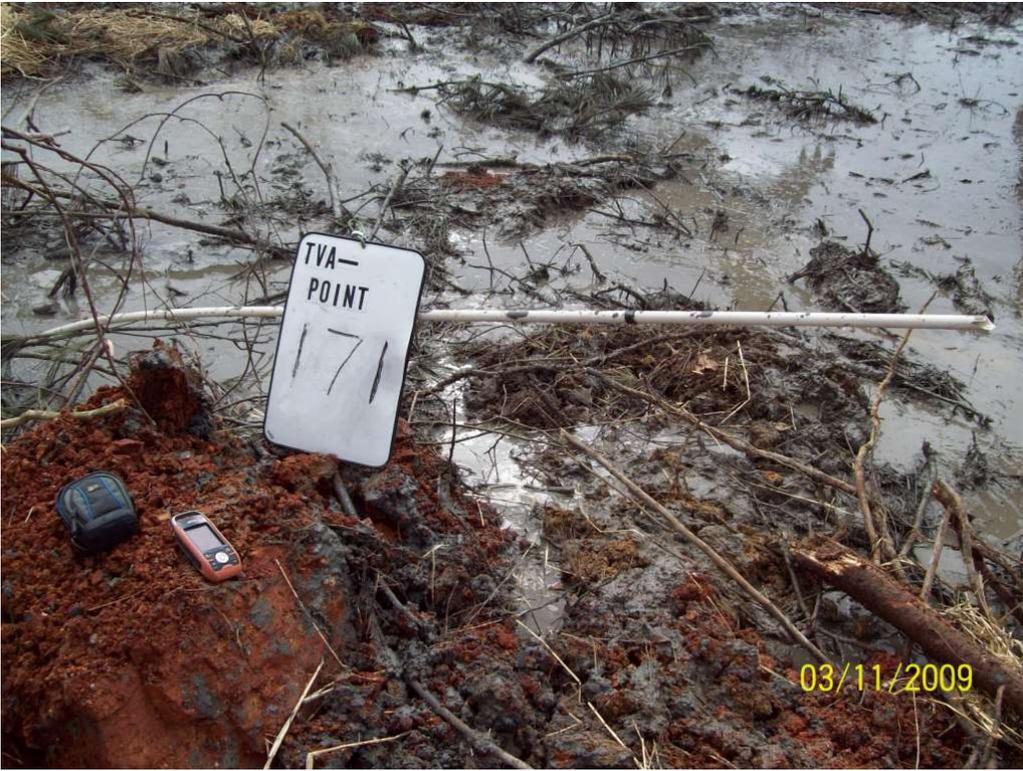
Client Name: Tennessee Valley Authority		Site Location: Kingston Fossil Plant –Harriman, Tennessee	Project No.: 60095742
Photo No.: 171	Date: 3-11-2009

Direction Photo Taken: Looking south.			
Description: PVC pipe 1-inch diameter.

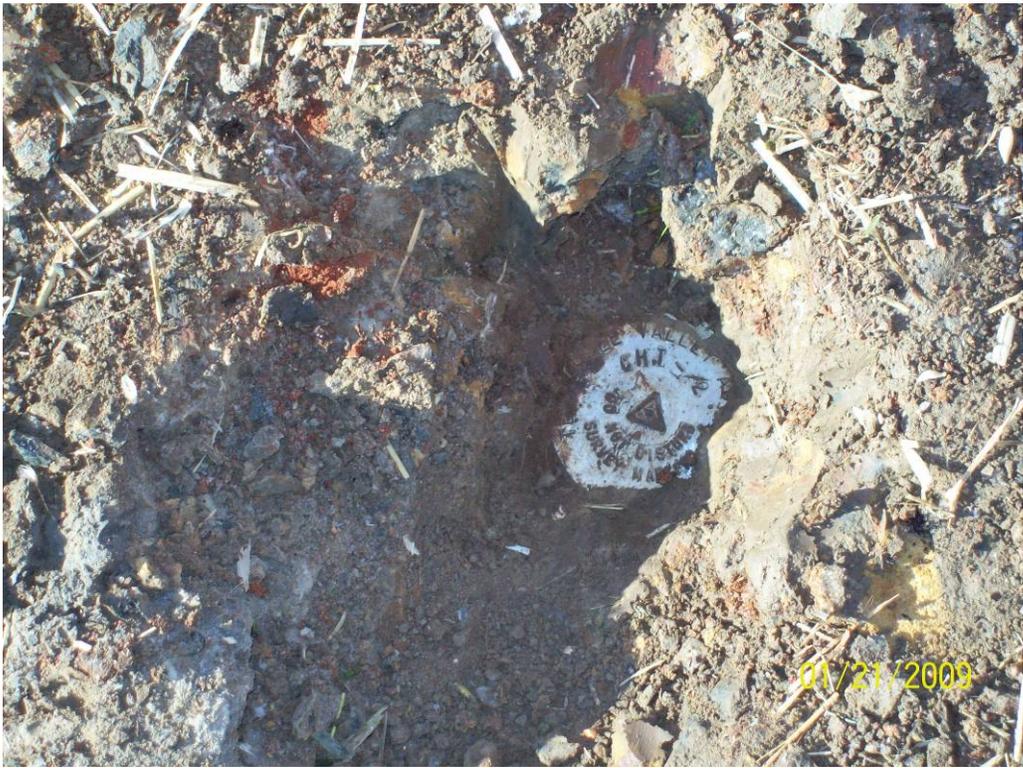
Photo No.: CHT-2	Date: 1-21-2009

Direction Photo Taken: Looking vertical.		
Description: Survey monument CHT-2.

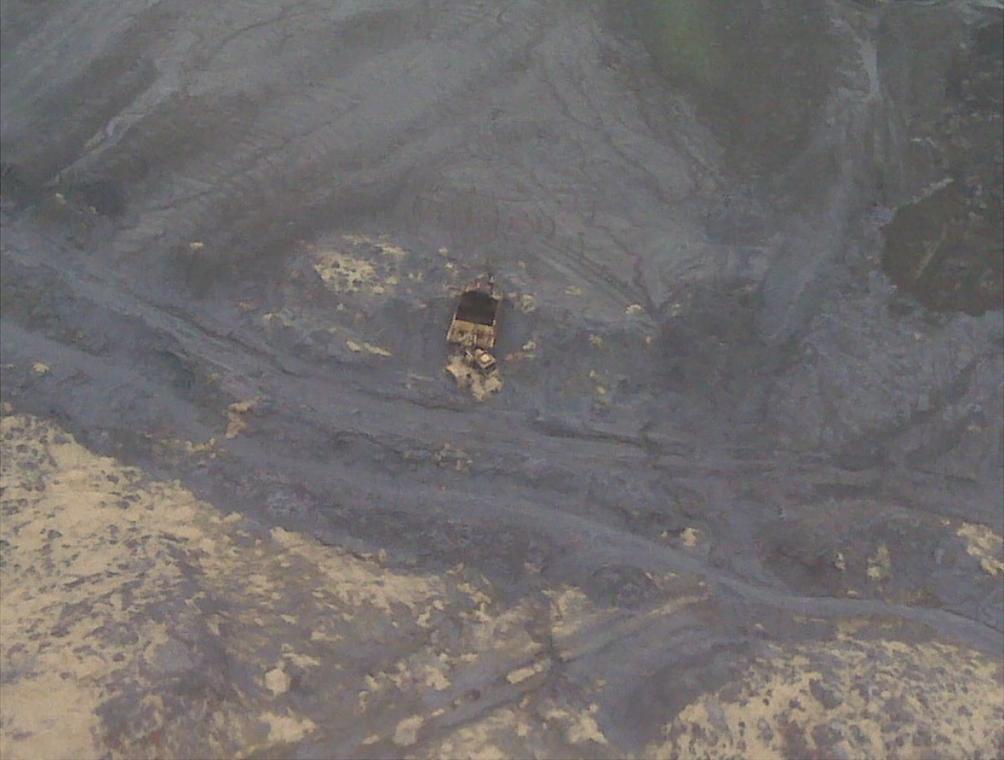
Client Name: Tennessee Valley Authority		Site Location: Kingston Fossil Plant –Harriman, Tennessee	Project No. 60095742
Photo No. Scraper	Date: 2-25-2009

Direction Photo Taken: Looking vertical/west.			
Description: Scraper formerly parked on Center Dike.
