Kingston Dredge Cell Failure

Root Cause Failure Analysis

6/25/09

AECOM

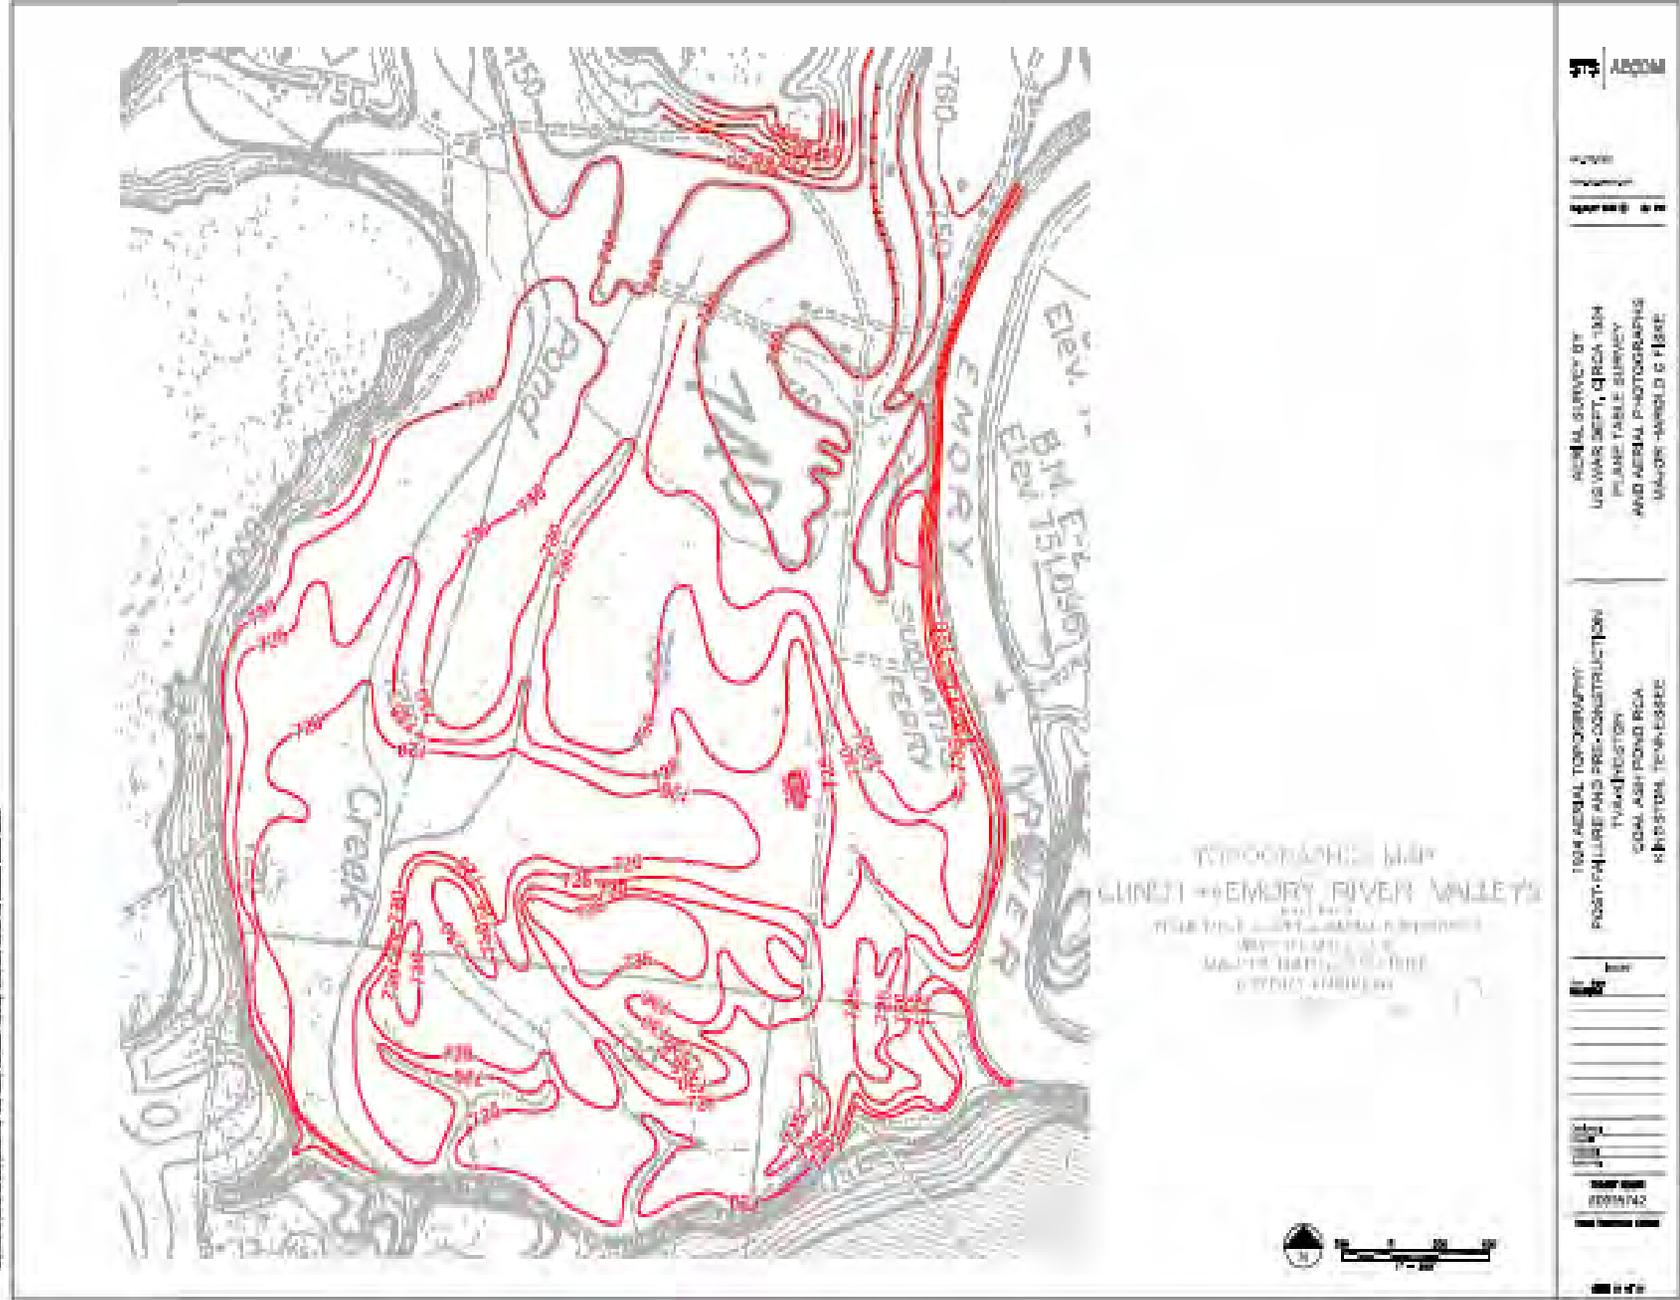
1924 Aerial and Plane Table Survey by War Department

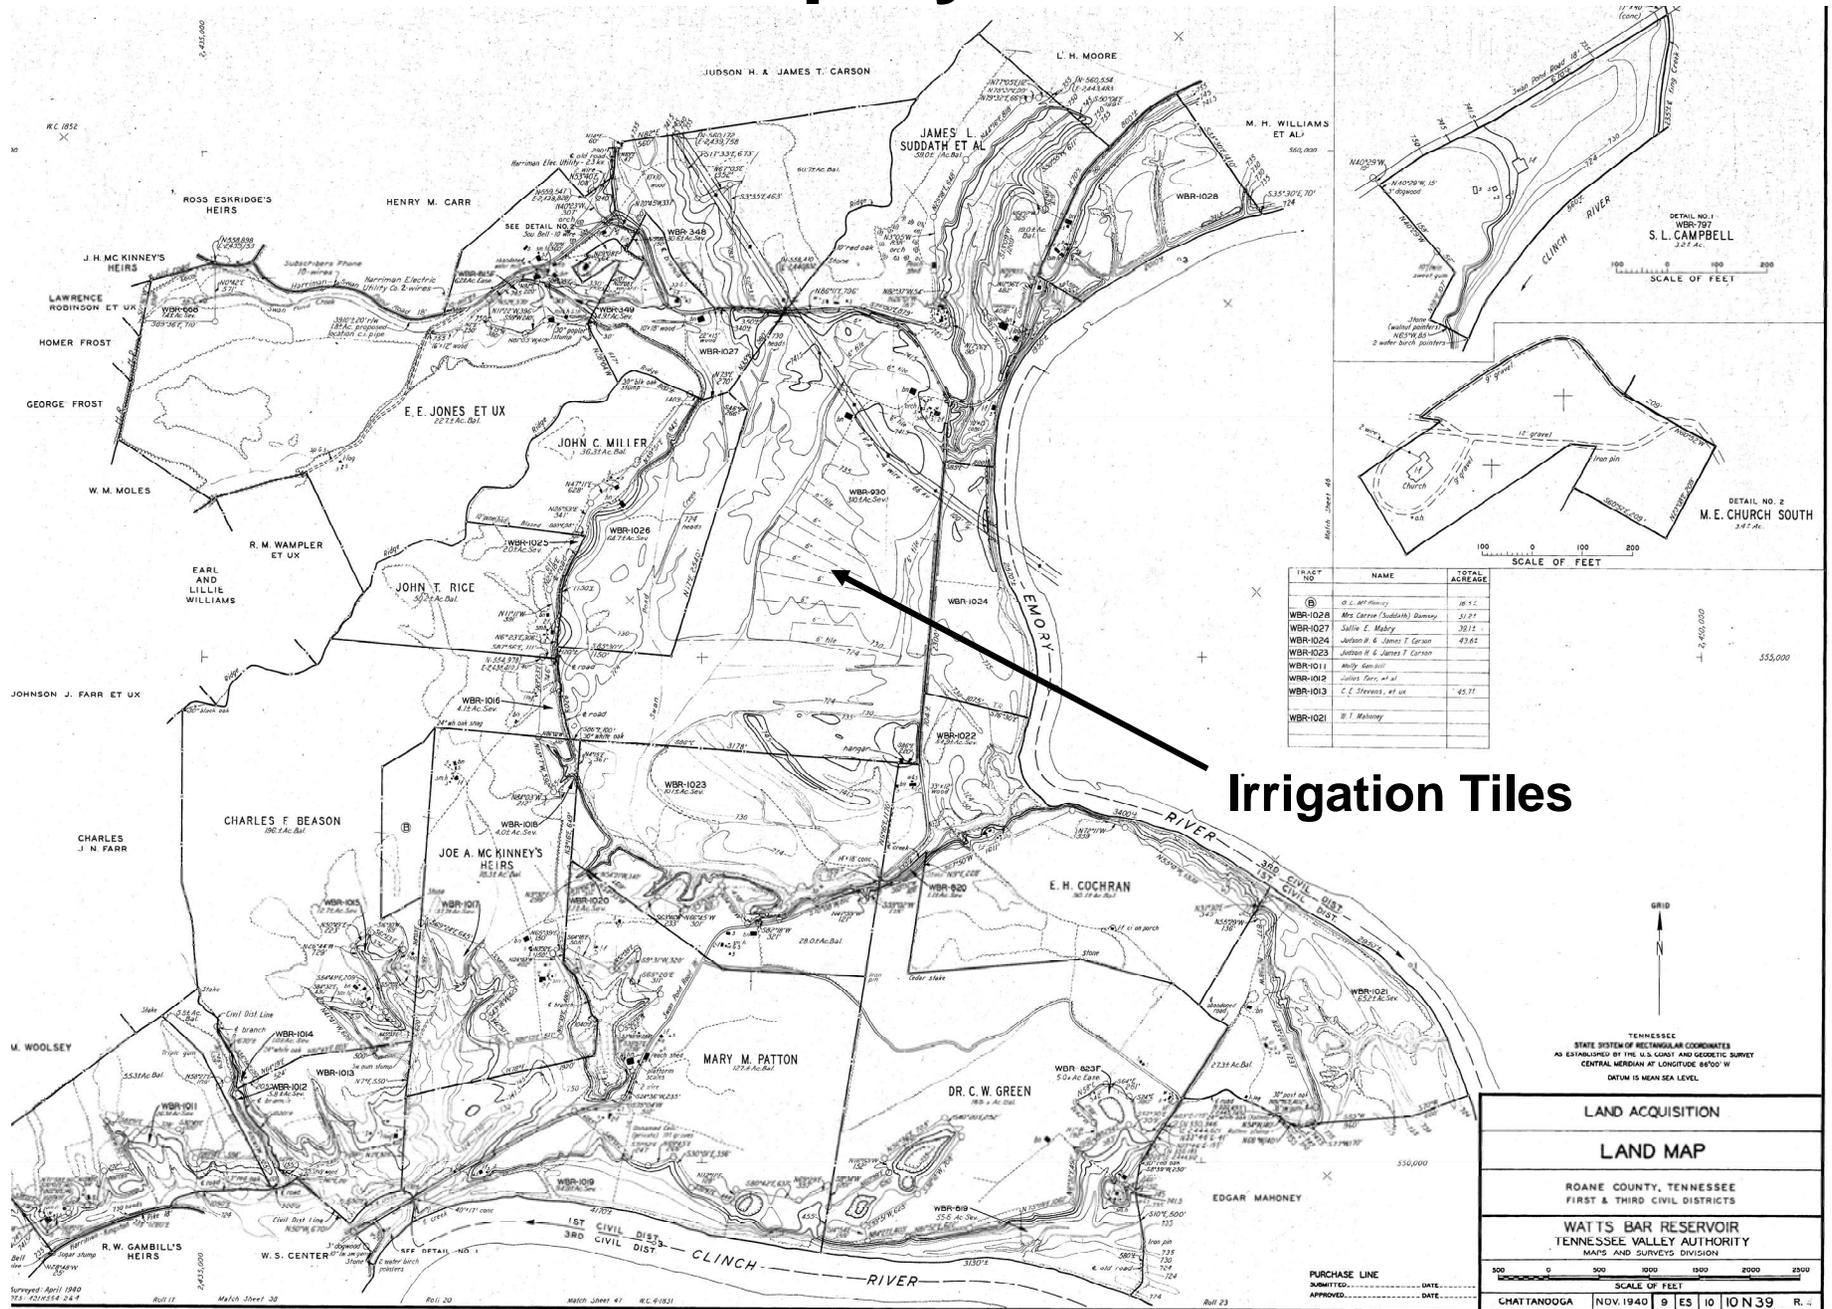
1940 Land Map by TVA

Irrigation Tiles

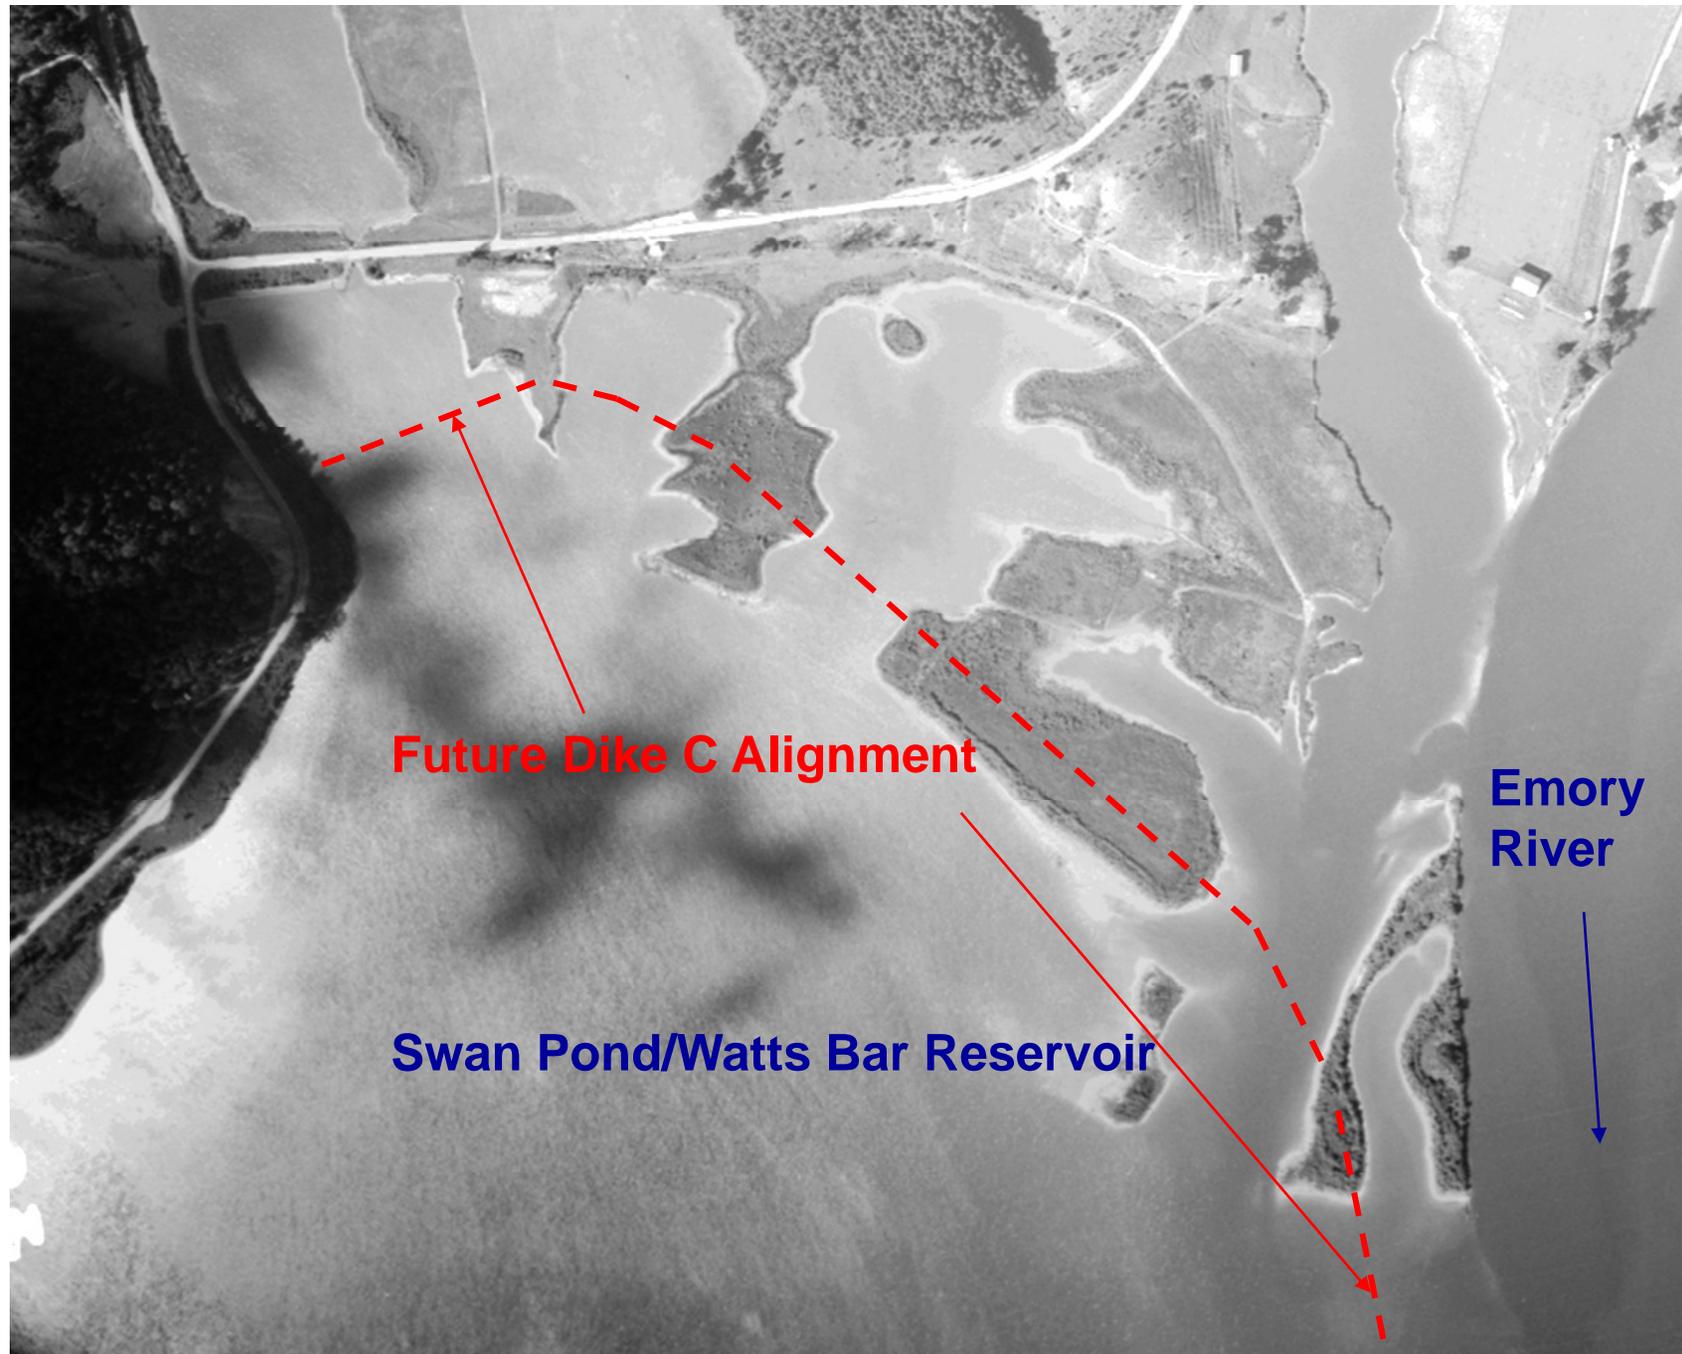
09-23-1949

Future Dike C Alignment

**Emory
River**

Swan Pond/Watts Bar Reservoir

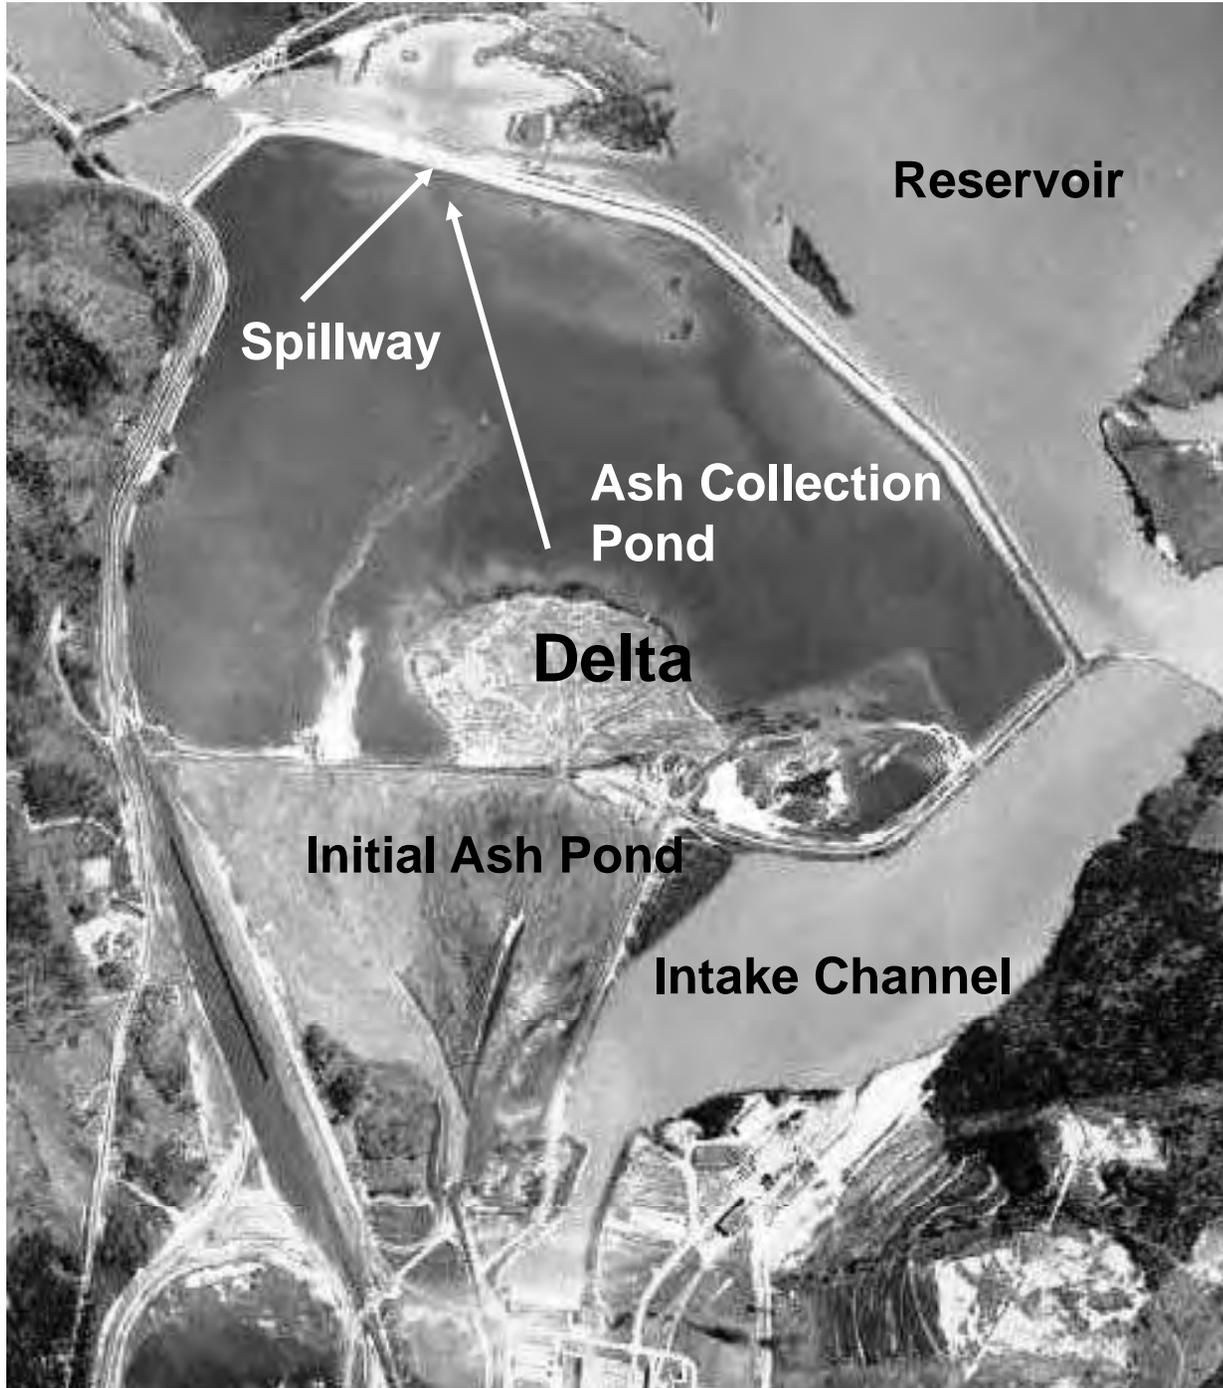
04-21-1962

Reservoir

Spillway

**Ash Collection
Pond**

Delta

Initial Ash Pond

Intake Channel

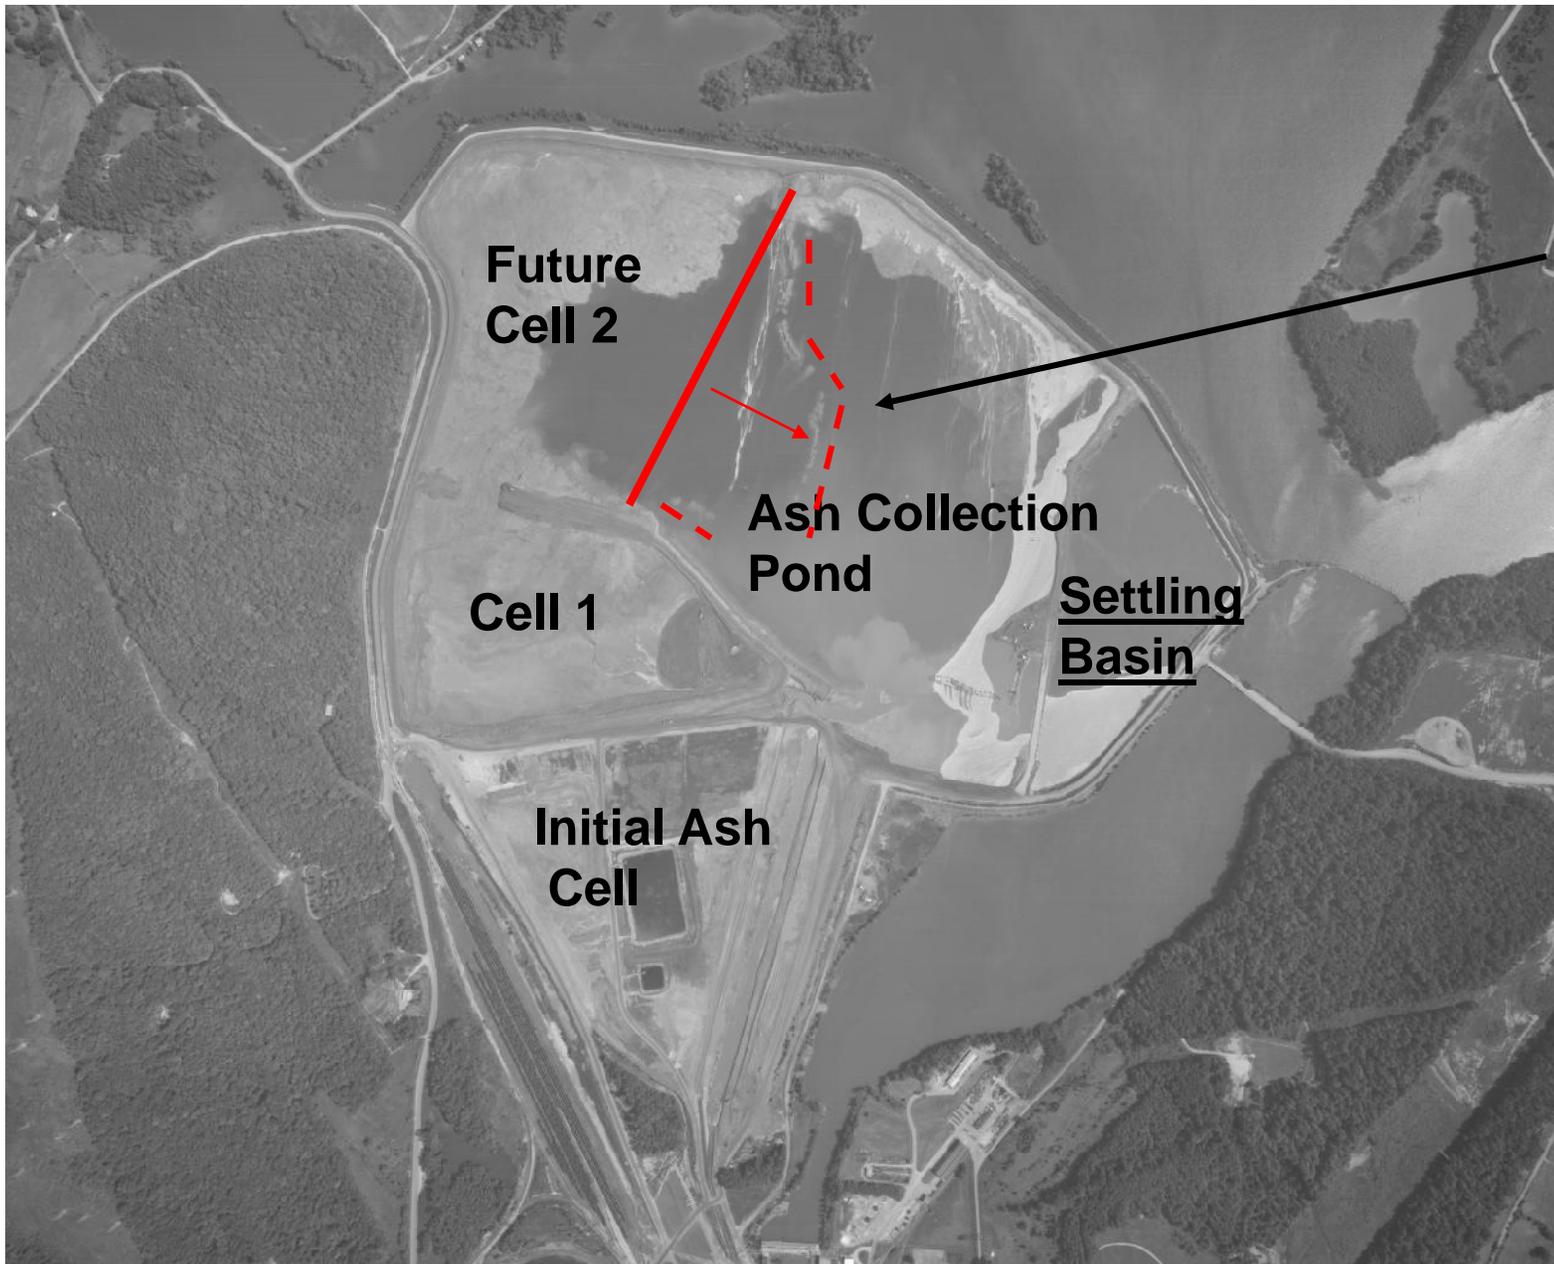
8-24-84

August 8,
1984 Divider
Dike D
Failure

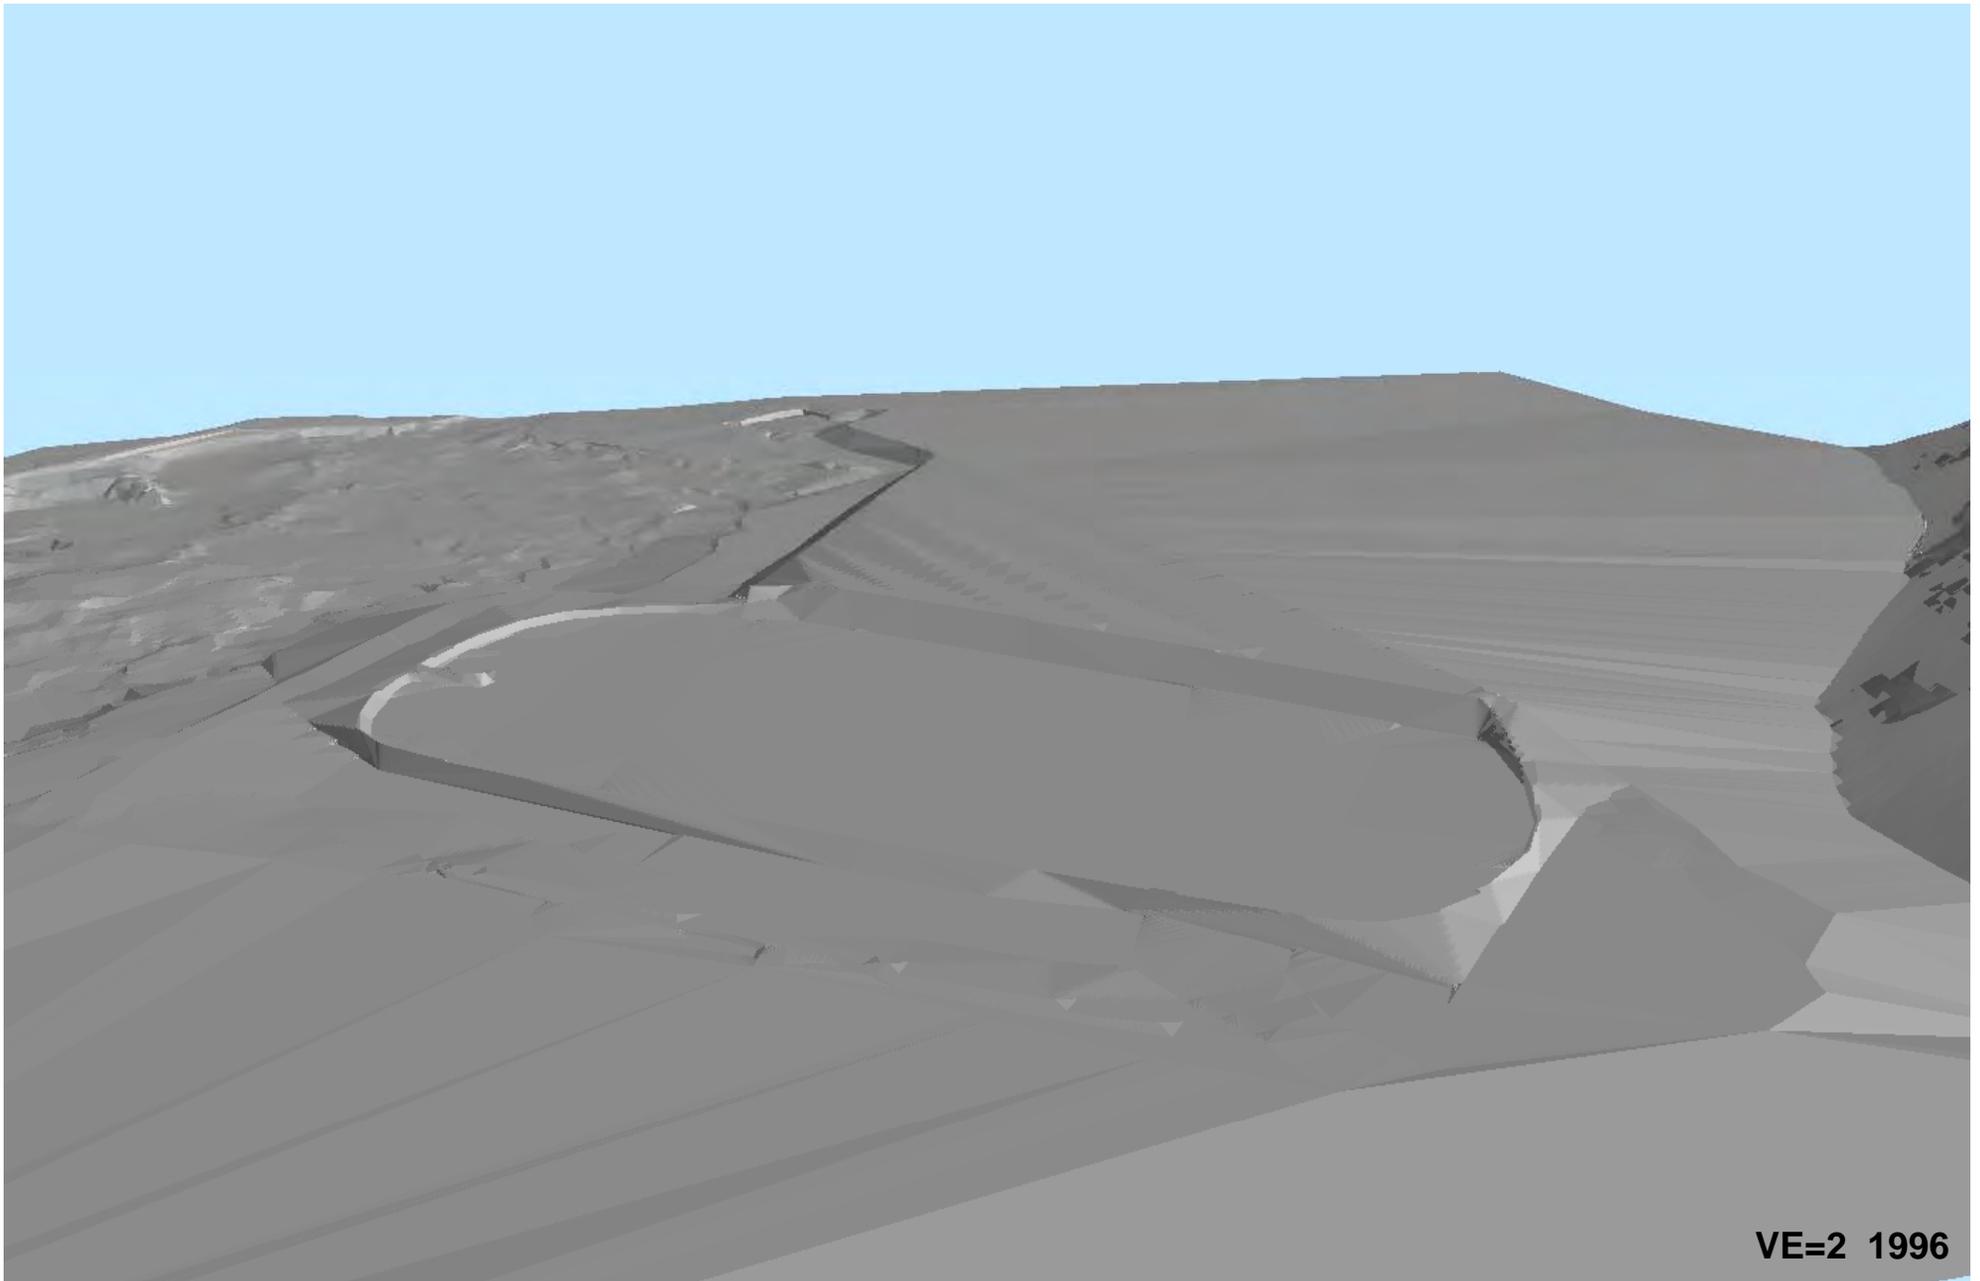
GIS Views of Dredge Cells Using TVA Surveys

1996 Pre-failure Topography from TVA Surveys

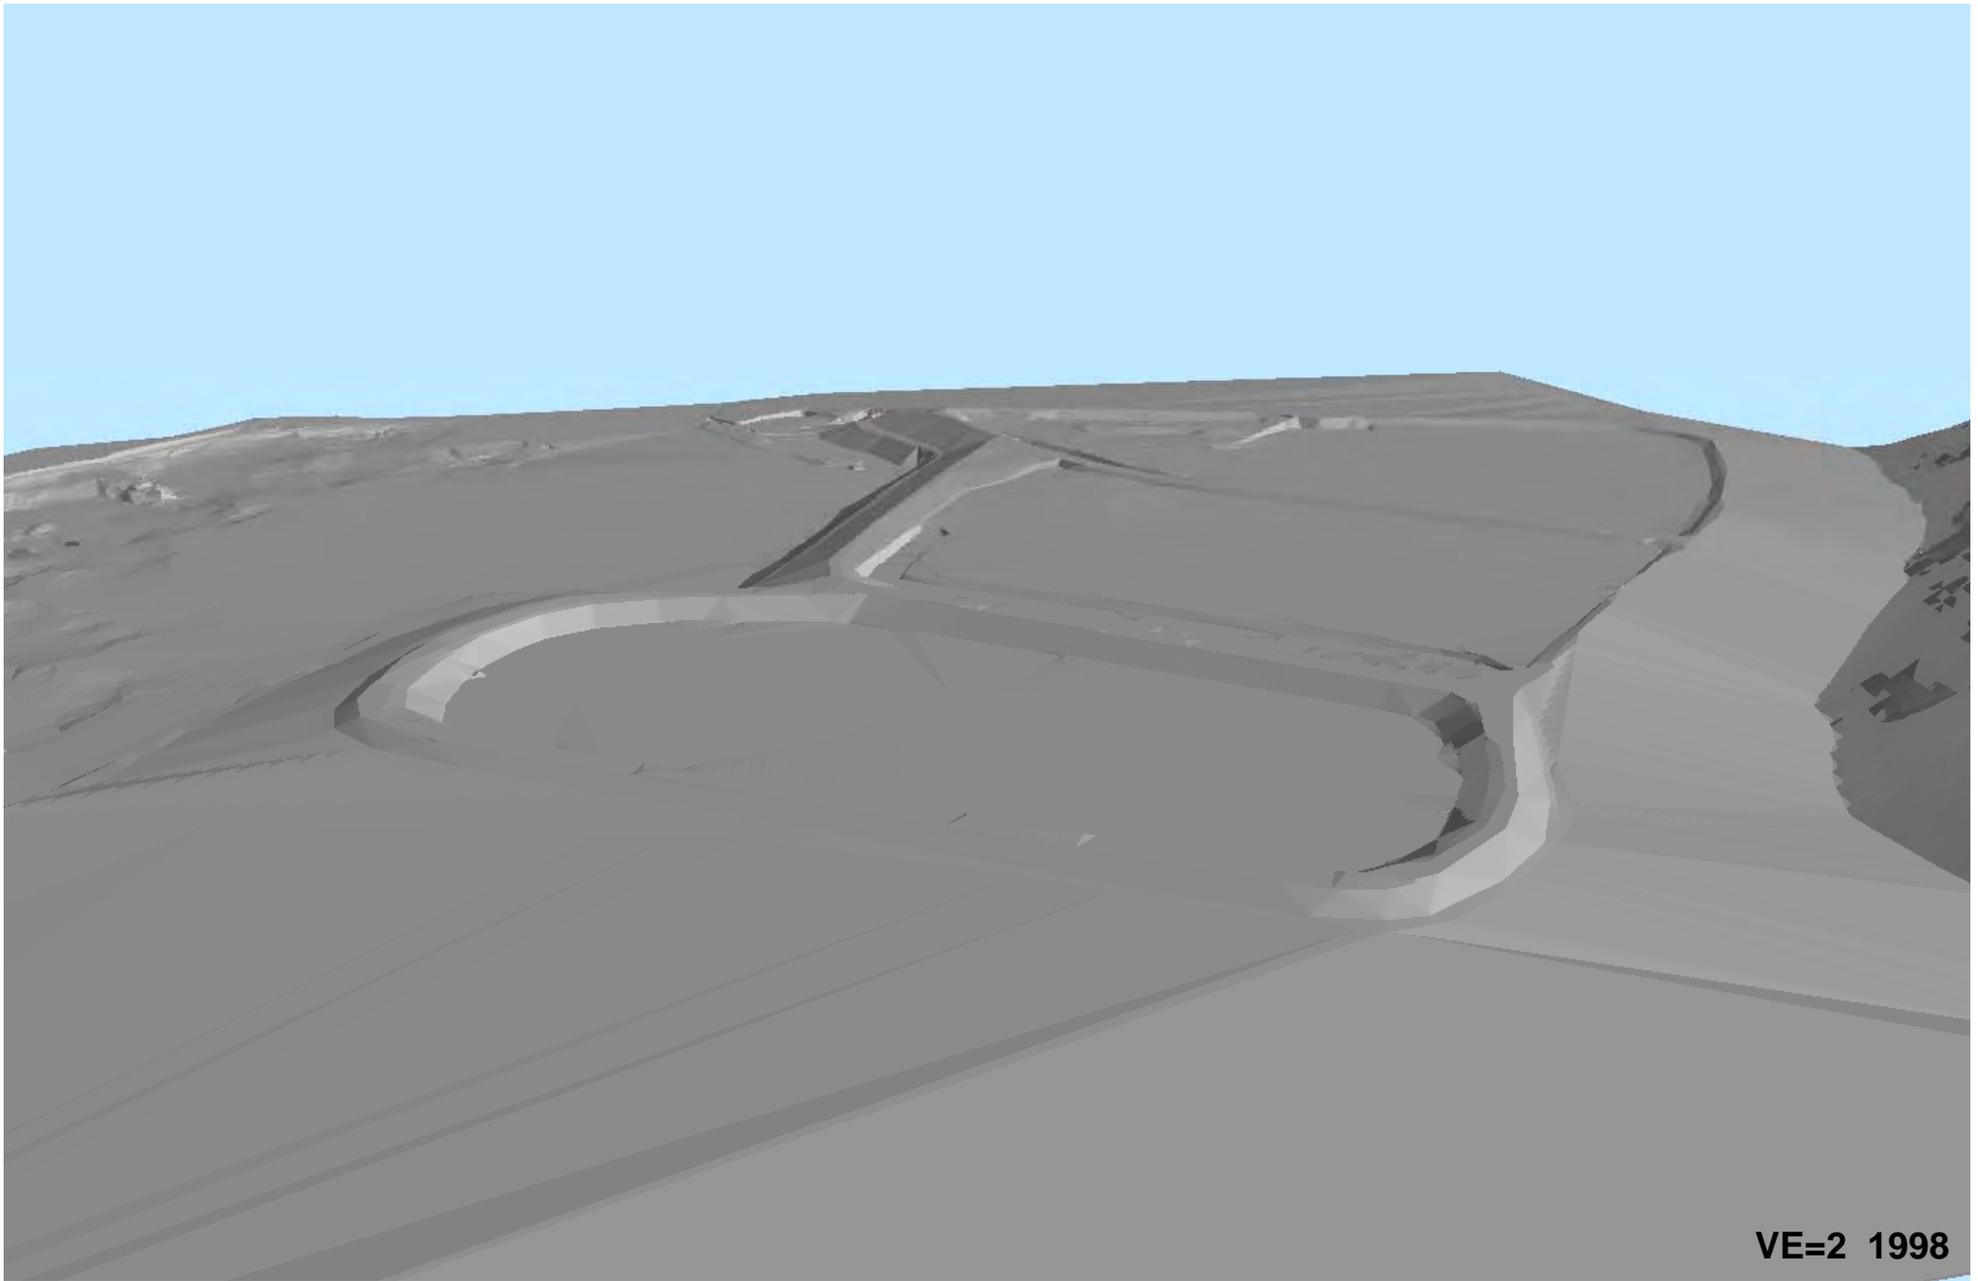
1998 Pre-Failure Topography from TVA Surveys

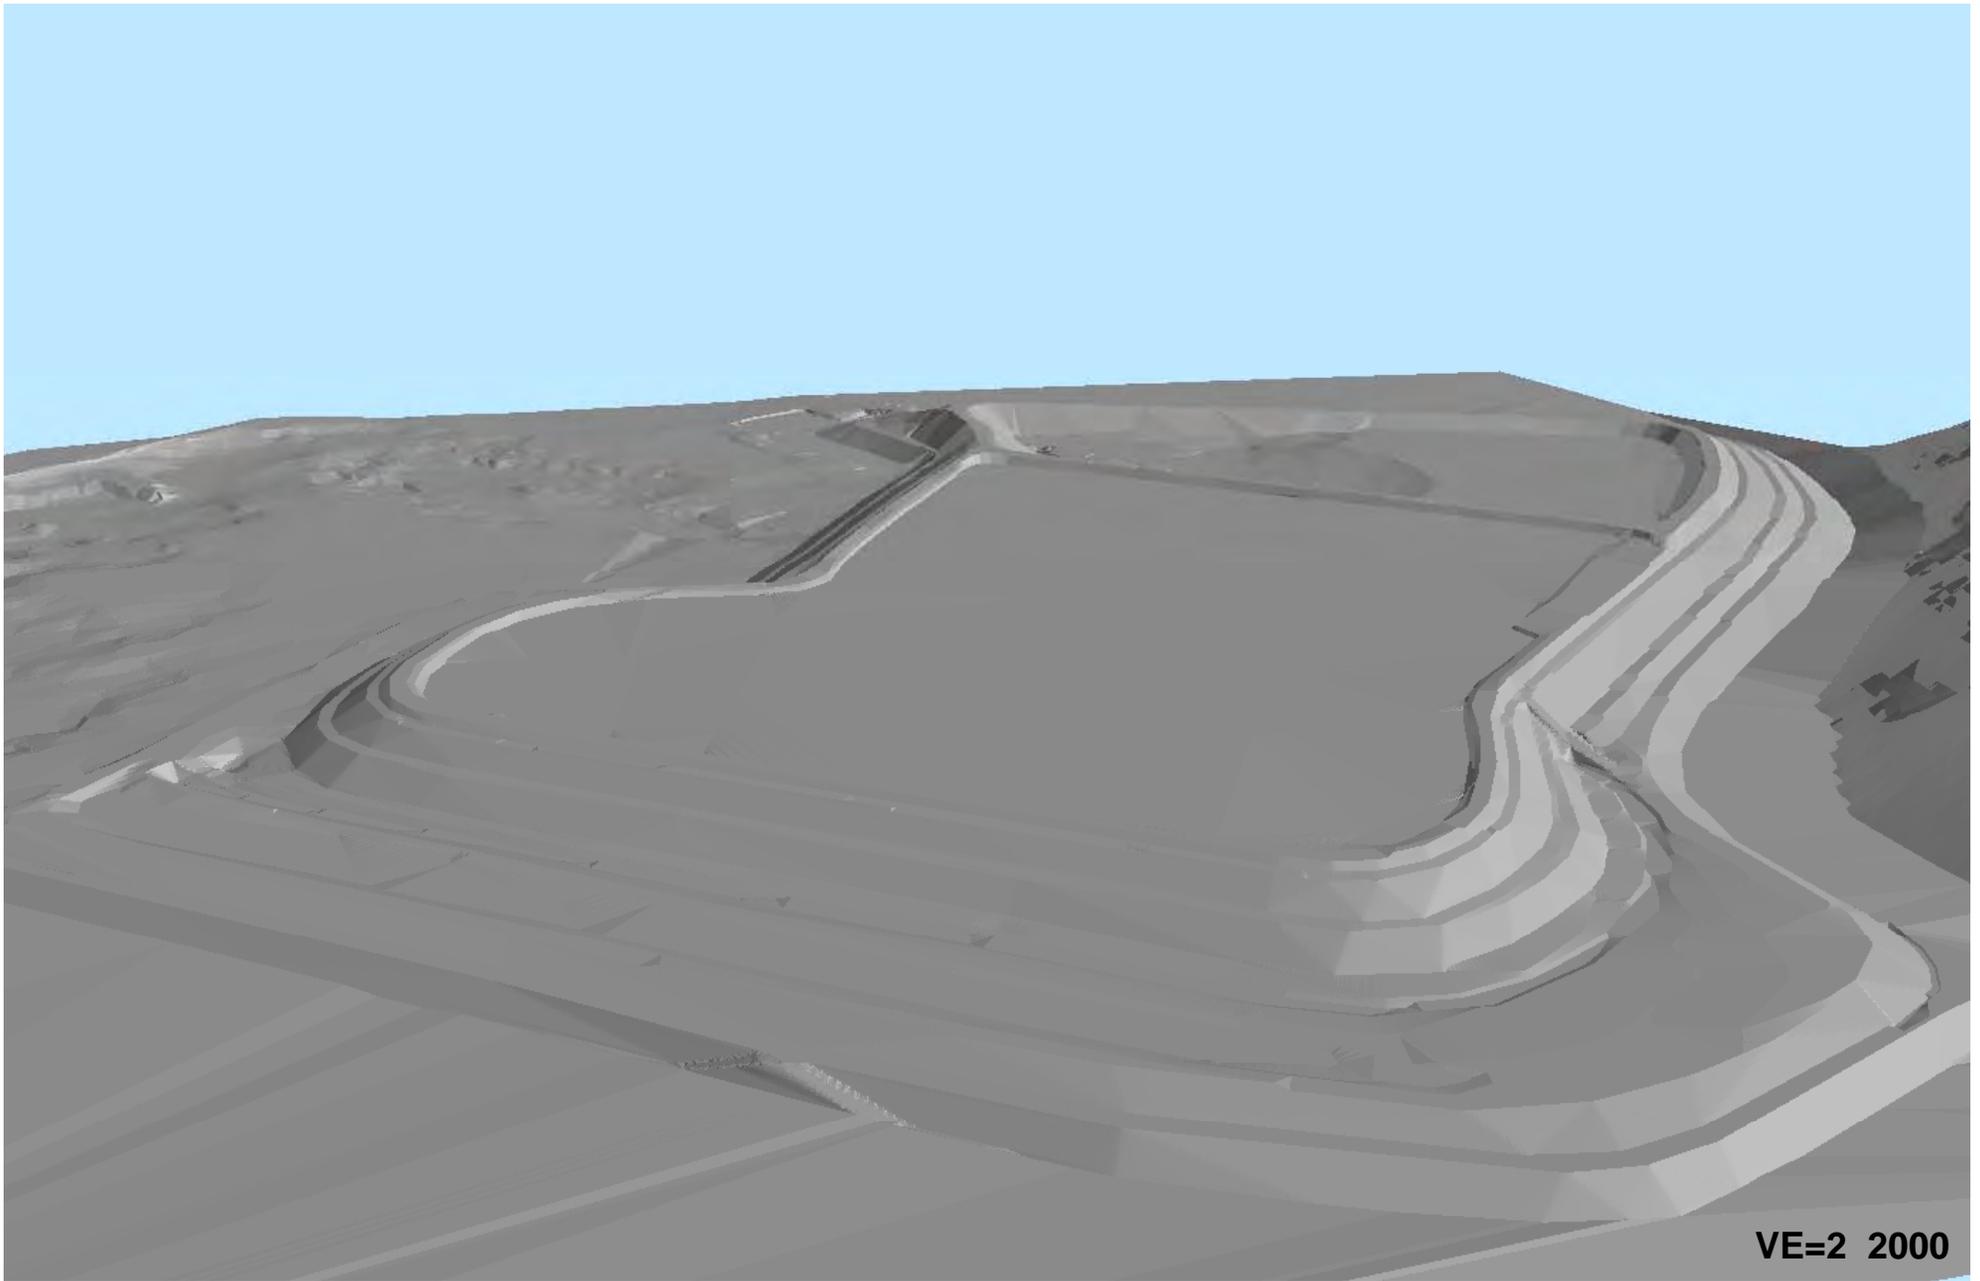
2000 Pre-Failure Topography from TVA Surveys

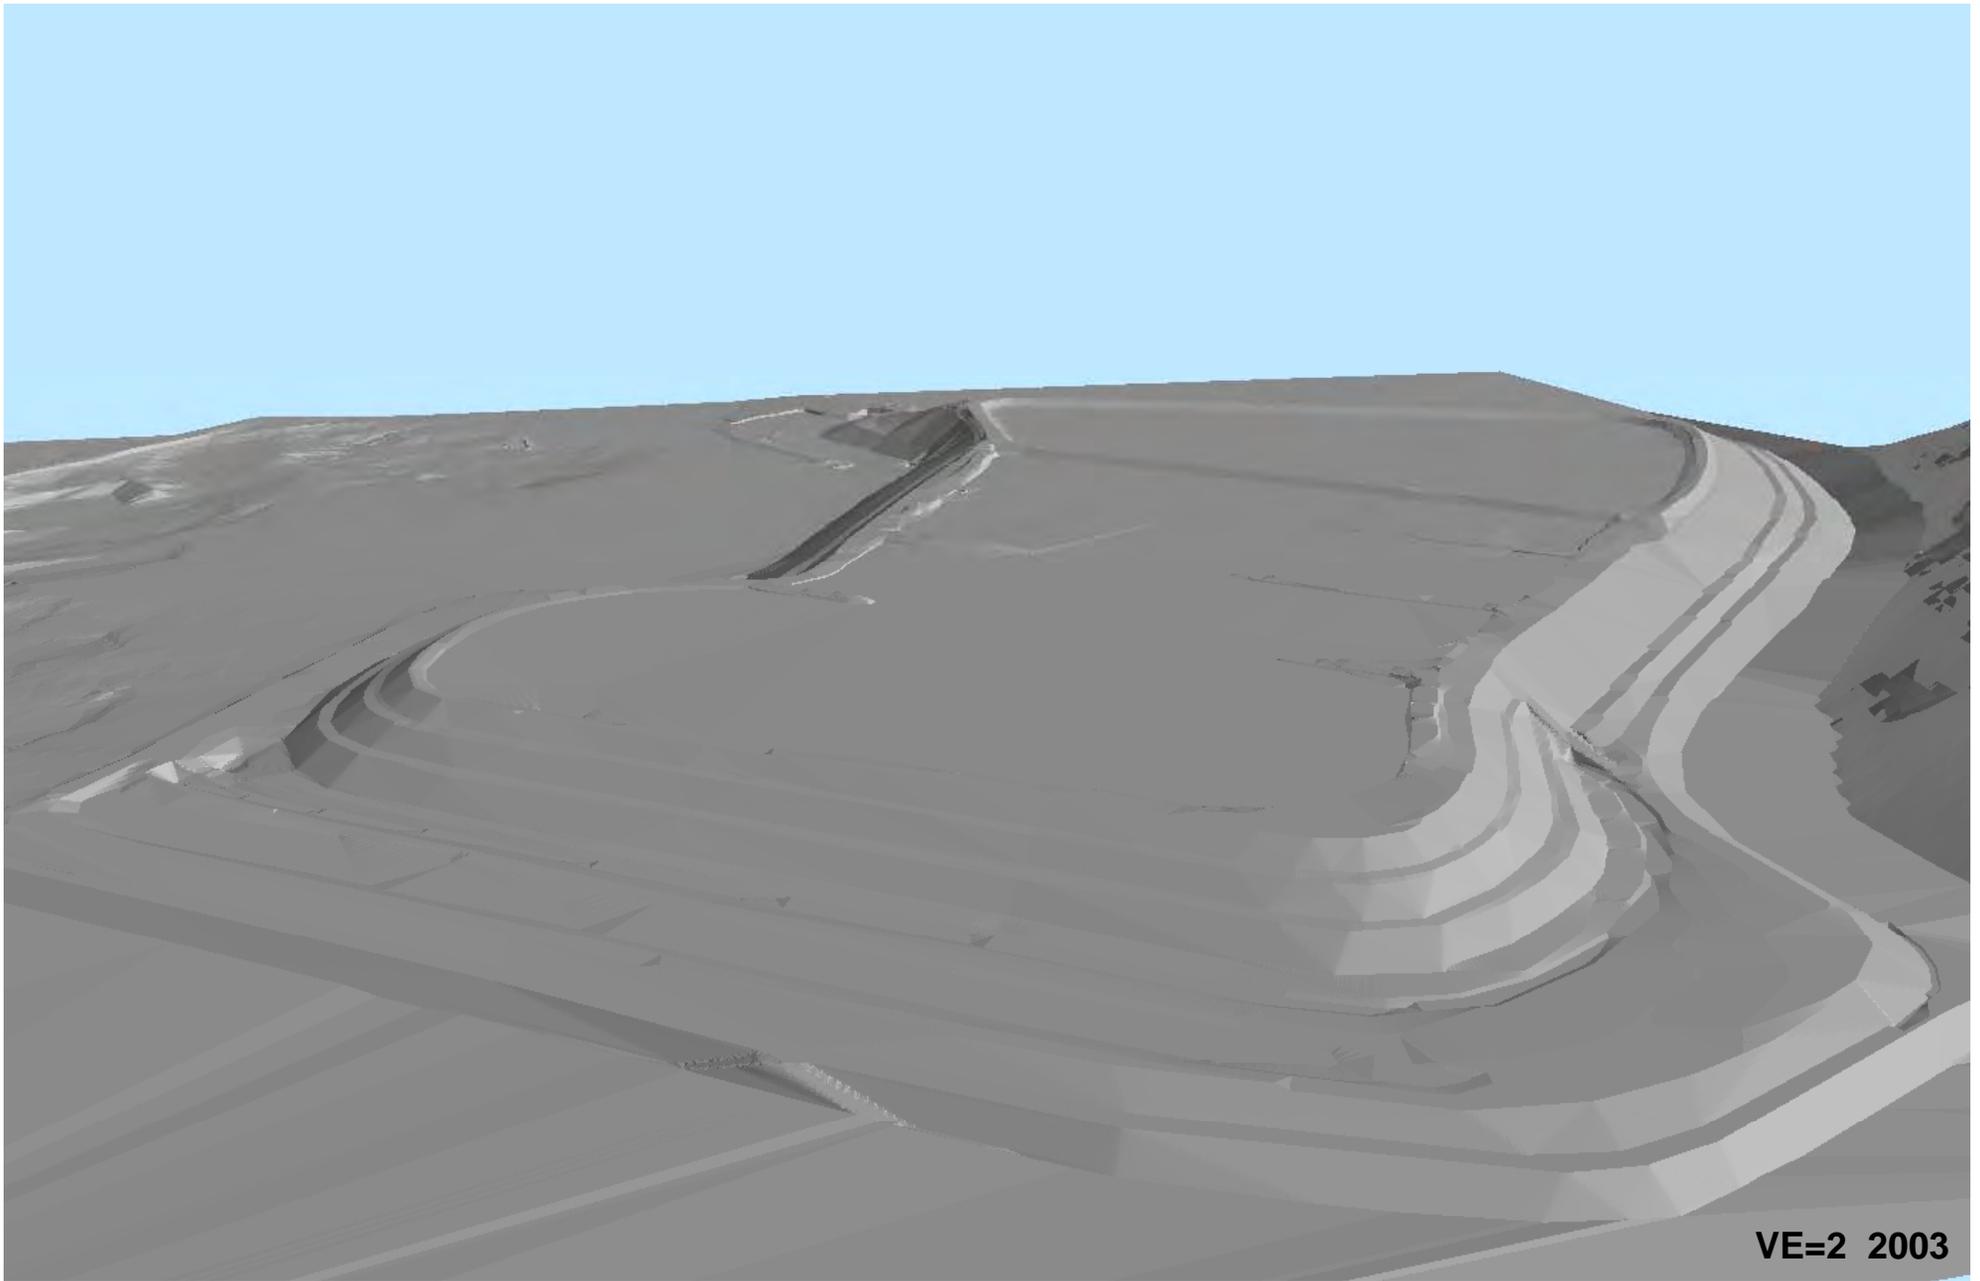
2003 Pre-Failure Topography from TVA Surveys

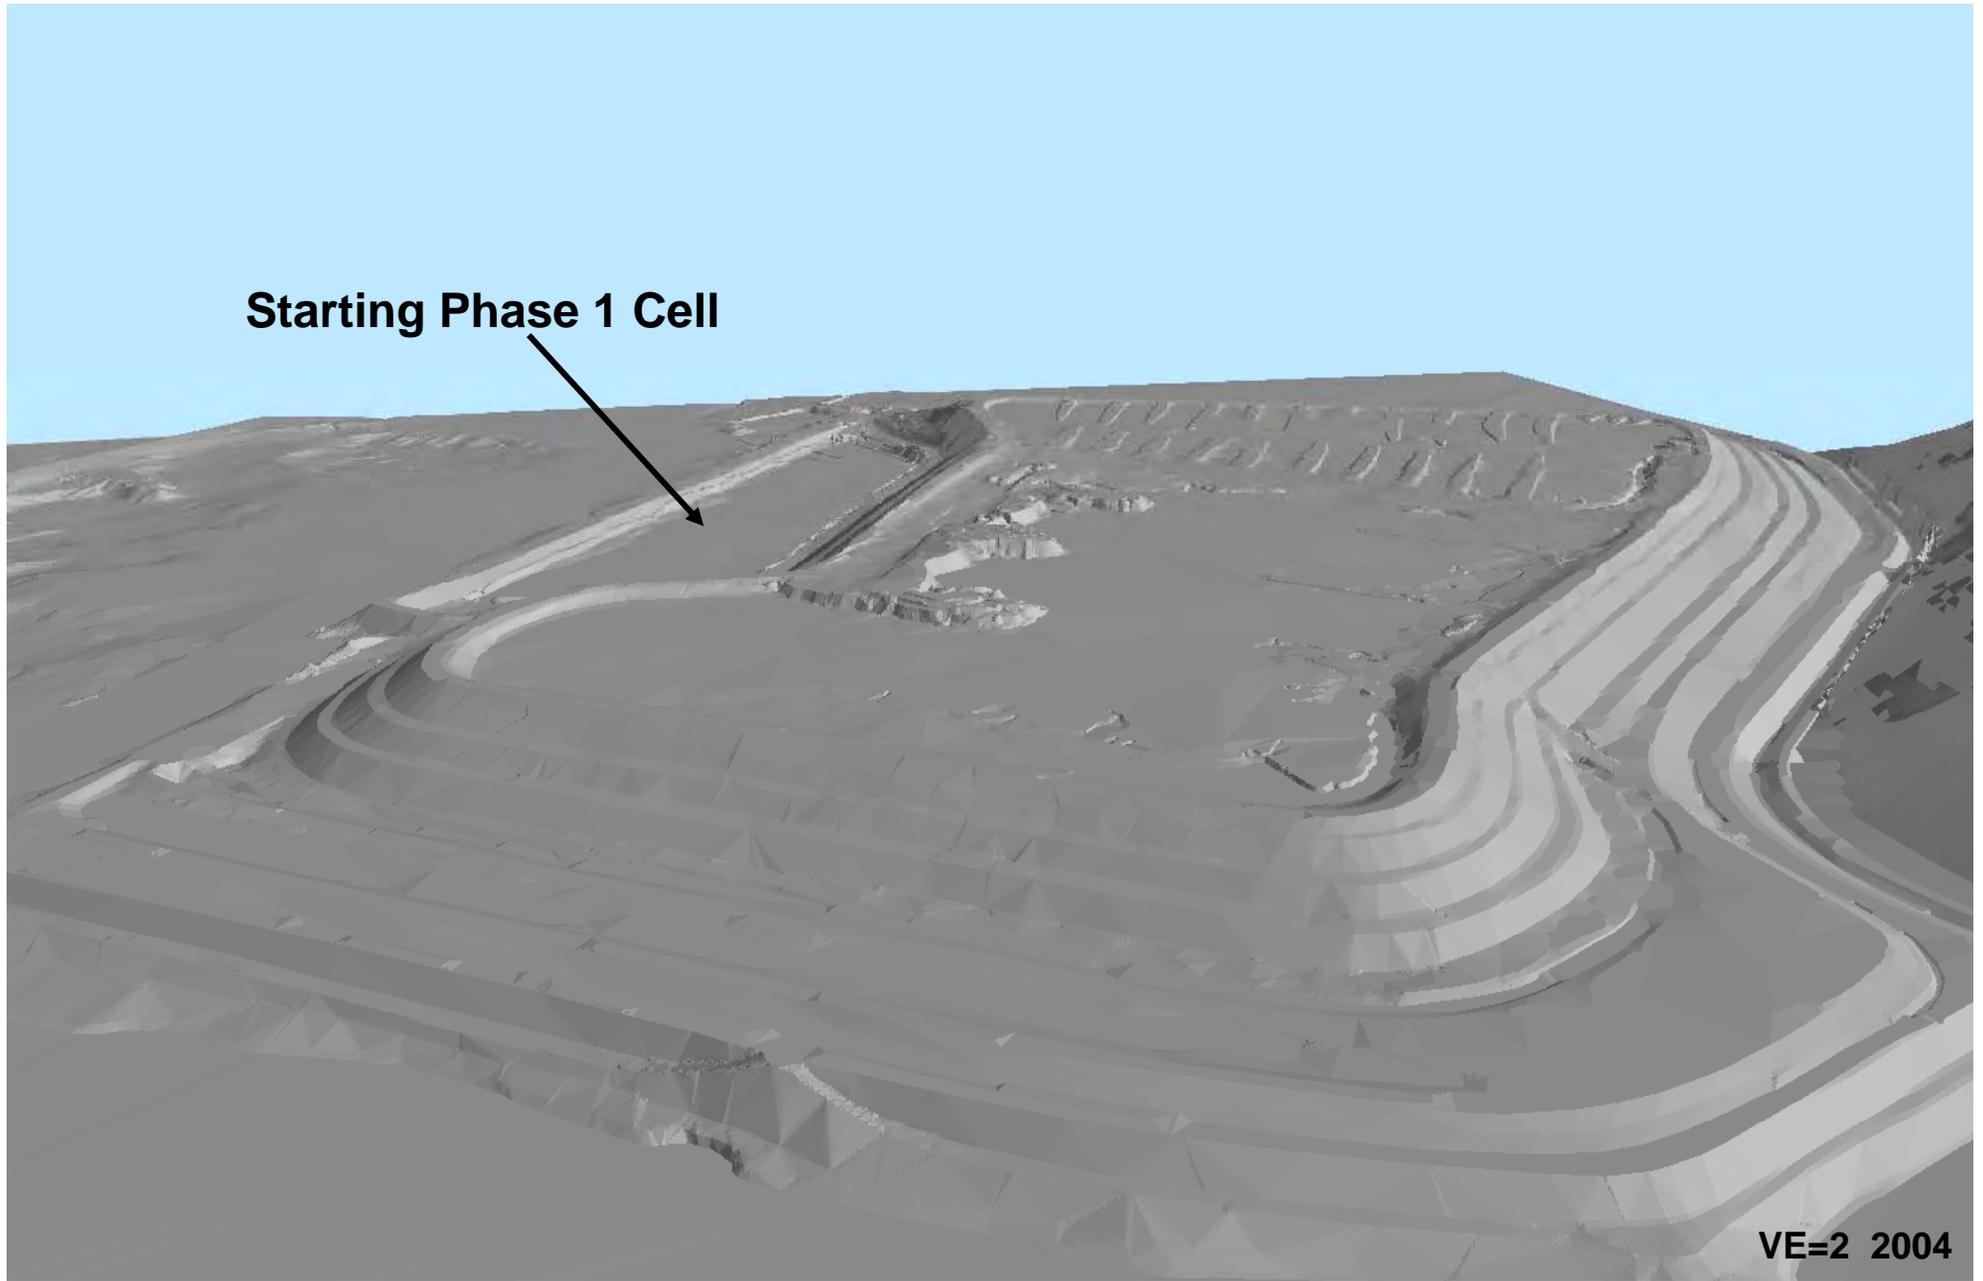
2004 Pre-Failure Topography from TVA Surveys
