Kingston Dredge Cell Failure

Root Cause Failure Analysis

6/25/09

AECOM

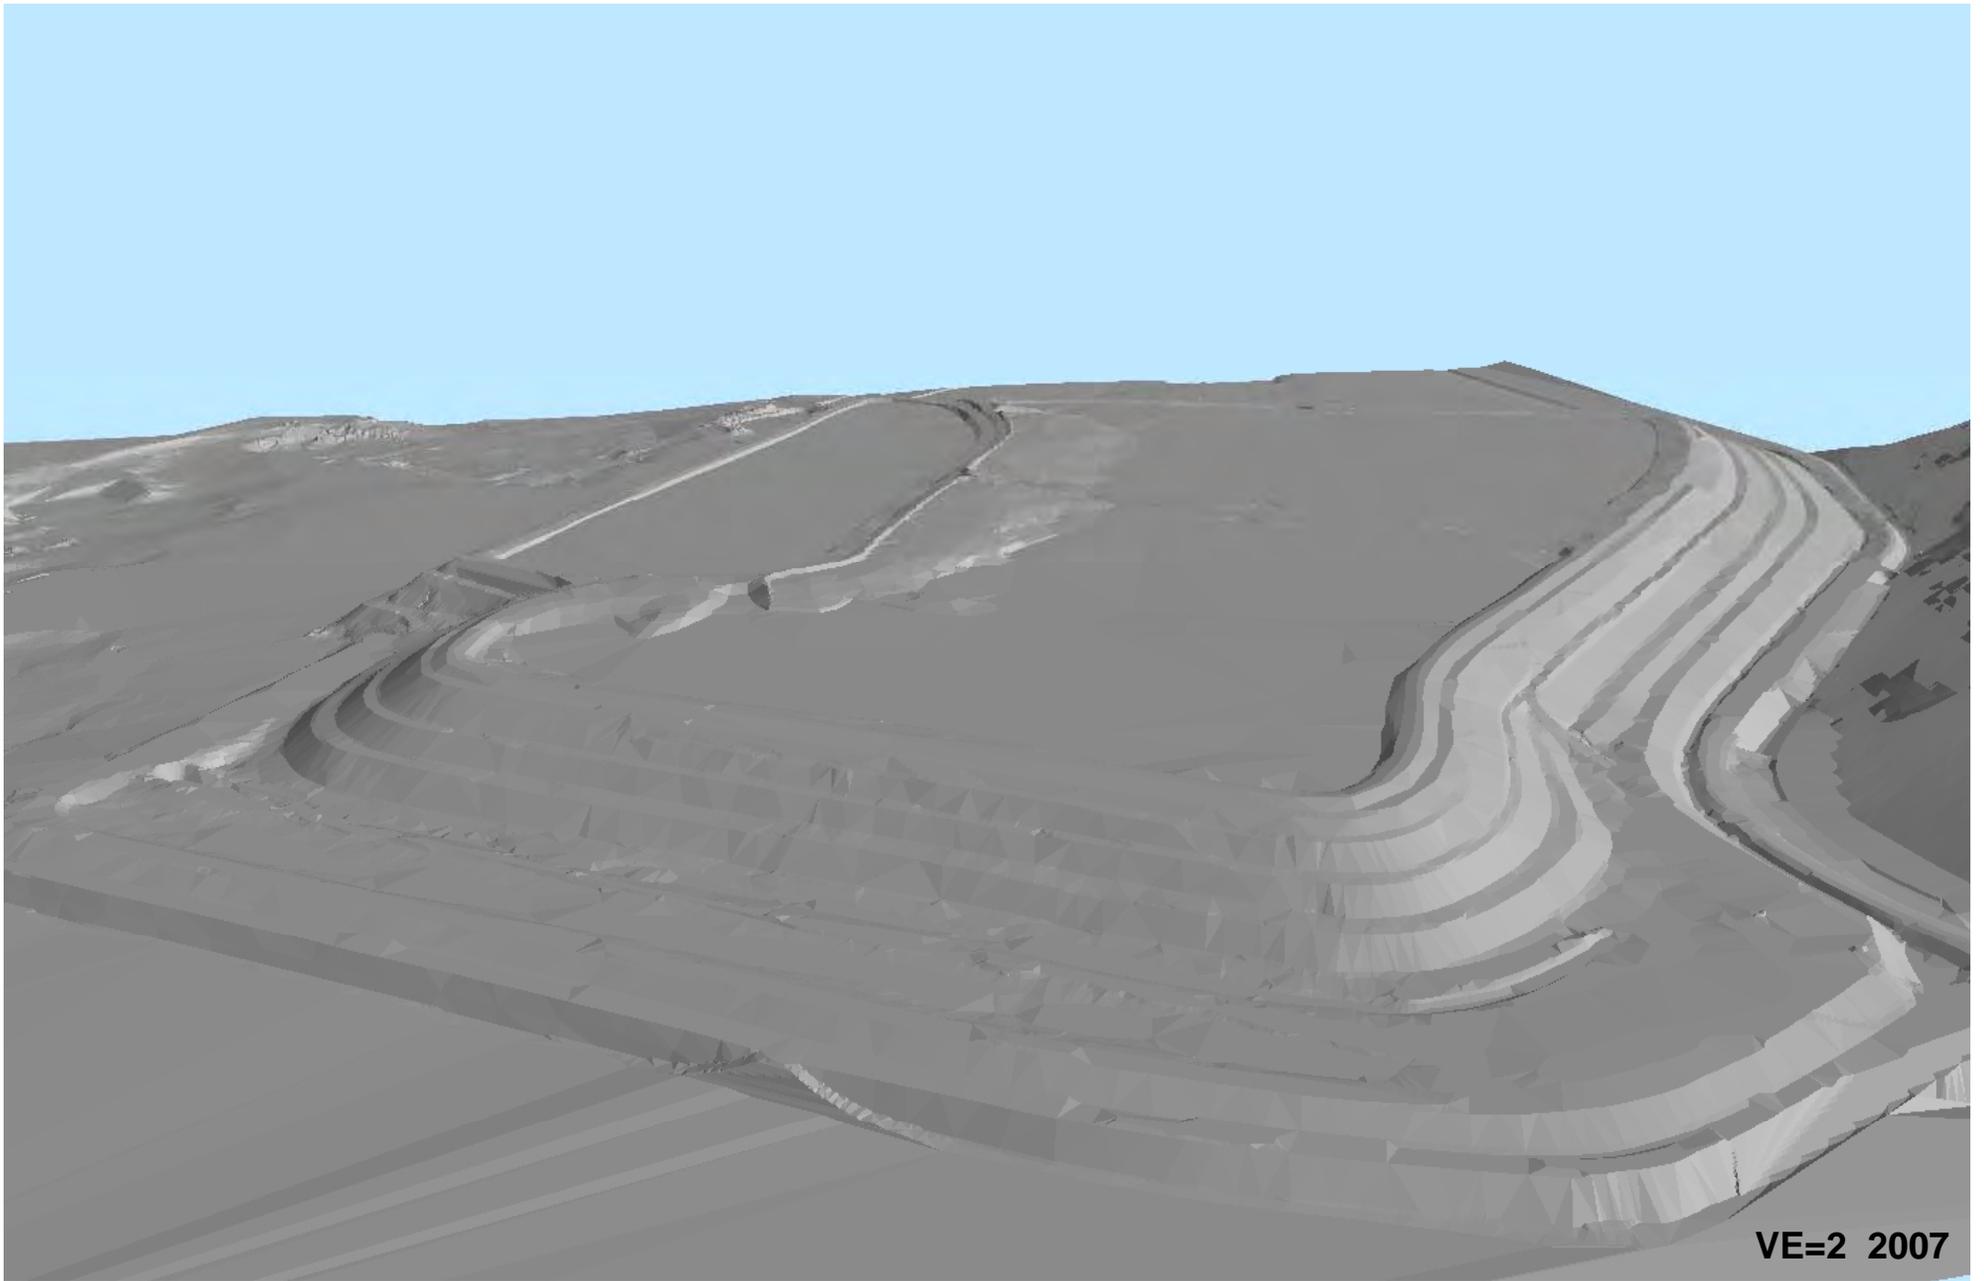
2007 Pre-Failure Topography from TVA Surveys

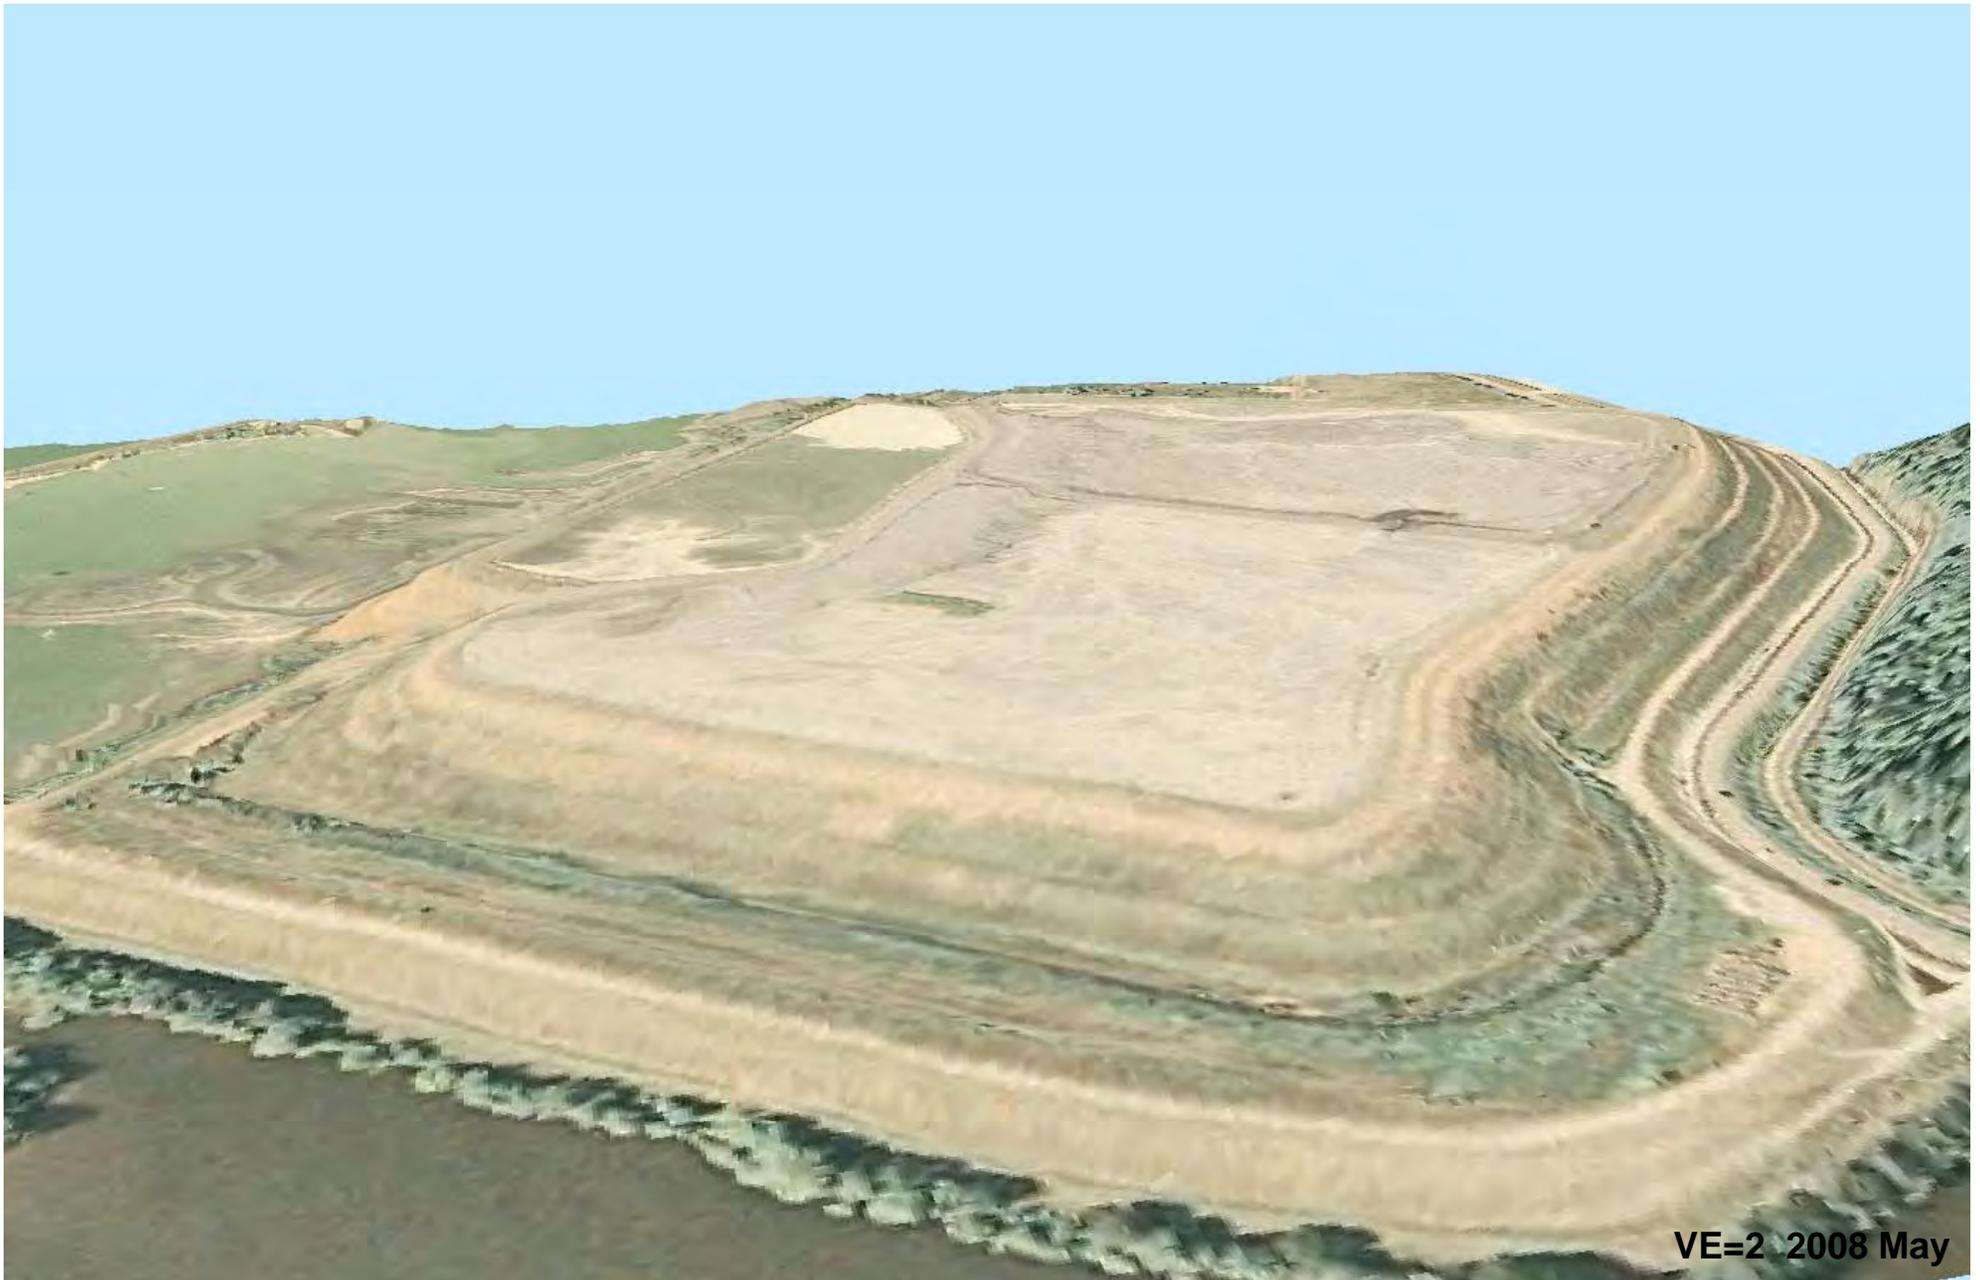
May 2008 Air Photo and Topography from Pre-Failure from TVA Surveys
