# Kingston Ash Disposal Cells

# **Failure Chronology**

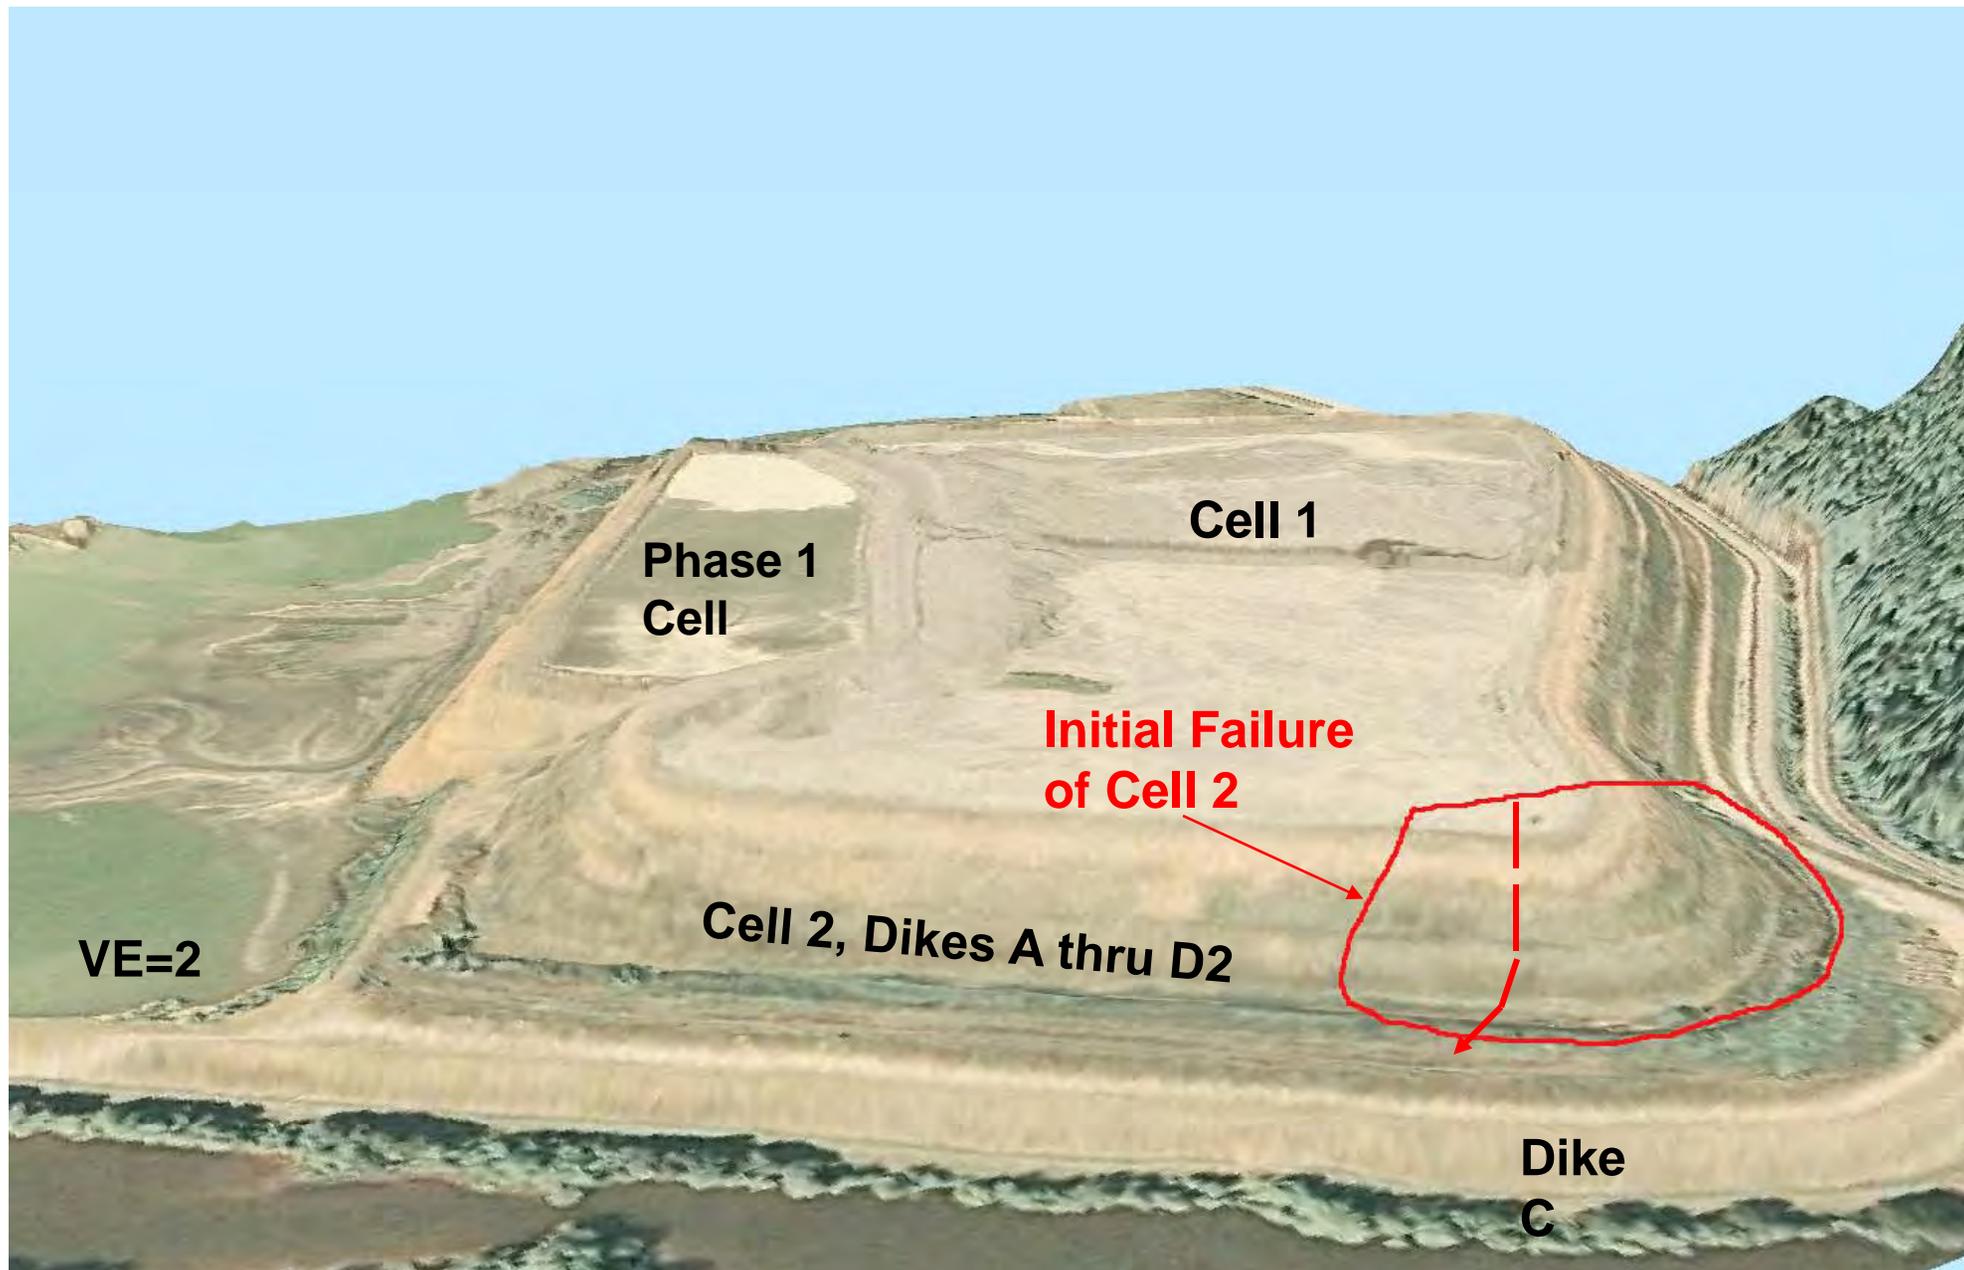
**December 22, 2008 Expected Failure Location at NW Corner of Cell 2**

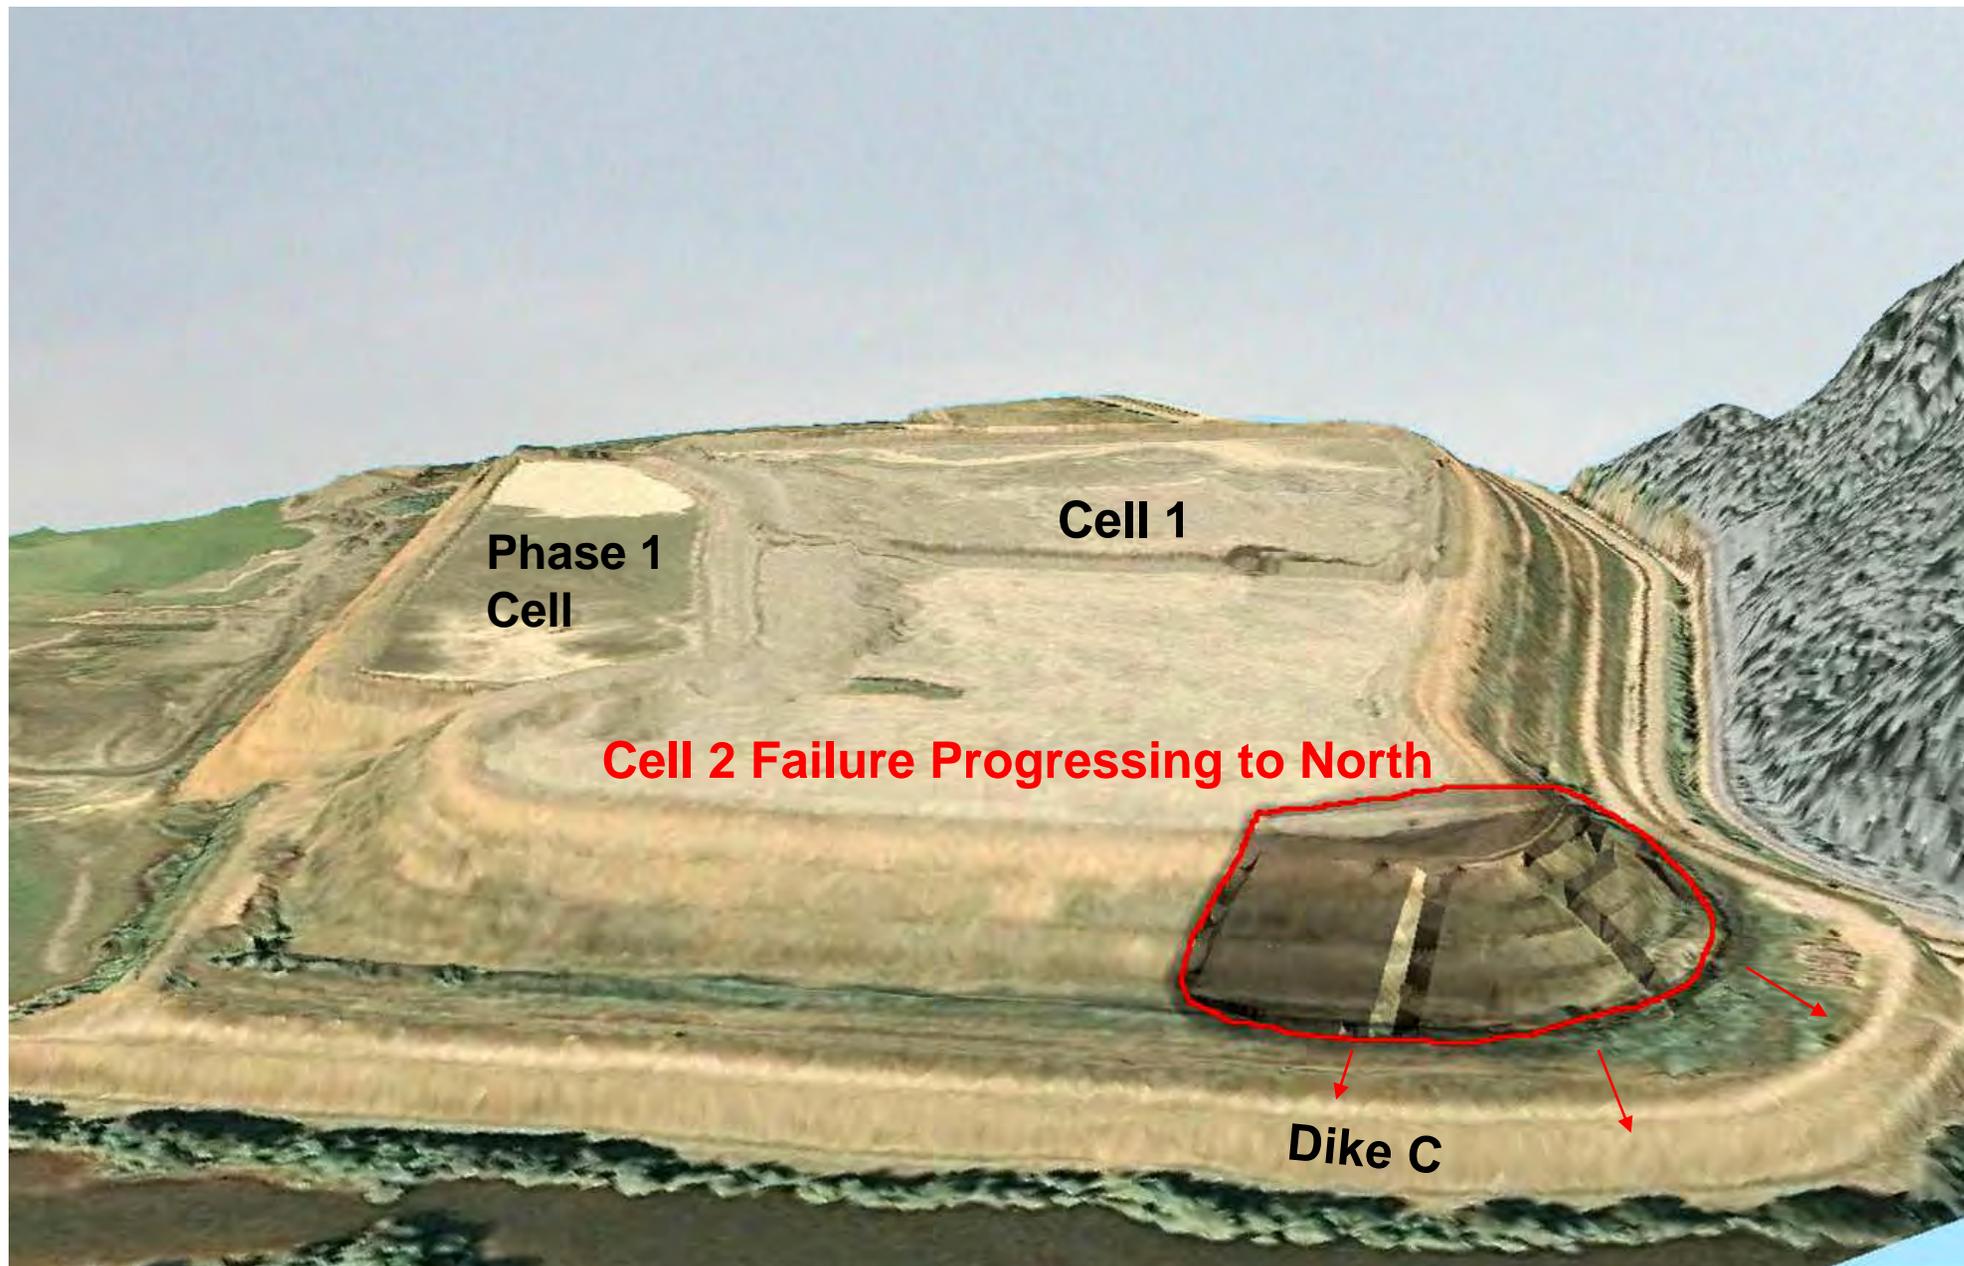
**December 22, 2008 Expected Failure Location at NW Corner of Cell 2**

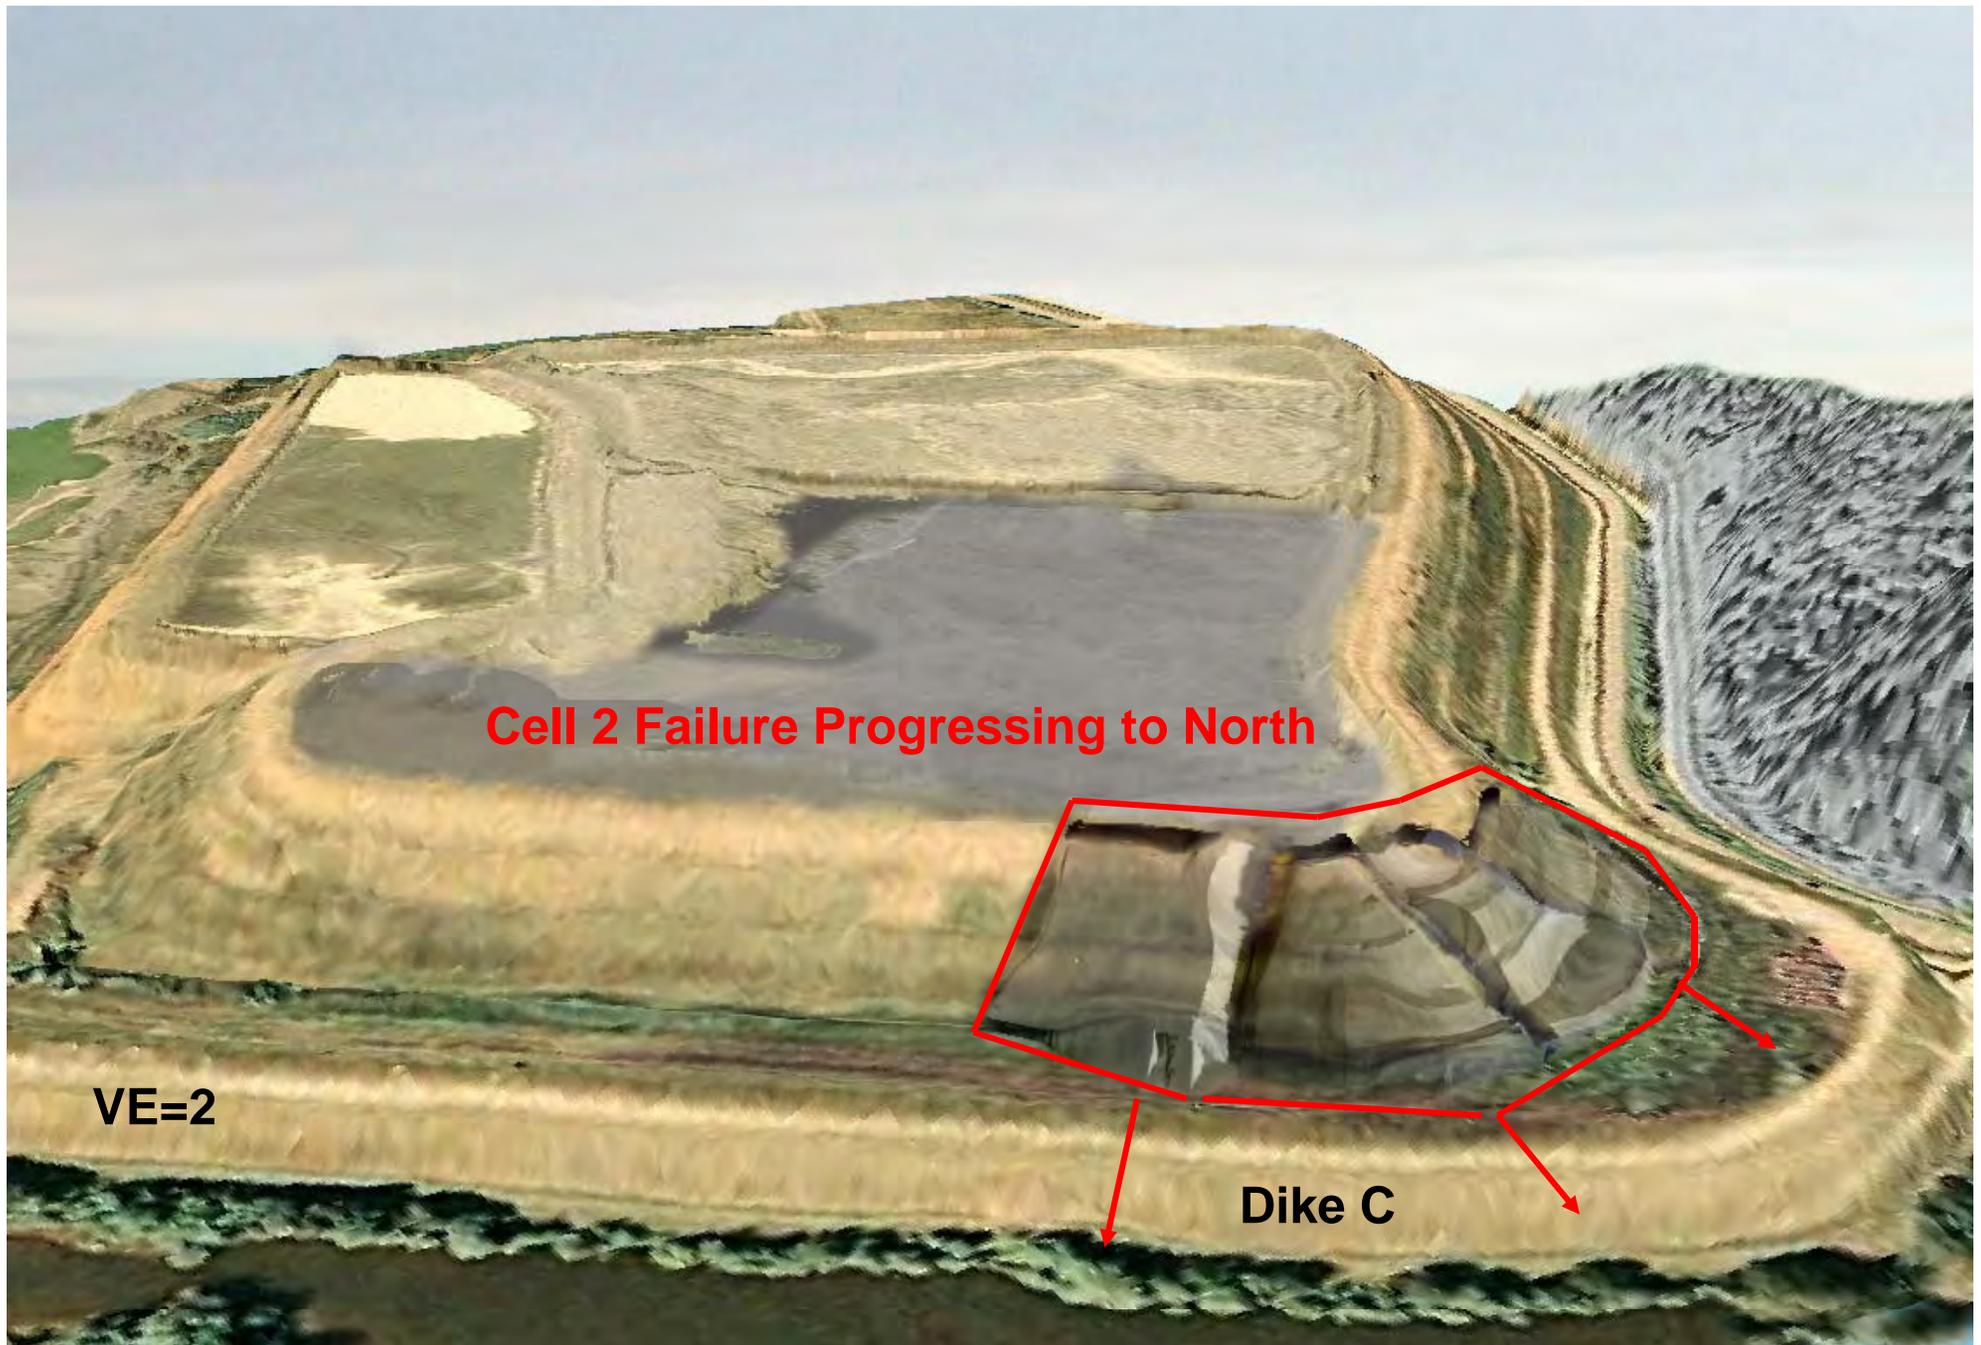
**Cell 2 Failure Progressing to North**

**December 22, 2008 Expected Failure Mode at NW Corner of Cell 2**

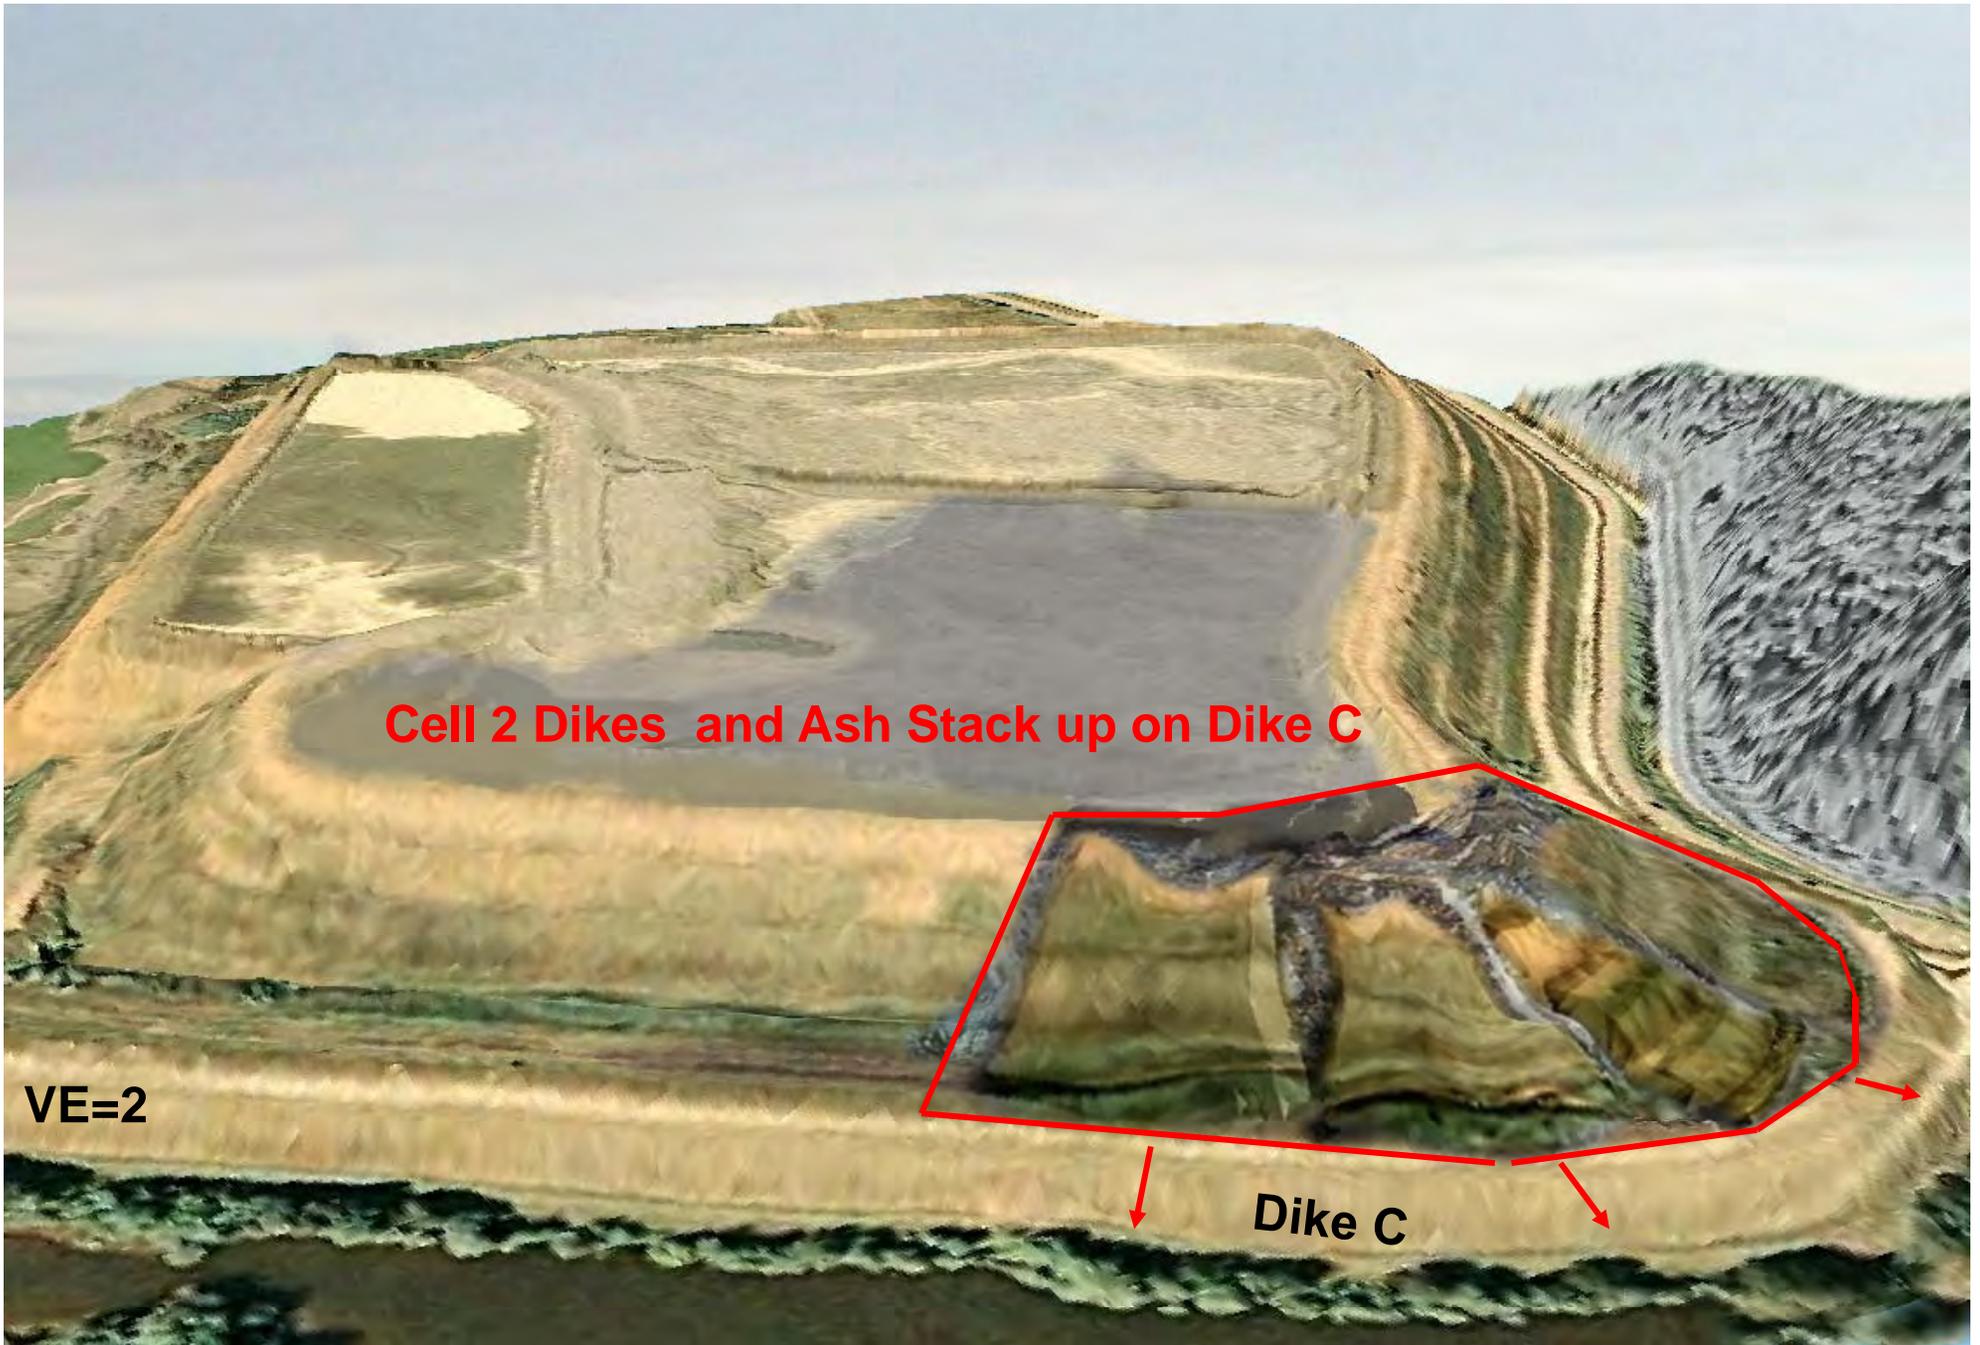
**December 22, 2008 Expected Failure Mode at NW Corner of Cell 2**

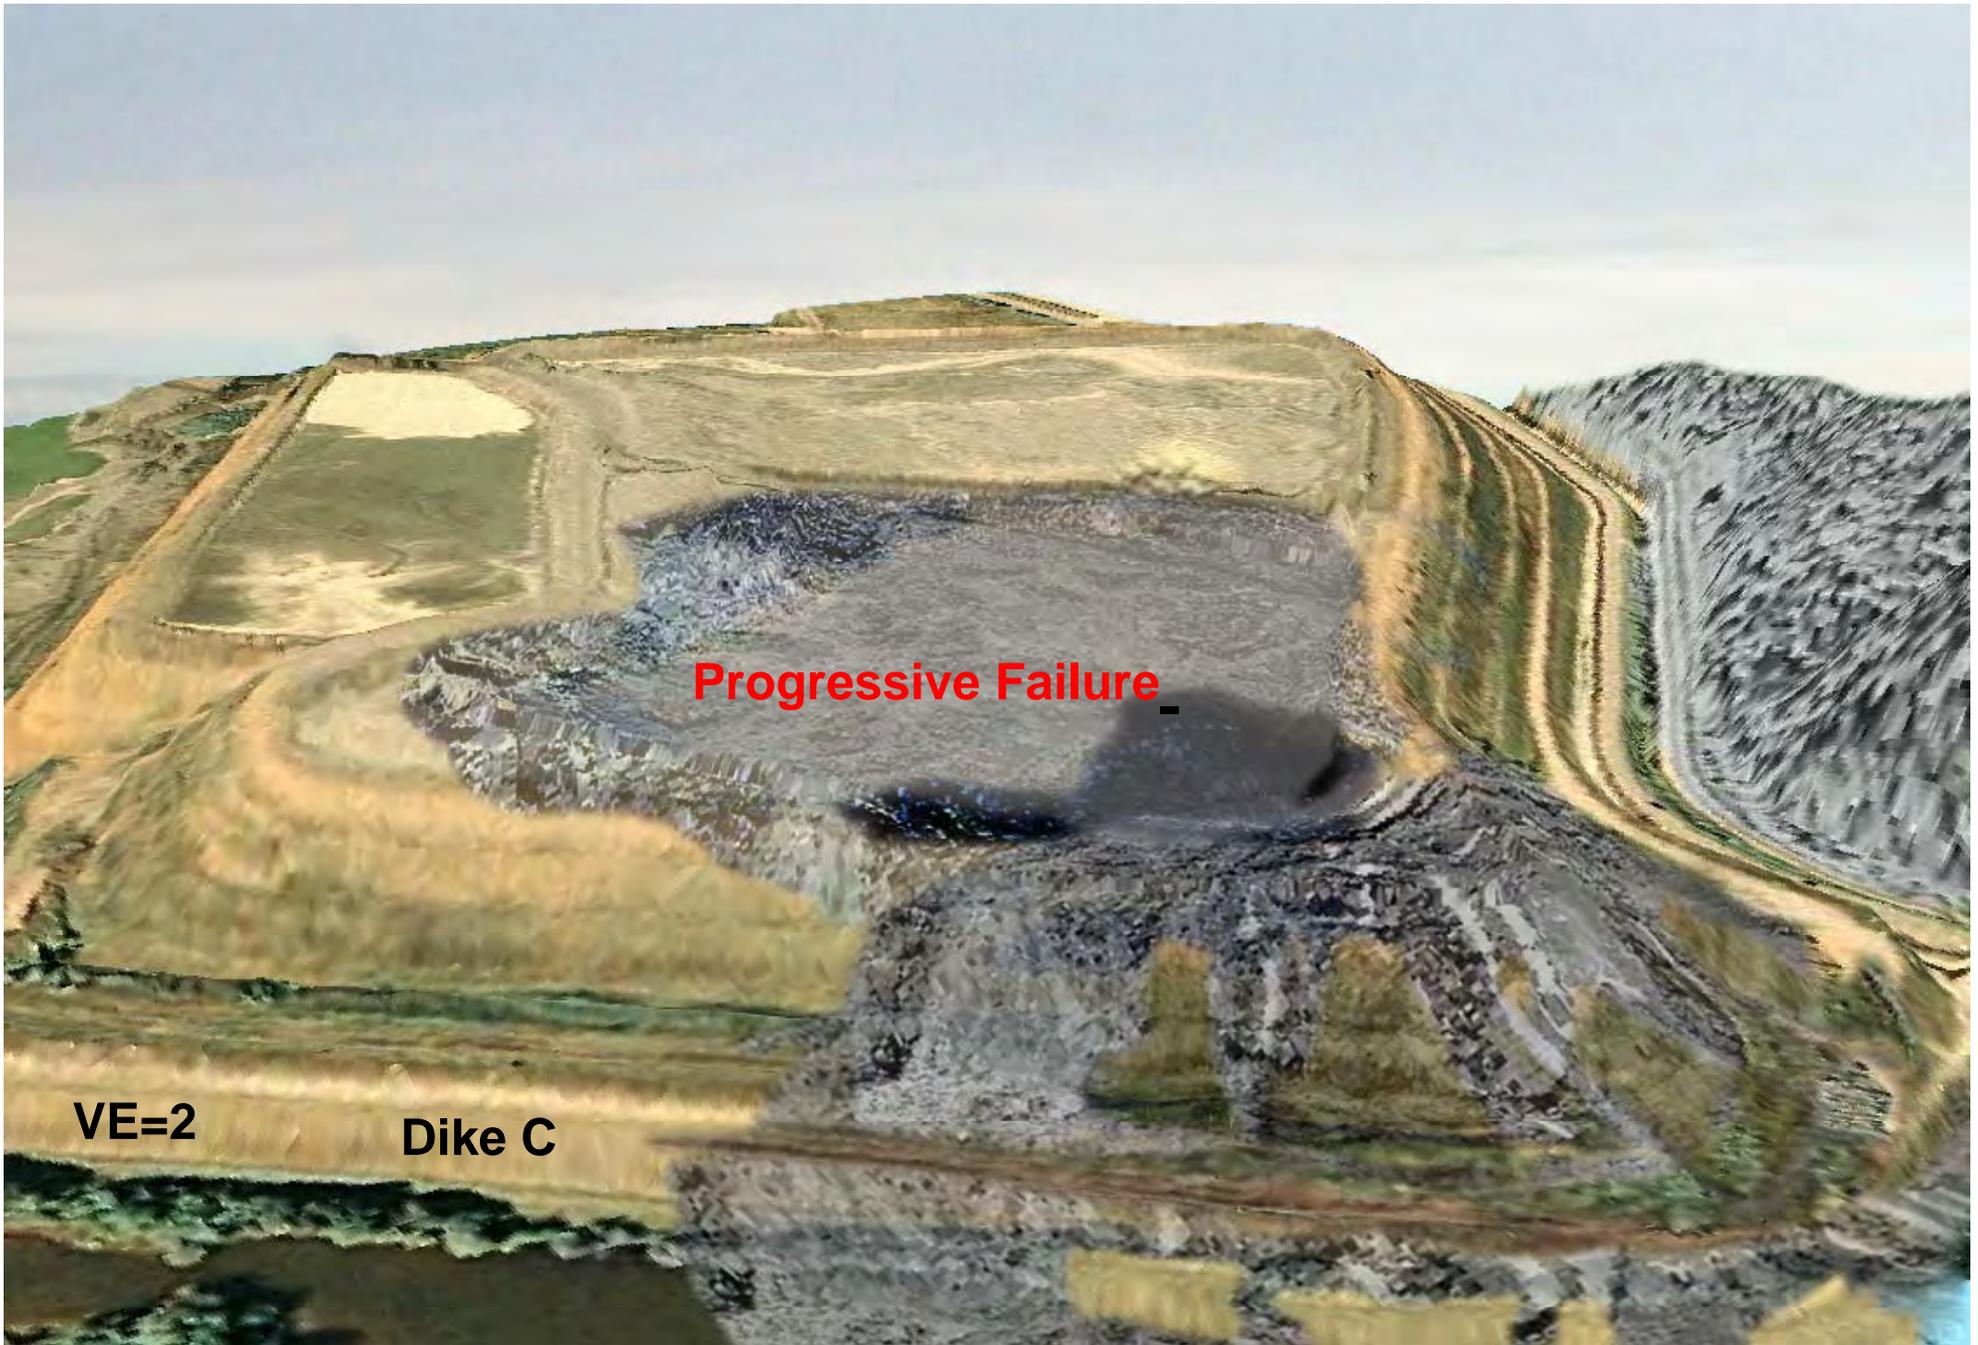
**December 22, 2008 Expected Failure Mode at NW Corner of Cell 2**

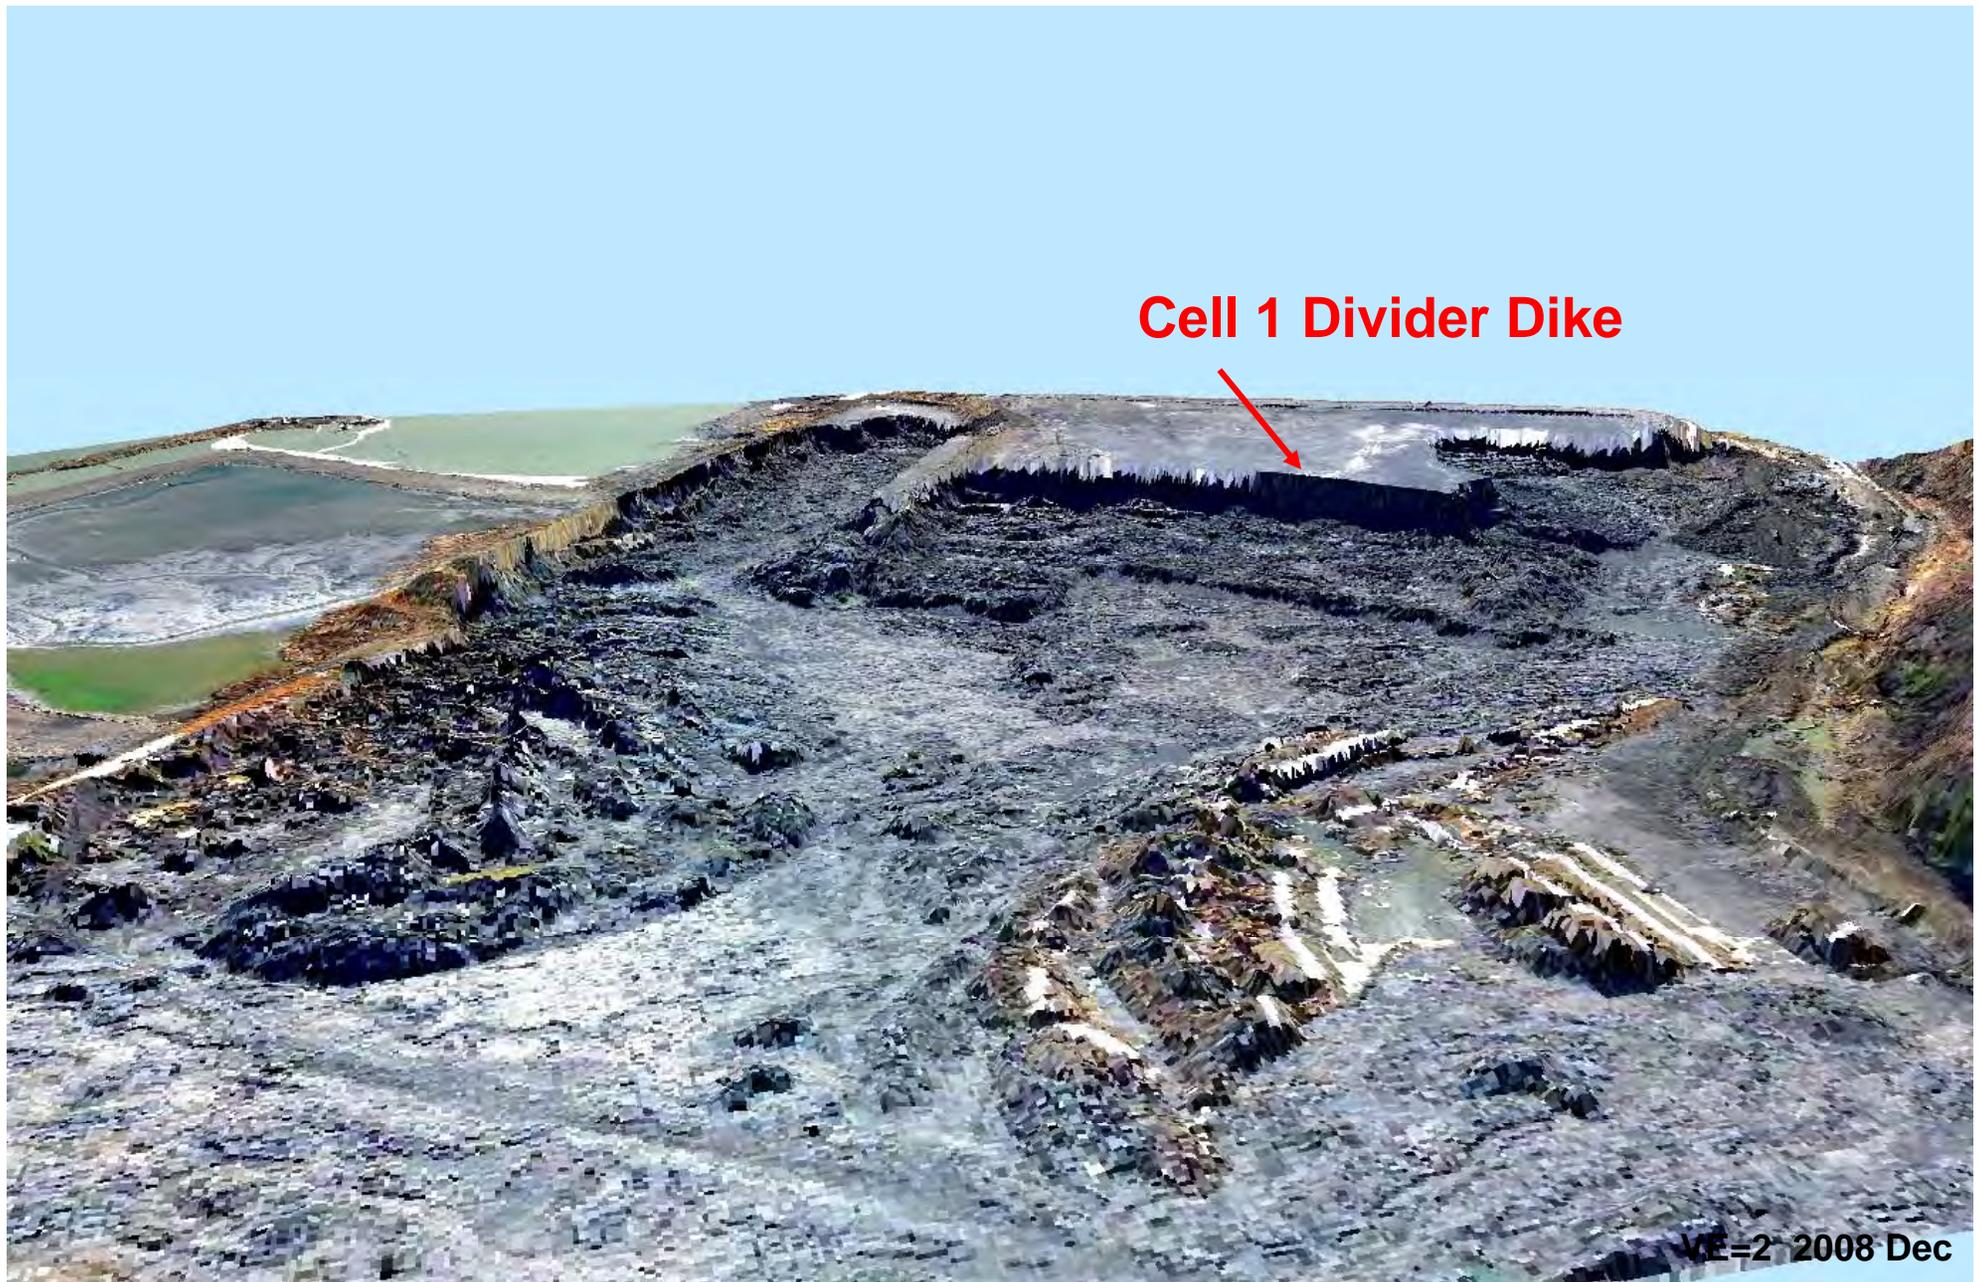
**December 23, 2008 Post Failure Photo Overlaid on TVA Surveys**

**5.4 Million Yards Lost**

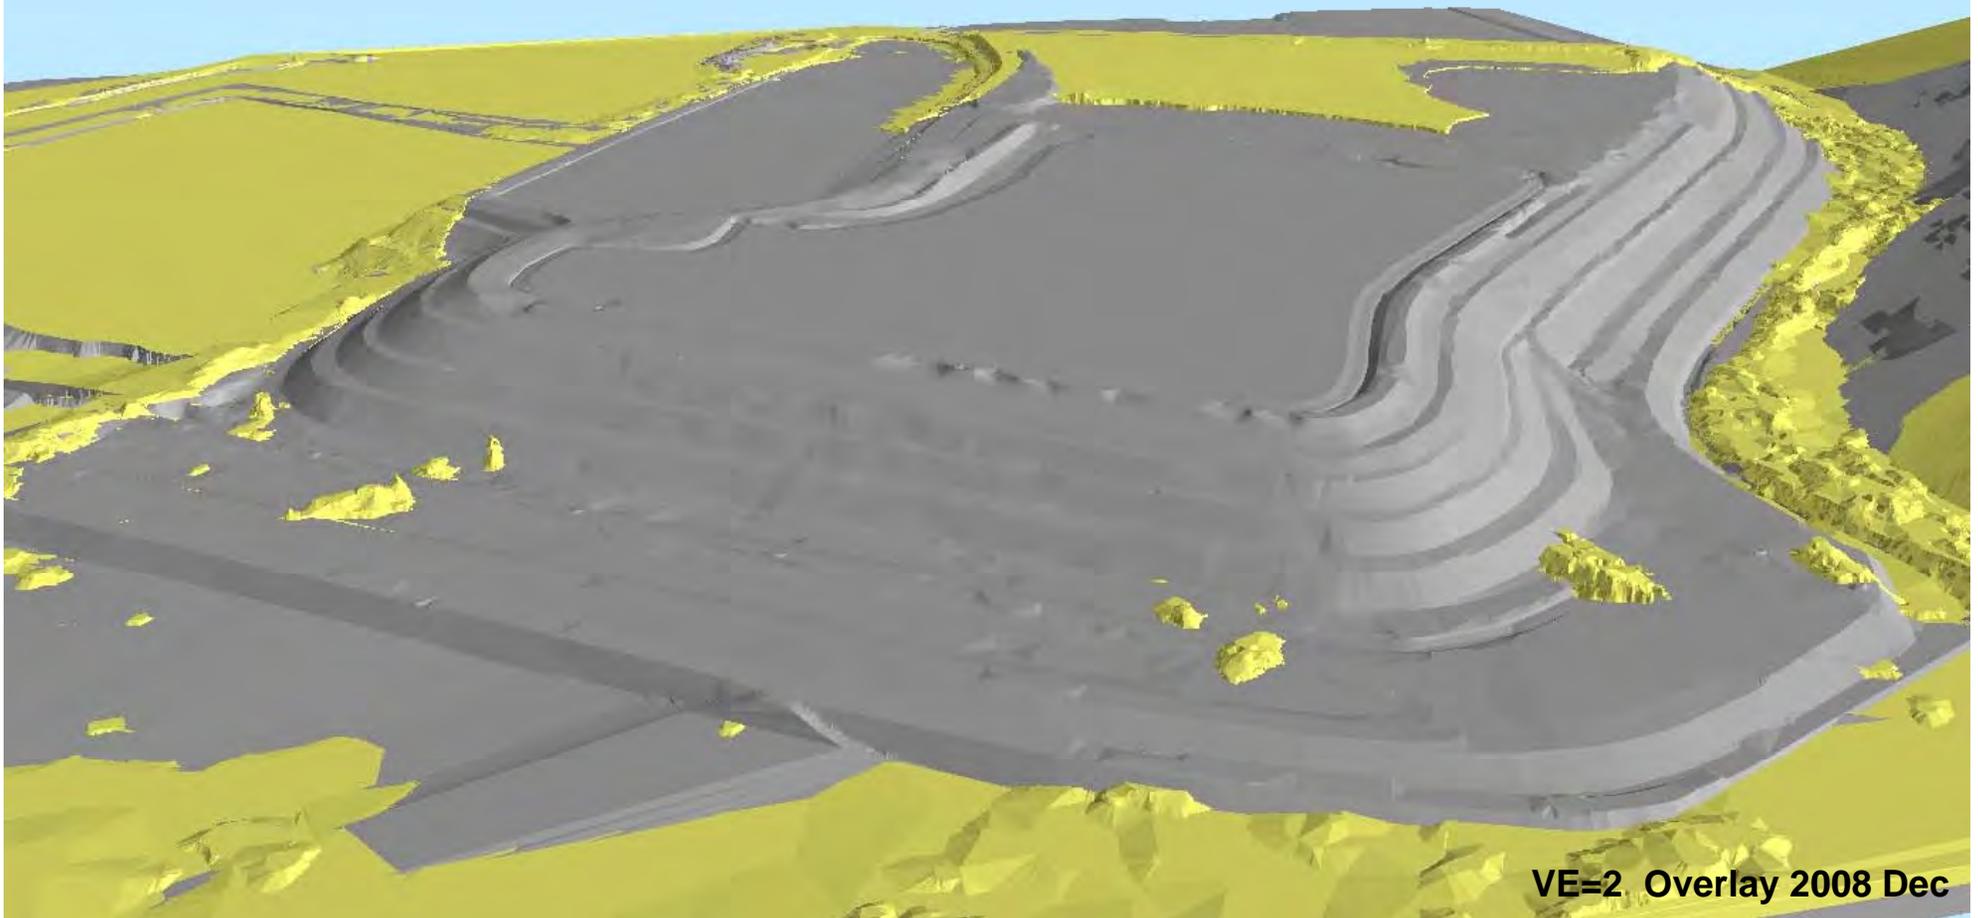
**Post Failure Overlaid Over Pre-Failure from TVA Surveys**

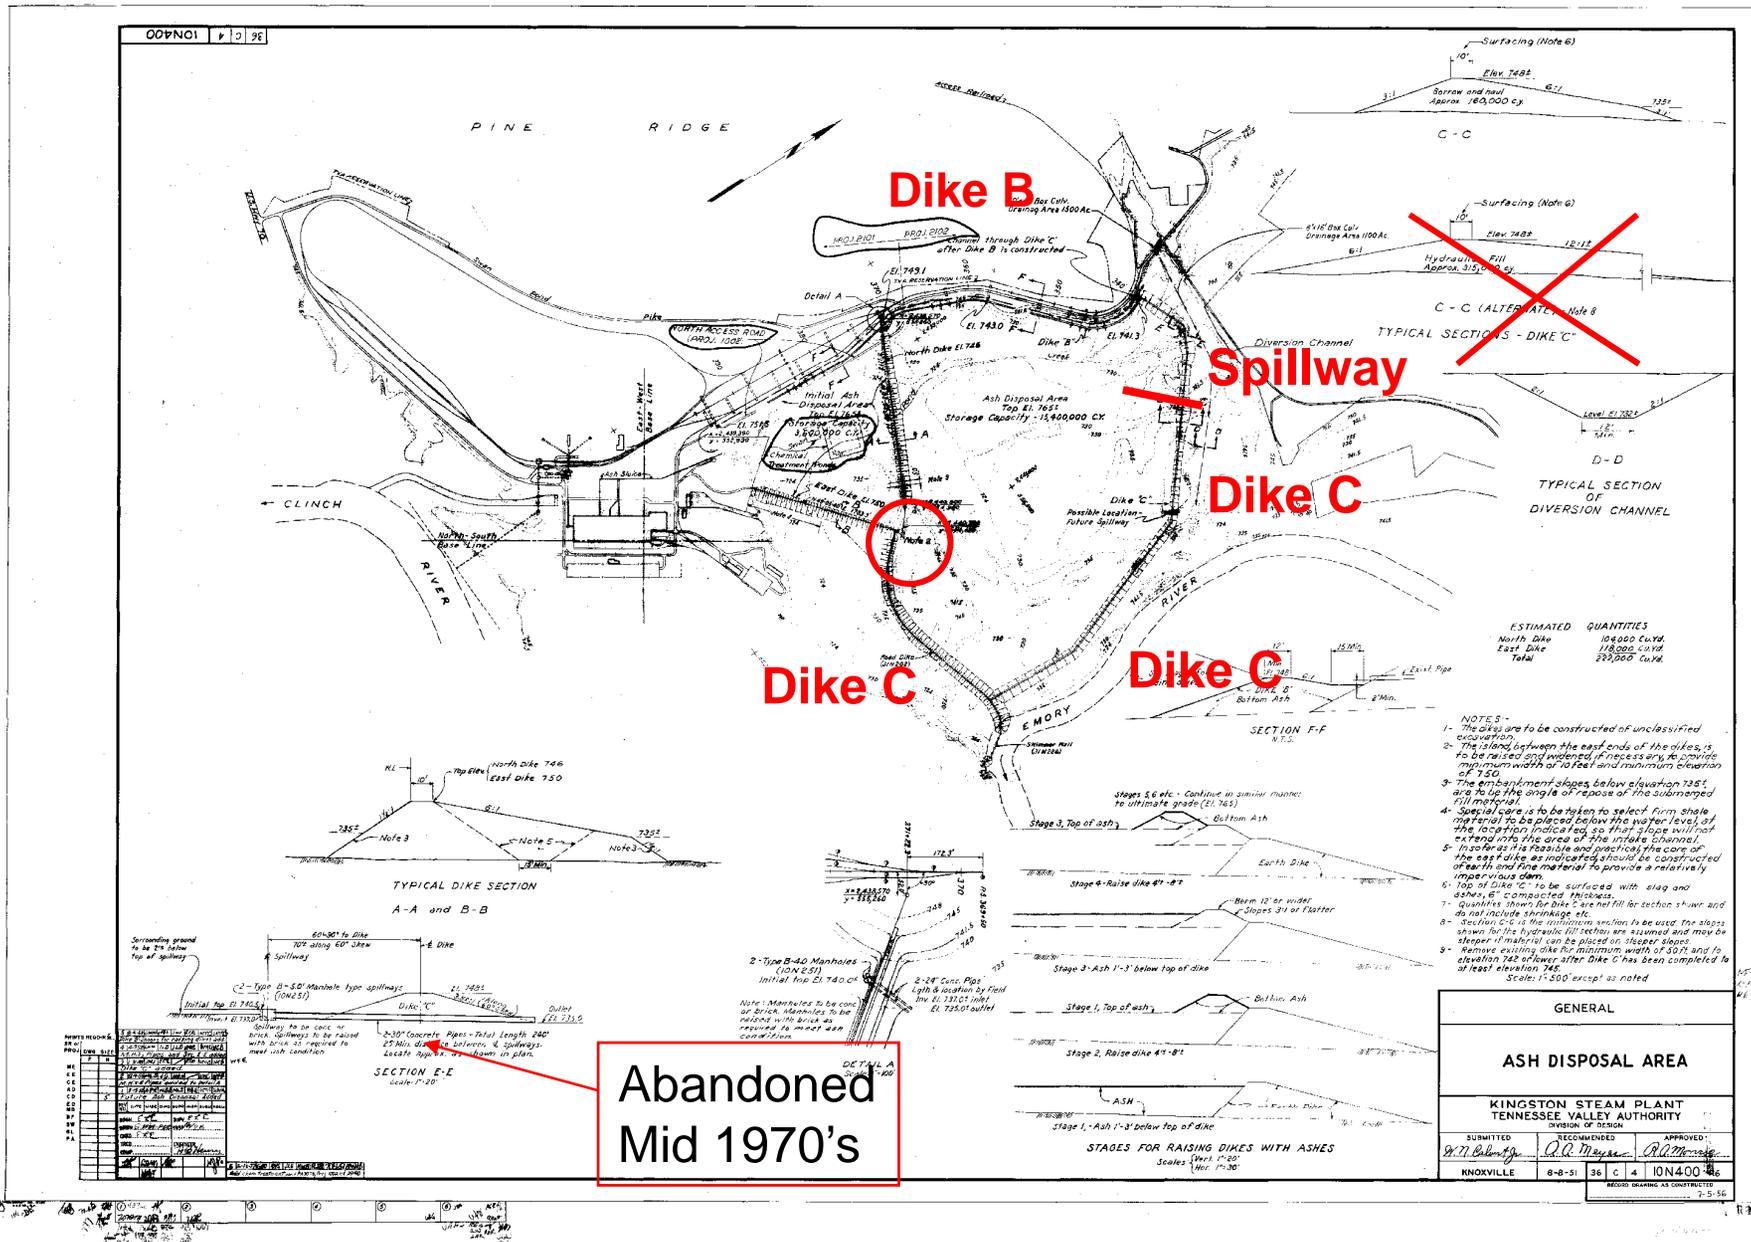
# TVA 1951 to 1977 Ash Pond Design

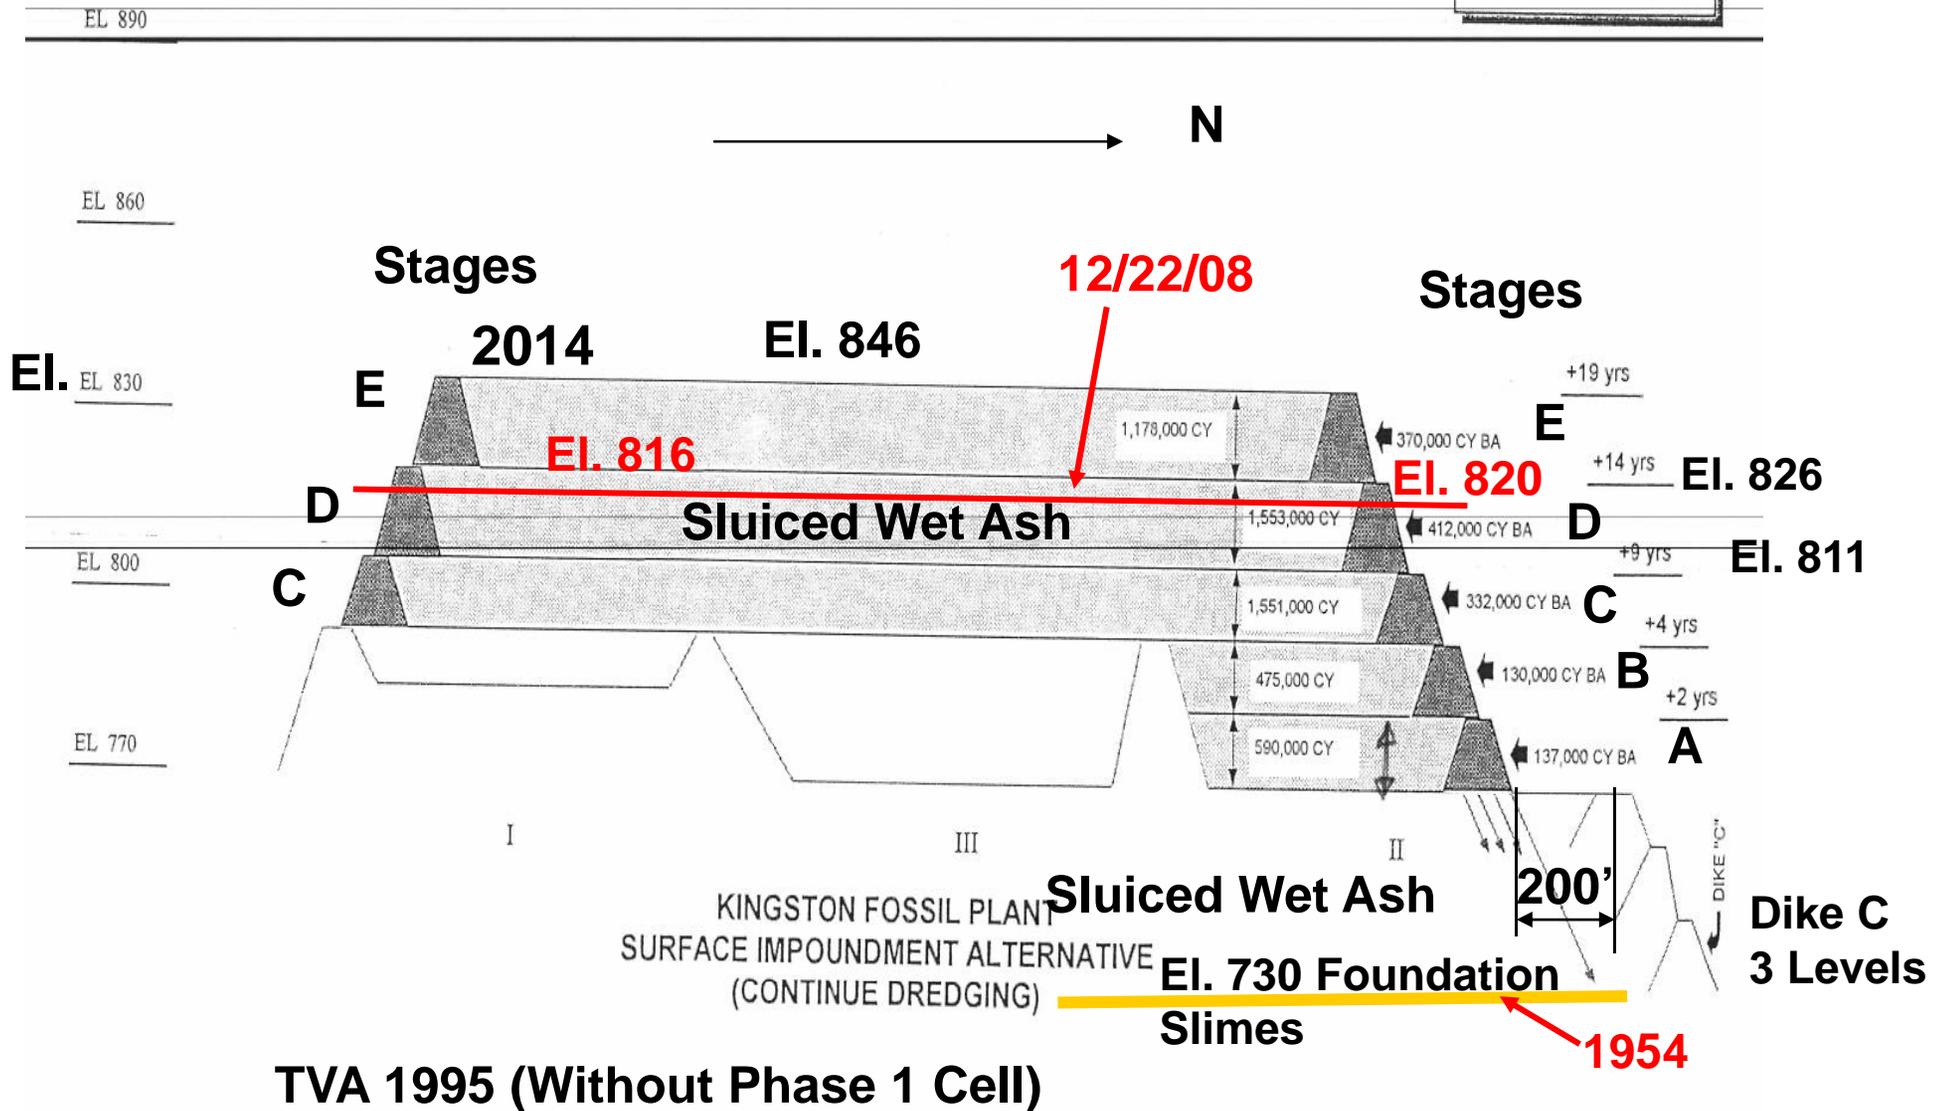
# Cells 1, 3 and 2 Expansion by Dredging
