# Kingston Ash Disposal Cells

# **Failure Chronology**

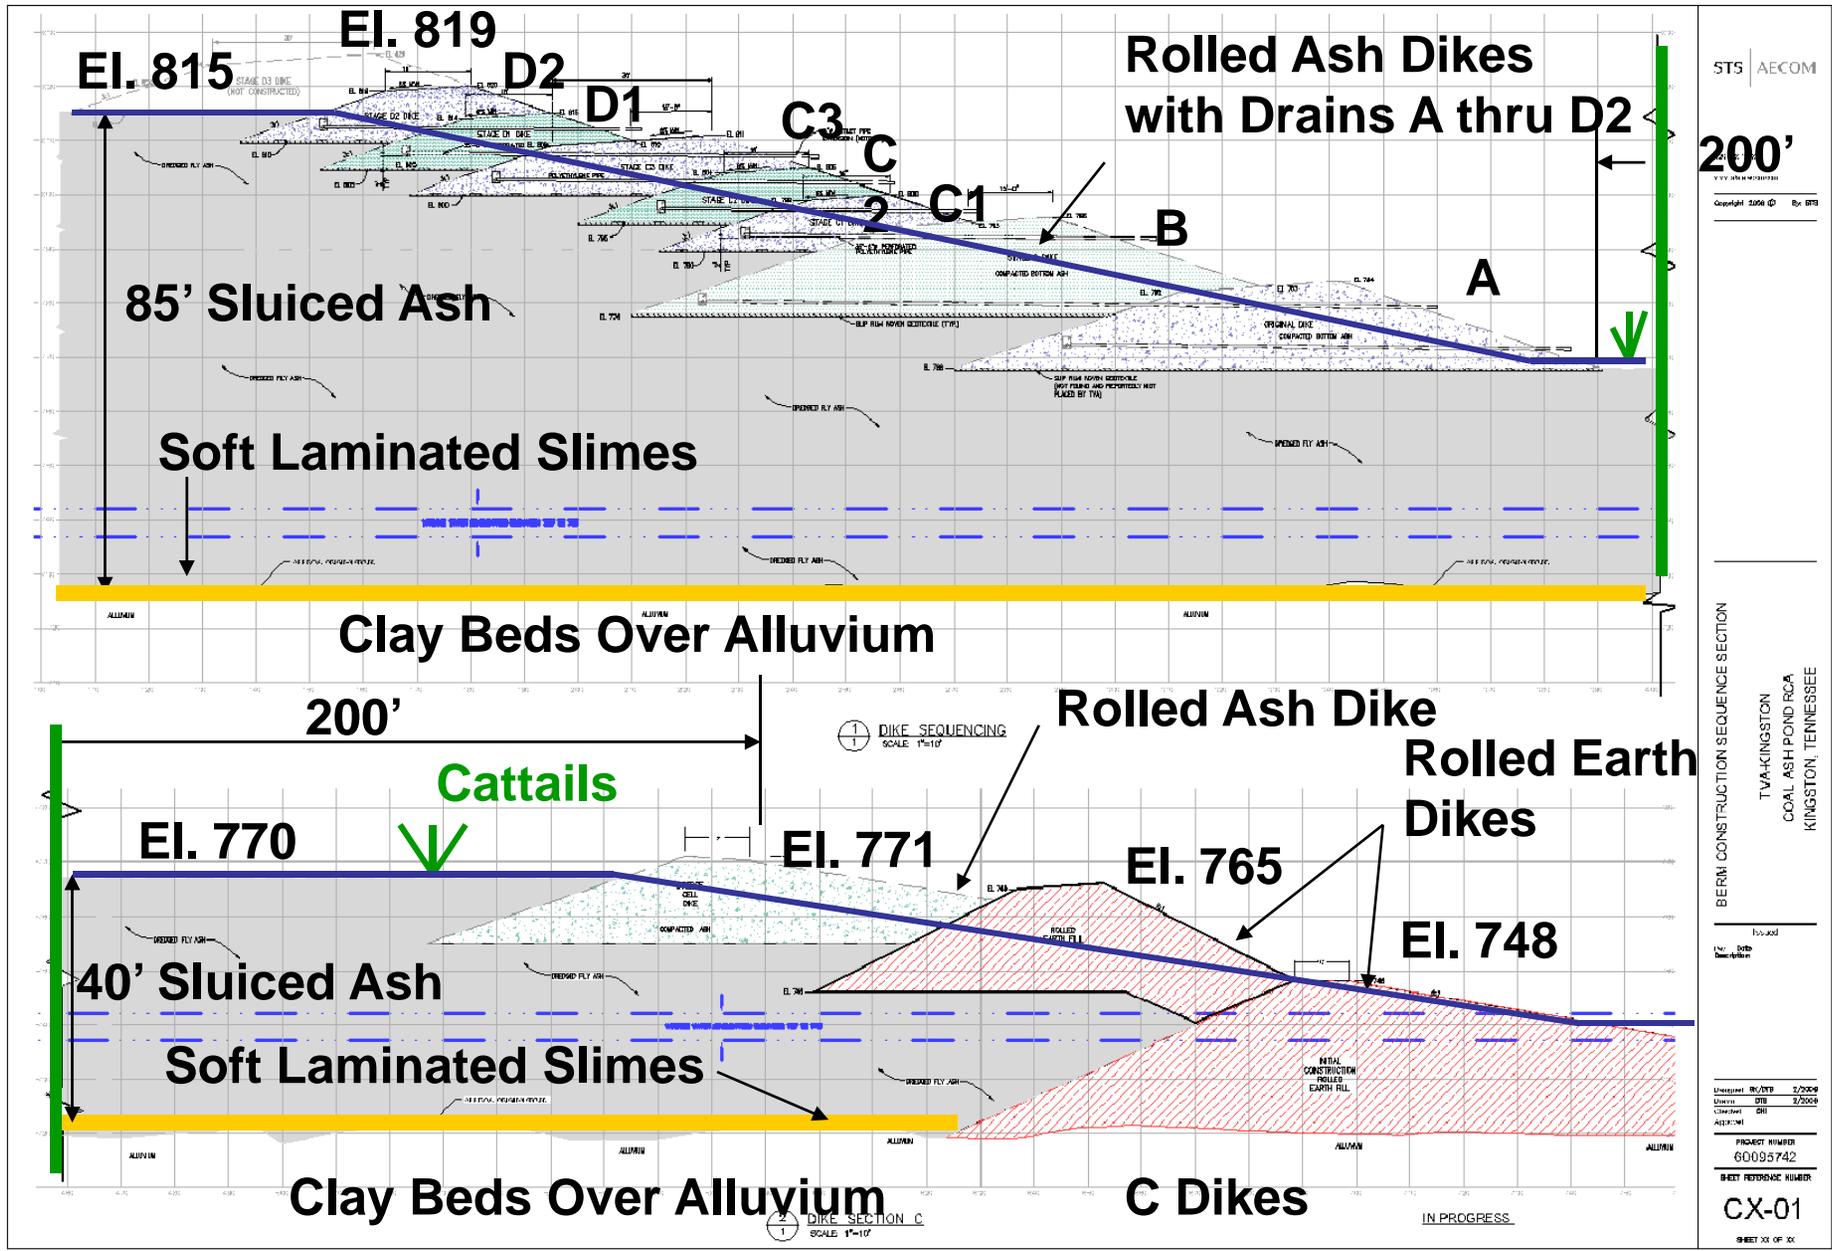
# Cell 2 and Dike C Cross-Section A-A'

BERM CONSTRUCTION SEQUENCE SECTION

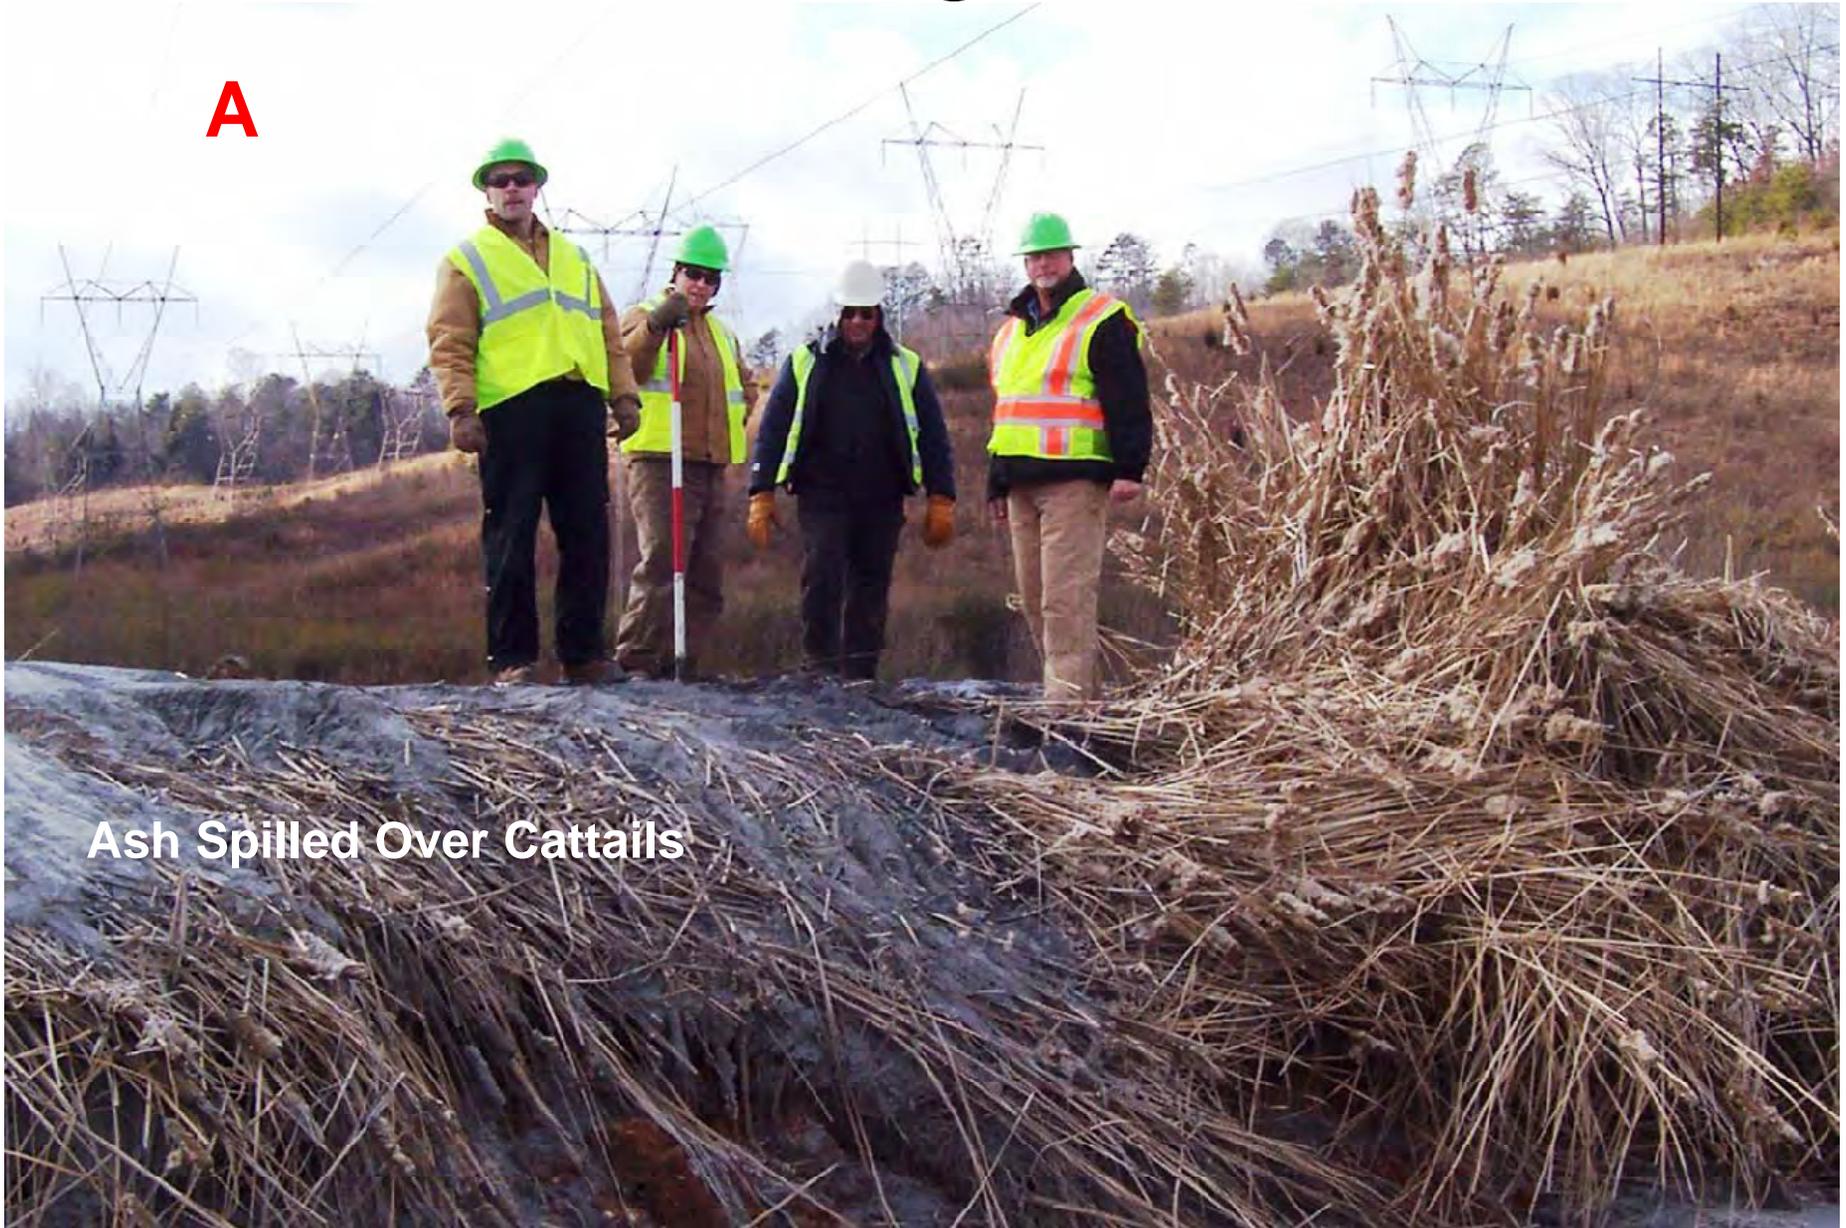
# Relic El. 670 Bench at North End of Slough 2

Ash Spilled Over Cattails

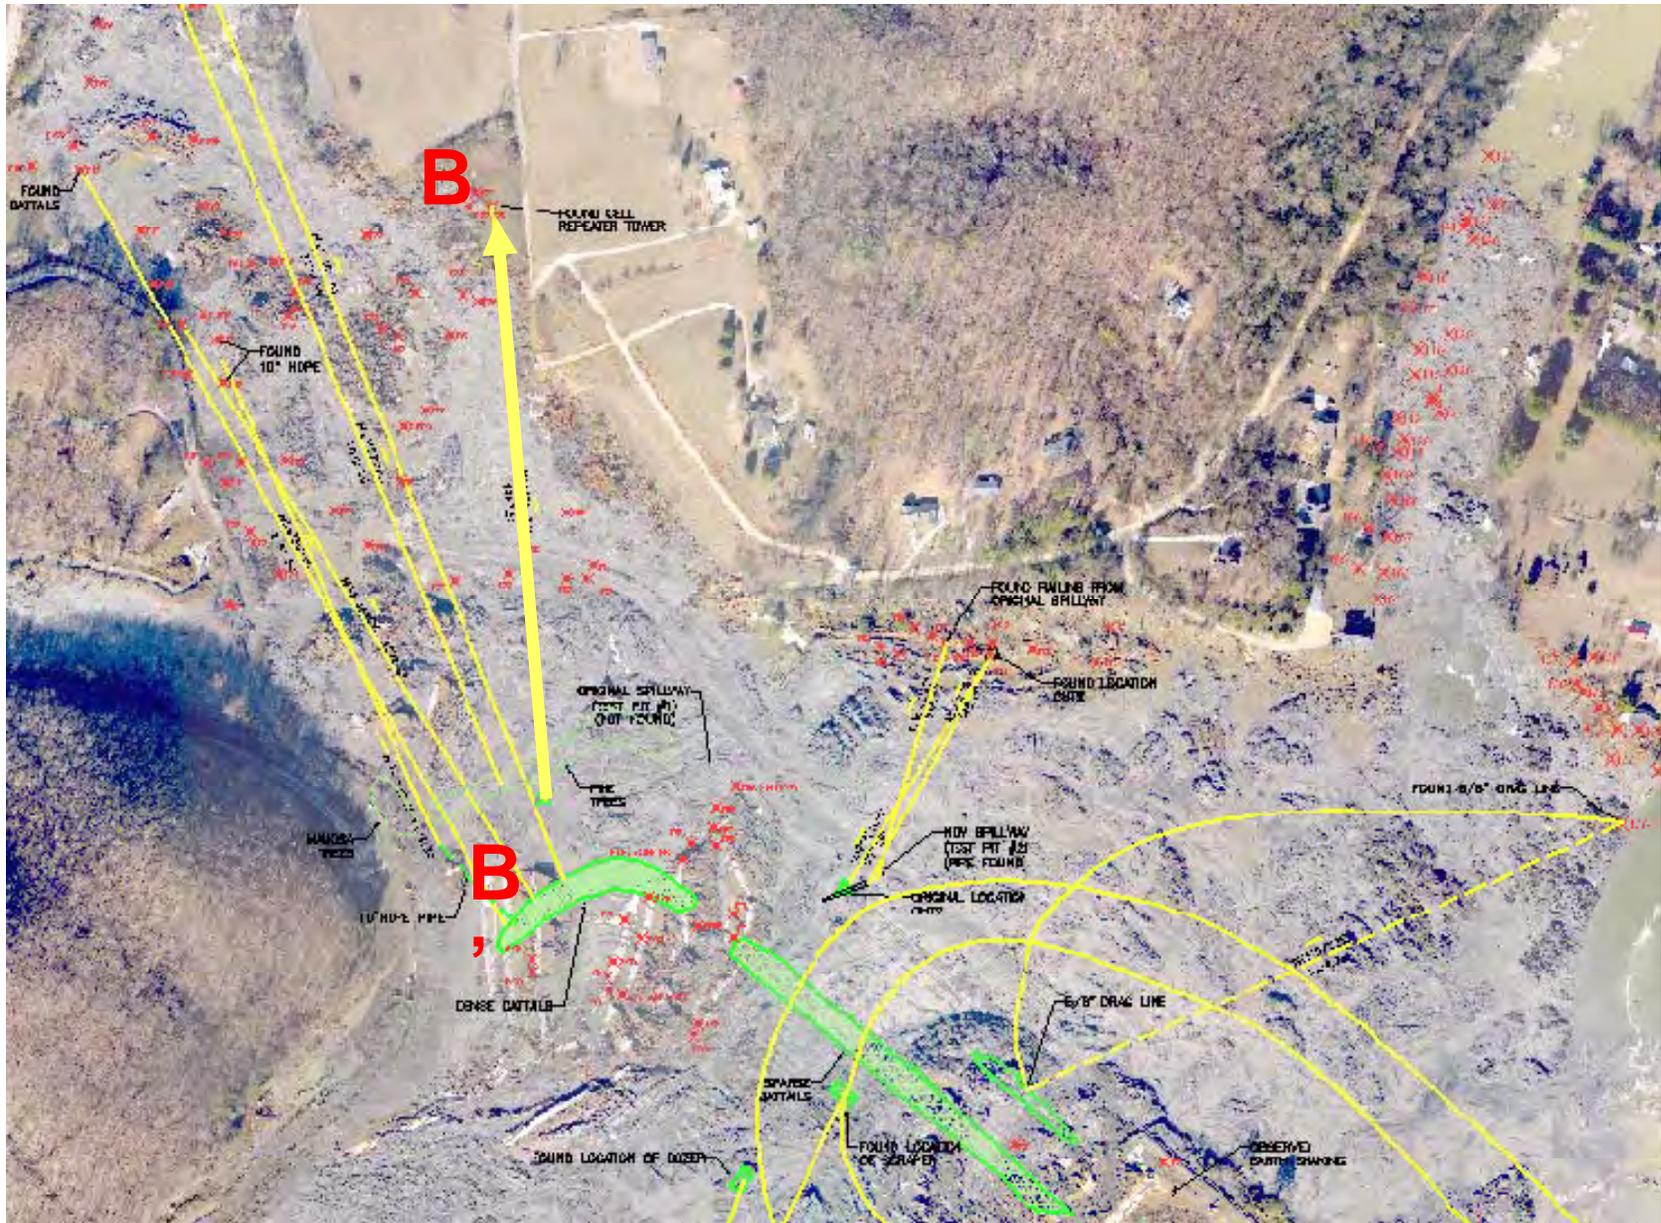
# Relic Survey Summary 2/13/09

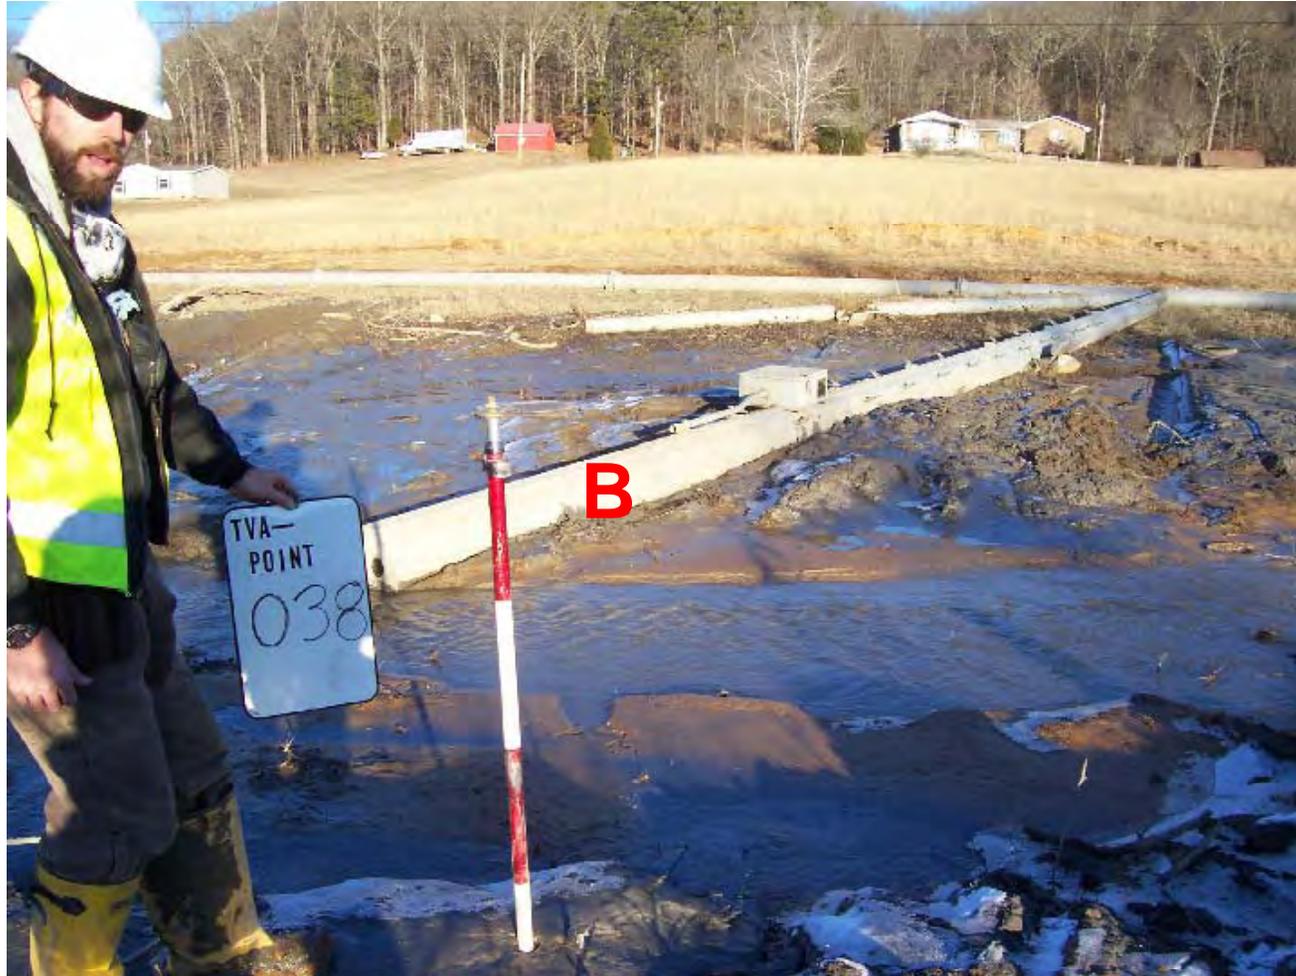
# Relic Cell Tower

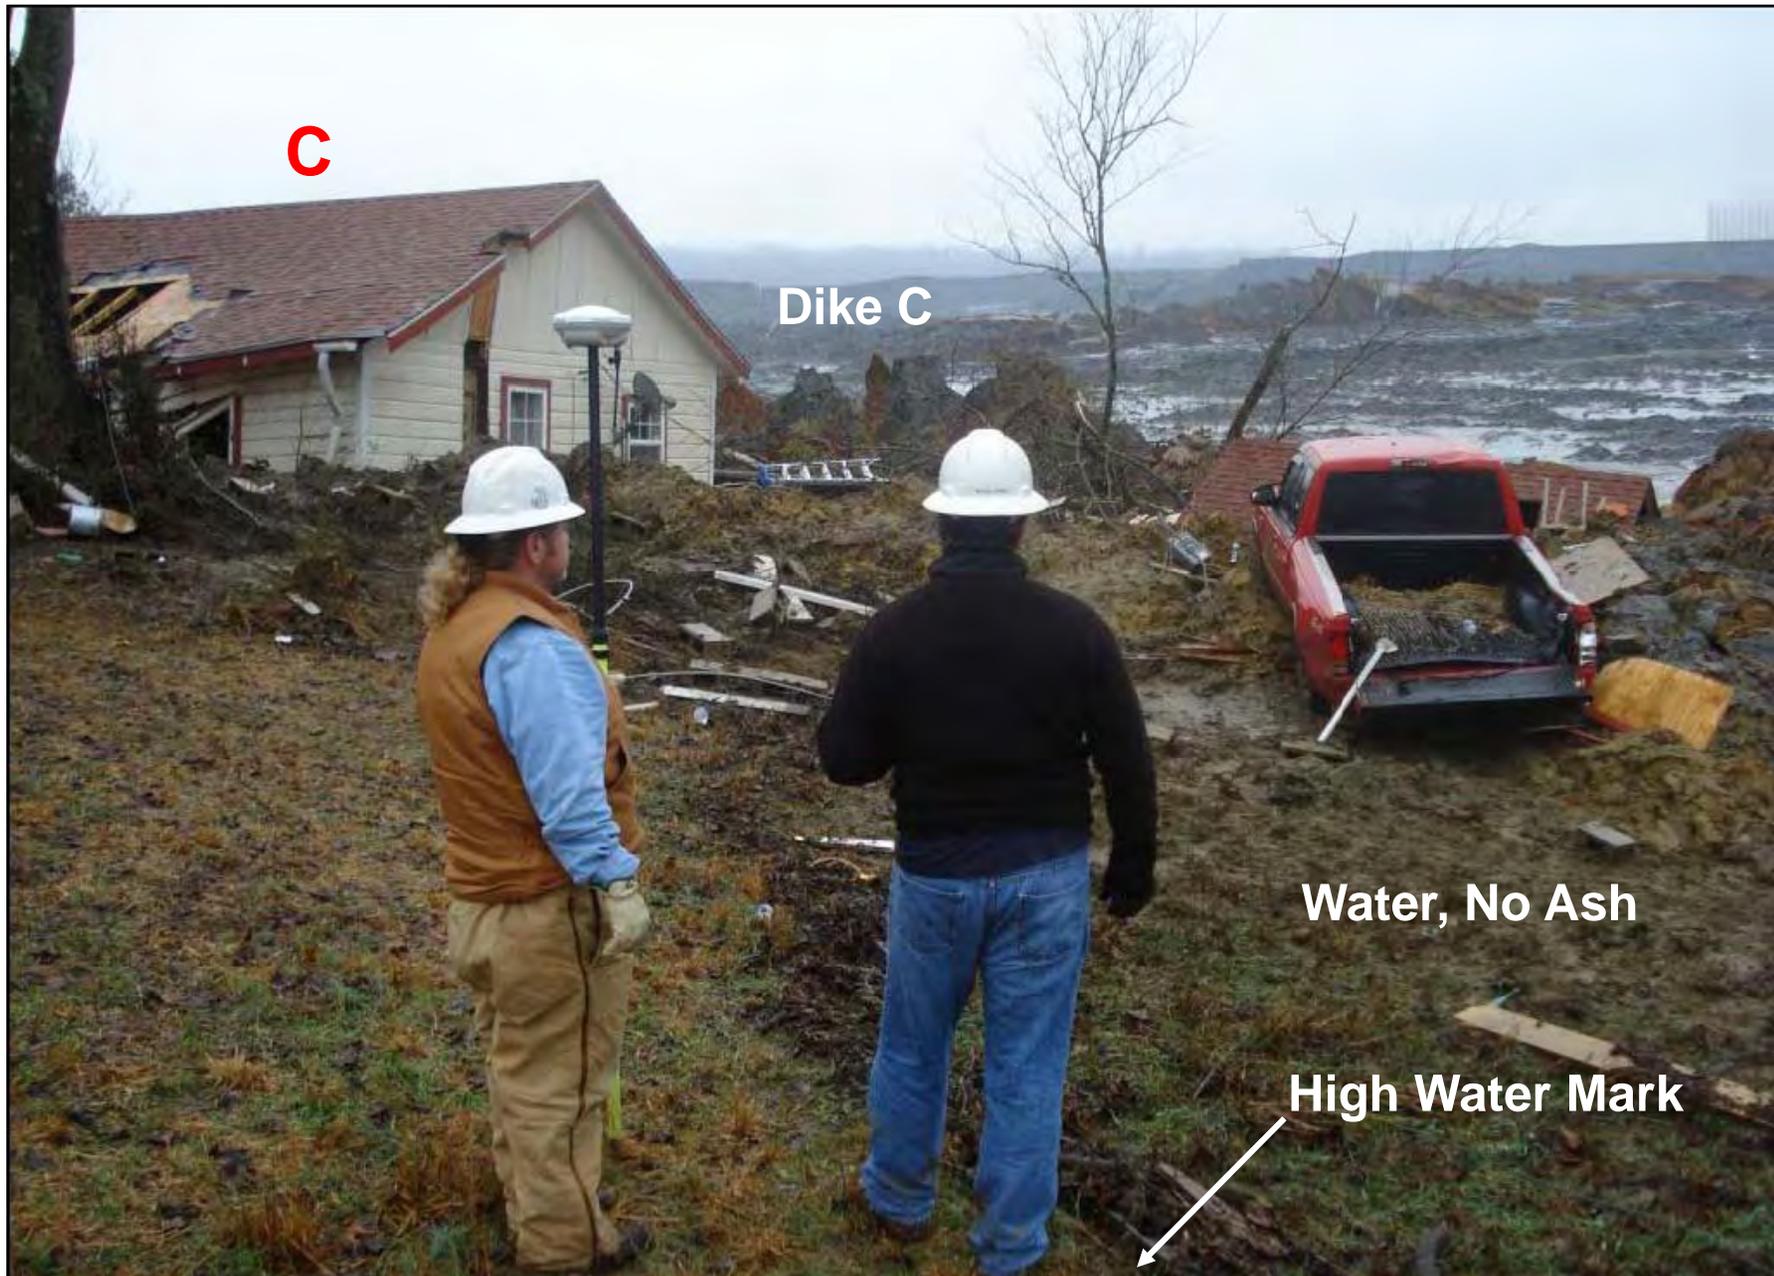
# Home Pushed onto Swan Pond Circle
