Weak Thin Layer of Silt and Ash Slimes at Bottom of Loose Ash

OSTERBERG/SPLIT SPOON SAMPLES AND CPT SENSITIVE SOIL(SLIMES) THICKNESS, FT.
 ROOT CAUSE ANALYSIS
 TVA KINGSTON DREDGE CELL FAILURE
 ON DECEMBER 22, 2008
 KINGSTON FOSSIL PLANT
 HARRIMAN, TENNESSEE

Photos and Selected Tests on Tube
Samples of Sensitive Silt and
Failure Slide Plane in 100 Series
Holes at toe of Cell 2

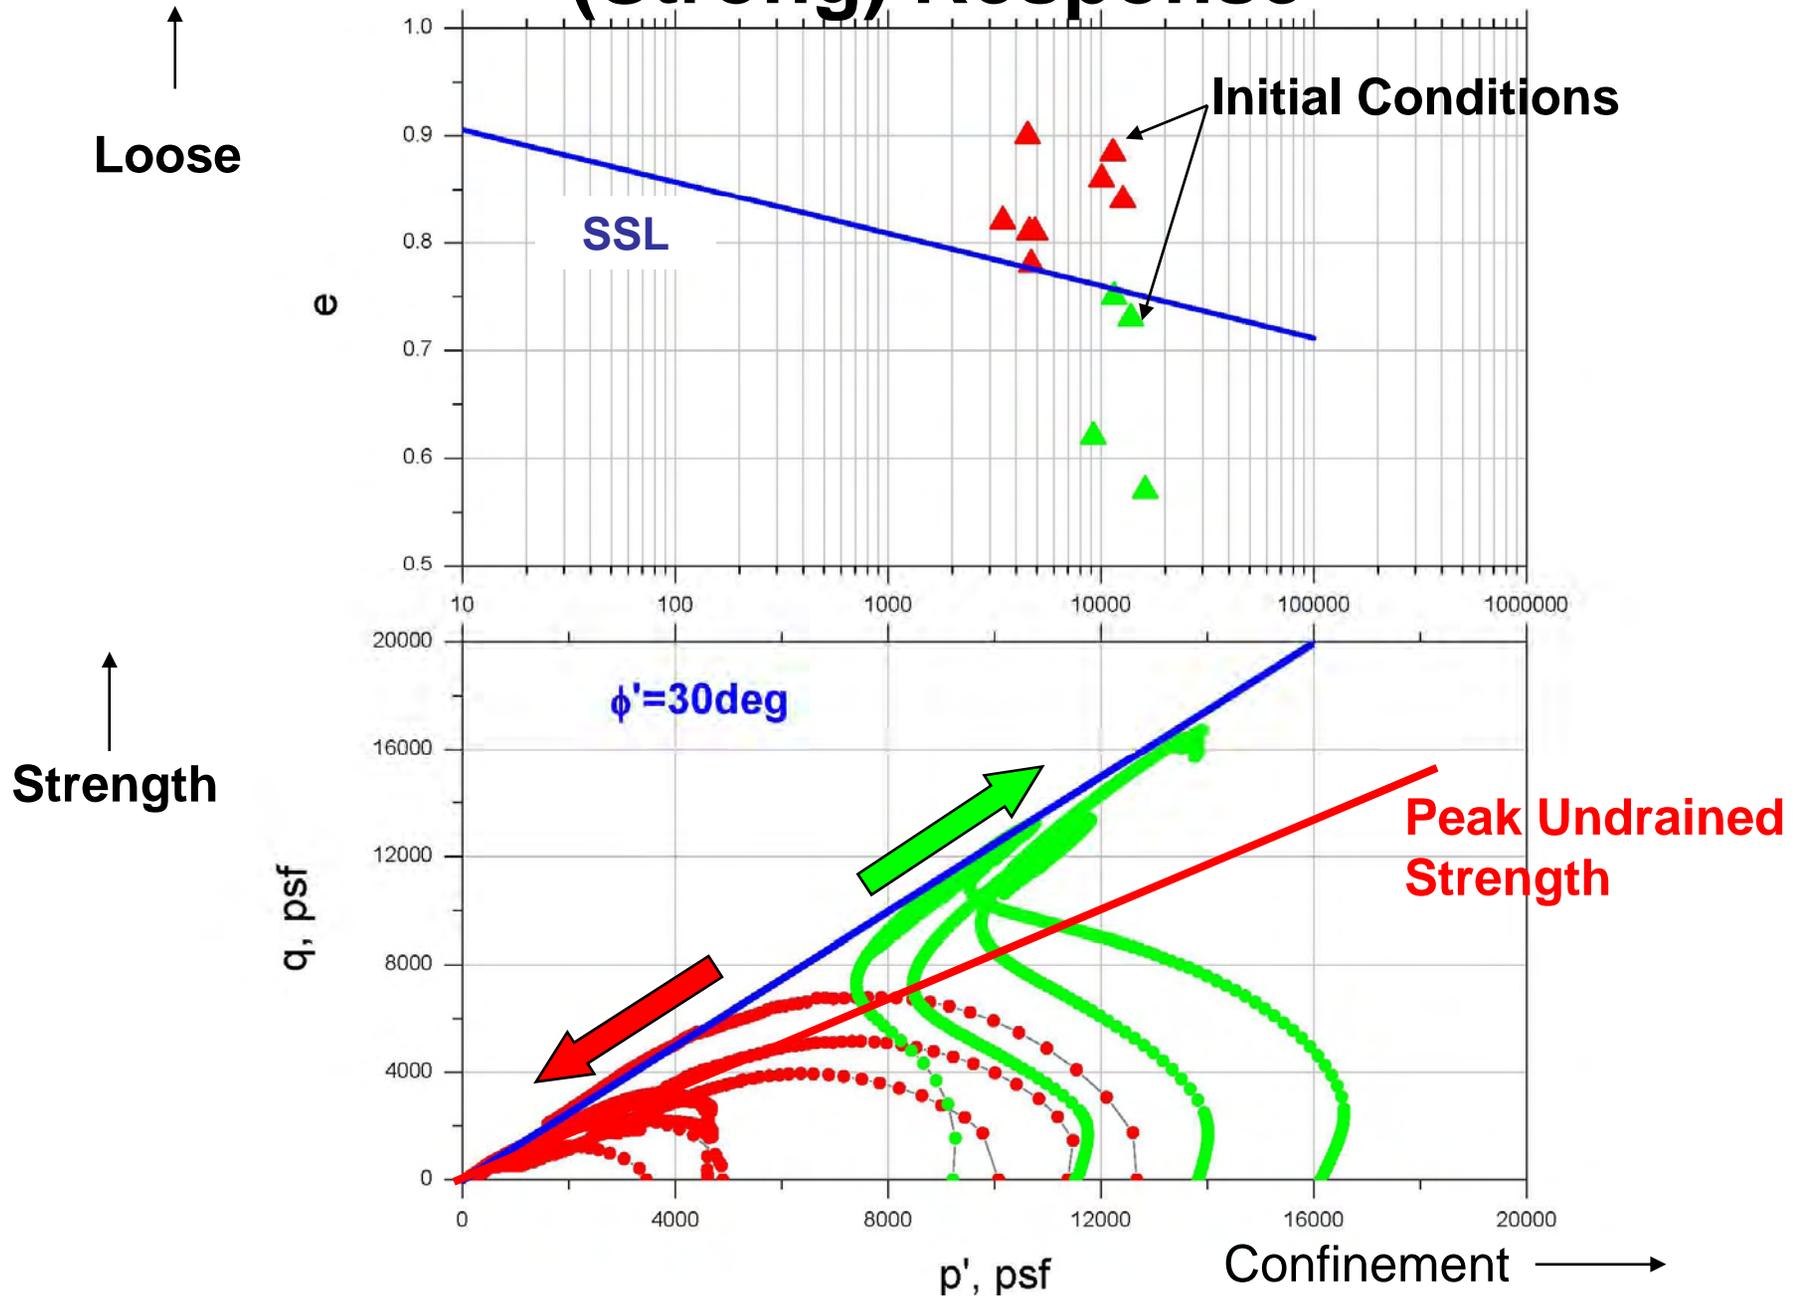
Undrained Contractive (Weak) vs. Dilative (Strong) Response

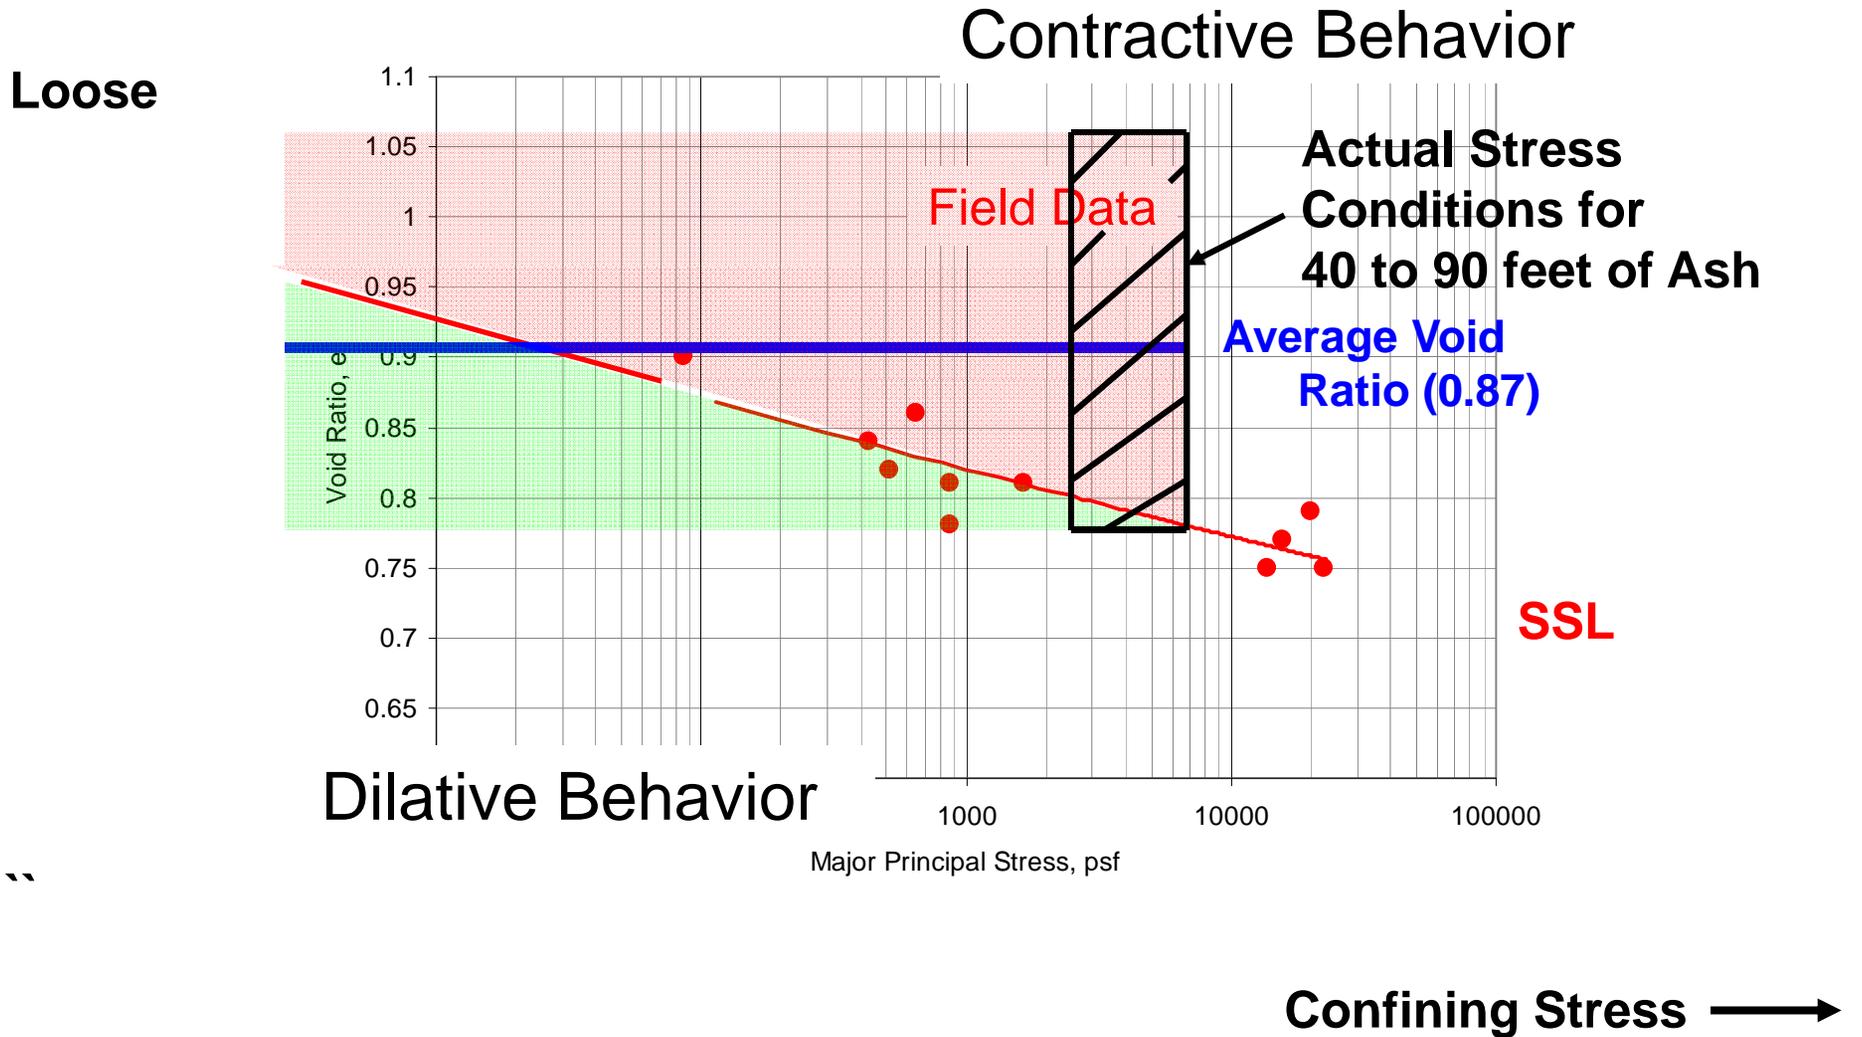
Estimated Critical State Line

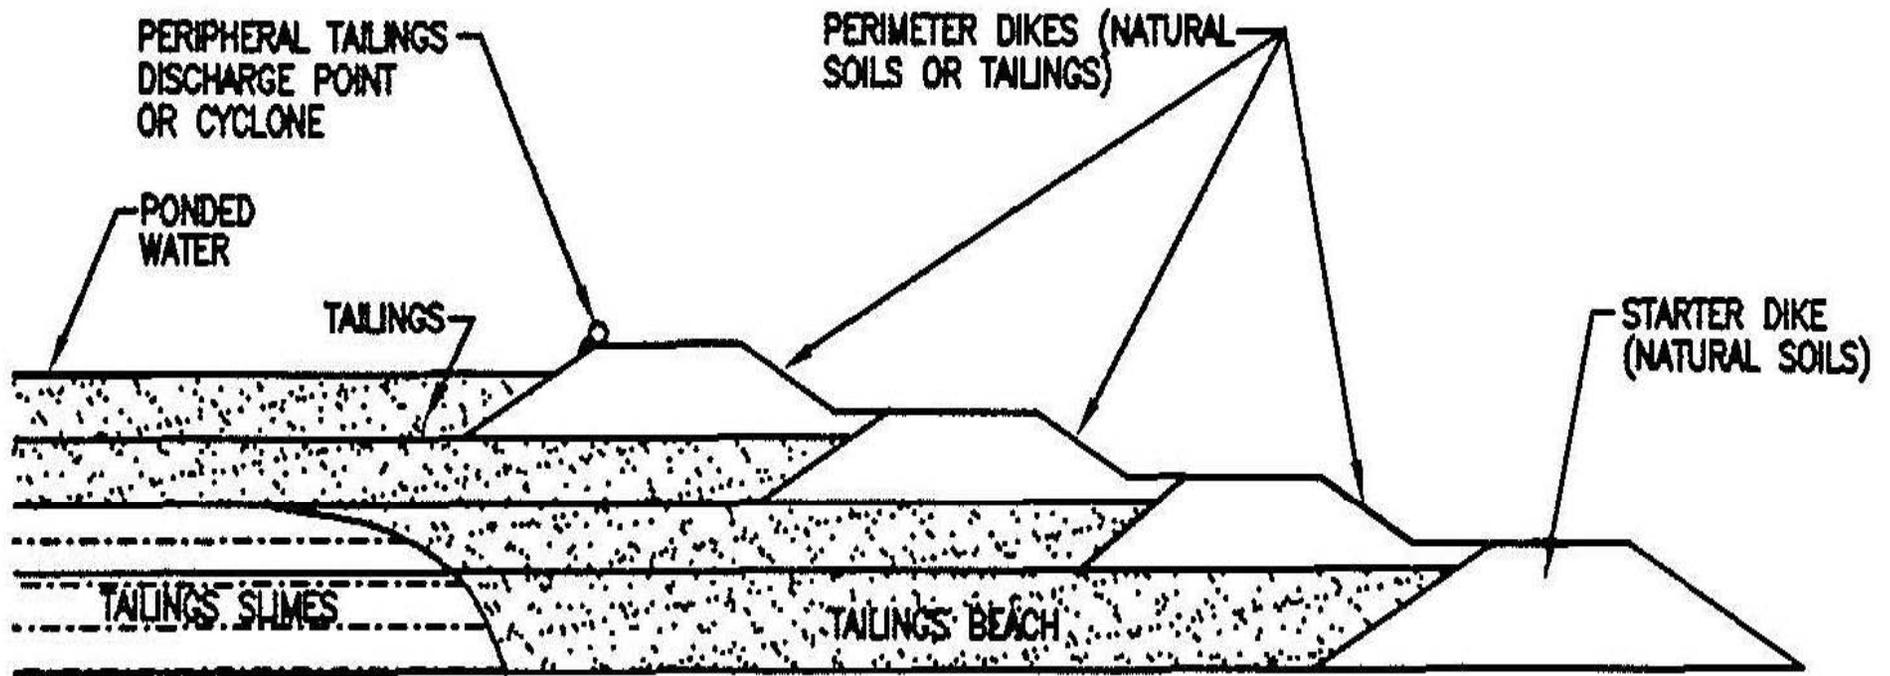
Tailings Dam Definitions

UPSTREAM METHOD (A)

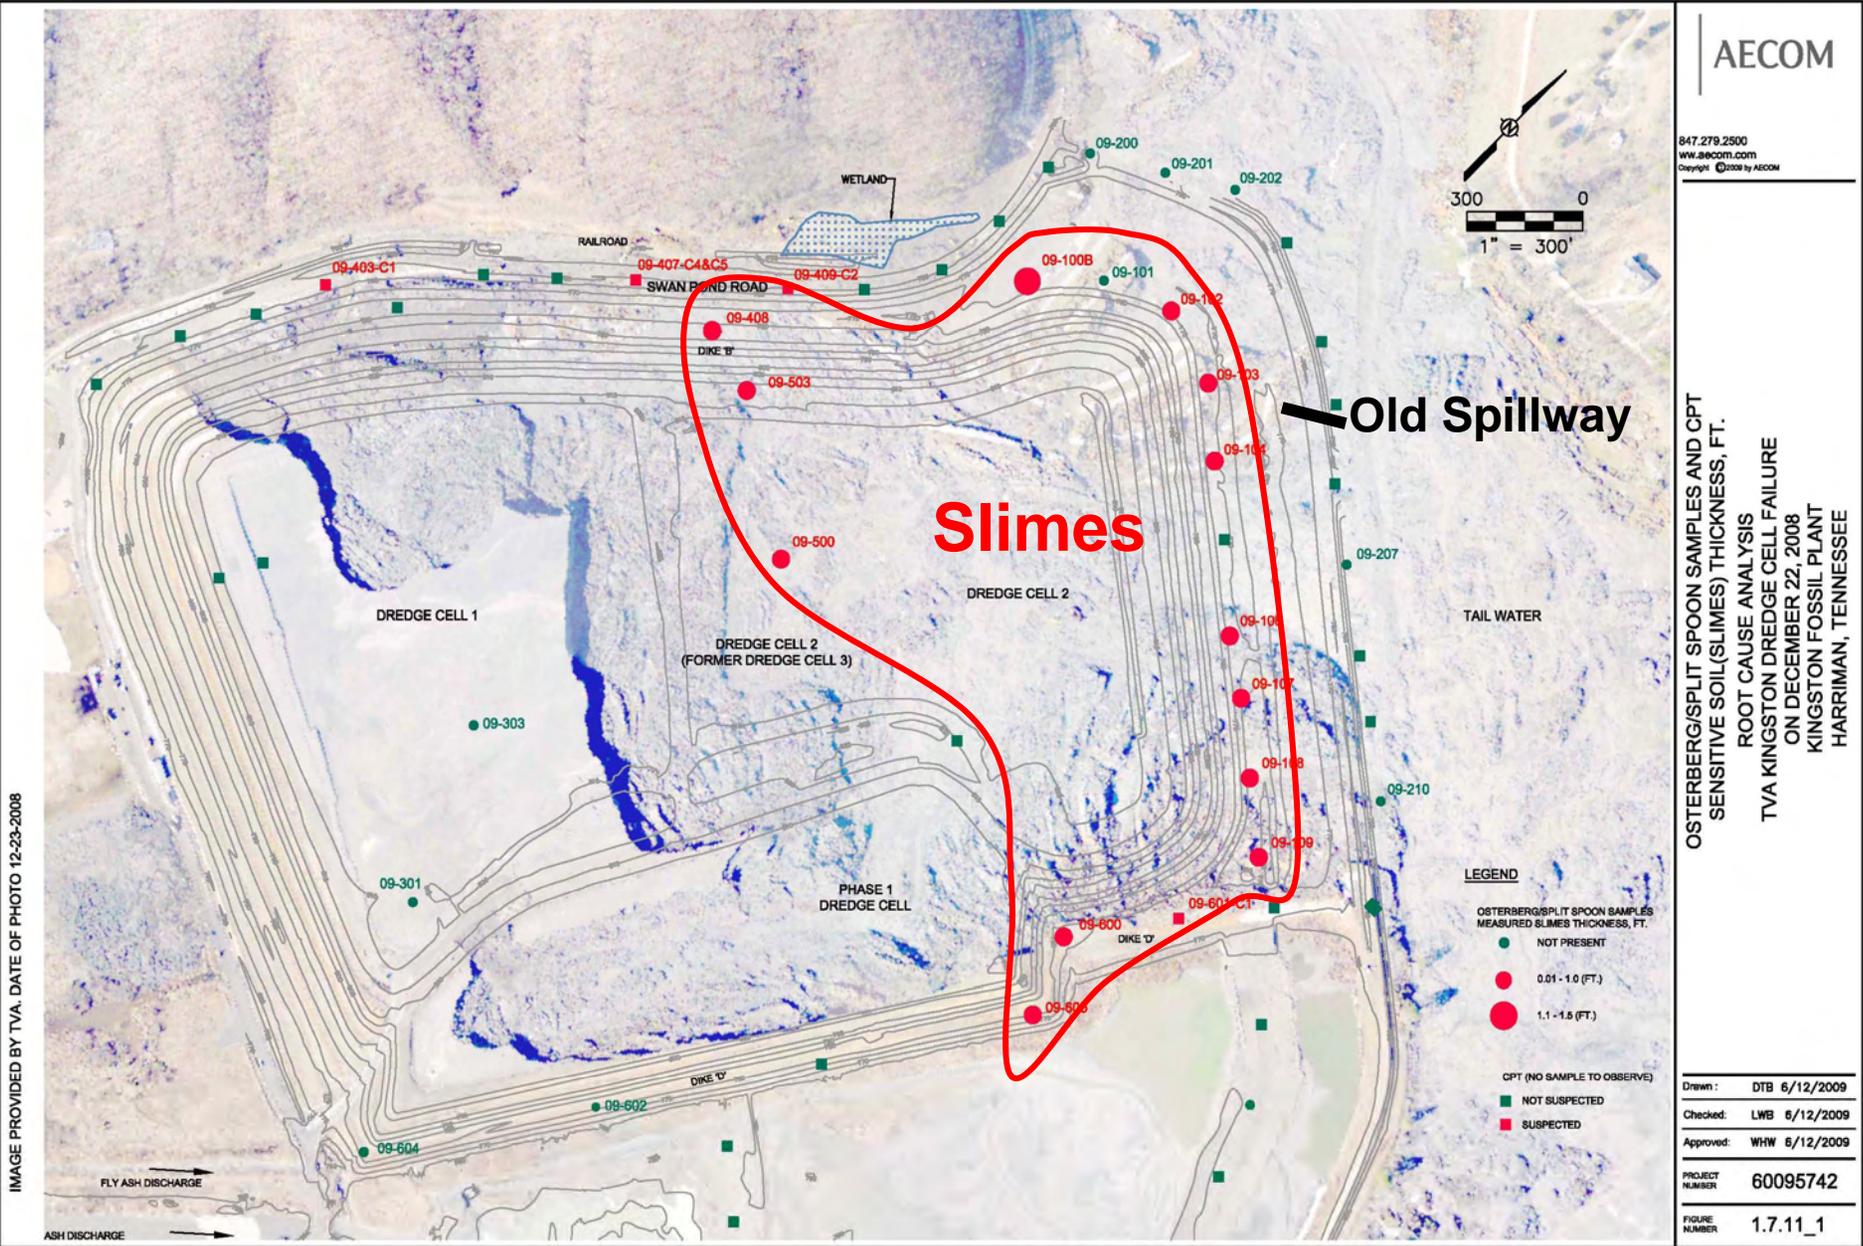
Location of Slimes Under Cell 2

- Under the Cell 2 and Old Cell 3 there is a layer of high void ratio laminated silt mixed with fine ash that has low undrained shear strength
- The silt and fine ash is sensitive, overconsolidated and behaves in a brittle manner initially, becomes plastic and then softens to low strength
- The silt and ash slime is highly structured and loses strength when disturbed

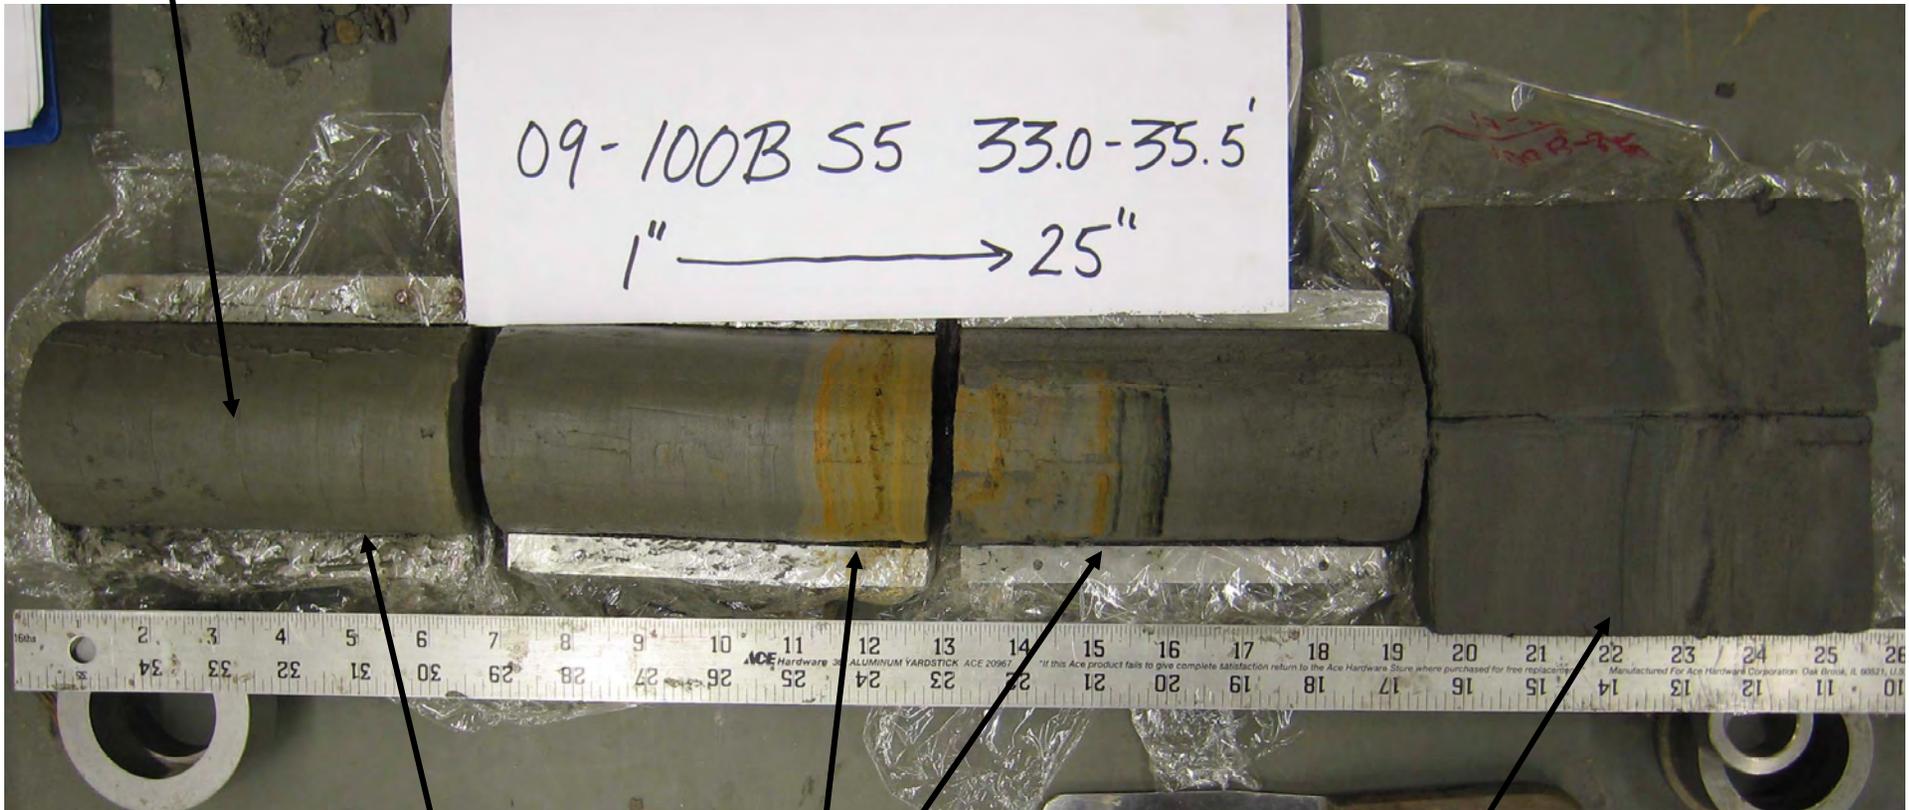
09-100B S5 33.0-35.5 ft

Intact Interfaces of Laminated Slimes & Ash

UNFAILED ASH

FAILED ASH

LAMINATED HIGH WATER CONTENT SLIMES

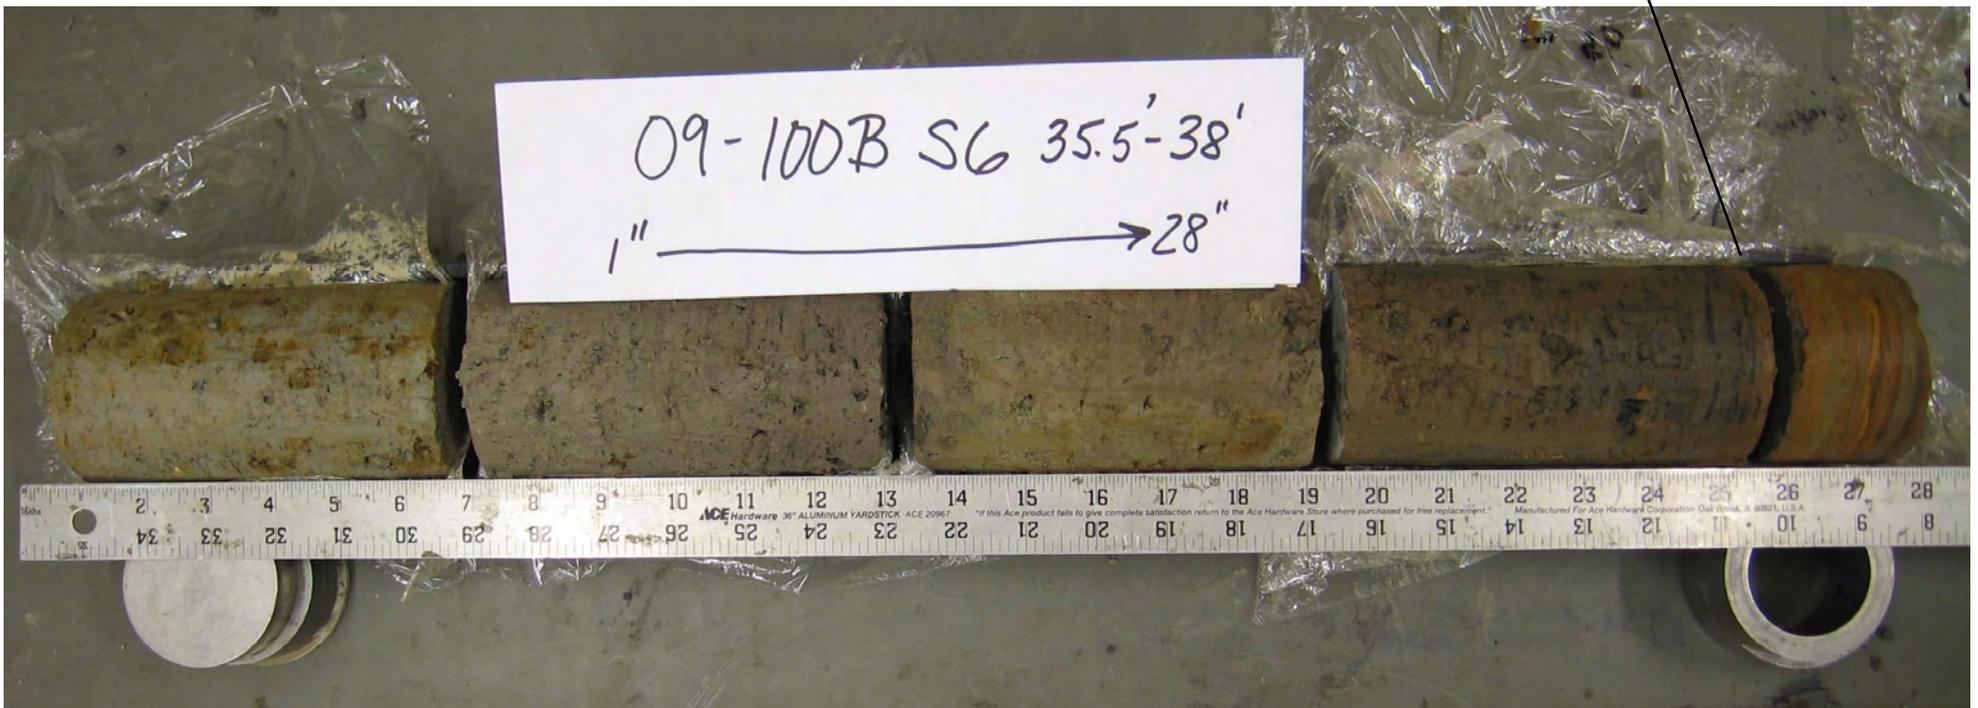
Unfailed Clay and Laminated Slimes Interfaces at 09-100B

NATIVE CLAY

LAMINATED
SLIMES

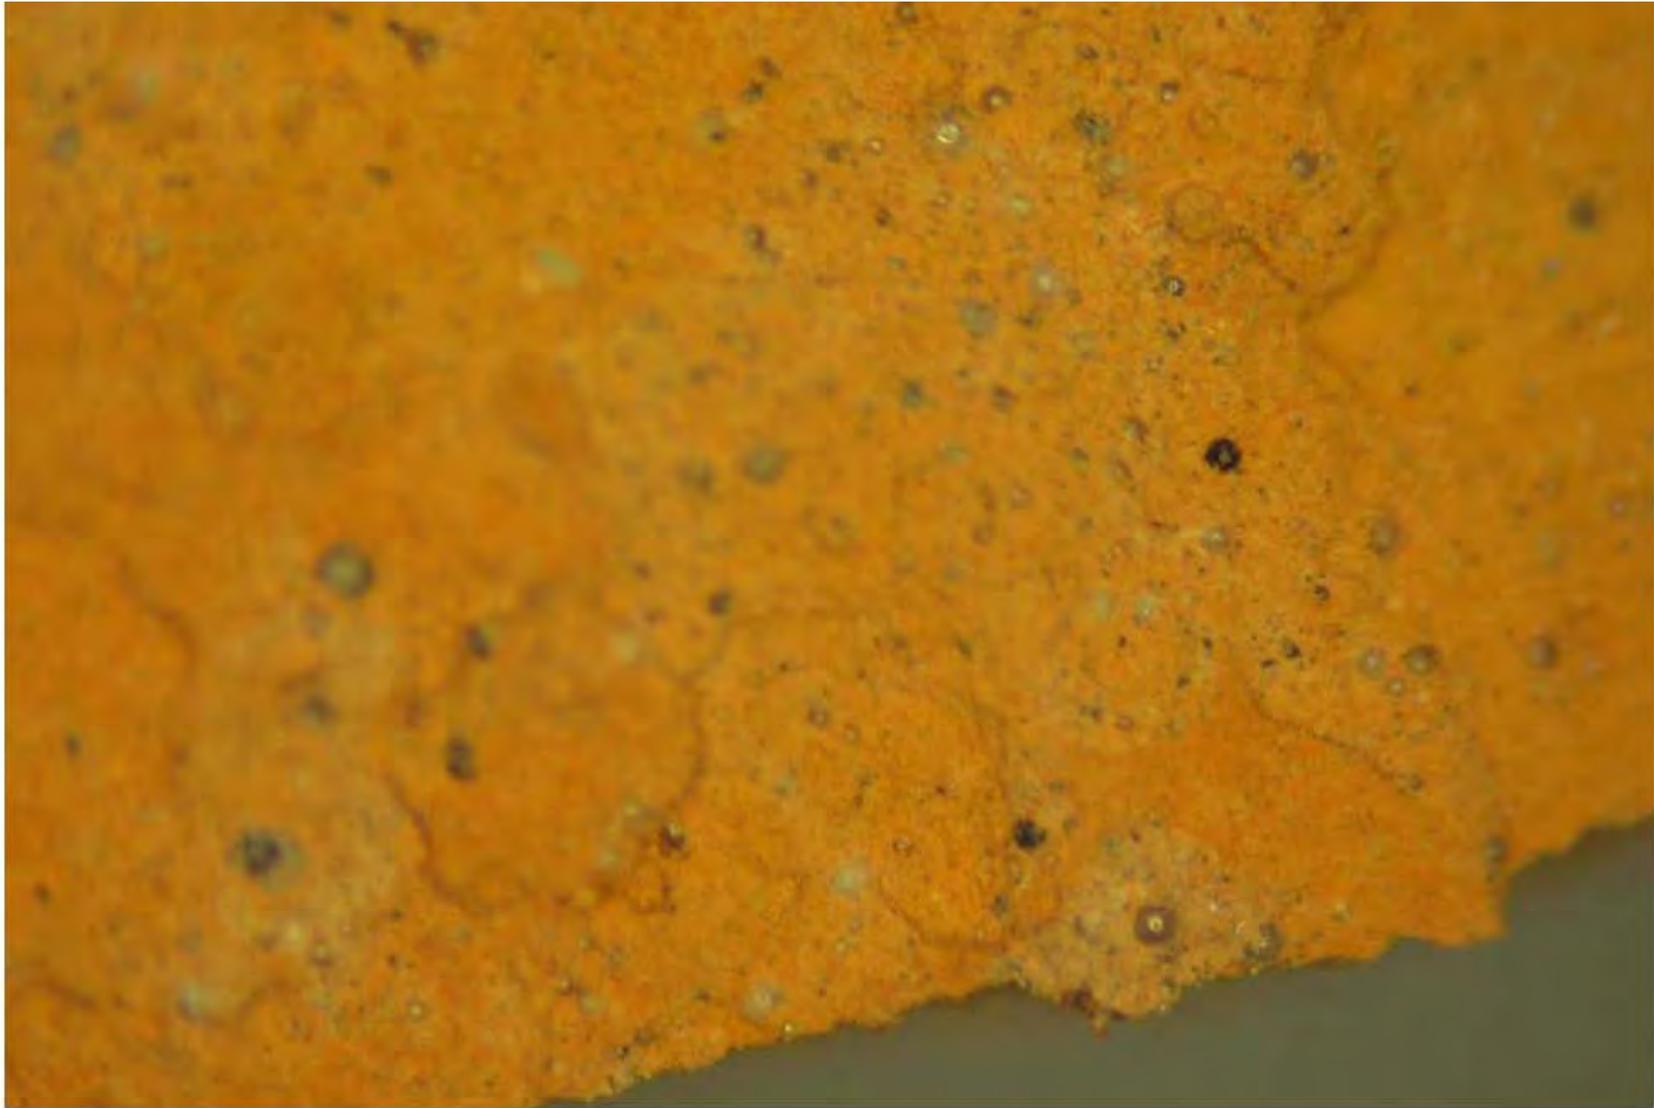
09-100B S6 35.5 to 38.0 ft

DSS G357 on 09-100B S6 (w = 119%)
– oven dry test specimen split open

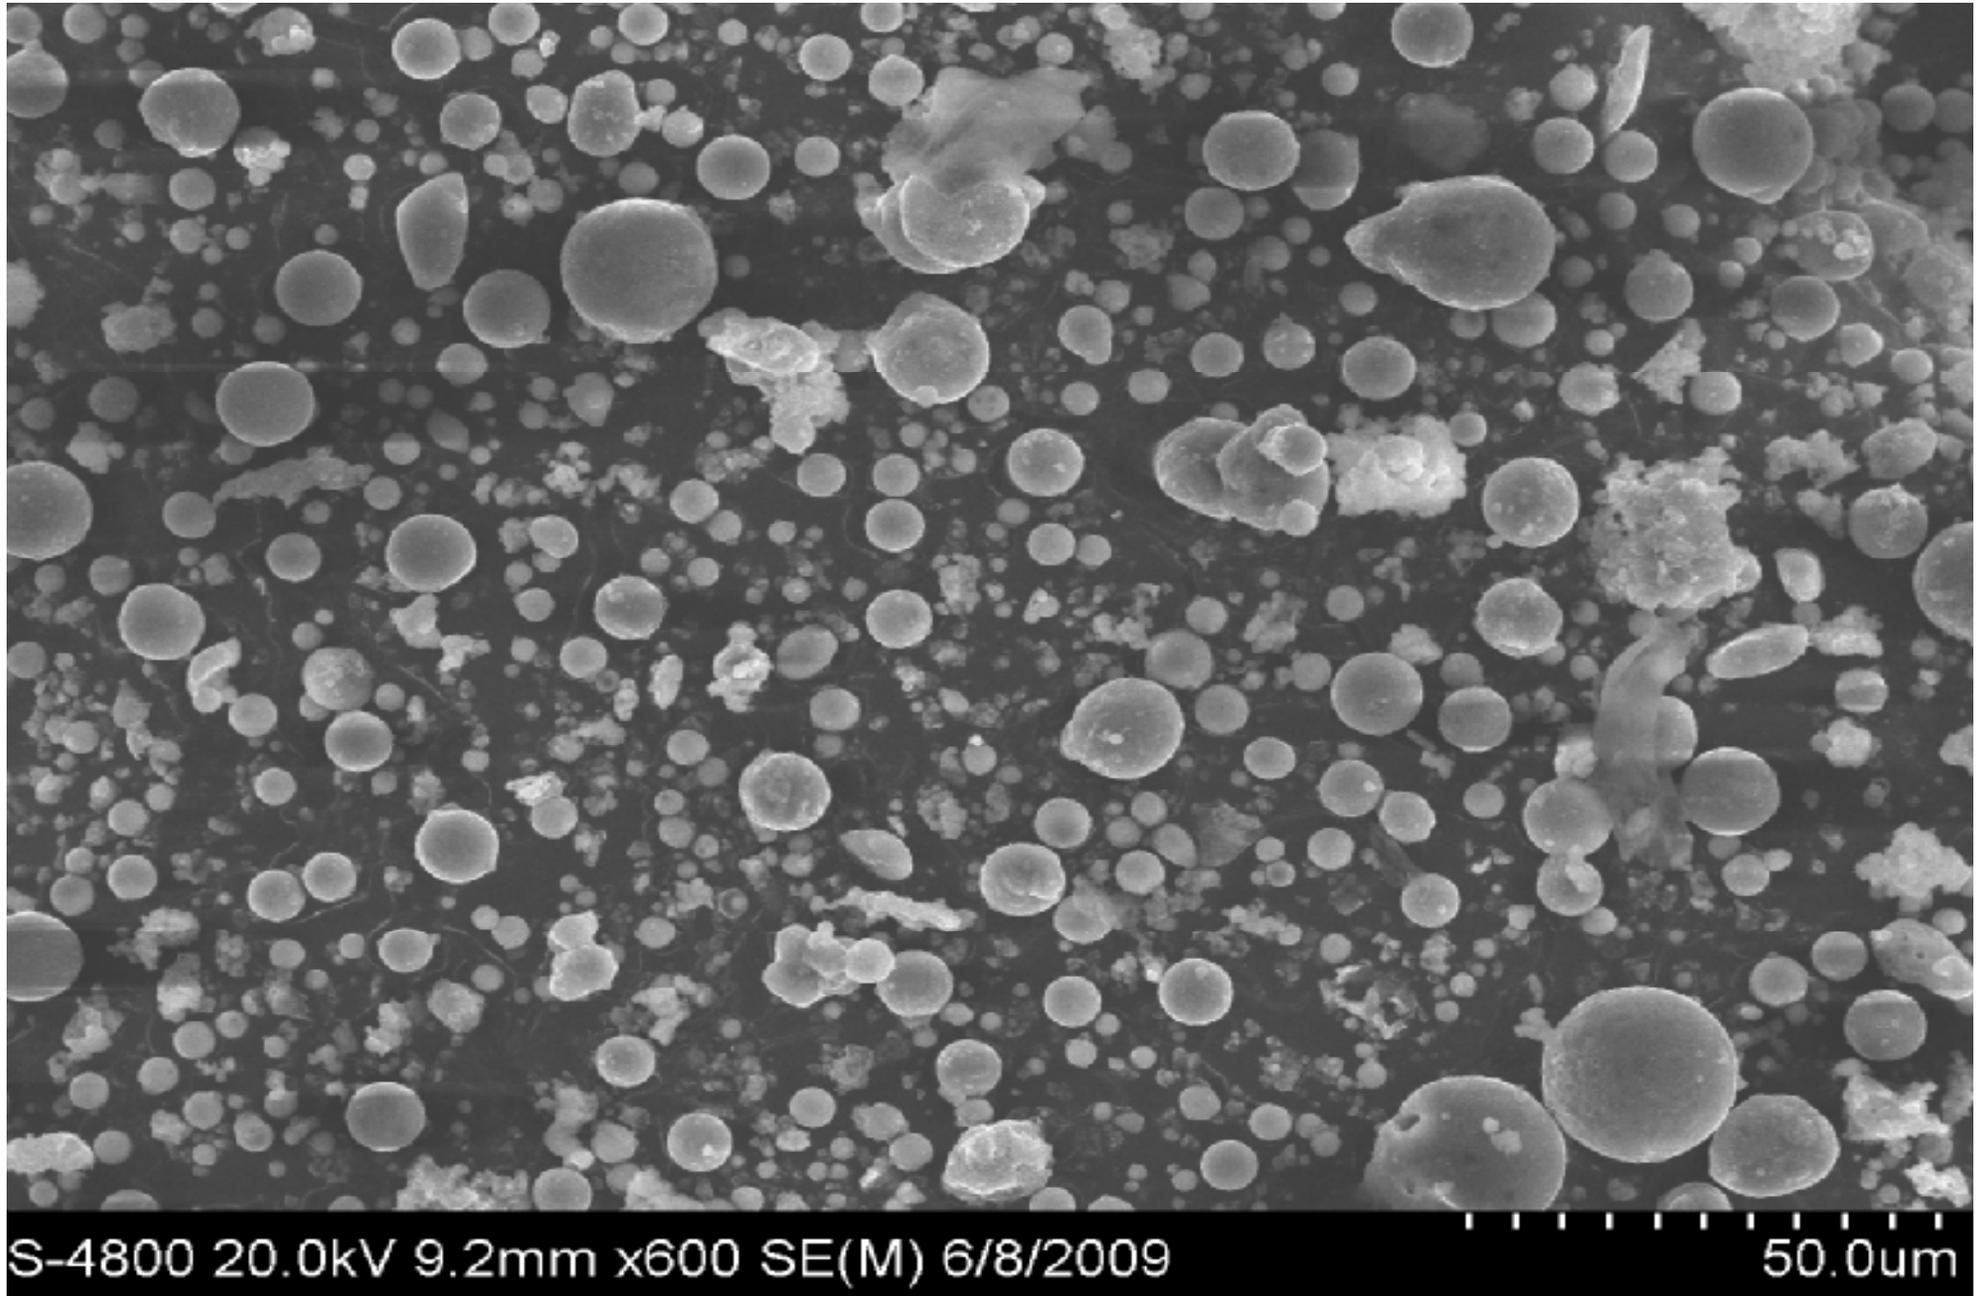
University of Kentucky Electron Microscope Scan of 09-503B Slimes

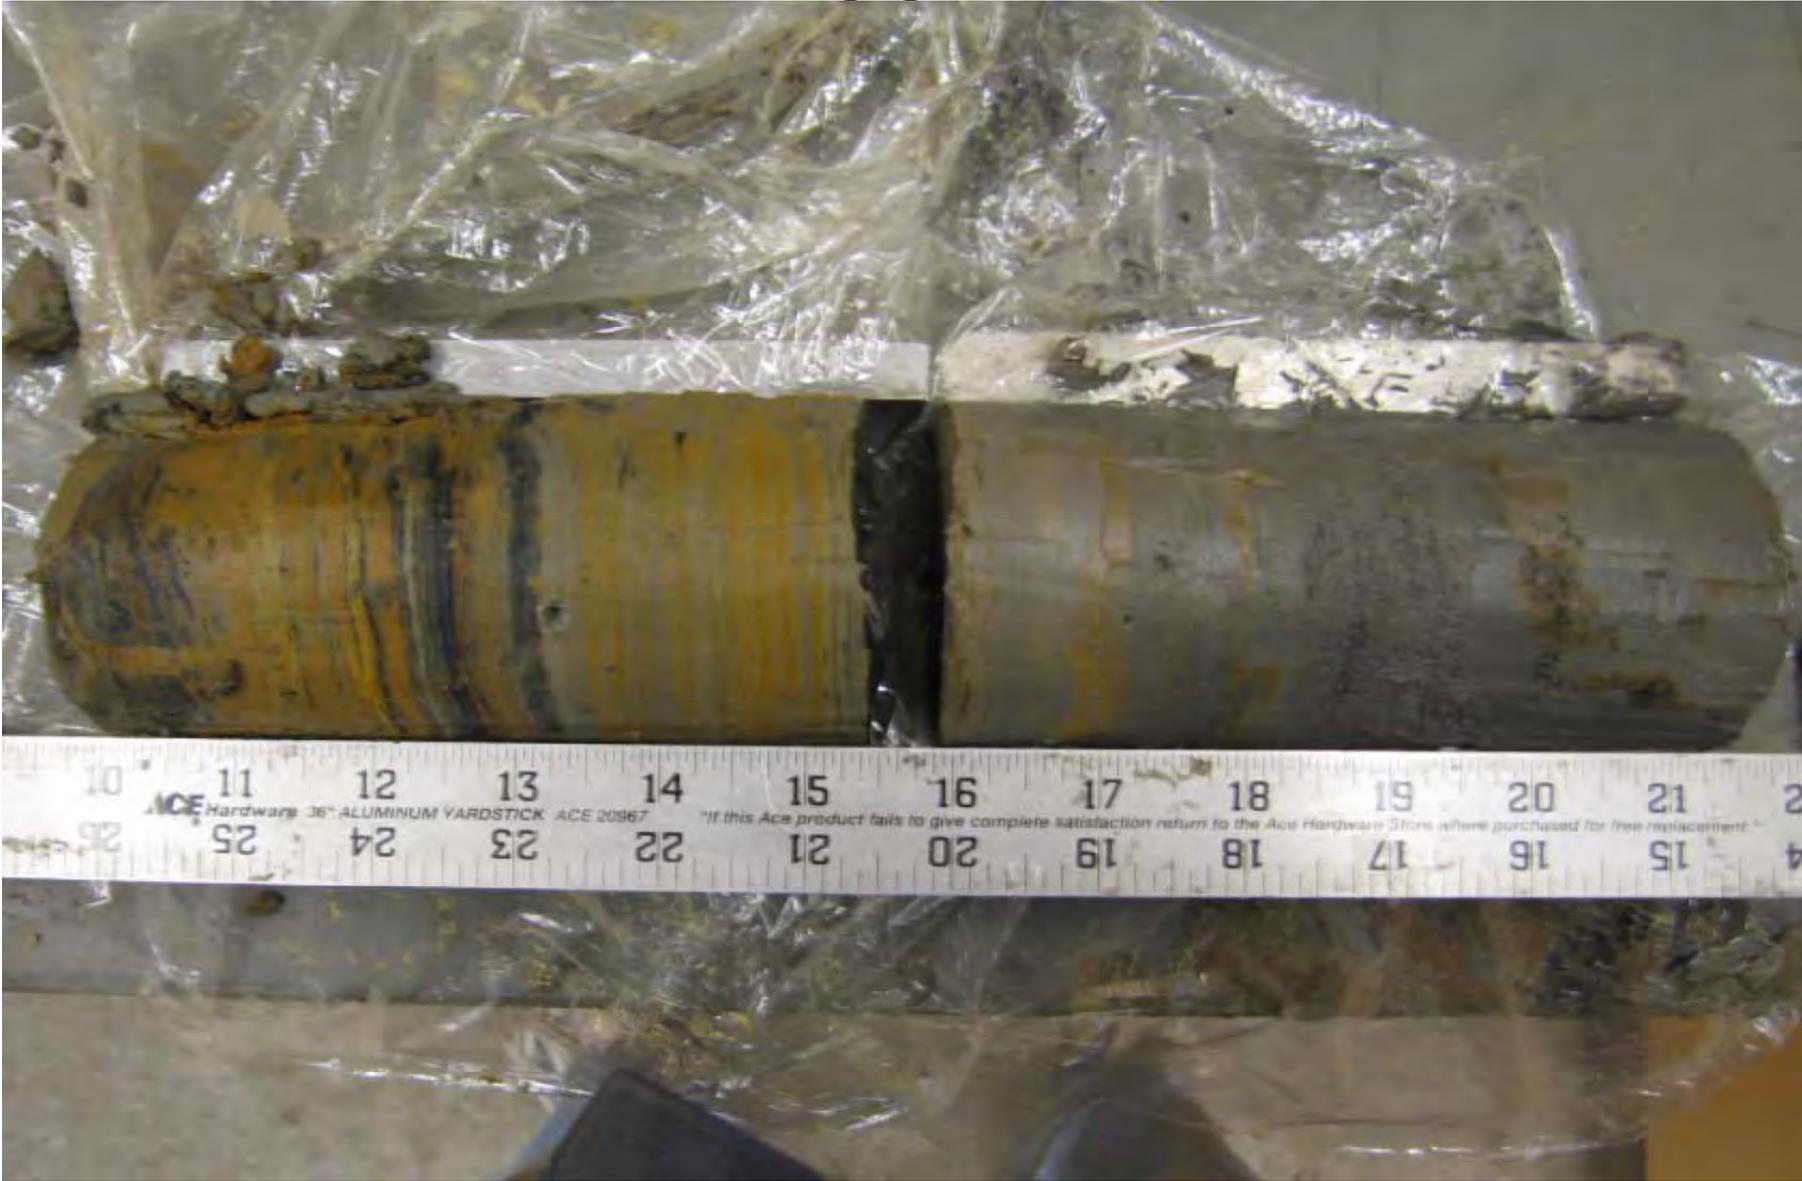
Photo of Laminated Slimes at 09-103B

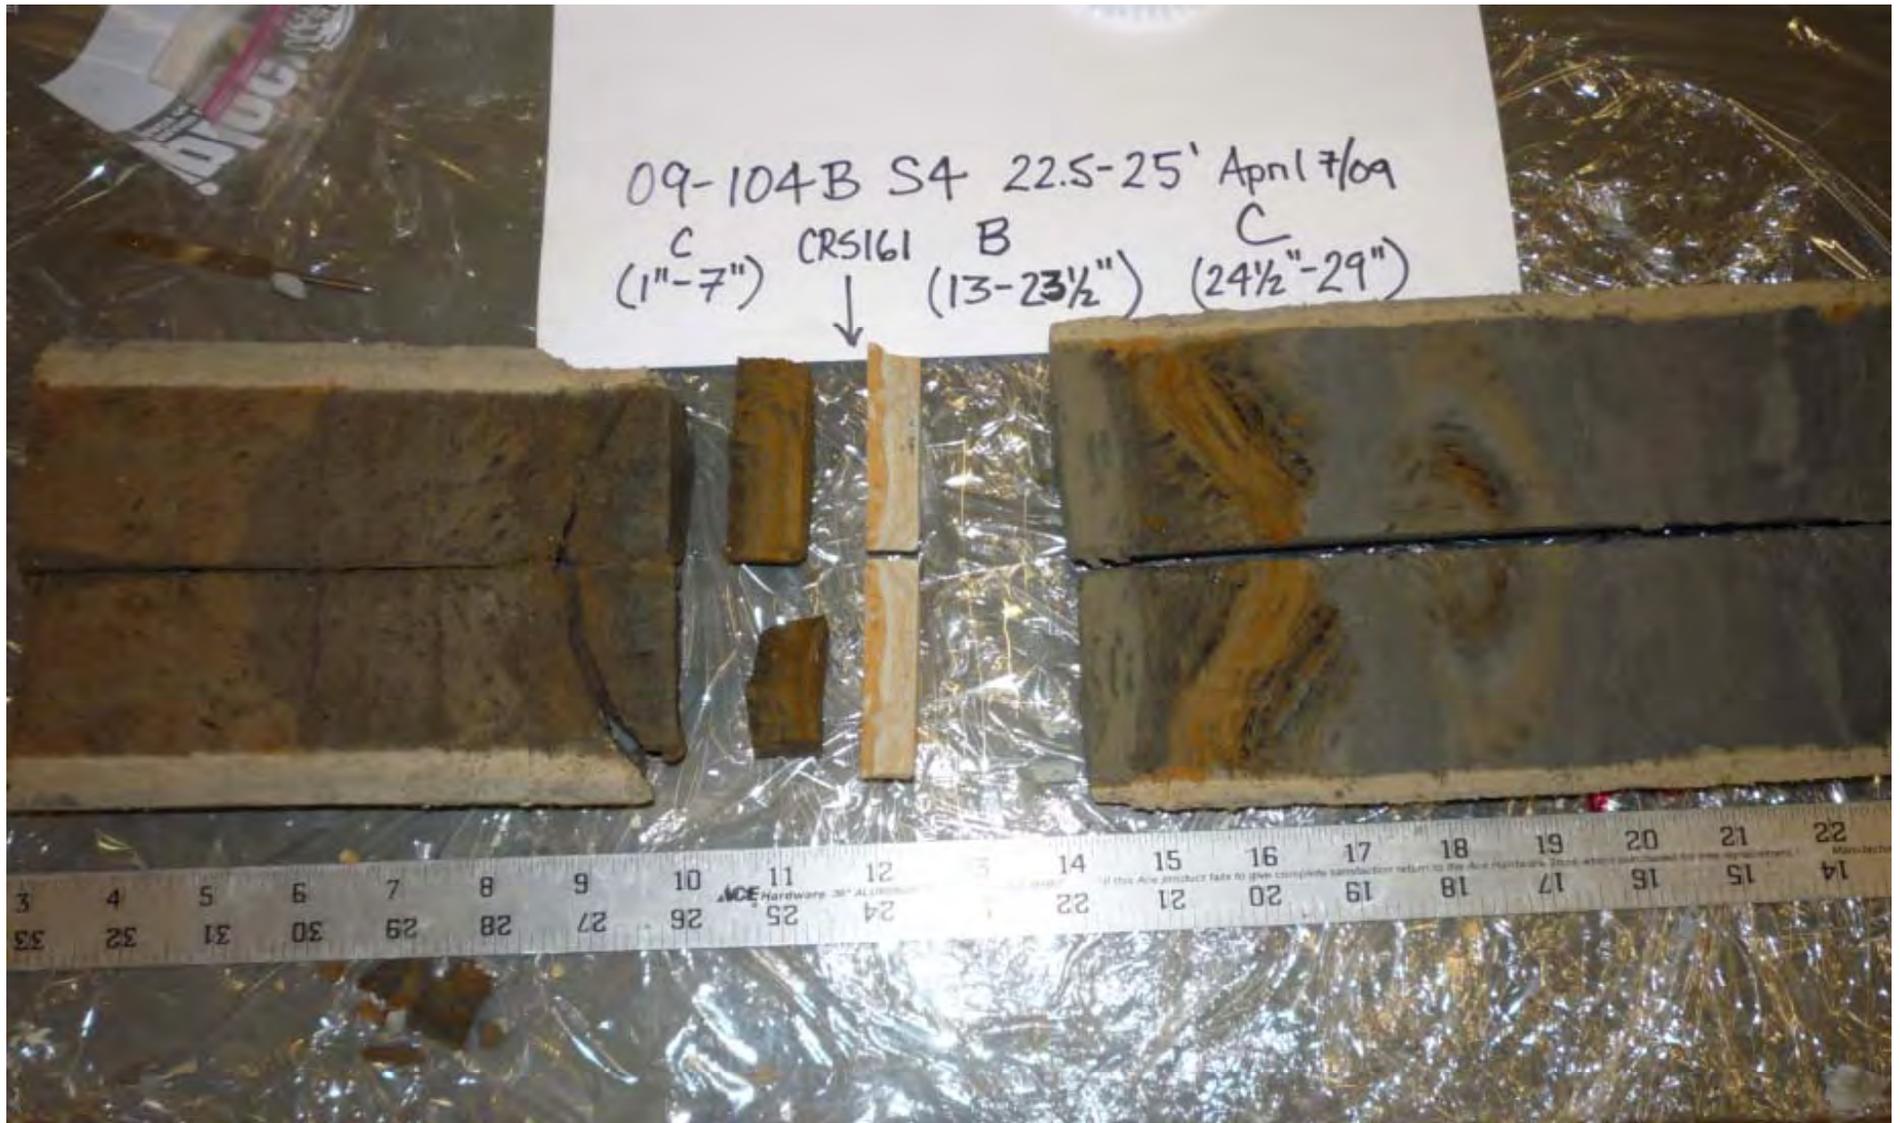
Photos of Unfailed Clay and Failed Laminated Slimes/Ash Interfaces at 09-104B

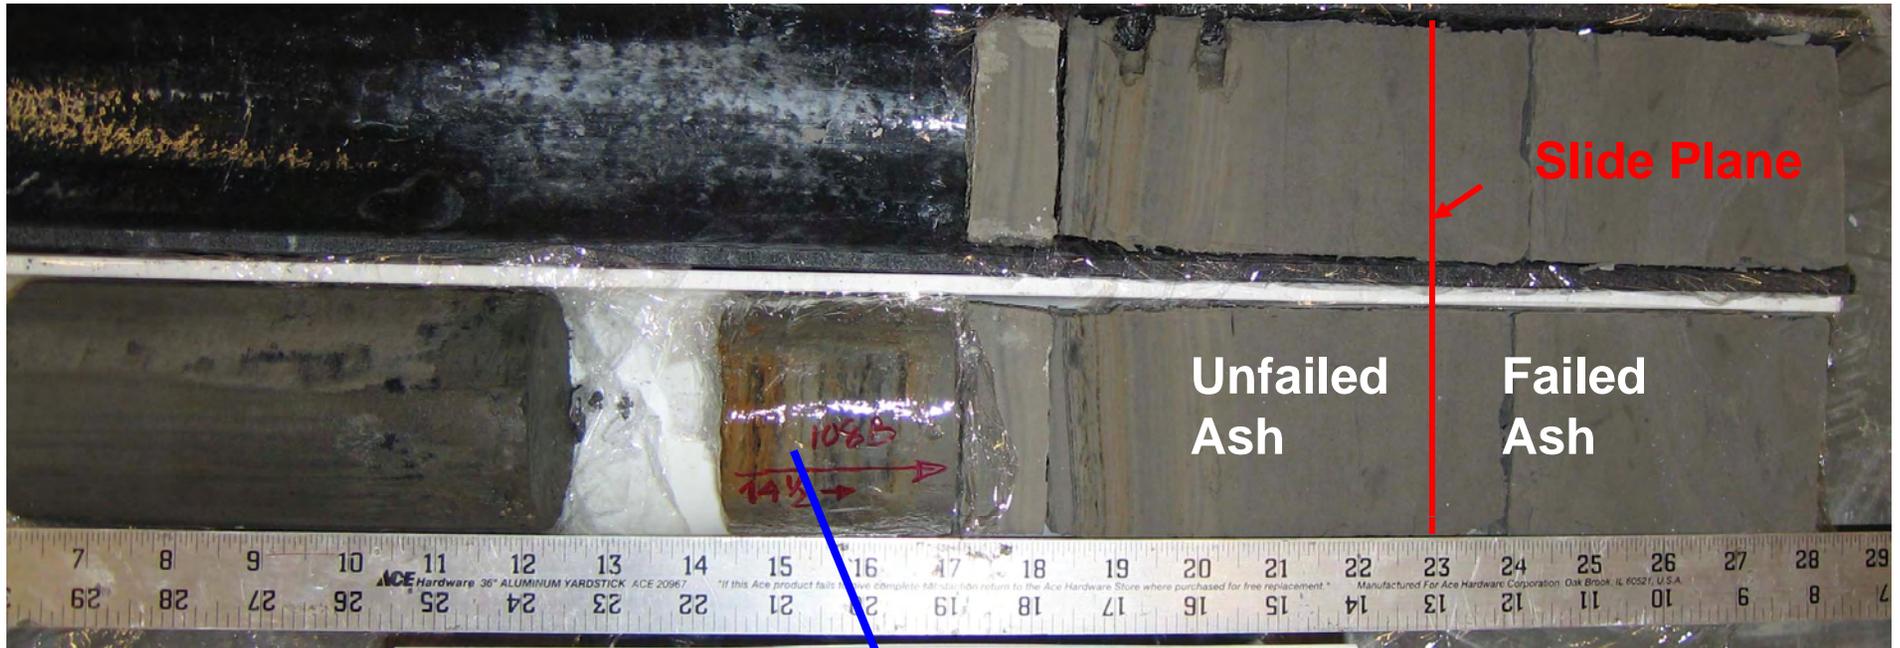
Laminated Silt/Ash Interface at 09-108B

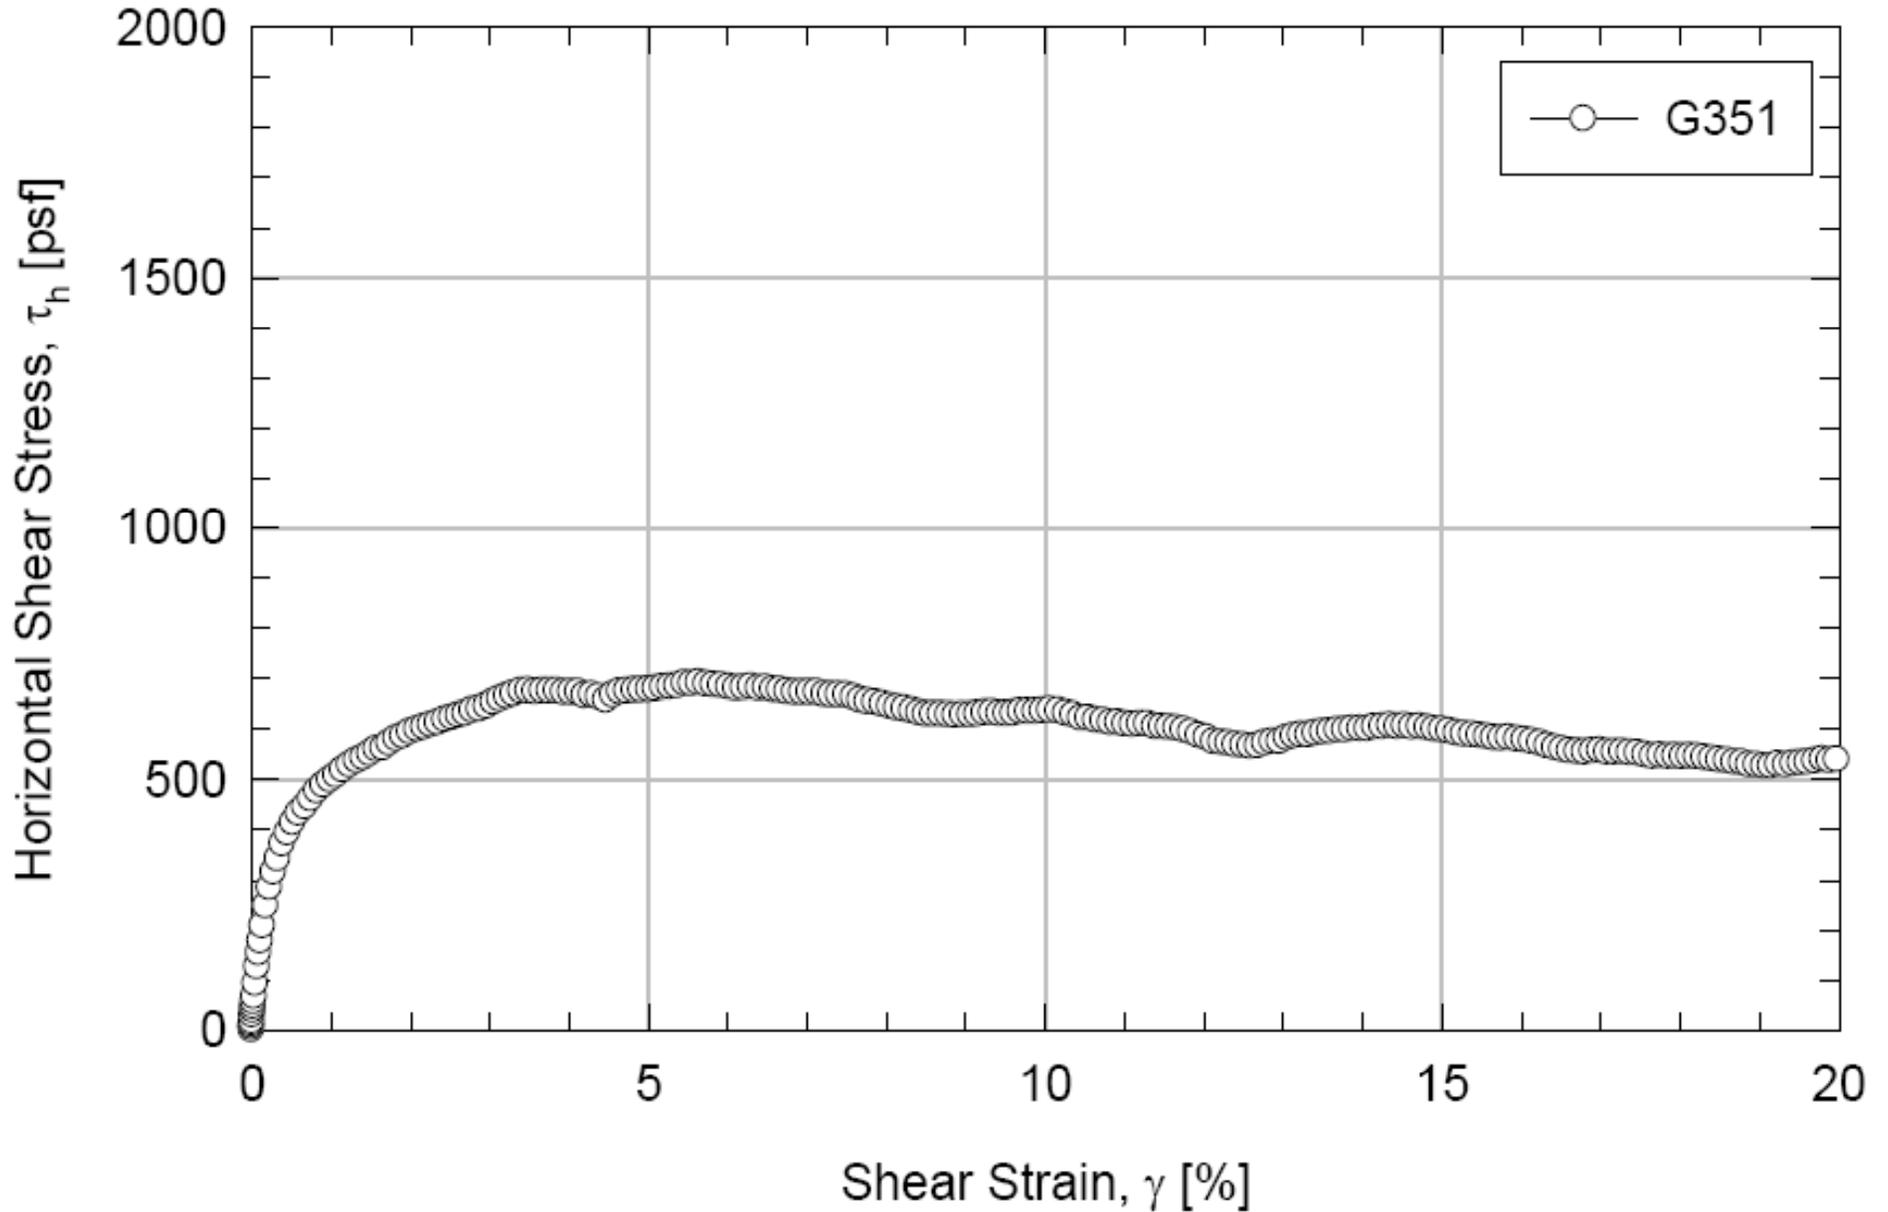
DSS at 09-108B, $S_u = 690$ psf
