Weak Thin Layer of Silt and Ash Slimes at Bottom of Loose Ash

OSTERBERG/SPLIT SPOON SAMPLES AND CPT SENSITIVE SOIL(SLIMES) THICKNESS, FT.
 ROOT CAUSE ANALYSIS
 TVA KINGSTON DREDGE CELL FAILURE
 ON DECEMBER 22, 2008
 KINGSTON FOSSIL PLANT
 HARRIMAN, TENNESSEE

Photos and Selected Tests on Tube
Samples of Sensitive Silt and
Failure Slide Plane in 100 Series
Holes at toe of Cell 2

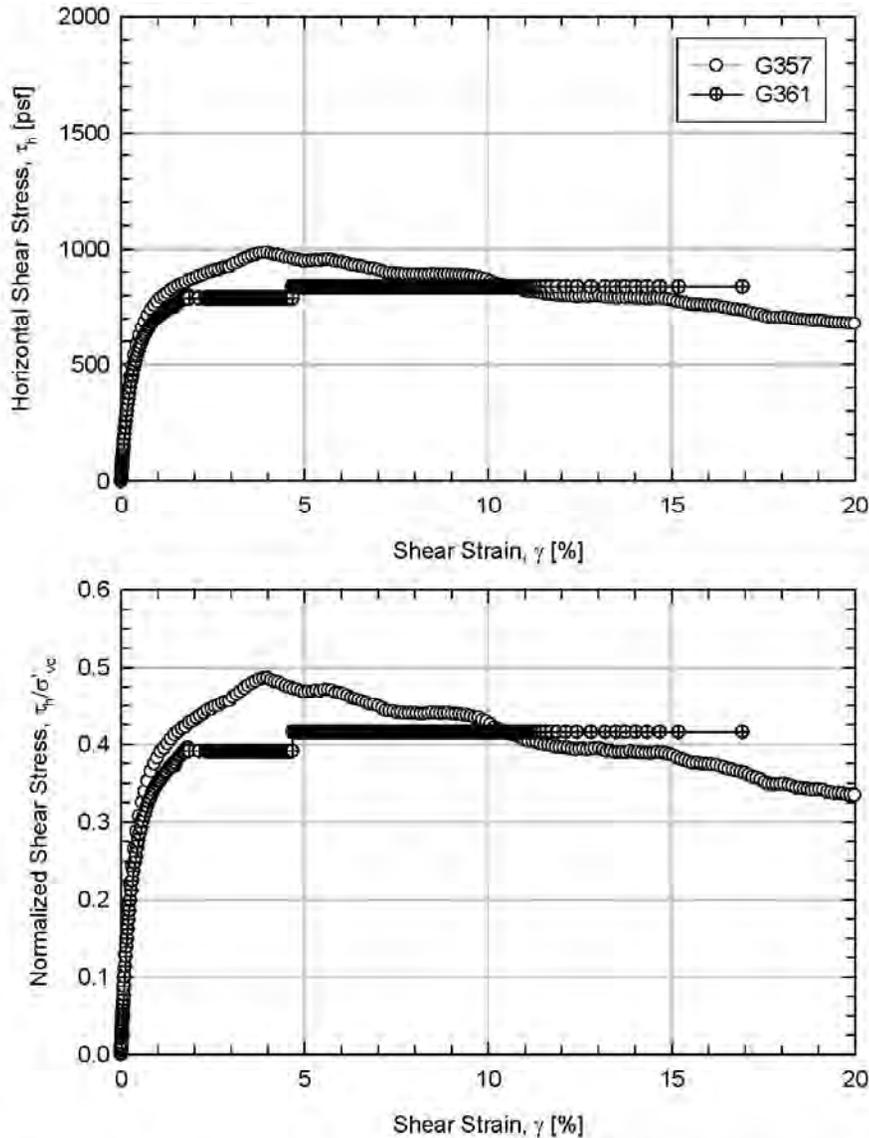
CKUDSS Creep Test on Slimes

Creep Failure at 85% of G357 in G361

Figure 5.4.62 Horizontal shear stress and normalized shear stress versus shear strain for test DSS G357 and creep test G361 on sample 09-100B S6 35.5-38.0 ft

- High Water Content 40% to 140% ($W_c = W_w/W_s$)
- High Liquidity Indices 3.5 to 7 (Rarely found in nature)
- Relatively low permeability 6.5×10^{-4} feet/day
- Specific Gravity $G_s = 2.2$ to 2.3 , Wet Density is 90 pcf
- CKU'DSS Shear Strengths range from 600 to 1,250 psf with Contractive Undrained Behavior
- CKU'DSS Creep test shows failure at 85% of peak shear strength

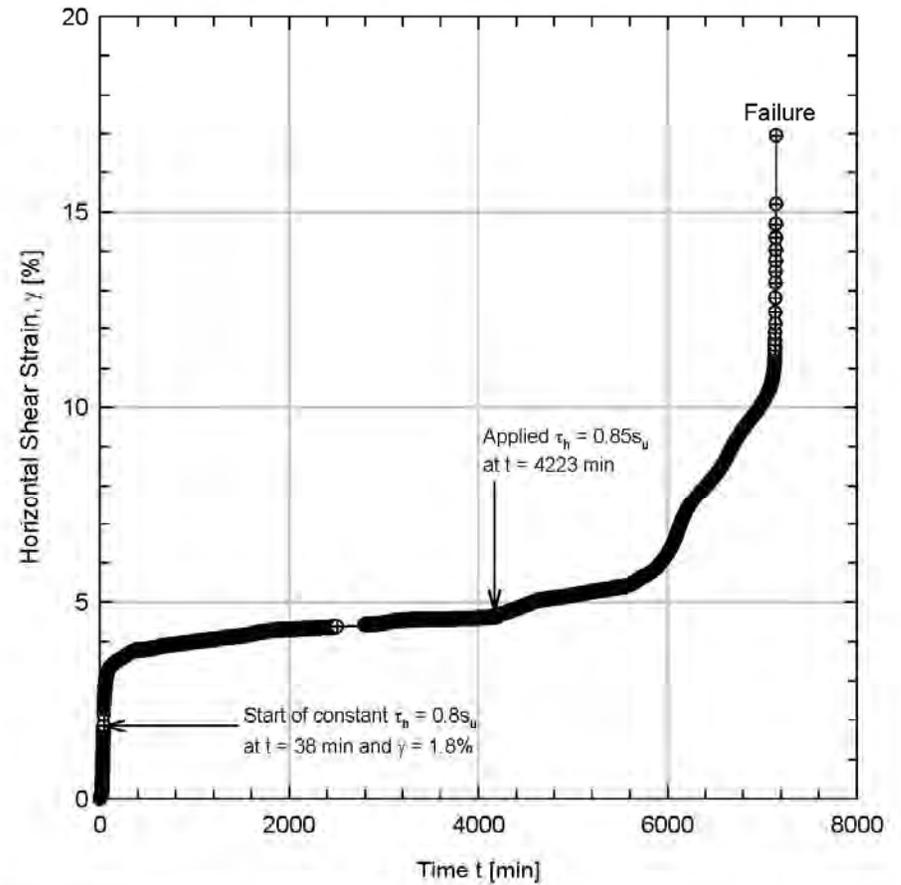
Figure 5.4.65 Horizontal shear strain versus time for DSS creep test G361 on sample 09-100B S6 35.5-38.0 ft

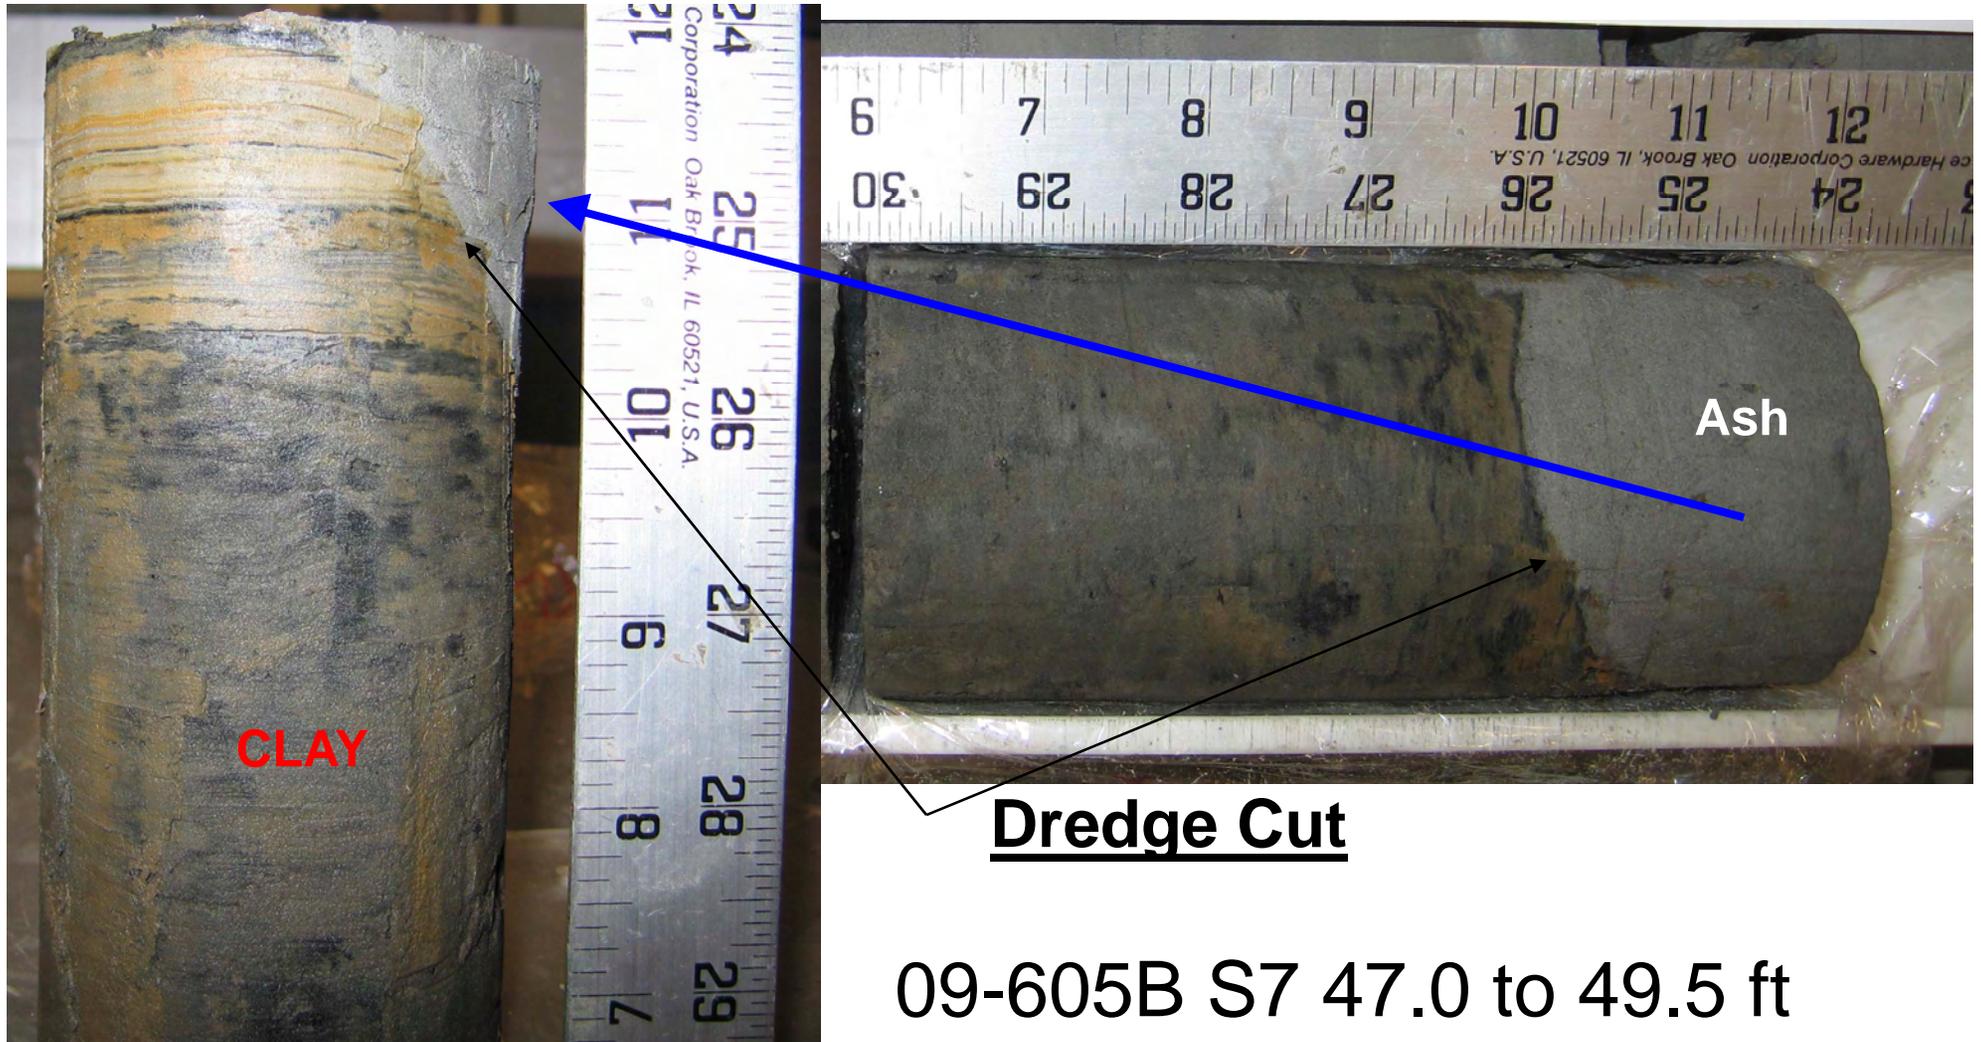
Interface of Laminated Slimes and Unfailed Flyash at 09-6005B

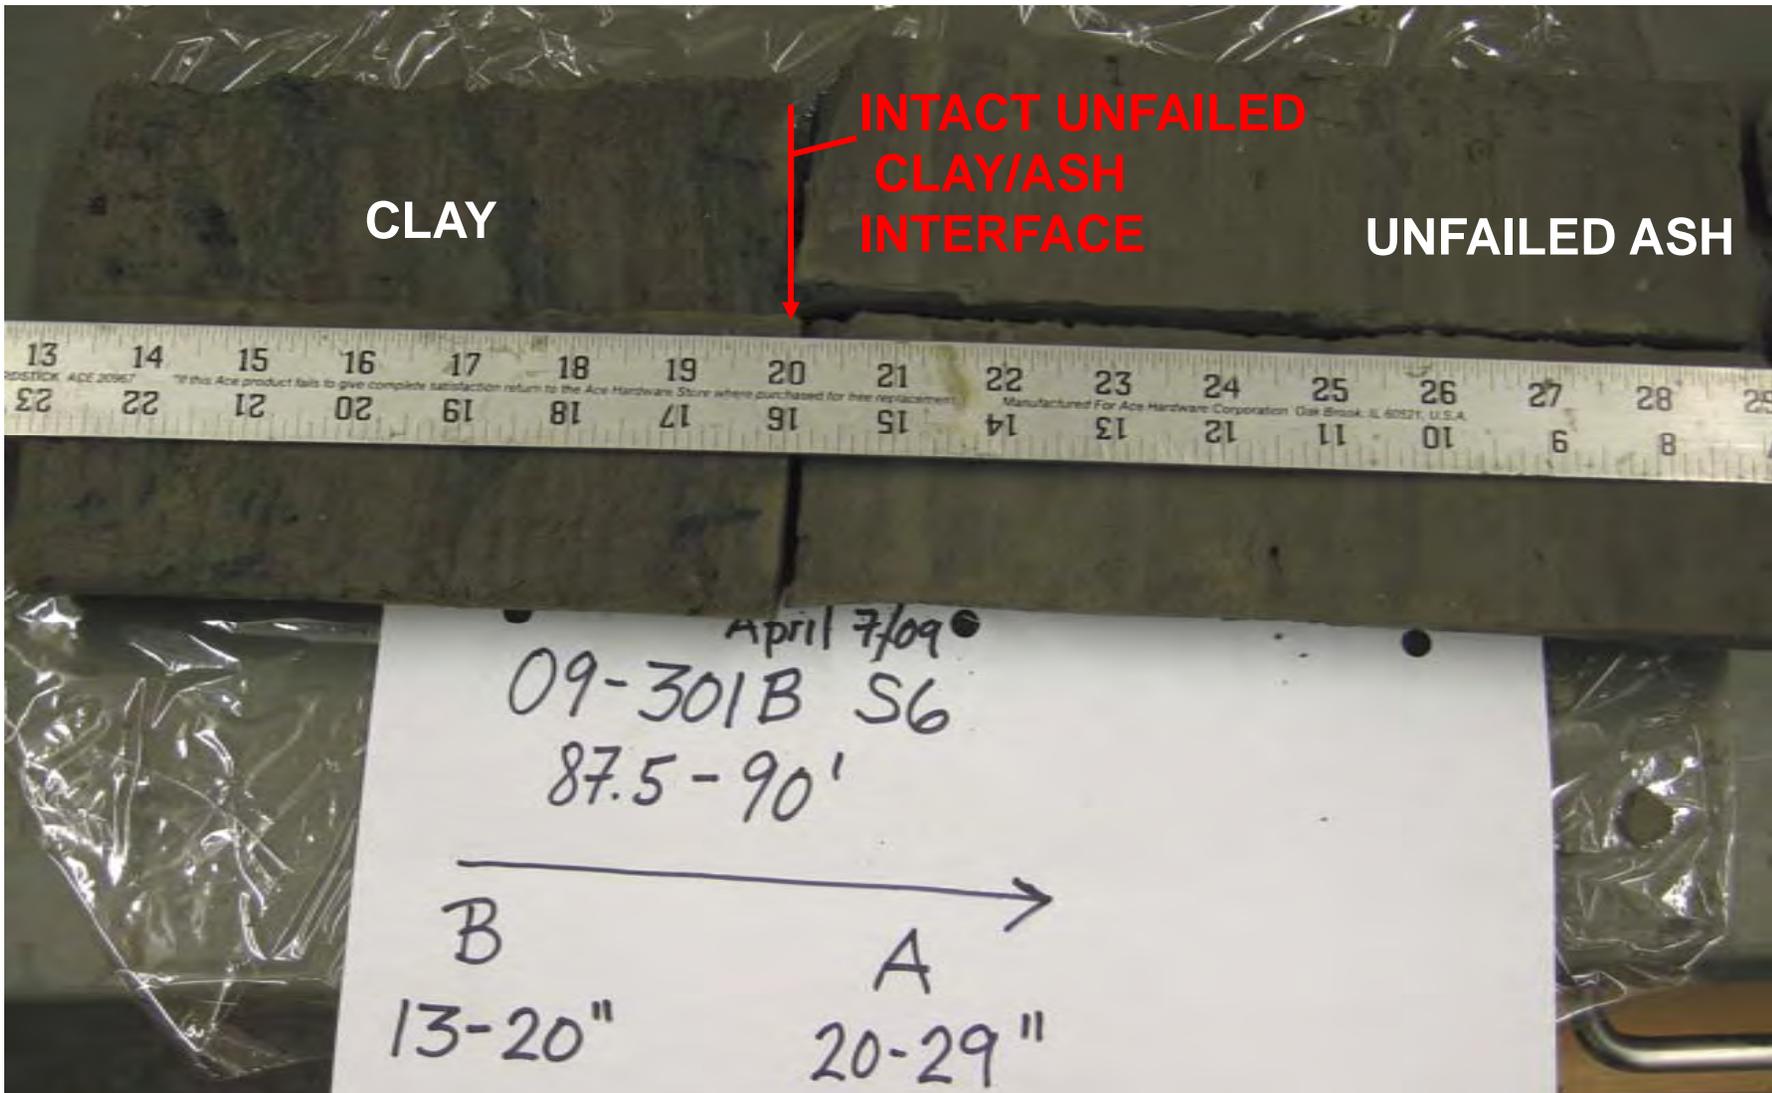
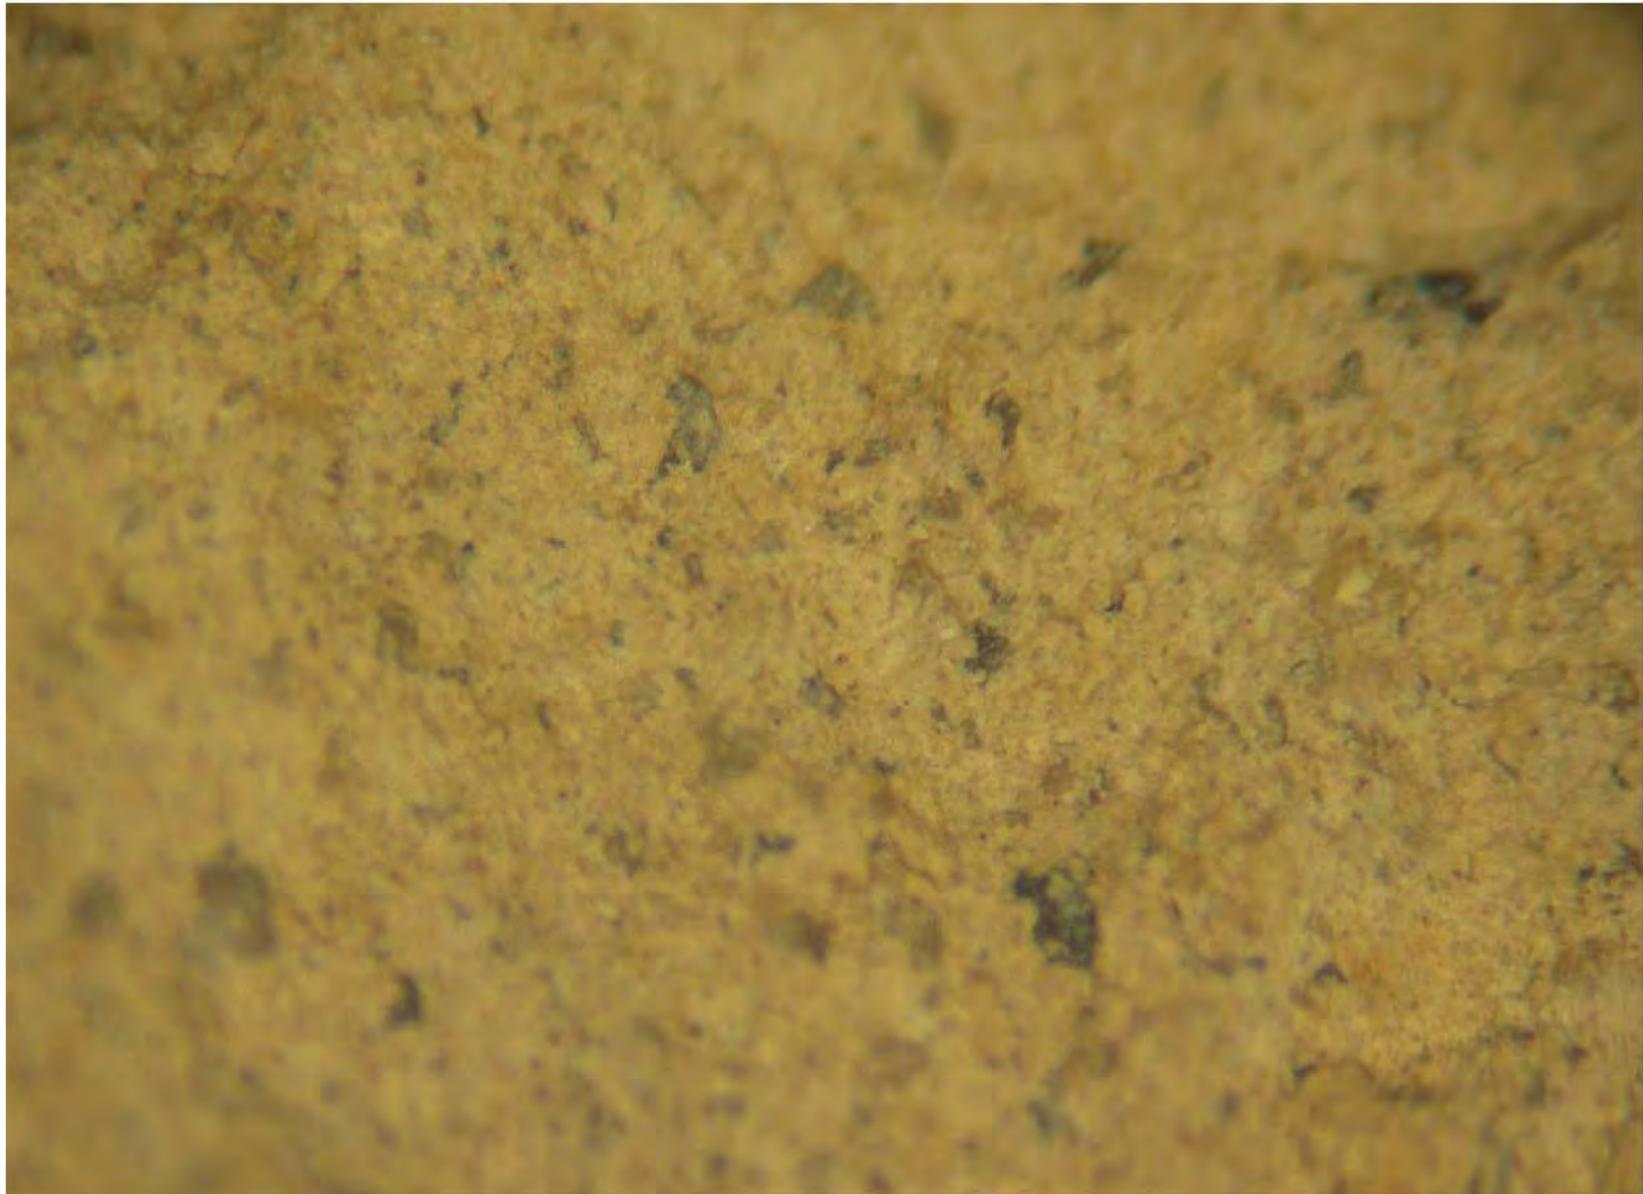
09-301B OST 6 87.5 to 90.0 ft

CLAY DSS G349 on 09-301B S6 ($w = 22\%$)
oven dry test specimen split open

LOCATION OF SLIDE PLANE

- Found Below Sensitive Silts and Ash
- Soft, Medium, Stiff to Very Stiff Silty Clay
- Medium Plasticity
- Moderate to High Sensitivity
- Relatively low permeability $k_v=4 \times 10^{-3}$ ft/day
- Overconsolidated due to Desiccation
- Specific Gravity 2.65 to 2.72
- Detected in >90% of the Borings and Probes
- Undrained Shear Strength from Vanes can be correlated to CPTu tip resistance using N_k

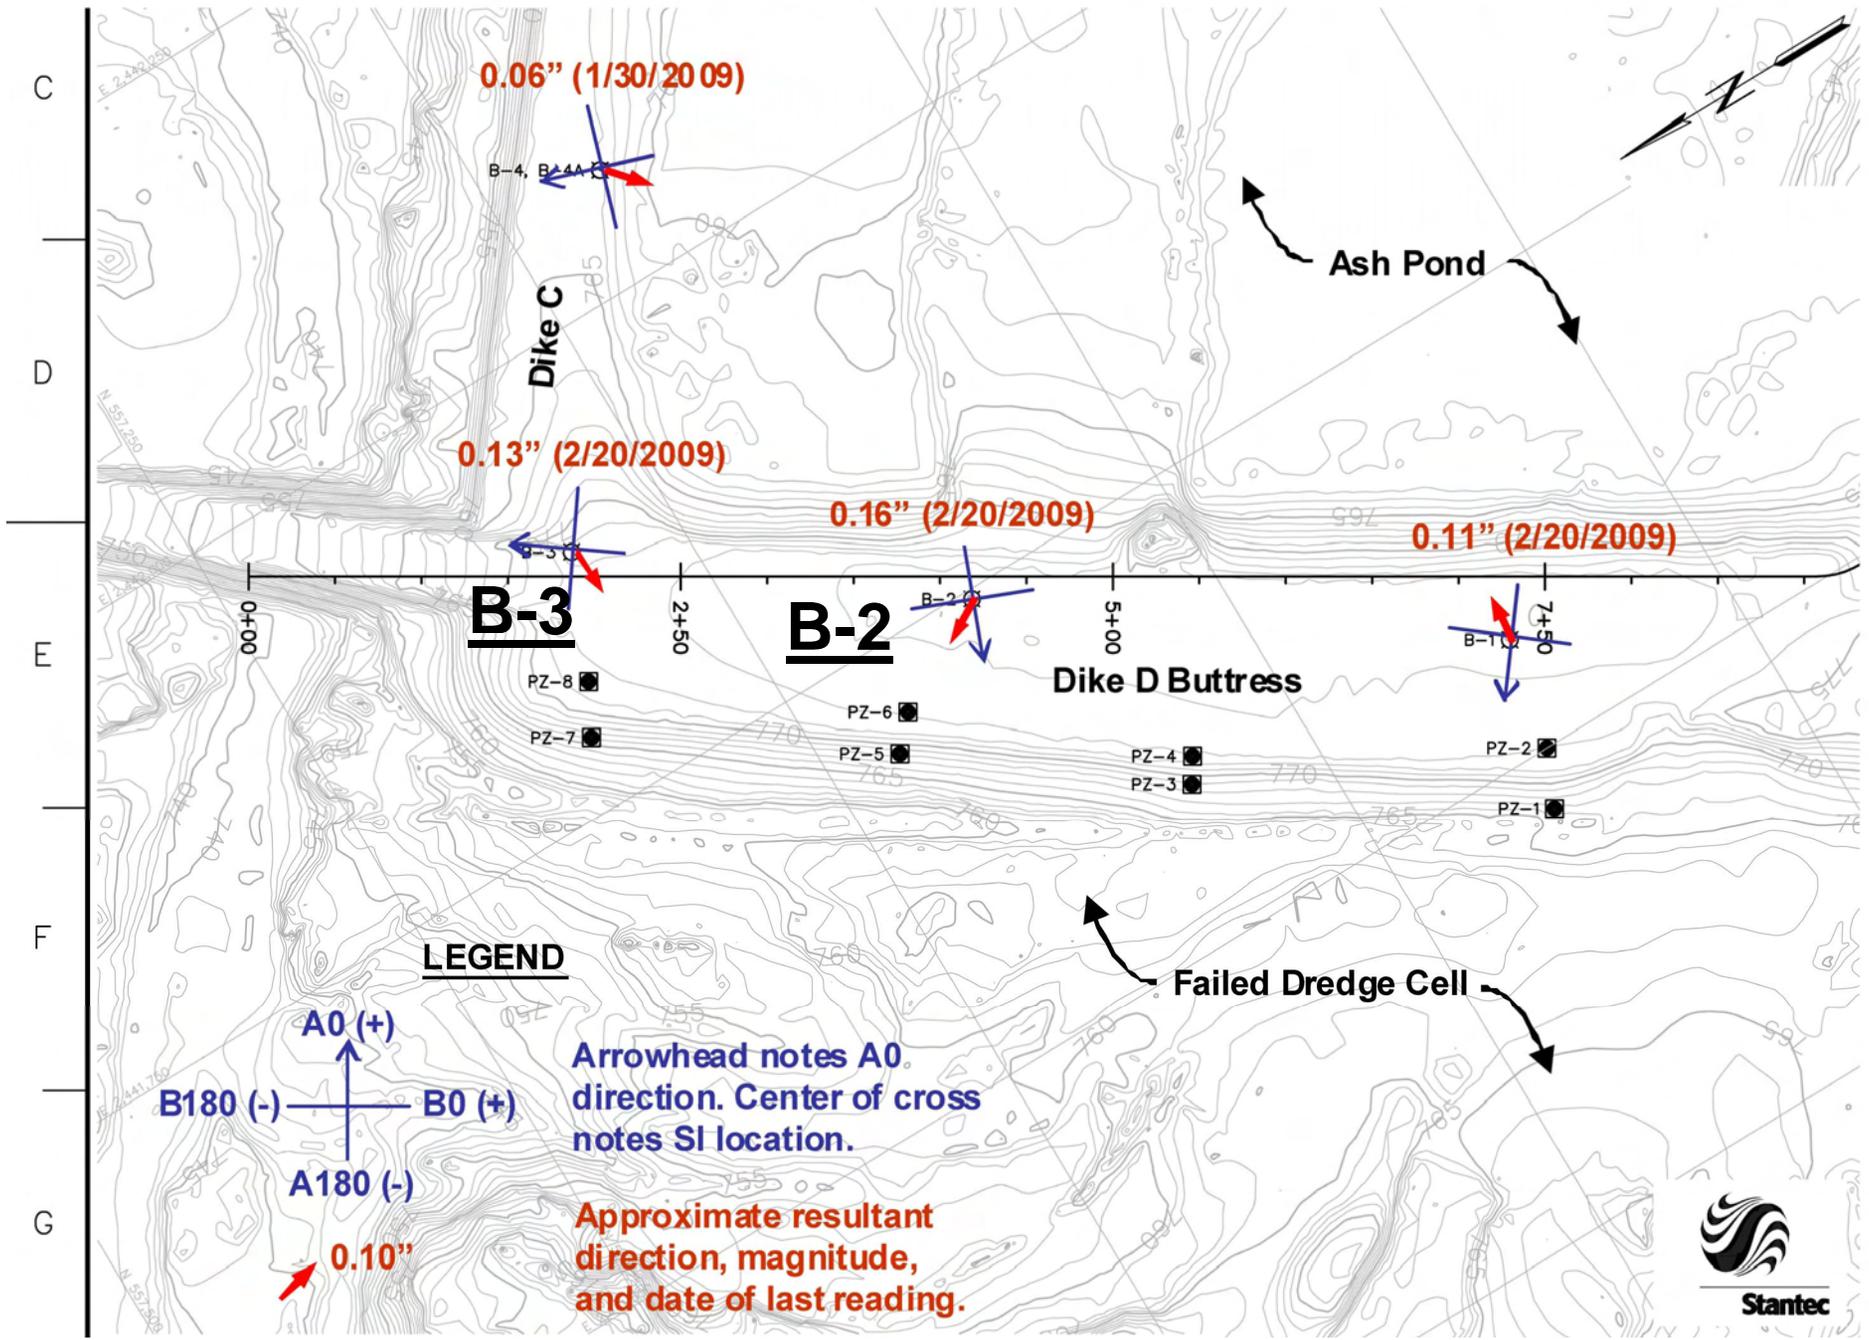
Dikes C and D Slope Inclinometer Locations and Movements

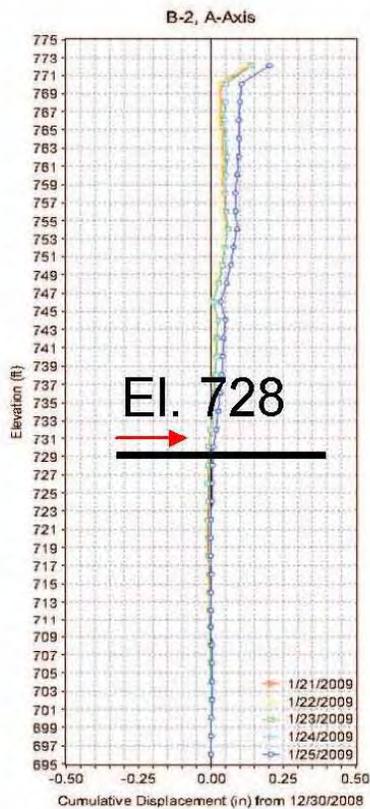
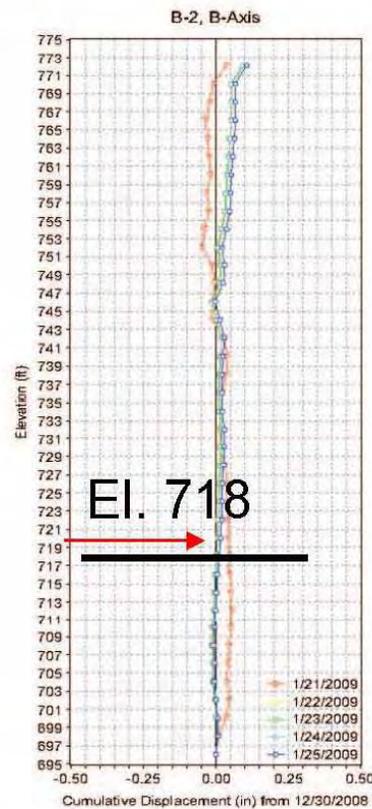
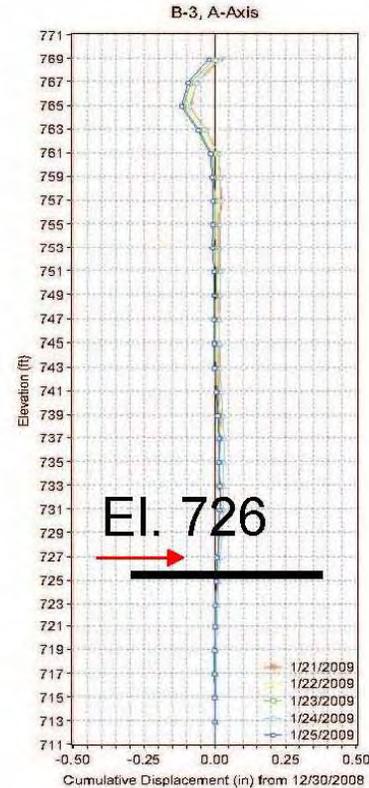
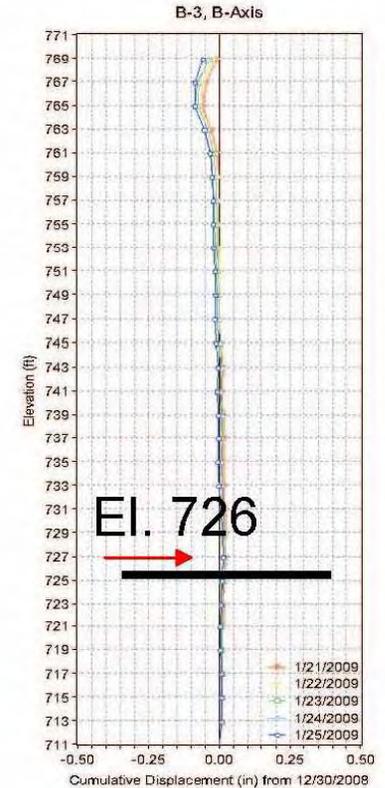
Detected Ground Movements from Dike D Inclinometers by Stantec

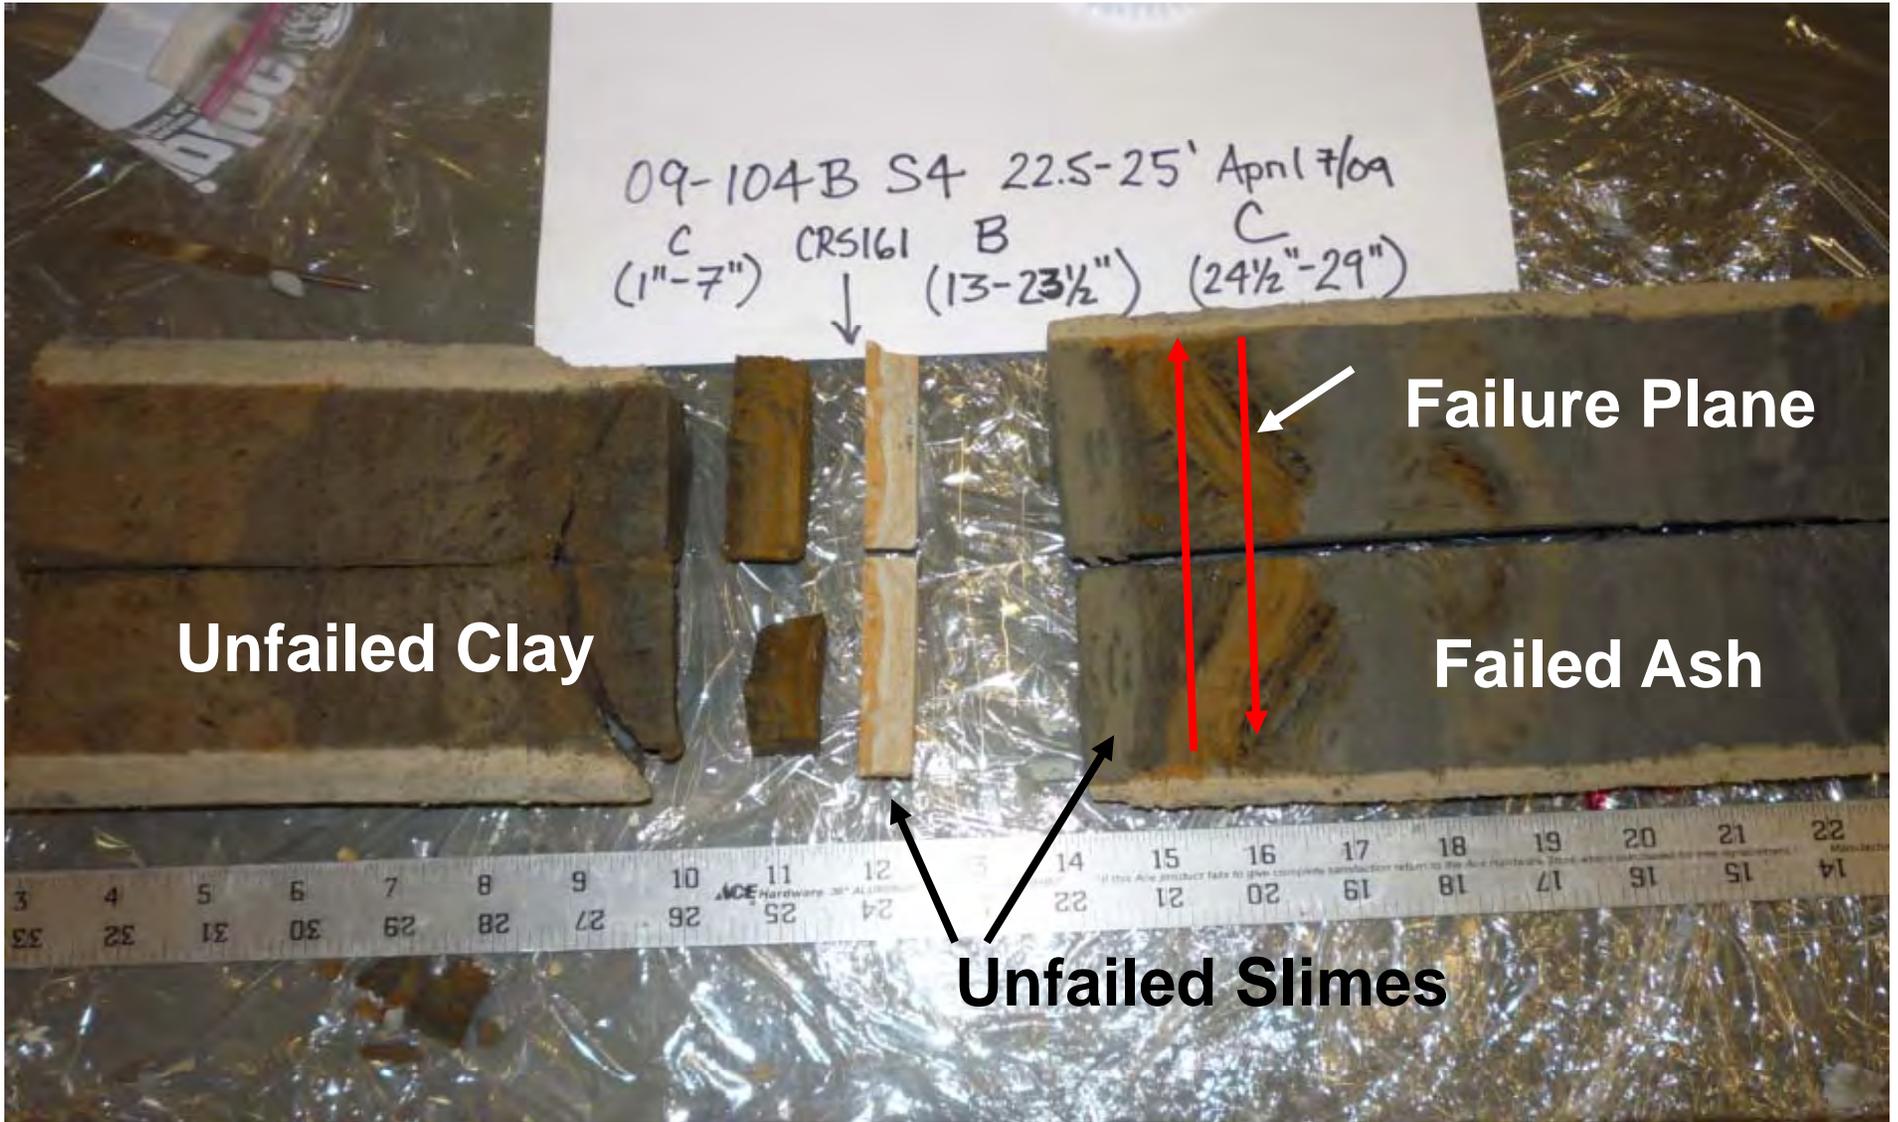
Photos of Slide Plane in Slimes at 09-104B

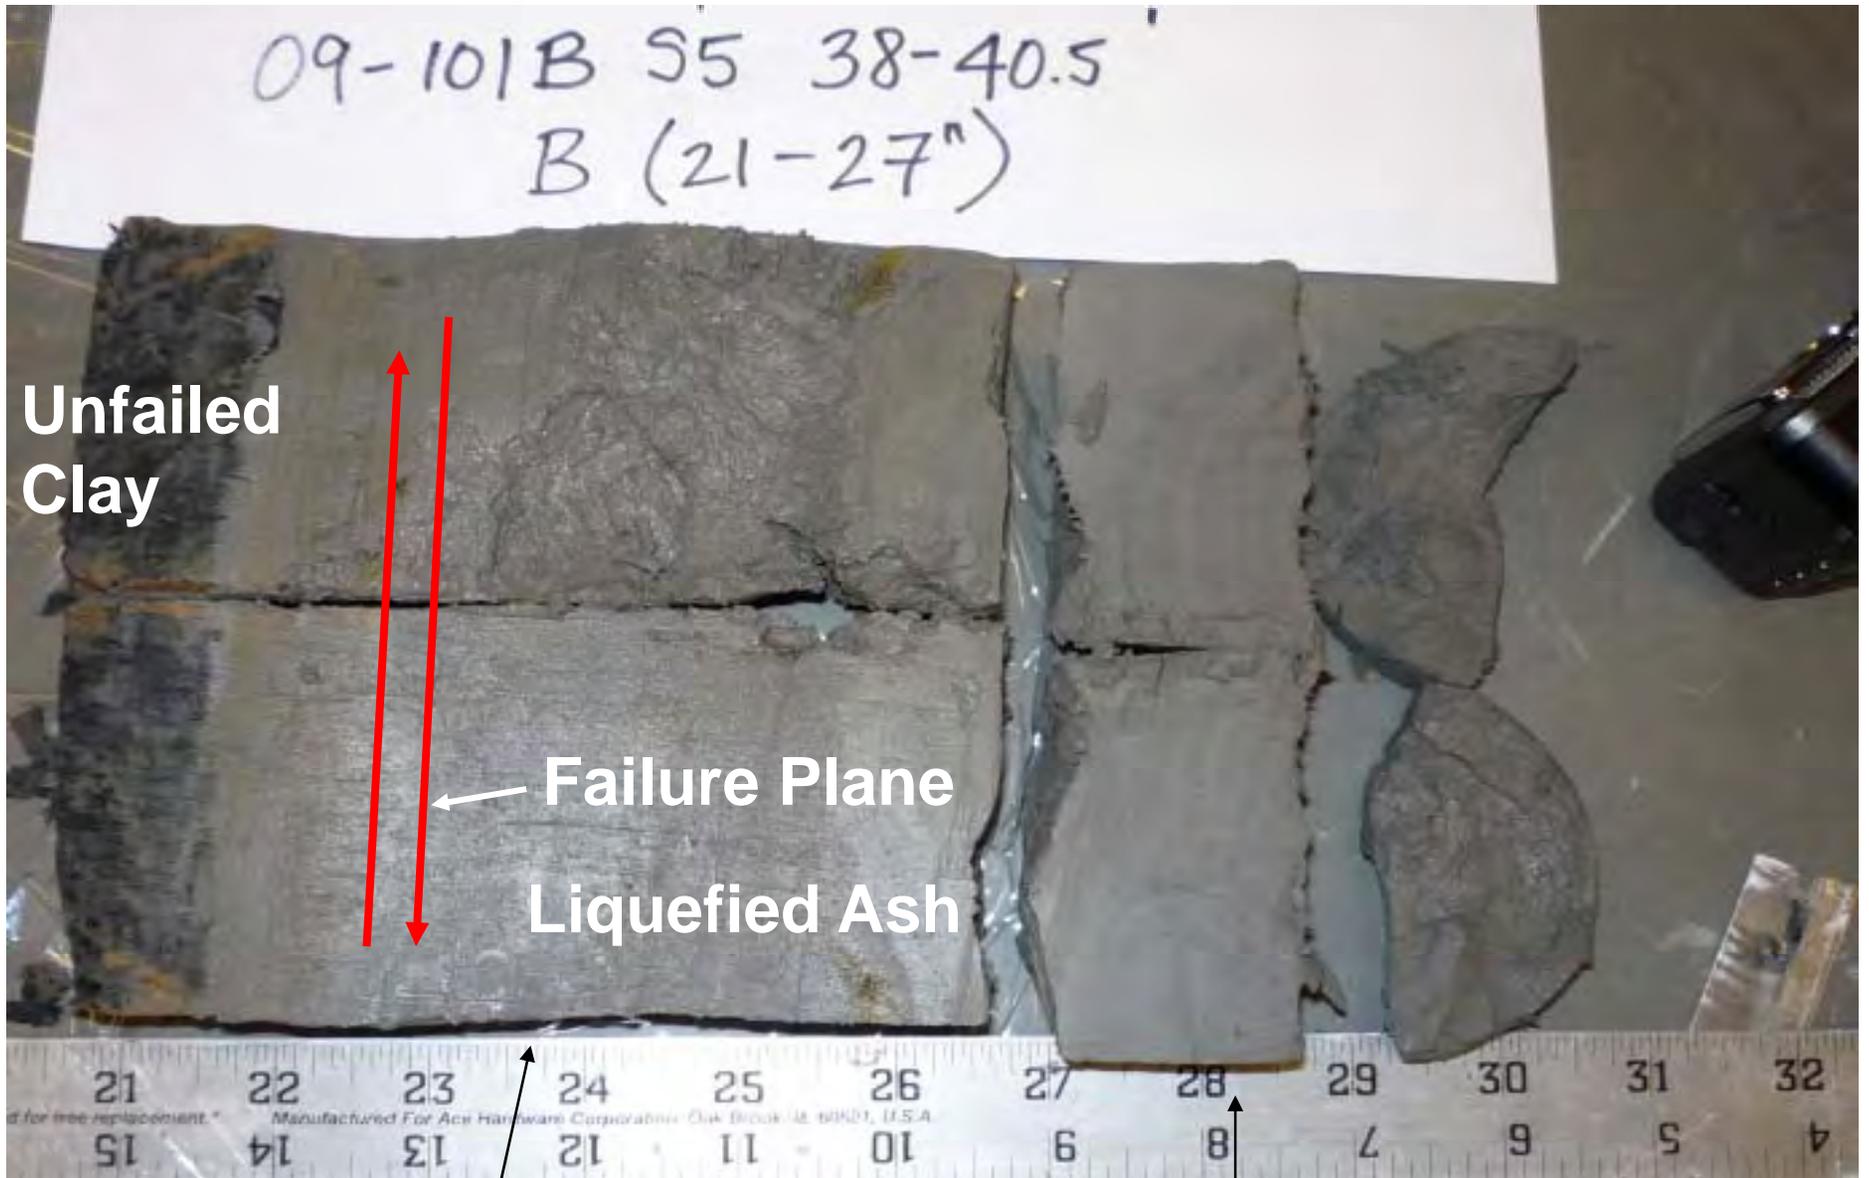
Failed Clay/Ash Interface at 09-101B

**4-INCH SHEAR PLANE OF
TOTAL LIQUEFACTION**

PARTIAL LIQUEFACTION

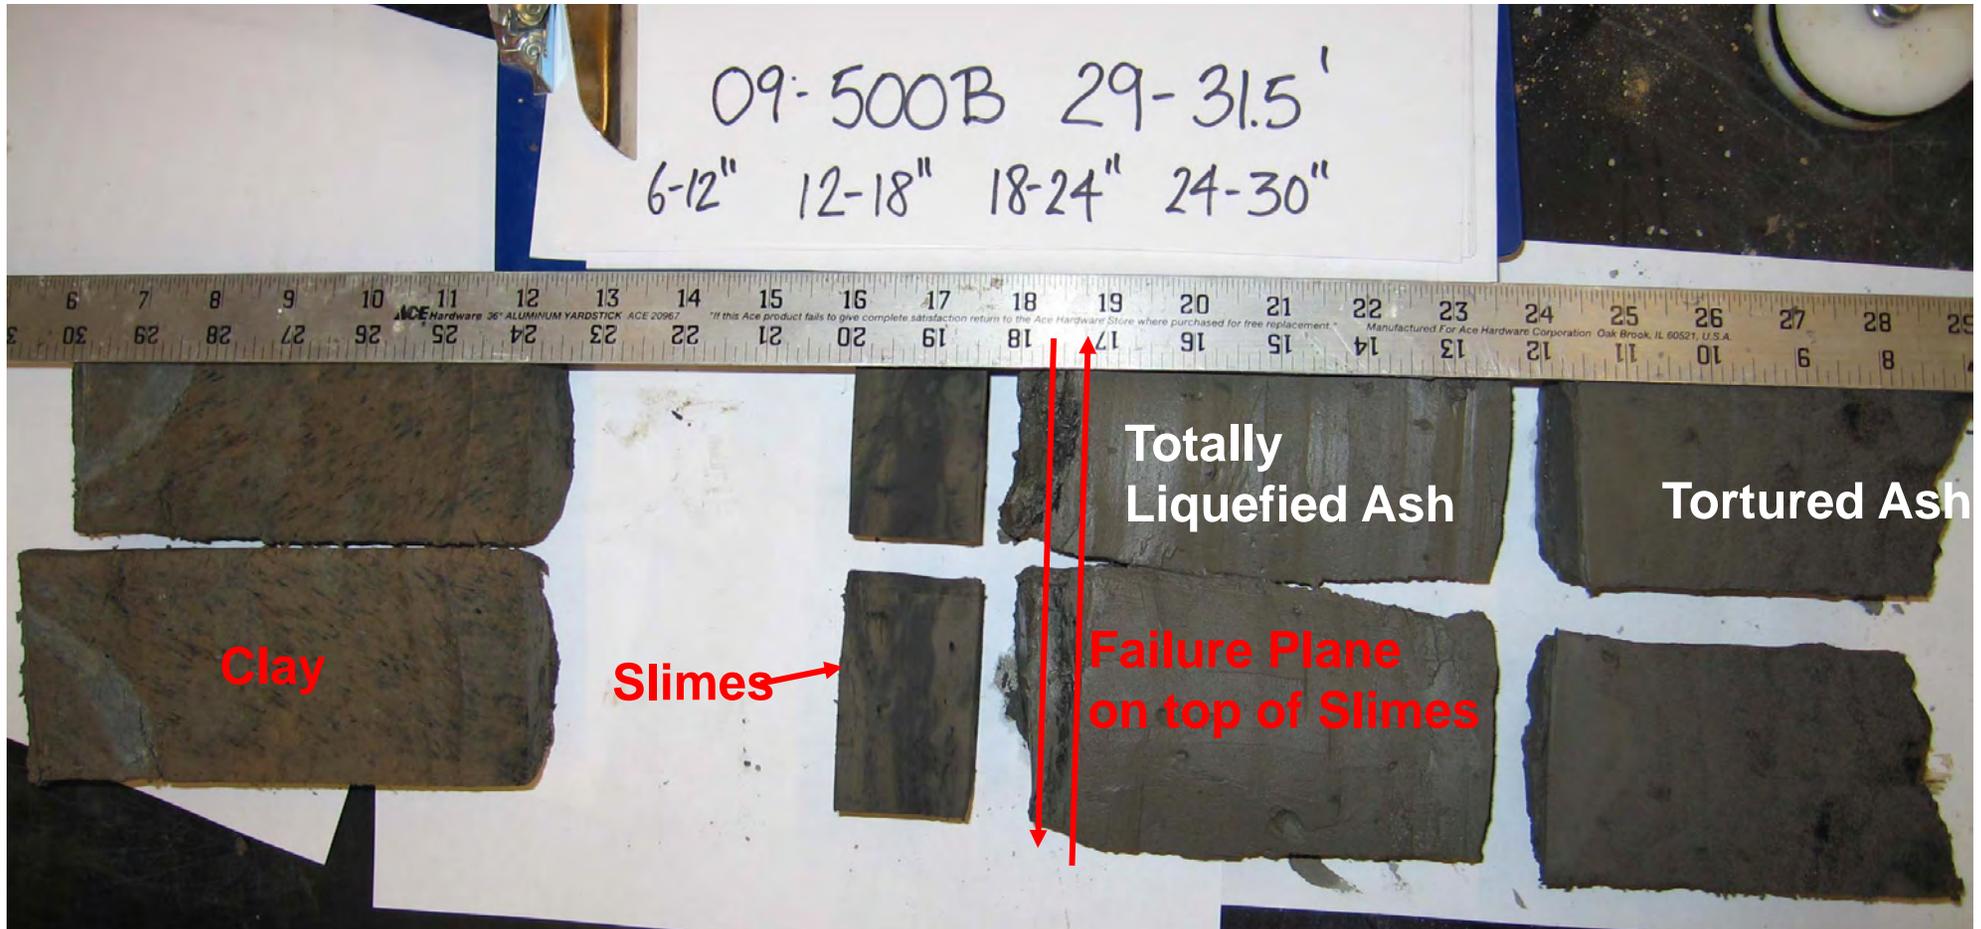
09-500B S5 29.0 to 31.5 ft

Clay/Laminated Slimes/Failed Ash at 09-500B, OST5

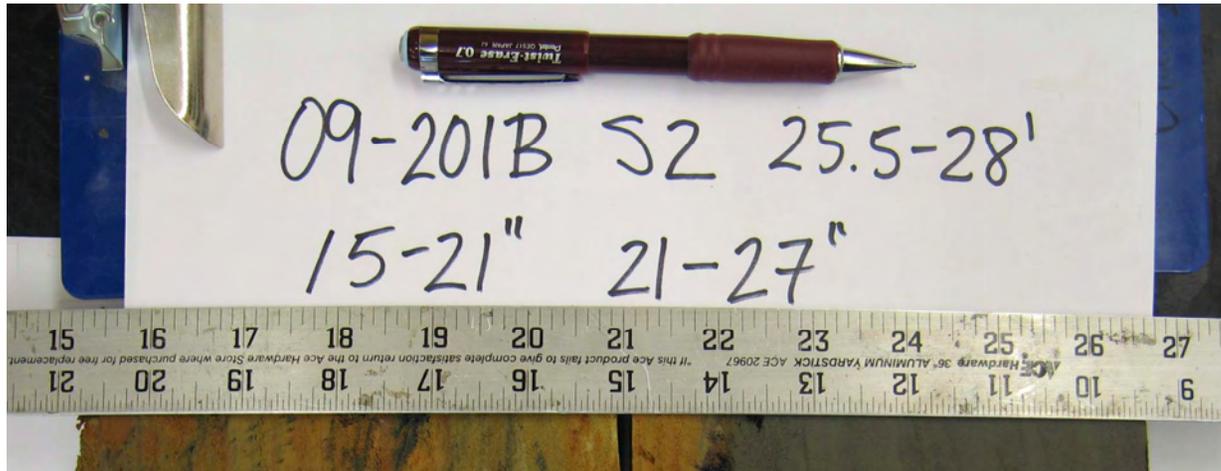
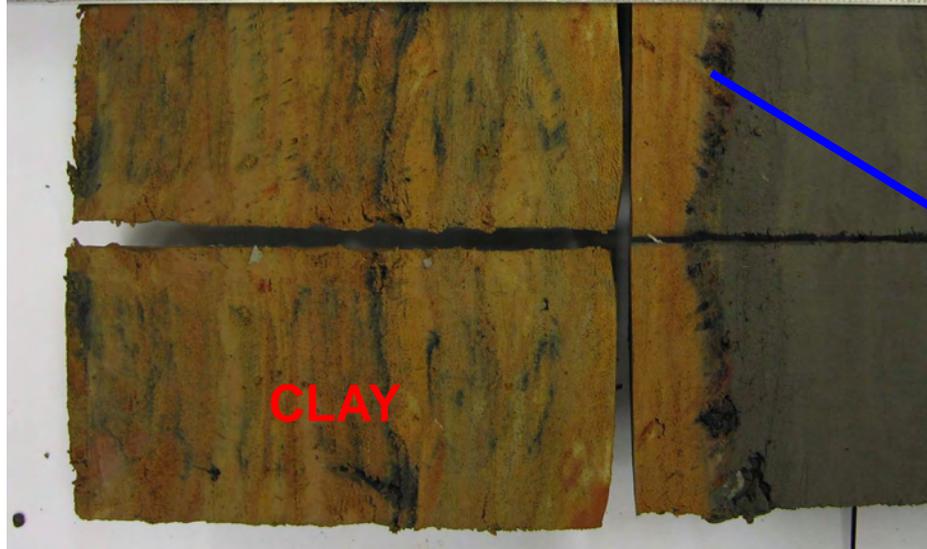
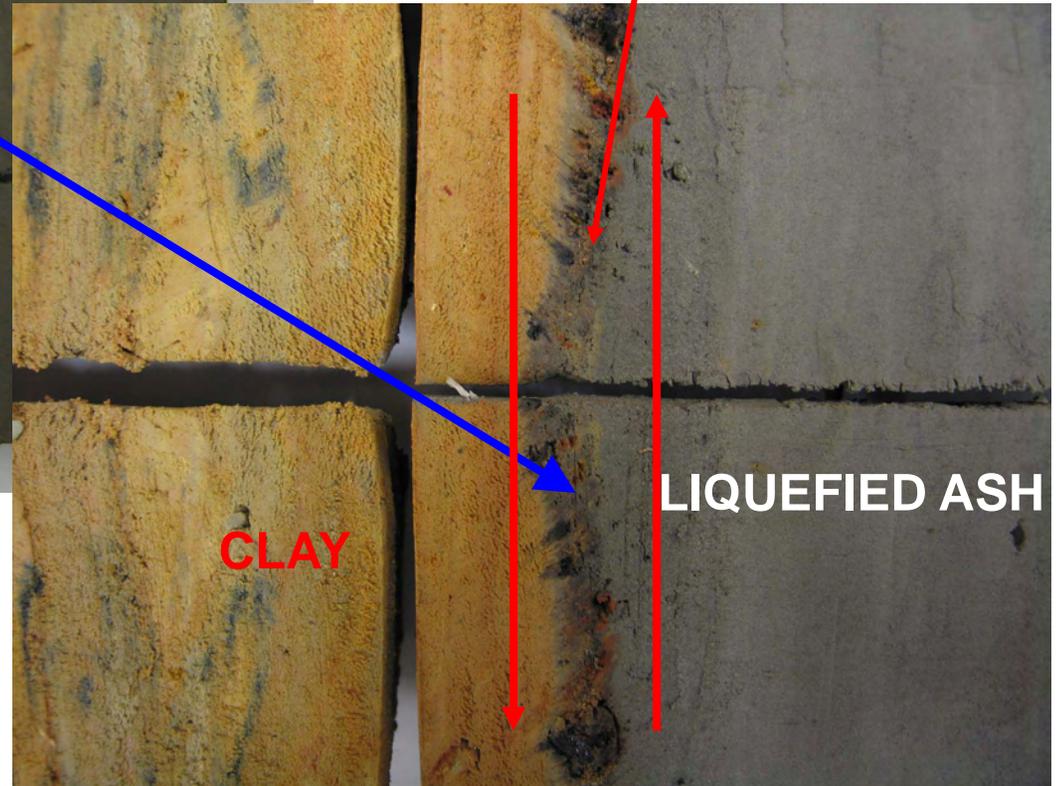
09-201B OST 2
25.5 to 28.0 ft

Clay/Failed Ash Interface at 09-201B

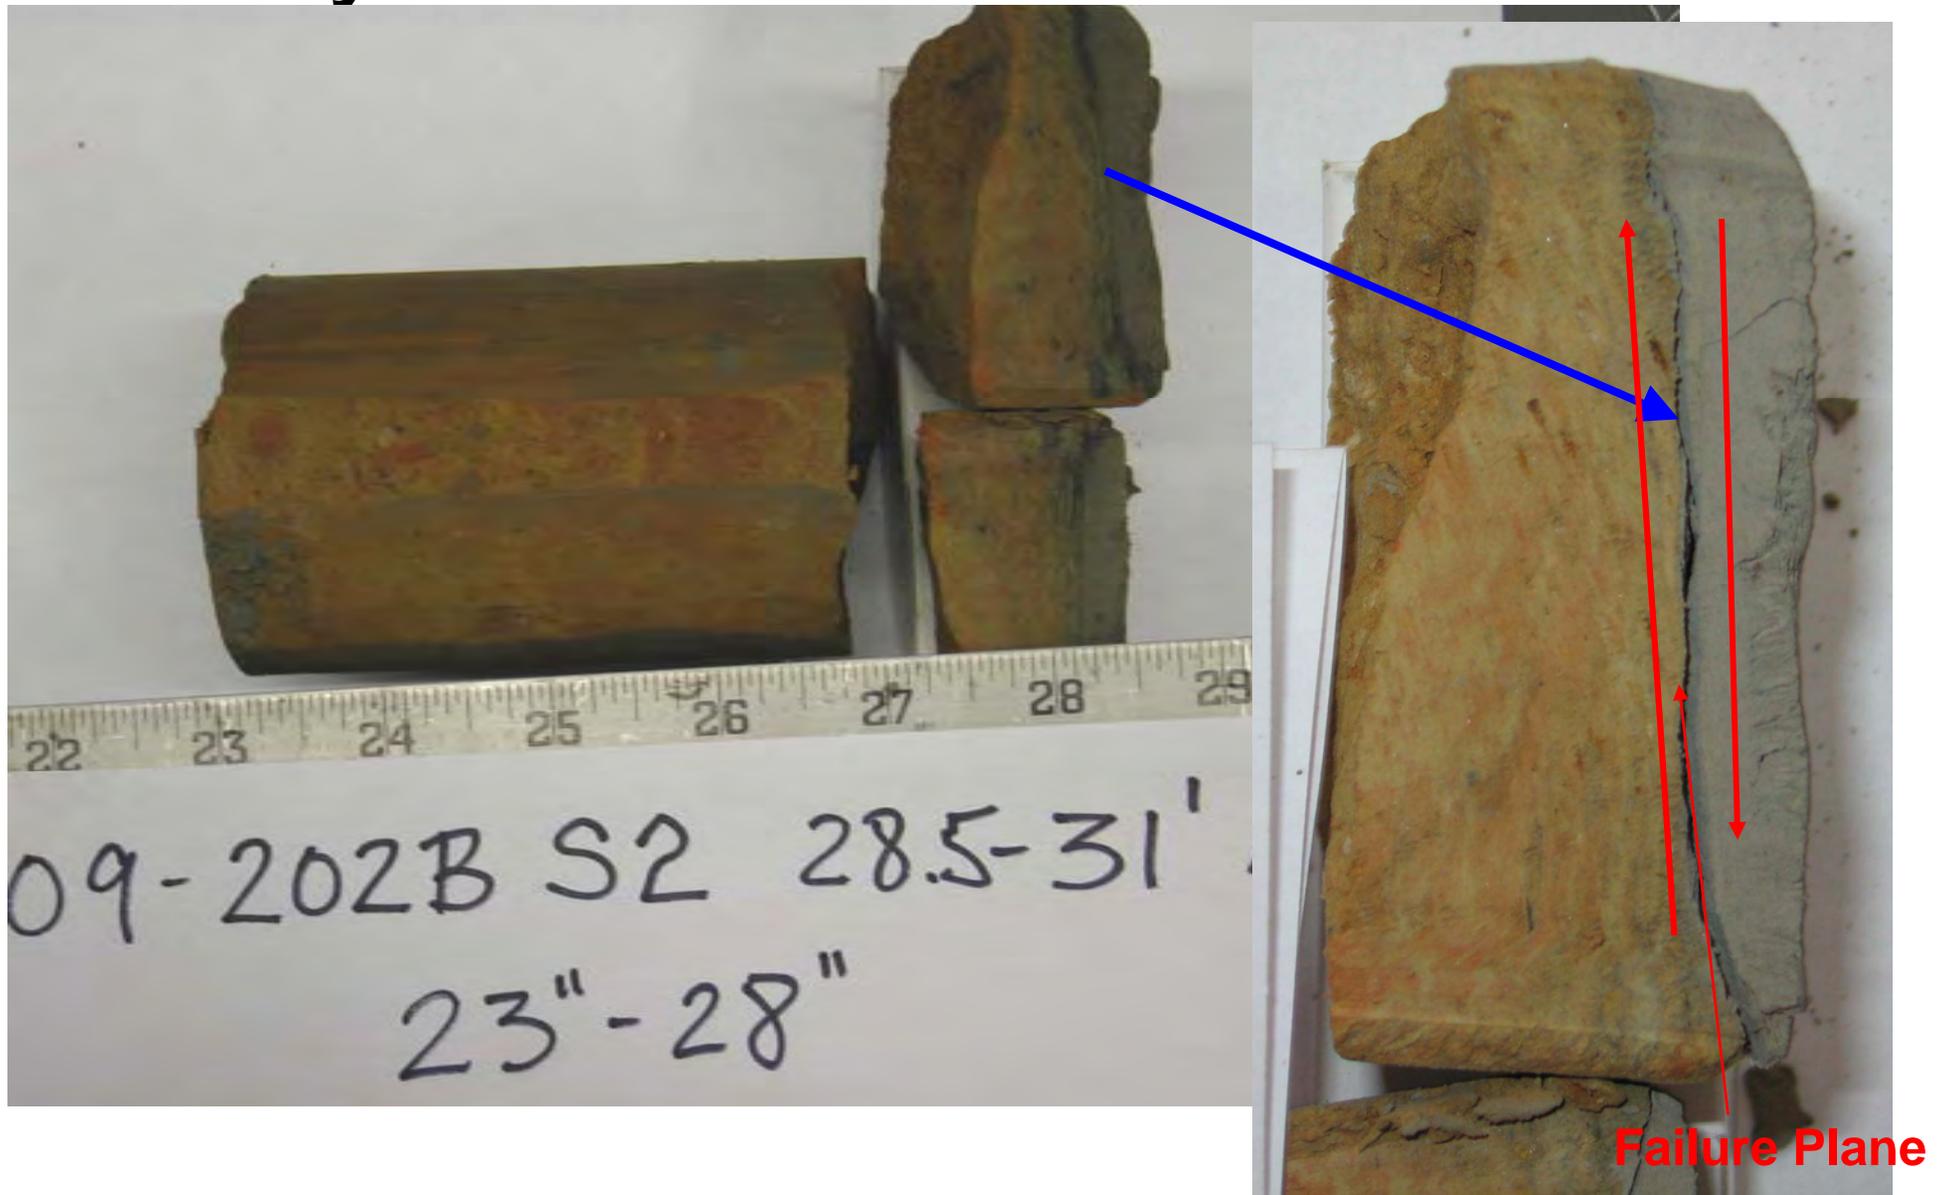
09-202B S2 28.5 to 31.0 ft

Clay/Ash Interface at 09-202B
