TVA Disposal Facility Assessment Phase 1 Plant Summary Watts Bar Fossil Plant (WBF)

**TVA Disposal Facility Assessment
Phase 1 Coal Combustion Product Disposal
Facility Summary
Watts Bar Fossil Plant (WBF)
Slag Disposal Area (AADA-1)**

TVA Disposal Facility Assessment
Phase 1 Coal Combustion Product Disposal
Facility Summary
Watts Bar Fossil Plant (WBF)
Ash Pond and Stilling Pond (AADA-2)

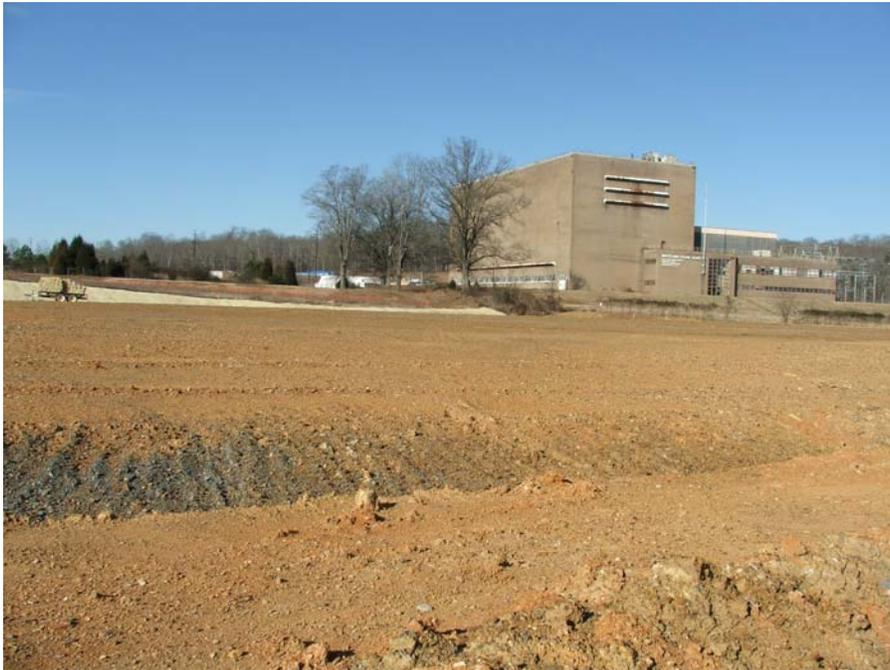
Drawing Mark AADA-1-4 Lack of vegetative cover on AADA and AADA slopes.

- Continue to monitor areas associated with the closure plan.
- Continue annual facility inspections.
- Monitor areas of erosion and repair as needed.

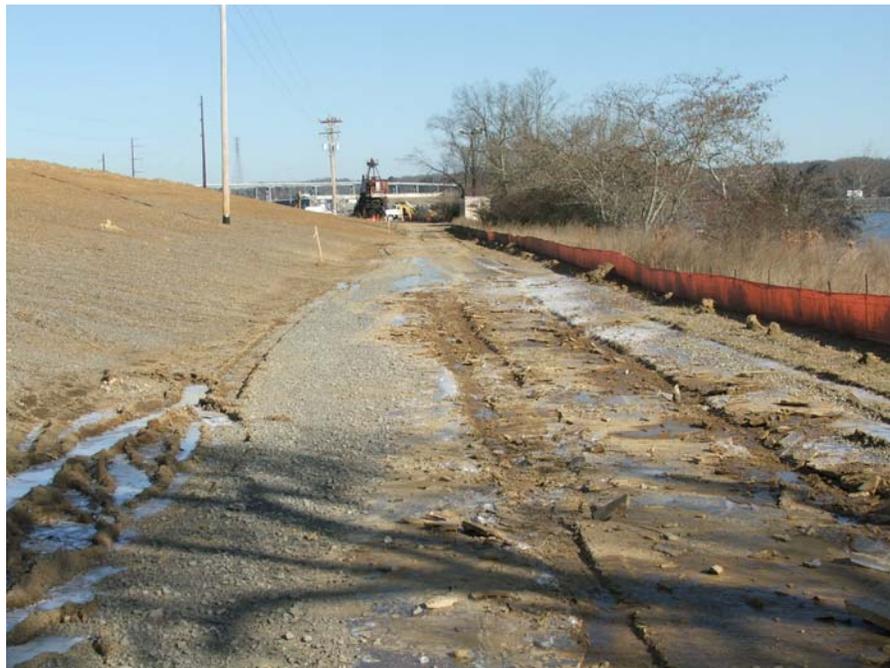
Drawing Mark AADA-1-3 Lack of drainage ditch at toe of AADA embankment.

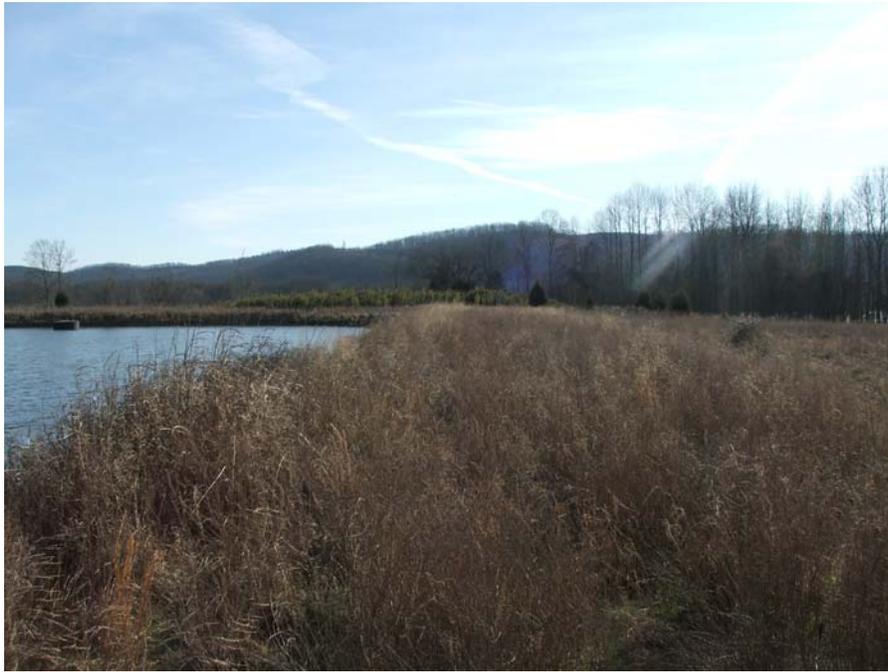
Drawing Mark P-1-1

- Excess vegetation, some woody, on the embankment.
- Steep slopes on the embankment.
- Erosion on the riverbank below the embankment toe and at the spillway discharge into the river.

Excess vegetation on embankment crest and slopes.

- Cut and maintain heavy/tall cattail and grass growth on interior slopes of ponds to allow better observation.
- Remove trees/brush from downstream dike slope of Stilling Pond and Ash Pond and outlet area.
- Continue to monitor areas associated with the closure plan.
- Continue annual dike and facility inspections.
