Tennessee Valley Authority
Regulatory Submittal for Kingston Fossil Plant

Documents submitted:
On-Scene Coordinator Report for the Non-Time Critical Removal Action for the
Embayment/Dredge Cell

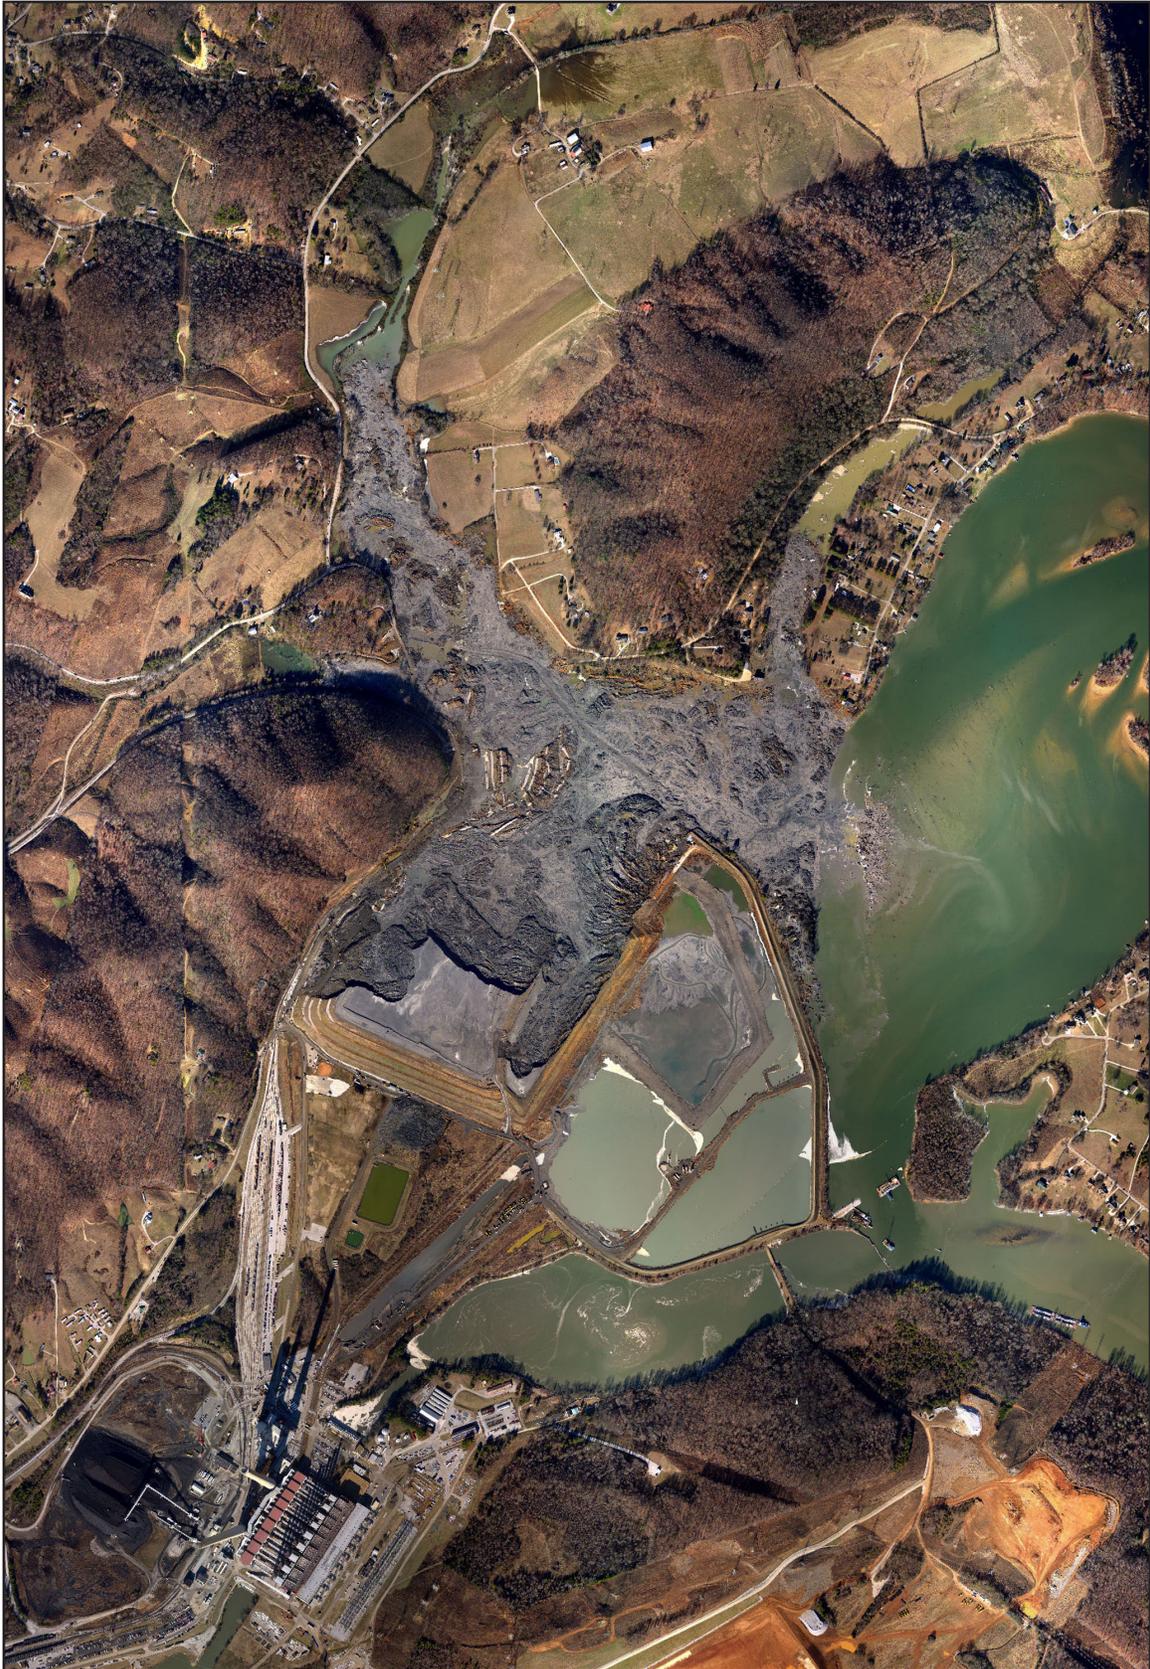
1A – Aerial image of the Kingston Ash Recovery Project site after release. December 28, 2008.

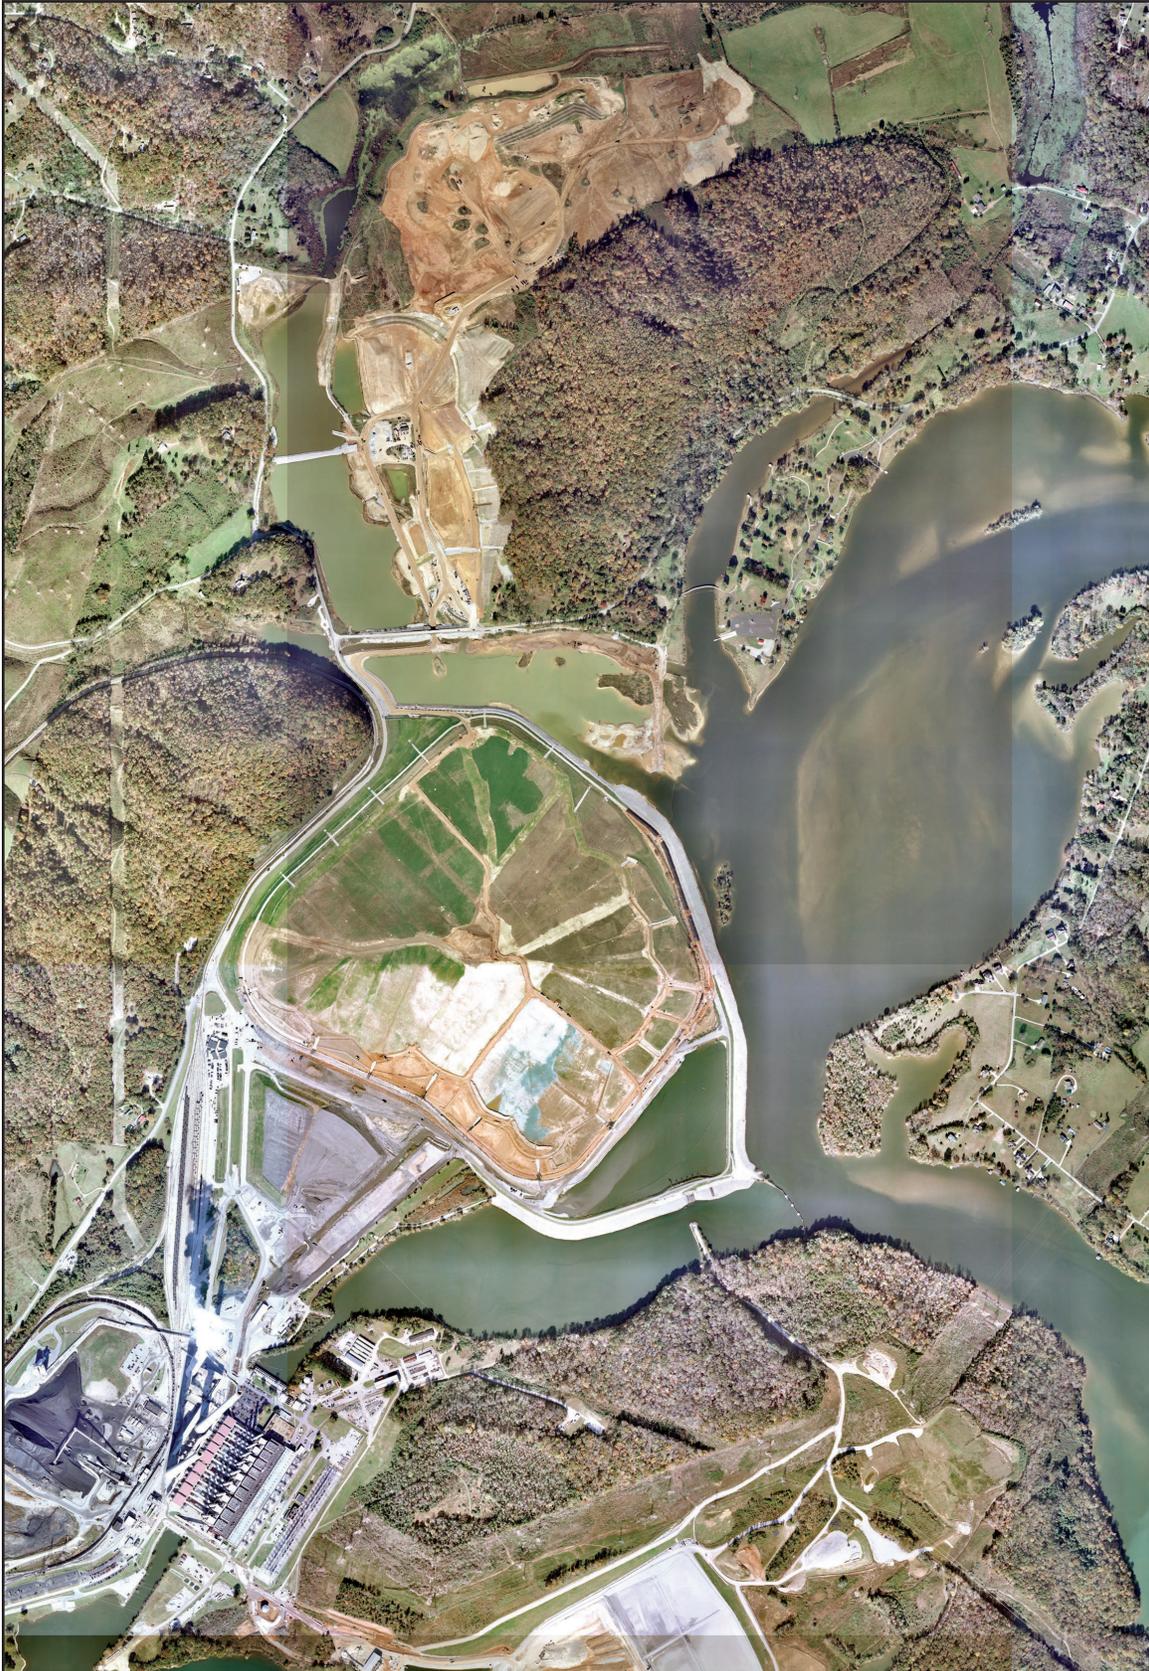
1B – Aerial image of the Kingston Ash Recovery Project site following Non-Time-Critical Removal Action. November 3, 2014.

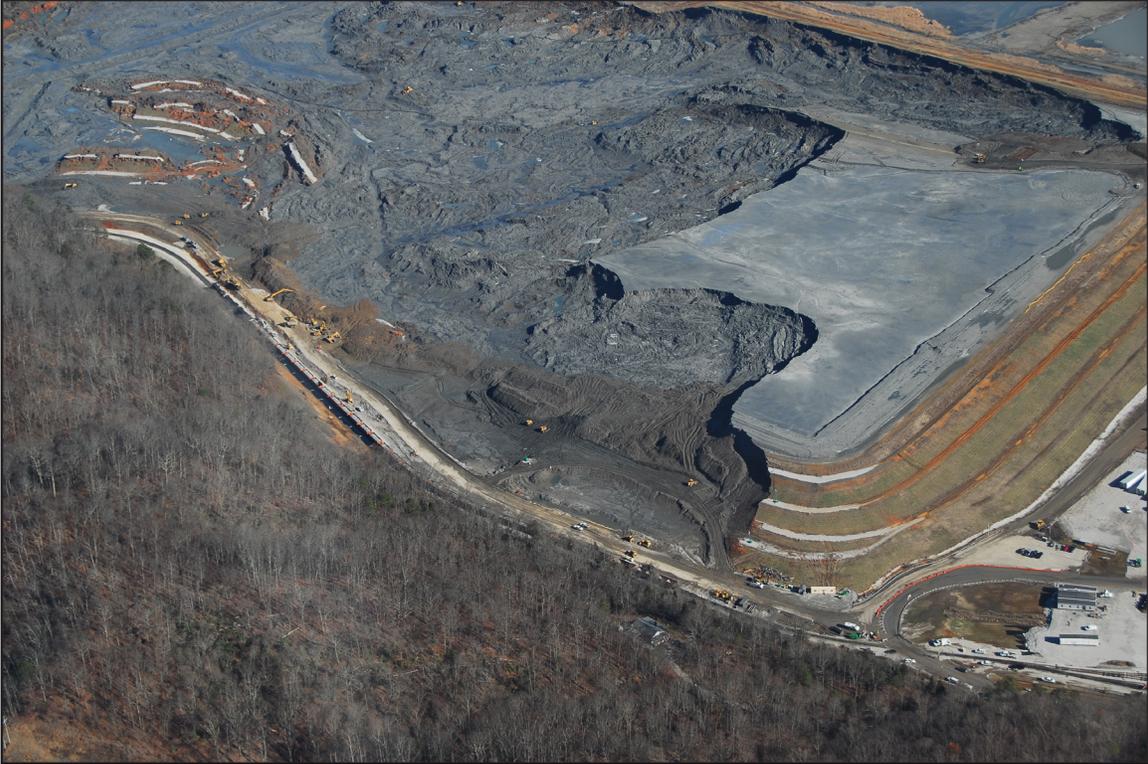
2A – Oblique of the failed Dredge Cell after release (viewing from the southwest). January 8, 2009.

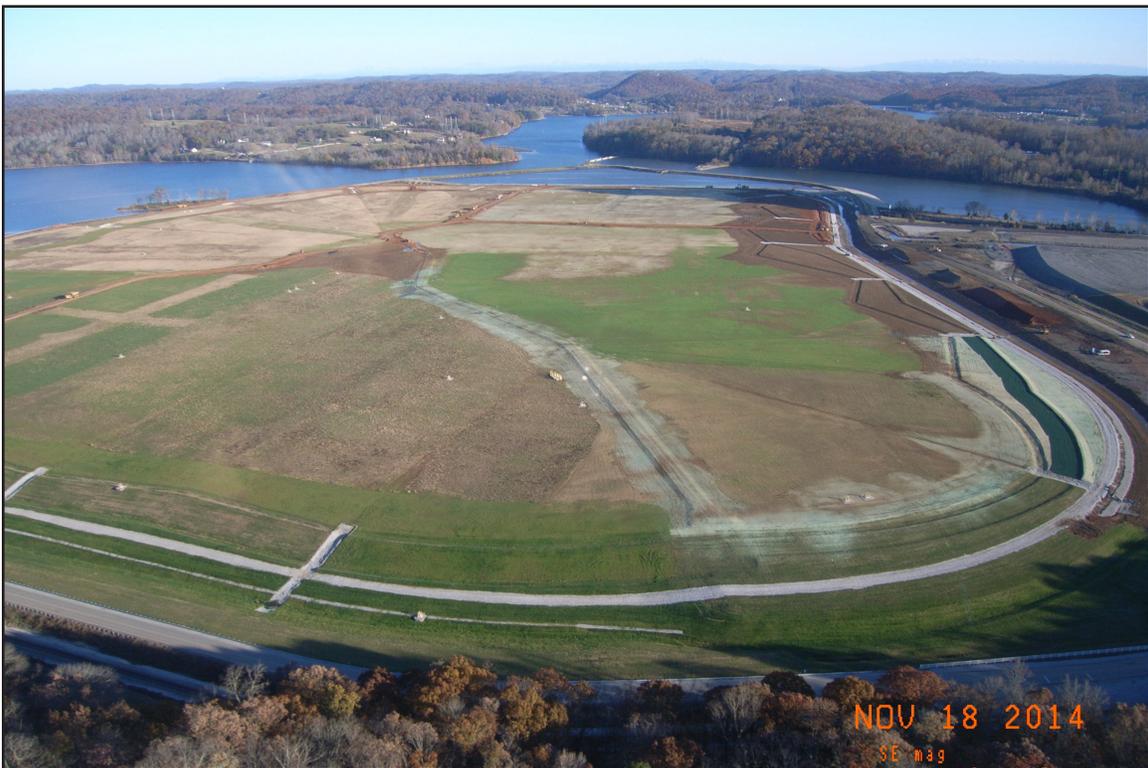
2B – Oblique of the failed Dredge Cell during Non-Time-Critical Removal Action. November 18, 2014.

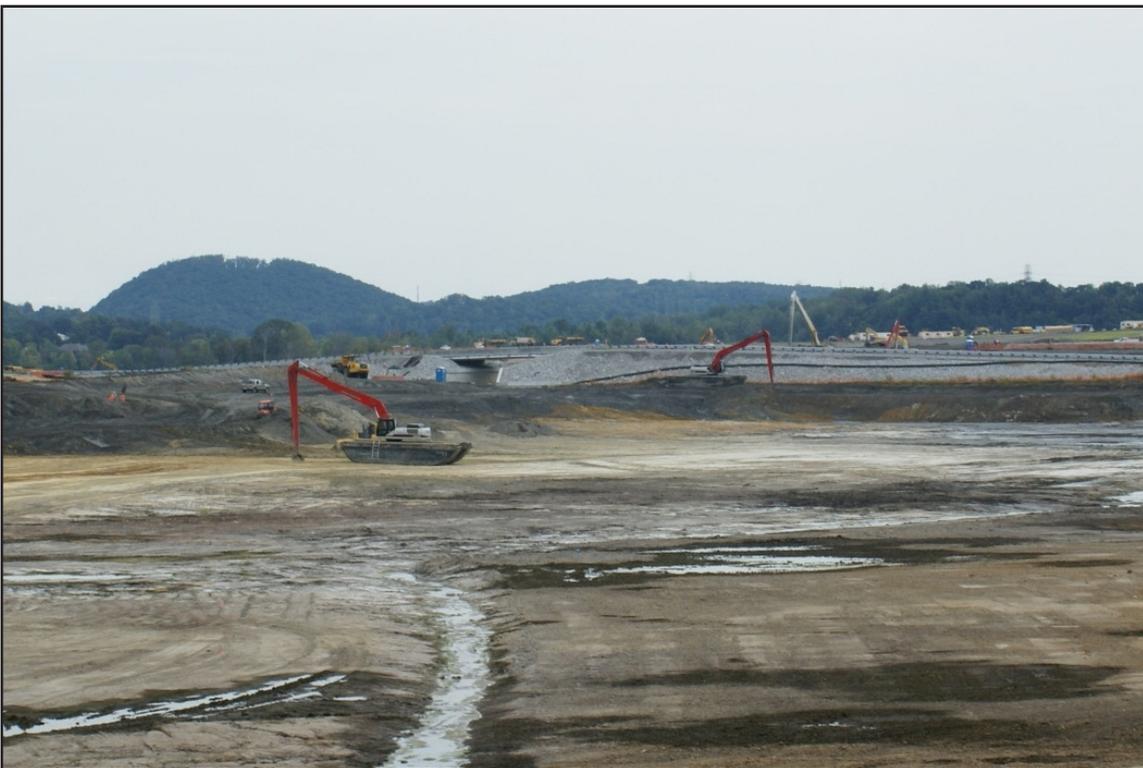
7B – Ash Removal: Bottom of the North Embayment following ash removal. September 19, 2011.

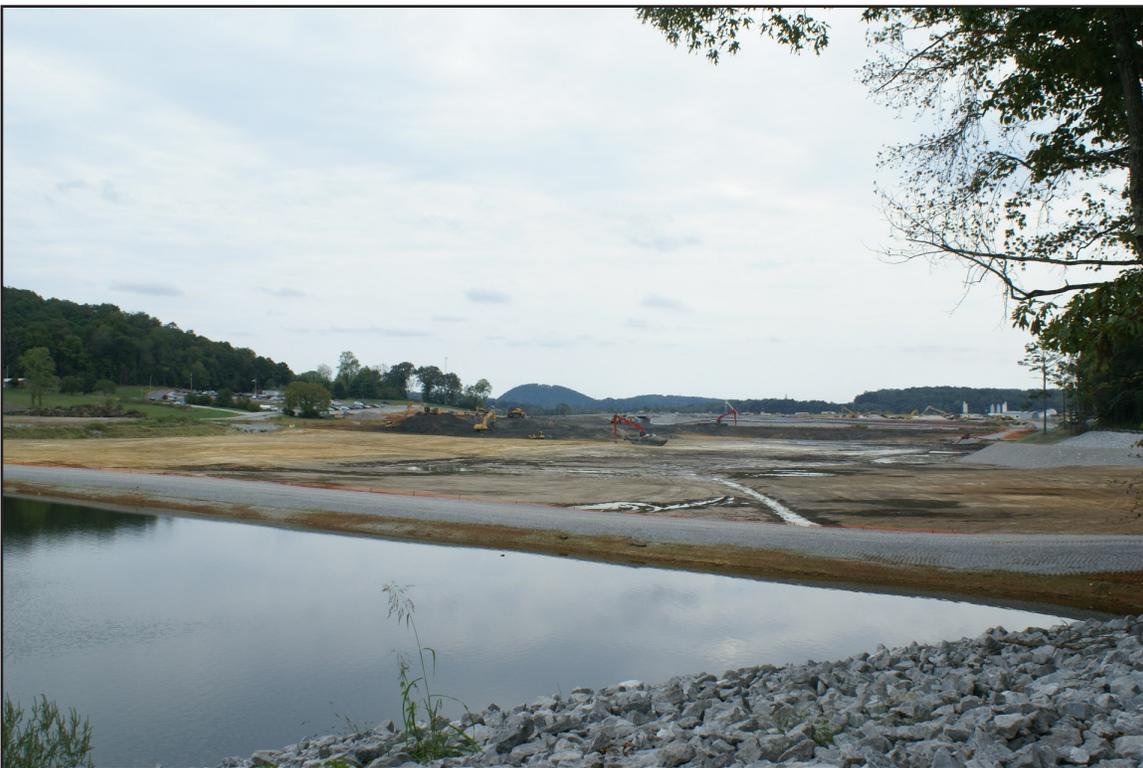
8B – Ash Removal: Completed North Berm diverting stormwater from the lower half of the North Embayment. September 18, 2011.

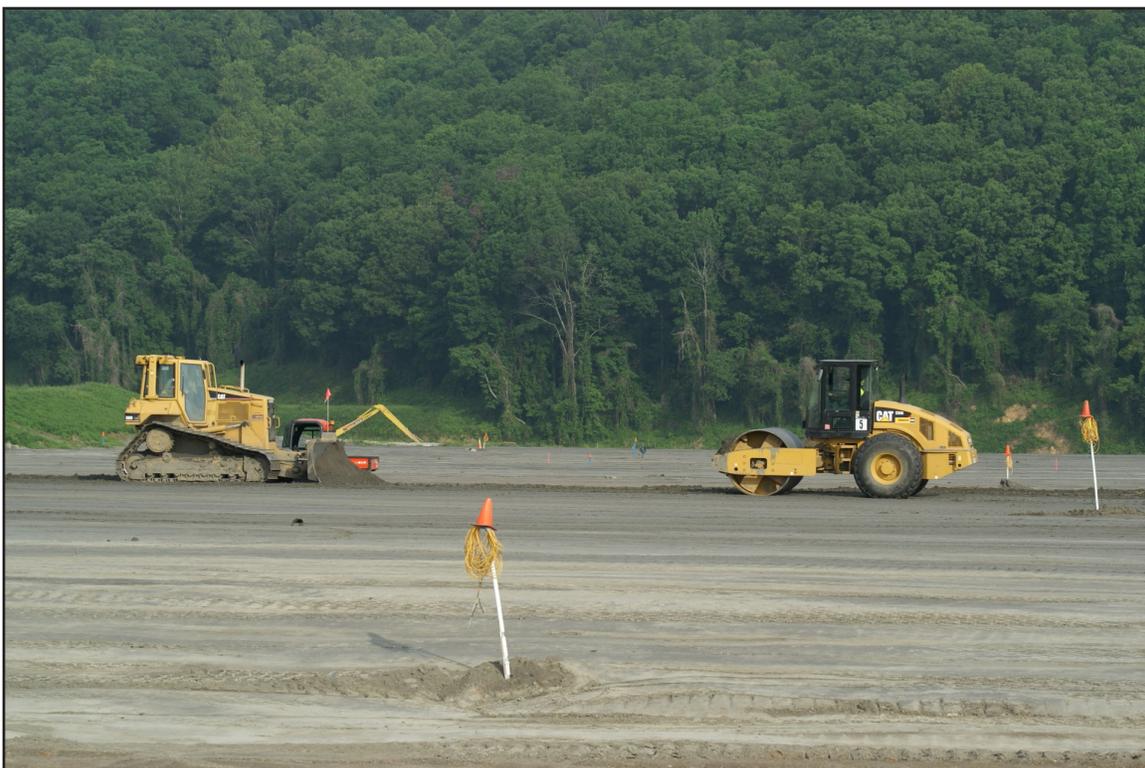
18B – Ash Stacking: Using dozer and smooth drum roller in the Dredge Cell to stack the ash. May 11, 2011.

- Ash stacking lessons learned. Geotechnical monitoring, including piezometers and inclinometers, proved critical to safely controlling ash stacking rates. Prolonged wet weather degraded the stacking subgrade and impaired productivity. Mitigation measures such as waiting for the conditions to dry out, “clipping” the subgrade surface and replacing that material, and disking or blading the material in place to enhance drying were effective at improving subgrade conditions, but were nominally successful during winter months.

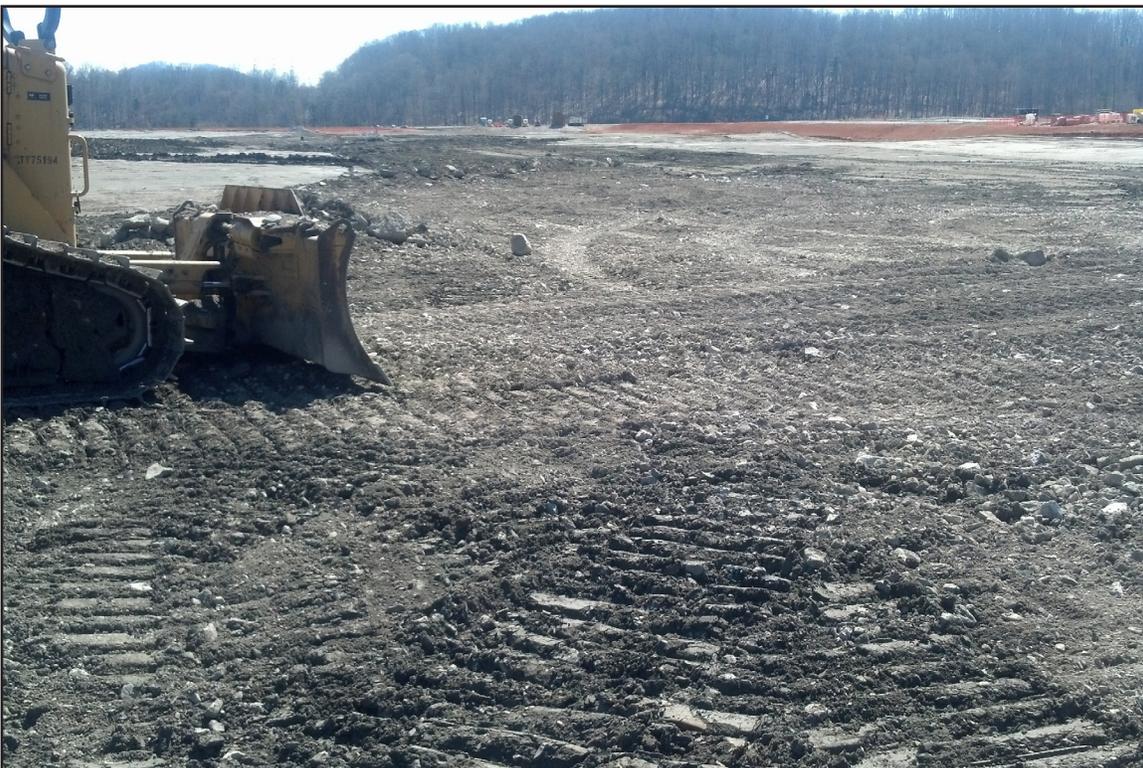
20B – Ash stacking: Stabilization of the subgrade in the Ash Pond using a gravel base. March 20, 2014.

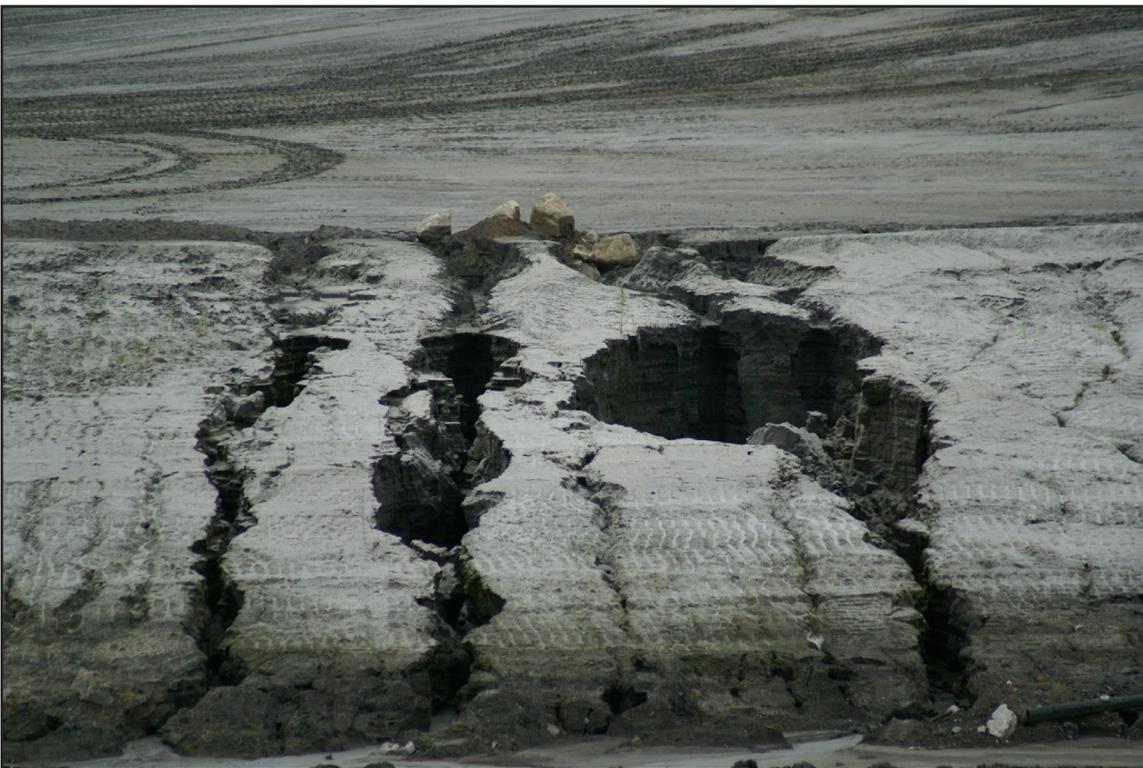
21B – Ash Stacking: Erosion damage to edge of ash stack following storm event. August 12, 2013.

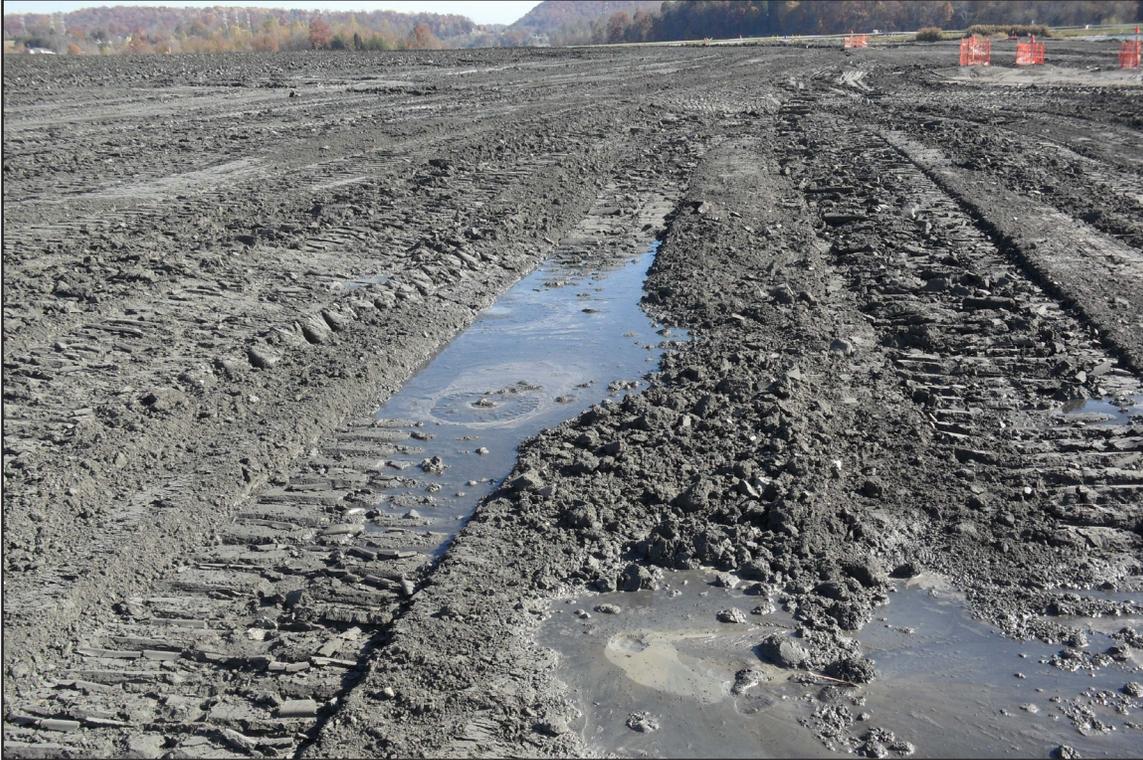
22A – Ash Stacking: Mud boils inducing wet subgrade conditions during ash stacking in the Lateral Expansion. November 8, 2011.

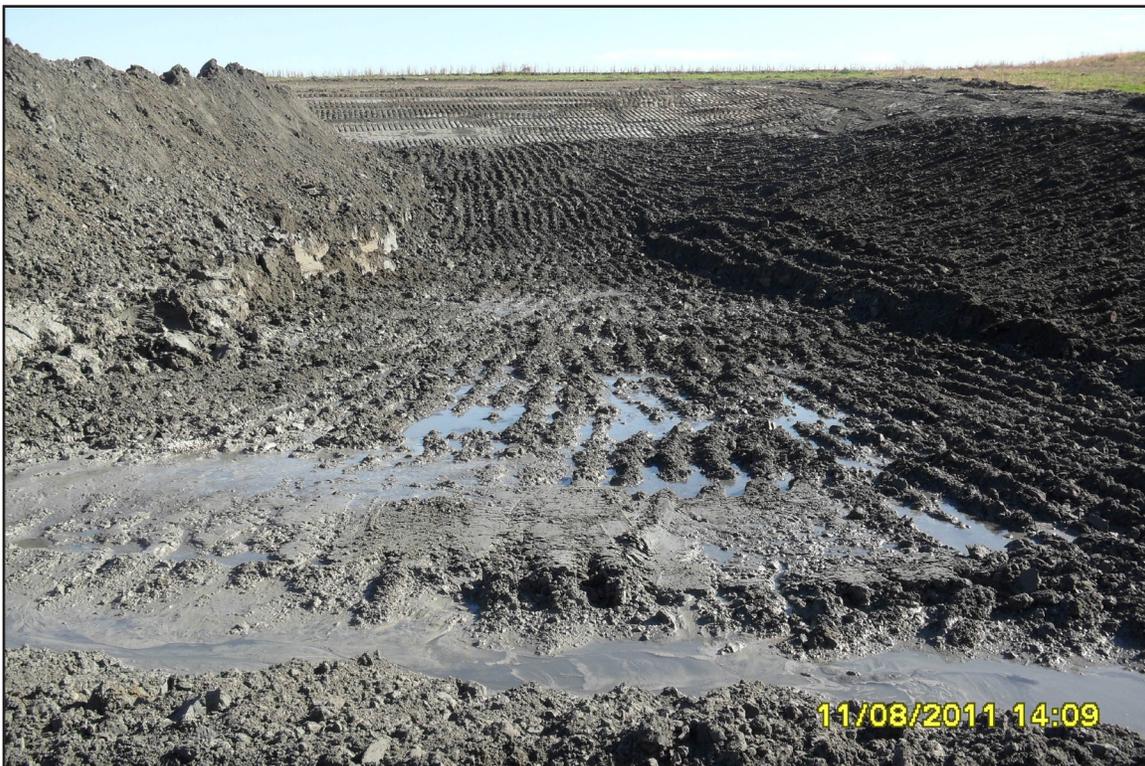
22B – Ash Stacking: Repair of mud boils by excavation of wet subgrade for construction of French drains. November 8, 2011.

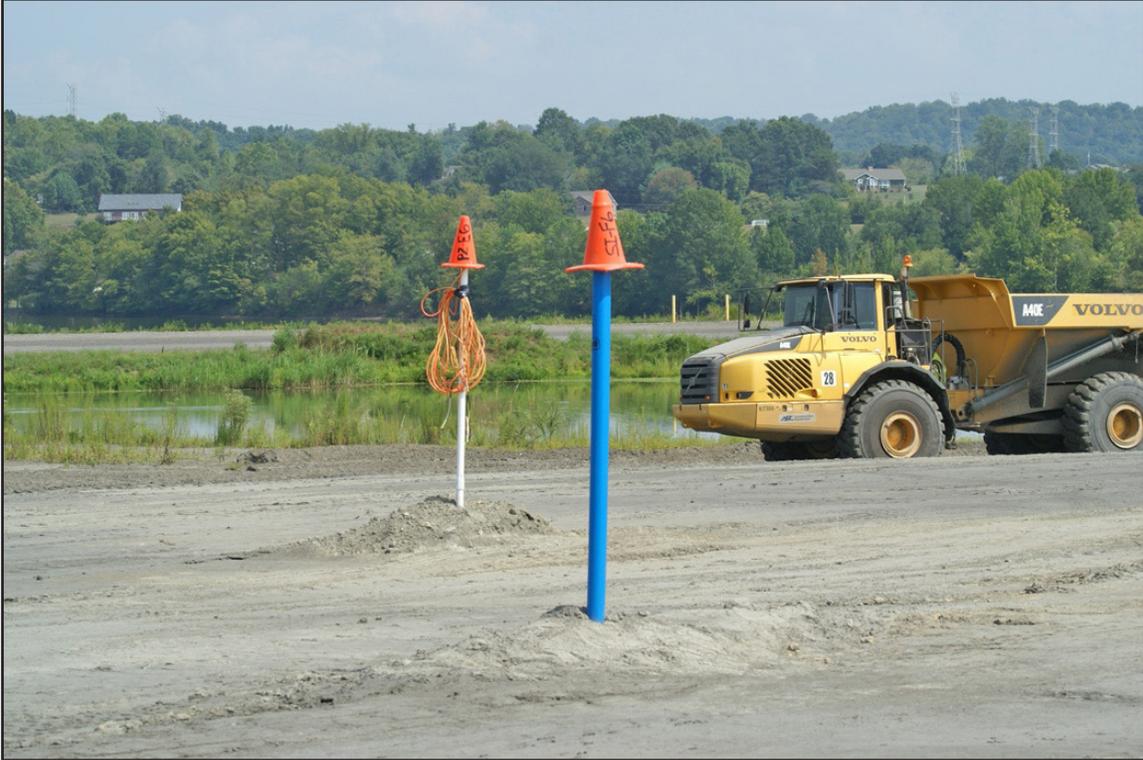
23A – Ash Stacking: Geotechnical instrumentation used for monitoring ash stacking; piezometers (white) and slope inclinometers (blue). August 30, 2011.

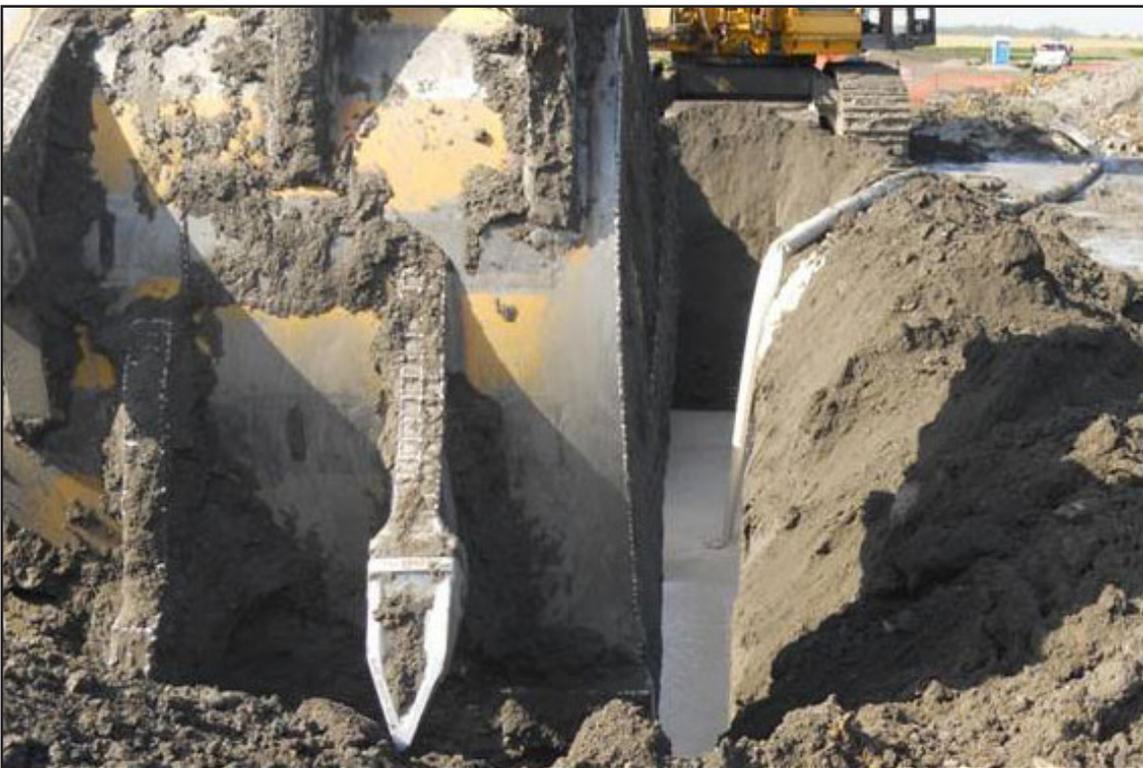
25B – PWS: Rock excavating teeth on bucket of long-reach excavators. April 14, 2011.

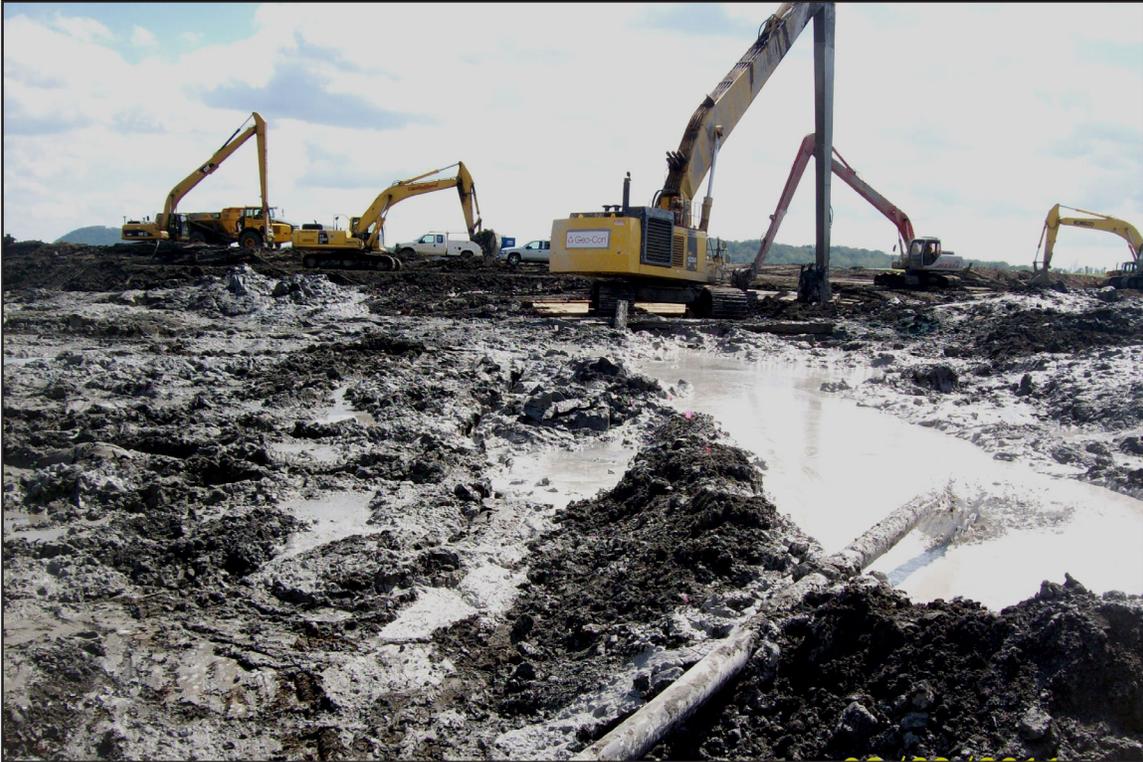
29A – PWS: Platform deterioration occurred due to rainfall and high water table, resulting in very wet conditions under excavator. September 29, 2011.

- Problems were encountered early in the trenching operations as work platform conditions deteriorated during trenching. Groundwater levels rose to near the ground surface, causing trench collapse and platform deterioration. Equipment support (layered crane mats) was impacted, requiring at times more than six layers of mats. Several options were tested for stabilization of the work platform so as to improve equipment support: stone/rock, stone/rock with geogrid reinforcing fabric, bottom ash, lime-treated fly ash, and cement-stabilized fly ash. Stone/rock surfacing was the most successful and cost-effective method for improving platform stability. Additional techniques proved helpful in abating near-surface groundwater levels that had led to deterioration of the platform: dewatering finger drains, raised platform elevation, and reducing spillage of slurry trench spoils onto the platform.

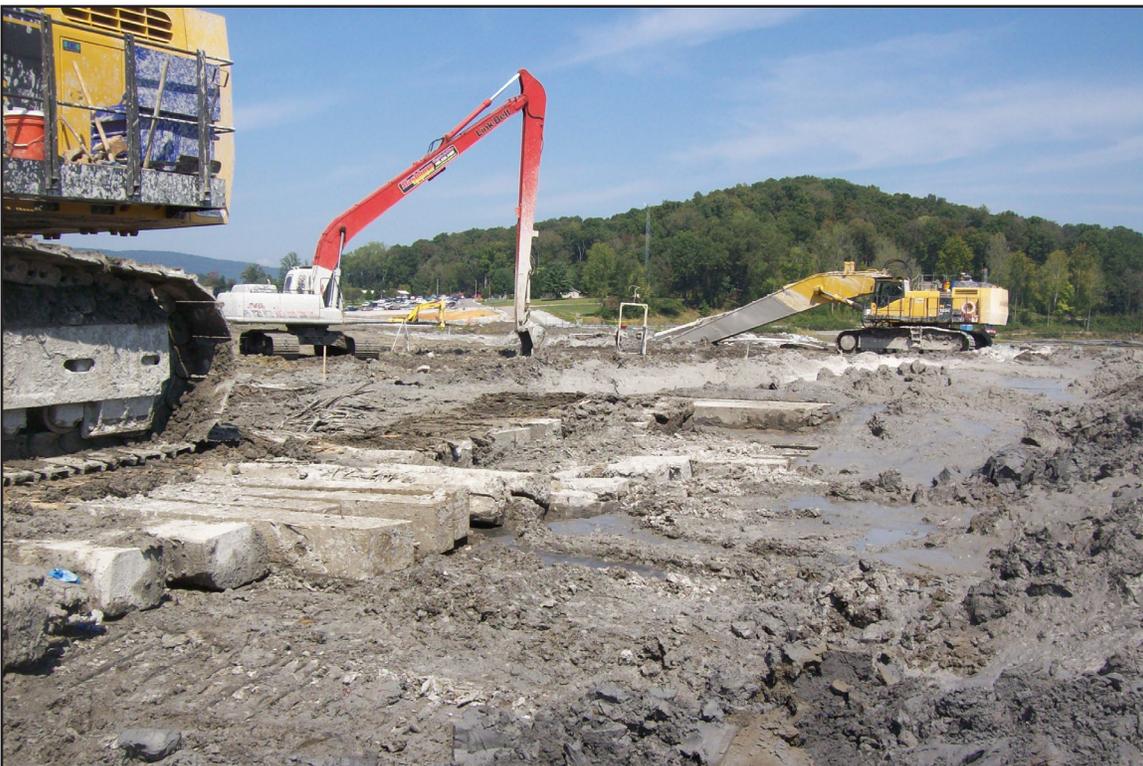
29B – PWS: Platform deterioration resulted in use of crane mats oftentimes stacked several layers thick. September 14, 2011.

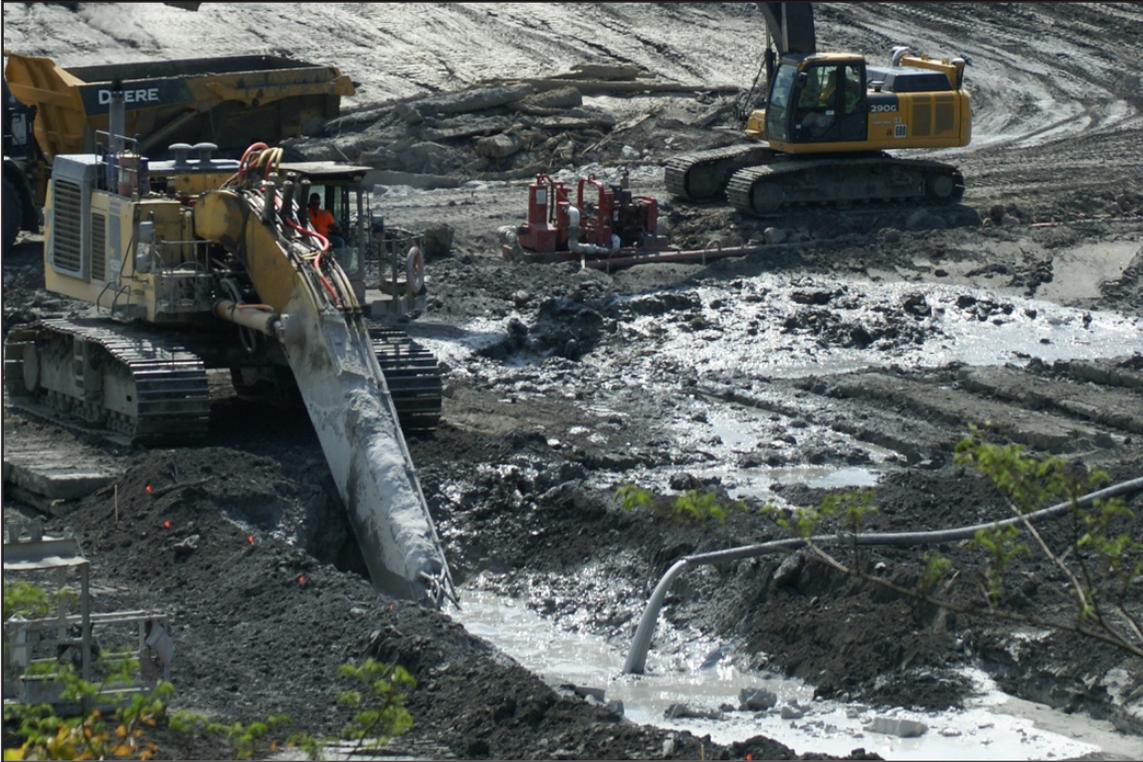
30A – PWS: Platform deterioration due to spoils spillage onto ground surface next to the trench. May 13, 2013.

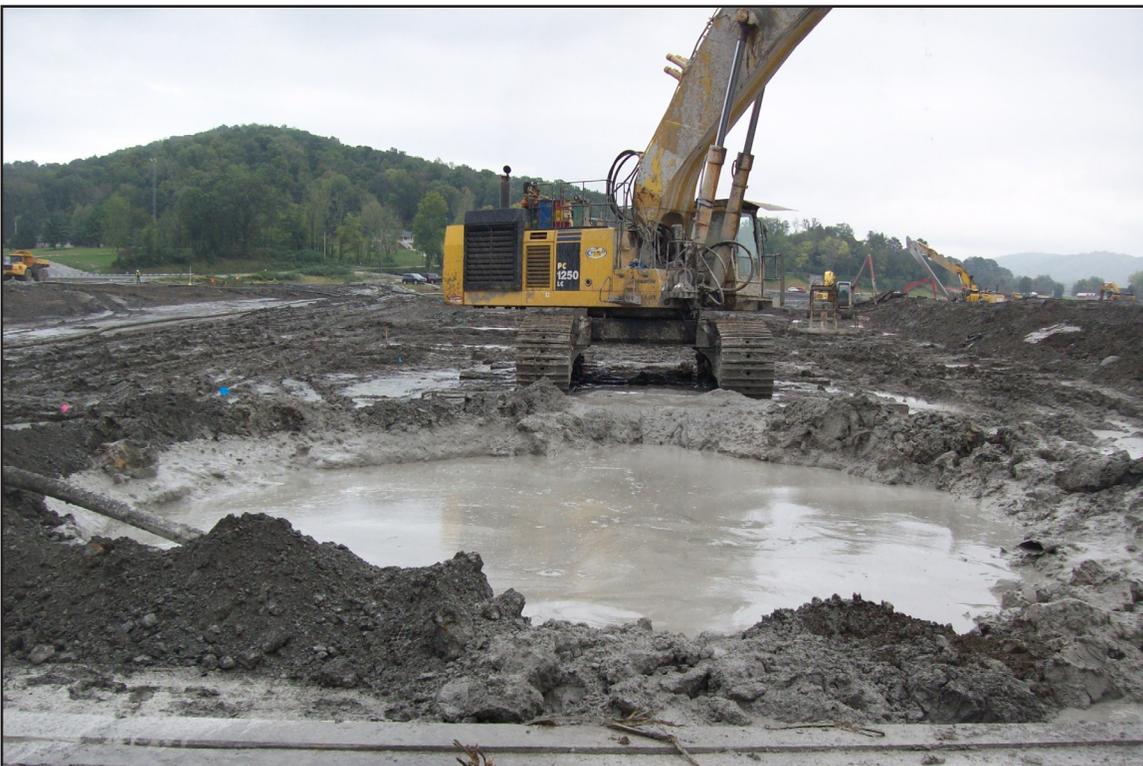
30B – PWS: Slurry trench collapse, resulting in wide trench at top. September 23, 2011.

- Problems were encountered during trenching operations that led to excessive sloughing and/or sidewall collapse. Several conditions contributed to trench sidewall instability: shallow depth to groundwater in some areas, artesian groundwater pressures near the base of Pine Ridge, liquefiable sands and fly ash, closely spaced shear walls that exacerbated liquefaction, and hard rock that further exacerbated liquefaction. Improvements that were successful in reducing collapse included raising the working platform elevation, sequencing the wall installations by skipping more than one shear wall in a pattern, and dewatering using both shallow well points in the ash and wells in the deeper sands. These efforts reduced frequency of trench collapse, but did not eliminate trench instability issues.

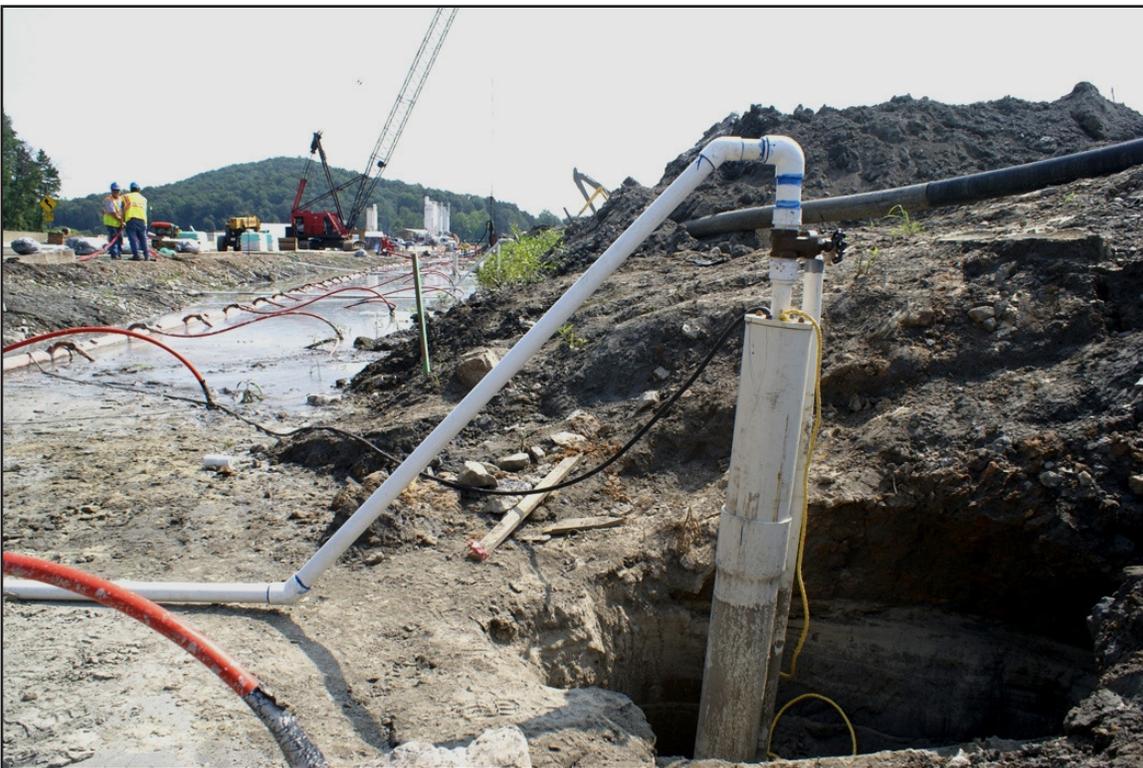
32B – PWS: Slurry trench construction stabilized using Griffin dewatering system (deep wells and shallow well points). June 14, 2012.

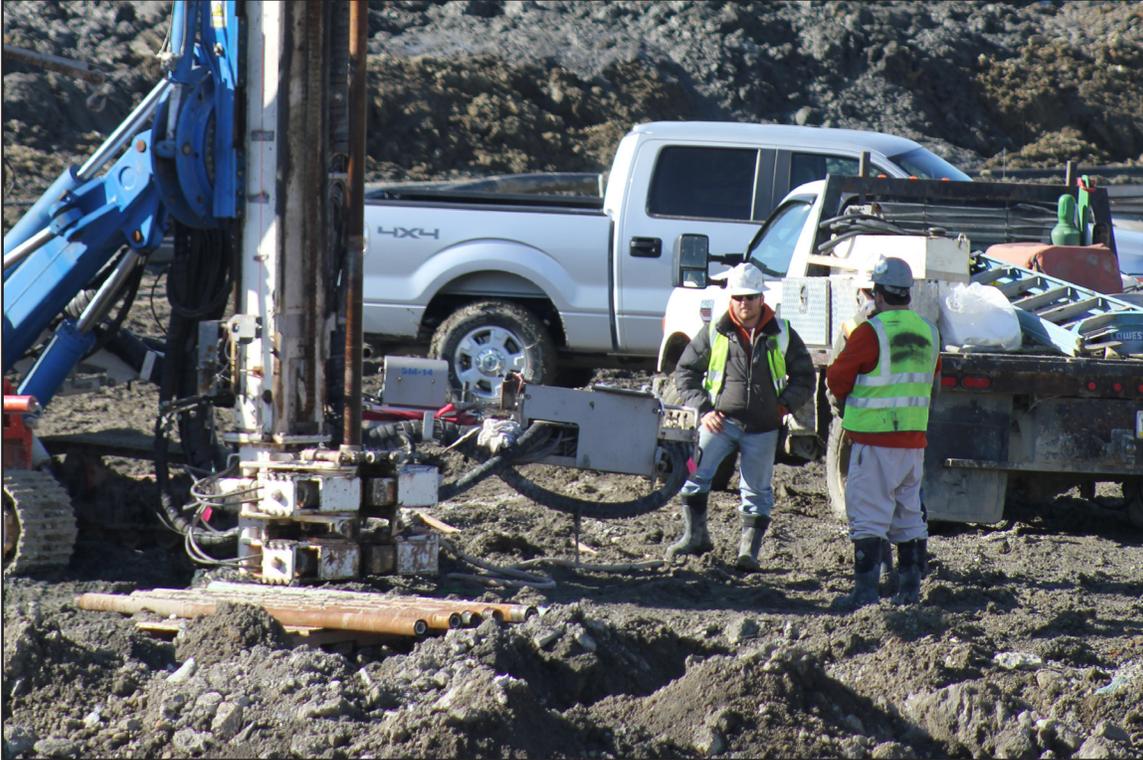
33A – PWS: GeoCon (Armstrong Drilling) predrilling holes for jet grout mitigation of wall defects. January 20, 2014.

- Coring for uniformity detected numerous inclusions of unconsolidated materials in sections of the wall. Most of these defects were a result of platform instability and wall collapse, as discussed above, as well as some areas of low strength. Mitigation of defects in the wall was accomplished by either excavating adjacent wall panels or by jet grouting of defects. Jet grouting consisted of pre-drilling 3- to 4-inch-diameter holes then pressure injecting cement grout to form columns nominally 4 ft in diameter within the unconsolidated material. A total of 5,490 linear ft of adjacent wall panels and 3,275 jet grout columns were constructed to repair defects. Approximately 18% of the wall required defect mitigation.

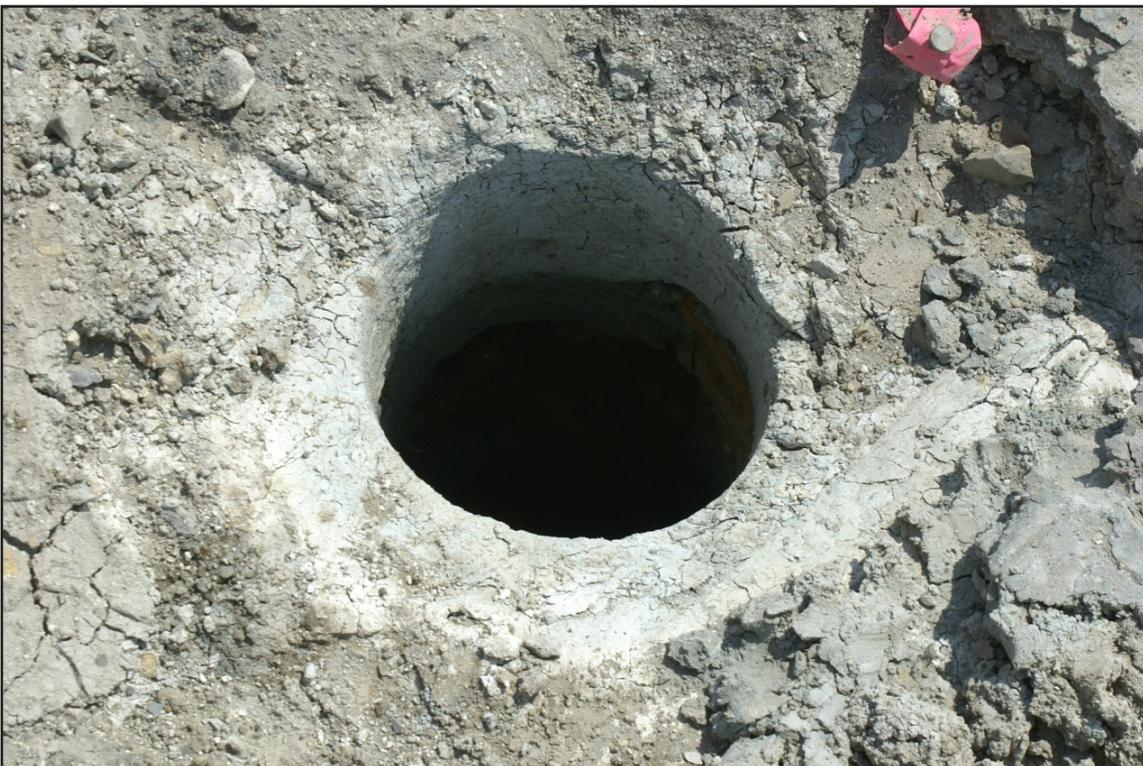
33B – PWS: Predrilled hole in wall for mitigation of wall defects. August 30, 2011.

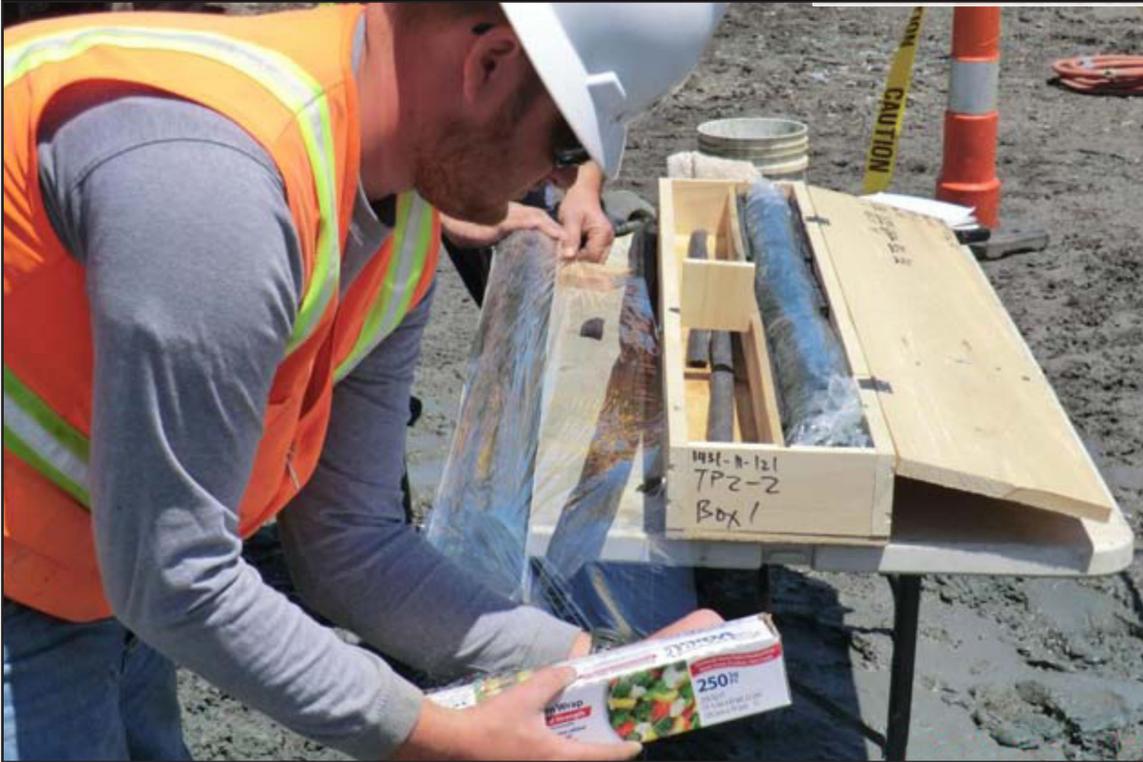
34A – PWS: S&ME logging cores of cured grout for quality control of wall uniformity. May 5, 2011.

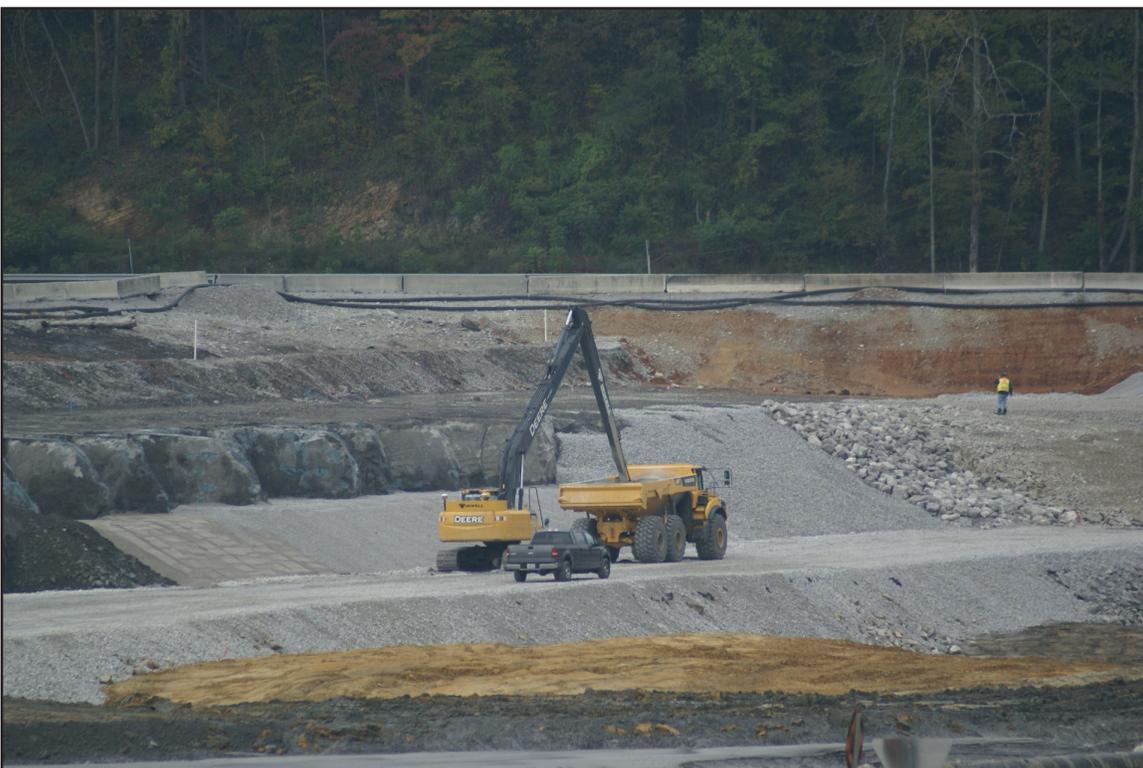
35B – Perimeter Containment: Placing No. 02 stone as rock buttress along Segment 8 of the perimeter wall. October 09, 2012.

- Problems were encountered prior to construction of the PWS adjacent to the Stilling Pond in that the dike dividing the Stilling Pond from the Ash Pond was found to be unstable. TVA undertook emergency construction of a rock buttress to stabilize the dike. Clean rock and riprap materials, as well as rock retrieved from the Sediment Basin and Dike 2 removal, were placed in the Stilling Pond as a counterweight to improve dike stability during trench construction.
