Tennessee Valley Authority
Regulatory Submittal for Kingston Fossil Plant

Documents submitted:
On-Scene Coordinator Report for the Non-Time Critical Removal Action for the
Embayment/Dredge Cell

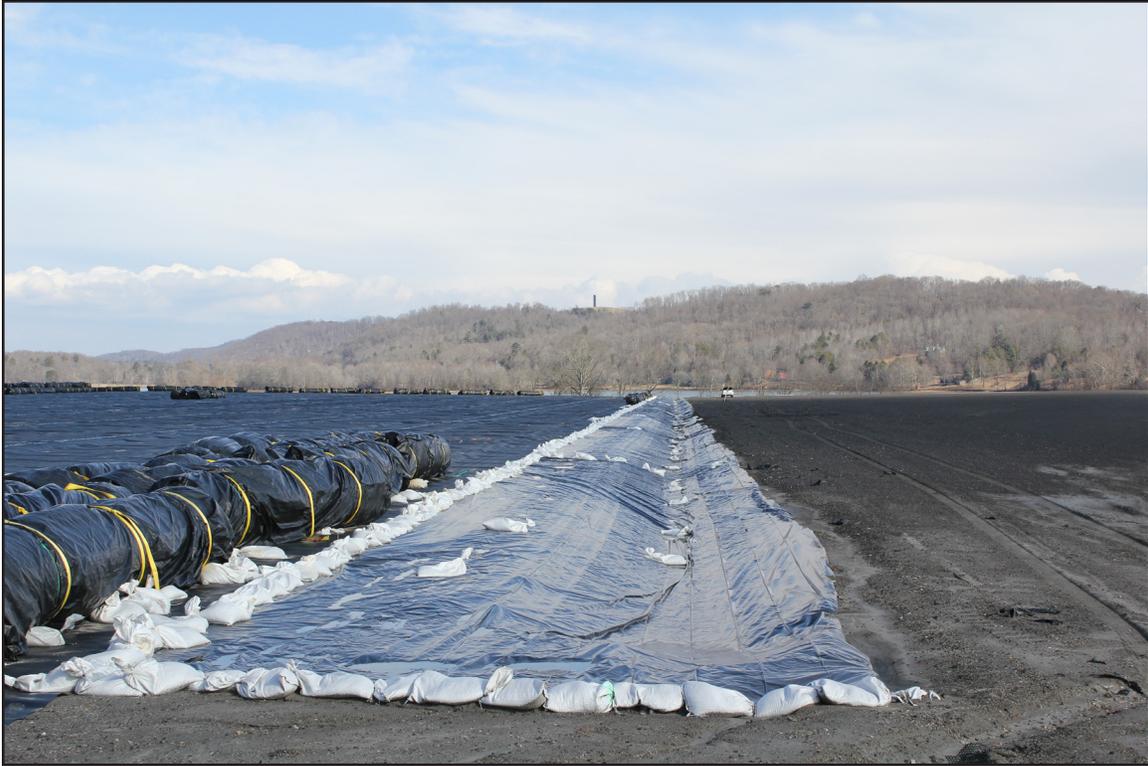
47A – Stormwater Management: Ditch lined with plastic tarp for erosion control. August 10, 2013.

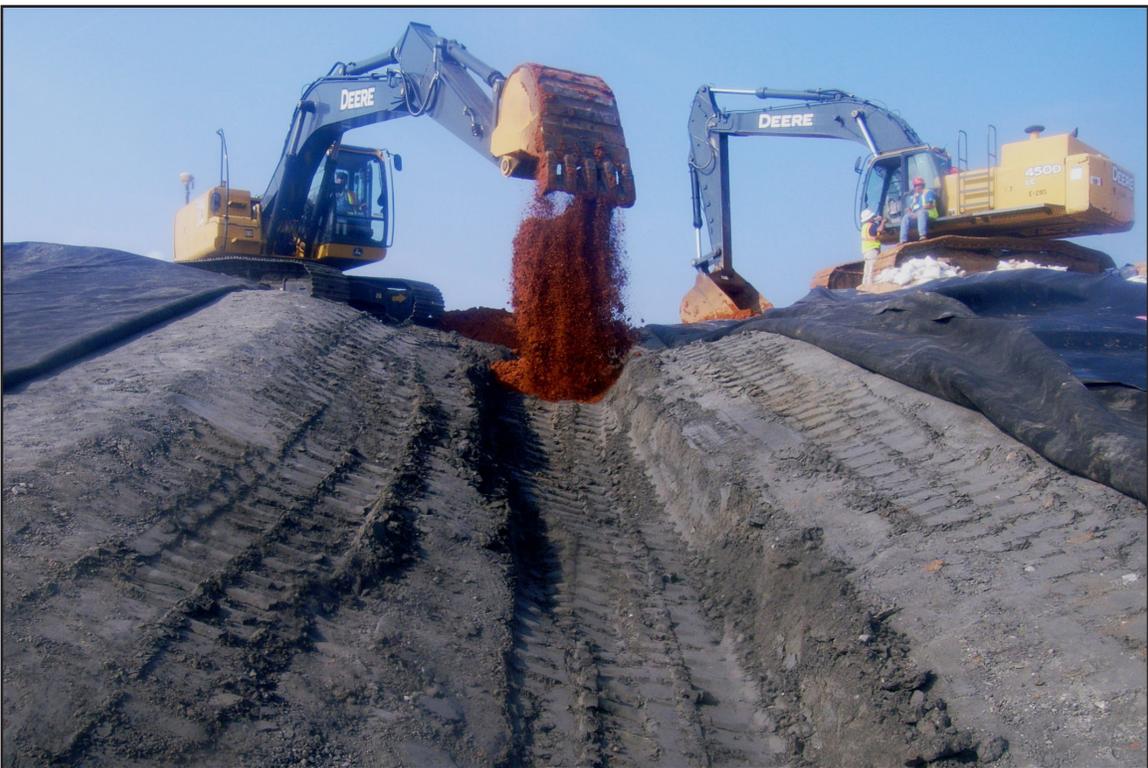
47B – Stormwater Management: Placing clay to line ditch in flumes for erosion control. August 28, 2013.
