Update on Kingston Ash Spill

**Anda Ray
Senior Vice President
Office of Environment & Research**

JULY 2009

Failure of Dredge Cell

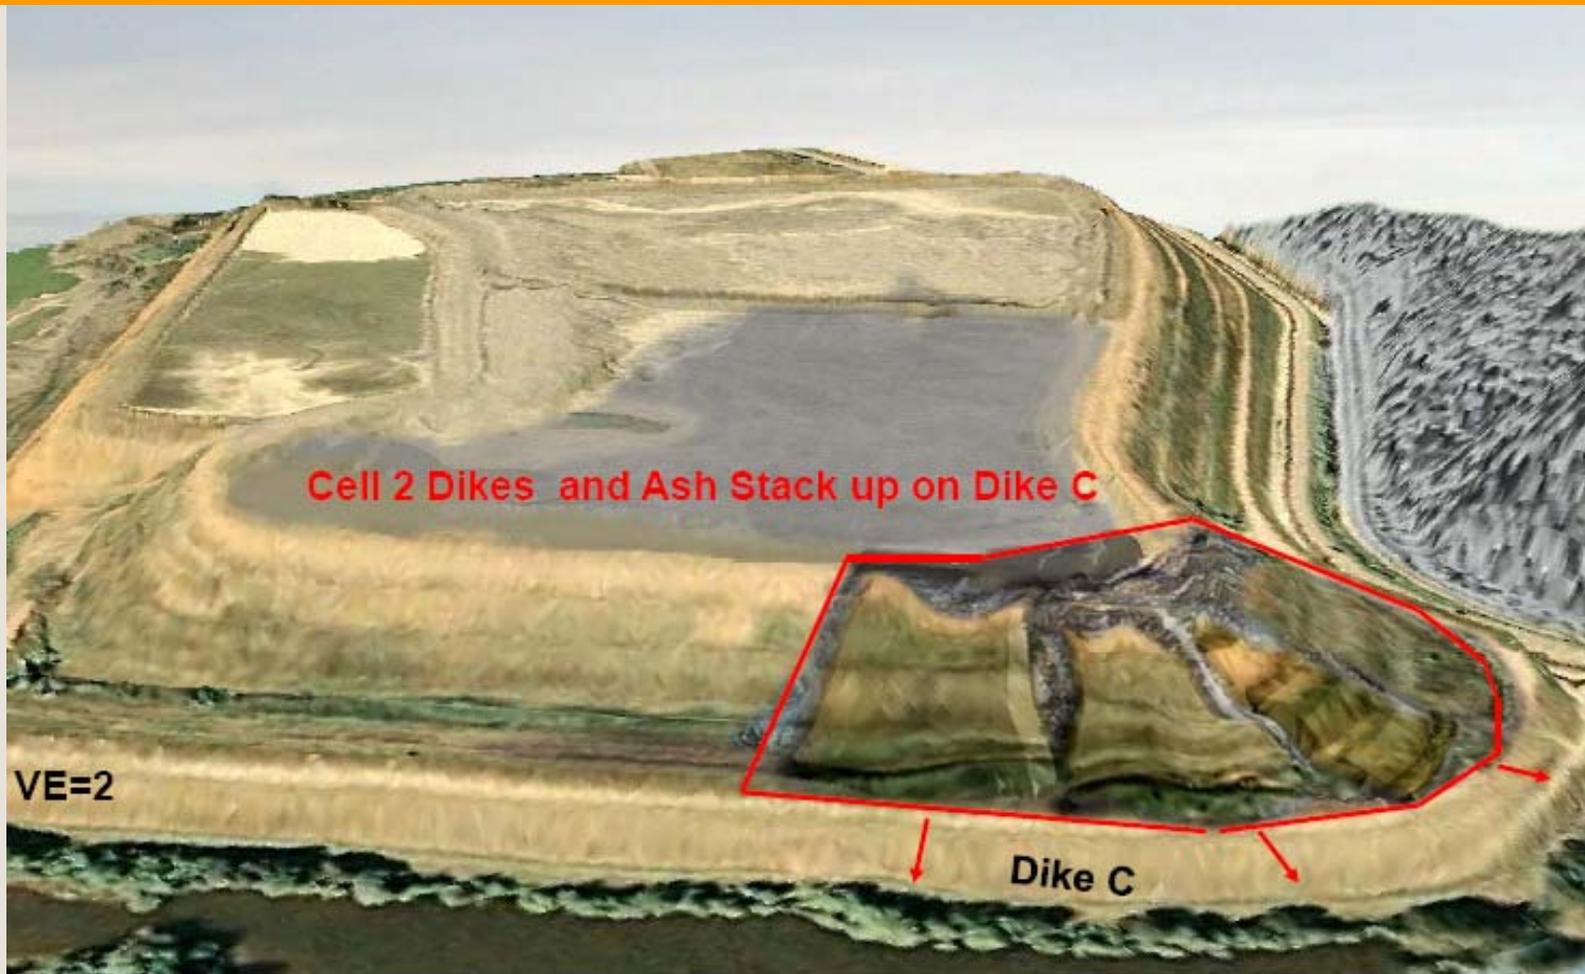
Dike Failed on December 22, 2008, between midnight & 1 a.m.

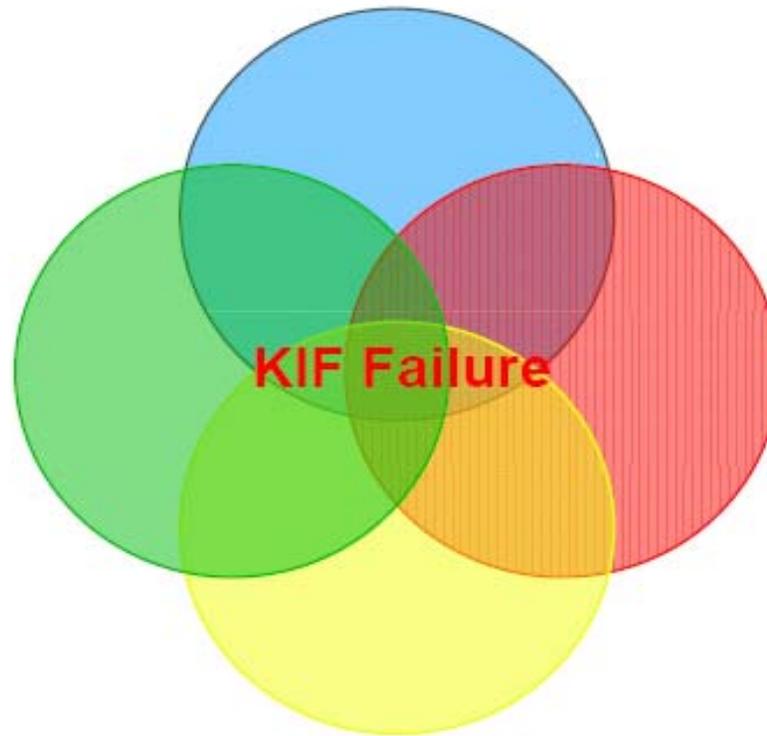
December 22, 2008 Expected Failure Mode at NW Corner of Cell 2

AECOM June 2009 Root Cause Report

Increased Loads Due to Higher Fill

Hydraulically
Placed
Loose Wet Ash

Fill Geometry &
Setbacks

Unusually Weak Slimes Foundation

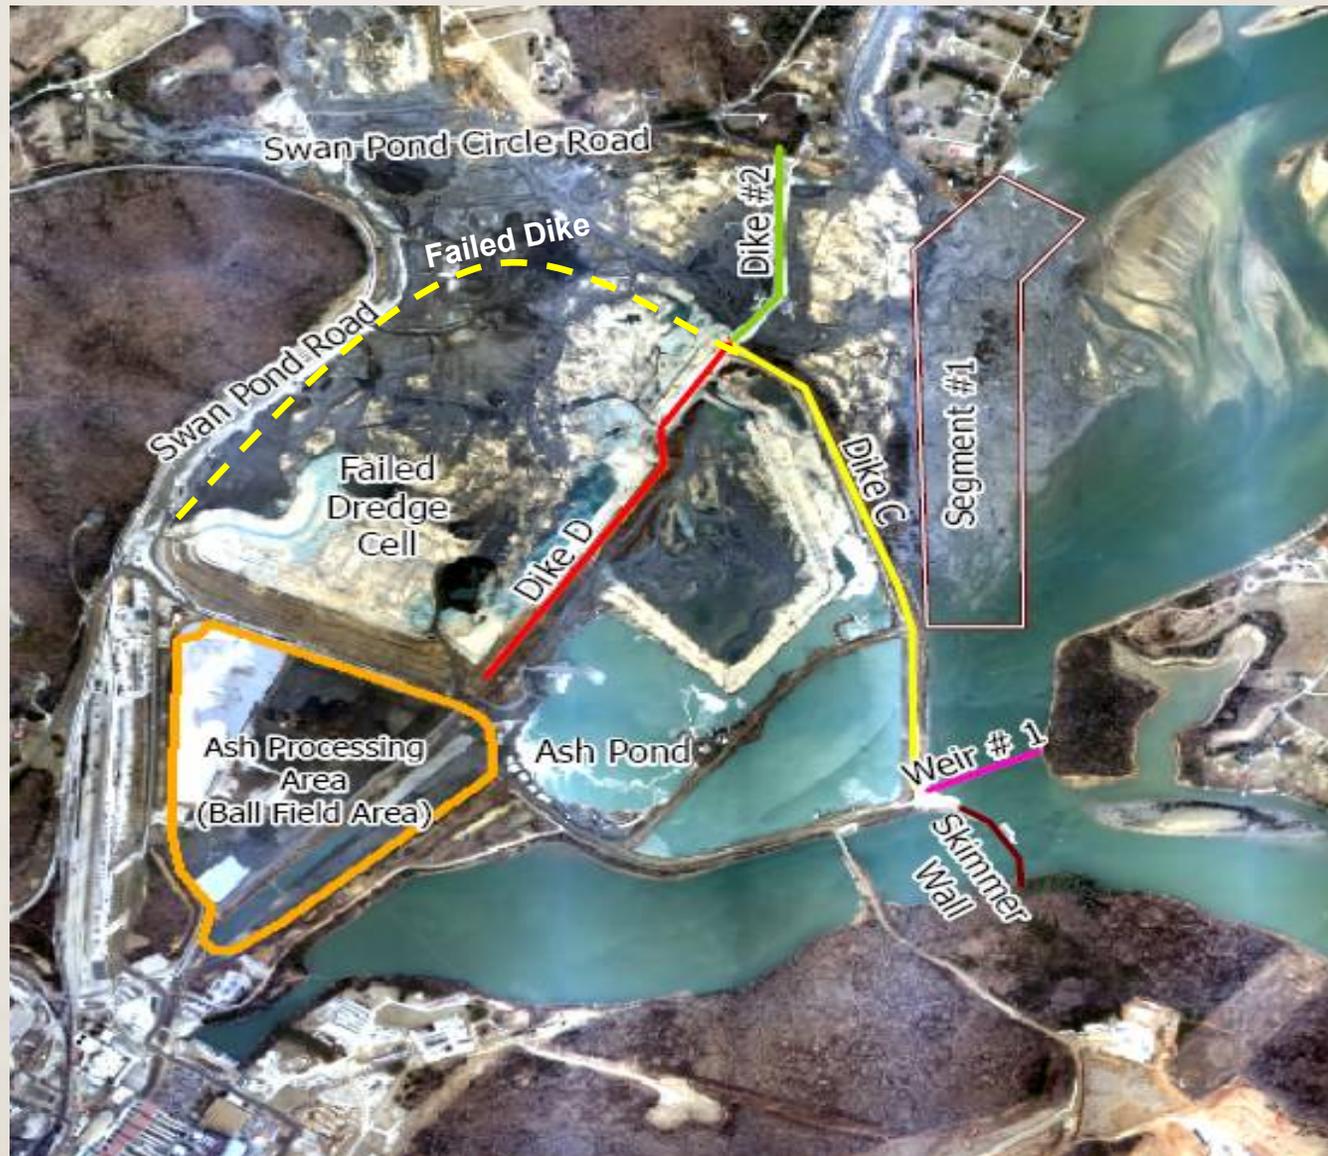
Aerial View of Site – Post Event

- 5.4 million cubic yards of coal ash released
- Debris covers about 300 acres (about half a square mile)
- No injuries
- 3 homes uninhabitable, 23 others damaged
- Roads, rail line and utilities damaged

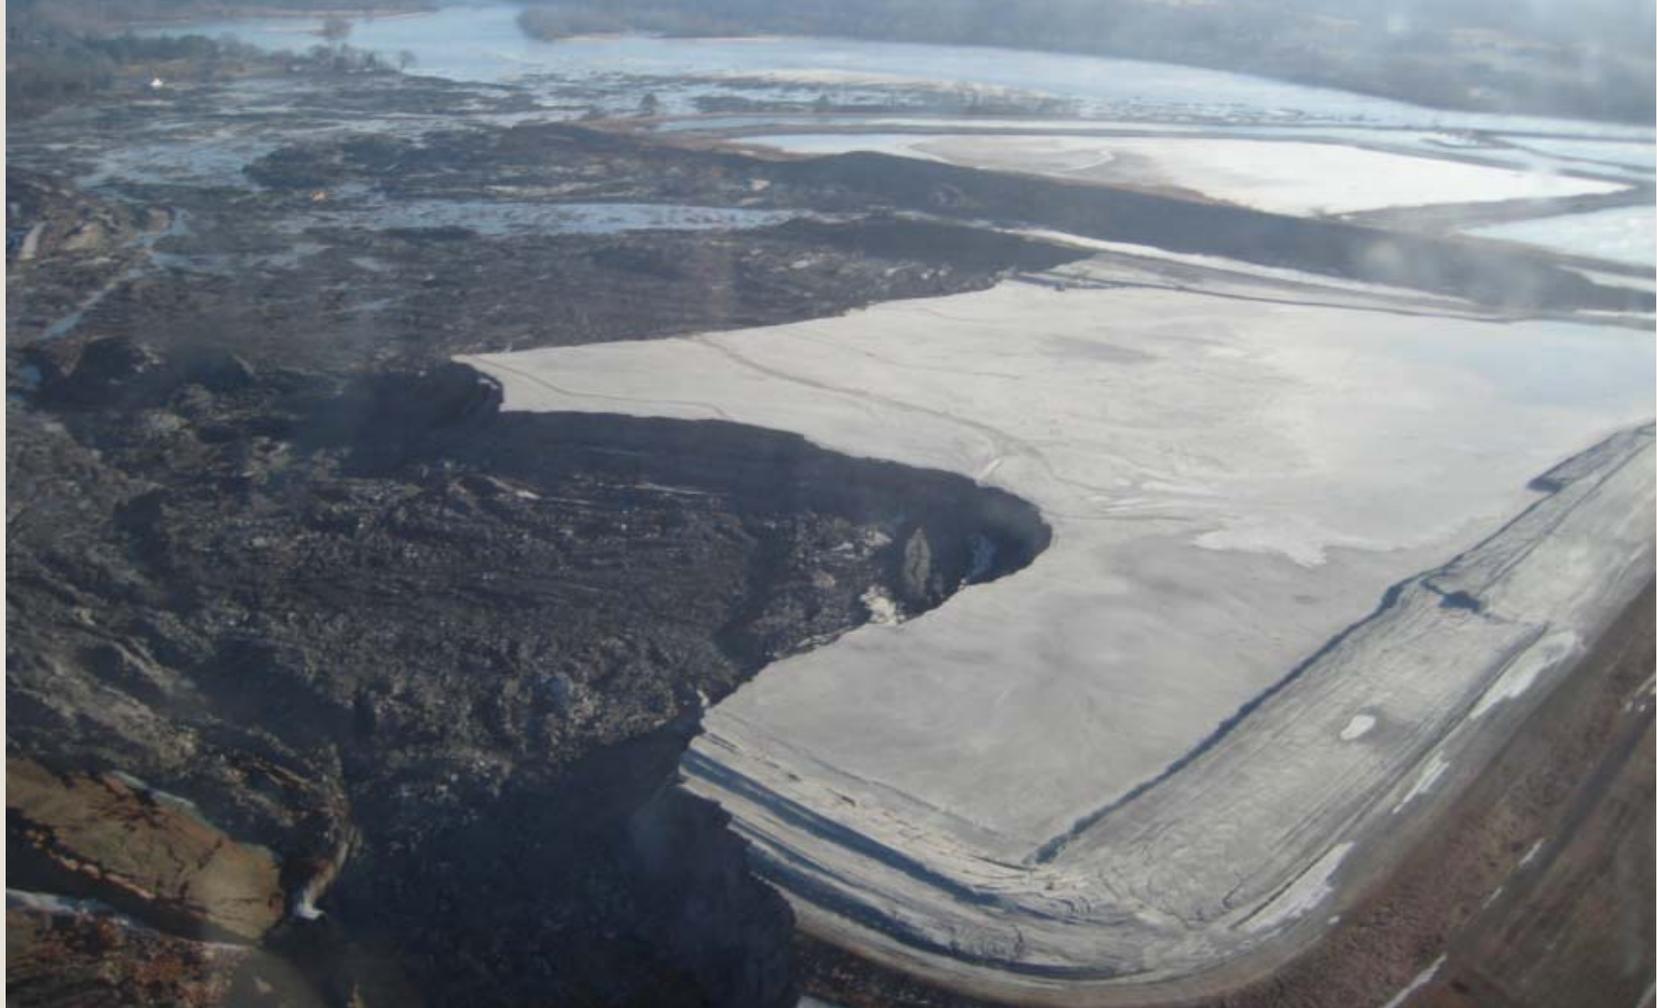
Failed Ash Cell

Dec 22 2008 10:18

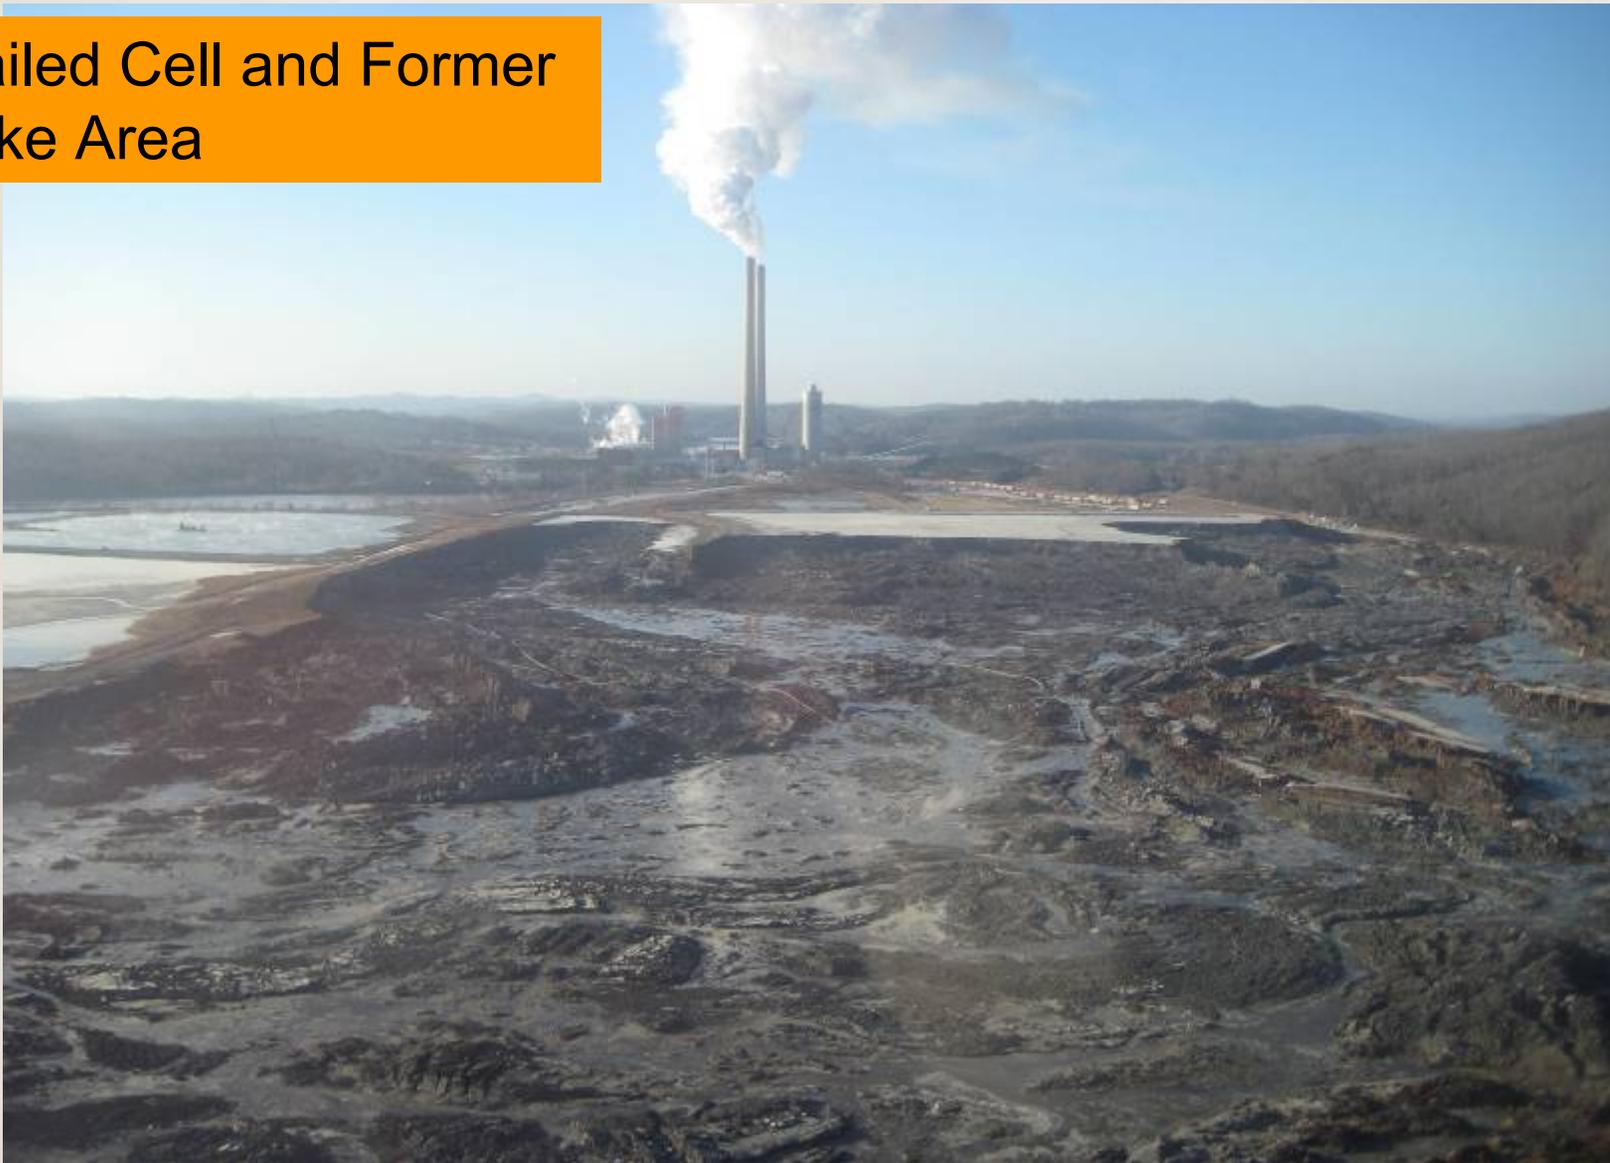
Failed Cell and Former
Dike Area

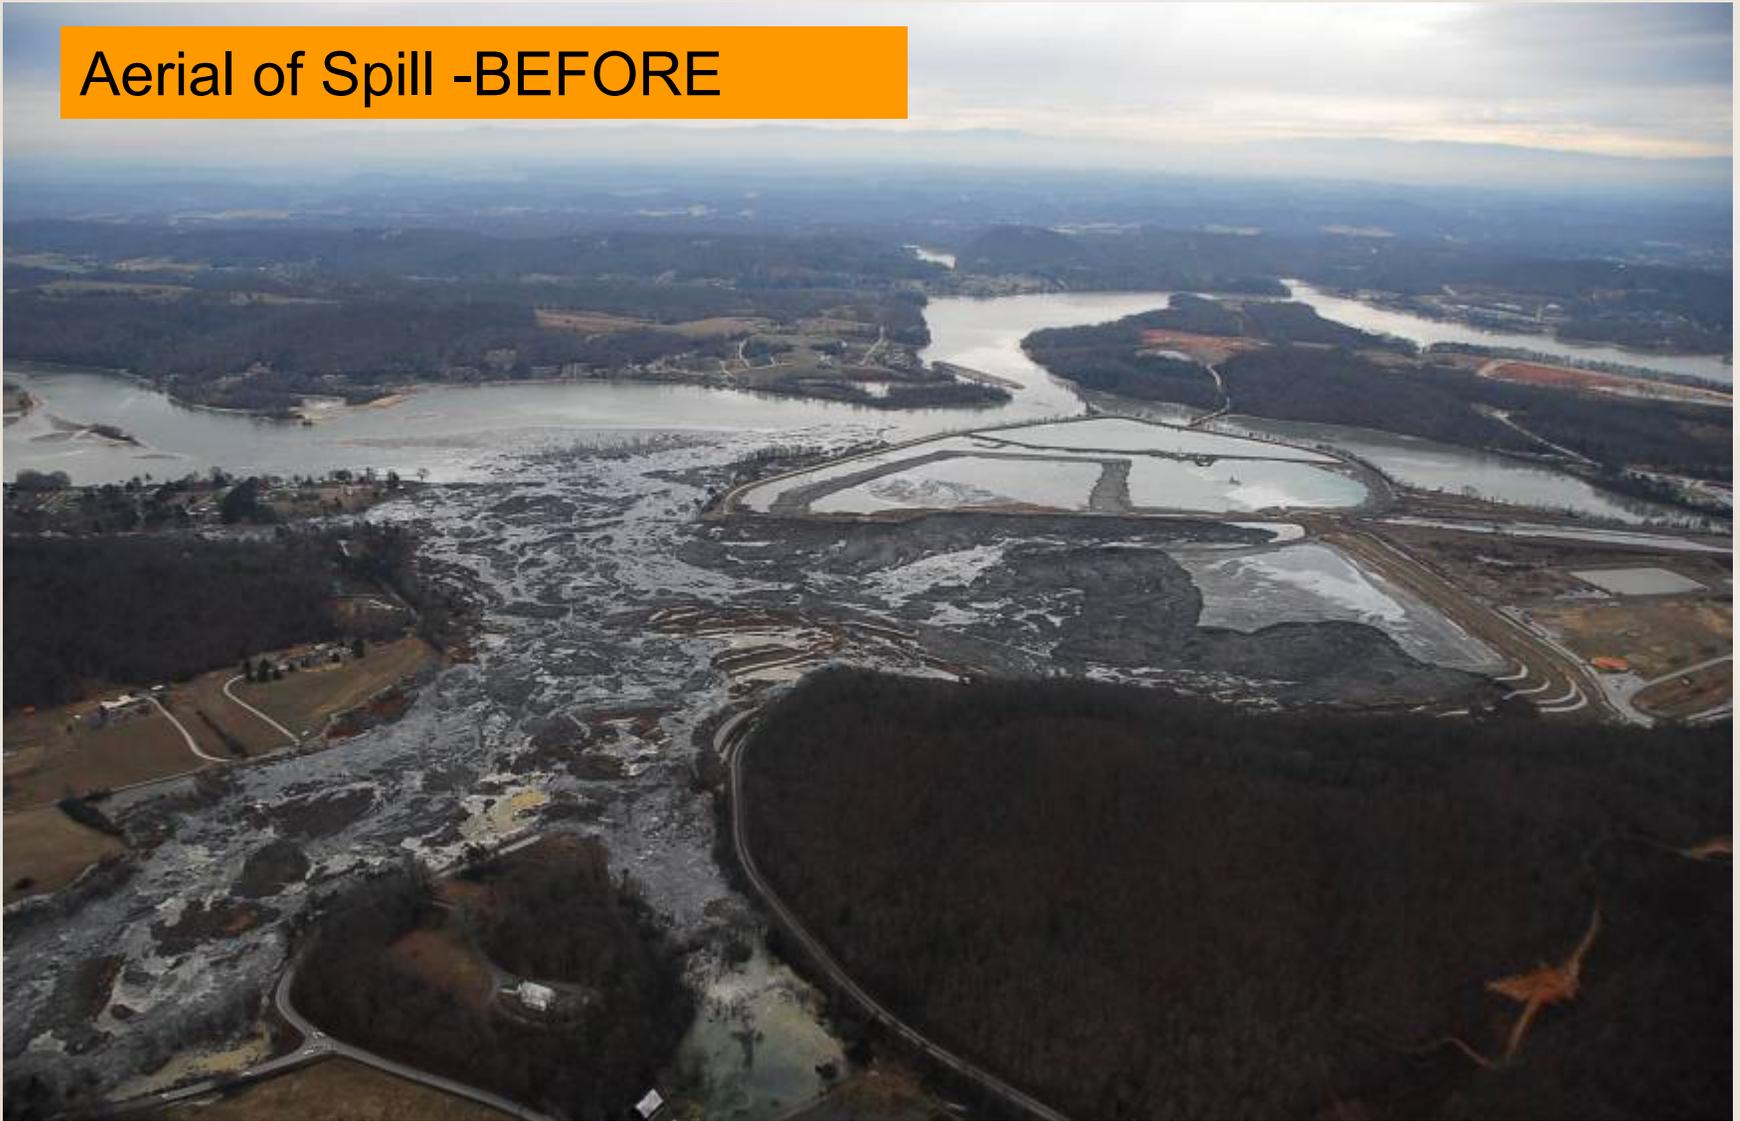
Aerial of Spill -BEFORE

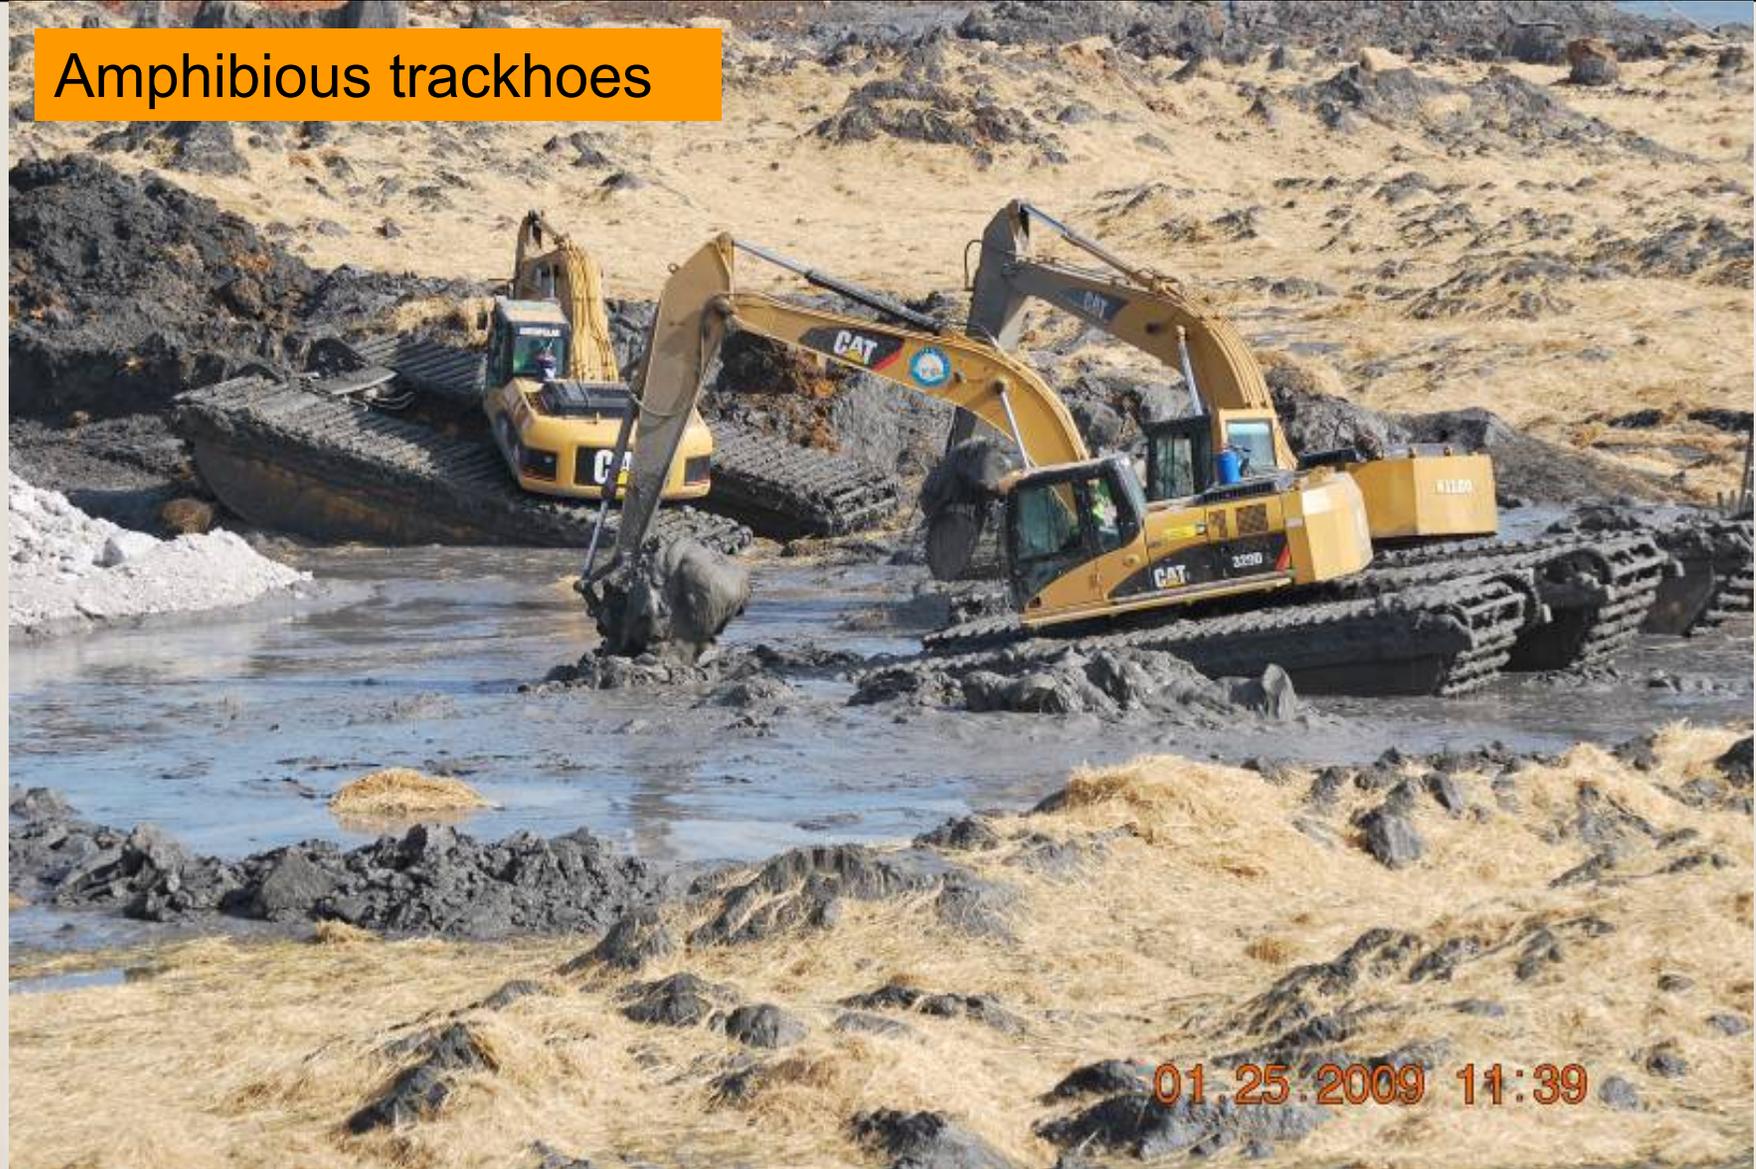
Amphibious trackhoes

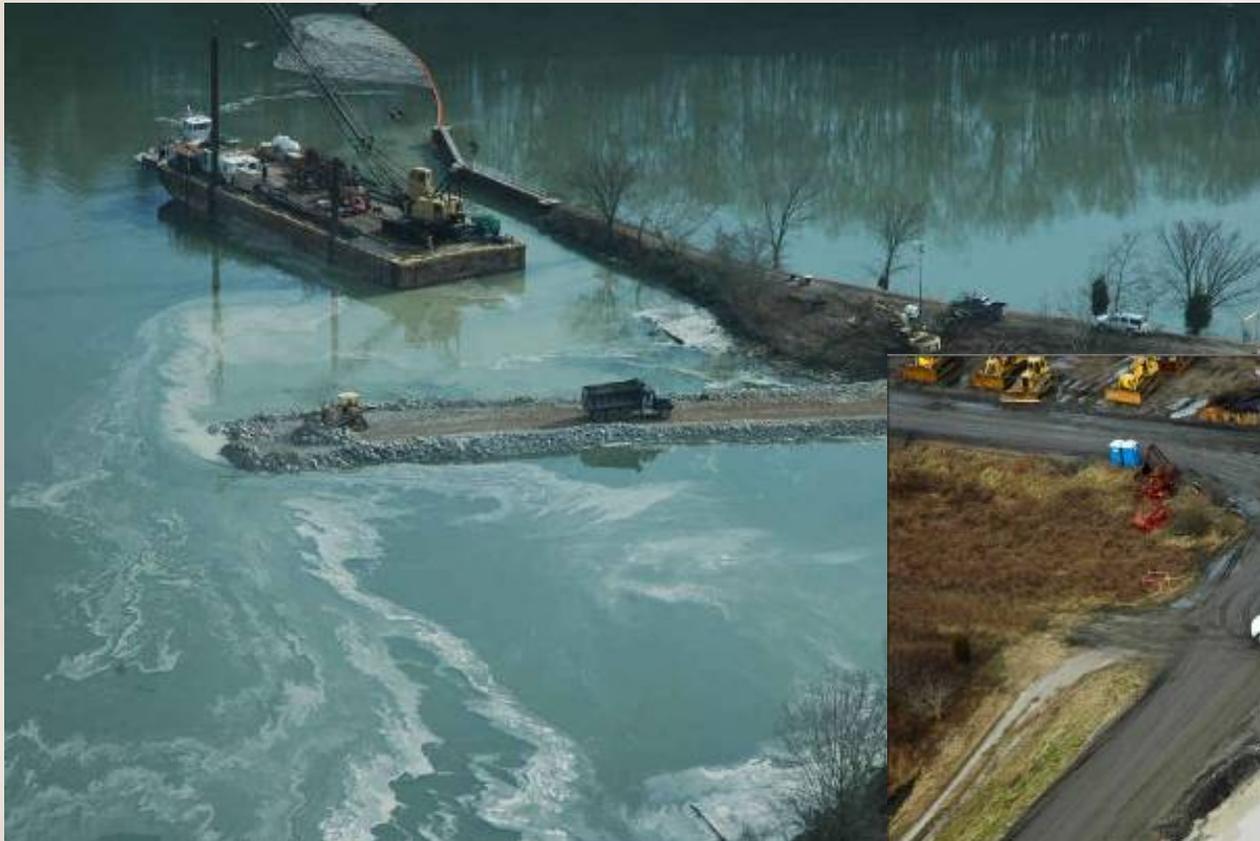
Collecting cenospheres ...

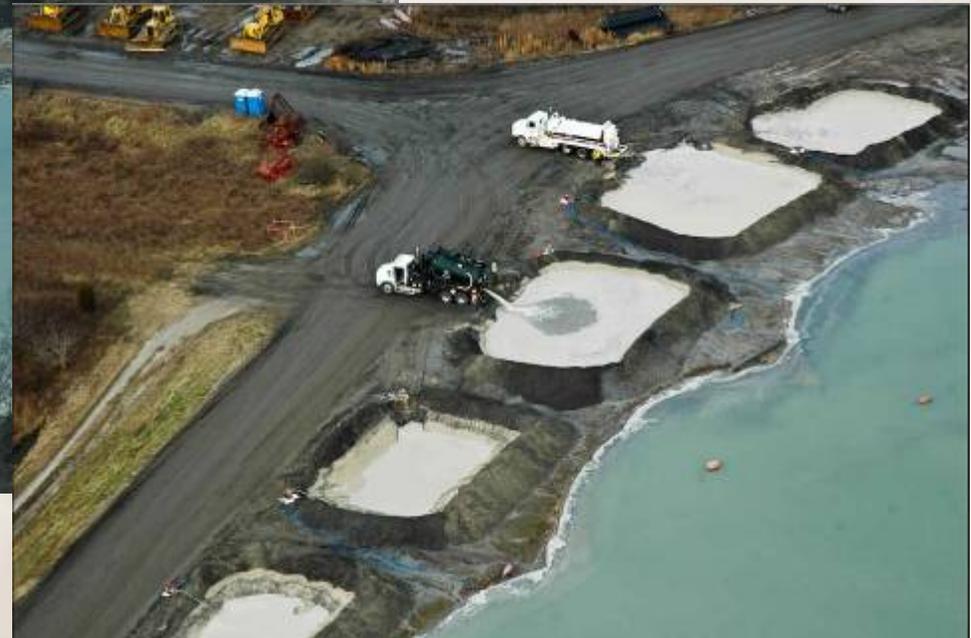
... and storing them

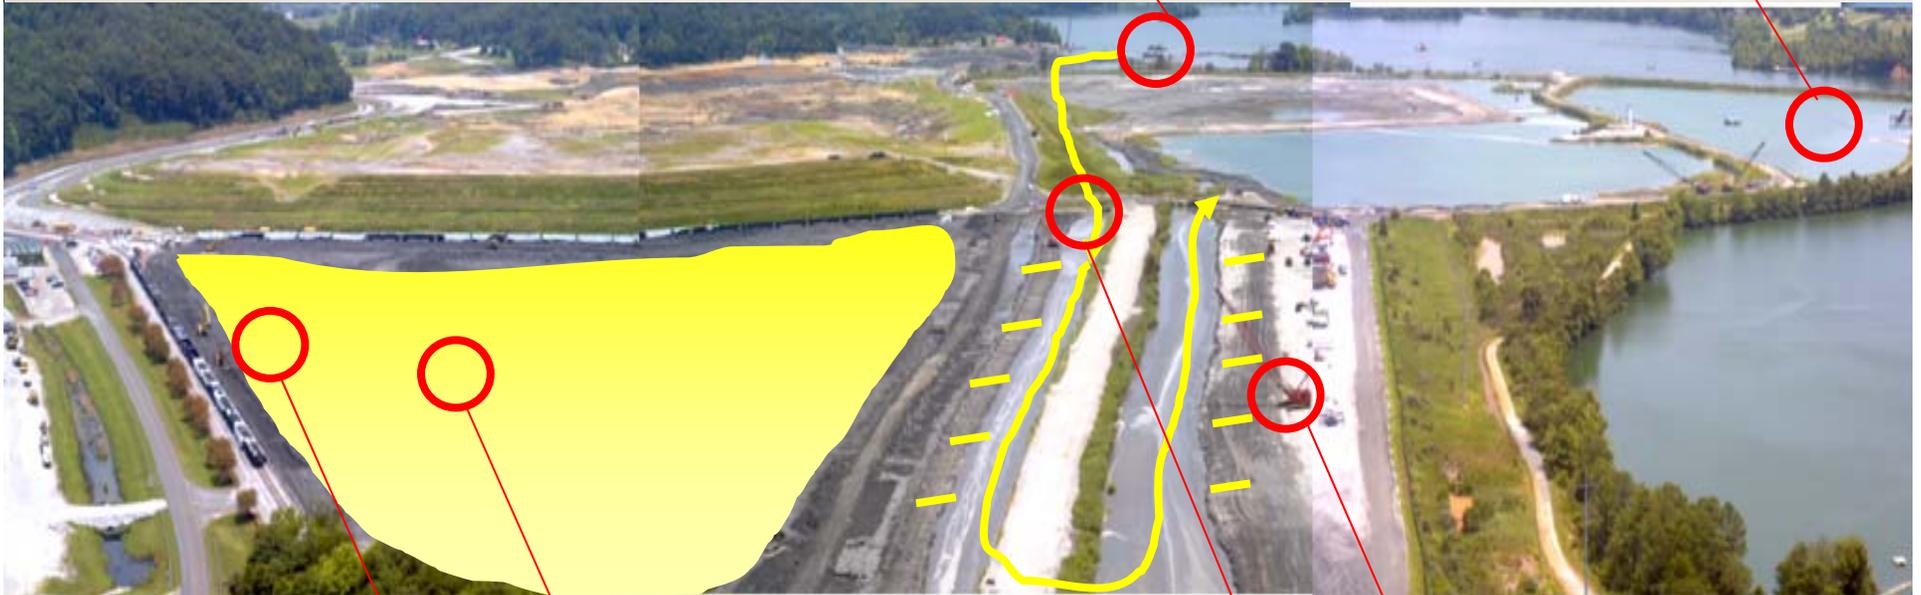
River Dredge

Settling Pond

Rail Loading

Temp Processing Area

Dipping Ash Sluice Channel

Discharge into Rim Ditch

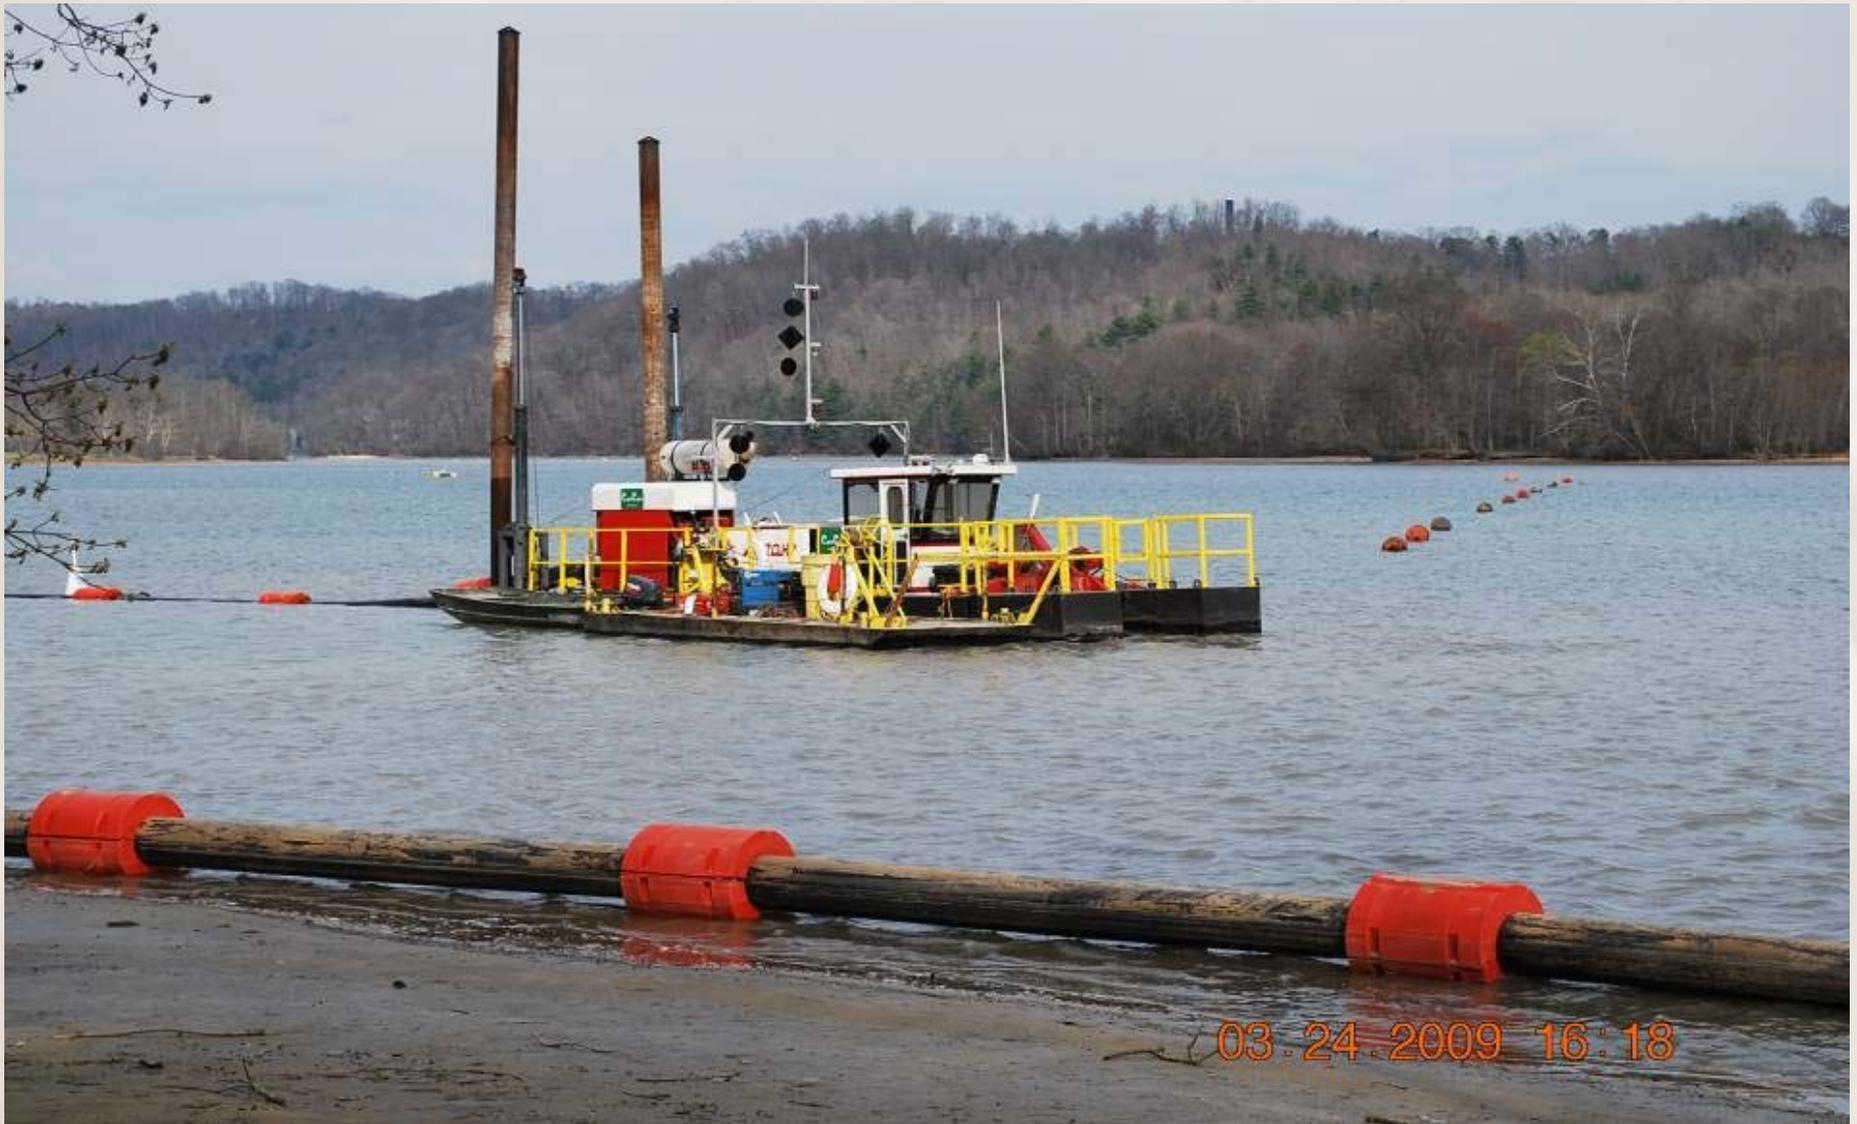
River Dredging

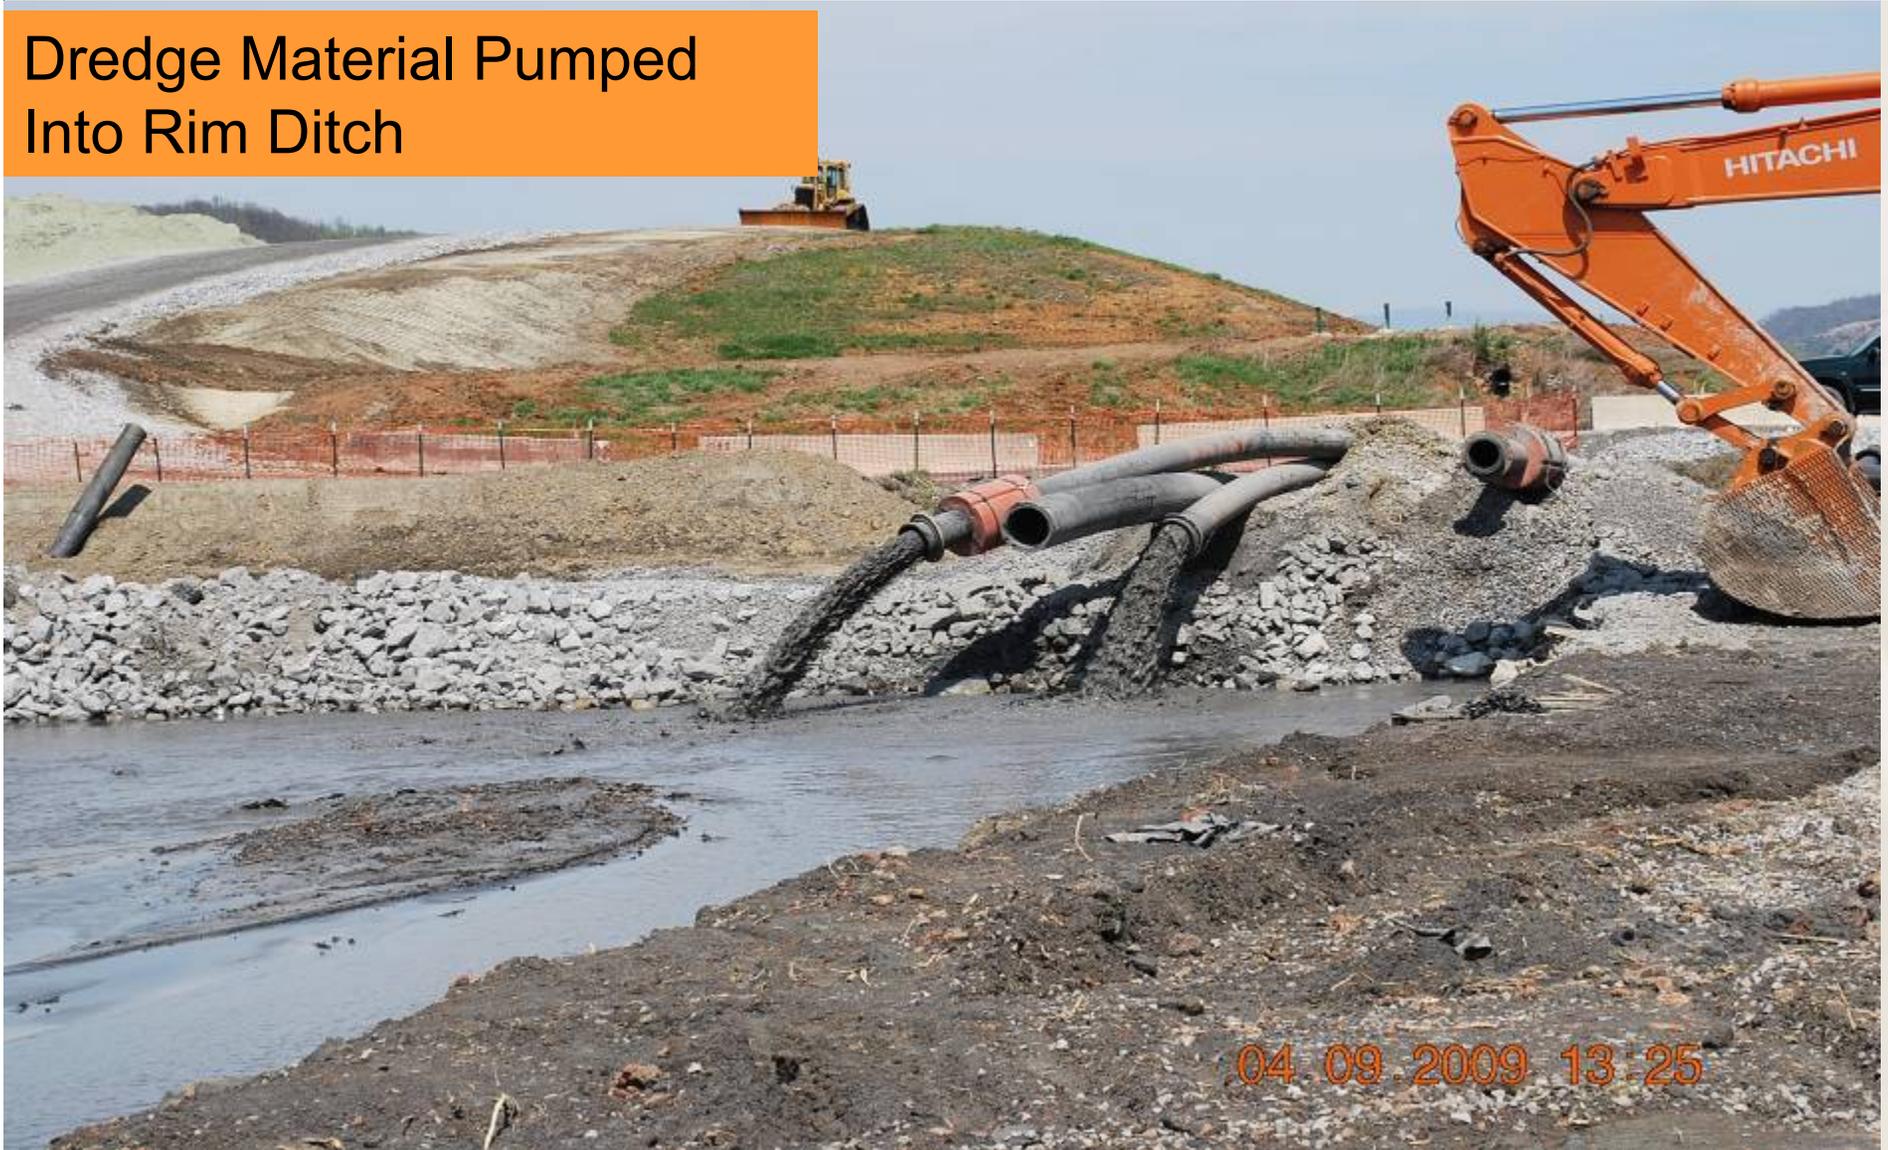
Dredge Material Pumped
Into Rim Ditch

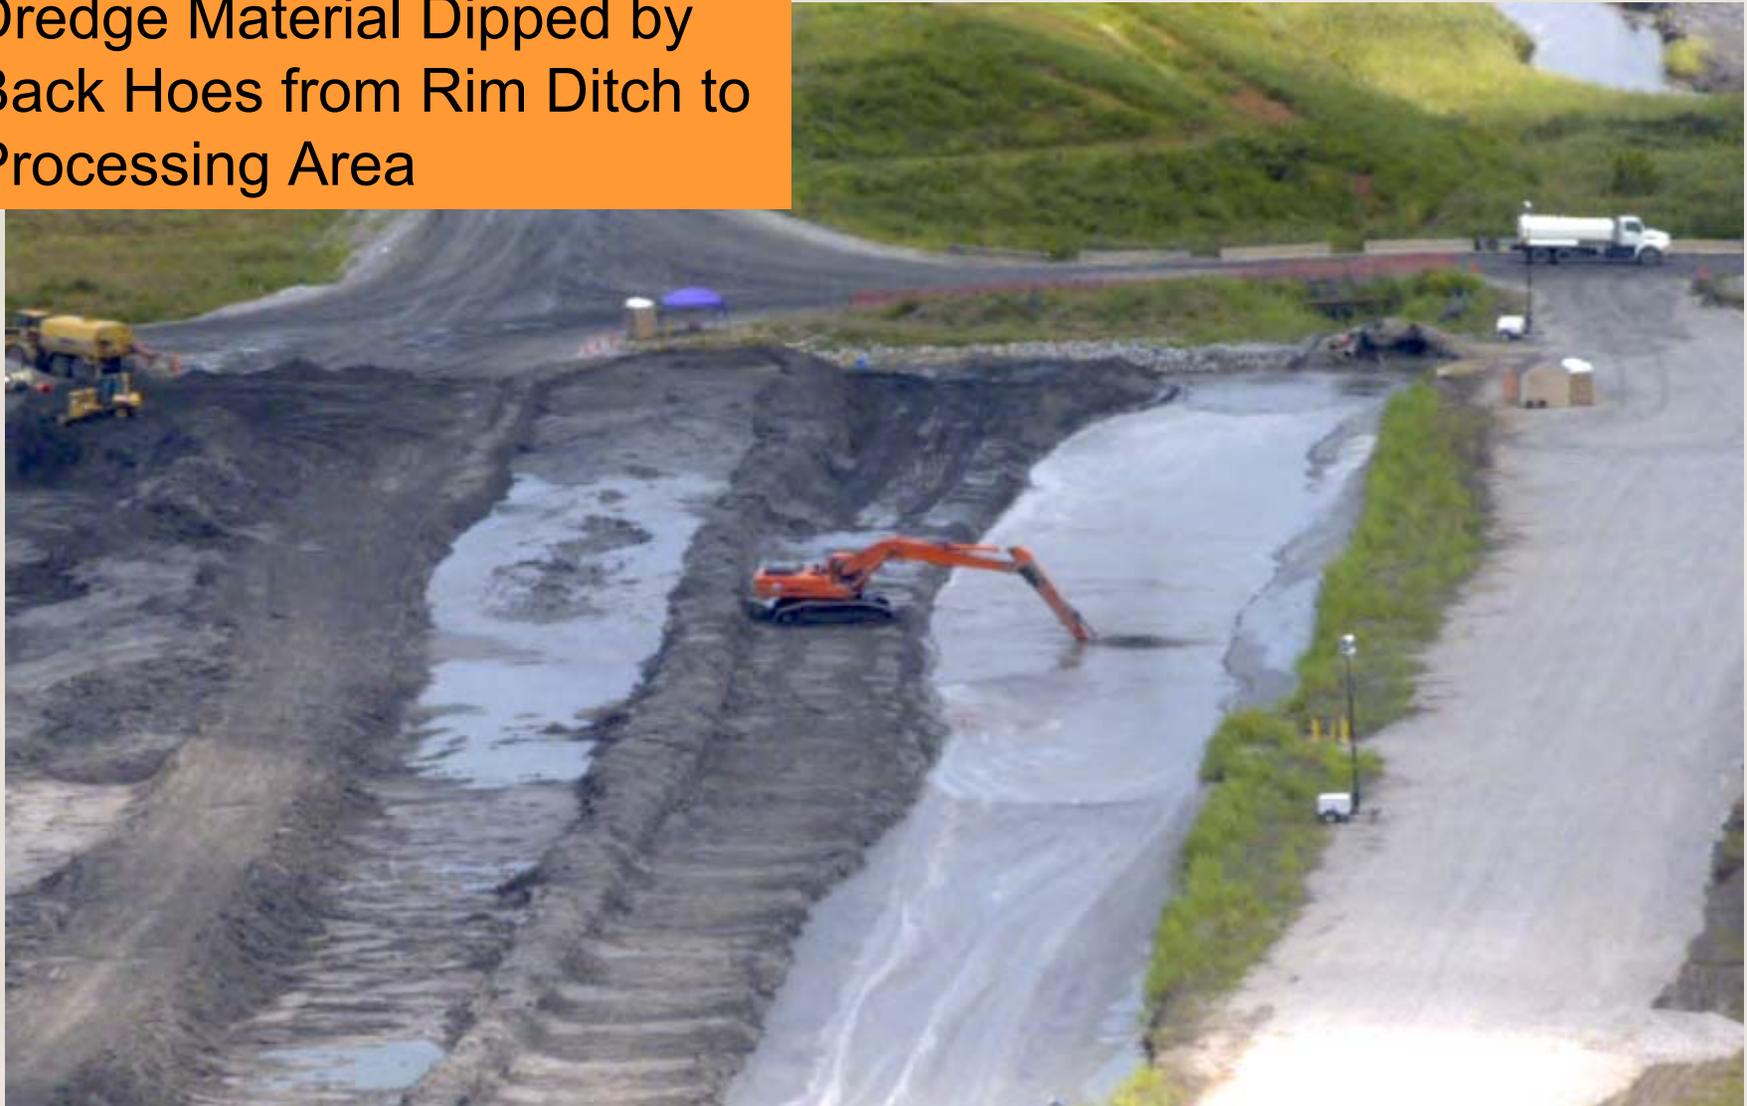
Dredge Material Dipped by Back Hoes from Rim Ditch to Processing Area

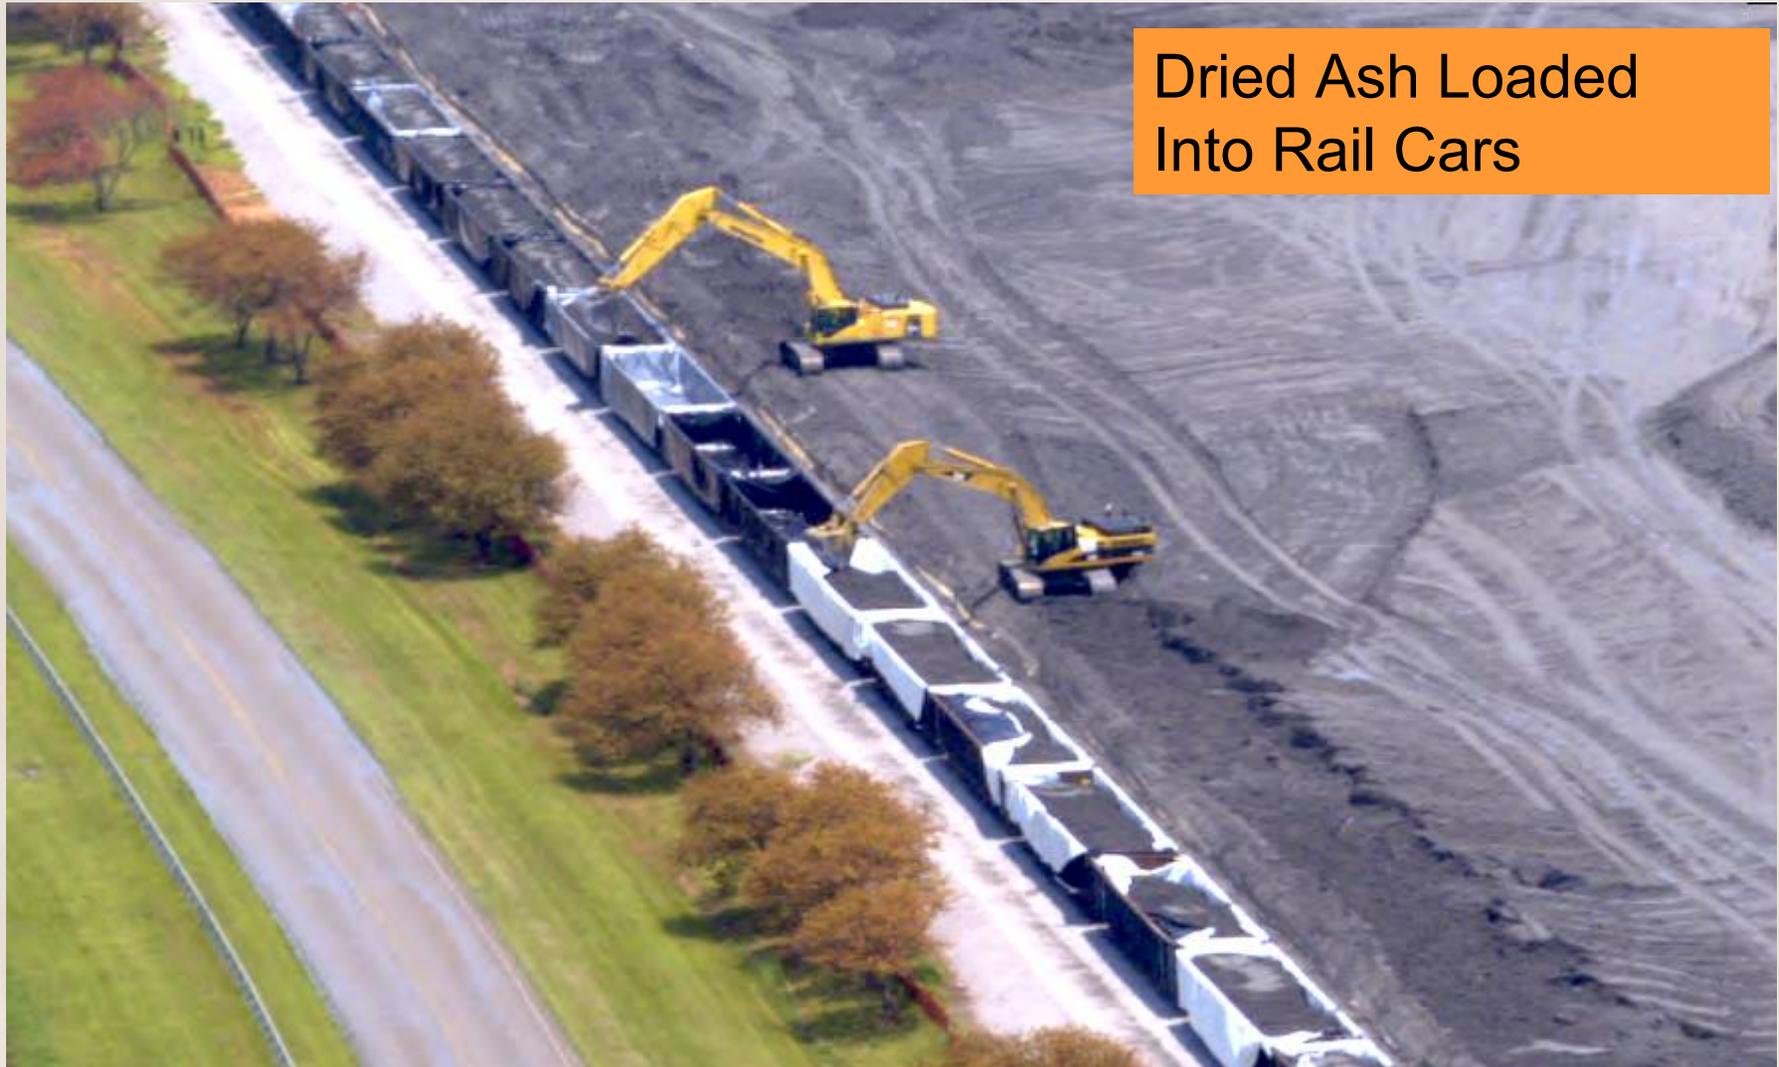
Dried Ash Loaded
Into Rail Cars
