Update on Kingston Ash Spill

**Anda Ray
Senior Vice President
Office of Environment & Research**

JULY 2009

Failure of Dredge Cell

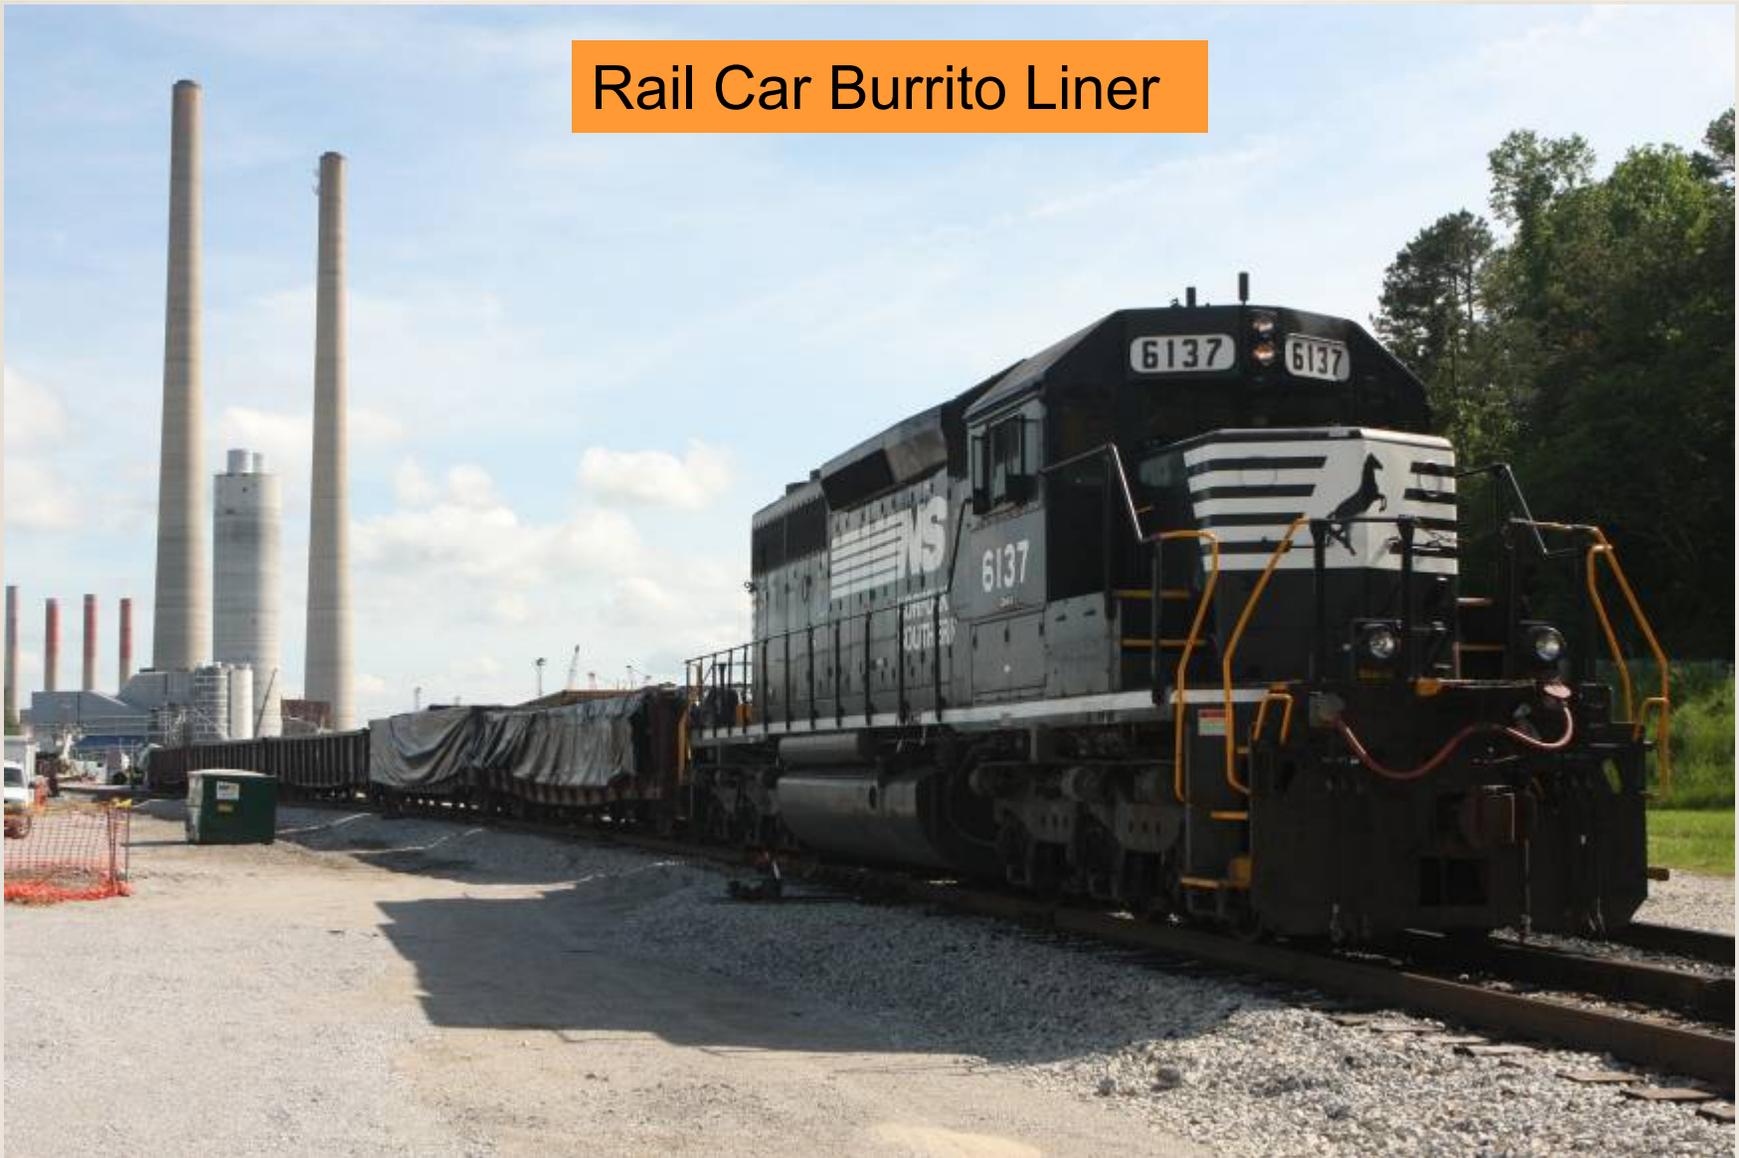
Rail Car Burrito Liner

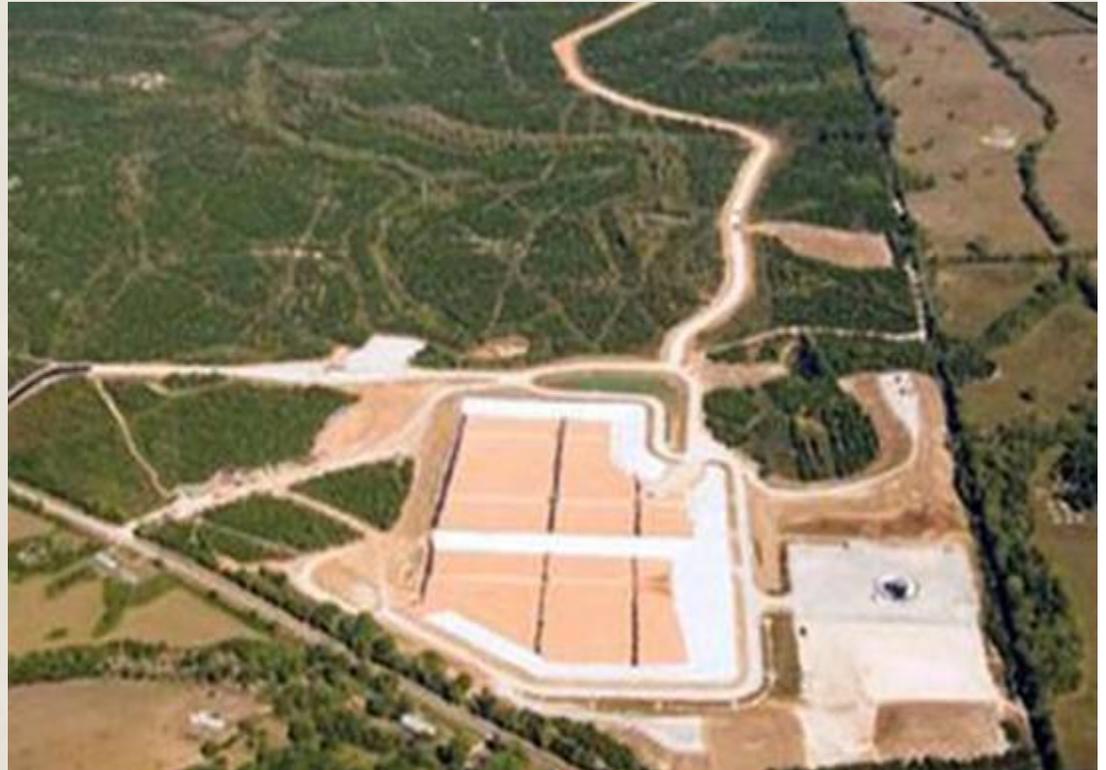
Class I landfill in Alabama, EPA Certified

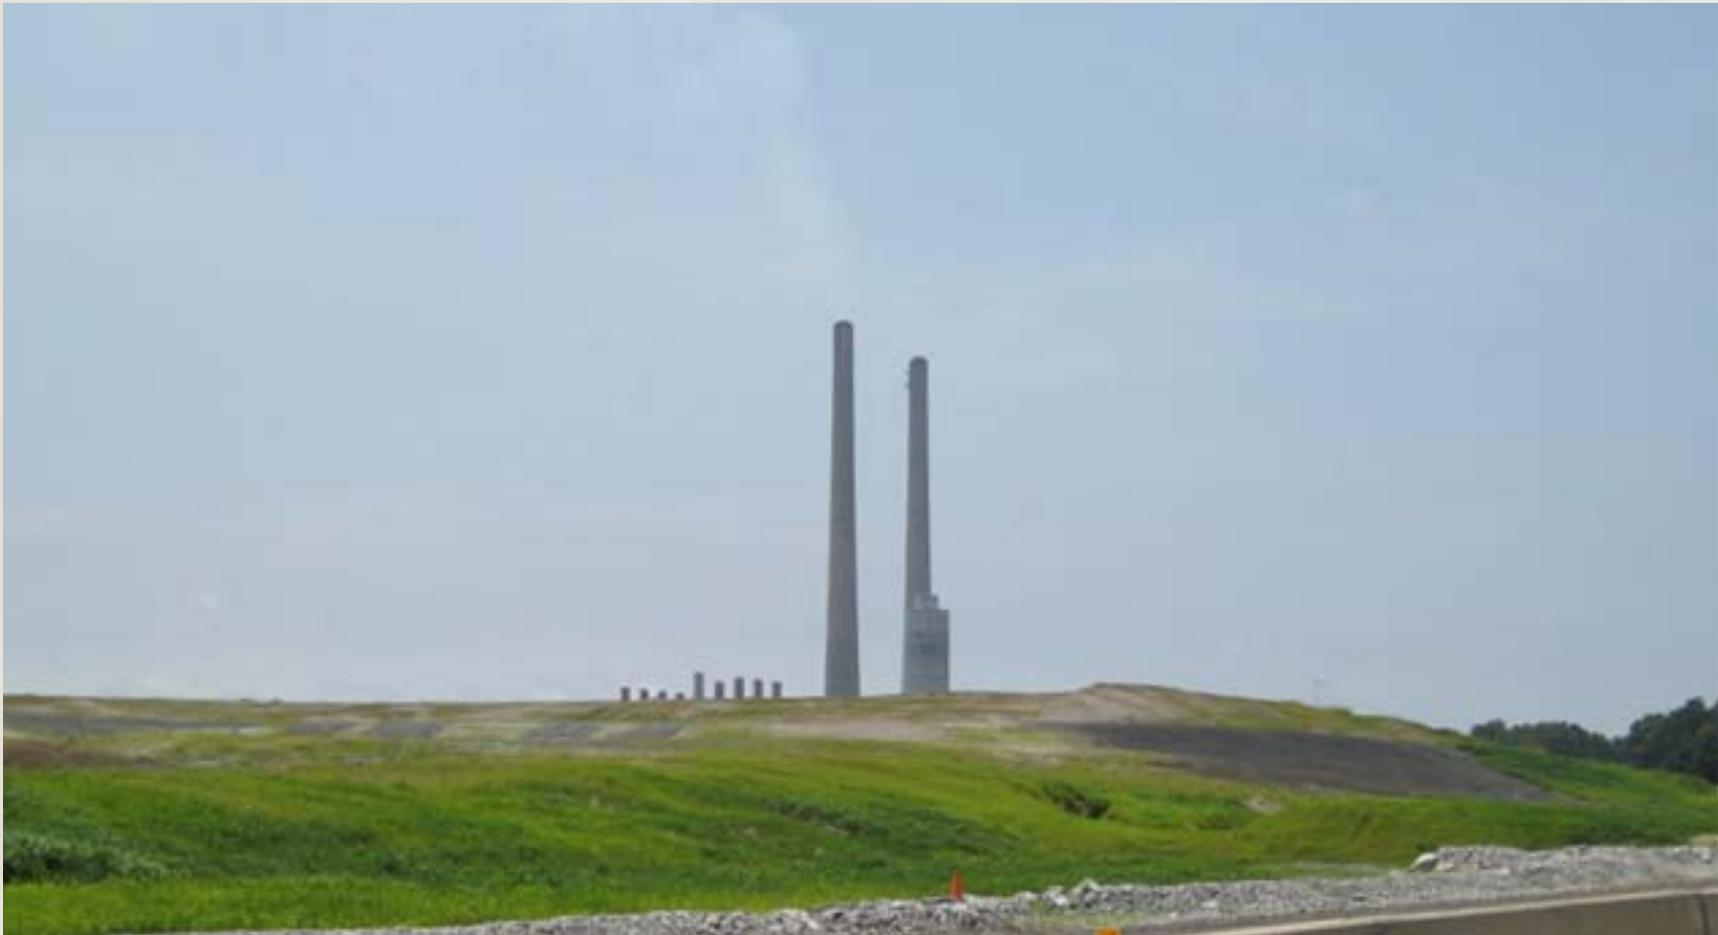
Failed Dredge Cell from Swan Pond Road
