TVA Melton Hill Dam Sustainable Recreation Area

Field monitoring and analysis of renewable and efficient technologies

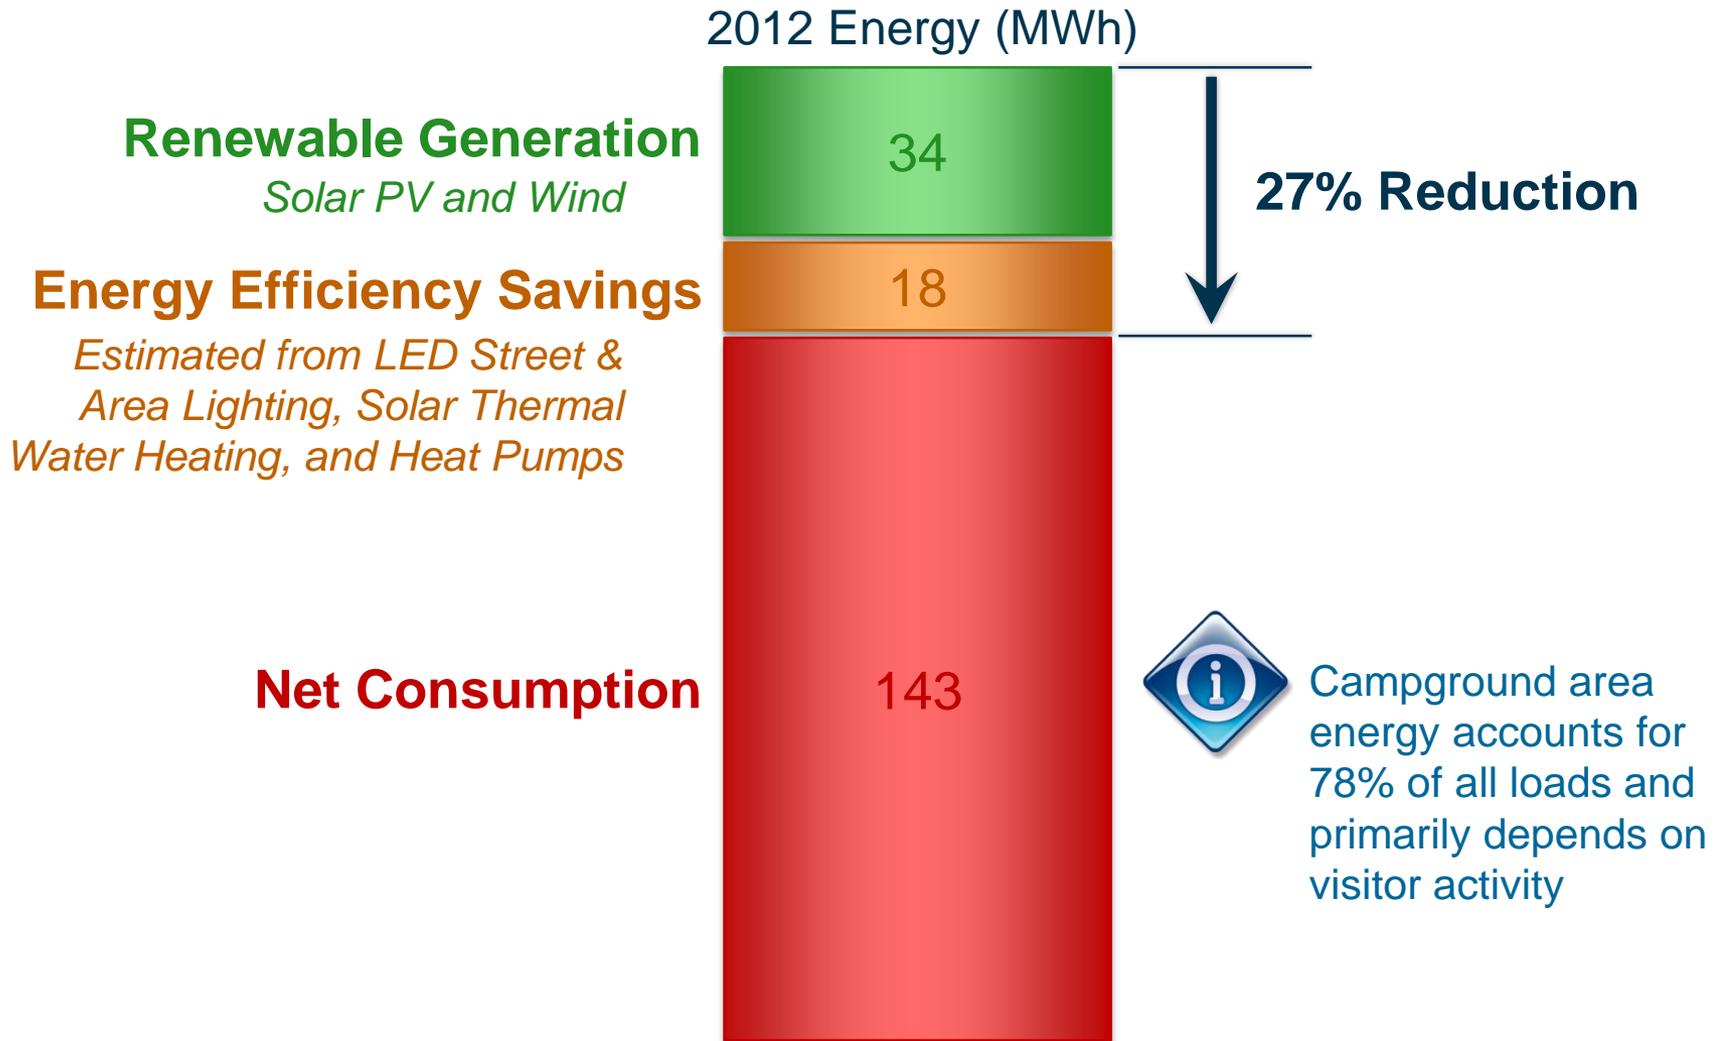
Net Energy Reduced by 27% for 2012

A combination of renewable generation and energy efficiency savings

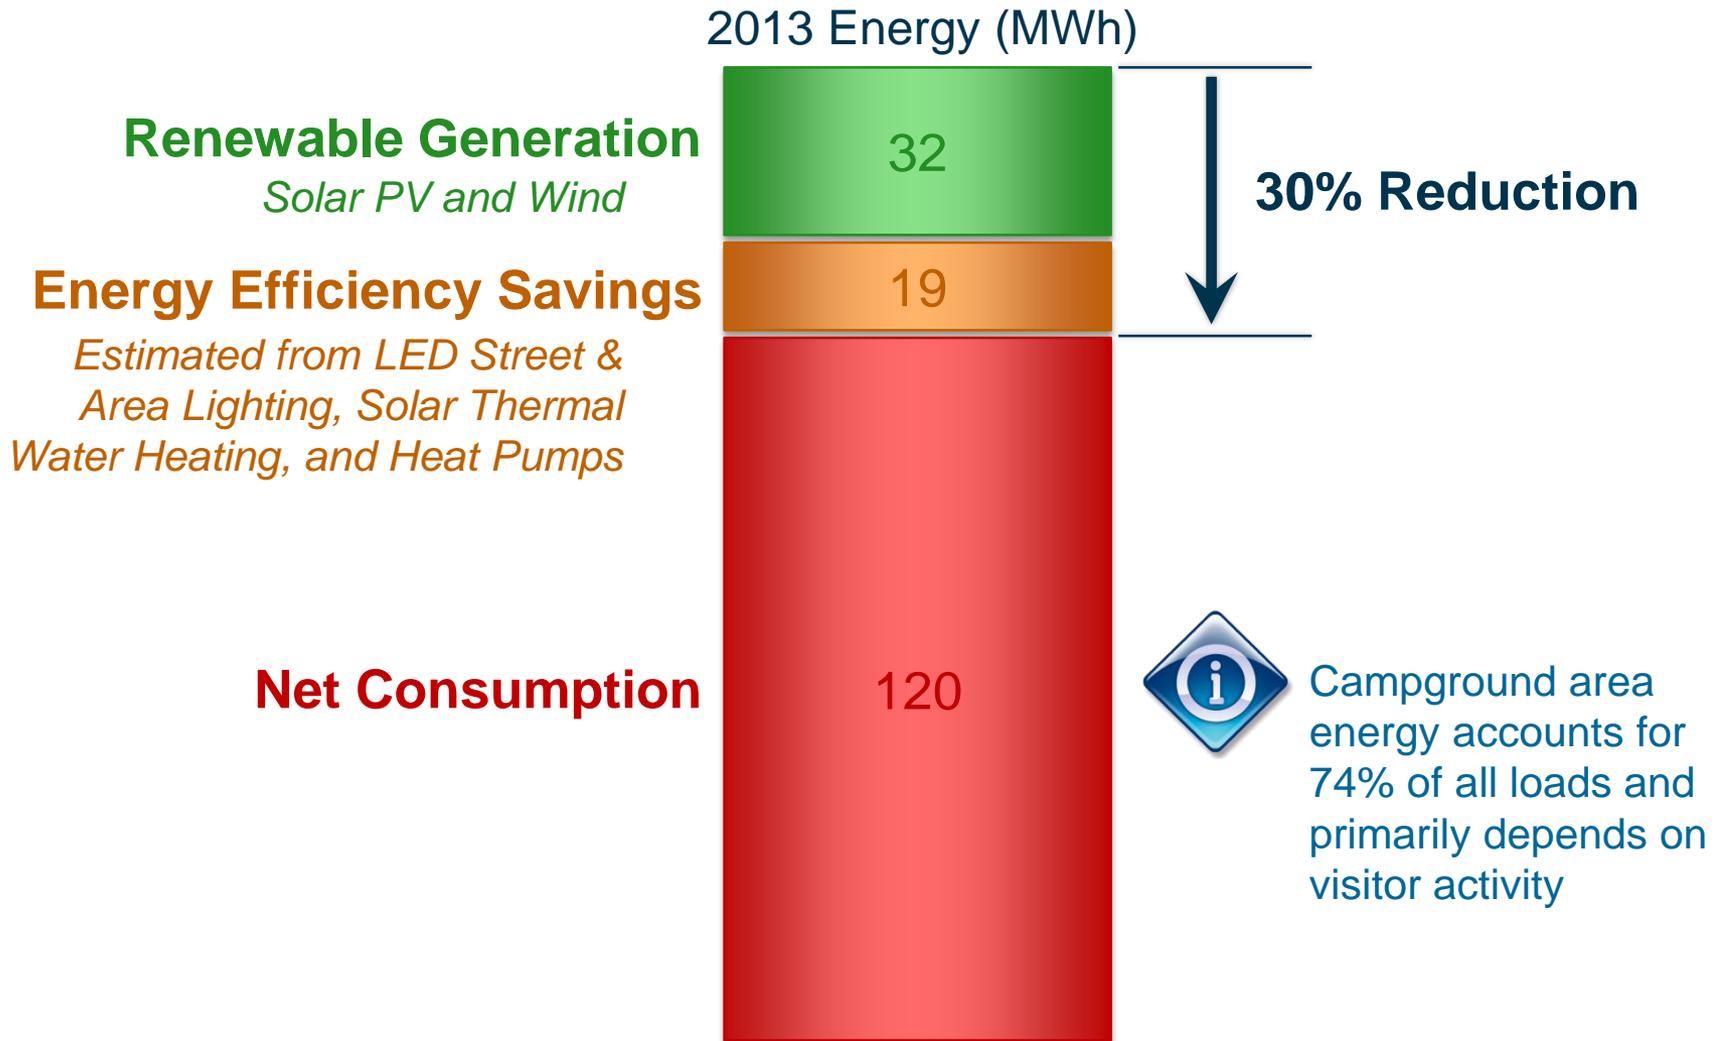
Net Energy Reduced by 30% for 2013

A combination of renewable generation and energy efficiency savings

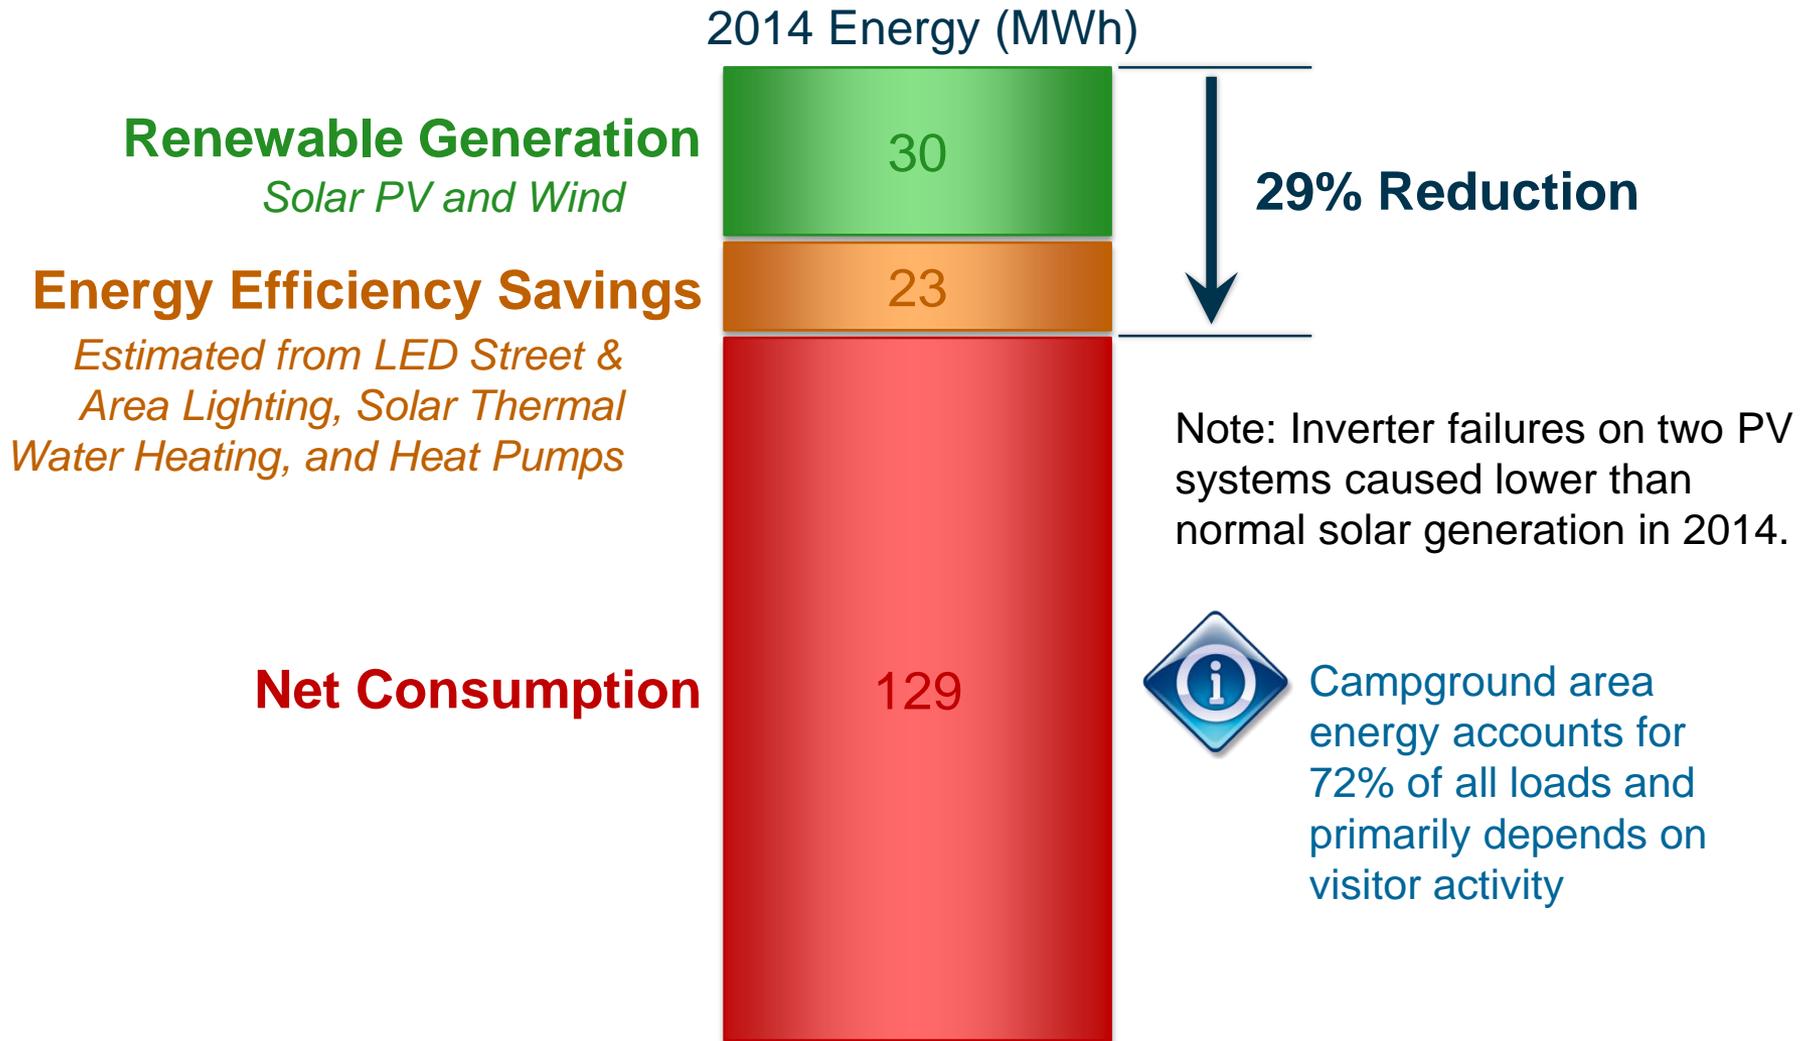
Net Energy Reduced by 29% for 2014

A combination of renewable generation and energy efficiency savings

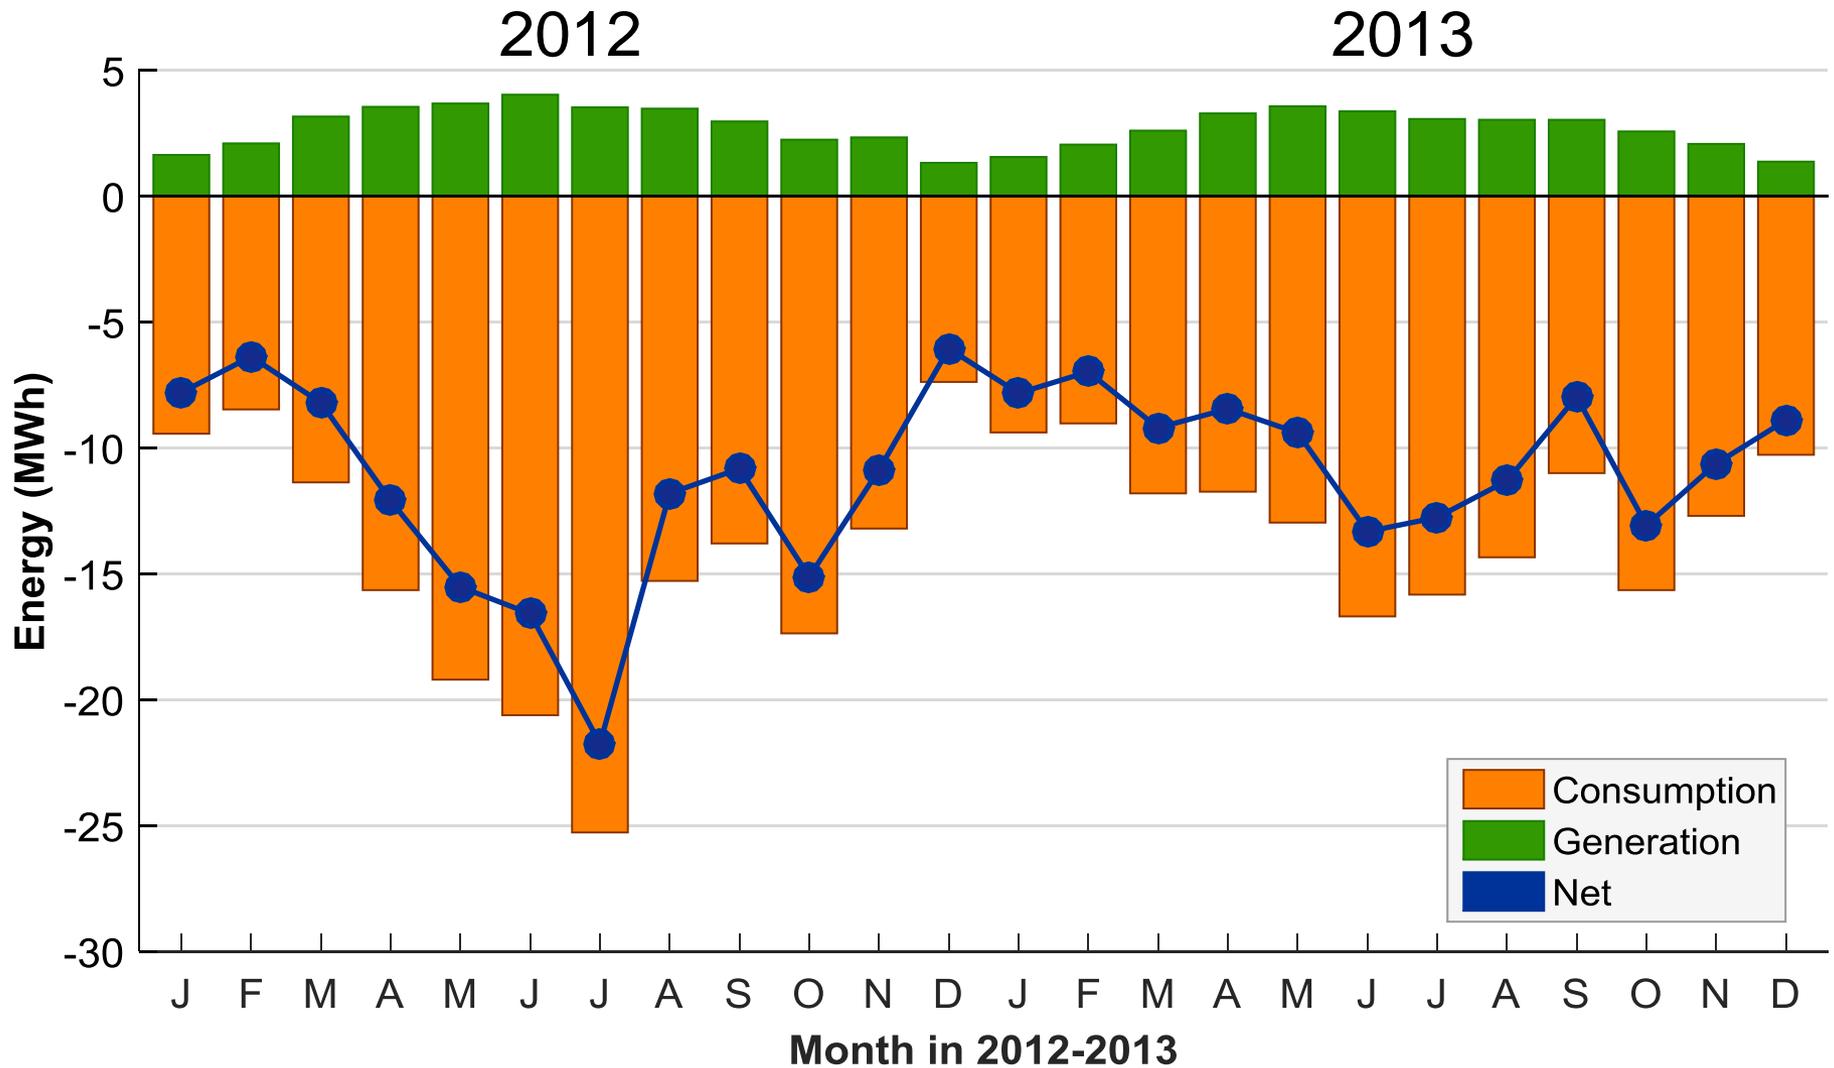
Monthly Generation, Consumption, and Net for Entire Recreation Area, 2012-2013

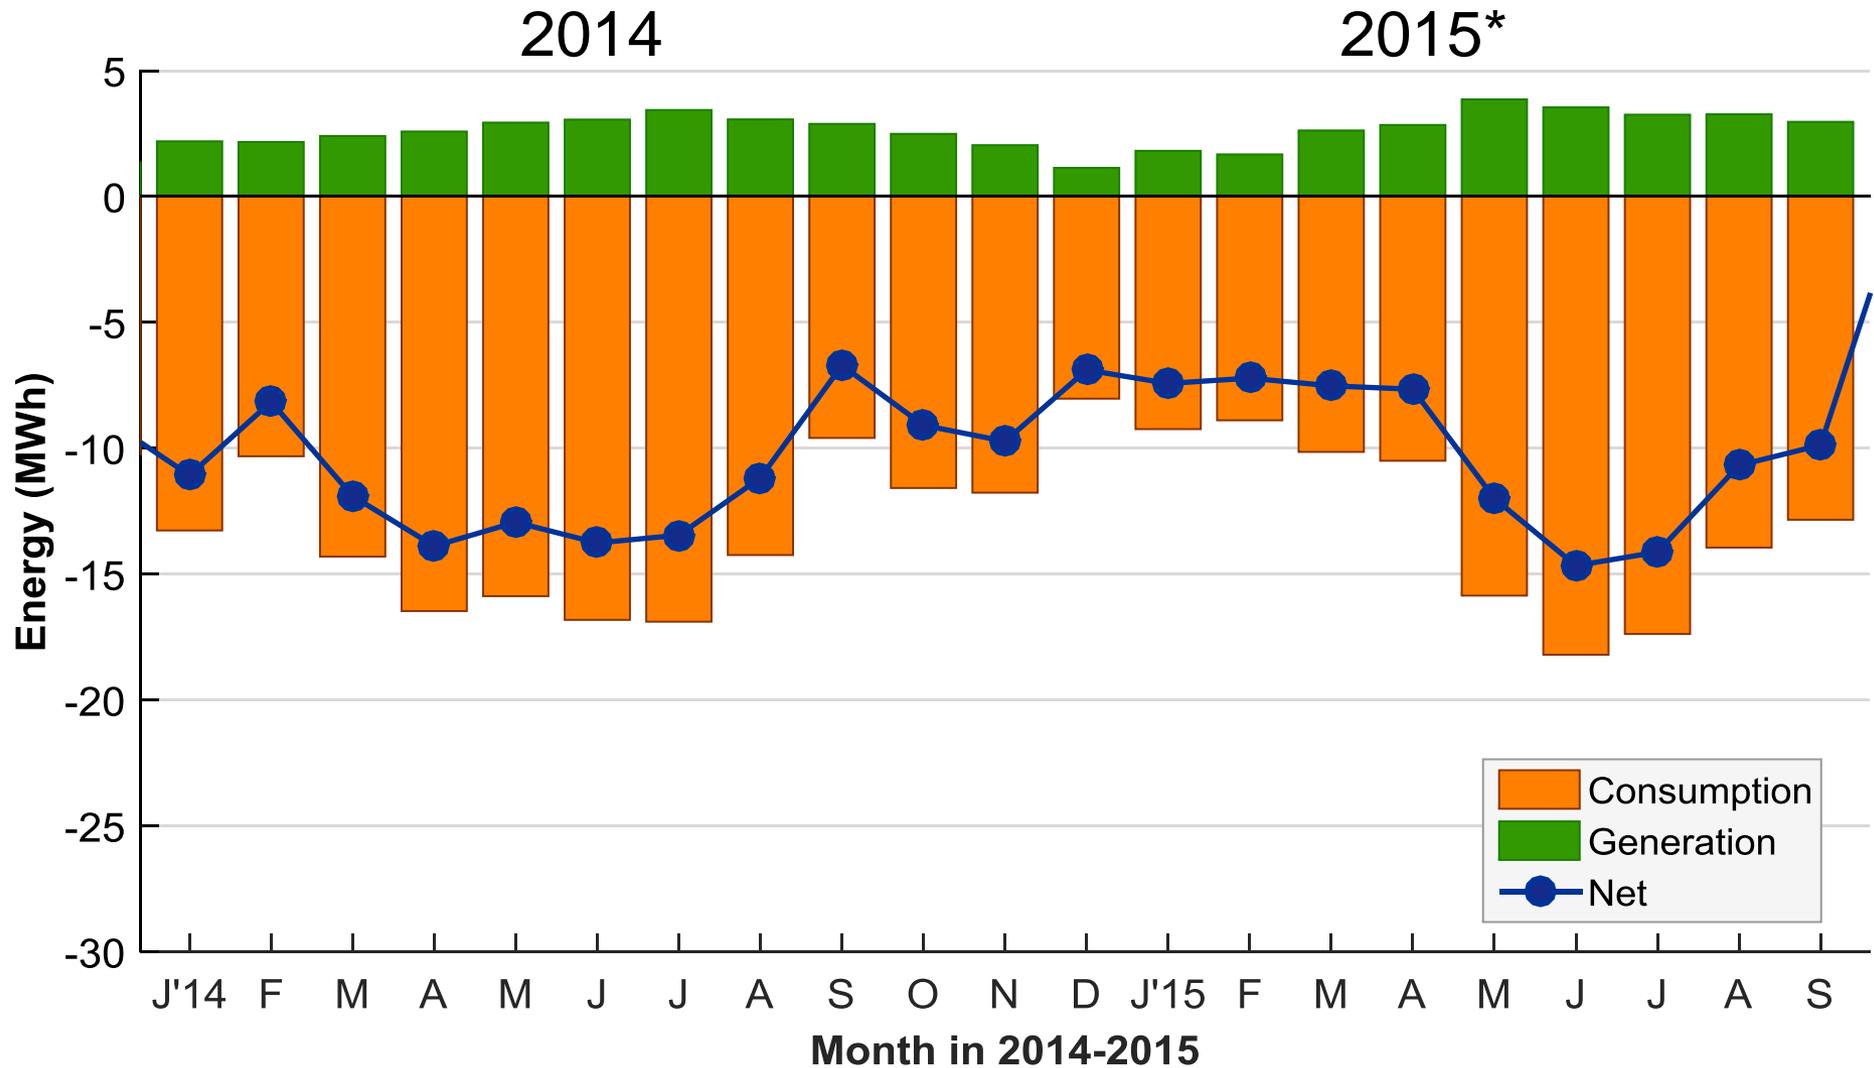
Monthly Generation, Consumption, and Net for Entire Recreation Area, 2014-Sep 2015

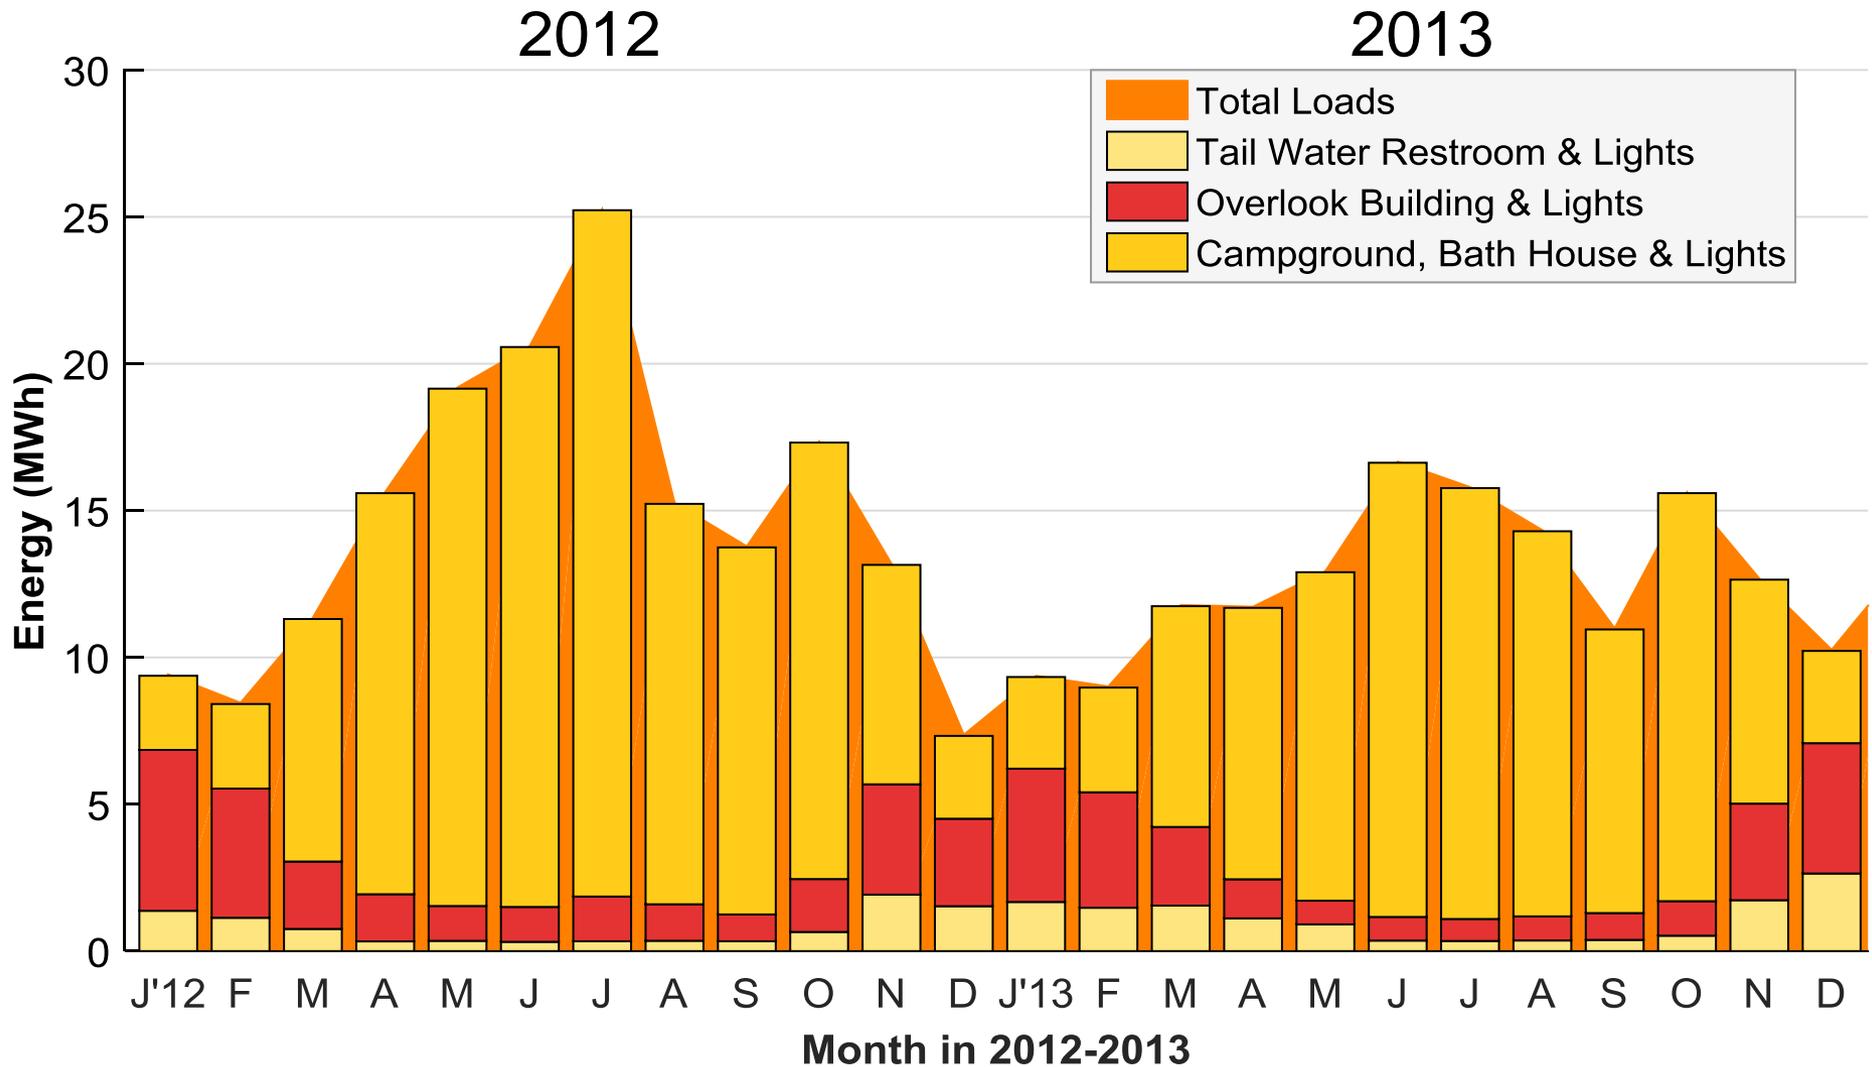
Monthly Energy Consumption: By Area, 2012-2013

Shown as stacked bars with shaded area for overall load in background

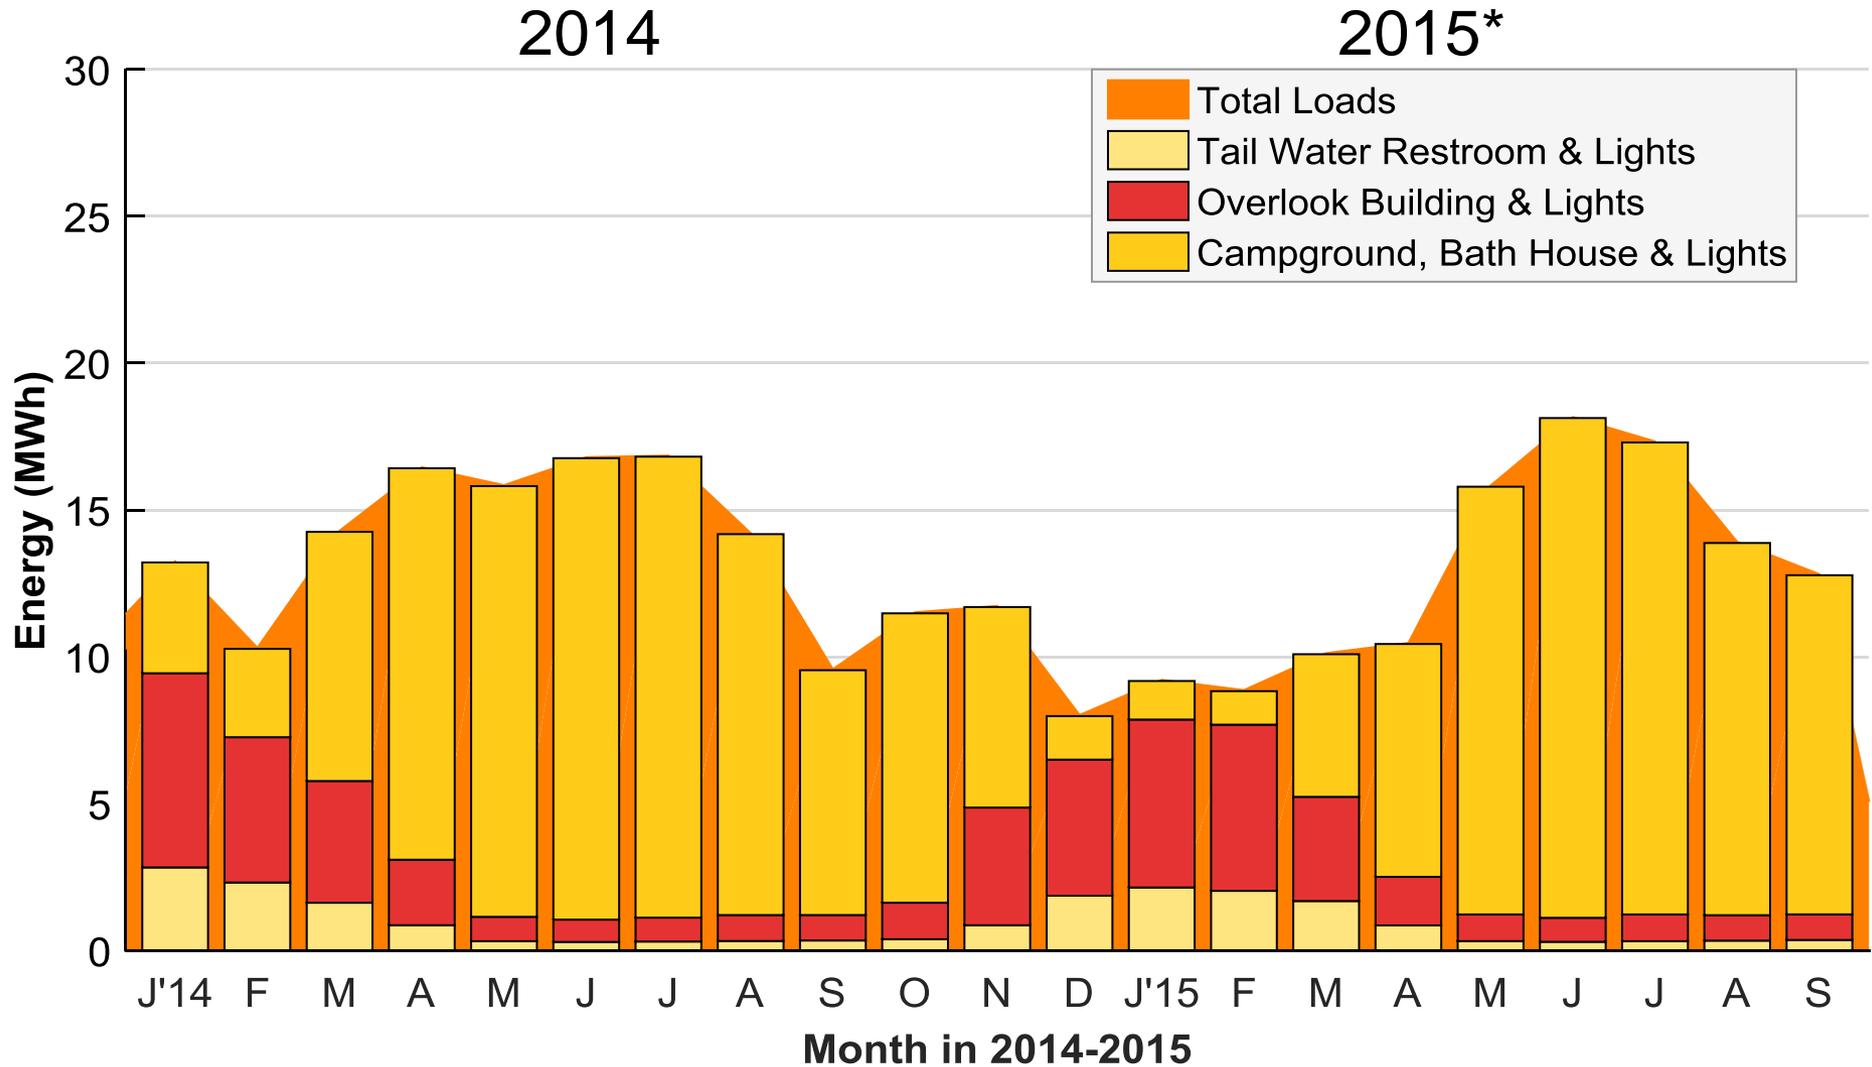
Monthly Energy Consumption: By Area, 2014-Sep 2015

Shown as stacked bars with shaded area for overall load in background

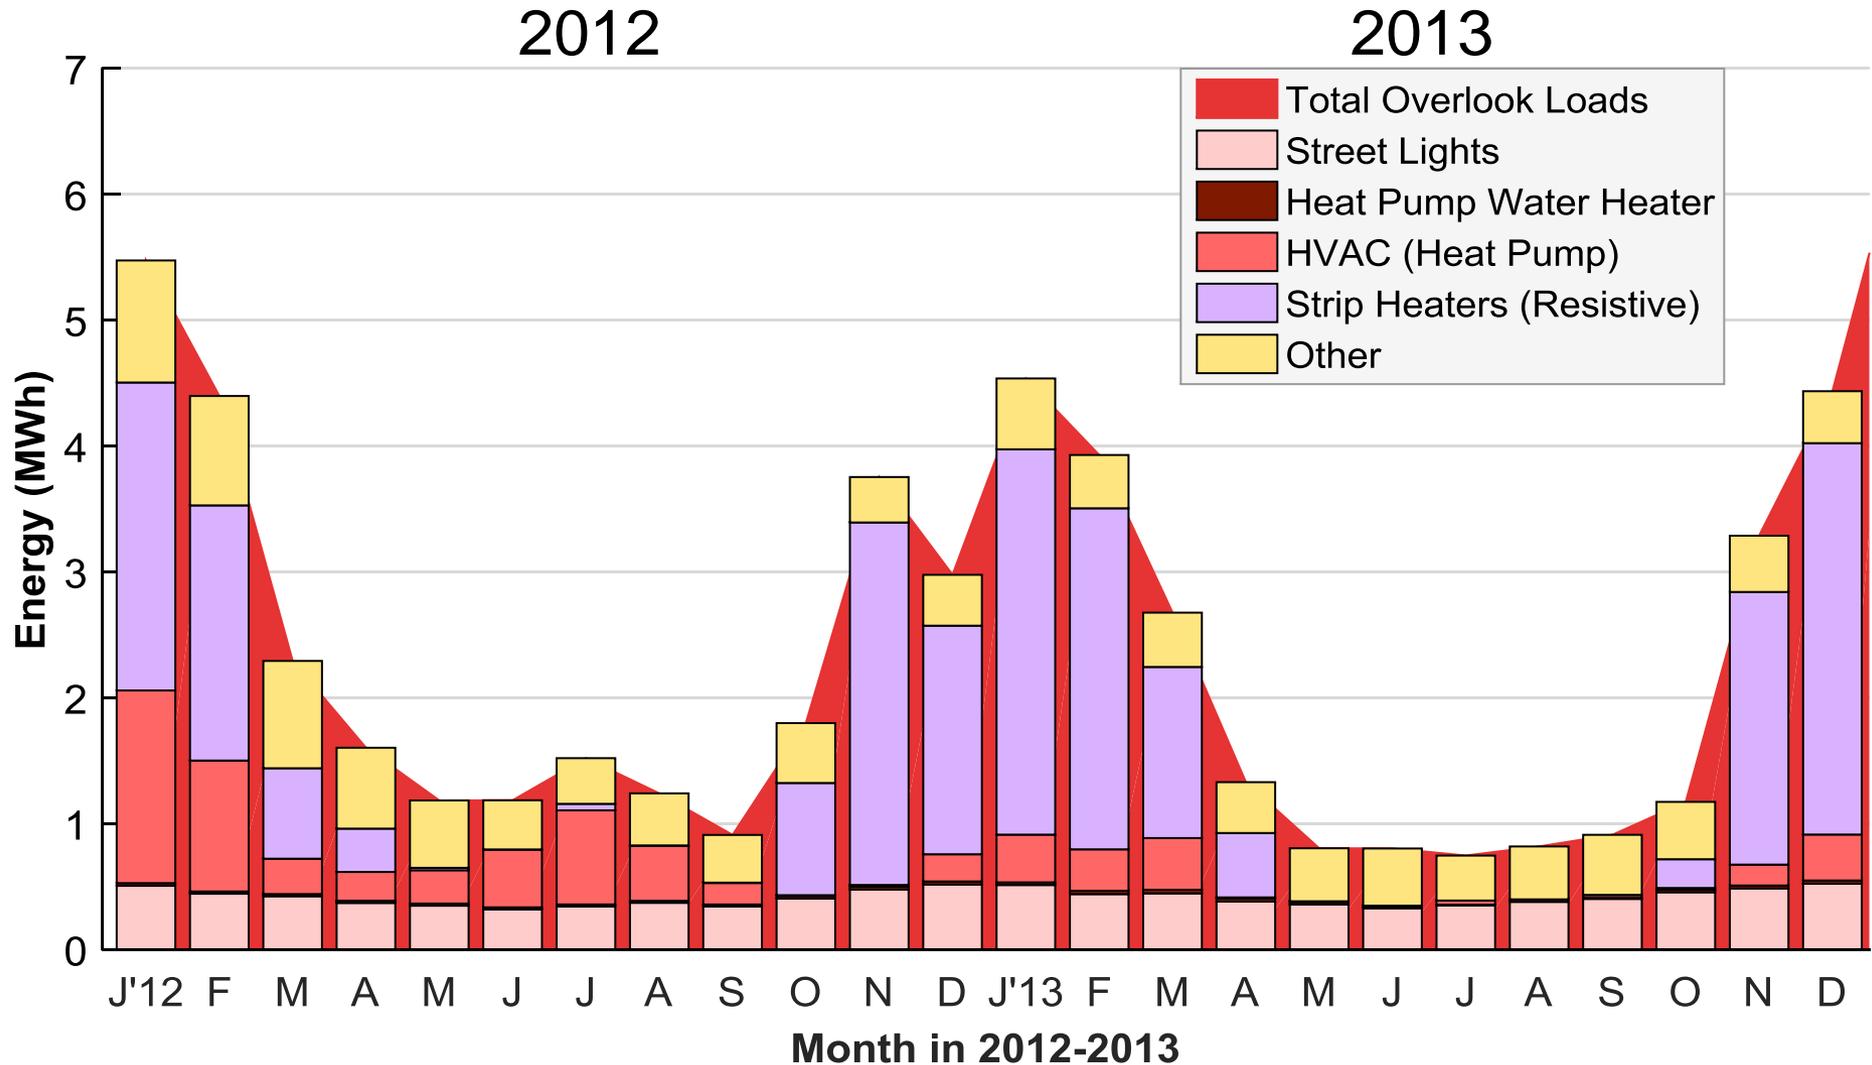
Monthly Energy Consumption: Overlook, 2012-2013

Shown as stacked bars with shaded area for total Overlook loads

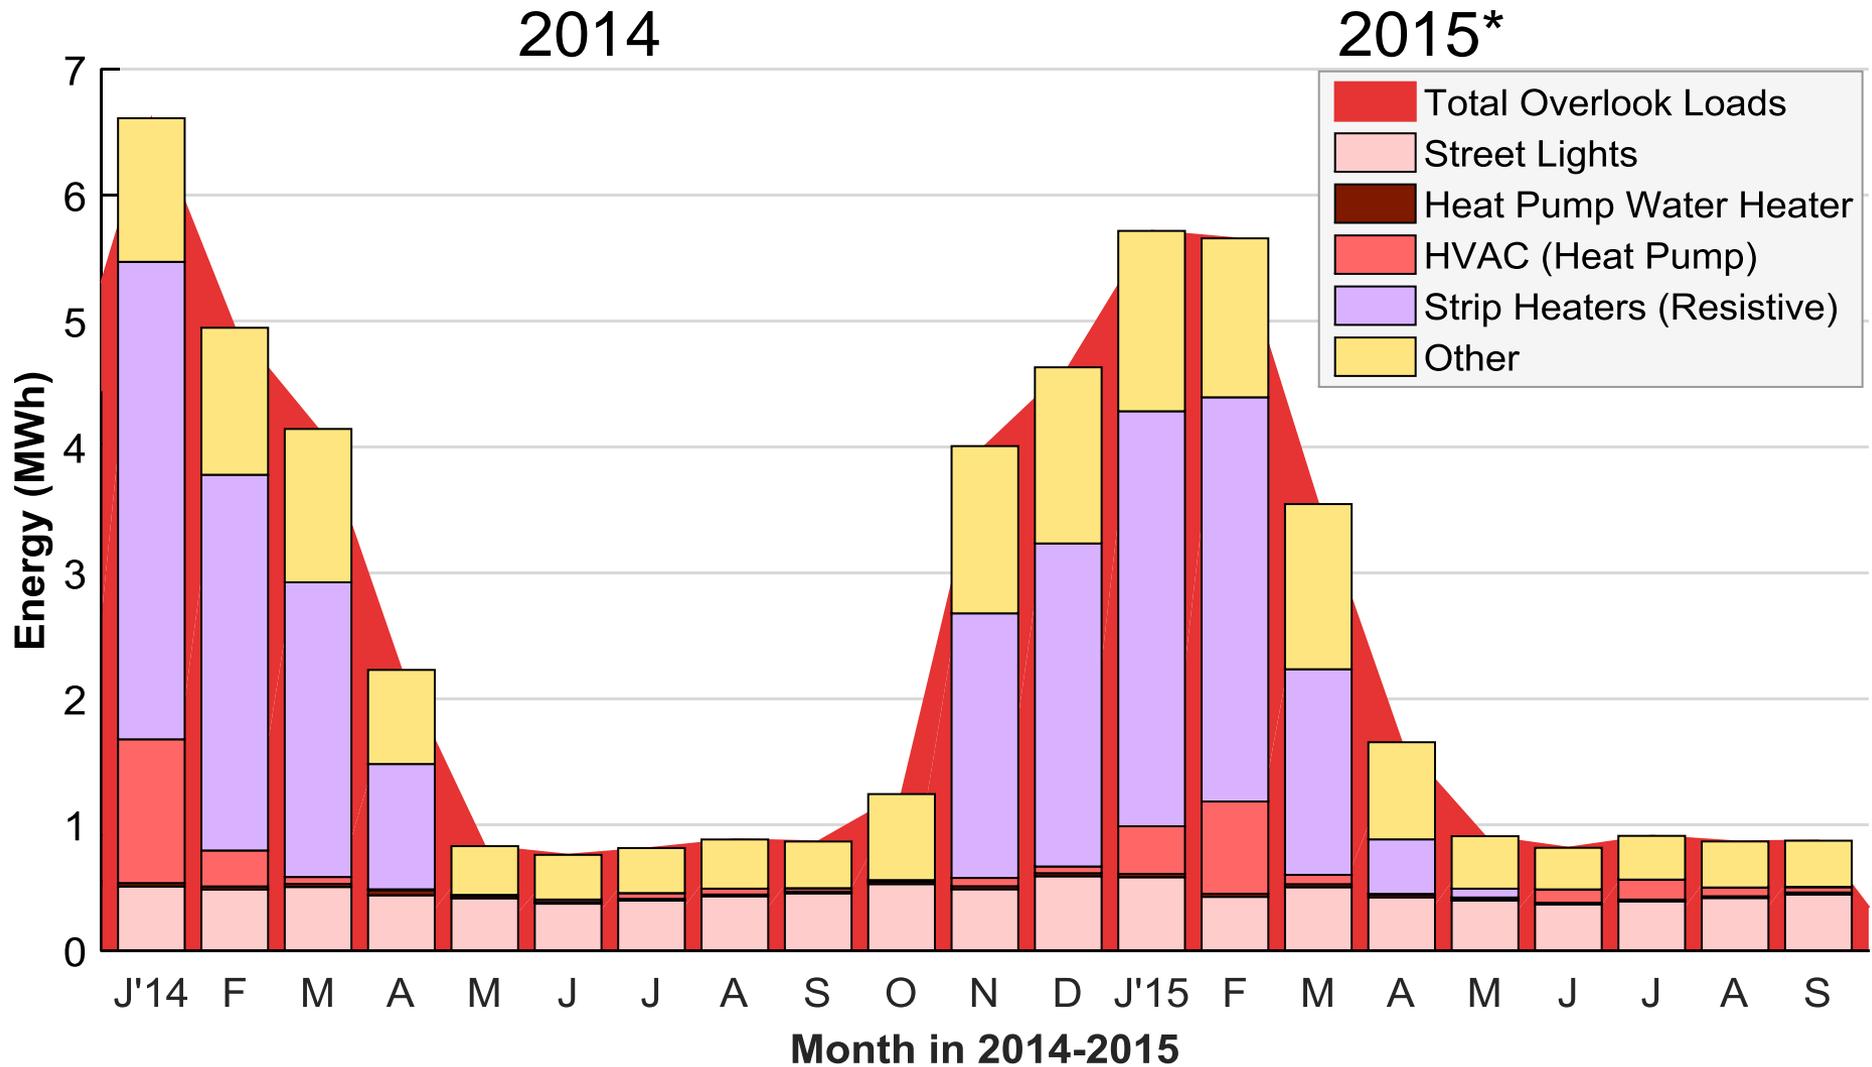
Monthly Energy Consumption: Overlook, 2014-Sep 2015

Shown as stacked bars with shaded area for total Overlook loads

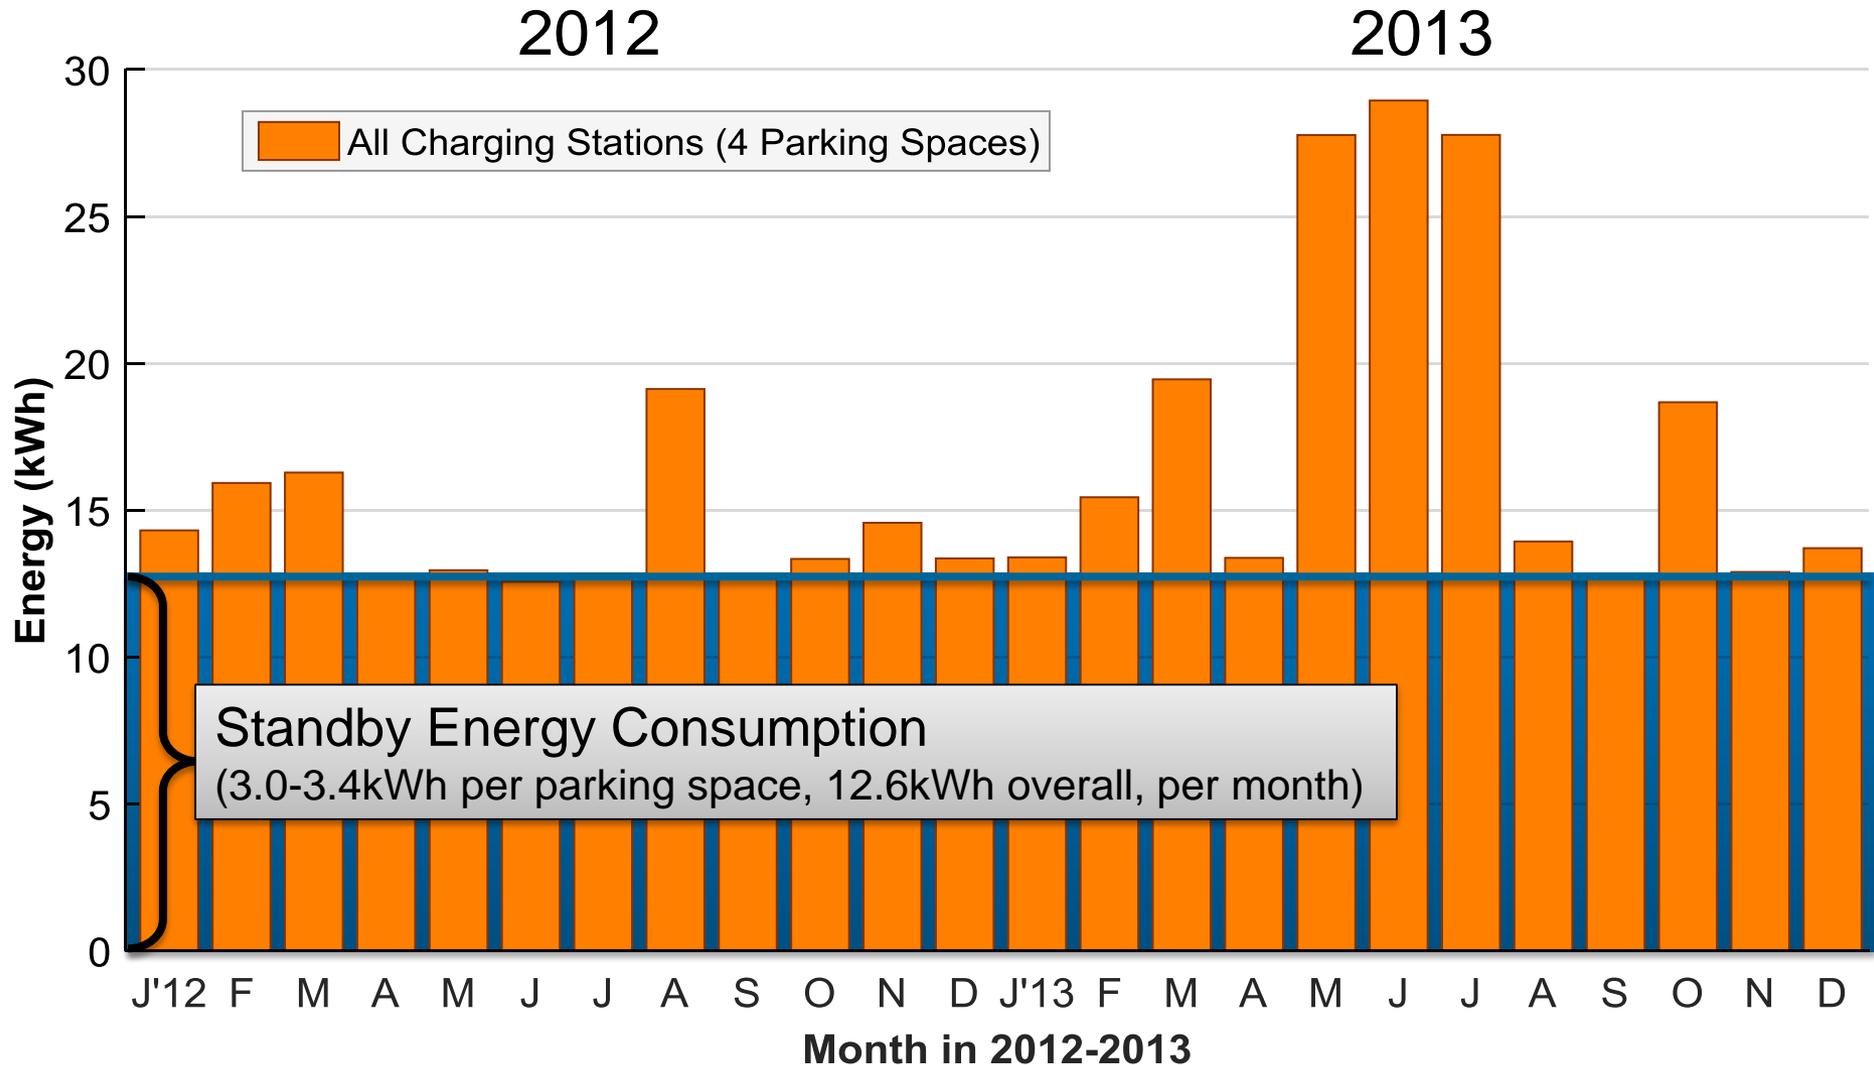
Monthly Consumption: Charging Stations, 2012-2013

Few vehicle charging instances observed; most occurred in 2013

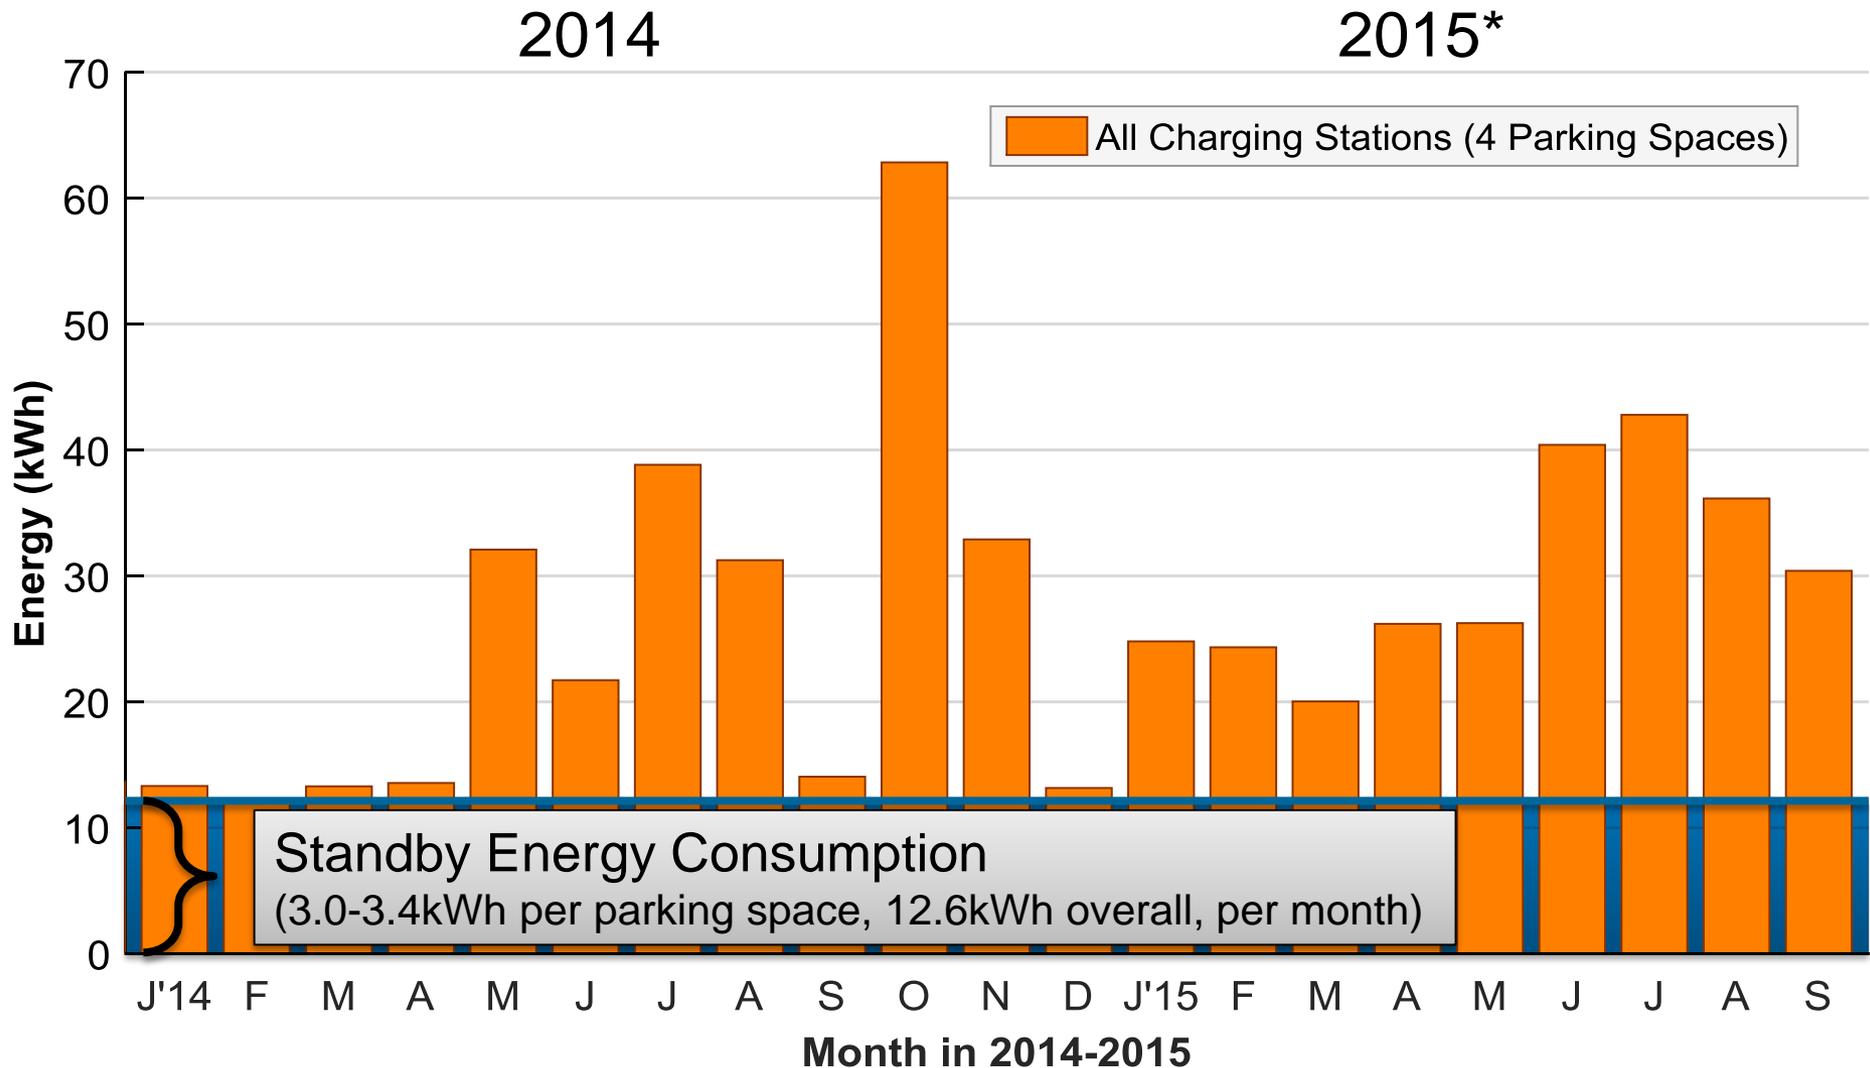
Monthly Consumption: Charging Stations, 2014-Sep 2015

9 months above 30 kWh in 2014-2015, compared to 0 months in 2012-2013

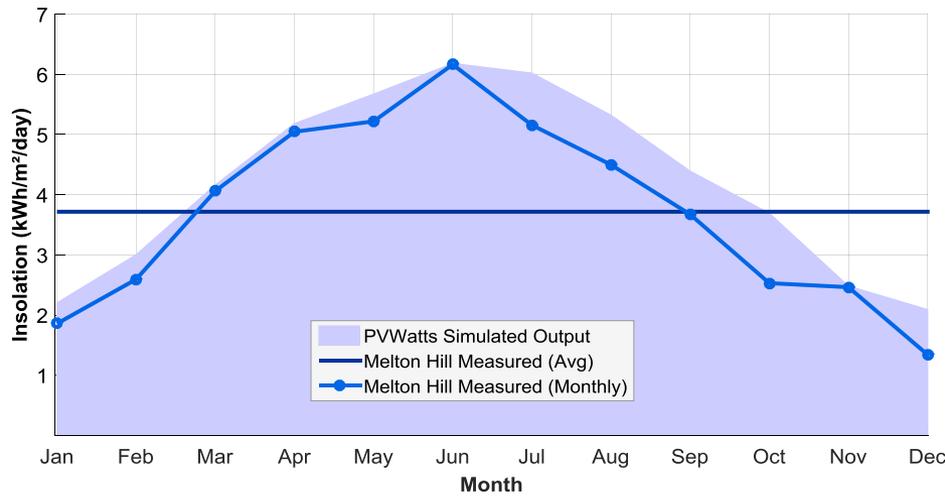
2012

Monthly Global Horizontal Insolation, 2012-2013

Average **3.72** kWh/m²/day

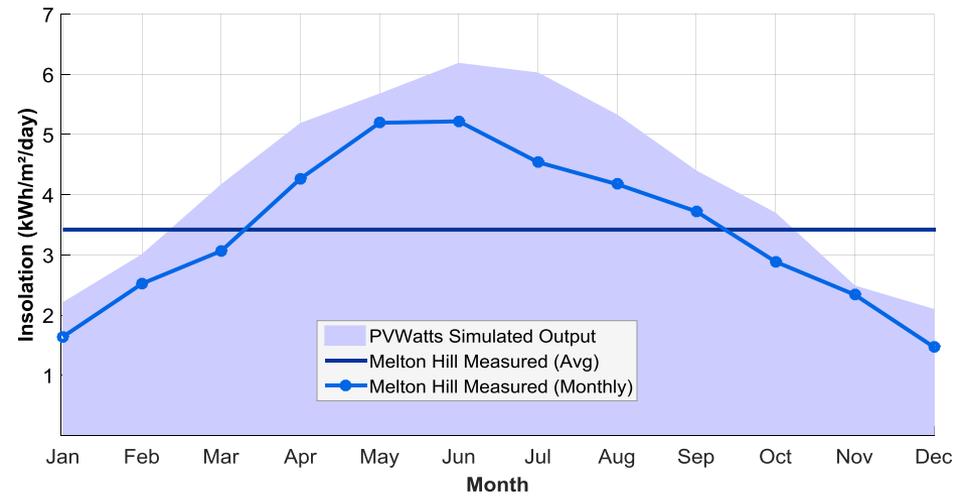
2013

Average **3.42** kWh/m²/day

8.1% reduction from 2012

(Oak Ridge weather station shows comparable 8.8% reduction from 2012)

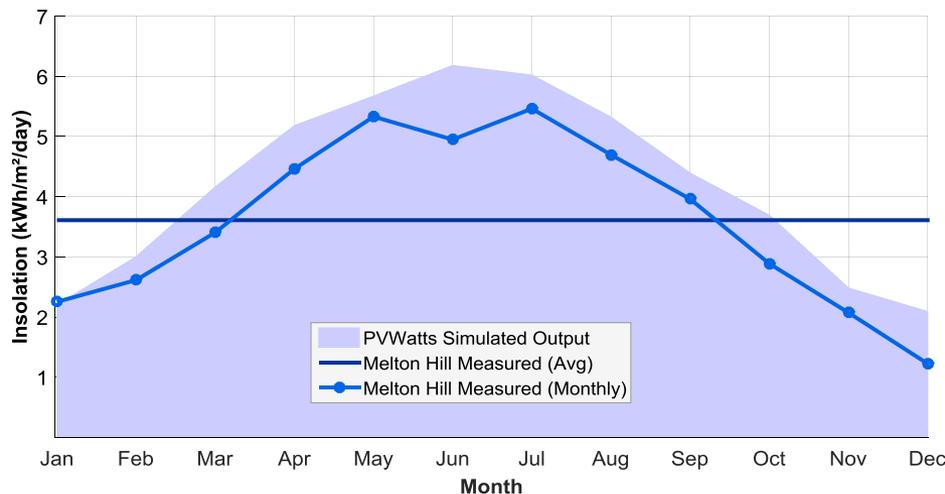
2014

Monthly Global Horizontal Insolation, 2014-Sep 2015

Average **3.61** kWh/m²/day

5.6% increase from 2013
