TVA Melton Hill Dam Sustainable Recreation Area

Field monitoring and analysis of renewable and efficient technologies

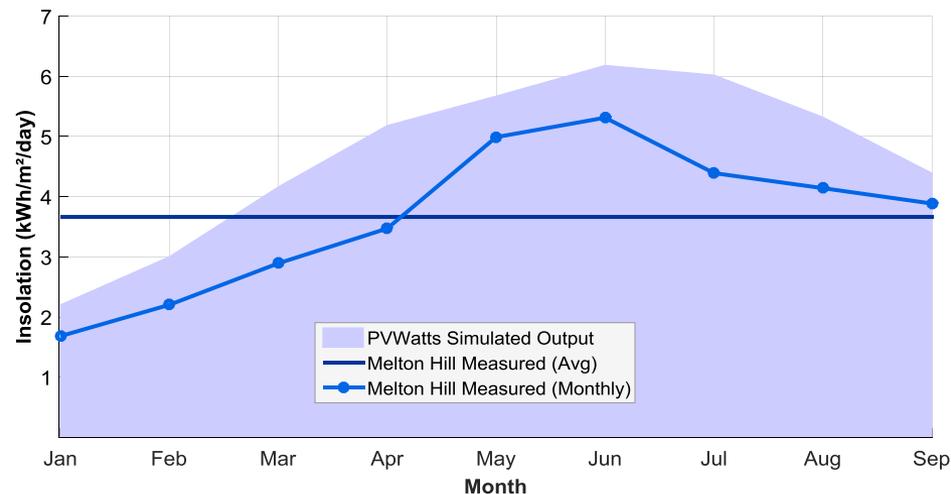
2015

Average **3.66** kWh/m²/day

11.4% reduction from Jan-Sep 2014

(Oak Ridge weather station shows comparable 5.5% reduction from Jan-Sep 2014)

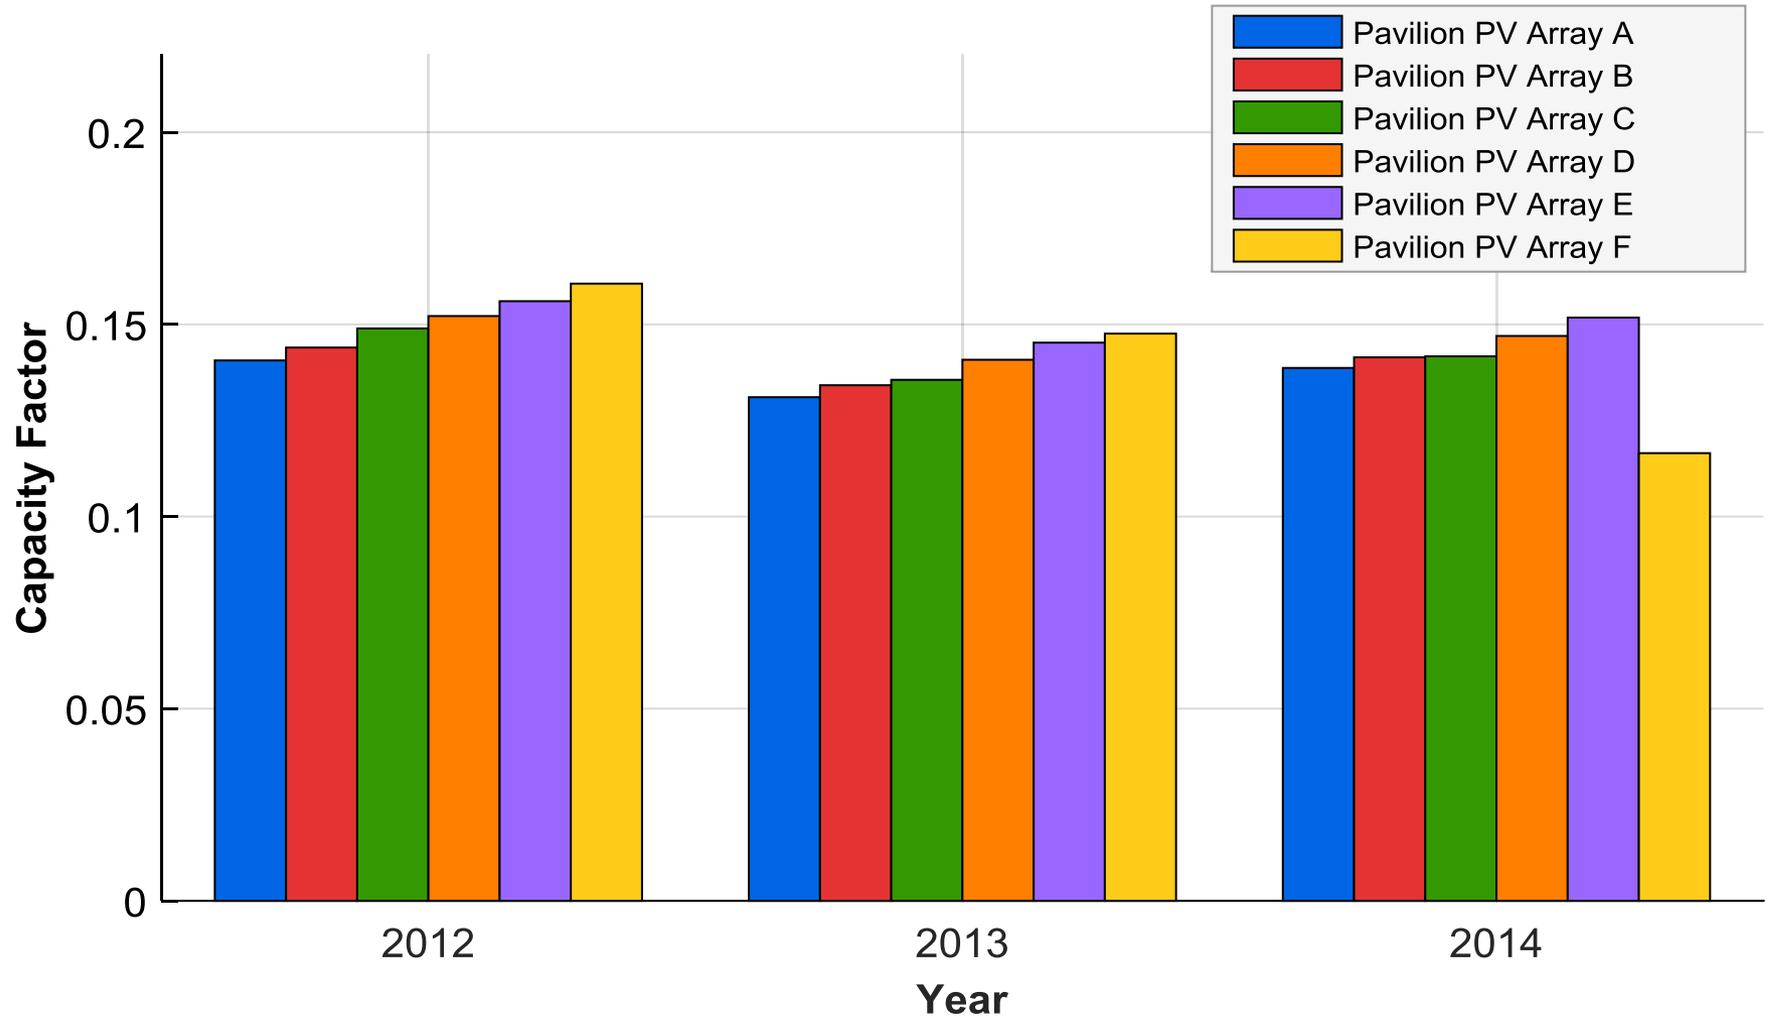
Annual Capacity Factors per System, 2012-2014

Pavilion Systems

Note: Capacity Factor for Array F was lower than normal in 2014 due to an inverter failure, lasting from 6/30/2014 to 9/12/2014.

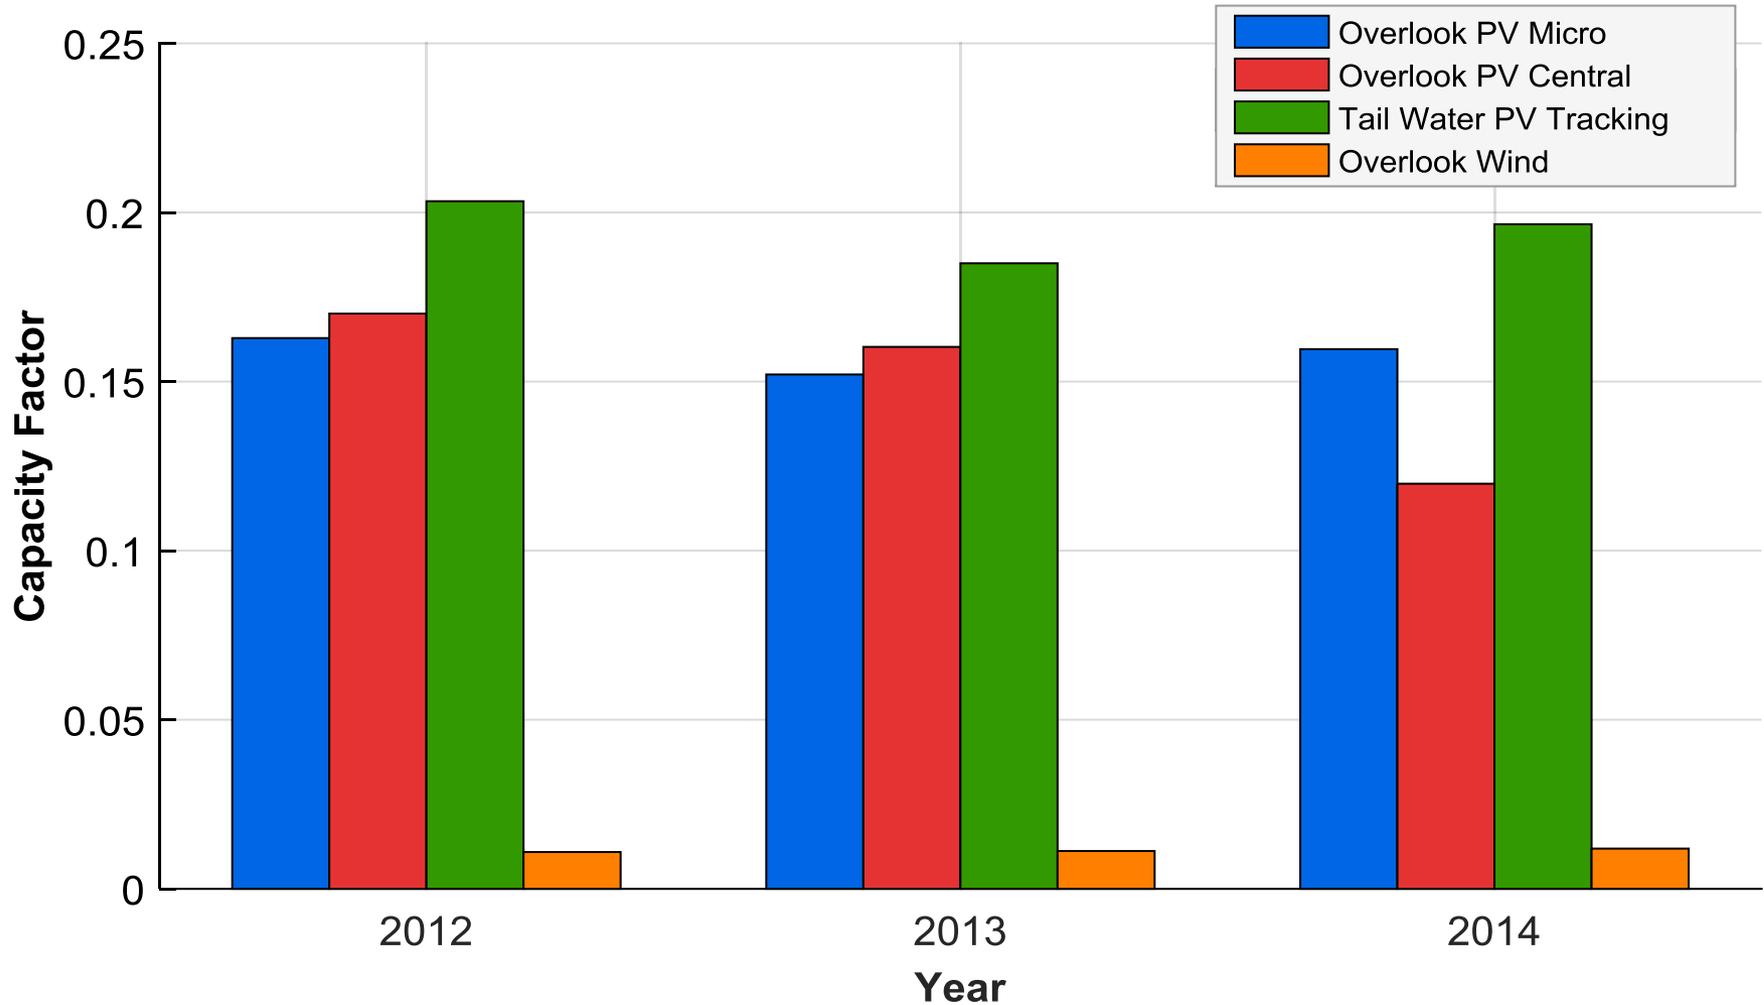
Annual Capacity Factors per System, 2012-2014

Overlook & Tail Water Systems

Note: Capacity Factor for Overlook PV Central was lower than normal in 2014 due to an inverter failure, lasting from 3/18/2014 to 6/5/2014.

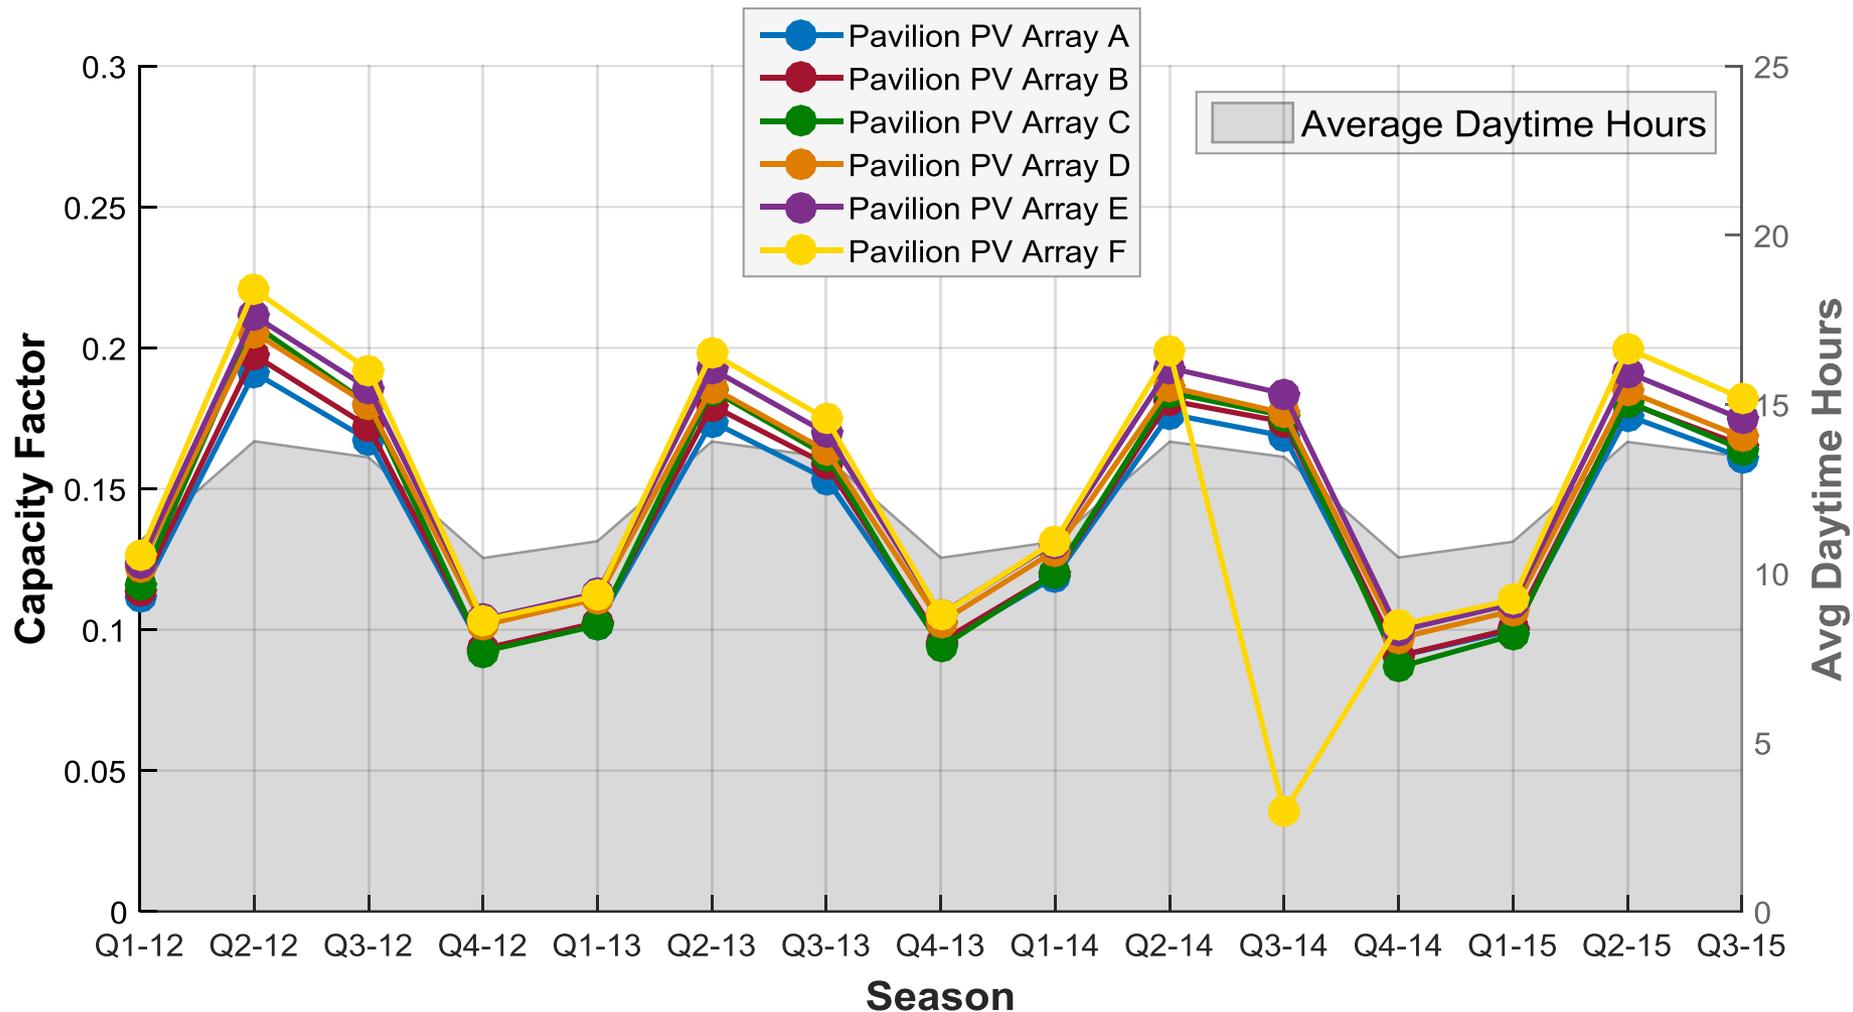
Seasonal Capacity Factors per System, 2012–Q3 2015

Pavilion Systems

Note: Capacity Factor for Array F was lower than normal in Q3 2014 due to an inverter failure, lasting from 6/30/2014 to 9/12/2014.

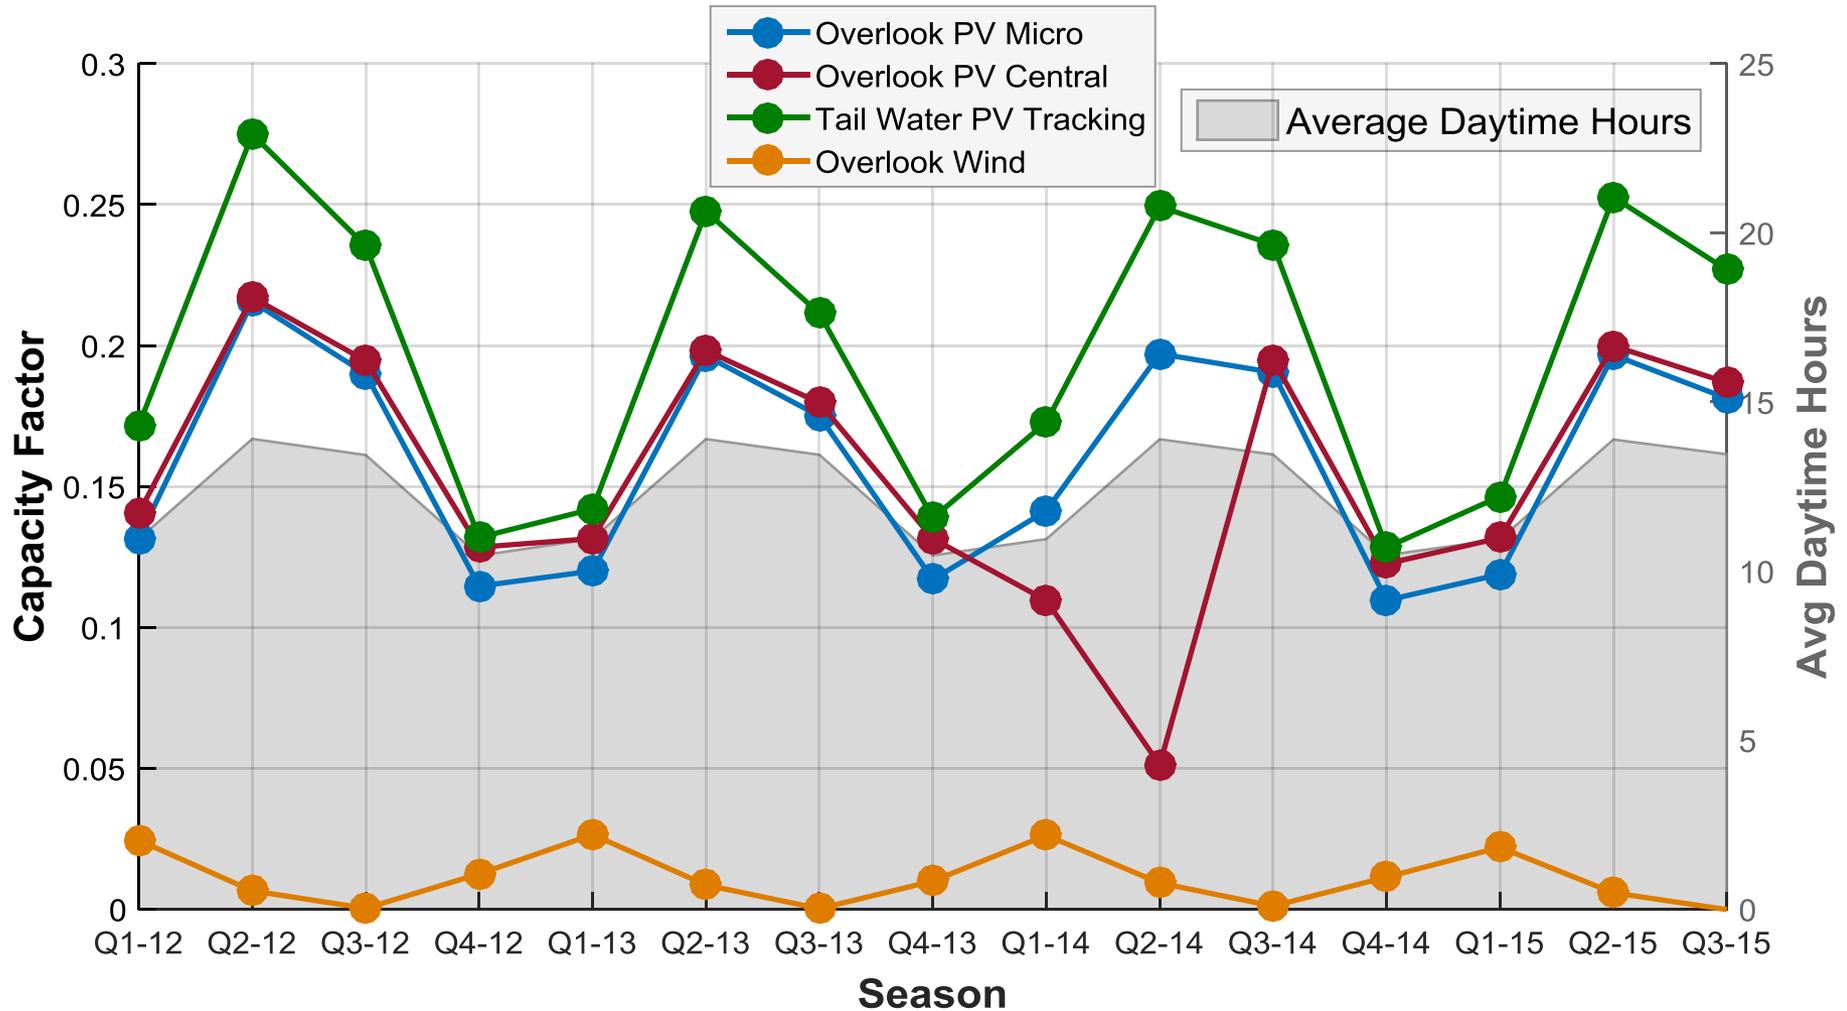
Seasonal Capacity Factors per System, 2012–Q3 2015

Overlook & Tail Water Systems

Note: Capacity Factor for Overlook PV Central was lower than normal in Q1 and Q2 2014 due to an inverter failure, lasting from 3/18/2014 to 6/5/2014.

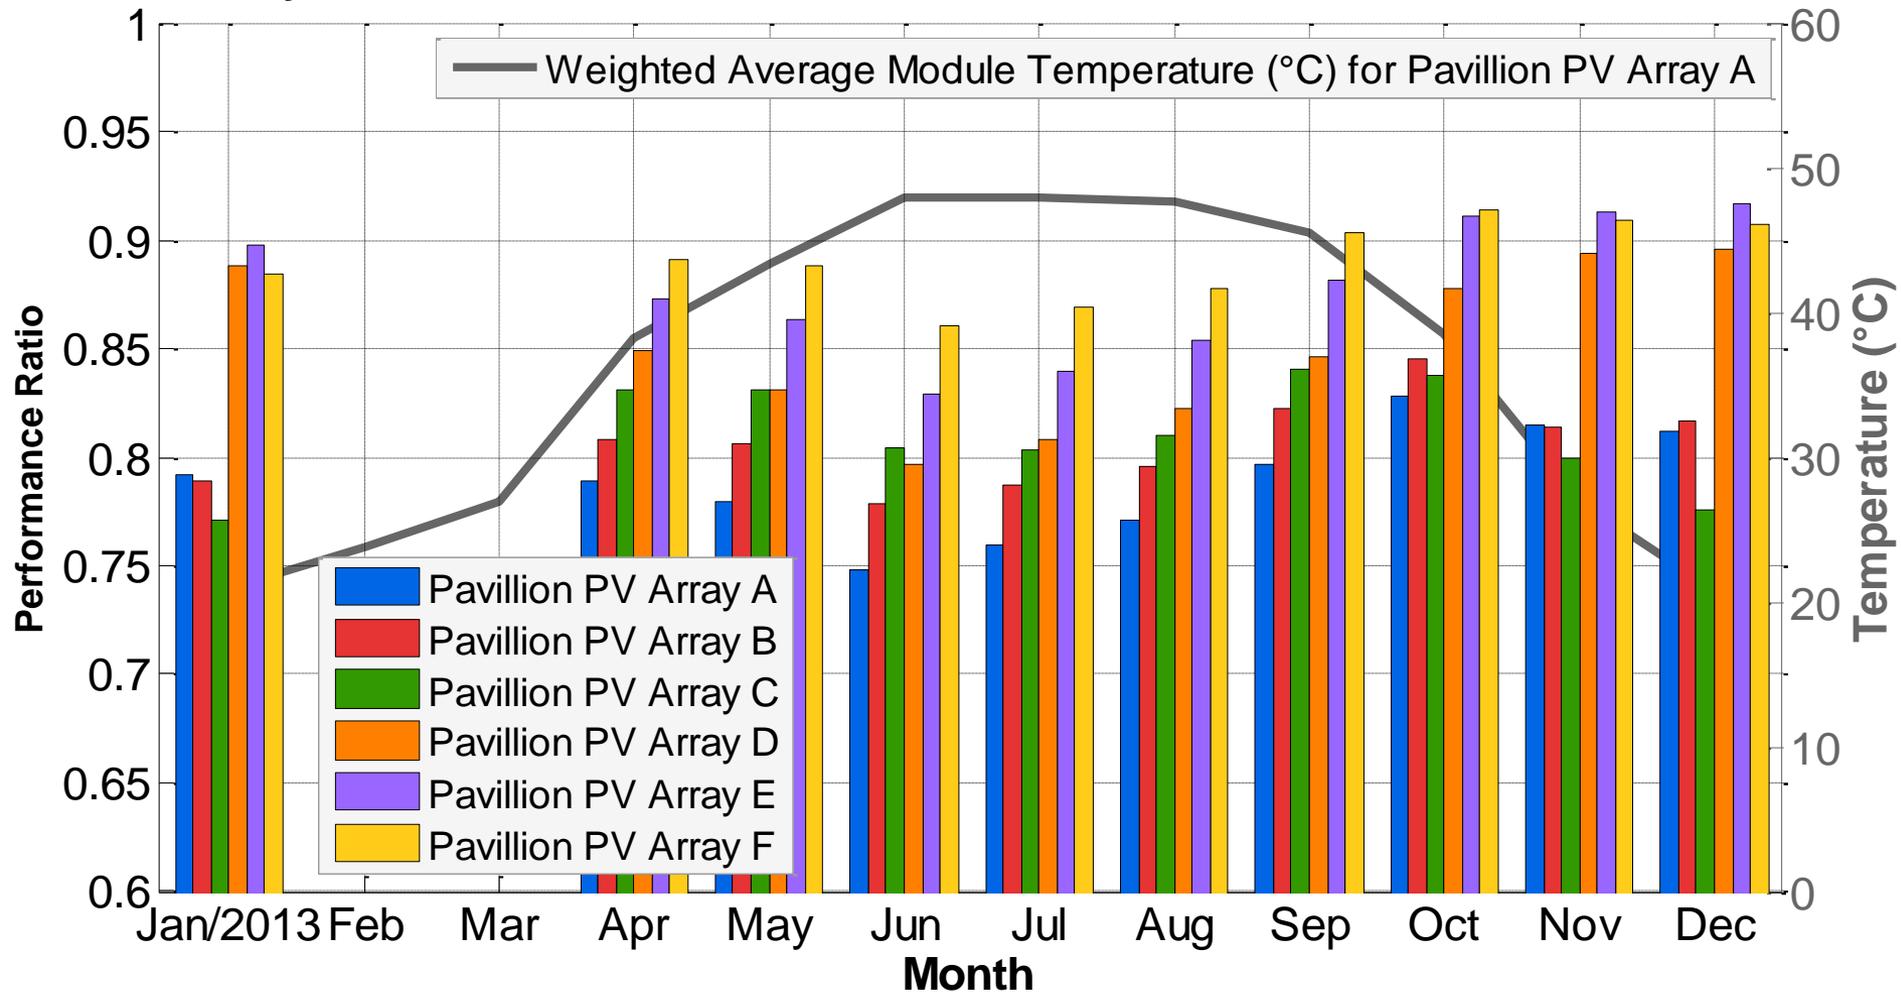
Monthly Performance Ratio Per System, 2013

Pavilion Systems

Note: No data in Feb-Mar 2013 due to a communication outage.

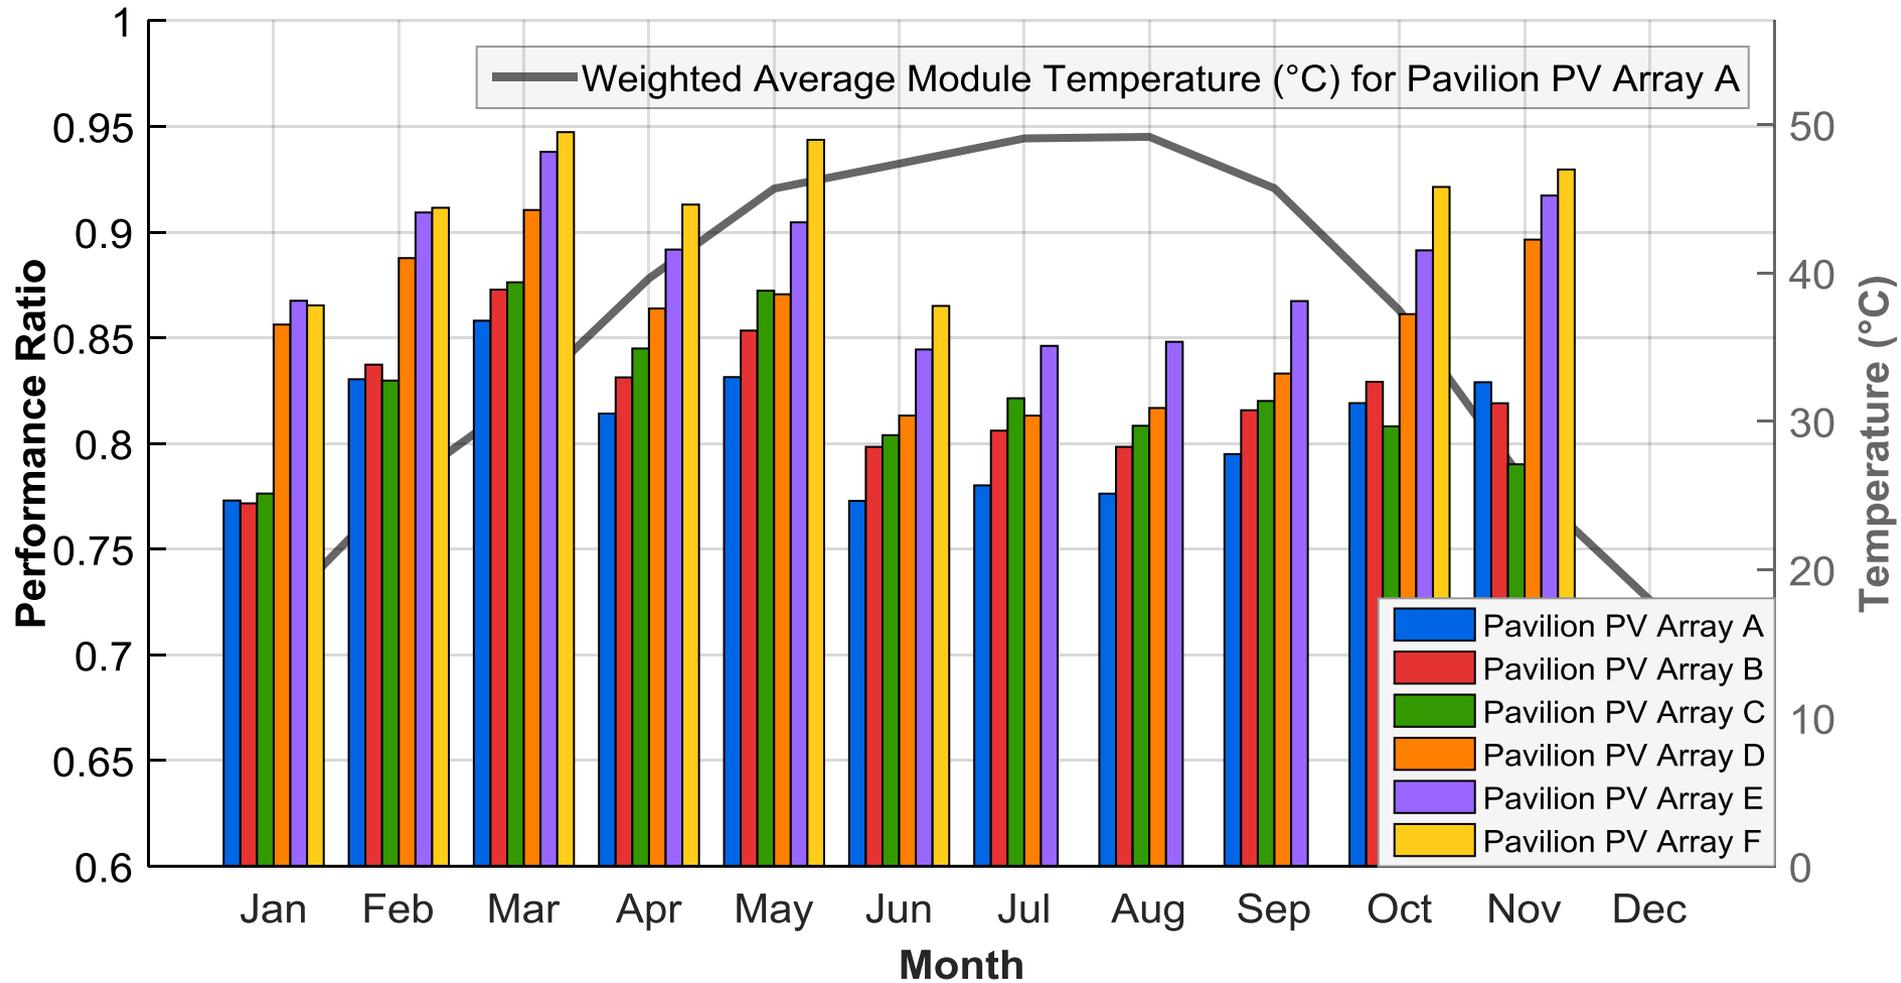
Monthly Performance Ratio Per System, 2014

Pavilion Systems

Note: No data in Dec 2014 due to a communication outage.

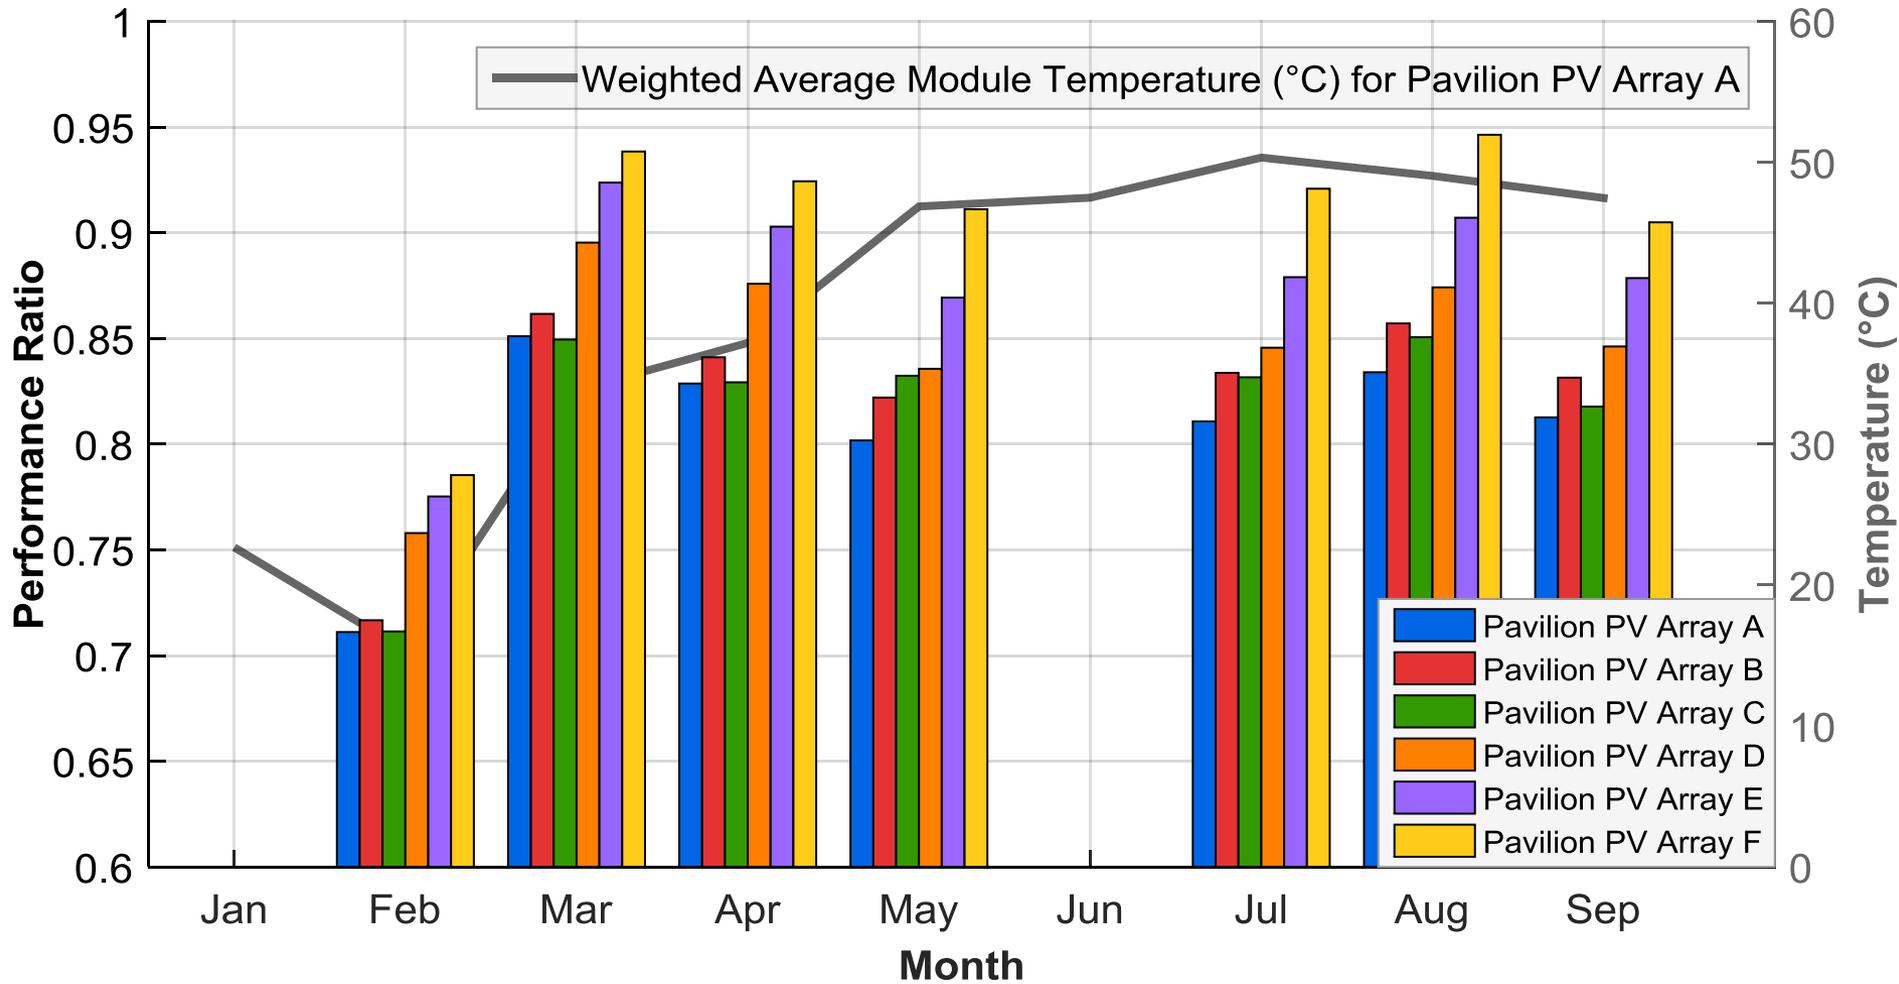
Monthly Performance Ratio Per System, Jan-Sep 2015

Pavilion Systems

Note: No data in Jan and Jun 2015 due to communication outages.

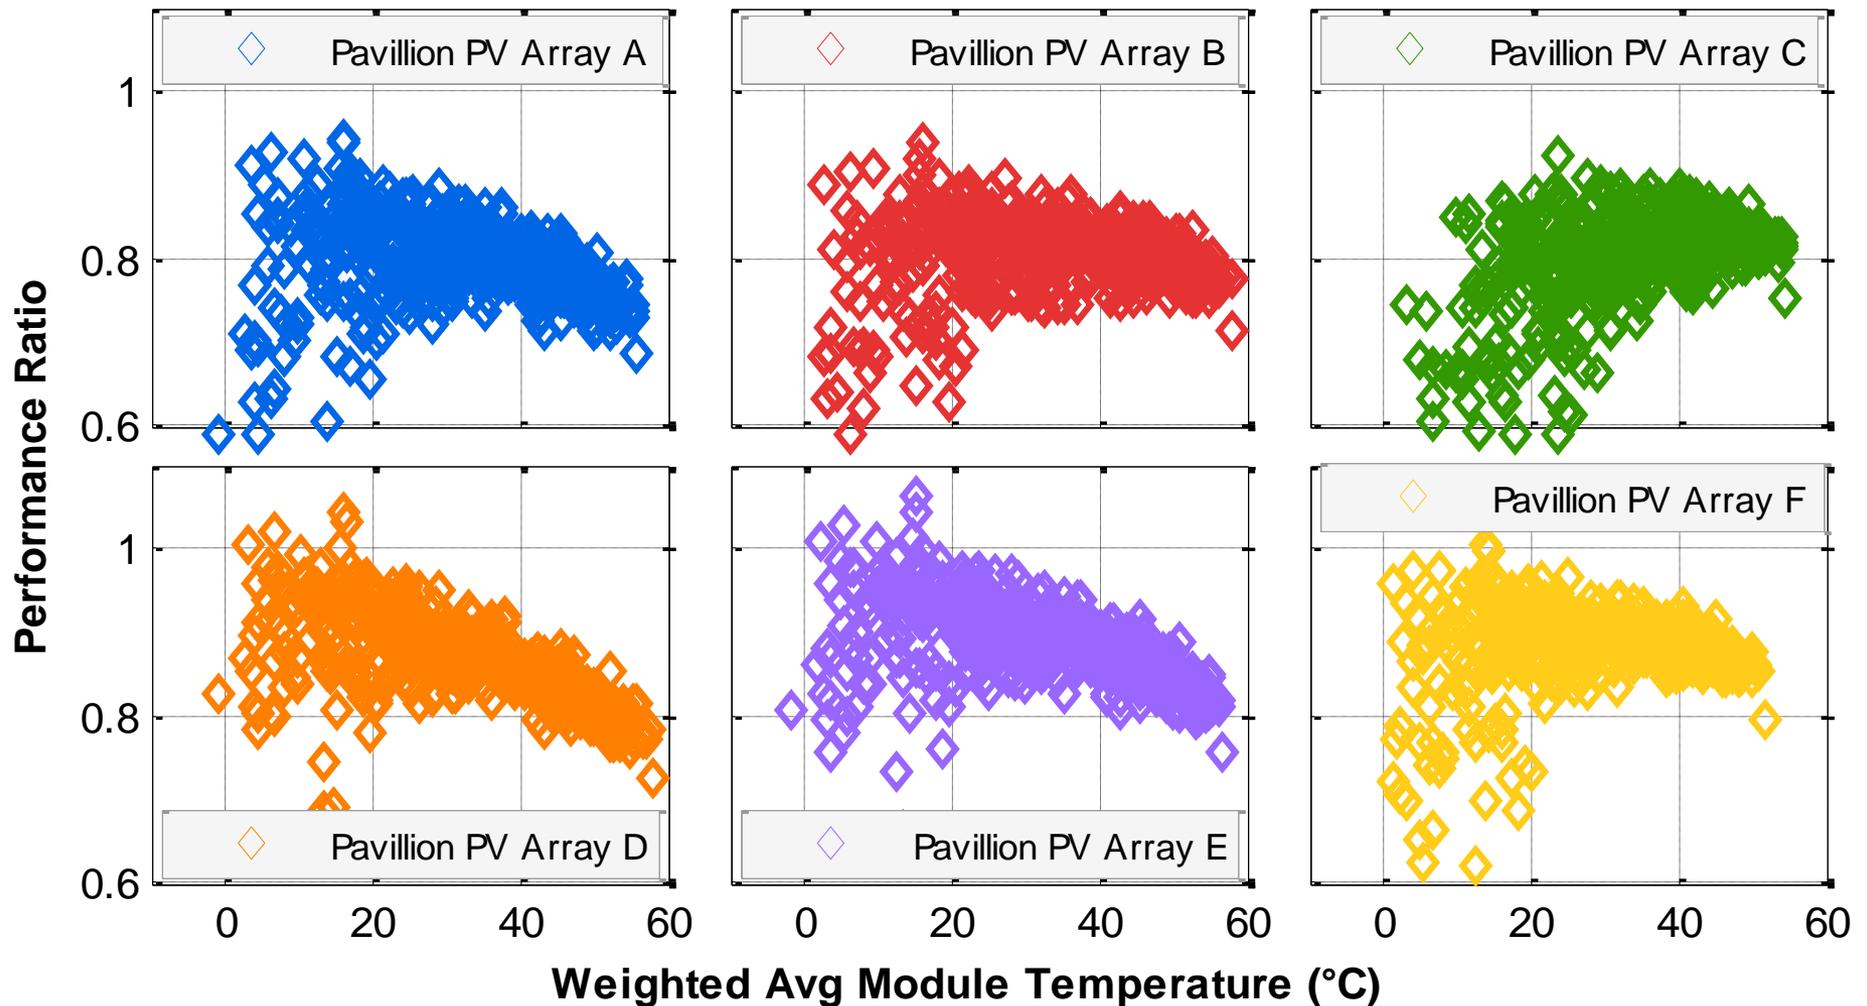
Daily Performance Ratio vs. Temperature, Oct 2012-Dec 2013

Pavillion Systems

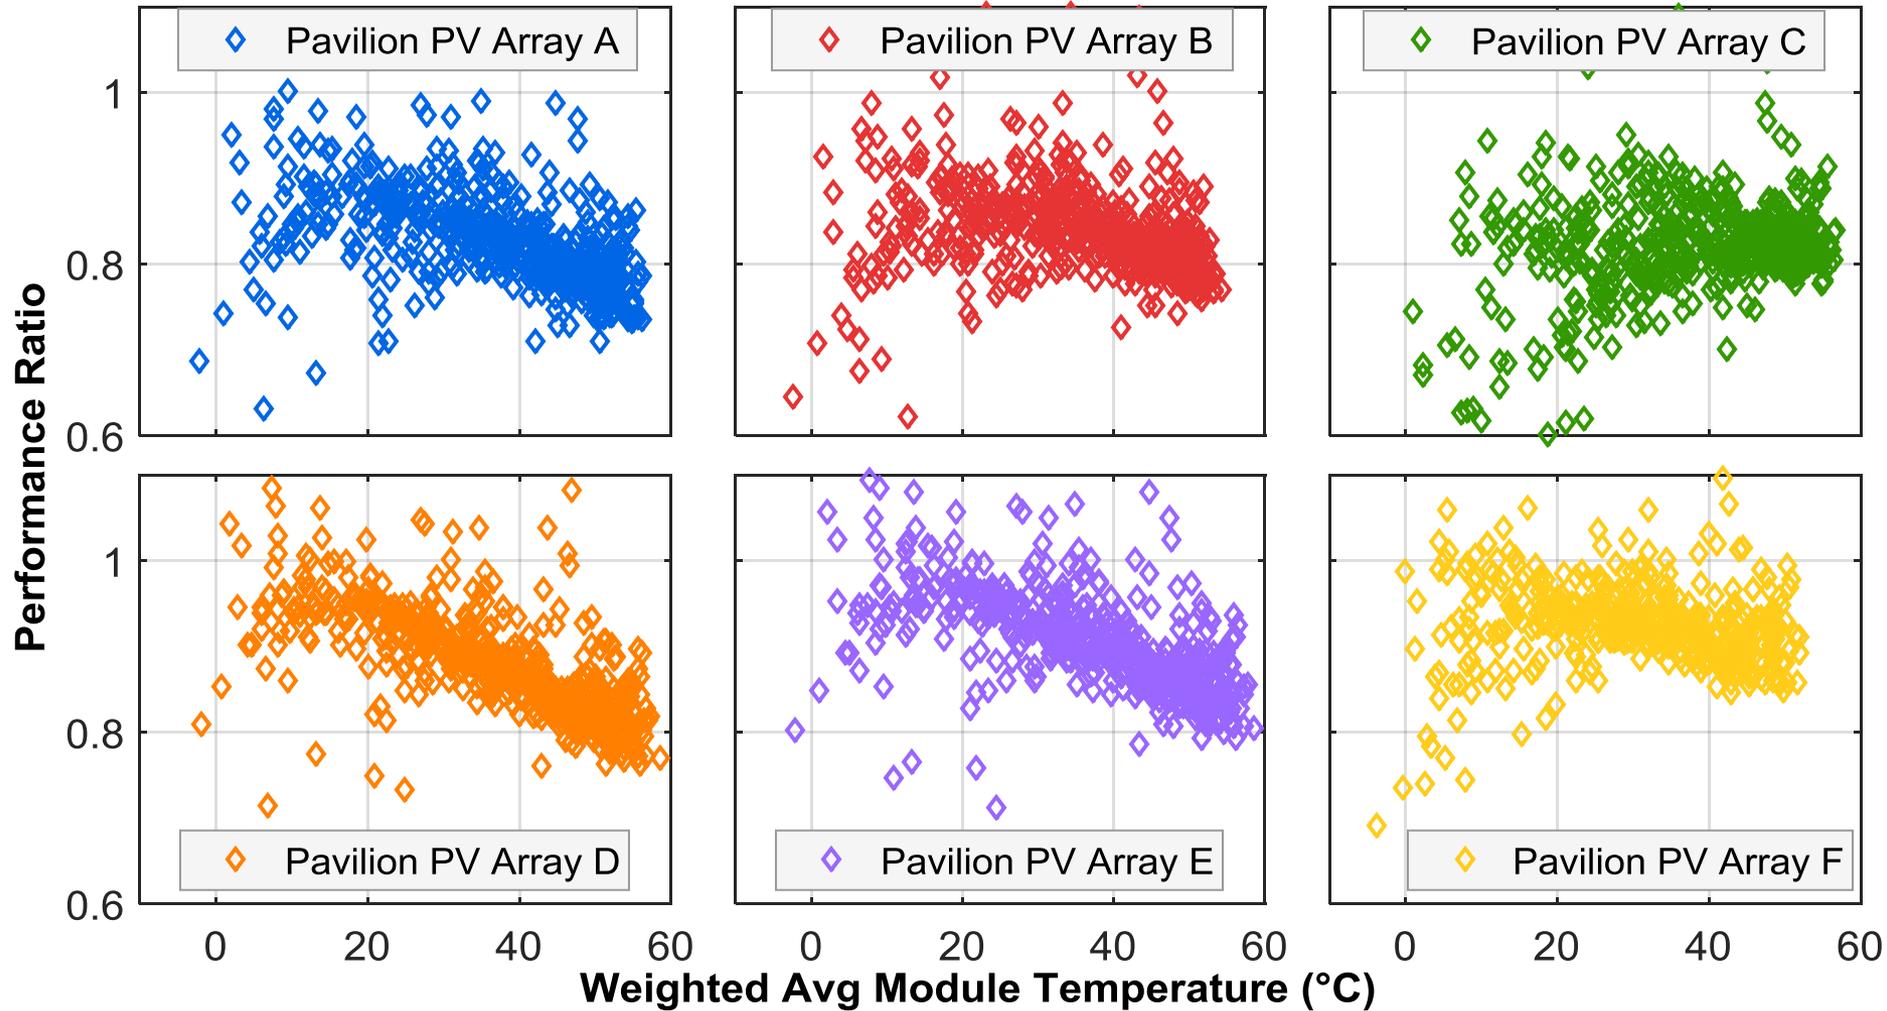
Daily Performance Ratio vs. Temperature, 2014-Sep 2015

Pavilion Systems

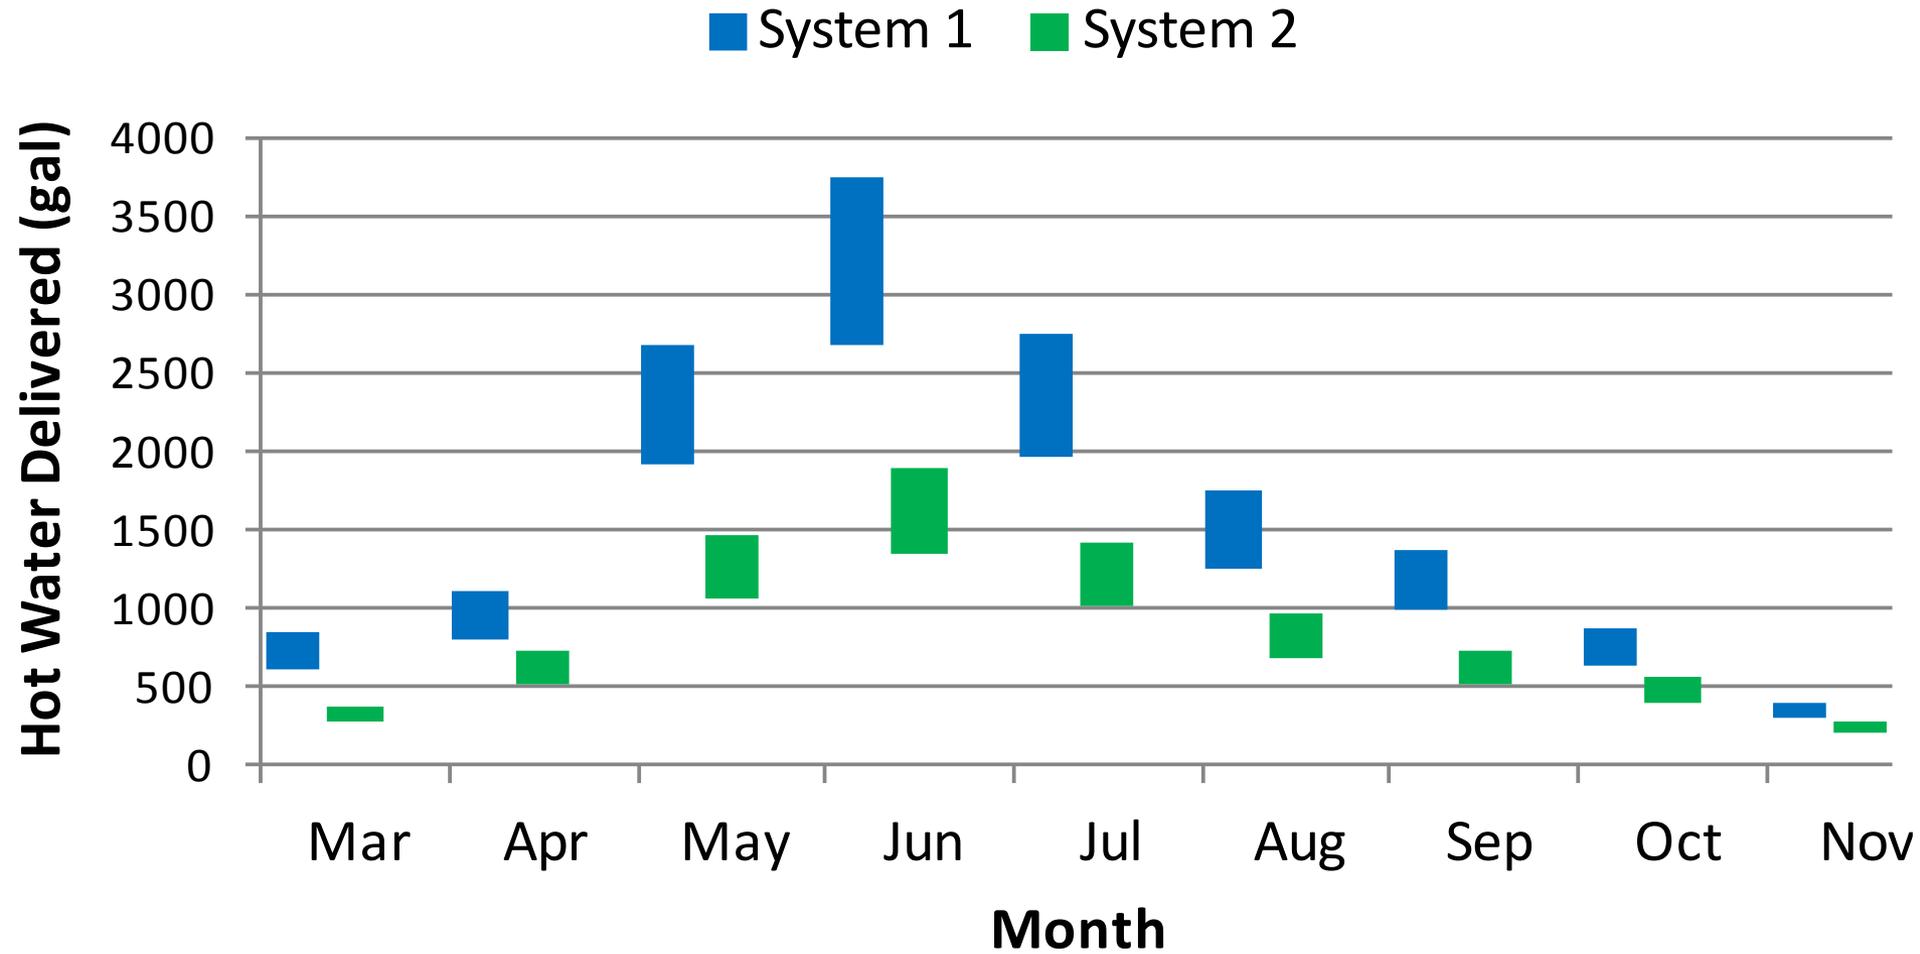
Monthly Hot Water Delivered

For 2012 camping season, colored bars show estimated volume range

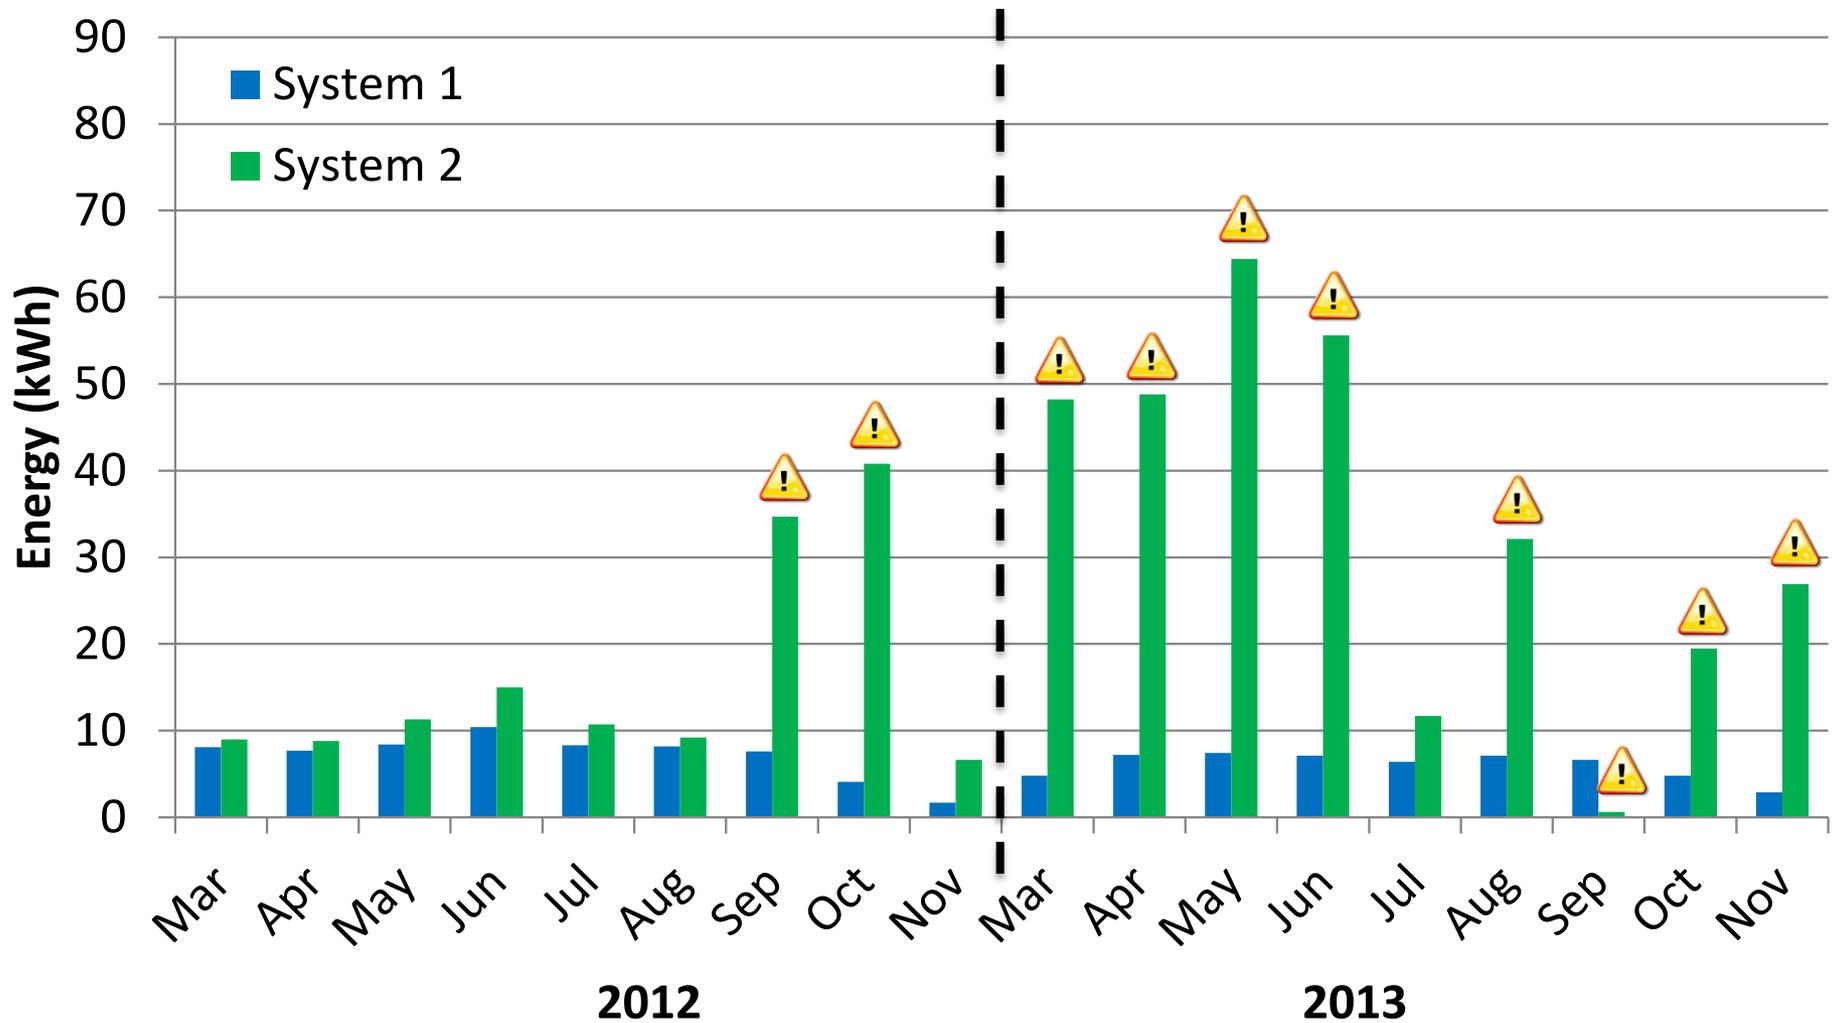
Circulation Pump Energy Consumption

By month, 2012-2013 camping seasons; unexpected energy for System 2

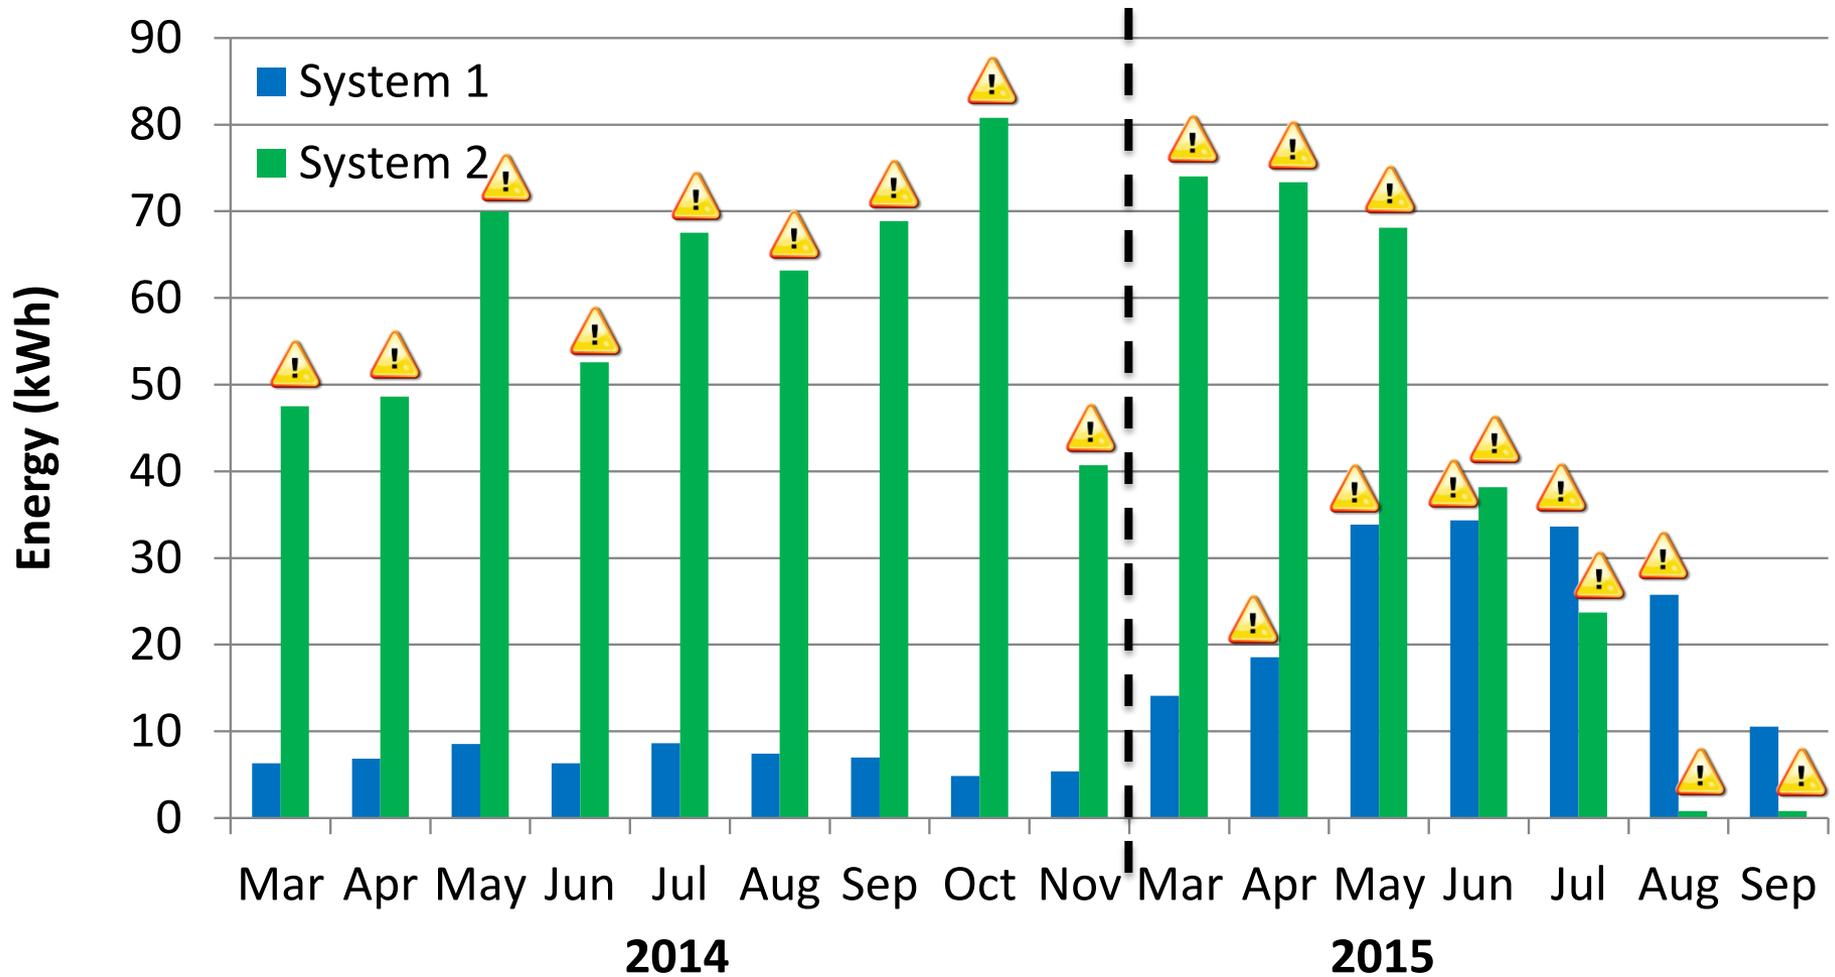
Circulation Pump Energy Consumption

By month, 2014-2015* camping seasons; unexpected energy for both systems**

** System 2 pump failed on 7/17/15; System 1 pump was turned off due to poor running condition 9/11/2015.
