TVA Melton Hill Dam Sustainable Recreation Area

Field monitoring and analysis of renewable and efficient technologies

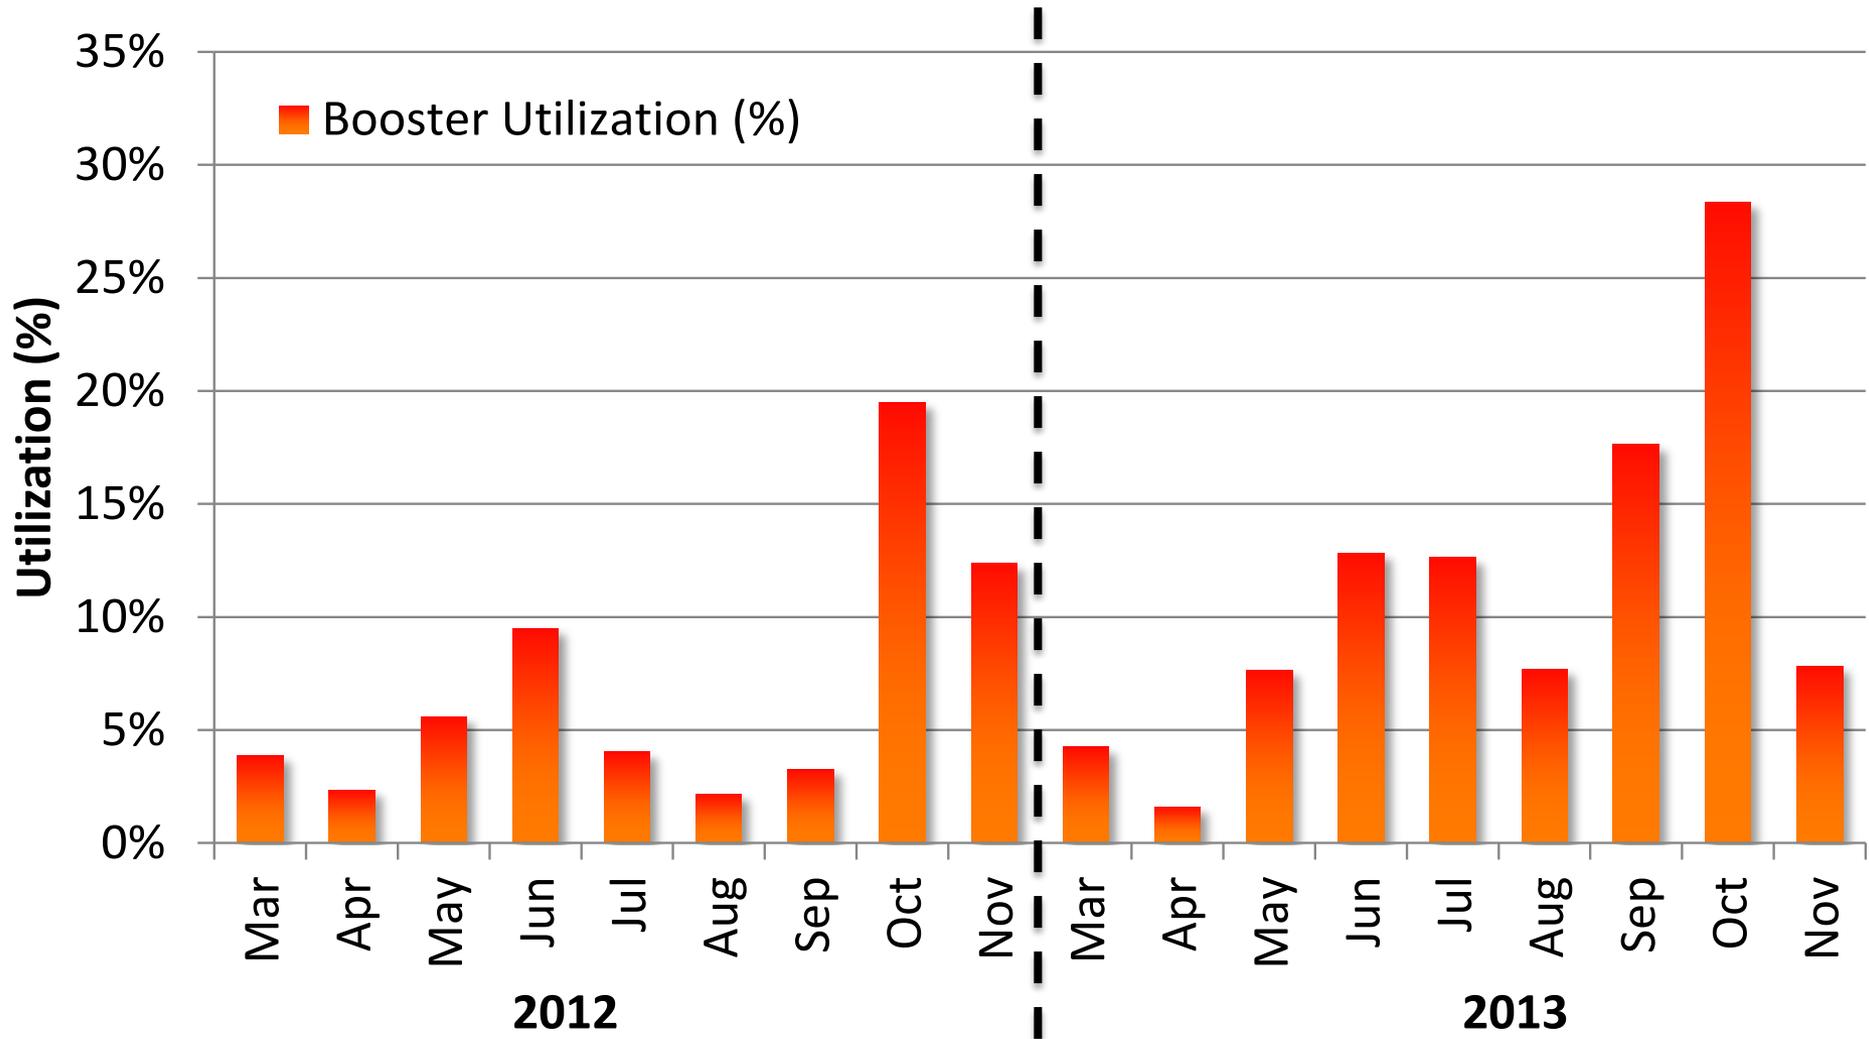
Booster Heater Utilization, 2012-2013

Tankless; percentage of time resistive element "on" during water flow

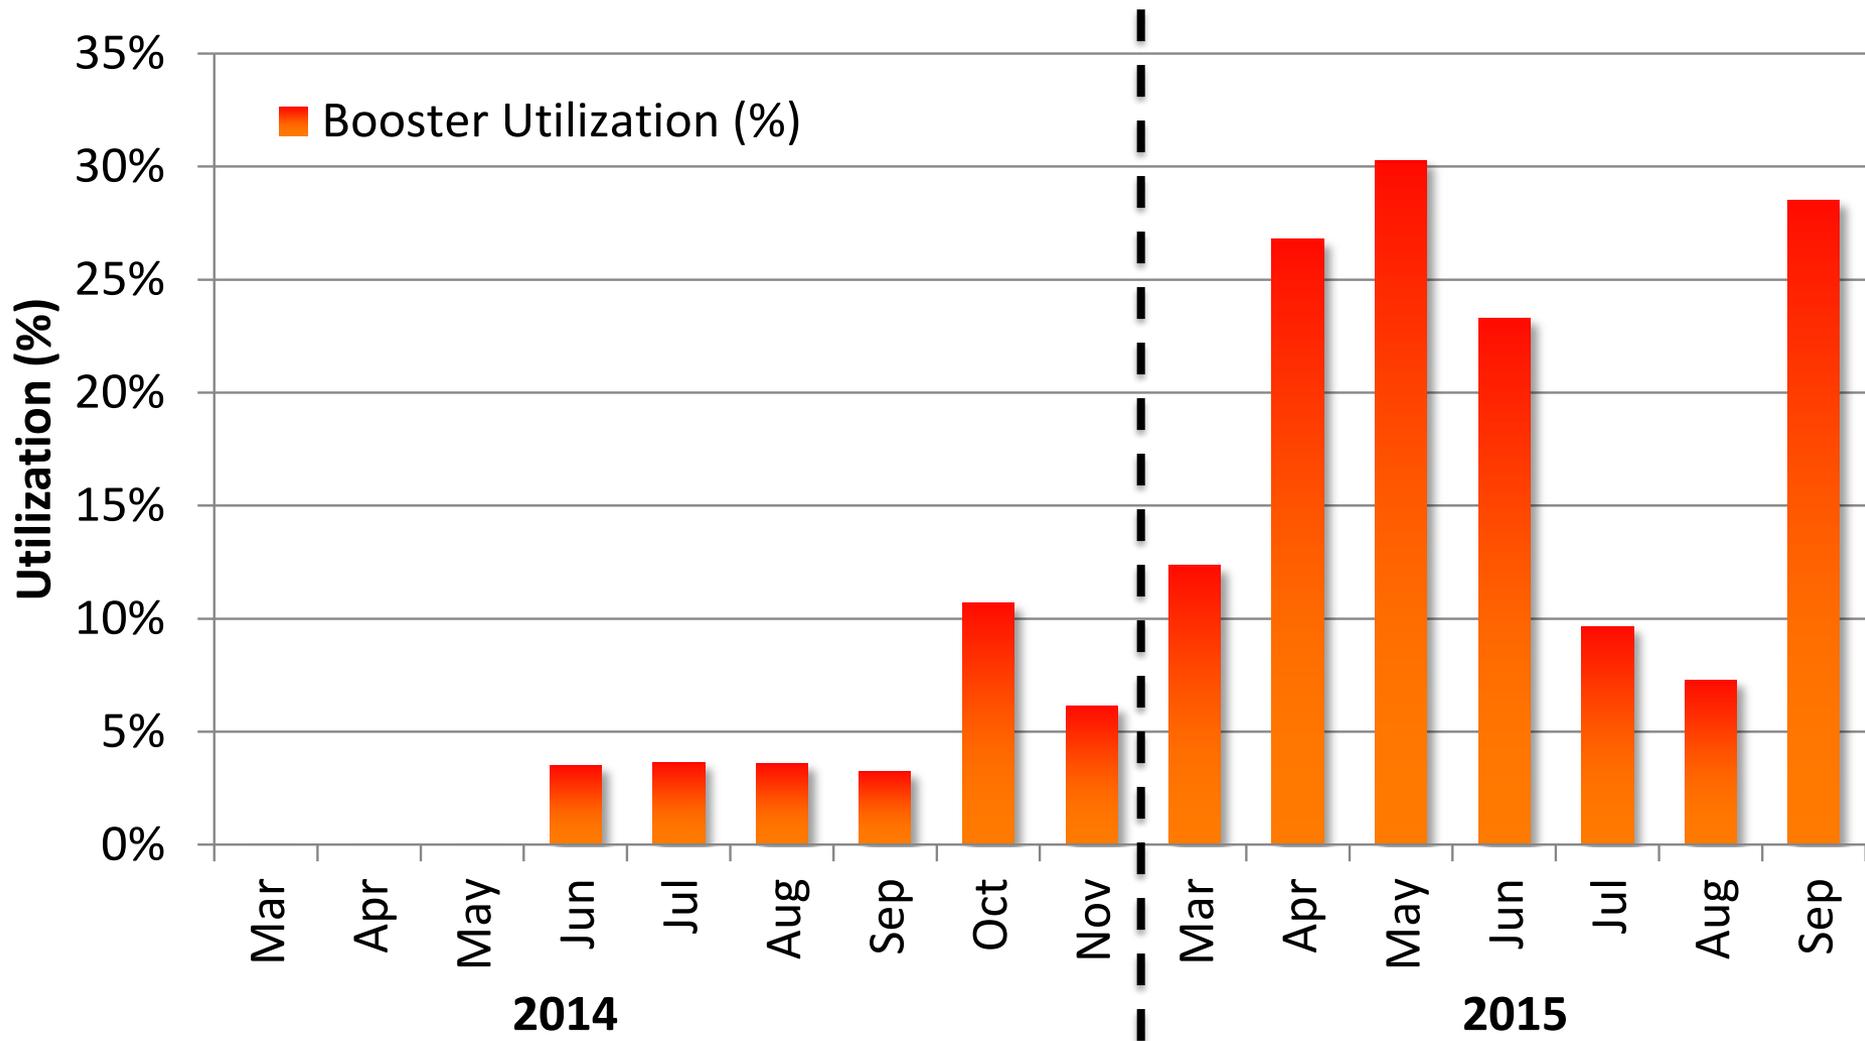
Booster Heater Utilization, 2014-Sep 2015

Tankless; percentage of time resistive element "on" during water flow

Note: System 2 pump failed on 7/17/15, and System 1 pump was turned off due to poor running condition 9/11/2015.

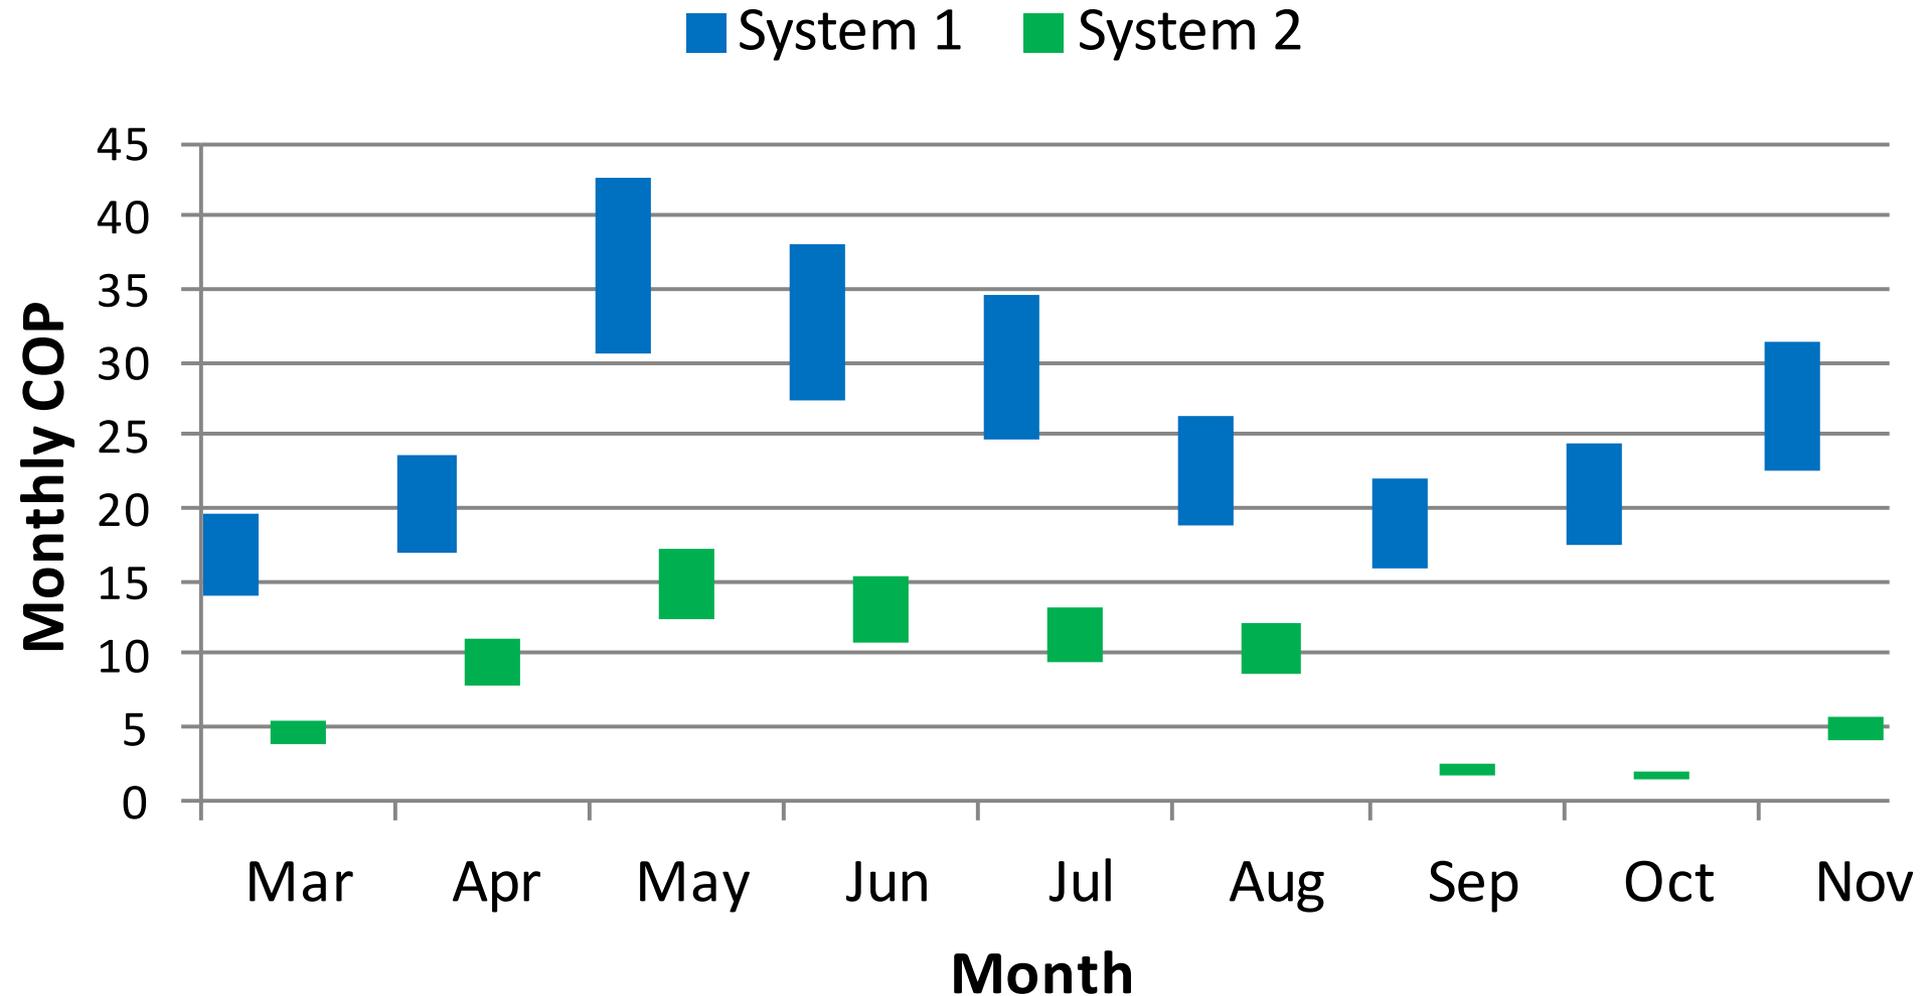
Monthly Coefficient of Performance

For 2012 camping season, colored bars show estimated COP range

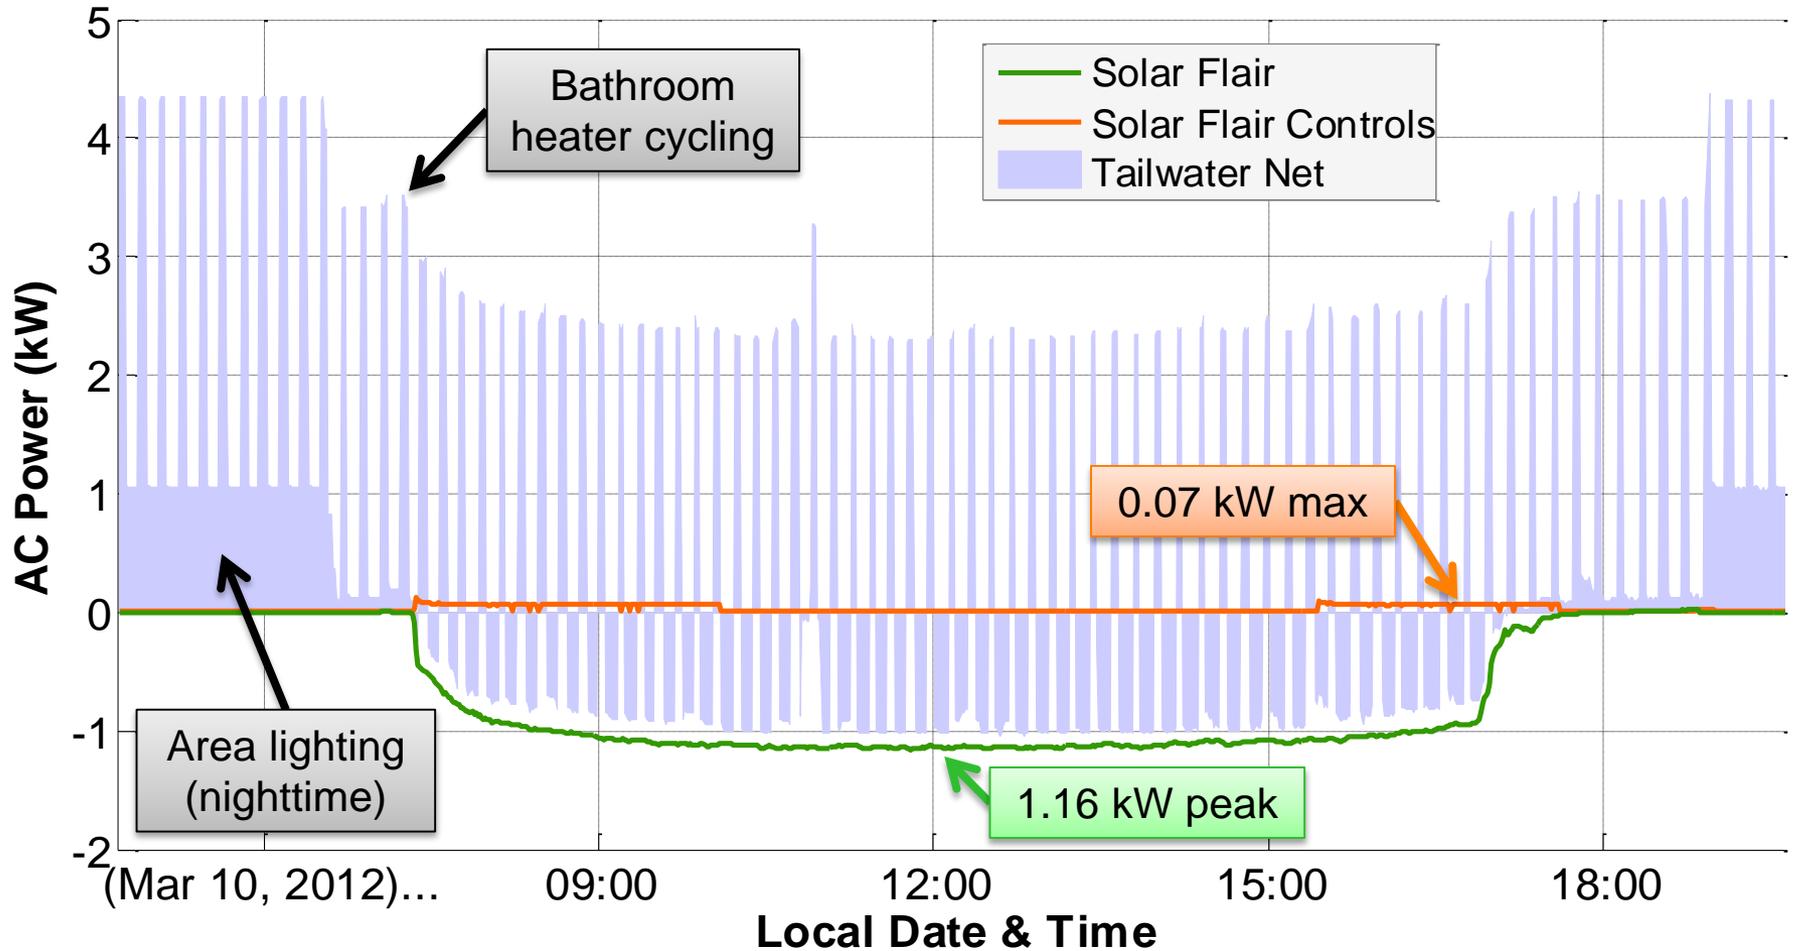
Power Profile: Tailwater Area

Sunny day, but no electric vehicle charging

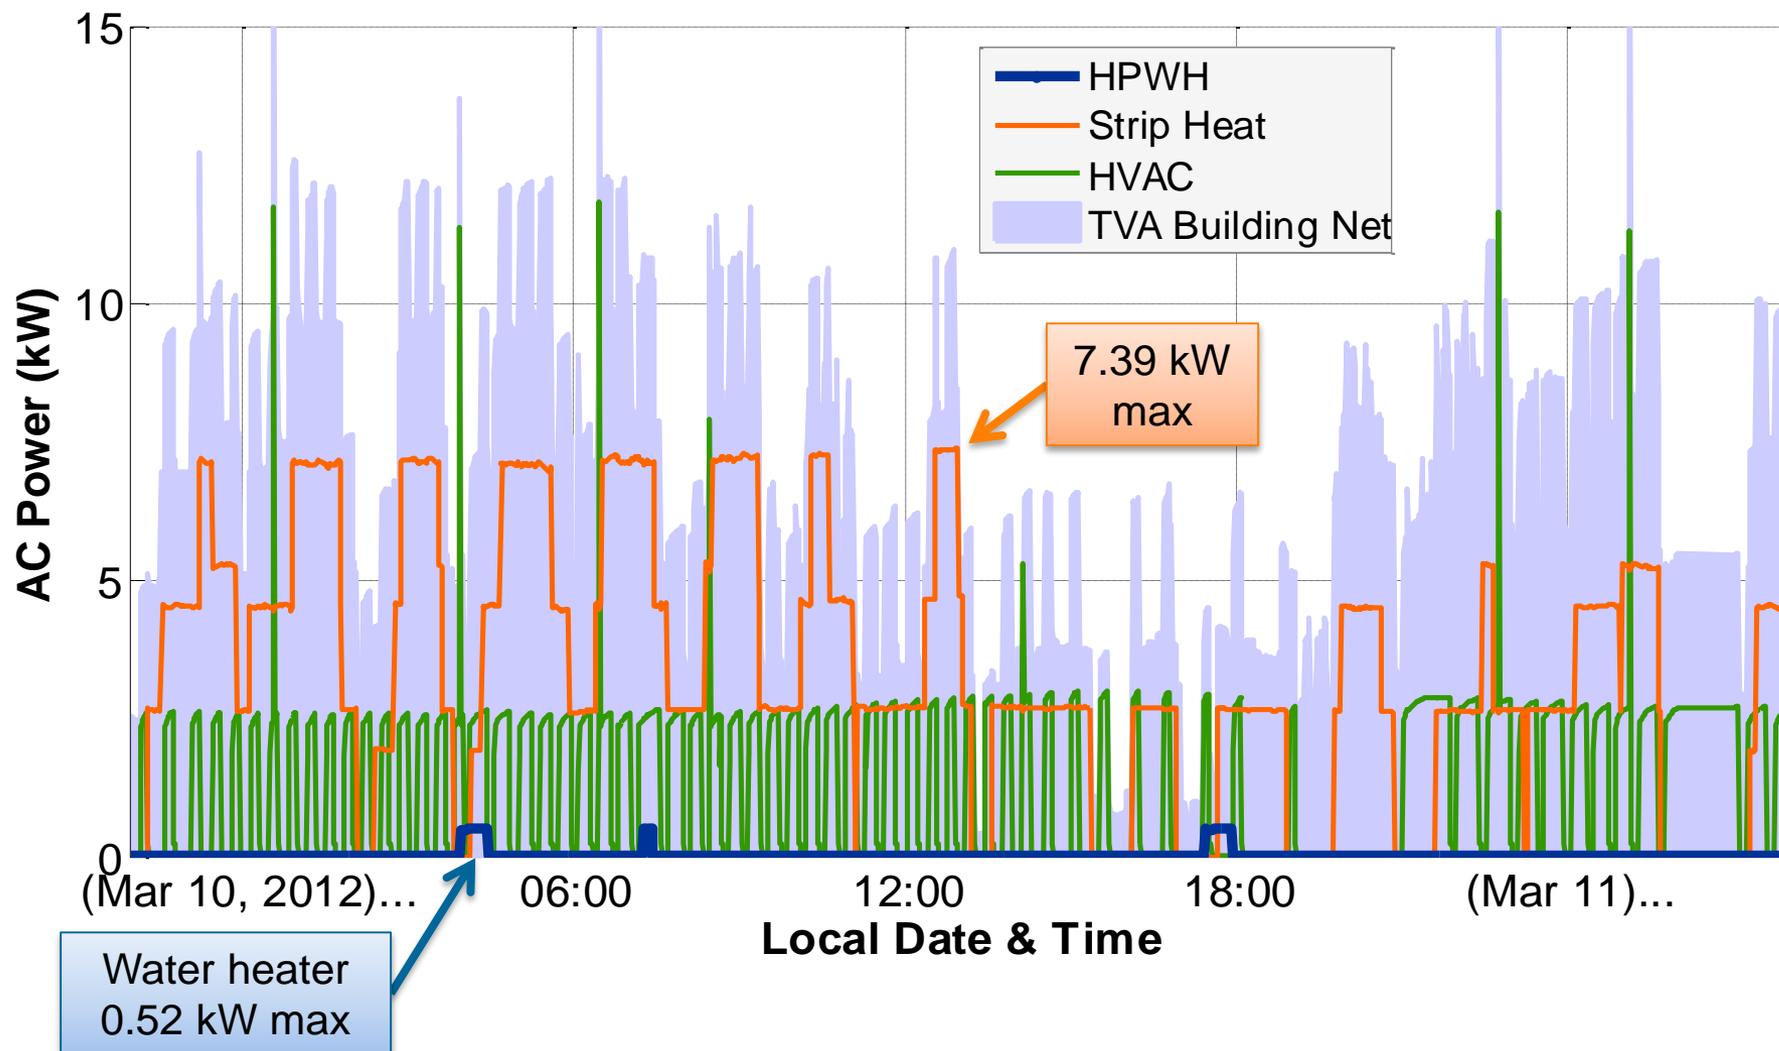
Power Profile: TVA Building at Overlook

Space conditioning systems dominate; minimal hot water usage

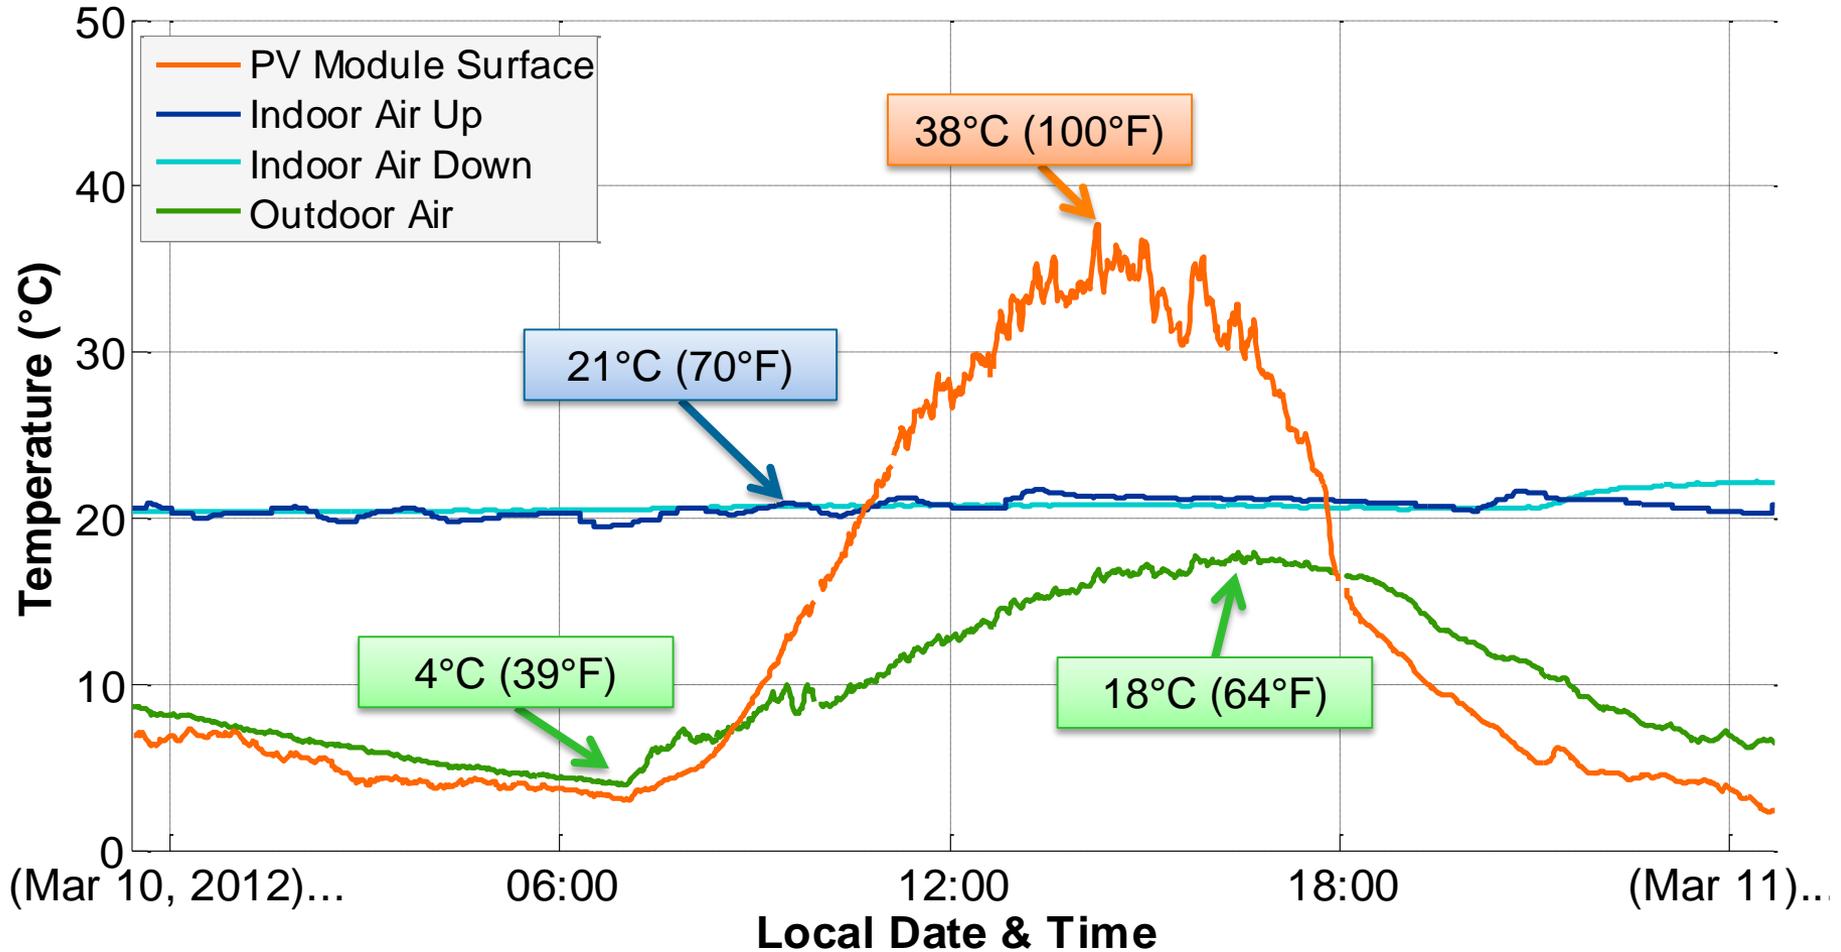
Temperature Profile at Overlook

Inside TVA building and at pergola PV system

PV module surface temperature measured on back side of module via surface-mount thermistor

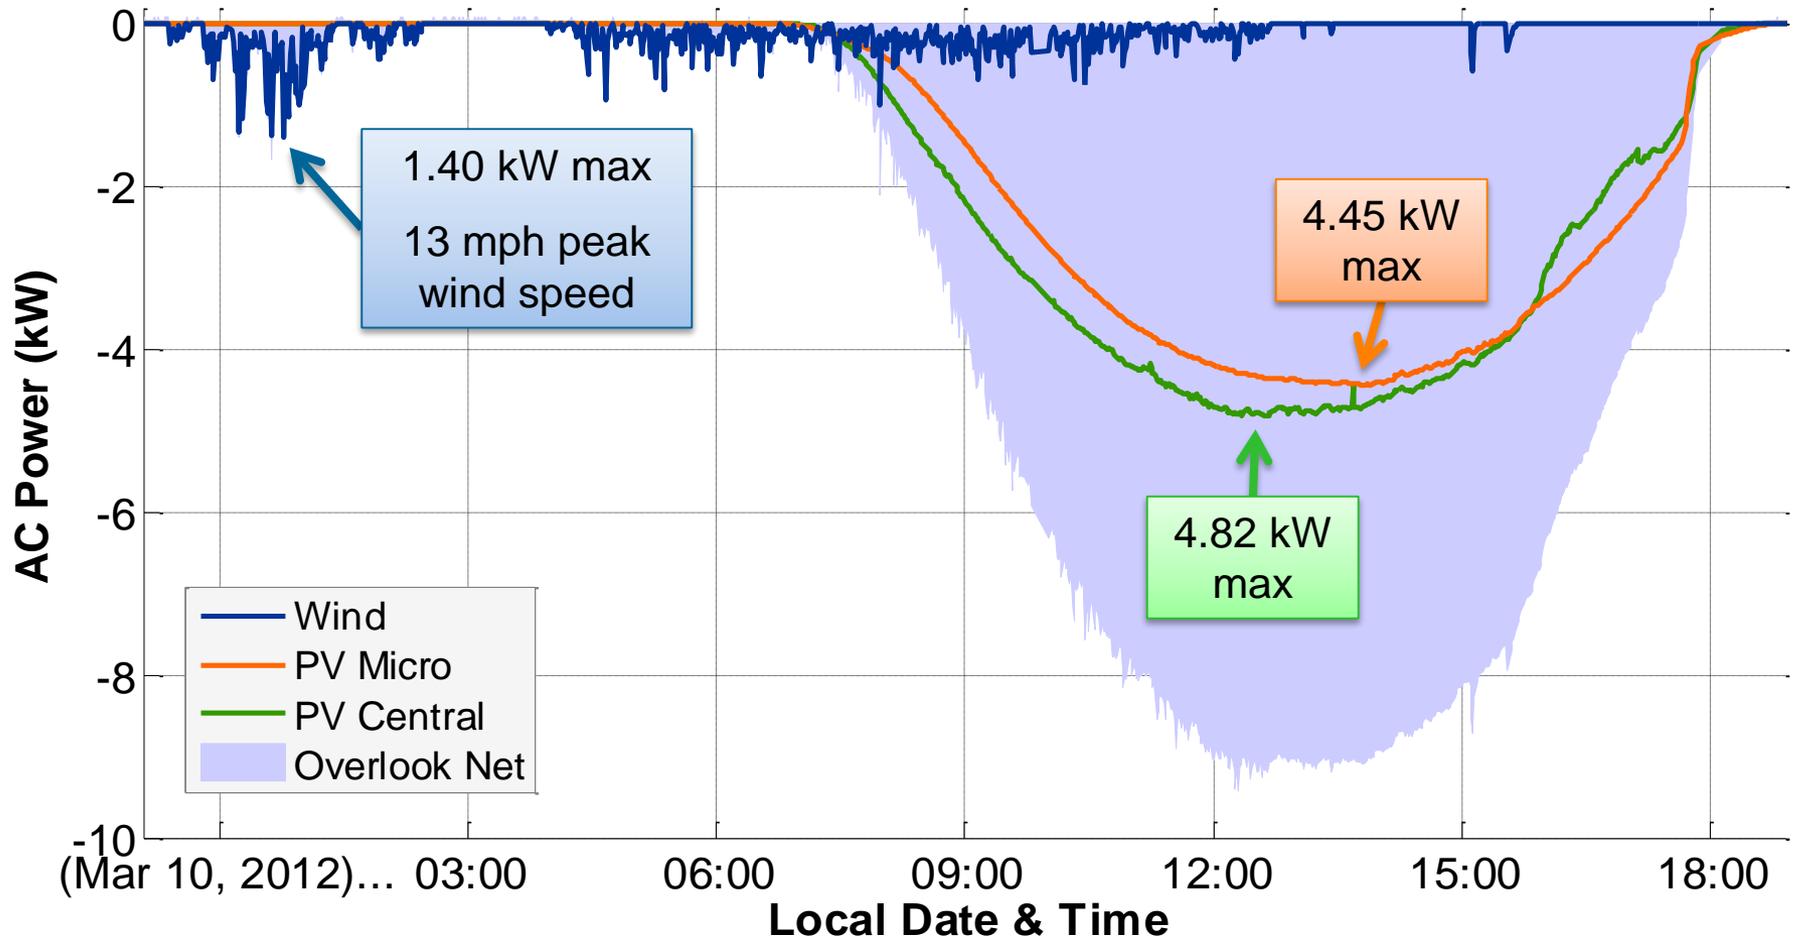
Power Profile: Overlook Renewables

Sunny day with some wind overnight, but no EV charging

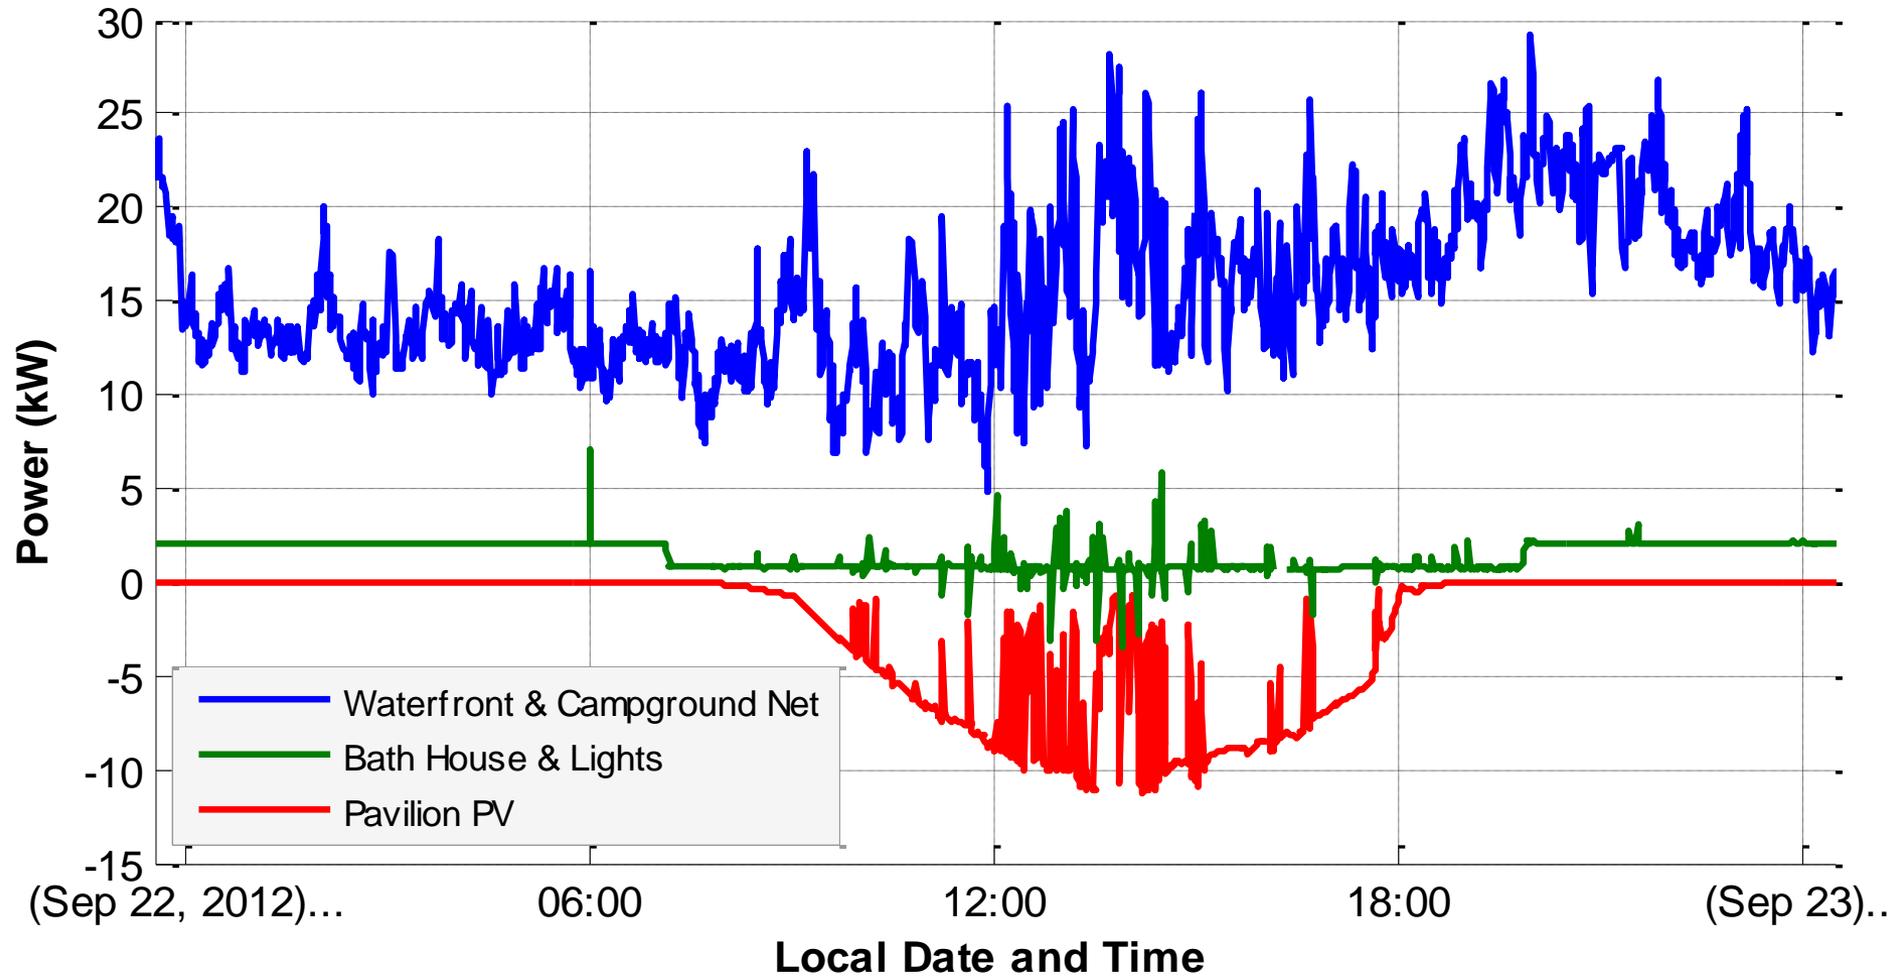
Power Profile: Campground Area with PV

Sep 22, 2012 – partly cloudy day; active campground usage

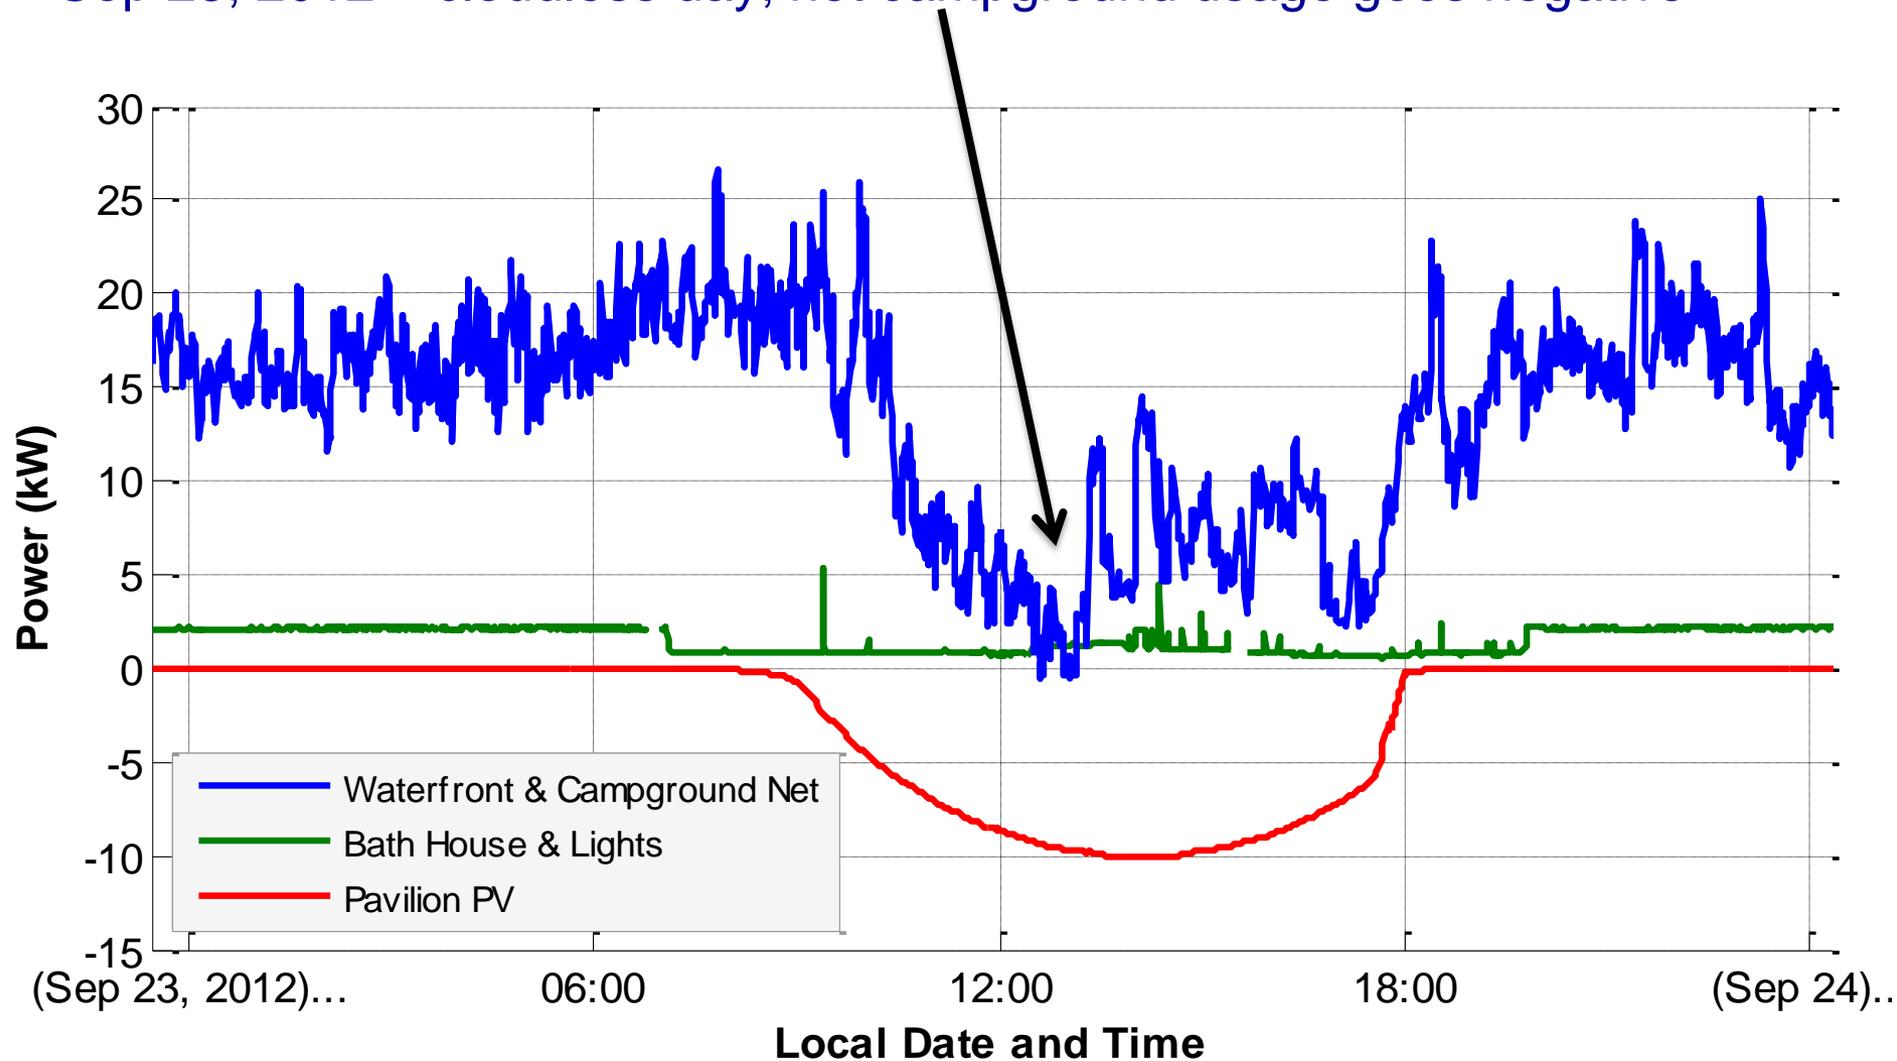
Power Profile: Campground Area with PV

Sep 23, 2012 – cloudless day; net campground usage goes negative

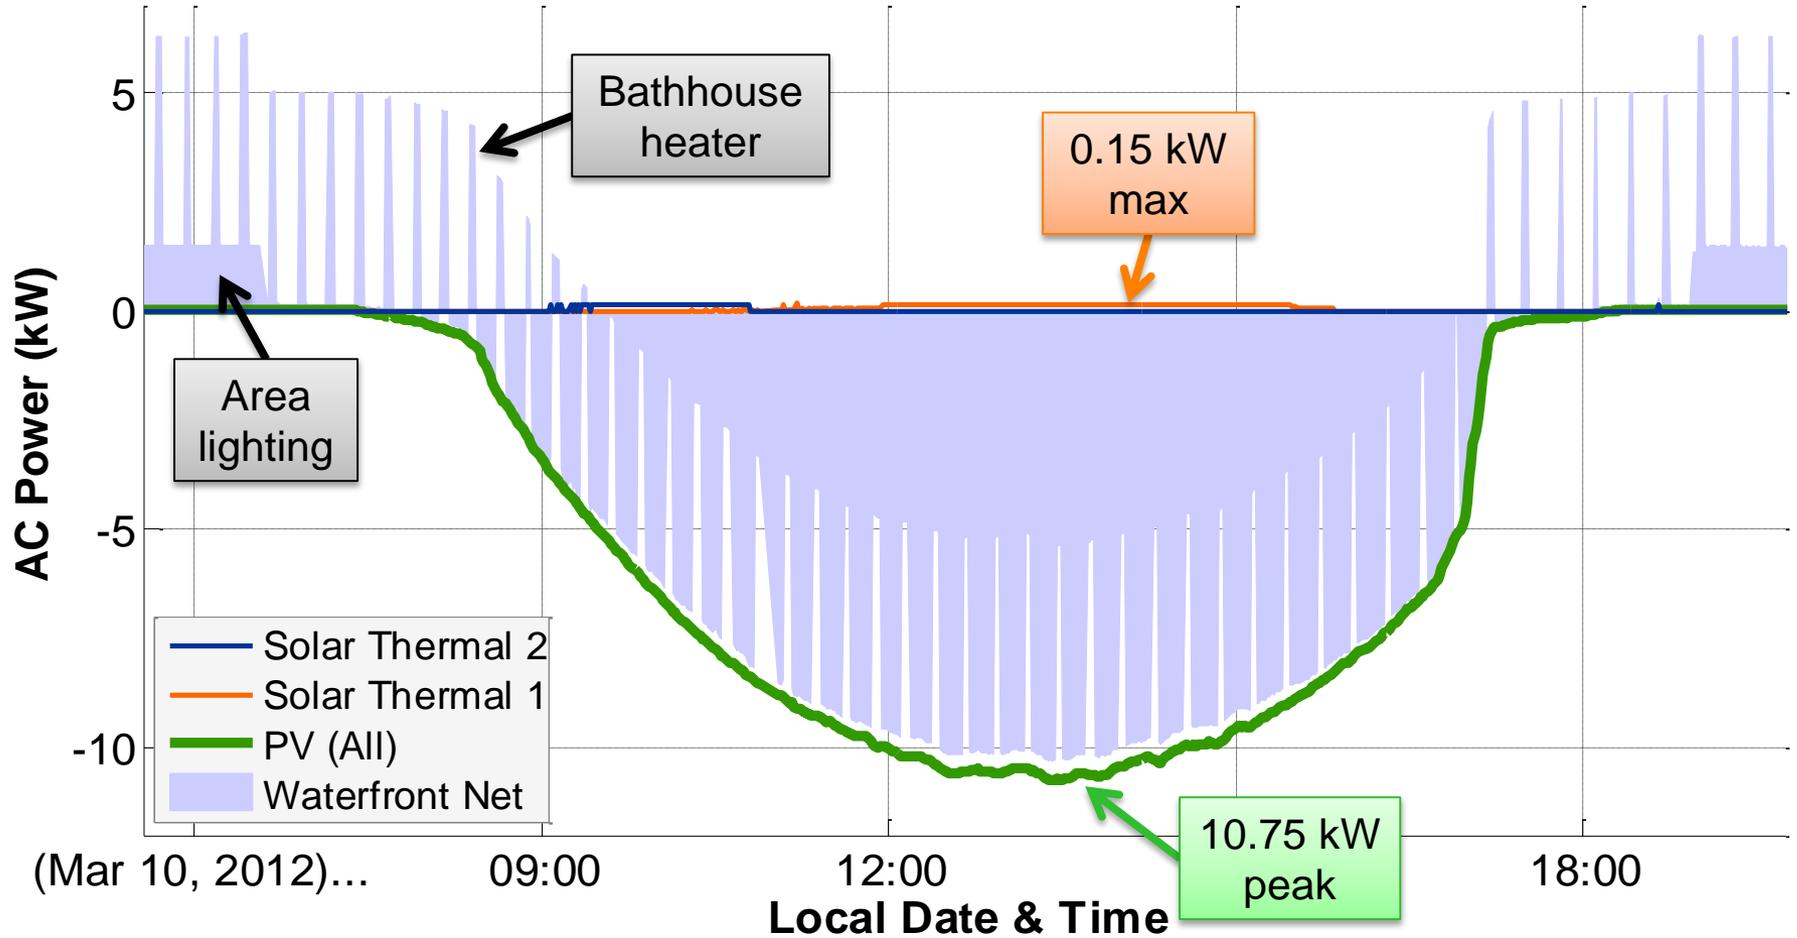
Power Profile: Bathhouse & Pavilion

Sunny day, no backup needed for solar thermal water heating

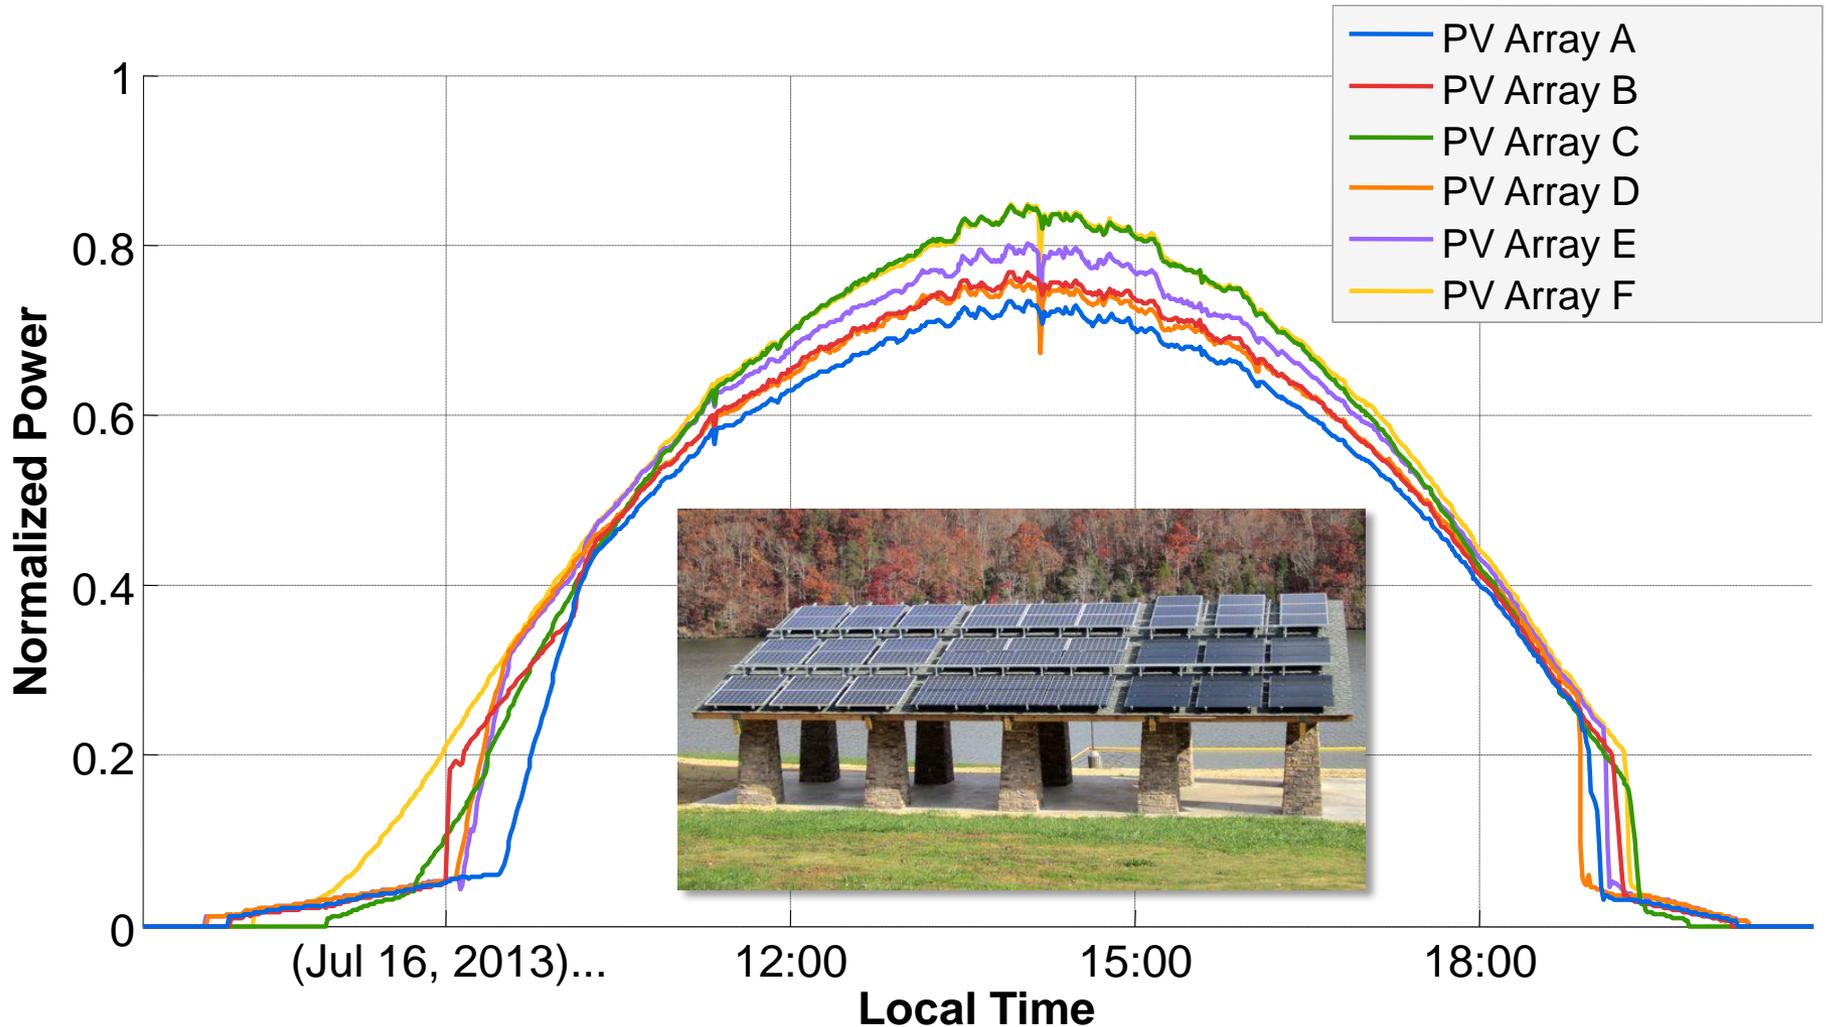
Power Profiles at Pavilion: Clear Day

July 16, 2013 – cloudless day; noticeable divergence in midday powers

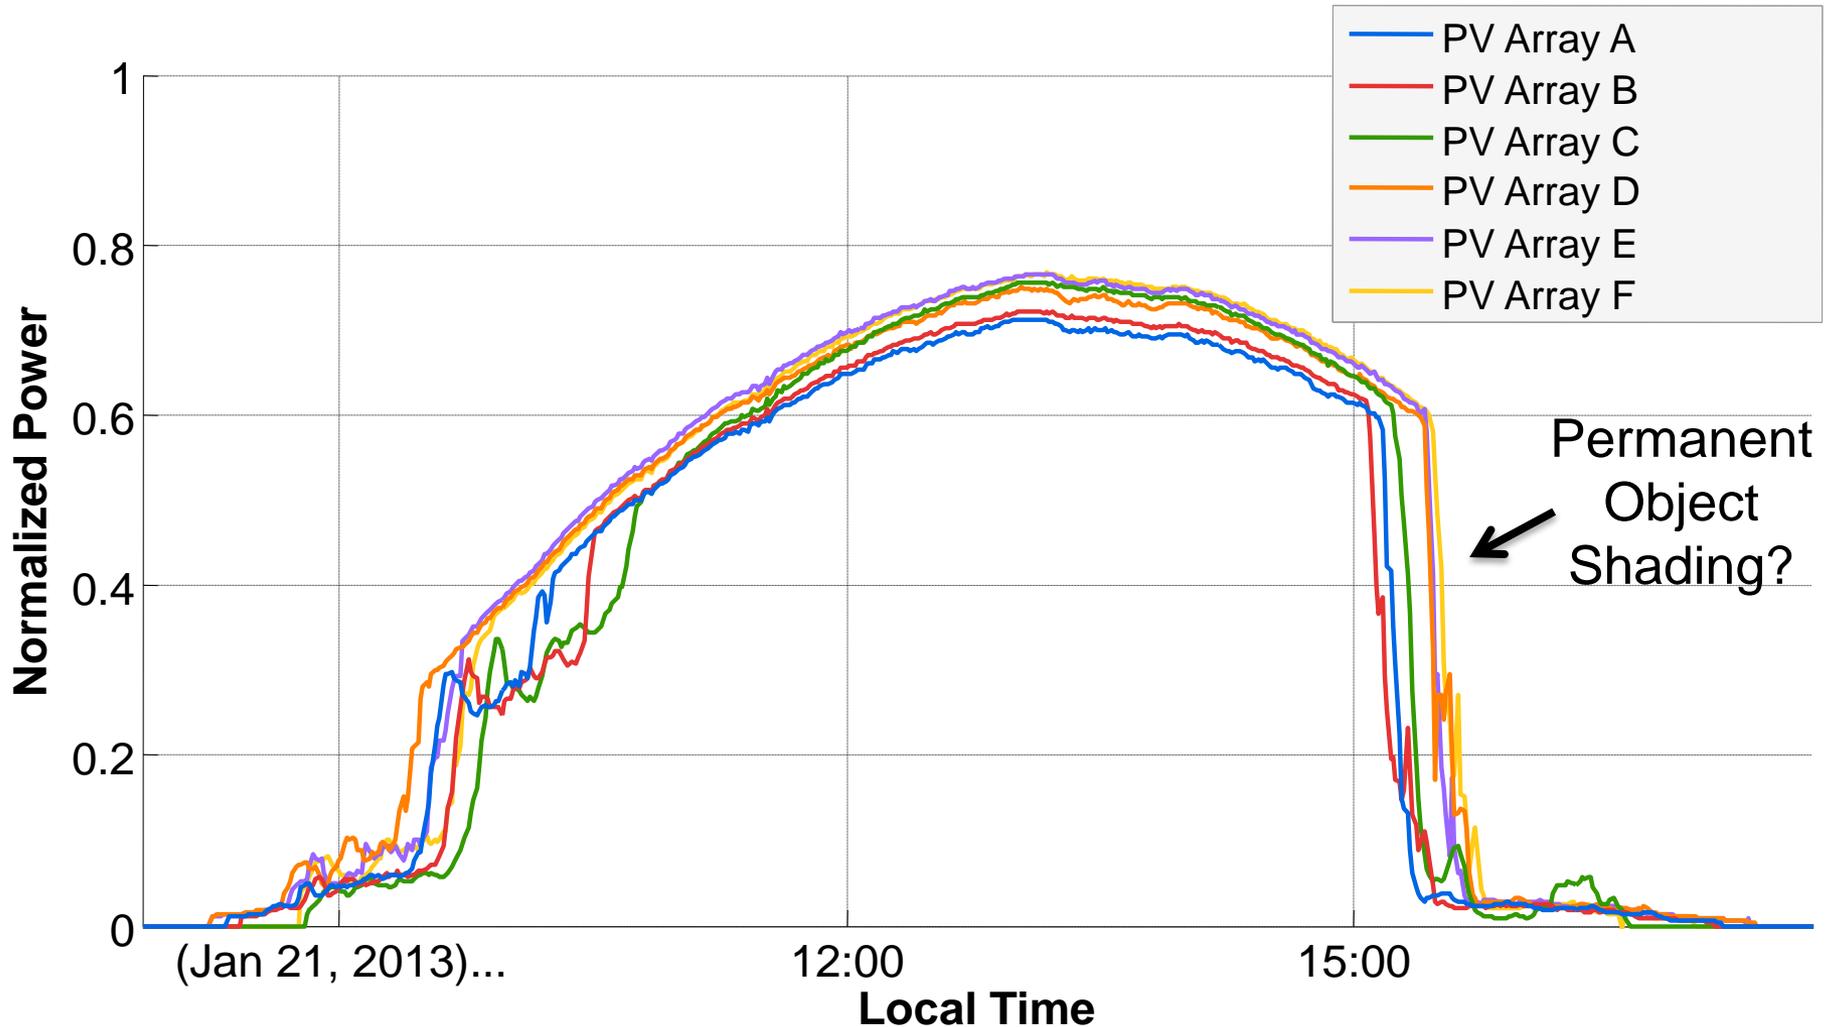
Power Profiles at Pavilion – Shading

Jan 21, 2013 – cloudless day; afternoon shading is prevalent on Pavilion
