TVA Melton Hill Dam Sustainable Recreation Area

Field monitoring and analysis of renewable and efficient technologies

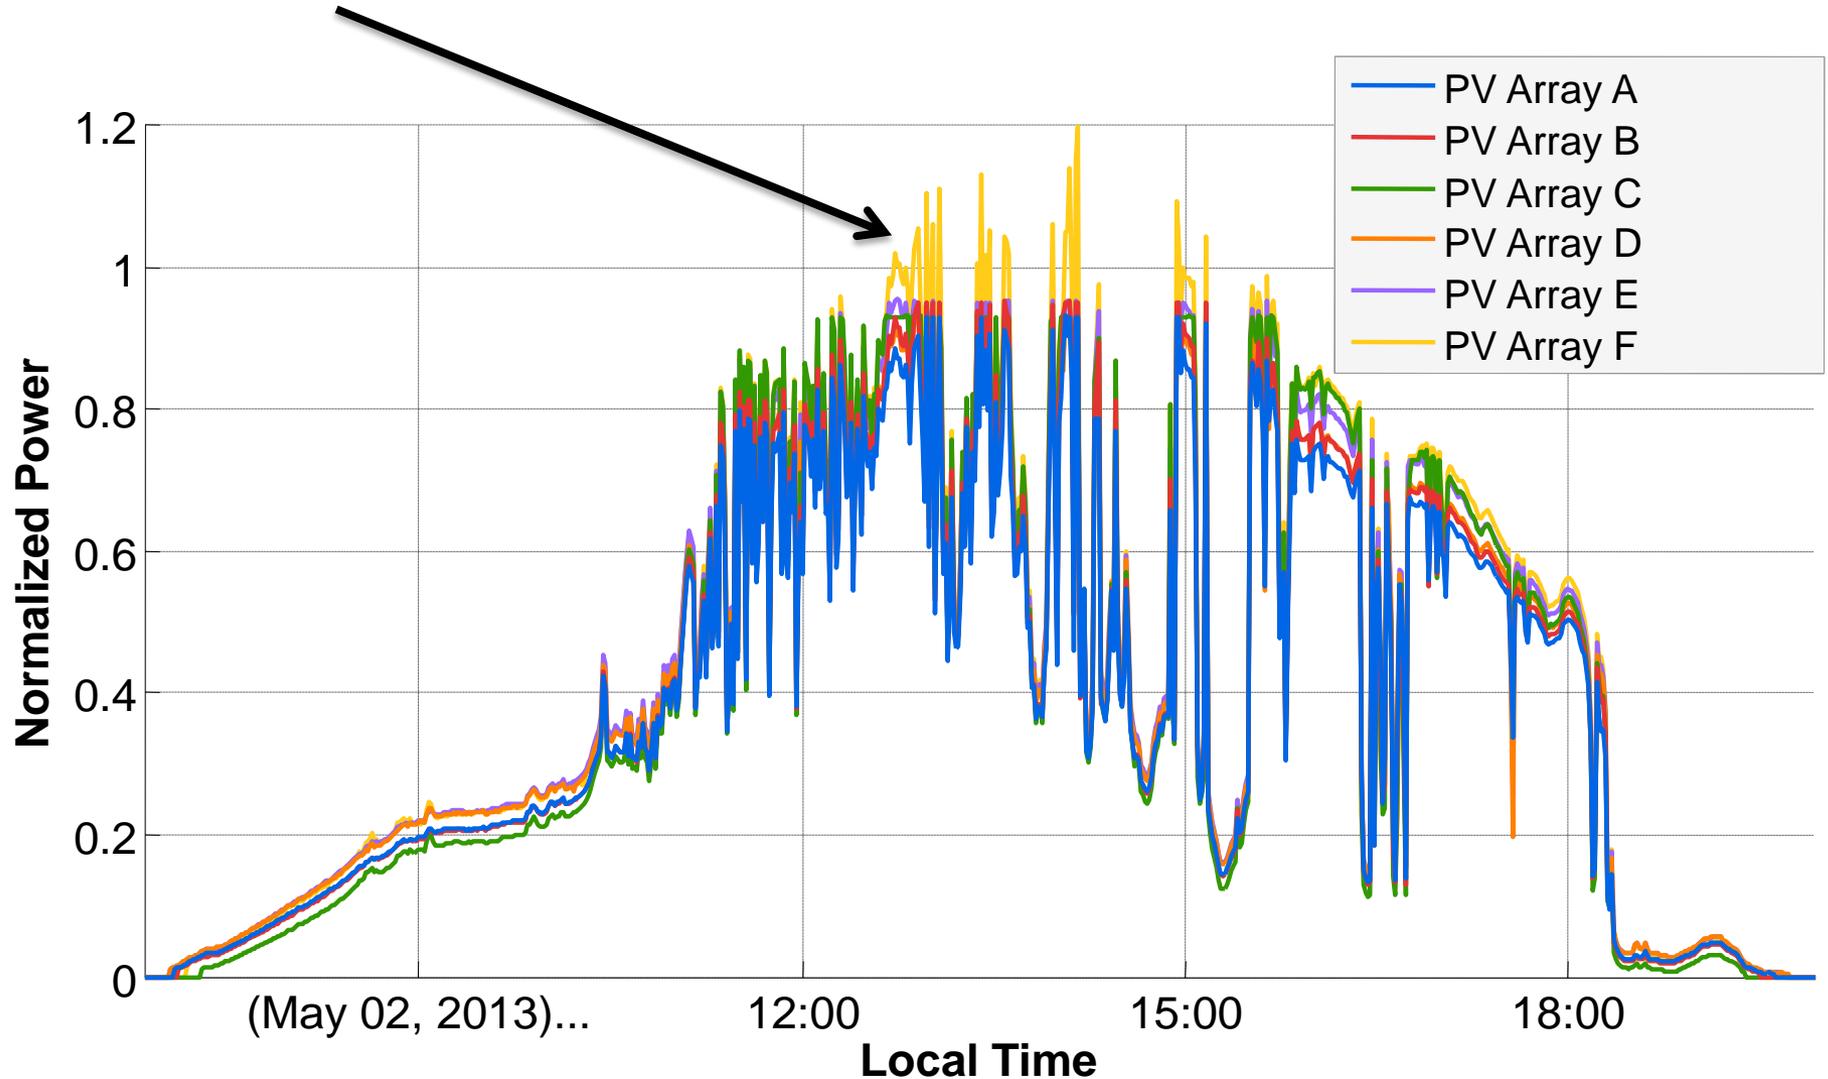
Power Profiles at Pavilion – Enhancement

May 2, 2013 – Pavilion Array F shows increased output, likely from cloud enhancement, because it is undersized relative to inverter (unlike others)

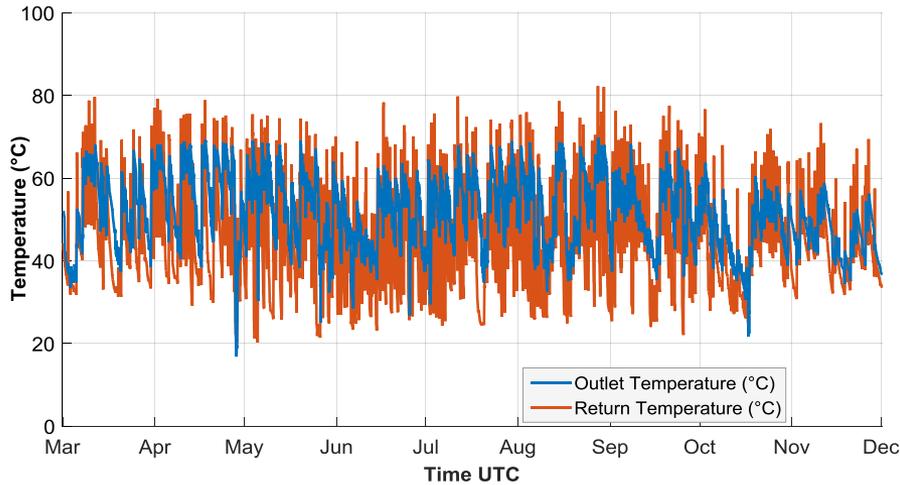
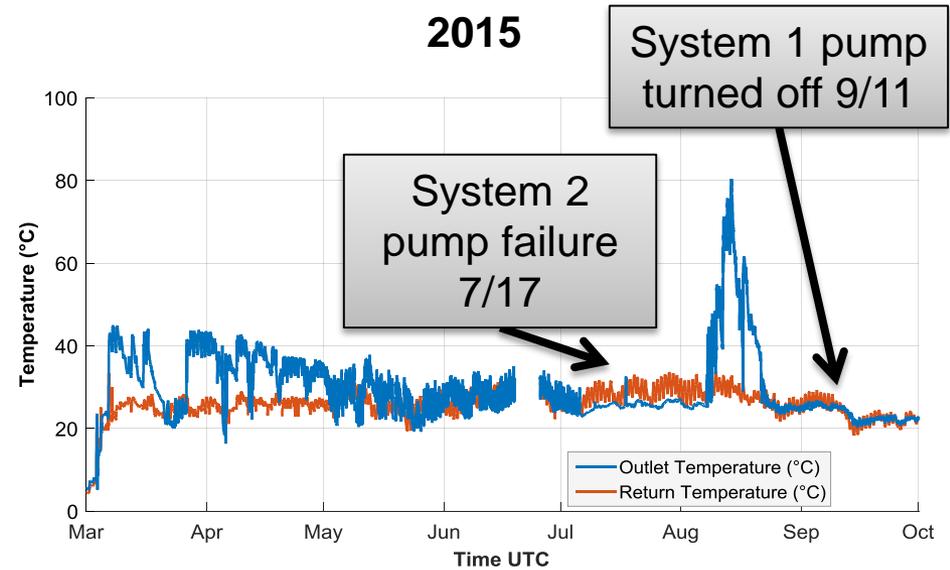
Power Profile: Bathhouse Solar Thermal Water Heating System 1 outlet & return temperatures, 2014 & 2015* camping seasons

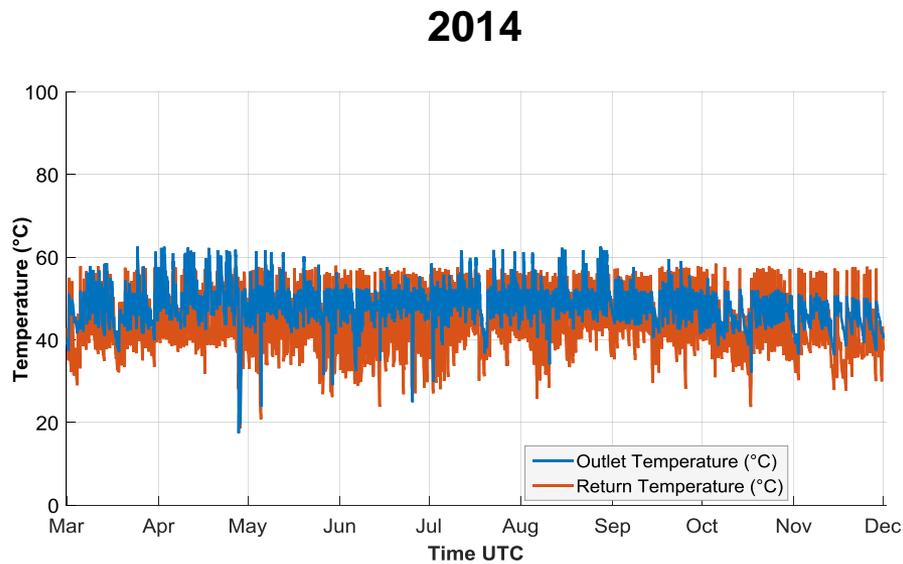
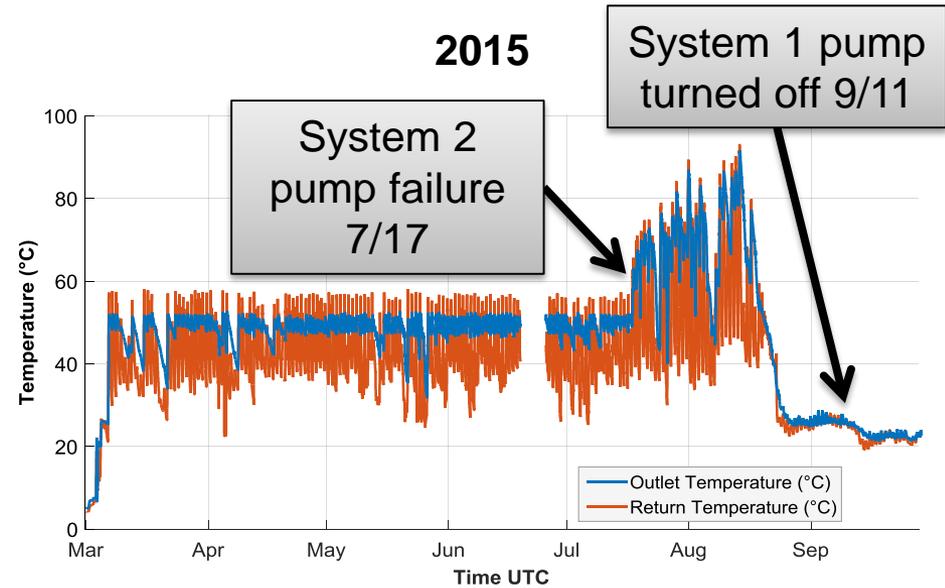
Power Profile: Bathhouse Solar Thermal Water Heating System 2 outlet & return temperatures, 2014 & 2015* camping seasons

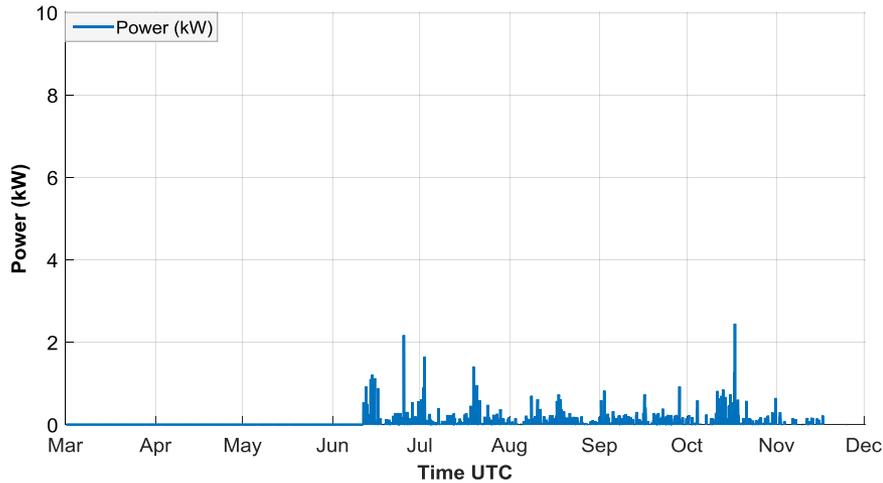
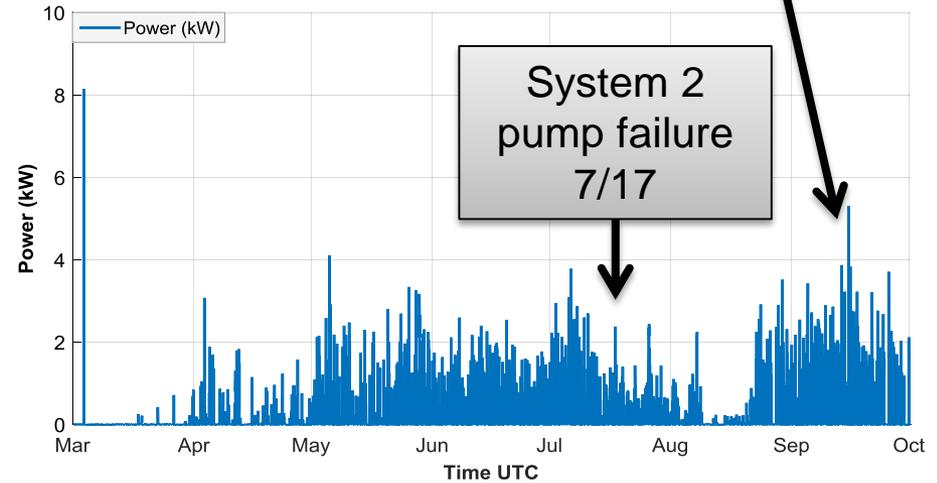
Power Profile: Bathhouse Solar Thermal Water Heating

Tankless water heater power, 2014 & 2015* camping seasons
