Agreement Log #: KRP-11-008

Non-Time-Critical Concurrence

Area: The North Embayment Grids 7-G, 7-H, 7-J, 7-K, and 7-L

Area Photo Log and Representative Photos

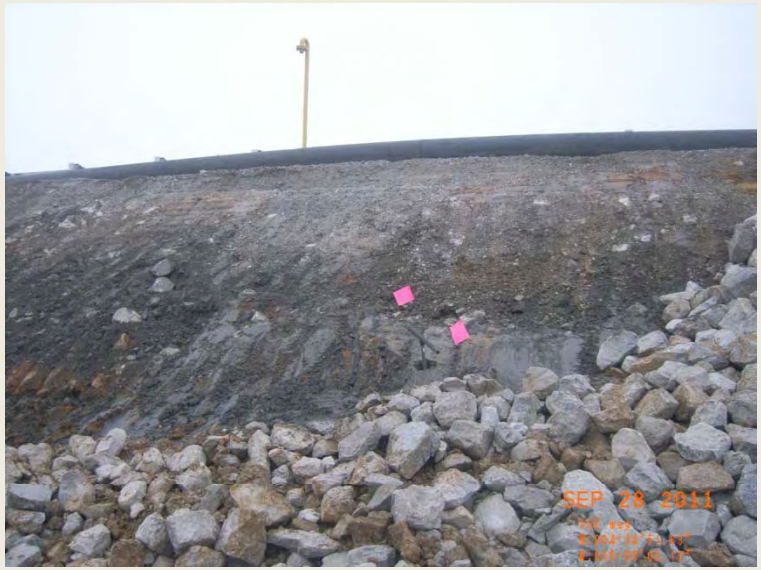
Slope cleaned to maximum safe steepness showing ash remaining

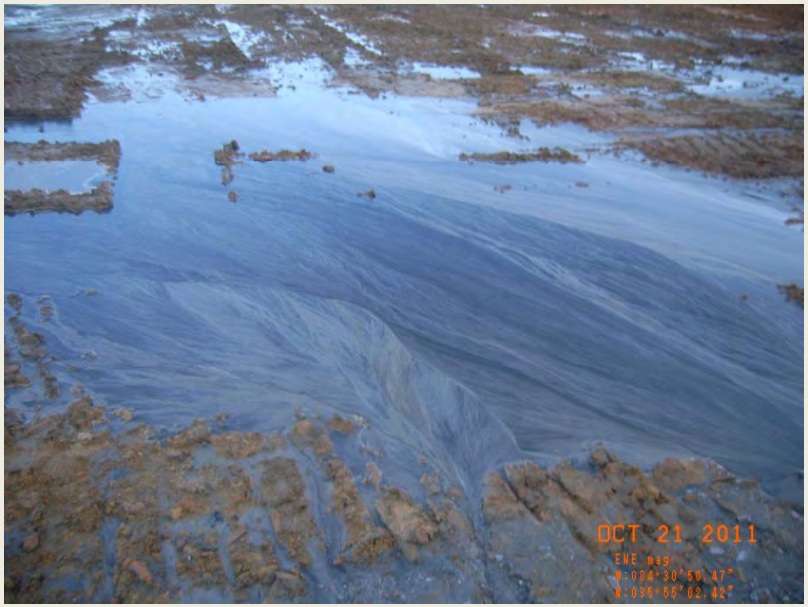
Ash seepage from toe of riprap

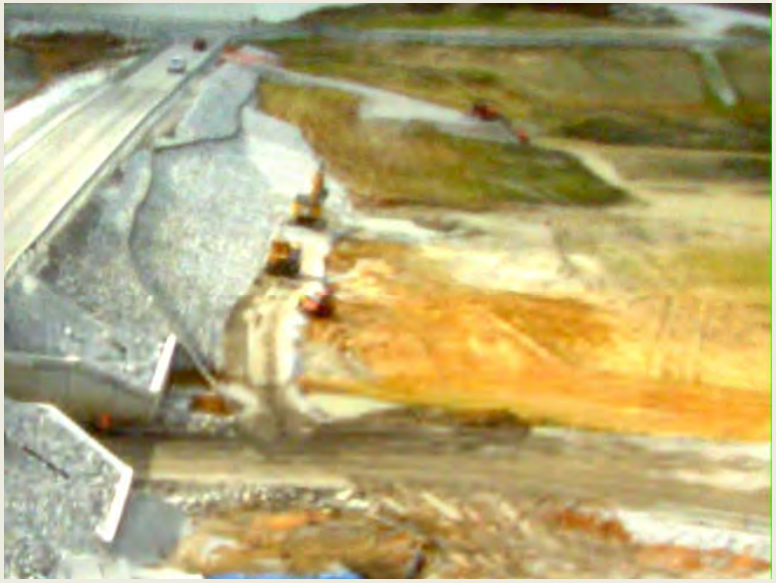
2011-11-30 Completed Filter and Pond
