**Adverse Environmental Impacts
Associated with Proposed Shady Oaks and Jagger
Branch Developments**

**Jagger Branch Embayment
Guntersville Lake
Alabama**

May 2007

**Mark A. Quarles, P.G.
(Tennessee No. 3834)**

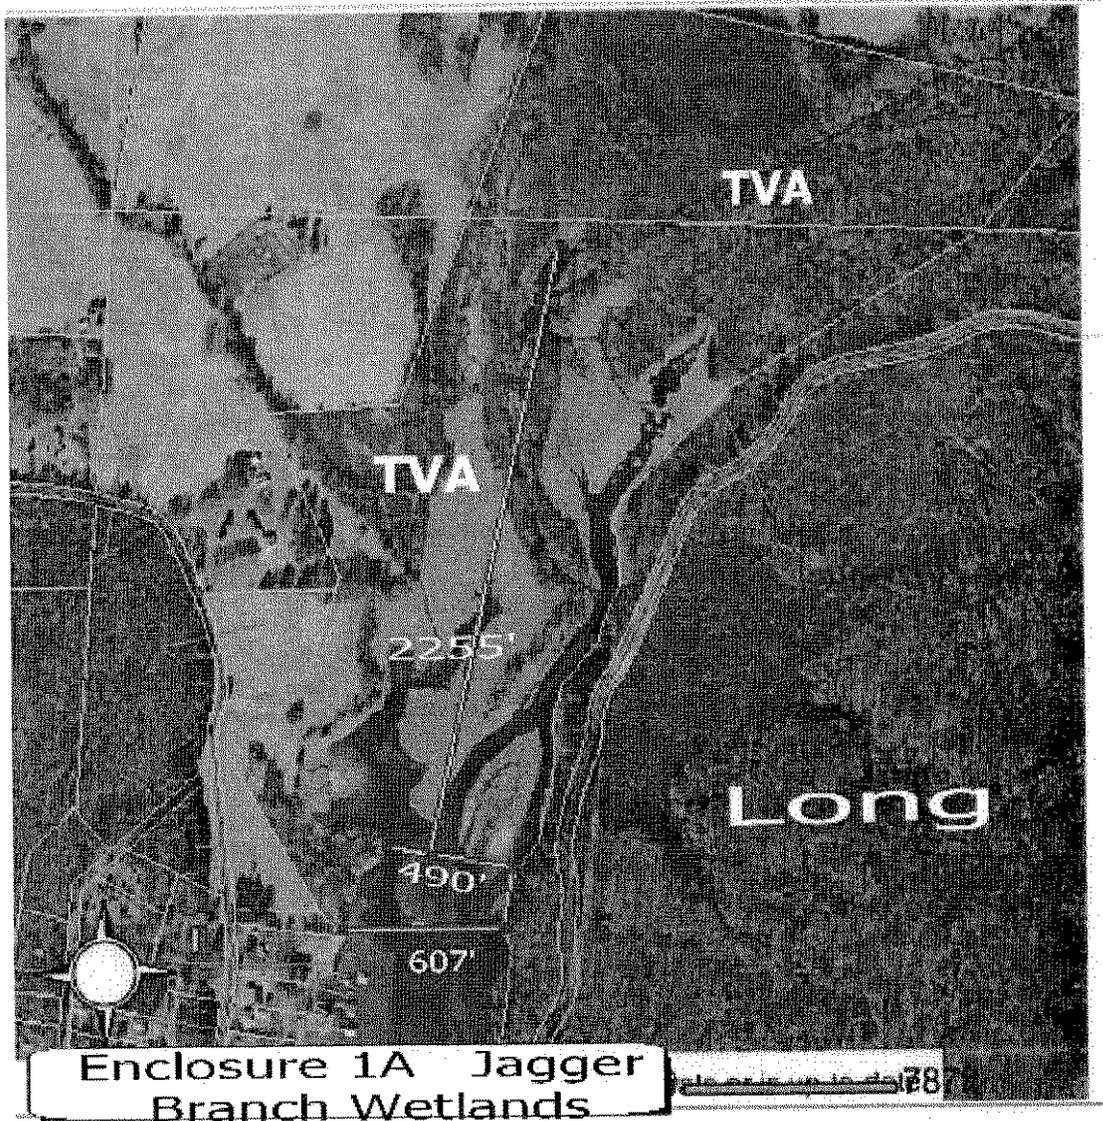
Figure 1
Recent Aerial Photo
Northern Jagger Branch Embayment

The permit applications submitted by both the Shady Oaks and Jagger Branch developers seem to have used out-dated topographic maps to illustrate where the docks will be located. The map that was used in the applications seems to have been based upon a 1983 United States Geologic Survey (USGS) topographic map made in 1983. Current aerial photography included in Figure 1 indicates that the wetted area of Jagger Branch embayment is now approximately 2,255 feet less than what was present in 1983. The proposed Jagger Branch development is situated at the southern most terminus of what is now an extension of the wetland that was designated in the land management plan as needing protection. Sediment deposition in the embayment has resulted in an approximate 26 percent reduction (43 acres) in bay aerial extent in less than 25 years. What was lost in usable acres of water to the northern extent of

Jagger Branch embayment has been gained in the creation of 43 more acres of protected sensitive resource area.
