Tennessee Valley Authority
Regulatory Submittal for Kingston Fossil Plant

Addendum to Construction of Lateral Expansion Facilities- Phase 1
Implementation of Phases 1& 2 Ash Processing Dredge Cell/ Settling Area

ADDENDUM TO CONSTRUCTION OF LATERAL EXPANSION FACILITIES-PHASE 1

Implementation of Phases 1 & 2 Ash Processing Dredge Cell/Settling Area

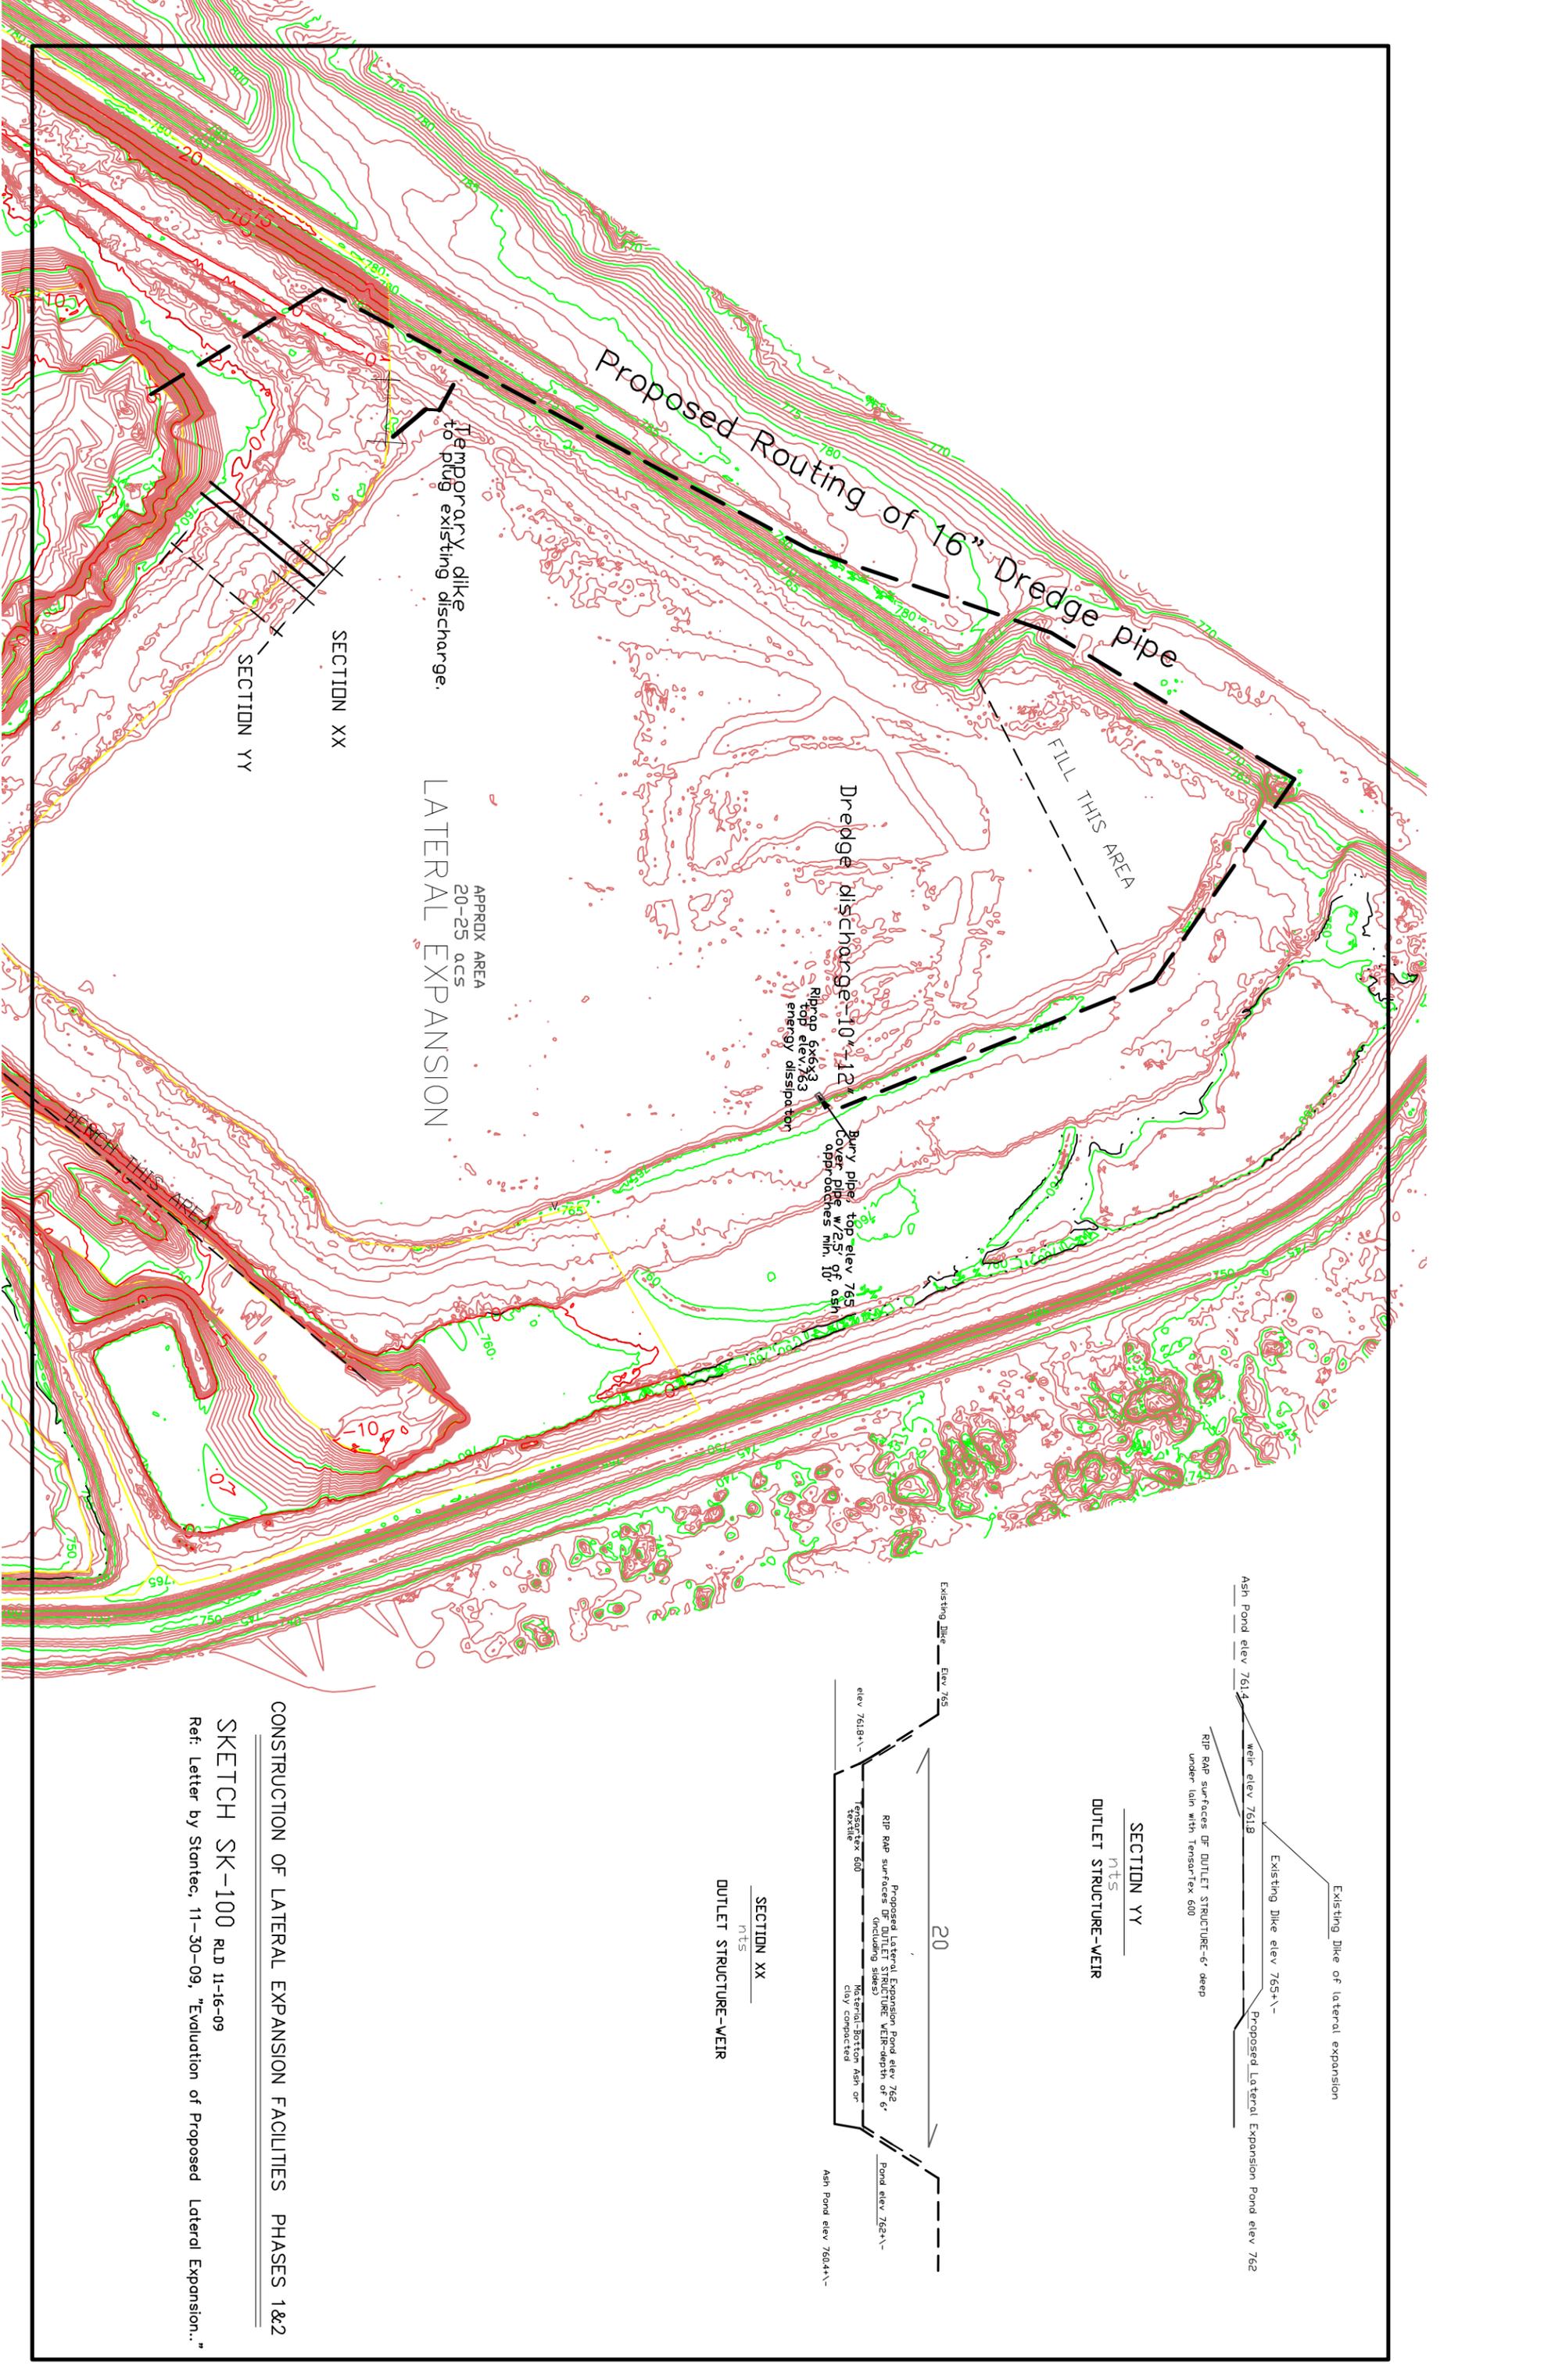
SKETCH SK-100 RLD 11-16-09

CONSTRUCTION OF LATERAL EXPANSION FACILITIES PHASES 1&2

The intake into the lateral expansion will be located near the north east corner to maximize the the detention time and will be directed into a riprap check dam to dissipate the energy and prevent scouring. The pipe will be held in place by covering with two feet of ash for approximately 25'. Note attached Sketch # SK-100 for the facilities noted above as well as the pipe routing from the ash pond to the lateral expansion
