Tennessee Valley Authority  
Regulatory Submittal for Kingston Fossil Plant

Addendum to Ash Stacking Height in Processing Area Work Plan R1  
Geosyntec concurrence with Work Plan and supporting documents

## **WORK PLAN**

### **ADDENDUM TO ASH STACKING HEIGHT in PROCESSING AREA WORK PLAN** (originally dated June 9, 2009)

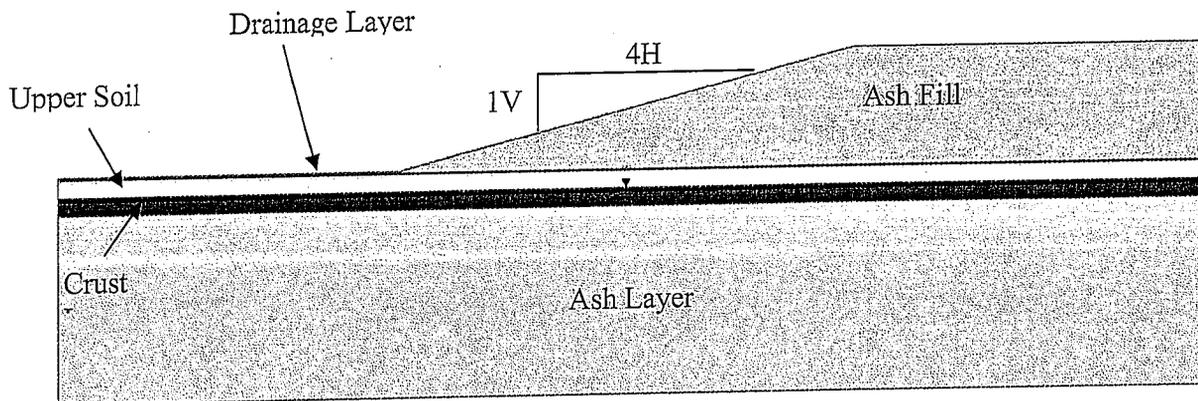
**Geometry:**

Material	Layer Thickness (ft)	Unit Weight (pcf)	Shear Strength
Ash Fill	30	100	$c=0, \phi = 25^\circ$
Drainage layer	1	135	$c=0, \phi = 35^\circ$
Upper Soil Layer	5	90	$c=0, \phi = 25^\circ$
Crust Layer	5	120	$c=500 \text{ psf}, \phi = 10^\circ$
Ash Layer	50	75	$c=0, \phi = 20^\circ$
Clayey Foundation Soil	20	100	$c=0, \phi = 28^\circ$

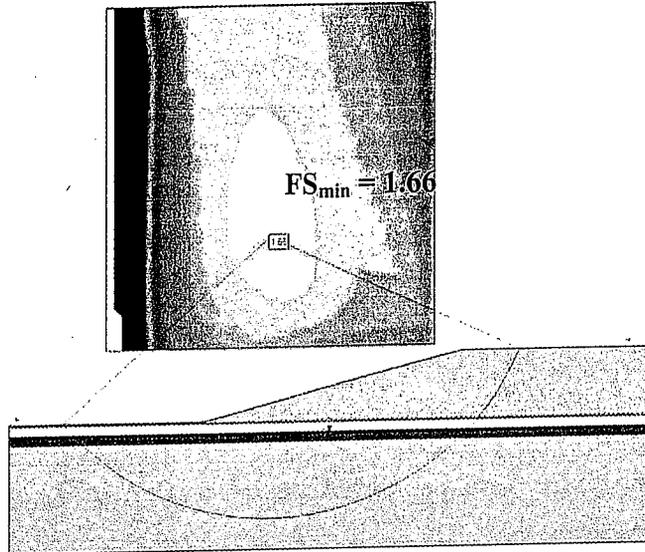
Results of Slope Stability Analysis (Circular Type Critical Surface).

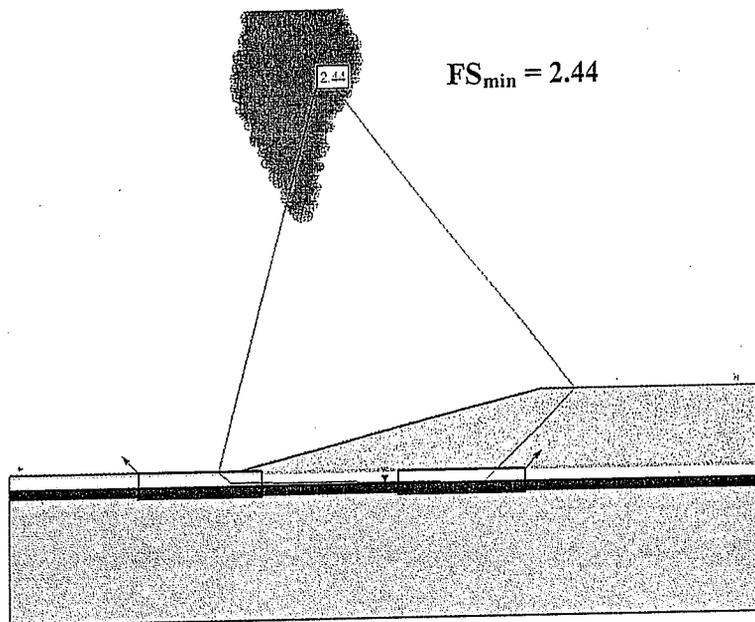
Results of Slope Stability Analysis (Block Type Critical Surface).

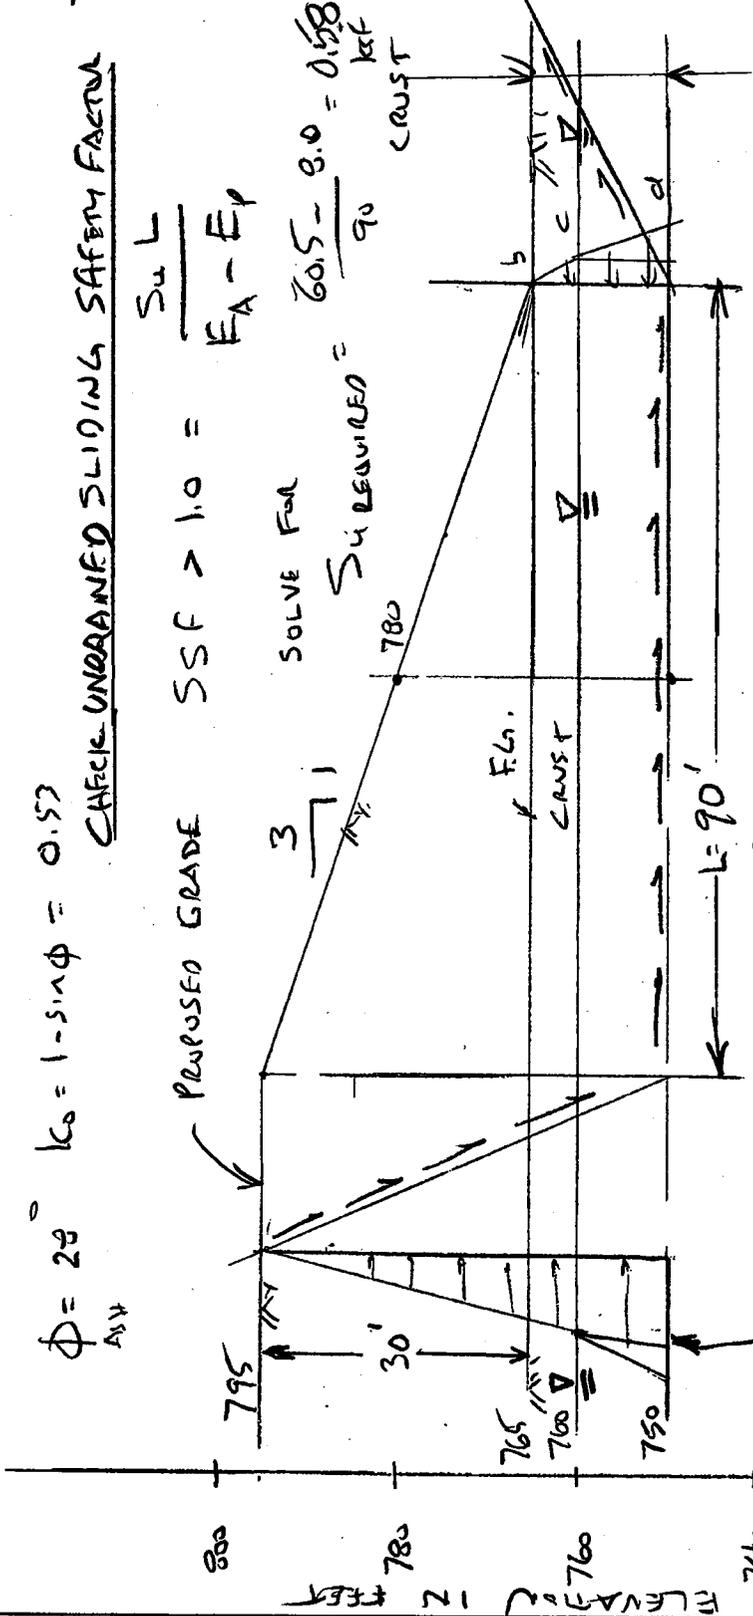
PROPOSED GRADE SSF > 1.0 =

SOLVE FOR  $S_u$  REQUIRED =  $\frac{60.5 - 8.0}{90} = 0.58$   $\frac{\text{ksf}}{\text{CRUST}}$

$\phi_{ASH} = 28^\circ$  DRAINED  
 $S_{us} = 100$  to  $300$  PSF (UNDRAINED)  
 STRAIN SOFTENING

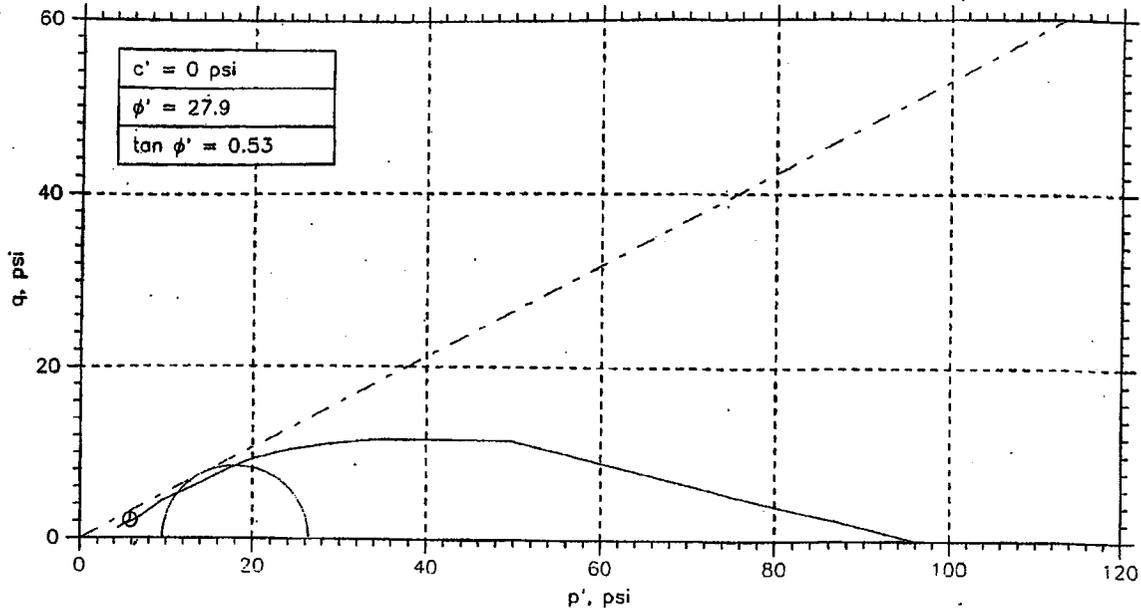
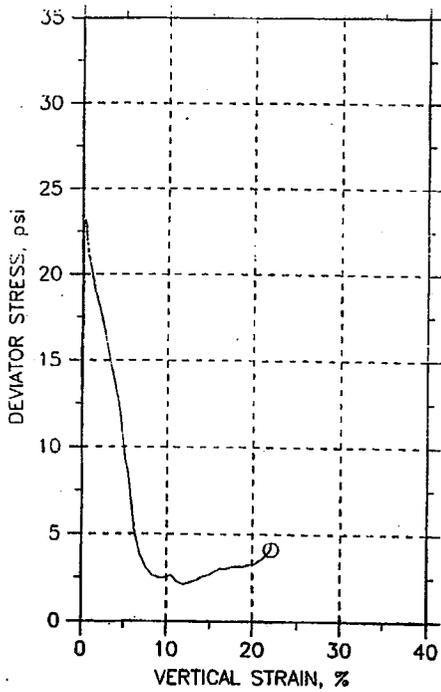
### TRIAxIAL COMPRESSION TEST REPORT

Symbol	⊙			
Test No.	57422008	12		
Initial	Diameter, mm	71.37		
	Height, mm	165.36		
	Water Content, %	70.21		
	Dry Density, pcf	63.73		
	Saturation, %	128.87		
	Void Ratio	1.2531		
Before Shear	Water Content, %	43.24		
	Dry Density, pcf	71.99		
	Saturation, %	100.00		
	Void Ratio	0.99452		
Back Press., psi	70			
Minor Prin. Stress, psi	96			
Max. Dev. Stress, psi	23.177			
Time to Failure, min	4.0005			
Strain Rate, %/min	0.15			
B-Value	---			
Estimated Specific Gravity	2.30			
Liquid Limit	NP			
Plastic Limit	NP			
Plasticity Index	NP			
Failure Sketch

Project: KINGSTON COAL TVA
Location: TN
Project No.: 60095742
Boring No.: 09-200 SE7
Sample Type: RECONST
Description: COAL ASH - DARK GRAY SPECIMEN RECONSTITUTED BY DRAINED SLURRY TECHNIQUE (B=0.99)
Remarks: FAILURE CRITERIA = MAXIMUM EFFECTIVE STRESS RATIO TEST PERFORMED AS PER ASTM D 4767

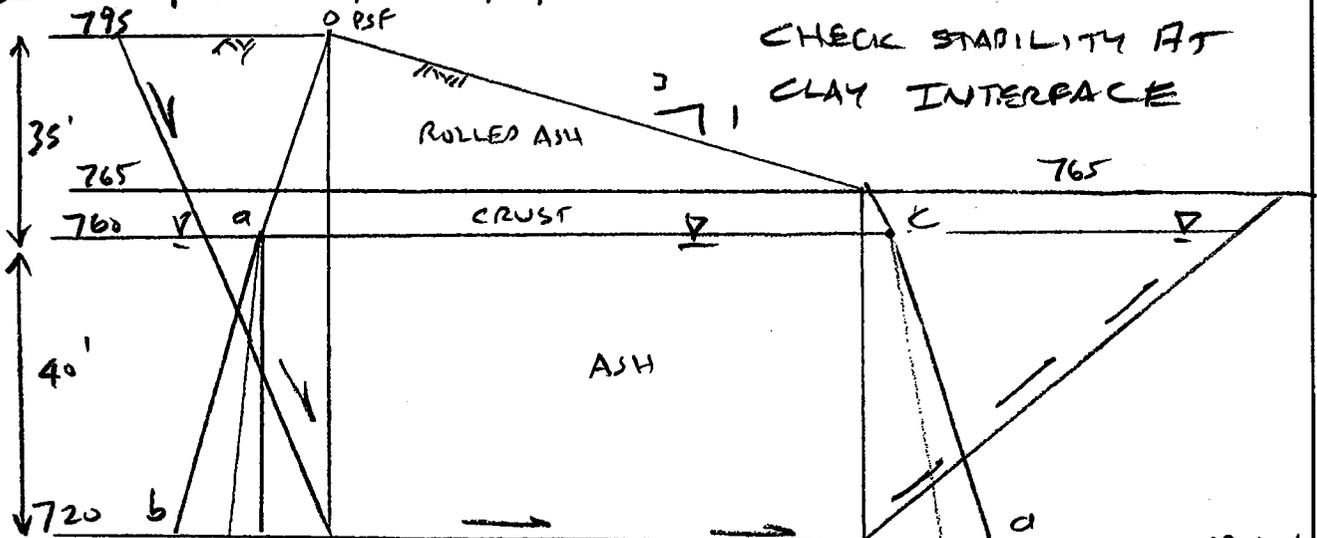
Project KINGSTON				Subject TEMPORARY STORAGE AT BALL FIELD		
Originated By CWH	Date 4/4/09	Checked By LWB	Date 4/04/9	STS Job No. 60095742	Scale NTS	Sheet No. 5 of 5

$\phi = 28$   
 $k_0^{ASH} = 1 - \sin \phi = 0.53$   
 $L = 90'$   
 CLAY \* 09.604  
 $S_u = 500 \text{ to } 3,525 \text{ pcf}$   
 C<sub>89-402</sub>

$P_a = 2.04 \text{ ksf/ft}$   
 $P_b = 2.04 + (0.11 - 0.0624) \cdot 0.53 \cdot (40) + 40 \cdot (0.0624)$   
 $P_b = 5.55 \text{ ksf/ft}$   
 $P_c = 0.29 \text{ ksf/ft}$   
 $P_d = 0.29 + 1.01 + 2.50$   
 $P_d = 3.80 \text{ ksf/ft}$

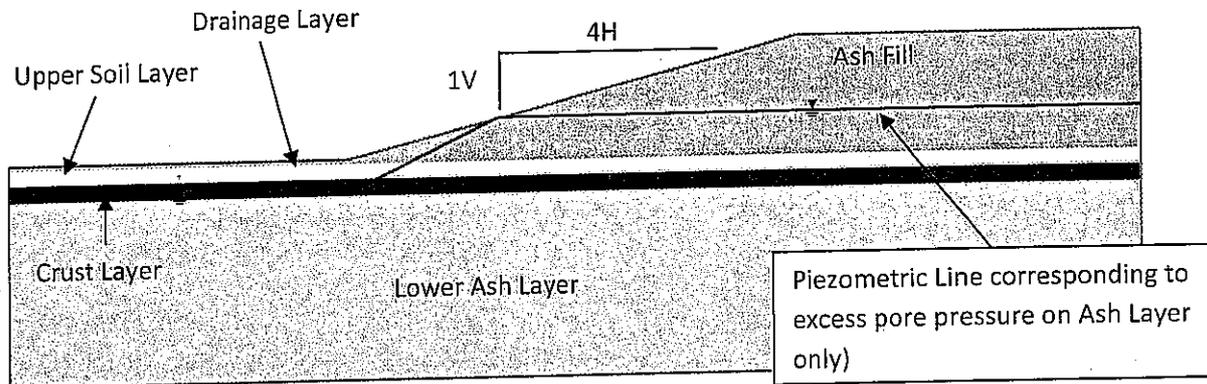
#### Geometry:

Material	Layer Thickness (ft)	Unit Weight (pcf)	Shear Strength
Ash Fill	30	100	$c=0, \phi = 25^\circ$
Drainage layer	1	135	$c=0, \phi = 35^\circ$
Upper Soil Layer	5	90	$c=0, \phi = 25^\circ$
Crust Layer	5	120	$c=500 \text{ psf}, \phi = 10^\circ$
Ash Layer	50	75	$c=0, \phi = 20^\circ$
Clayey Foundation Soil	20	100	$c=0, \phi = 28^\circ$

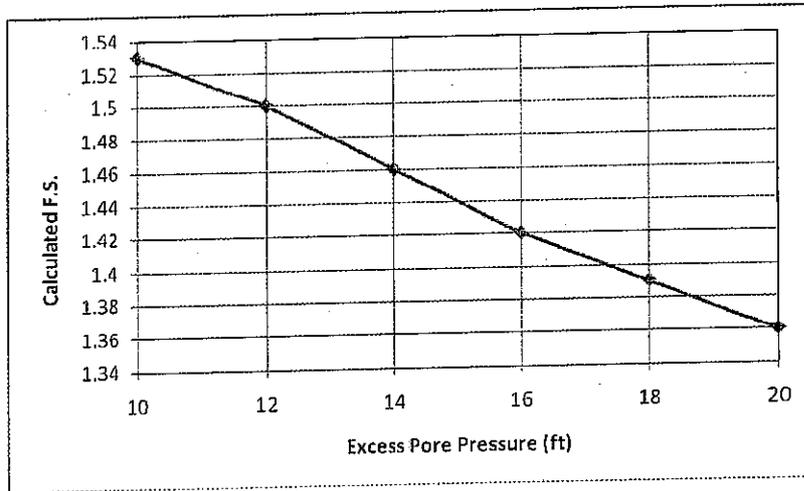
Summary of Results

Excess Pore Pressure in the Lower Ash (ft)	Excess Pore Pressure Ratio	Calculated FS
10	0.21	1.53
12	0.25	1.50
14	0.29	1.46
16	0.33	1.42
18	0.37	1.39
20	0.42	1.36

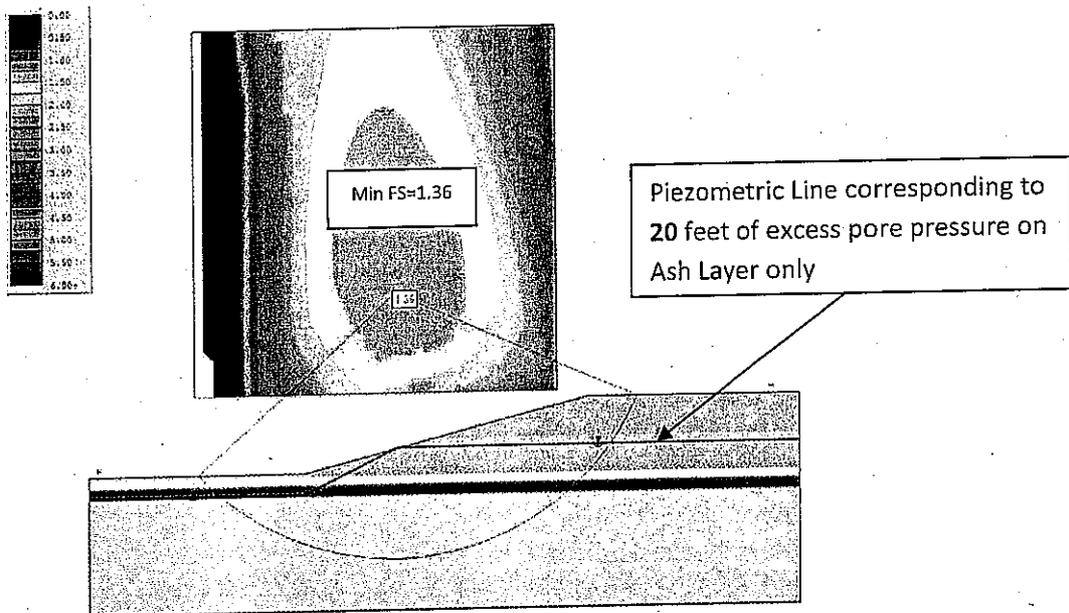
Graphic Result for an Example Case (Excess Pore Pressure in the Lower Ash = 20 feet)

Input file for the Example Case(Excess Pore Pressure in the Lower Ash = 20 feet)

<p><b><u>Document Name</u></b></p> <p>File Name: 4H to 1V 20' excess pp.sli</p> <p><b><u>Project Settings</u></b></p> <p>Project Title: TVA Kingston Ball Field - Case No.8          Failure Direction: Right to Left          Units of Measurement: Imperial Units          Pore Fluid Unit Weight: 62.4 lb/ft3          Groundwater Method: Water Surfaces          Data Output: Standard          Calculate Excess Pore Pressure: Off          Allow Ru with Water Surfaces or Grids: Off          Random Numbers: Pseudo-random Seed          Random Number Seed: 10116          Random Number Generation Method: Park and Miller v.3</p> <p><b><u>Analysis Methods</u></b></p> <p>Analysis Methods used:          Spencer</p> <p>Number of slices: 25          Tolerance: 0.005          Maximum number of iterations: 50</p> <p><b><u>Surface Options</u></b></p> <p>Surface Type: Circular          Search Method: Grid Search          Radius increment: 10          Composite Surfaces: Disabled          Reverse Curvature: Create Tension Crack          Minimum Elevation: Not Defined          Minimum Depth: 3</p> <p><b><u>Material Properties</u></b></p> <p><b><u>Material: Upper Soil Layer</u></b>          Strength Type: Mohr-Coulomb          Unit Weight: 90 lb/ft3          Cohesion: 0 psf          Friction Angle: 25 degrees          Water Surface: None</p> <p><b><u>Material: Ash Layer (Consolidated)</u></b>          Strength Type: Mohr-Coulomb          Unit Weight: 75 lb/ft3          Cohesion: 0 psf          Friction Angle: 20 degrees          Water Surface: Piezometric Line 1</p>	<p>Custom Hu value: 1</p> <p><b><u>Material: Ash Fill</u></b>          Strength Type: Mohr-Coulomb          Unit Weight: 100 lb/ft3          Cohesion: 0 psf          Friction Angle: 25 degrees          Water Surface: None</p> <p><b><u>Material: Gravel Layer</u></b>          Strength Type: Mohr-Coulomb          Unit Weight: 130 lb/ft3          Cohesion: 0 psf          Friction Angle: 35 degrees          Water Surface: None</p> <p><b><u>Material: Crust</u></b>          Strength Type: Mohr-Coulomb          Unit Weight: 120 lb/ft3          Cohesion: 500 psf          Friction Angle: 10 degrees          Water Surface: None</p> <p><b><u>List of All Coordinates</u></b></p> <p><b><u>Material Boundary</u></b></p> <table border="0"> <tr><td>0.000</td><td>758.000</td></tr> <tr><td>300.000</td><td>758.000</td></tr> </table> <p><b><u>Material Boundary</u></b></p> <table border="0"> <tr><td>90.000</td><td>768.000</td></tr> <tr><td>300.000</td><td>768.000</td></tr> </table> <p><b><u>Material Boundary</u></b></p> <table border="0"> <tr><td>0.000</td><td>767.000</td></tr> <tr><td>300.000</td><td>767.000</td></tr> </table> <p><b><u>Material Boundary</u></b></p> <table border="0"> <tr><td>0.000</td><td>763.000</td></tr> <tr><td>300.000</td><td>763.000</td></tr> </table> <p><b><u>External Boundary</u></b></p> <table border="0"> <tr><td>90.000</td><td>768.000</td></tr> <tr><td>0.000</td><td>768.000</td></tr> <tr><td>0.000</td><td>767.000</td></tr> <tr><td>0.000</td><td>763.000</td></tr> <tr><td>0.000</td><td>758.000</td></tr> <tr><td>0.000</td><td>710.000</td></tr> <tr><td>300.000</td><td>710.000</td></tr> <tr><td>300.000</td><td>758.000</td></tr> <tr><td>300.000</td><td>763.000</td></tr> <tr><td>300.000</td><td>767.000</td></tr> <tr><td>300.000</td><td>768.000</td></tr> </table>	0.000	758.000	300.000	758.000	90.000	768.000	300.000	768.000	0.000	767.000	300.000	767.000	0.000	763.000	300.000	763.000	90.000	768.000	0.000	768.000	0.000	767.000	0.000	763.000	0.000	758.000	0.000	710.000	300.000	710.000	300.000	758.000	300.000	763.000	300.000	767.000	300.000	768.000
